Landscaping Publication Report

SWR0090

Locality: Willinge Drive Estuary Drive Rotary Landscaping 2018

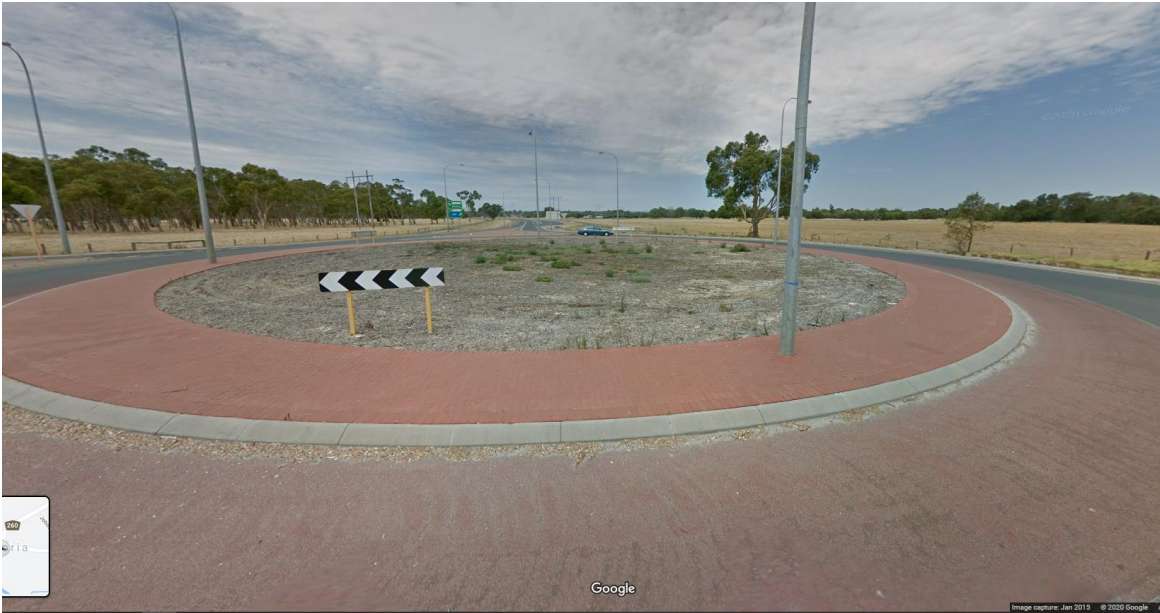
Figure 1. Post construction 2017

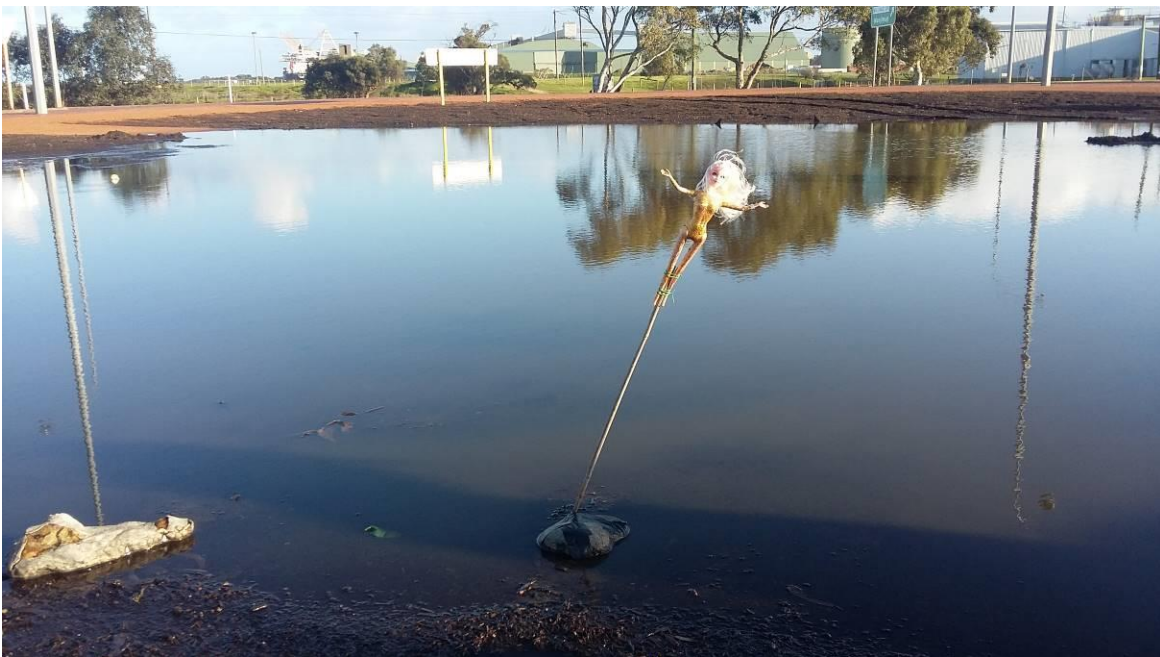
Construction of a roundabout on Willinge Drive/ Estuary Drive was completed in 2016. In the preceding winter, the centre of the roundabout became flooded due to poor drainage material used in the centre island.

Figure 2. Winter 2017 – Significant rainfall and poor draining soils resulted in the centre island becoming waterlogged.

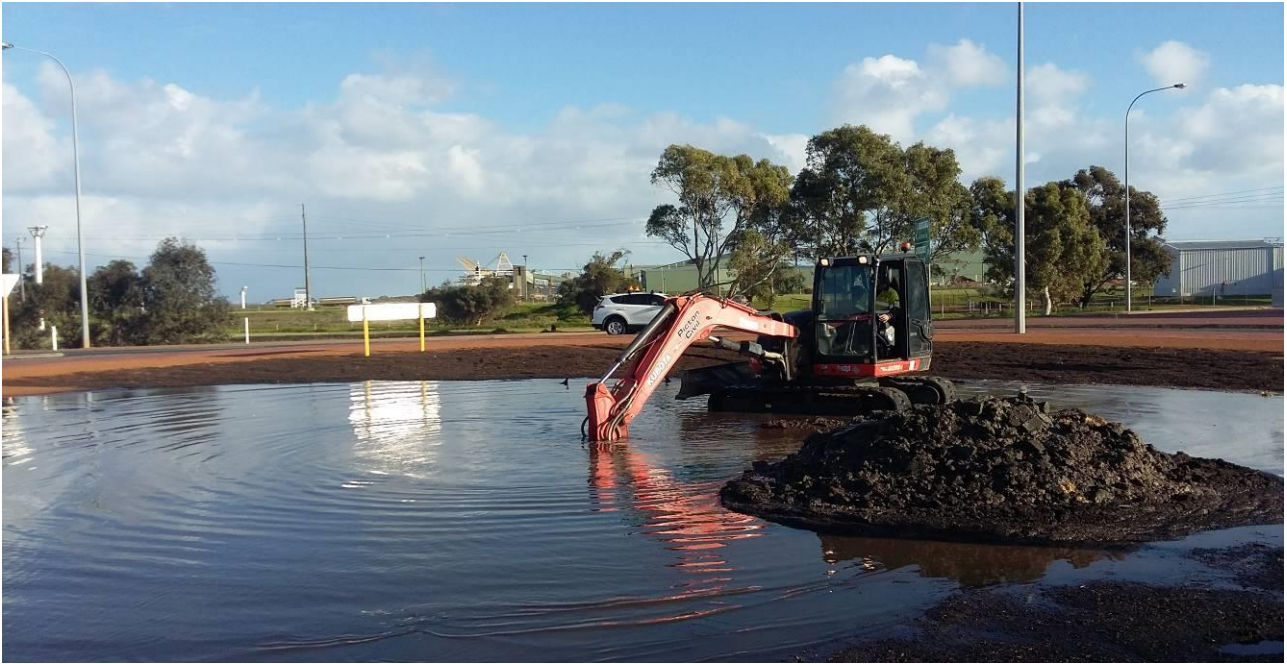
Figure 3. Excavator used to install a soakwell in the low point of the roundabout

A sump was placed in the centre islands and a directional drill used to install a drainage pipe. The Leschenault Community Nursery supplied plants for the project while the Activ Foundation installed planted the centre island.

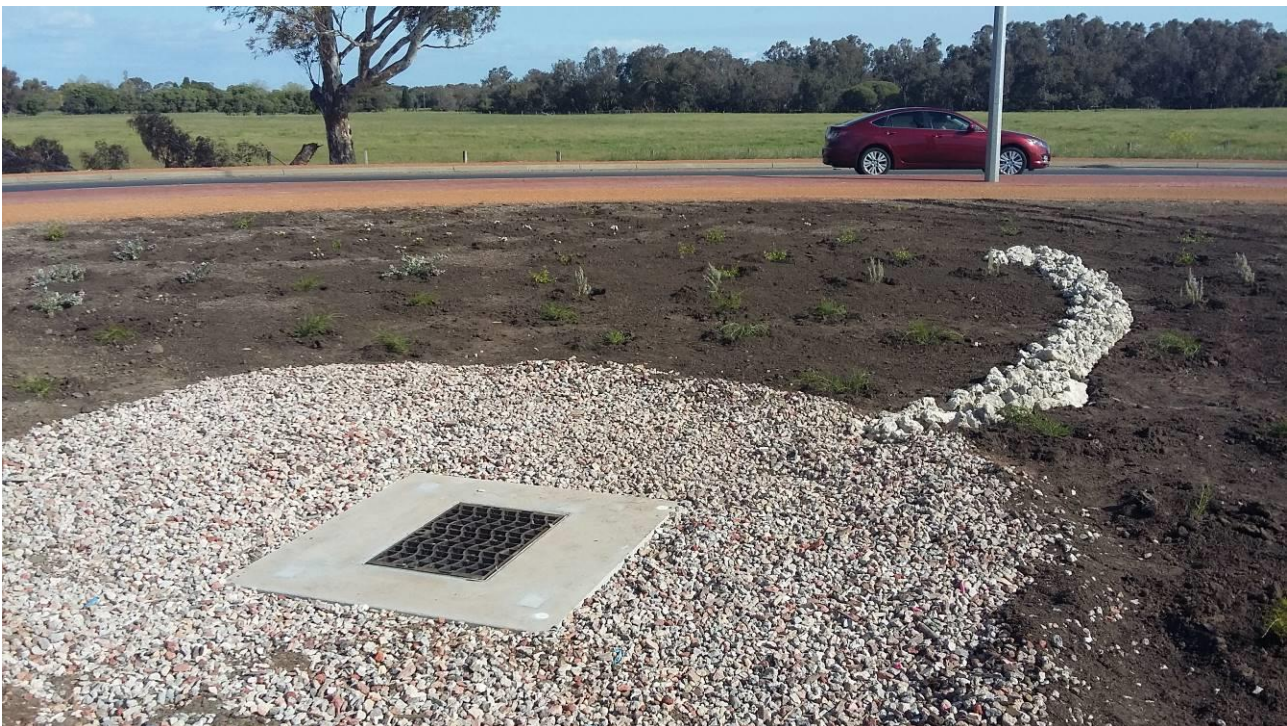
Figure 4. Sump installed with slotted drainage and rock pitching

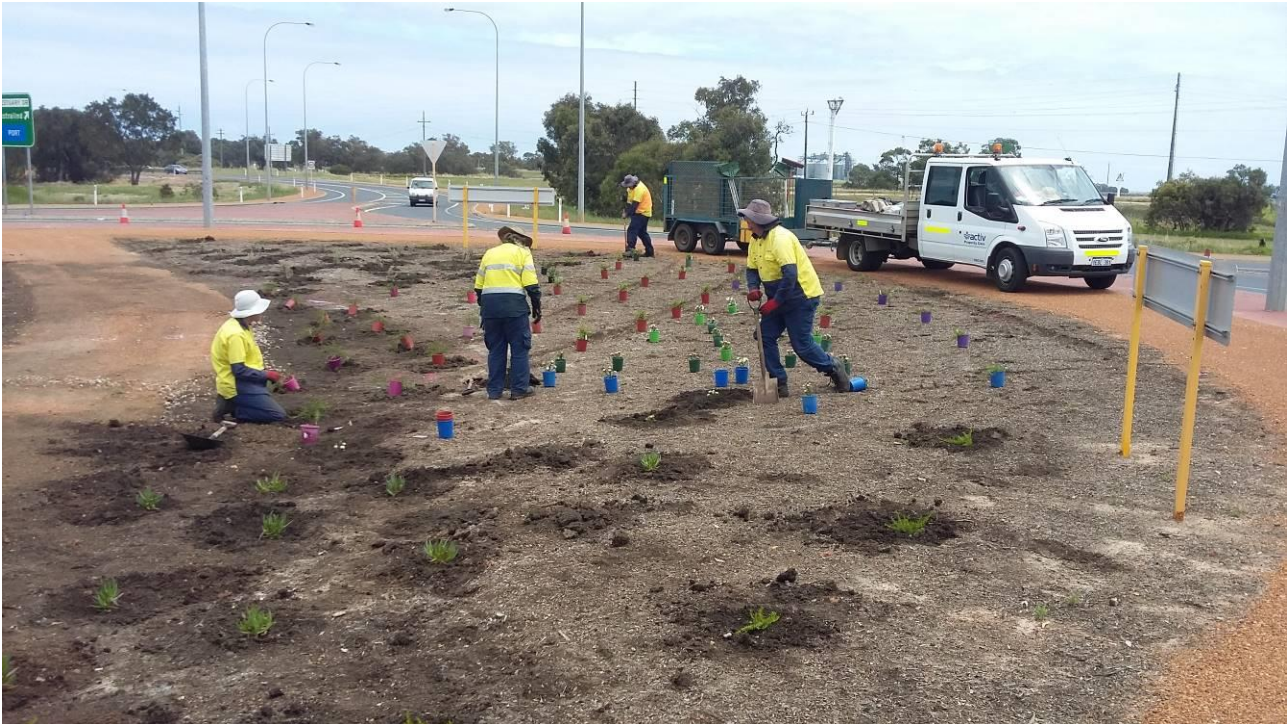
Figure 5. Activ Foundation planting seedlings Winter 2017

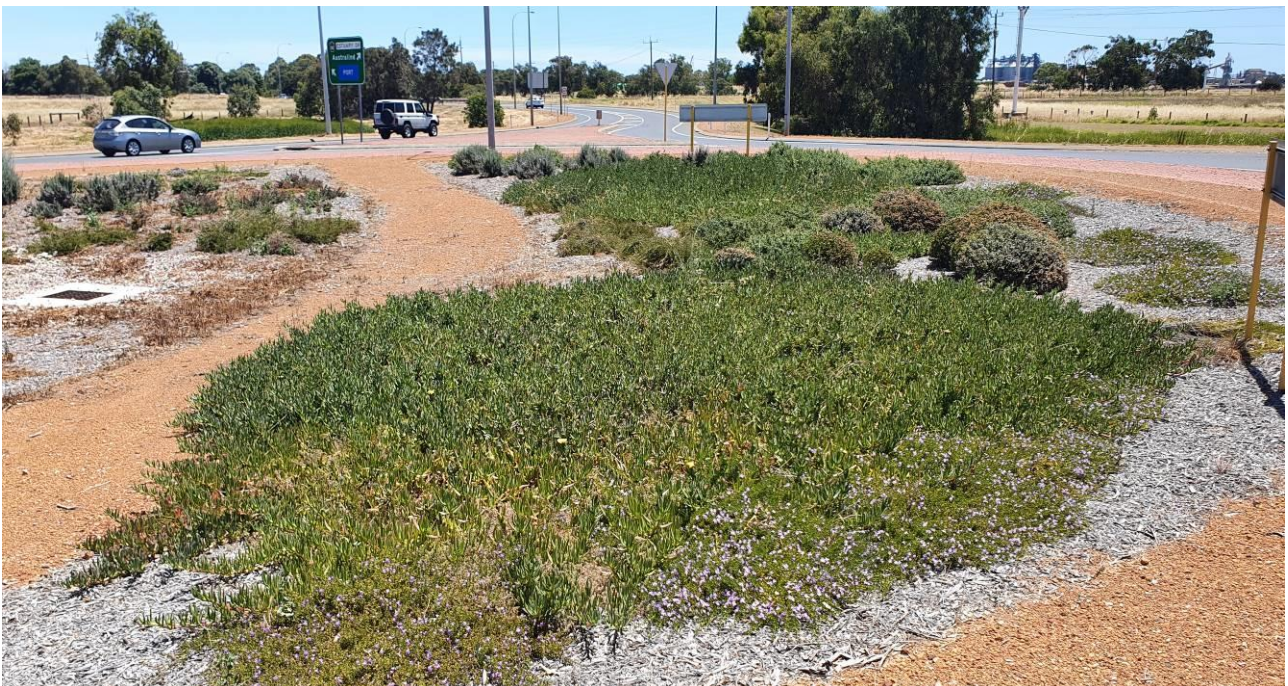
Figure 6. Completed Landscaping 2020

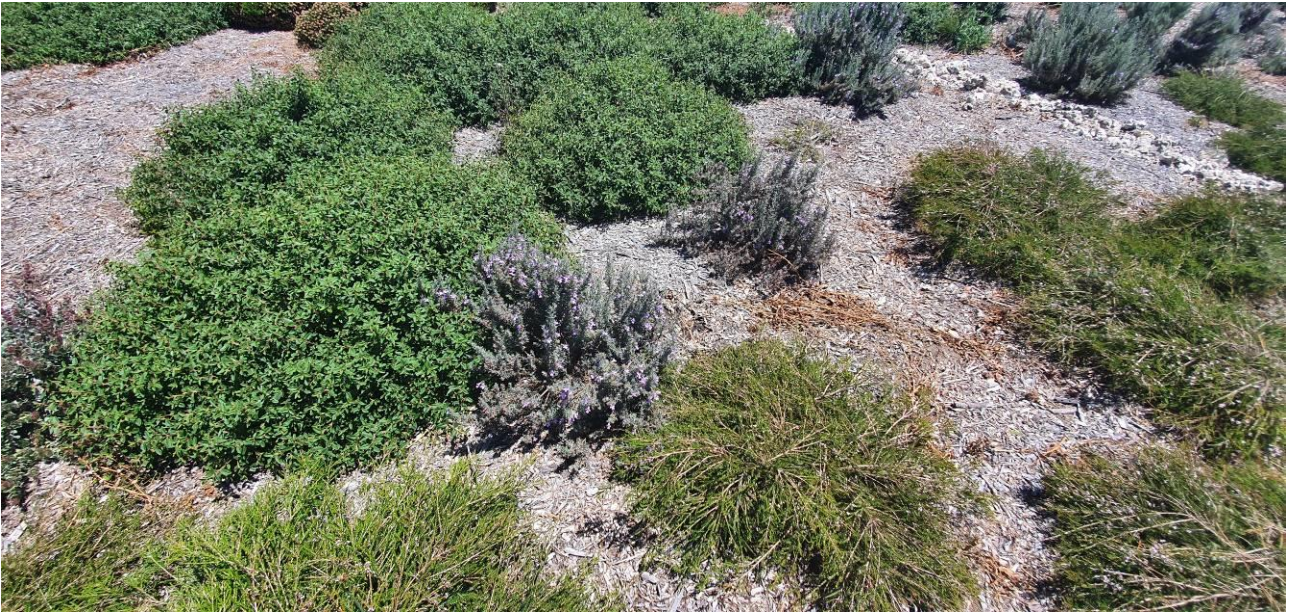
Figure 7. Plants growth 2020.
