A Report on the Archaeological Assessment of the Forestry Department's Divisional Headquarters

Prepared for Main Roads Western Australia on behalf of
Amergin Consulting (Australia), TPG: Town Planning,
Urban Design and Heritage Pty Ltd,
Coffey Environments Pty Ltd and BG&E Pty Ltd

February 2015

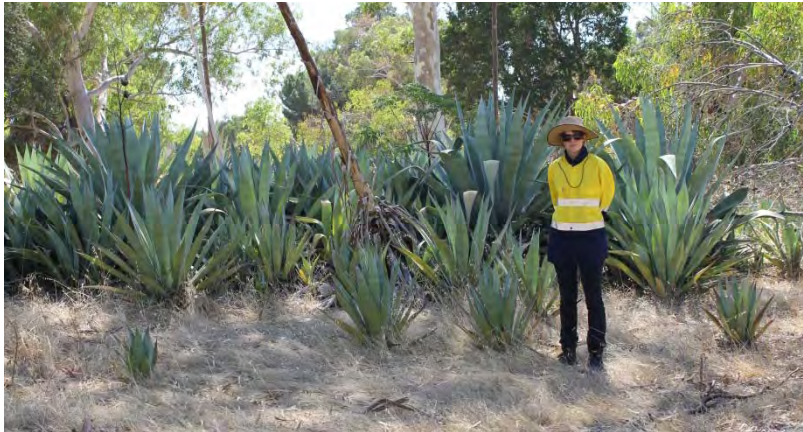
Location:
400173 mE 6483961 mN

Photo 1: *Agave* spp. is a dominant introduced vegetation associated with the Forestry Department Divisional Headquarters – with Susannah Kendall.

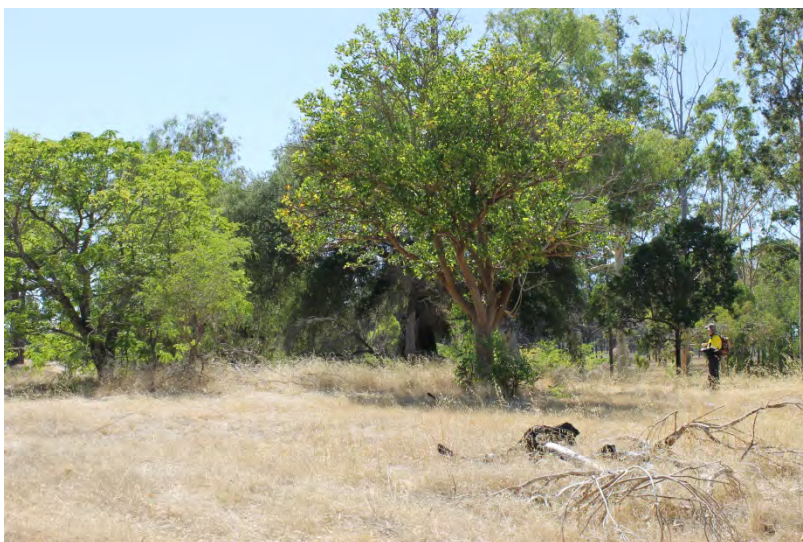
Location:
400182 mE 6483982 mN

Photo 2: View south-east of vegetation profile with Darren Cooper.

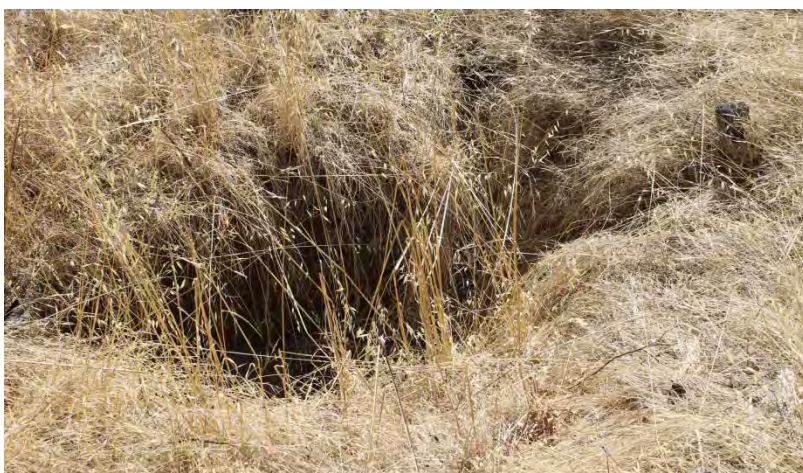
Location:
400143 mE 6483918 mN

Photo 3: Grass coverage limits ground surface visibility across most areas. This is an exposed septic tank.

The survey team also identified numerous potential hazards such as asbestos fencing and open septic tanks throughout the survey area. Care should be taken by all site-workers to ensure workplace safety.

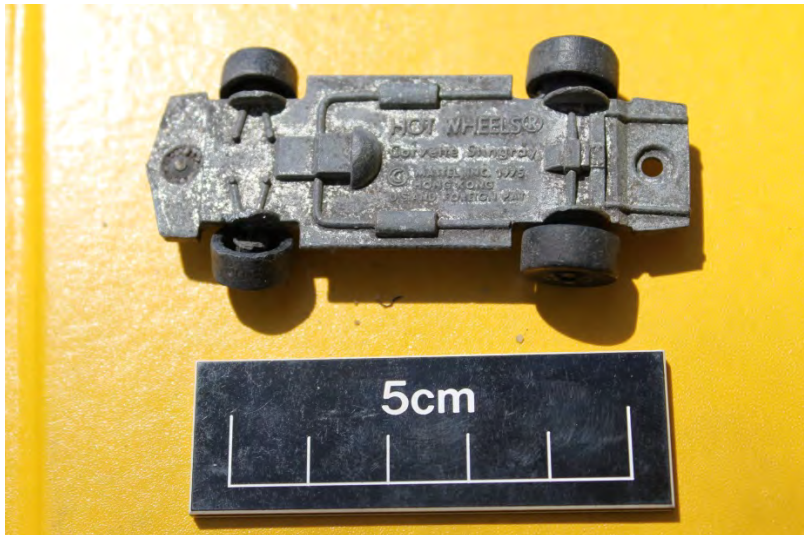
Location:
400374 mE 6484309 mN

All of the assemblage was observed to be from the post-war period. Very few items could be segregated based on gender, age or origin except for the occasional child's toy (for example Photo 5) and a patterned ceramic egg-cup (Photo 6). These few items were identified in the northern parts of the study area near what appears to be residential buildings.

Photo 5: A 'Hot Wheels' car base manufactured in 1970.

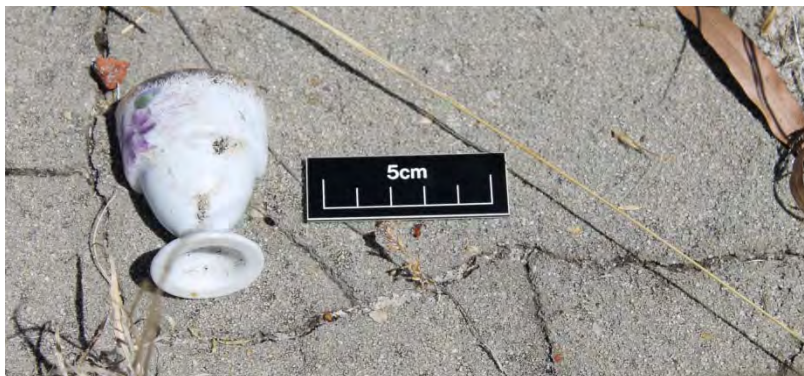
Location:
00398 mE 6484323 mN

Photo 6: An ornate patterned ceramic egg cup.

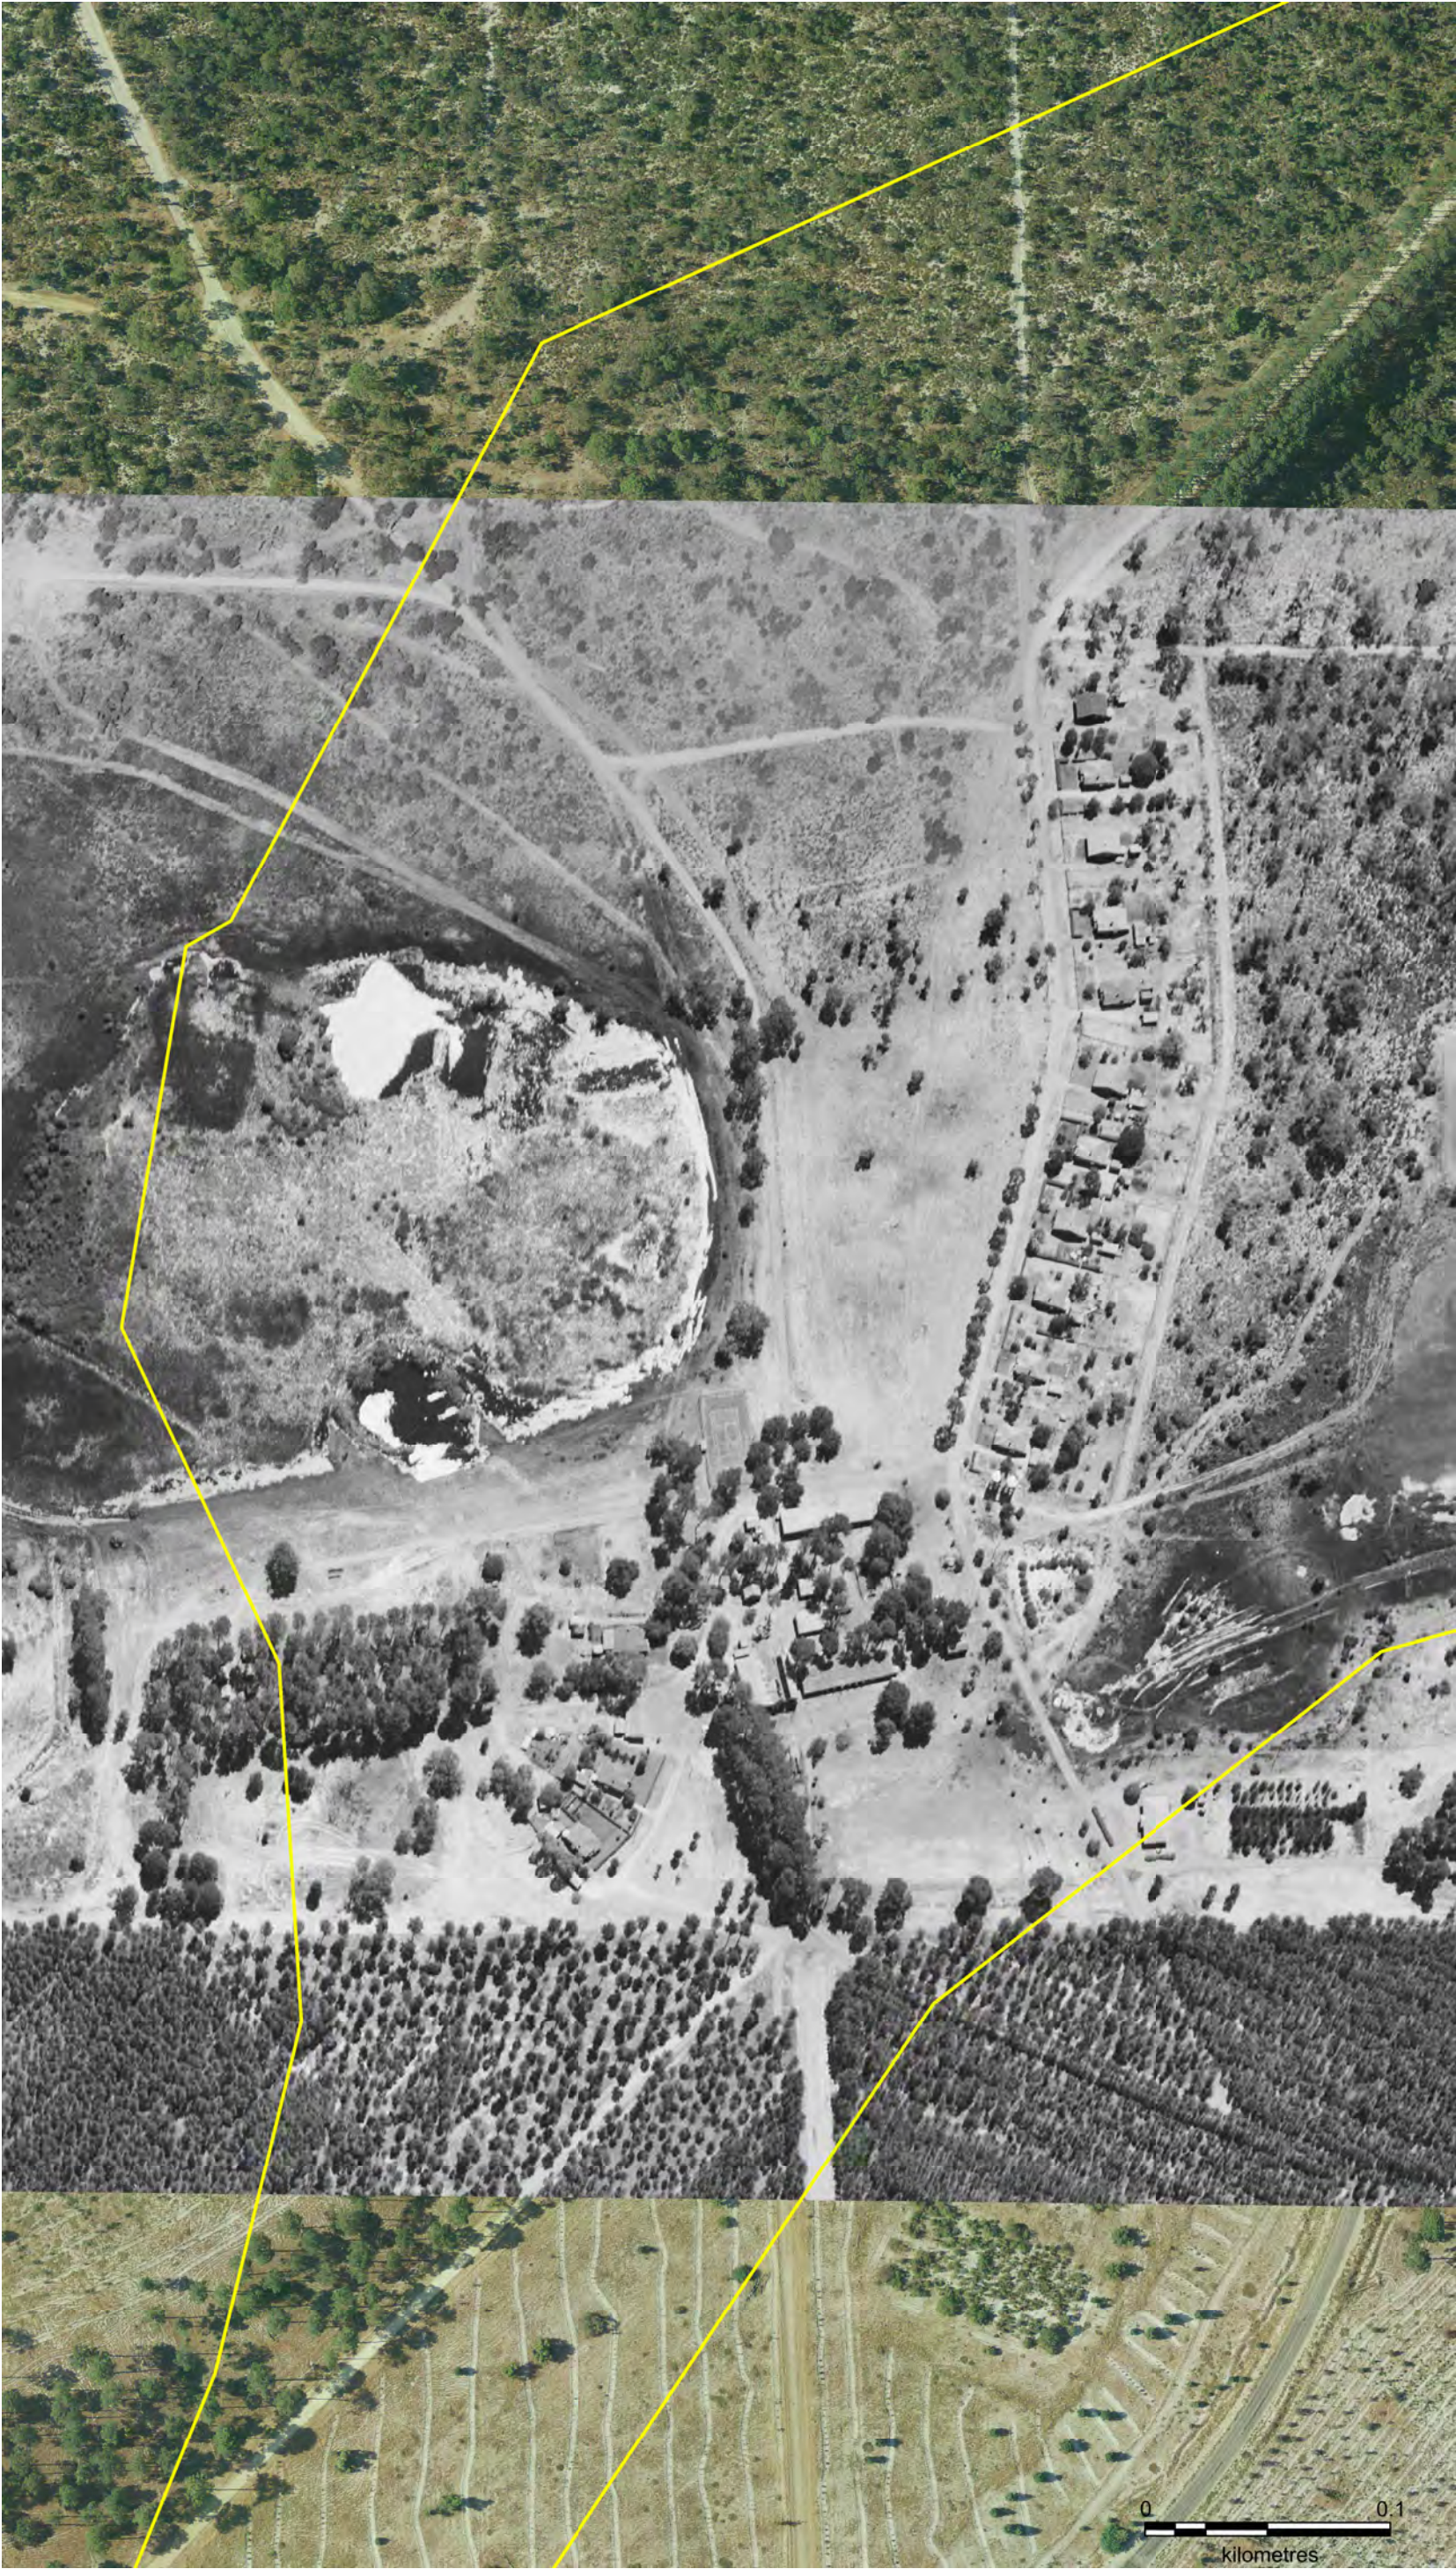
FIGURE 2:
Landgate
imagery from
1965 imposed
over current
aerial
photography

As the need for on-site workers declined, the Tender Board sold many of the houses which were removed from the property. Aerial photographic evidence from 1983 shows many buildings were still present; by 1995 they were gone (Figure 2).

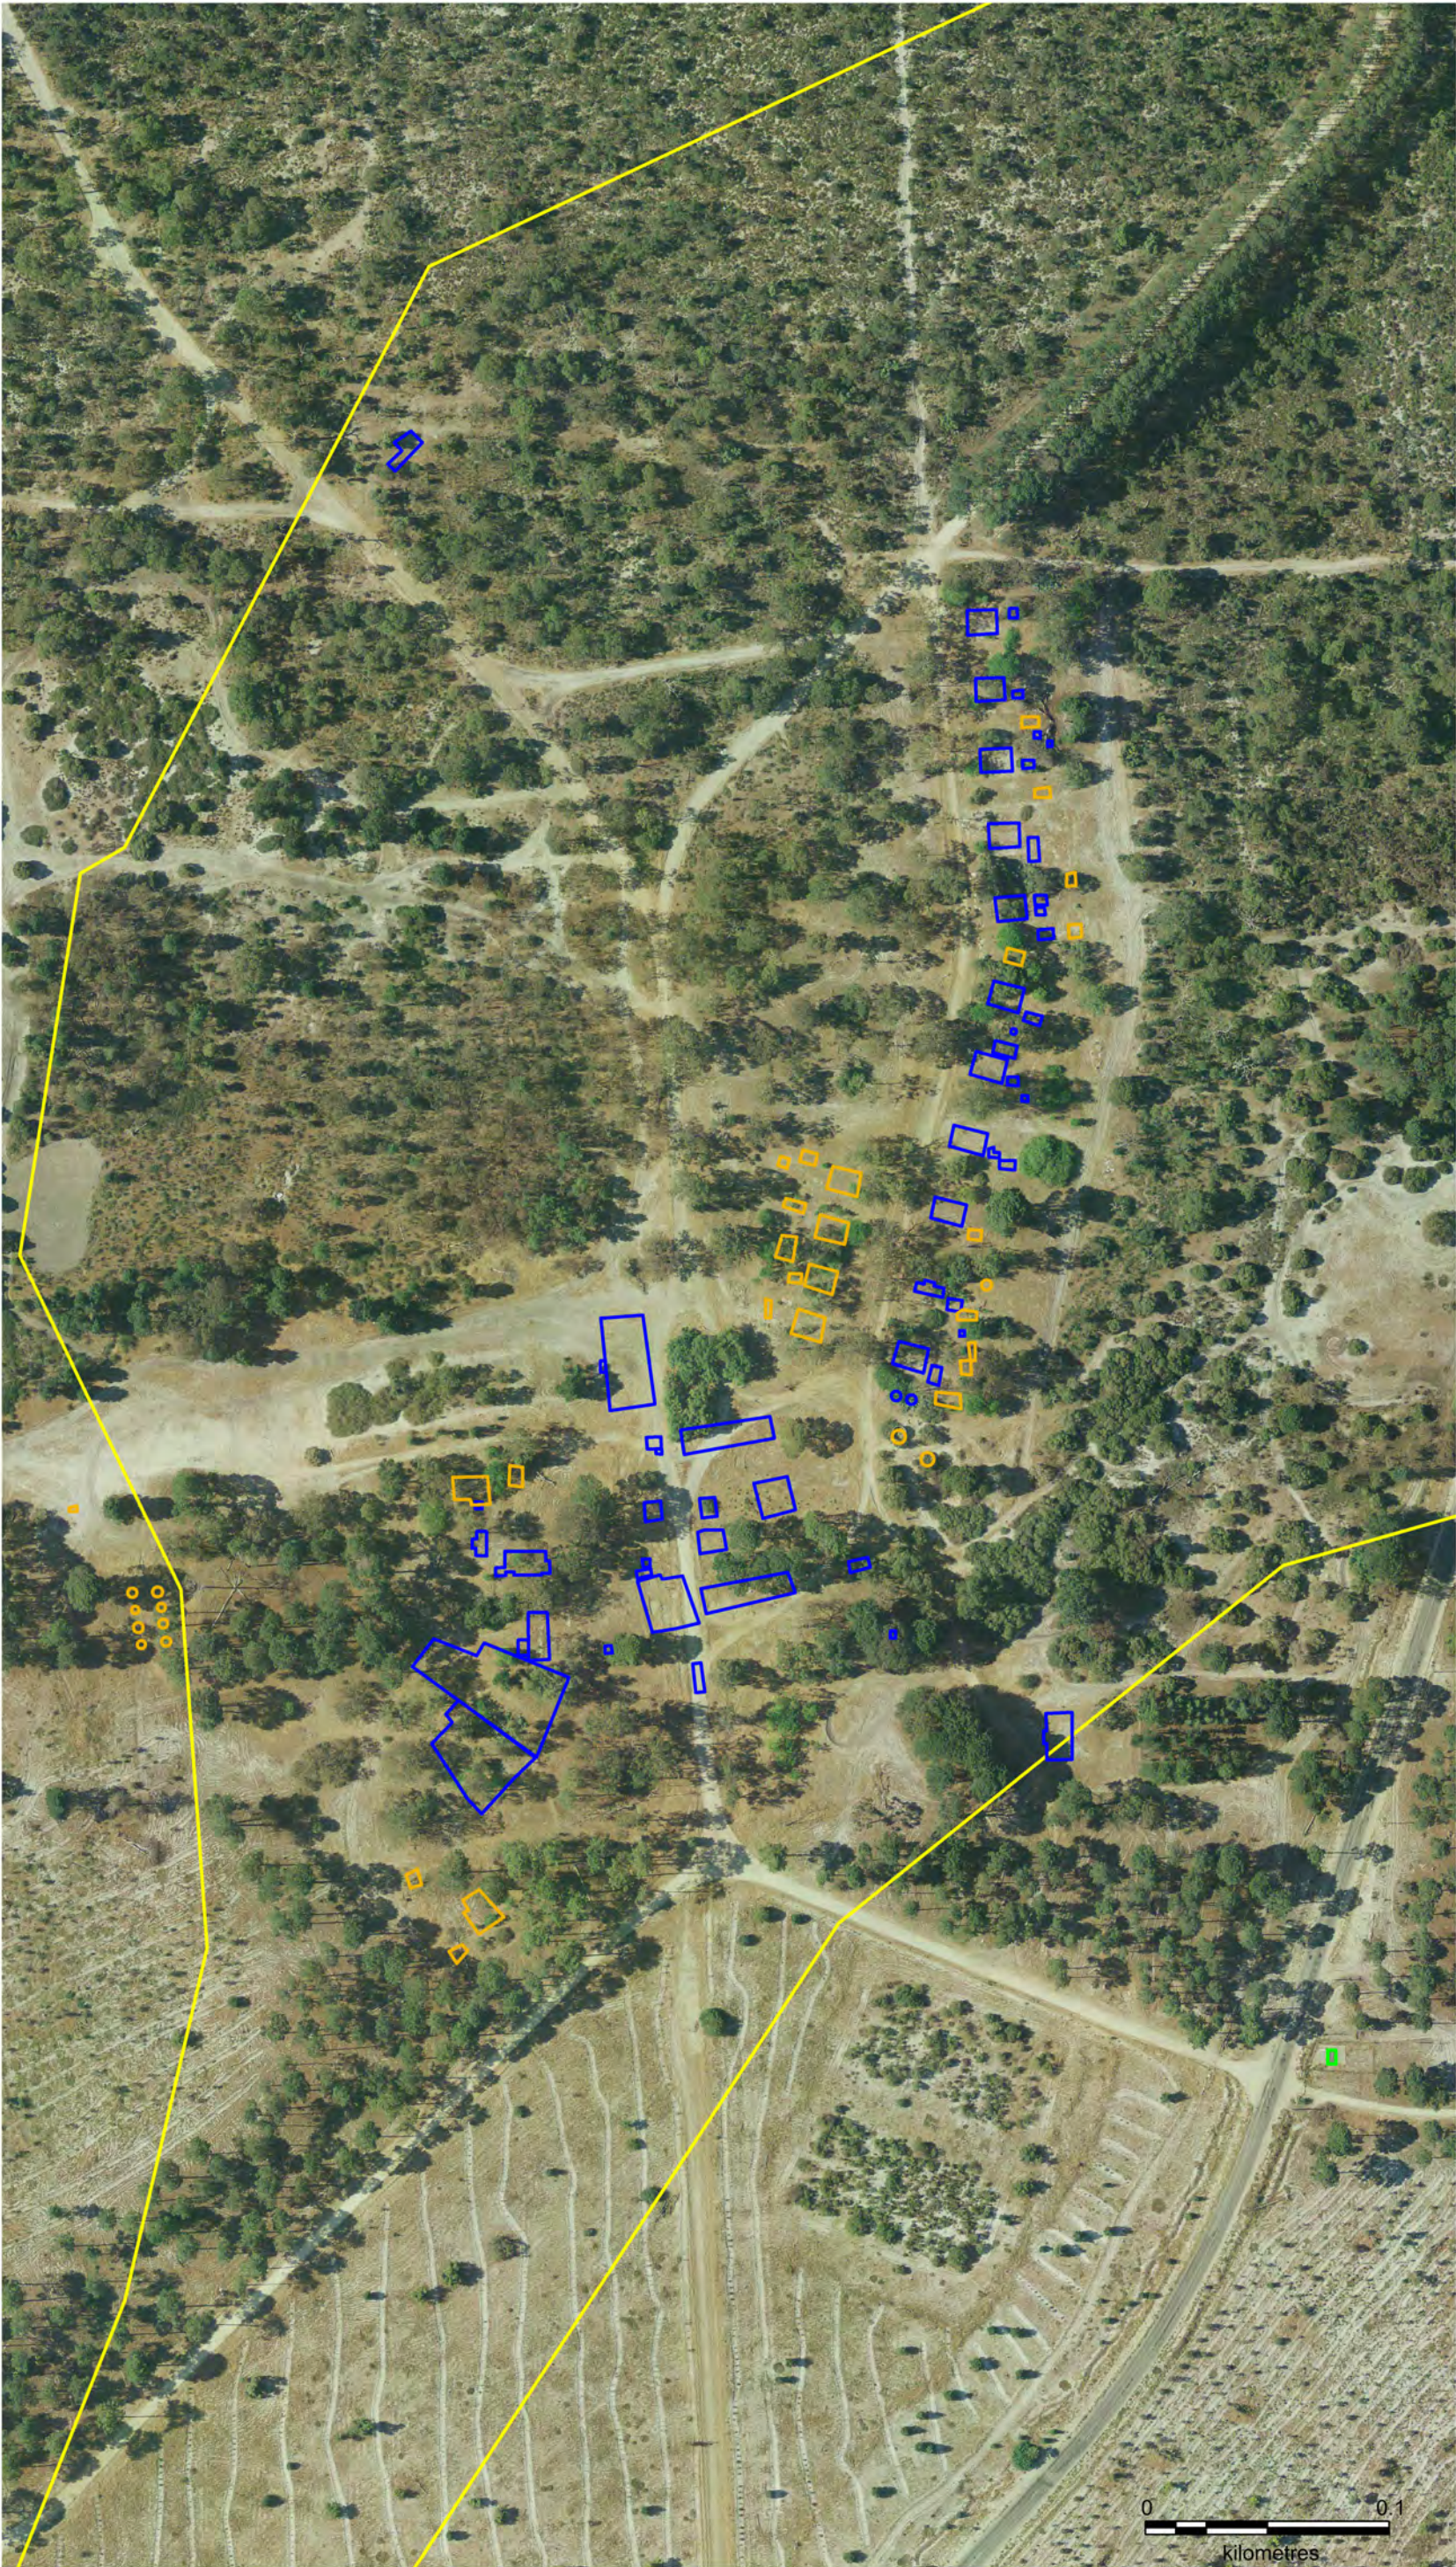
FIGURE 5:
Structures
identified as a
result of
Aerial Imagery
review

A total of 86 structures were identified during the inspection of Landgate aerial photography. The quality and geo-referencing of the imagery was generally problematic, so the locations of the structures are indicative only. A total of 58 were in place prior to 1965 with 28 being constructed between 1965 and 1983. It should be noted that these numbers are figurative only as tree canopy cover or similar may have obscured smaller buildings.

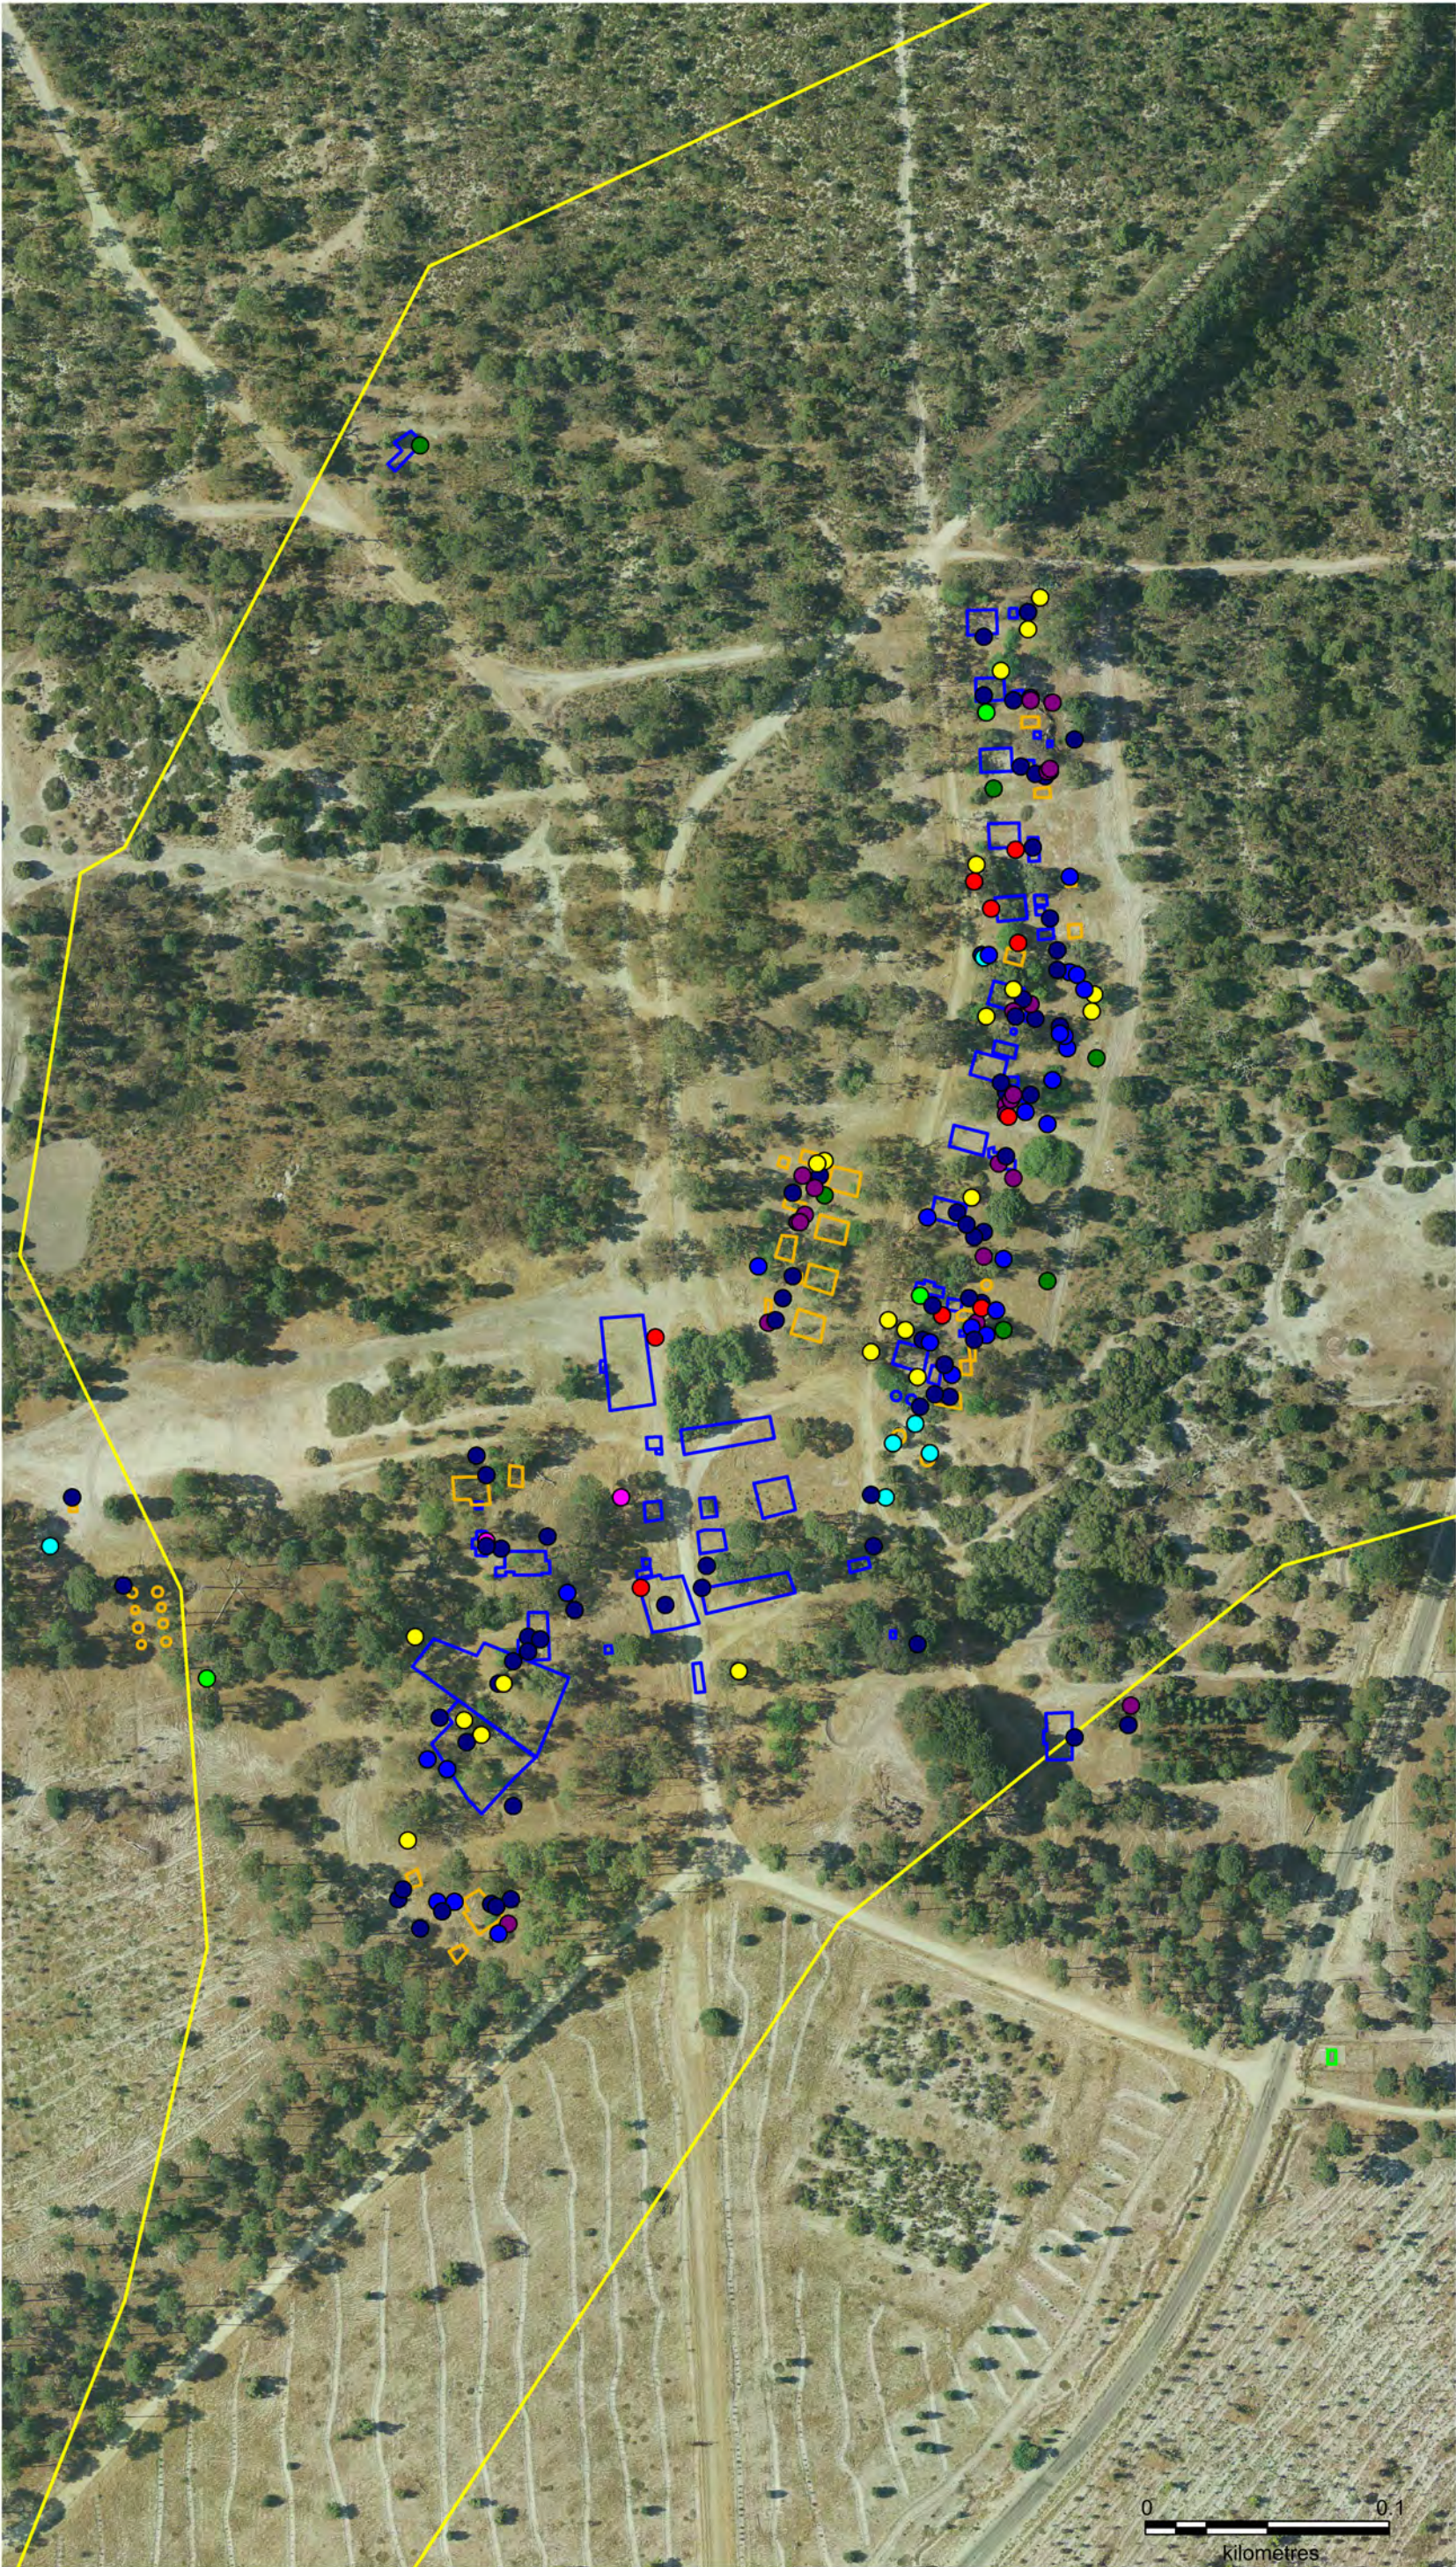
FIGURE 6:
Results of
Archaeological
Investigation

The field survey identified 169 points of interest, which were weighted towards structural items, especially open septic tanks. The results of the survey can be summarised as follows:

- i) Little evidence of an archaeological assemblage spread over the entire area;
- ii) The only extant evidence of building structures were generally fences, concrete wet-area floors, ant caps, septic tanks and toilet bowls;
- iii) Many trees and shrubs in the area were introduced and planted, particularly along fencelines;
- iv) Almost all artefacts were post-war, suggesting that little remains of pre-war settlement; and
- v) Little evidence (n=9; 5.33%) of an assemblage related to social/domestic activities.

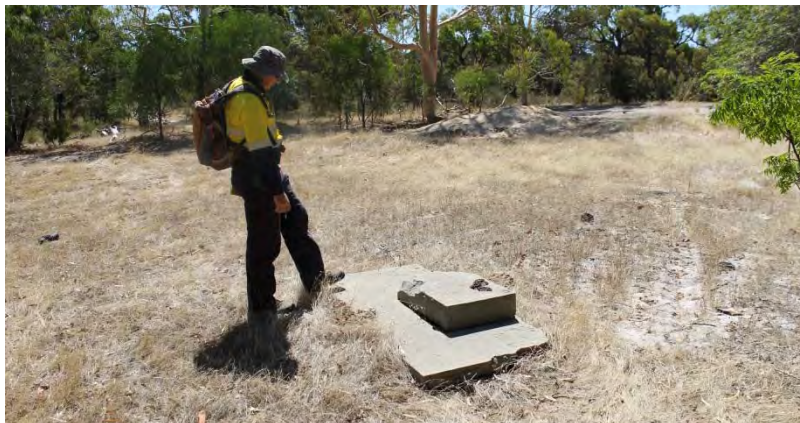
Location:
400378 mE 6484409 mN

Photo 7: A concrete plinth showing hand and footprints with the date '1982'. With Darren Cooper.

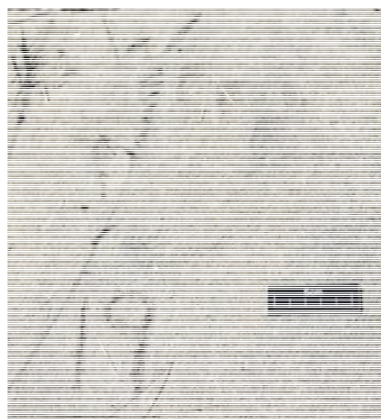
Location:
400378 mE 6484409 mN

Photo 8: View on LHS of the concrete plinth showing a handprint with '19'.

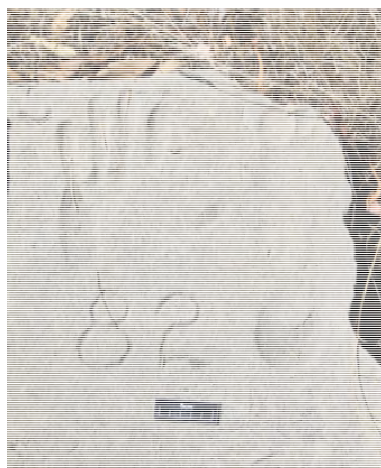
Location:
400378 mE 6484409 mN

Photo 9: View on RHS of the concrete plinth showing a hand and footprint with '82'.

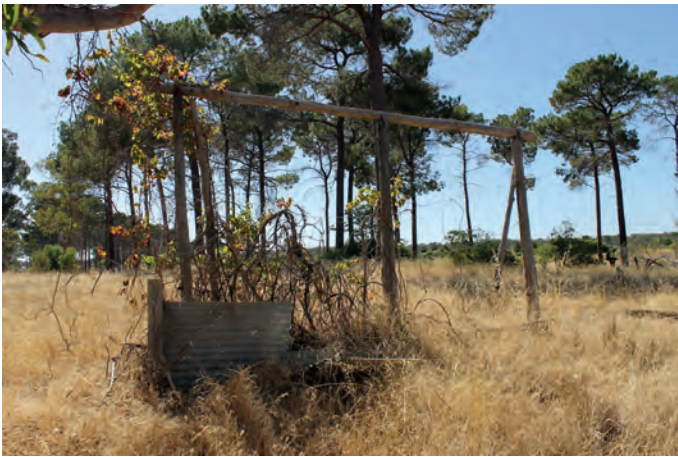
IMG_0004.....400155 mE 6483893 mN
View SE of grapevine. Note asbestos sheeting.

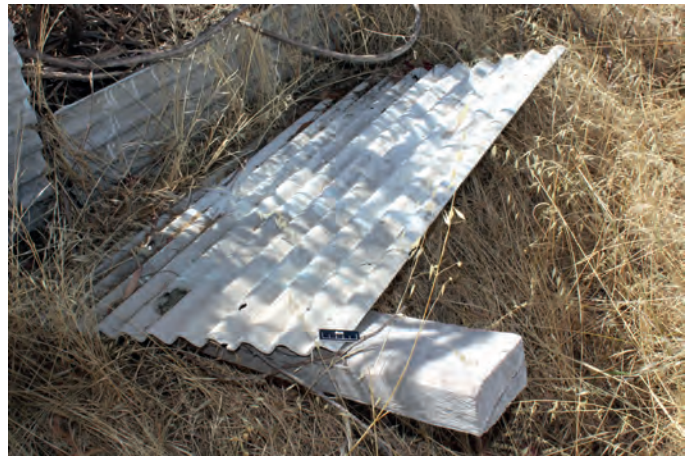
IMG_0005.....400143 mE 6483918 mN
View asbestos sheeting at Grapevine base.

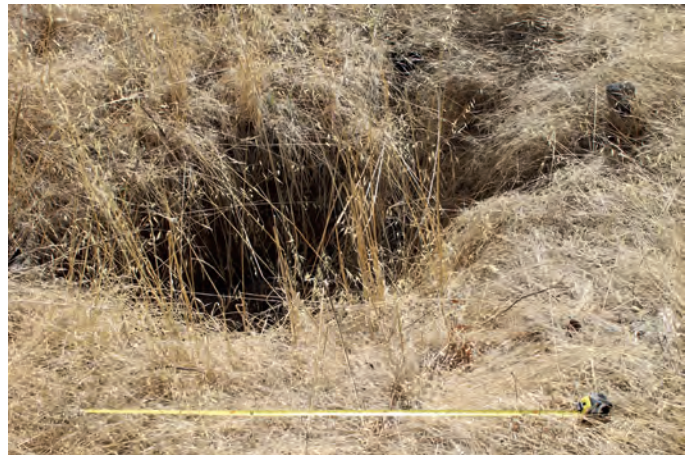
IMG_0011.....400143 mE 6483918 mN
Hidden open septic tank. Note grass coverage.

Potential hazards such as asbestos fencing and open septic tanks are distributed throughout the survey area. Care should be taken by all site-workers to ensure workplace safety.

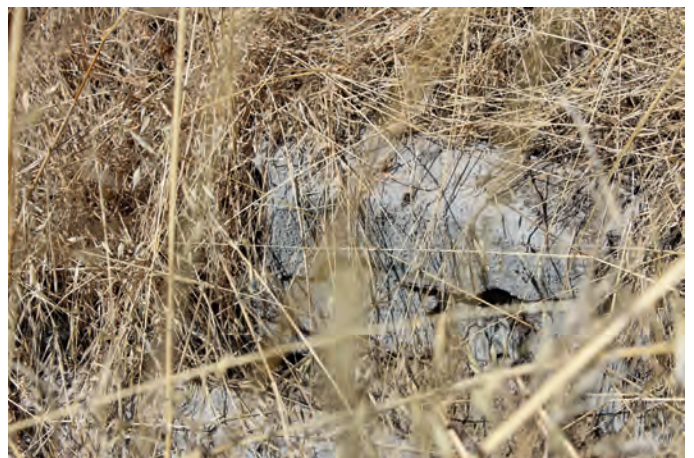
IMG_0013.....400143 mE 6483918 mN
Septic tank. Note 'brick' construction.
