EPBC 2010/5419 Compliance Report 2018

Dampier Highway Duplication Project

Client: Main Roads Western Australia

29-Nov-2018

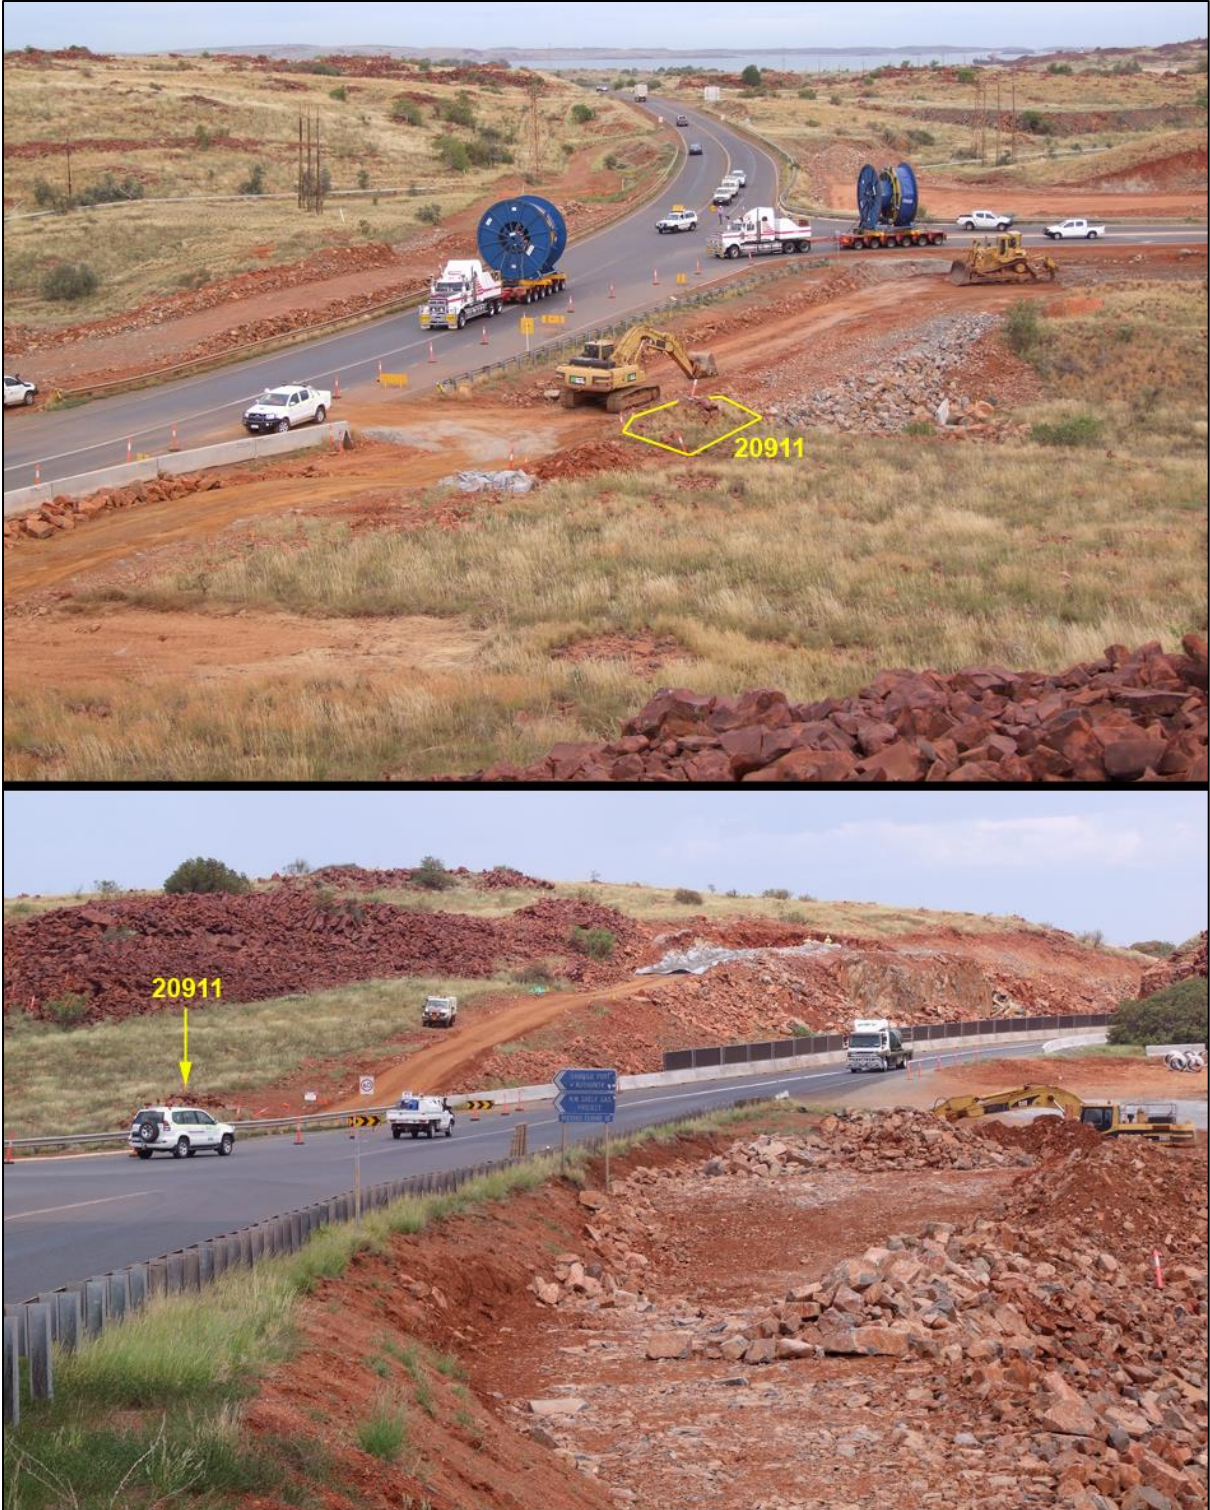
FIGURE 3: Location of site 20911 adjacent to the works area (March 2012)

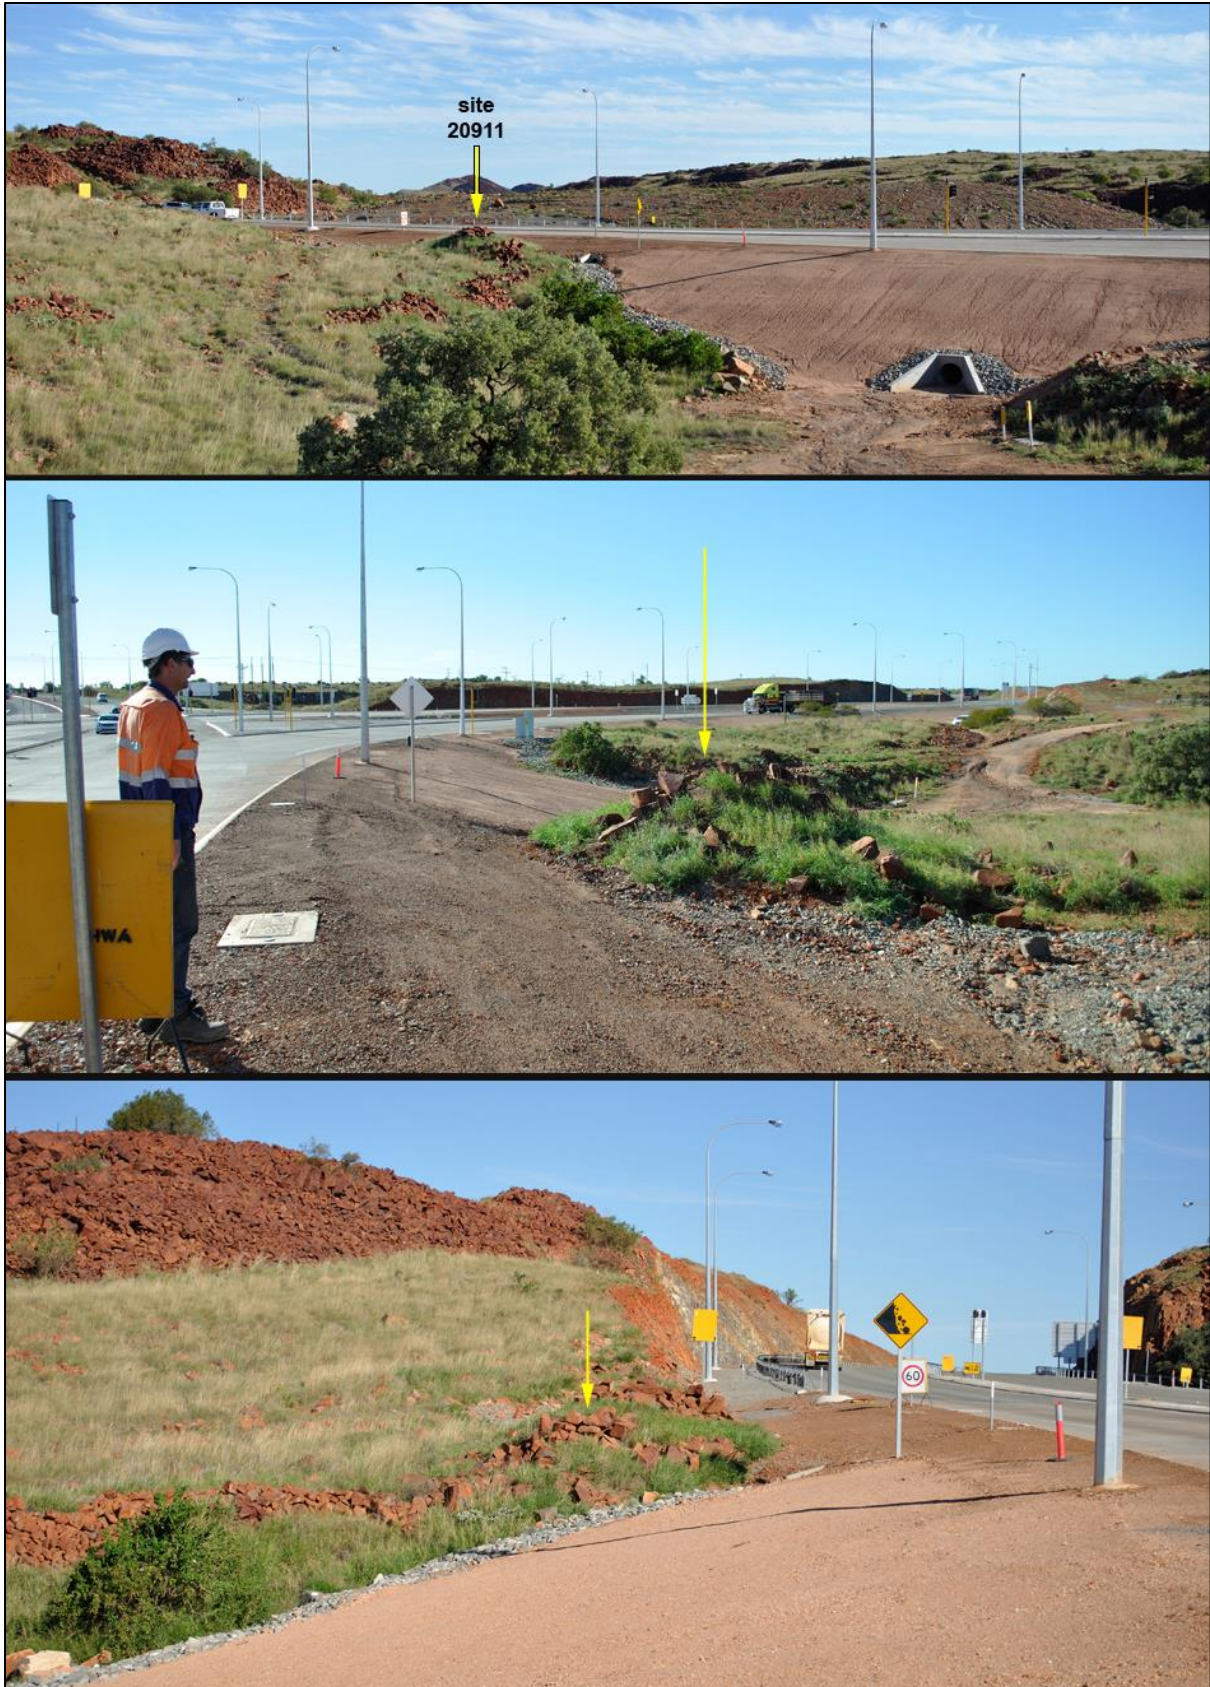
FIGURE 4: Site 20911 from the north-east, south and north (May 2013)

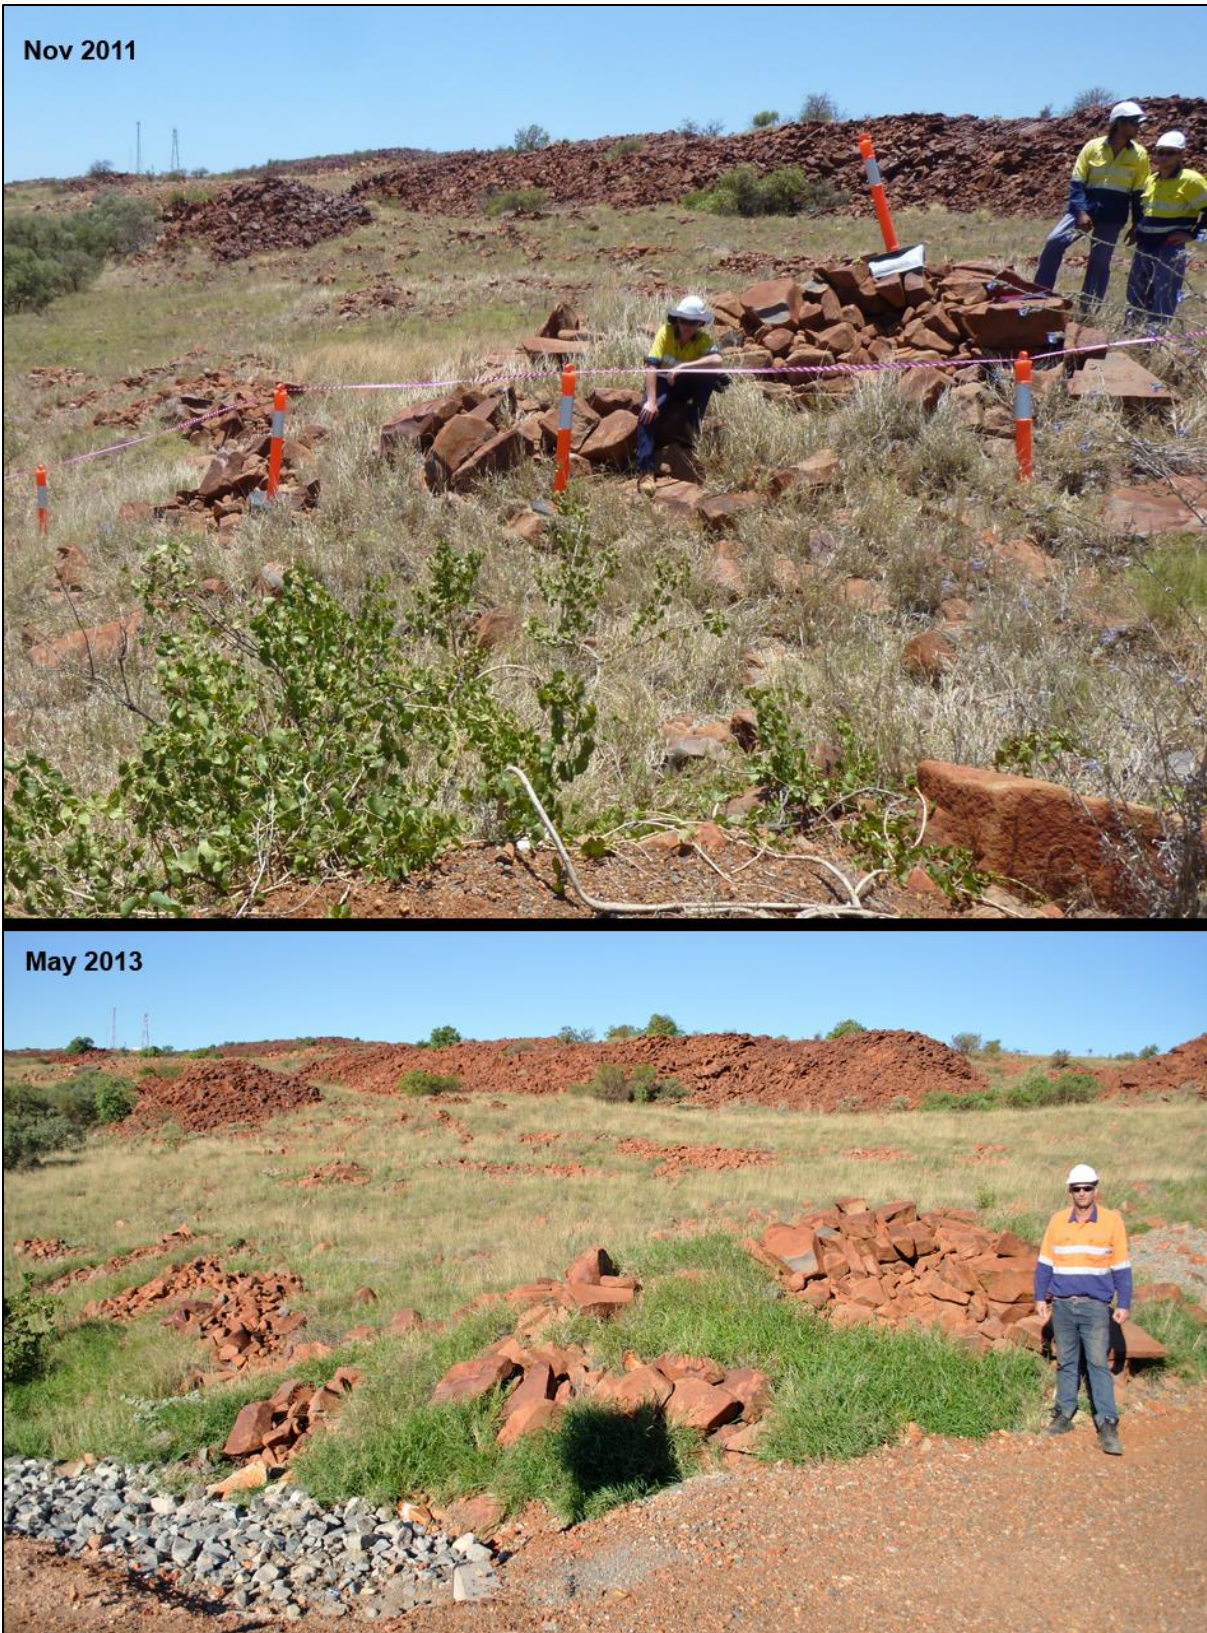
FIGURE 5: Site 20911 pre- and post-development showing no disturbance to the site rocks

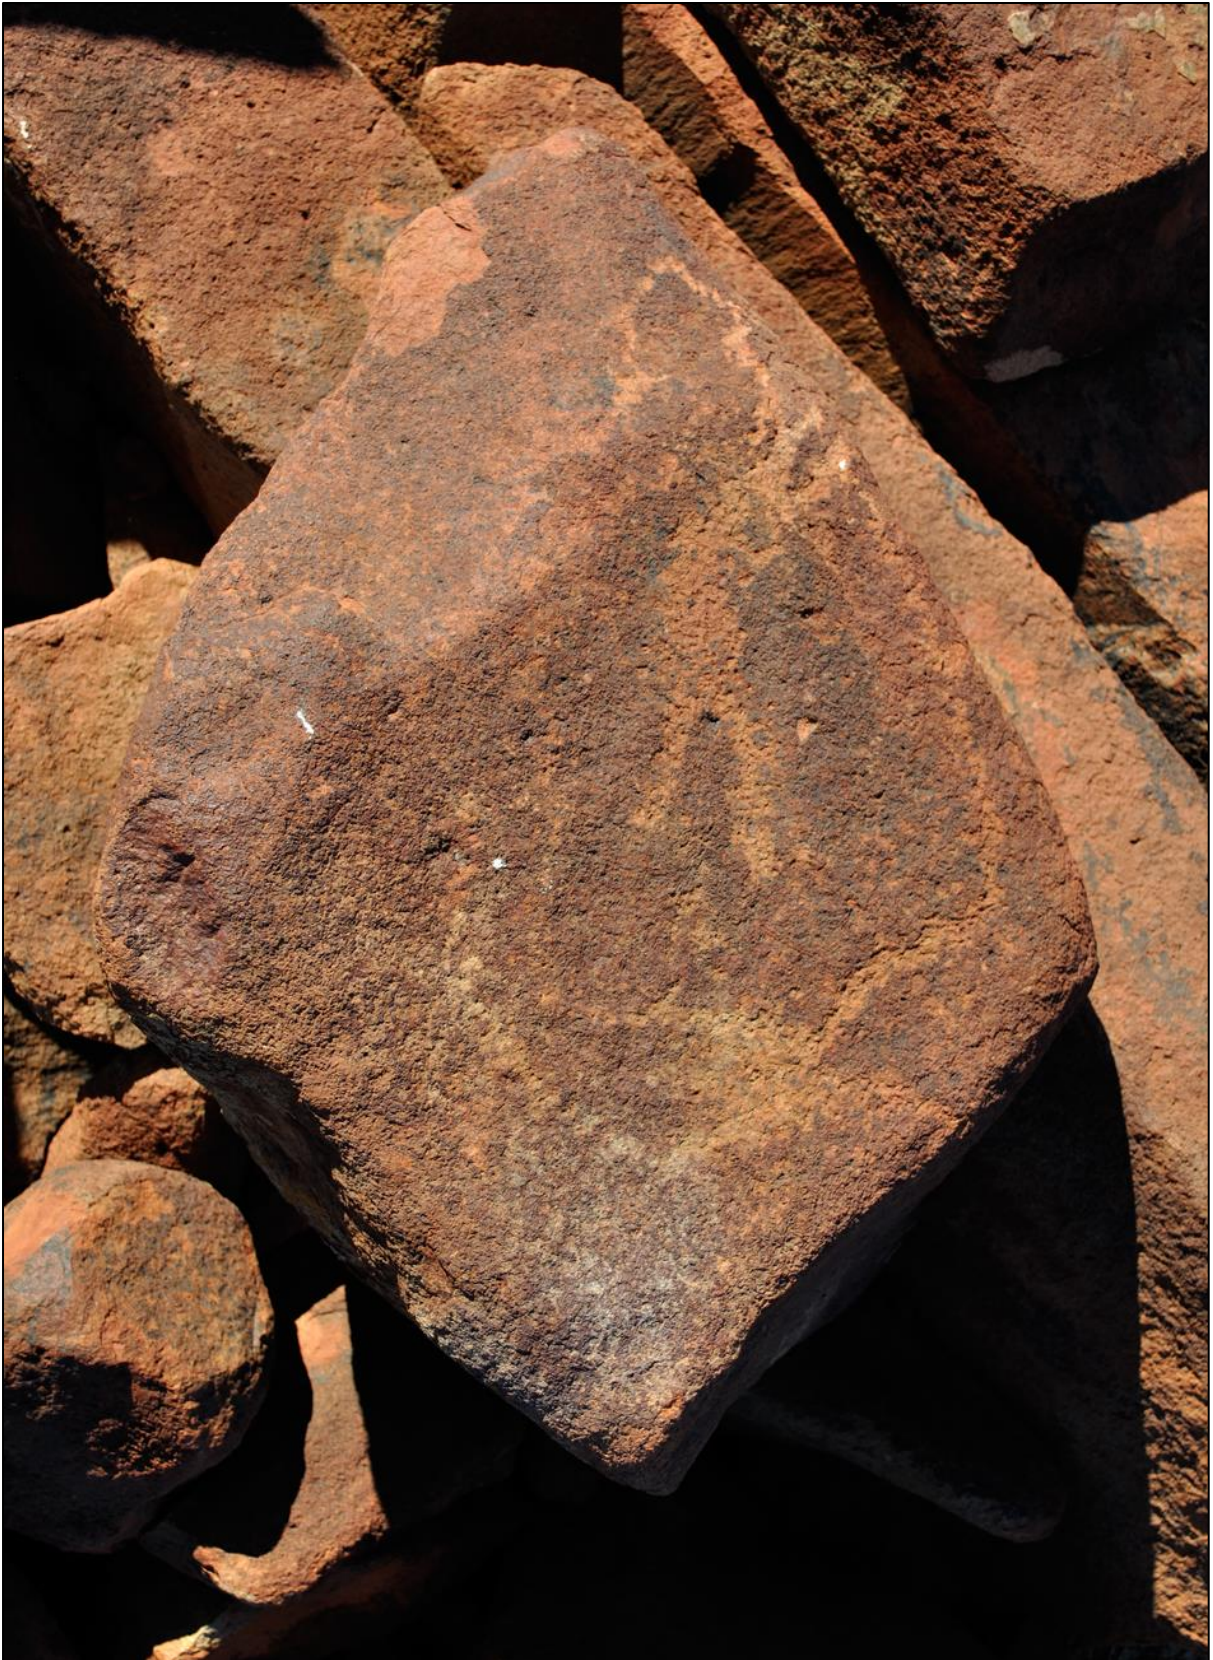
FIGURE 6: Site 20911 petroglyph, May 2013
