Fremantle Traffic Bridge

Preliminary findings regarding bridge condition

The 2021 routine inspection of the Fremantle Traffic Bridge, undertaken as part of Main Roads Asset Management Strategy for timber bridges, has confirmed the timber and steel elements of the bridge are continuing to deteriorate.

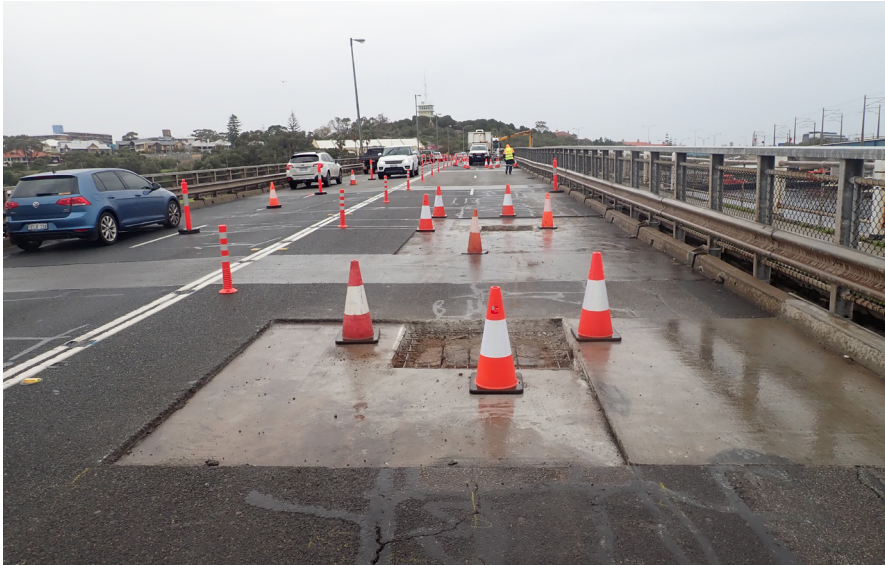
We've had to close the bridge in recent years for emergency repairs to failed sections of the Reinforced Concrete Overlay (RCO). The RCO provides weather protection for the majority of the timber deck but does not protect the outside timber (stringers/bearers/

edge decking). In particular, the original detailing of the RCO is insufficient in width, allowing rain ready access to these edge components. Drainage from the bridge enters the wood which speeds up timber deterioration. The deck is thin and cracked due to movement of timber

underneath where the timber work is not tightly held together. The concrete overlay had an estimated life of 15 years but is now 47 years old. The guard railing system is below expectations of current standards.

Sections of the road surface removed.

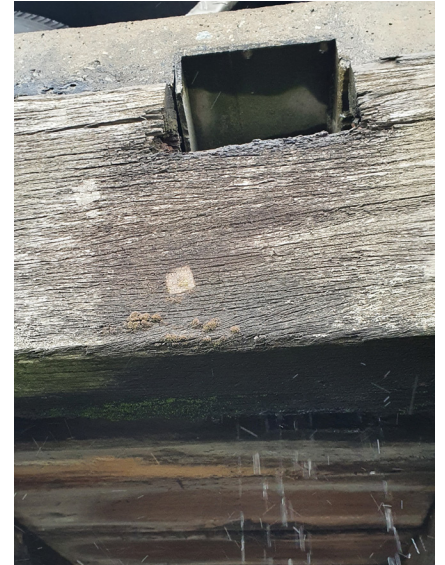
Edge of longitudinal deck plank deterioration and saturation.

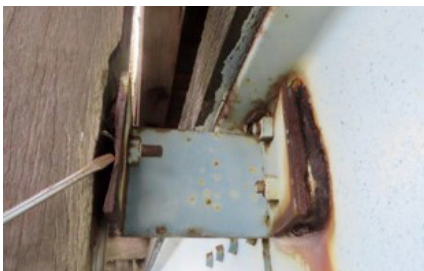
The footpath has extensive deterioration throughout, particularly external elements exposed to the weather with rotting to the timber resulting in capacity loss. Bolted connections on the footpath are heavily corroded and this has resulted in splitting of many timber components.

Corrosion of bolted connections.

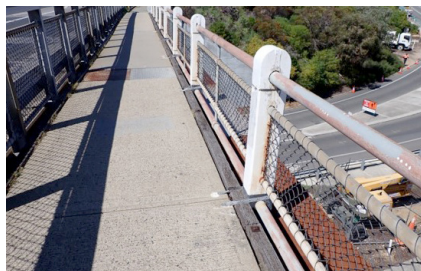
The balustrade (footpath handrail) height is 900mm. The recommended balustrade height for cyclists is 1400mm. It is not practical to upgrade the balustrading system; the repairs to post fixing, to achieve adequate capacity is anticipated to be

problematic. The timber posts, particularly their fixings, are in 100% poor condition.

Footpath balustrade.

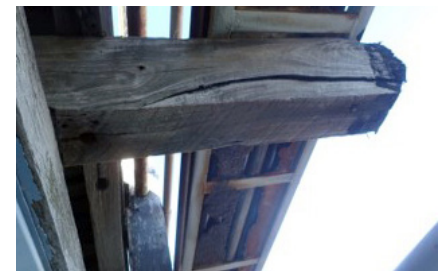
There is extensive corrosion to cable tray and pipes below the footpath.

Tray below footpath.

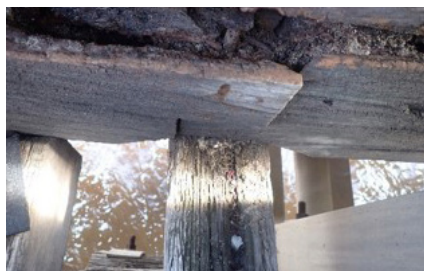
Footpath condition.

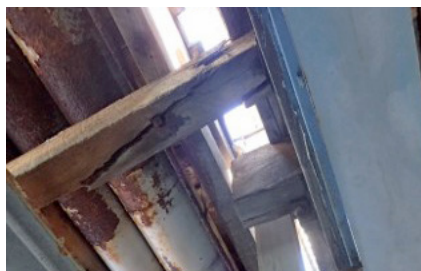
Deterioration of bolt connections.

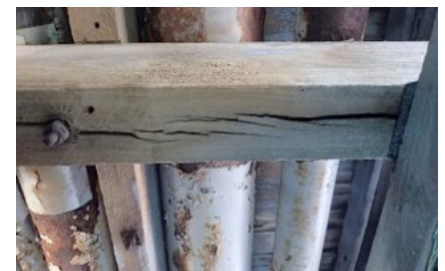
Pipes below footpath.

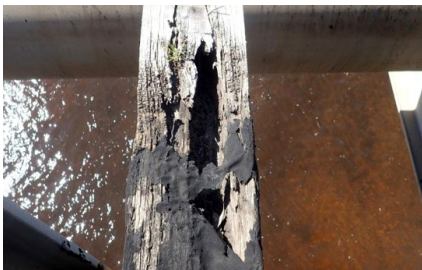
Span 3 LHS top of bearer 5.

Bridge bearers support the deck of the bridge. Some bearers (image below) are affected by rot, and sealing the exposed timber is not likely to be successful. 60% of external bearers are in fair or poor condition. This rot is mainly at the exposed edges; however, it is now progressing to within the bridge as the timber sucks in the moisture.

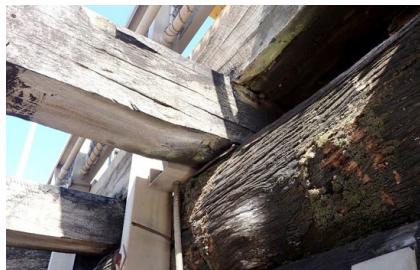
The stringers made of wandoo wood have lasted well, but further exposure to weather and water will cause ongoing deterioration. Stringers inspected showed 10% in excellent condition, with 65% good, 20% fair and 5% poor.

Weathering of outside stringer.

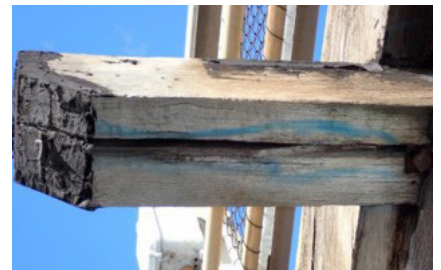
An outcome of the corroded bolts is splitting of the timber elements, which reduces the structural effectiveness. There is no effective repair for these components.

Weathered timber - split bearer and corbel.

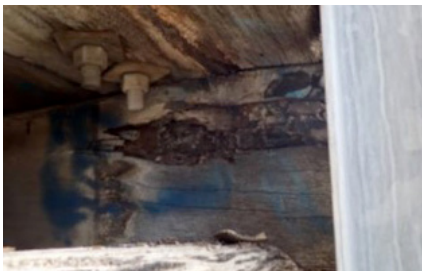
Timber at the location of bolts securing the guardrail post to the deck.

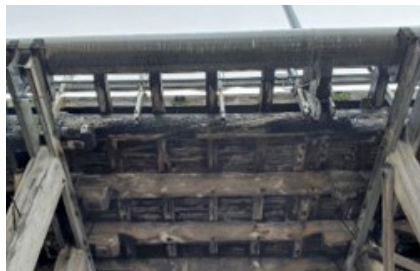
Deck reinforcing and lack of shelter to outside stringers.

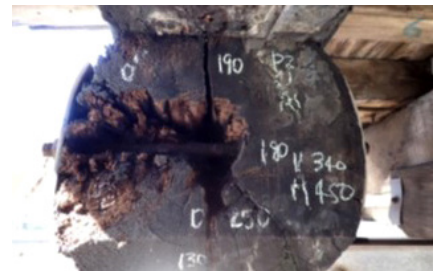
Weathered split timber from corroding bolts.

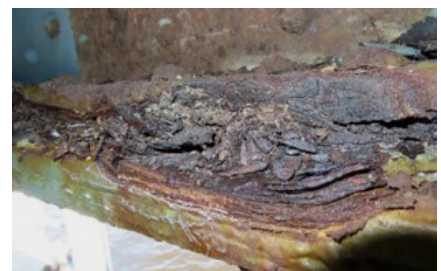
Steel elements of the bridge have widespread paint coating failure. All surfaces show widespread spot corrosion. Additionally, there are areas with local section loss in the main girders, supporting stringers and bracing. To repair surface corrosion on the steel, the only option is to blast clean the steel work and re-coat. The age of

Heavy corrosion.

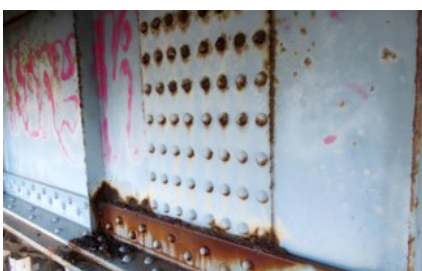
The failure of the coating system has caused a large number of rivet heads to be in an advanced state of corrosion.

Corrosion of bolts and rivet heads.

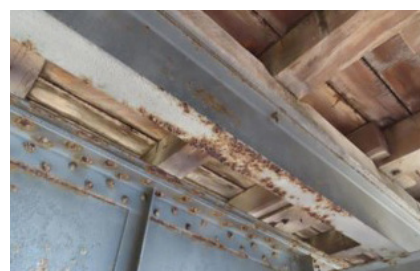
Main girder, transverse support and stringer.

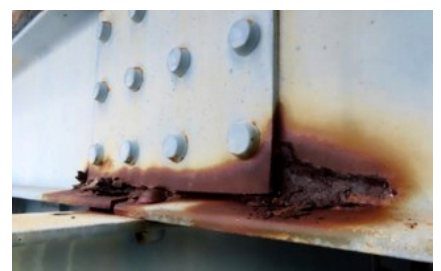
Span 17 stringer 11 loss of section.

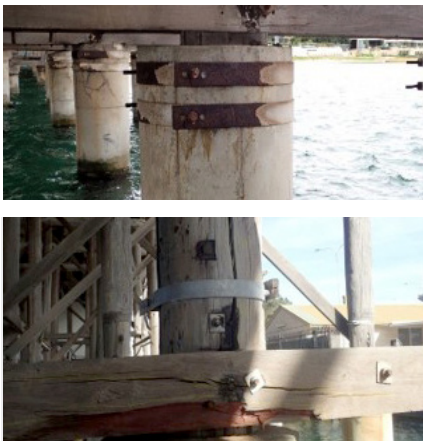
The piles above water level have had concrete pile pot repairs near water level. These are showing cracking and rusting of the supporting repair bands.

Above the pot is a splice in the pile. The bolts are rusting, causing splitting to the splice zone. This rust induced splitting is also affecting the bracing and waling, which are important structural elements due to the very tall piles at this bridge.

In the navigation spans, the piles support a series of timber capping beams, those exposed to the weather are deteriorating.

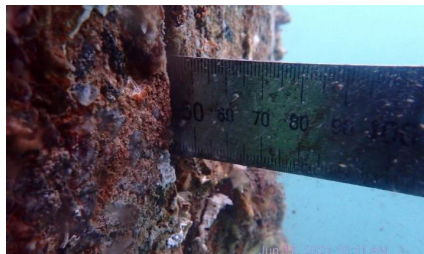
In other piers, the timber was historically protected using non-structural casings around the timber pile, with the gap filled with sand. Some of these casings are now cracked with sand leaching out. Without the protection of the sand, then Teredo worms have the ability to enter through the small concrete cracks and attack the timber piles. Core samples taken show Teredo worm attack is not significant at this time, however the reduction in the timber pile protection is a concern.

Cracks in the concrete protection jacket allowing sand to leach out
