Structures Engineering

Routine Visual Bridge Inspection Guidelines (Level 1 Inspections) for Bridges

Document No: 6706-02-2234

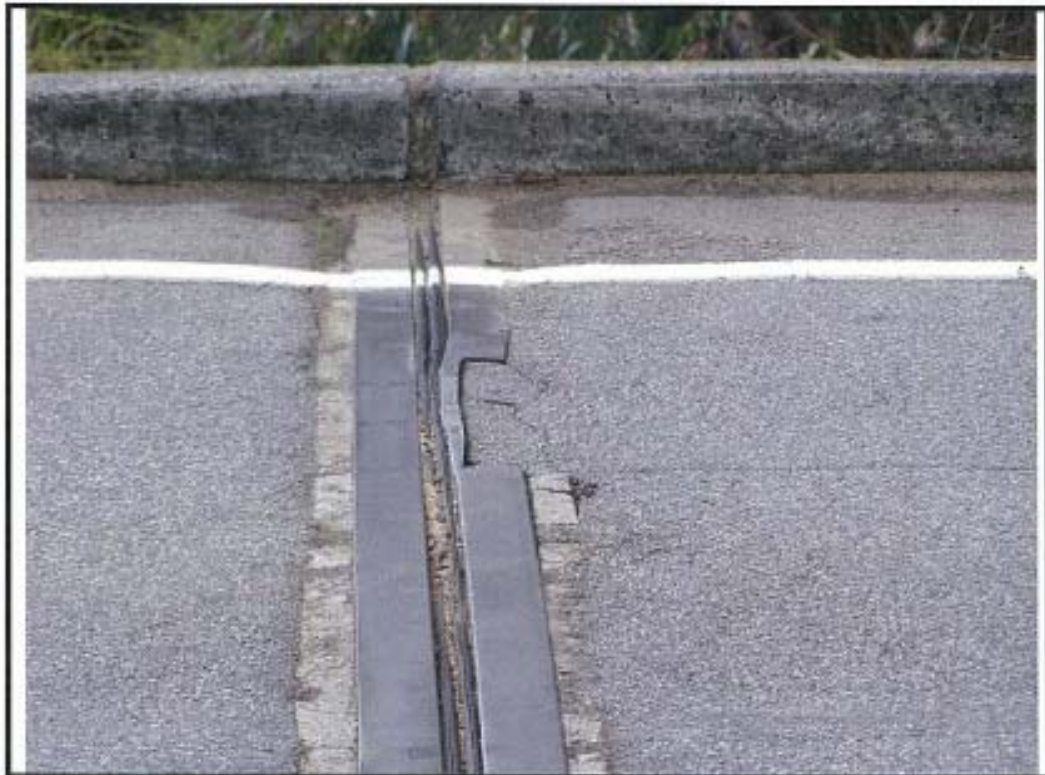
Photo No. 5: Top Surface of Wabo Rubber is Perished

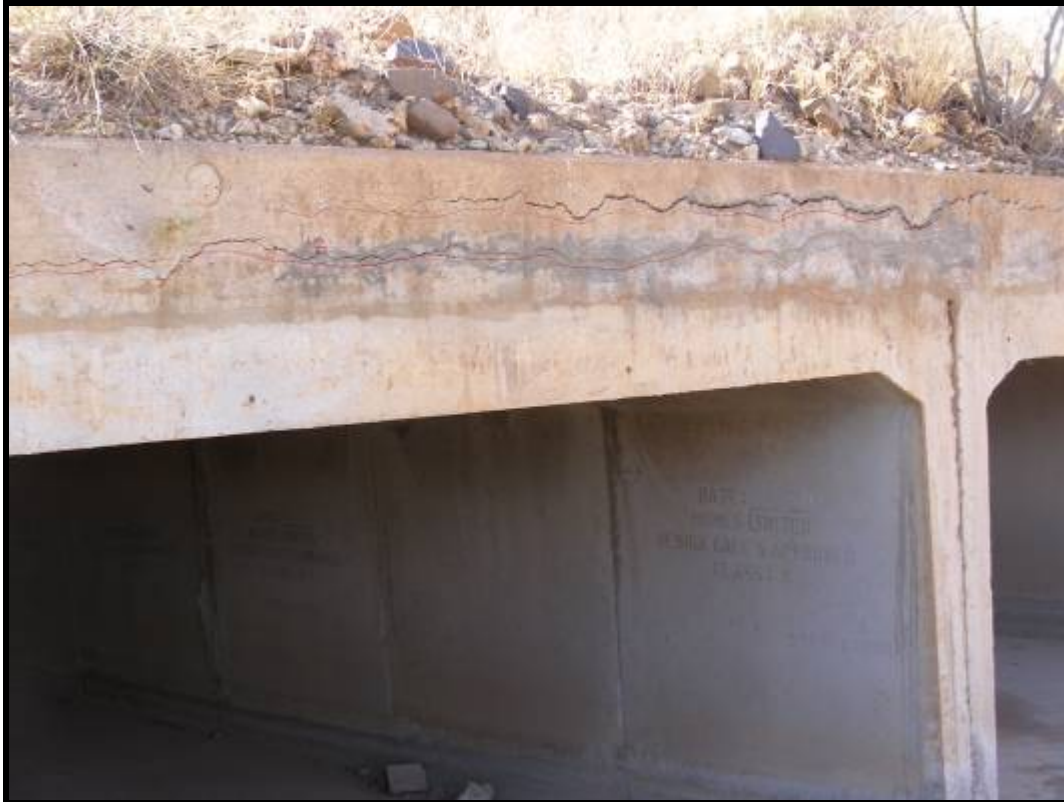
Photo No. 3: Headwall LHS, Heavy Cracks over Barrels 1 and 2

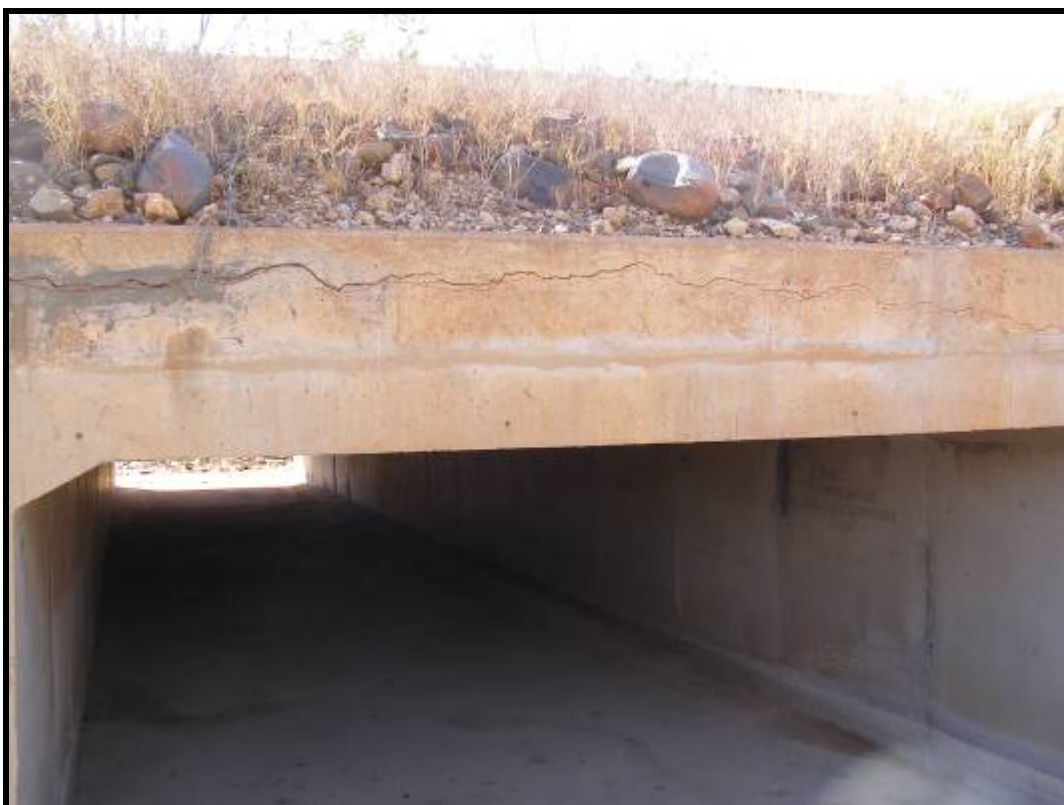
Photo No. 4: Headwall LHS, Heavy Crack over Barrel 3

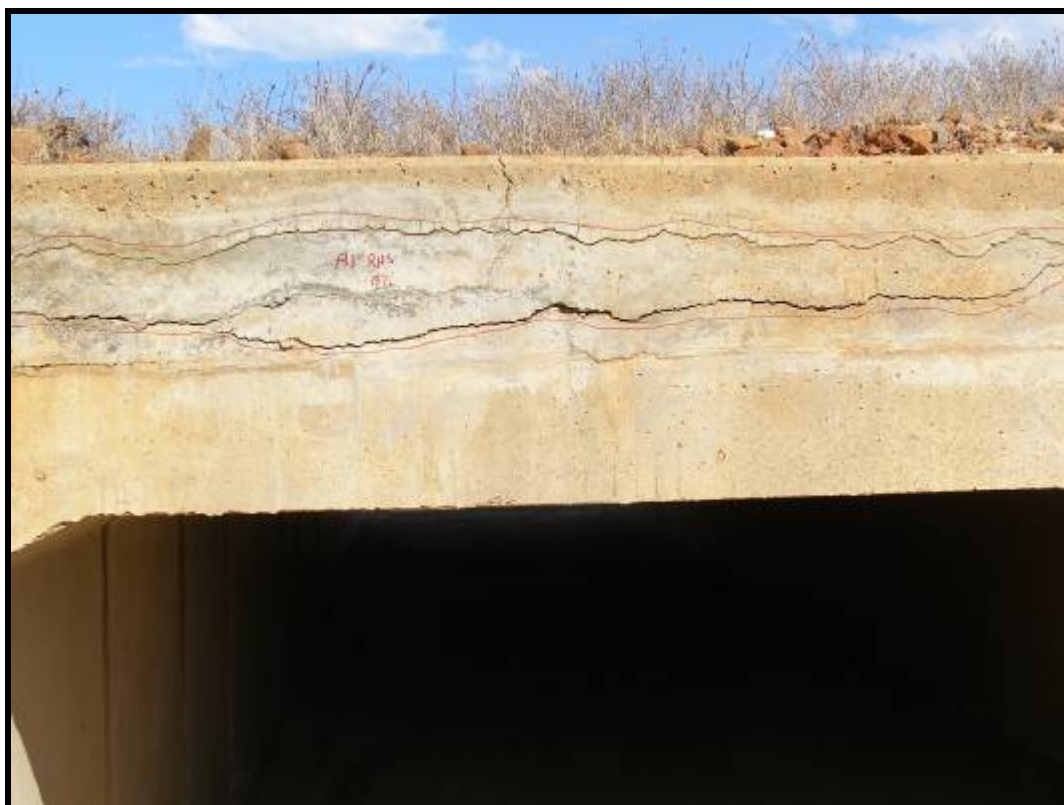
Photo No. 6: Headwall RHS, Heavy Cracks over Barrel 1

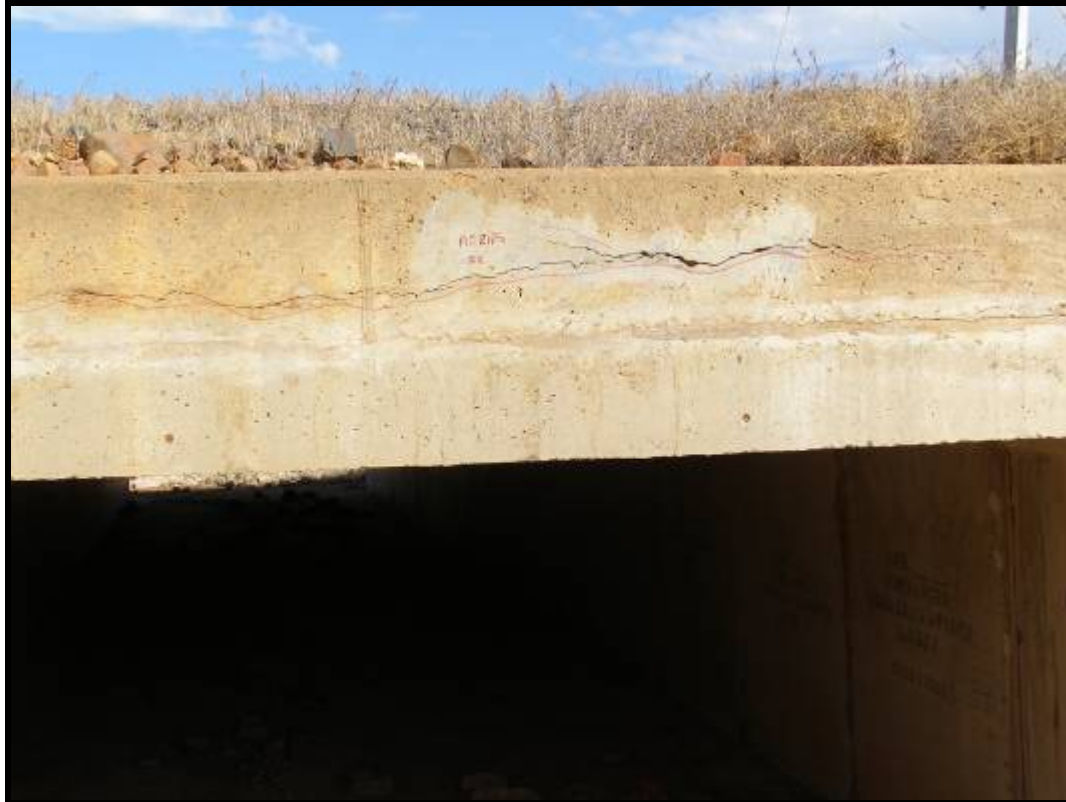
Photo No. 7: Headwall RHS, Heavy Cracks over Barrel 3

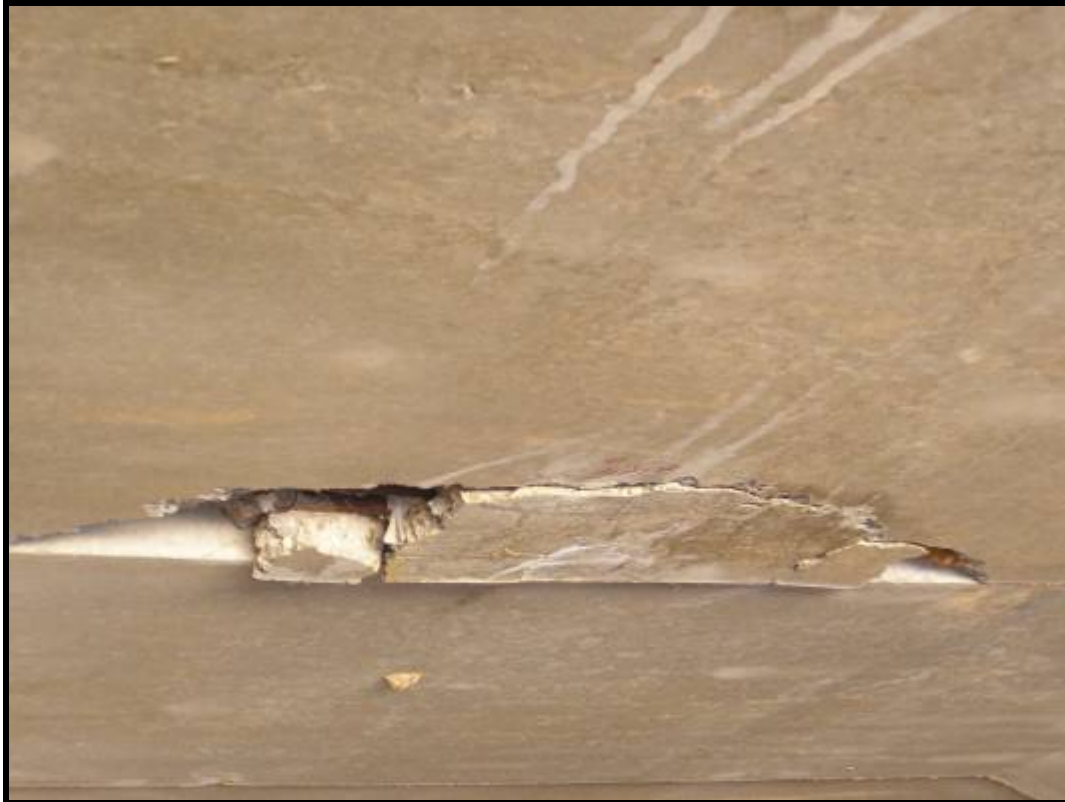
Photo No. 9: Concrete Spall and Exposed Reinforcement, Barrel 1, Unit 4

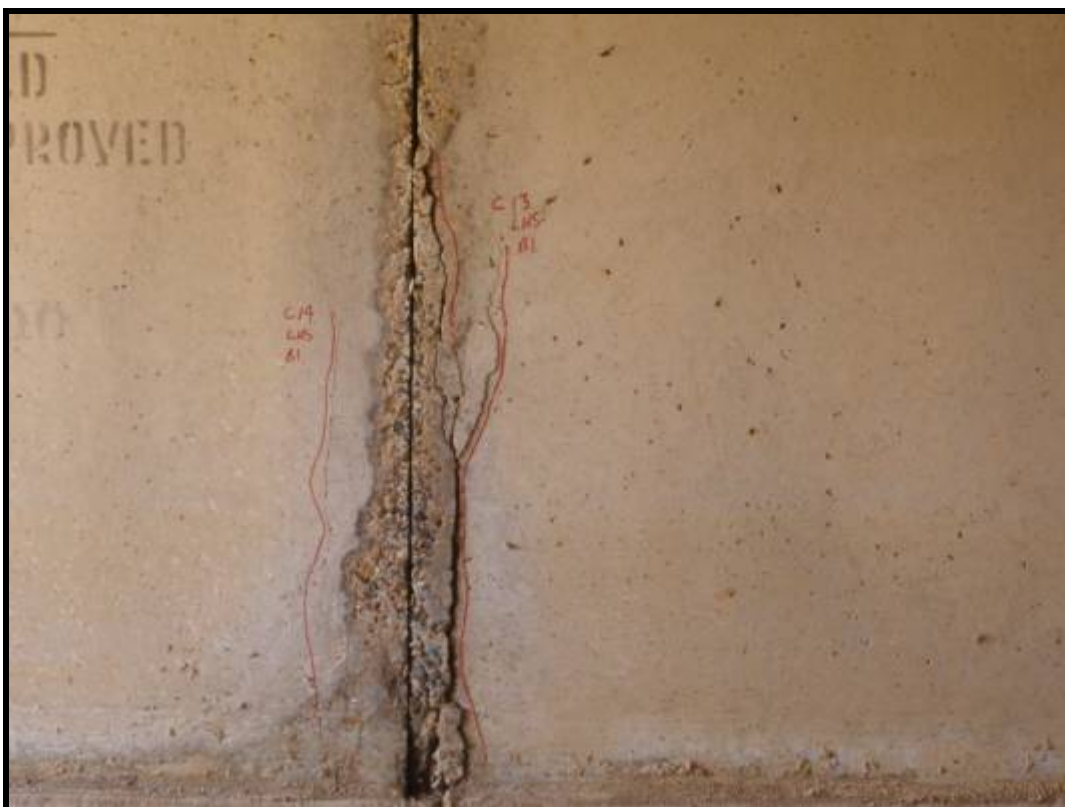
Photo No. 10: Heavy Vertical Cracks in Barrel 1, Units 13 and 14

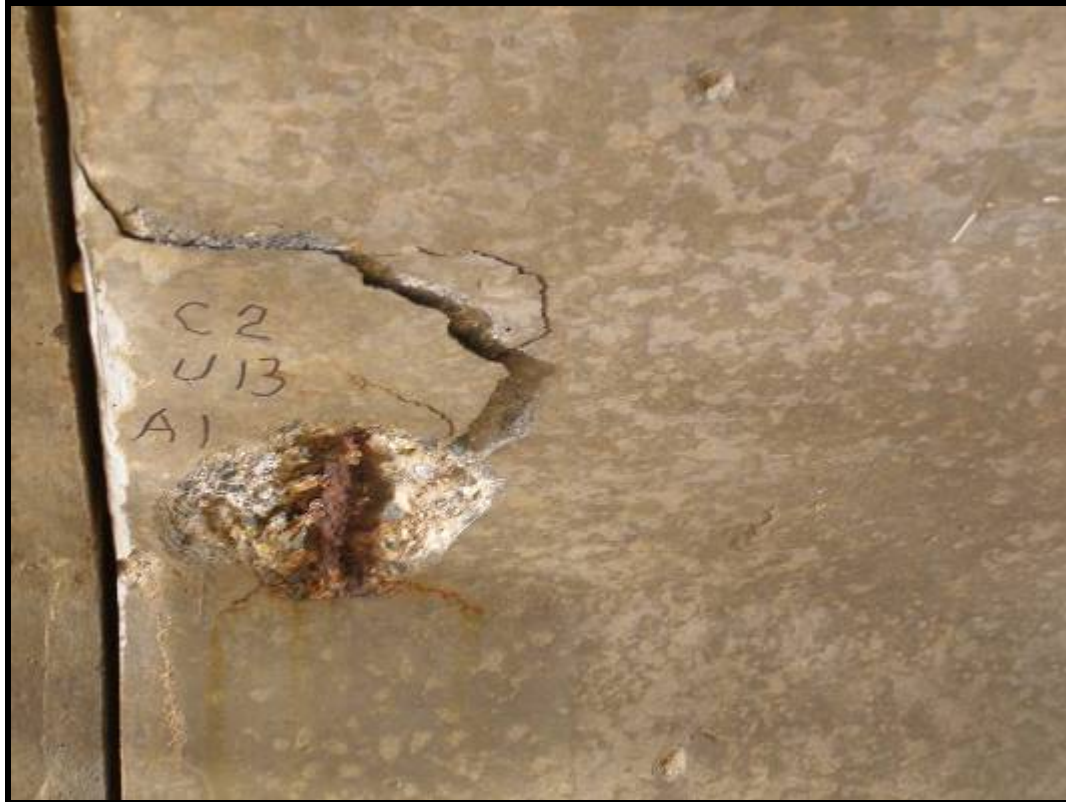
Photo No. 11: Spalled Concrete, Corroded Reinforcement, Barrel 3, Unit 2

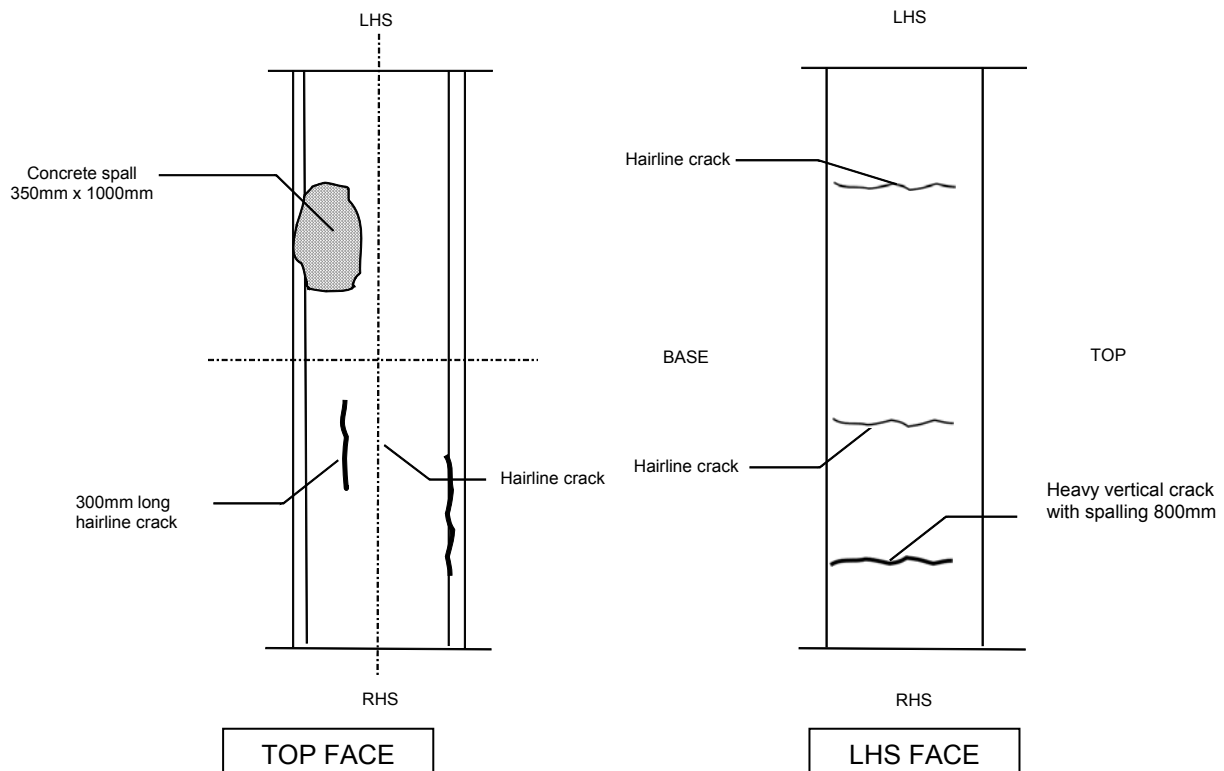
Sketch No. 2: Barrel 1 Defects
(Note – Sketches are not generally required for L1 inspections)

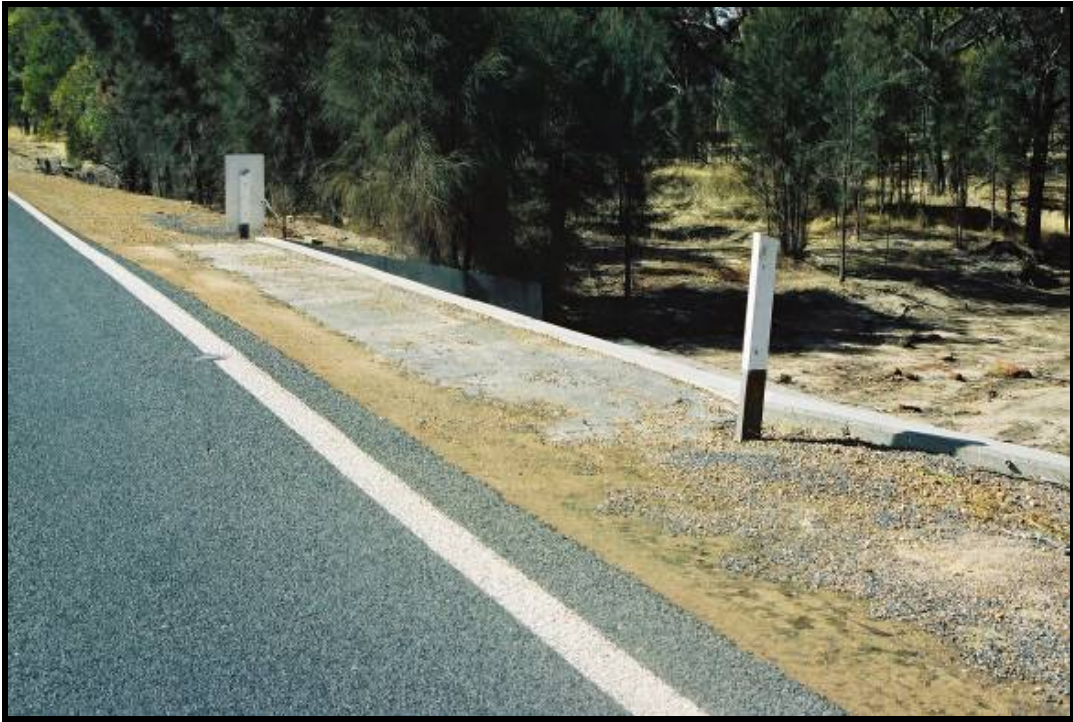
Photo 1 - MISSING WIDTH MARKER

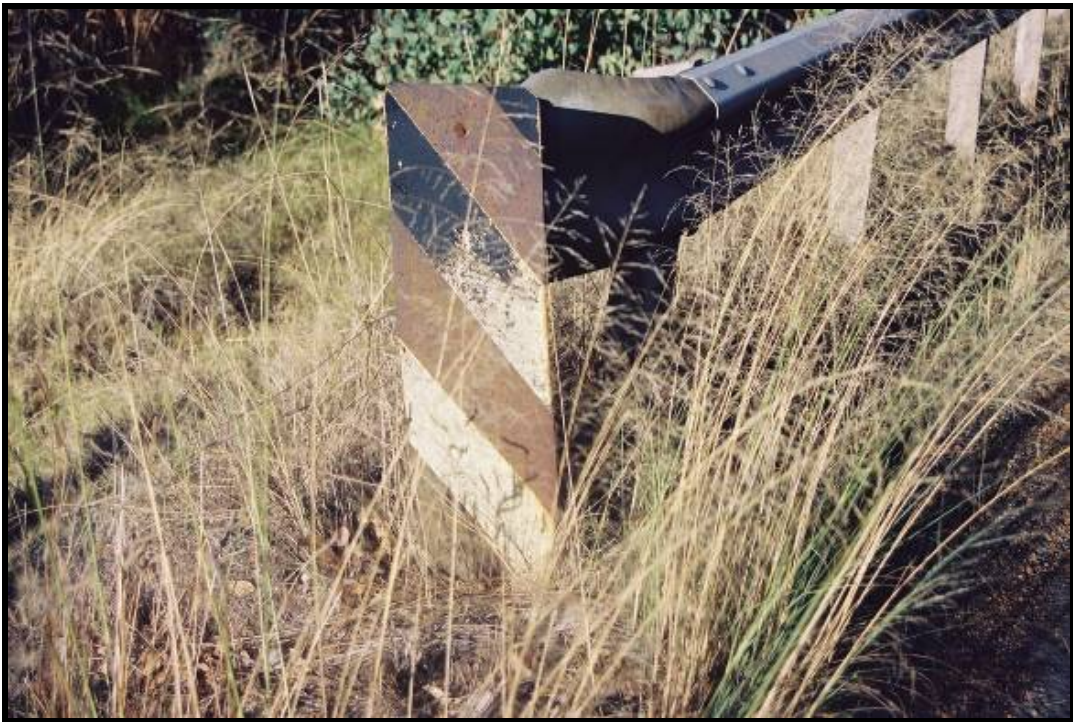
Photo 2 - WIDTH MARKER HAS LOST ITS REFLECTIVITY AND IS CONCEALED BY HIGH GRASS GROWTH

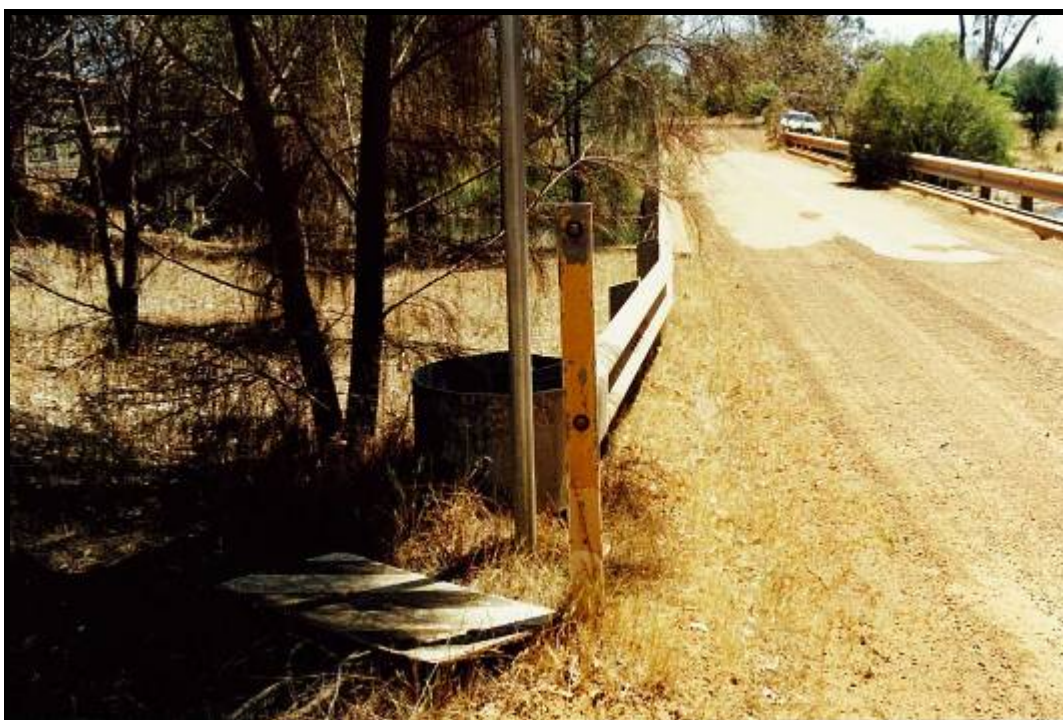
Photo 3 - WIDTH MARKER BROKEN OFF POST

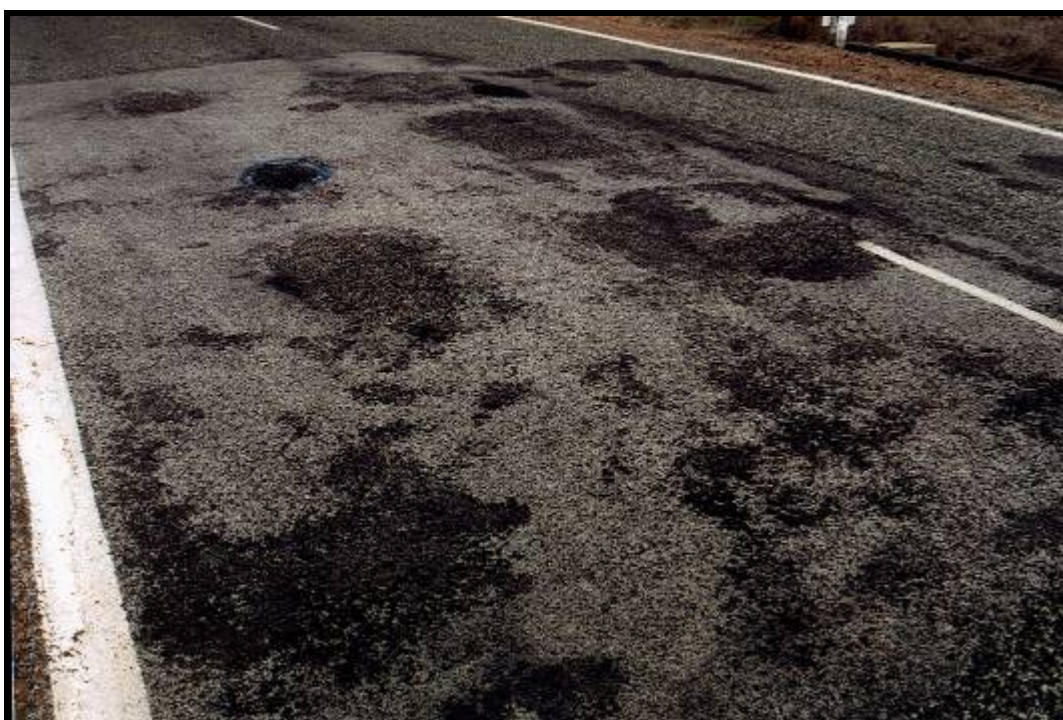
Photo 4 - POOR ROAD SURFACE, POTHOLE, BUMPS, CRACKS, WHEEL RUTS

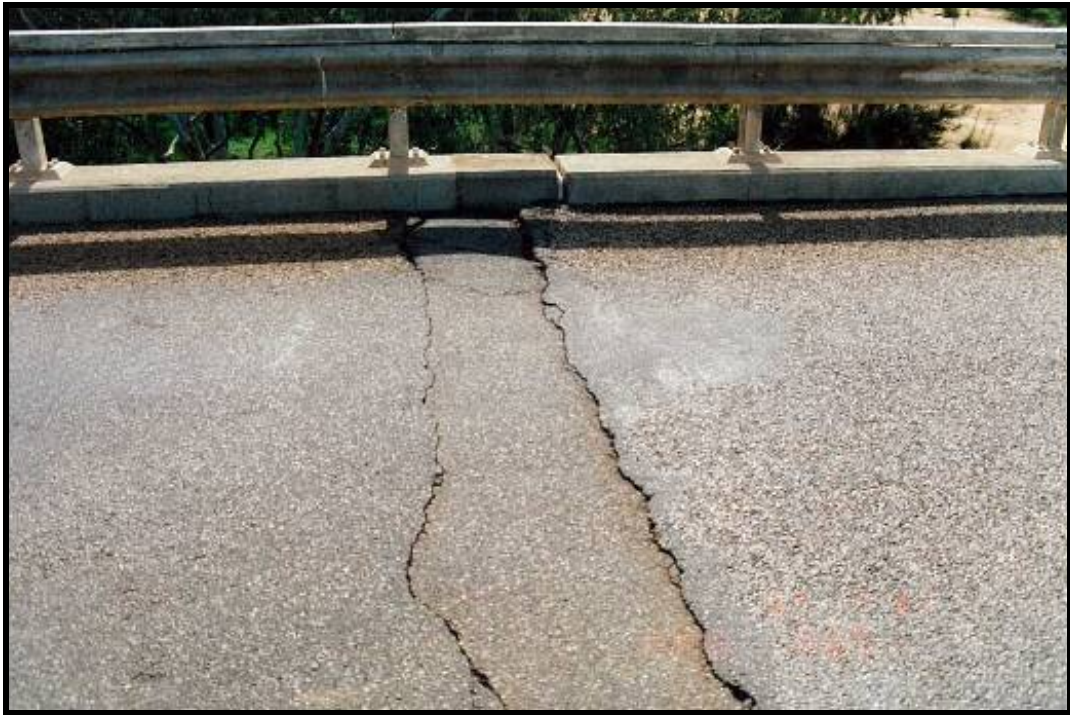
Photo 5 - CRACKS IN THE ROAD PAVEMENT AND SETTLEMENT AT THE ABUTMENT

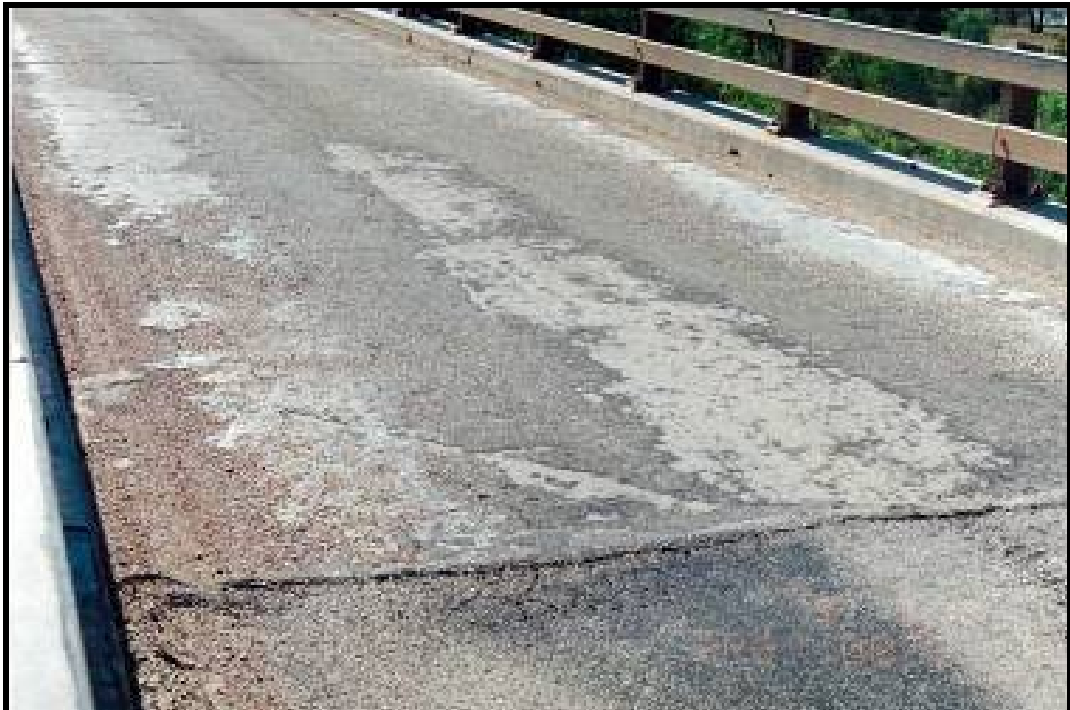
Photo 6 - STRIPPING OF SEAL SURFACE AND SETTLEMENT AT THE ABUTMENT

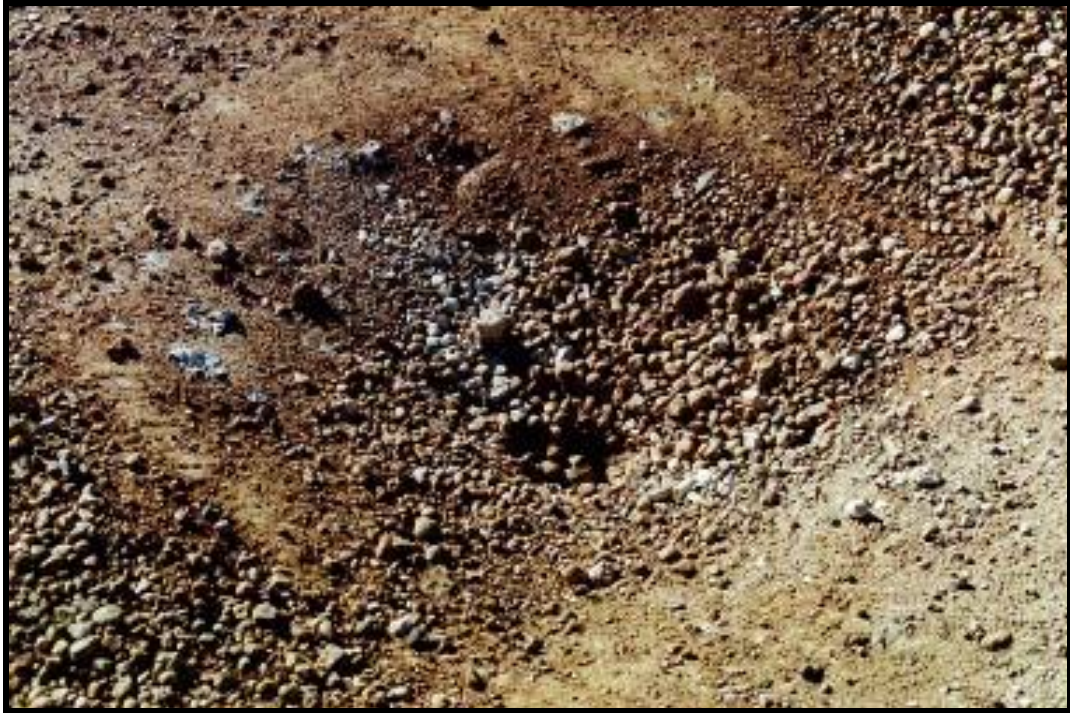
Photo 7 - POTHOLE IN GRAVEL ROAD SURFACE
(Failed stringer and decking subsequently found underneath)

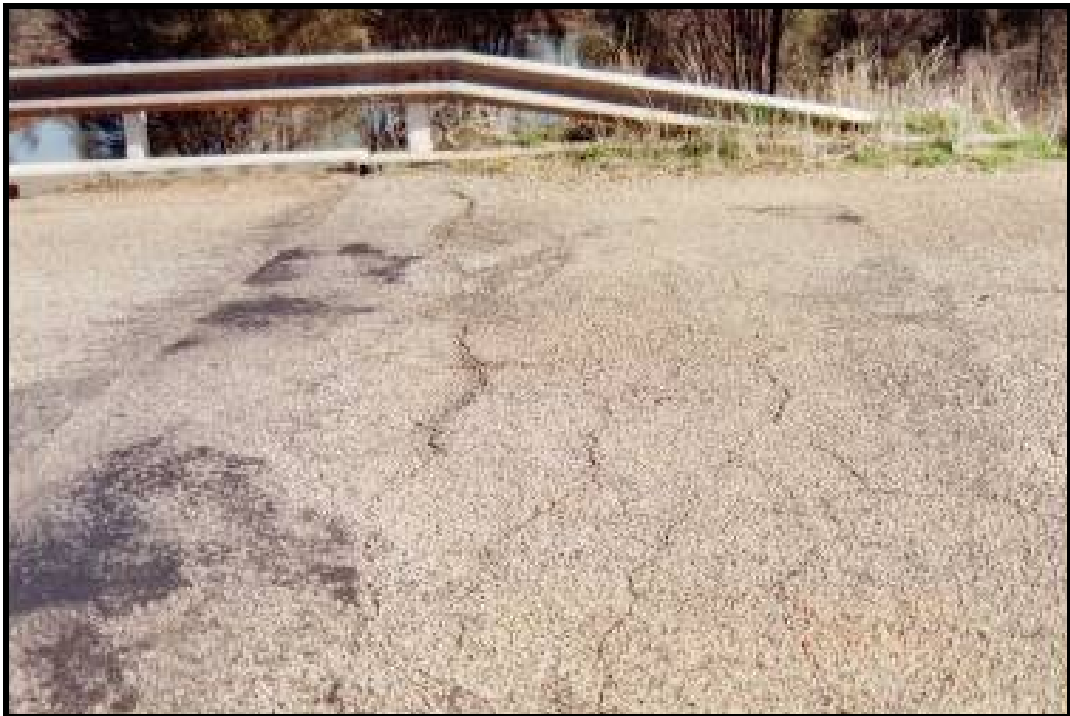
Photo 8 - LARGE TRANSVERSE CRACKS IN ROAD APPROACH

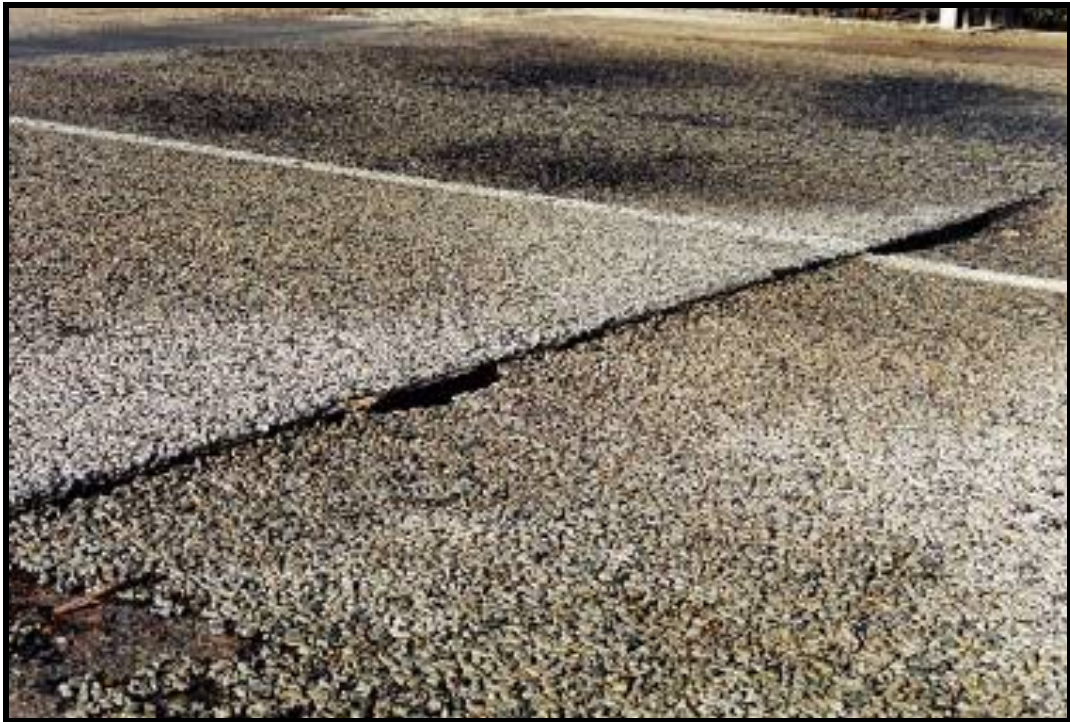
Photo 9 - SETTLEMENT AT ROAD APPROACH

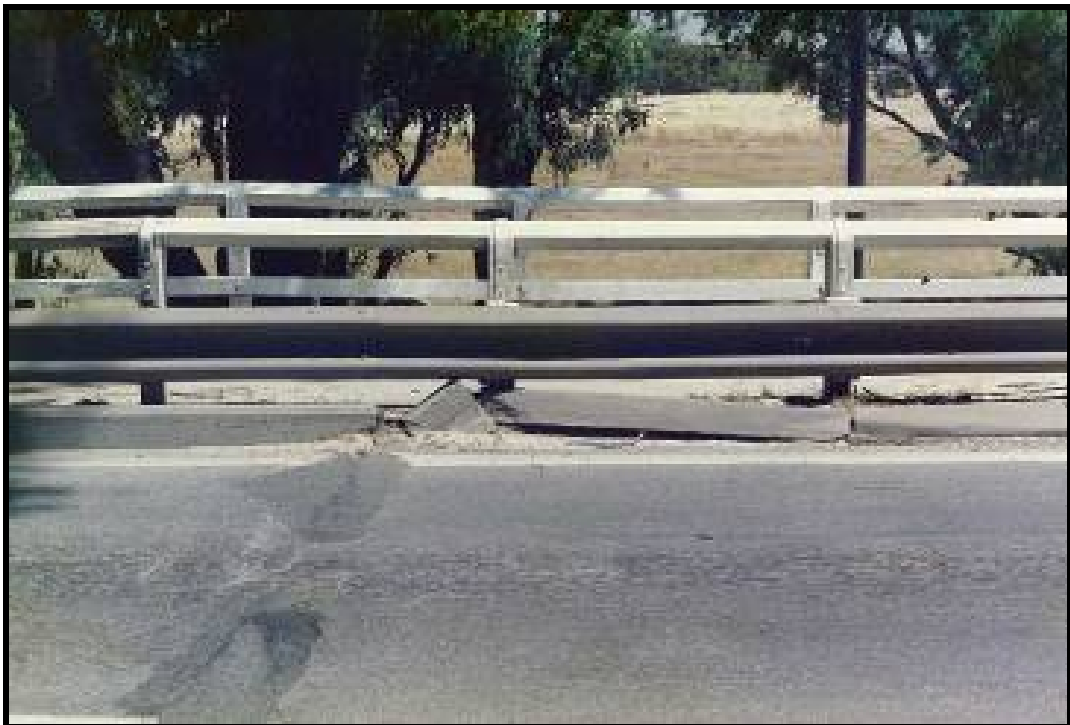
Photo 10 - DAMAGED KERBING

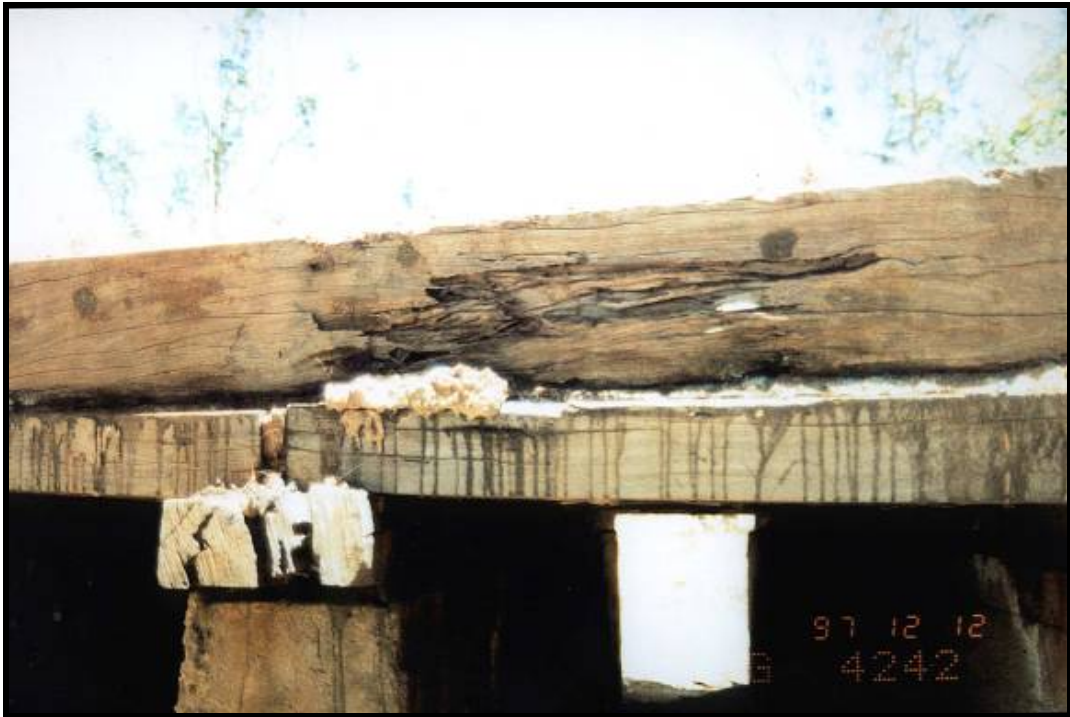
Photo 11 - ROTTED TIMBER KERBS (and timber fullcap) – REQUIRE REPLACEMENT

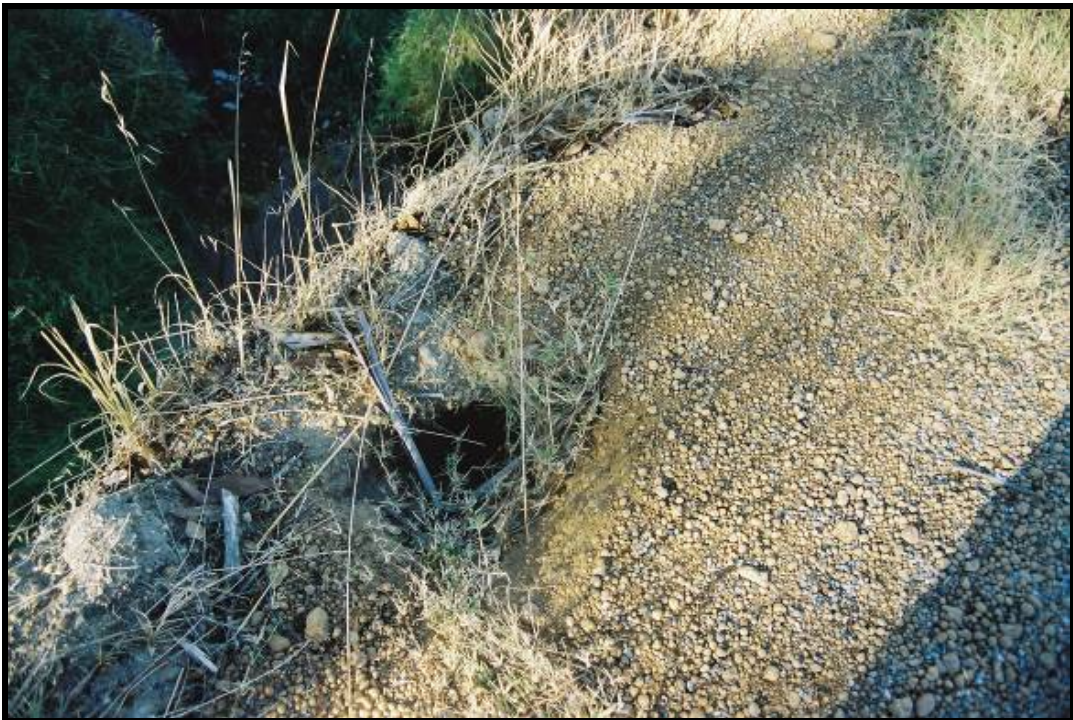
Photo 12 - HOLE IN ROAD SHOULDER

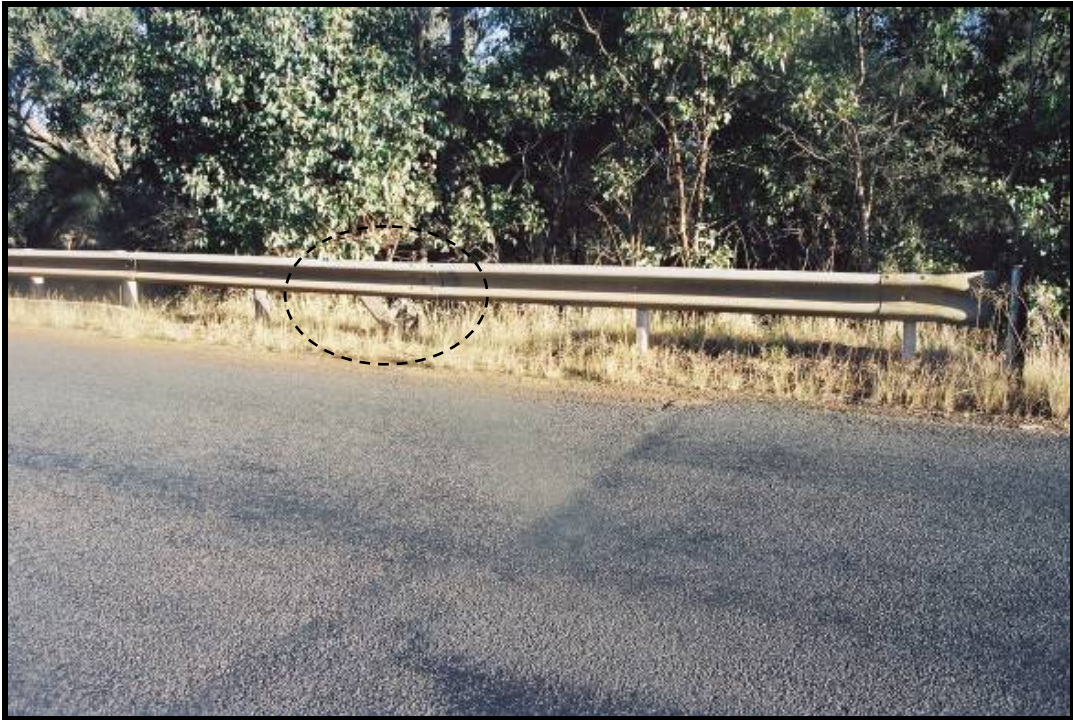
Photo 13 - DEPARTURE RAILING HAS BROKEN POSTS

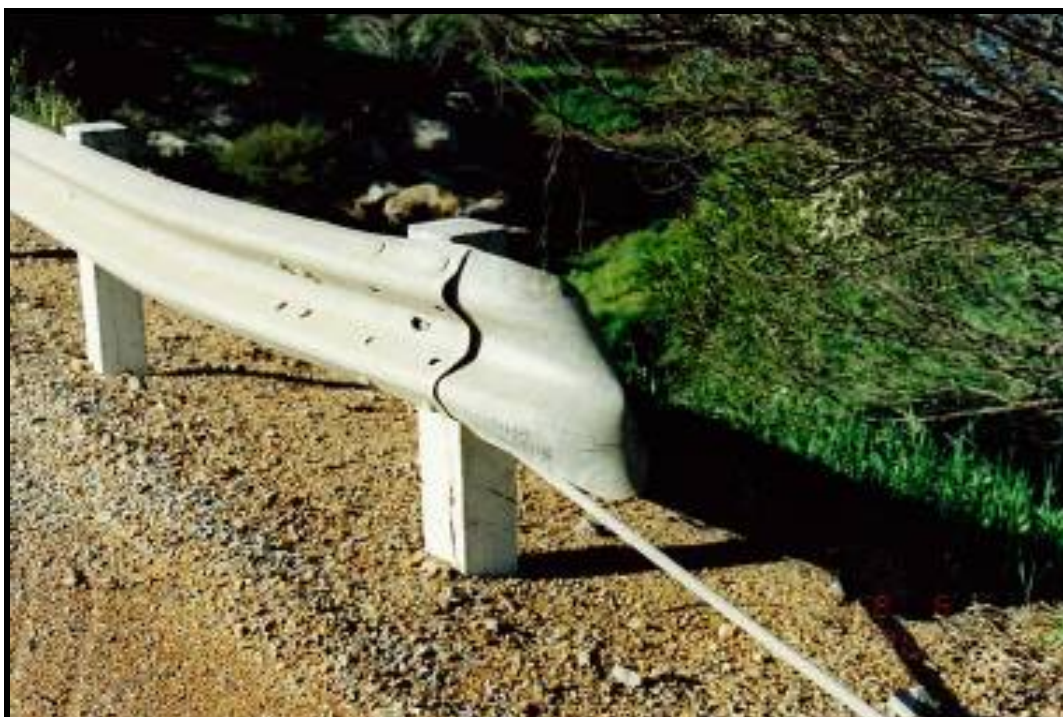
Photo 15 - DAMAGED FISHTAIL AT ABUT 1 RHS

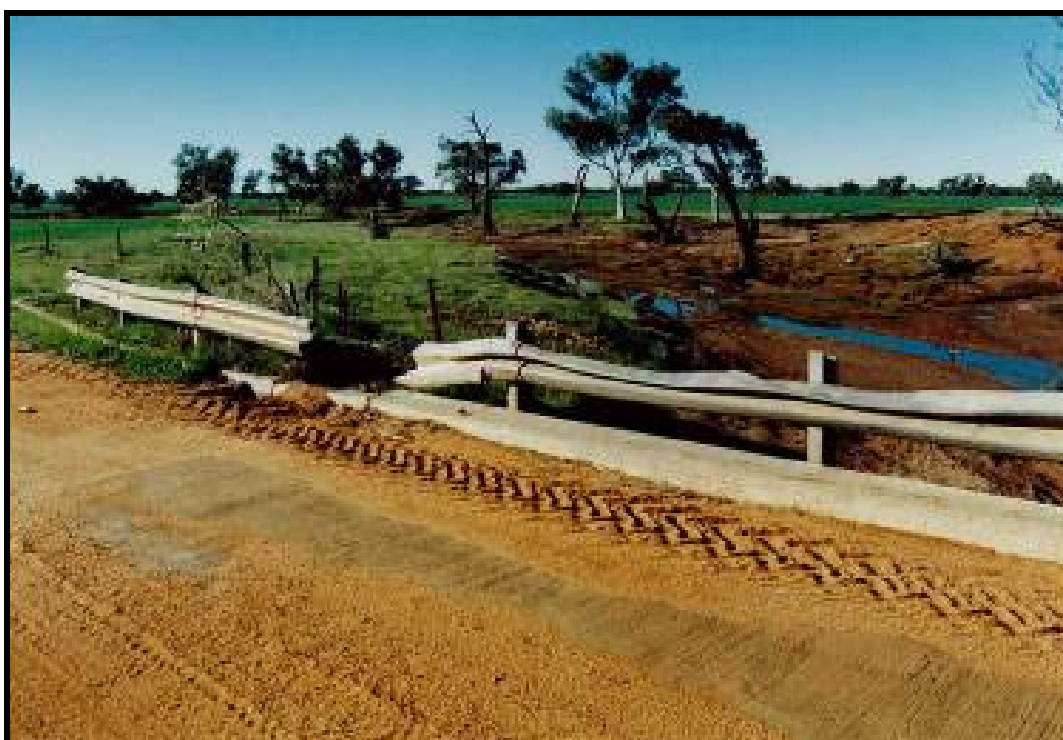
Photo 16 - IMPACT DAMAGE TO RHS GUARDRAIL

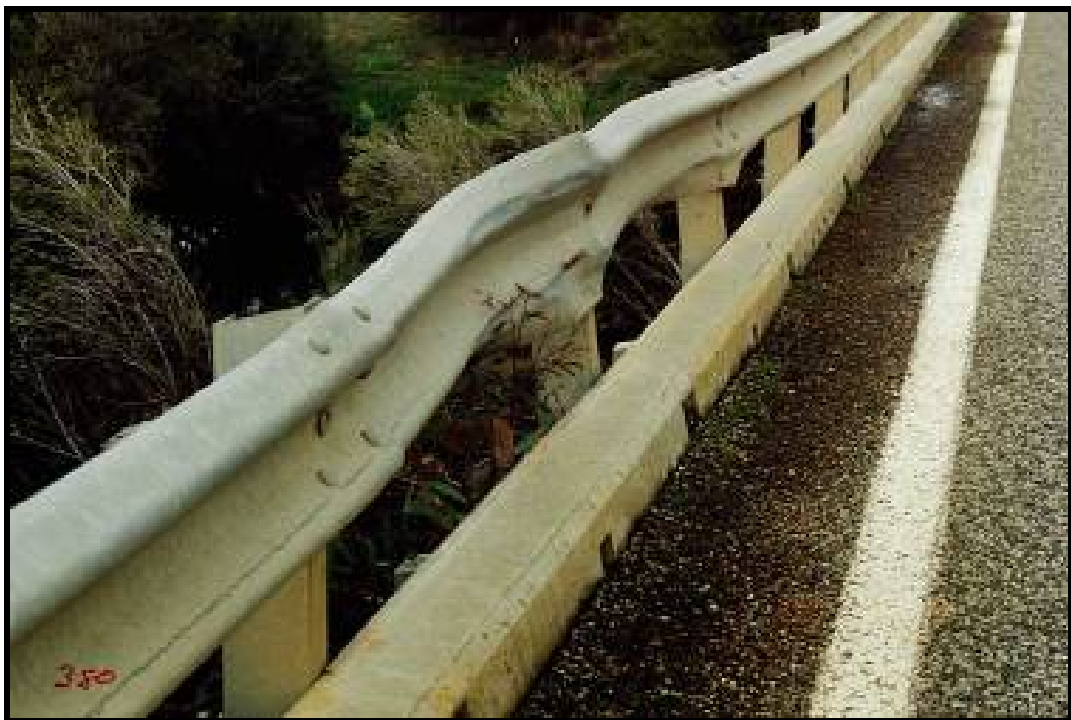
Photo 17 - IMPACT DAMAGE ALONG FLEX-BEAM

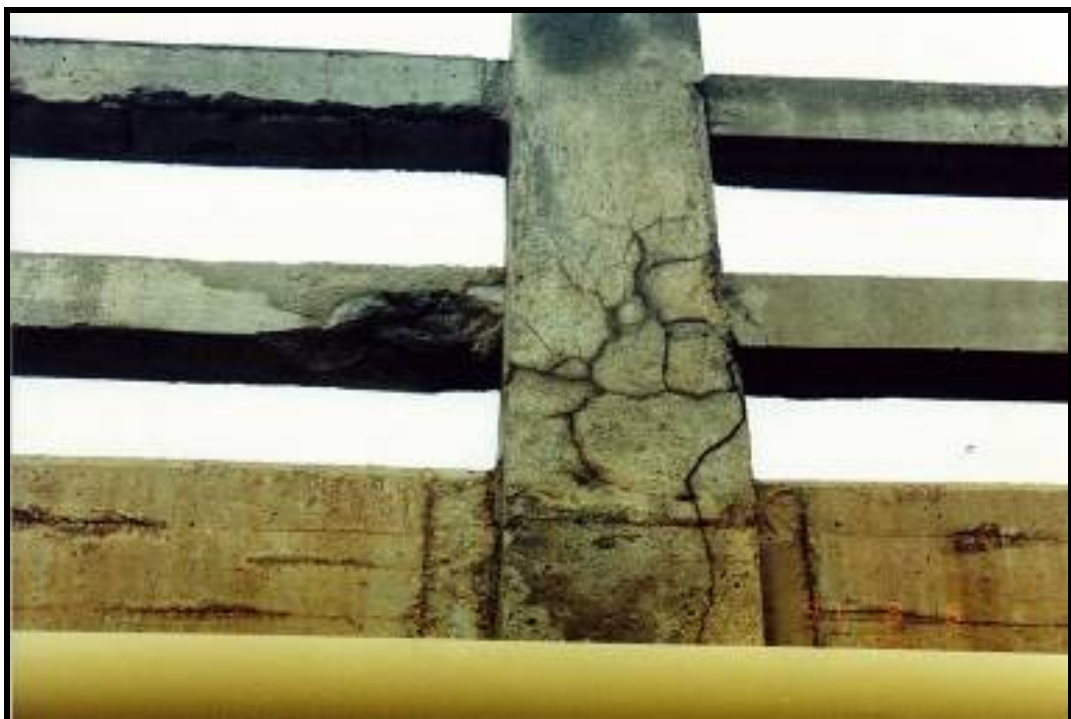
Alkali Aggregate Reactivity – AAR or Alkali Silica Reaction (ASR) is the phenomenon where some aggregates react adversely with the alkalis in cement to produce a highly expansive alkali-silica gel. Three factors must be present: reactive silica in the aggregate; significant alkalinity; and moisture. The expansion of the gel under moist conditions leads to cracking and deterioration of the concrete. AAR can be difficult to recognise and identify. Typical adverse features of AAR in concrete structures include cracking expansion and consequent misalignment of components, spalling of fragments of surface concrete and the presence of gel in fractures. It is advisable to undertake testing (Level 3 Inspection) to conclusively diagnose AAR. A photograph can be found in Appendix D, Photo 18.

Photo 18 - ADVANCED ASR CRACKING IN POSTS AND RAILS

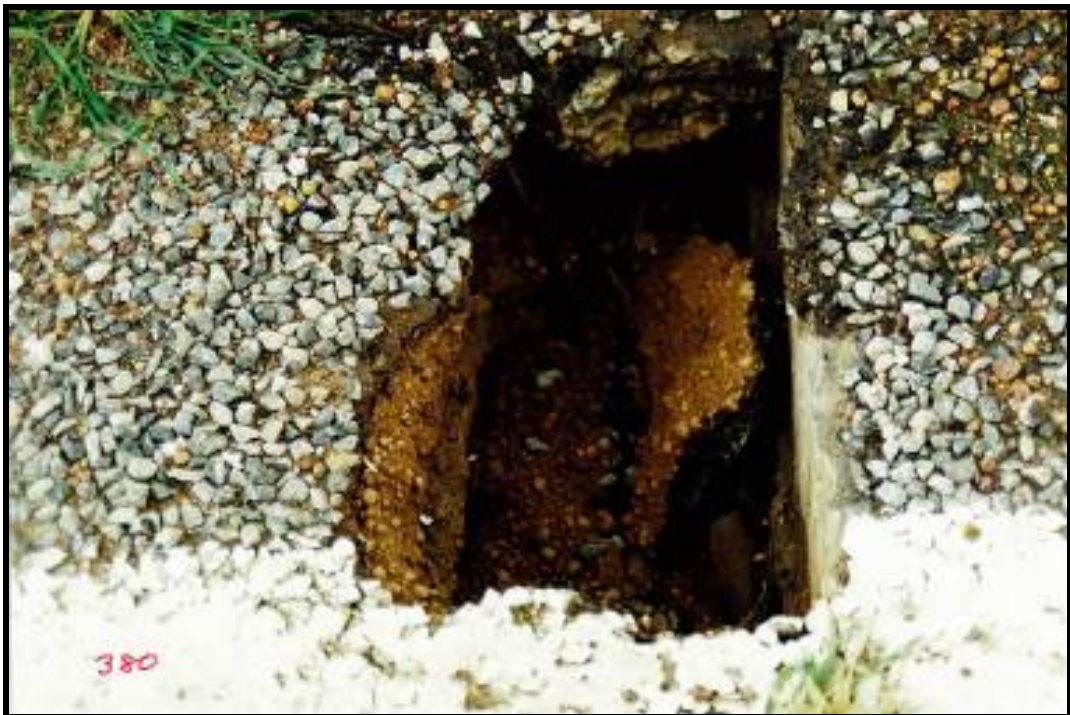
Photo 24 - LARGE HOLE IN ROAD APPROACH CAUSED BY POOR ROAD DRAINAGE

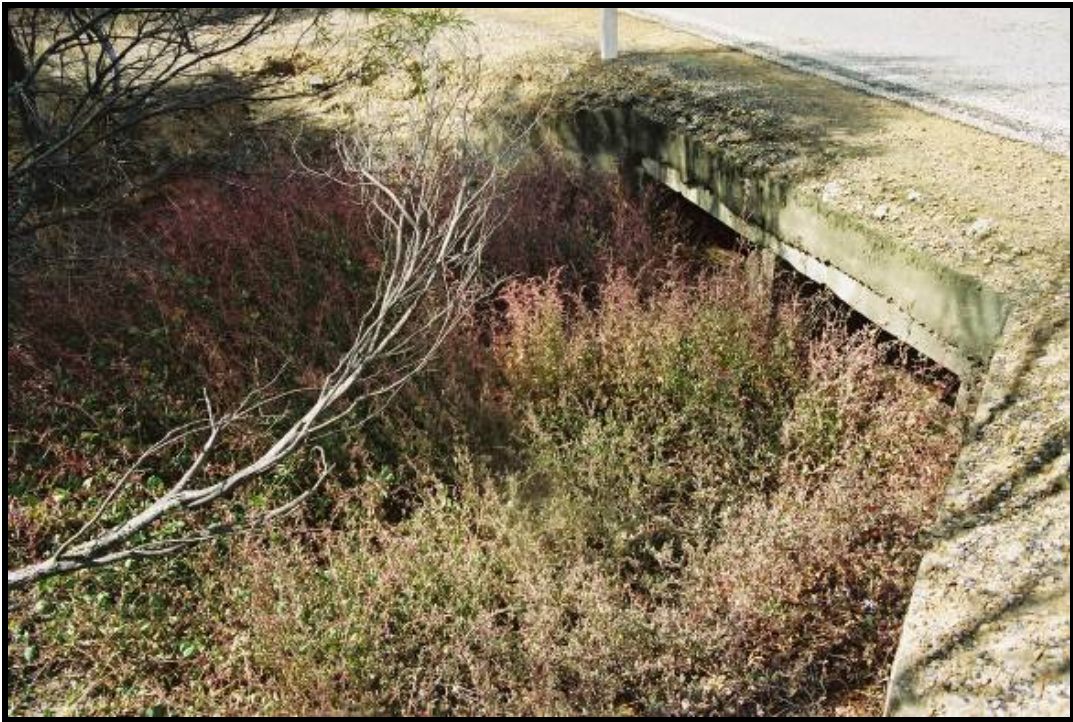
Photo 25 - BRIDGE OPENING IS BLOCKED BY HEAVY VEGETATION
