Structures Engineering

Routine Visual Bridge Inspection Guidelines (Level 1 Inspections) for Bridges

Document No: 6706-02-2234

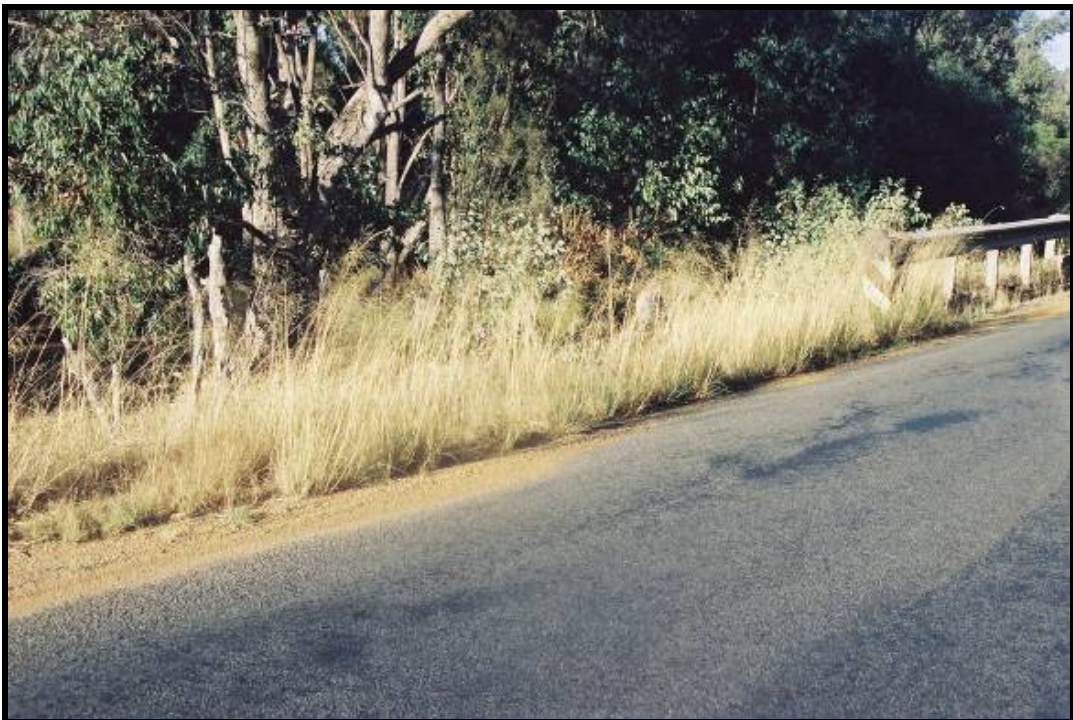
**Photo 26 - EXCESSIVE VEGETATION GROWTH ALONG ROAD SHOULDER
(Potential Fire Hazard)**

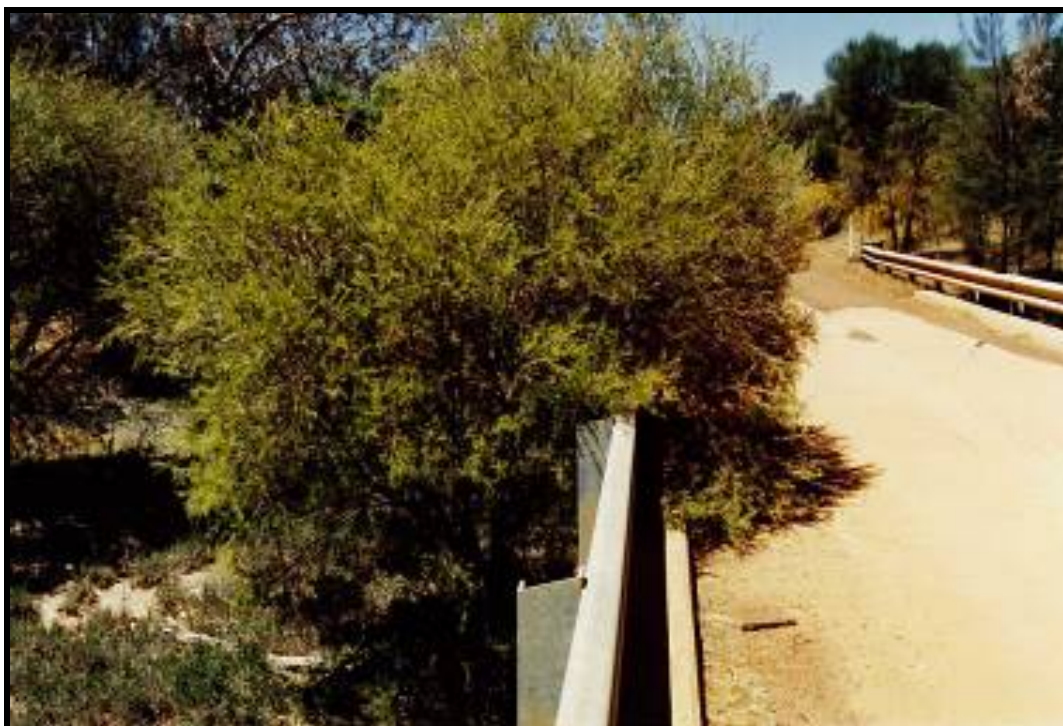
Photo 27 - TREE GROWING OVER RAIL AND ONTO ROAD

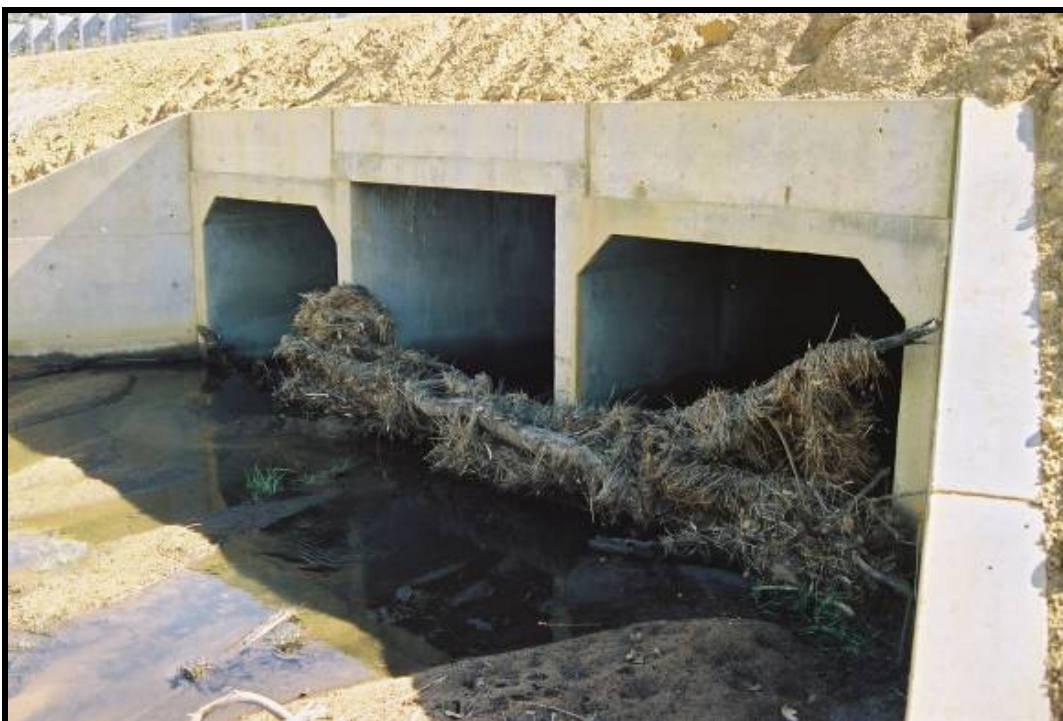
**Photo 28 - PRECAST BOX UNITS HAVE A BUILD-UP OF BRANCHES AND WEEDS
(This could cause future flow and/or scour problems)**

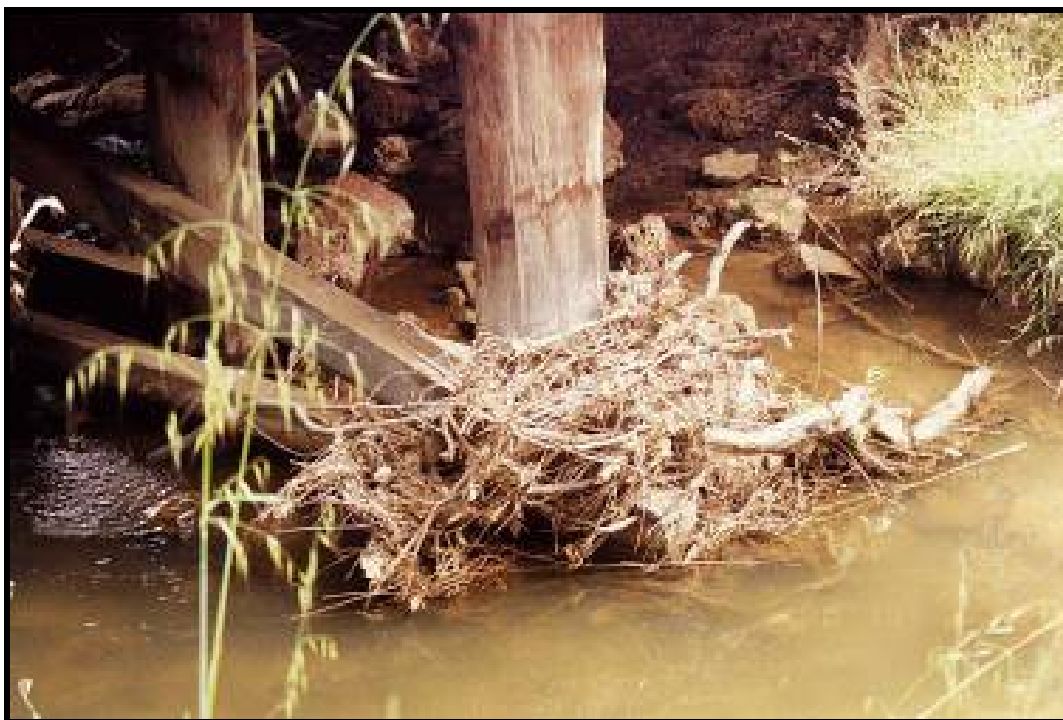
Photo 29 - DEBRIS BUILD-UP AROUND A TIMBER PIER PILE

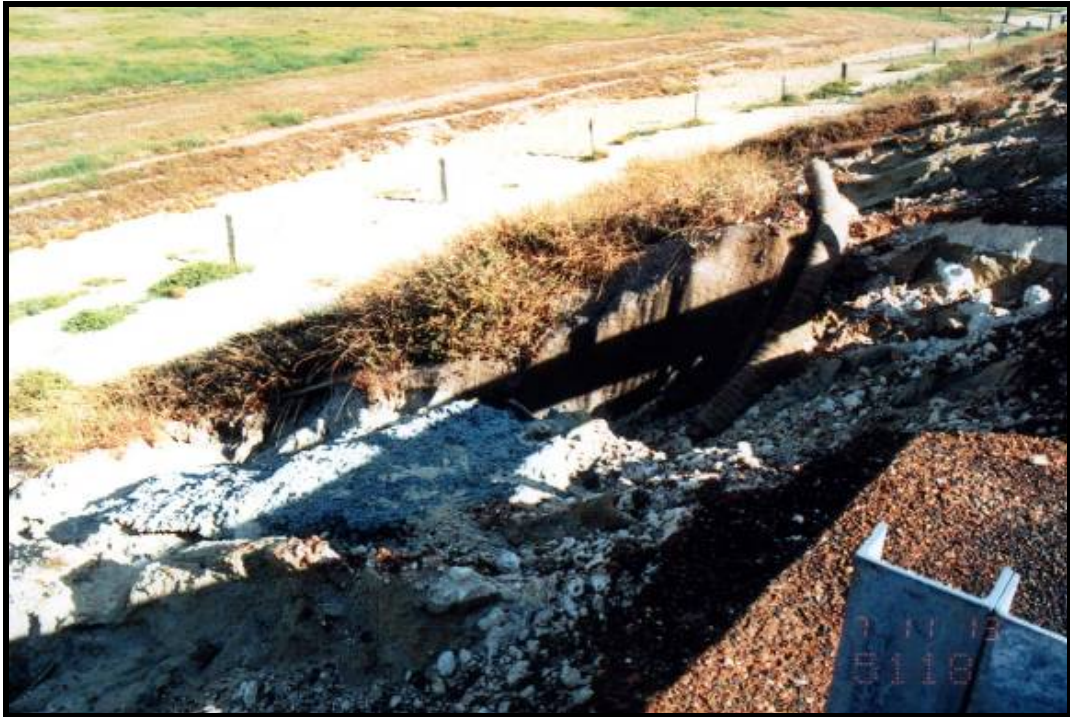
Photo 31 - SCOURING OF EMBANKMENT CAUSED BY EXCESSIVE ROAD RUNOFF

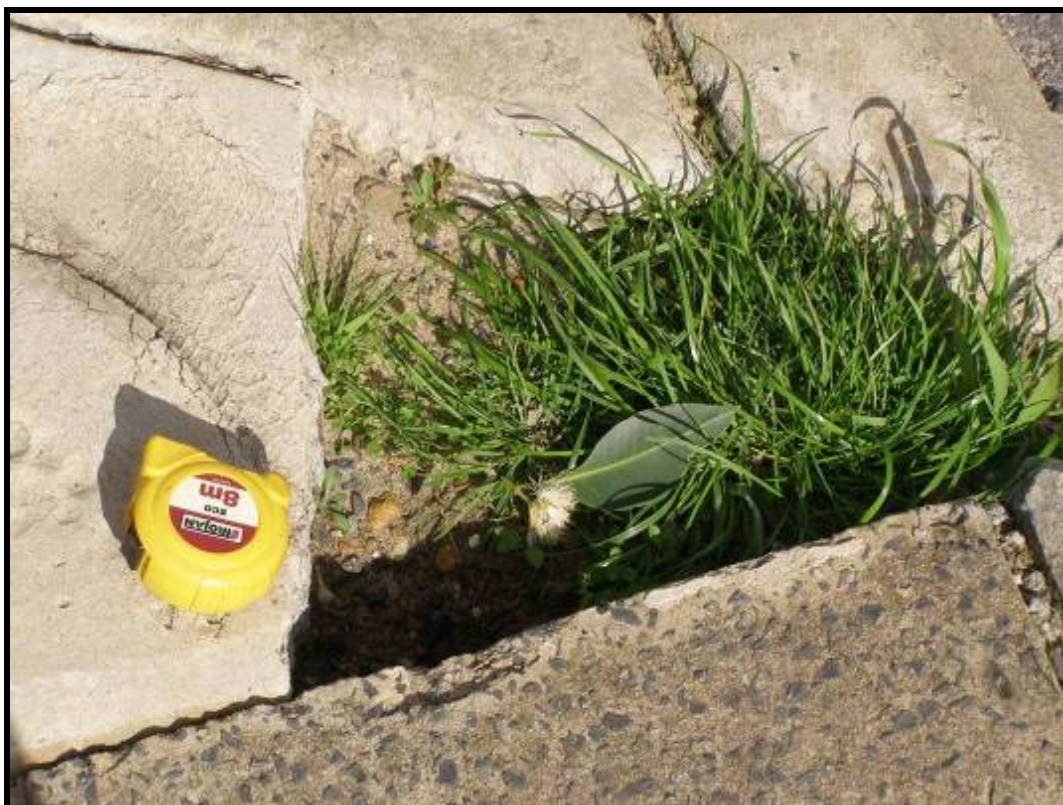
Photo 39 - HOLE IN FOOTPATH AT ABUTMENT 2

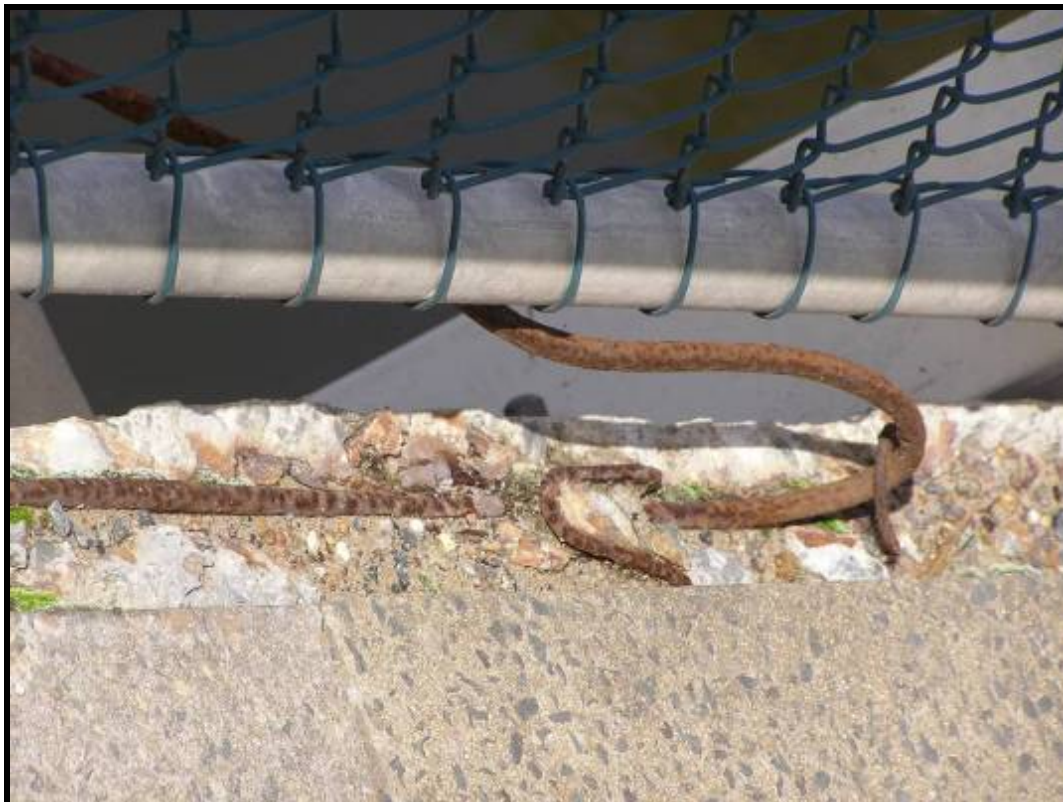
Photo 40 - TYPICAL POOR CONDITION OF CONCRETE KERB, LHS OF FOOTPATH

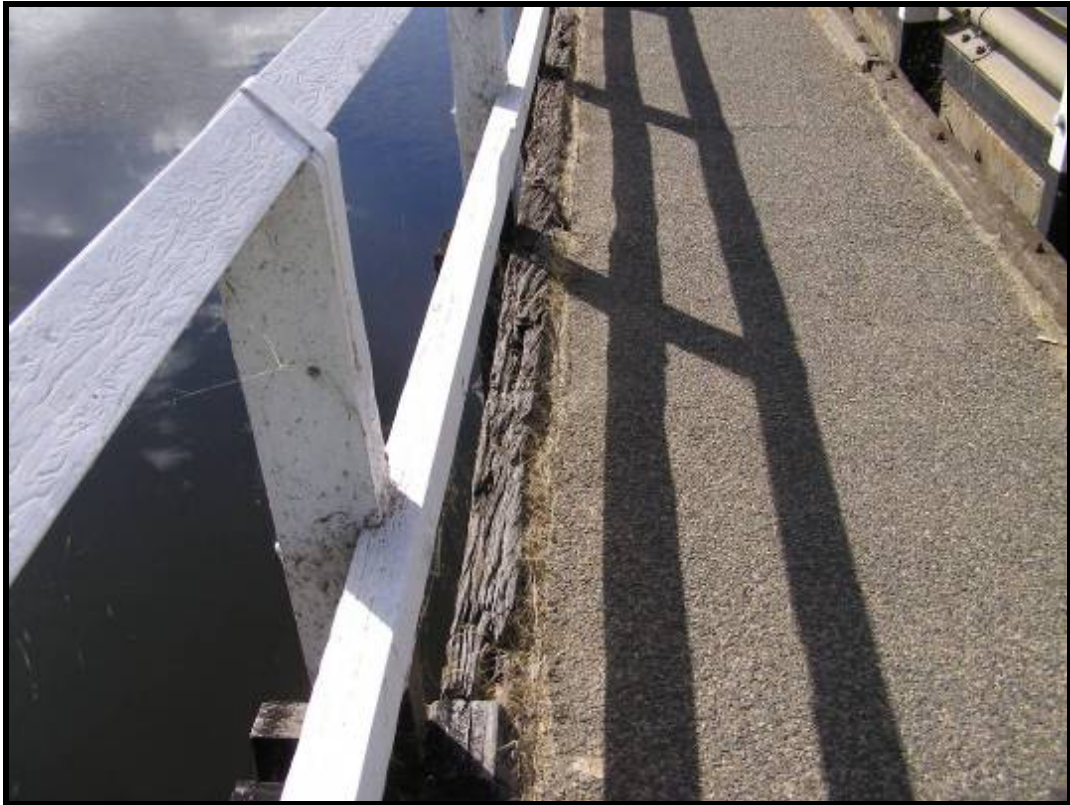
Photo 41 - TYPICAL POOR CONDITION OF TIMBER KERB, LHS OF FOOTPATH

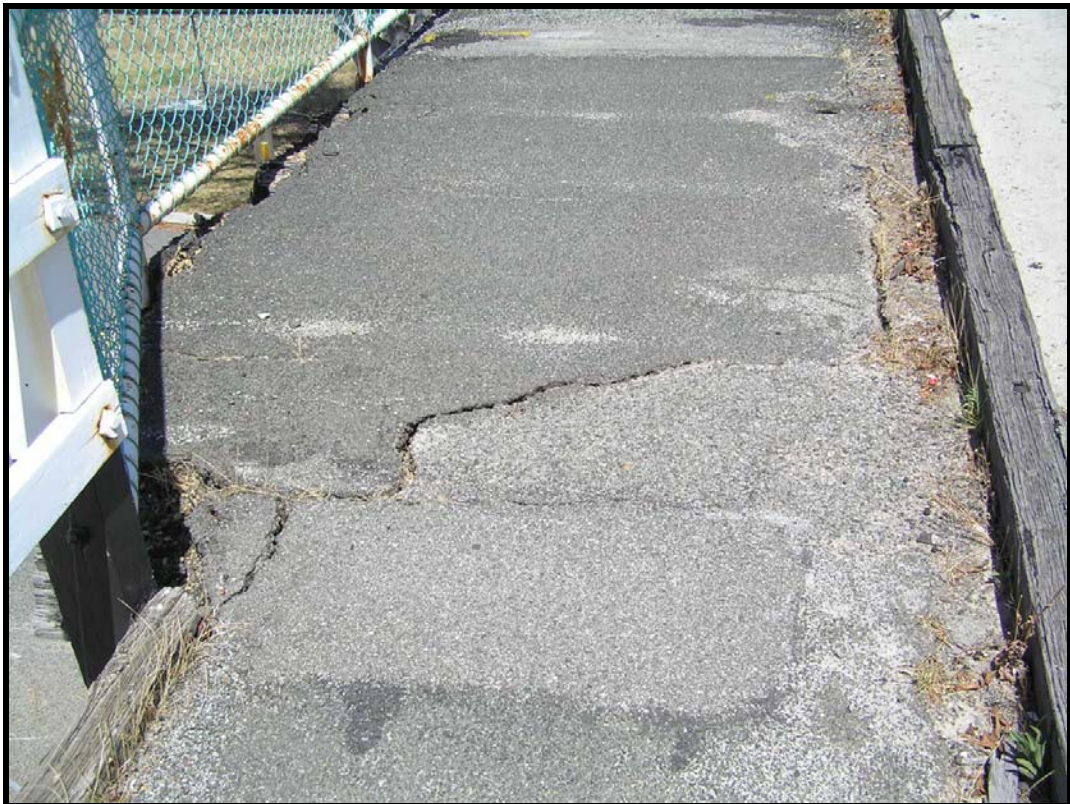
Photo 42 - POOR CONDITION OF FOOTPATH SURFACE

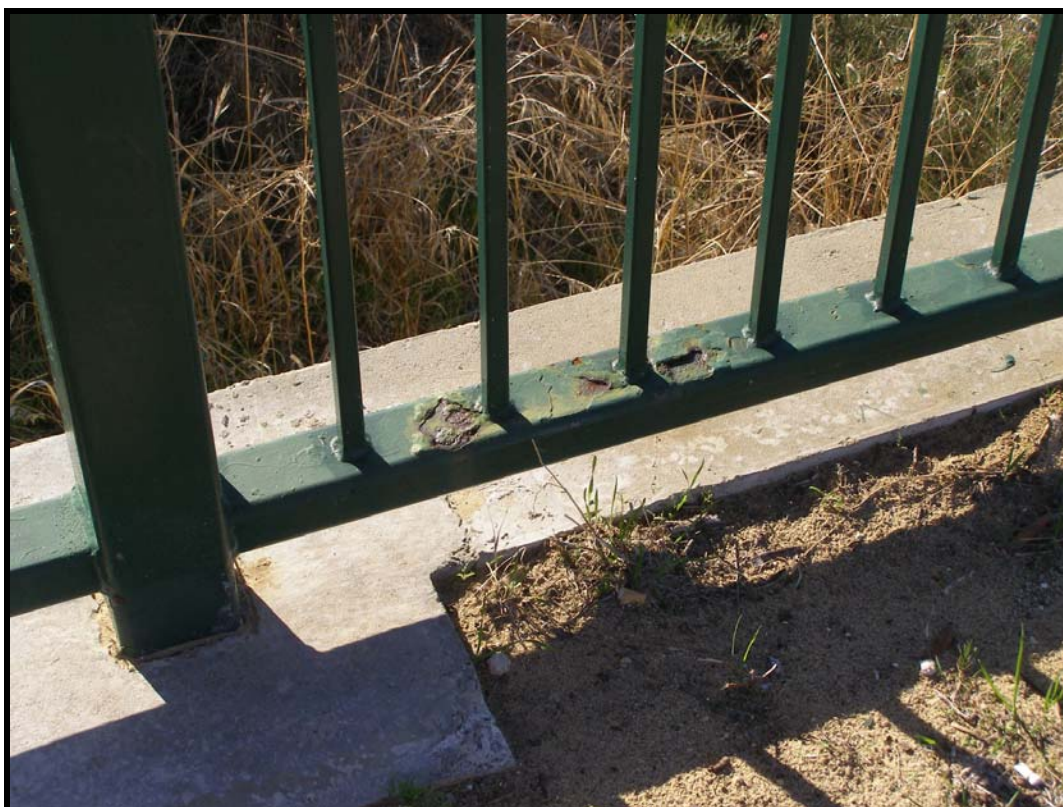
Photo 43 - CORROSION OF PEDESTRIAN BARRIER

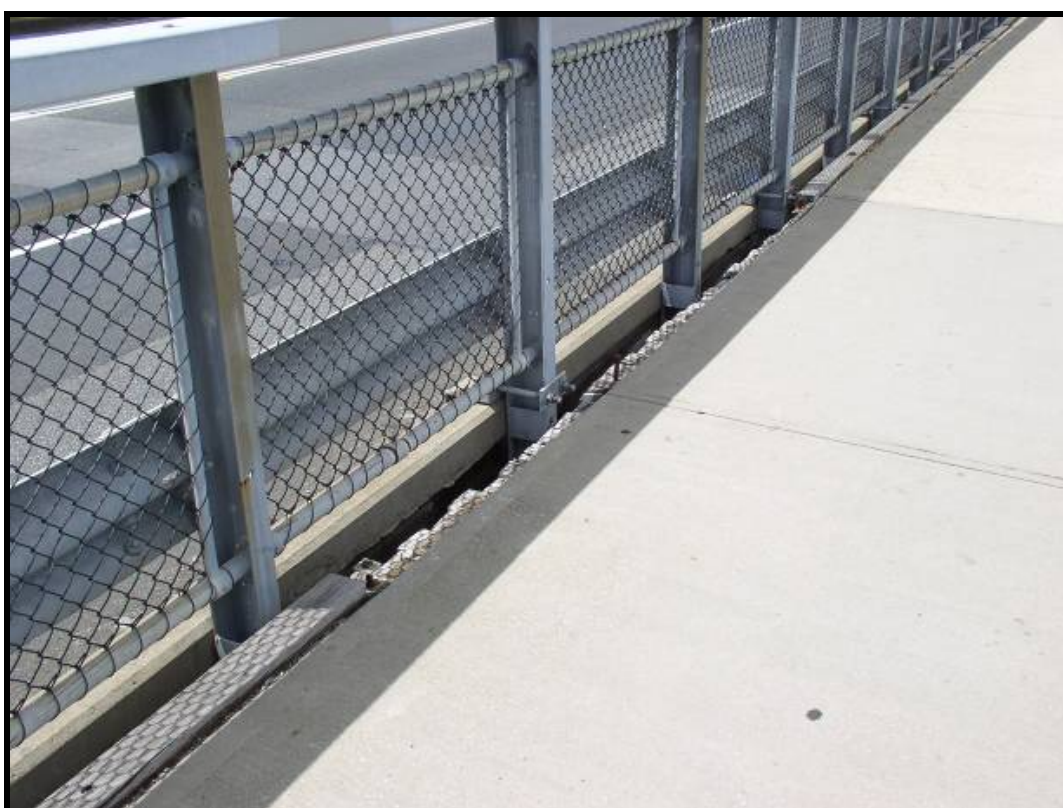
**Photo 44 - LHS KERB OF FOOTPATH MISSING OVER SPAN 28
EXPANSION JOINTS AND DECK JOINTS
(TIMBER AND NON-TIMBER BRIDGES)**

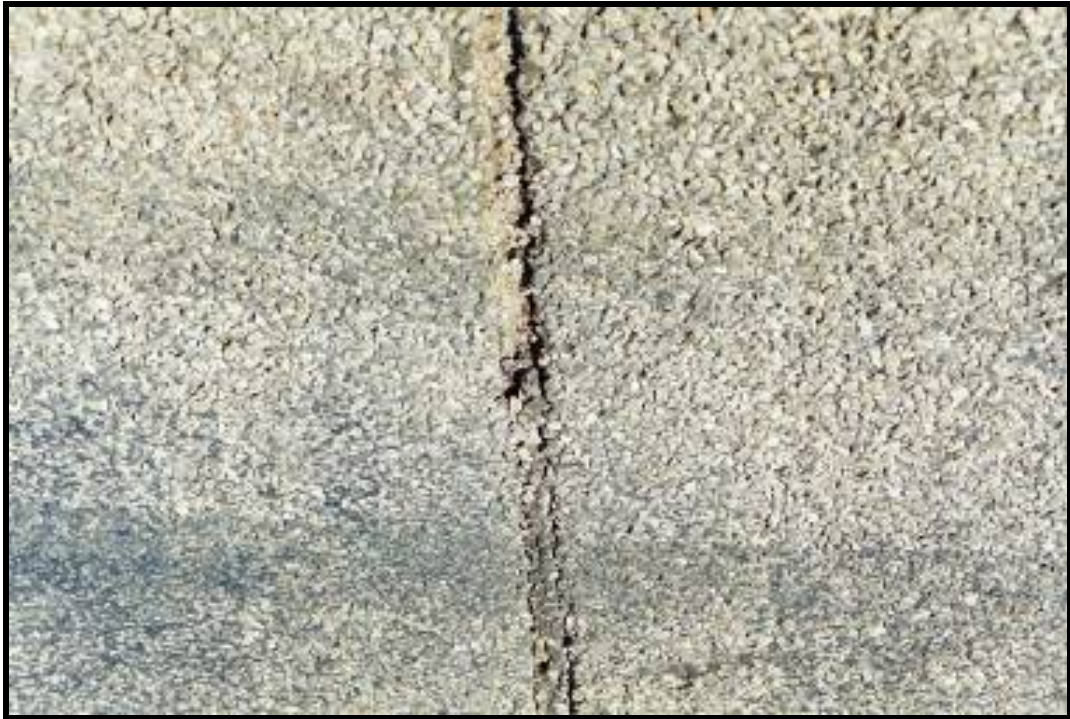
Photo 47 - WABO JOINT FILLED WITH ROAD SEAL

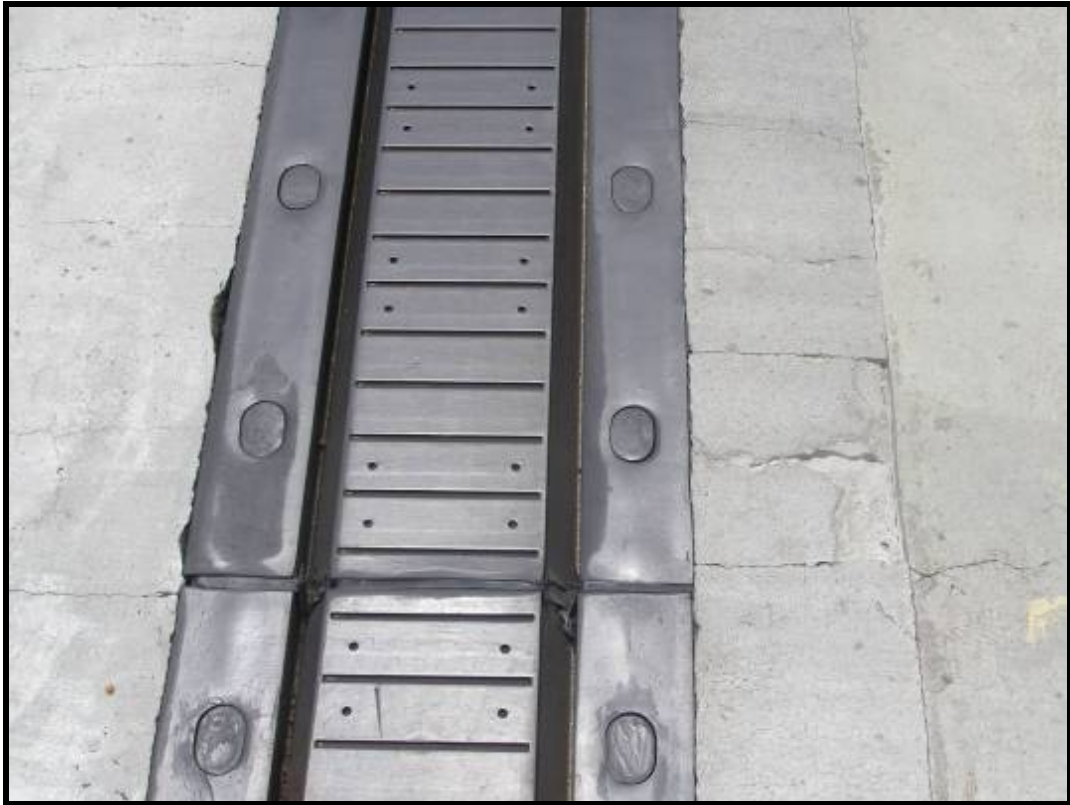
Photo 49 - CRACKS AND SPALLS TO CONCRETE AT DECK JOINT

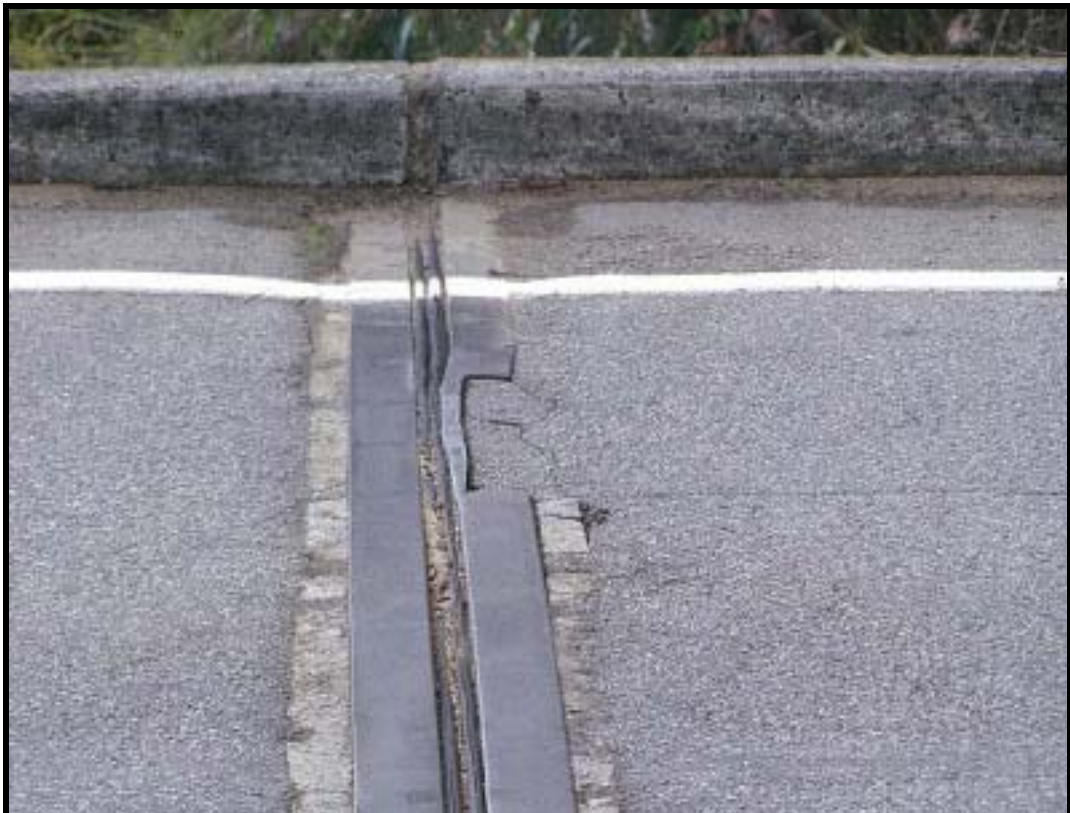
**Photo 50 - DAMAGED SECTION OF STEEL ANGLE
BEARINGS (TIMBER AND NON-TIMBER BRIDGES)**

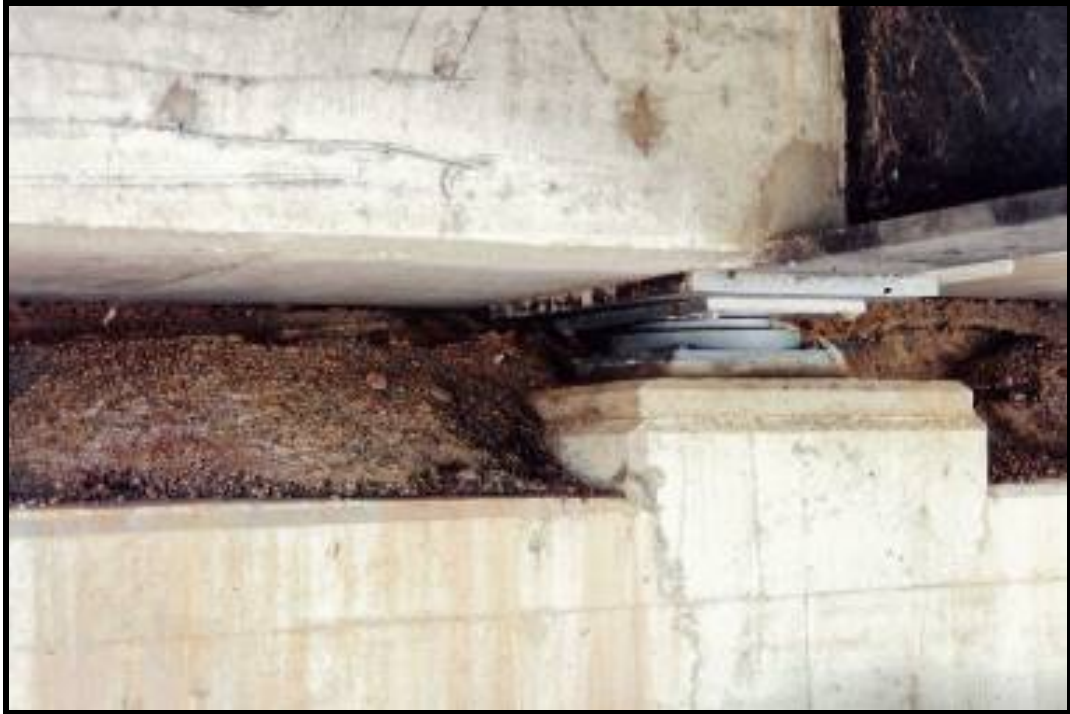
Photo 51 - BUILD-UP OF DEBRIS AROUND THE BEARING

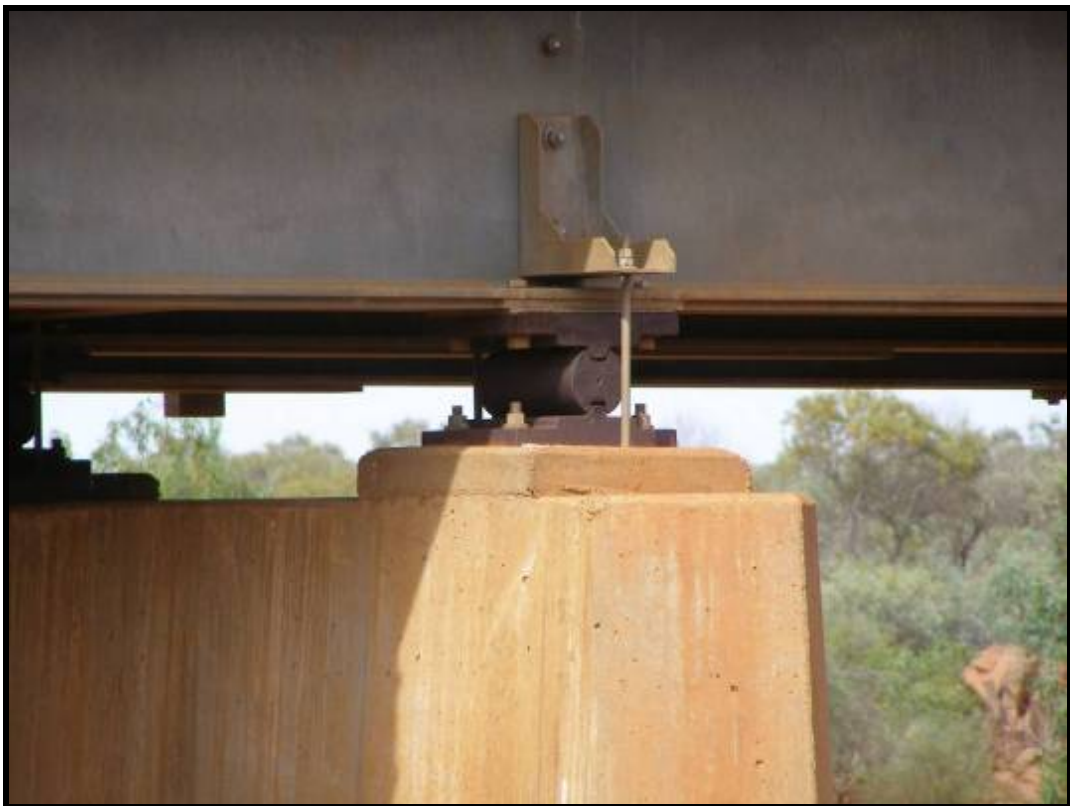
Photo 52 - CORRODED ROCKER BEARING

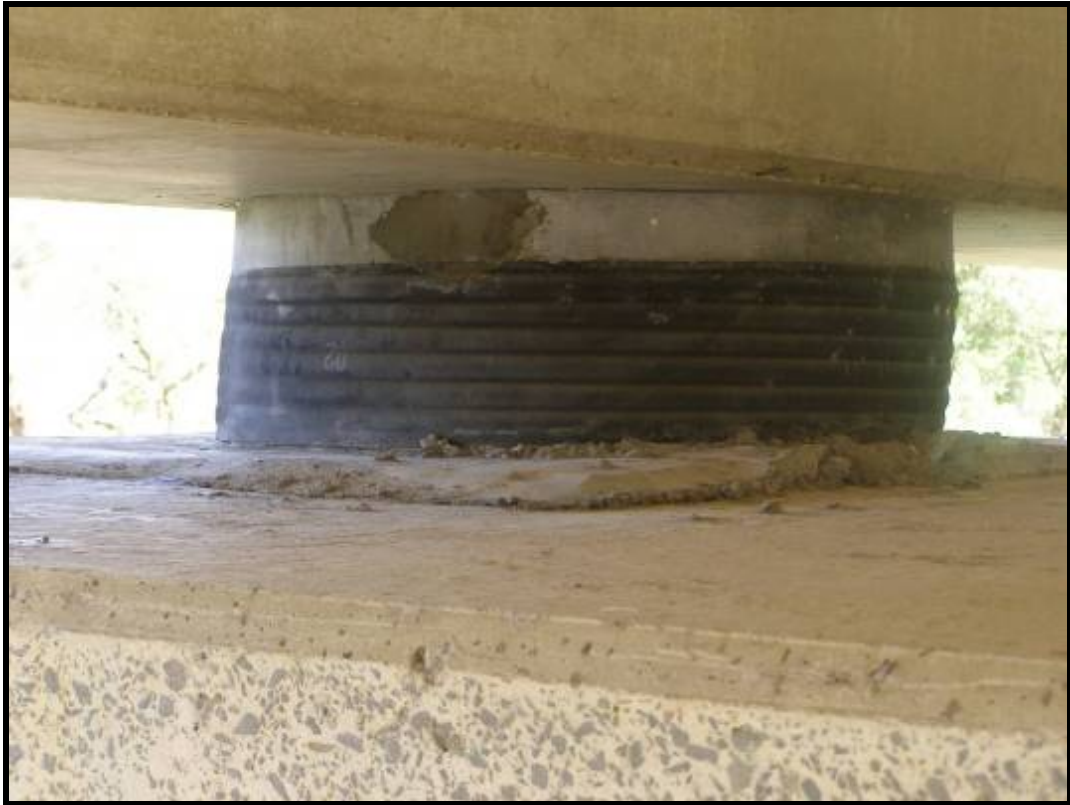
Photo 53 - SLIGHT BULGING OF ELASTOMERIC BEARING

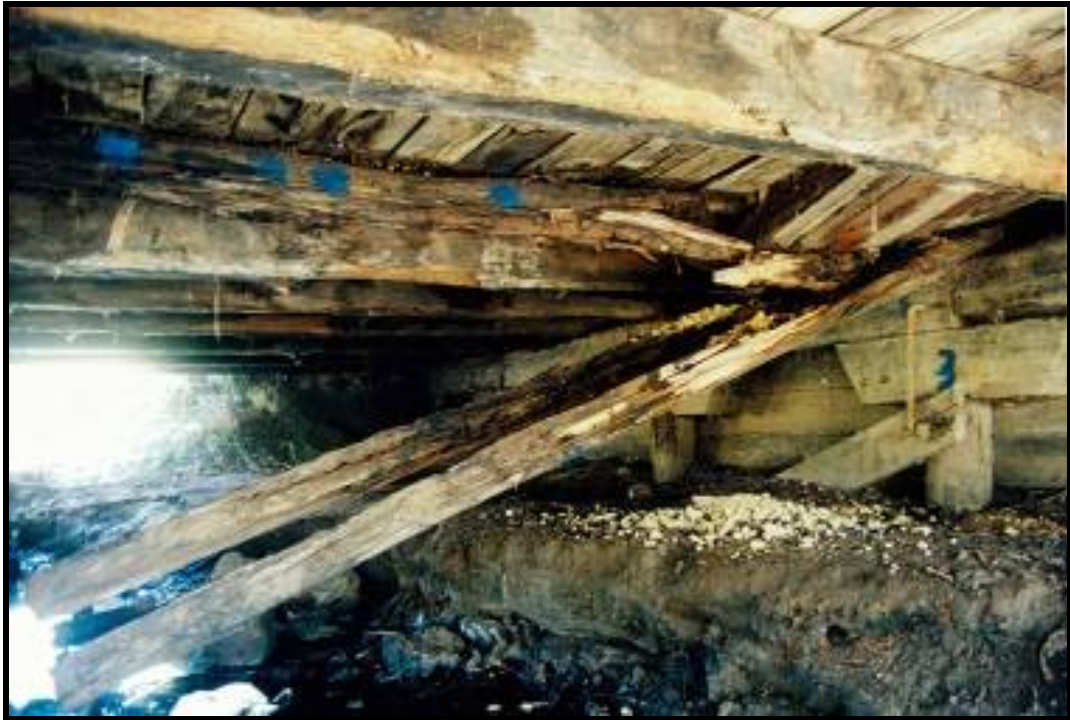
Photo 55 - FAILED STRINGER AND DECKING (Related to pothole shown at Photo 7)

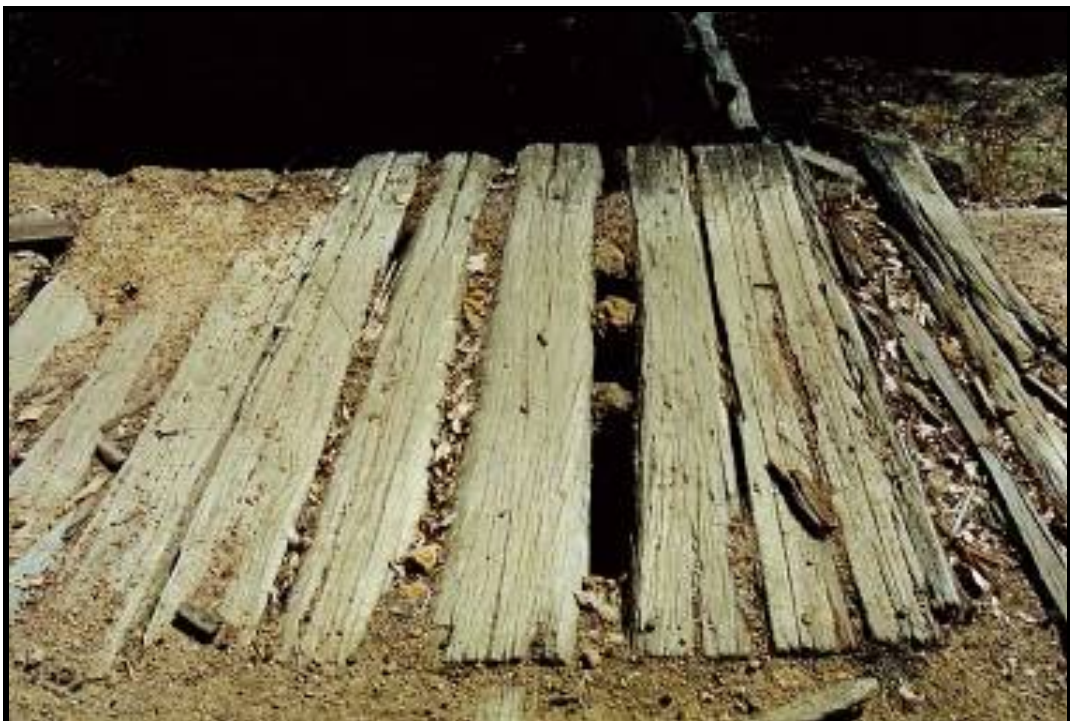
Photo 56 - DECK PLANKS IN VERY POOR CONDITION

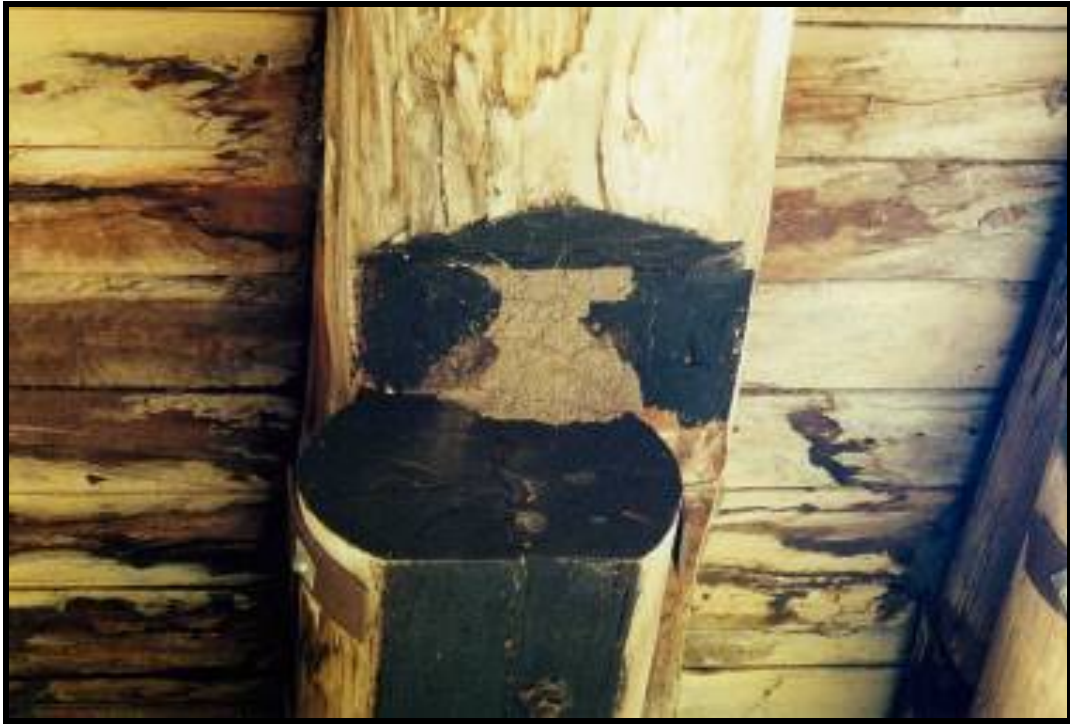
Photo 57 - TERMITE NEST IN STRINGER

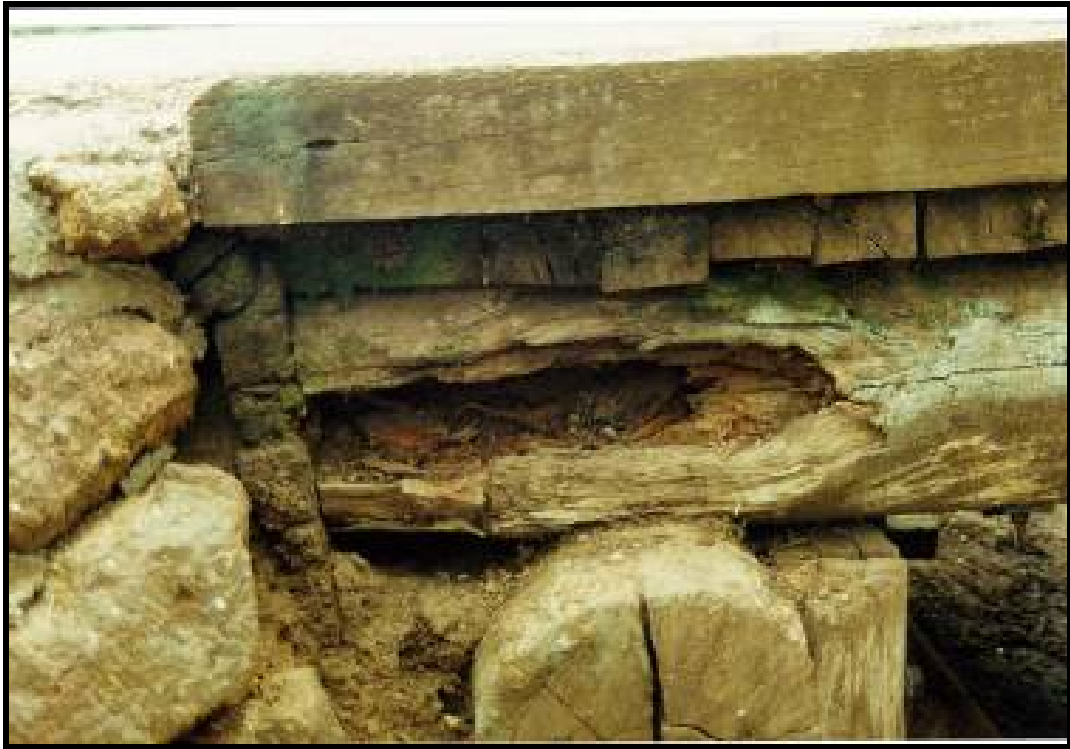
Photo 59 - LARGE ROT ZONE IN THE END OF THE OUTSIDE STRINGER

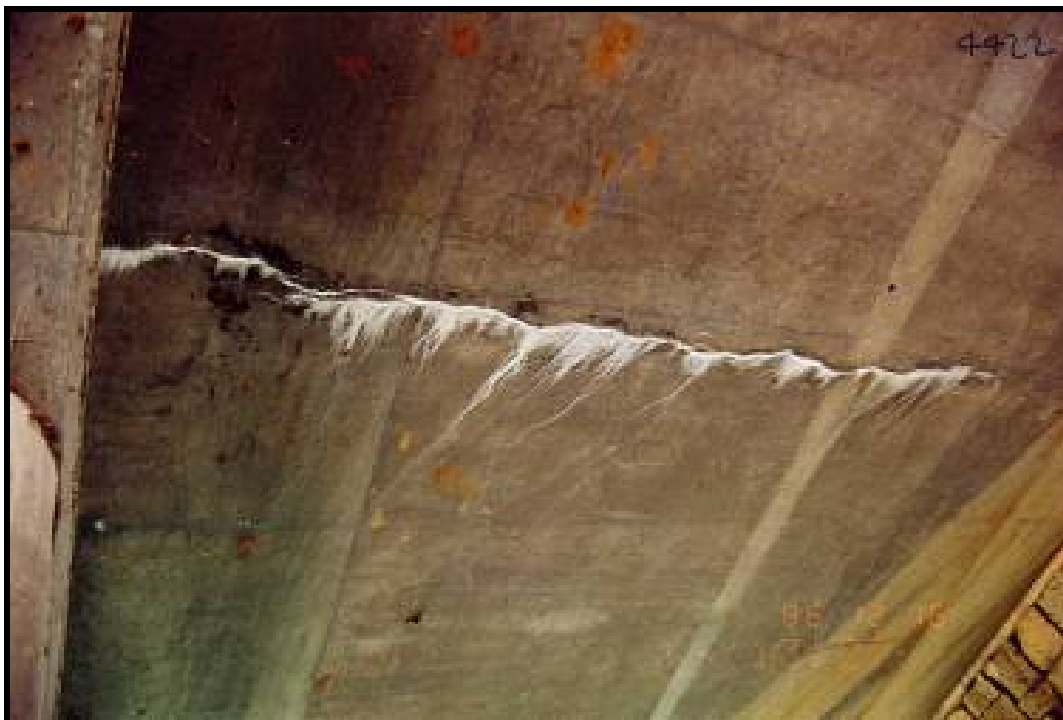
Photo 61 - EFFLORESCENCE FROM CRACK IN DECK SOFFIT

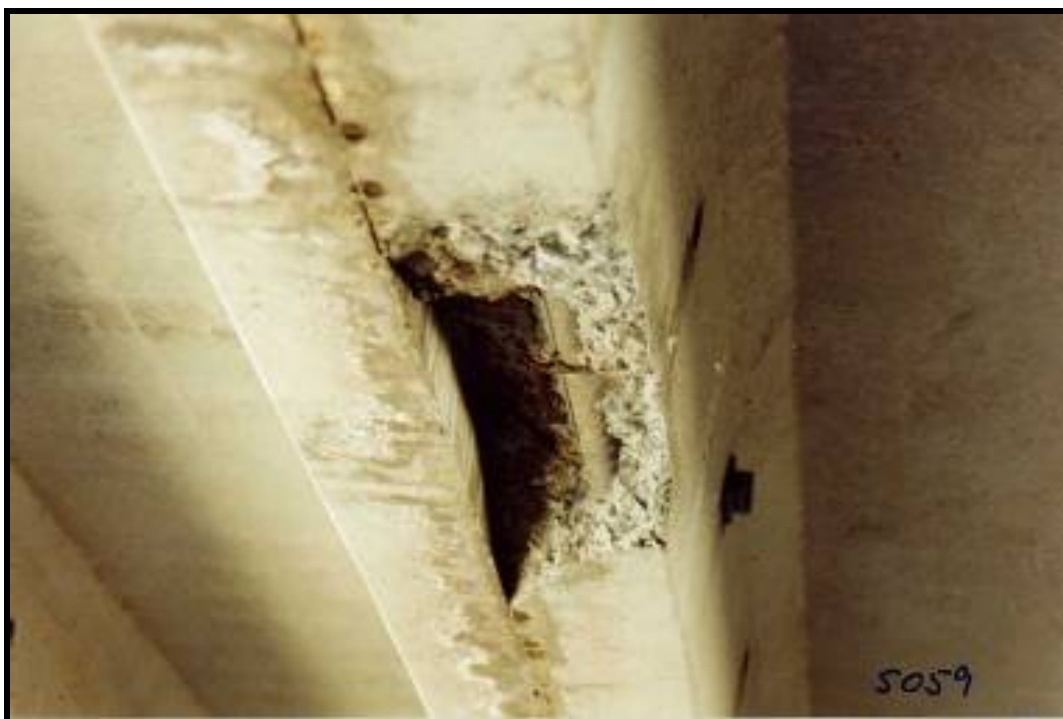
Photo 62 - DAMAGED U-BEAM LEG, EXPOSING REINFORCEMENT

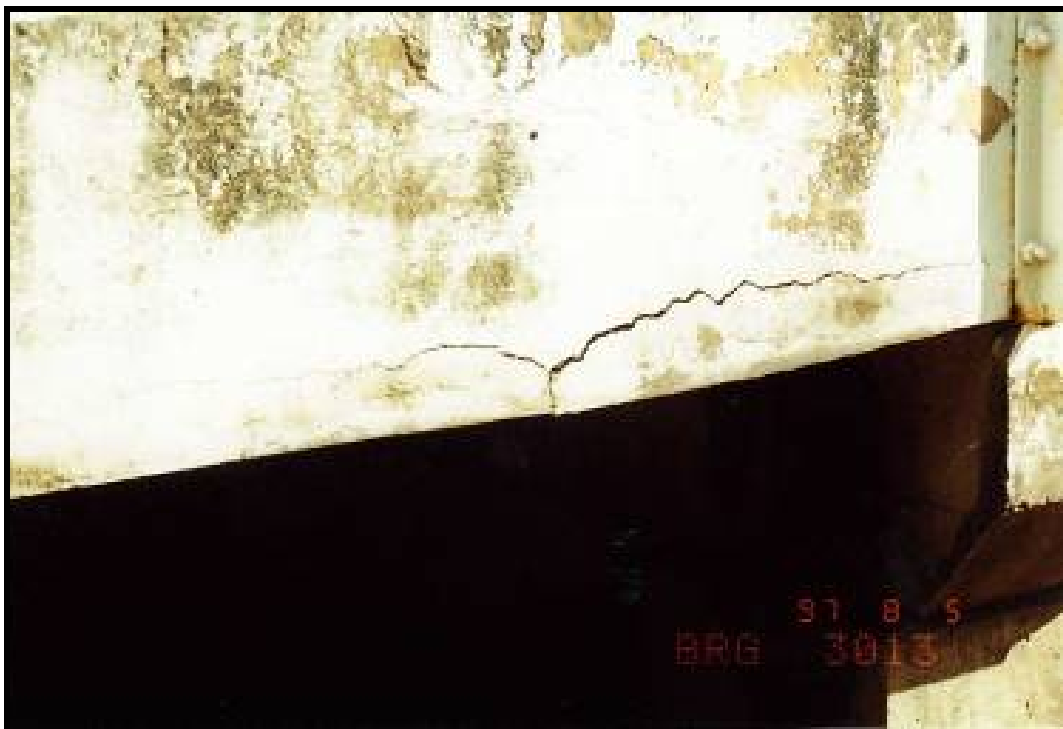
Photo 63 - HEAVY HORIZONTAL CRACK IN SIDE OF DECK

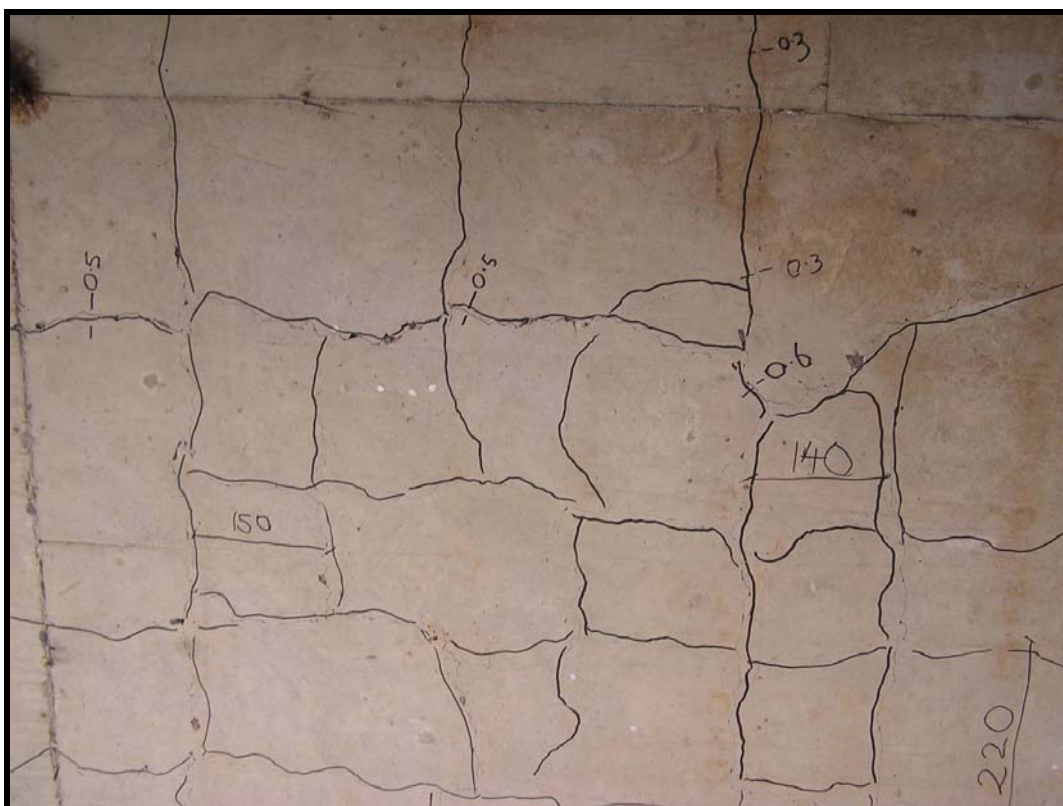
Photo 64 - MEDIUM SIZED CRACKS FORMING DECK BLOCK CRACKING
(NOTE: Mapping is *not* required for L1 inspection but block cracking should be noted)

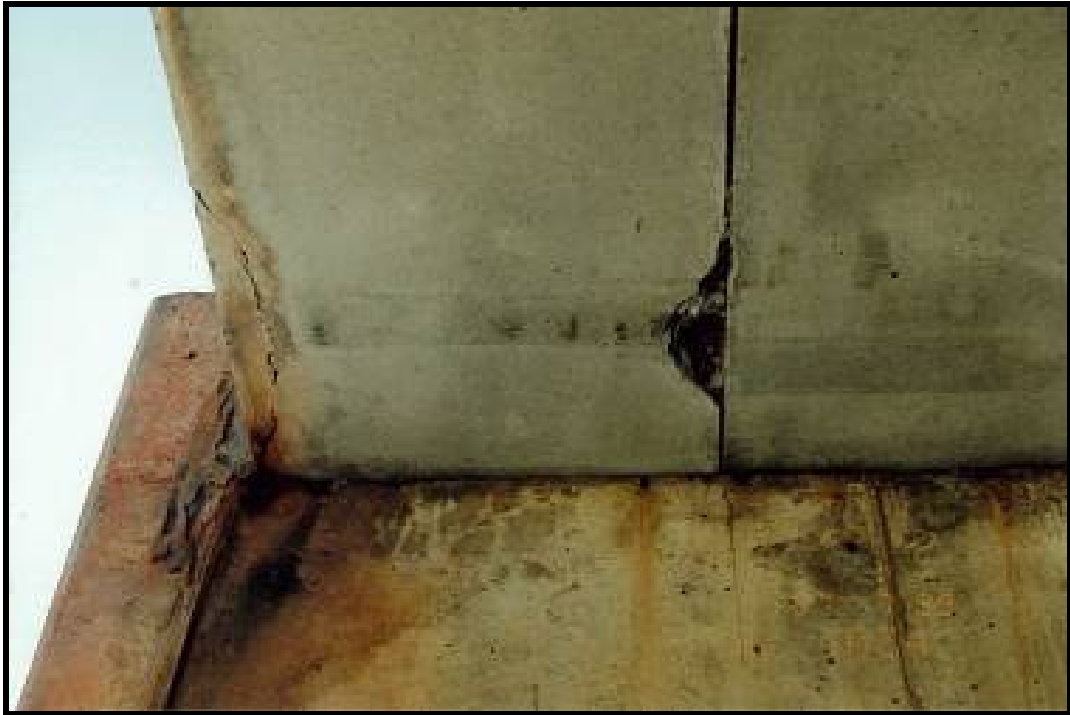
Photo 65 - DAMAGED SECTION OF BEAM (No change since previous inspection)

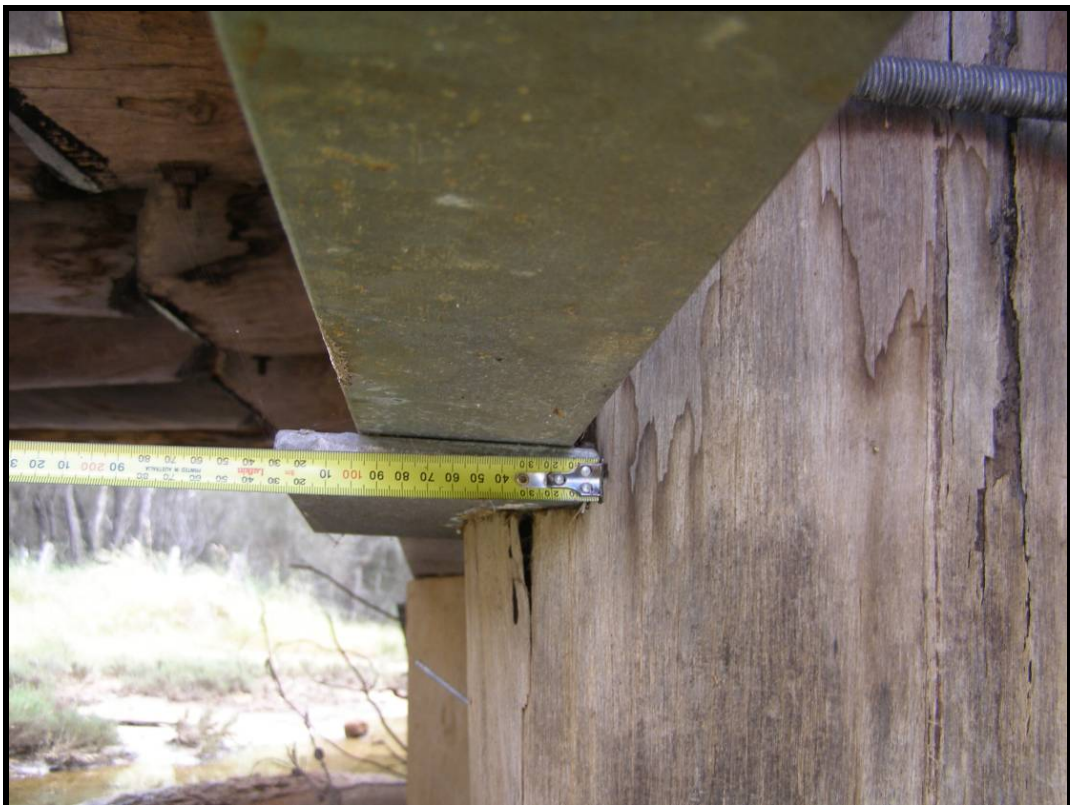
Photo 68 - HALFCAP SEATING STARTING TO SHOW SIGNS OF DISTRESS

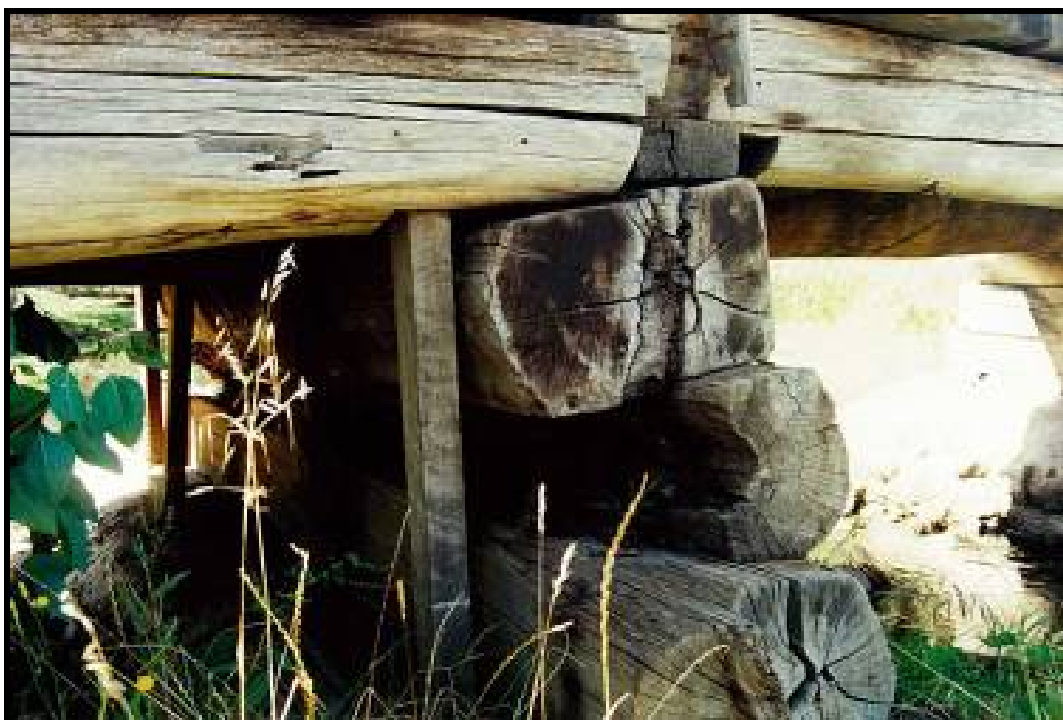
Photo 73 - FAILURE OF BEDLOG 2
