Structures Engineering

Routine Visual Bridge Inspection Guidelines (Level 1 Inspections) for Bridges

Document No: 6706-02-2234

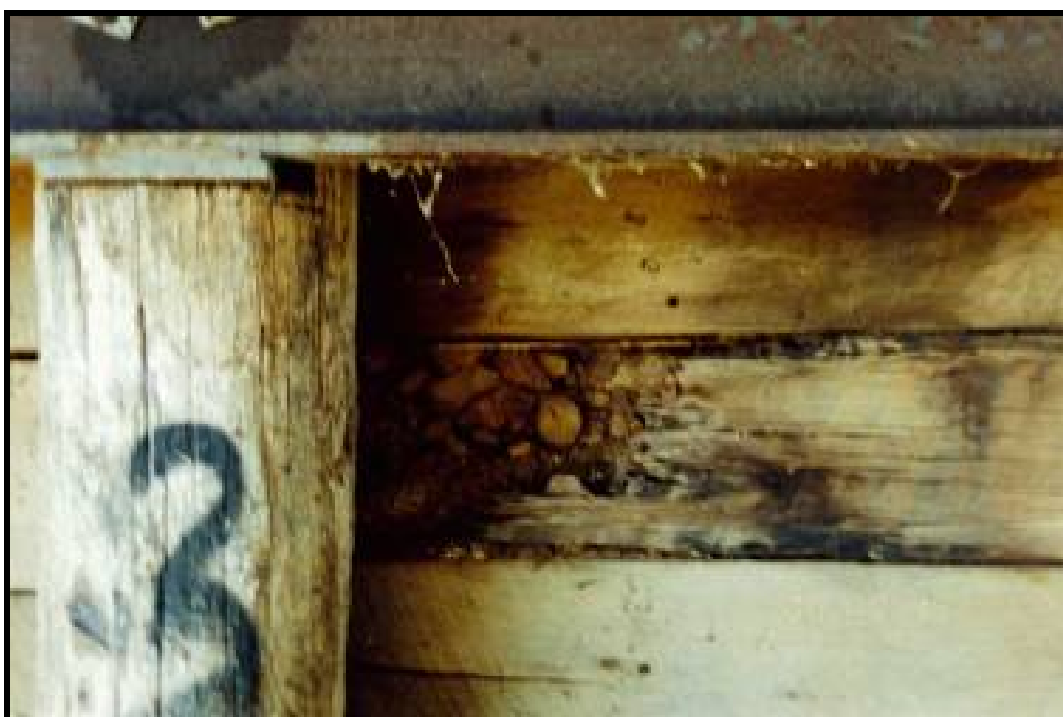
Photo 74 - FAILED SHEETING

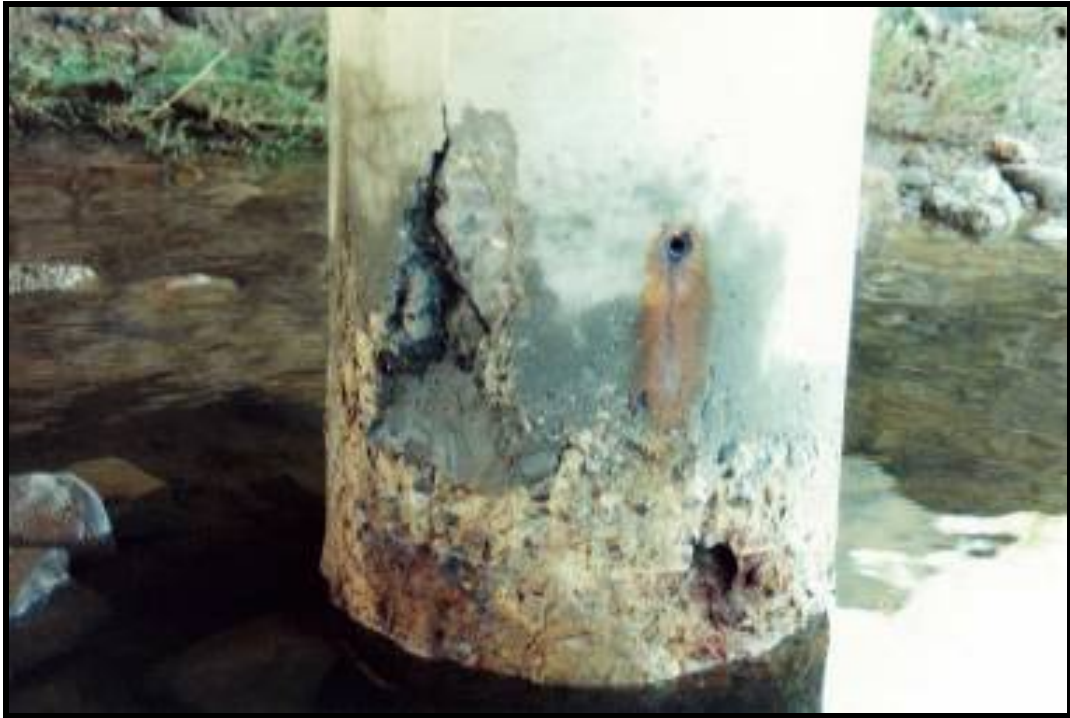
Photo 75 - BADLY DAMAGED COLUMN

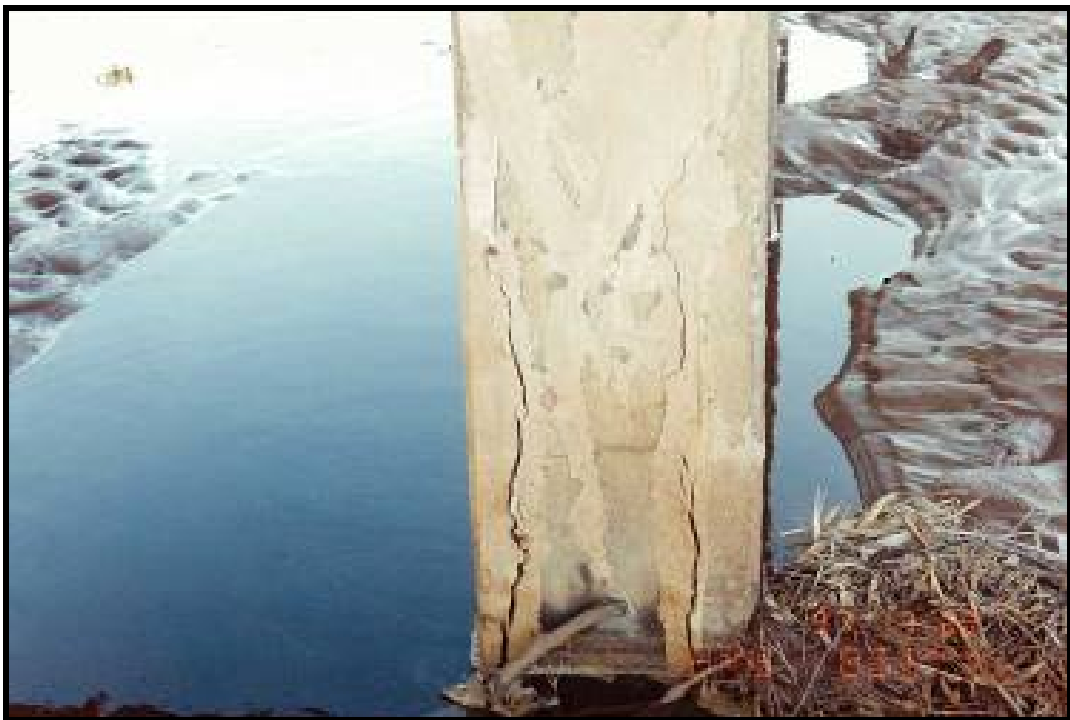
Photo 76 - HEAVY CRACKING FROM STEEL CORROSION, PIER 3, PILE 4

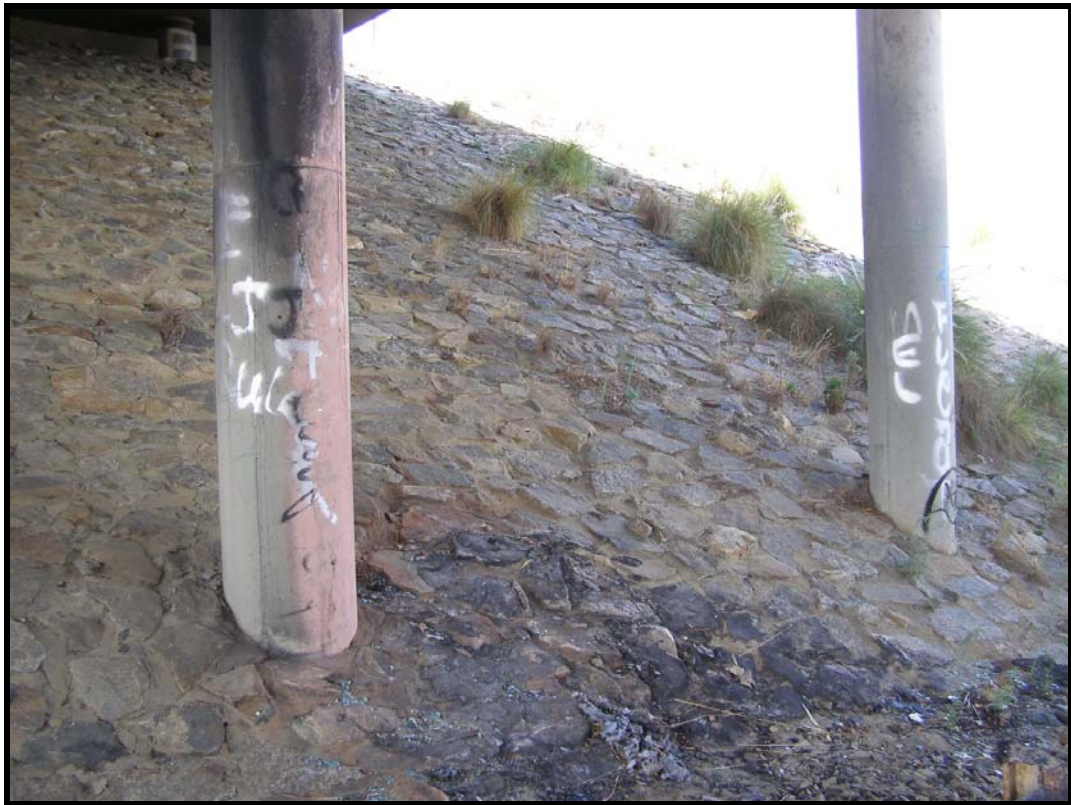
Photo 80 - FIRE DAMAGE TO CONCRETE COLUMN

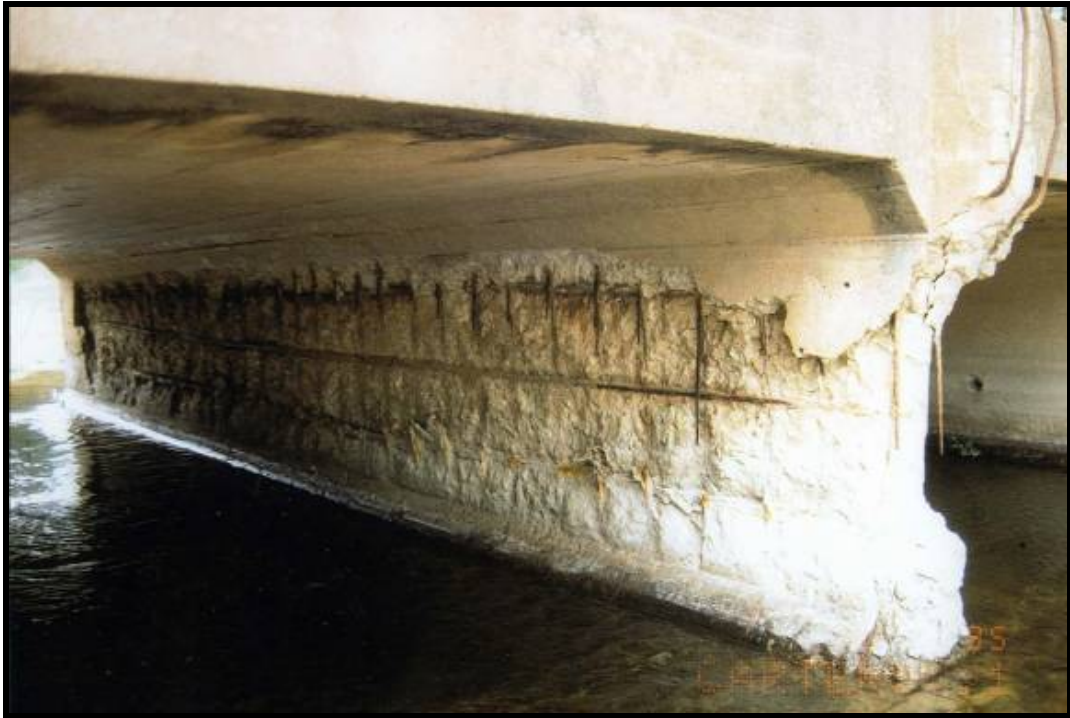
Photo 81 - BADLY ERODED CONCRETE WALL PIER

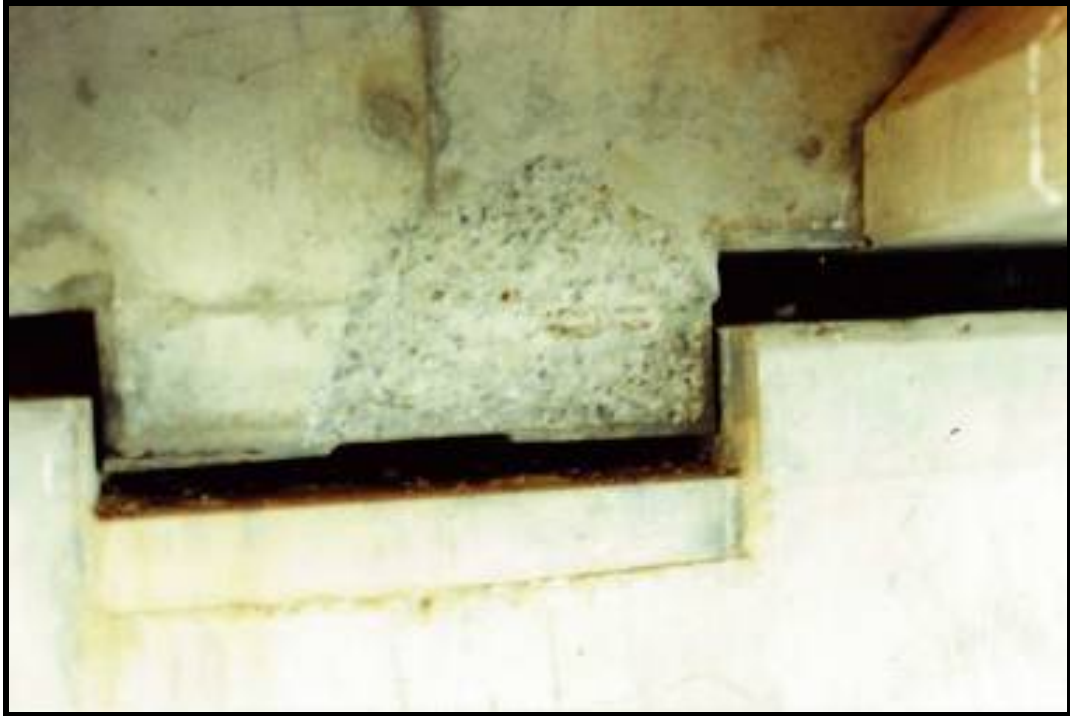
Photo 83 - SPALLED CONCRETE AT ABUT 1 SHEAR KEY

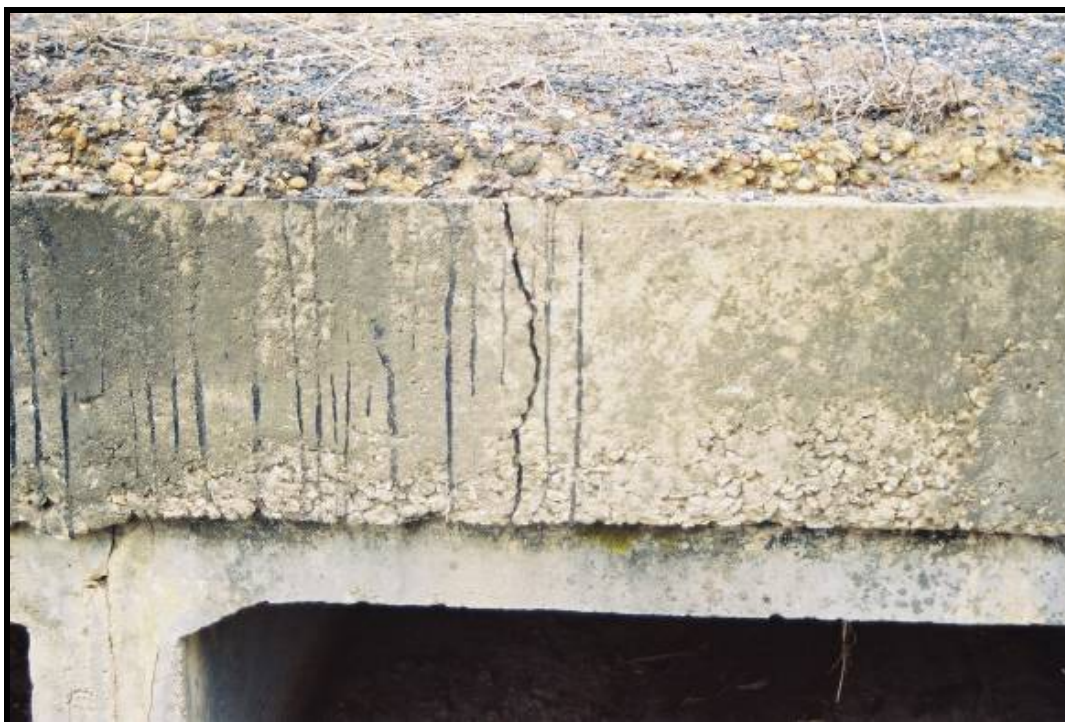
Photo 84 - PRECAST BOX UNIT HEADWALL HAS HONEYCOMBING, HEAVY CRACK

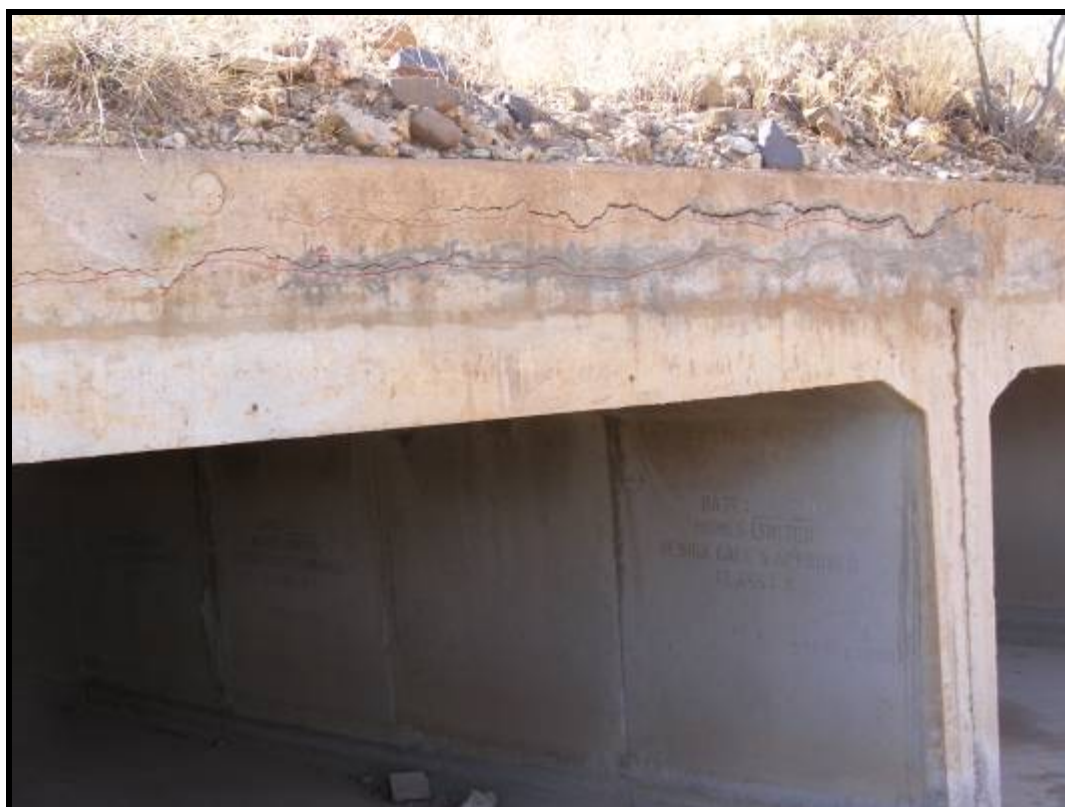
Photo 85 - HEADWALL LHS, HEAVY CRACKS OVER BARRELS 1 AND 2

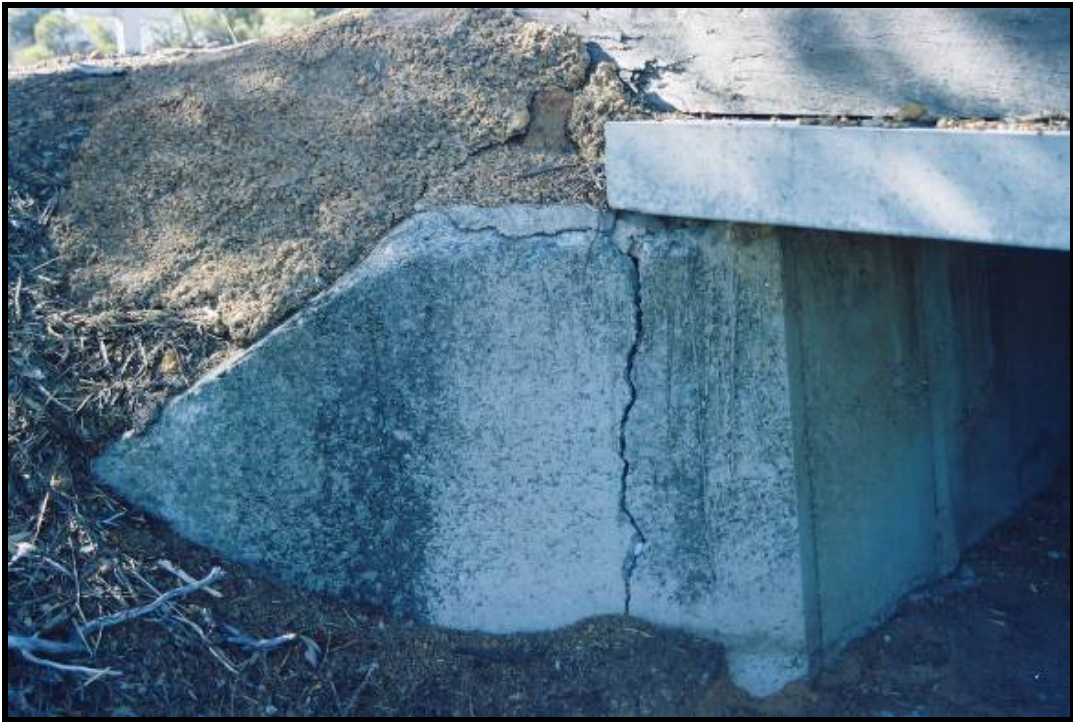
Photo 86 - PRECAST BOX UNIT WING WALL HAS HEAVY VERTICAL CRACK BUT APPEARS STABLE

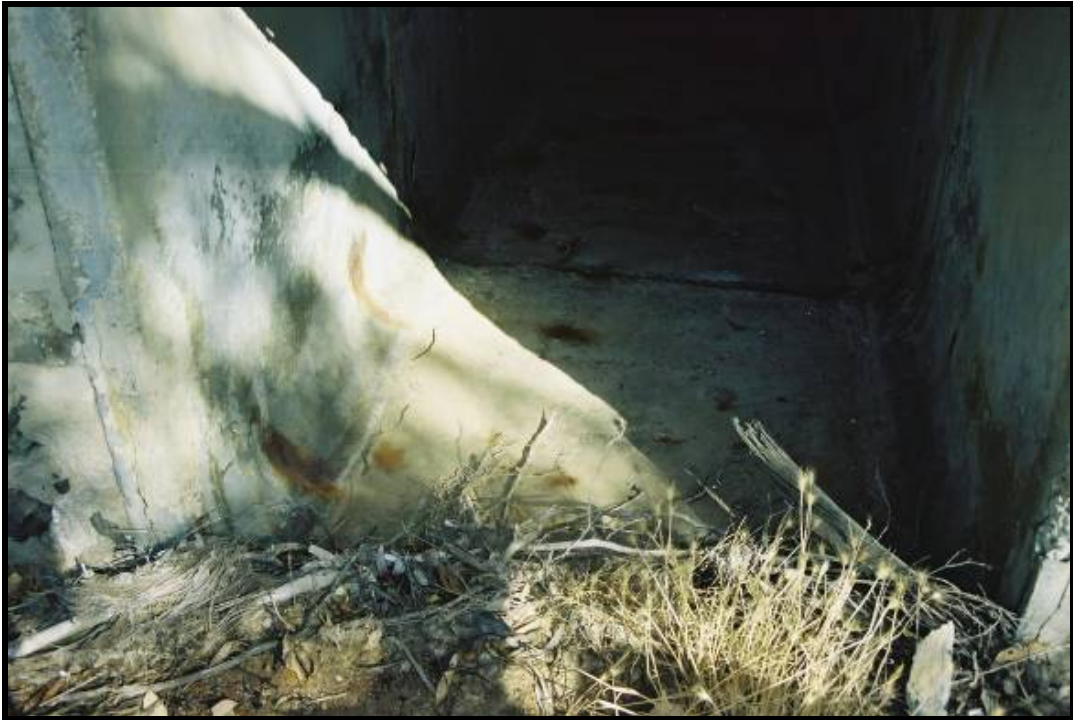
Photo 87 - PRECAST BOX UNIT MEDIUM CRACKING AND RUST STAINING IN THE BASE SLAB

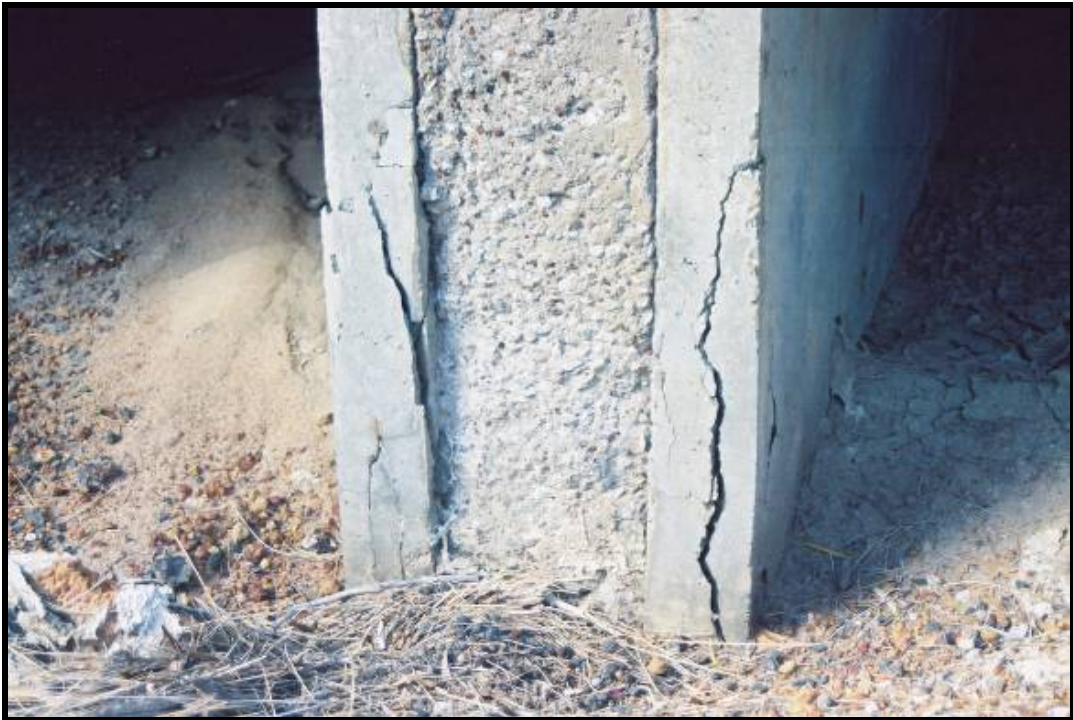
Photo 89 - PRECAST BOX UNIT OUTSIDE LEGS HAVE HEAVY CRACKING CAUSED BY CORRODED REINFORCEMENT

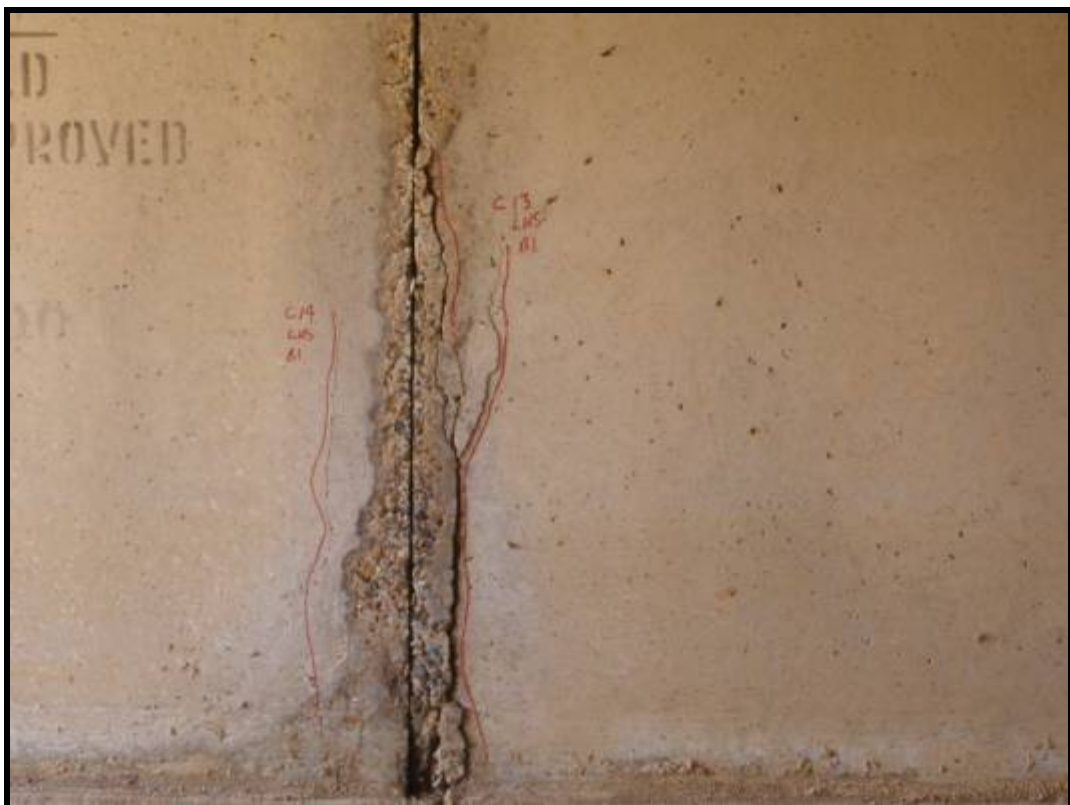
Photo 90 - HEAVY VERTICAL CRACKS IN BARREL 1, UNITS 13 AND 14

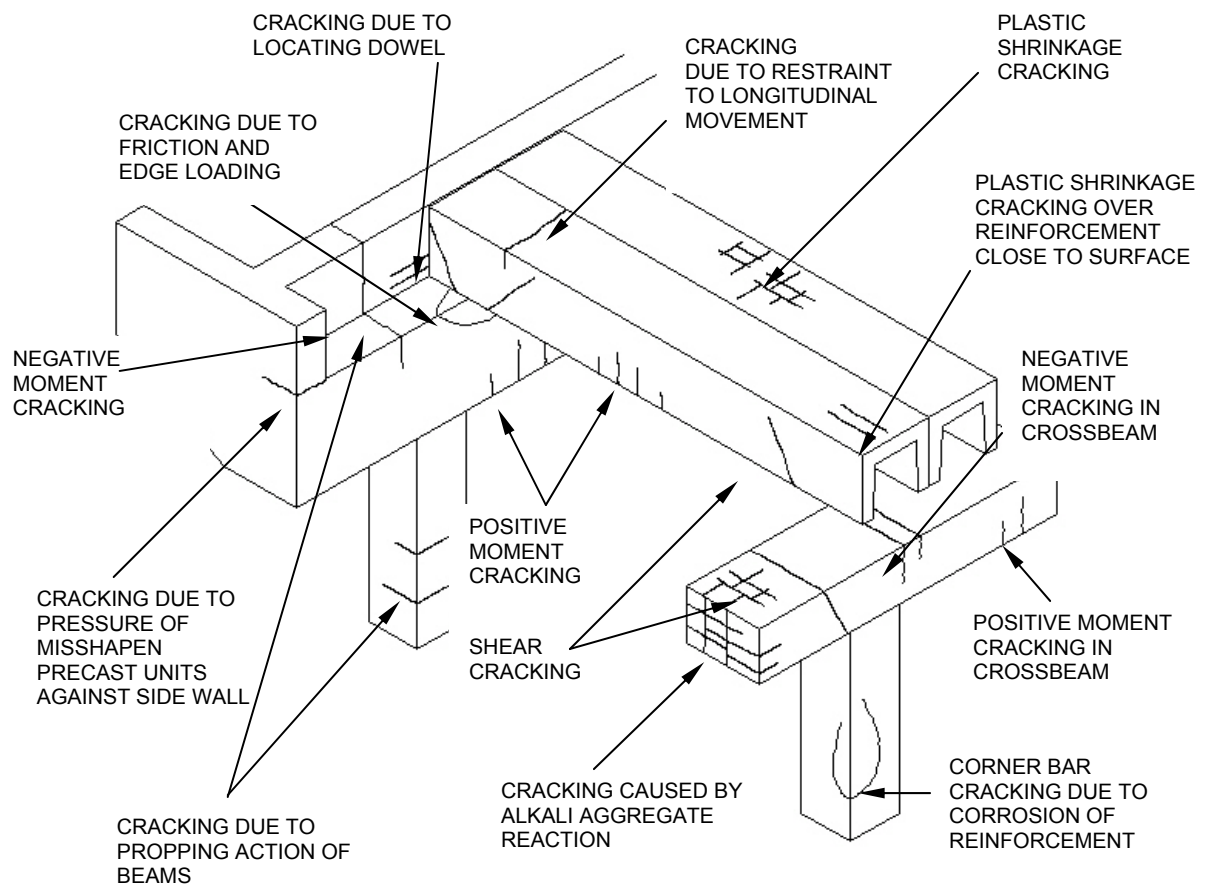
Cracking – It is recognised that in reinforced concrete, cracks will form in tension zones. These fine structural cracks are considered harmless but as reinforcement is further stressed the initial cracks open up and progressively spread to longer and wider cracks. Further cracking can result in blocks forming and at this stage a detailed inspection is required. Cracks should be photographed to enable historical recording of crack propagation and growth. Common crack locations in concrete are given in Appendix D, Sketch 1.

Sketch 1 - COMMON CRACK LOCATIONS AND TYPES IN CONCRETE STRUCTURES
