Structures Engineering

Sign Gantry Guidelines (Level 1 and Level 2 Inspections)

SIGN GANTRY INSPECTION GUIDELINES

Document No. 6706-02-2239

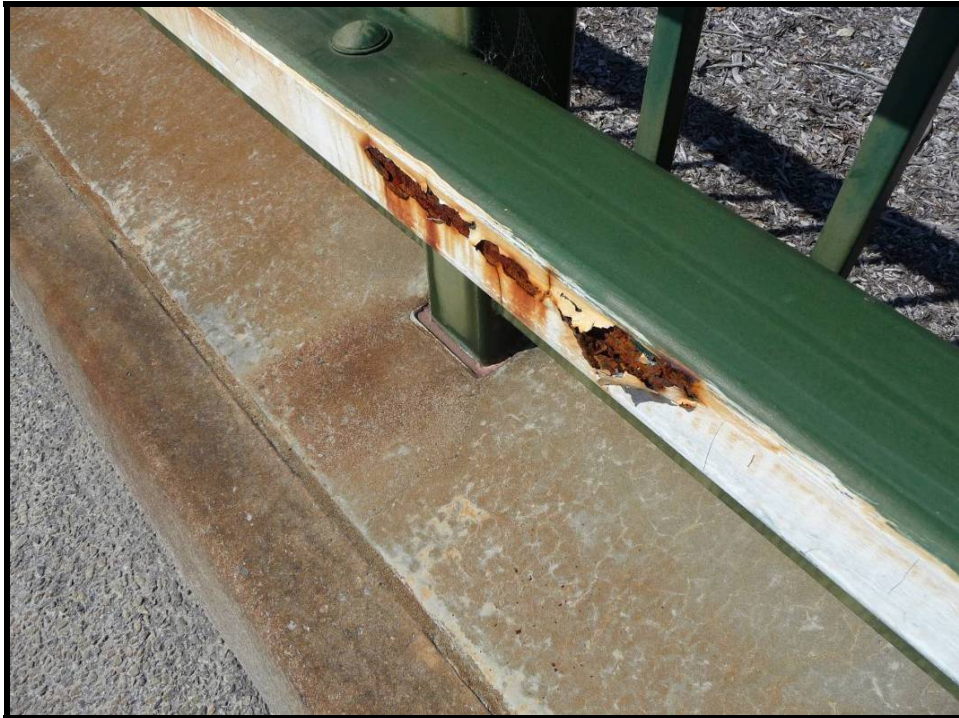
Photo 1 - CORROSION TREATMENT REQUIRED TO LEFT HAND SIDE BARRIER
(Indicative photo only, representative of similar defects for a gantry)

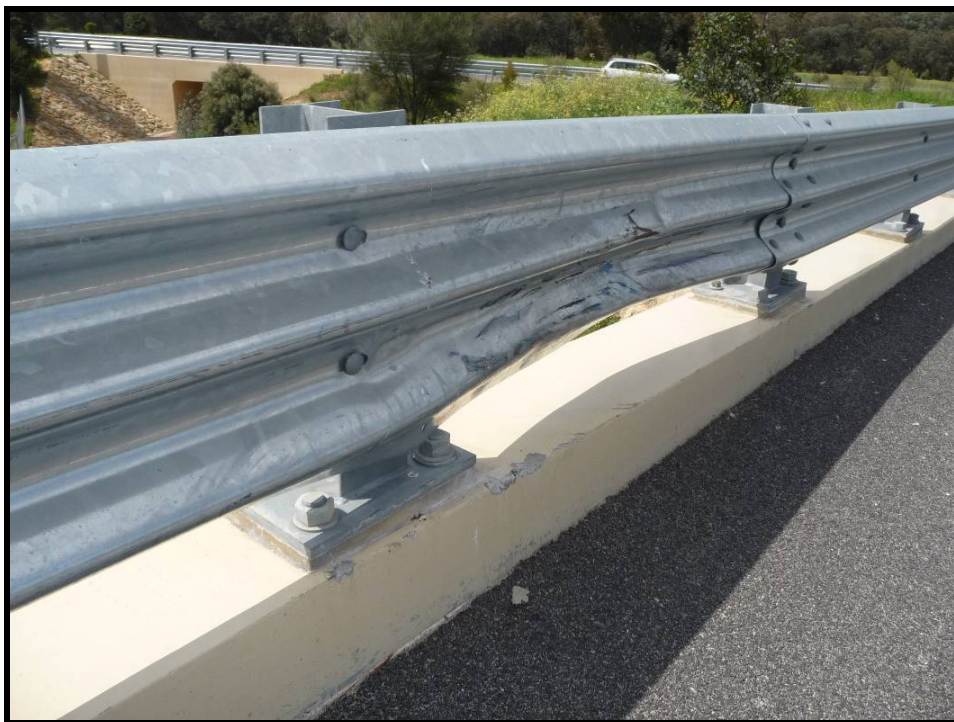
Photo 2 - MINOR IMPACT DAMAGE TO BARRIER, CONNECTION STILL OKAY
(Indicative photo only, representative of similar defects for a gantry)

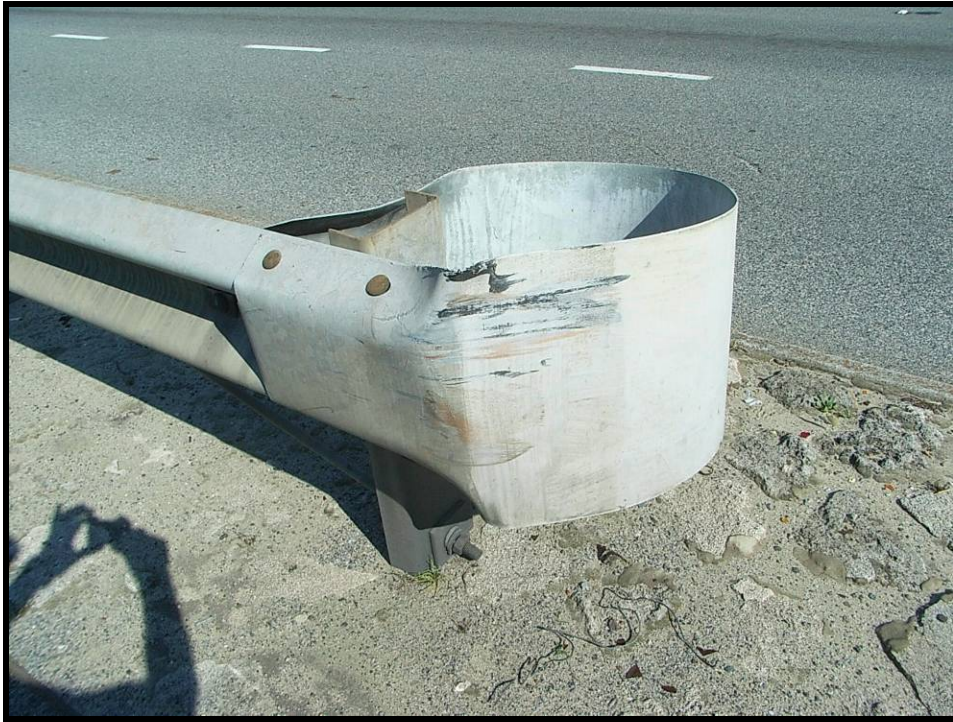
Photo 3 - MINOR IMPACT DAMAGE TO END TERMINAL
(ALSO NOTE, END TERMINAL IS SUB-STANDARD)
(Indicative photo only, representative of similar defects for a gantry)

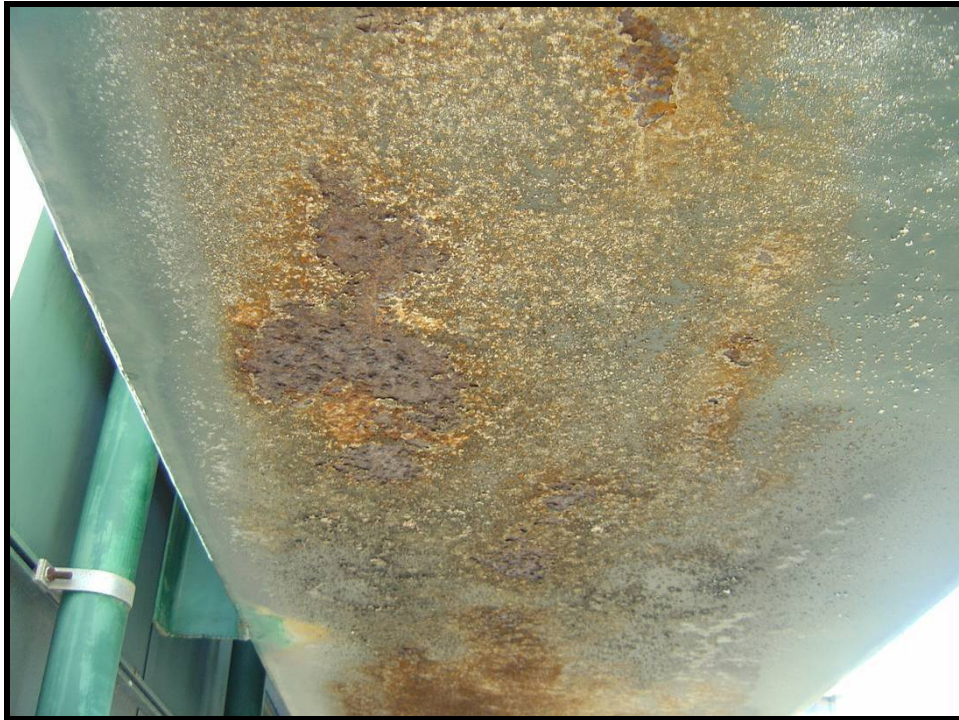
**Photo 4 - ADVANCED CORROSION TO SOFFIT OF GANTRY BEAM
(FOR LEVEL 2 INSPECTION: CS3, PITTING IN ISOLATED AREAS)**

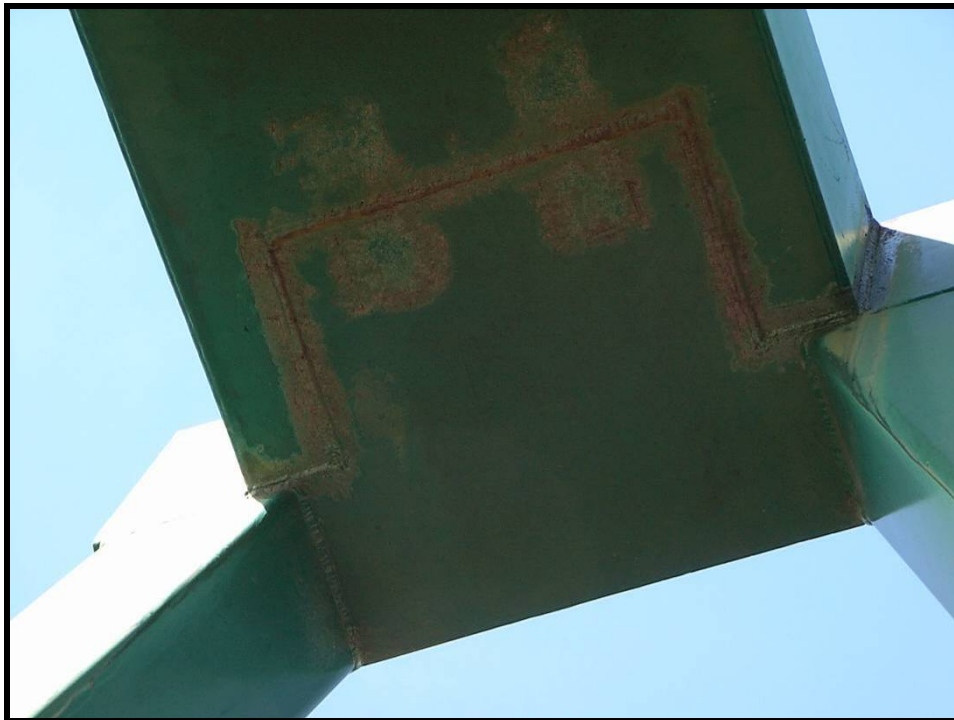
**Photo 5 - CORROSION TO WELDS AT BEAM AND COLUMN CONNECTION
(FOR LEVEL 2 INSPECTION: CS2, SURFACE CORROSION ONLY, NO PITTING OR LOSS OF SECTION)**

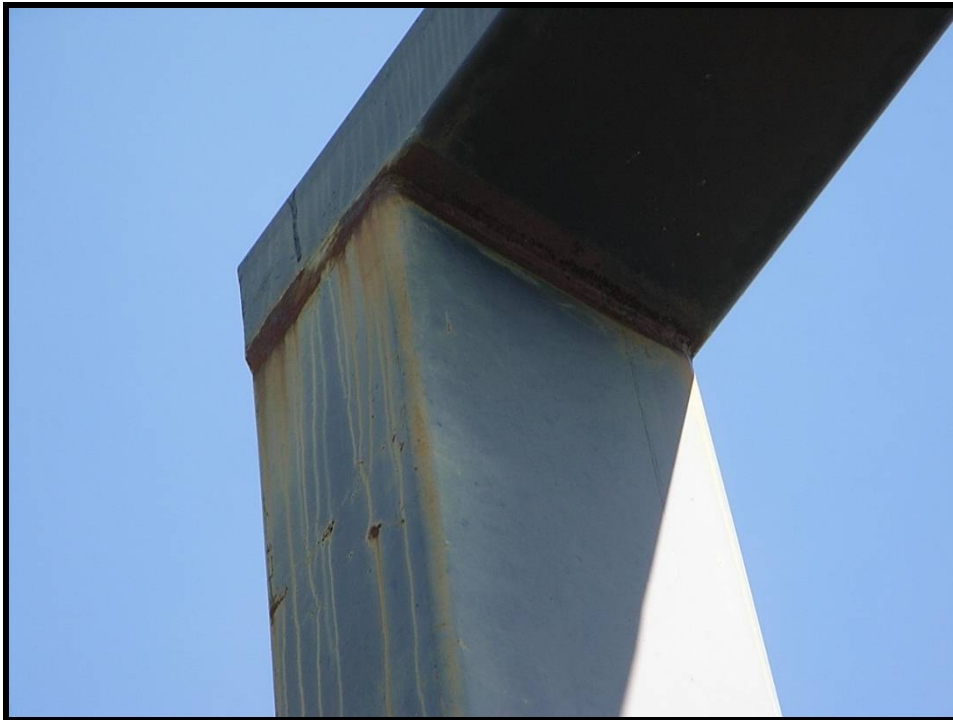
**Photo 6 - CORROSION TO WELDS AT BEAM AND COLUMN CONNECTION
(FOR LEVEL 2 INSPECTION: CS2, INSIGNIFICANT SECTION LOSS)**

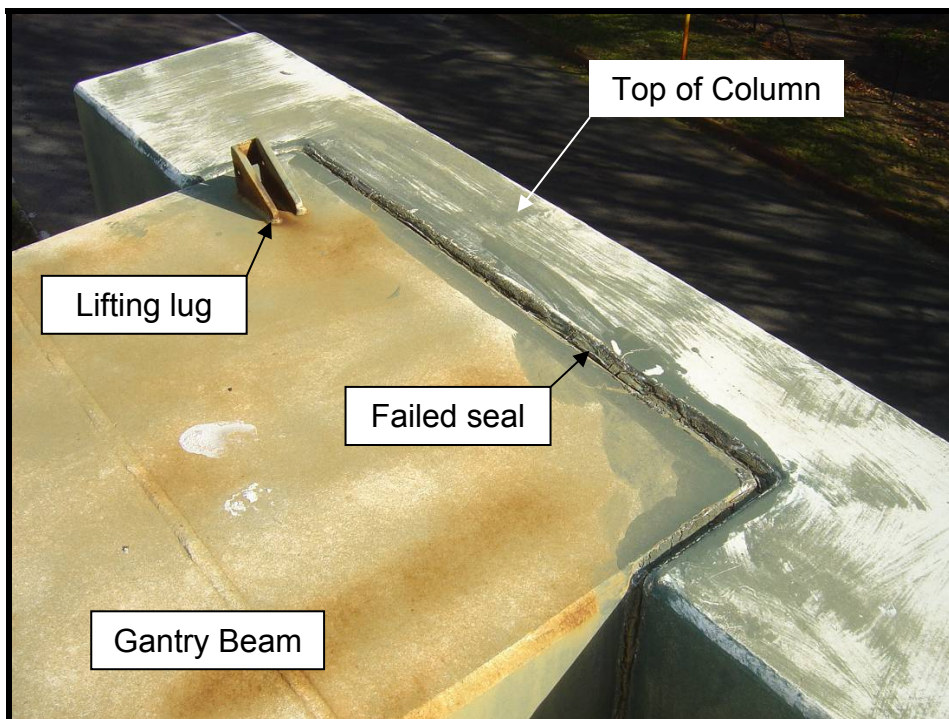
**Photo 7 - FLEXIBLE SEALANT FAILING AT GANTRY BEAM AND COLUMN
CONNECTION, DETERIORATED PAINTWORK TYPICAL THROUGHOUT**

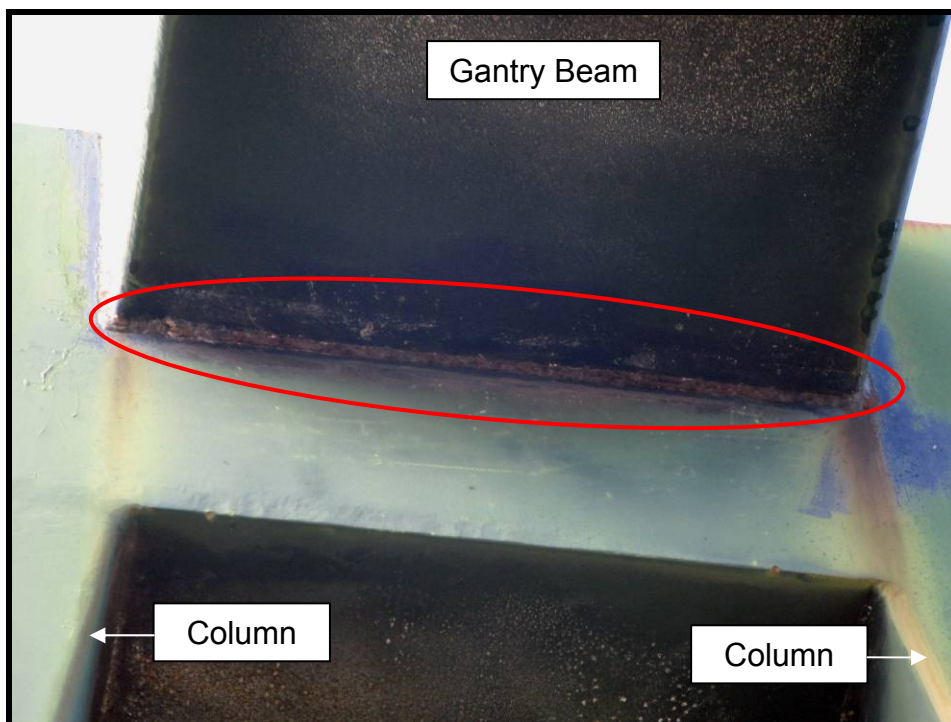
Photo 8 - CORROSION TO WELDED GANTRY BEAM AND COLUMN CONNECTION
(FOR LEVEL 2 INSPECTION: CS2, INSIGNIFICANT SECTION LOSS)

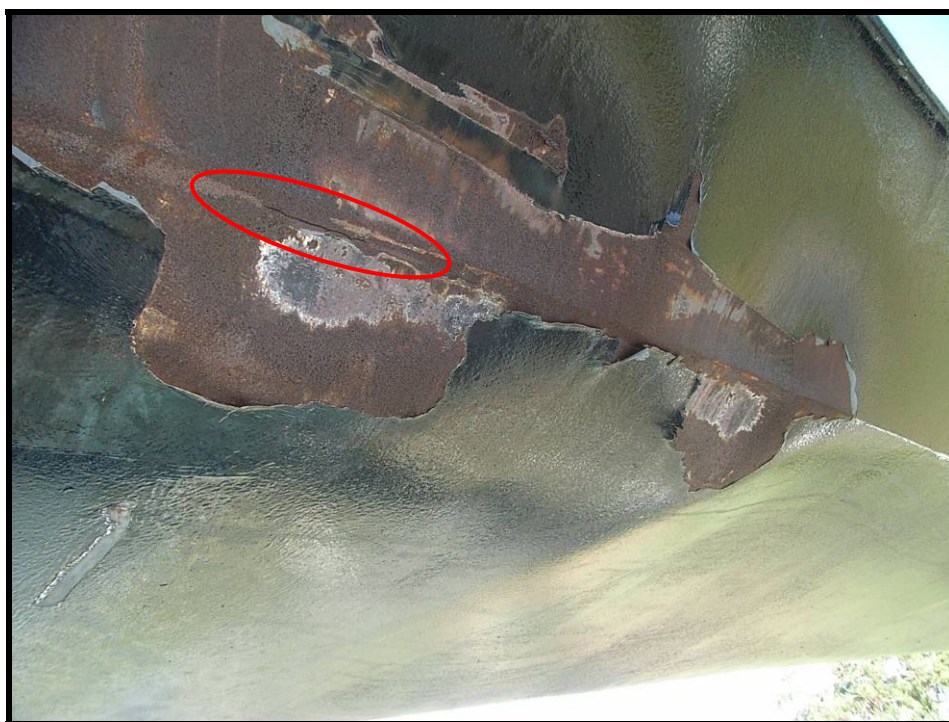
Photo 9 - IMPACT DAMAGE TO SOFFIT, CAUSING CRACK IN WEB/SOFFIT WELD
(REFER FOR ENGINEERING INSPECTION AND ASSESSMENT)
(FOR LEVEL 2 INSPECTION: CS4, STEEL CRACKING)
(Indicative photo only, representative of similar defects for a gantry)

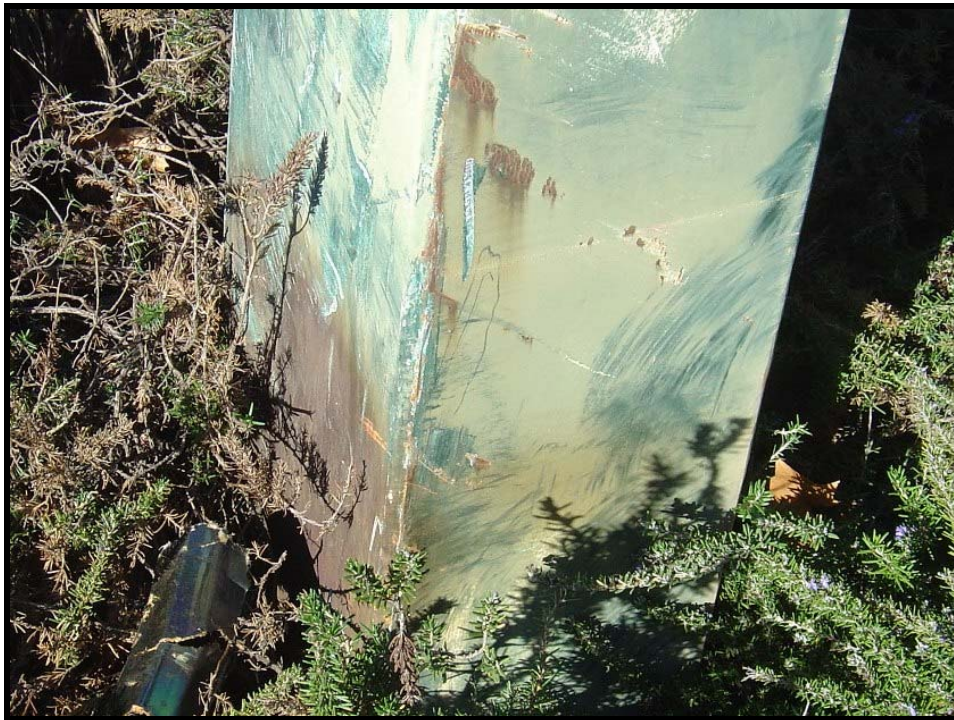
**Photo 10 - IMPACT DAMAGE, CORROSION AND DETERIORATED PAINTWORK AT GROUND LEVEL OF COLUMN 1 RIGHT HAND SIDE
(FOR LEVEL 2 INSPECTION: CS2, NO DISTORTION OF SHAPE)**

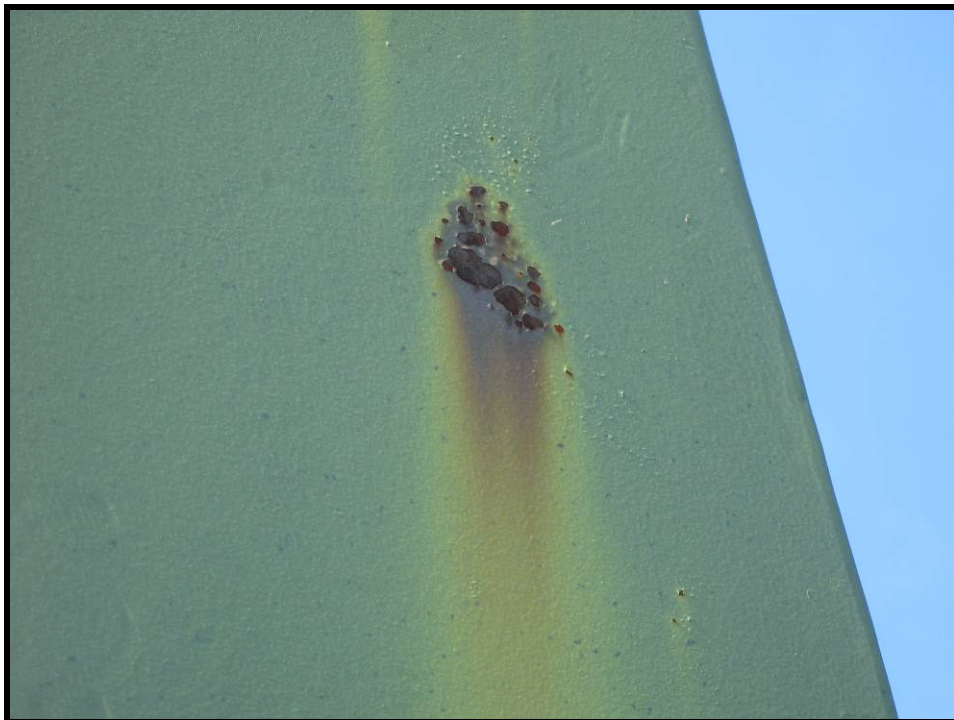
**Photo 11 - LOCALISED CORROSION TO COLUMN 2 ON LEFT HAND SIDE
(FOR LEVEL 2 INSPECTION: CS2, SURFACE CORROSION AND INSIGNIFICANT SECTION LOSS)**

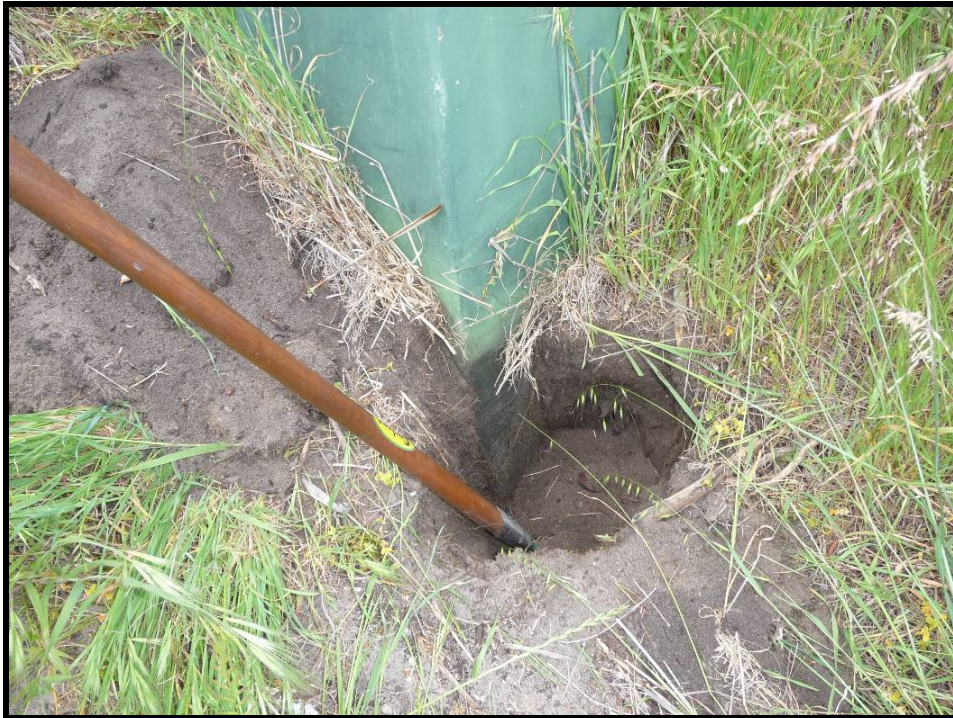
Photo 12 - FOOTING GREATER THAN 500 mm BELOW GROUND LEVEL

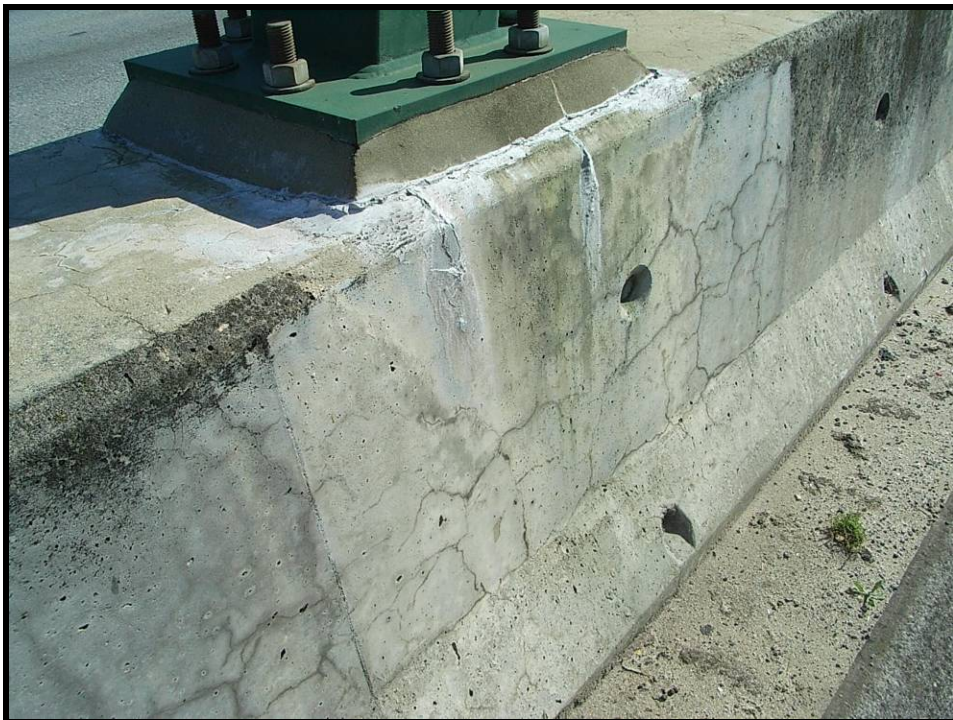
**Photo 13 - CRACKING TO FOOTING
(FOR LEVEL 2 INSPECTION: CS2, FINE CRACKING WITH NO SPALLING)**

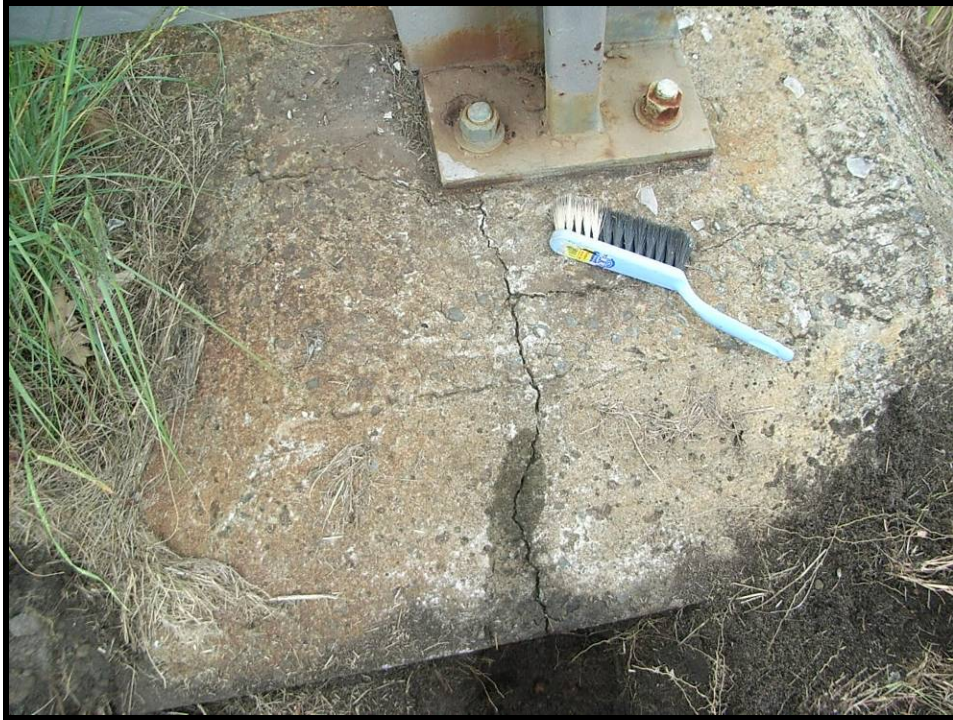
**Photo 14 - SHRINKAGE CRACKING TO CONCRETE FOOTING
(FOR LEVEL 2 INSPECTION OF FOOTING: CS3, MEDIUM CRACKING)**

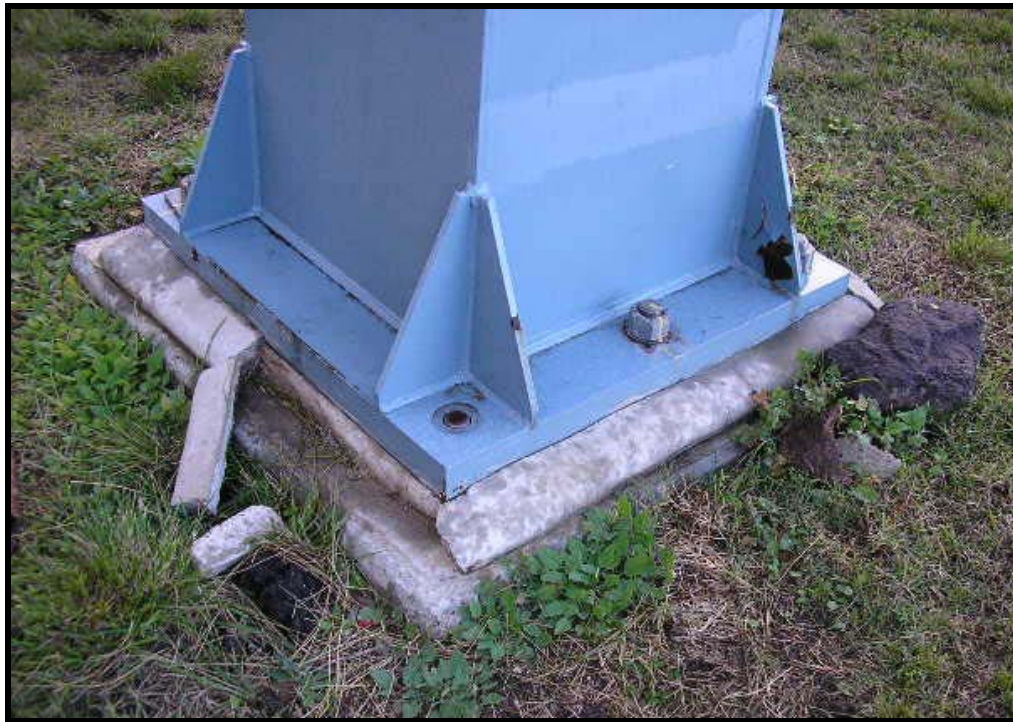
Photo 15 - FAILED ANCHOR BOLTS – NO WASHERS – CRACKED MORTAR UNDER BASE PLATE – MINOR CORROSION TO GUSSET AND BASE PLATES
(FOR LEVEL 2 INSPECTION OF ANCHOR BOLTS: CS4, FAILED BOLTS)
(FOR LEVEL 2 INSPECTION OF MORTAR GROUT PAD: CS3, SOME MORTAR LOSS)
(FOR LEVEL 2 INSPECTION OF GUSSET: CS2, SURFACE CORROSION)

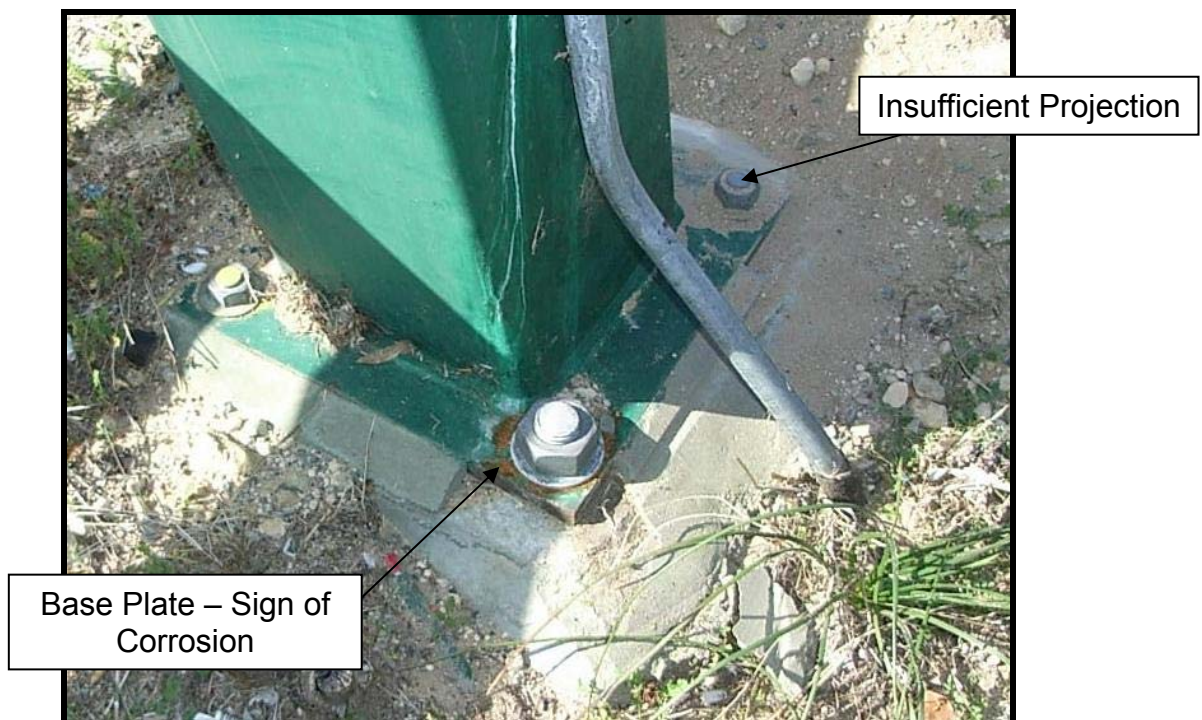
Photo 16 - LOOSE LEVELLING NUTS
(FOR LEVEL 2 INSPECTION OF MORTAR GROUT PAD: CS3, SOME MORTAR LOSS)
(FOR LEVEL 2 INSPECTION OF BASE PLATE: CS2, SURFACE CORROSION)

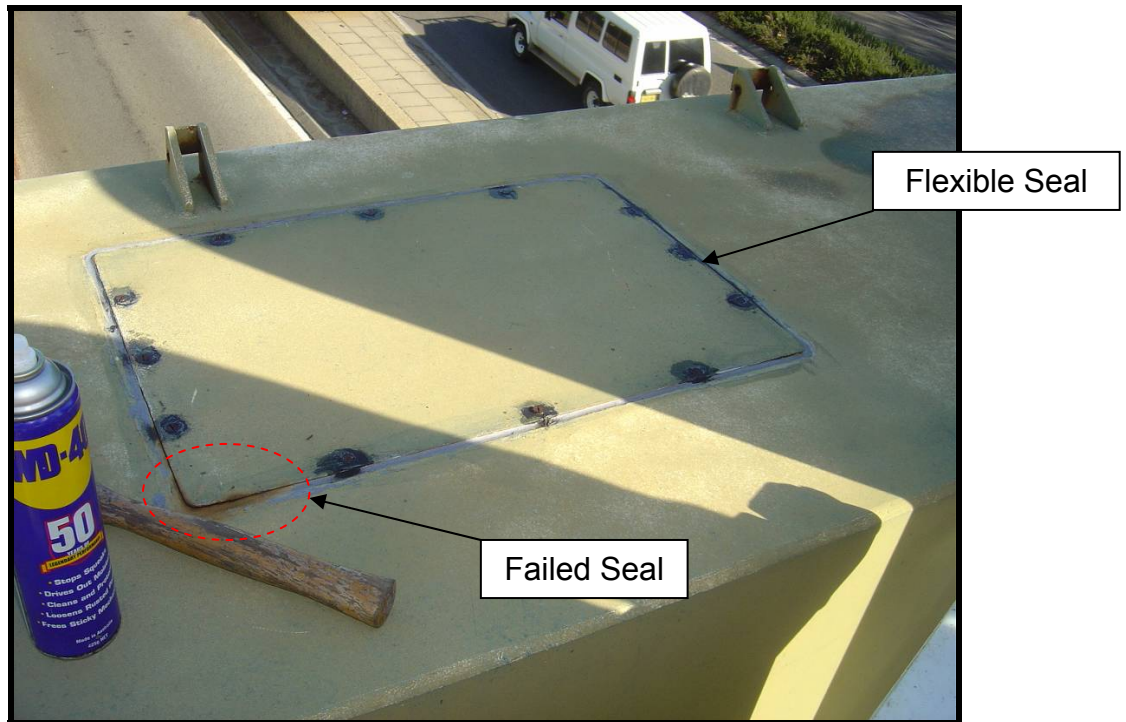
Photo 17 - FAILURE OF FLEXIBLE SEAL TO ACCESS HATCH

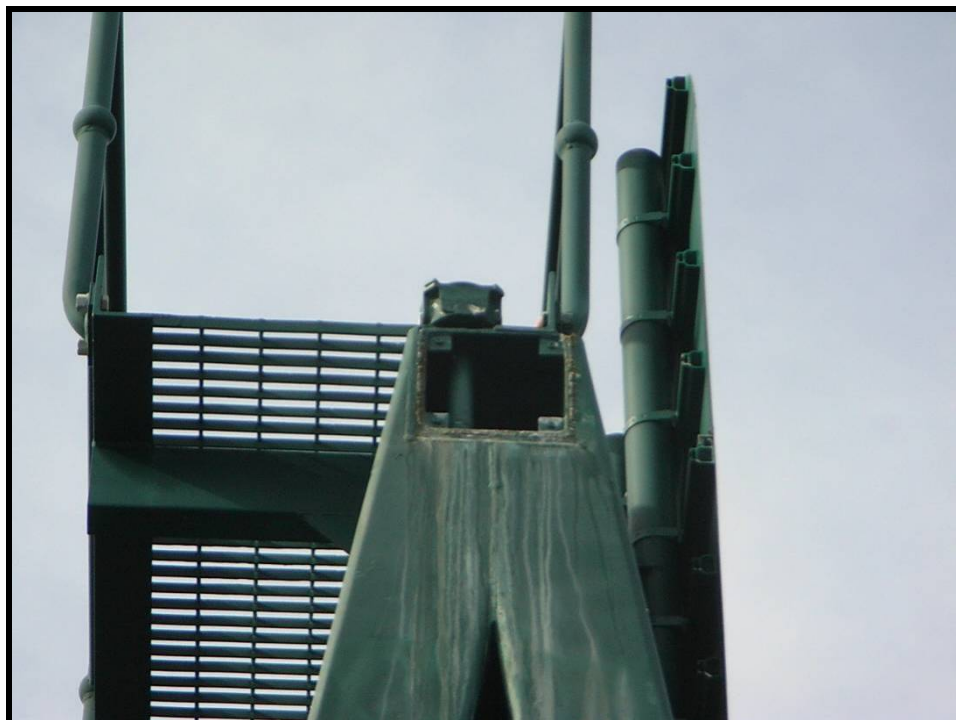
Photo 18 - MISSING ACCESS PLATE AT LEFT HAND SIDE OF GANTRY BEAM

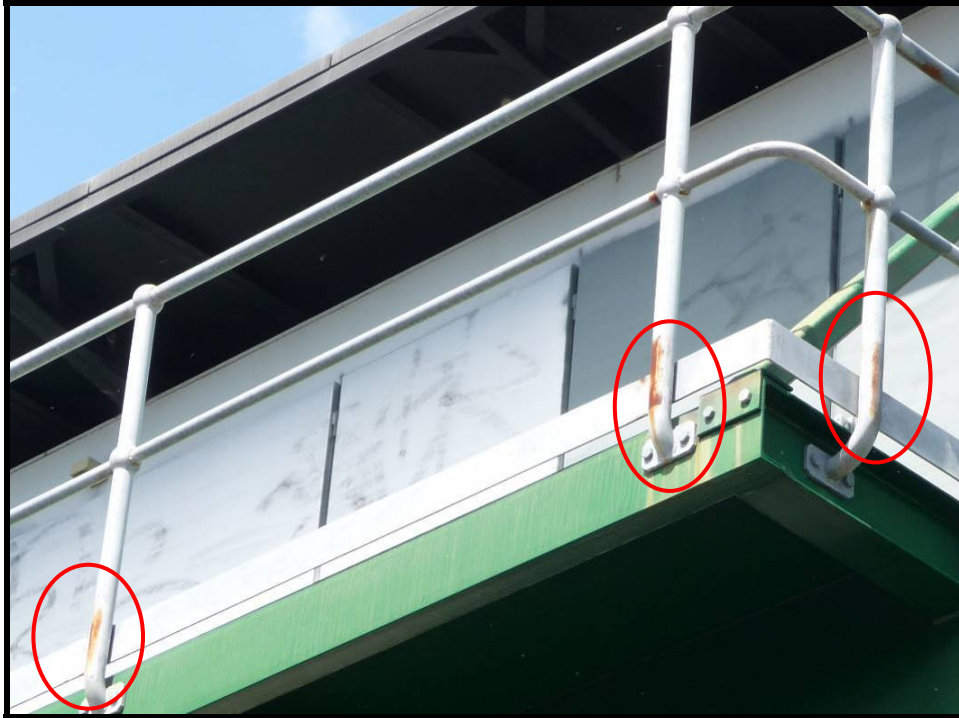
Photo 19 - CORROSION TO MAINTENANCE ACCESS BALUSTRADE

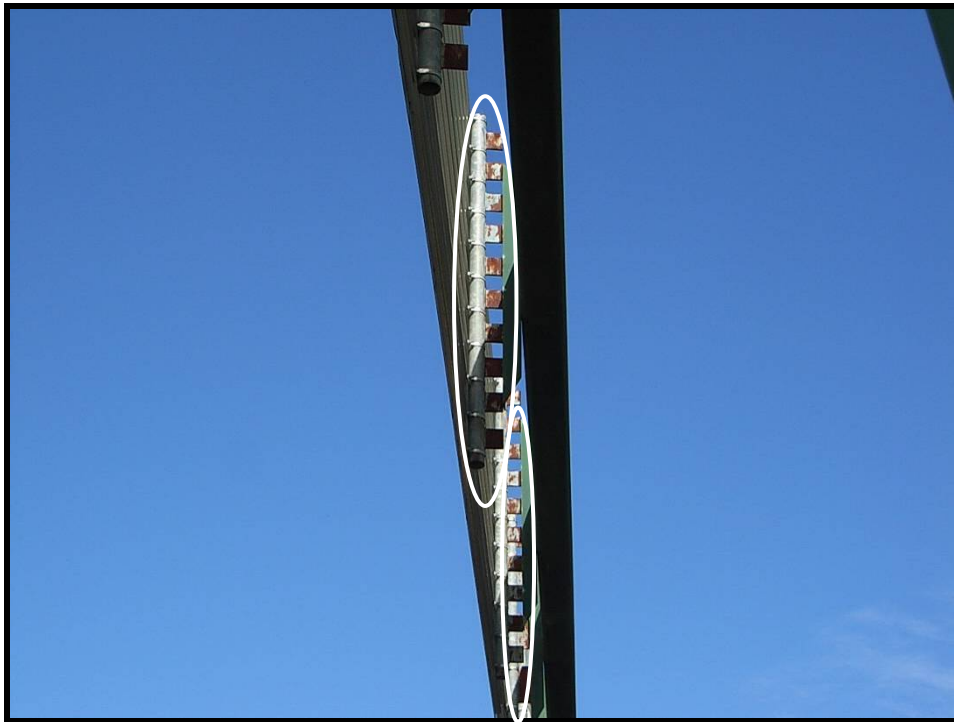
**Photo 20 - CORROSION TO SIGN MOUNTING BRACKET CLEATS
(FOR LEVEL 2 INSPECTION: CS2, MINOR CORROSION)**

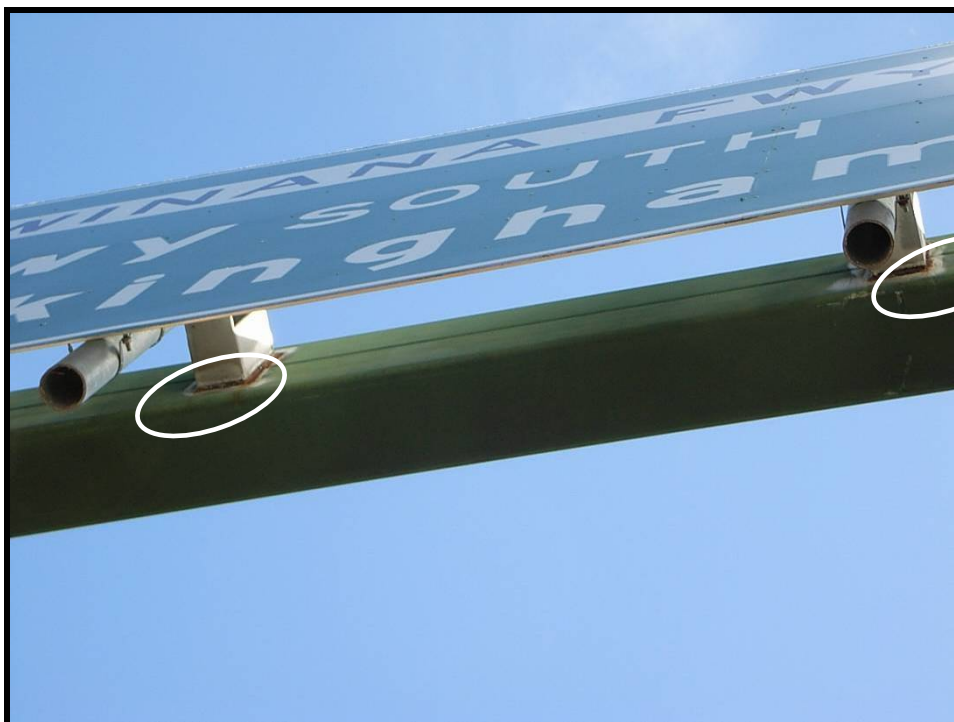
**Photo 21 - CORROSION TO SIGN MOUNTING BRACKET WELDS
(FOR LEVEL 2 INSPECTION: CS2, MINOR CORROSION)**

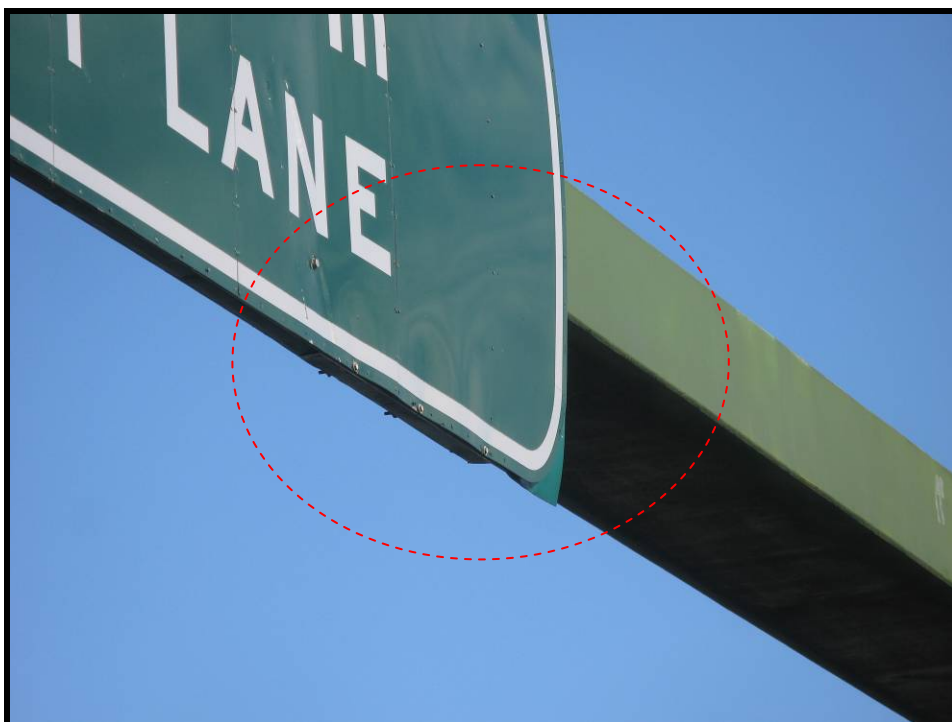
Photo 22 - IMPACT DAMAGE TO SIGN

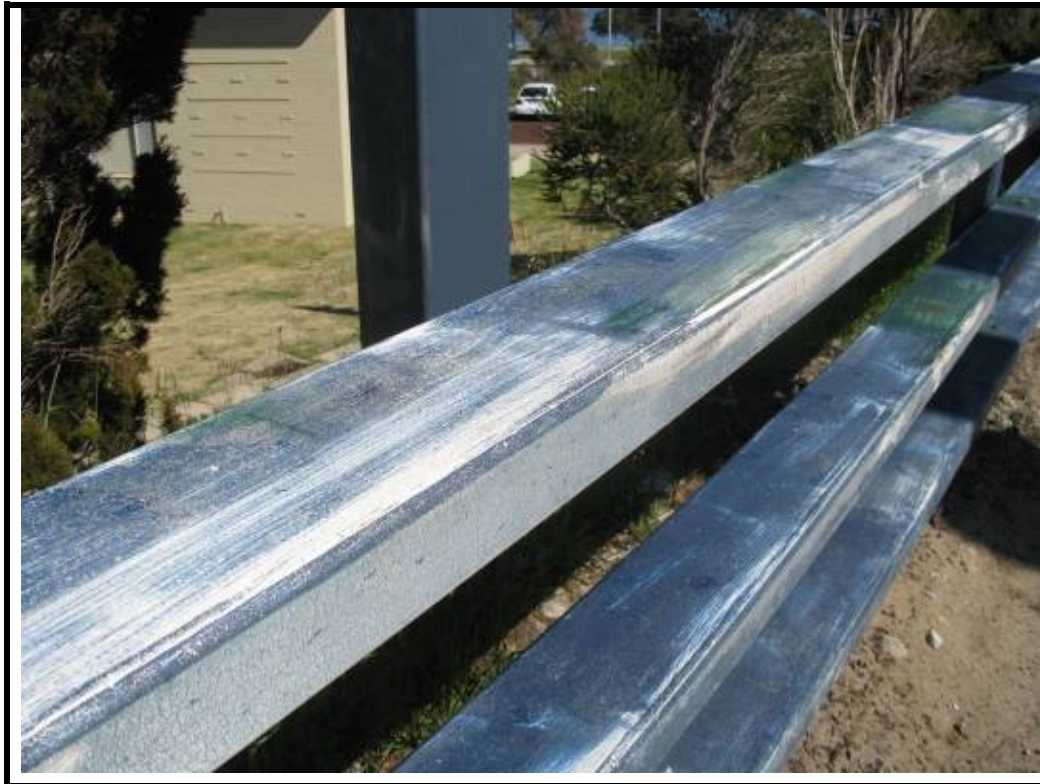
Photo No. 3: 3-rail Barrier protection to LHS column, note weathered paint condition

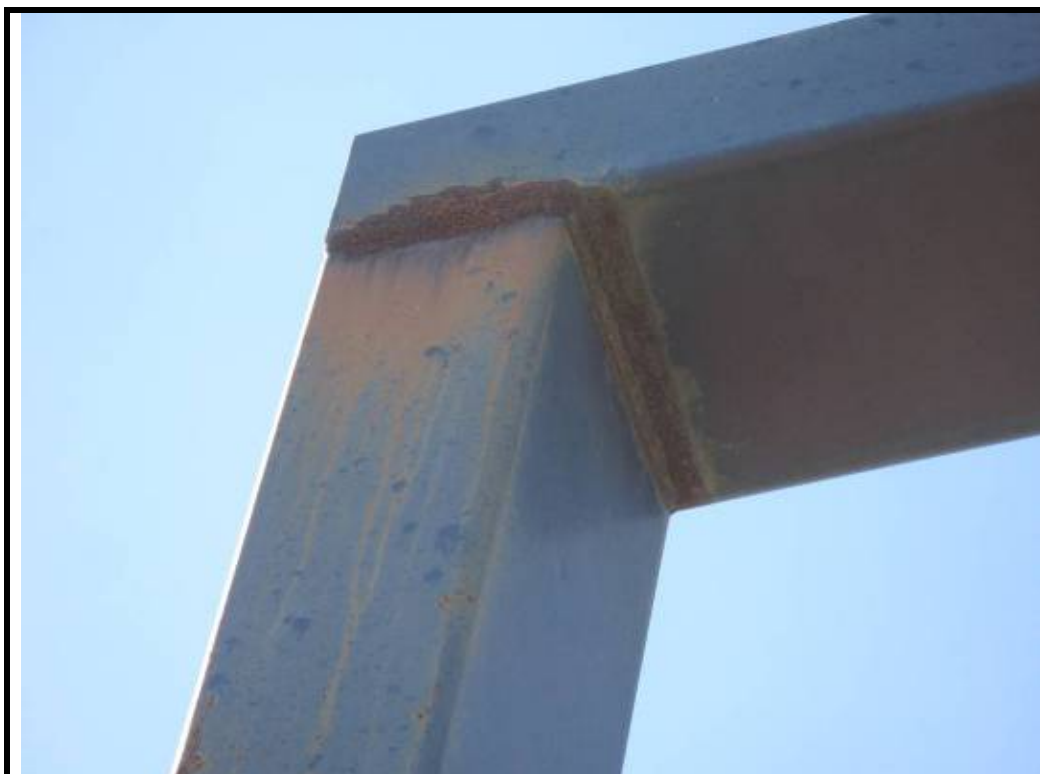
Photo No. 4: RHS connection of Gantry Column to Gantry Beam, note corrosion

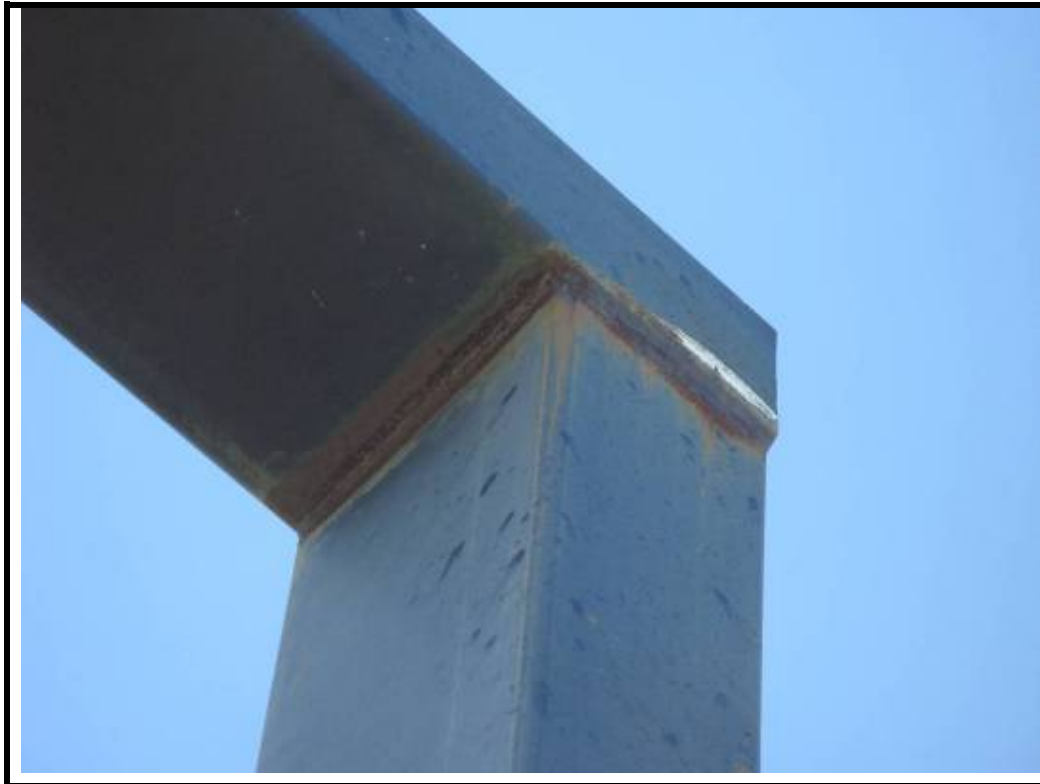
Photo No. 5: LHS connection of Gantry Column to Gantry Beam, note corrosion

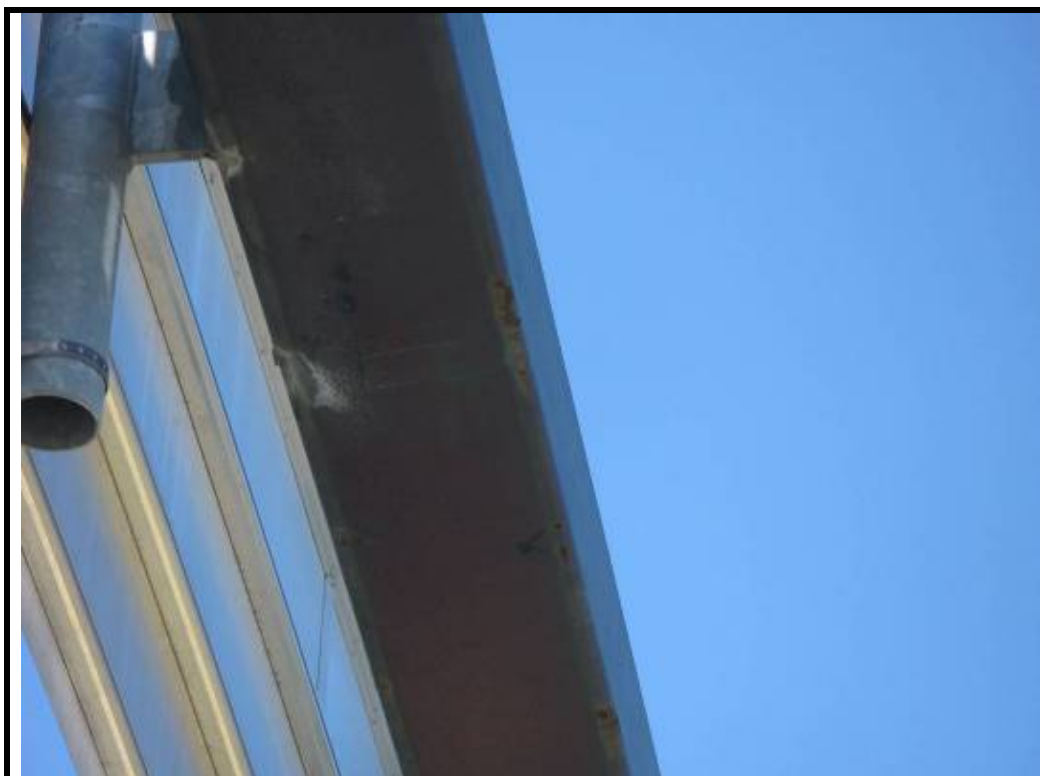
Photo No. 6: Corrosion to Gantry Beam (typical)

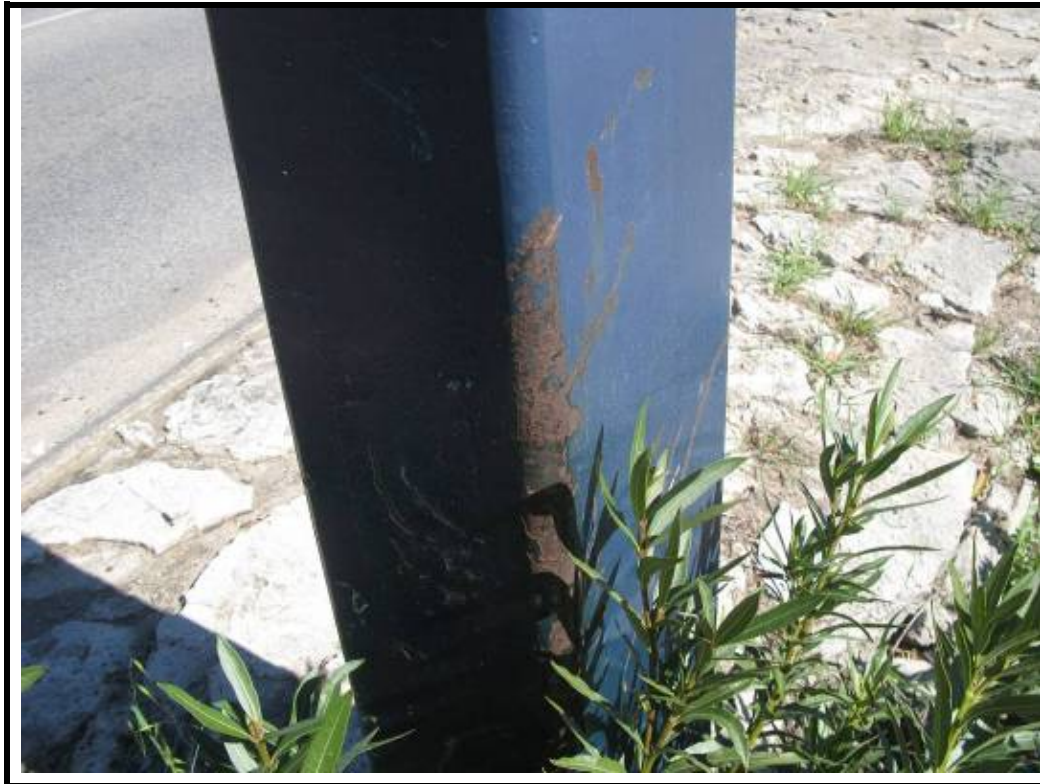
Photo No. 7: Surface corrosion to RHS column, note stone pitching

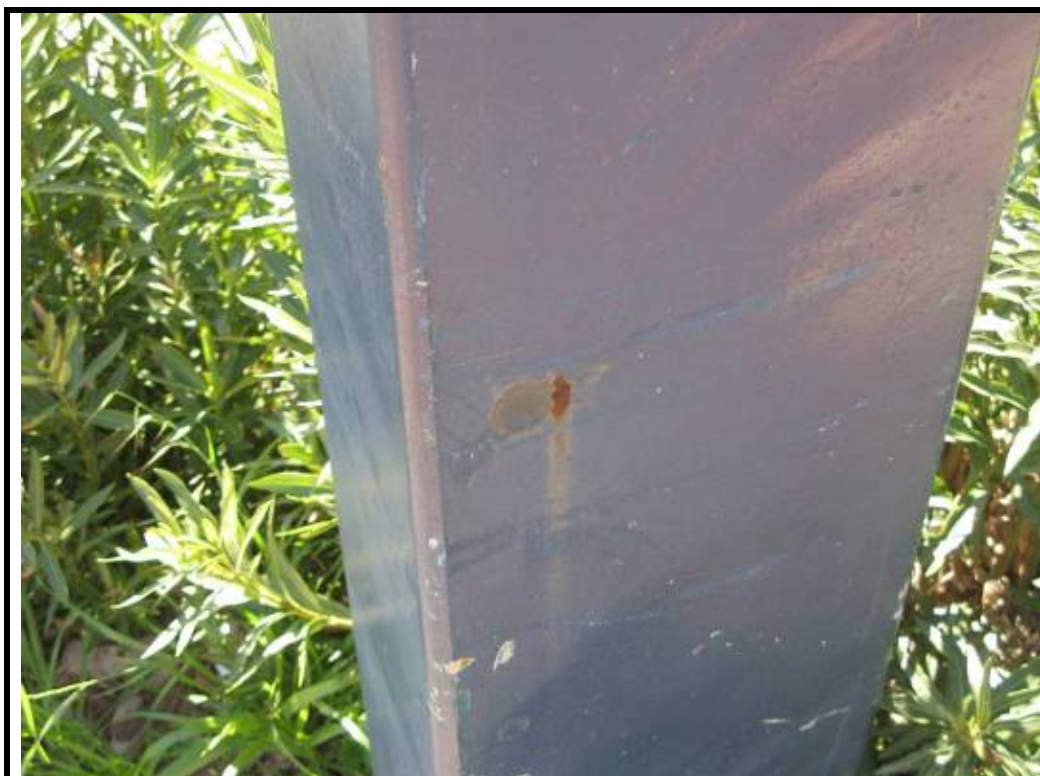
Photo No. 8: Surface corrosion to LHS column

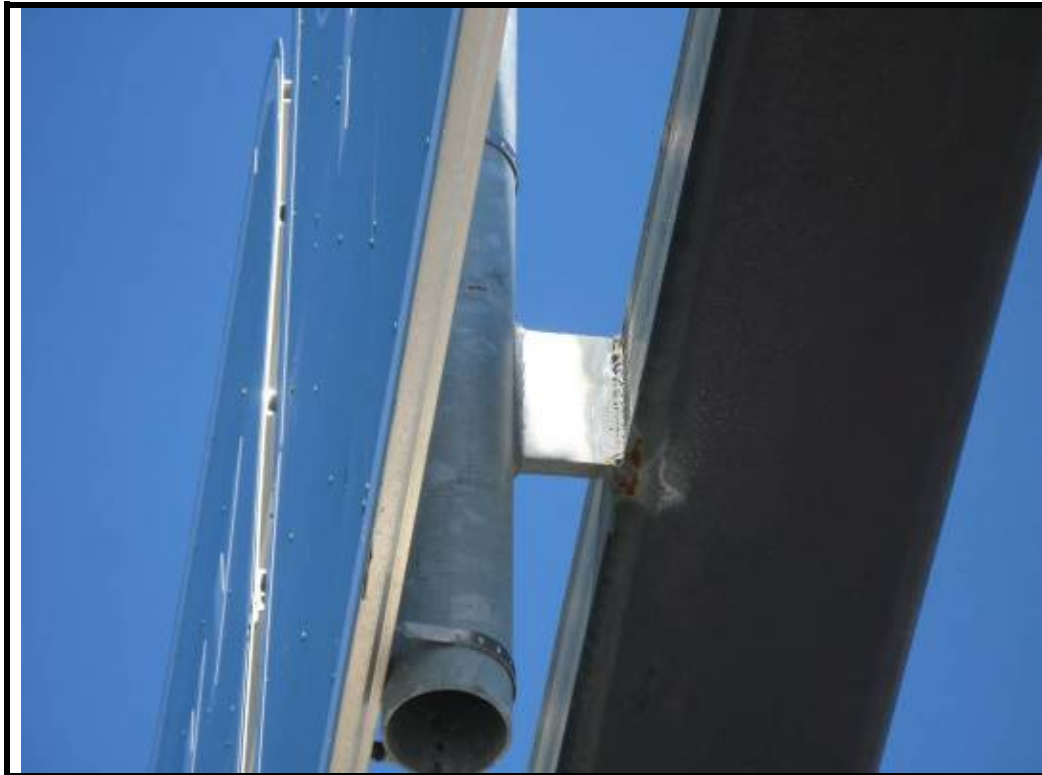
Photo No. 9: Corrosion between sign fixing bracket and gantry beam (typical)

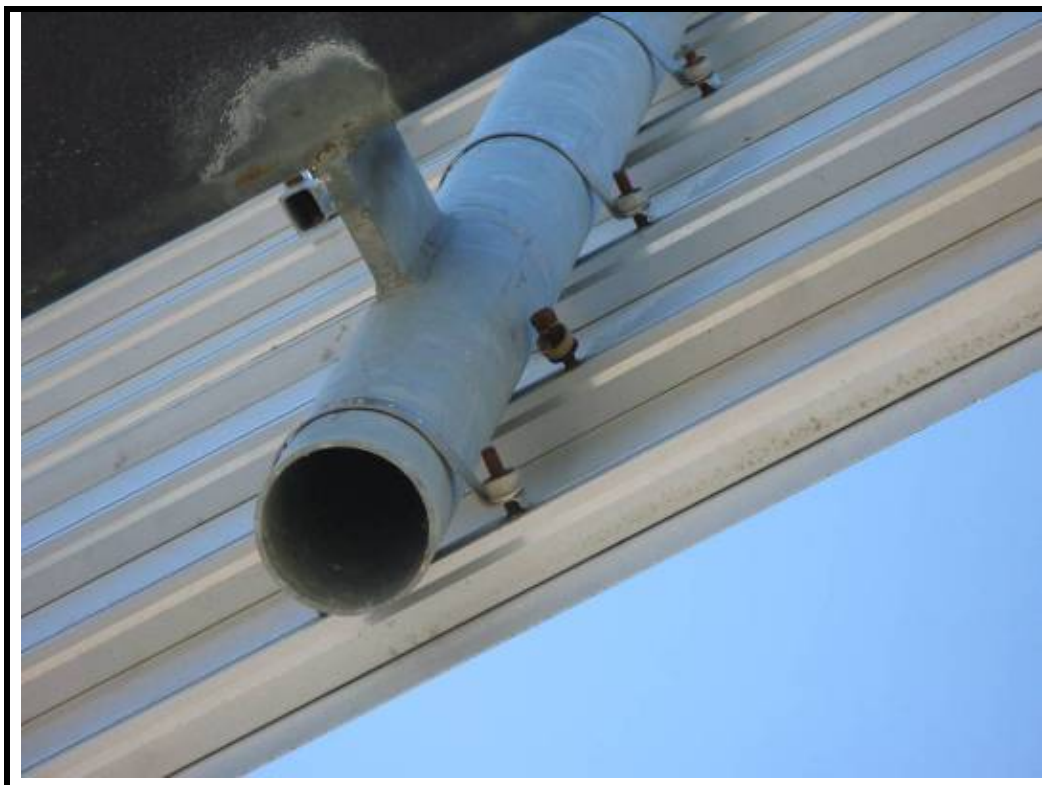
Photo No. 10: Corroded sign attachment bolts
