Structures Engineering

Sign Gantry Guidelines (Level 1 and Level 2 Inspections)

SIGN GANTRY INSPECTION GUIDELINES

Document No. 6706-02-2239

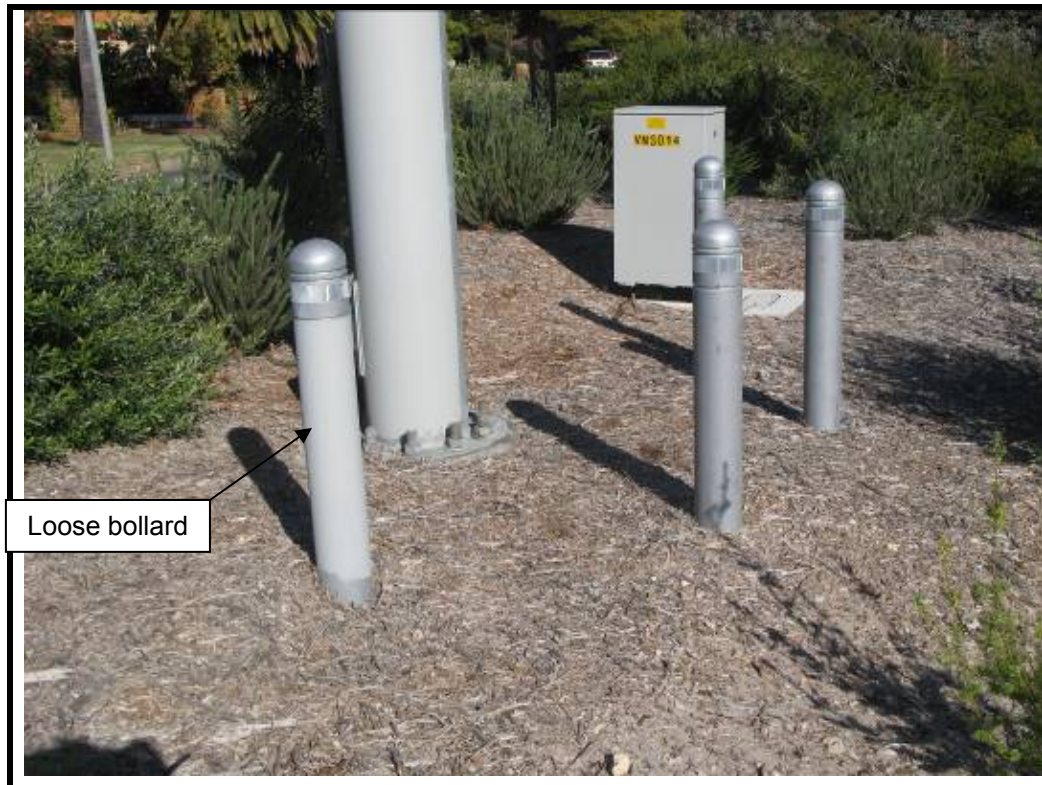
Photo No. 3: 4No. Bollards with reflective tape. 1No. Bollard loose

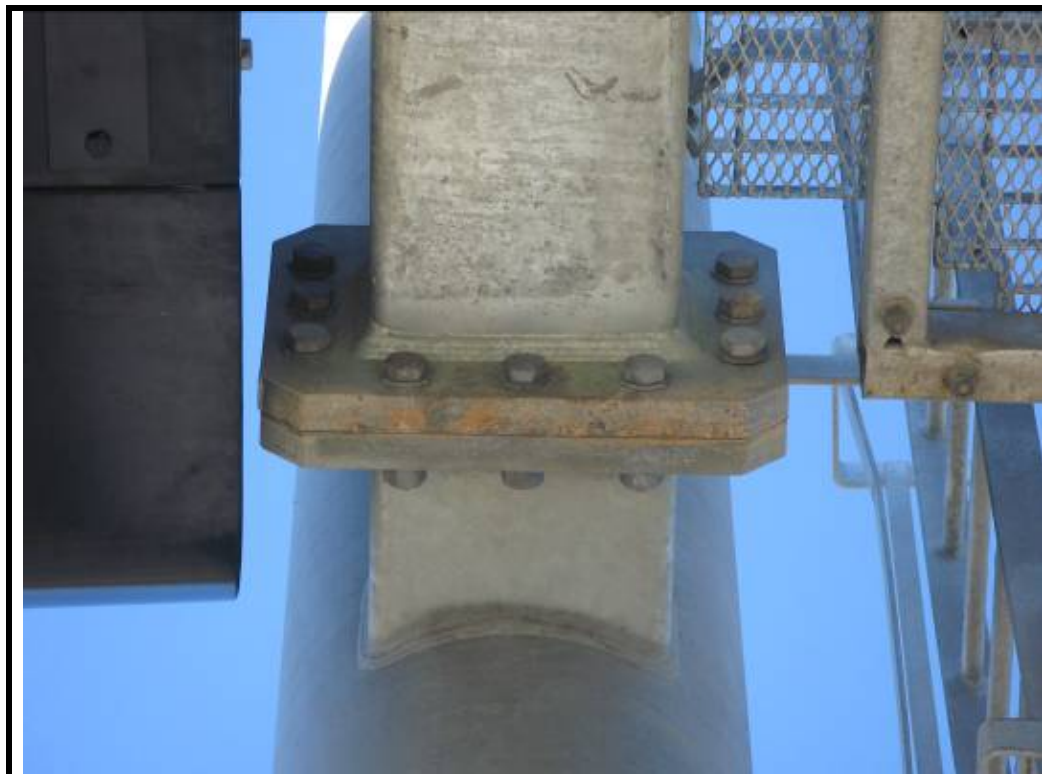
Photo No. 4: Lower bolted connection between beam and column, note minor discolouration

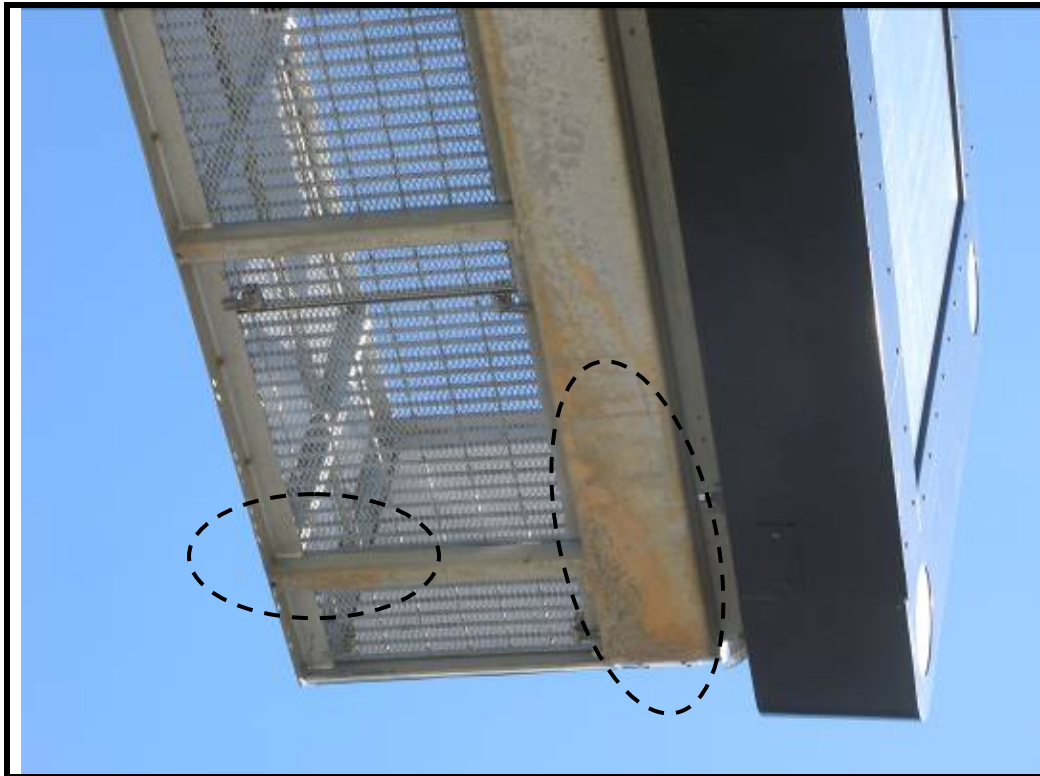
Photo No. 5: Possible corrosion to underside of cantilever end of beam and walkway support

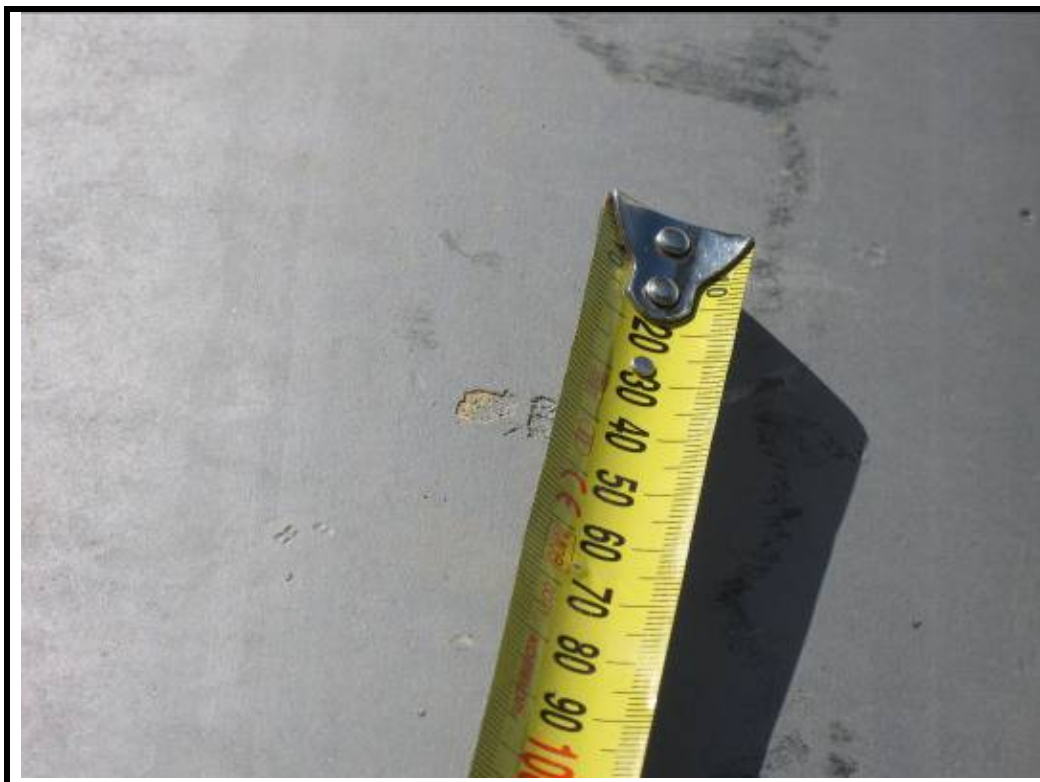
Photo No. 6: Minor chip to column surface (typical)

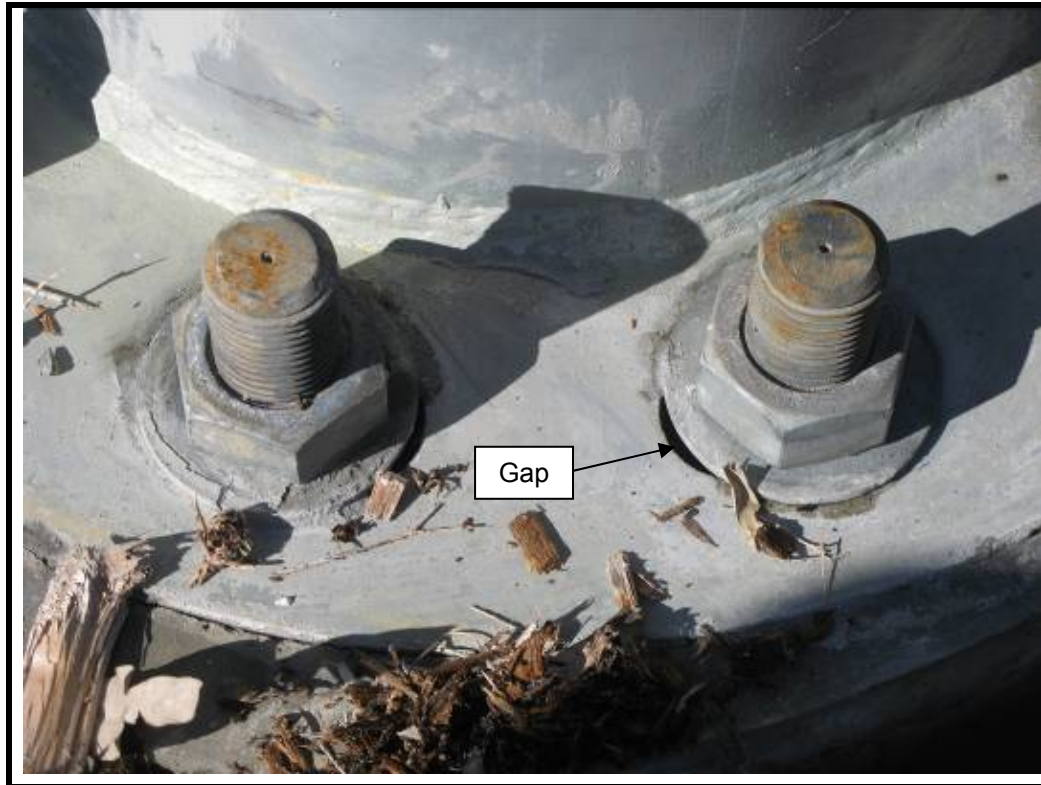
Photo No. 7: Base plate weld to column – also note surface corrosion to HD bolts and gap

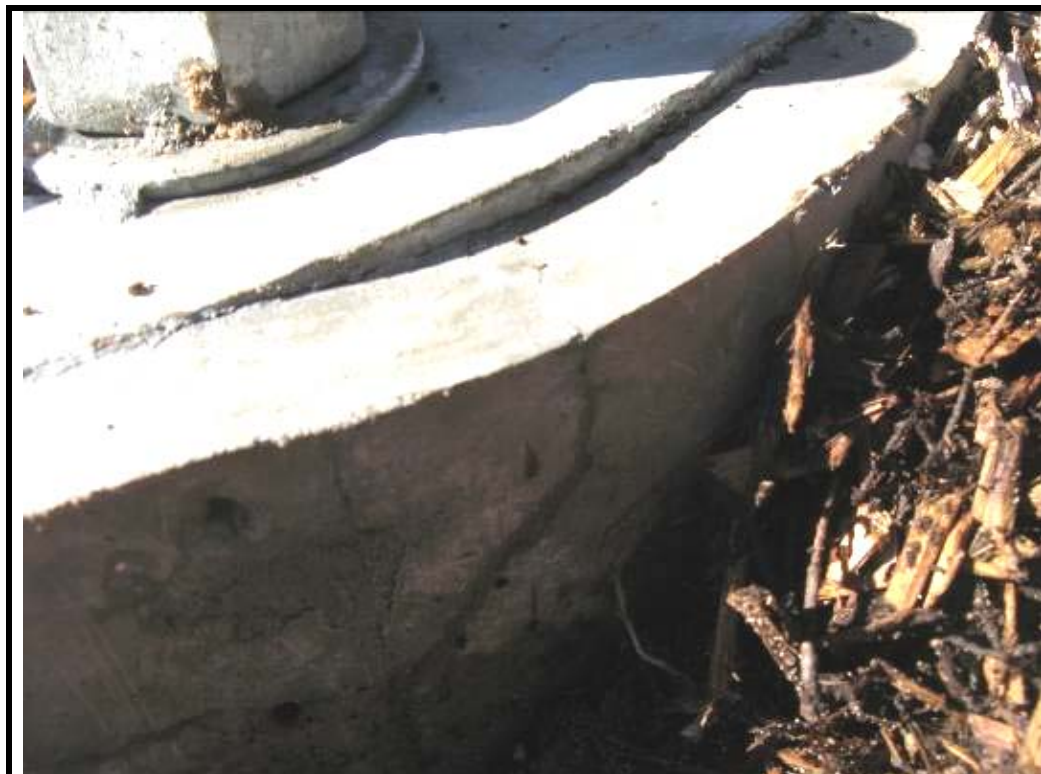
Photo No. 8: Hairline crack to mortar

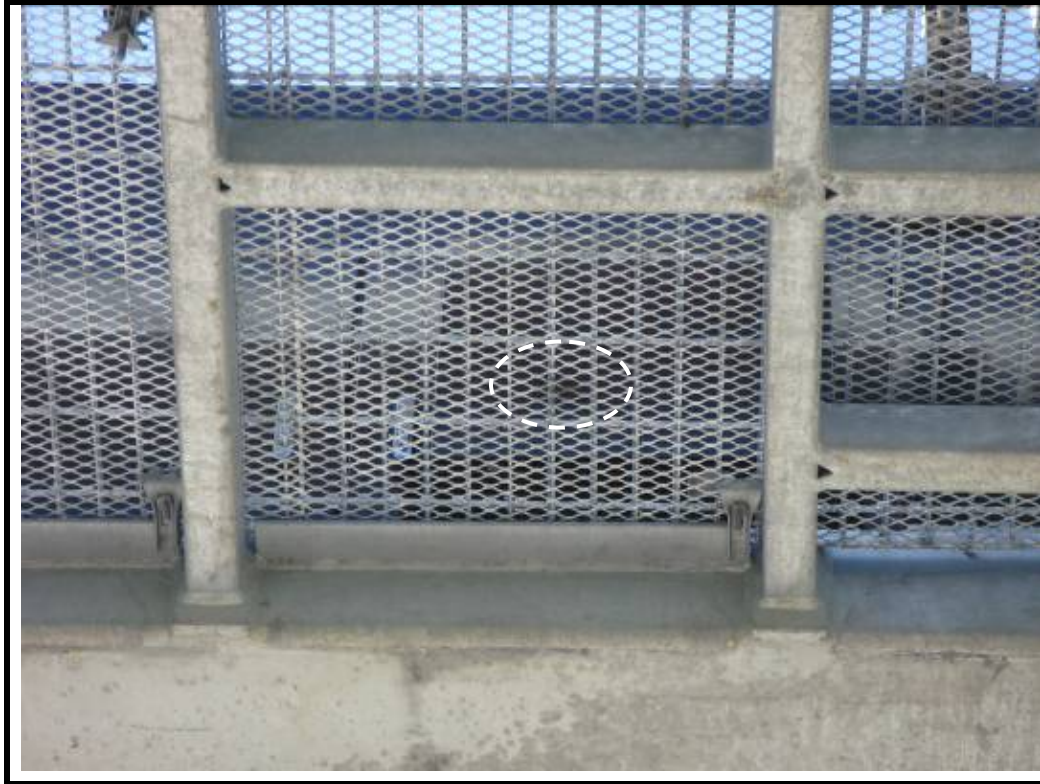
Photo No. 9: Possible corrosion to access walkway

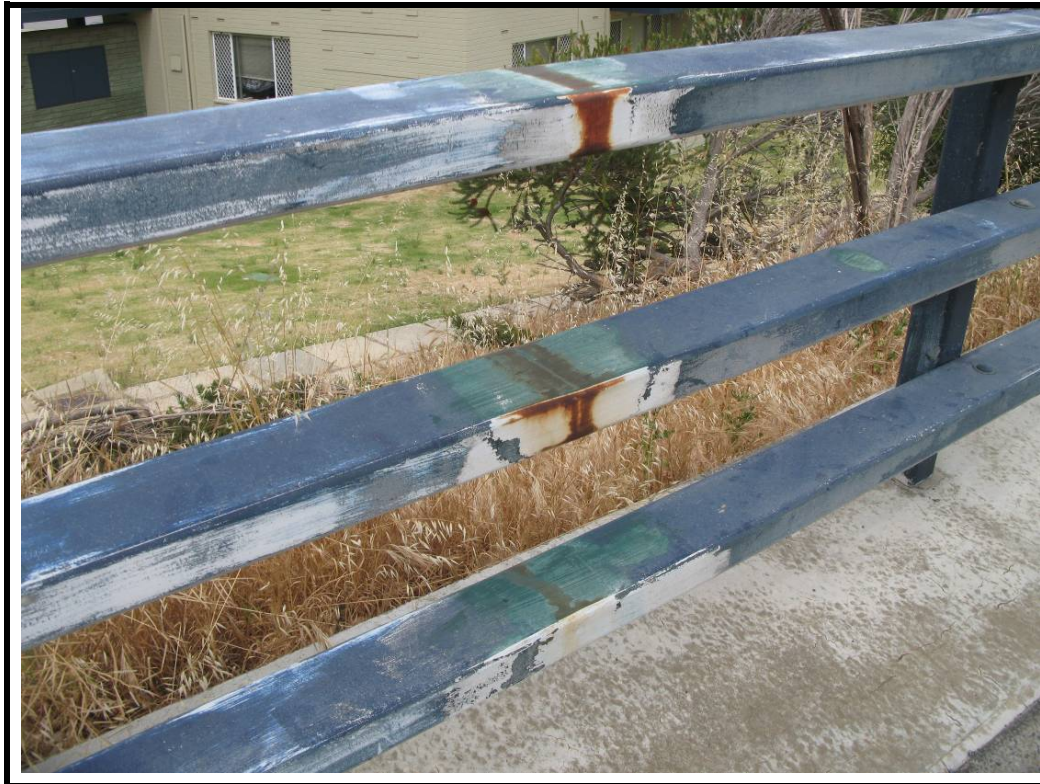
Photo No. 5: Corrosion to welded splices on guardrail, weathered paint system

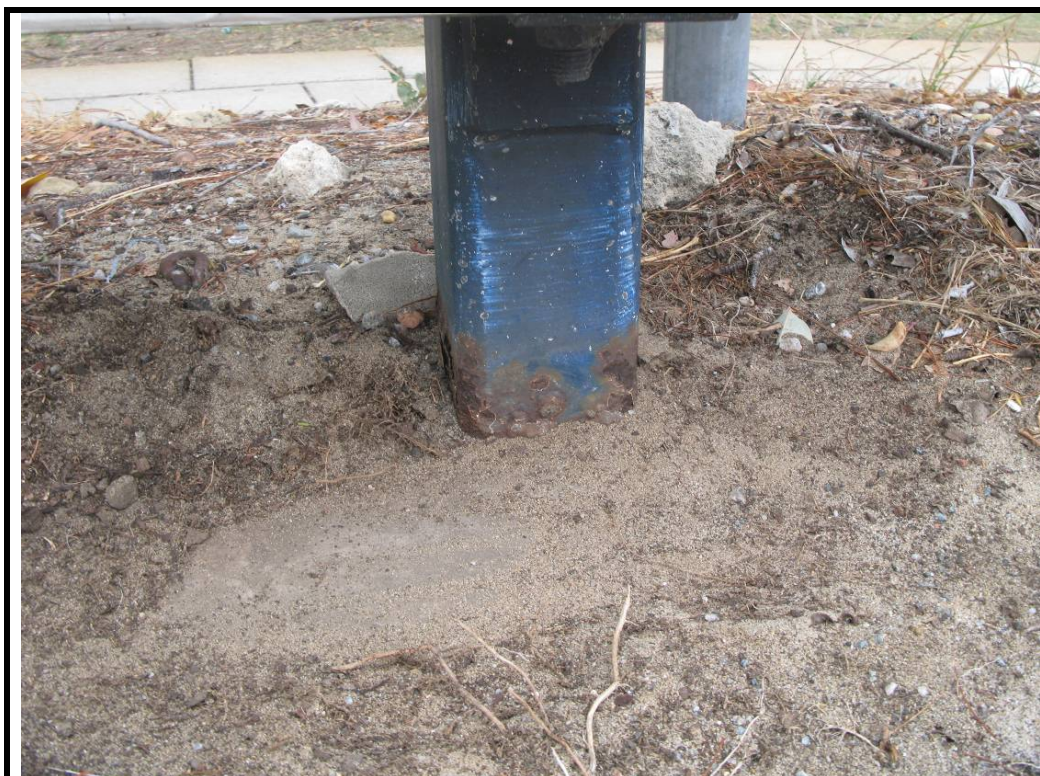
Photo No. 6: Corrosion at foot of guardrail posts

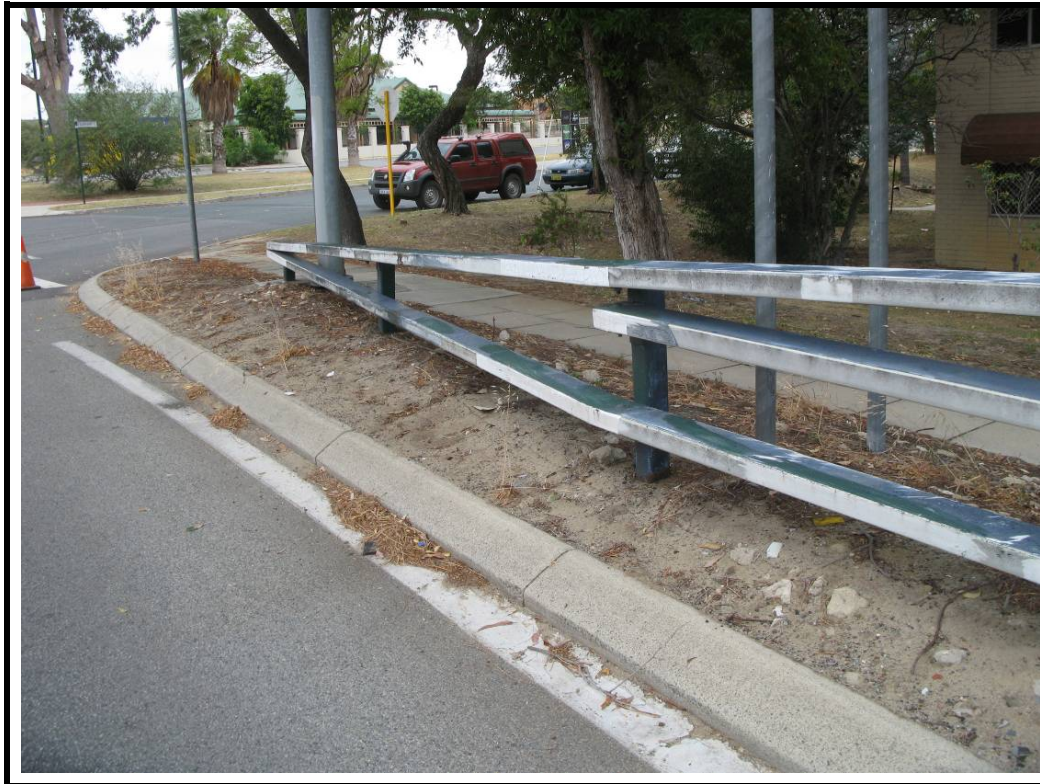
Photo No. 7: Substandard end terminal

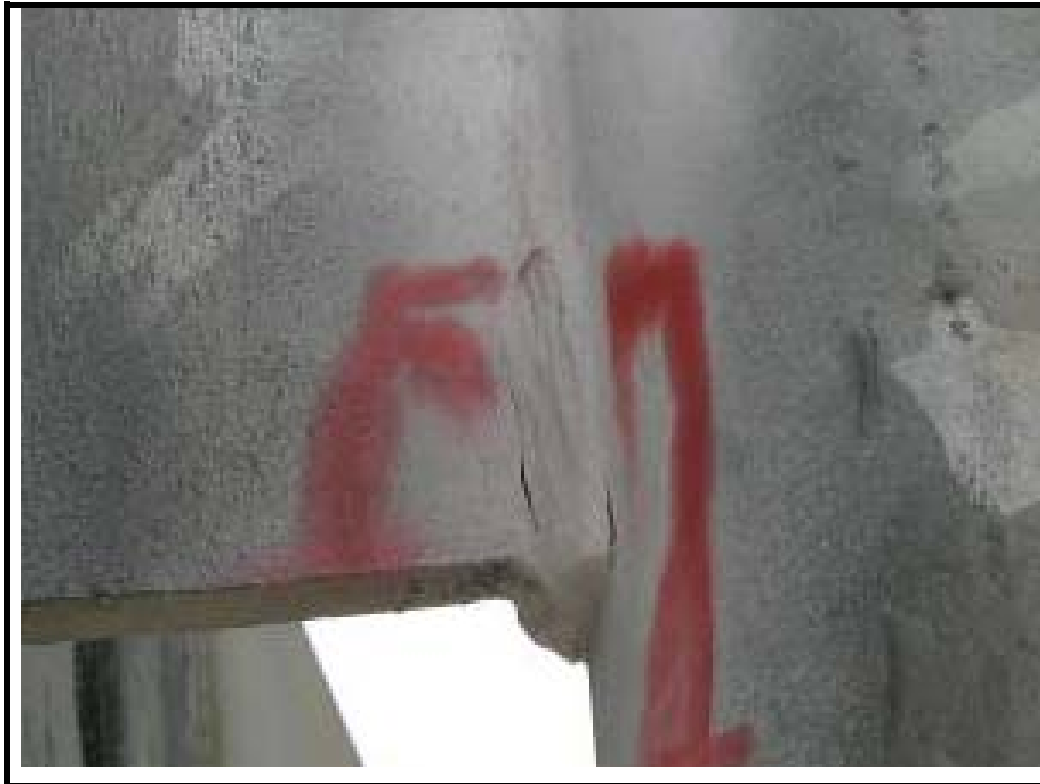
Photo No. 13: Sign connection 1 – close up of lack of fusion

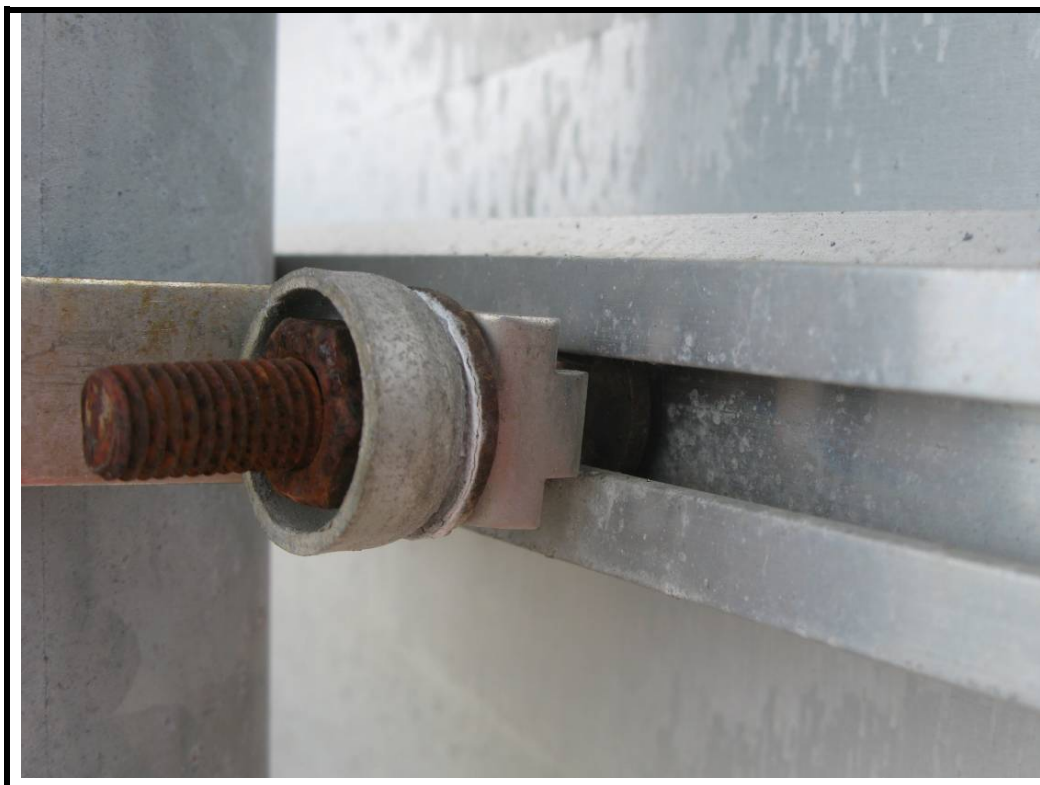
Photo No. 20: Galvanic corrosion to sign mounting bolts (typical)

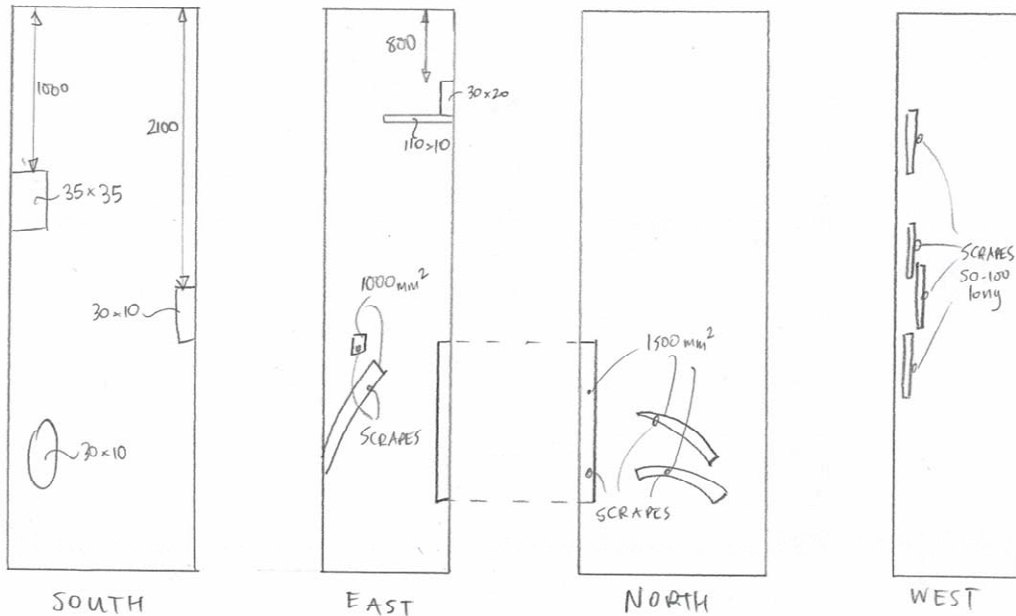
SKETCH No. 1: RHS column defects

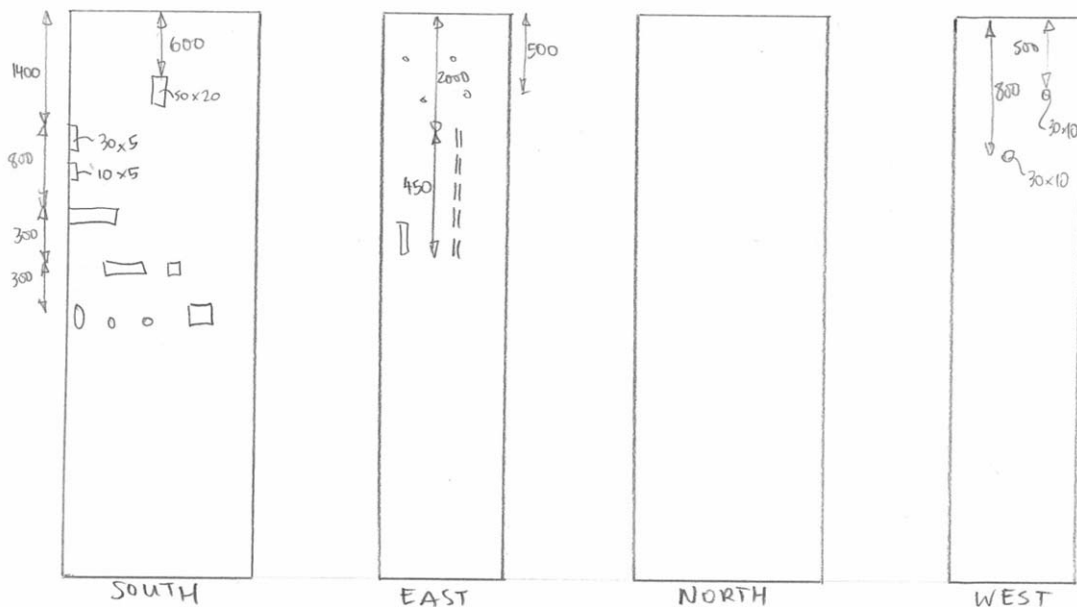
SKETCH No. 2: LHS column defects
