Black cockatoo breeding activity census 2019-20 for Muchea North
Great Northern Highway, Muchea to Wubin Upgrade Stage 2 Project

Prepared for Main Roads WA

April 2020

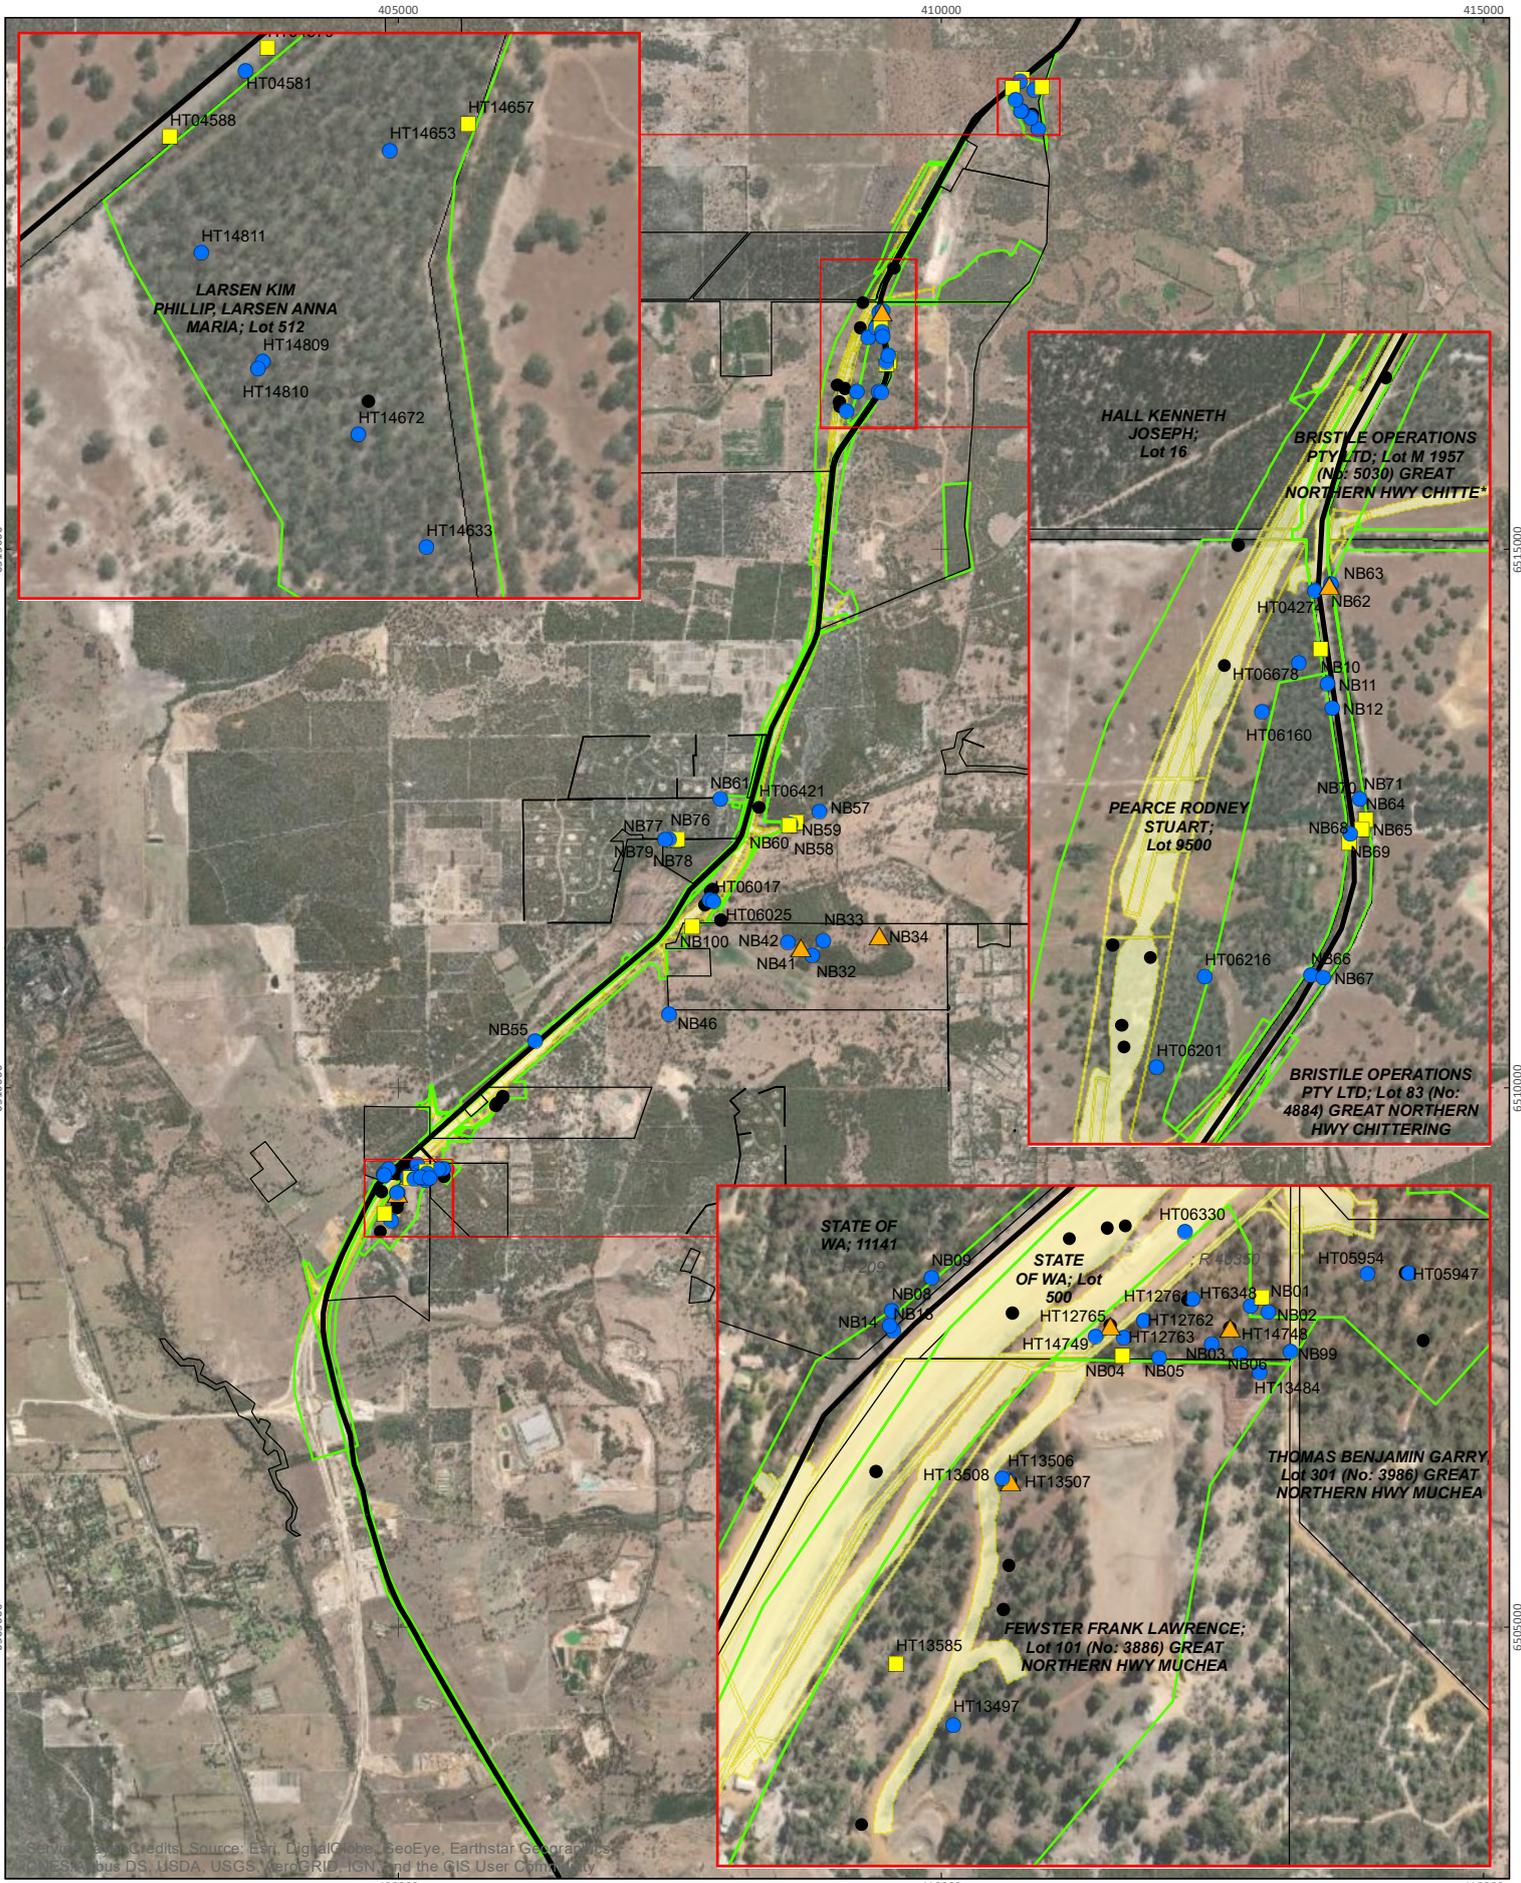
Figure 2

Confirmed breeding events were recorded in three artificial nesting hollows and three natural nesting hollows by Phoenix, (Table 2; Figure 2). Evidence of nesting activity was observed in a further ten artificial nesting hollows and four natural nesting hollows (Table 2; Figure 2).

Monitoring results for 2018-19 breeding season

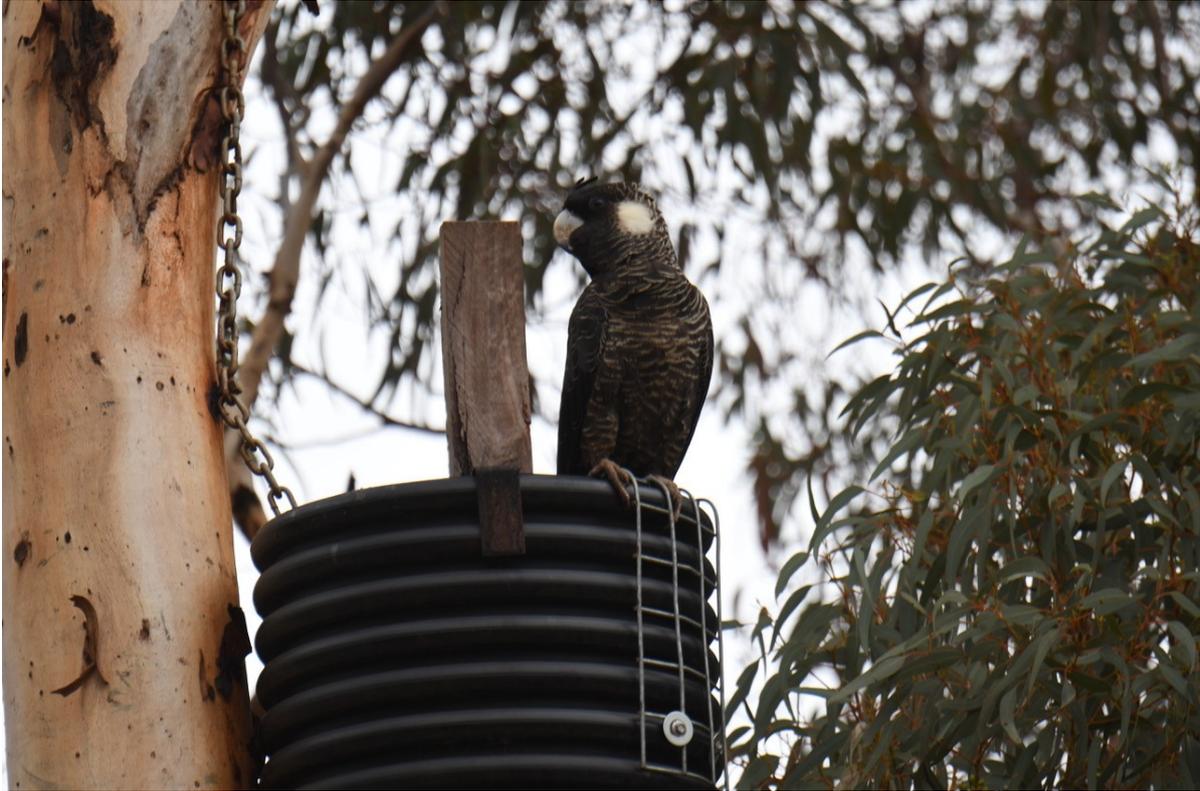
- NB34, NB41 and NB63 – are presumed to have resulted in successful fledging of a chick. Images of large chicks were seen with a camera in all three artificial nest hollows in December 2019 (Figure 3).
- HT12765 and HT13507 – female was flushed from hollow, presumed to be sitting on eggs.
- HT06348 – two eggs were observed with a camera in the hollow in October 2019, however these had been predated by November 2019.

Figure 3 Female flushed from a nest box (September 2019)

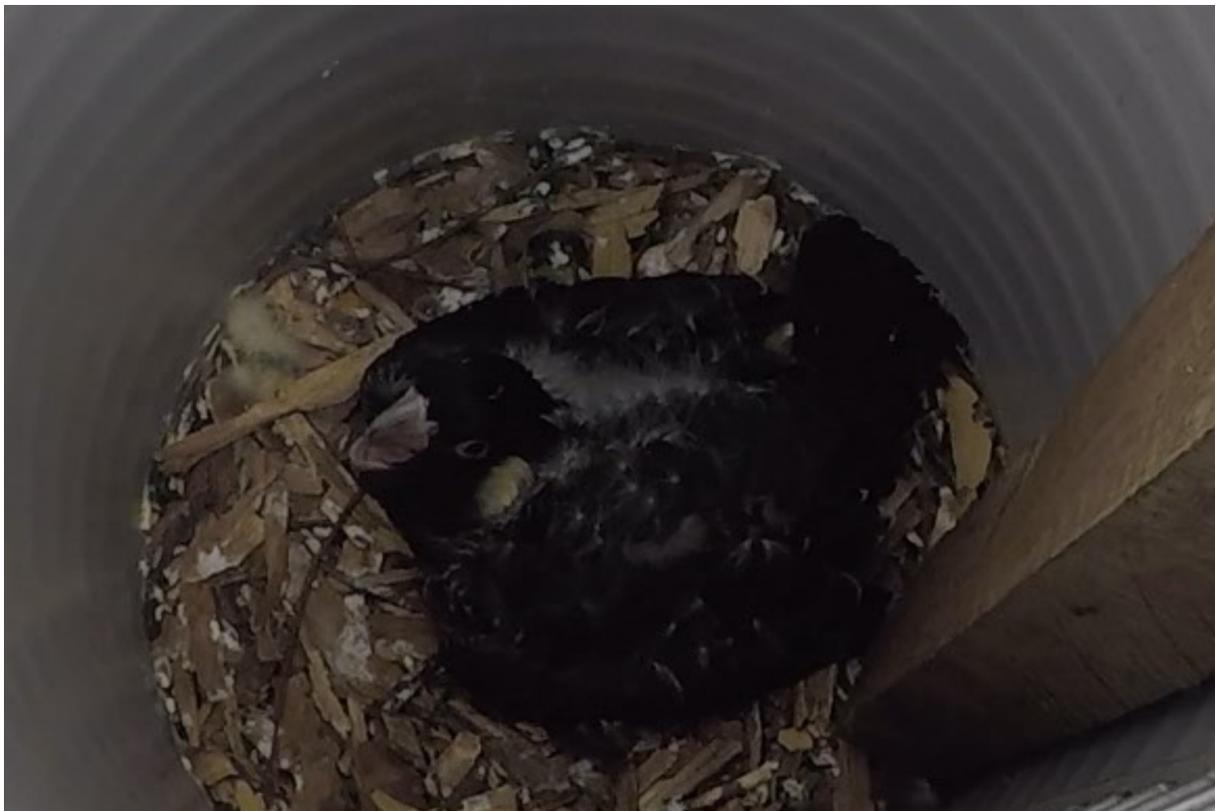
Figure 4 Chick in nest box (December 2019)

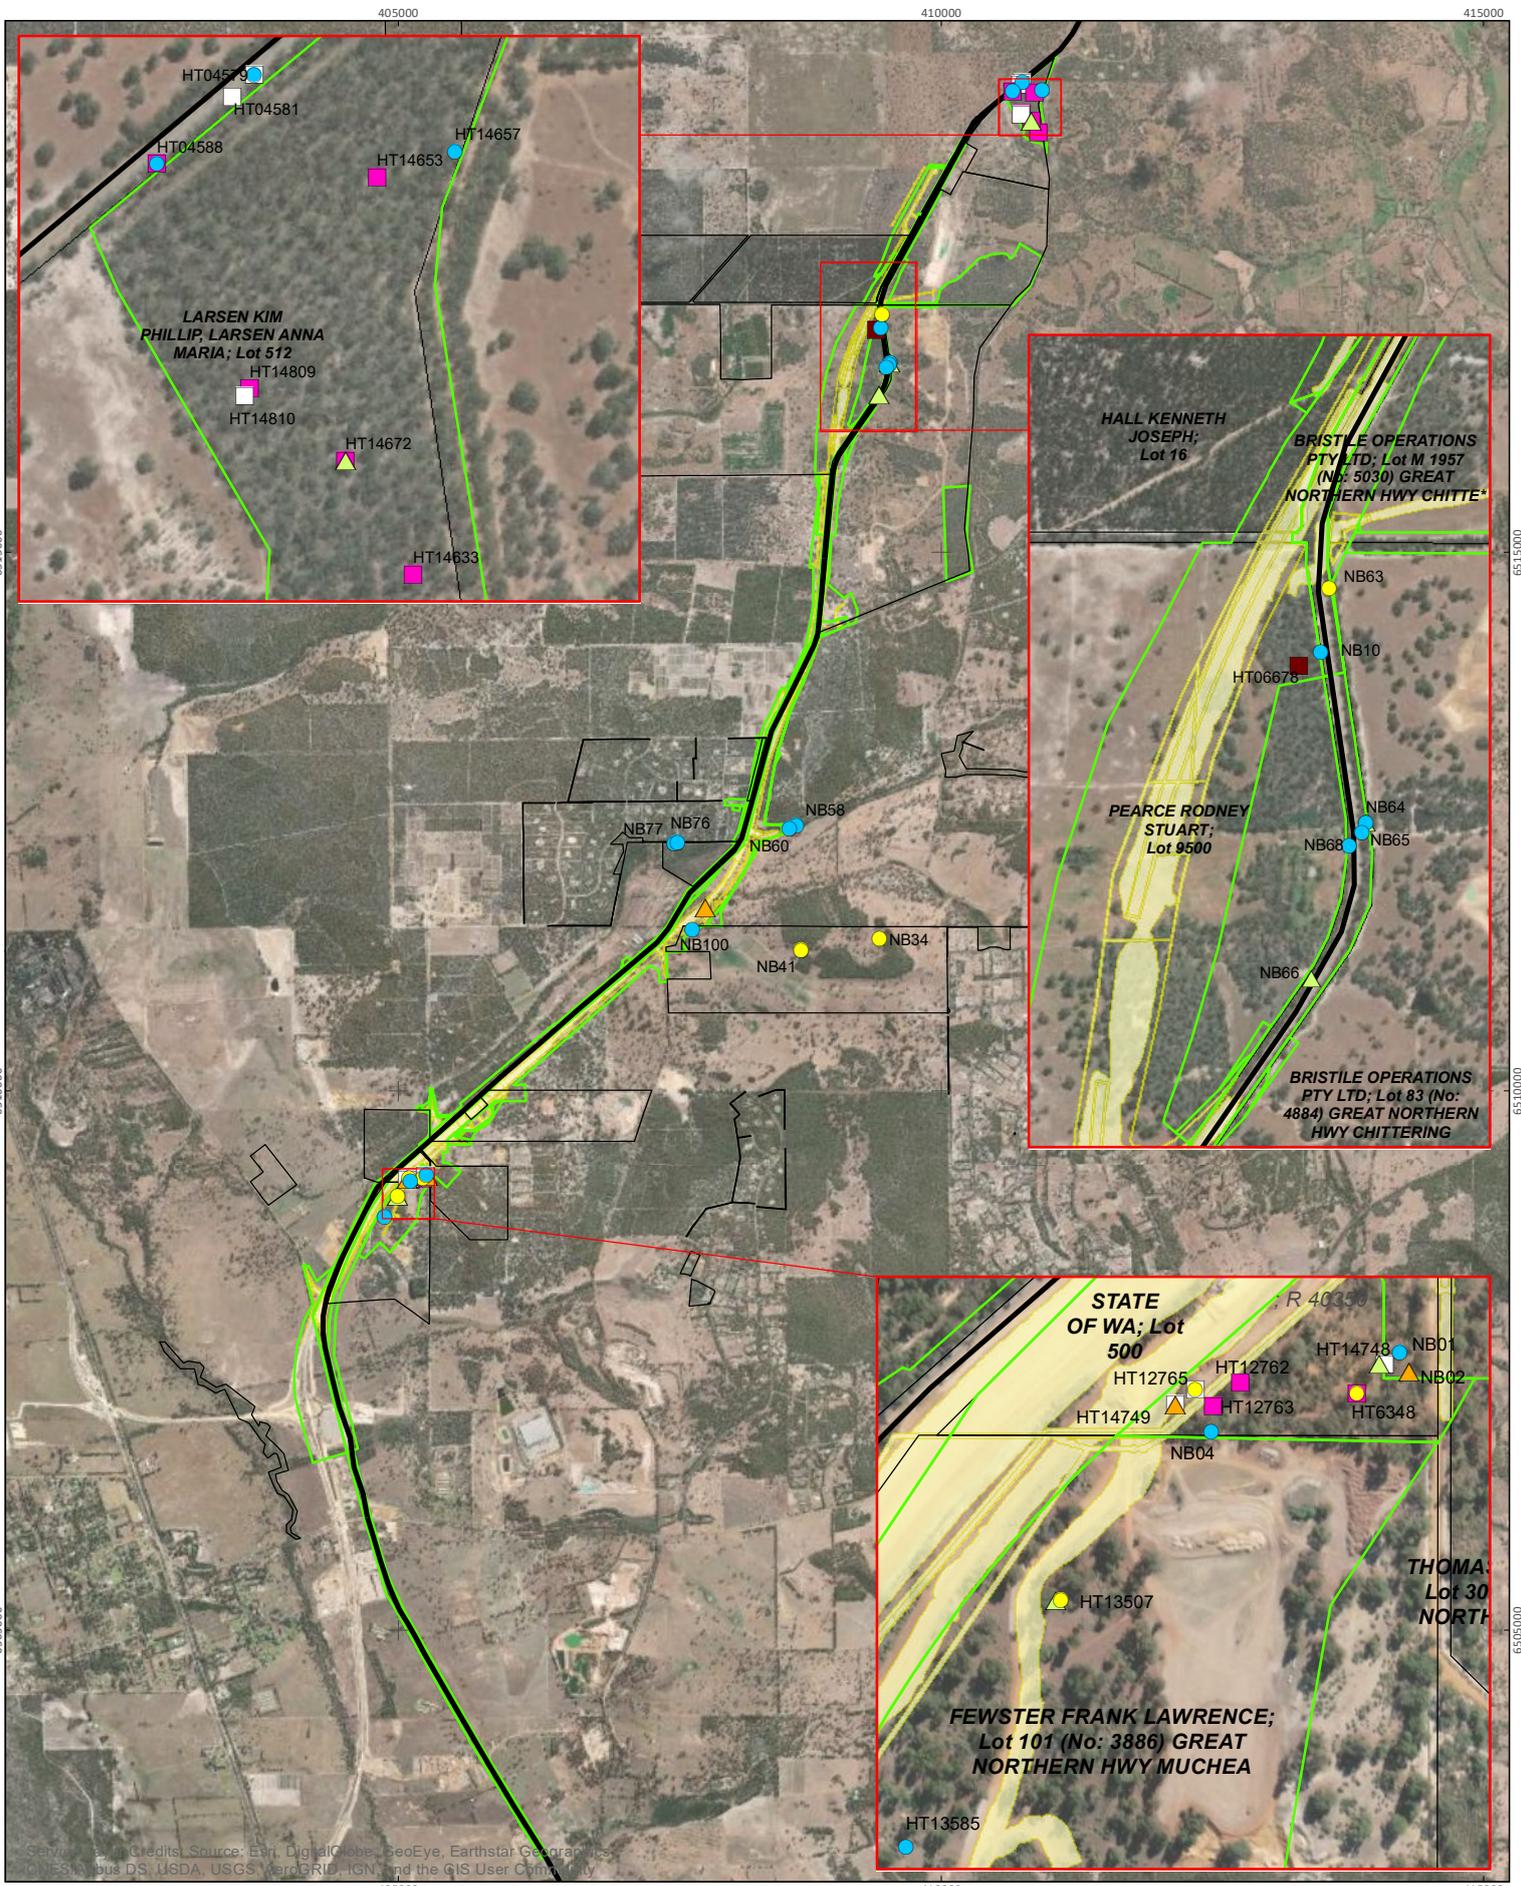
Figure 5

Breeding events and evidence of nesting activity in the 2019-20 season were identified in the same general areas as in the previous seasons, including the two areas that were identified as having a higher rate of breeding activity, Reserve 40350 and Lot 512 (Figure 3). An additional cluster where there was evidence of nesting or breeding activity was on a property where several artificial nesting hollows were installed after it was observed that Carnaby's Cockatoos were present in higher numbers, indicating the area could be a favourable breeding area (Nesci Estate and surrounding road reserve) (Phoenix 2017b).

Confirmed breeding events and Evidence of nesting activity across breeding seasons
