Appendix E: Tree Hollow Inspection Memorandum (SW Environmental, 2020)

RE: (SW303) Bussell Highway (H043) Duplication Project: Tree hollow inspection

ATTACHMENT 1 SERVICES, METHODS & RESULTS

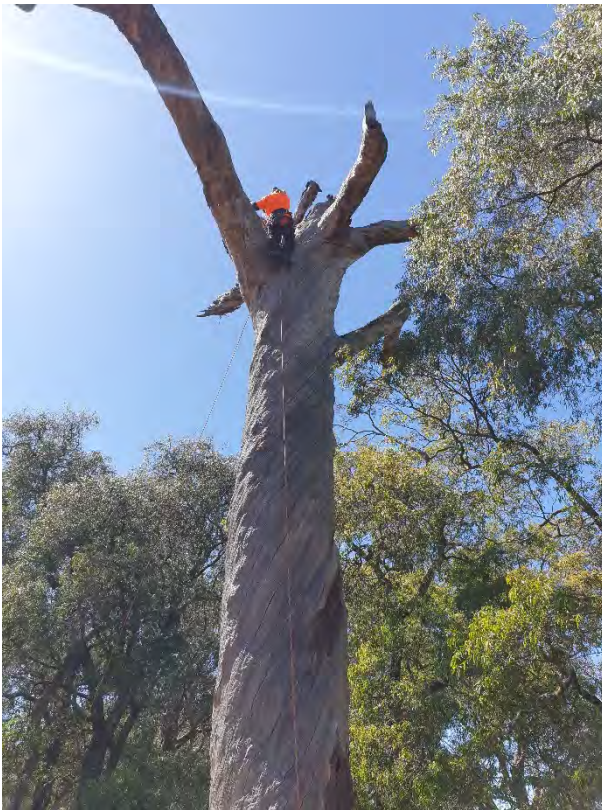
Photo 1 Tree 1 being climbed by an arborist.

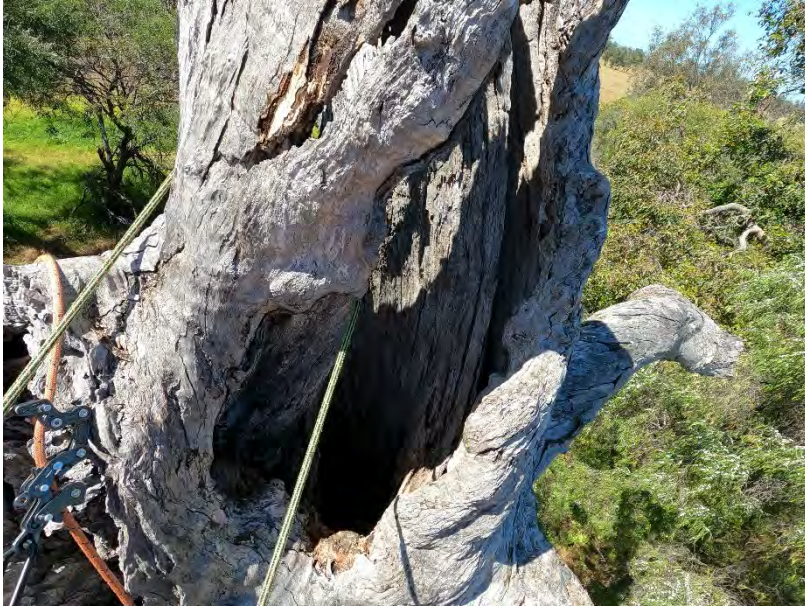
The vertical hollow had possible old heavy chews around the bottom of the rim of the entrance. There did not appear to be any recent chews or obvious signs of black cockatoo activity. A Western Ringtail Possum appears to be visible nesting at the bottom of the hollow (post-processing).

Tree 1 therefore has a single large vertical hollow, suitable for black cockatoo breeding (with possible old chews) but not being currently used by black cockatoos. The hollow was being actively used by Western Ringtail Possum at the time of the survey.

Photo 2 Tree 1 hollow entrance with possible old heavy chews at the base of the entrance.

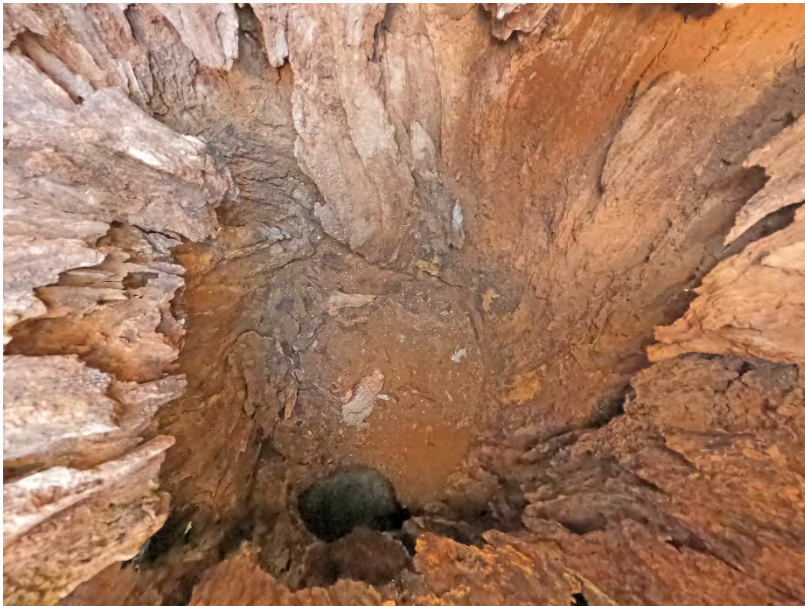
Photo 3 Tree 1 hollow interior with Western Ringtail Possum curled in the bottom of the hollow.

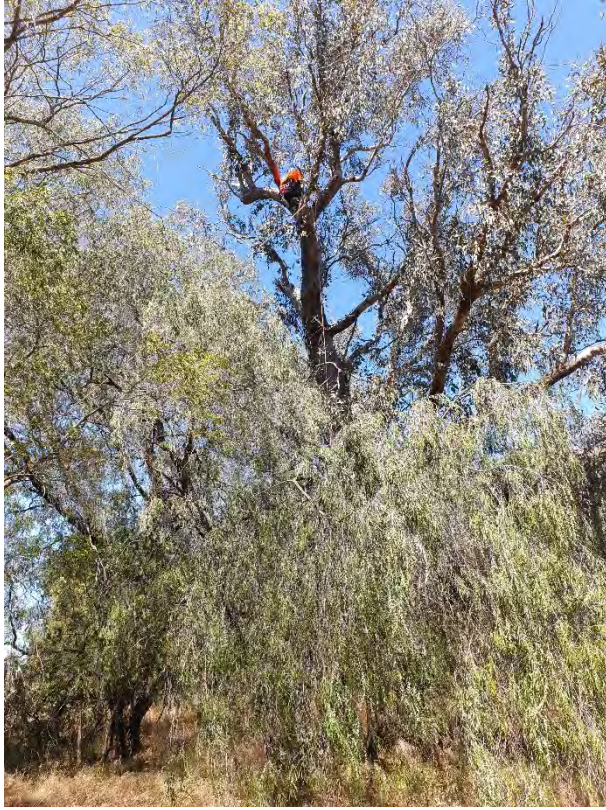
Photo 4 Tree 2 being climbed by an arborist.

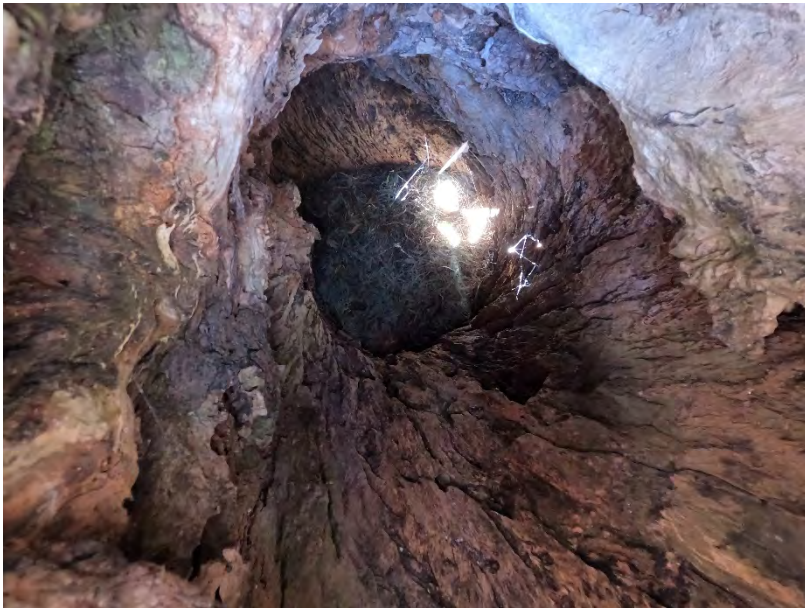
The large Flooded Gum contained multiple knot type hollows up through the main trunk. The hollows were confirmed as being connected throughout with a single hollow blocked off about 120 cm below the main fork into a fissure. The hollow/fissure blockage was made by a Western Ringtail Possum nest.

Tree 2 therefore has a single hollow network with multiple large entrances but is unsuitable for black cockatoo breeding given that there does not appear to be a hollow floor. The hollow network was being actively used by Western Ringtail Possum.

Photo 5 Tree 2 hollow floor, a Western Ringtail Possum nest made of *Agonis flexuosa* leaves.

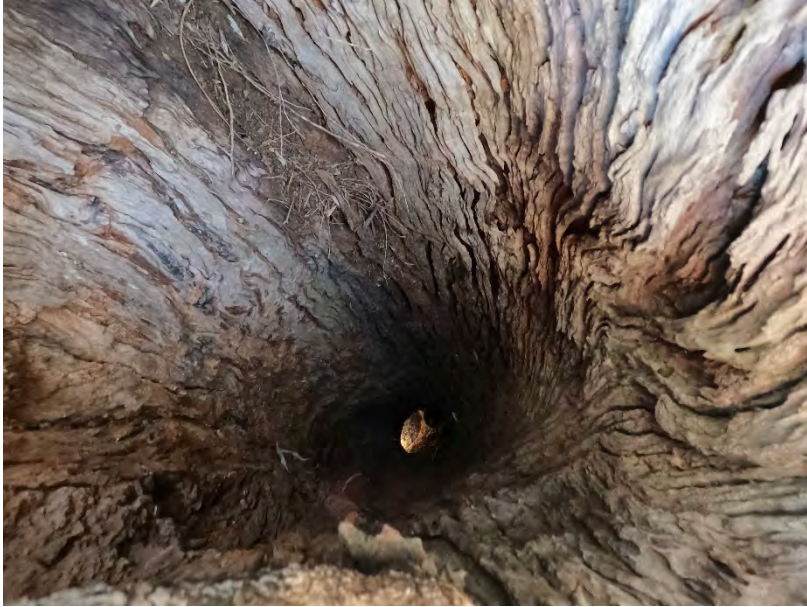
Photo 6 Tree 2 hollow network showing connectivity through the trunk.

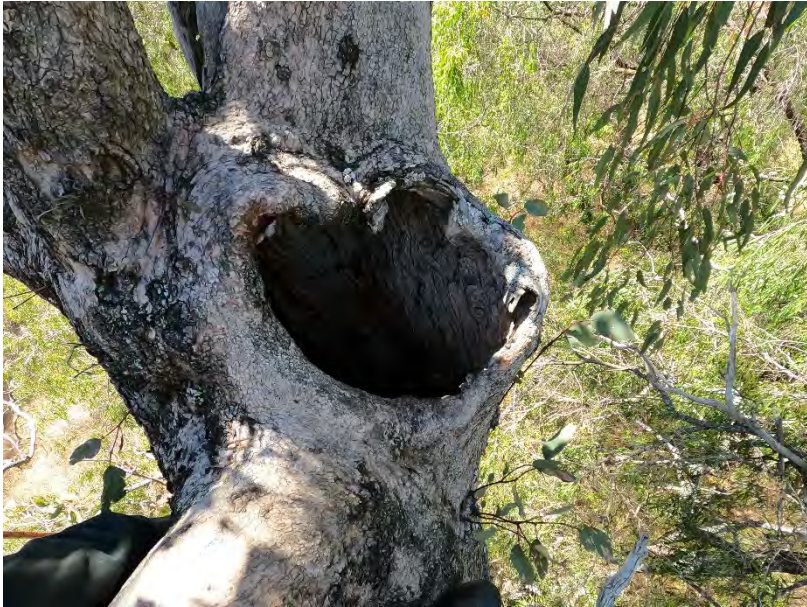
One of the knot hollows (with a circa 20 cm aperture) contained several light chew marks. The formation of these could be attributed to a number of species or could have been a result of hollow prospecting. While the entrances were suitably large for black cockatoo access, the hollow network is unlikely to be used by any nesting birds (cockatoos or otherwise) as the hollows appeared to be connected without a chamber, other than the Western Ringtail Possum nest.

Photo 7 Tree 2 main entrance, with light chews on the rim just visible.

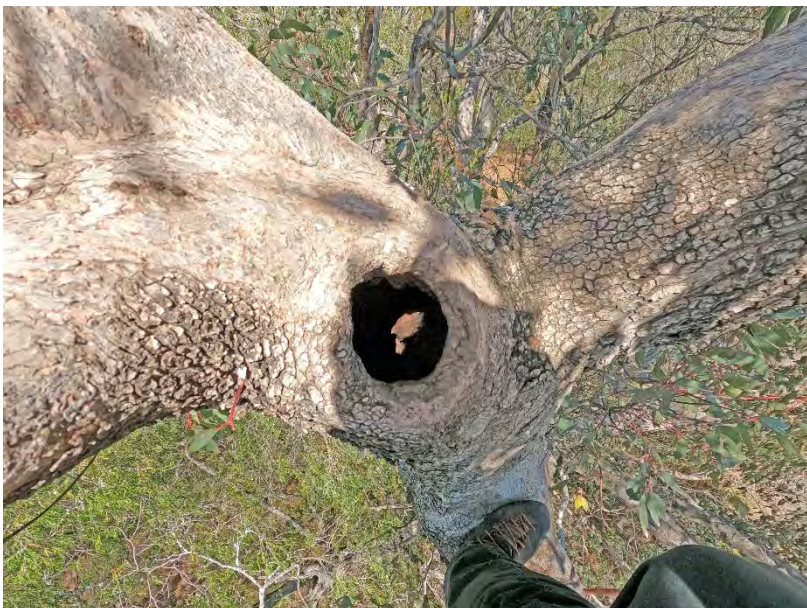
Photo 8 Tree 2 alternative entrance without chews but connected through the main trunk.
