Detailed Visual Bridge
Inspection Guidelines
for Concrete and Steel
Bridges
(Level 2 Inspections)

Document No: 6706-02-2233

**CONDITION ASSESSMENT – LEVEL 2
DETAILED VISUAL BRIDGE INSPECTION GUIDELINES FOR
CONCRETE & STEEL BRIDGES**

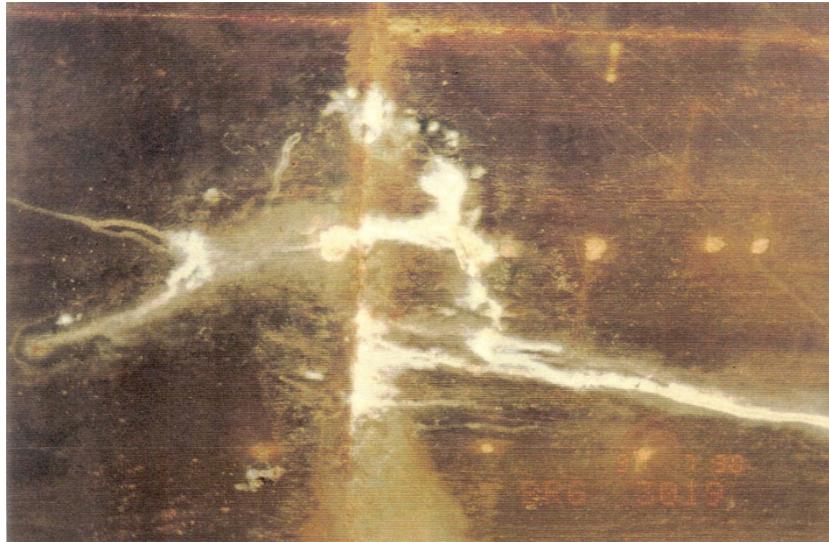
FIGURE 11.6 - EFFLORESCENCE ON DECK SOFFIT

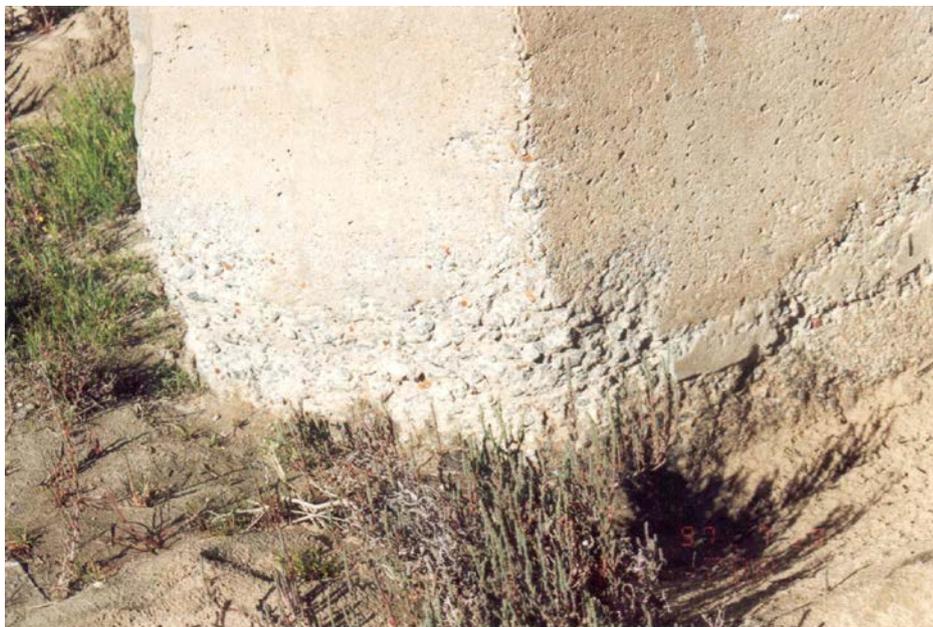
FIGURE 11.11 - EROSION OF CONCRETE DUE TO WATER WASH

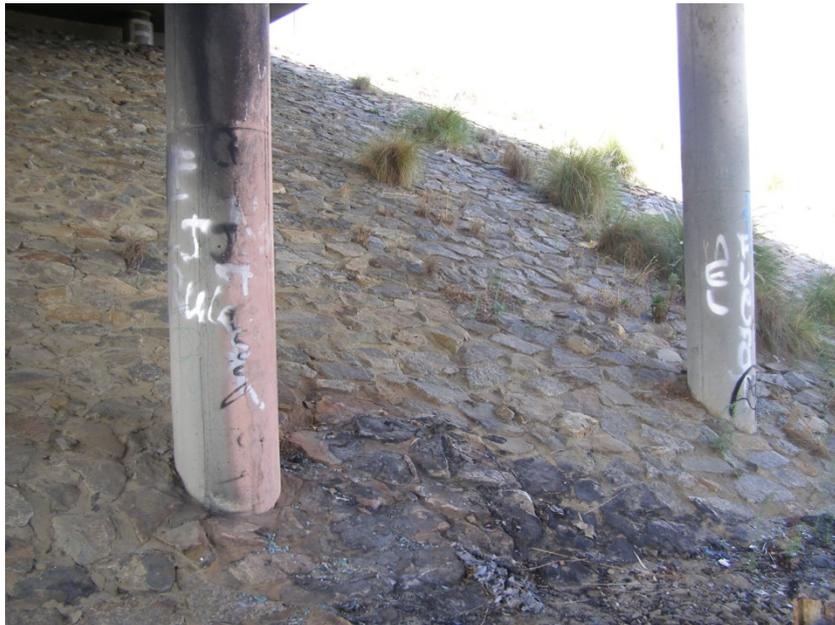
FIGURE 11.12 - FIRE DAMAGE TO CONCRETE COLUMN

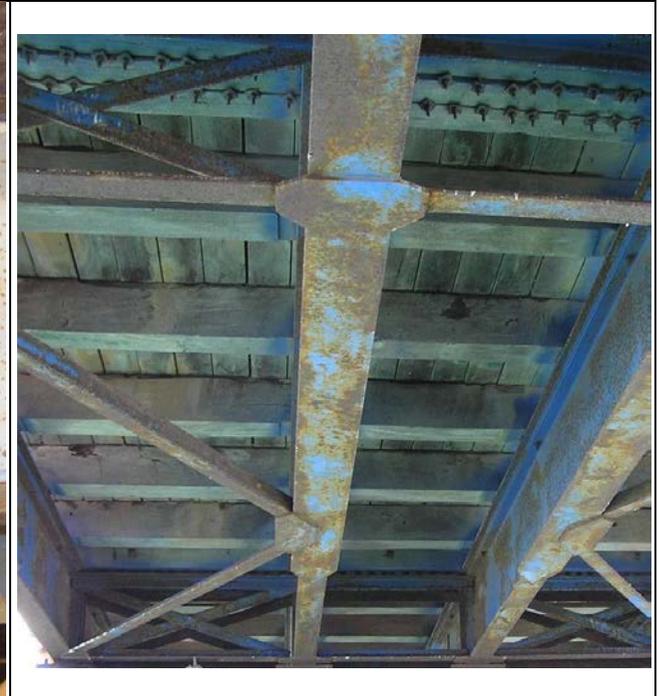
Quite widespread but superficial surface corrosion.

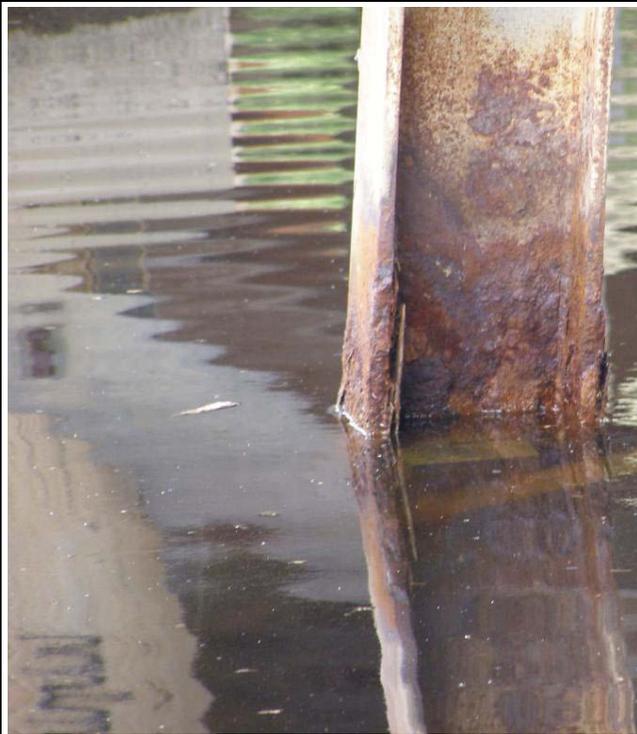
Loss of section from flange and web evident. Note that the Inspector should consider if there is greater deterioration below current water level.

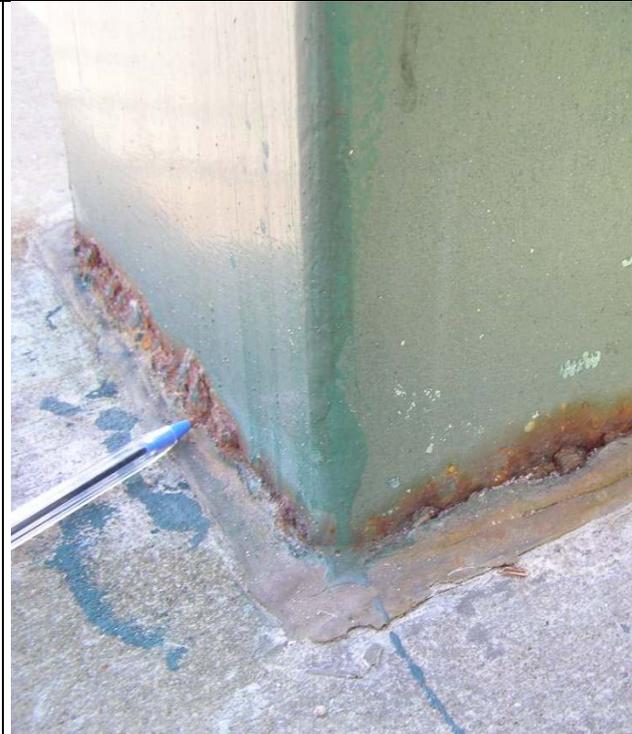
Surface corrosion on the weld with a non-continuous hairline crack.

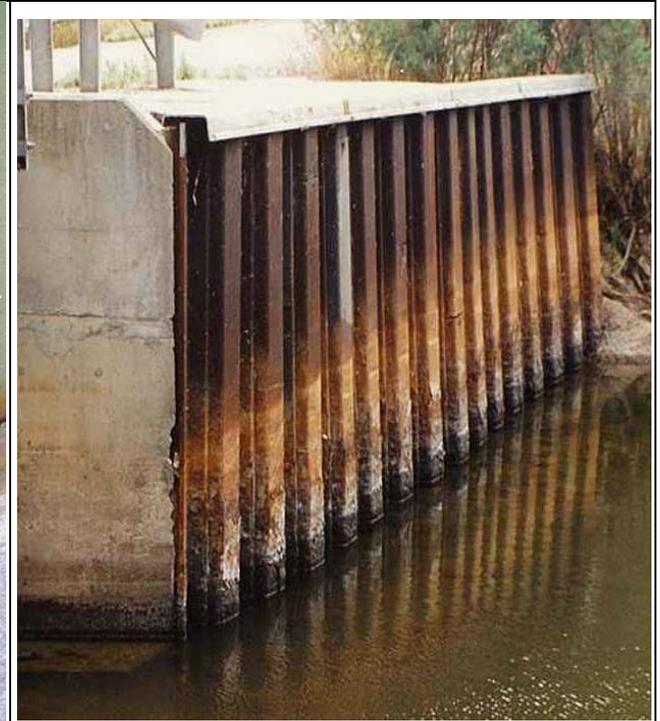
Active surface corrosion and pitting in isolated areas of the wing wall with loss of section.

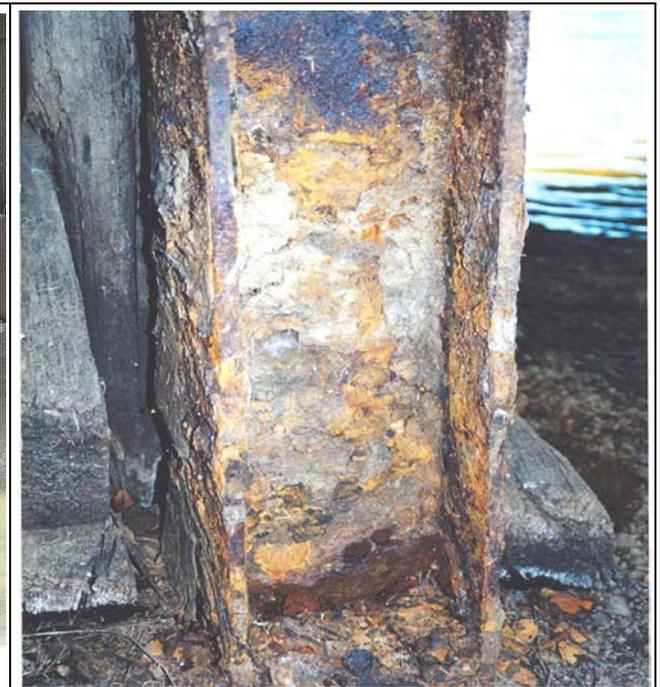
Severely corroded steel section.

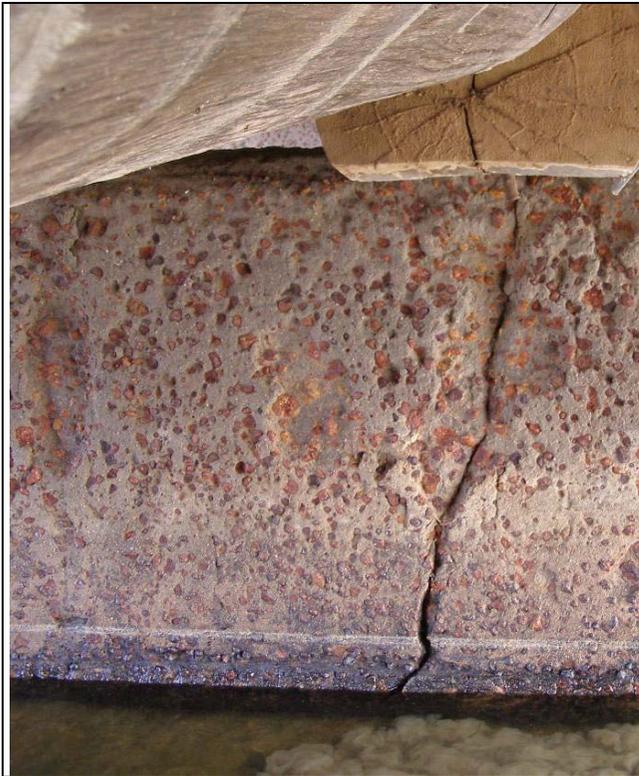
Unreinforced mass concrete pier wall. Single heavy crack which appears stable. Some abrasion.

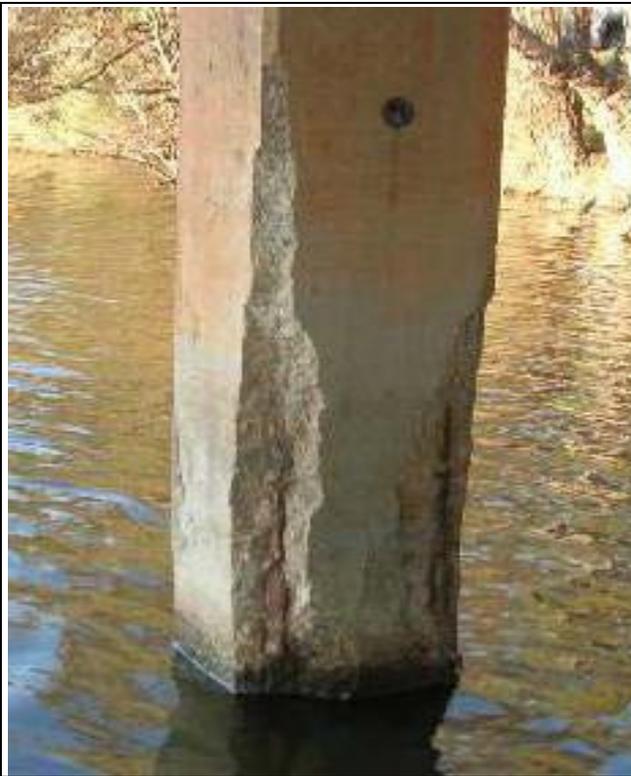
Reduced section capacity based on loss of section area from spalling, in tidal zone so assume deterioration will proceed rapidly.

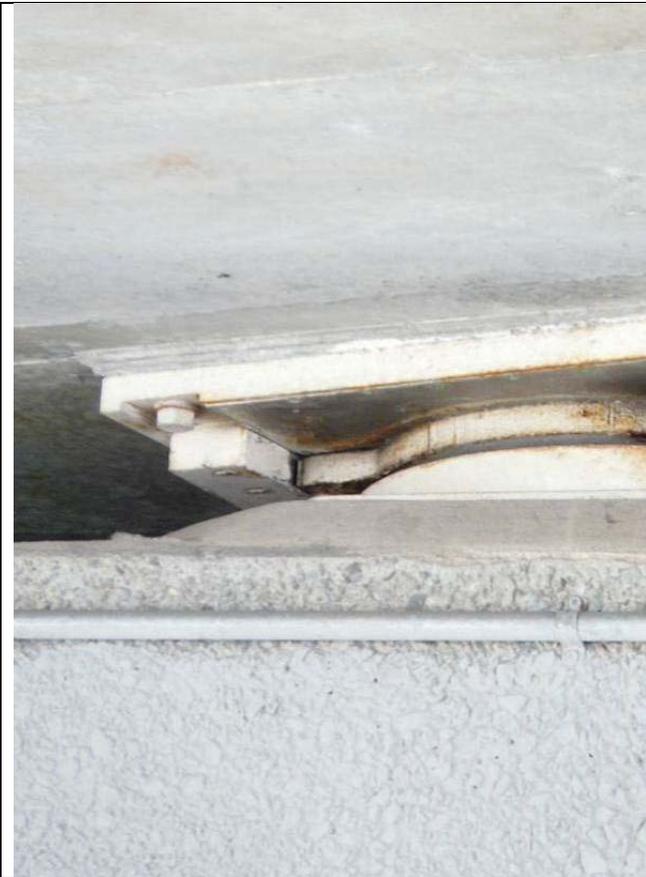
Minor corrosion only.

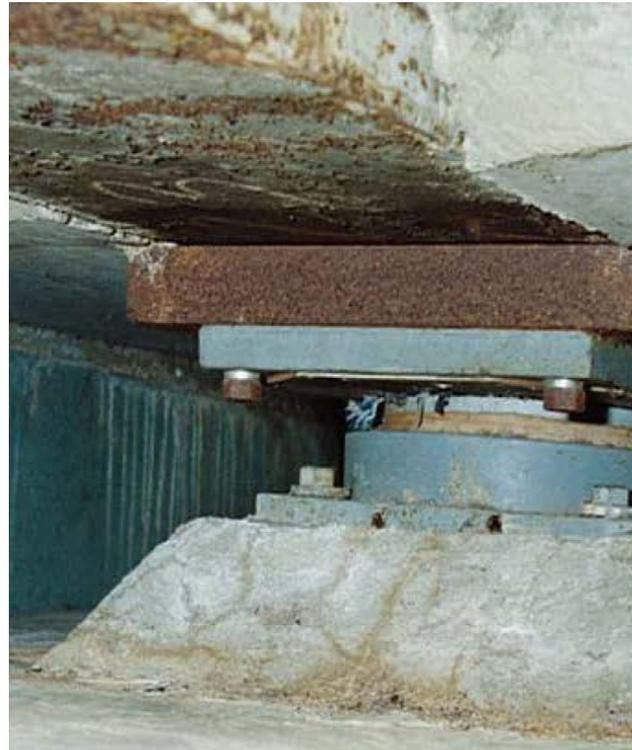
Hairline cracking of the mortar pad but still sound. Minor corrosion of connections. (Note: the packing plate is not considered part of the Bearing Unit.)

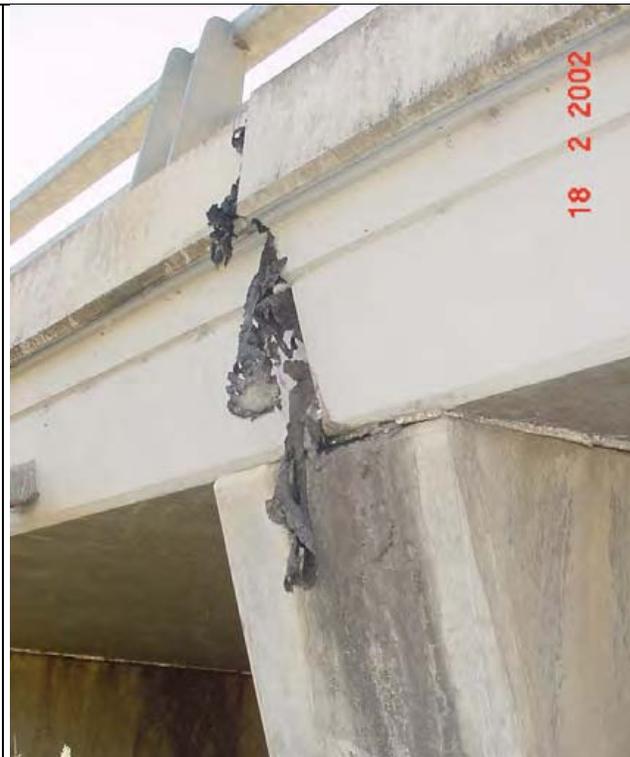
Significant loss of sealant.

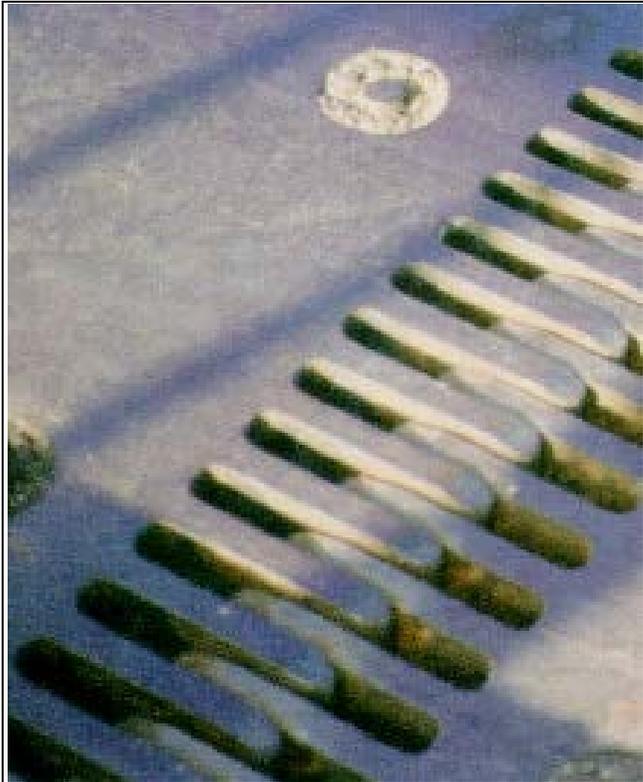
Minor displacement of fingers relative to one another (needs further investigation). Loss of waterproofing at bolted connection.

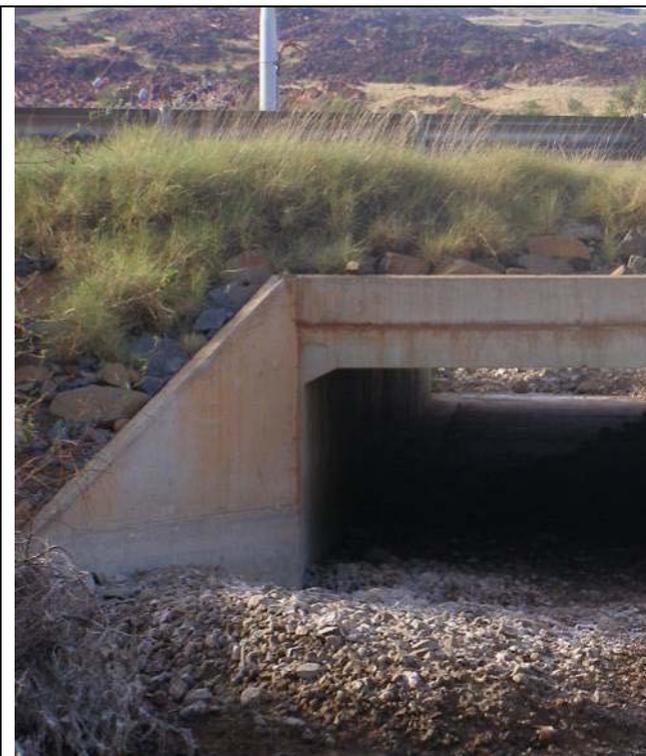
Water/rust staining only on the wing wall, no evidence of any degradation.

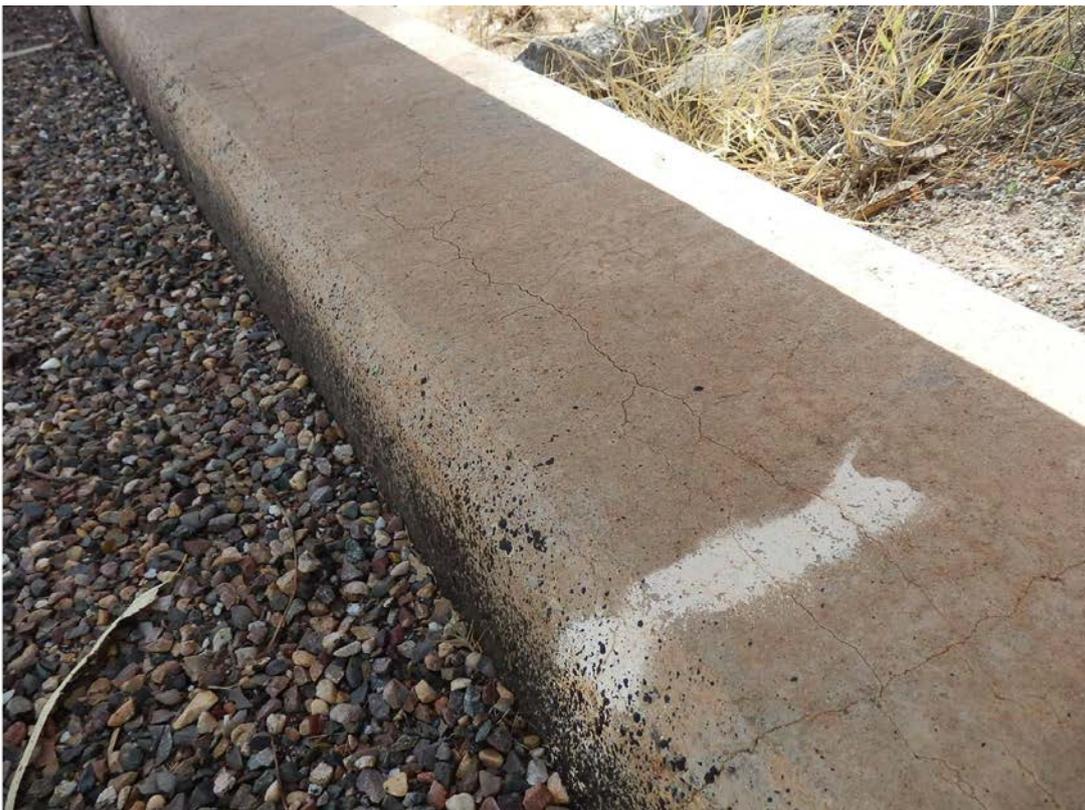
Photo No. 8: Various cracking to abutment 1 right hand side kerb. Concrete is solid. (Taken: 30-Jul-2013)

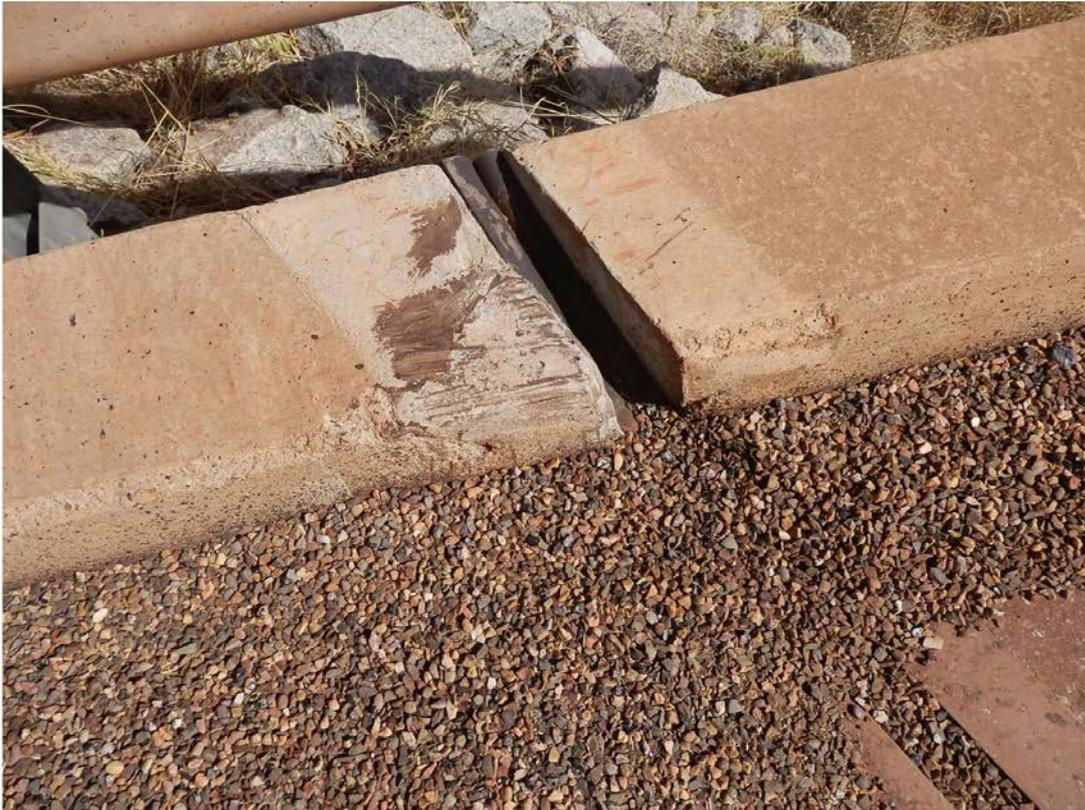
Photo No. 9: Abutment 1 expansion joint cover plate to kerb missing. Road debris filling joint gap. (Taken: 30-Jul-2013)

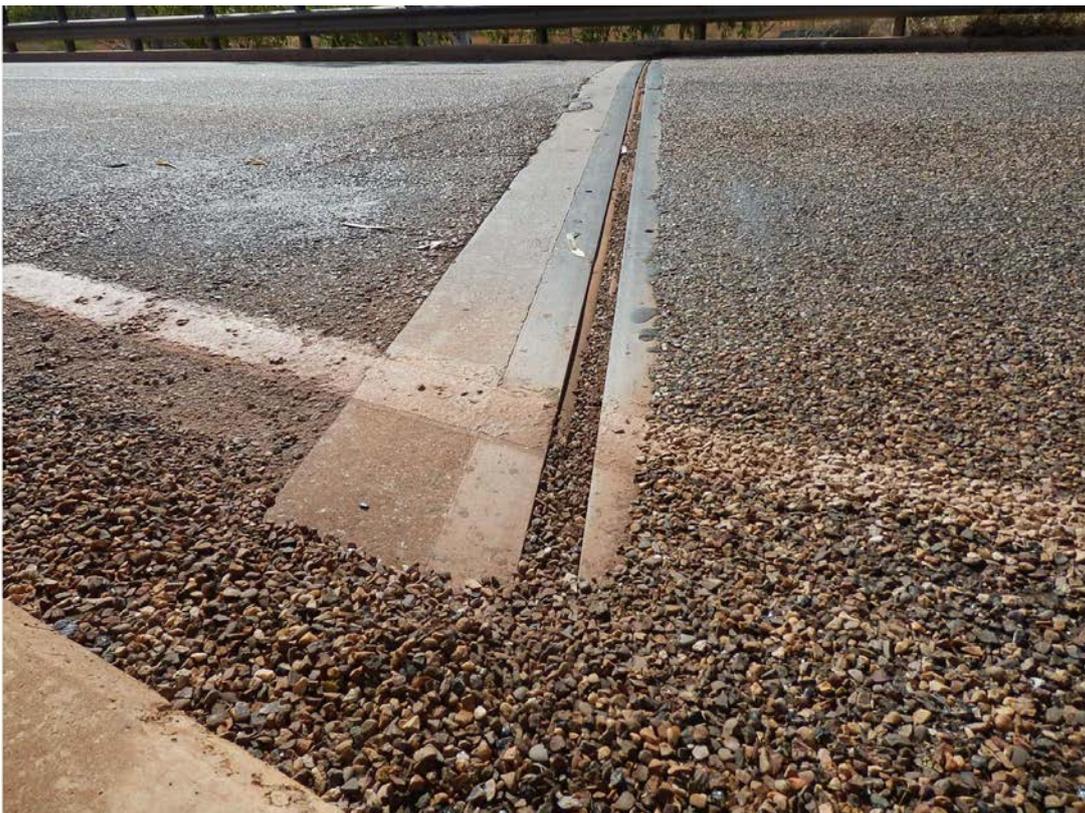
Photo No. 10: Abutment 1 expansion joint. Compressive seal gap full of road debris. (Taken: 30-Jul-2013)

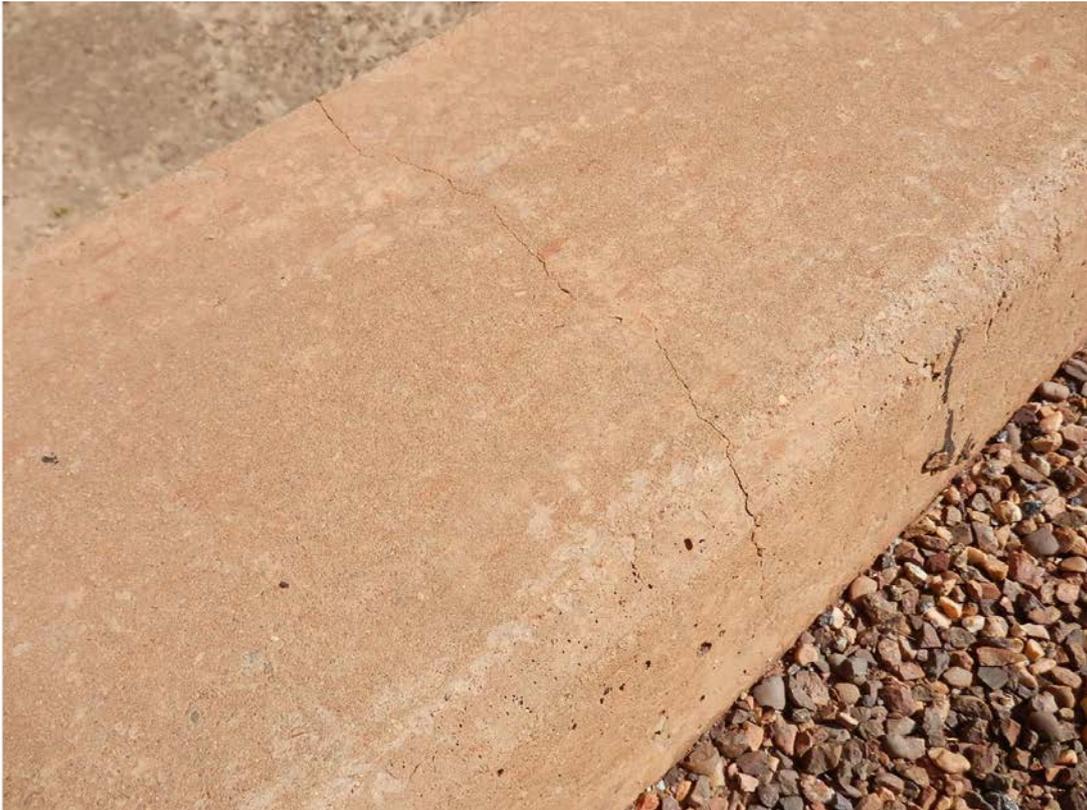
Photo No. 13: Typical cracking to kerbs on bridge deck. Left hand side shown here. (Taken: 30-Jul-2013)

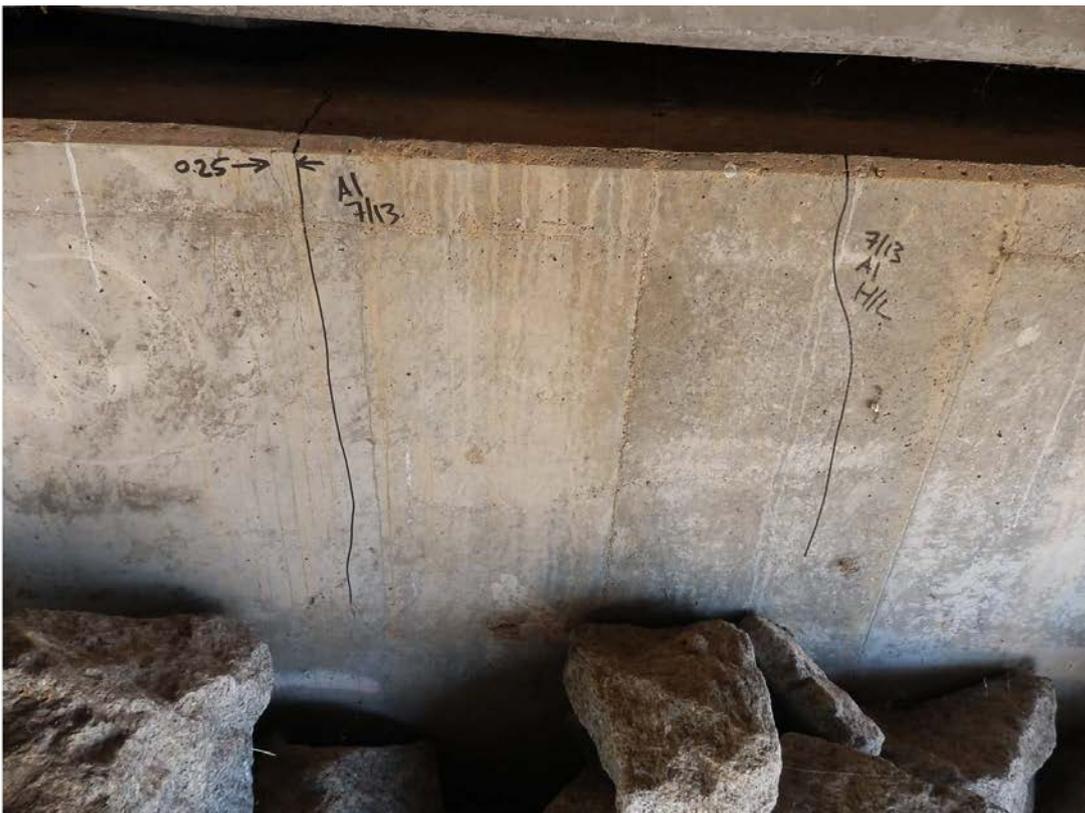
Photo No. 22: Abutment 1 capbeam between beams 2 and 3. Hairline to 0.25mm vertical cracking. (Taken: 30-Jul-2013)

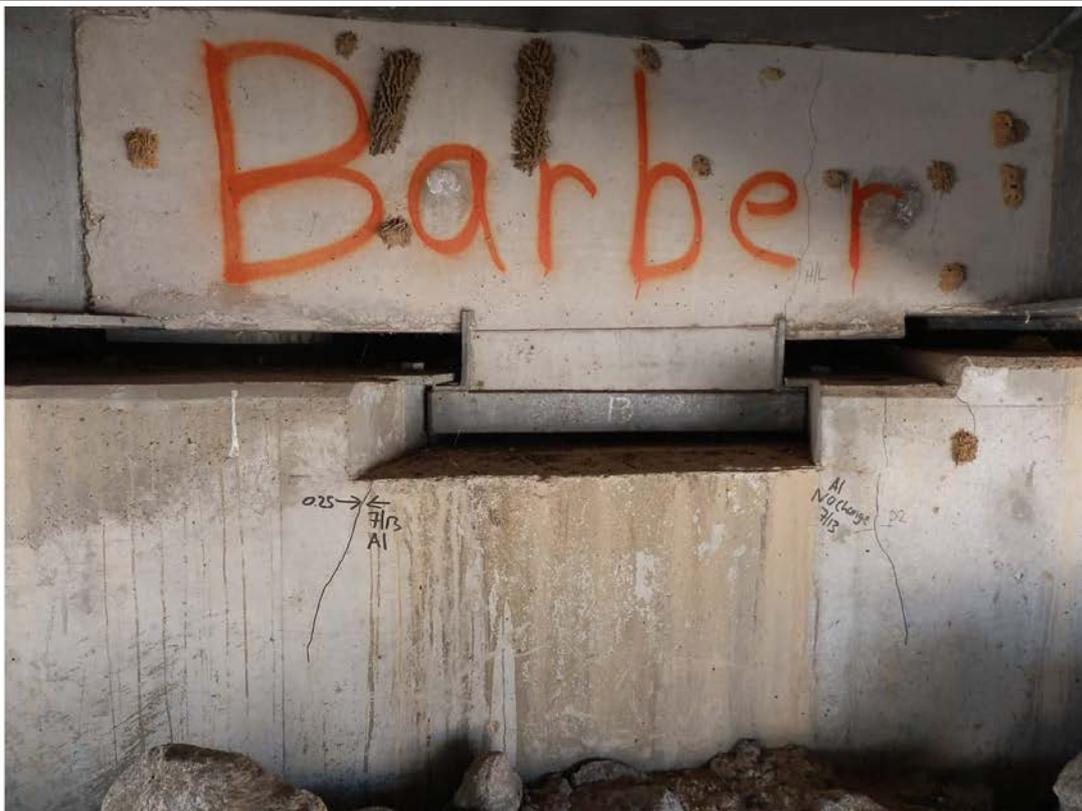
Photo No. 23: Abutment 1 diaphragm and capbeam. 0.25mm cracks as previously recorded. (Taken: 30-Jul-2013)

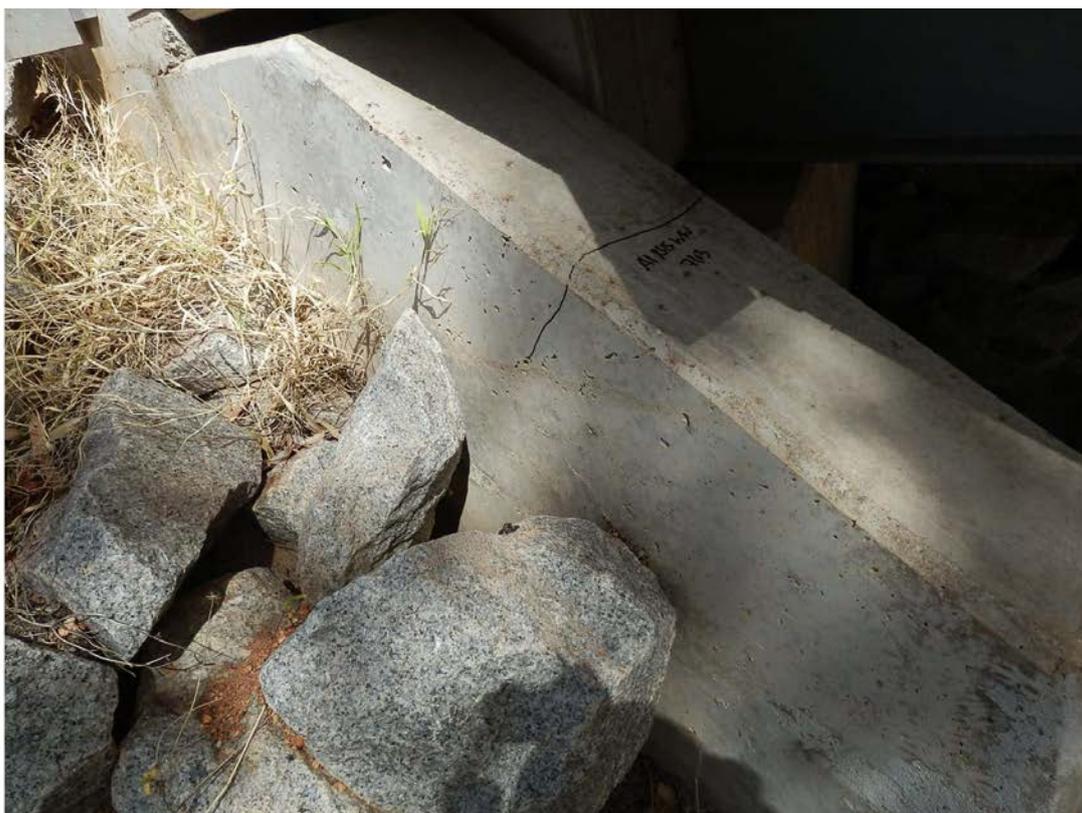
Photo No. 24: Abutment 1 right hand side wing wall. 0.15mm crack to top face of wall (Taken: 30-Jul-2013)

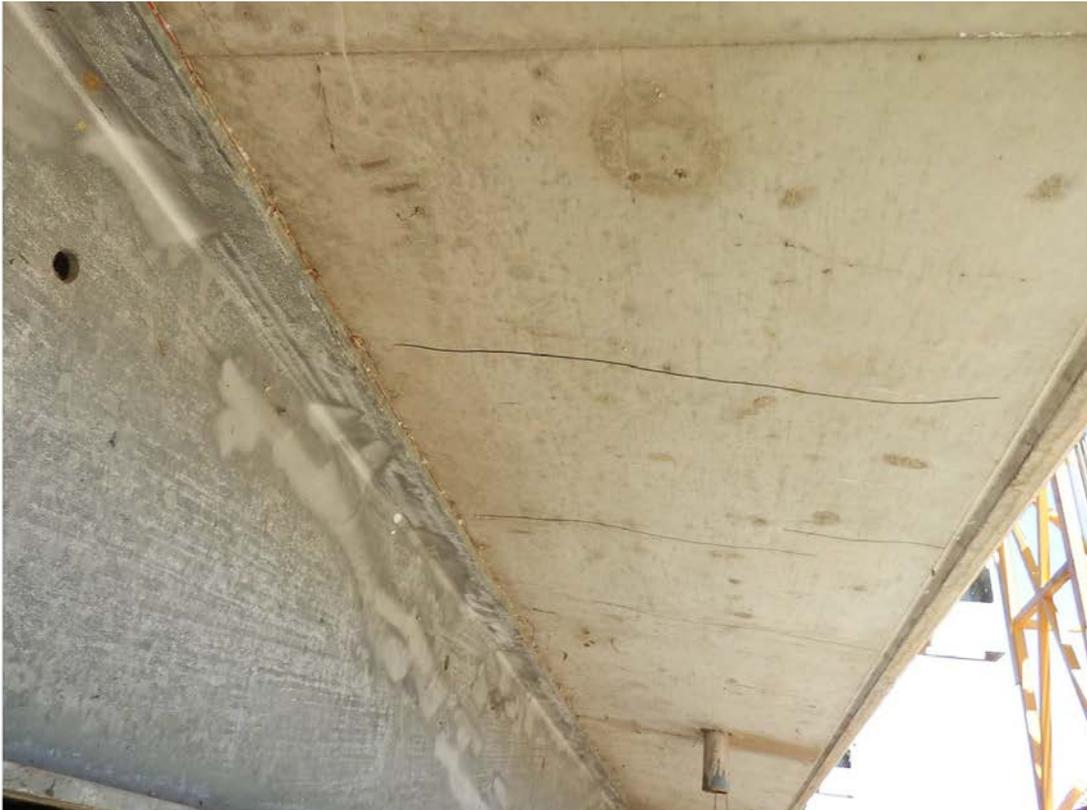
Photo No. 27: Hairline cracking to left hand side cantilever of span 1. (Taken: 31-Jul-2013)

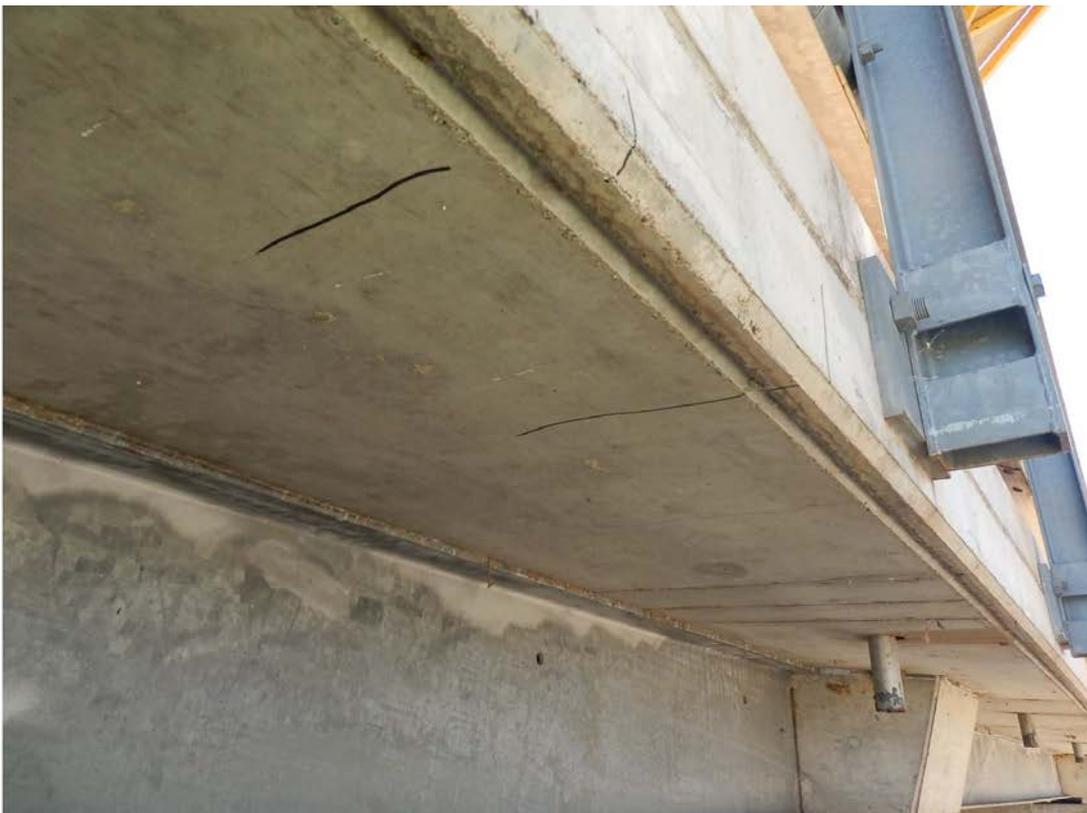
Photo No. 28: Hairline cracking to right hand side cantilever of span 1. (Taken: 31-Jul-2013)

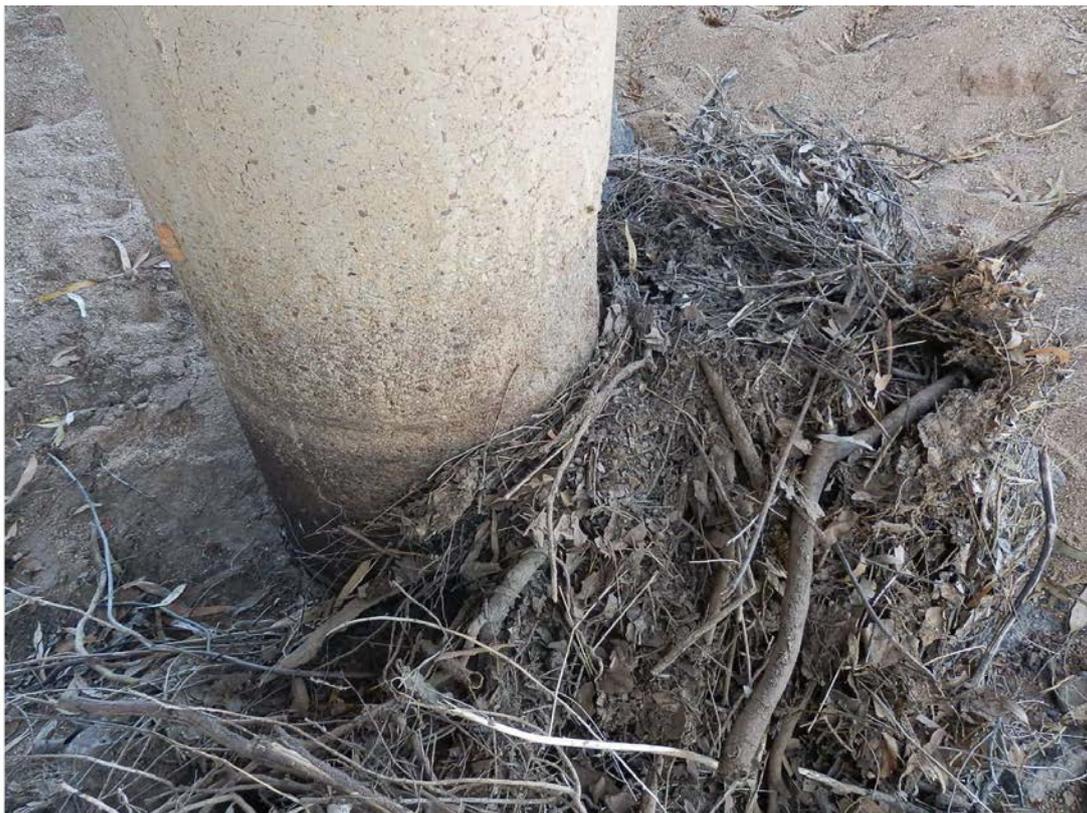
Photo No. 30: Flood debris up against previous fire damaged column. Unable to remove by hand but no obvious signs of deterioration to upper section that could be seen. (Taken: 31-Jul-2013)

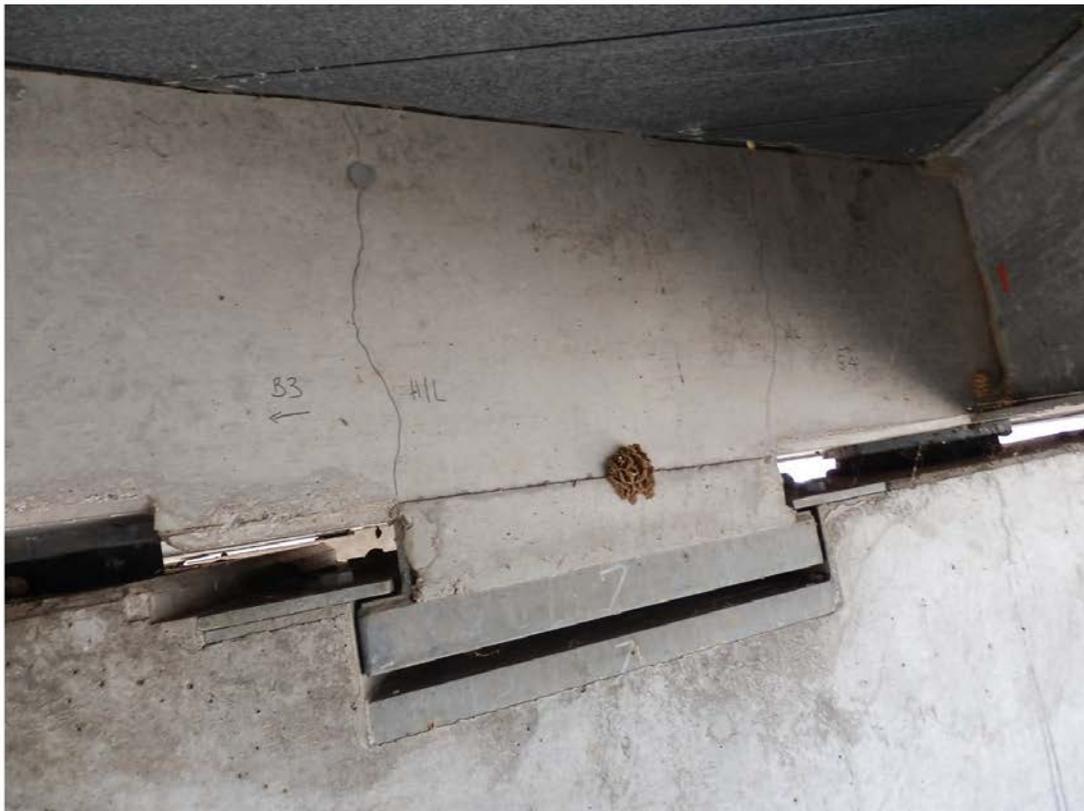
Photo No. 31: Pier 1 shear key/ diaphragm. Hairline cracks from internal corner up to shutter bolt hole. Abutment 1 face. (Taken: 31-Jul-2013)

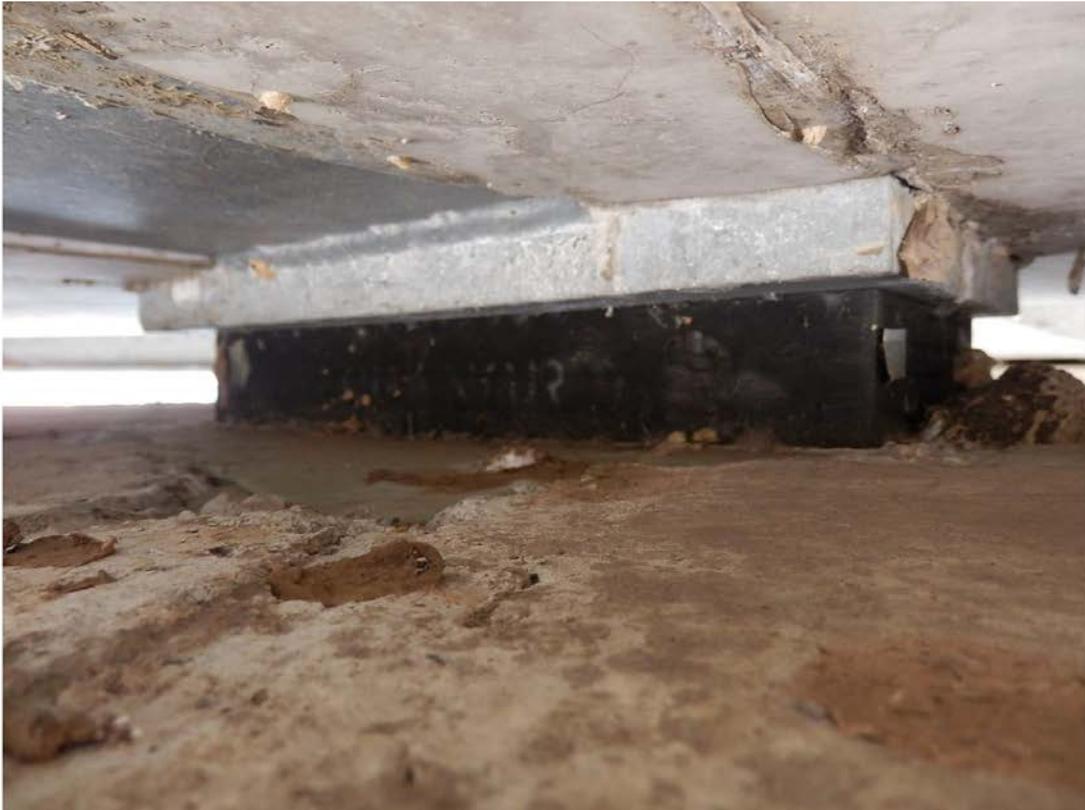
Photo No. 33: Pier 1 typical bearing pad in good condition. (Taken: 31-Jul-2013)

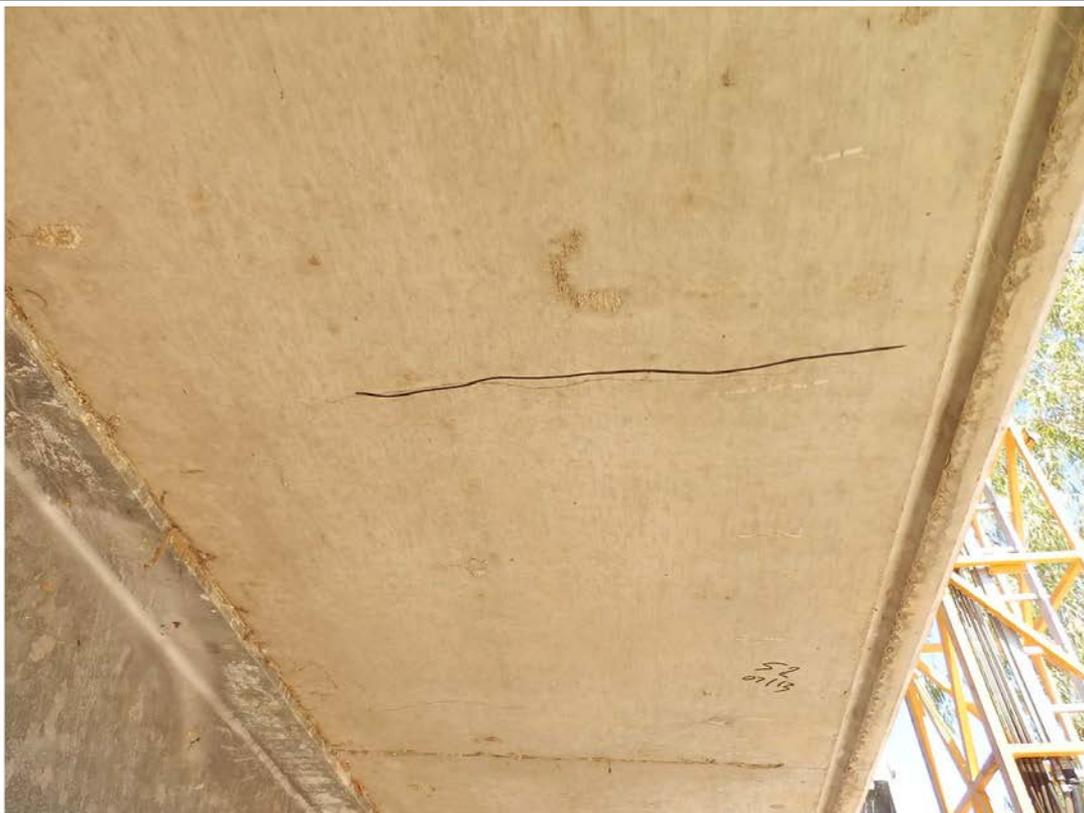
Photo No. 35: Span 2 left hand side cantilever. Hairline cracks. (Taken: 31-Jul-2013)

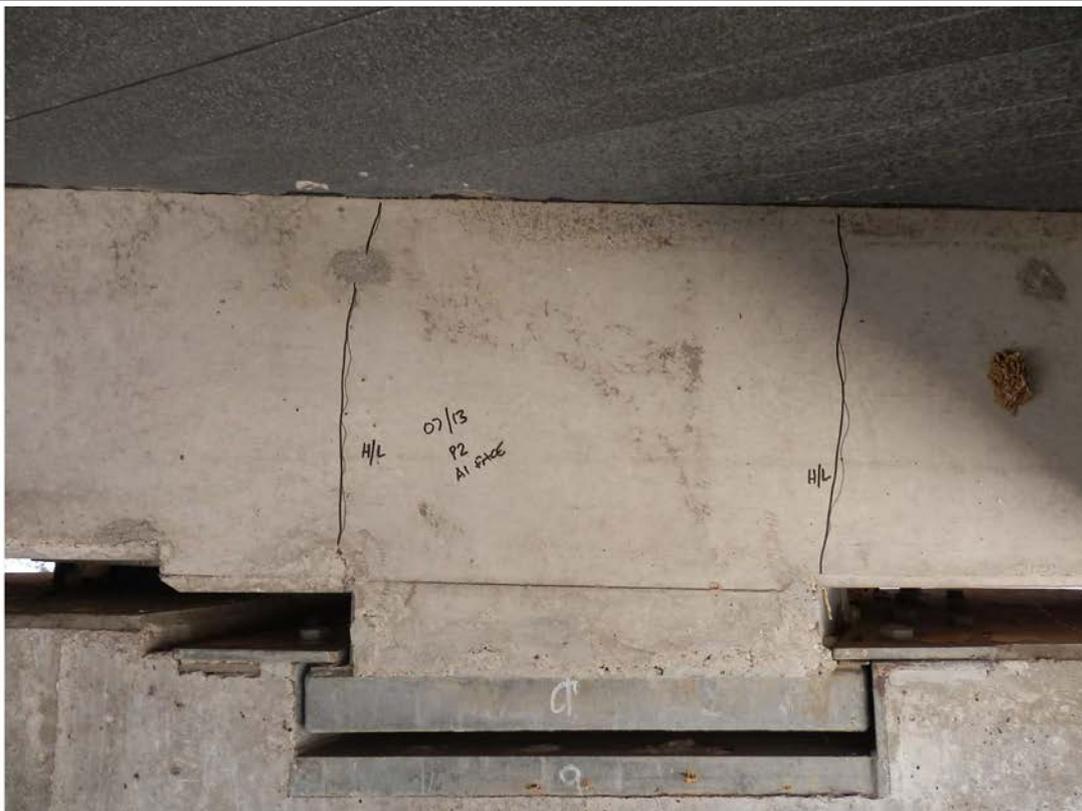
Photo No. 39: Pier 2 abutment 1 face. Hairline cracking at shear key. (Taken: 31-Jul-2013)

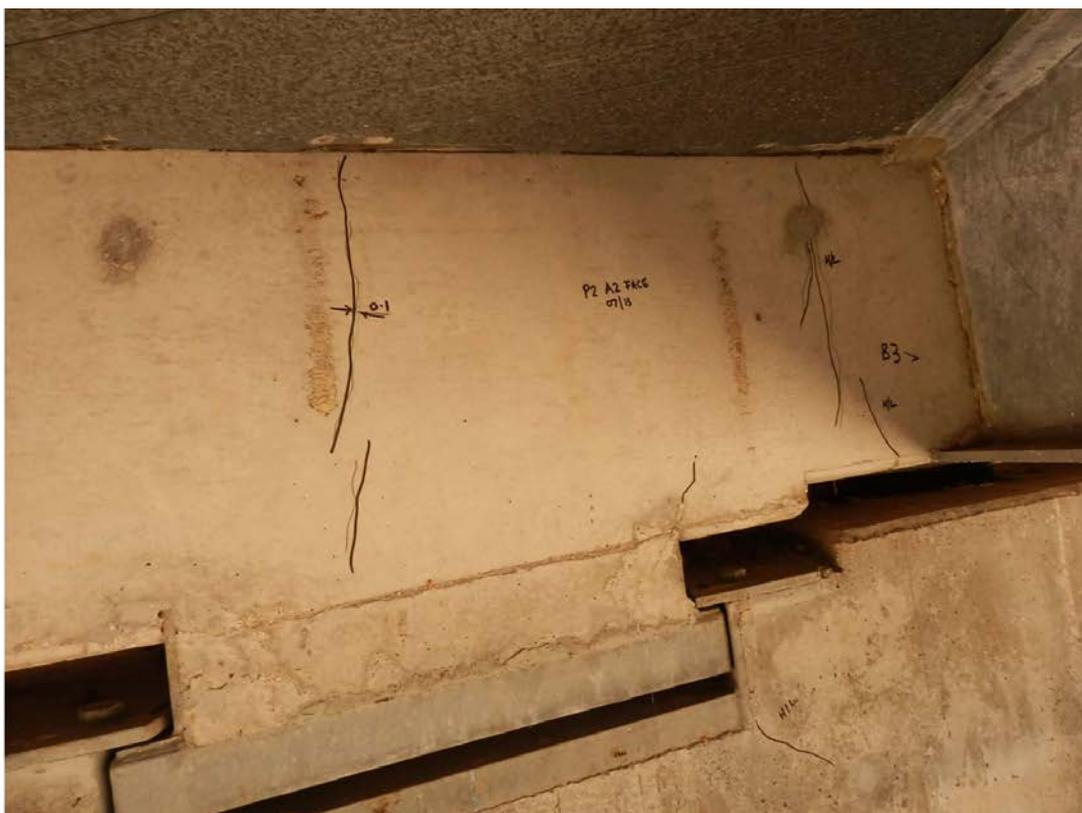
Photo No. 40: Pier 2 abutment 2 face. Hairline cracking (up to 0.1mm) at shear key. (Taken: 31-Jul-2013)

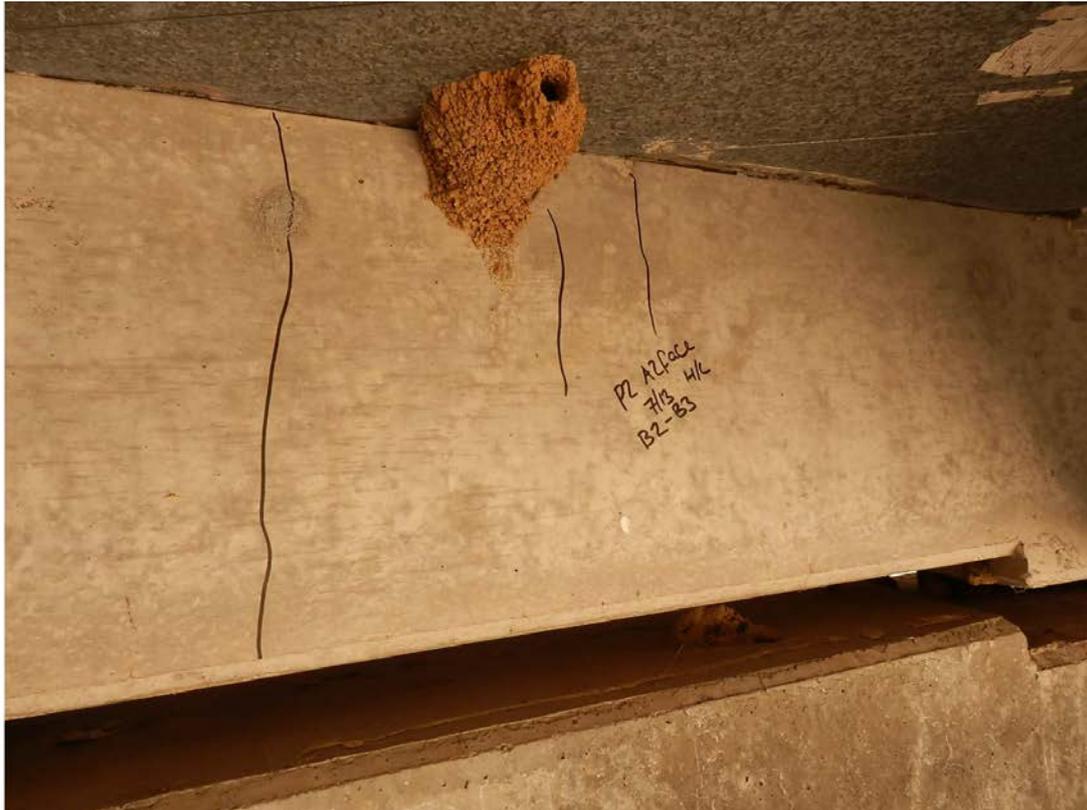
Photo No. 41: Pier 2 abutment 2 face. Hairline cracks in diaphragm between beams 2 and 3. (Taken: 31-Jul-2013)

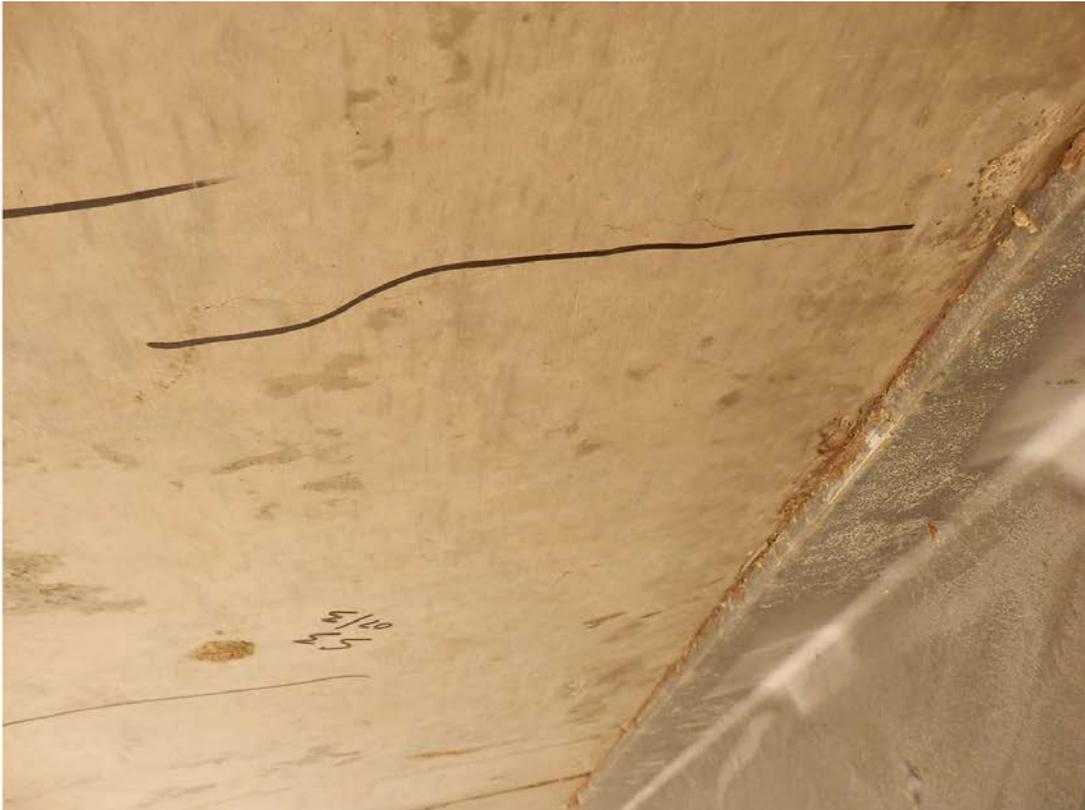
Photo No. 43: Span 3 left hand side cantilever. Transverse hairline cracks. (Taken: 31-Jul-2013)
