Detailed Visual Bridge
Inspection Guidelines
for Concrete and Steel
Bridges
(Level 2 Inspections)

Document No: 6706-02-2233

**CONDITION ASSESSMENT – LEVEL 2
DETAILED VISUAL BRIDGE INSPECTION GUIDELINES FOR
CONCRETE & STEEL BRIDGES**

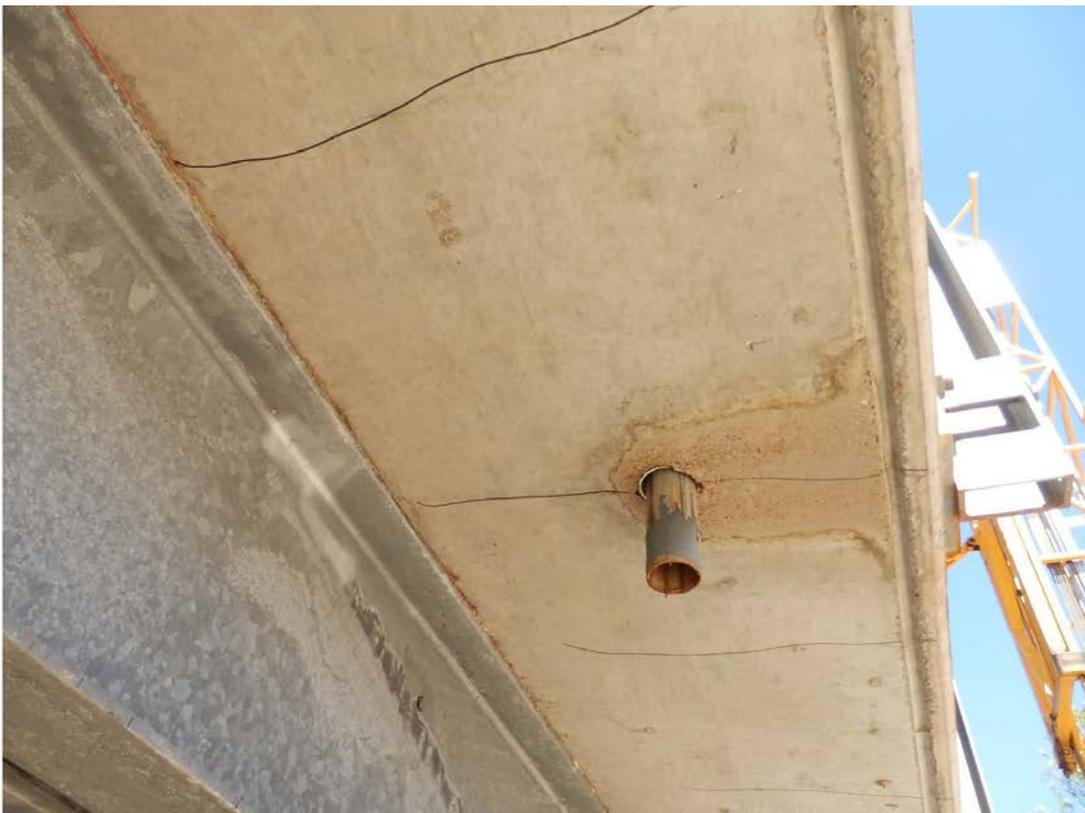
Photo No. 44: Span 3 left hand side cantilever. Transverse hairline cracks. (Taken: 31-Jul-2013)

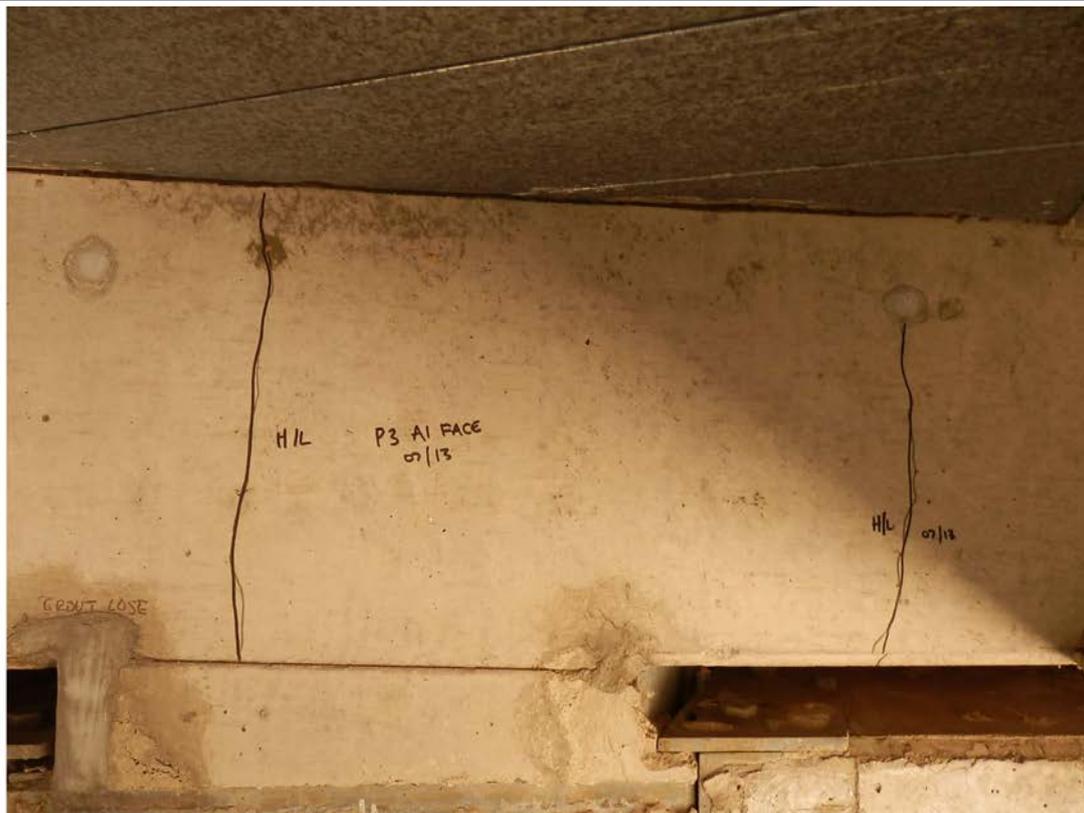
Photo No. 47: Pier 3 abutment 1 face. Hairline cracking. (Taken: 31-Jul-2013)

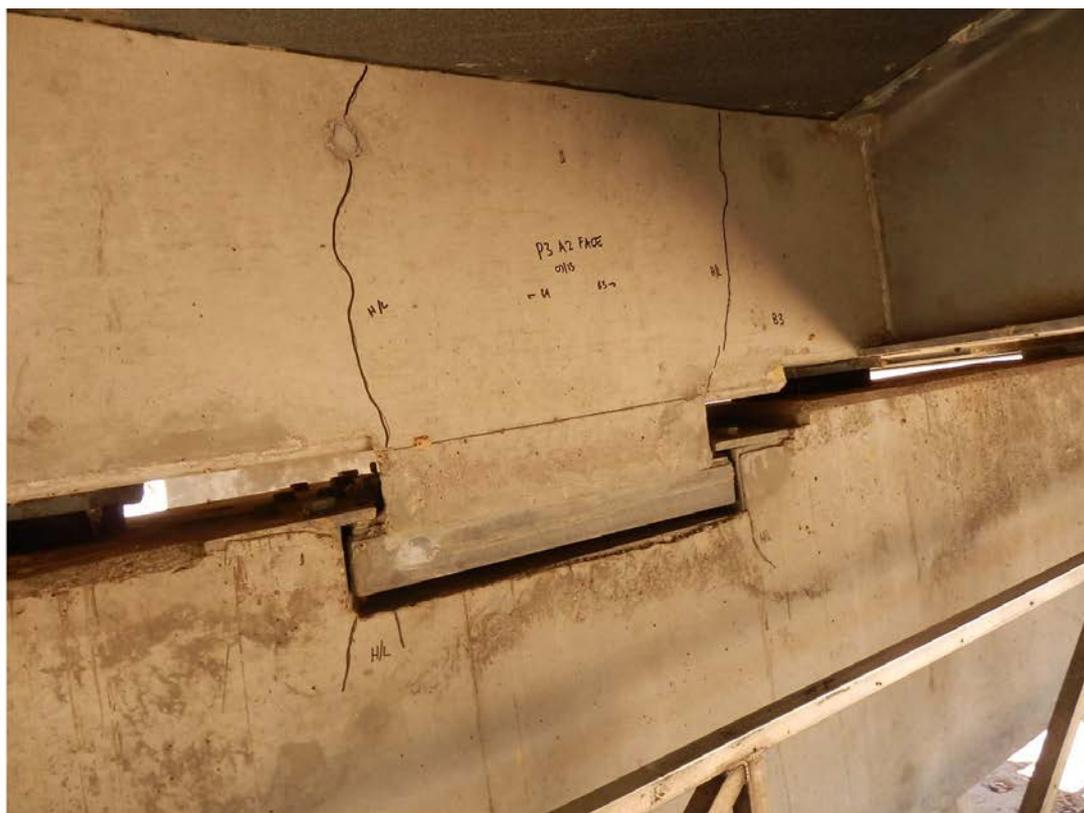
Photo No. 48: Pier 3 abutment 2 face. Minor hairline cracking. (Taken: 31-Jul-2013)

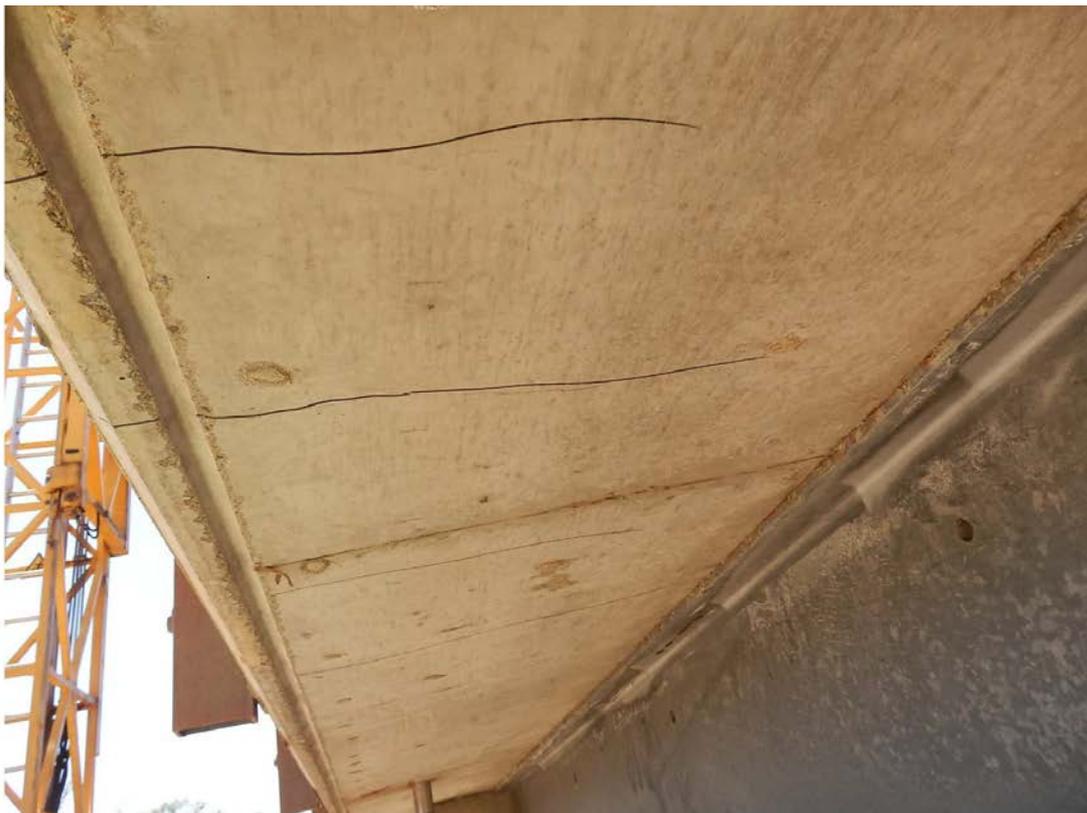
Photo No. 52: Span 4, left hand side cantilever. Hairline cracking at approximately 400mm centres. (Taken: 31-Jul-2013)

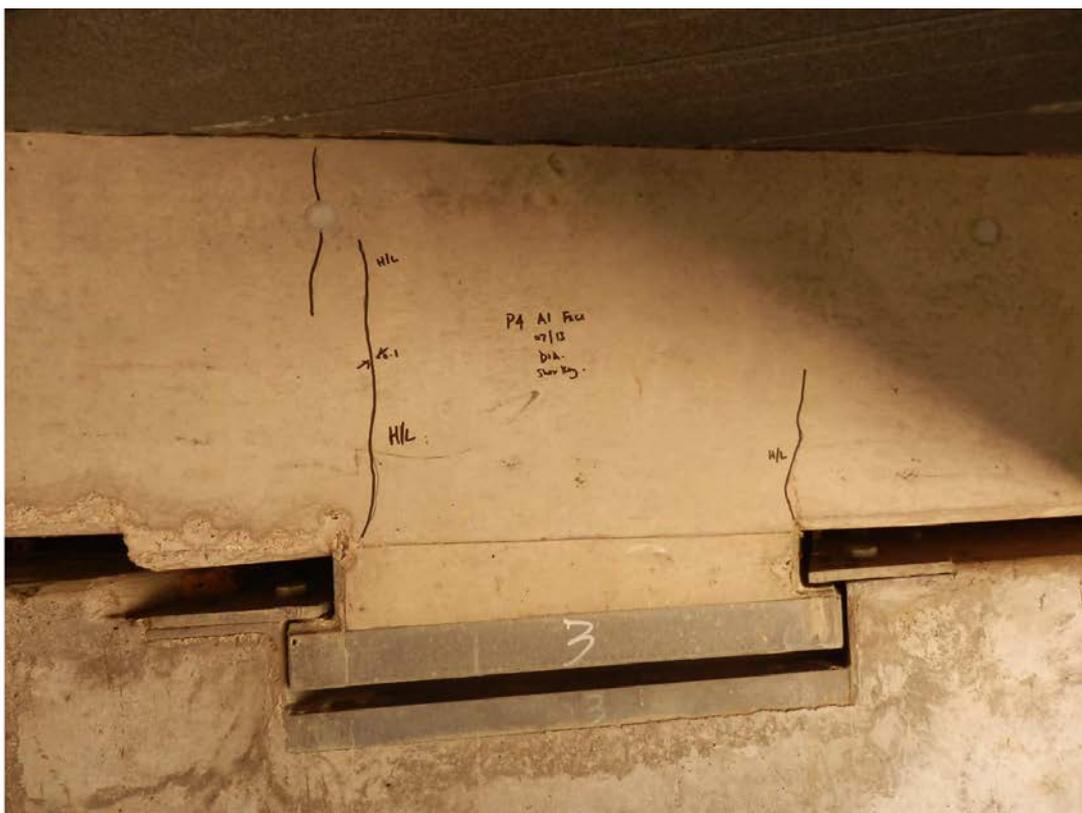
Photo No. 54: Pier 4 abutment 1 face. Hairline cracking from internal corners of shear key up to plastic bolt hole form for the formwork during construction. (Taken: 31-Jul-2013)

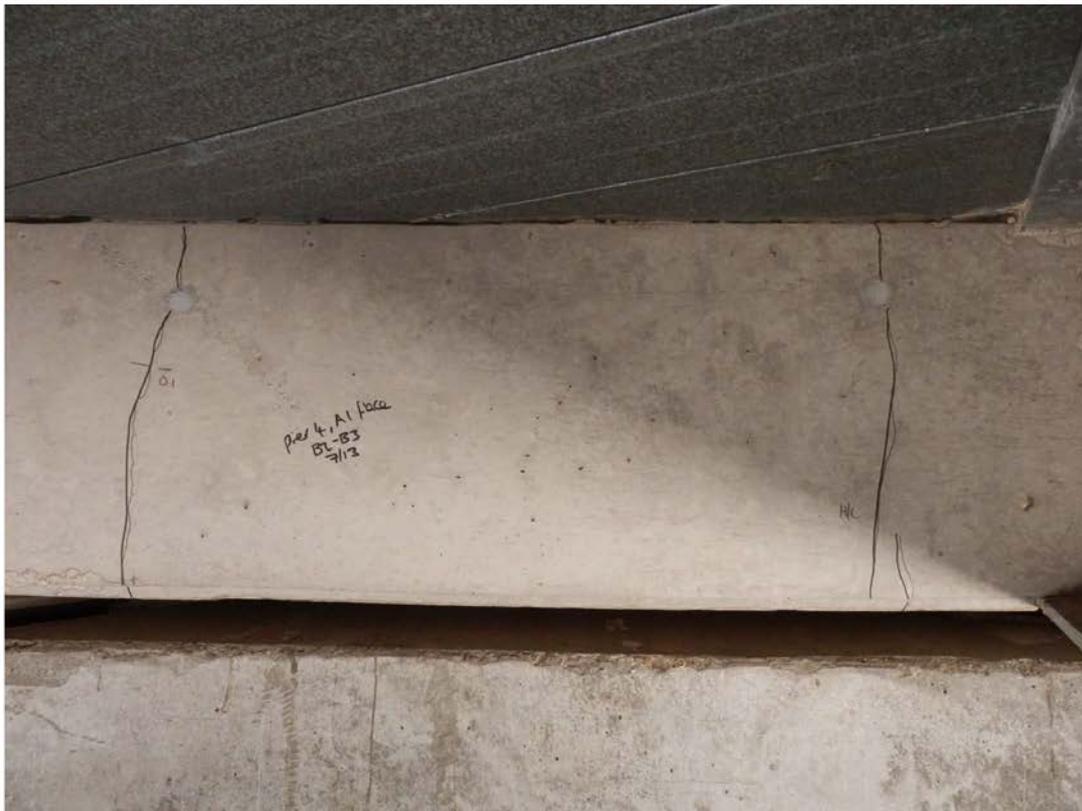
Photo No. 55: Pier 4 abutment 1 face diaphragm between beams 2 and 3. Vertical 0.1mm cracks from bolt hole formers for the original shuttering. (Taken: 31-Jul-2013)

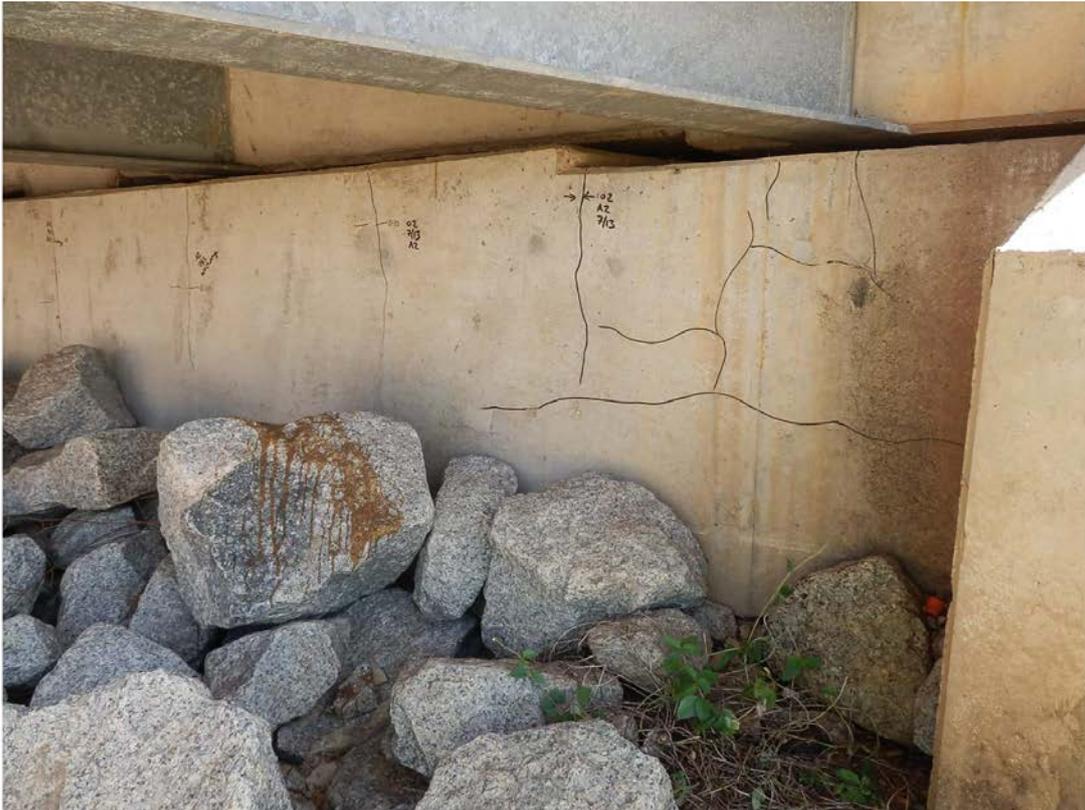
Photo No. 59: Abutment 2 capbeam. Various cracking, hairline, 0.2mm and 0.3mm. (Taken: 30-Jul-2013)

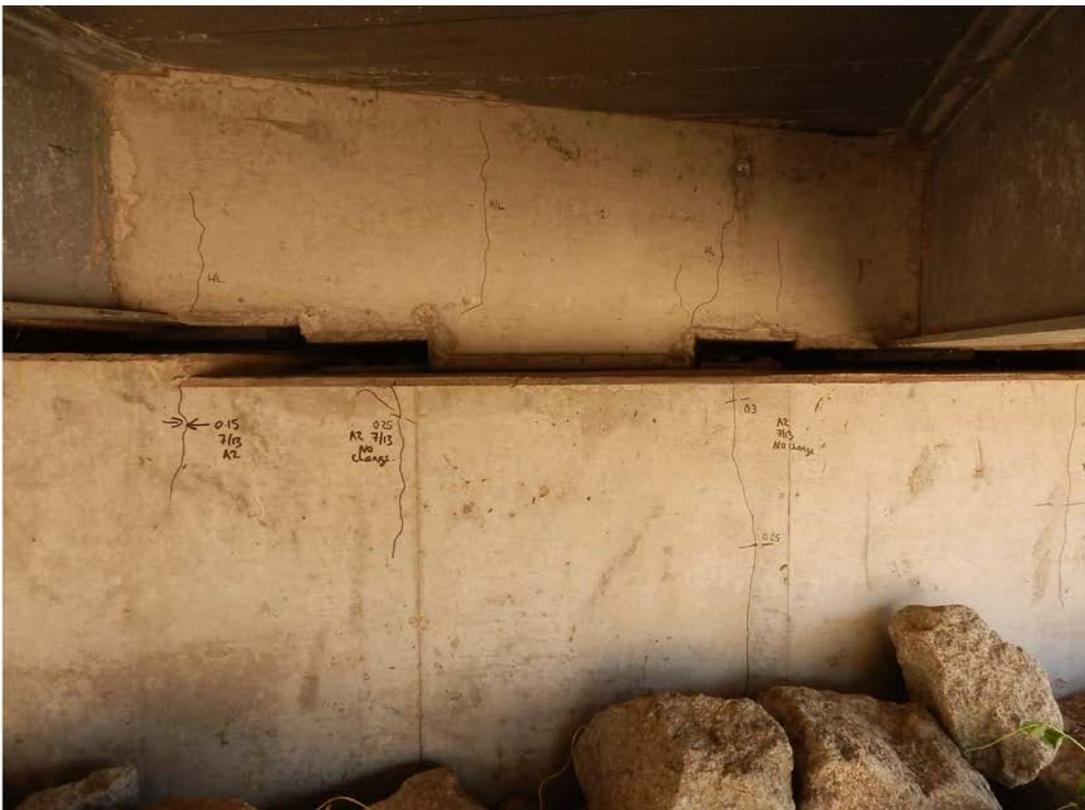
Photo No. 60: Abutment 2. Cracking to capbeam and diaphragm at shear key. (Taken: 30-Jul-2013)

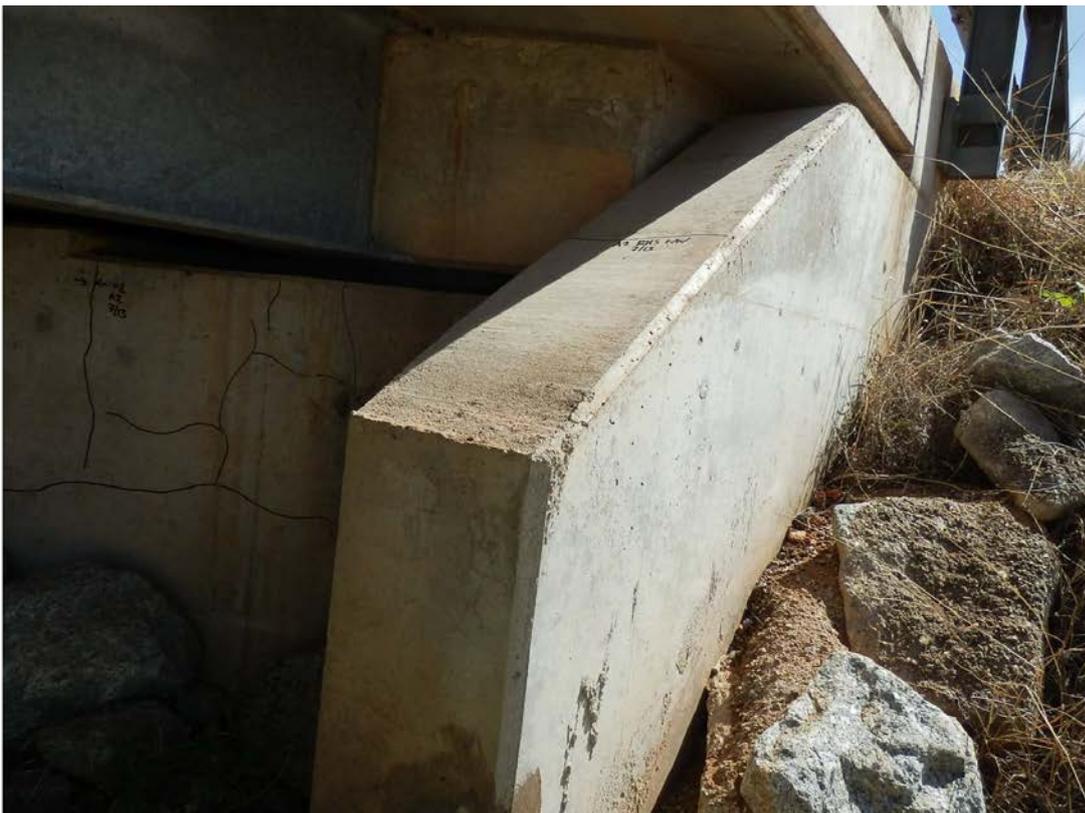
Photo No. 62: Abutment 2 right hand side wing wall. 0.15mm crack to top face of wall. (Taken: 30-Jul-2013)

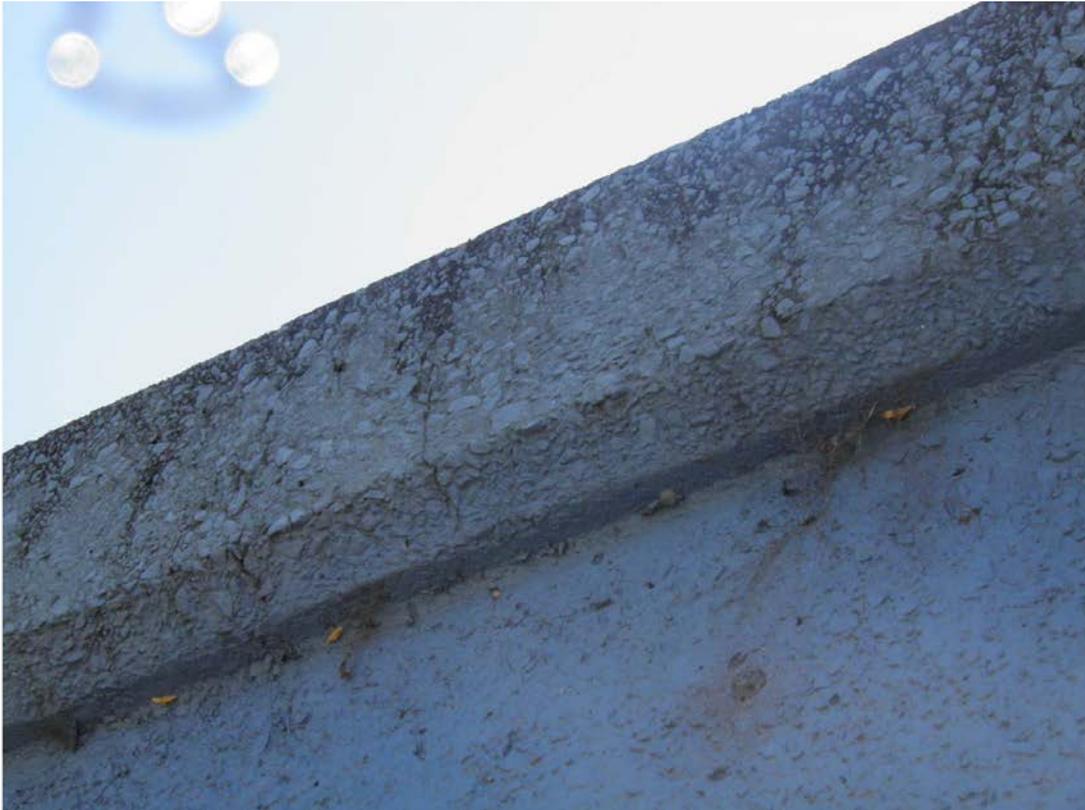
Photo No. 19: Cracks to abutment 2 left hand side head wall cap (Taken: 02-Nov-2016)
