Phytophthora Dieback Management Plan: Albany Ring Road

Report prepared for
Main Roads Western Australia
April 2020

Southern Ecology
damien@southernecology.com.au
www.southernecology.com.au
0408 802 404
27 Newbold Rd
Torbay WA 6330
Project Reference: SE1810

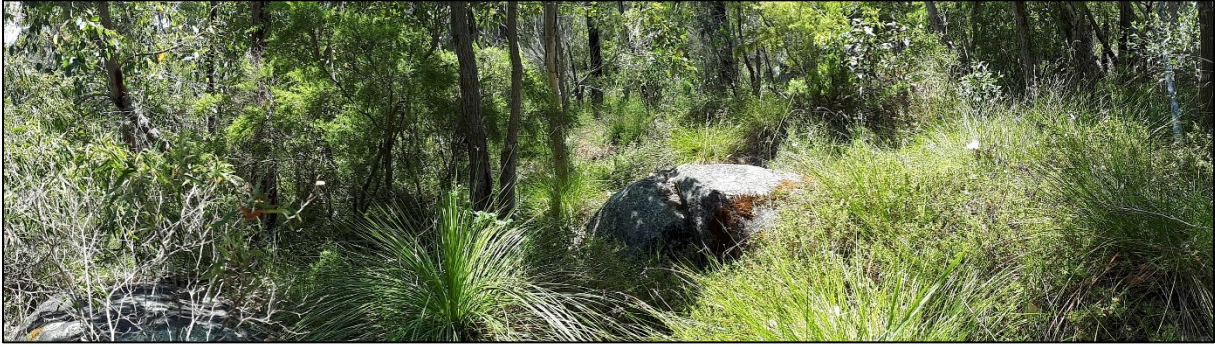
Plate 1. Upland forest (Marri/Jarrah Coastal Hills Forest) on Mt Melville, with sufficient indicator species for interpretation through symptomatic evidence of *Phytophthora*.

The ability to detect *Phytophthora* through symptomatic evidence (interpretability) was highest in vegetation in upland or granite communities in Good to Excellent condition. This graded to low interpretability in Degraded native vegetation and to Uninterpretable in most wetland vegetation types (Plate 1-3). A list of susceptible host species present across the Survey Area is provided (Table 3). The incidence and pattern of disease symptoms in these taxa were considered an indication of the potential presence of *Phytophthora cinnamomi*.

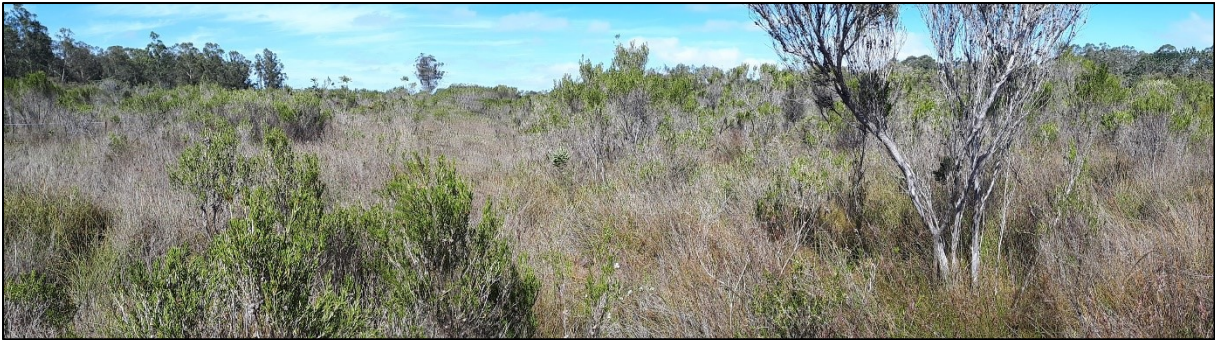
Plate 2. Wetland vegetation (*Homalospermum firmum*/*Callistemon glaucus* Peat Thicket) dominated by species from the Myrtaceae and Cyperaceae that do not display obvious disease symptoms.

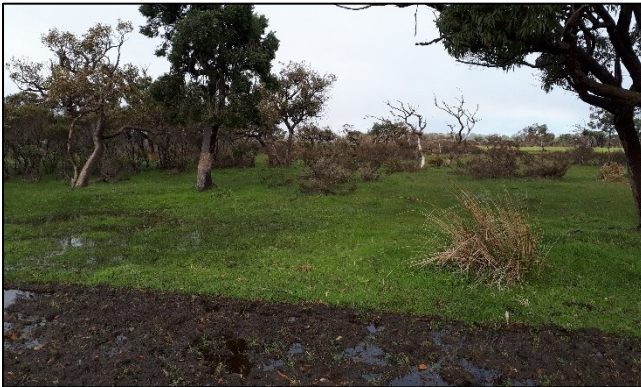
Plate 3. Degraded vegetation (Uninterpretable) in a water-gaining site where incipient pathogens are likely to occur but are asymptomatic.

Areas were determined to be Uninterpretable (25.93 ha) either due to a low natural incidence of indicator species (i.e. very long unburnt or wetland type vegetation) or was where native vegetation was in Degraded to Good Condition (i.e. other disturbances may have removed indicator species). No Uninterpretable areas were considered as Protectable due the water gaining hydrology and high-level soil historic disturbance. Excluded areas (191.7 ha) consisted mainly of paddocks, agricultural areas or plantations, where *Phytophthora* species may be present but are asymptomatic.

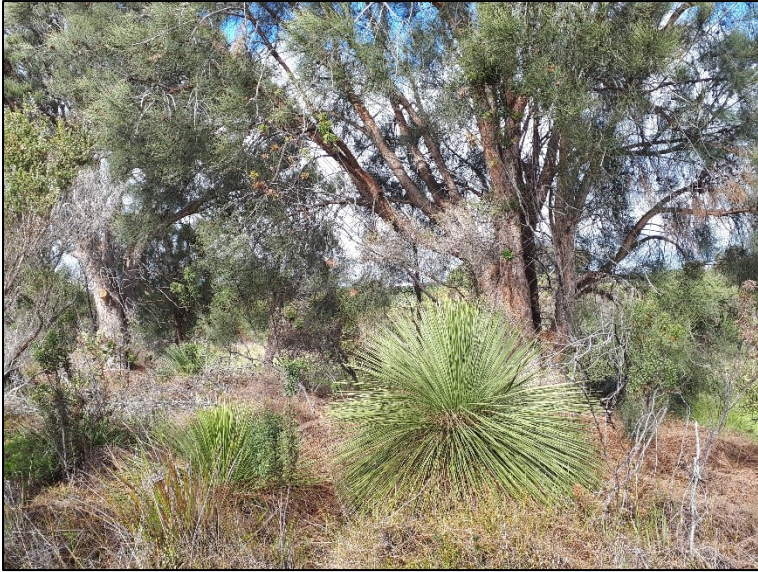
Plate 4. Uninfested and Protectable vegetation.

The field interpretation combined with the soil and root sampling delineated the Survey Area into four disease status categories for the purposes of managing the spread of *Phytophthora cinnamomi* (Table 5, Plates 4 and 5). A total of 1.05 ha was determined to be Uninfested with *Phytophthora cinnamomi*, which occurred in three separate areas in the Survey Area. All Uninfested areas in the Survey Area are considered to be preliminary Protectable Areas. The Protectability of these areas may change depending on project activities and their recommended management is discussed in section 4.4.2.

Three areas have been delineated as preliminary Protectable Areas that require general Clean on Entry (CoE) soil hygiene standards (see below). These areas occur exclusively within the potential project footprint, therefore may be completely removed during construction. Subsequently, the CoE management recommendations provided apply only to operations (i.e. geo-tech survey) prior to approval and initiation of the removal of remnant vegetation.

- Demarcation of Protectable Areas should be check/retaped after the approval of this Management Plan and shortly prior to construction.
- Work in Protectable Areas should be scheduled for periods of low soil moisture.

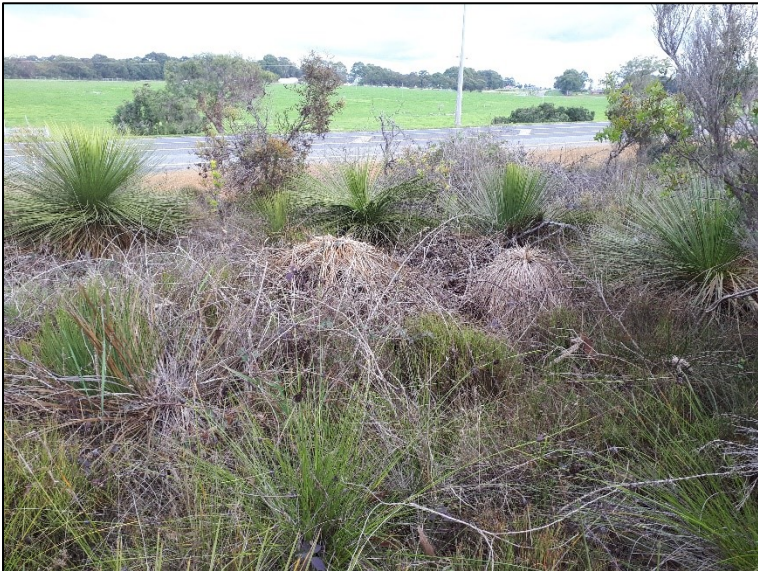
Plate 5. *Xanthorrhoea platyphylla* deaths associated with *Phytophthora cinnamomi*.
