EPBC 2017/7880 Annual Compliance Report 2020/2021

Marble Bar Road Coongan Gorge Realignment
and MO30 Material Pit Expansion: Pilbara
Region, WA.

Northern Quoll Camera Trap Monitoring Program (Phase 2 - 2021)

Coongan Gorge Realignment

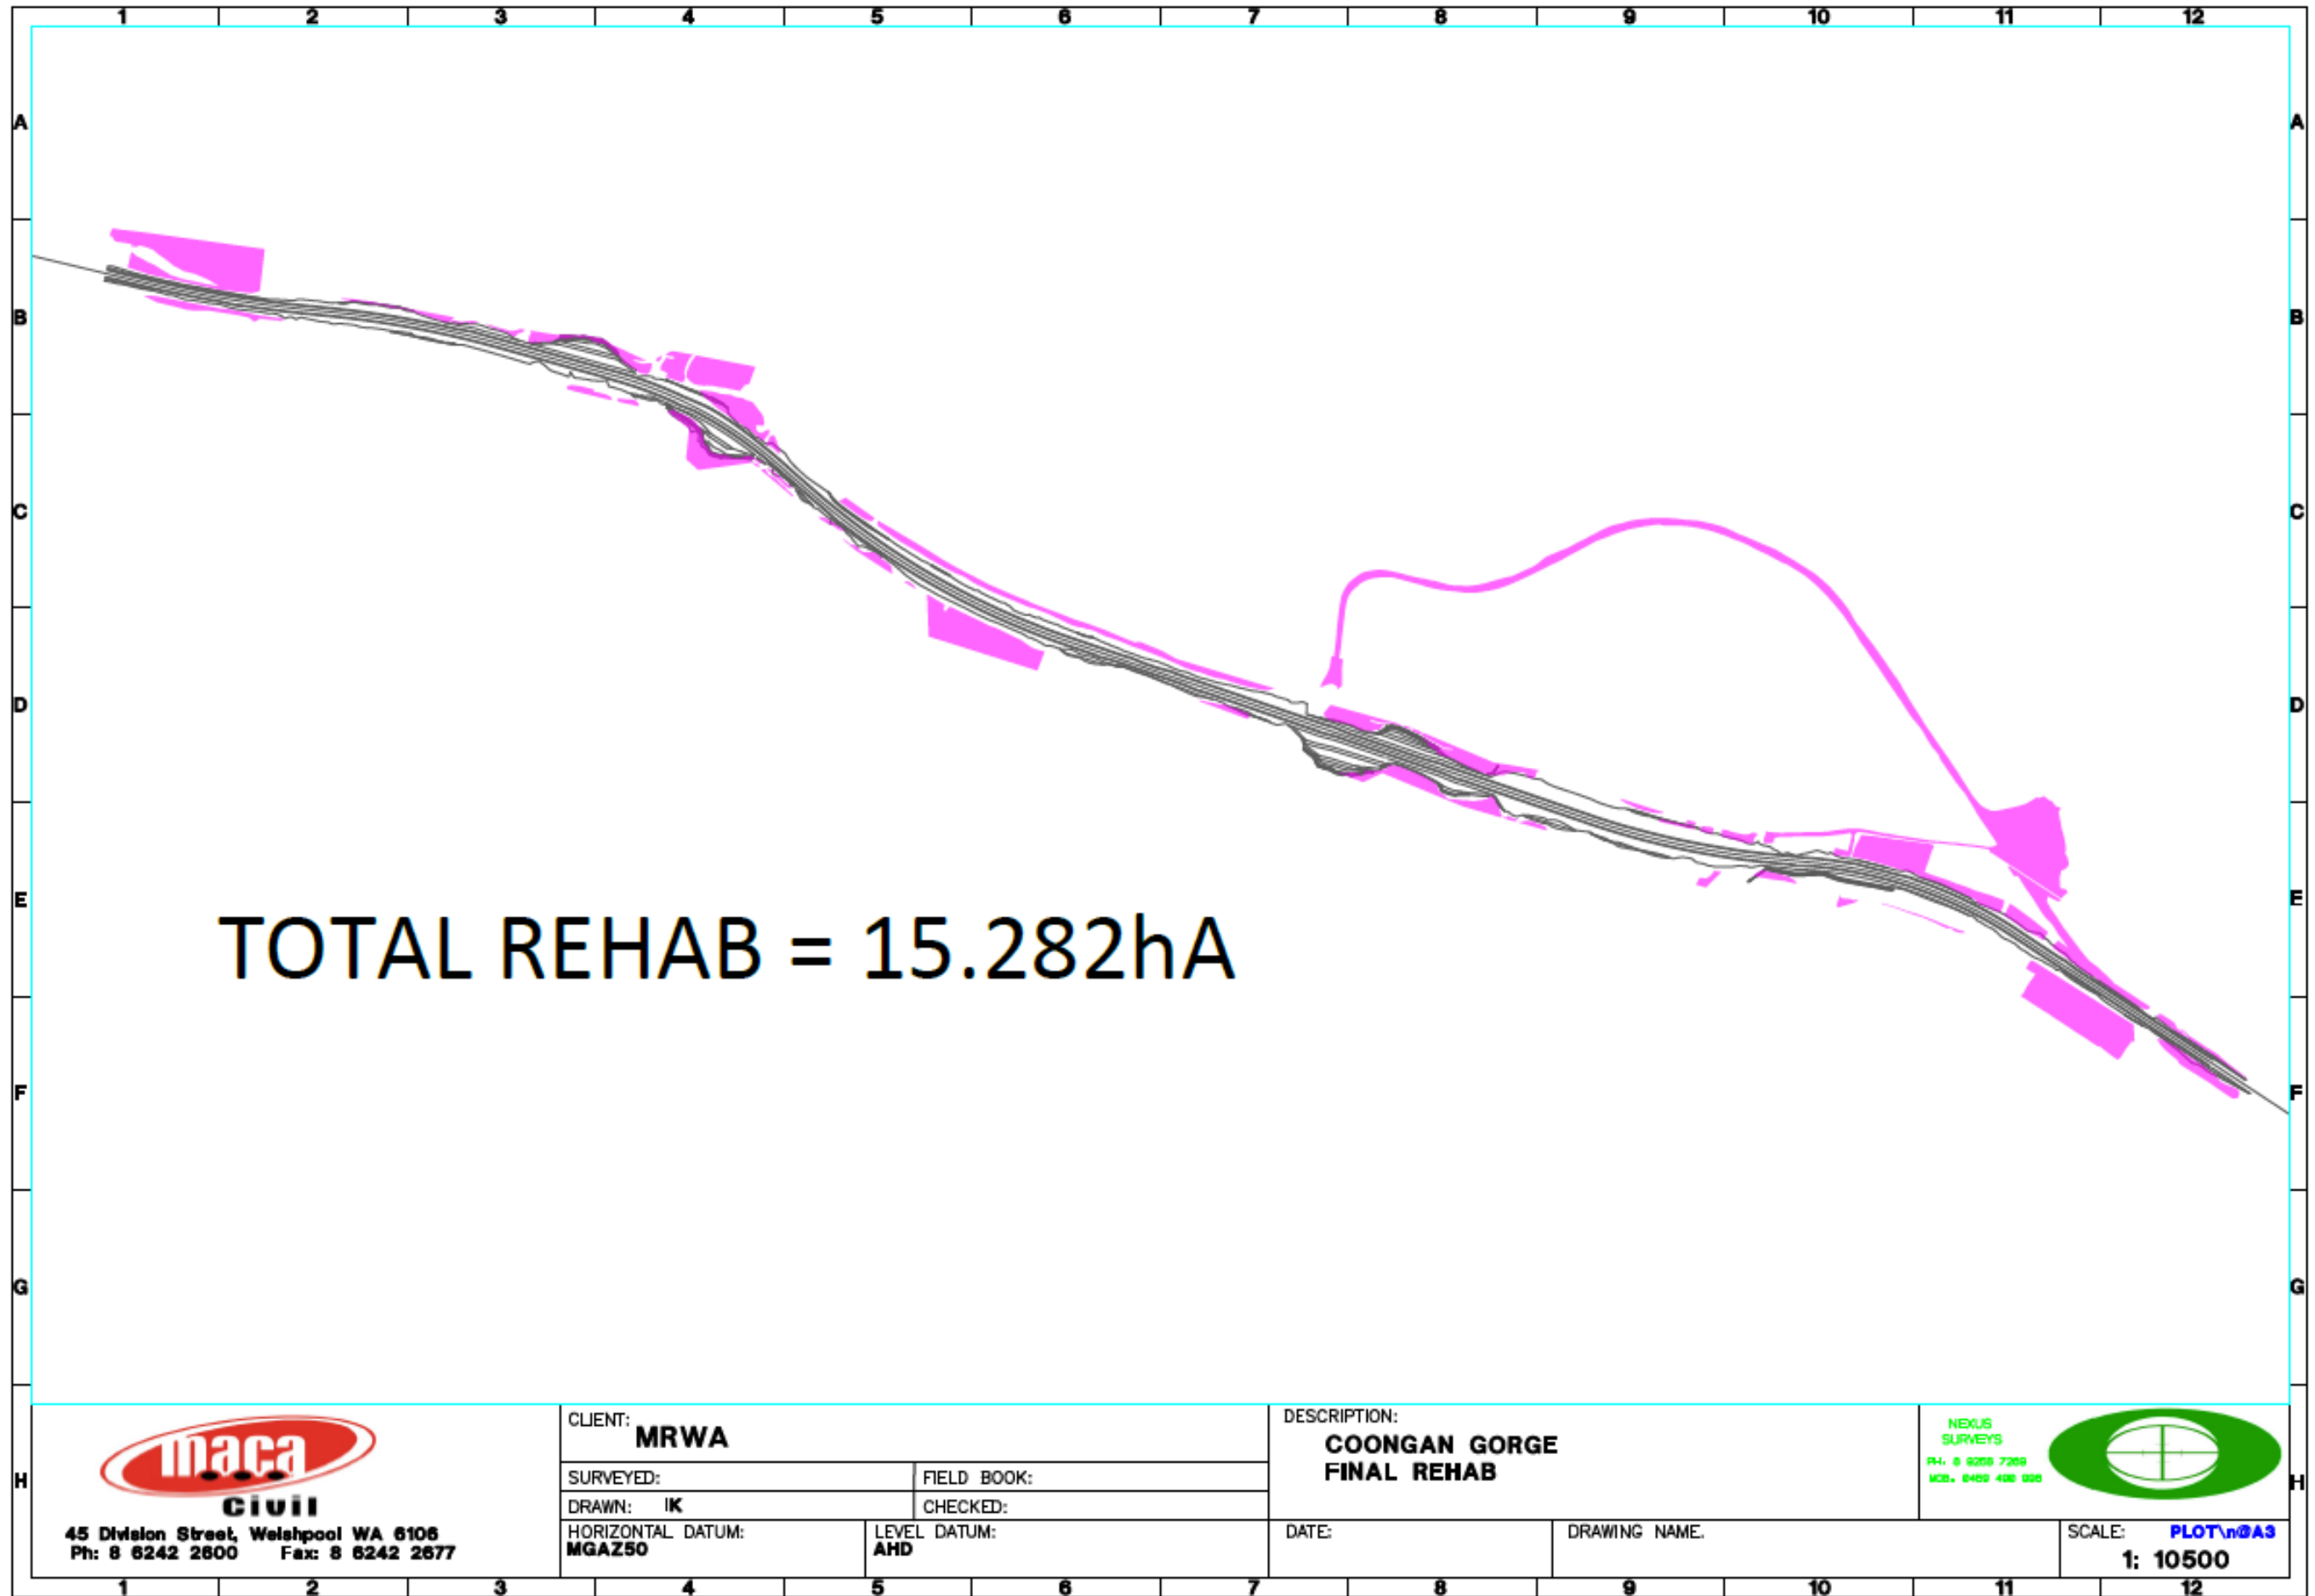
Attachment 1: Map of Rehabilitated Areas

DESCRIPTION: COONGAN GORGE FINAL REHAB	
DATE:	DRAWING NAME:

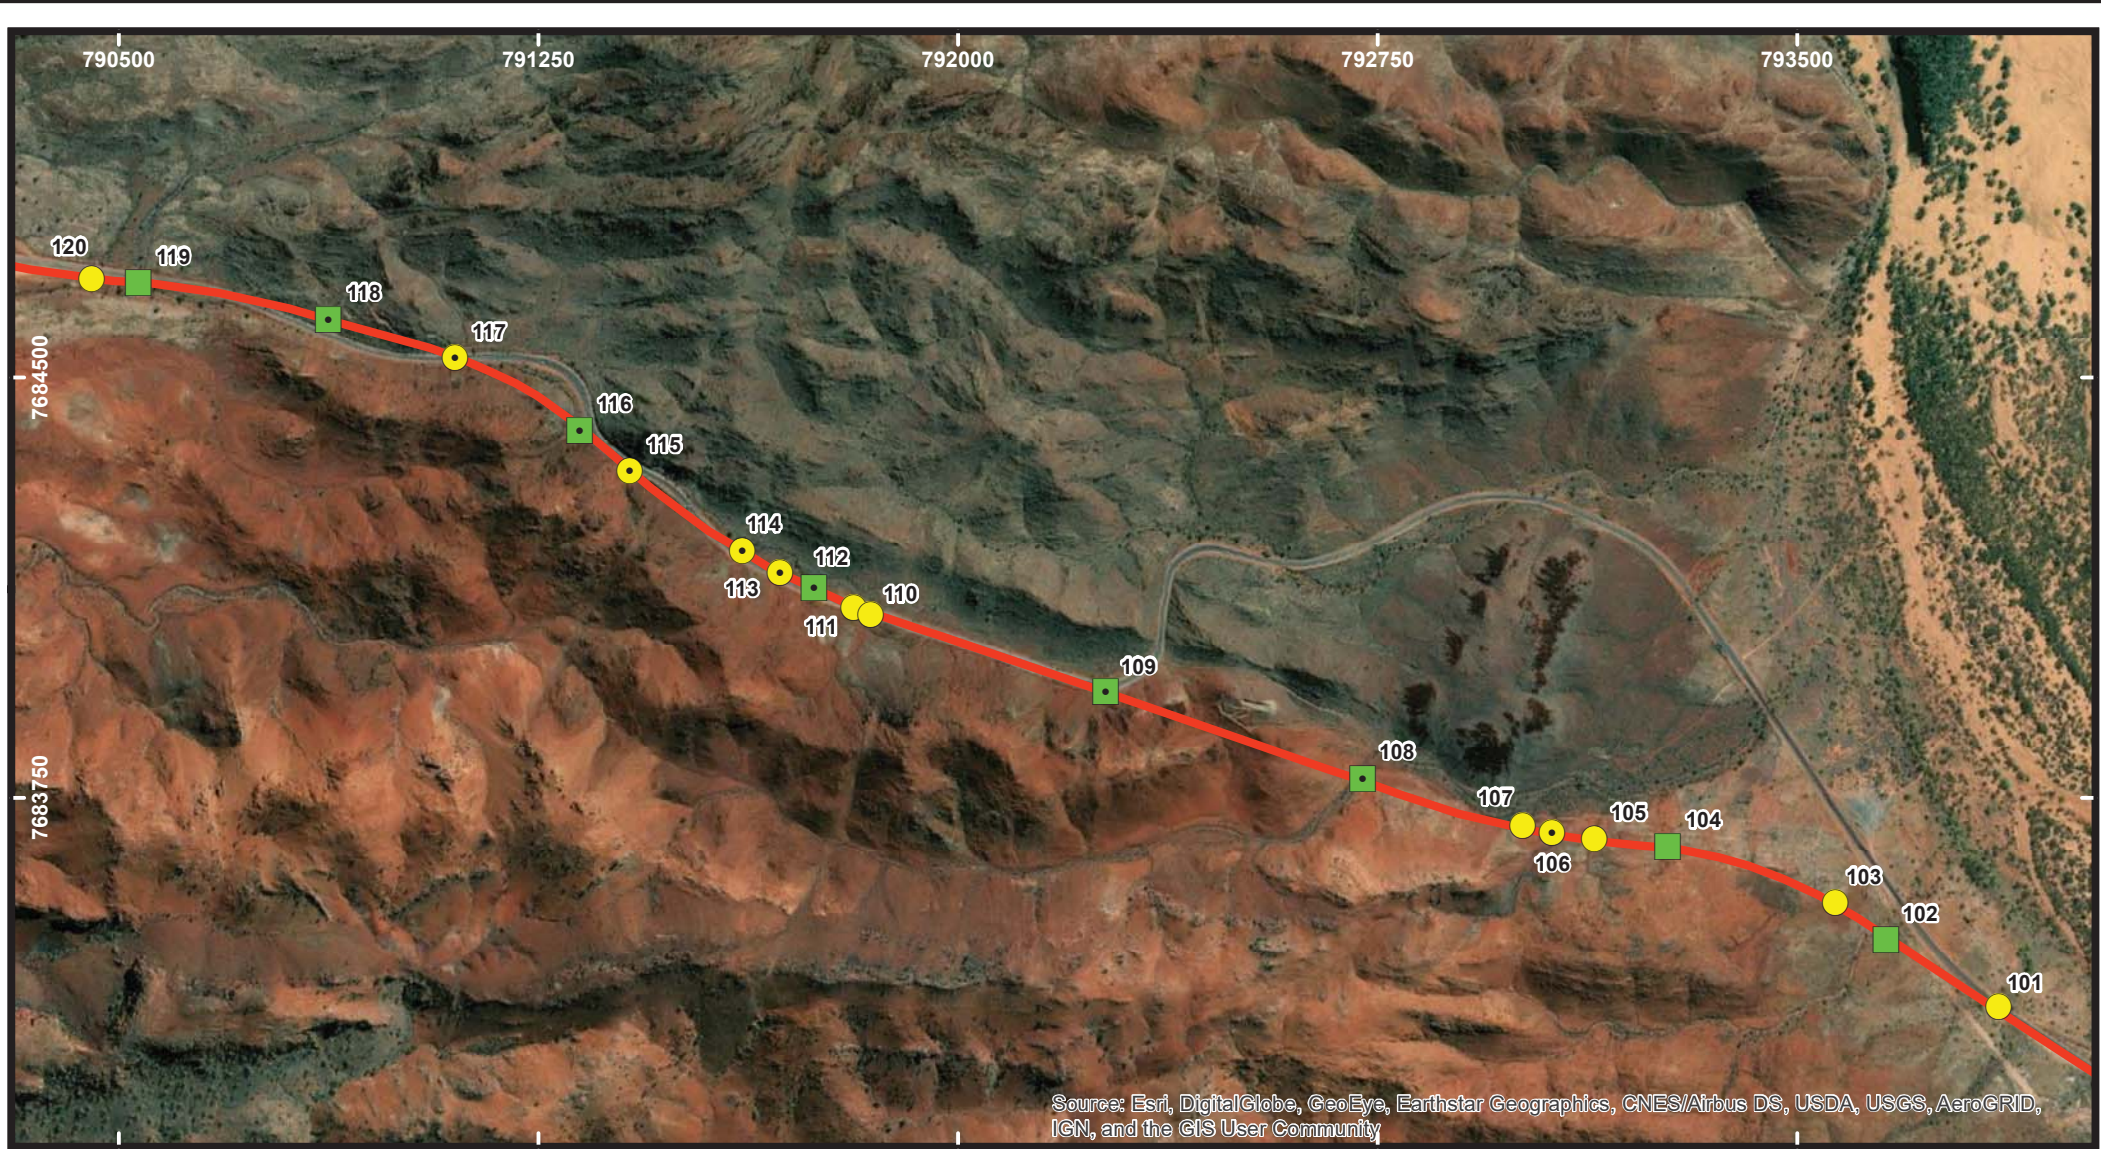
Projection/Coordinate System: UTM/MGA Zone 50 | Figure: 1

Culverts were installed at 20 locations along the new road realignment. Twelve sites utilised pipe culverts and eight, box culverts (Figure 1). The number of actual culverts at each site ranges from one to five as determined by anticipated hydraulic requirements.

**Culvert
Locations**

Culverts were installed at 20 locations along the new road realignment. Twelve sites utilised pipe culverts and eight, box culverts (Figure 1). The number of actual culverts at each site ranges from one to five as determined by anticipated hydraulic requirements.
