# Roe Highway Extension

## Flora and Vegetation Monitoring and Management Plan

Prepared for  
Main Roads Western Australia  
by Strategen

December 2015

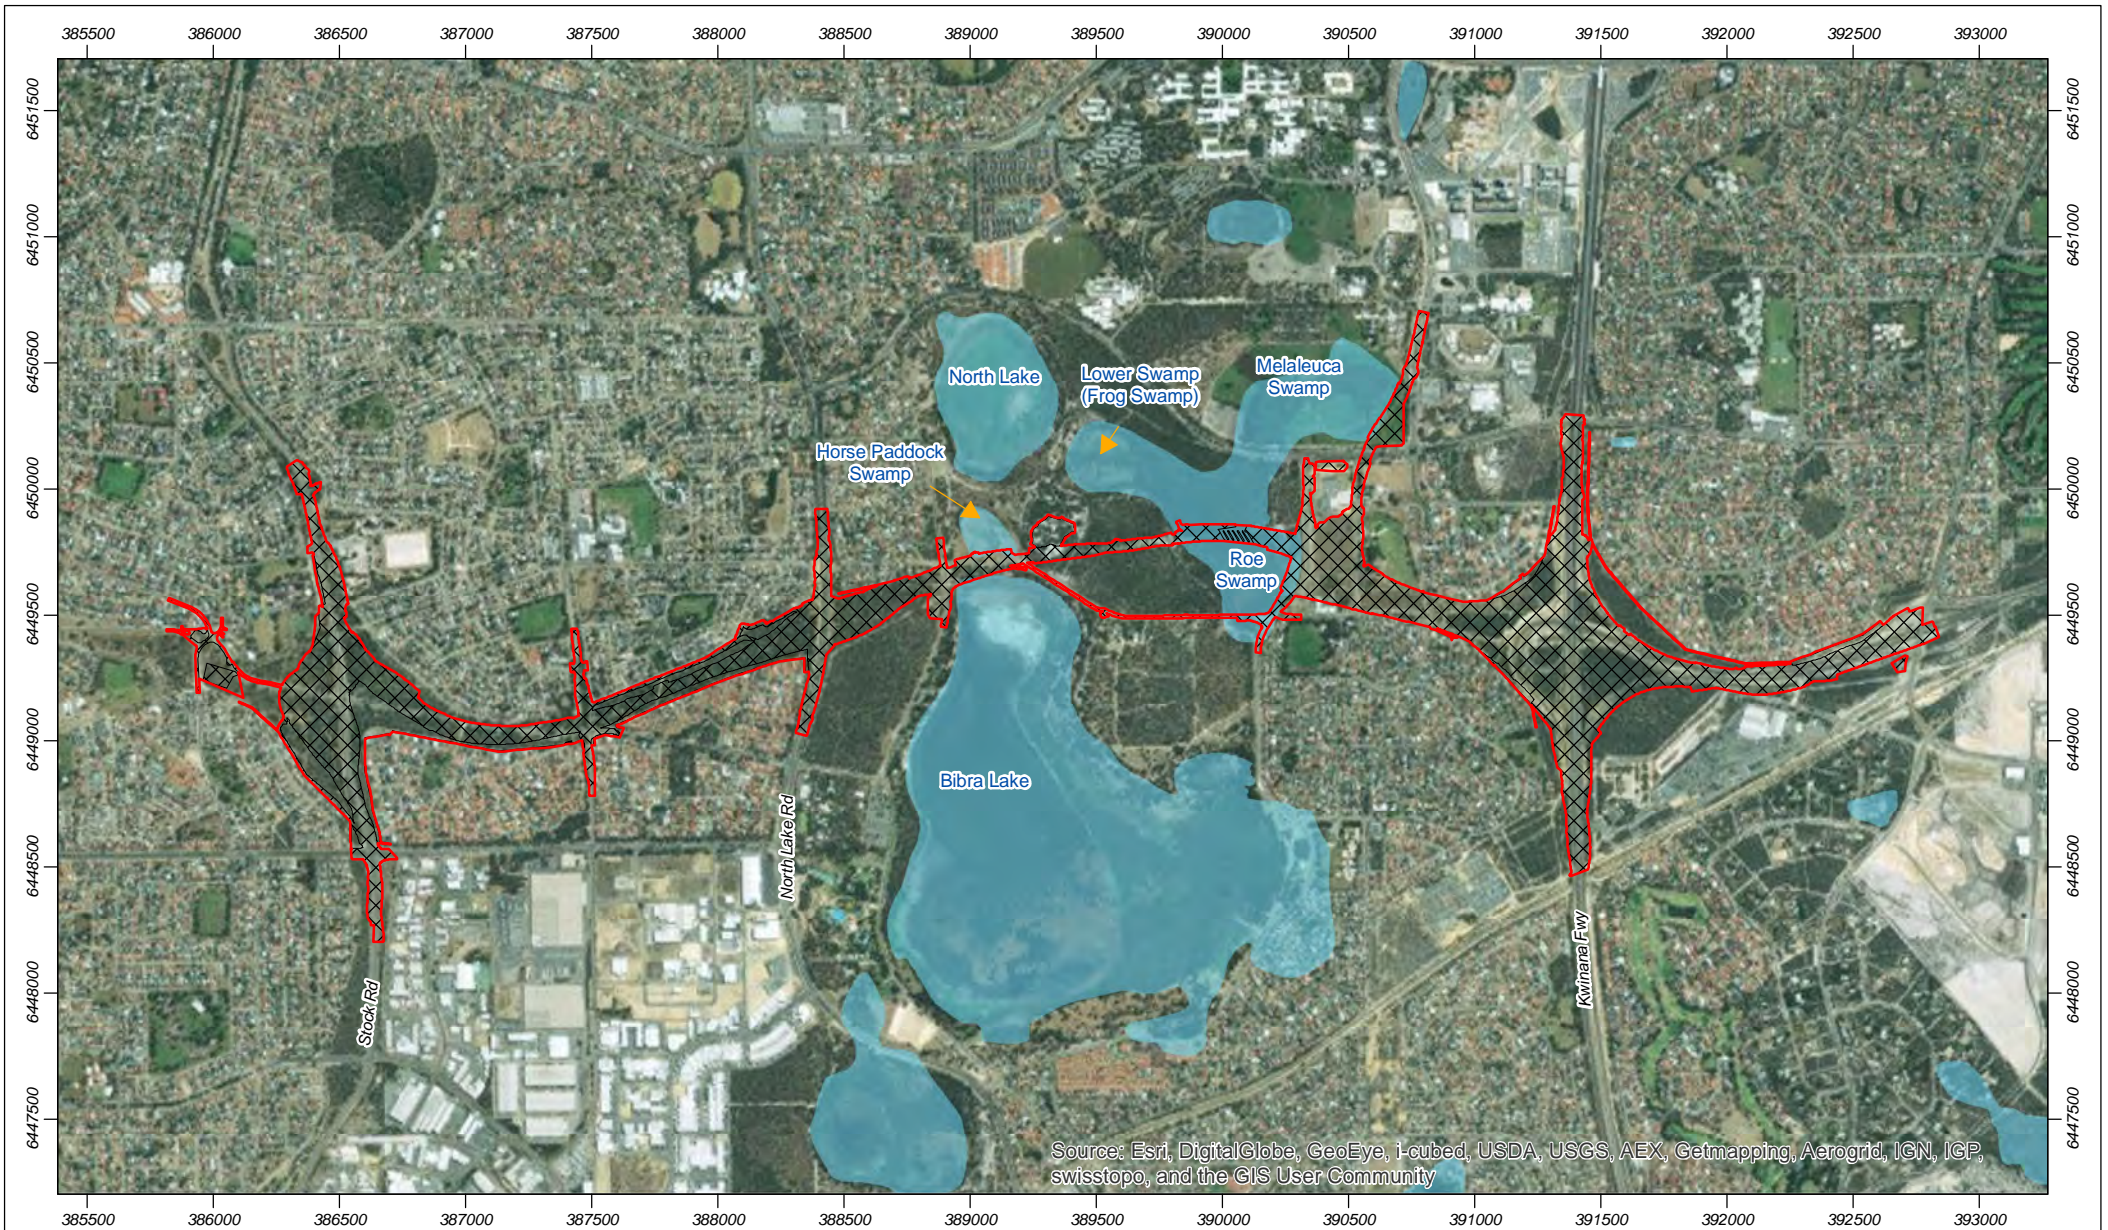
**Figure 1: Project development envelope**

Main Roads Western Australia (Main Roads) proposes to construct the Roe Highway Extension (the Project, Figure 1) which is part of the Perth Freight Link project (Figure 1). This document presents the flora and vegetation monitoring and management actions to manage the potential impacts of the Project on vegetation health condition.

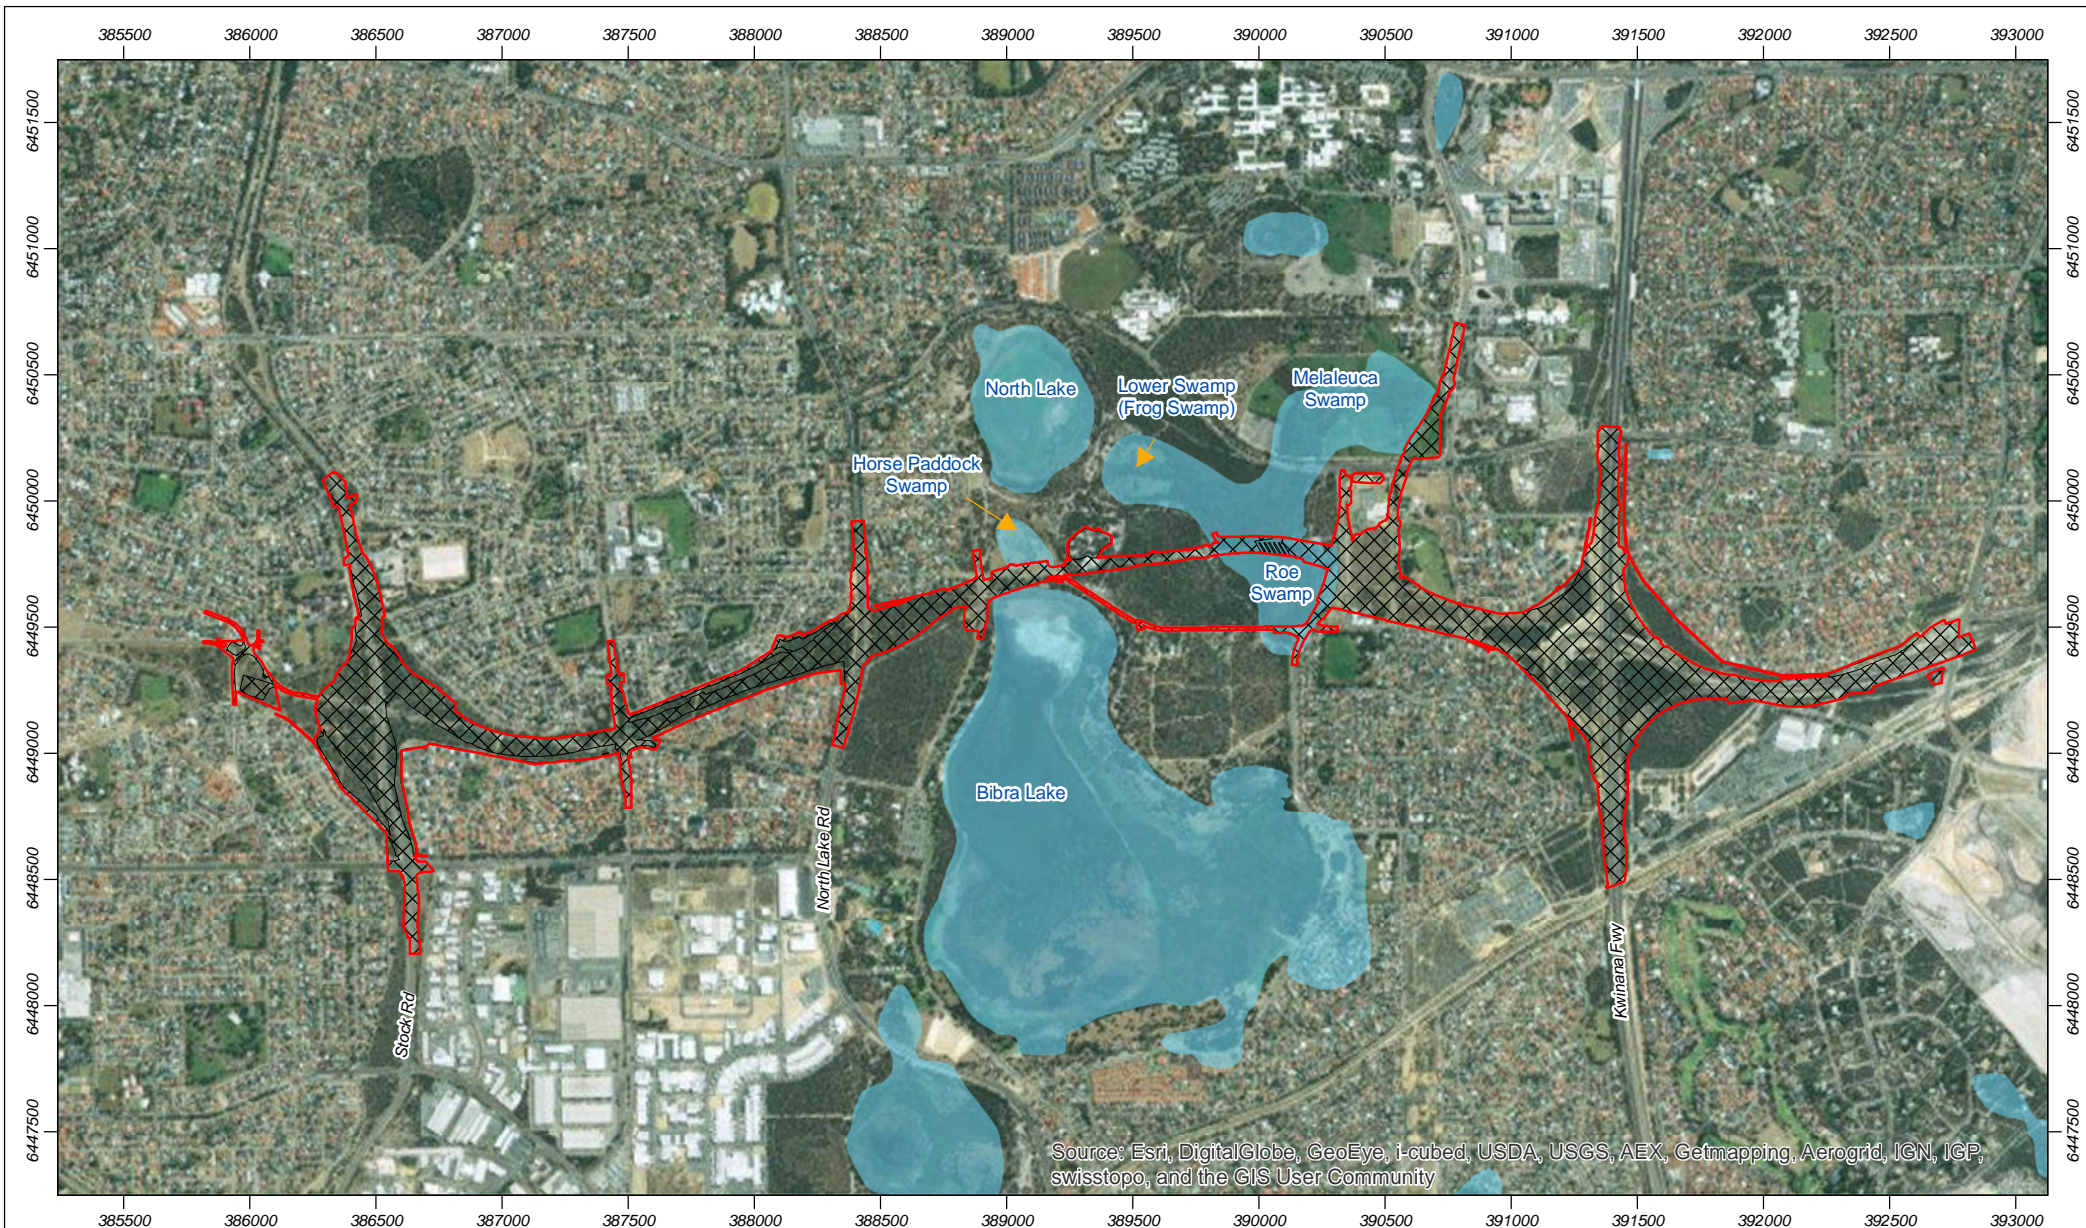
**Figure 1: Project development envelope**

Scale 1:30,000 at A4  
 0 200 400 600 800 1,000 Meters  
 Coordinate System: GDA 1994 MGA Zone 50  
 Note that positional errors may occur in some areas  
 Date: 3/12/2015  
 Author: DWhite  
 Source: Aerial image: ESRI, approx. 2010; Client 2015; Wetlands: DPaw 2015.

Main Roads Western Australia (Main Roads) proposes to construct the Roe Highway Extension as part of the Perth Freight Link project (the Project, Figure 1). This document outlines the approaches to be implemented for the rehabilitation of areas that have been temporarily disturbed by the Project.

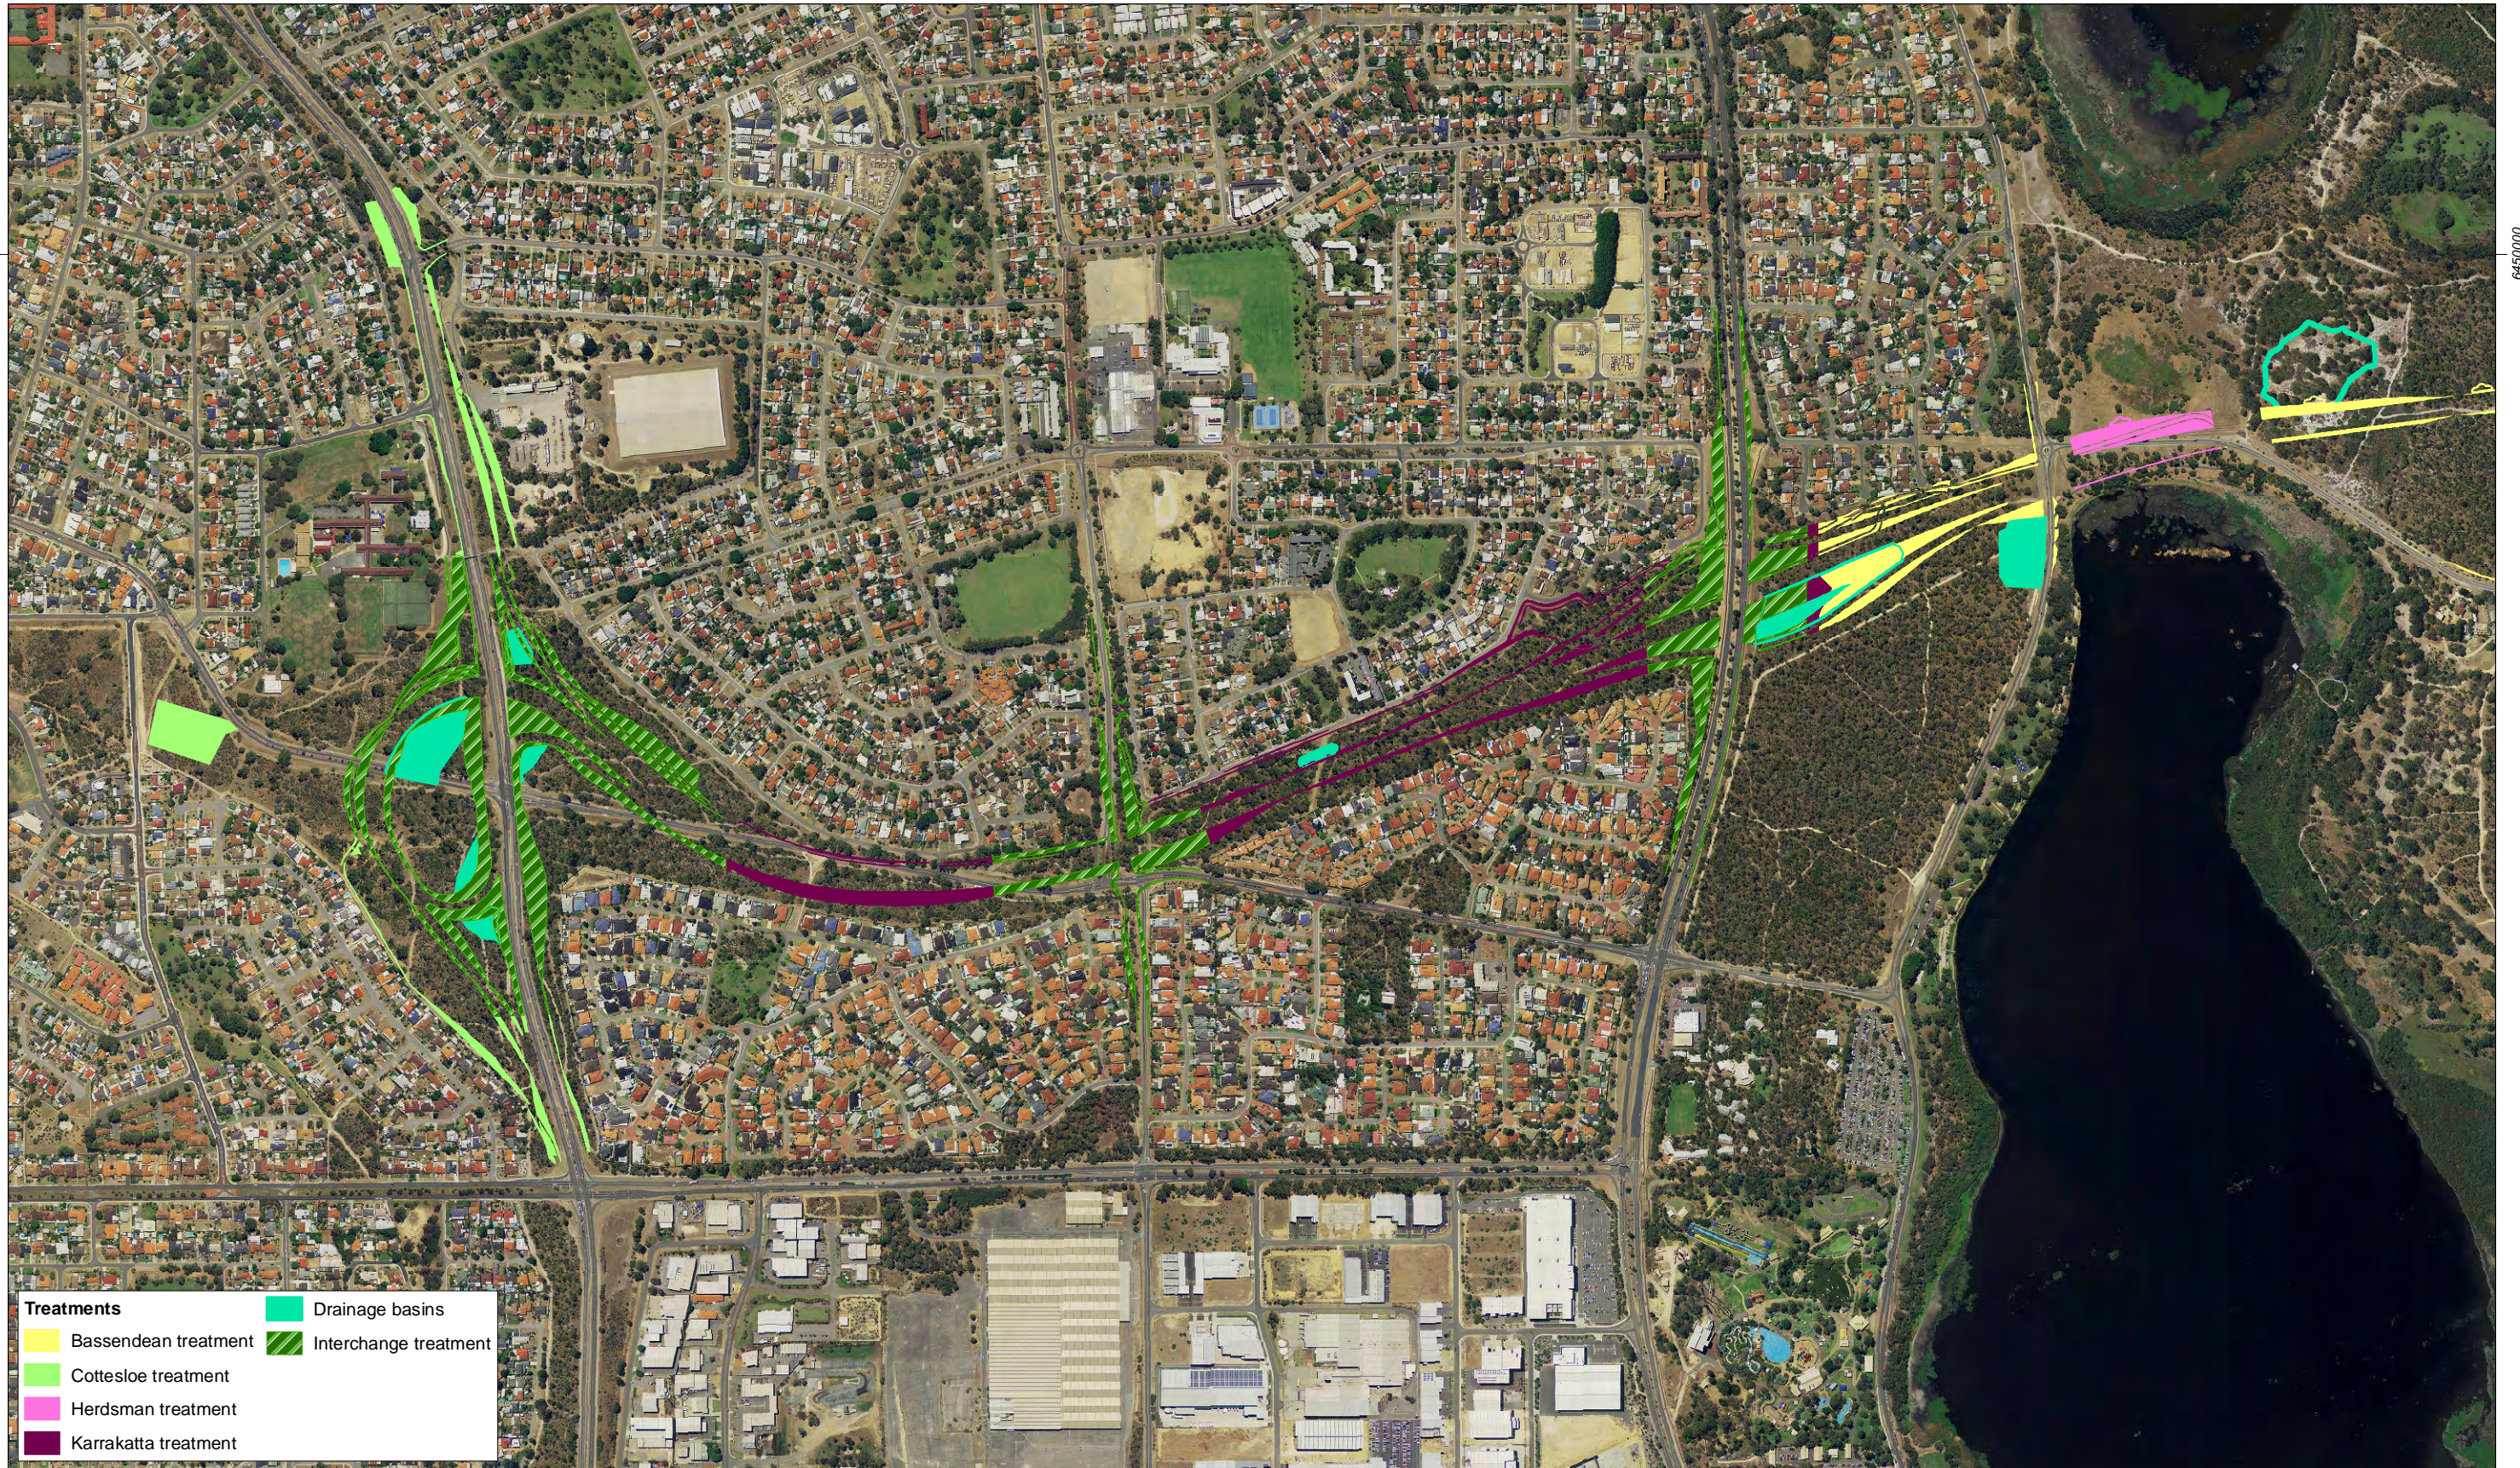
Trigger	Action
Monitoring indicates rehabilitation areas (roadside batters, redundant roads and drainage basins as per Table 4, Figure 2 and Figure 3) do not meet completion criteria described in Table 9 for native plant density, diversity, structure or survival rate.	<ol style="list-style-type: none"> <li>1. Determine missing vegetation components (via monitoring report).</li> <li>2. Identify likely cause of failure (e.g. weeds, lack of water, inappropriate timing of rehabilitation, lack of nutrients, poor soil condition, lack of water, insect/fungus attack, dieback, and predation by herbivores).</li> <li>3. Address cause of failure (this may involve weed control, fertilising, watering strategies, soil stabilisation, pest control, tree guards, fencing).</li> <li>4. Plan infill planting to compensate for missing vegetation components.</li> <li>5. Continue monitoring annually until completion criteria are met.</li> </ol>

Species diversity.	All areas	Establish no less than 25 species throughout the rehabilitation area which includes a mixture of overstorey, mid storey and groundcover reflective of the vegetation complex detailed in Table 4, Figure 2 and Figure 3.
	All areas	Establish no less than 10 species within any 100 m <sup>2</sup> area
Vegetation condition	All areas	Vegetation is: <ul style="list-style-type: none"> <li>well formed and exhibits signs of healthy growth;</li> <li>free of disease symptoms (e.g. yellowing, wilting etc); and</li> <li>free from signs of insect pests.</li> </ul>
Number of bare areas per quadrat.	All non-irrigated areas of planting (or direct seeding)	No bare soil areas >10 m <sup>2</sup> .
	All irrigated areas of planting (or direct seeding)	No bare soil areas >5 m <sup>2</sup> .
Number of erosion gullies >200 mm in depth.	All areas	No erosion gullies >200 mm in depth.
