Clearing Assessment Report/ Vegetation Management Plan (VMP) – CPS 818

South Western Highway (H009) Willowdale Road
Intersection Upgrade
South West Region
EOS 3083

D24#365361
January 2026

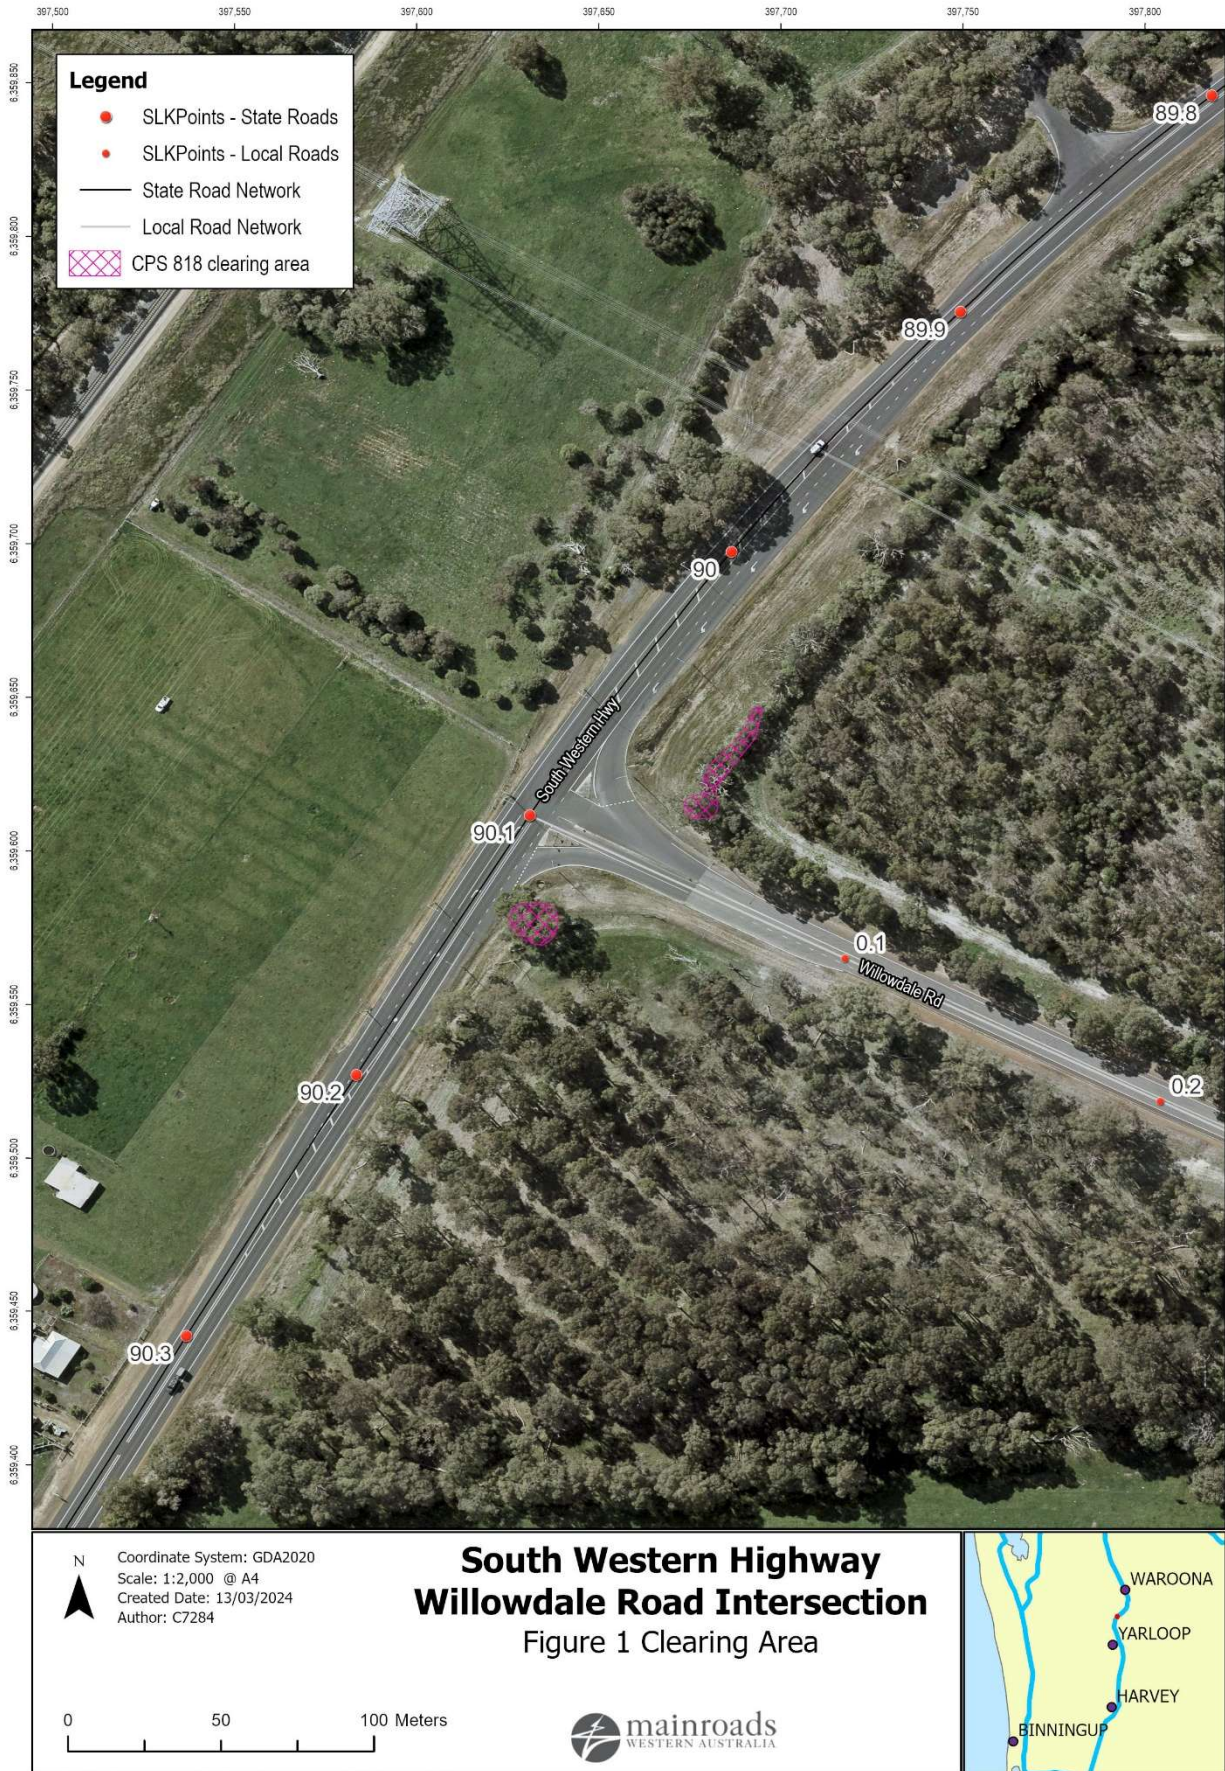
Figure 1. Clearing Area

The areas of native vegetation to be cleared are shown in Figure 1. The 5 km Study Area is shown in Figure 2. Street view images of the proposed clearing are shown in Figure 3 and Figure 4.

The Clearing Area is located on South Western Highway, Wagerup, SLK 89.68 – 90.17 within the Shire of Waroona as shown in Figure 1. The central coordinate of the proposal is -115.9057990° E, 32.8970130° S.

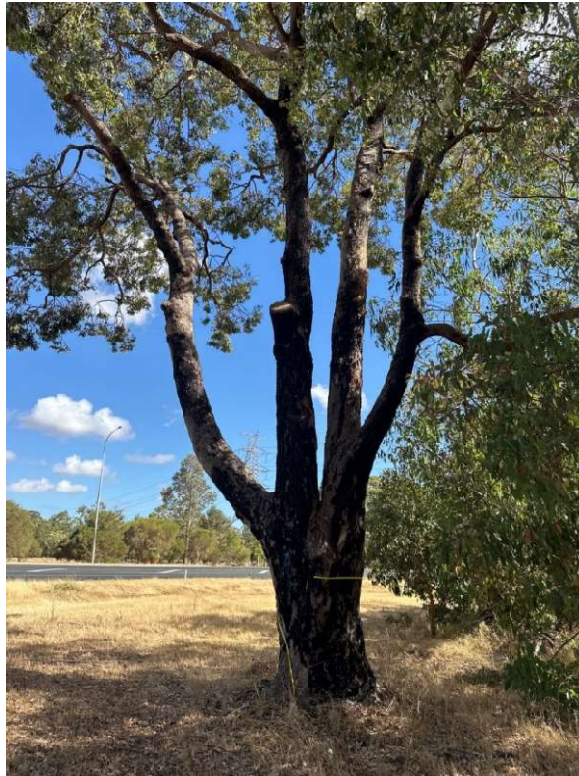
**Photo 1. Multi-stem DBH *Corymbia calophylla* (CC01),
NE corner Willowdale Road/South Western Highway.**

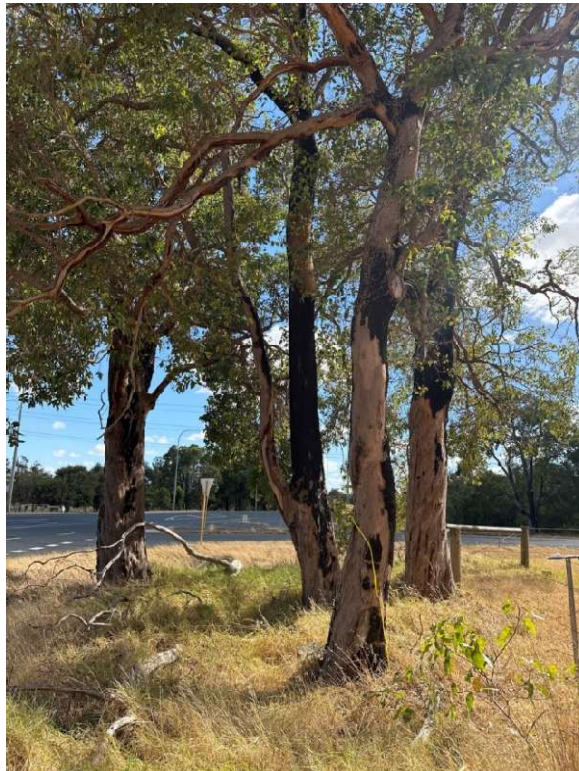
**Photo 2. Patch of four *Corymbia calophylla* (CC02-05),
SE corner Willowdale Road/South Western Highway**

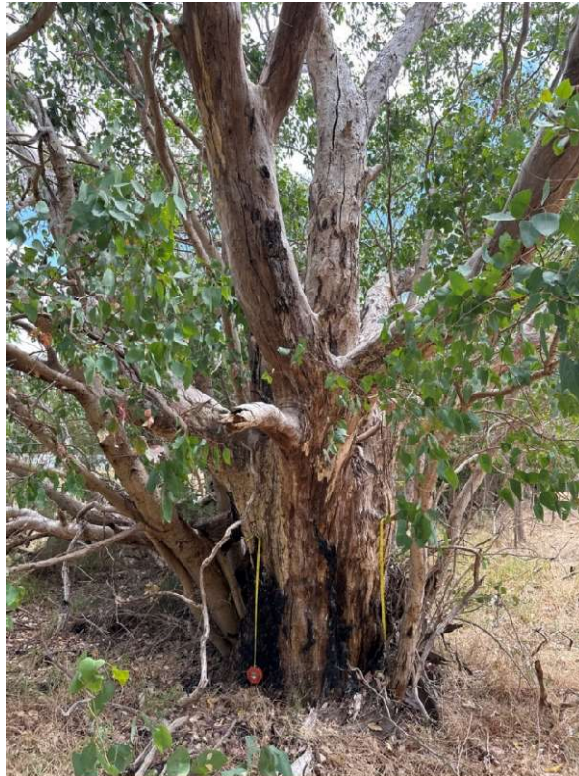
Photo 3. Resprouted *Eucalyptus rudis* (ER01), NE corner Willowdale Road/South Western Highway near fence line

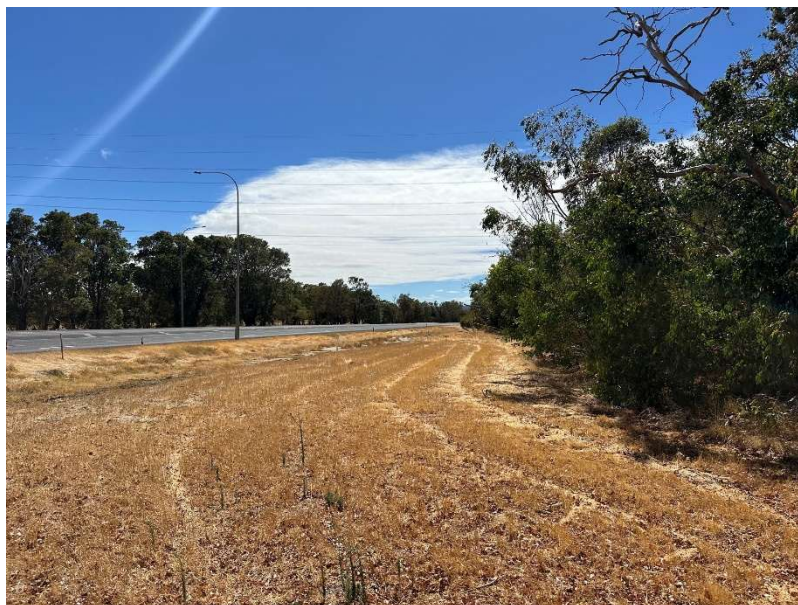
Photo 4. Regenerating *Melaleuca raphiophylla* and *Eucalyptus rudis*, north of Willowdale Road/South Western Highway
