Clearing Desktop Report – Short Form

Proposal Name:	Albany Hwy 300.3-308 SLK Gordon North – Additional Geotechnical Investigations		
Region/Directorate:	Great Southern		
Road/Bridge Name & No:	Albany Hwy (H001)		
Proposal Location (SLK):	SLK 300.3 – 308		
TRIM Link to Spatial Data:	D22#1287759 (Proposal area – 32 test pads)		
EOS No:	1914		
Expected Proposal Start Date:	January 2023		
Project No:	21115568	Task Code:	19303
LISC TRIM No:	D22#1286150	HRA TRIM No:	D22#1254169

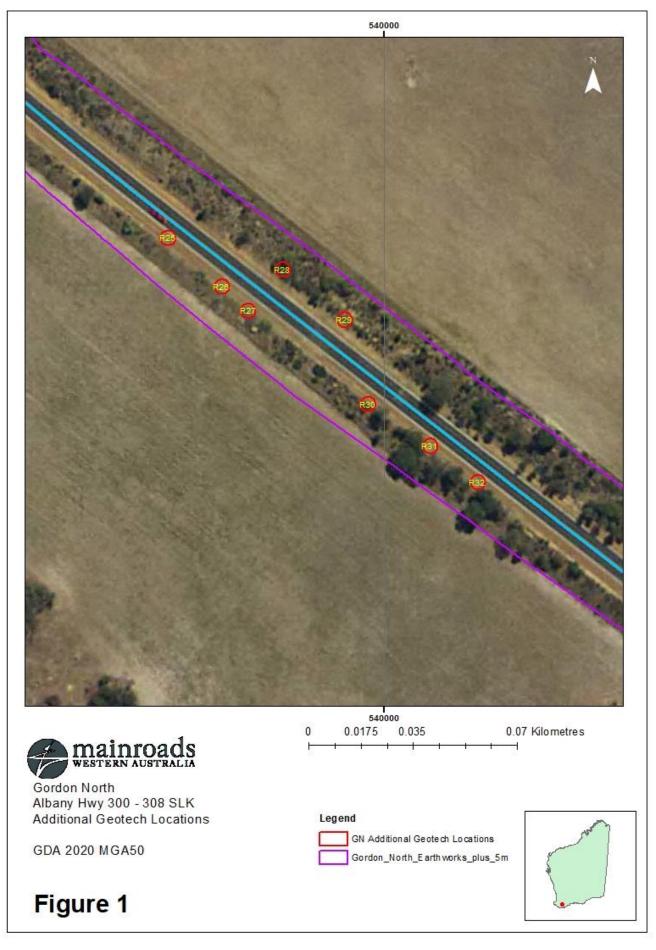
Figure 1: Geotechnical Test Pit Locations (50% clearing)

Each geotechnical pad will nominally be a 6 metre (m) diameter circle $(28.27m^2)$ and test pits will extend to a maximum depth of up to 2 m. Cleared or partially cleared areas have been selected for Test Pit locations where possible. Of the 32 test pit locations, R1-R26 are cleared, with R27-R32 having up to 50% native vegetation. This CDR focuses on the clearing requiring for R27-R32 (6 test pads) – $(6 \times 0.5 \times 28.27 = 84.8m^2)$.

The Proposal footprint has been designed so that required clearing is limited to six test pit locations which contain vegetation. The other 30 test pit locations are already cleared. These six test pit locations are also in areas where approximately half of these areas are existing cleared areas. Typically, geotechnical crews choose already cleared areas (where possible) to minimise the need to clear vegetation.

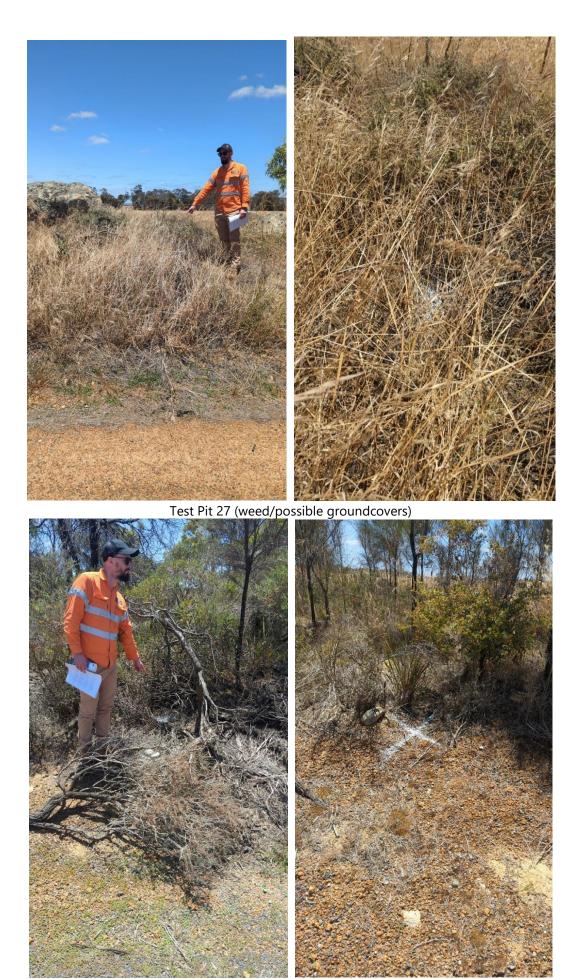
Test Pit 28 (cleared/groundcover?)

Test Pit 29 (cleared/midstorey)

Site Vegetation Description/Association:	GSBL (2019) mapped the vegetation for test pit locations R27-R32 as Mixed Shrubland.	
	Ecologia (2020) mapped the vegetation condition for test pit locations R27-R32 as a mix of cleared or Degraded-Good.	
Site Vegetation Condition:	Based on the photos of each test location (Appendix 1), the vegetation condition ranges from Degraded to Completely Degraded/Cleared.	
	One Beard's (1976) vegetation association (967) has been mapped over the Proposal area:	
Dro Europoon Evtont	Medium woodland; wandoo & yate.	
Pre-European Extent Remaining (%):	The pre-European extent of this Vegetation Association was 216,684 ha at a Statewide level. 36,536 (16.86%) of the pre-European extent of Vegetation Association 967 remains at a Statewide level, with 202 ha (71.68%) remaining at a LGA level.

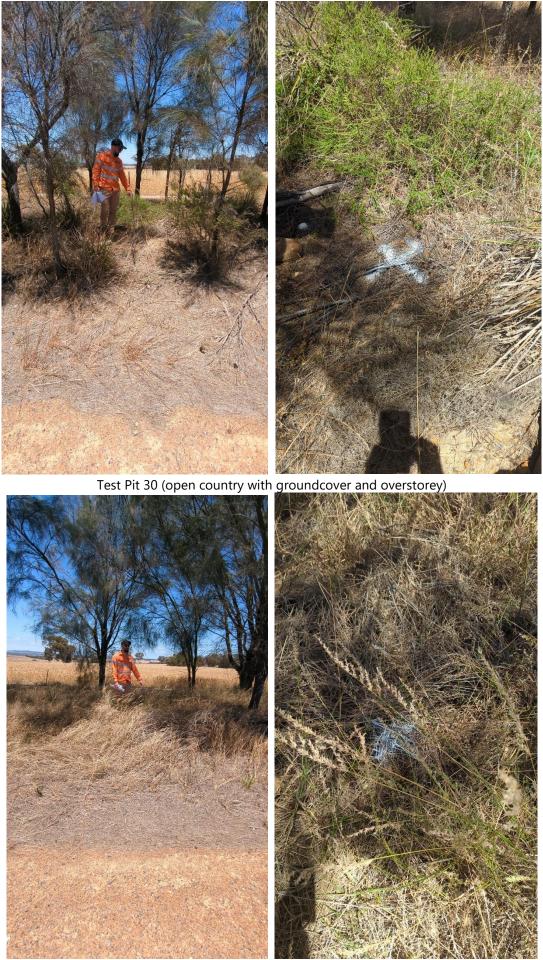
Test Pit 31(open country with possible groundcover and overstorey)

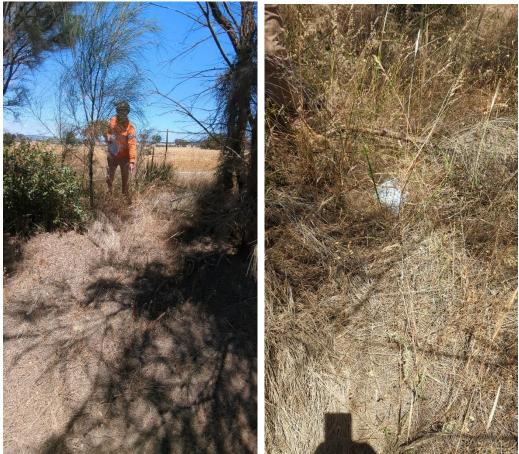
Test Pit 32 (open country with possible groundcover and overstorey)
