Clearing Assessment Report – CPS 818

Ardyaloon Trochus Hatchery Access
Road Upgrade

March 2023

EOS# 2219

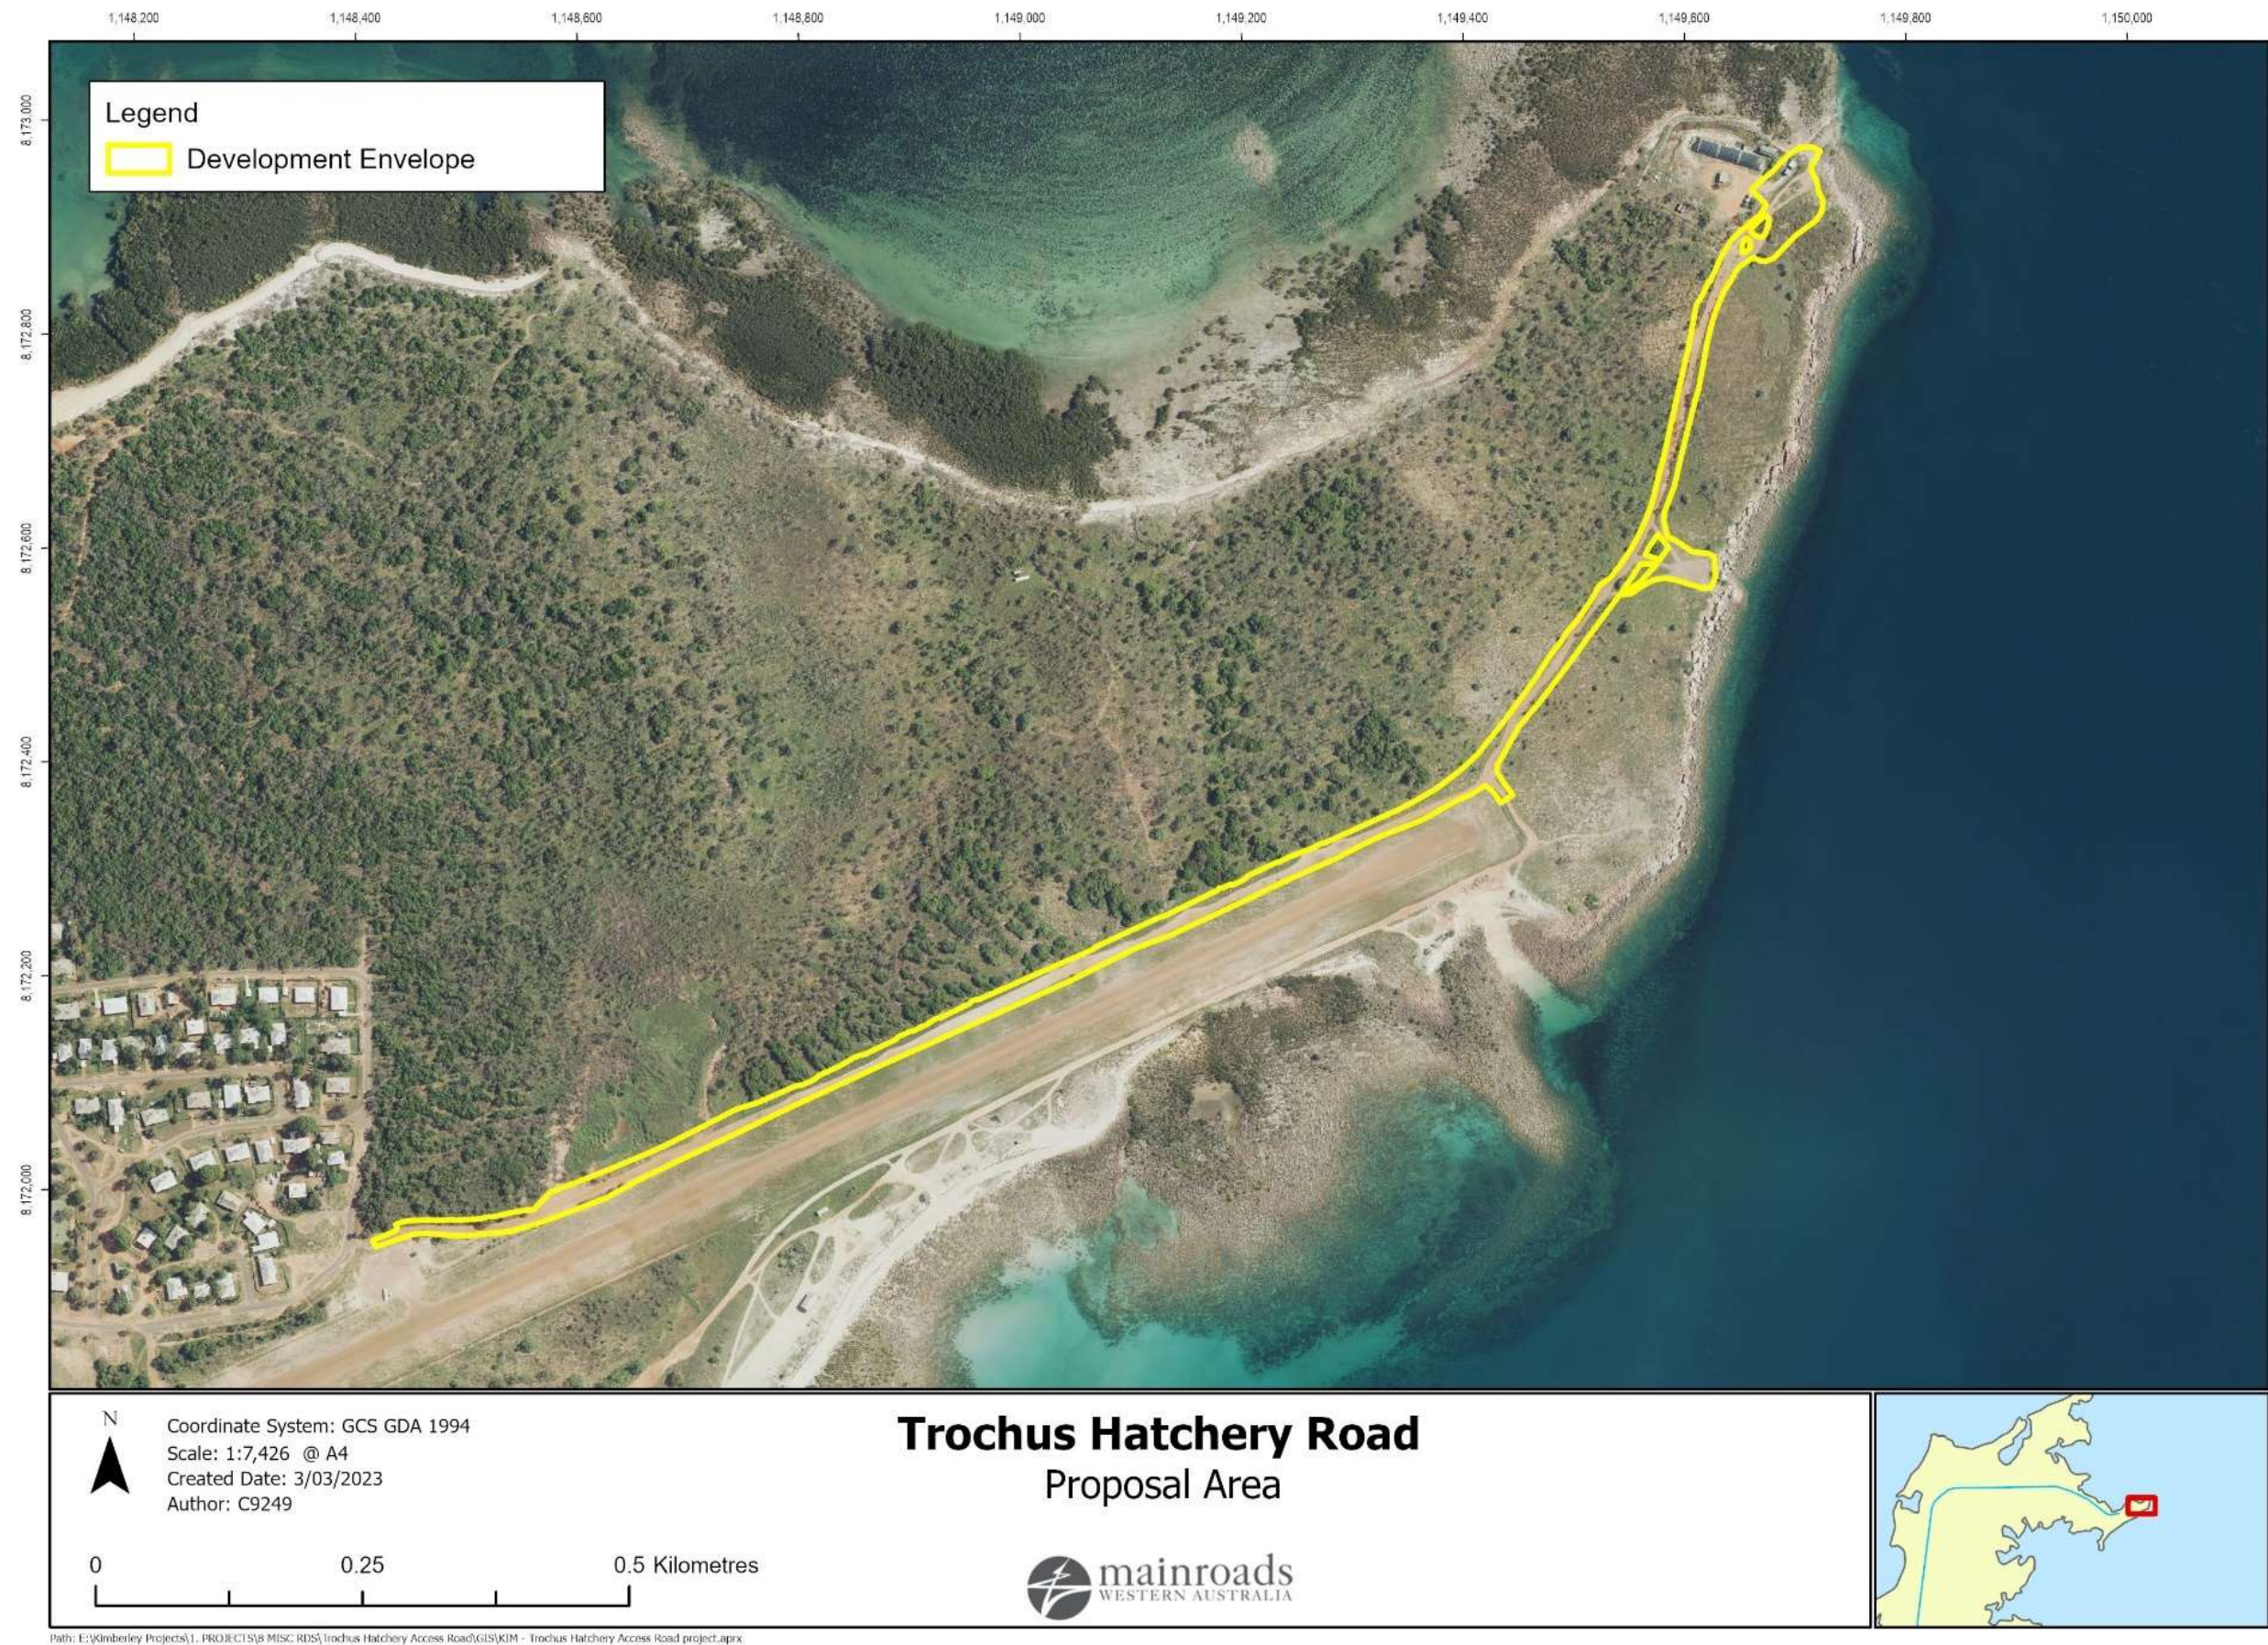
Figure 1. Proposal Area

The Development Envelope is located on the private, community managed, Hatchery Access Road next to the Ardyaloon Community as shown in Figure 1. The planned works will occur between SLK 0 to 1.7 of the Hatchery Access Road. The centroid of the key Project Area locations is provided below.

The location of the proposed works is at Figure 1.

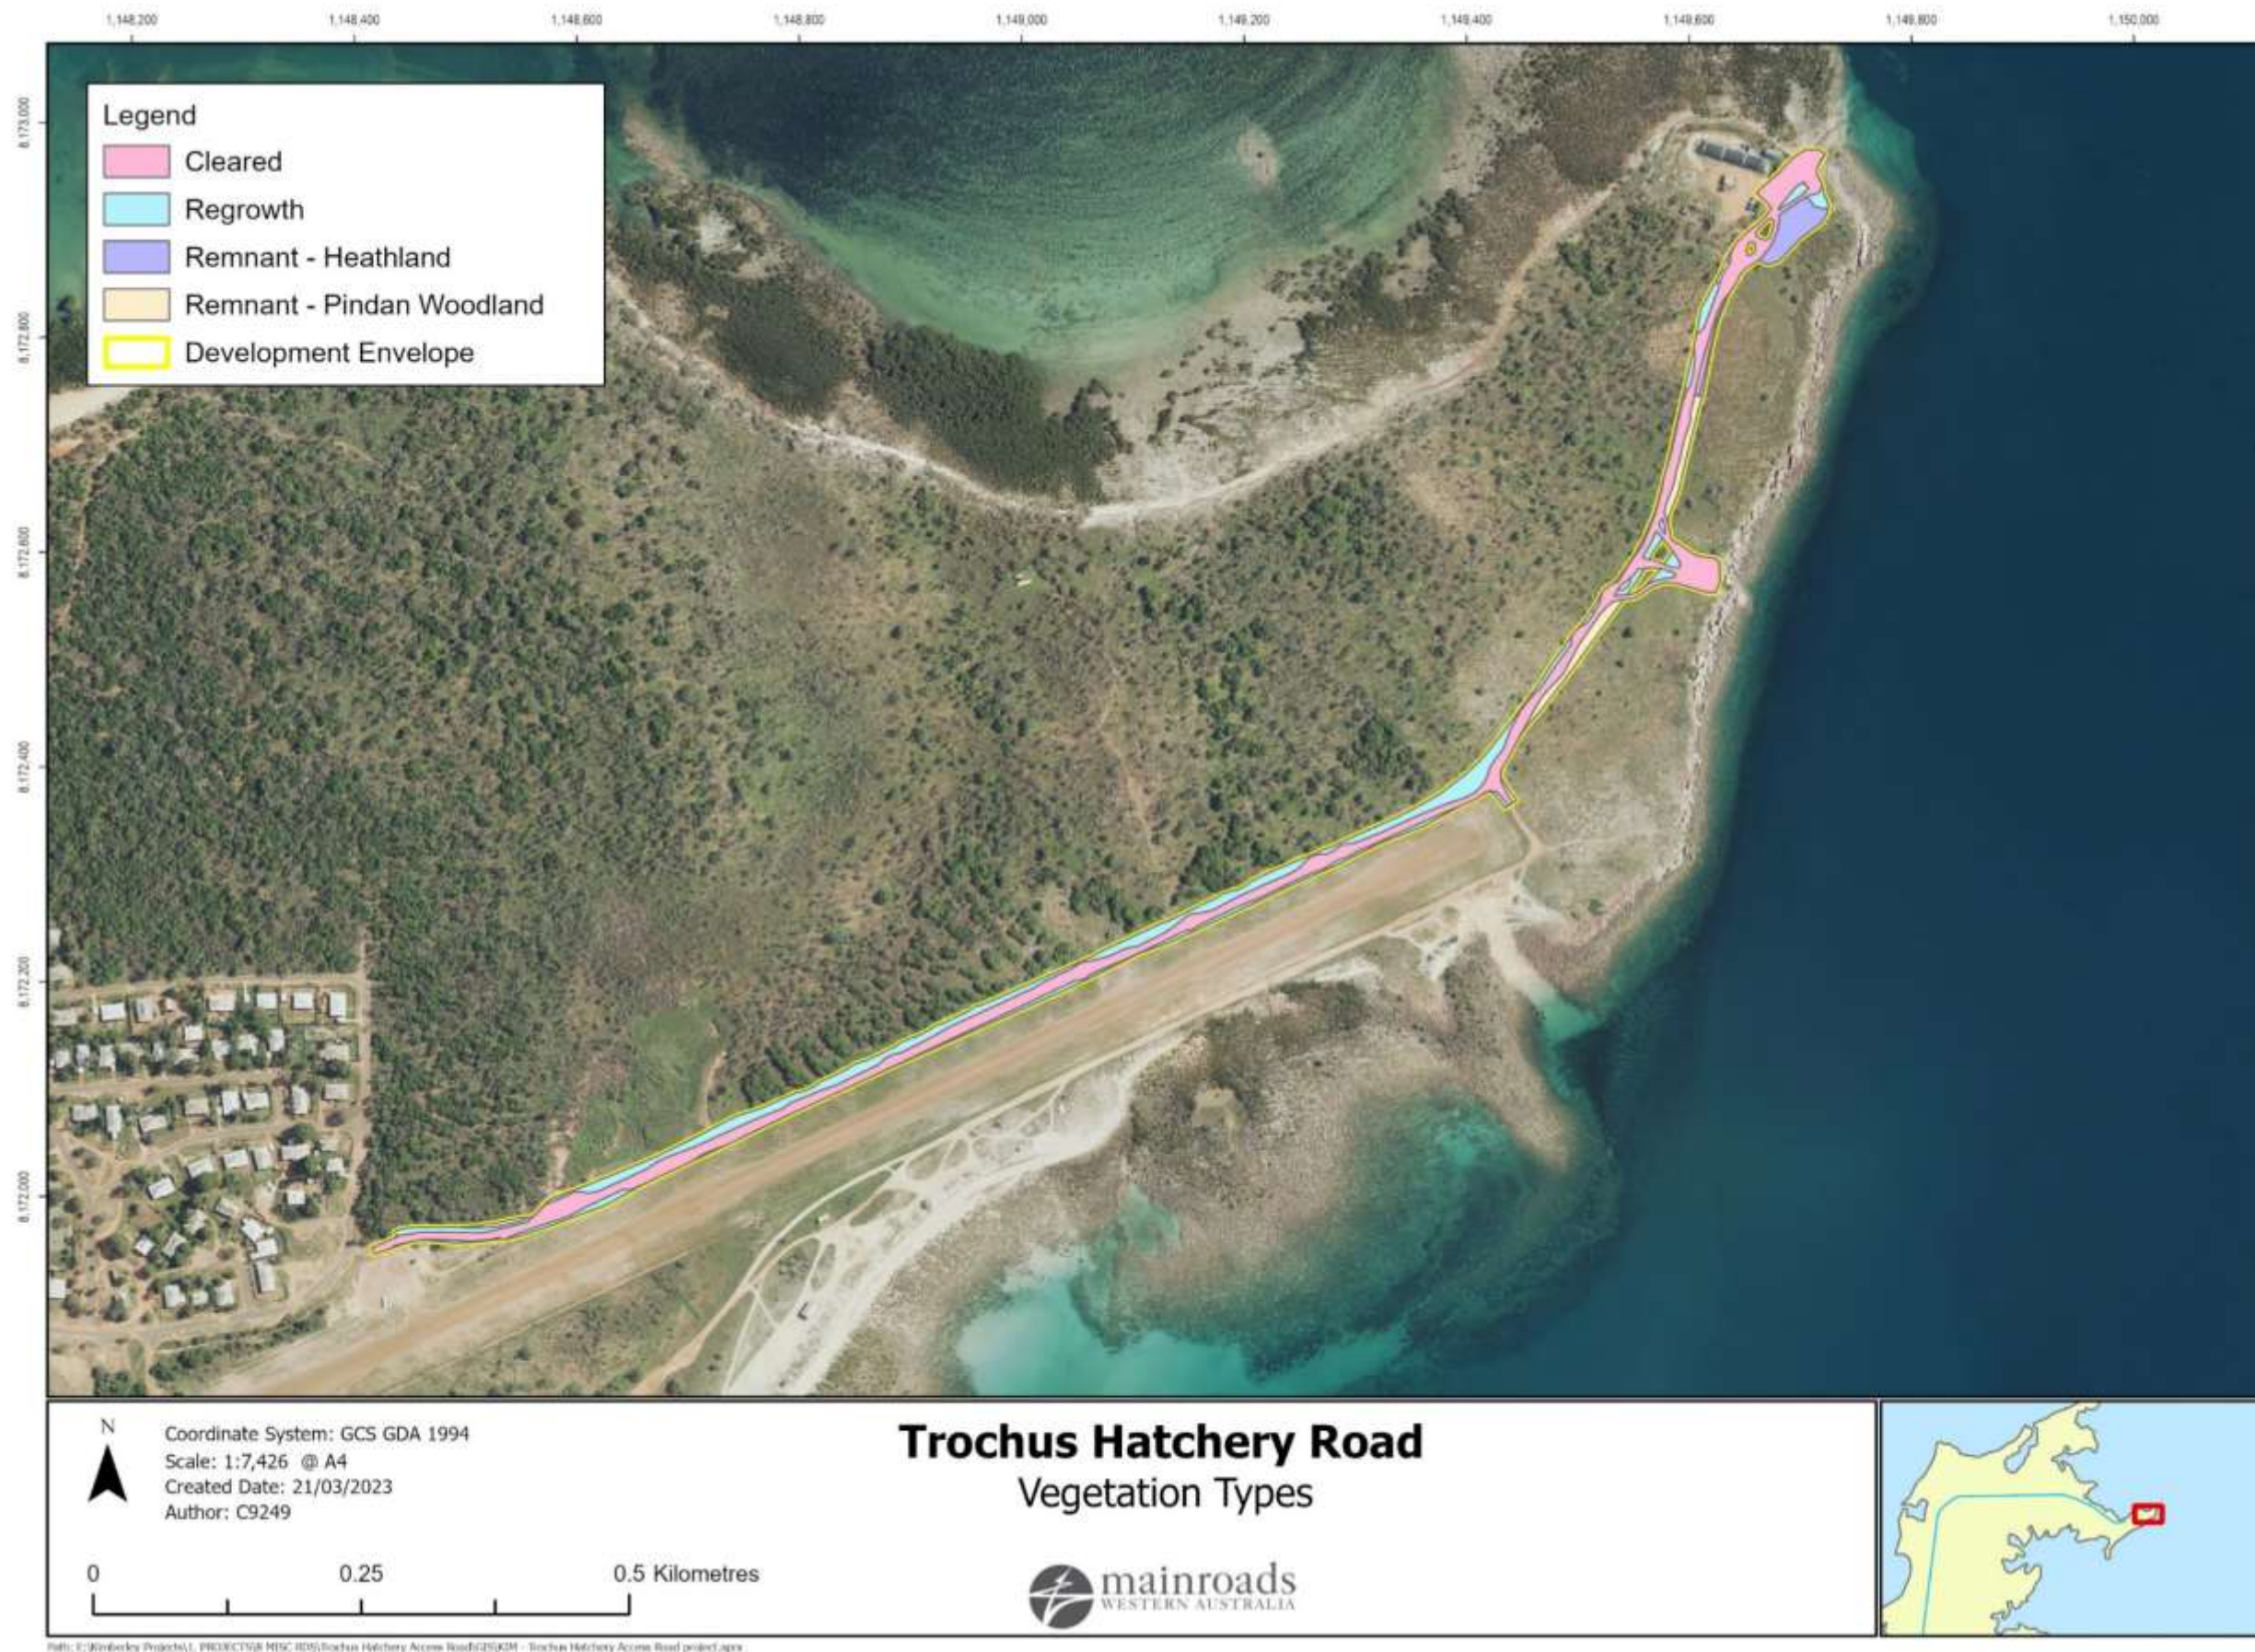
Figure 2. Vegetation Types within Trochus Hatchery Road Clearing Footprint

The type of vegetation to be cleared under this Proposal is Pindan Woodland, Heathlands and regrowth and shown in Table 2.

Four vegetation communities were identified within the Survey area. The areas of these vegetation communities in the Survey Area and estimated clearing extent in the Development envelope is provided in Table 5. No Monsoon Vine Thicket vegetation will be cleared as part of the project.
