Clearing Desktop Report – CPS 818

York-Merredin (M041) Bridge 0597
Upgrade

May 2021

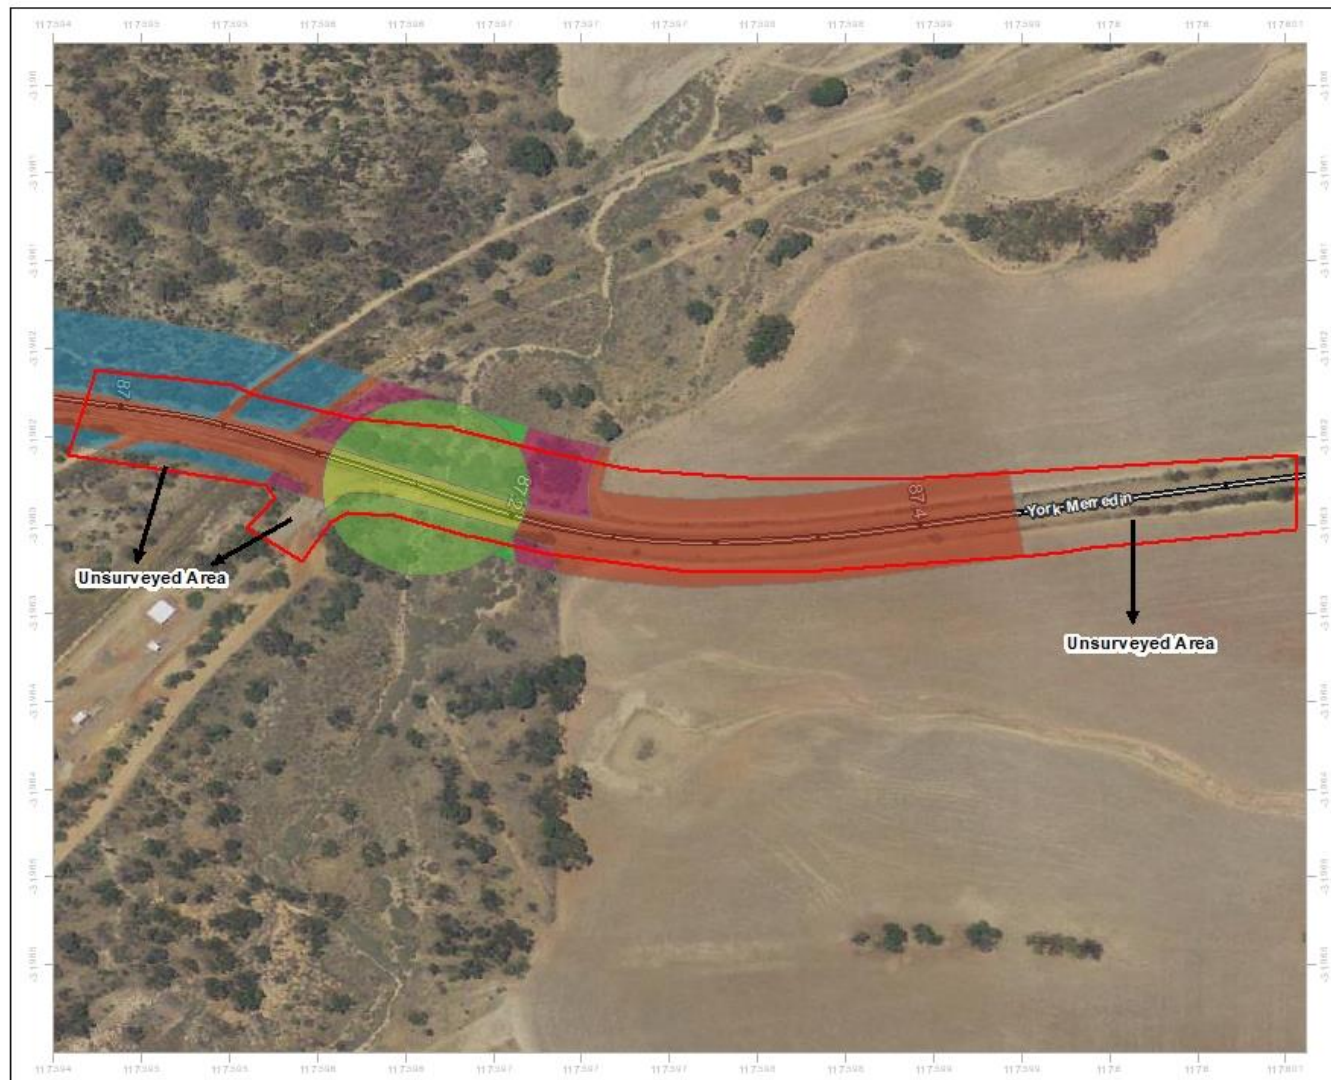
Figure 4

Vegetation Types Mapping

Approximately 0.08 ha supporting native vegetation and located within the southern section of the project area was not surveyed. Examination of Google Map street view images shows that the vegetation mapped in adjacent areas next to the road extends to the unsurveyed segments. Another area (0.14 ha) on the easternmost section of the project area occurs outside of the biological survey area. This section supports only planted *Acacia acuminata* shrubs and is analogous to the adjoining mapping provided by Ecoscape (Ecoscape 2021). The location of the unsurveyed areas and corresponding images are provided in Appendix 3.

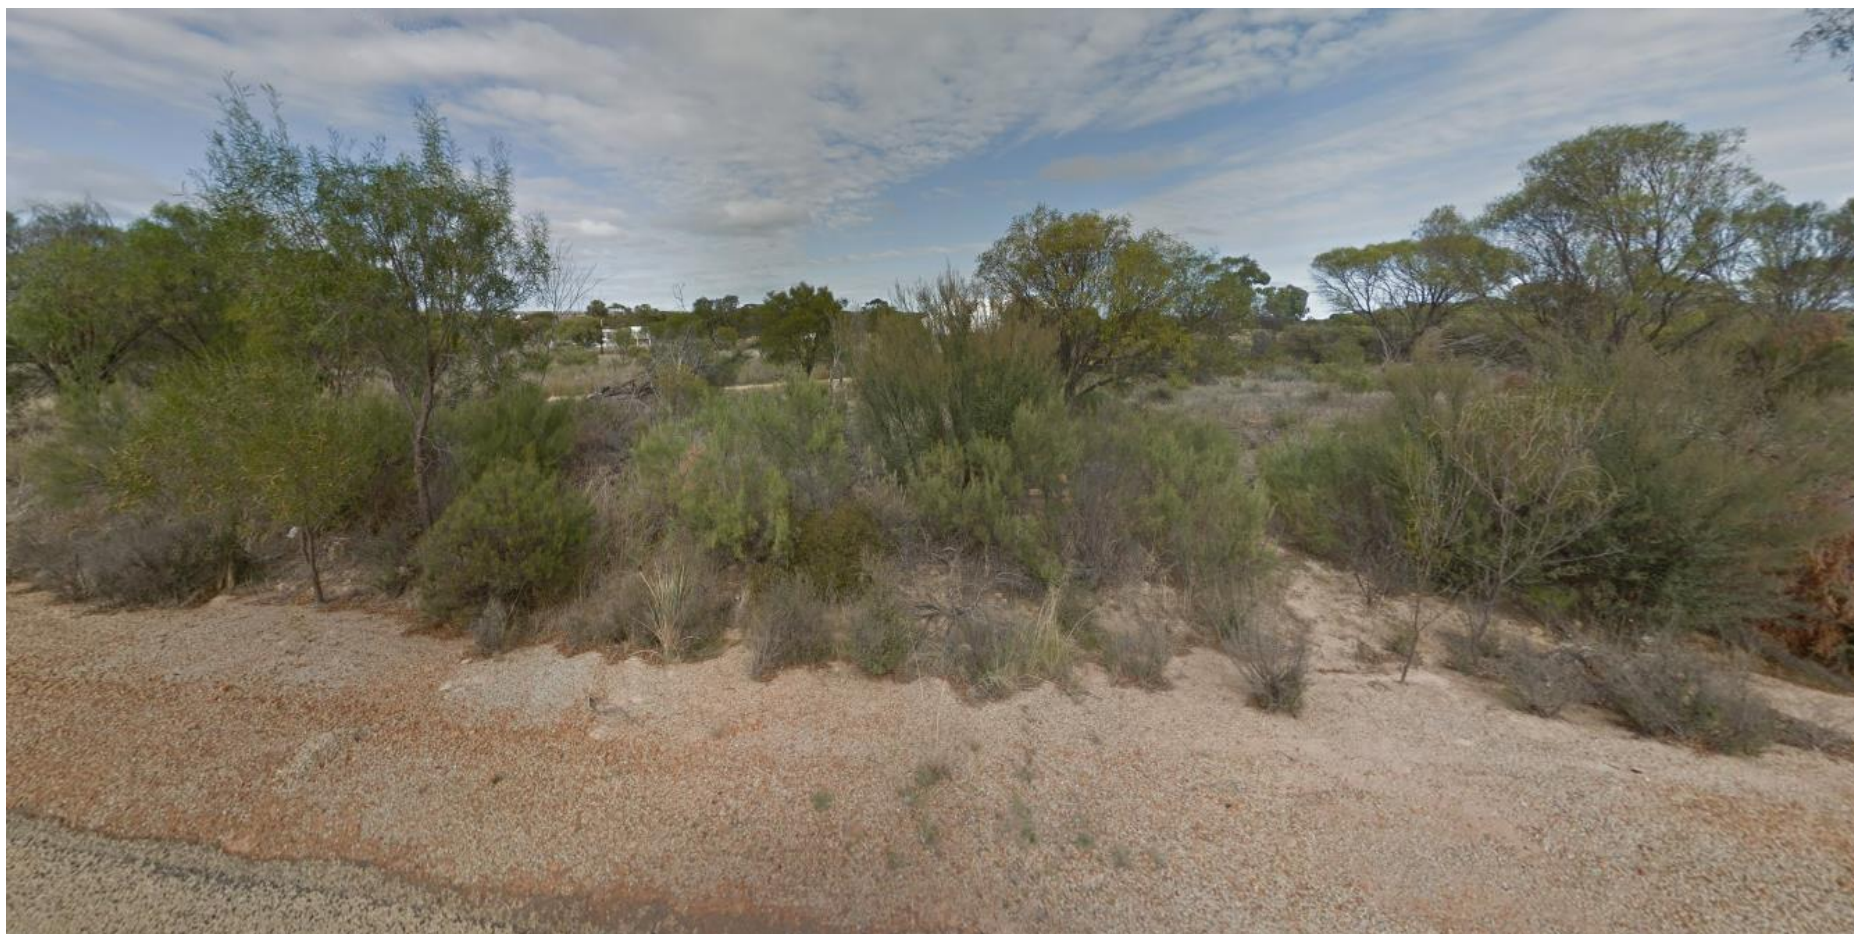
Image 1 - *Acacia acuminata* low open woodland over *Allocasuarina campestris* and *Grevillea anethifolia* mid open shrubland over *Mesomelaena pseudostygia*, *Persoonia quinquenervis* and *Monachather paradoxus* low open sedgeland/shrubland/tussock grassland (AaLOW) mapped the segment adjacent to the road extends over 'Unsurveyed Area 1' which is a small section of 0.04 ha.

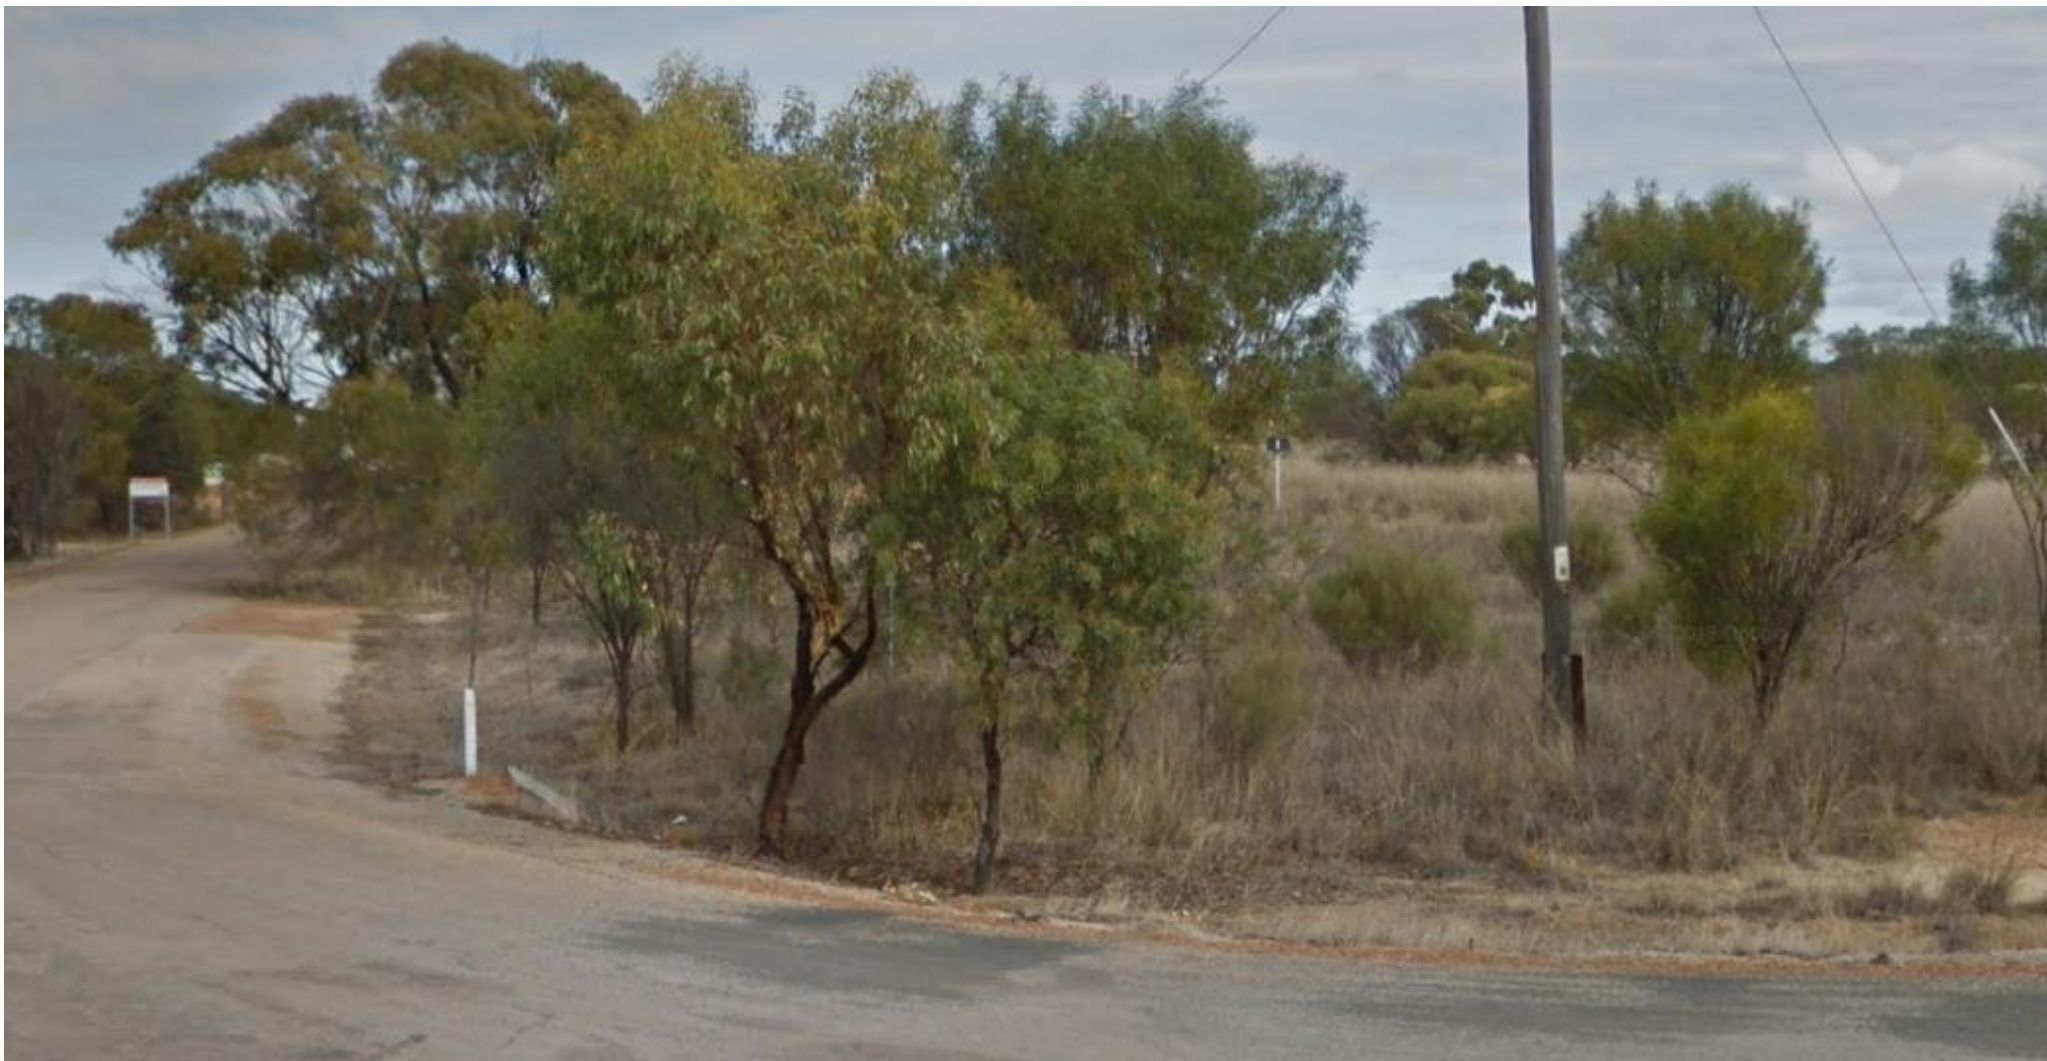
Image 2. *Eucalyptus loxophleba* subsp. *loxophleba* low woodland over *Maireana brevifolia*, *Lomandra effusa* and *Enchylaena tomentosa* low open chenopod shrubland/forbland (EILW) mapped for the section mapped adjacent to the road extends to 'Unsurveyed Area 2' which covers 0.04 ha.

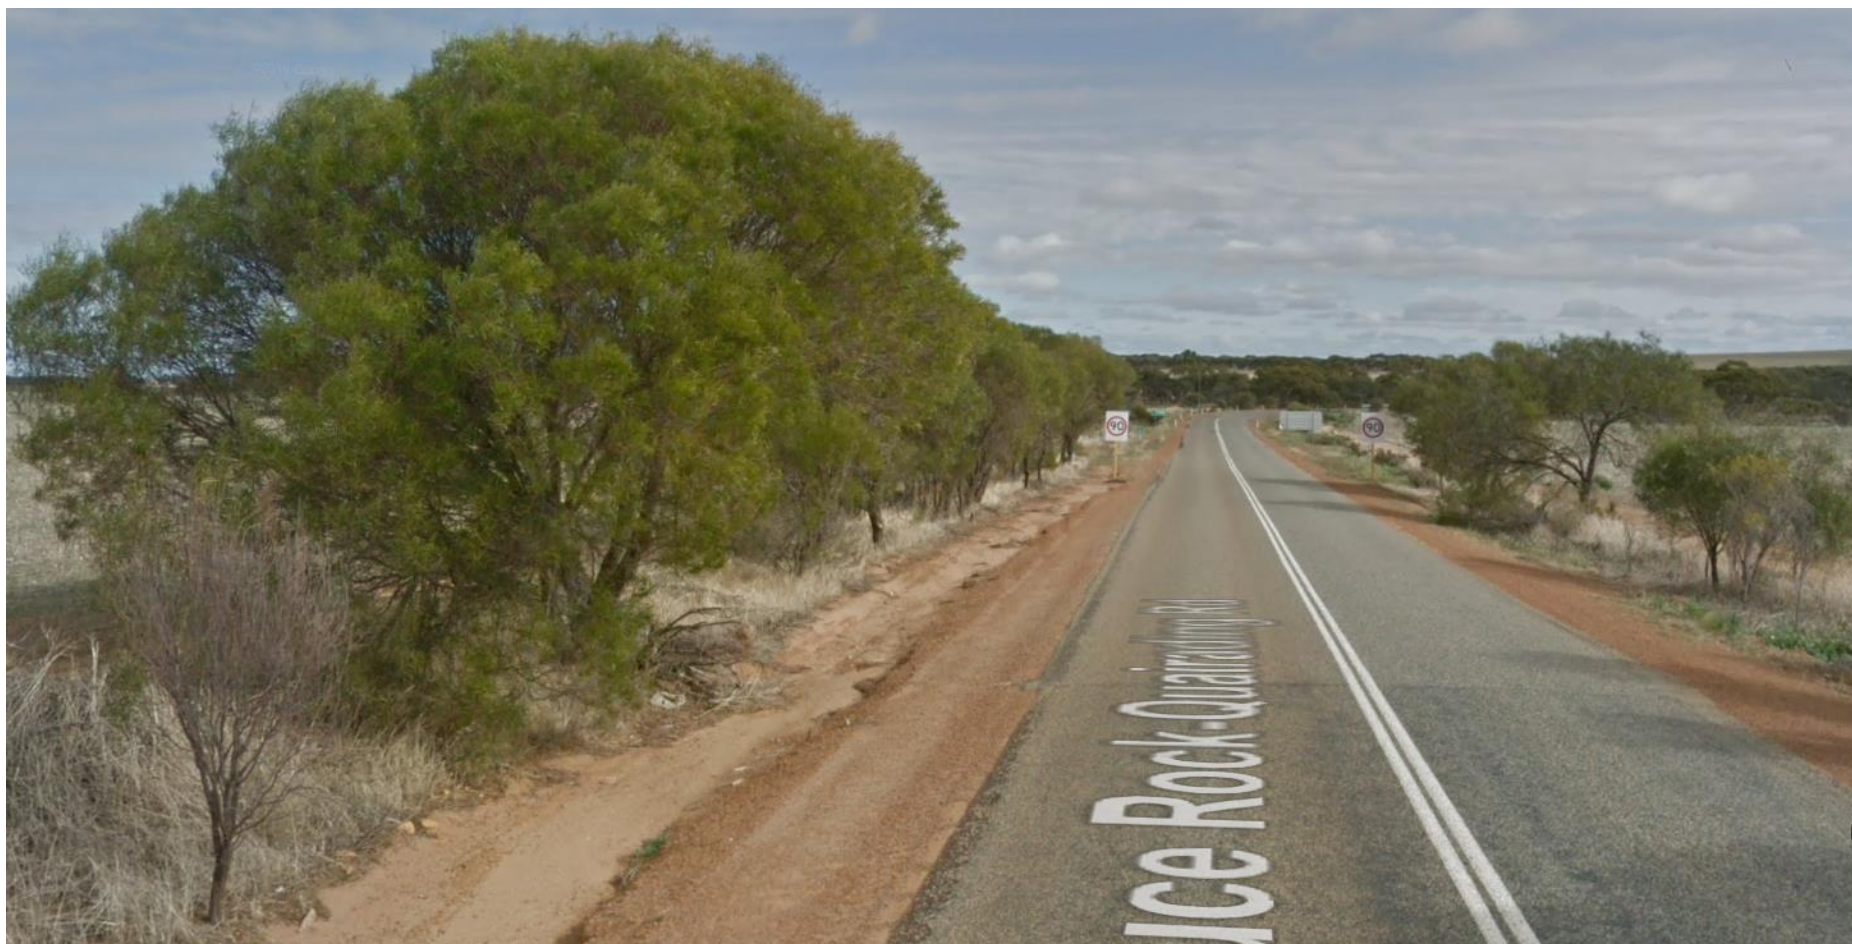
Image 3 – Unsurveyed Area 3 located around SLK 87.55 and showing disturbed habitat supporting planted *Acacia acuminata* on both sides of the road.
