# Clearing Assessment Report/ Vegetation Management Plan (VMP) – CPS 818

Bridge 3197 – Bridge Replacement  
Wheatbelt Region  
EOS 1452

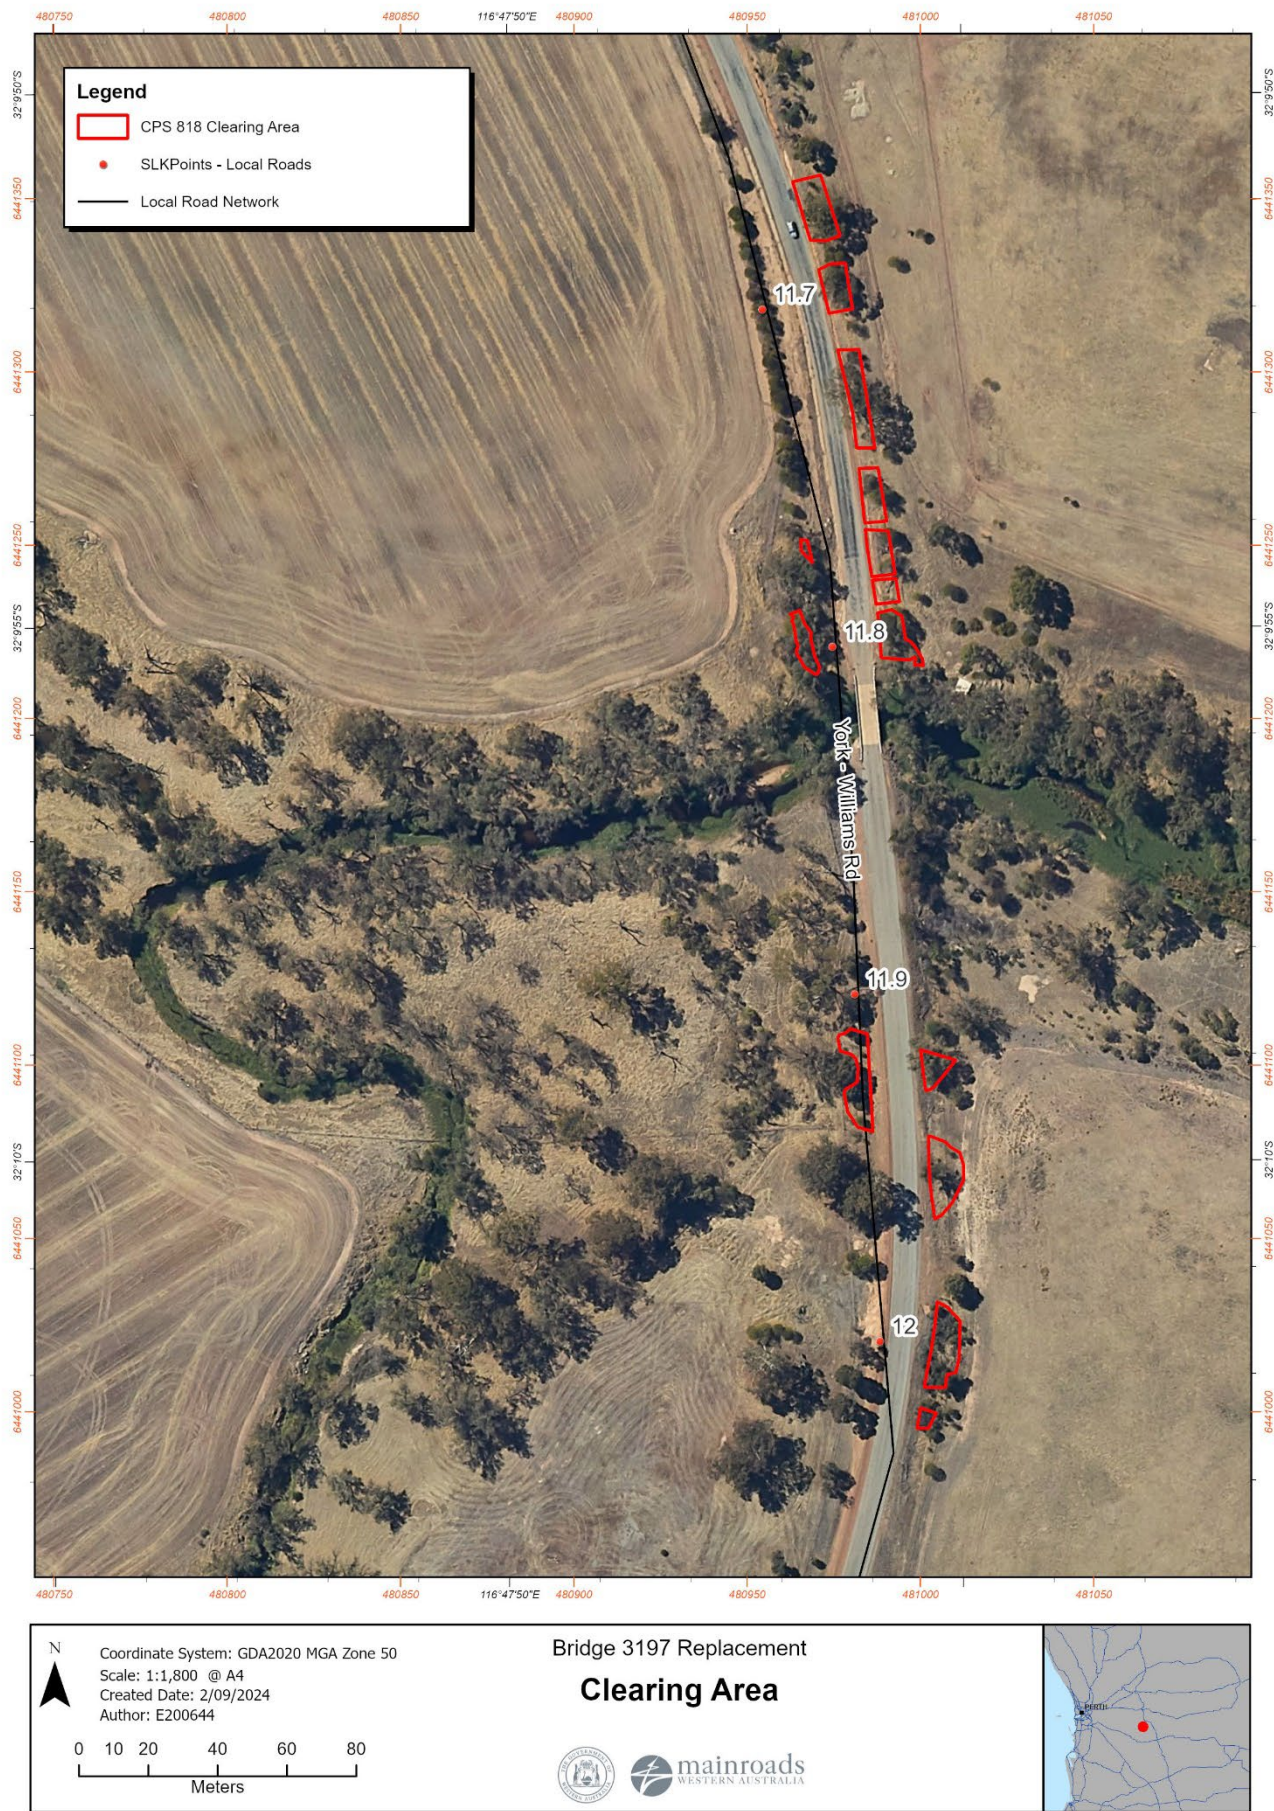
Figure 1. Clearing Area

The Clearing Area is located on York-Williams Road approximately 15km southwest of Beverley, SLK 11.65 to SLK 12.04, in the Shire of Beverley as shown in Figure 1.

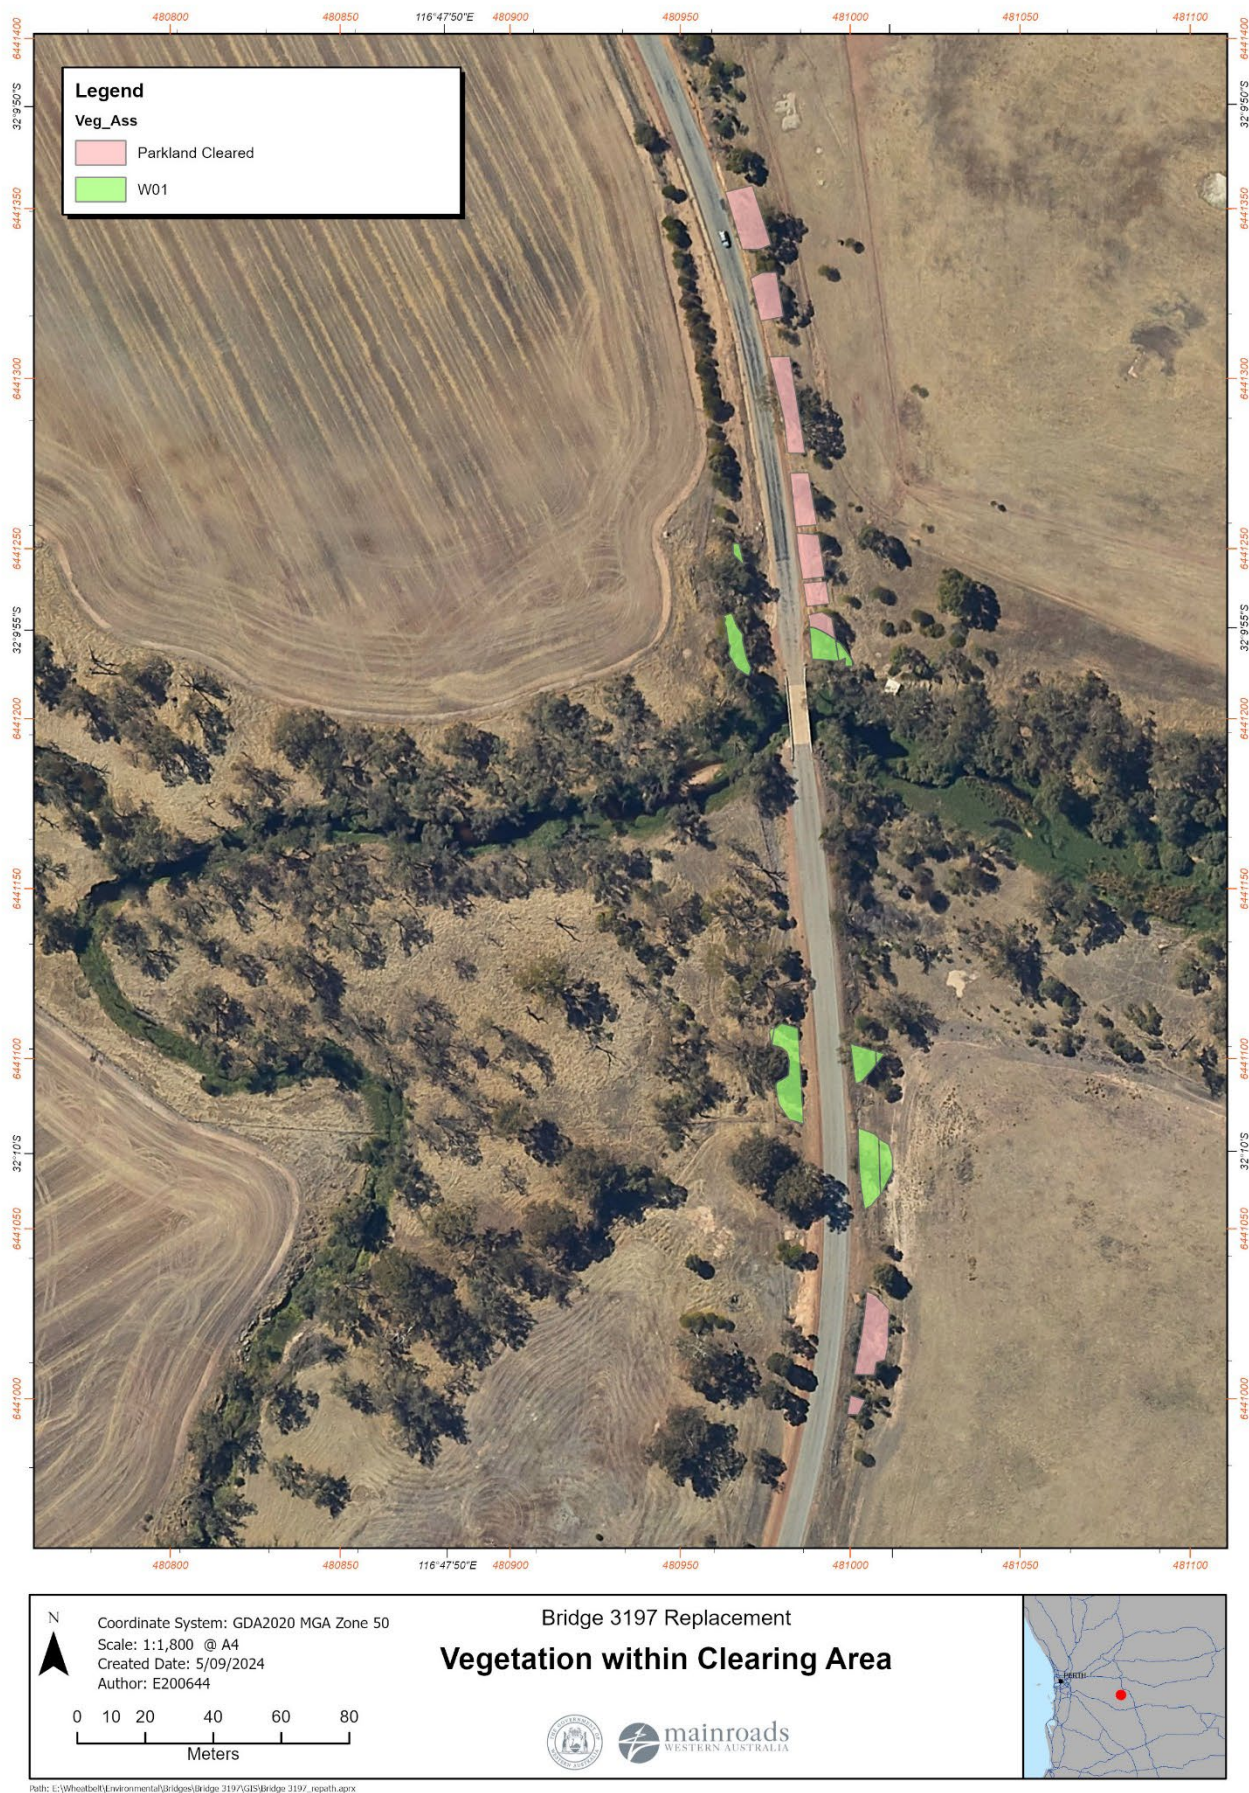
Figure 2. Vegetation within Clearing Area

The areas of native vegetation to be cleared are shown in Figure 2.

- *Eucalyptus* mid open woodland vegetation type (W01), dominated by *Eucalyptus loxophleba* subsp. *loxophleba* and *Eucalyptus rudis* subsp. *rudis*, with an understorey primarily comprised of tall sparse *Acacia* shrub layer or low sparse shrub layer, together with infestations of introduced grasses.
- Open Eucalypt woodland containing remnant upper Stratum but cleared of native understorey described as 'Parkland Cleared'.

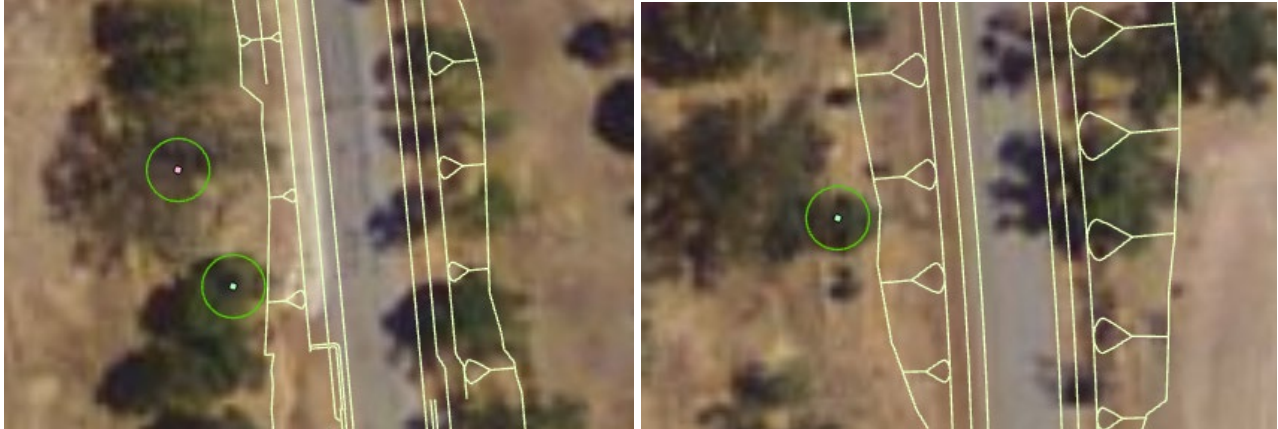
| Design or Management Measure | Discussion and Justification |
|---|---|
| <b>Steepen batter slopes</b> | <p>The steepening of Proposal fill batters from 3:1 slopes in the 15% design to up to 2:1 slopes in the final design will enable the retention of three DBH trees.</p> |

| Design or Management Measure | Discussion and Justification |
|---|---|
| | <div data-bbox="344 284 1617 715"></div> <p data-bbox="344 719 1057 751">Three DBH trees to be retained due to steepening of batters.</p> <div data-bbox="344 858 1594 1193"></div> <p data-bbox="344 1198 1001 1230">15% road design (page 122 of IFC bridge design report)</p> |

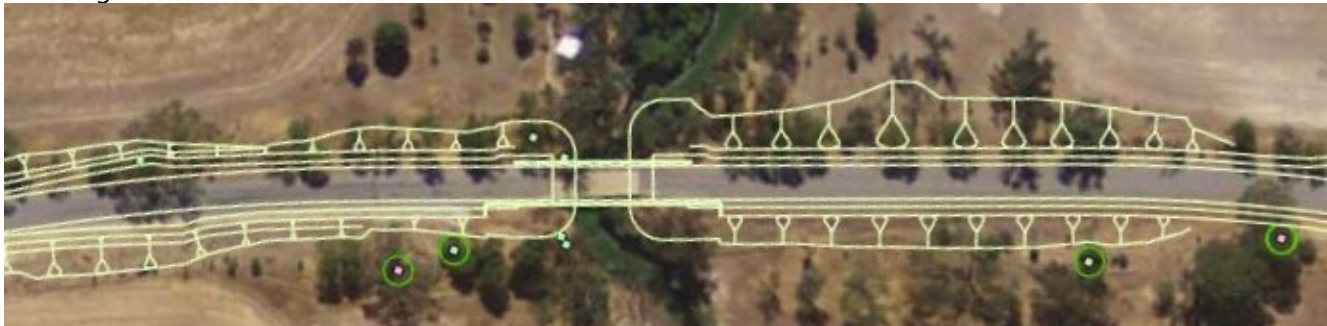
| Design or Management Measure | Discussion and Justification |
|---|---|
| | <div data-bbox="344 279 1630 638"></div> <p data-bbox="344 638 470 670">IFC design</p> <div data-bbox="344 670 1666 997"></div> <p data-bbox="344 997 1041 1034">IFC design and potential fauna habitat trees to be retained.</p> |

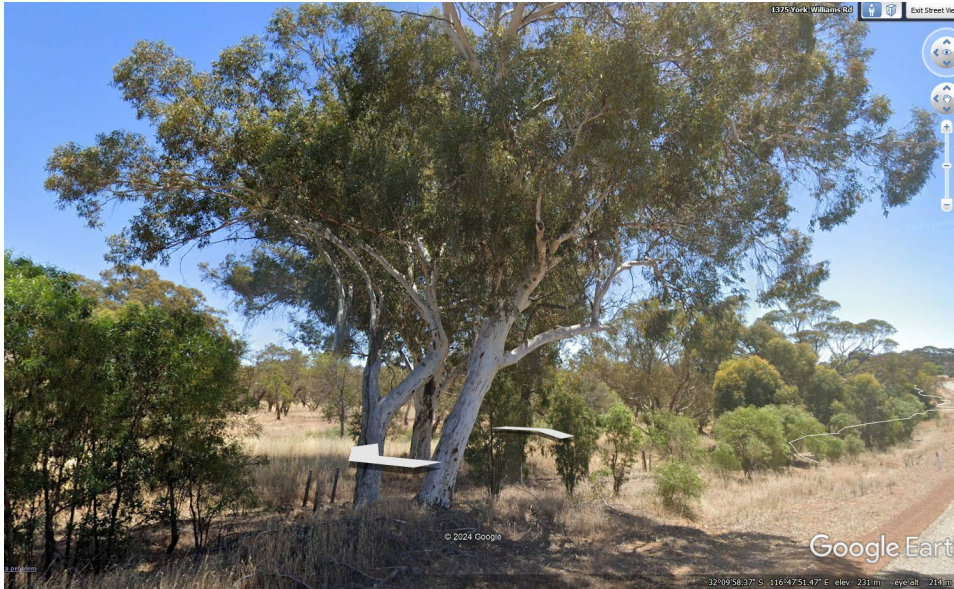
| Design or Management Measure | Discussion and Justification |
|---|---|
| <b>Installation of barriers and rock pitching</b> | <p>Safety barriers have been incorporated from SLK 11.72 to SLK 11.98 that allow for a steeper batter slope, with rock pitching incorporated where the fill batter has been steepened to a slope greater than 1:3. The combination of barriers and rock pitching will enable the retention of three DBH trees. The extension of the barrier on the RHS to SLK 11.98 allows two additional DBH trees to be retained.</p> <div data-bbox="344 424 1294 1015"></div> <p>Two DBH Trees to be retained due to proposed barrier installation.</p> |

| Design or Management Measure | Discussion and Justification |
|---|---|
| | <p>The drawing illustrates the proposed bridge structure and its integration with the surrounding road. The top portion shows the 'Initial 15% road design' with a road profile and elevation data. The bottom portion shows the 'IFC design incorporating rock pitching and guard rails extending on the RHS to SLK 11.98 (Drainage design SLK 11.94 to 11.85 to be finalised)'. The drawing includes labels for 'YORK-WILLIAMS ROAD', 'BRIDGE 3197. REFER TO STRUCTURAL DRAWINGS FOR DETAILS.', 'YORK', 'WILLIAMS', and 'EXTENT OF WORKS'. Elevation data points are provided along the road profile, ranging from 11680 to 11980. The drawing also shows the 'RMC01' structure and the 'YORK-WILLIAMS ROAD' crossing the bridge.</p> |

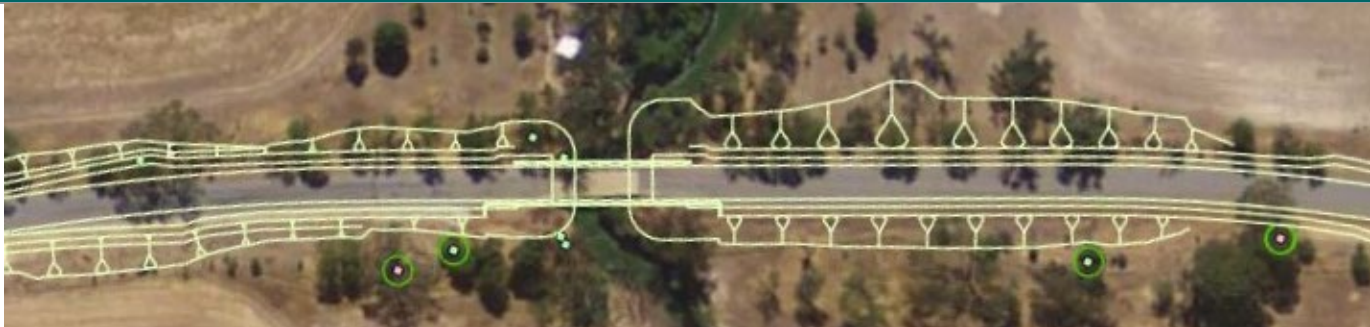
| Design or Management Measure | Discussion and Justification |
|---|---|
| | <p data-bbox="344 612 1556 643">IFC design and five potential fauna habitat trees to be retained, including two overlapping at SLK 11.96.</p> |

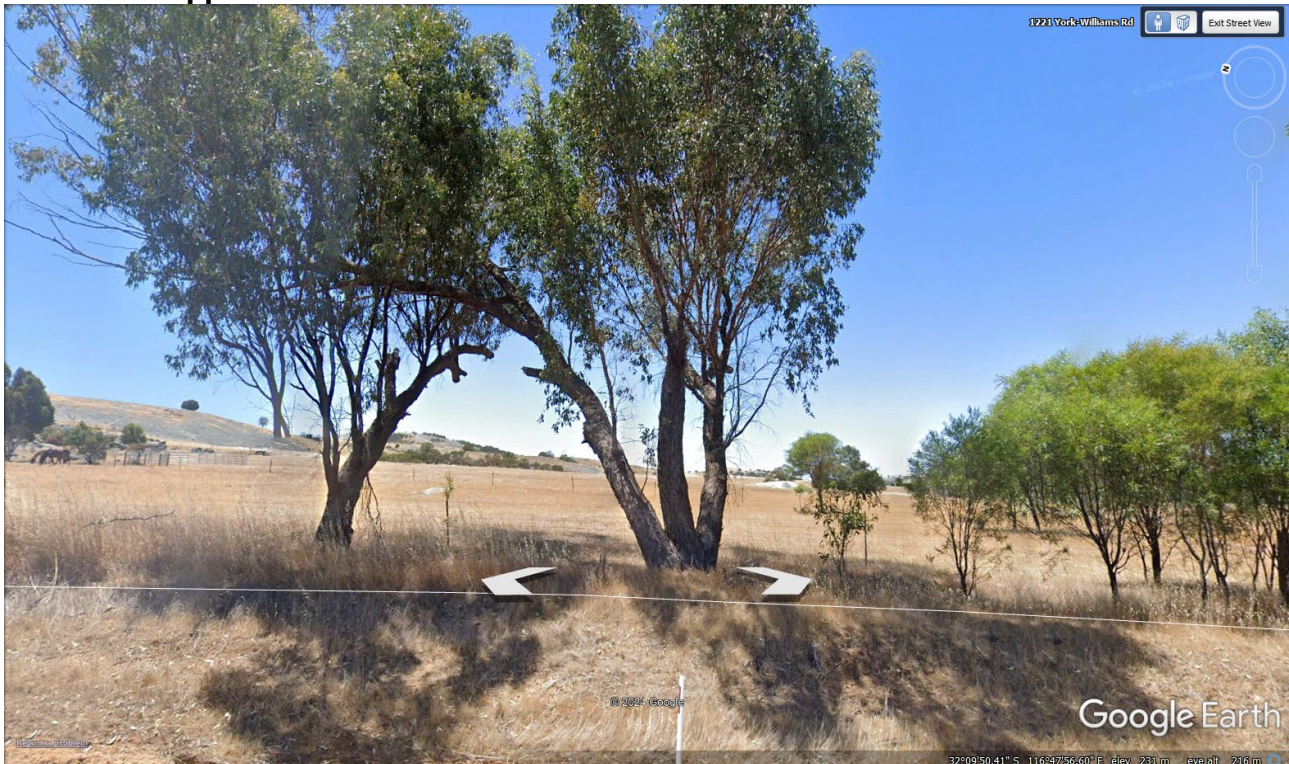
**SLK 11.68 – Left hand side of carriageway (LHS) – Isolated trees, regrowth vegetation and understorey of weeds.**

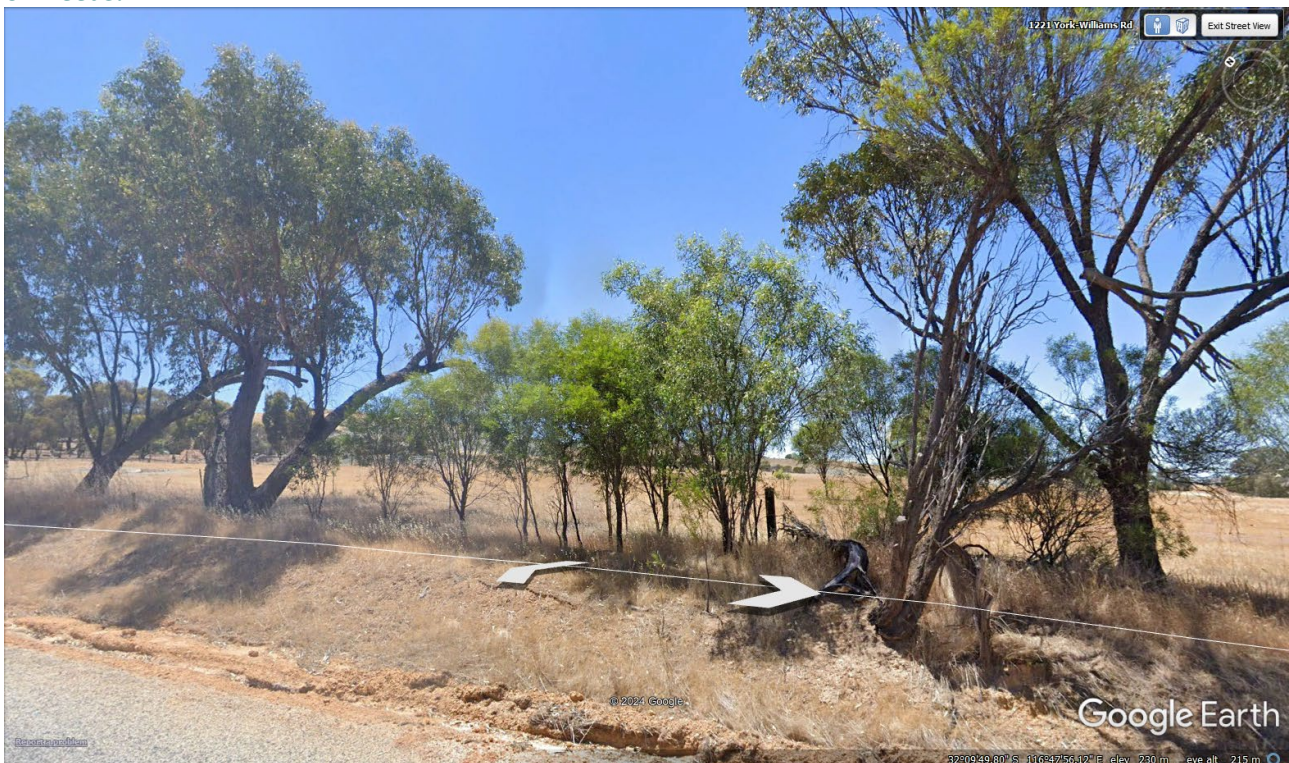
**SLK 11.7 – LHS – Overstorey trees, regrowth vegetation and understorey of weeds.**

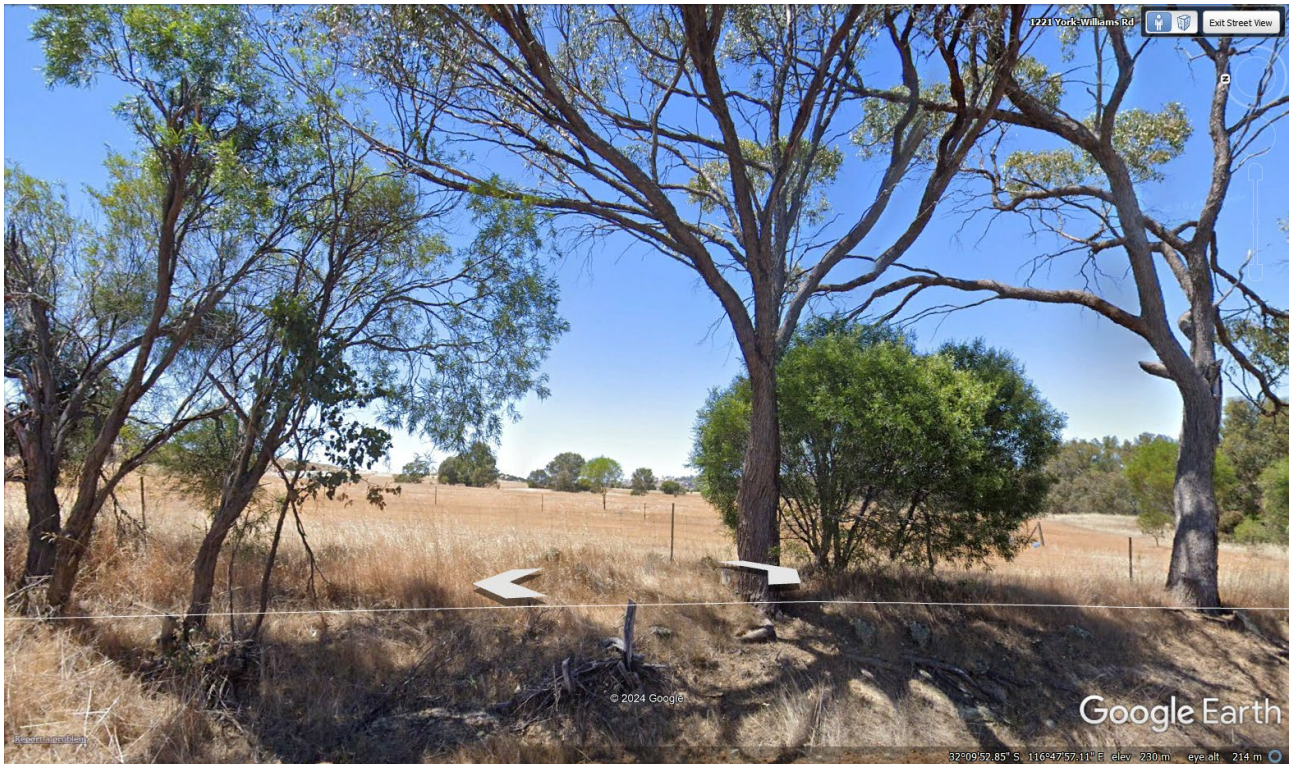
**SLK 11.73 – LHS – Overstorey trees, regrowth vegetation and understorey of weeds.**

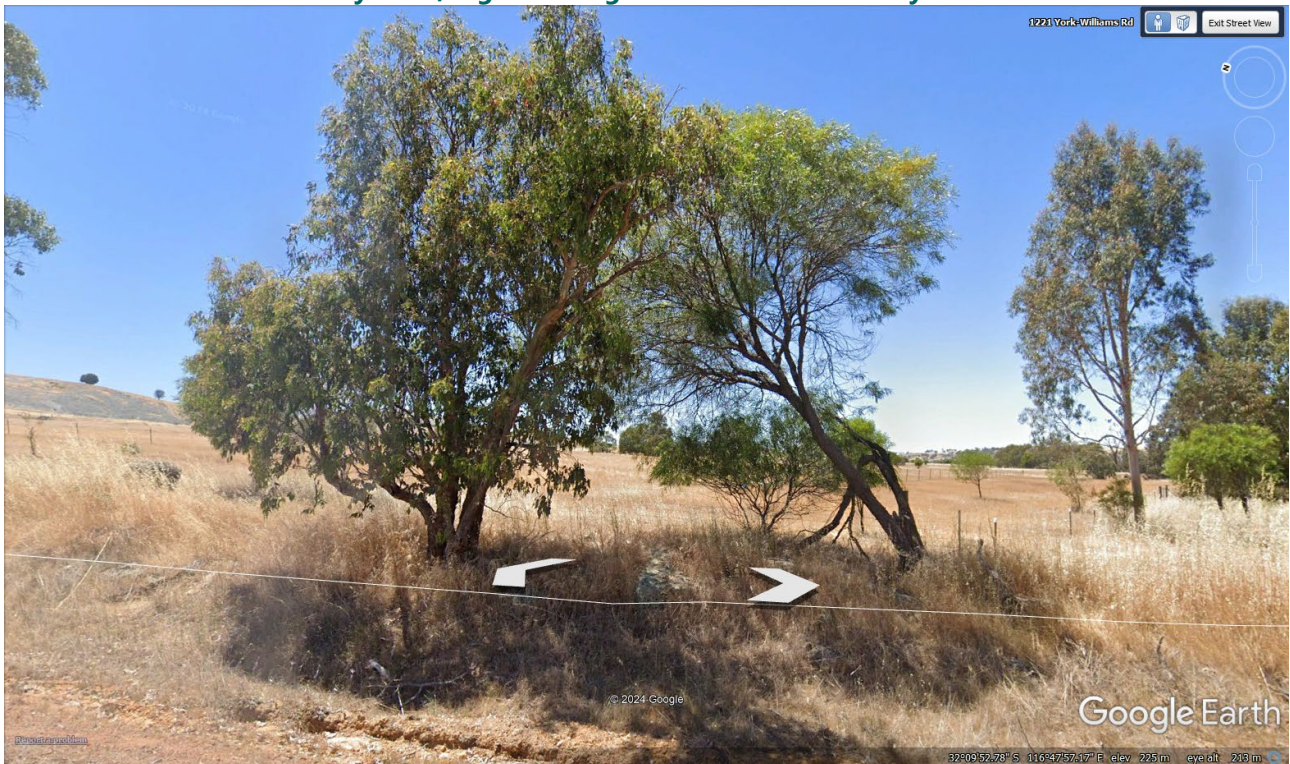
**SLK 11.76 – LHS – Isolated juvenile trees and understorey of weeds.**

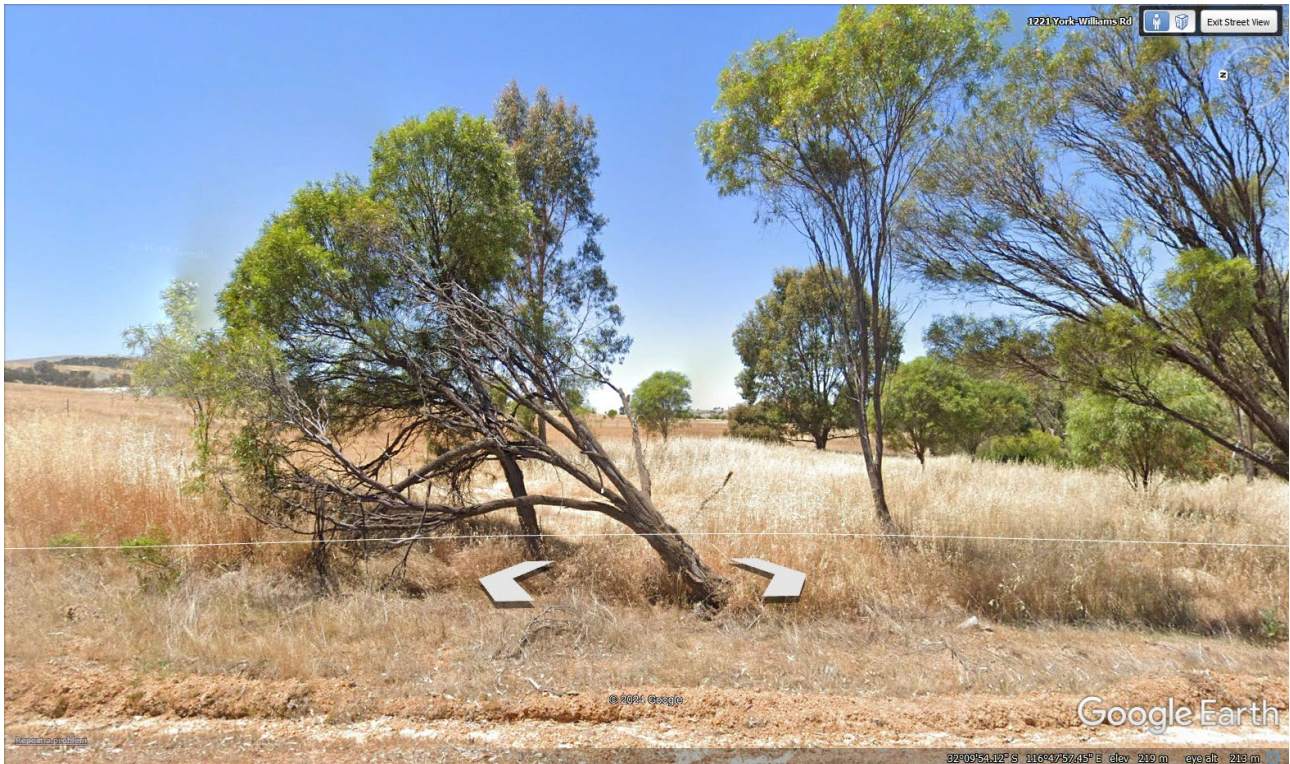
**11.78 SLK – LHS – Isolated juvenile trees and understorey of weeds.**

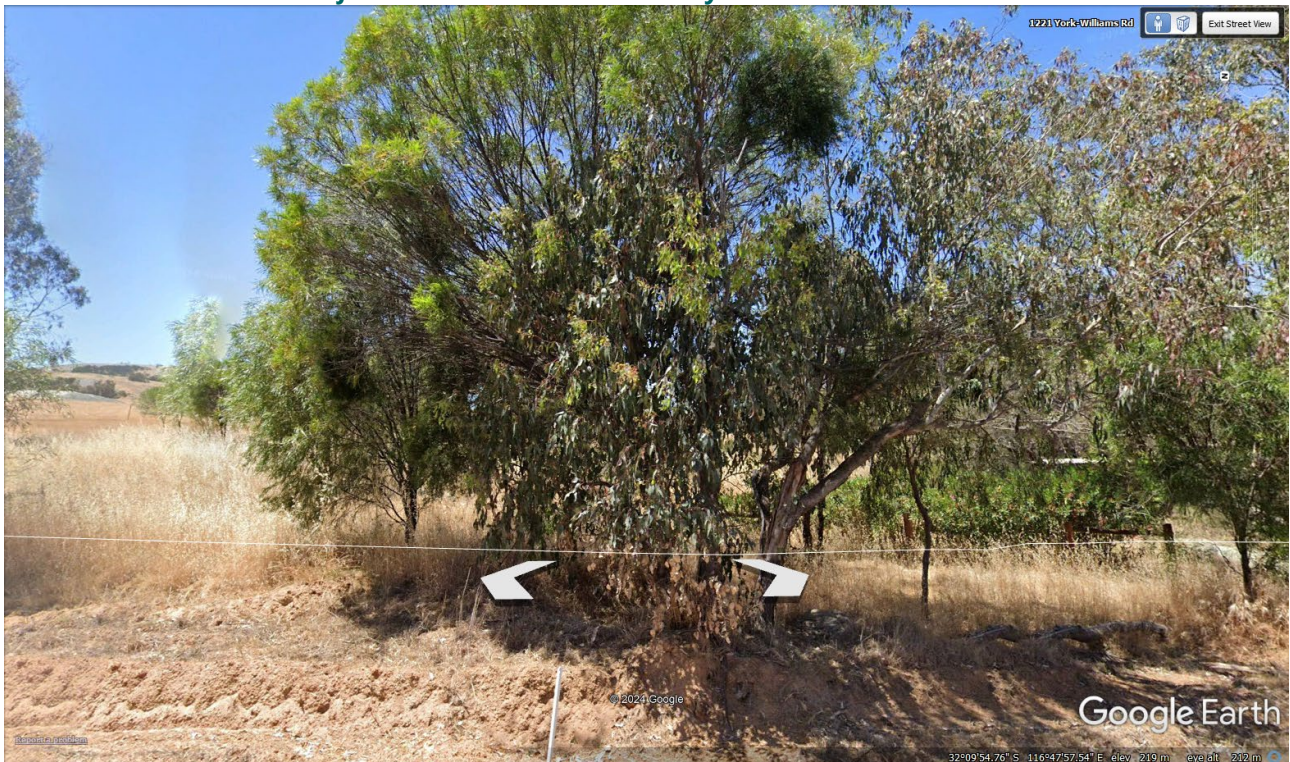
**SLK 11.8 – LHS – Left hand side of patch is mapped as Parkland Cleared & right hand side of patch is *Eucalyptus* mid open woodland.**

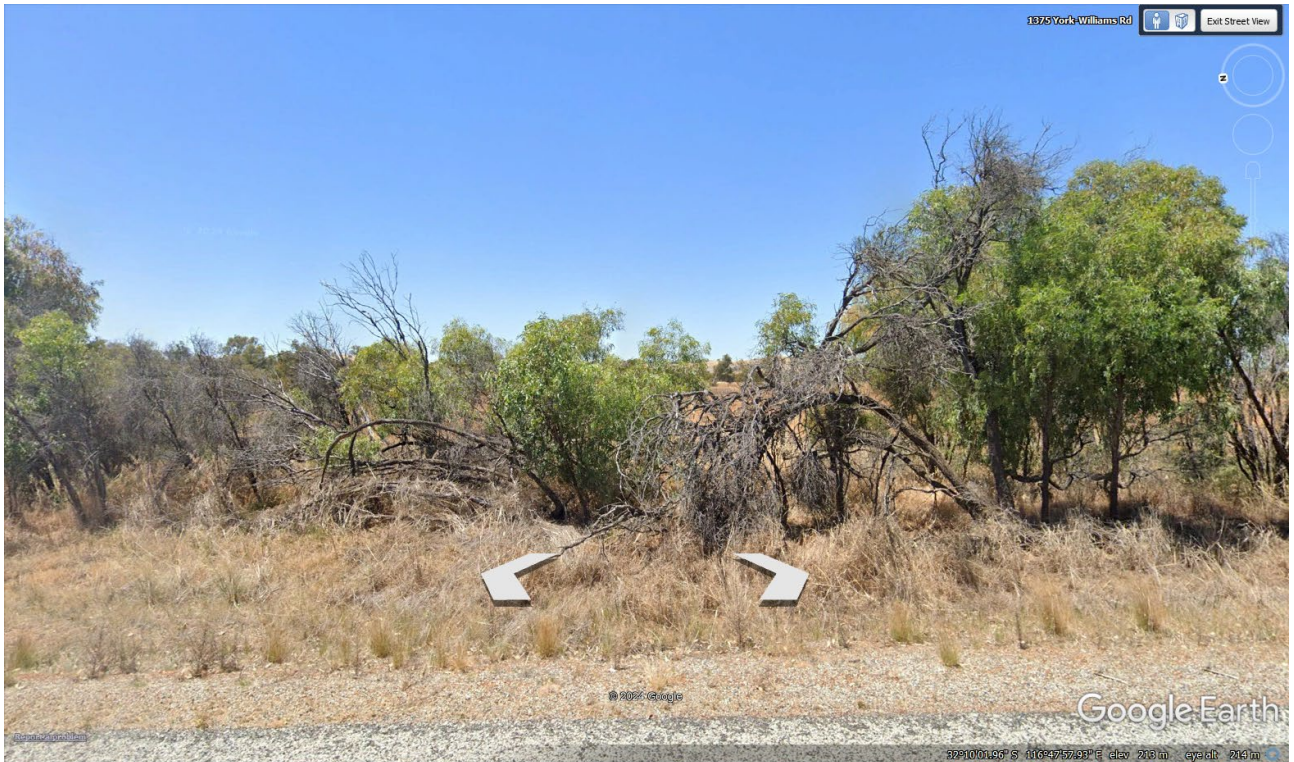
**SLK 12 – LHS – Regrowth and dead vegetation within road reserve adjacent to cleared paddock.**

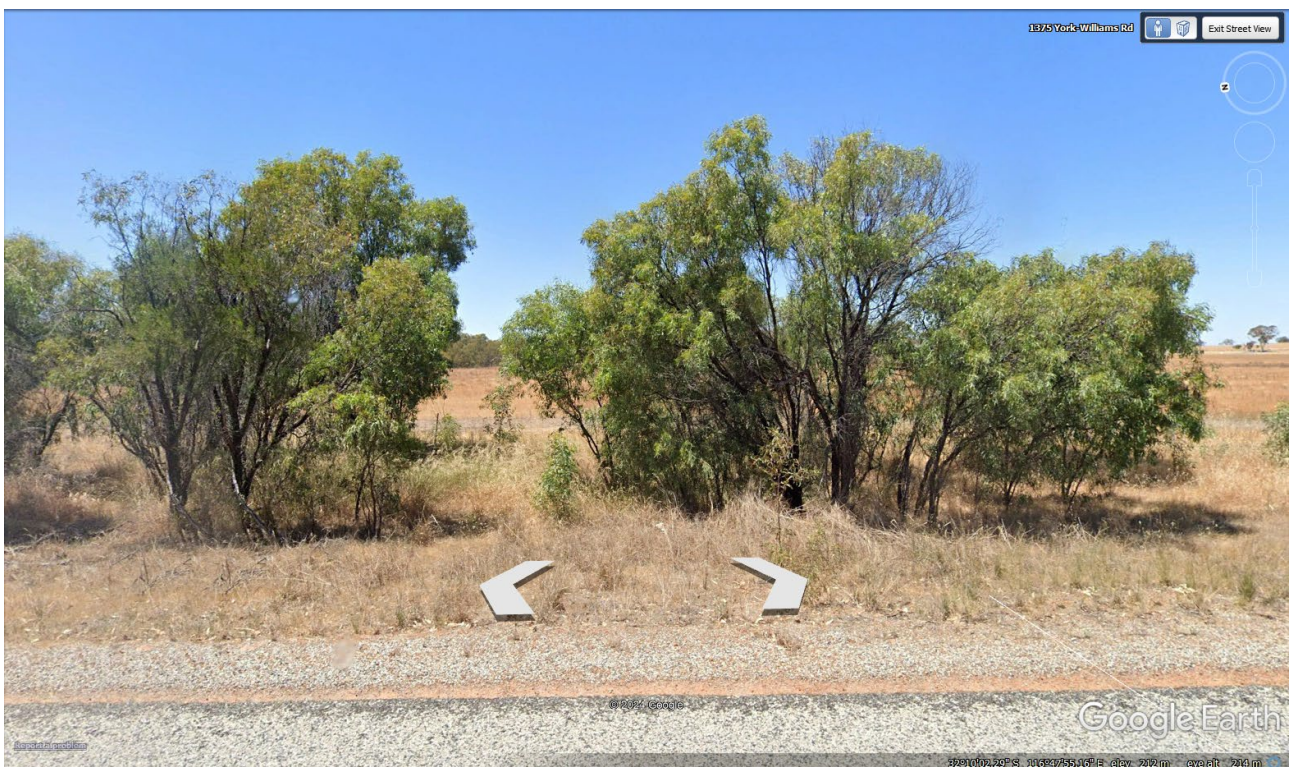
**SLK 12.2 – LHS – Regrowth vegetation within road reserve.**

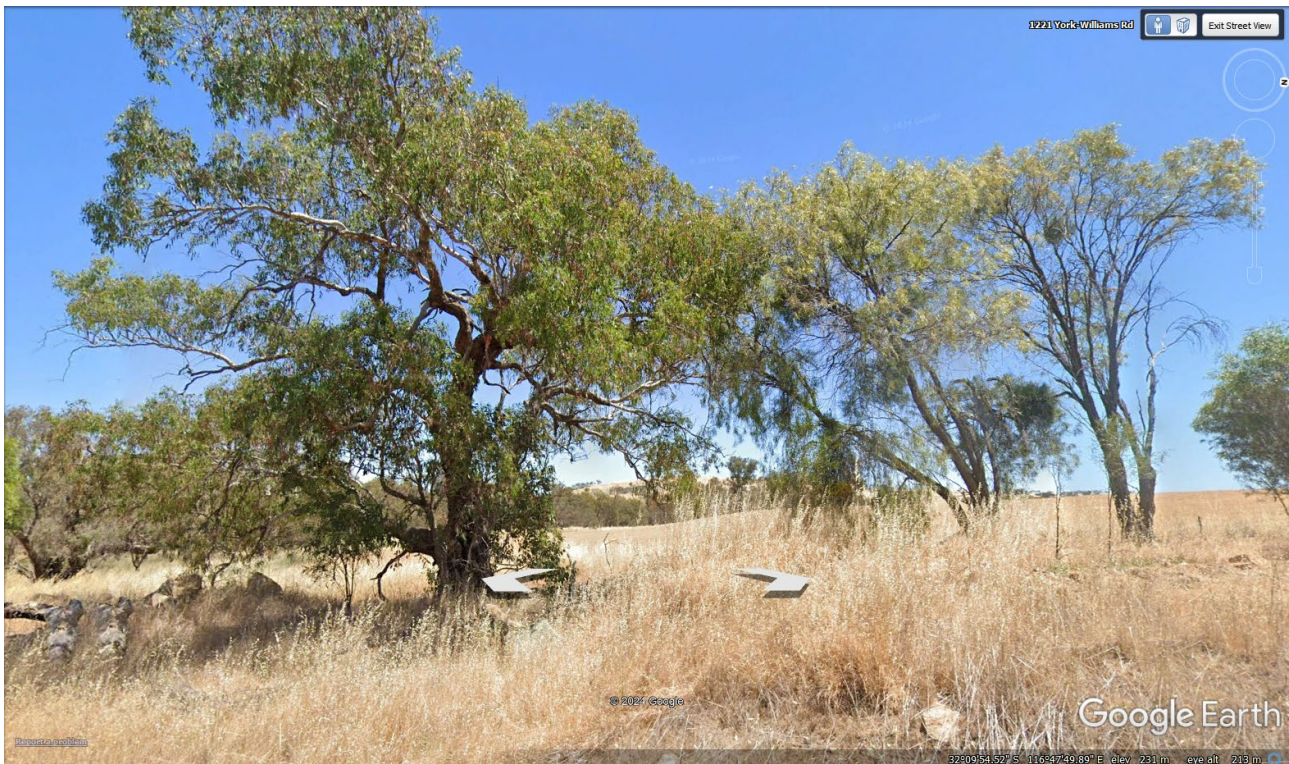
**SLK 11.78 – Right hand side of carriageway (RHS) – Overstorey trees with understorey of weeds. DBH tree on left hand side to be retained.**

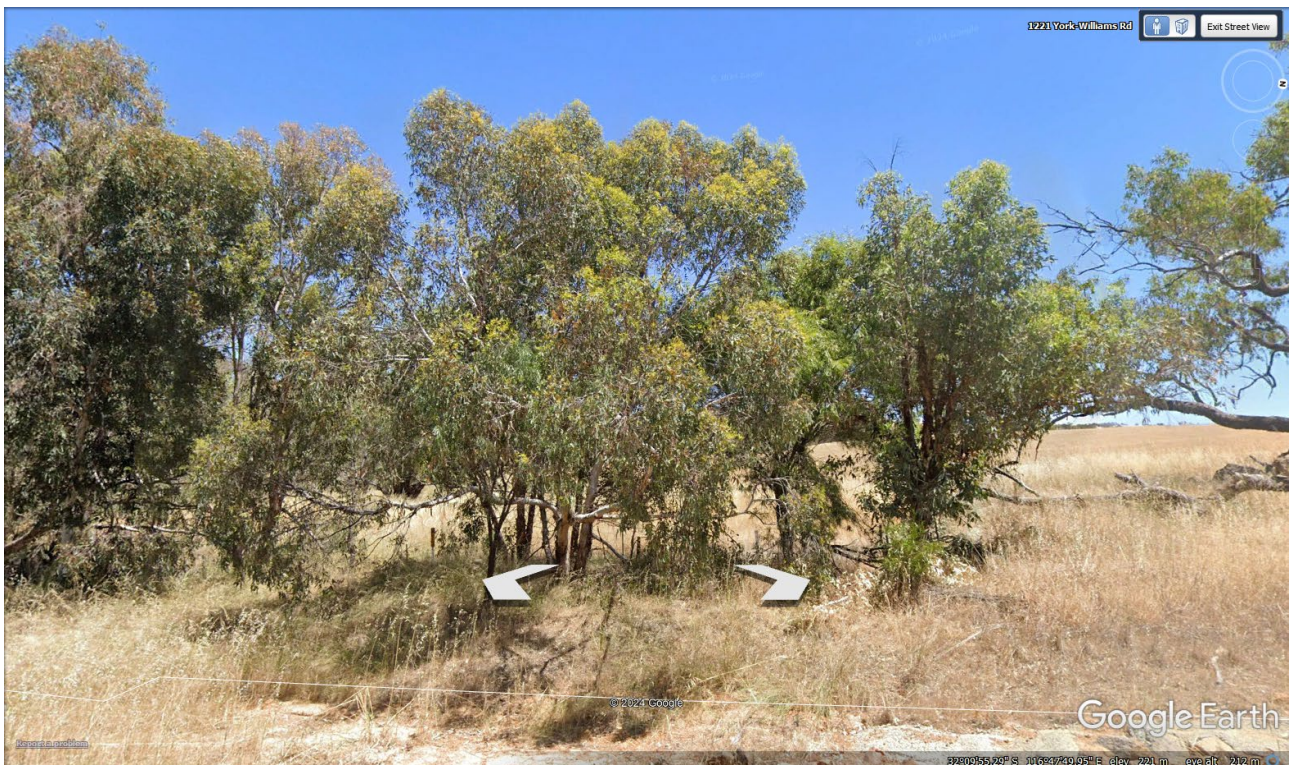
**SLK 11.8 – RHS – Juvenile trees, regrowth vegetation and understorey of weeds.**

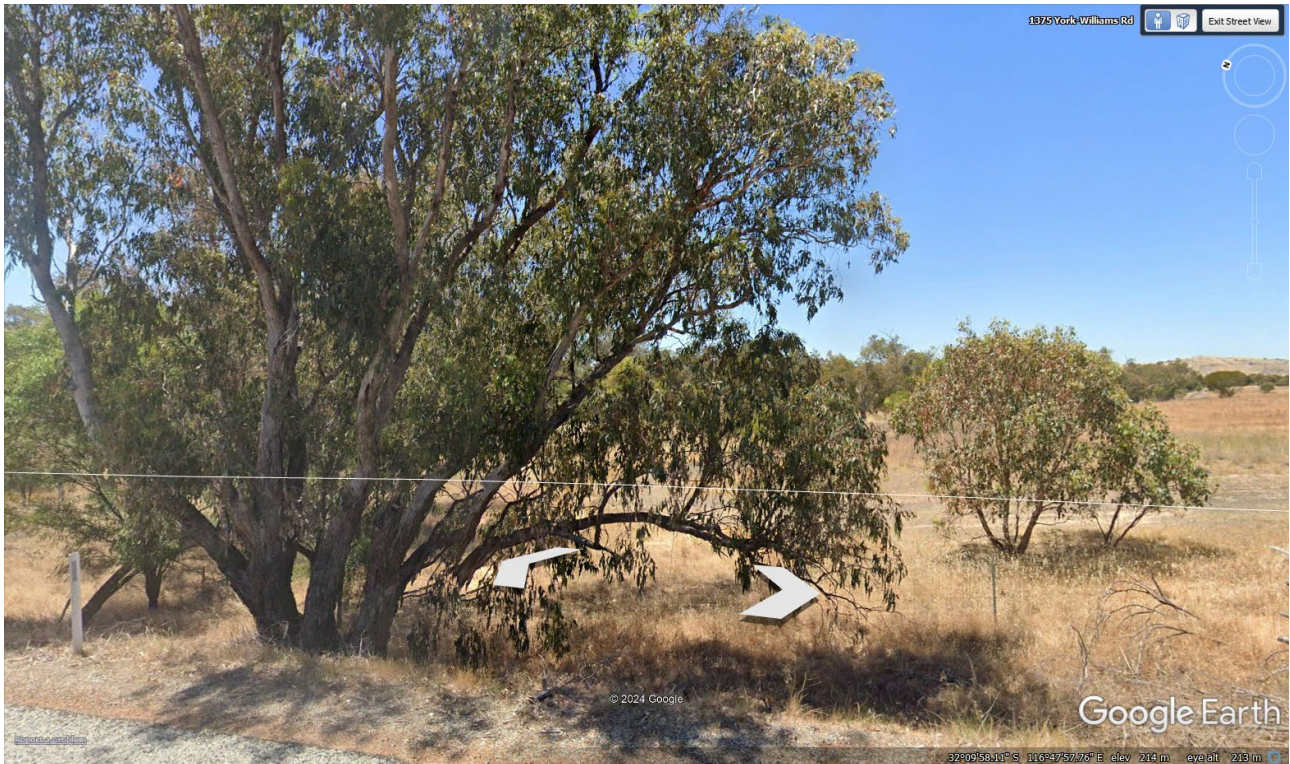
**SLK 11.92 – LHS – Overstorey trees, regrowth vegetation and understorey of weeds.**

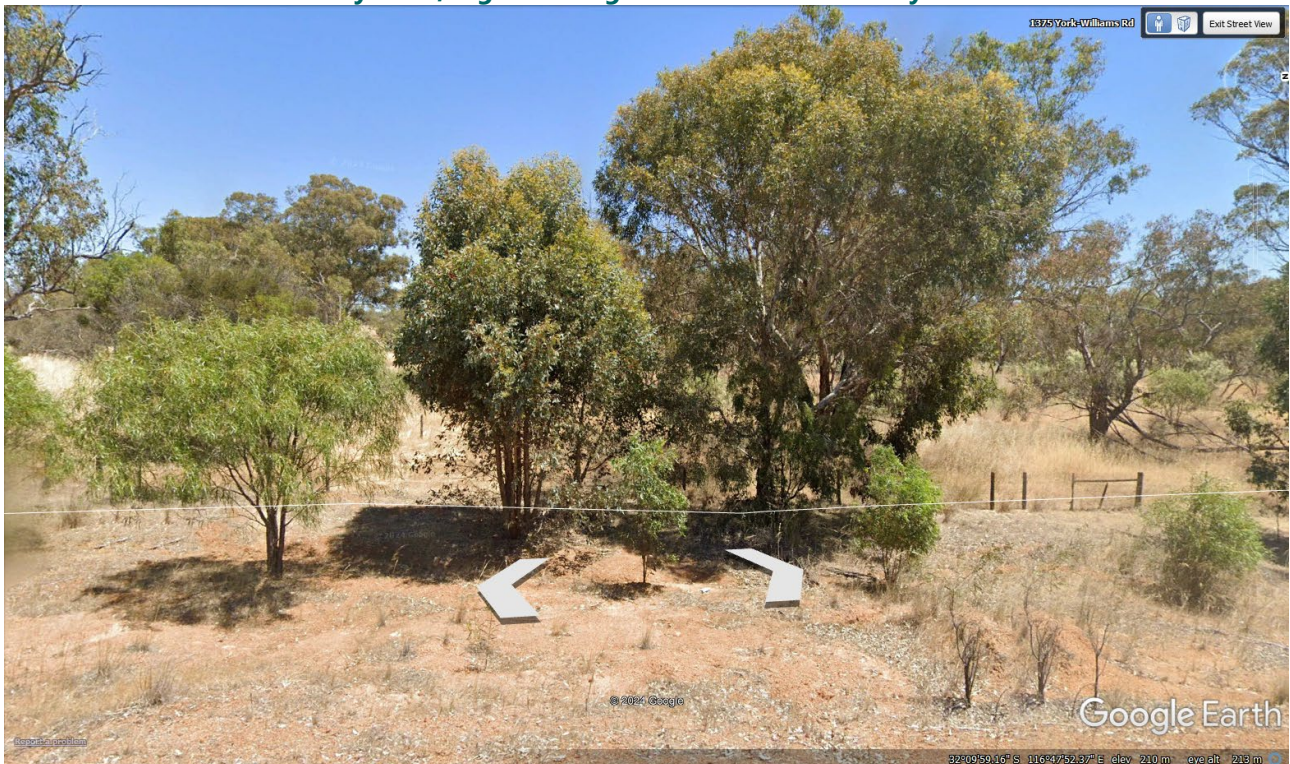
**SLK 11.92 – RHS – Overstorey tree, regrowth vegetation and understorey of weeds. Mature tree in rear to be retained.**

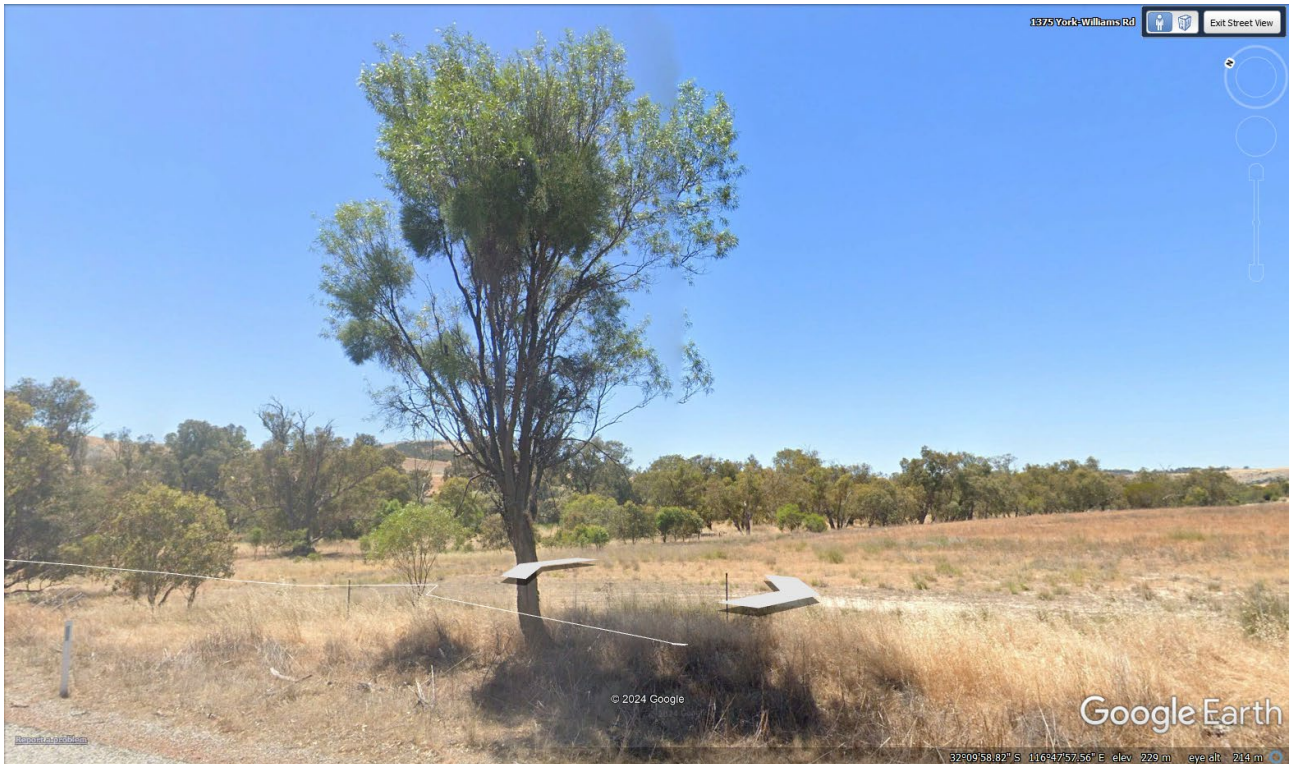
**SLK 11.95 – LHS – Isolated tree with understorey of weeds.**
