Clearing Assessment Report – CPS 818

T4 Widening - M002 – Bindoon
Moora – SLK 30.50 – SLK 35.00

July 2022

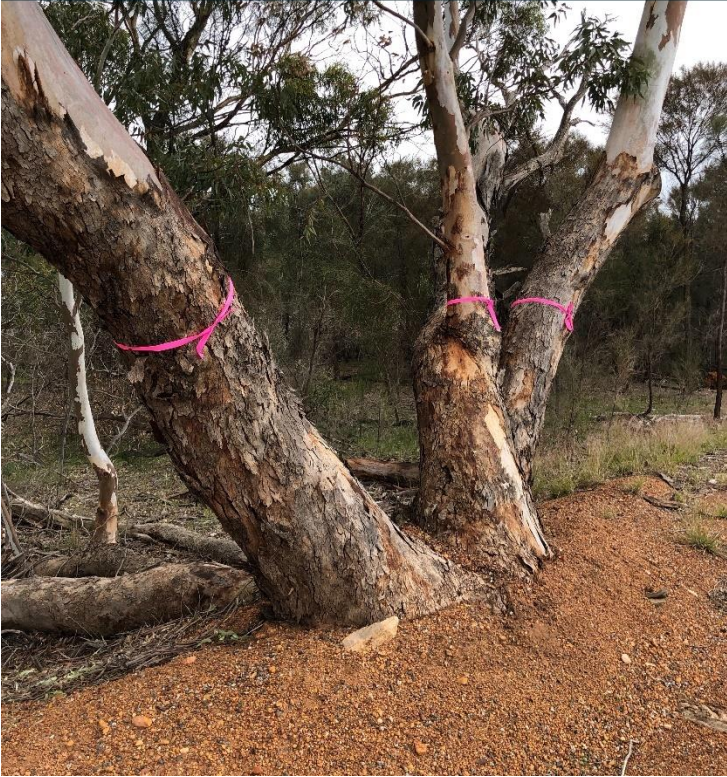
3	31.83	<p>Clearing of one tree - <i>Eucalyptus wandoo</i></p> <p>Site inspection noted a multi-trunk tree comprising three trunks. Two of the trunks displayed a DBH of >30cm and one a DBH of greater than >50cm.</p> <p>All trunks are required to be cleared.</p> <p>No hollows were observed.</p> <p>Tree located within 'Completely degraded' vegetation with the understorey comprising introduced weeds and grass species.</p> <p>Due to the proximity of Tree Number 2 and Tree Number 3 at the same recorded SLK, they have been grouped where their location has been illustrated in Figure 1.</p>	<div><div><div><div><div></div><div>M002</div></div><div><div></div><div>SINGLE</div></div></div><div><div><div>Bindoon Moora Rd</div><div>0031.83</div><div>Lat/Long: -31.113675, 116.051930</div><div>Created on: 5/07/2022 11:51:42 AM</div></div></div></div>

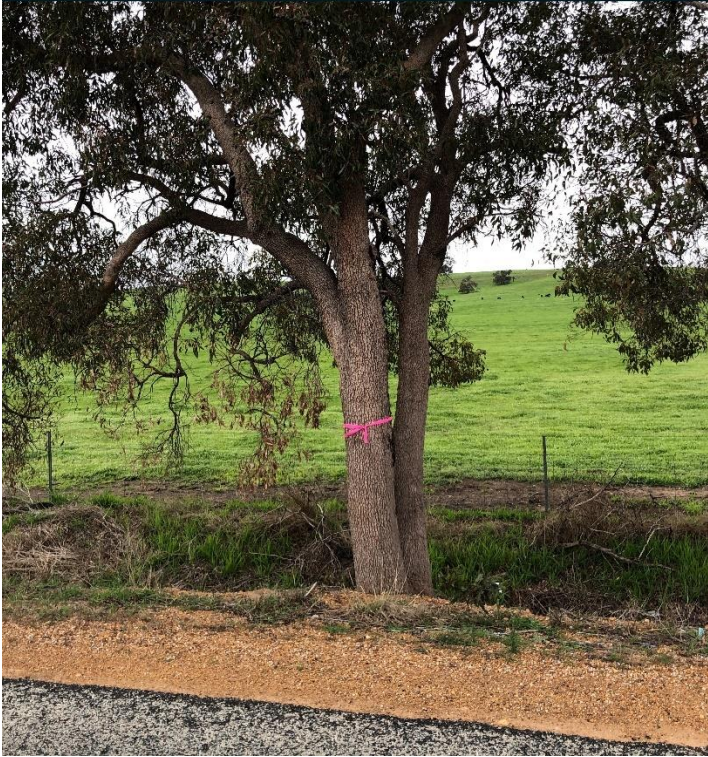
</div>
4	32.58	<p>Clearing of one tree - <i>Corymbia calophylla</i> (Marri)</p> <p>Site inspection noted a multi-trunk tree comprising two trunks. One of the trunks displayed a DBH of >30cm and one a DBH of <30cm.</p> <p>Only the trunk closest to the road is required to be cleared (DBH >30cm).</p> <p>No hollows were observed.</p> <p>Tree located within 'Completely degraded' vegetation with the understorey comprising introduced weeds and grass species.</p> <p>Due to the proximity of Tree Number 4 and Tree Number 5 at the same recorded SLK, they have been grouped where their location has been illustrated in Figure 1.</p>	<div><div><div><div><div></div><div>M002</div></div><div><div></div><div>SINGLE</div></div></div><div><div><div>Bindoon Moora Rd</div><div>0032.58</div><div>Lat/Long: -31.106903, 116.052485</div><div>Created on: 5/07/2022 12:00:10 PM</div></div></div></div>

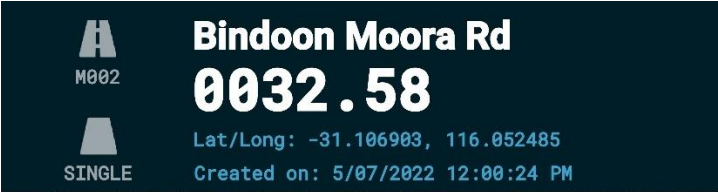
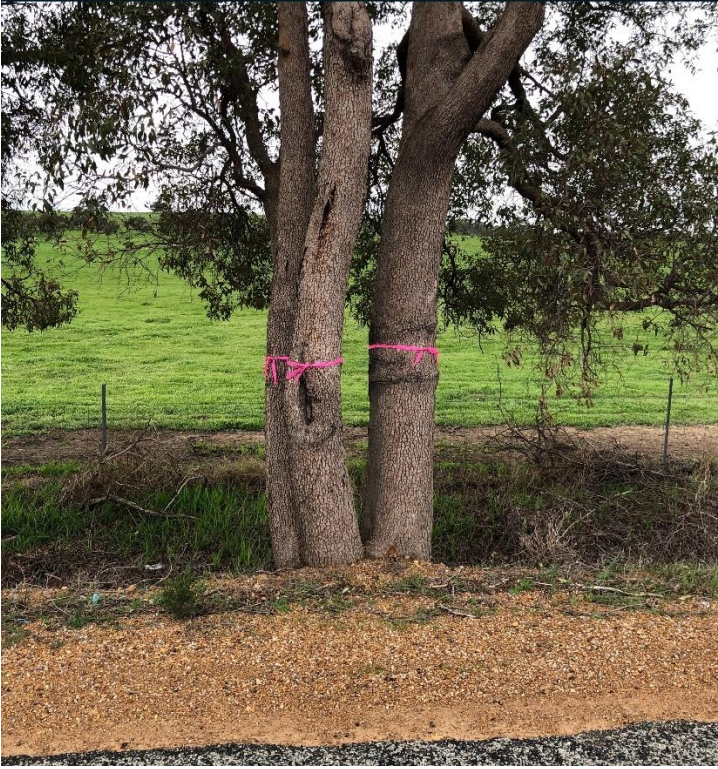
5	32.58	<p>Clearing of one tree - <i>Corymbia calophylla</i> (Marri)</p> <p>Site inspection noted a multi-trunk tree comprising three trunks. Two of the trunks displayed a DBH of >30cm and one a DBH of <30cm.</p> <p>All of the trunks are required to be cleared.</p> <p>No hollows were observed.</p> <p>Tree located within 'Completely degraded' vegetation with the understorey comprising introduced weeds and grass species.</p> <p>Due to the proximity of Tree Number 4 and Tree Number 5 at the same recorded SLK, they have been grouped where their location has been illustrated in Figure 1.</p>

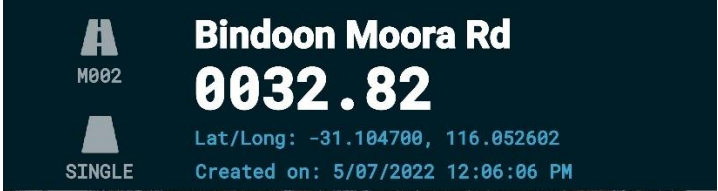
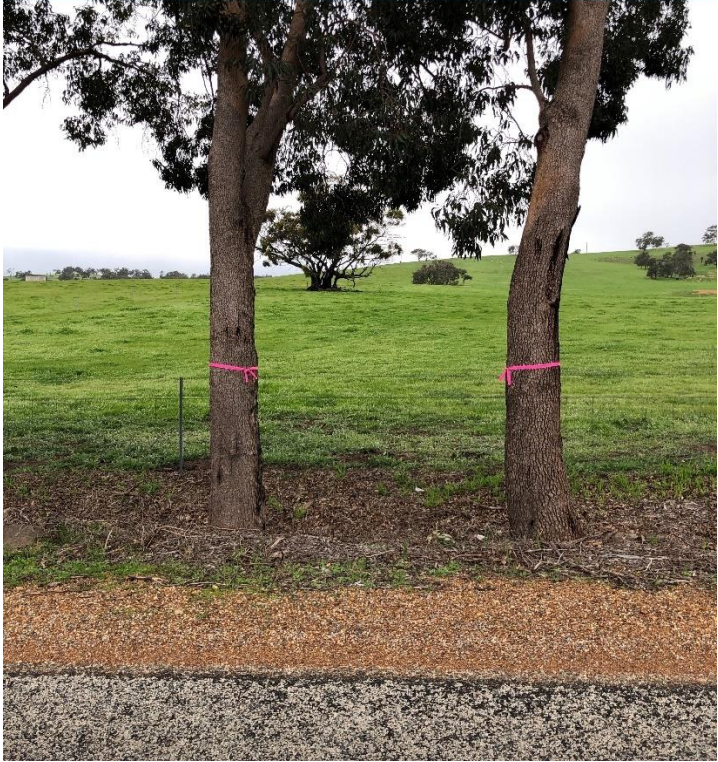
6 - 7	32.82	<p>Clearing of two trees - <i>Corymbia calophylla</i> (Marri)</p> <p>Site inspection noted two, single trunk trees displaying a DBH of >30cm.</p> <p>No hollows were observed.</p> <p>Tree located within 'Completely degraded' vegetation with the understorey comprising introduced weeds and grass species.</p> <p>Due to the proximity of Tree Number 6 and Tree Number 7 at the same recorded SLK, they have been grouped where their location has been illustrated in Figure 1.</p>

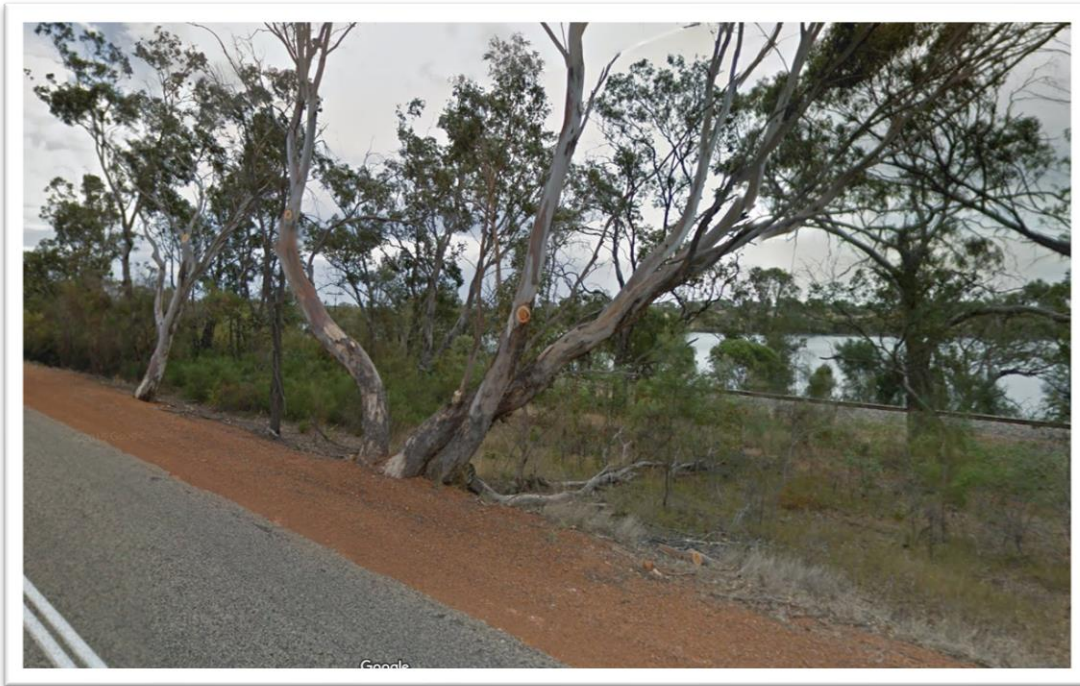
Activities associated with the Project are confined to the previously impacted maintenance zone. Trees proposed to be cleared are growing in association with the shoulder of the road, not within the areas of remnant vegetation located further to the west within the railroad reserve. As machinery movement will be limited to these already impacted areas, the risk of spreading dieback into uninfested areas is avoided. **Plate 1** displays an example of a trees to be cleared (Tree 2 and Tree 3), their location within the road shoulder, the separation from areas of remnant vegetation and the nature reserve on the other side of the raised railway line.

Plate 1: Tree 7 and Tree 8 located within the previously impacted road shoulder
