# Clearing Desktop Report – CPS 818

M053 Pinjarra Williams Road – SLK  
102 – 104 T4 Widening

July 2022

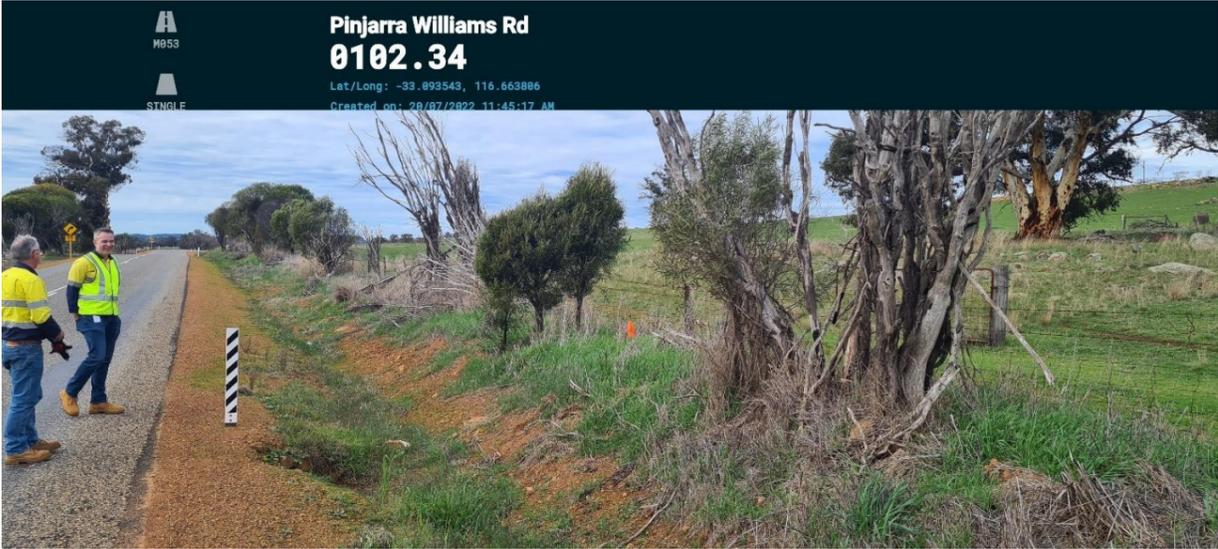
<p style="text-align: center;"><b>View of Tree 1 Location</b></p>

CULVERT	COMMENT	PHOTOS
102.34 - RHS	<p>Culvert extension required on RHS – <b>Clearing required</b></p> <p>Groundcover strata layer contains introduced weed species only.</p> <p><b>Tree 1</b> - One dead tree located outside of maintenance zone (<b>CPS818</b>)</p>

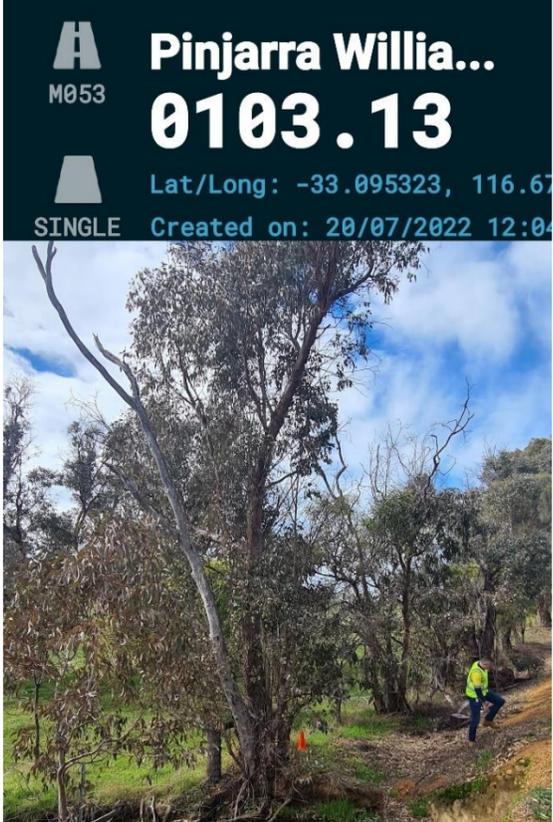
<p style="text-align: center;"><b>Tree 2</b></p>

<p style="text-align: center;"><b>Tree 1</b></p>
103.14 - LHS	<p>Culvert extension required on LHS – <b>Clearing required</b></p> <p><b>Tree 2</b> - One tall (10m) tree (<i>Eucalyptus rudis</i>) contained within maintenance zone. No hollows noted. Not suitable DBH for hollow formation. However due to size of tree, estimated age is &gt; 10 years. <b>Clearing therefore proposed under CPS 818</b></p> <p><b>Tree 3</b> - One dead tree (2m), snapped trunk. <b>Clearing proposed under 818</b></p>

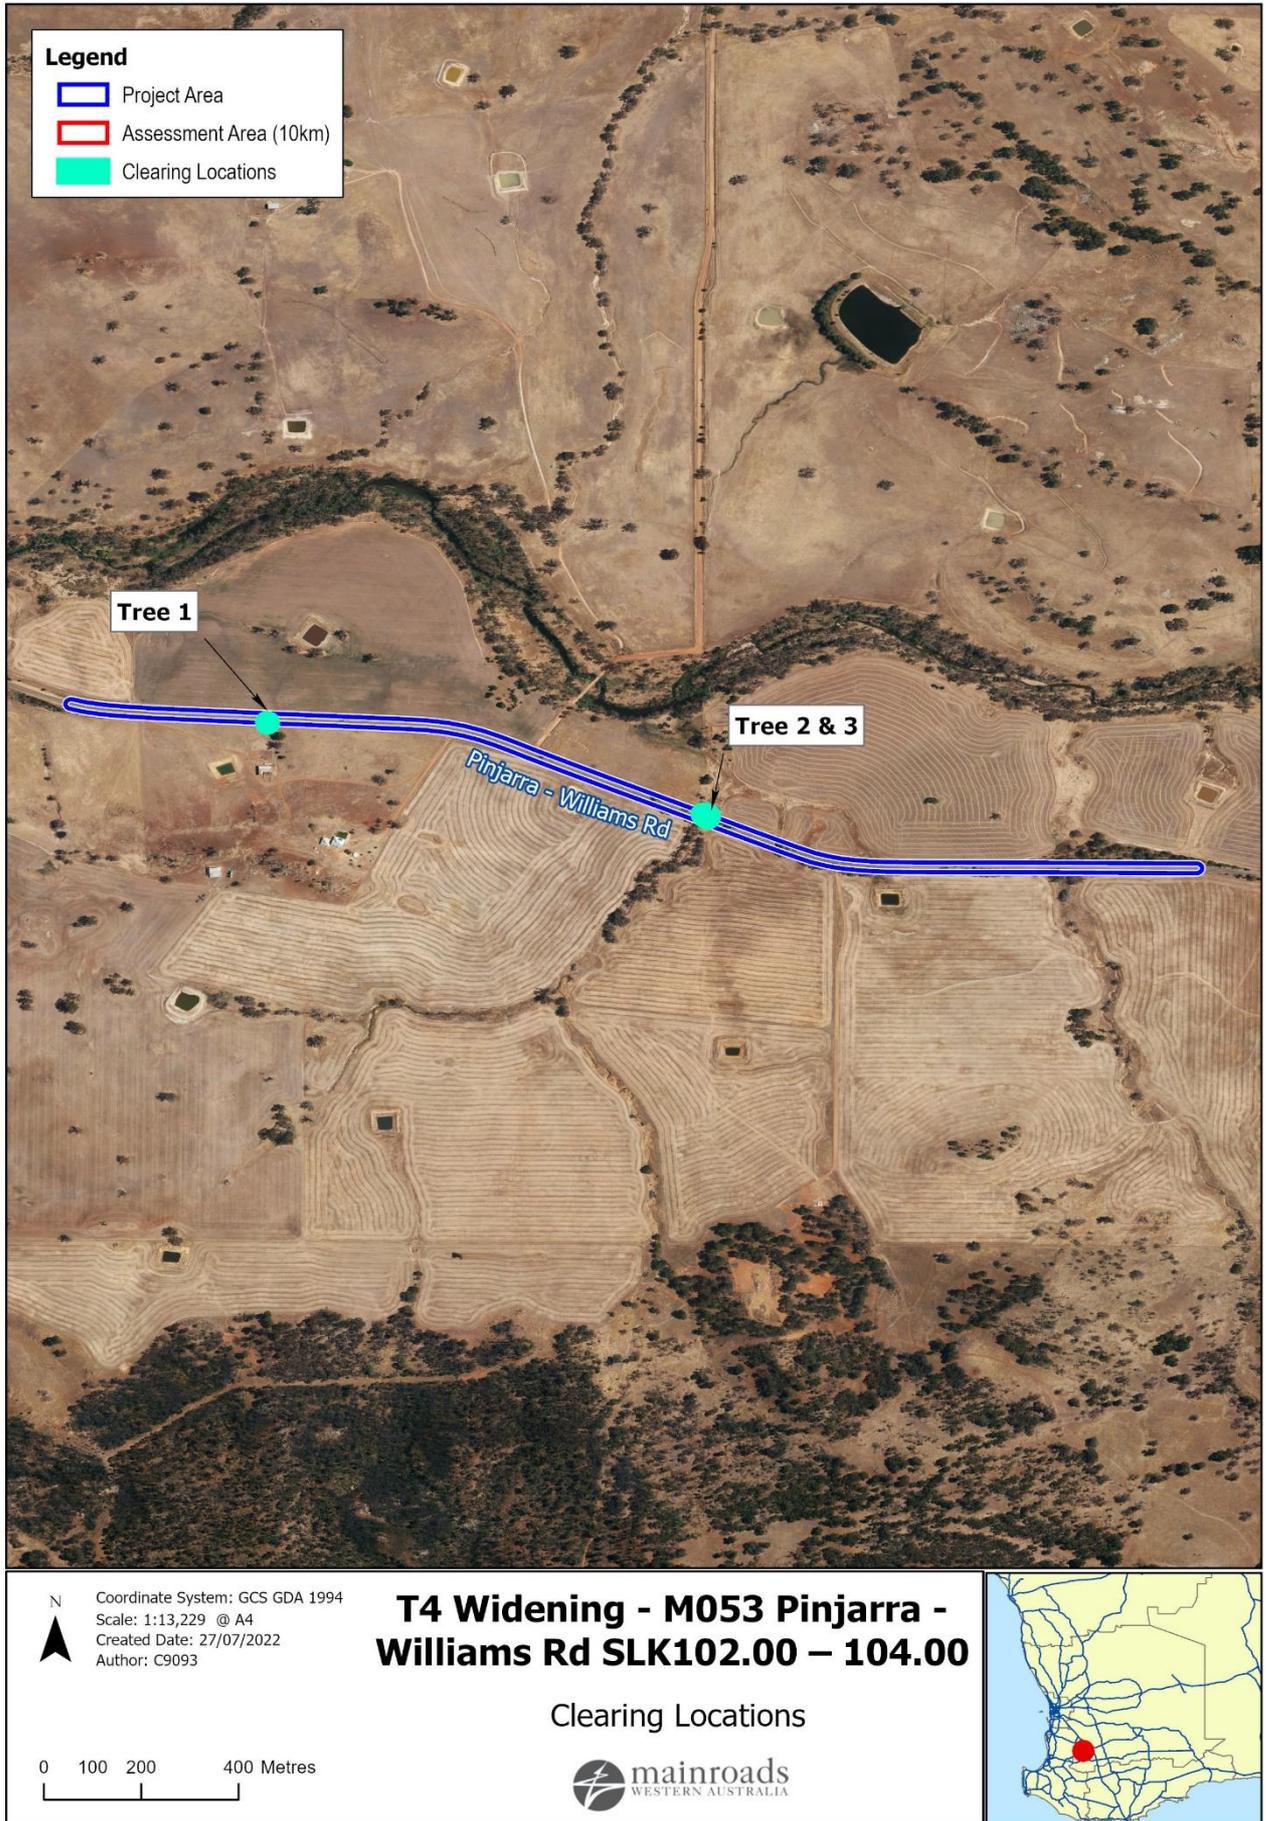
Figure 1: Project Area and Clearing Locations

**Project Location(s):** The Project Area is located on the Pinjarra to Williams Road between SLK 102.00 to SLK 104.00, within the Shire of Williams as shown in **Figure 1**.

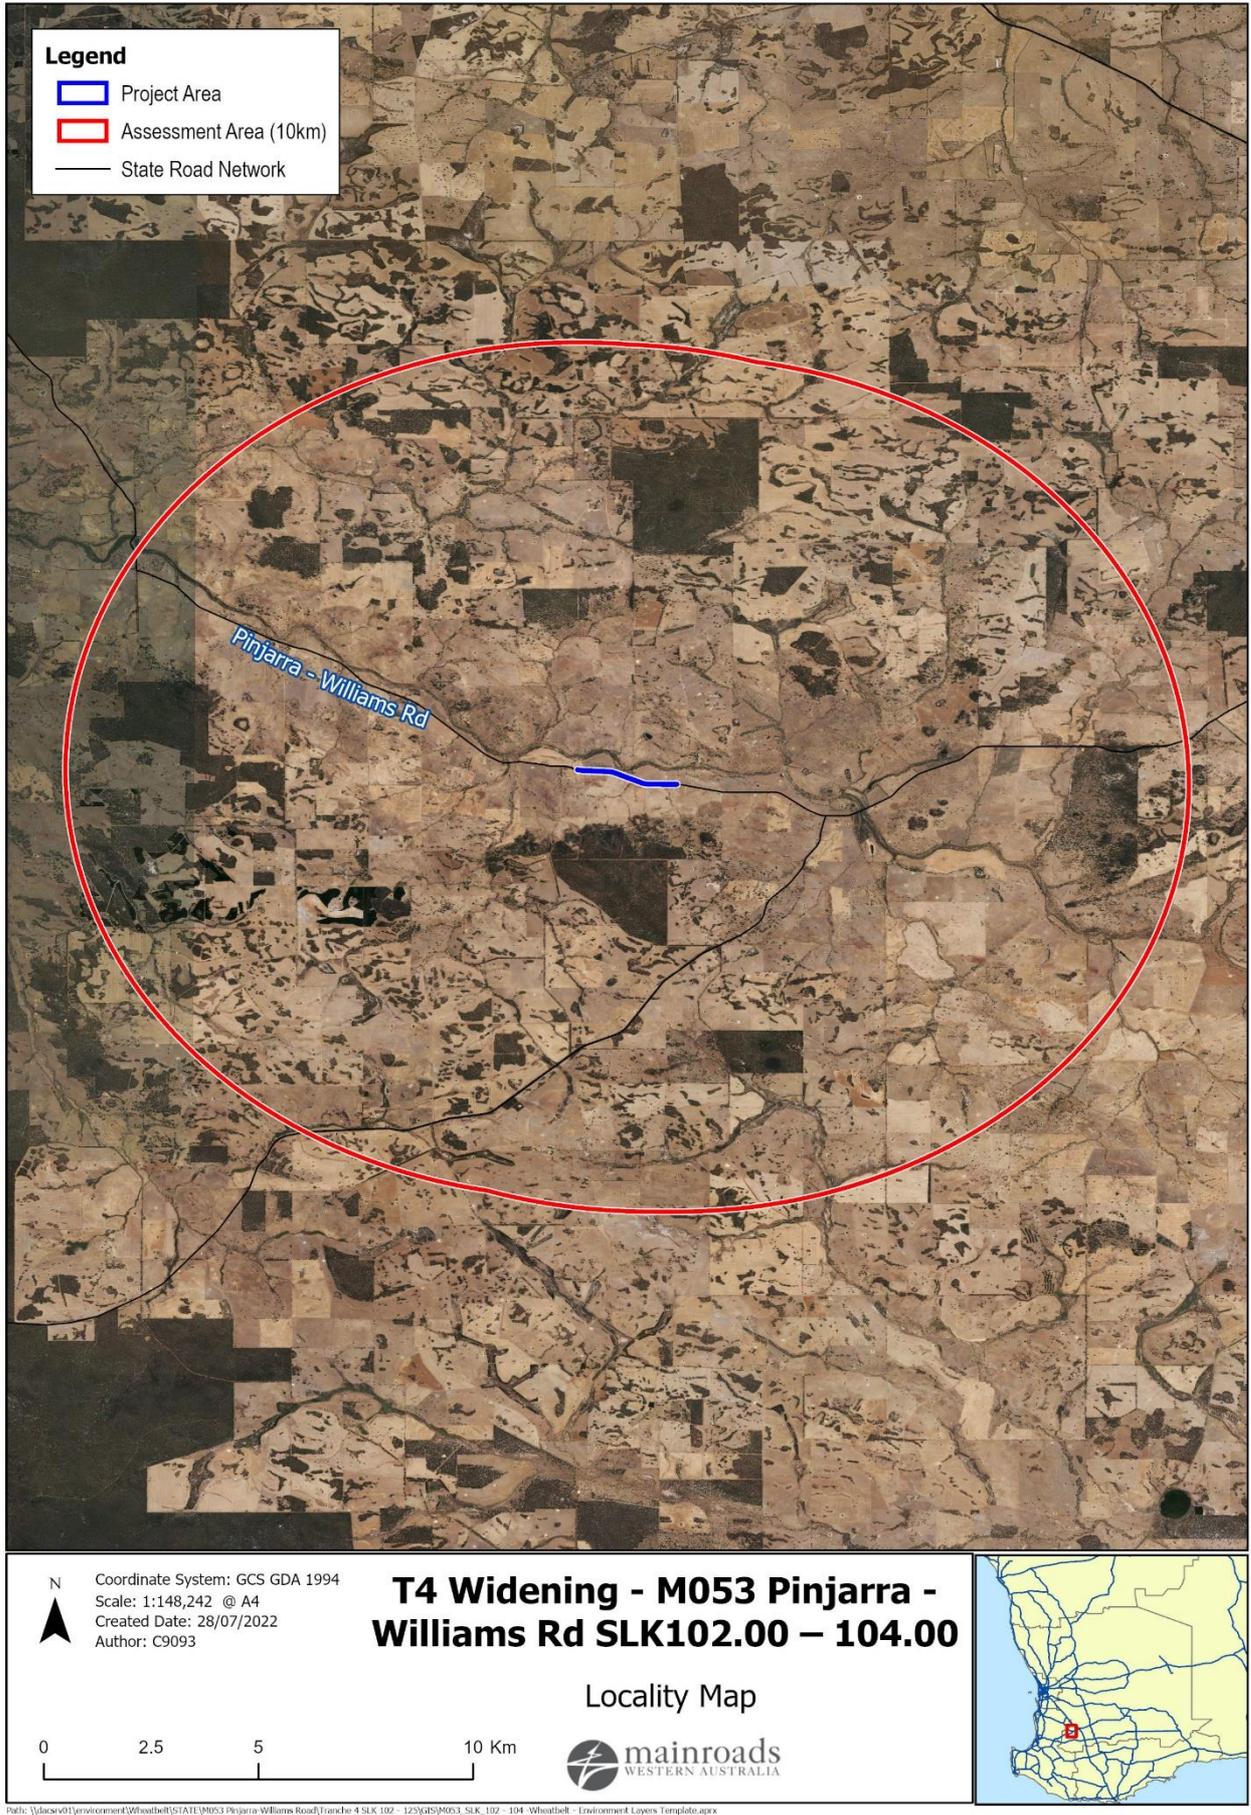
Figure 2: Project Location and Study Area

The assessment area is confined to a local area of a 10 km radius, as shown in **Figure 2**.

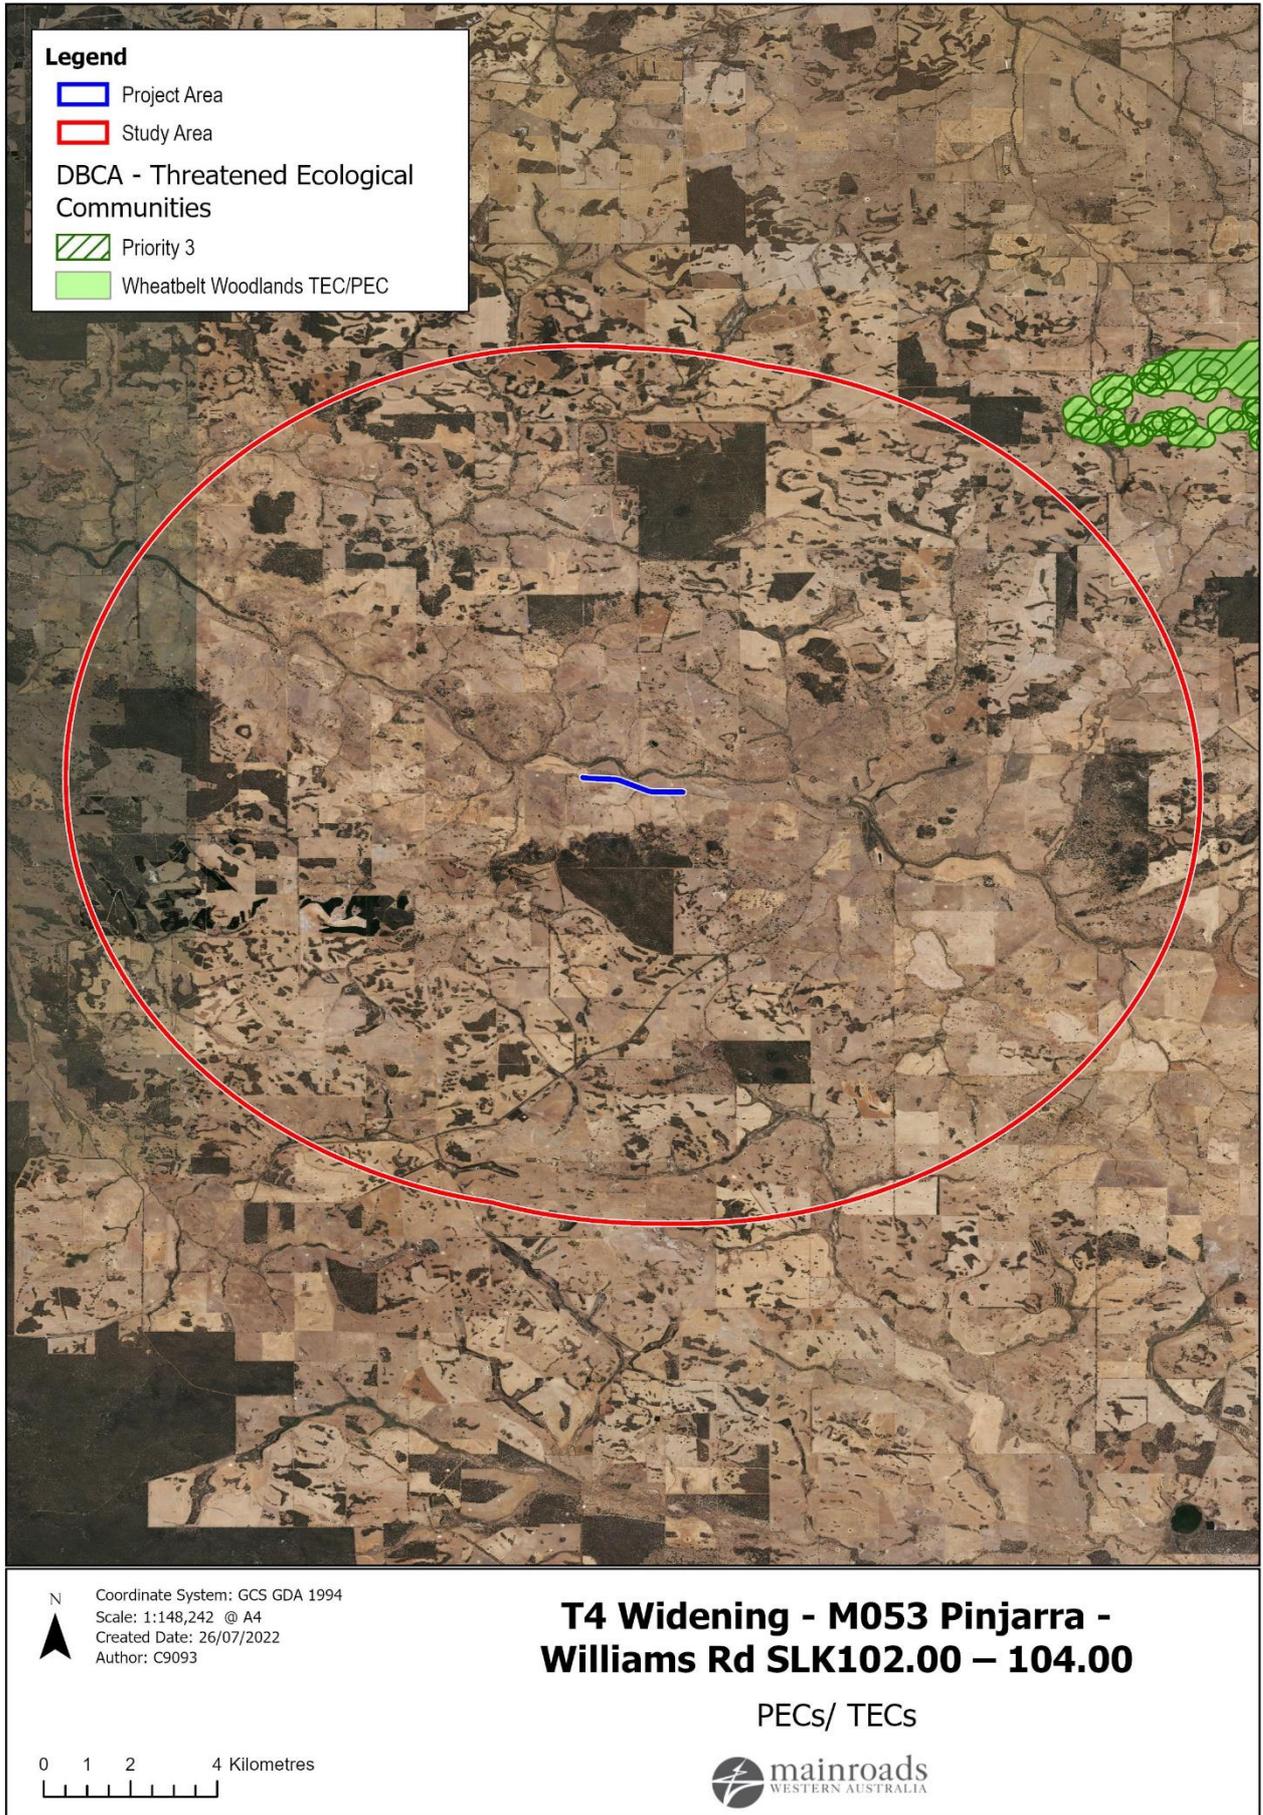
Figure 5: TEC/PEC – Study Area

<p><b>Proposed clearing is not at variance to this Principle</b></p>
<p><b>Comments</b></p> <p>According to Main Roads TEC/PEC layer (<b>Figure 5</b>), there are no known incidences of TECs or PECs within the Project Area area, or within the 10km Study Area. The closest known location of a TEC/PEC is an incidence of the Eucalypt Woodlands of the Wheatbelt, a Threatened Ecological Community (TEC) listed as Critically Endangered under the <i>Environment Protection and Biodiversity Conservation Act 1999</i> (EPBC Act) and a State Priority Ecological Community (PEC) (Priority 3), located approximately 11.7km to the north west of the Project Area.</p> <p>The three isolated trees proposed to be cleared within a fragmented and Completely degraded landscape do not represent PEC or TEC vegetation.</p> <p><b>Assessed Outcome</b></p> <p>Proposed clearing is not at variance to this Principle.</p>

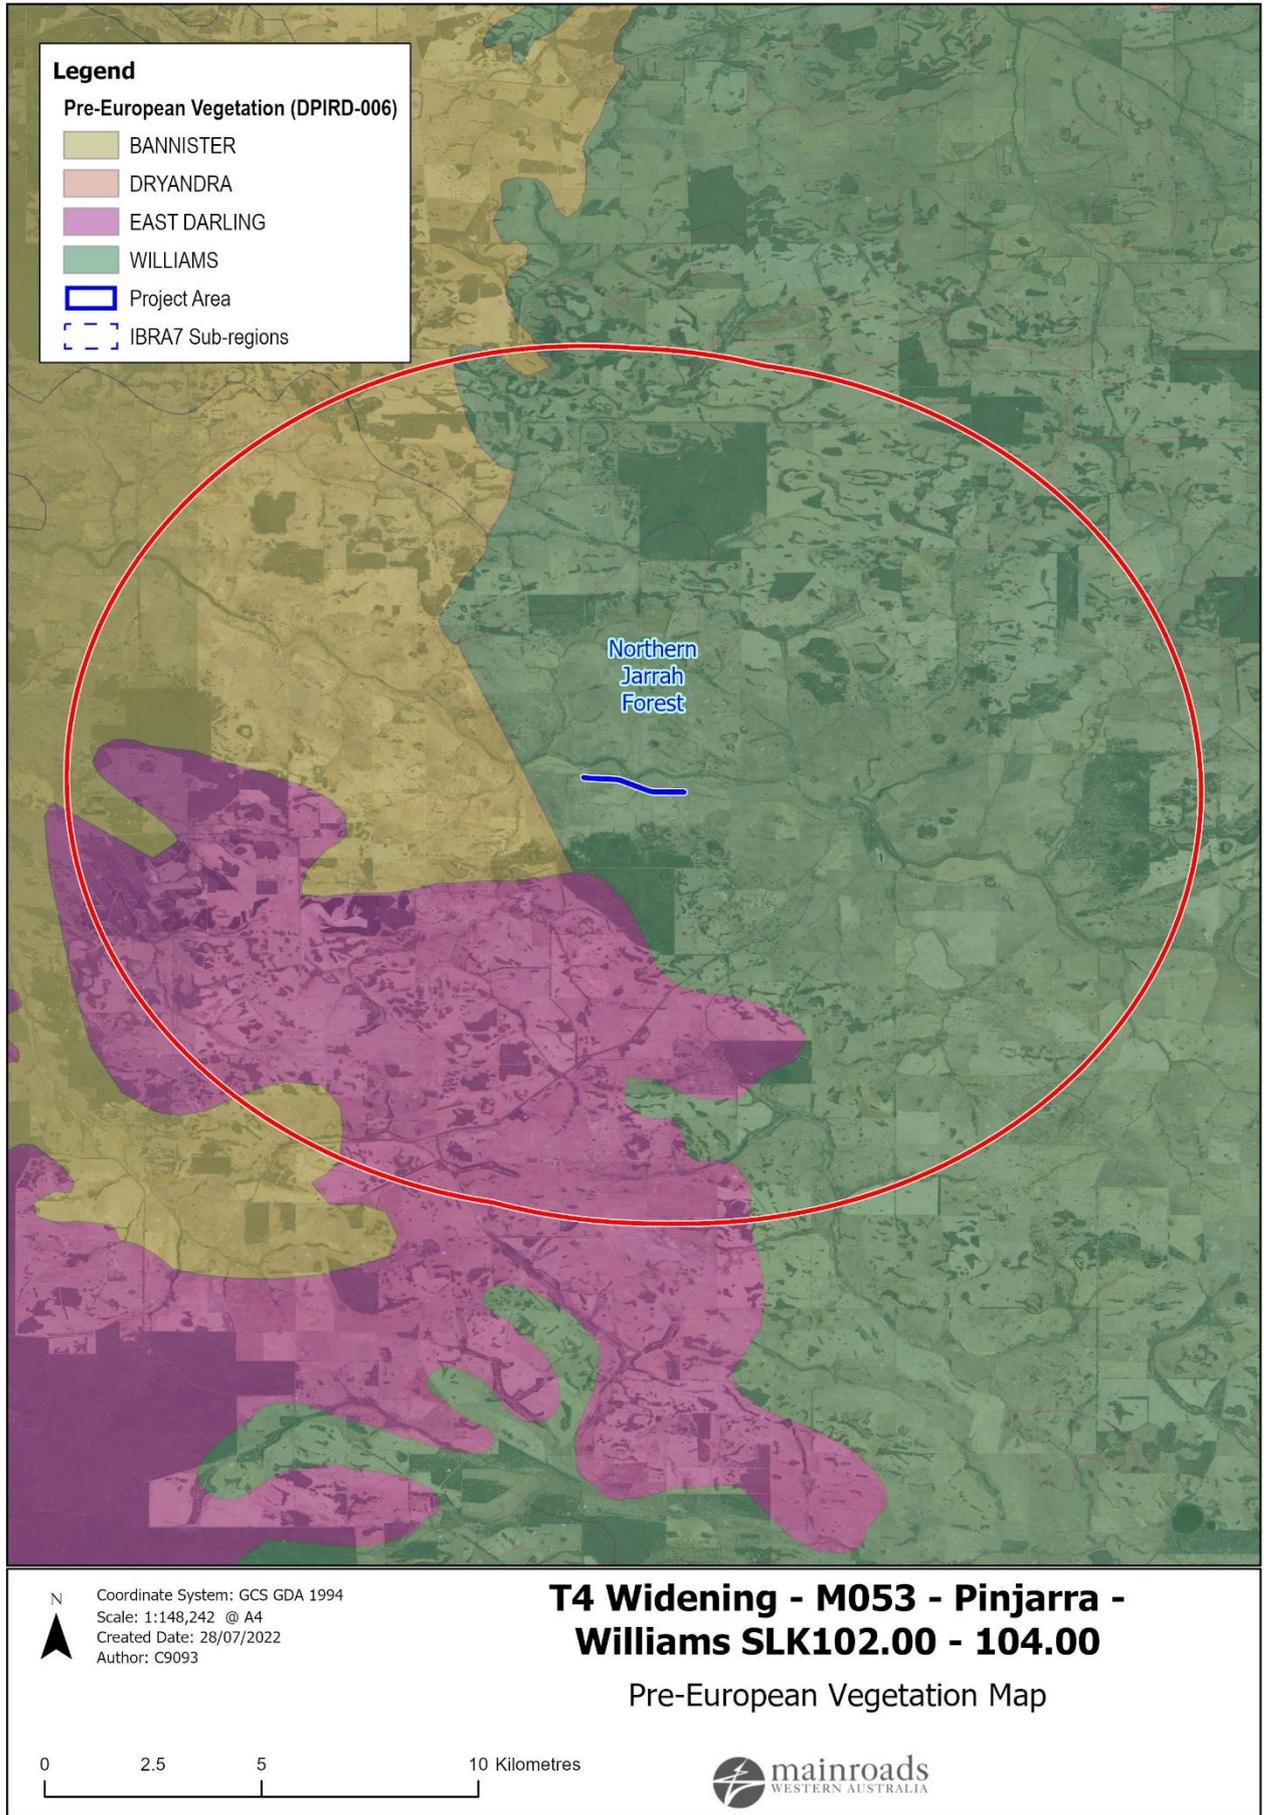
Figure 6: Pre-European Vegetation – Study Area

The Project Area is located within the Northern Jarrah Forest IBRA sub-region of the Jarrah Forest bioregion (Figure 6). Vegetation Association Williams (4) retains 26.95% of its representation at the State-wide scale, 32.22% at the IBRA Subregion scale and 17.86% within the Shire of Williams. The Vegetation association is described as Medium woodland of Marri and Wandoo. The species proposed to be cleared within the 0.01ha of proposed disturbance are *Eucalyptus rudis* and an *Acacia* sp. and are not representative of the key species associated with this vegetation type.

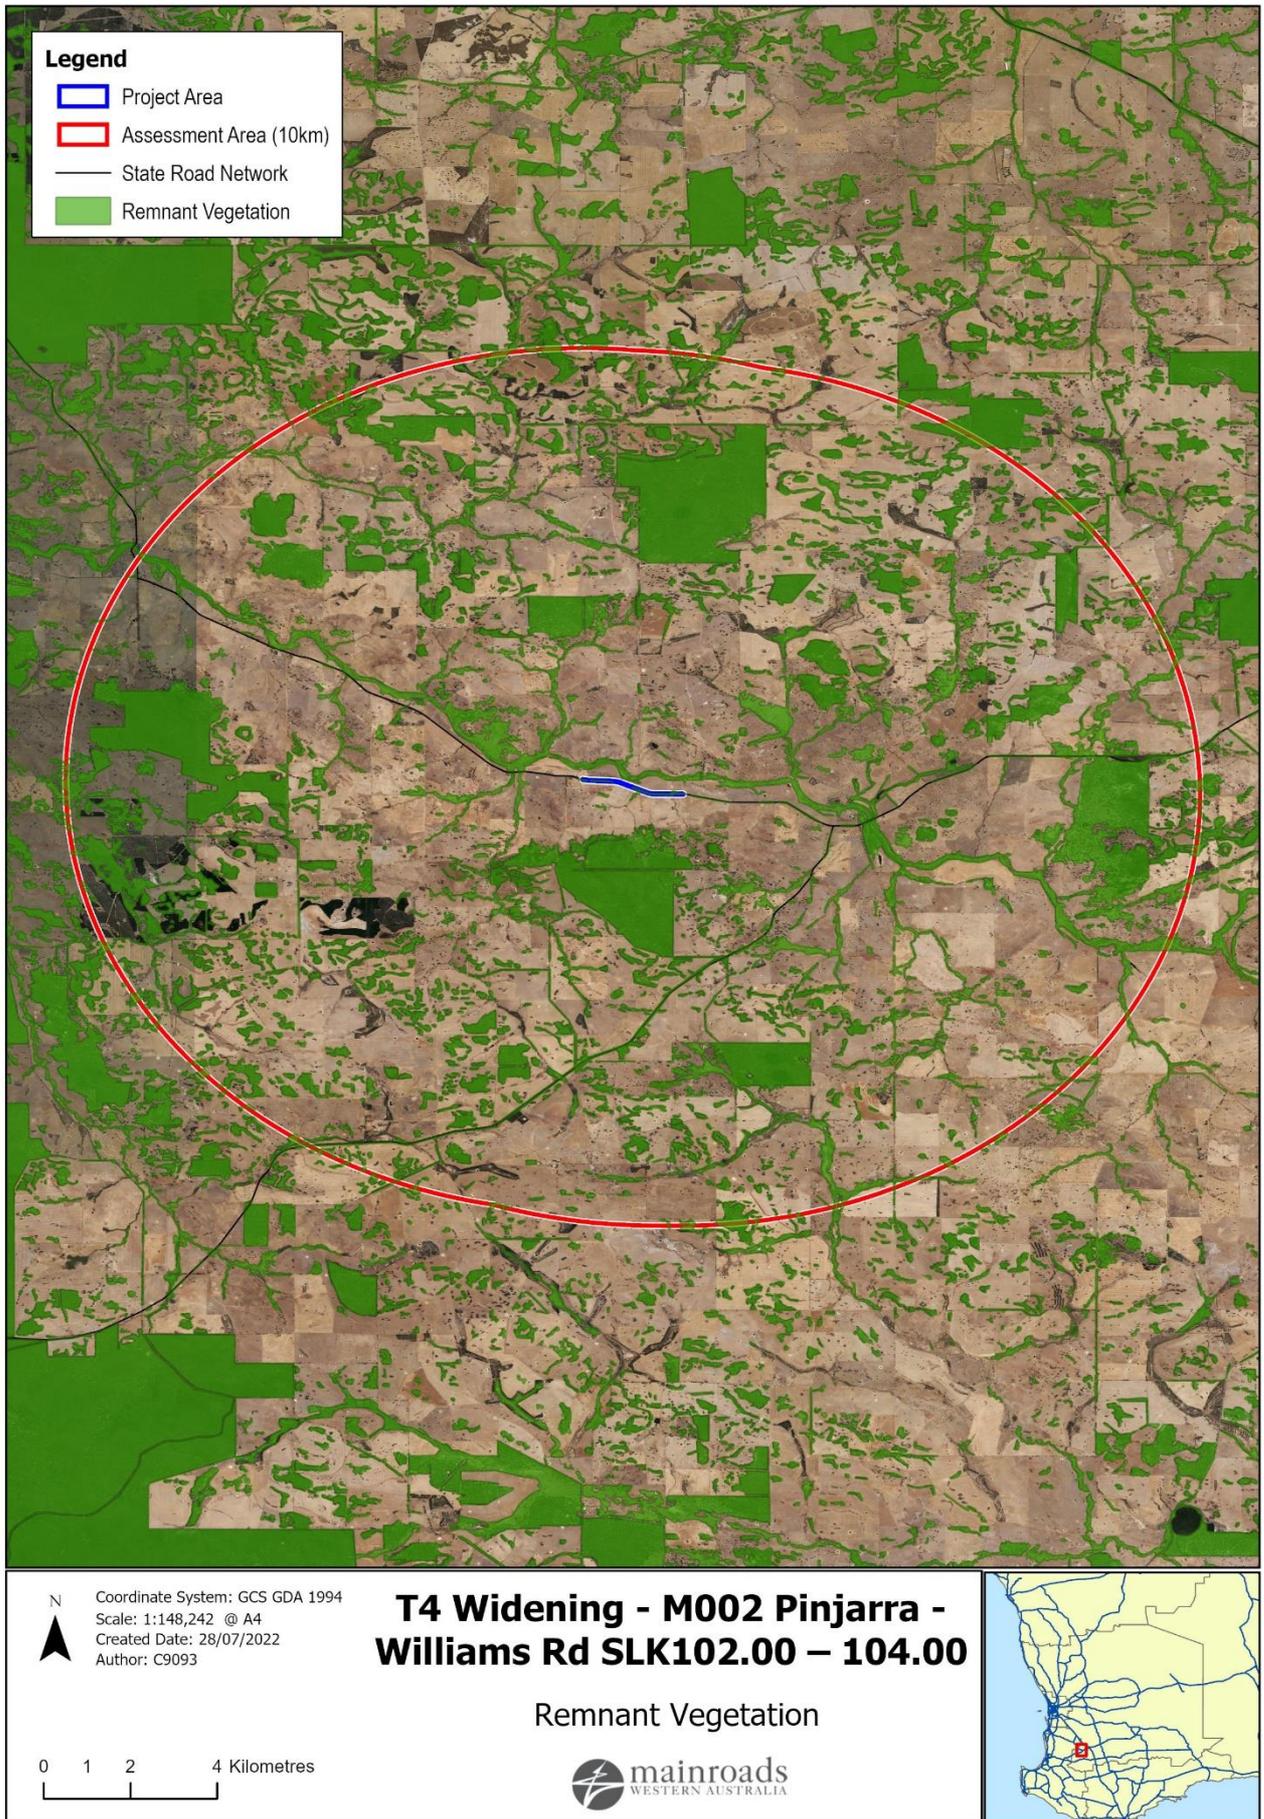
**Figure 7: Remnant Vegetation – Study Area**

Within the 10km study area a significant proportion (21.12%) of native vegetation remains including the Lavender Nature Reserve (Figure 7). The proposed clearing will not affect any regional habitat linkage.

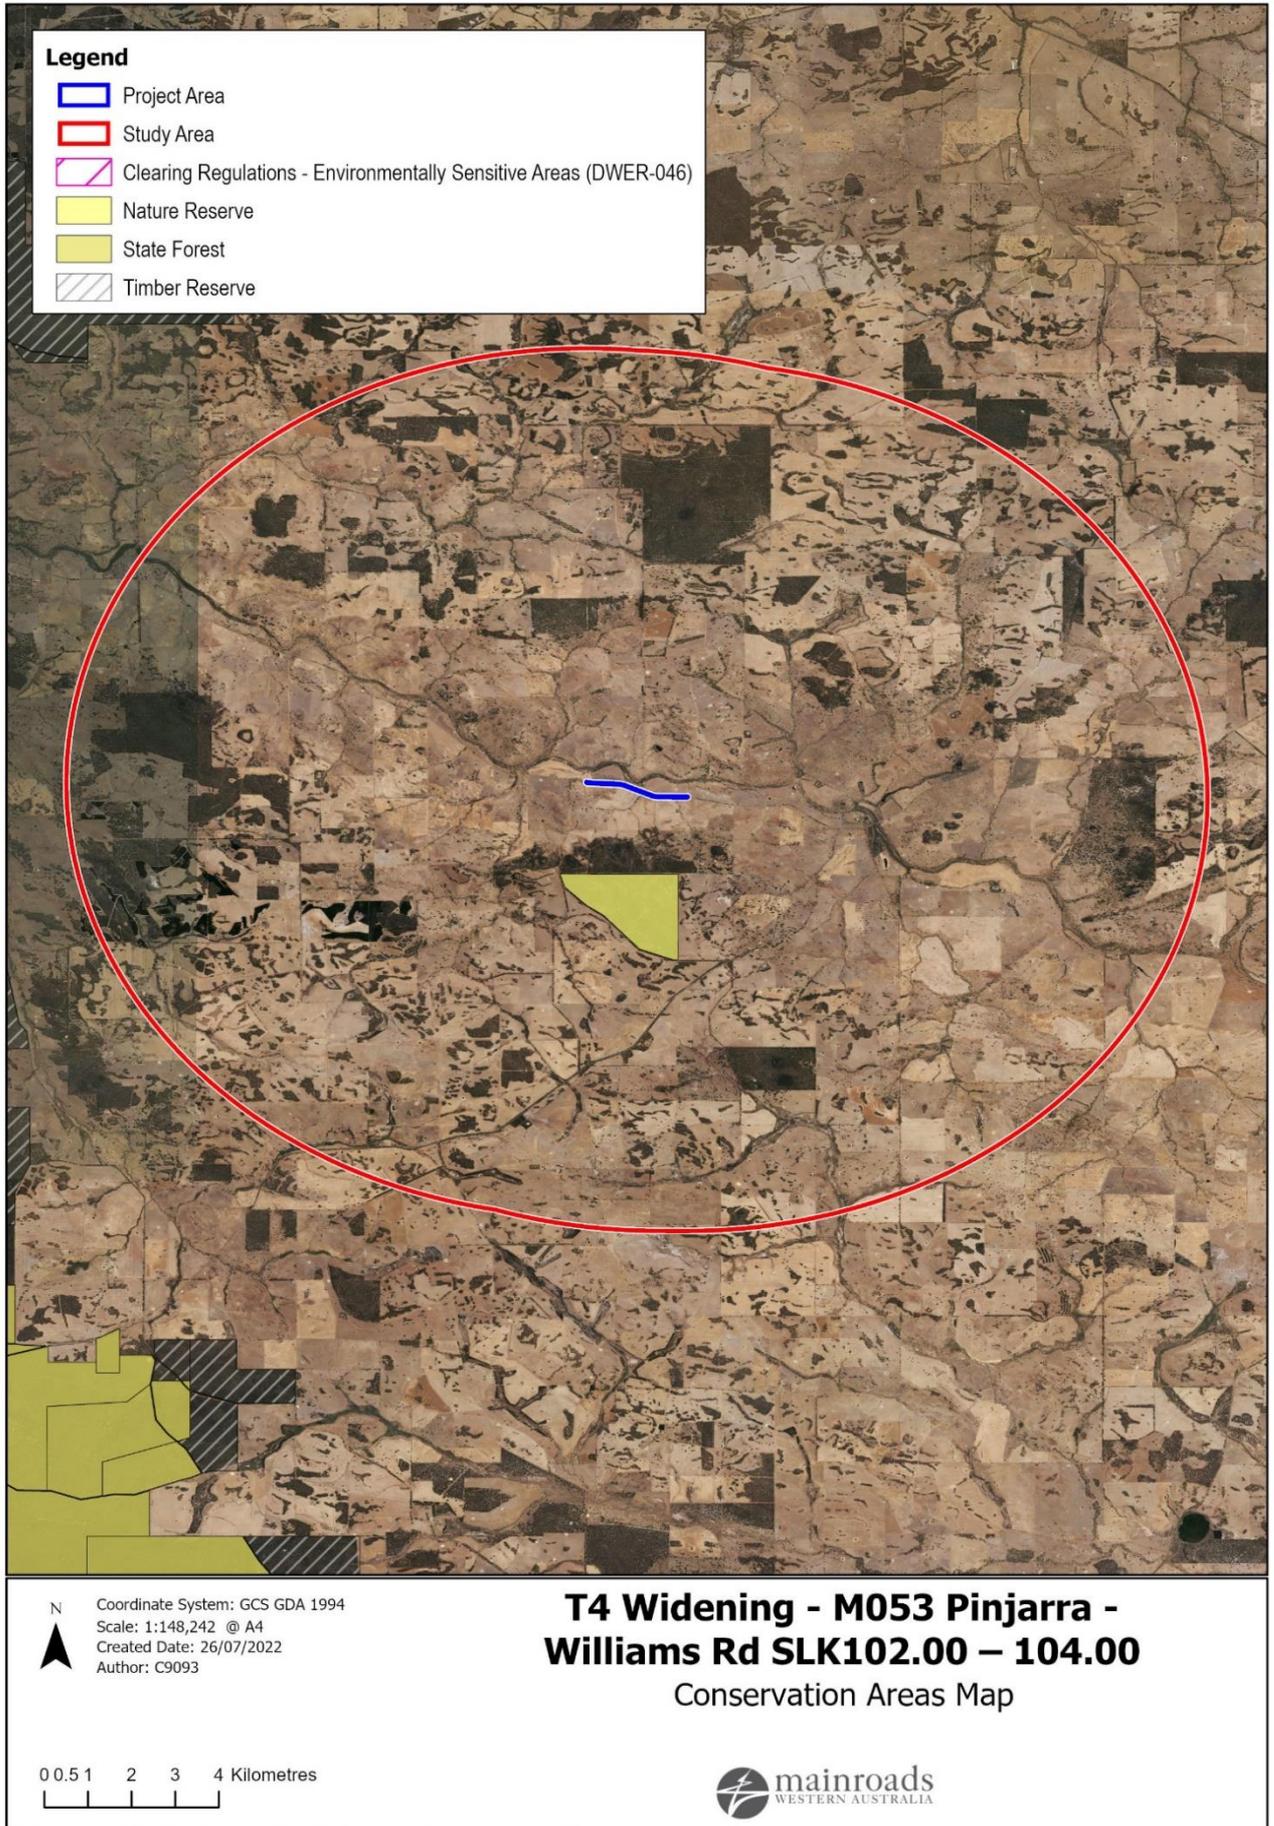
**Figure 8: DBCA Managed Lands, Heritage – Study Area**

<p><b>Proposed clearing is not at variance to this Principle</b></p>
<p><b>Comments</b></p> <p>According to Main Roads GIS DBCA Lands and Waters layer (<b>Figure 8</b>), the Lavender Nature reserve is located approximately 1.7km to the South of the Project Area. Due to the spatial separation and the regional hydrology reporting northward, away from the Lavender Nature reserve, no impacts are anticipated. The proposed clearing of 0.01 ha comprising three trees is unlikely to have any impact on any ecological linkages.</p> <p><b>Assessed Outcome:</b></p> <p>Project Area clearing not at variance to this Principle.</p>
<p><b>Methodology</b></p> <p>DBCA shapefiles                  EPA (2016)                  Main Roads Site Inspection 20 July 2022</p>

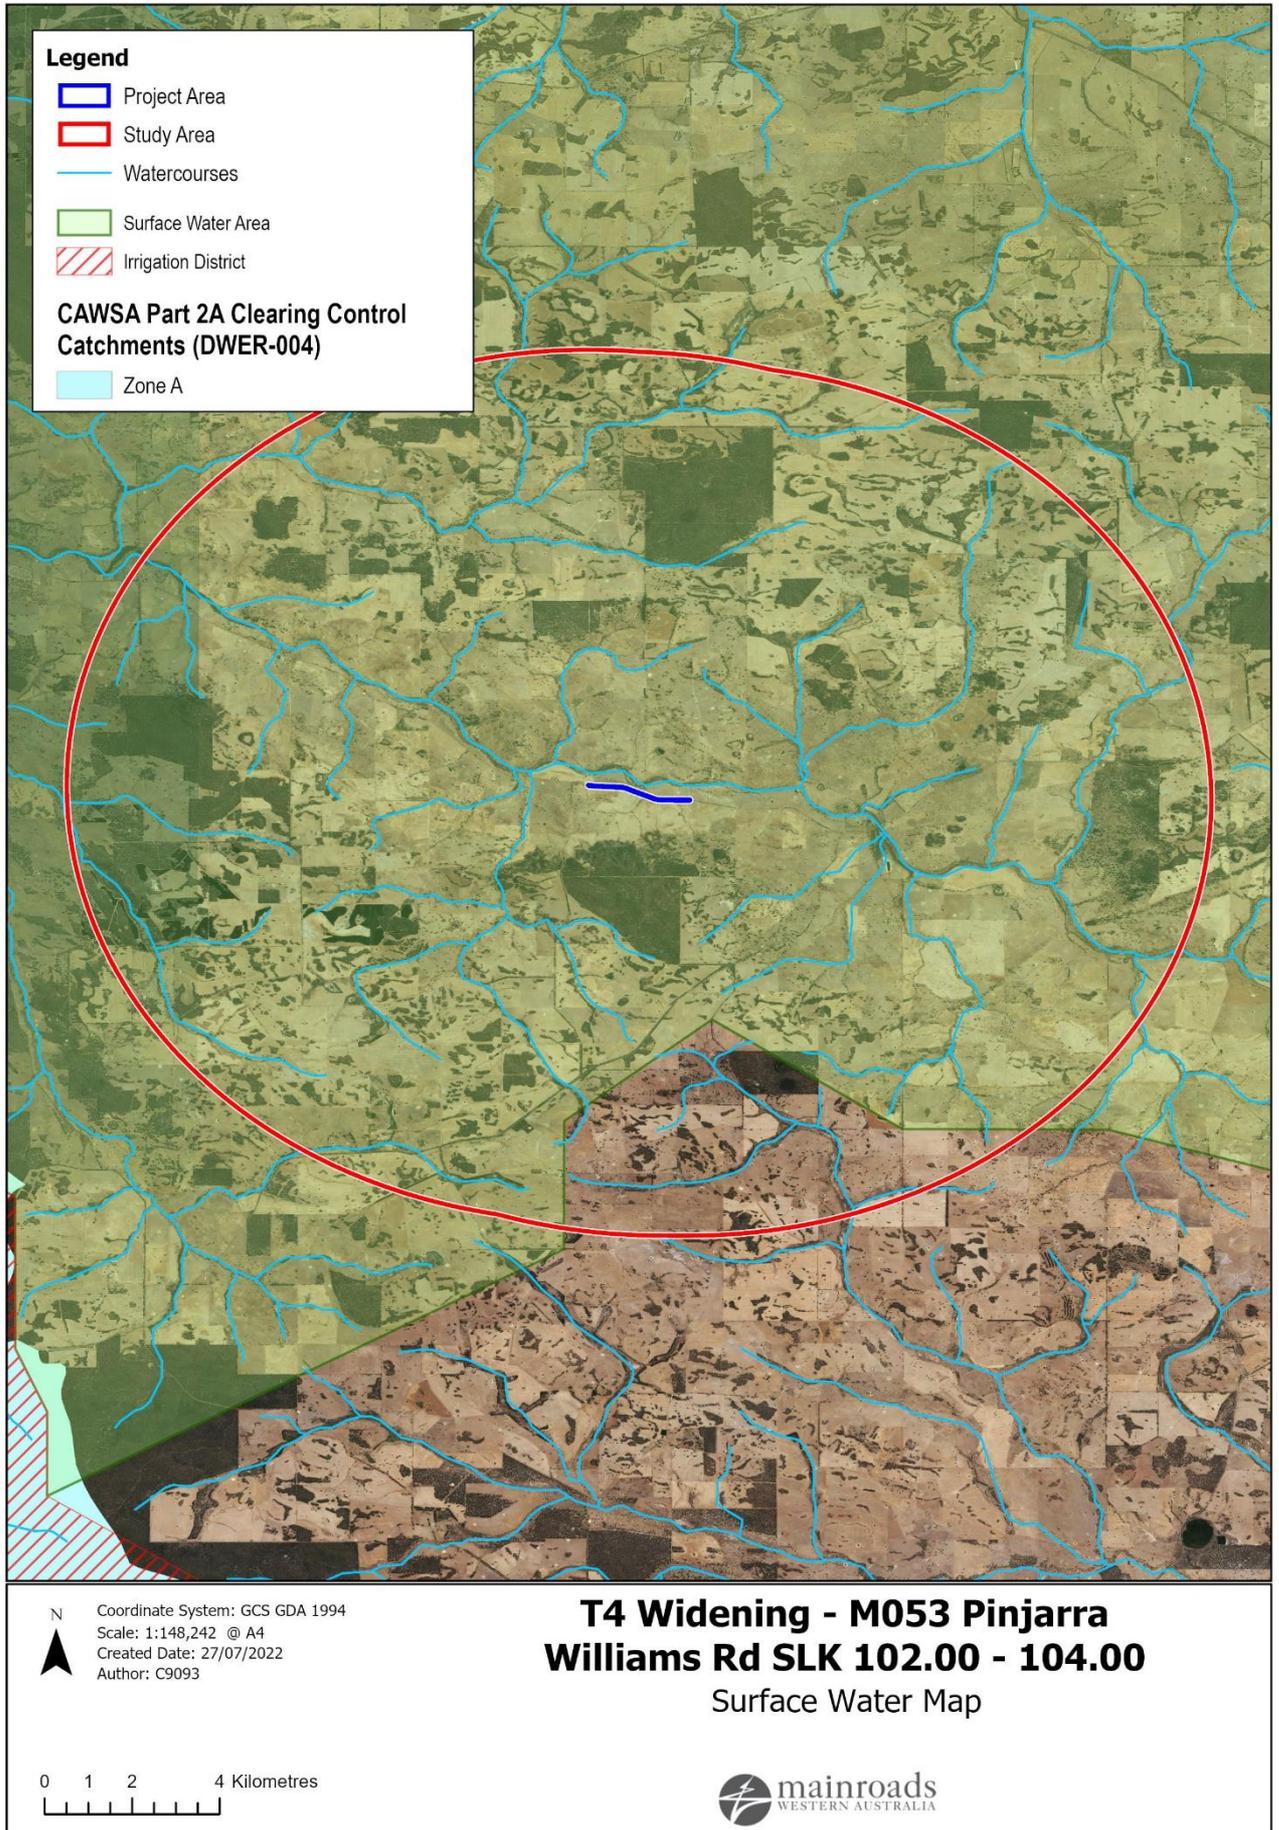
Figure 9: Water Constraints – Study Area

<p><b>Proposed clearing may be at variance to this Principle</b></p>
<p><b>Comments</b></p> <p>The Williams River runs roughly parallel to the Project Area in an east to west direction, approximately 150m to the north at its closest point (<b>Figure 9</b>).</p> <p>Culverts under the Pinjarra – William Rd transit localised ephemeral drainage from farmland to the south, northward to the Williams River. One tree proposed to be cleared (Tree 2) is located adjacent to one of these culverts. Removal of this individual tree comprises a clearing area of approximately 0.006ha.</p> <p>Due to the minor, non-perennial nature of the drainage and the clearing impact only comprising a single tree, in a Completely degraded landscape with no native understory present, no impacts to the values of the drainage line are anticipated.</p> <p>Furthermore, as activities are proposed for dry conditions, no impacts to the riparian system are anticipated from the implementation of the Project Area.</p> <p><b>Assessed Outcome</b></p> <p>Proposed clearing may be at variance to this Principle.</p>

<p><b>Proposed clearing is not likely to be at variance to this Principle</b></p>
<p><b>Comments</b></p> <p>The Williams River runs roughly parallel to the Project Area area in an east to west direction, approximately 150m to the north at its closest point (<b>Figure 9</b>).</p> <p>A search of ArcGIS shapefiles has confirmed that only minor localised drainage intersects the Clearing Area. The proposed works will not disturb or interrupt any natural drainage and surface run-off patterns. The Project Area will require clearing of three trees located within the existing maintenance zone comprising 0.01ha, with only a single tree located adjacent to a minor non-perennial drainage line comprising 0.06ha of clearing.</p> <p>Given the ‘Completely degraded’ nature of the vegetation present, the clearing of this small amount of vegetation is unlikely to cause a deterioration in the quality of surface or underground water. In addition, contract documentation will incorporate management actions to ensure potential indirect and short-term impacts, such as sedimentation and erosion, are managed.</p> <p>Analysis of GIS databases reveal that the Clearing Area is not located within a:</p> <ul style="list-style-type: none"> <li>• RIWI Act Ground Water or Irrigation district;</li> <li>• Public Drinking Water Source Area; or</li> <li>• CAWSA Clearing Control Catchment.</li> </ul> <p>The Project Area is located within the Murray River System surface water area; however, no clearing will occur within or close to a mapped watercourse.</p> <p>Dewatering is not proposed and no change to groundwater level or quality is anticipated from the removal of the trees. Standard operational controls will be implemented with regards to potential spill risks.</p> <p>Given no dewatering or major drainage modifications are likely to be required and the scale of clearing is relatively minor and linear in nature, no deterioration of surface or underground water levels or quality is expected to result from clearing.</p> <p><b>Assessed Outcome:</b></p> <p>Project Area clearing not likely to be at variance to this Principle.</p>
