mainroads  
WESTERN AUSTRALIA

# Preliminary Clearing Impact Assessment

Munjina Roy Hill Road Rail Bridge

February 2021

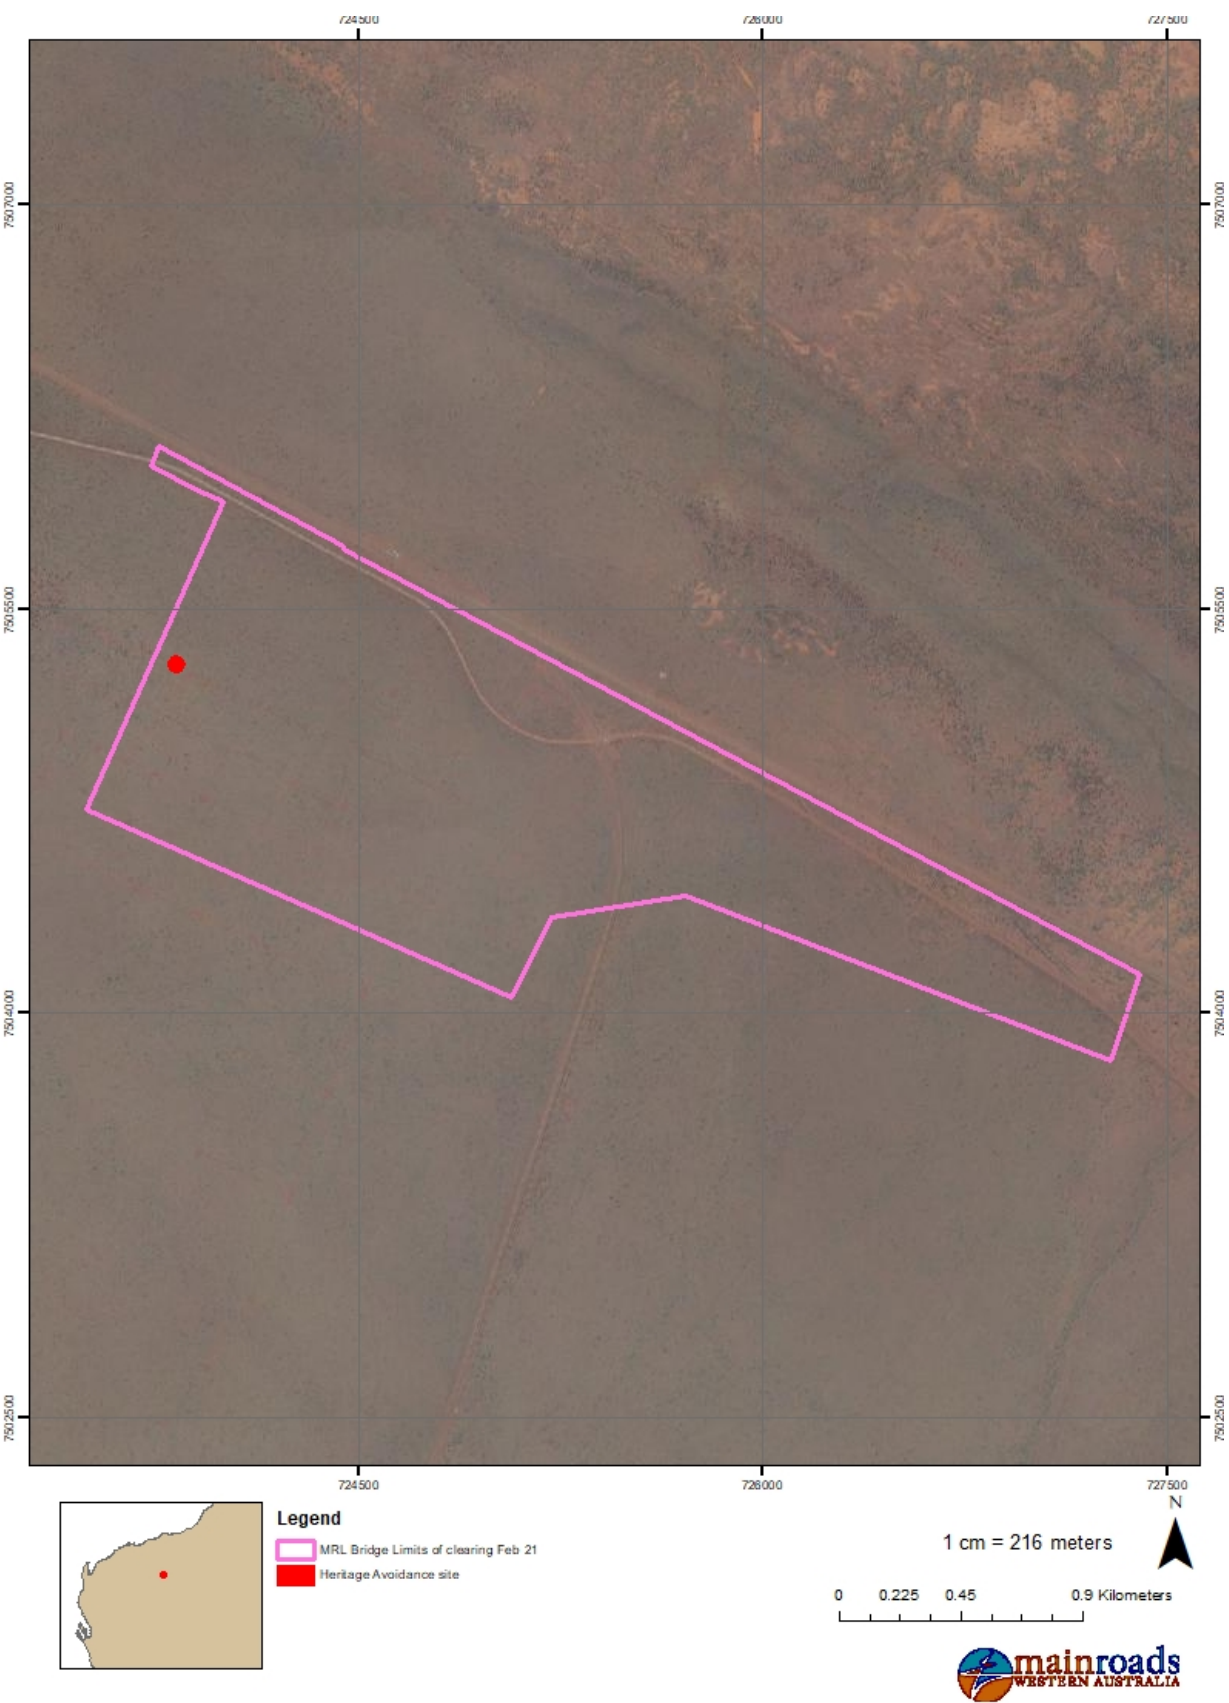
Figure 1. Project Area

The project area is located on Munjina Roy Hill Rd, a local road approx. 55km from Great Northern Highway / Auski Roadhouse intersection, in Shire of Ashburton as shown in Figure 1.
