Clearing Assessment Report – CPS 818

Auski Intersections and associated
infrastructure

March 2022

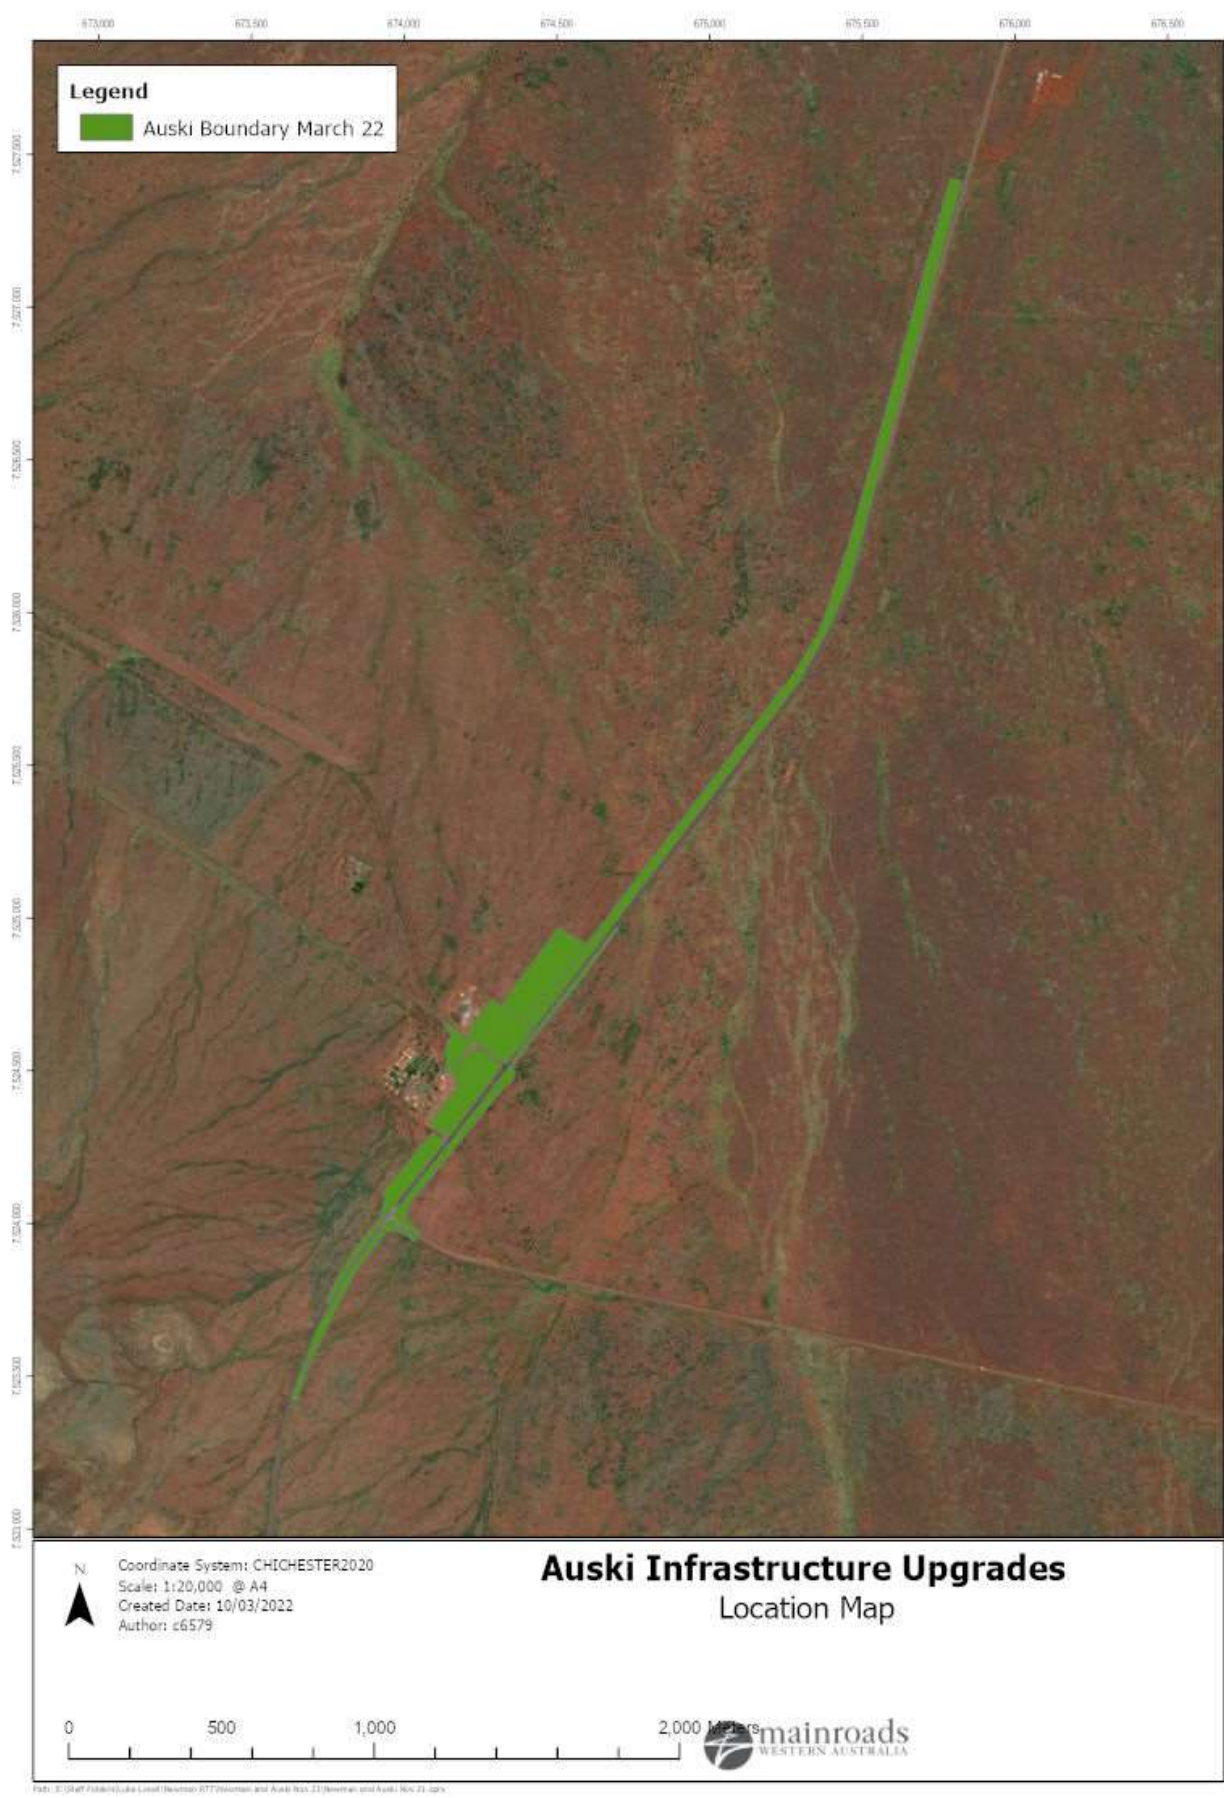
Figure 1. Project Area

Project Location(s): The project area is located on Great Northern Highway, Shire of Ashburton, 1361- 1356.5 as shown in Figure 1.

The location of the proposed works is at Figure 1.

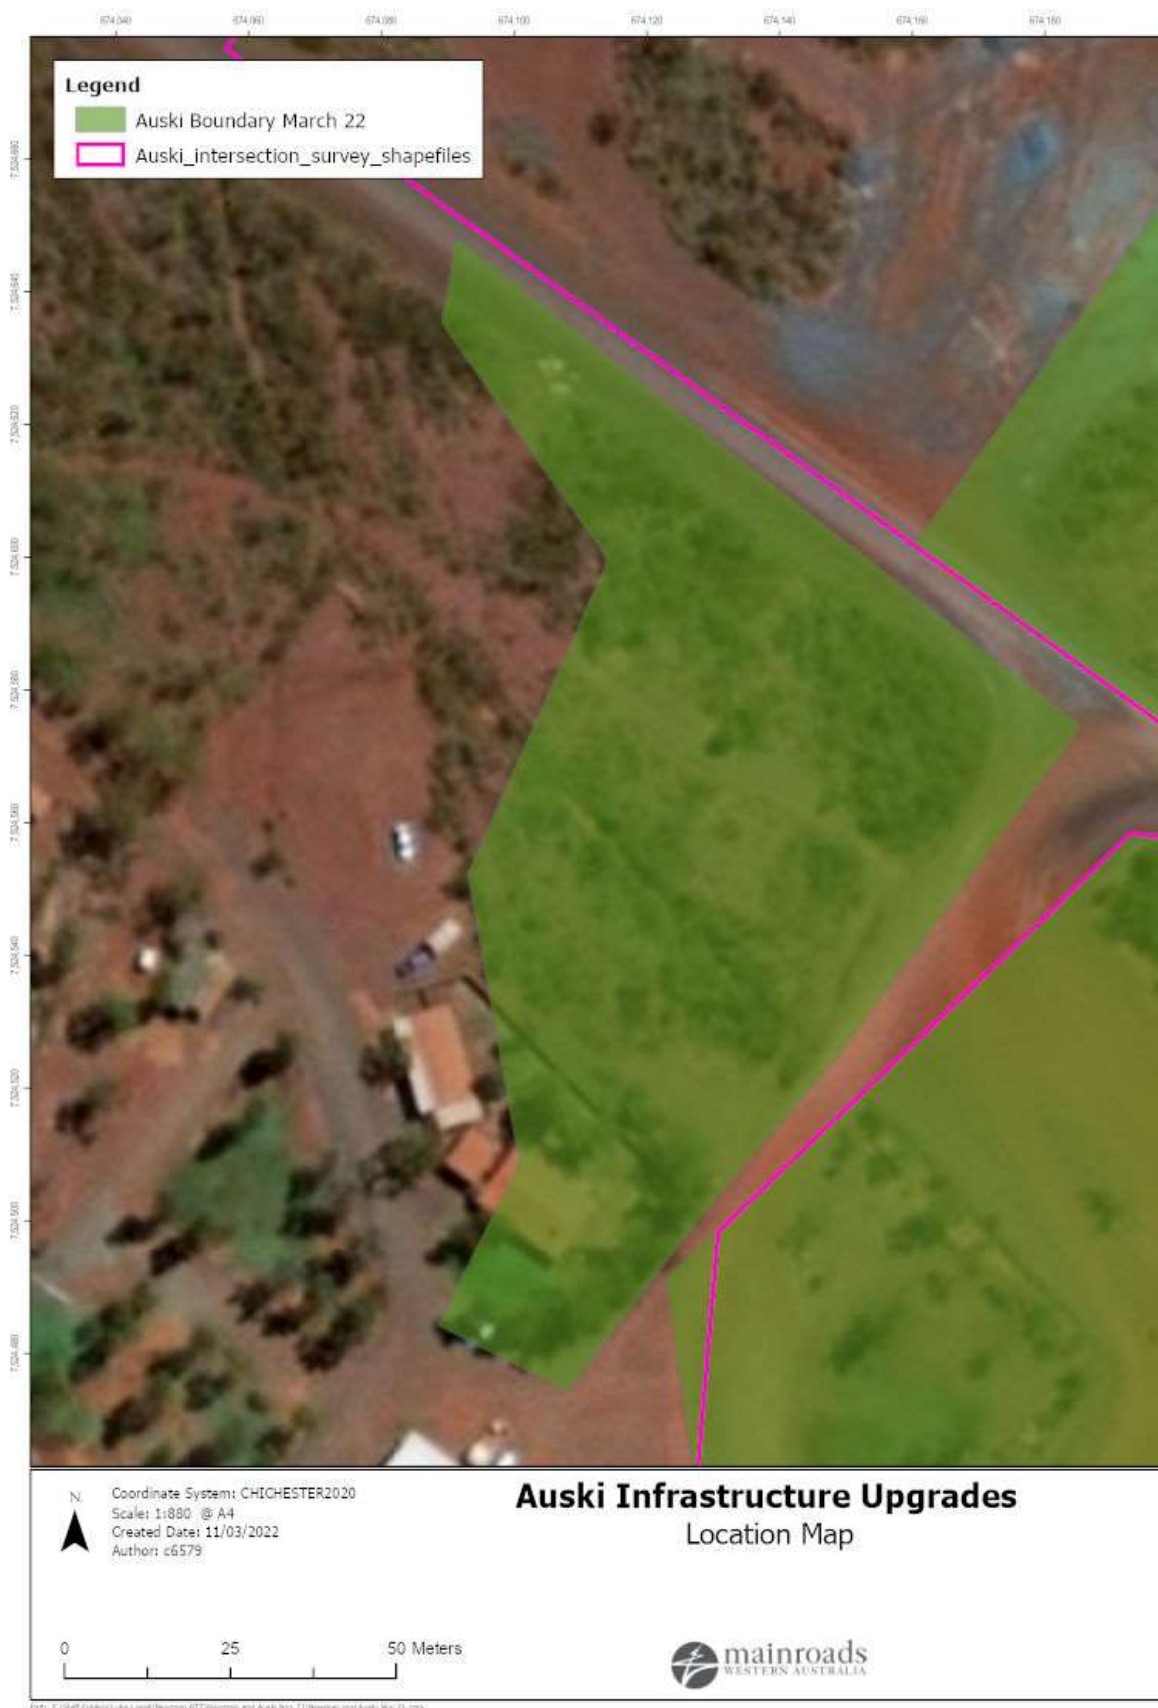
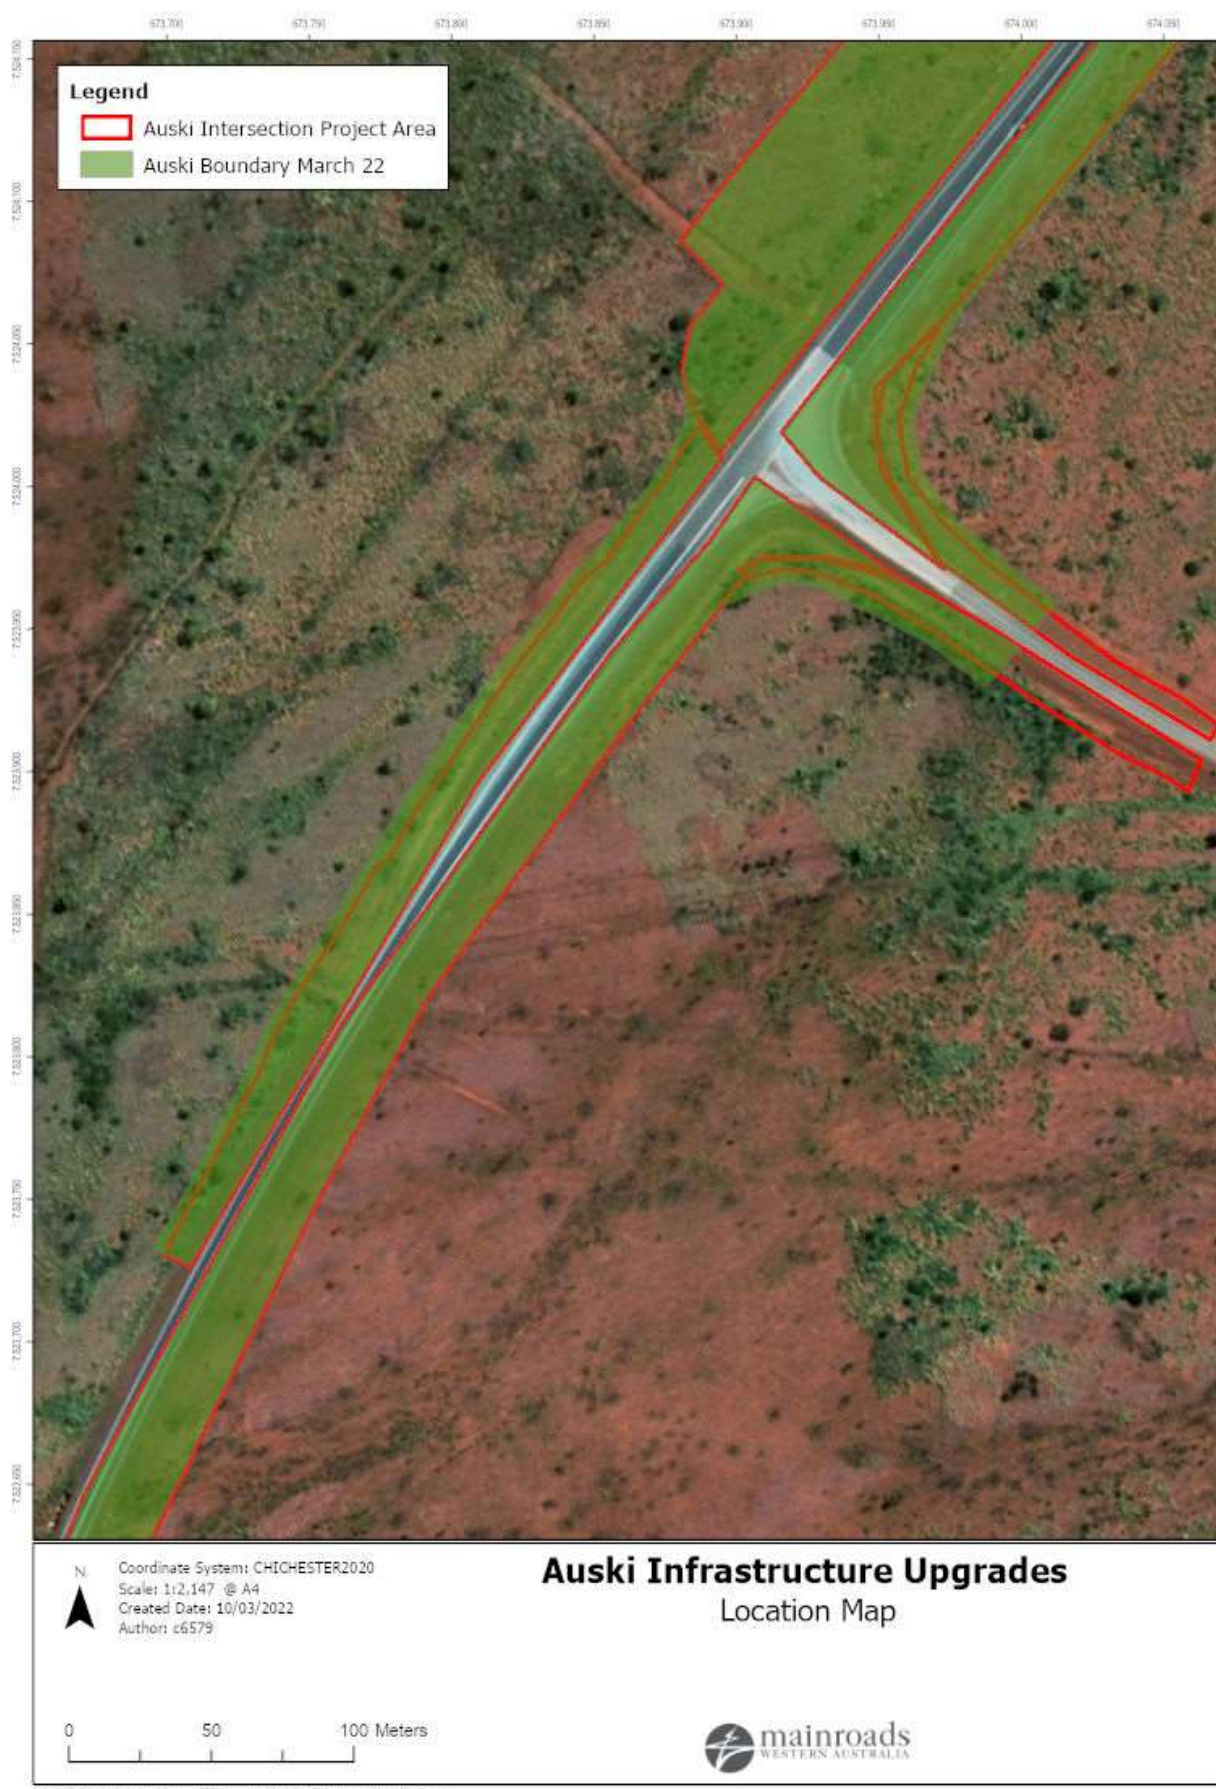
An additional adjacent 2.58 ha of area outside the biological survey area was identified as required for the project. From street view and aerial imagery, the majority of this vegetation in these extended areas is in degraded condition (Figures 3 and 4). Revised database searches were conducted on these new areas with no significant flora likely to occur within the extended areas. No flora of conservation significance flora was identified as potentially occurring within the extended areas which has not already addressed within the biological survey. As per the greater survey, due to the

degraded and fragmented condition of the vegetation it is considered highly unlikely the extended areas represents key habitat for native fauna species.

The 2.58 ha part of the project area outside the biological survey area with 2.28 ha identified using imagery as being mixed Acacia shrubland over *Triodia* hummock grassland in degraded condition and the remaining veg identified as *Eucalyptus gamophylla* low open mallee woodland over *Acacia inaequilatera*, *Hakea lorea* tall open shrubland over *Triodia pungens*, *Triodia basedowii* low open hummock grassland
