Preliminary Clearing Impact Assessment

M008 Vasse Hwy [000 to 008.20 SLK] Bussell Hwy to Sues Road - Seal Widening

March 2021

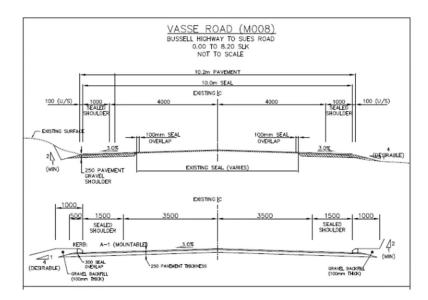
The proposal includes minor road widening of the Vasse Highway (M008) between 0.0 SLK (Bussell Highway) and 8.2 SLK (Sues Road). The widening will extend the existing circa 8m wide pavement and seal to 10m wide, using low cost widening treatments, as per Main Roads 2031 – Typical Cross Section map (below).

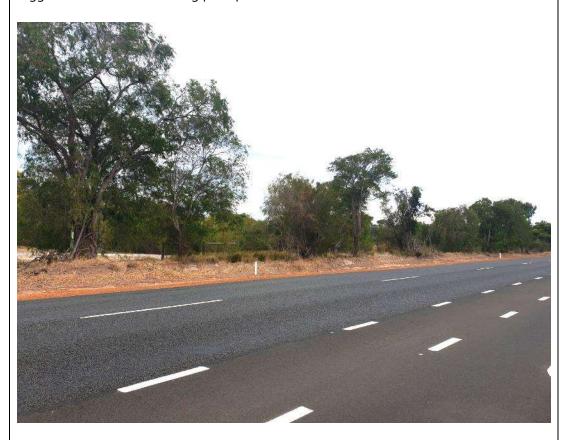
Photo 1 Several small trees and shrubs along the front edge opposite and north of Neville Hyder Drive, mapped as KgBa (Degraded) (TEC/PEC).

Only 0.027 ha of KgBa Degraded vegetation unit will be cleared. This represents 0.36 % of the total patch. The portion of the patch to be cleared is less than 4.5m wide and spread over 70m – given the Degraded condition, and small area, it is unlikley to be representative of native vegetation comprised of a high level of biological diversity and therefore not likely to trigger variance to this clearing principle.

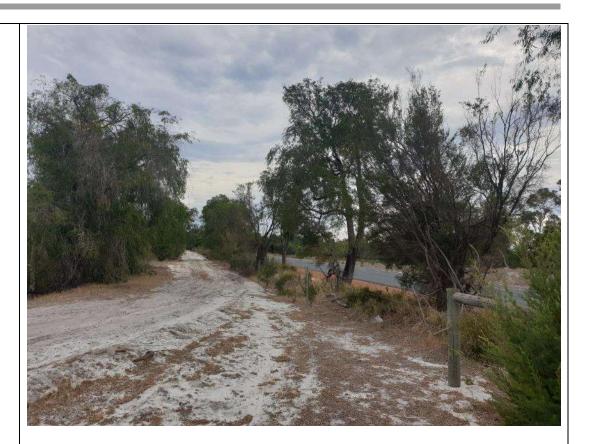
Photo 2 Same patch of road verge vegetation (TEC) showing the fire break. Note the narrow vegetation extent.
