# Clearing Desktop Report – Short Form

<b>Proposal Name:</b>	Bridge 4854 Replacement		
<b>Region/Directorate:</b>	South West Region		
<b>Local Government Authority:</b>	City of Busselton (CoB)		
<b>Road/Bridge Name and No:</b>	Bridge 4854 – Boallia Road 2050033		
<b>Proposal Location (SLK):</b>	6.96 SLK		
<b>TRIM Link to Spatial Data:</b>	D21#618339		
<b>EOS No:</b>	2350		
<b>Expected Proposal Start Date:</b>	14/07/2022		
<b>Project No:</b>	21100308	<b>Task Code:</b>	11.02
<b>LISC TRIM No:</b>	D21#613472	<b>HRA TRIM No:</b>	D21#273303

# ENVIRONMENTAL SITE INSPECTION REPORT FOR A CLEARING DESKTOP REPORT (CDR)

## Bridge 4854 Replacement and EOS # 2350

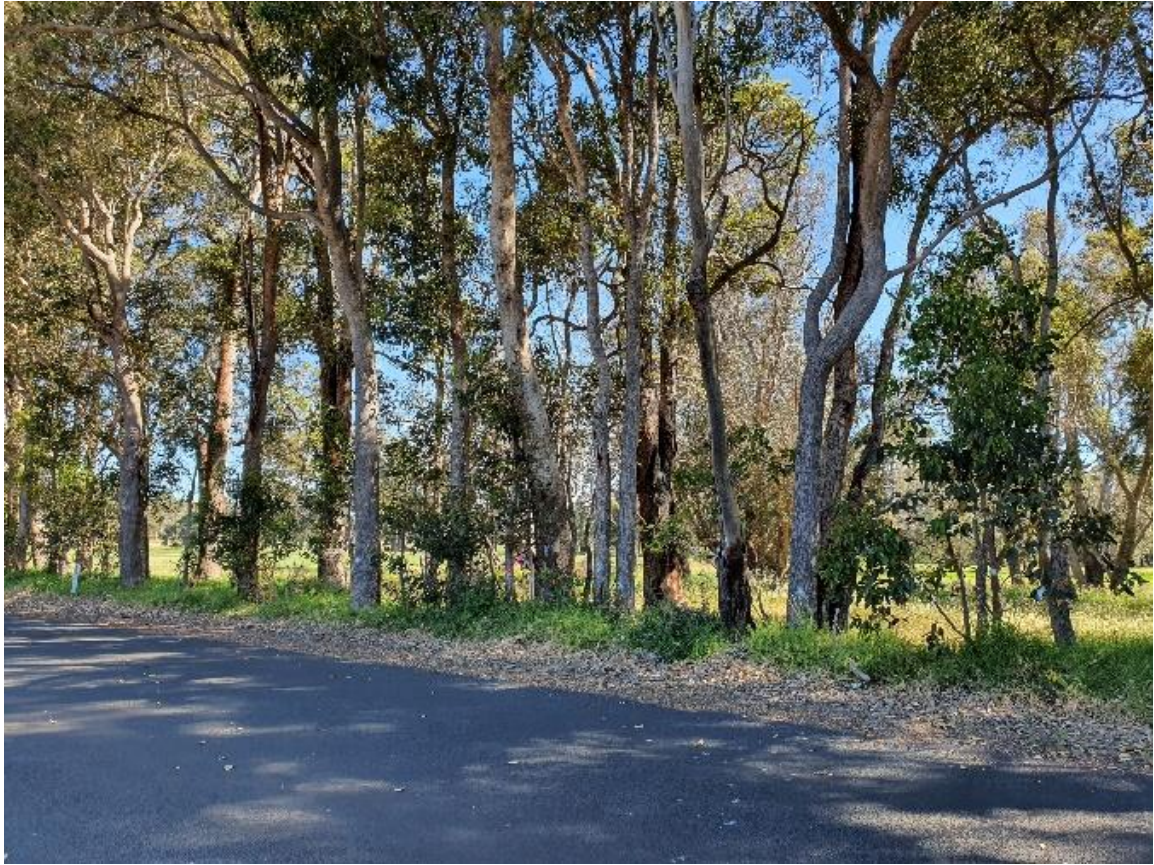
Photo 1: Trees with white dots within the Proposal area, identifying those requiring removal. Photo taken in the southern extent of the Proposal area facing south.

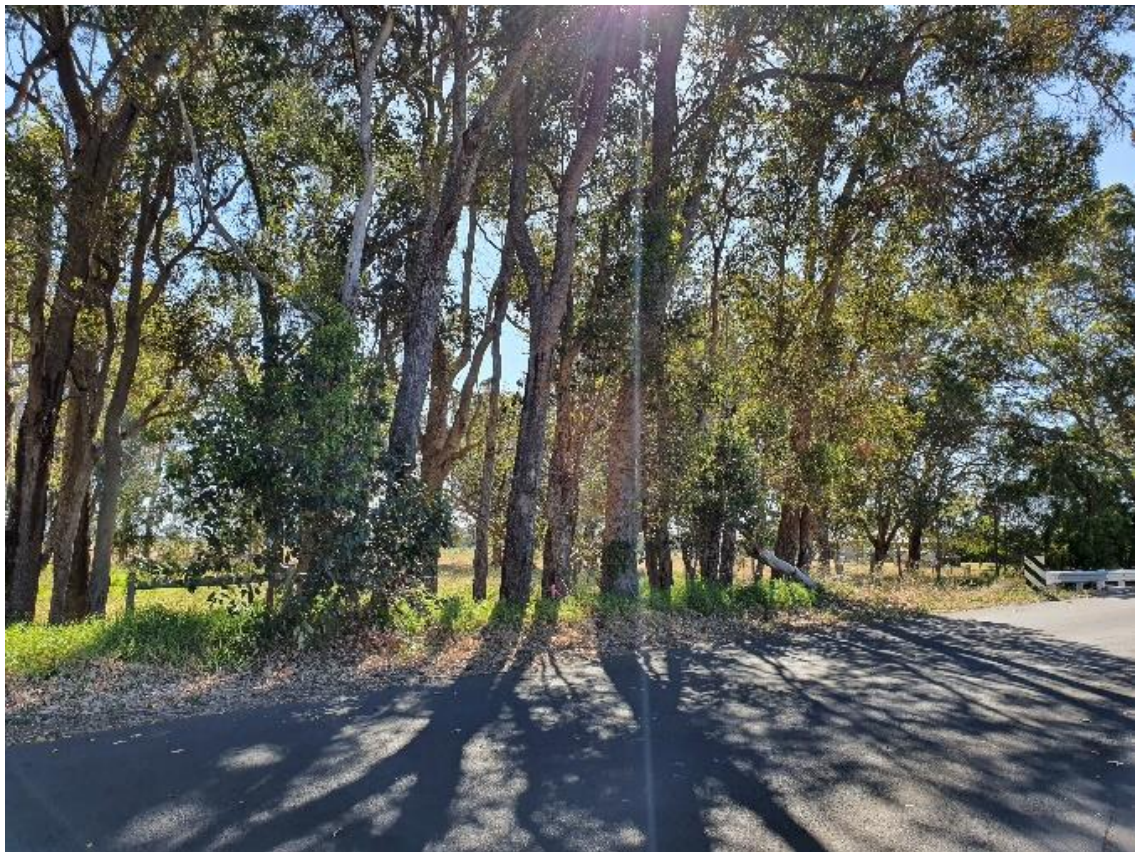
Photo 2: Trees with white dots within the Proposal area, identifying those requiring removal. Photo taken in the southern extent of the Proposal area facing west.

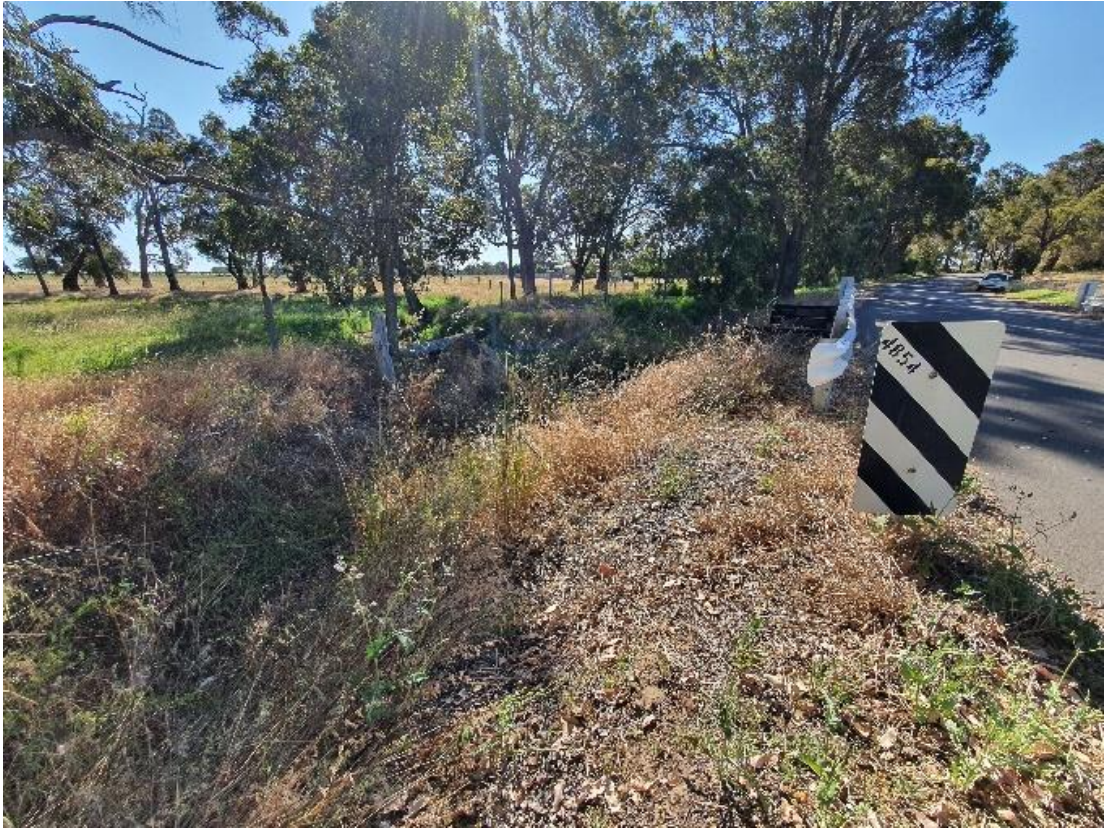
Photo 3: Representative of the watercourse banks within the Proposal area, demonstrating the highly degraded and weed invaded condition. Photo taken on the southern side of Boallia Road facing west.

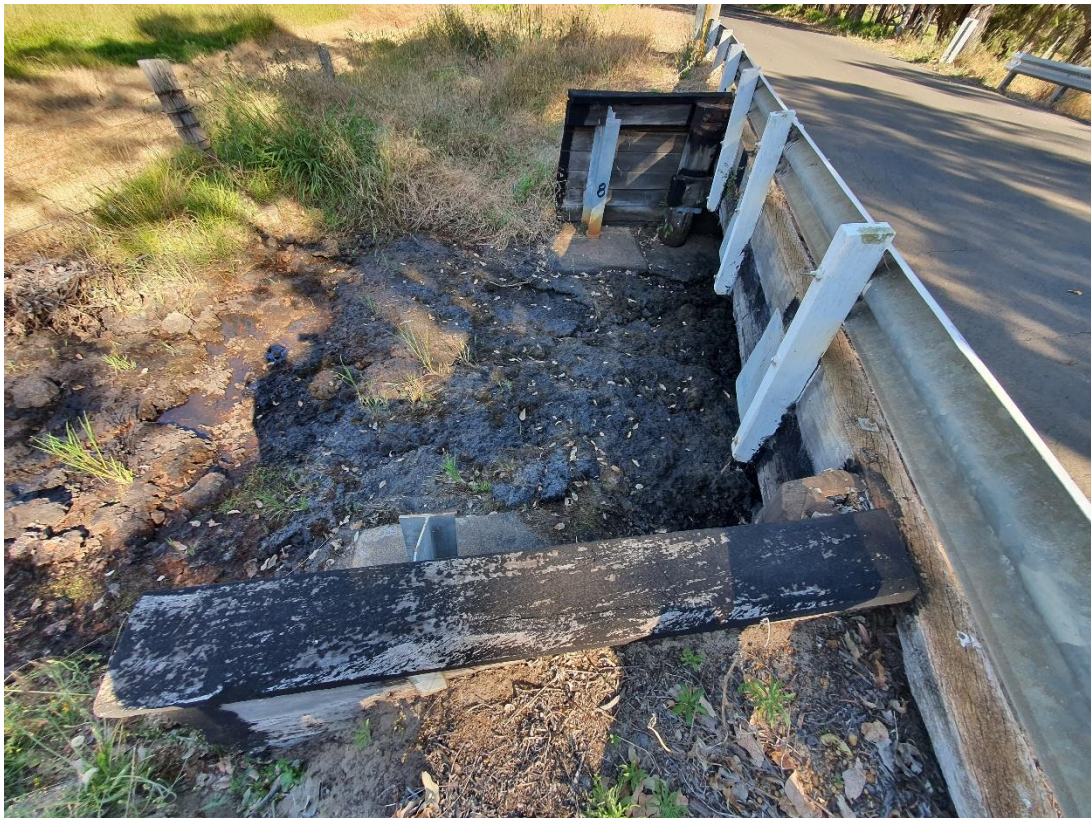
Photo 4: Representative photo of the watercourse within the Proposal area, depicting the rocky and dry riverbed. Photo taken in the northern side of Boallia Road facing east.
