# Clearing Desktop Report – CPS 818

Driveway 4341 South Western Hwy  
(H009) Sightline Clearing, Kent River

June 2022

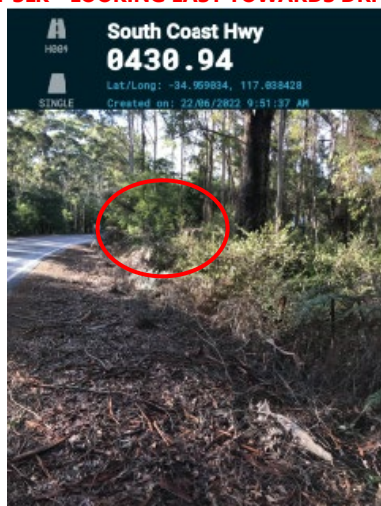
START SLK - LOOKING EAST TOWARDS DRIVEWAY

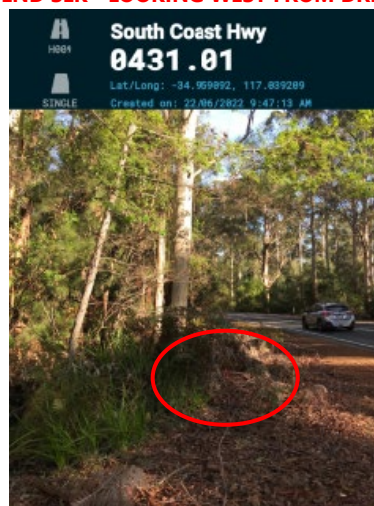
END SLK - LOOKING WEST FROM DRIVEWAY

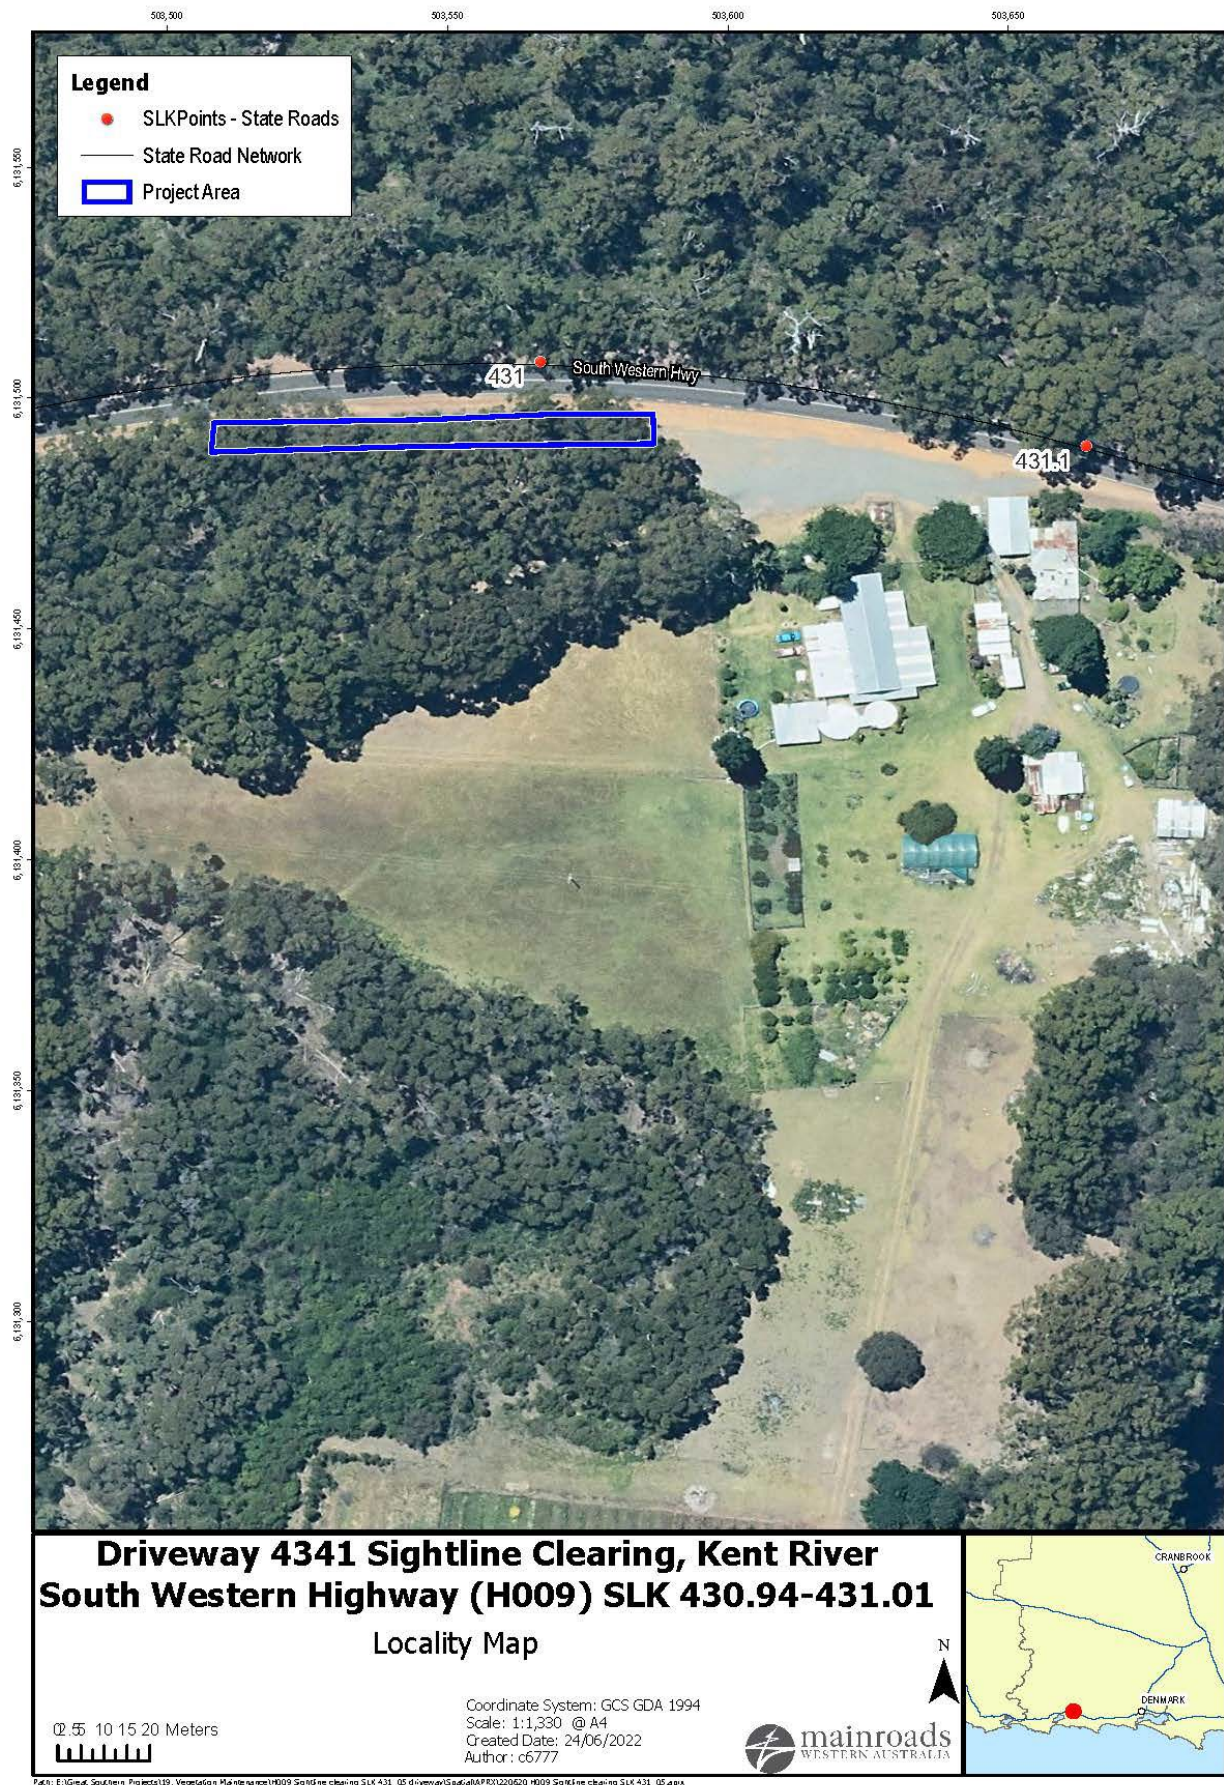
**Figure 1. Project Area**

**Project Location(s):** The Project Area is located on South Western Highway (H009) SLK 430.94-431.01 near Kent River in the Shire of Denmark, as shown in **Figure 1**.
