# Kwinana Freeway Upgrade (Roe Highway to Mortimer Road)

Tuart Woodlands and Forests of the SCP and Banksia Woodlands of the SCP TEC habitat quality scoring

25 March 2026

| Project name | | Westport Roads IPT | | | | | |
|---|---|---|---|---|---|---|---|
| Document number | | WPRP-IPT-MR-09-RPT-EN-0020 | | | | | |

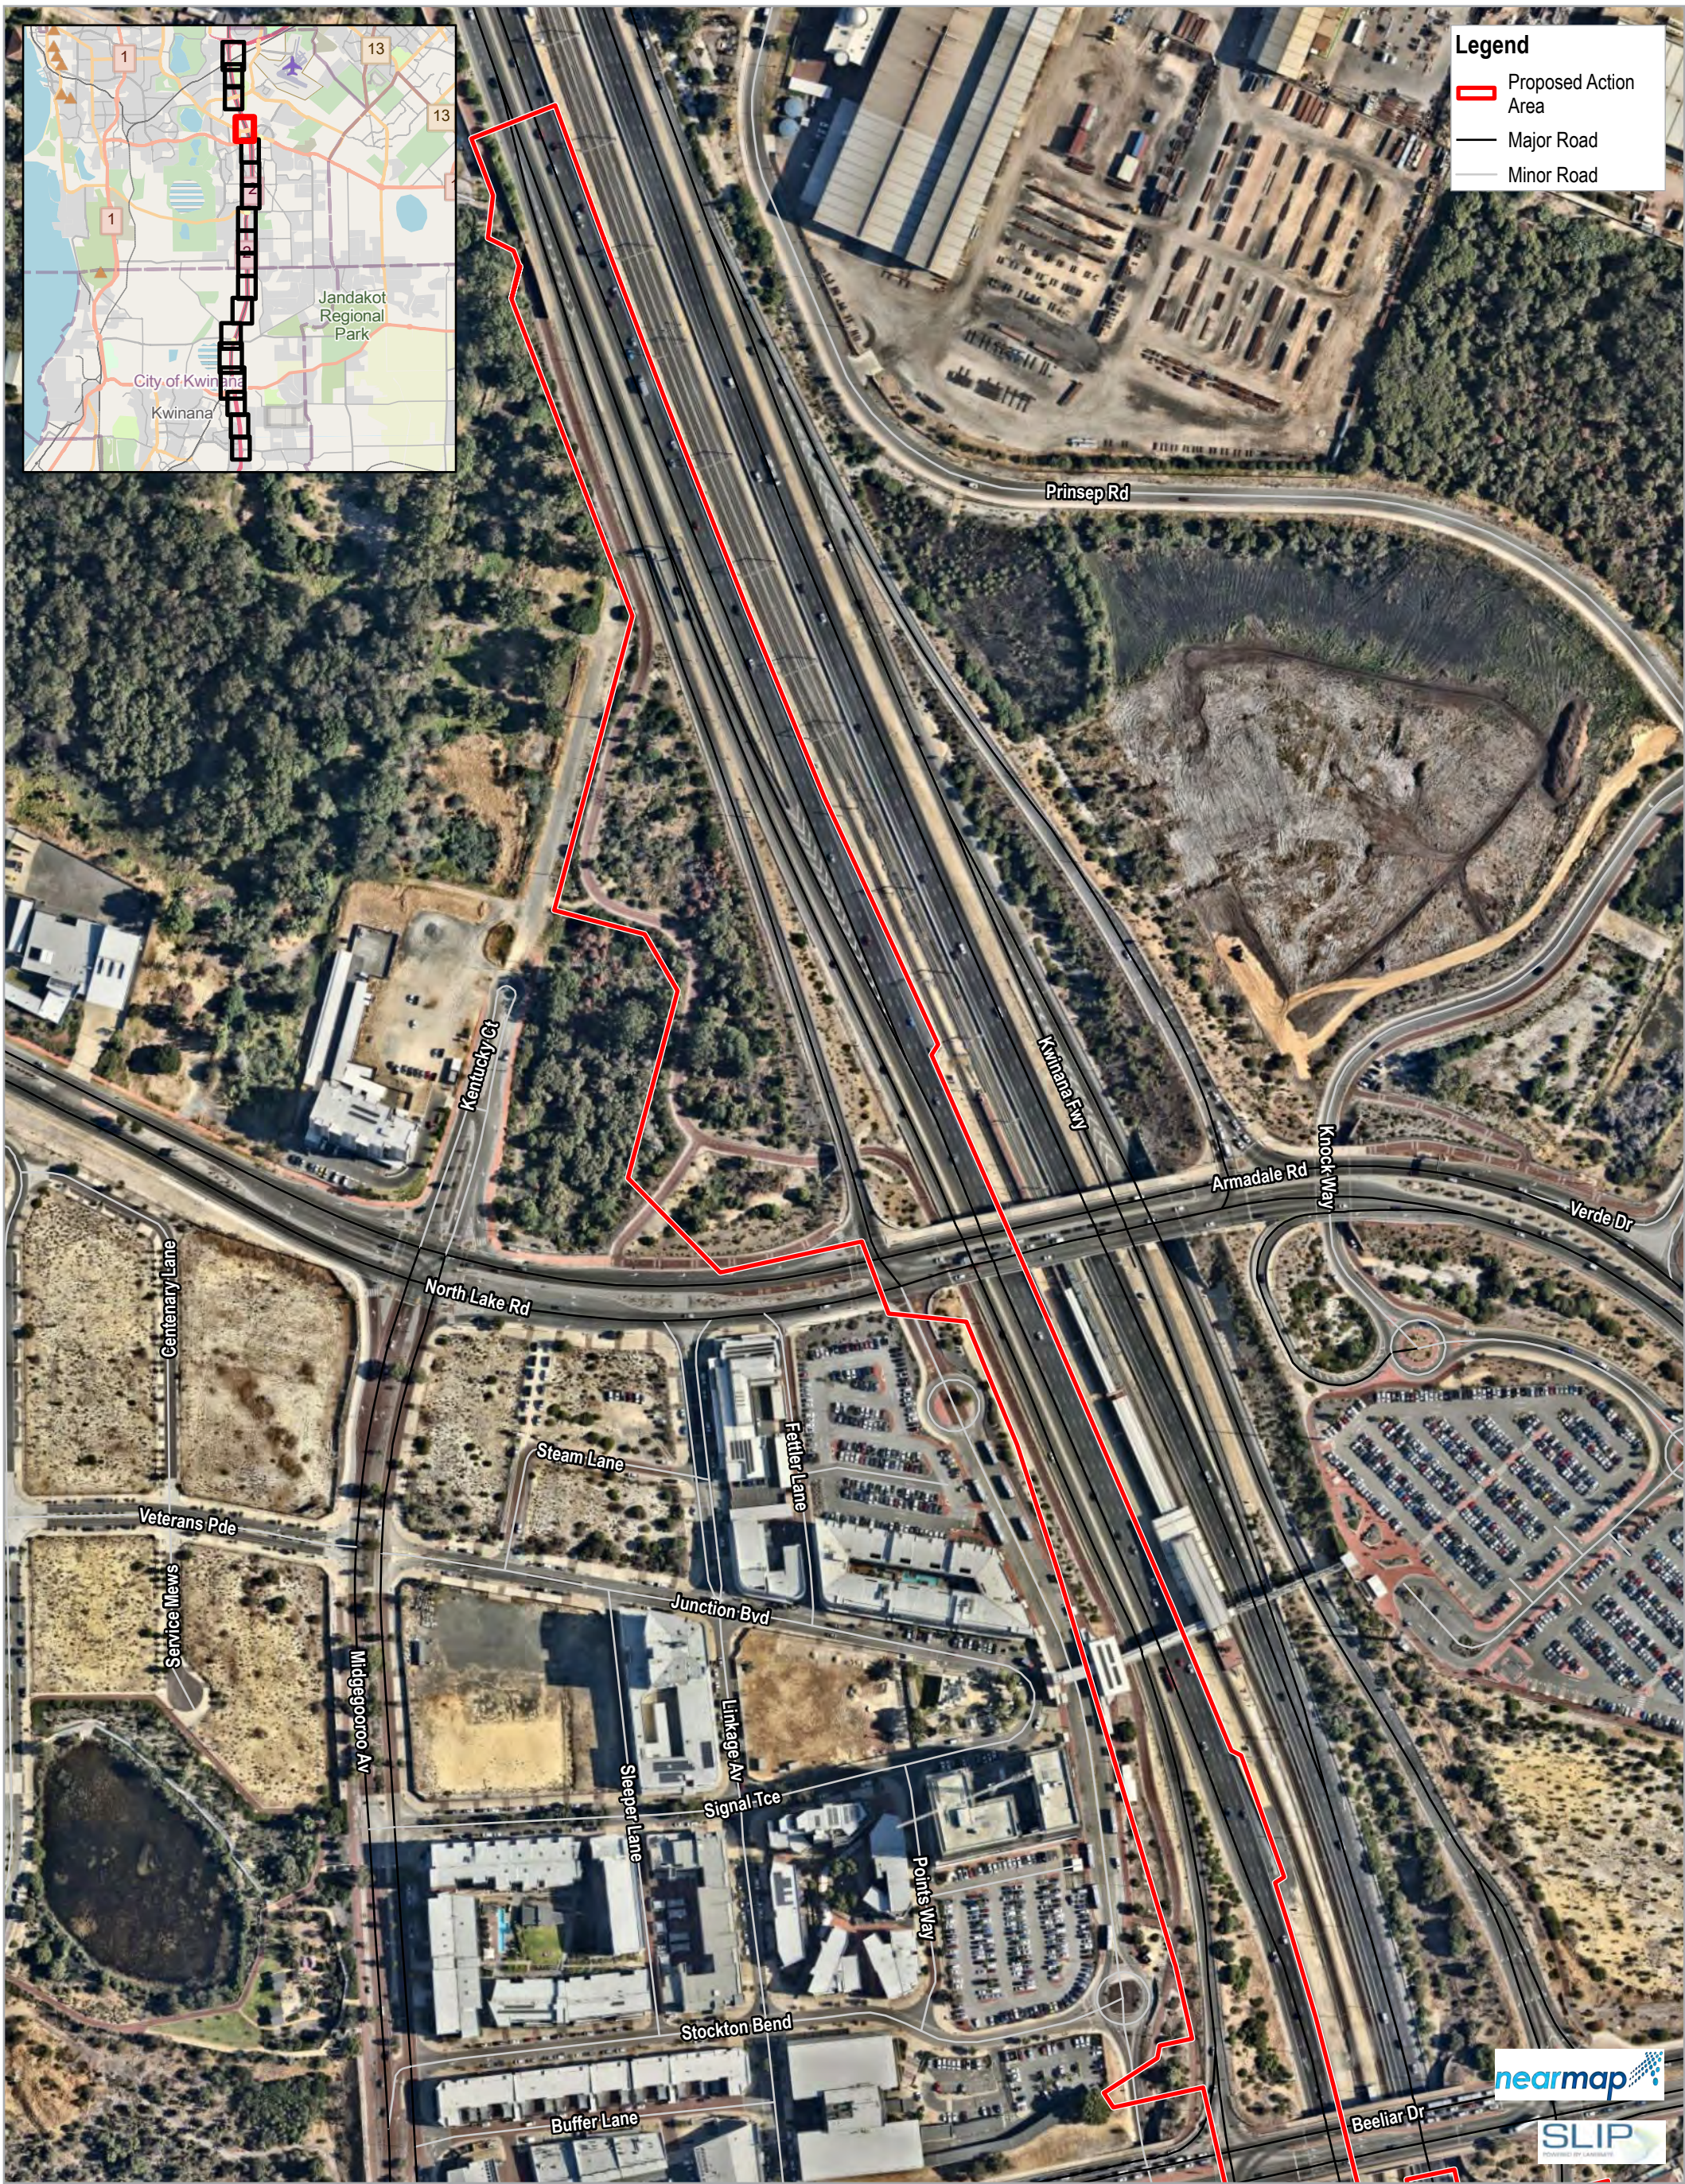
Figure 1      Tuart Woodlands and Forests of the Swan Coastal Plain TEC patches

The Tuart TEC HQS calculated using the framework provided by DCCEEW is presented in Table 4. The habitat quality of the three Tuart TEC patches that intersect the PAA ranged from 3.91 (TT02) to 5.13 (TT01). The Site Habitat Quality Score for Tuart TEC within the PAA is calculated to be 4.51. The locations of the Tuart TEC patches are shown in Figure 1.

Figures showing the location of Tuart TEC and Banksia TEC patches and relevant sampling locations are provided in Appendix A.

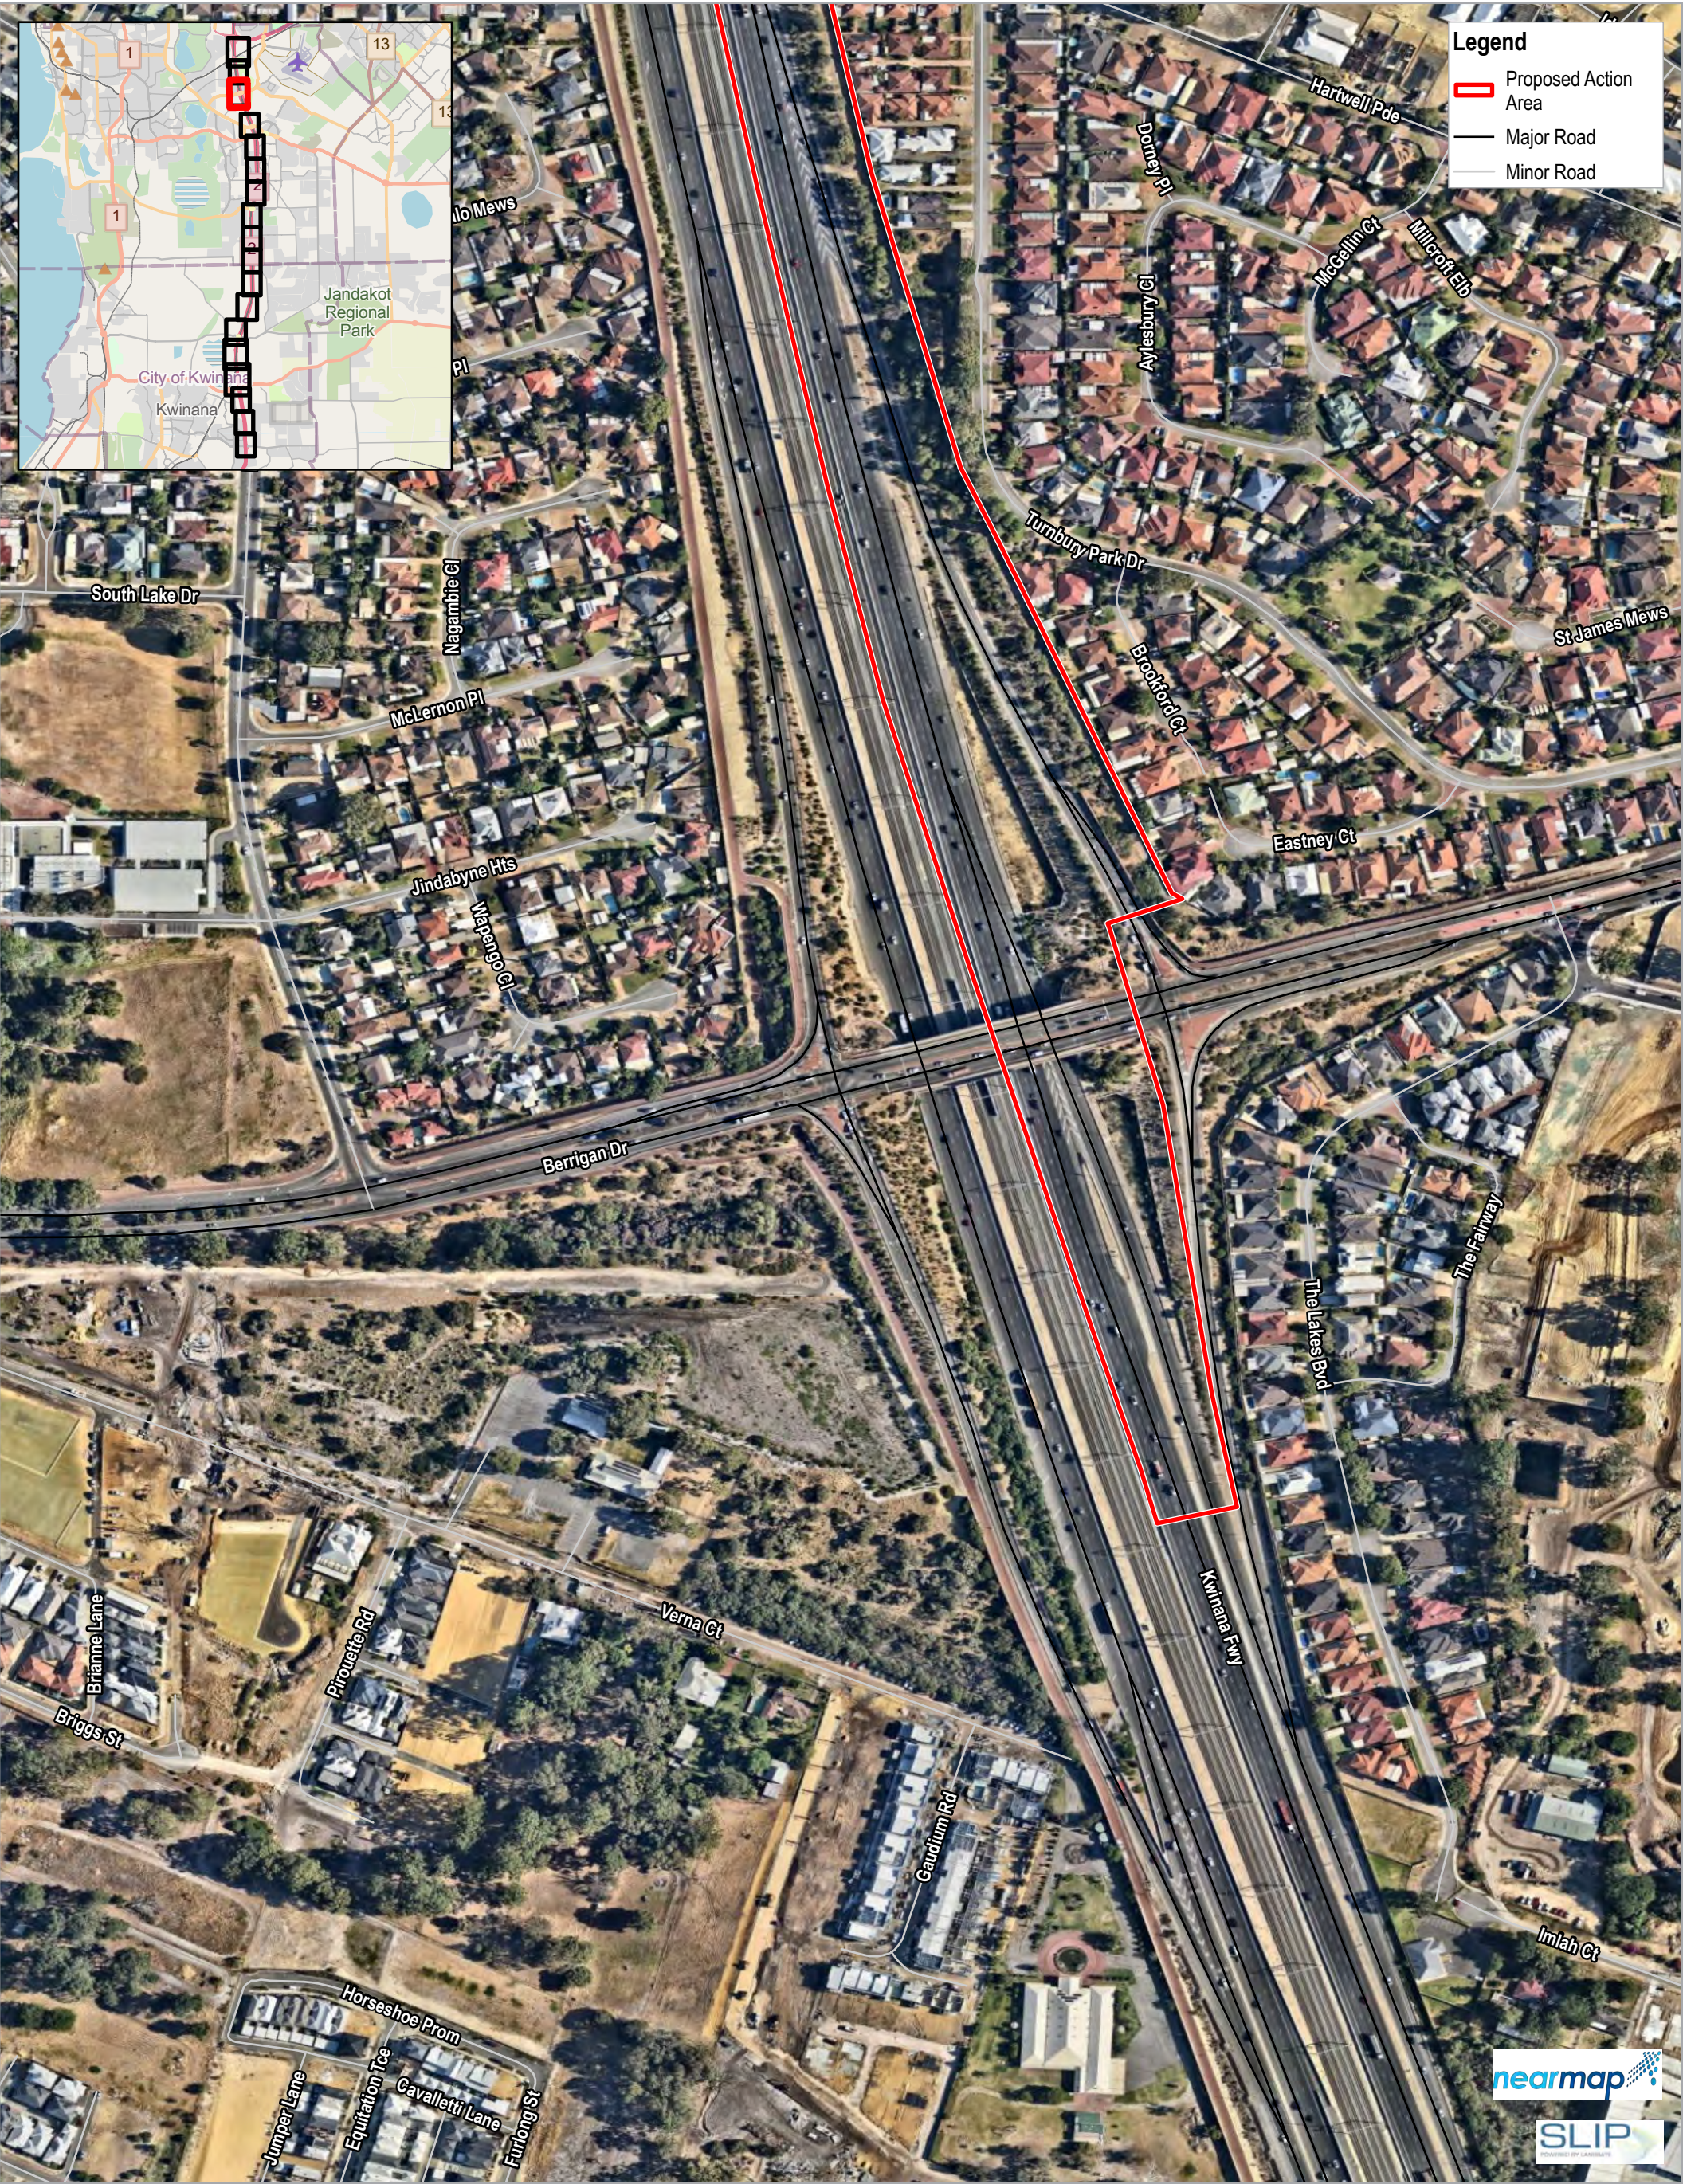
Figure 2      Banksia Woodlands of the Swan Coastal Plain TEC patches

The locations of the Banksia TEC patches are show in Figure 2.

**Banksia Woodlands of the Swan  
Coastal Plain TEC Patches**
