Bunbury Outer Ring Road

Southern Section

Priority and Threatened Ecological
Communities - Baseline Report

Bunbury Outer Ring Road (Southern Section) - Threatened and Priority Ecological Communities
Vegetation and Drainage Monitoring - Baseline Report (EcoEdge, 2022)

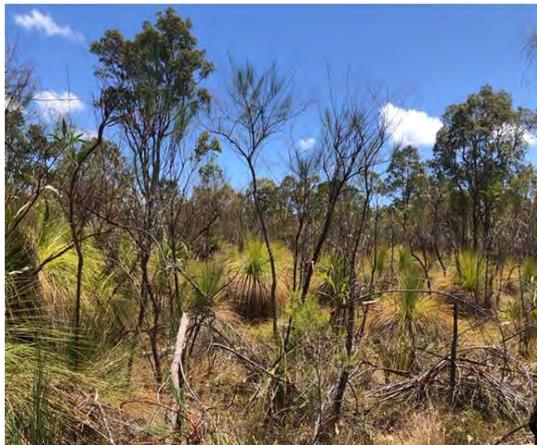
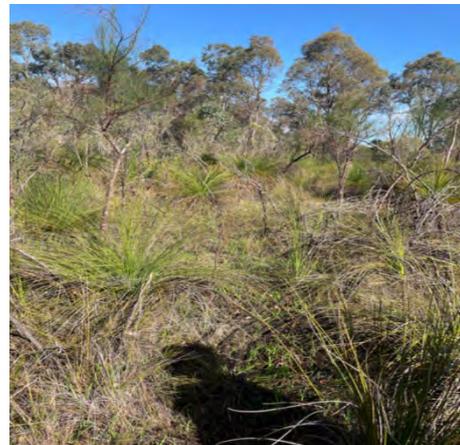
Figure 8. No inundation but yellowing of *Xanthorrhoea preissii* leaves at site CP-NS-R-1, in 2020 and in 2022 in a healthier state.

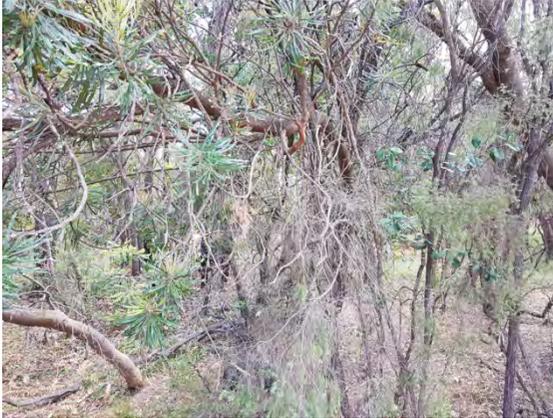
1 BW-S-PI-5_P09

20/11/19 Good, 2-10% weeds

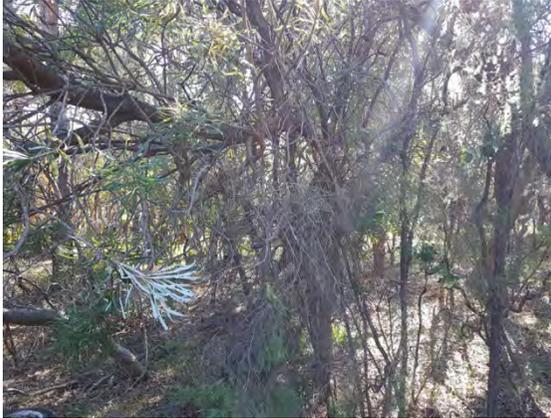
22/05/20 Good, 2-10% weeds

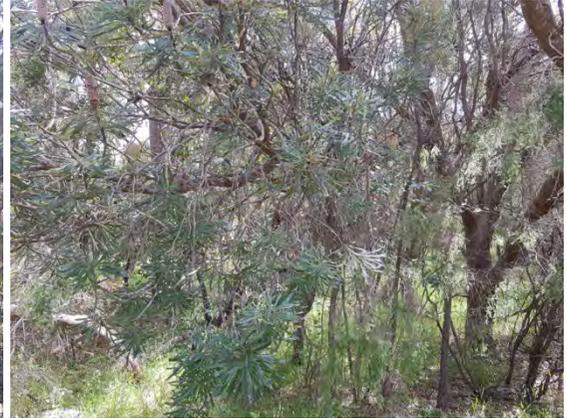
23/10/20 Good, 10-30% weeds

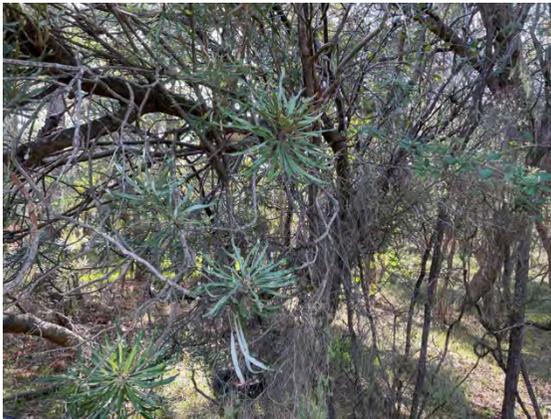
25/05/22 Good, 30-70% weeds

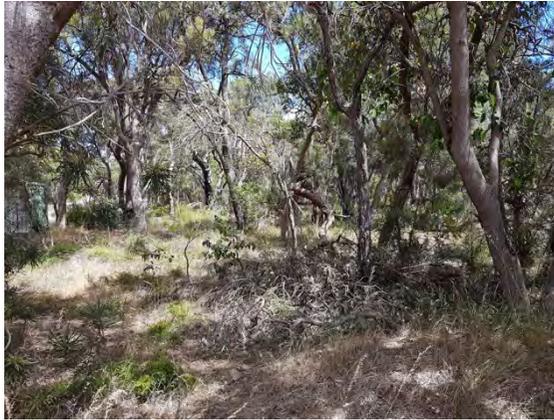
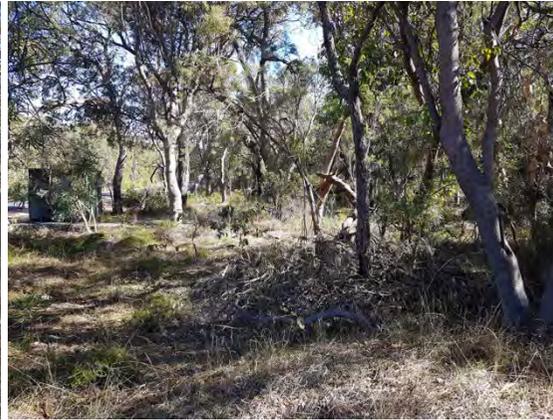
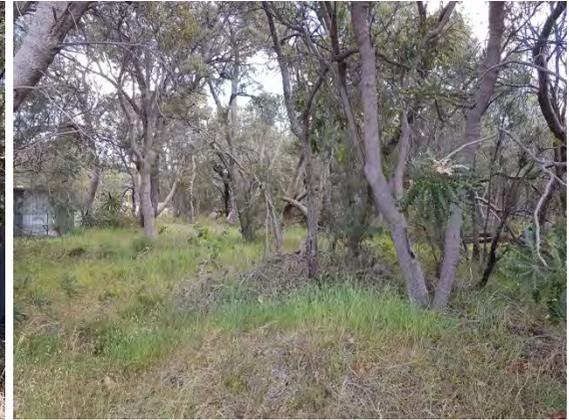
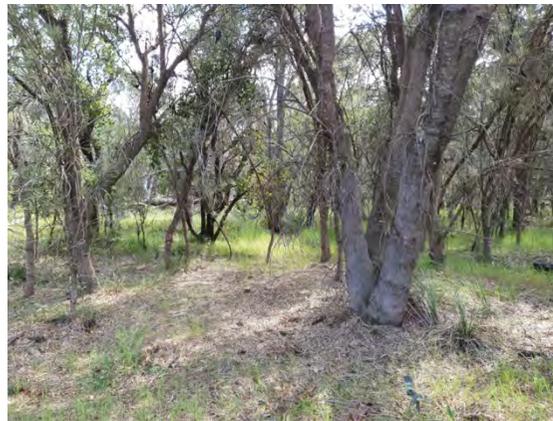
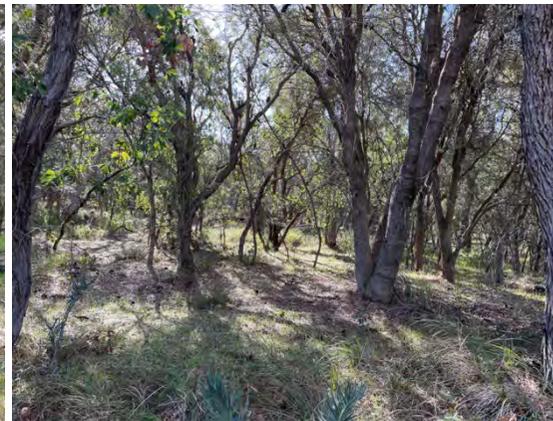
2 BW-S-PI-5_P10

20/11/19 Good, <2 weeds

22/05/20 Good, <2% weeds

23/10/20 Good, 2-10% weeds

14/10/2021 Good, 2-10% weeds

25/05/2022 Good, 10 – 30% weeds

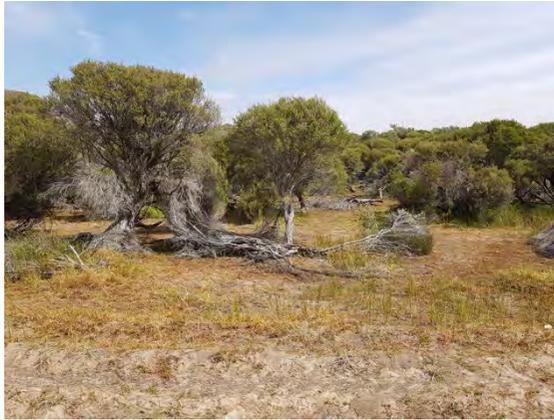
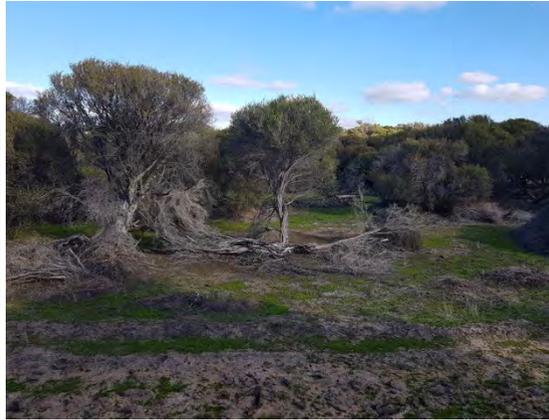
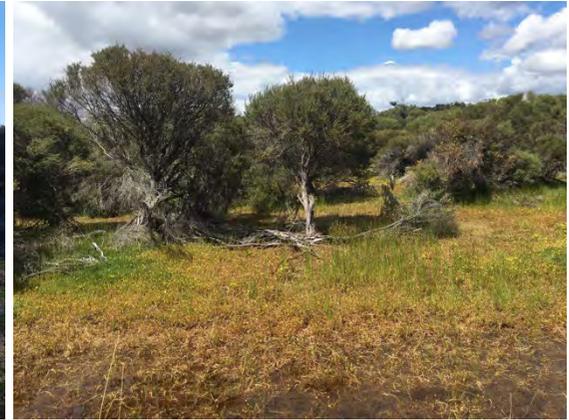
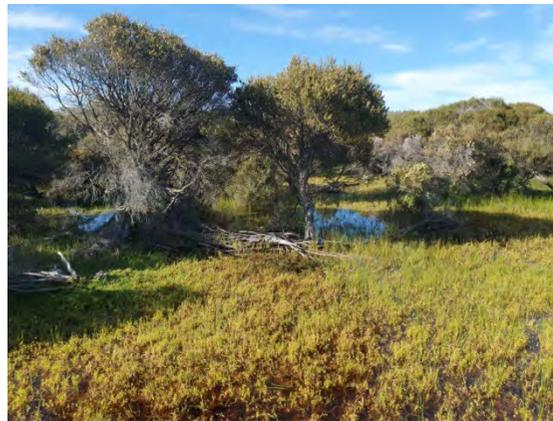
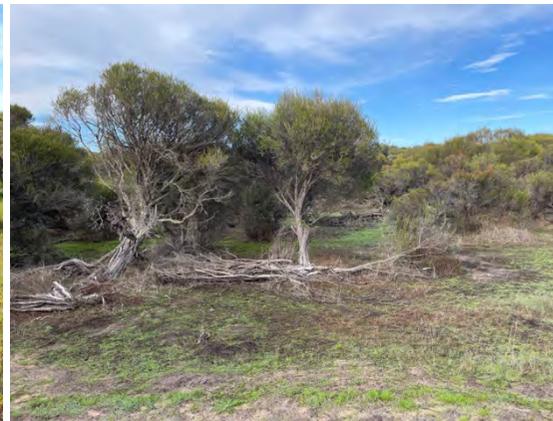
3 CP-S-PI-1_P01

6/11/19 Degraded, 10-30% weeds

20/05/20 Degraded, 10-30% weeds

21/10/20 Degraded, 30-70% weeds

15/10/21 Degraded, 30-70% weeds

26/05/22 Degraded, 30-70% weeds

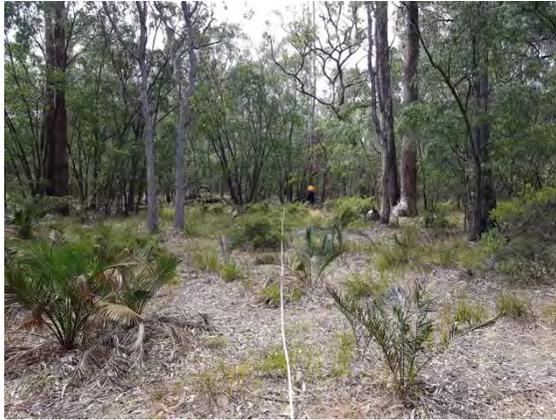
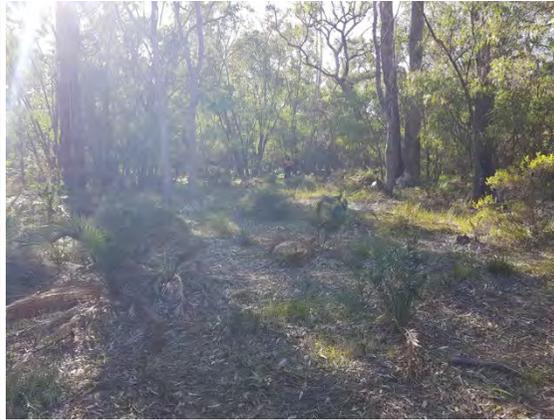
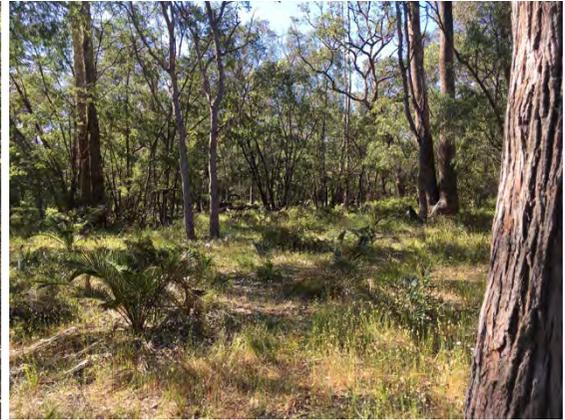
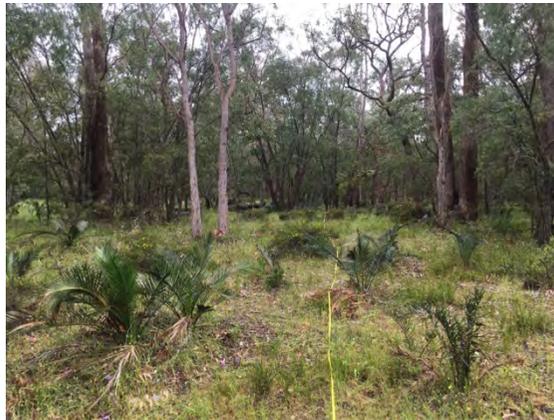
4 BTW-S-R-2_T1S

22/11/19 Very Good

22/05/20 Very Good, 2-10% weeds

26/10/20 Very Good, 10-30% weeds

23/10/21 Very Good, 10-30% weeds

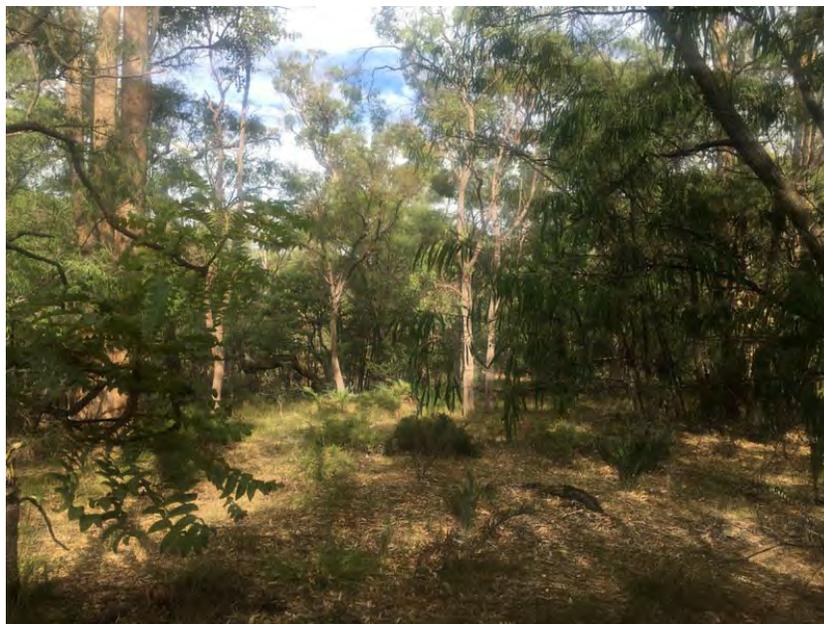
Photo direction	Northeast
General comments	Site appears generally healthy, no abnormal drying effects observed.

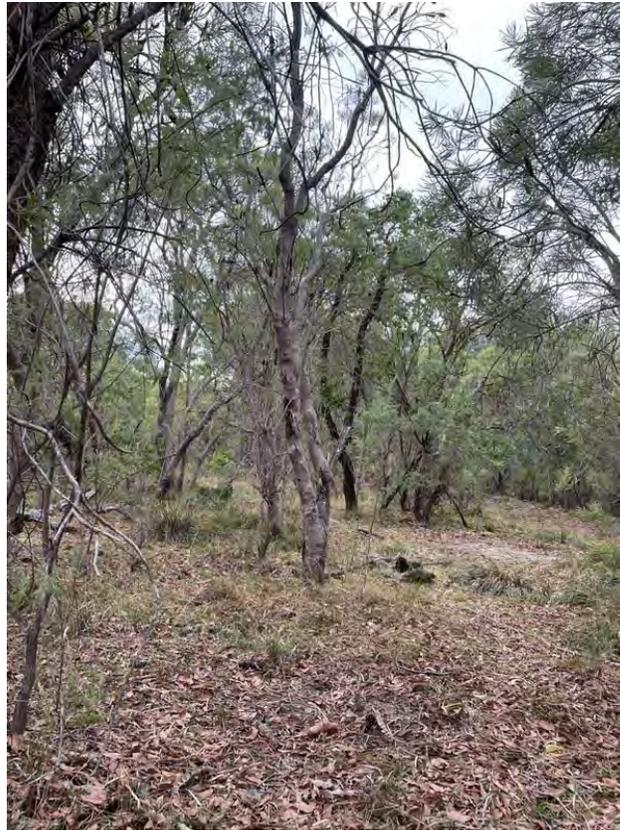
Created	2022-05-26 01:08:31 UTC by Debbie Brace
Updated	2022-05-26 06:51:14 UTC by Debbie Brace
Location	-33.38581398208233, 115.6514684495408
Site name	BW-S-PI-1
Point name	BW-S-PI-1
Recorder	Debbie Brace
Date	2022-05-26
Issue Y/N	No

General comments	No issue
------------------	----------

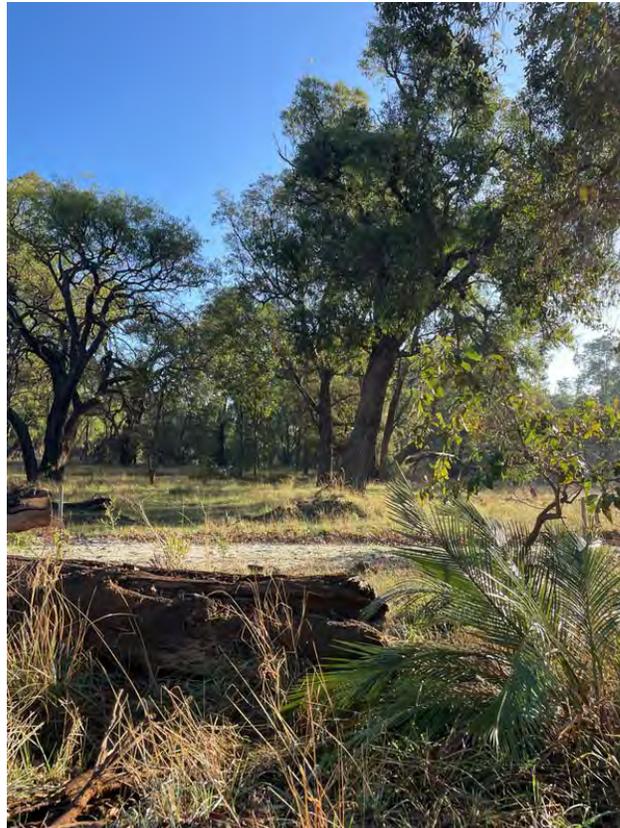
Created	2022-05-25 01:05:40 UTC by Debbie Brace
Updated	2022-06-21 01:27:33 UTC by Debbie Brace
Location	-33.416336081215285, 115.66270378971014
Site name	BW-S-PI-2
Point name	BW-S-PI-2
Recorder	Debbie Brace
Date	2022-05-25
Issue Y/N	No

Photo direction	North
General comments	No issue

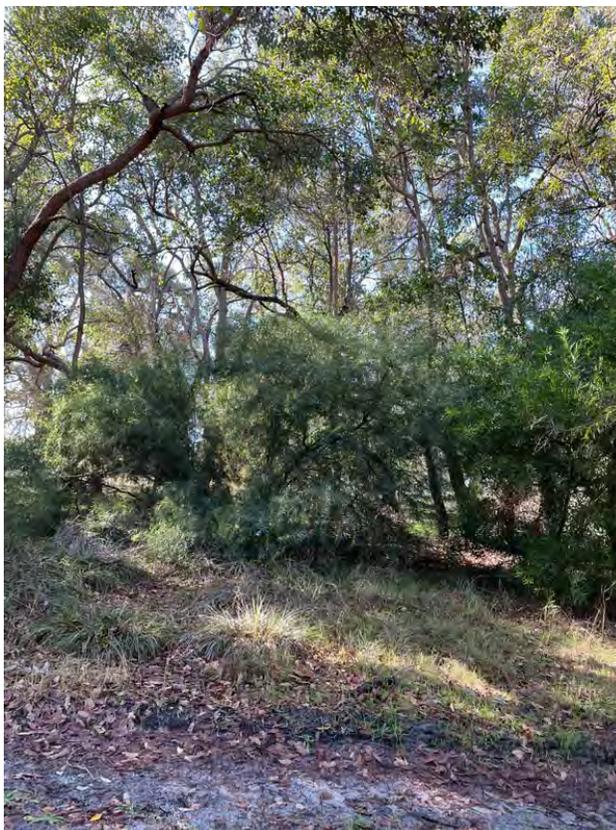
Created	2022-05-25 02:54:54 UTC by Debbie Brace
Updated	2022-05-26 06:56:27 UTC by Debbie Brace
Location	-33.422771479133154, 115.64726080745459
Site name	BW-S-PI-3
Point name	BW-S-PI-3
Recorder	Debbie Brace
Date	2022-05-25
Issue Y/N	No

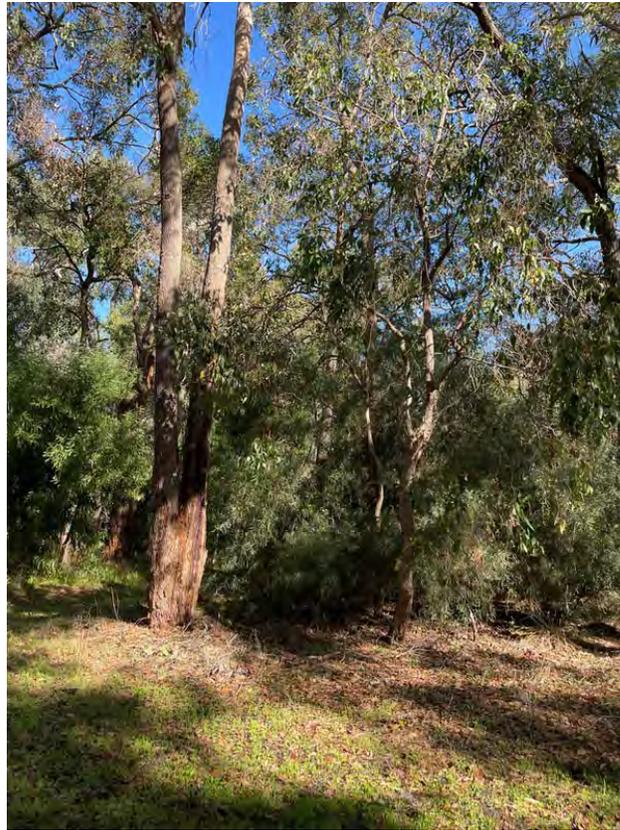
Created	2022-05-25 02:56:39 UTC by Debbie Brace
Updated	2022-06-21 01:26:04 UTC by Debbie Brace
Location	-33.42754823918287, 115.64018979287202
Site name	BW-S-PI-4
Point name	BW-S-PI-4
Recorder	Debbie Brace
Date	2022-05-25
Issue Y/N	No

General comments	No issue
------------------	----------

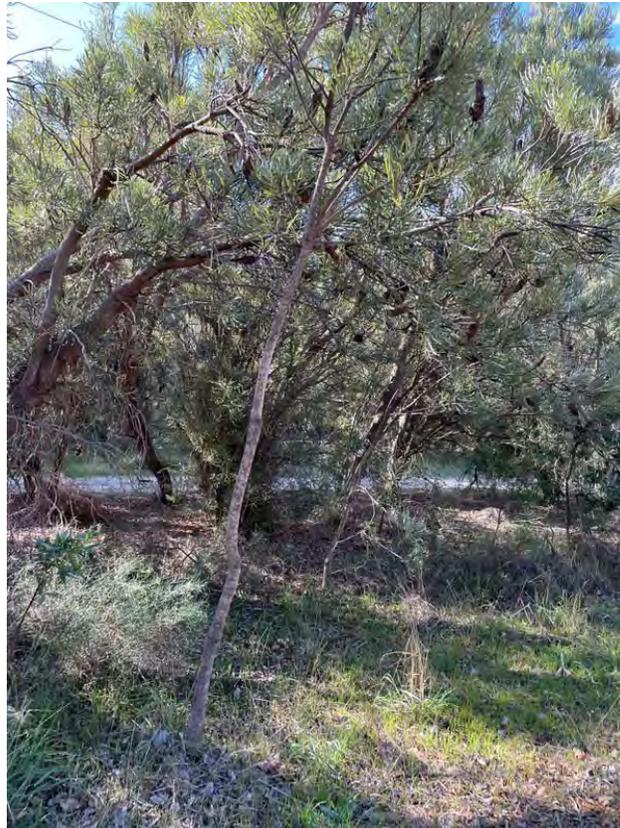
Created	2022-05-25 06:07:36 UTC by Debbie Brace
Updated	2022-06-21 01:39:26 UTC by Debbie Brace
Location	-33.43892043358543, 115.61399169266222
Site name	BW-S-PI-5
Point name	BW-S-PI-5
Recorder	Debbie Brace
Date	2022-05-25
Issue Y/N	No

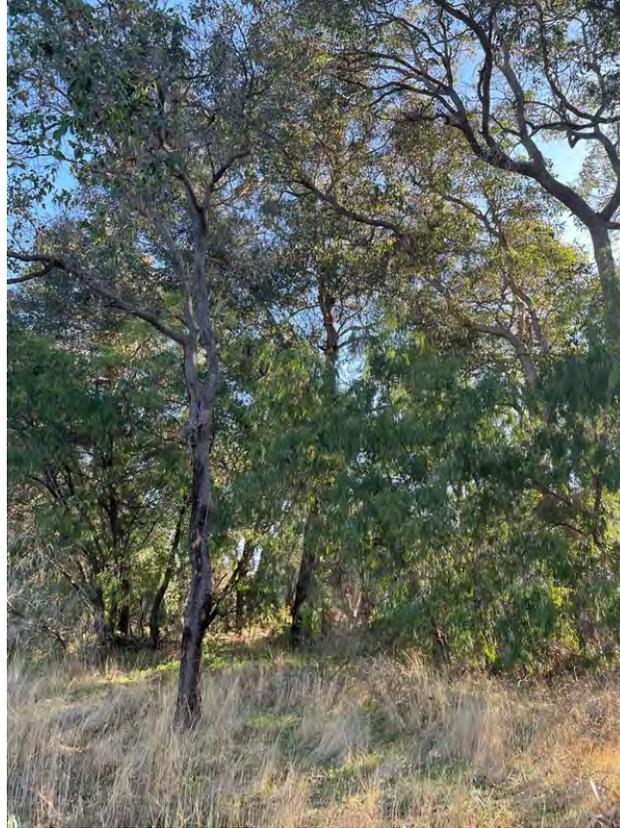
Created	2022-05-25 07:04:19 UTC by Debbie Brace
Updated	2022-06-21 01:40:35 UTC by Debbie Brace
Location	-33.45177007665466, 115.60600176025969
Site name	BW-S-PI-6
Point name	BW-S-PI-6
Recorder	Debbie Brace
Date	2022-05-25
Issue Y/N	No

General comments	No issue
------------------	----------

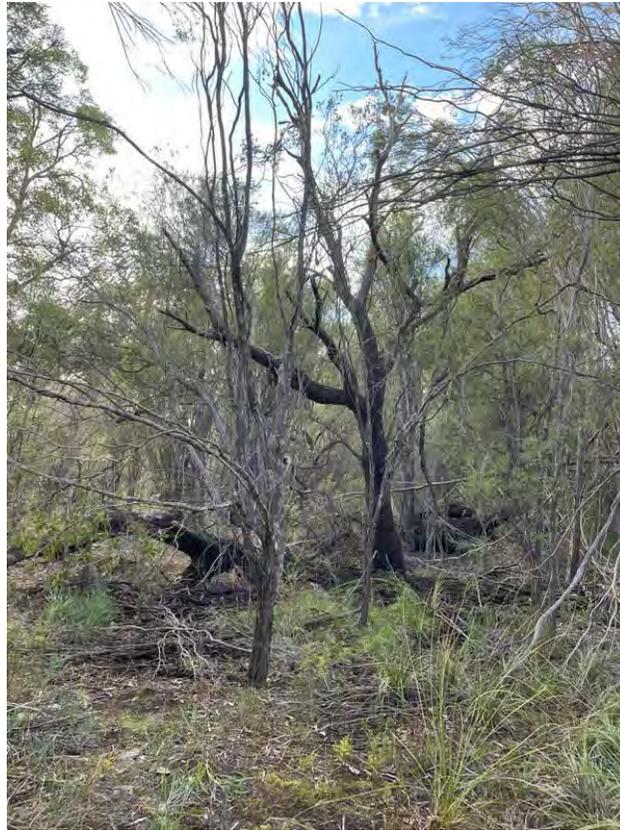
Created	2022-05-26 00:26:02 UTC by Debbie Brace
Updated	2022-05-26 07:15:02 UTC by Debbie Brace
Location	-33.374419292207726, 115.65891617695927
Site name	BW-S-R-1_T1
Point name	BW-S-R-1_T1
Recorder	Debbie Brace
Date	2022-05-26
Issue Y/N	No

General comments	No issue
------------------	----------

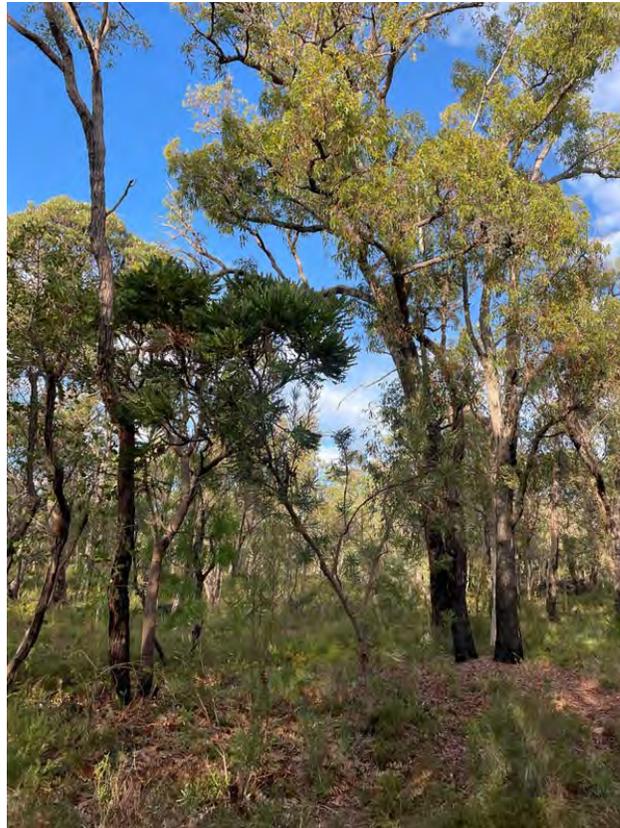
Created	2022-05-26 00:40:06 UTC by Debbie Brace
Updated	2022-05-26 07:14:08 UTC by Debbie Brace
Location	-33.37935282752947, 115.65655162572875
Site name	BW-S-R-1_T2
Point name	BW-S-R-1_T2
Recorder	Debbie Brace
Date	2022-05-26
Issue Y/N	No

General comments	No issue
------------------	----------

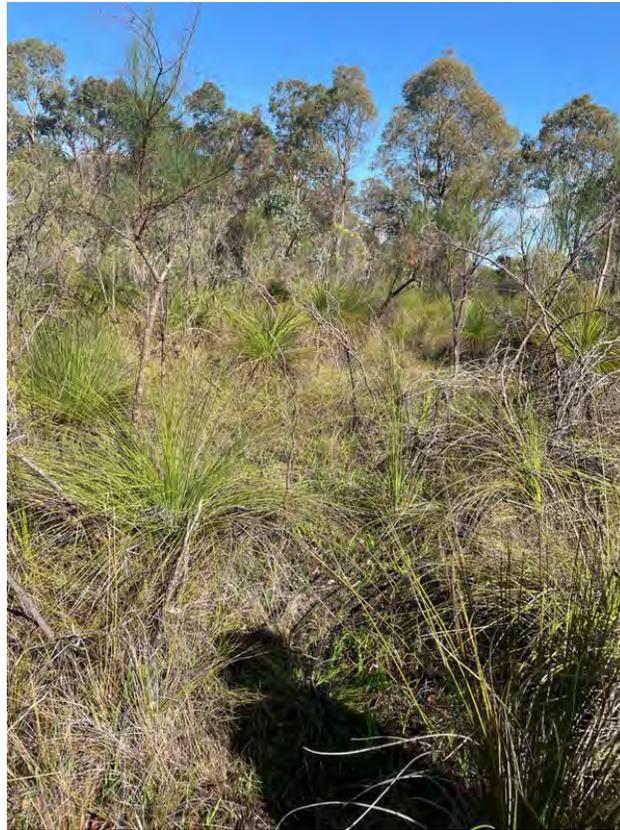
Created	2022-05-24 03:33:46 UTC by Debbie Brace
Updated	2022-05-26 06:30:10 UTC by Debbie Brace
Location	-33.327461892375375, 115.76989785301751
Site name	CP-NS-R-1
Point name	CP-NS-R-1
Recorder	Debbie Brace
Date	2022-05-24
Issue Y/N	No

Southwest

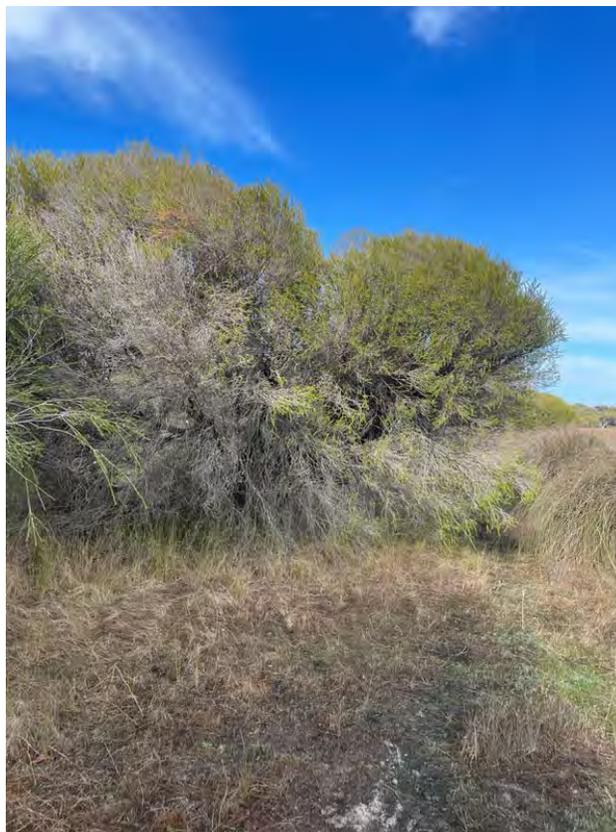
Created	2022-05-26 01:52:09 UTC by Debbie Brace
Updated	2022-05-26 06:49:57 UTC by Debbie Brace
Location	-33.38476611304412, 115.66191287722035
Site name	CP-NS-R-2
Point name	CP-NS-R-2
Recorder	Debbie Brace
Date	2022-05-26
Issue Y/N	No

General comments	No issue
------------------	----------

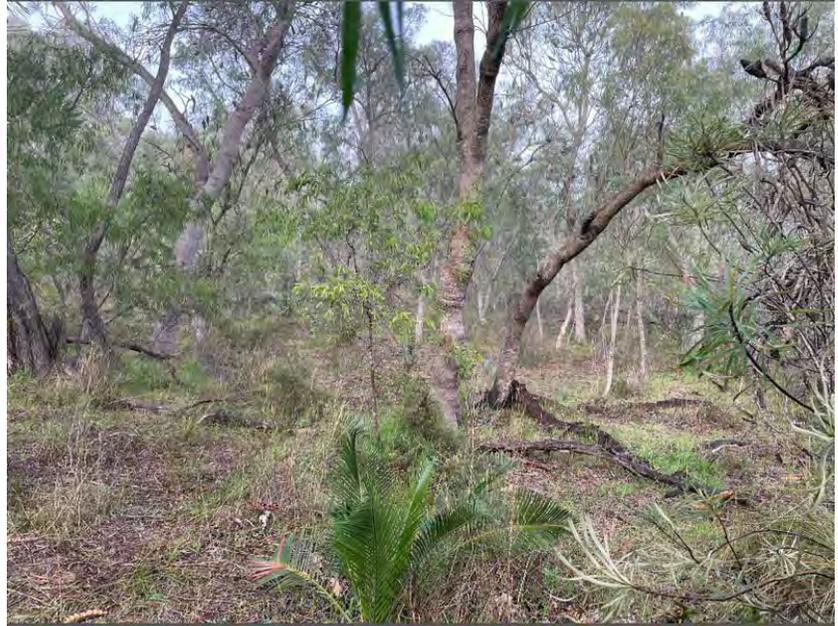
Photo direction	South
General comments	No issues

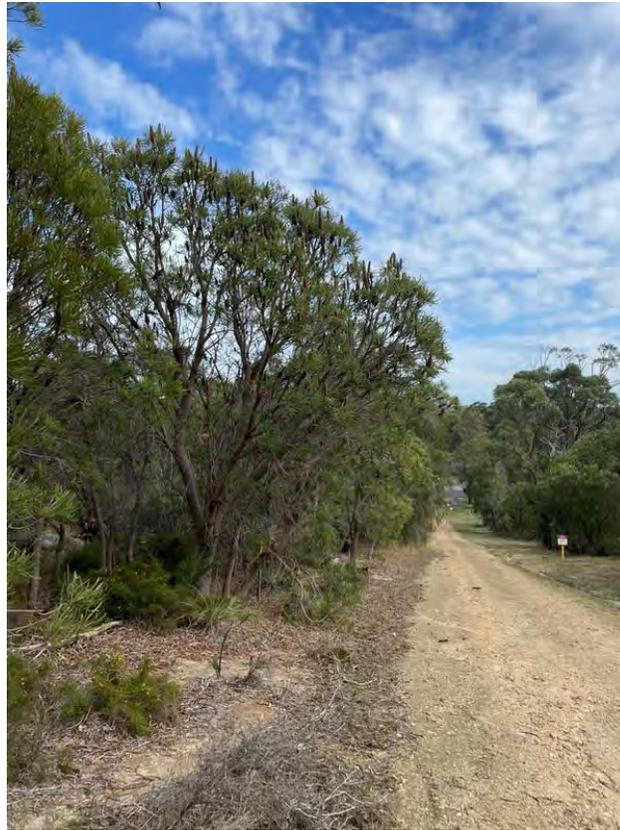
Created	2022-05-26 02:55:23 UTC by Debbie Brace
Updated	2022-05-26 06:52:00 UTC by Debbie Brace
Location	-33.38536583821613, 115.64596488151294
Site name	TW-S-PI-2
Point name	TW-S-PI -2
Recorder	Debbie Brace
Date	2022-05-26
Issue Y/N	No

General comments	No issue
------------------	----------

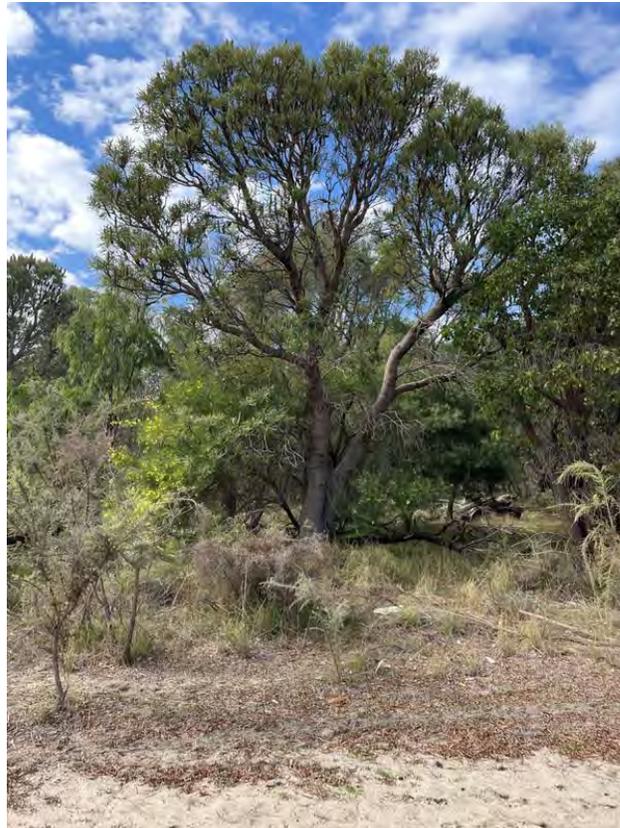
Created	2022-05-26 03:31:34 UTC by Debbie Brace
Updated	2022-05-26 06:53:41 UTC by Debbie Brace
Location	-33.3880097217998, 115.64355311856868
Site name	TW-S-PI-3
Point name	TW-S-PI-3
Recorder	Debbie Brace
Date	2022-05-26
Issue Y/N	No

General comments	No issue
------------------	----------
