NorthLinkWA
Perth-Darwin National Highway

Condition Environmental Management Plan

Flora and Vegetation – Progressive Rehabilitation

Perth–Darwin National Highway (Swan Valley Section)

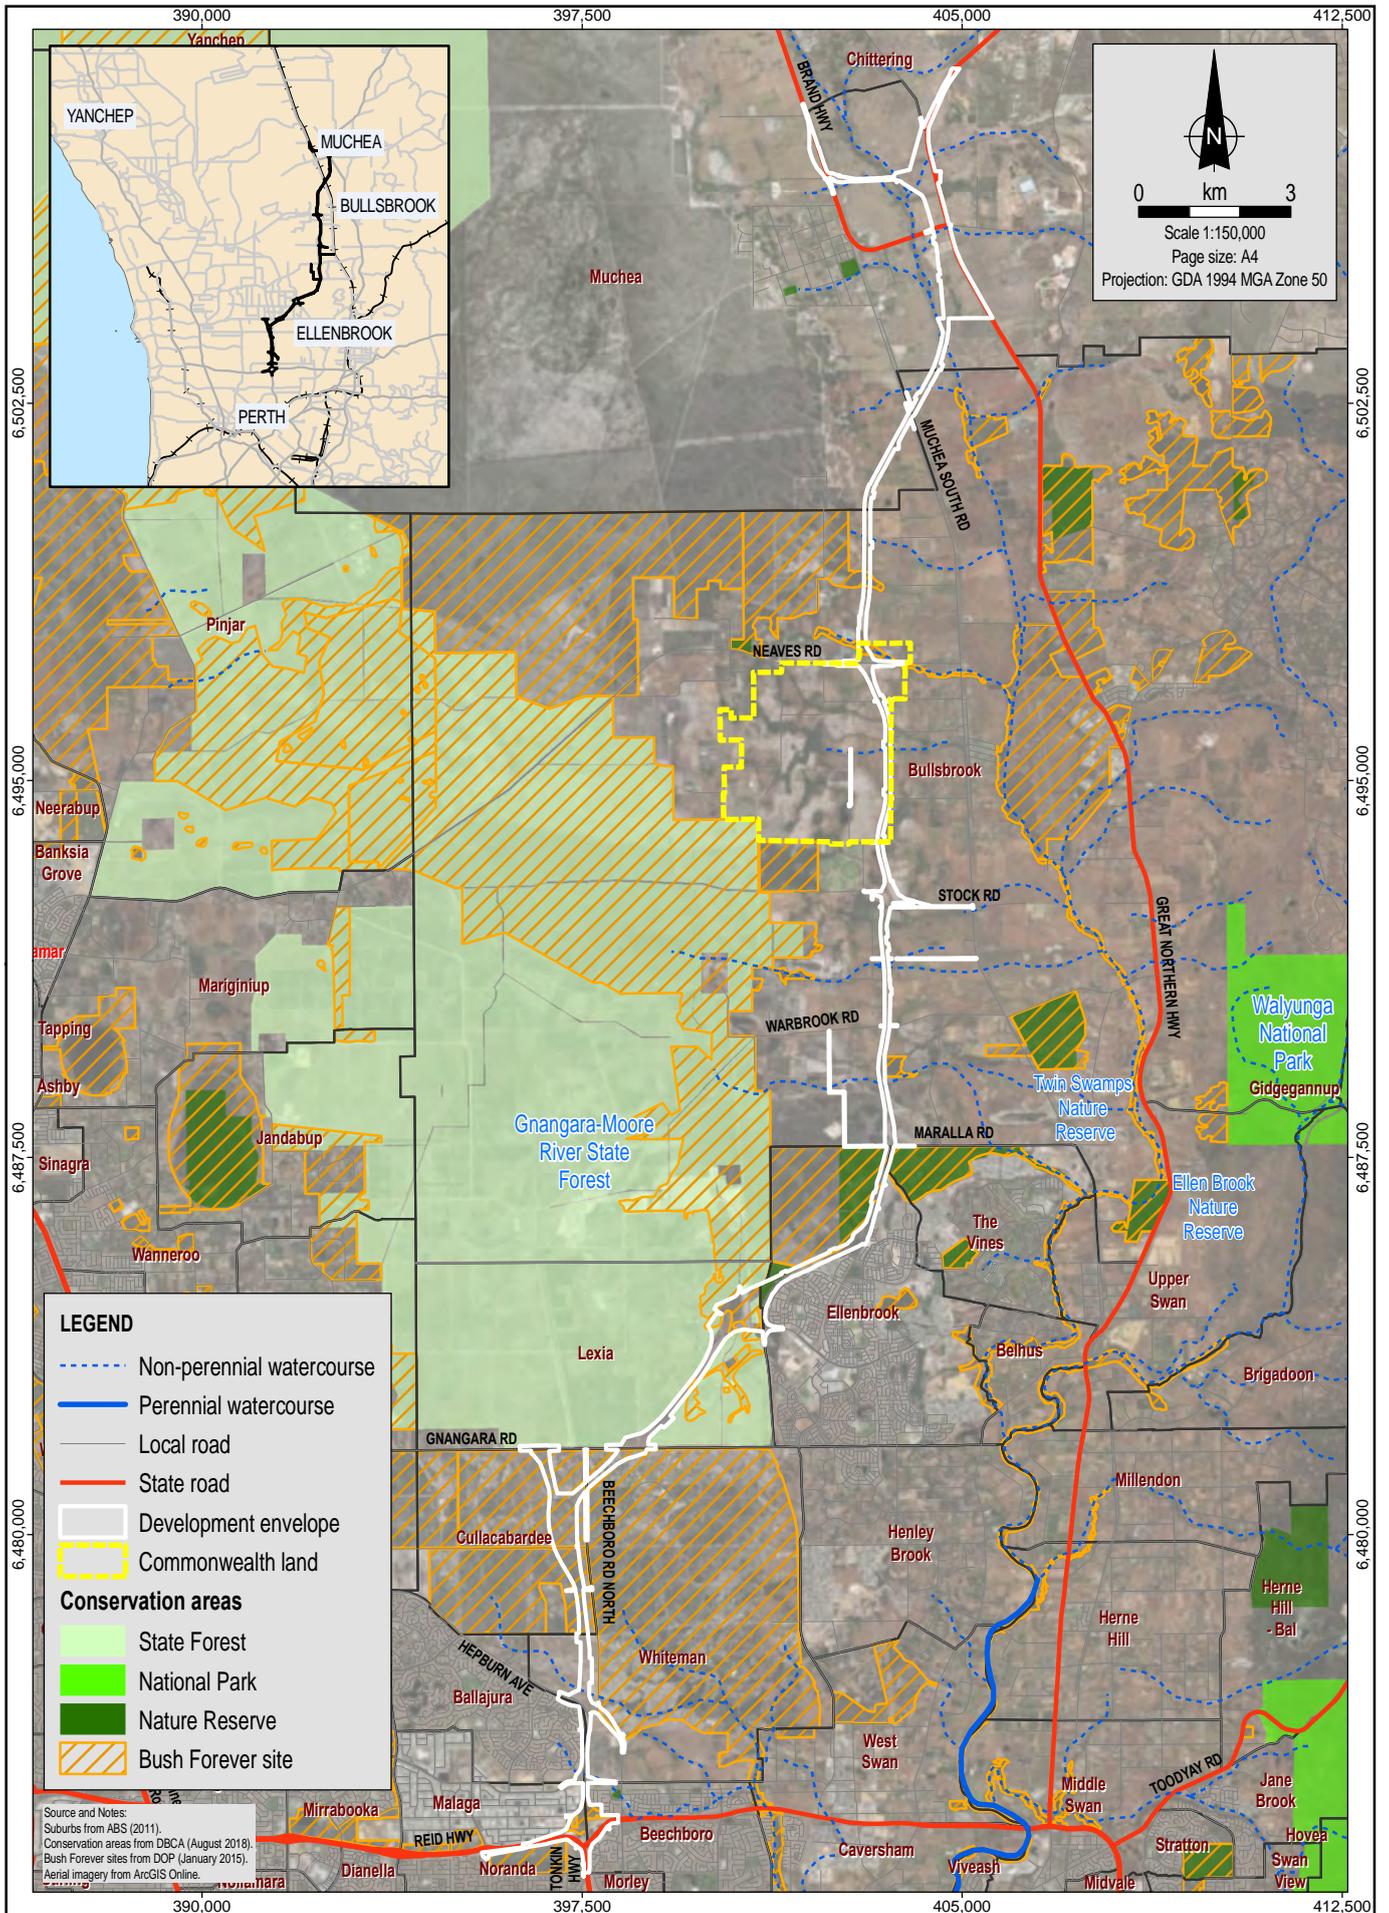
MRWA proposes to construct a new 38 km section of the Perth–Darwin National Highway (PDNH) (Figure 1) between Malaga and Muchea in Western Australia (the proposal). The proposal will consist of a dual carriageway highway and will connect the intersection of Tonkin Highway and Reid Highway in the south with Great Northern Highway and Brand Highway in the north.

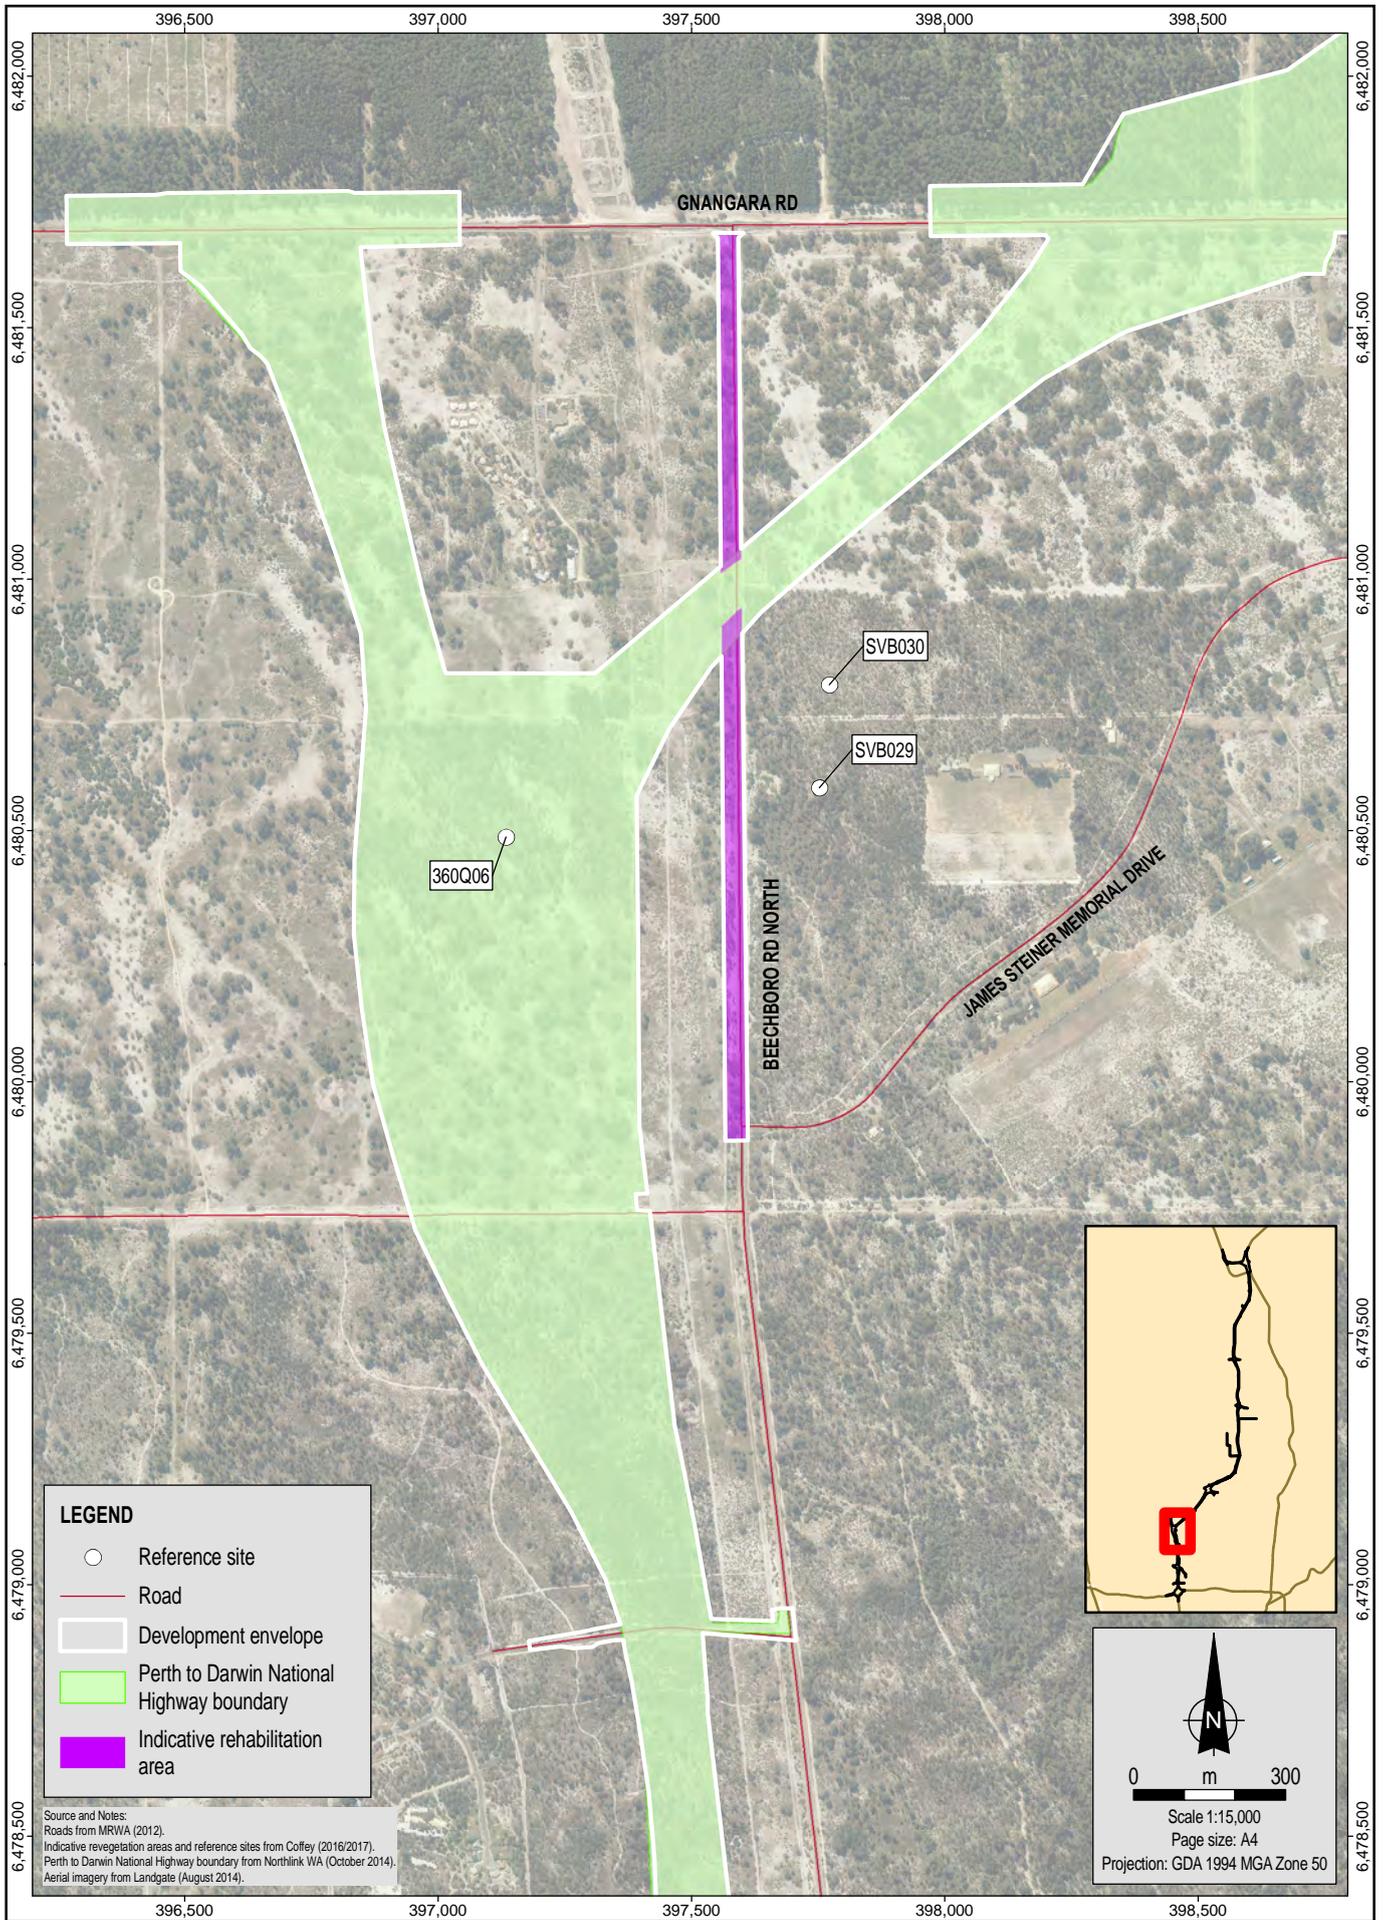
The section of Beechboro Road North from Jules Steiner Memorial Drive to Gngara Road will be decommissioned and revegetated (the rehabilitation site) (Figure 2).

Reference sites used in developing the completion criteria are the quadrats 360Q06, SVB029 and SVB030 (shown in Figure 2) from the Level 2 floristic survey carried out as part of the PER (Coffey, 2015b). These quadrats are the closest to the rehabilitation site for which full data is readily obtainable. Table 7 contains a summary of species richness and projected foliage cover from these three sites. A list of species found in these sites is included in Appendix A.
