# Bunbury Outer Ring Road

## Southern Section

Ministerial Statement 1191

Compliance Assessment Report

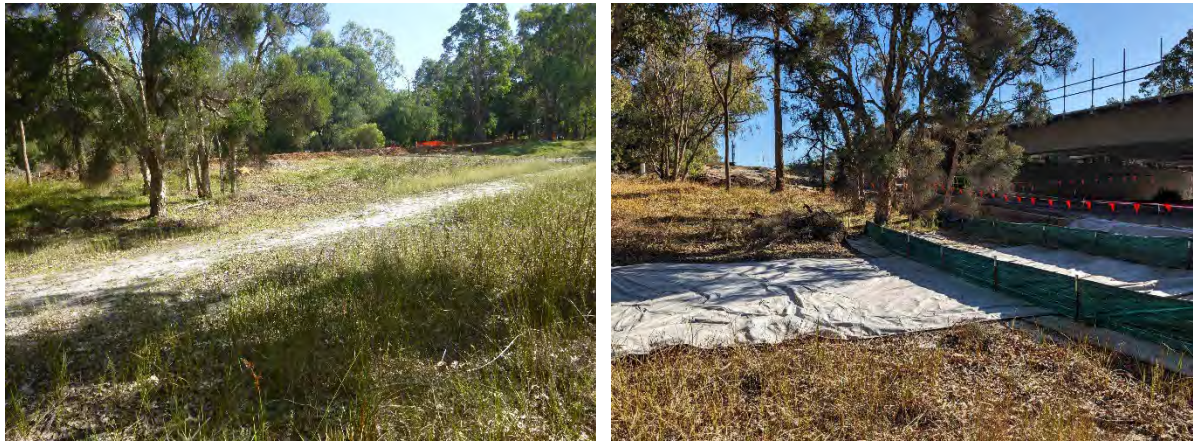
**Plate 1.** Differences in sampling habitat and the development of construction at BSM-S-PI-1.  
Left: BSM-S-PI-1 in Q2 2023. Right: BSM-S-PI-1 in Q2 2024.

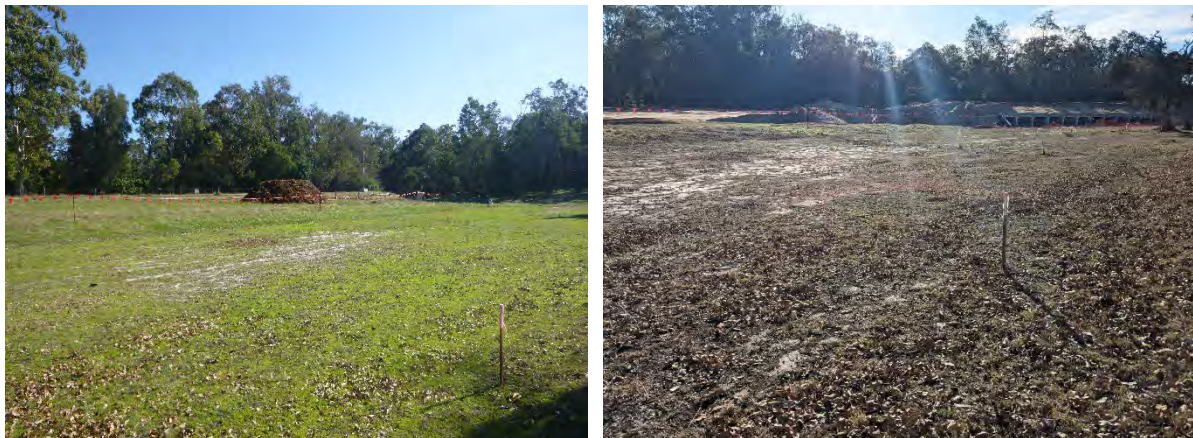
The installation of large box-culverts downstream of the BSM-S-PI-2 was also observed during this sampling period. Clearing works commenced directly after Q2 monitoring in 2023, with the completed installation of the culverts in Q2 2024 (Plate 2). Additional construction works are ongoing in the area.

**Plate 2.** Ongoing construction works at BSM-S-PI-2 from photopoint monitoring locations.  
Left: BSM-S-PI-2 during Q2 monitoring 2023. Right: BSM-S-PI-2 in Q2 2024.

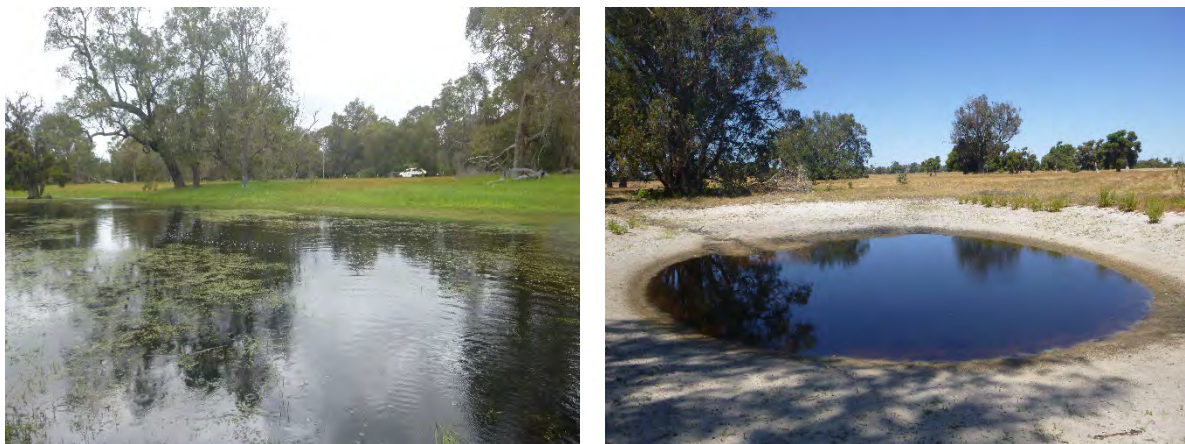
**Plate 3.** Differences in sampling habitat and water depth at BSM-S-PI-2. Left: BSM-S-PI-2 during annual BSM sampling in 2022 (Q3). Right: BSM-S-PI-2 in Q4 2023.

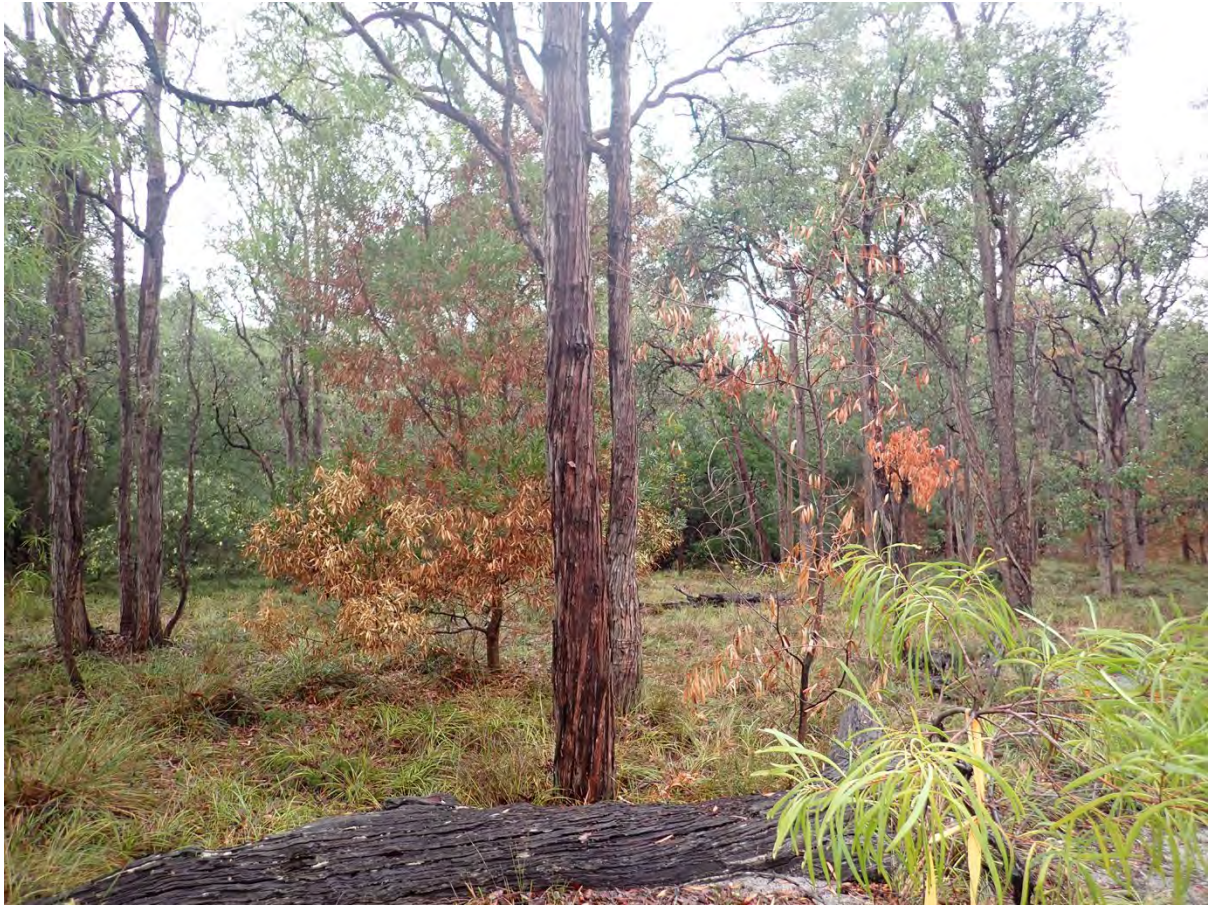
Figure 21. Dead *Acacia longifolia* trees within BW-S-PI-4.

The impact of drought was evident across the site with but was not uniform. The impacts were scattered with some species being more affected than others including young jarrah trees and *Xylomelum occidentale* and interestingly the weed species *Acacia longifolia* (**Figure 21**).

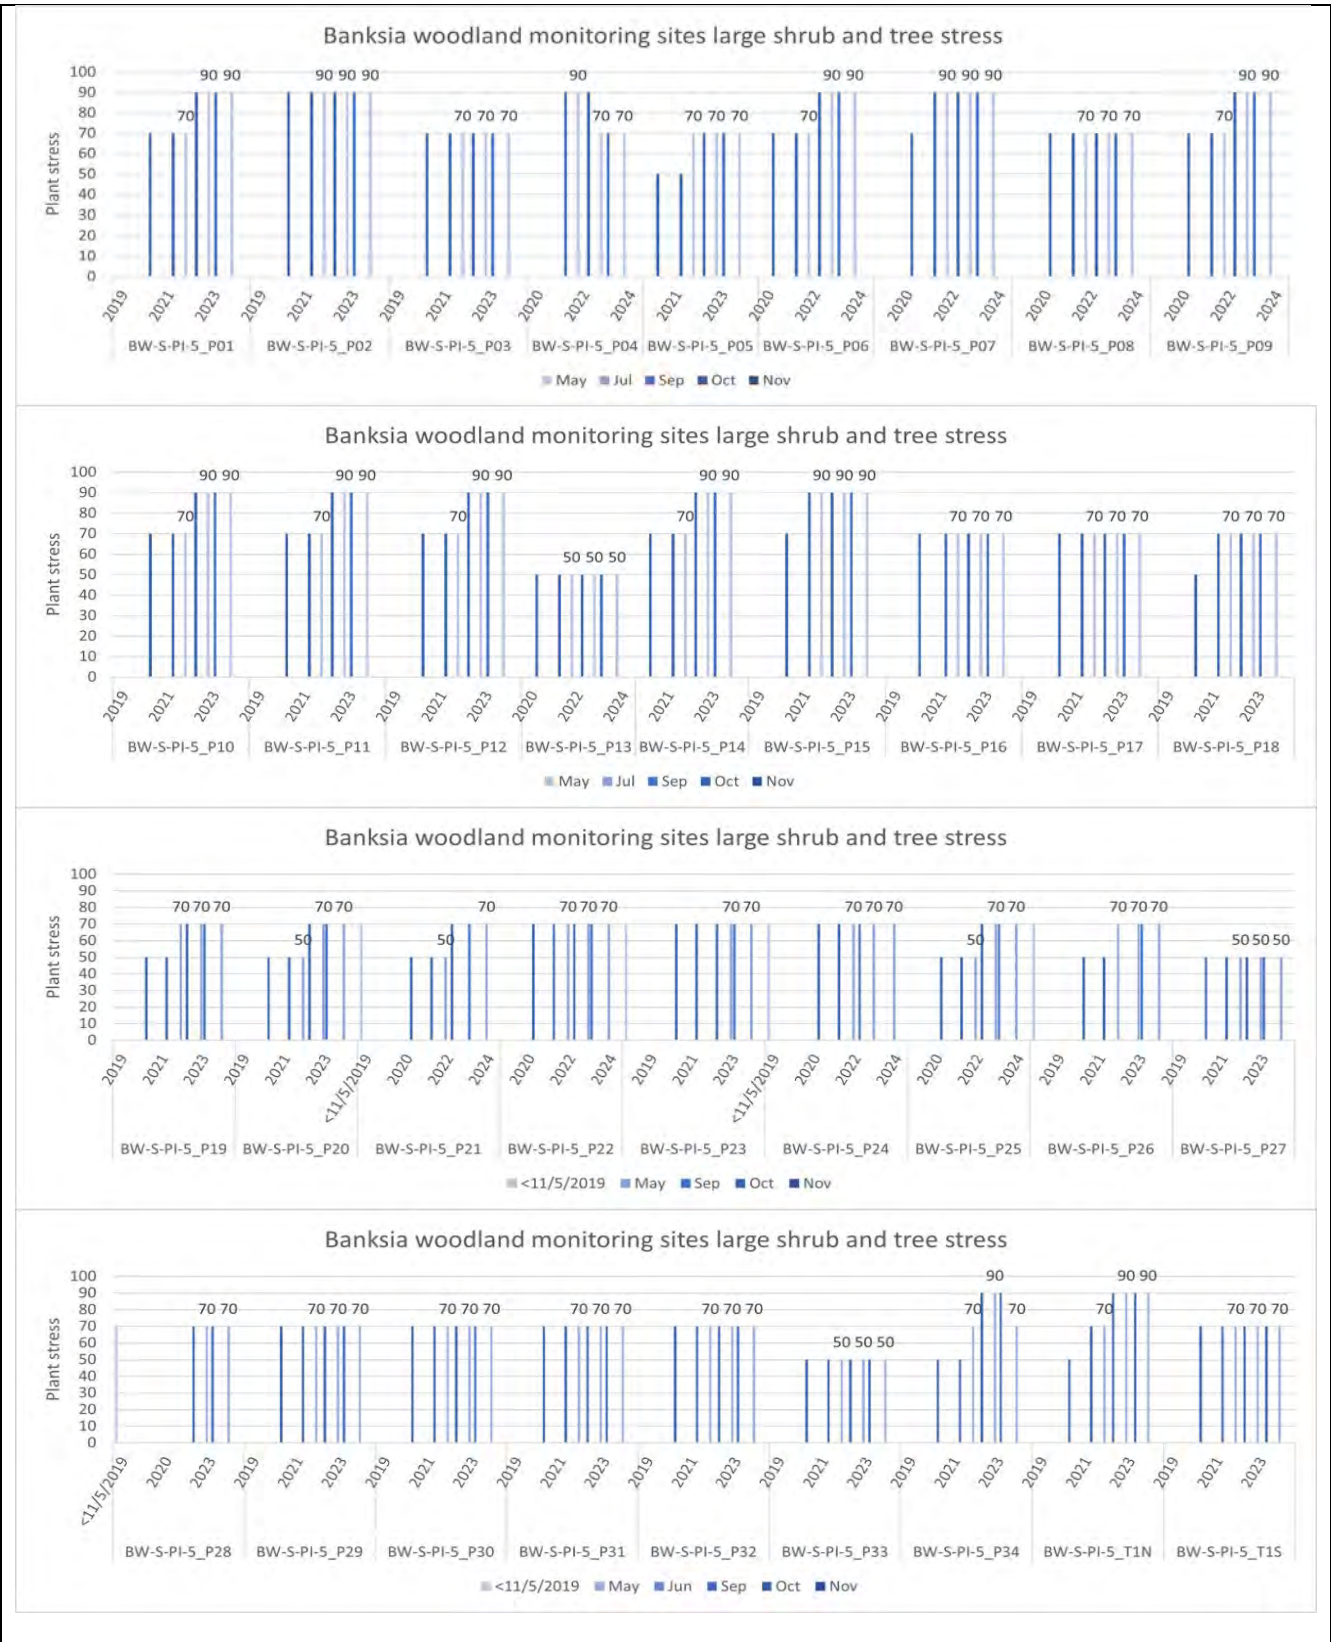
Figure 22. Change in average large shrub and tree stress for Banksia woodland potential impact site BW-S-PI-5.

BW-S-PI-5 has 36 monitoring points. Stress levels in trees and large shrubs have remained stable at 16 sites, reduced at 18 sites and increased at only two sites (BW-S-PI-5\_P04 and P34) since monitoring commenced in 2019. The reduction in stress and overall stability at the site is attributed recuperation of stressed trees and large shrubs with persistent average rains which followed the drier and warmer than average 2019 monitoring period (**Figure 22**).

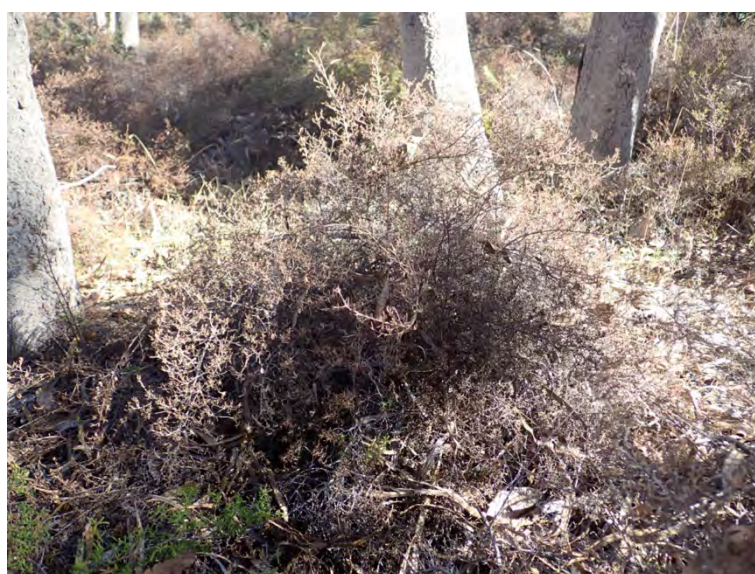
Figure 23. Drought affected *Hibbertia hypericoides* located near BW-S-PI-5\_P23.

Similar to other sites such as BW-S-PI-3 the impacts of the record summer / autumn 2024 drought were evident but scattered or patchy and largely limited to certain species – such as *Banksia grandis*, *Banksia attenuata*, *Eucalyptus marginata* (mostly saplings) and the small shrub *Hibbertia hypericoides* (**Figure 23**). **Figure 24** and **Figure 25** show the variable pattern of stress in the vegetation with some areas such as **Figure 24** directly adjacent recent clearing along Bussell Highway appearing unstressed and other such as **Figure 25** in the bush near monitoring point BW-S-PI-5\_P025 being stressed.

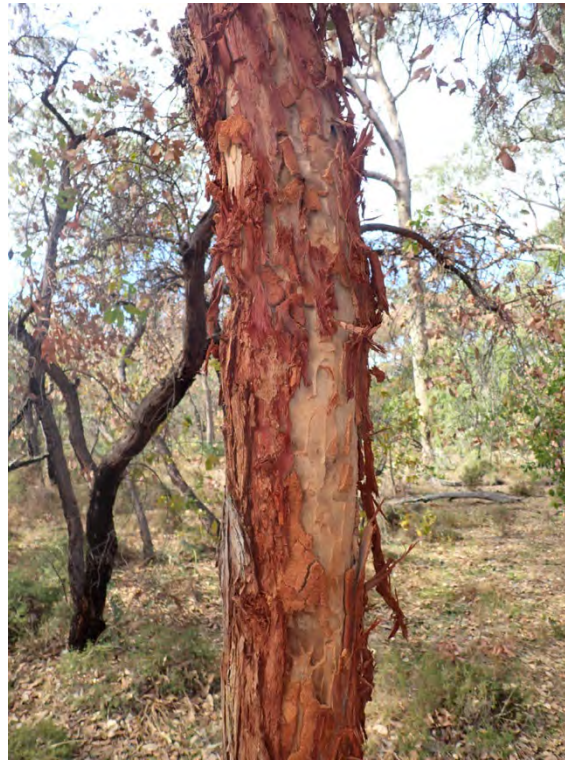
Figure 26. Highly stressed Jarrah sapling tunnelled out by Jarrah wood borer which has been predated by forest red-tail-cockatoos.

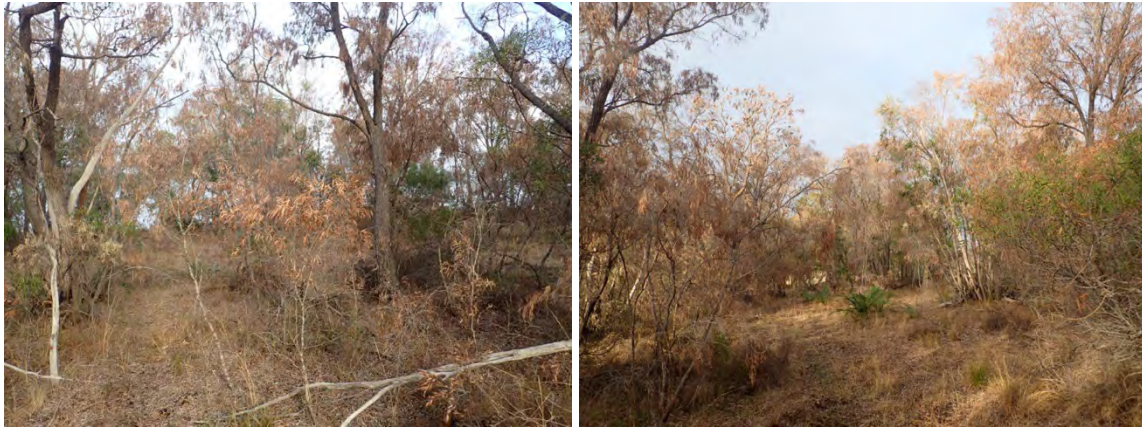
Figure 28. Stressed and dead *Agonis flexuosa* and *Banksia attenuata* near BW-S-PI-8\_P06 and P07.

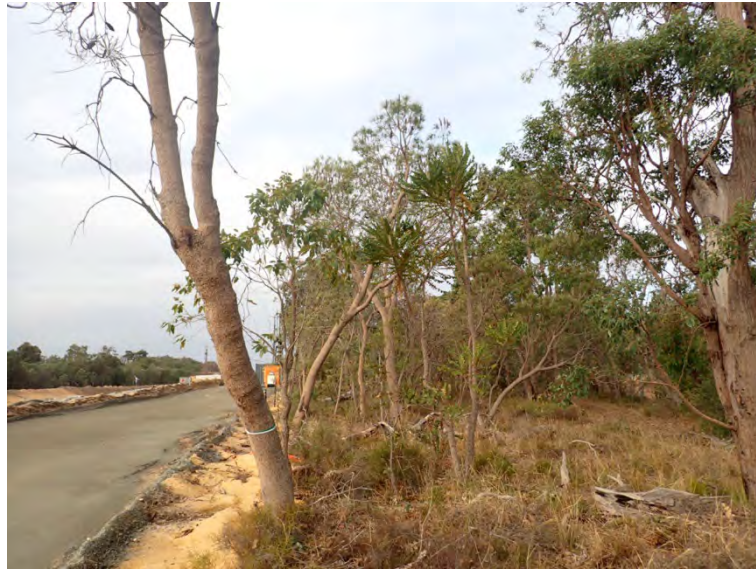
Figure 30. BW-S-PI-8 adjacent to cutting near BW-S-PI-8\_P01.

Although BW-S-PI-8 monitoring site is adjacent to batters constructed for the BORR, it is difficult to draw a link between the observations at this site and the BORR project. This is because of the patchiness of manifested stress with a mix of stressed and unstressed vegetation across the monitoring area, including vegetation immediately adjacent to the batters which was relatively unstressed compared to vegetation further from the batters (**Figure 31** and **Figure 32**). Potential impacts due to the batters are also likely to have been observed in previous monitoring rounds, including drainage monitoring rounds (**section 5.4**).

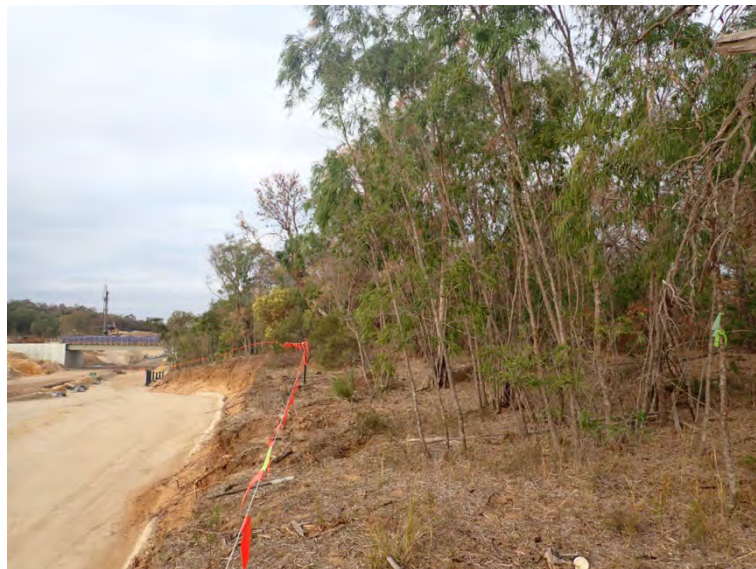
Figure 31. BW-S-PI-8 adjacent to cutting near BW-S-PI-8\_P06.

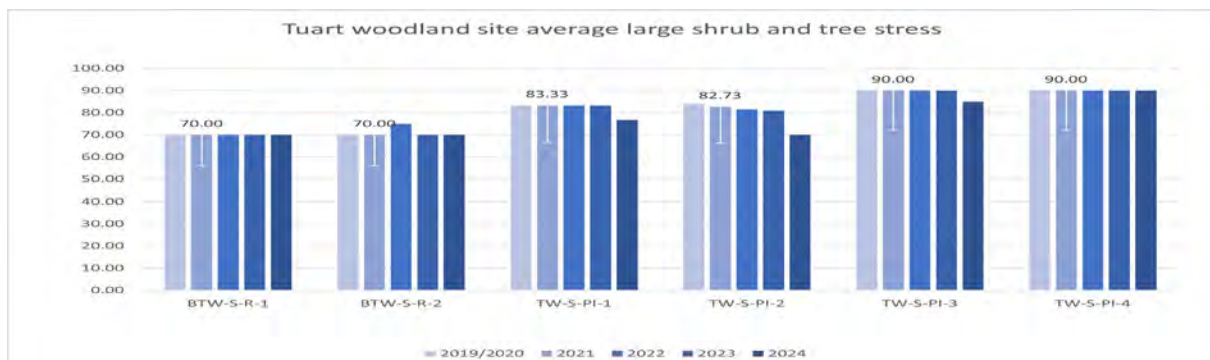
Figure 33. Change in average large shrub and tree stress for Tuart woodland potential impact and reference sites.

Average stress increased at two of the three Tuart woodland potential impact sites, (TW-S-PI-2 and TW-S-PI-3) relative to baseline levels, with largest increase in stress occurring at TW-S-PI-2. However, none of the average site increases was above 20%. The other potential impact site TW-S-PI-4 and the two reference sites BTW-S-R-1 and BTW-S-R-2 remained stable. The averaged stress for each site is shown in **Figure 34**. Further analysis was undertaken to investigate increases in stress at specific monitoring points where an increase in stress was recorded within the Potential impact sites. This occurred at TW-S-PI-2 and TW-S-PI-3. The graphs of sites with stable and reduced stress are shown in **Appendix 6**.

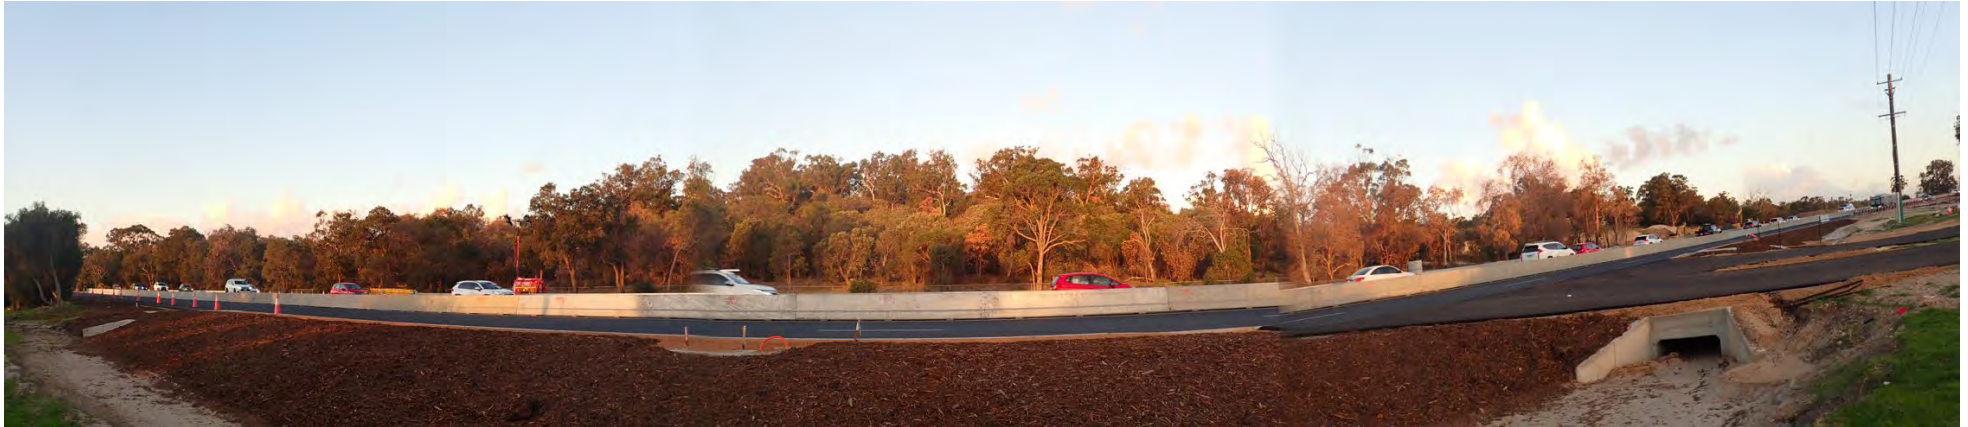
Figure 36. Panoramic view looking east towards TW-S-PI-2 showing patchy, stressed vegetation extending north well beyond the TW-S-PI-2 monitoring area.

Similar to BW-S-PI-8, it is possible that the increased manifestation of drought impacts at this site relative to others which remained relative stable could be linked to its steeper topography location near the top of the landscape (**Figure 36**), BW-S-PI-8 (**Figure 29**). The means the site would drain faster and earlier in the season than lower flatter sites such as BW-S-PI-5, BW-S-PI-3, BW-S-PI4 which generally experienced lower levels of manifested stress, and therefore have less moisture available for plant growth.

The impacts of the drought were evident across the whole site, however similar to the other drought affected the sites the impacts were not uniform, but patchy and scattered across the site and some species were more affected than others. This patchiness is shown in the panoramic photograph which is taken from the west and looking east into the monitoring site **Figure 37**. This photograph shows the impact occurs far beyond the 50 m monitoring buffer. The most affected species were the canopy species including *Agonis flexuosa*, *Banksia attenuata*, *Banksia grandis*, *Xylomelum occidentale* and *Eucalyptus marginata*. Most of the understorey, including the priority 3 listed *Lasiopetalum membranaceum* whilst stressed appeared ok, the exception being the common small shrub *Hibbertia hypericoides*, and to a lesser extent *Styphelia propinqua* which were very stressed in some patches. This species-specific stress appeared common across most of the Banksia and Tuart woodland sites.

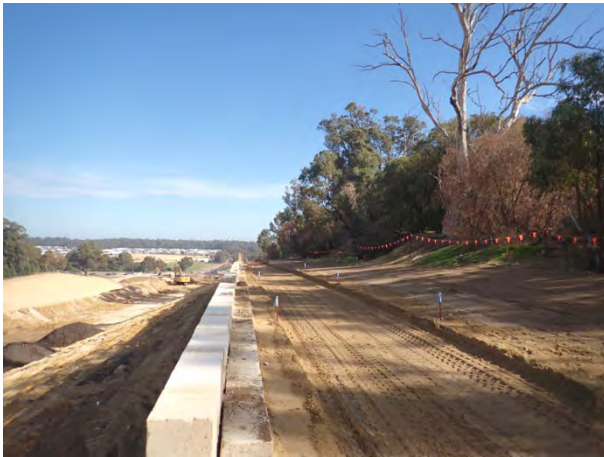
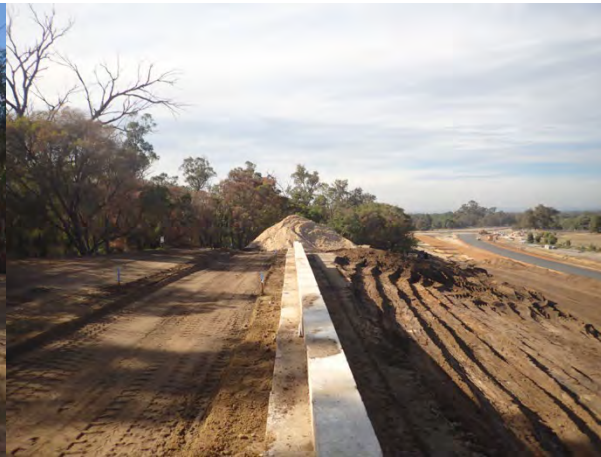
Figure 37. Location of steep cutting adjacent to TW-S-PI-2\_P07 and

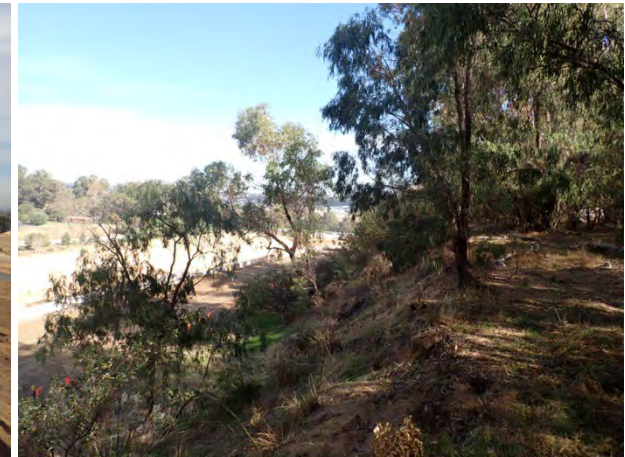
Figure 38. Relatively healthy vegetation adjacent TW-S-PI-2\_P06.

As for BW-S-PI-8, although this site is located adjacent to batters associated with road construction, **Figure 36** and **Figure 38**, it is unclear if these have had an influence given the vegetation immediately adjacent to the batters is generally similar to that observed hundreds of metres from the site, with a mix of stressed and unstressed vegetation (**Figure 39**). If the batters did influence vegetation stress, it is expected that impacts from the batters would be experienced more substantially adjacent to it and then taper off with distance. This was not generally the case.

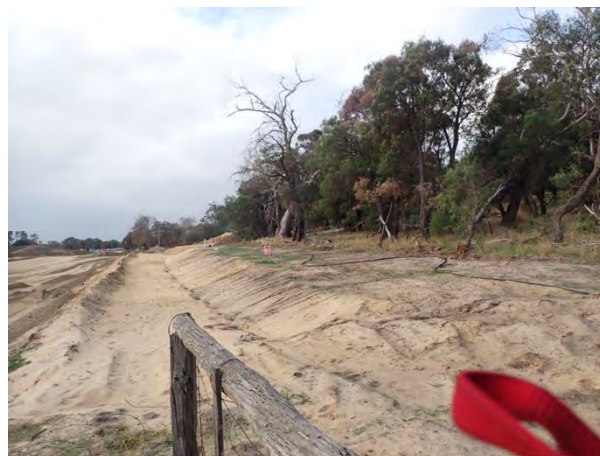
Figure 40. Vegetation adjacent TW-S-PI-3\_P01.

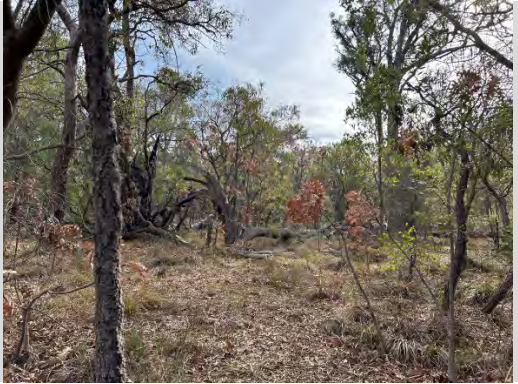
#	Site	Site name	Affected species	General comments	latitude	longitude	Estimated level of impact.	Photo
	Potential impact sites							
1	BW-S-PI-1	BW-S-PI-1_D1 (a24)	<i>Banksia grandis</i> , <i>Banksia attenuata</i>	Regularly scattered <i>Banksia</i> death, approximately 50% dead of banksia species only	-33.38588156	115.6516445	2-10%

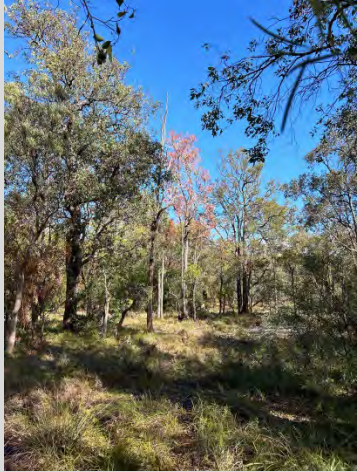
3	BW-S-PI-4	BW-S-PI-4_D1(w20)	<i>Eucalyptus marginata</i>	Wood borer and Bark stripping by cockatoos affecting some <i>E. marginata</i>	-33.42666702	115.639844	2-10%

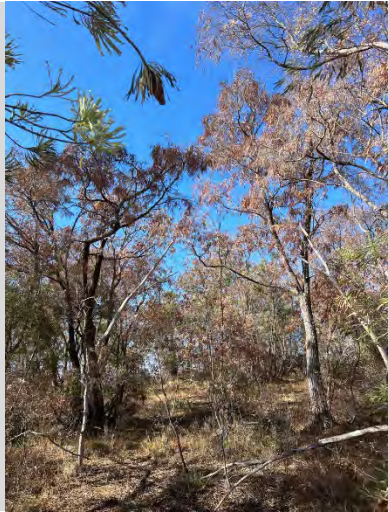
4	BW-S-PI-8	BW-S-PI-8	<i>Agonis flexuosa</i>	Stressed <i>A. flexuosa</i>	-33.4300577	115.629749	30-70%

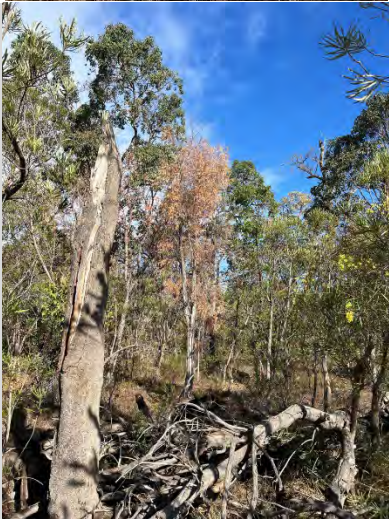
5	BW-S-PI-8	BW-S-PI-8_D1 (su22)	<i>Agonis flexuosa</i>	Stressed <i>flexuosa</i> A.	-33.43058108	115.6277186	30-70%

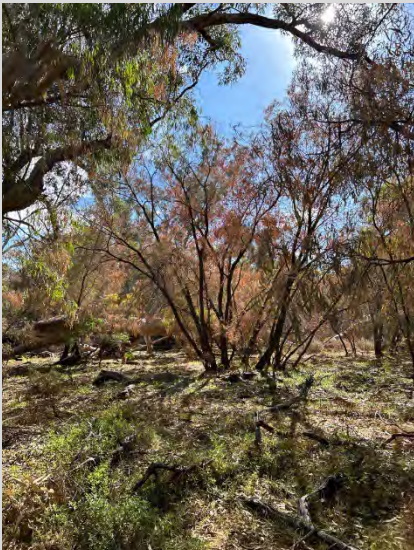
#	Site	Site name	Affected species	General comments	latitude	longitude	Estimated level of impact.	Photo
7	TW-S-PI-2	TW-S-PI-2_D1 (su 22)	Shrubs	Localise drying low shrubs – <i>Hibbertia hypericoides</i> , <i>Orthrosanthus laxus</i> and <i>Styphelia propinqua</i>	-33.38544358	115.6461724	10-30%	 
	TW-S-PI-2	TW-S-PI-2_D1 (a24)	<i>Agonis flexuosa</i>	Patches of dead <i>A. flexuosa</i> . Tuart alive	-33.38515578	115.6469832	10-30%

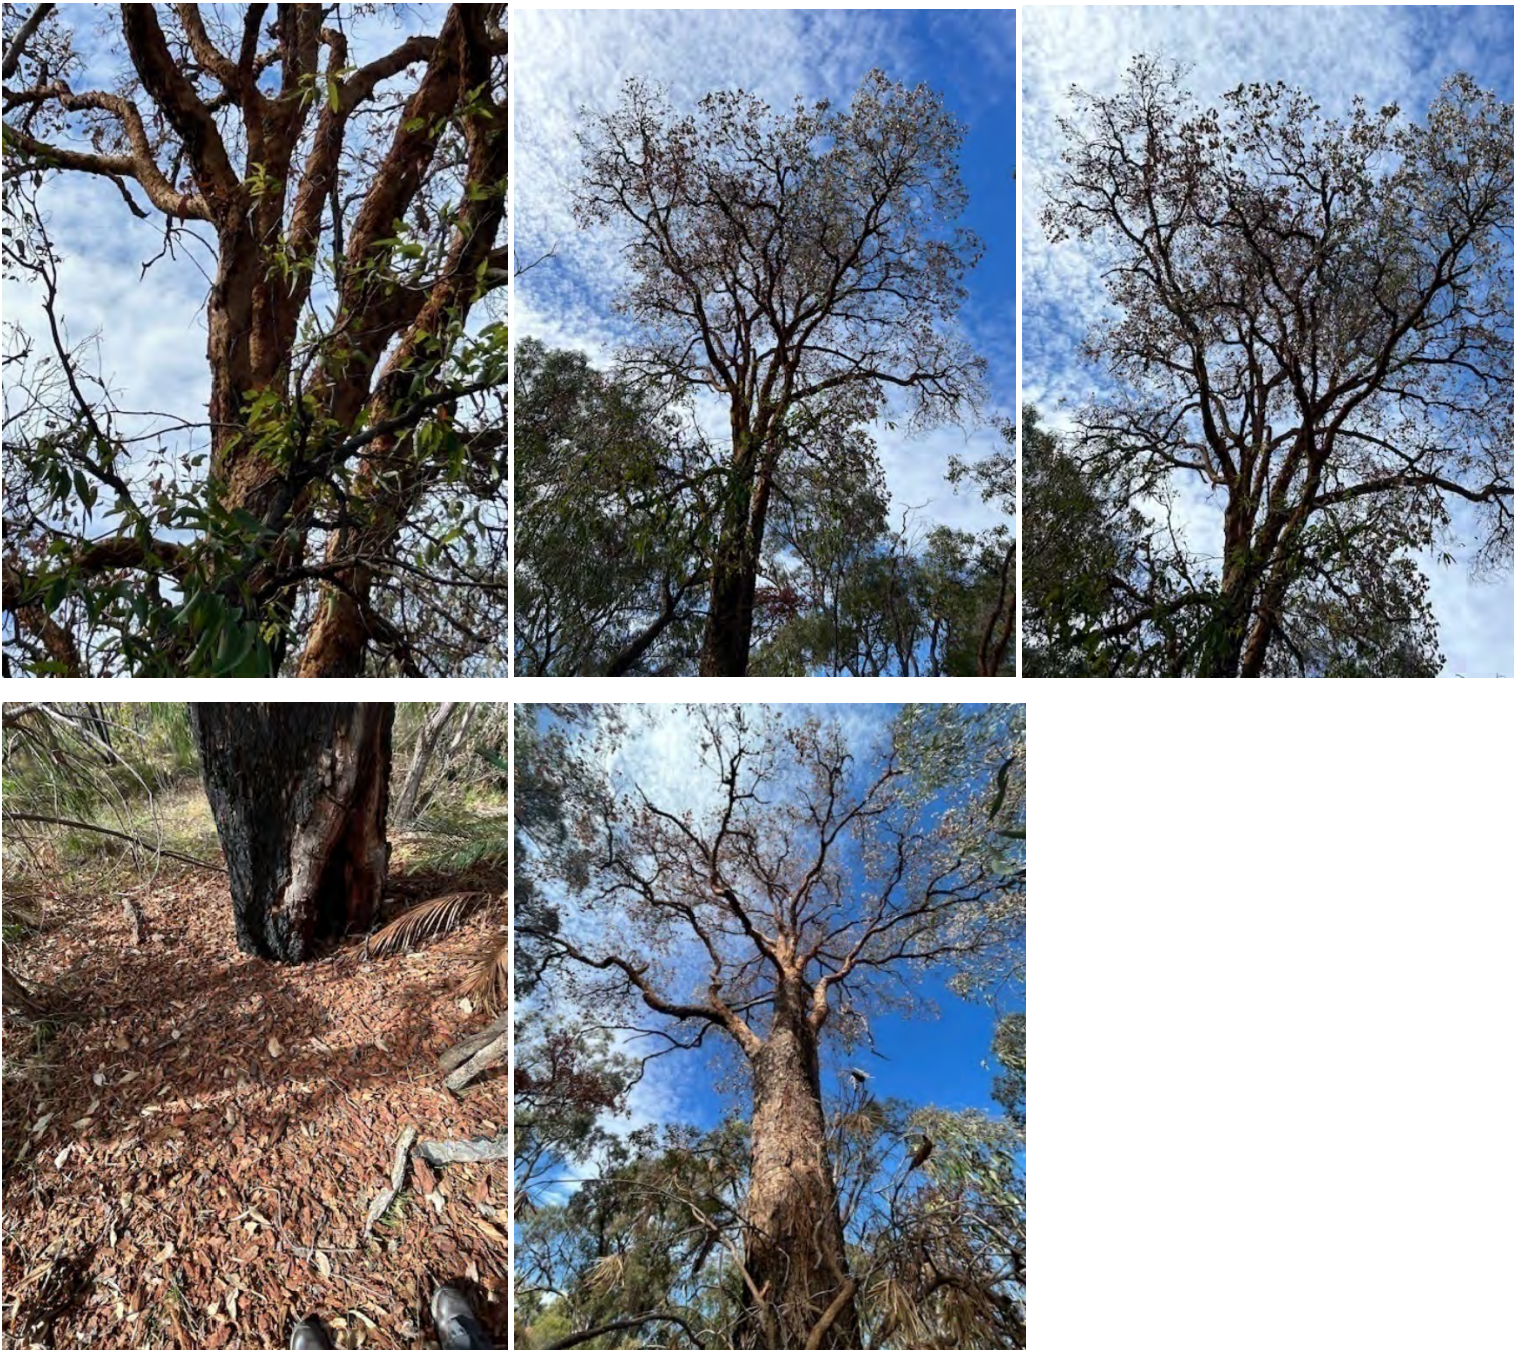
Figure 46. Photos of stressed *E. marginata* trees at TW-S-PI-2 due to wood borer and native cockatoos.

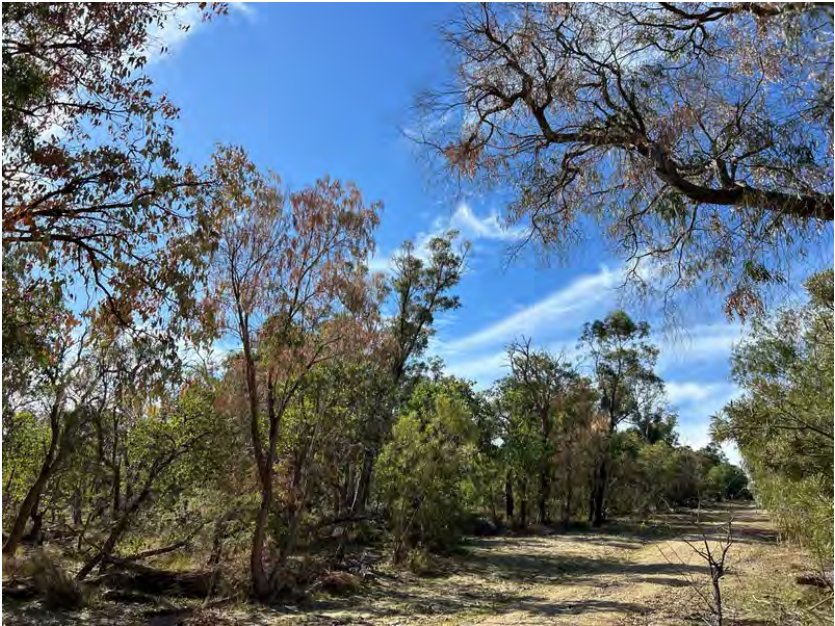
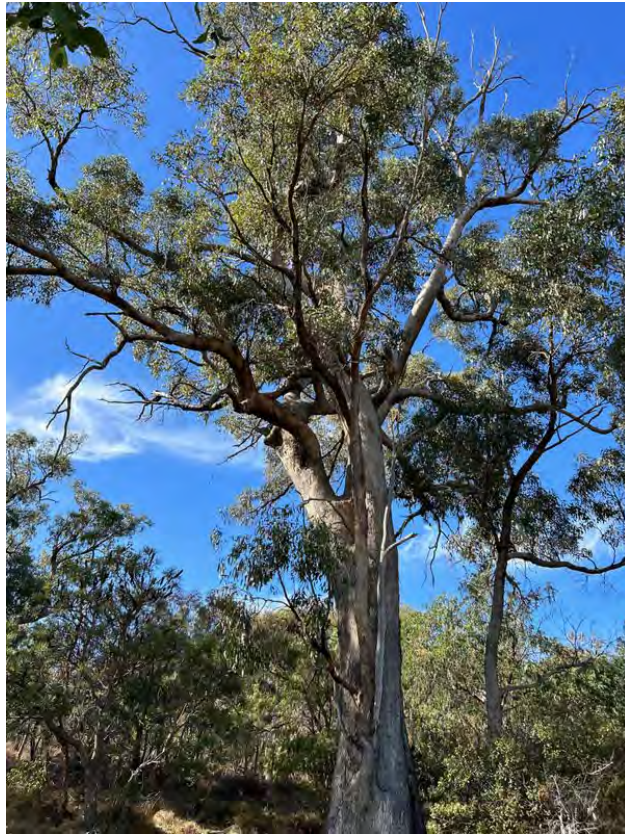
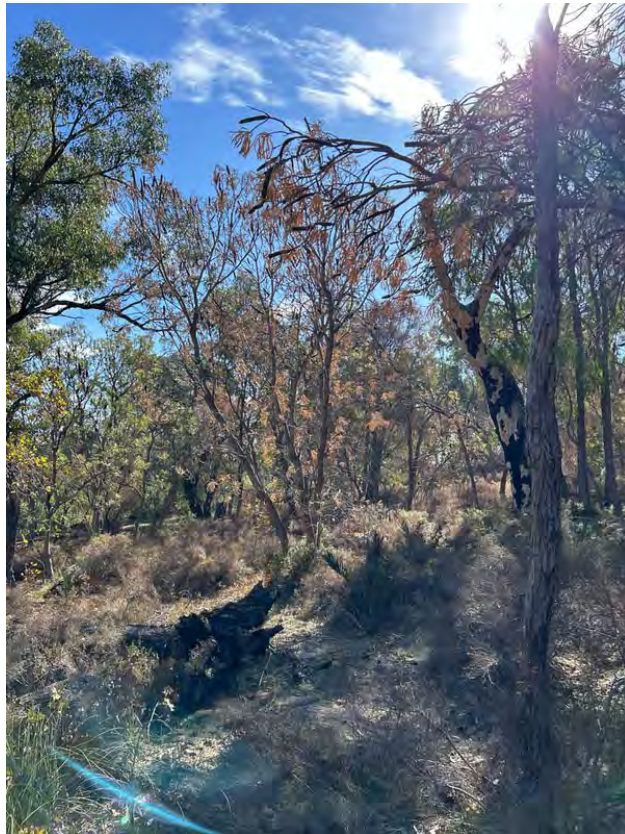
Created	2022-05-26 02:55:23 UTC by Debbie Brace
Updated	2024-05-24 03:57:00 UTC by Debbie Brace
Location	-33.38536583821613, 115.64596488151294
Site name	TW-S-PI-2
Point name	TW-S-PI -2
Recorder	Debbie Brace
Date	2024-05-24
Issue Y/N	Yes
Issue	Drying effects
Species affected	Banksia attenuata, Eucalyptus marginata, Agonis flexuosa

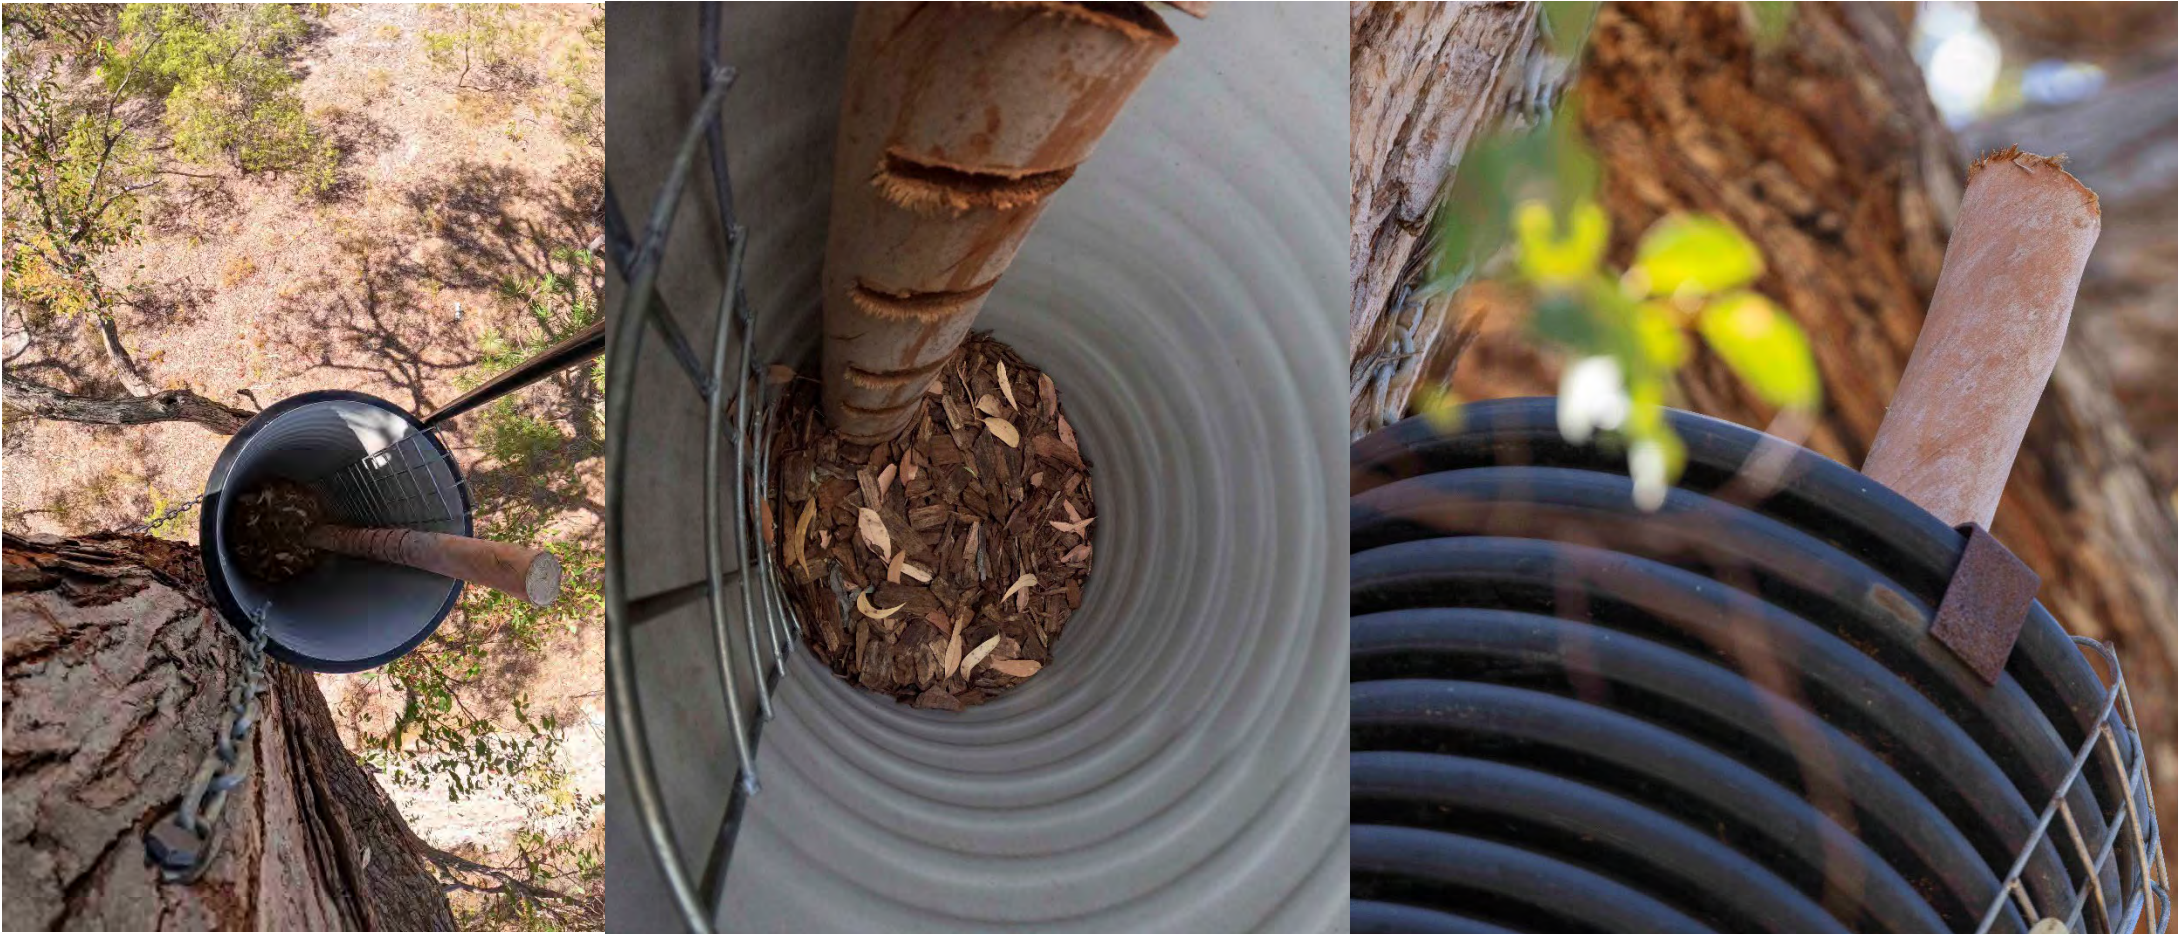
Hollow No	Comments	Chipping on Post score 0-10	Signs of nesting on floor	Recommended repairs
D01	No signs of nesting or prospecting by Black Cockatoos	0	NIL	NIL

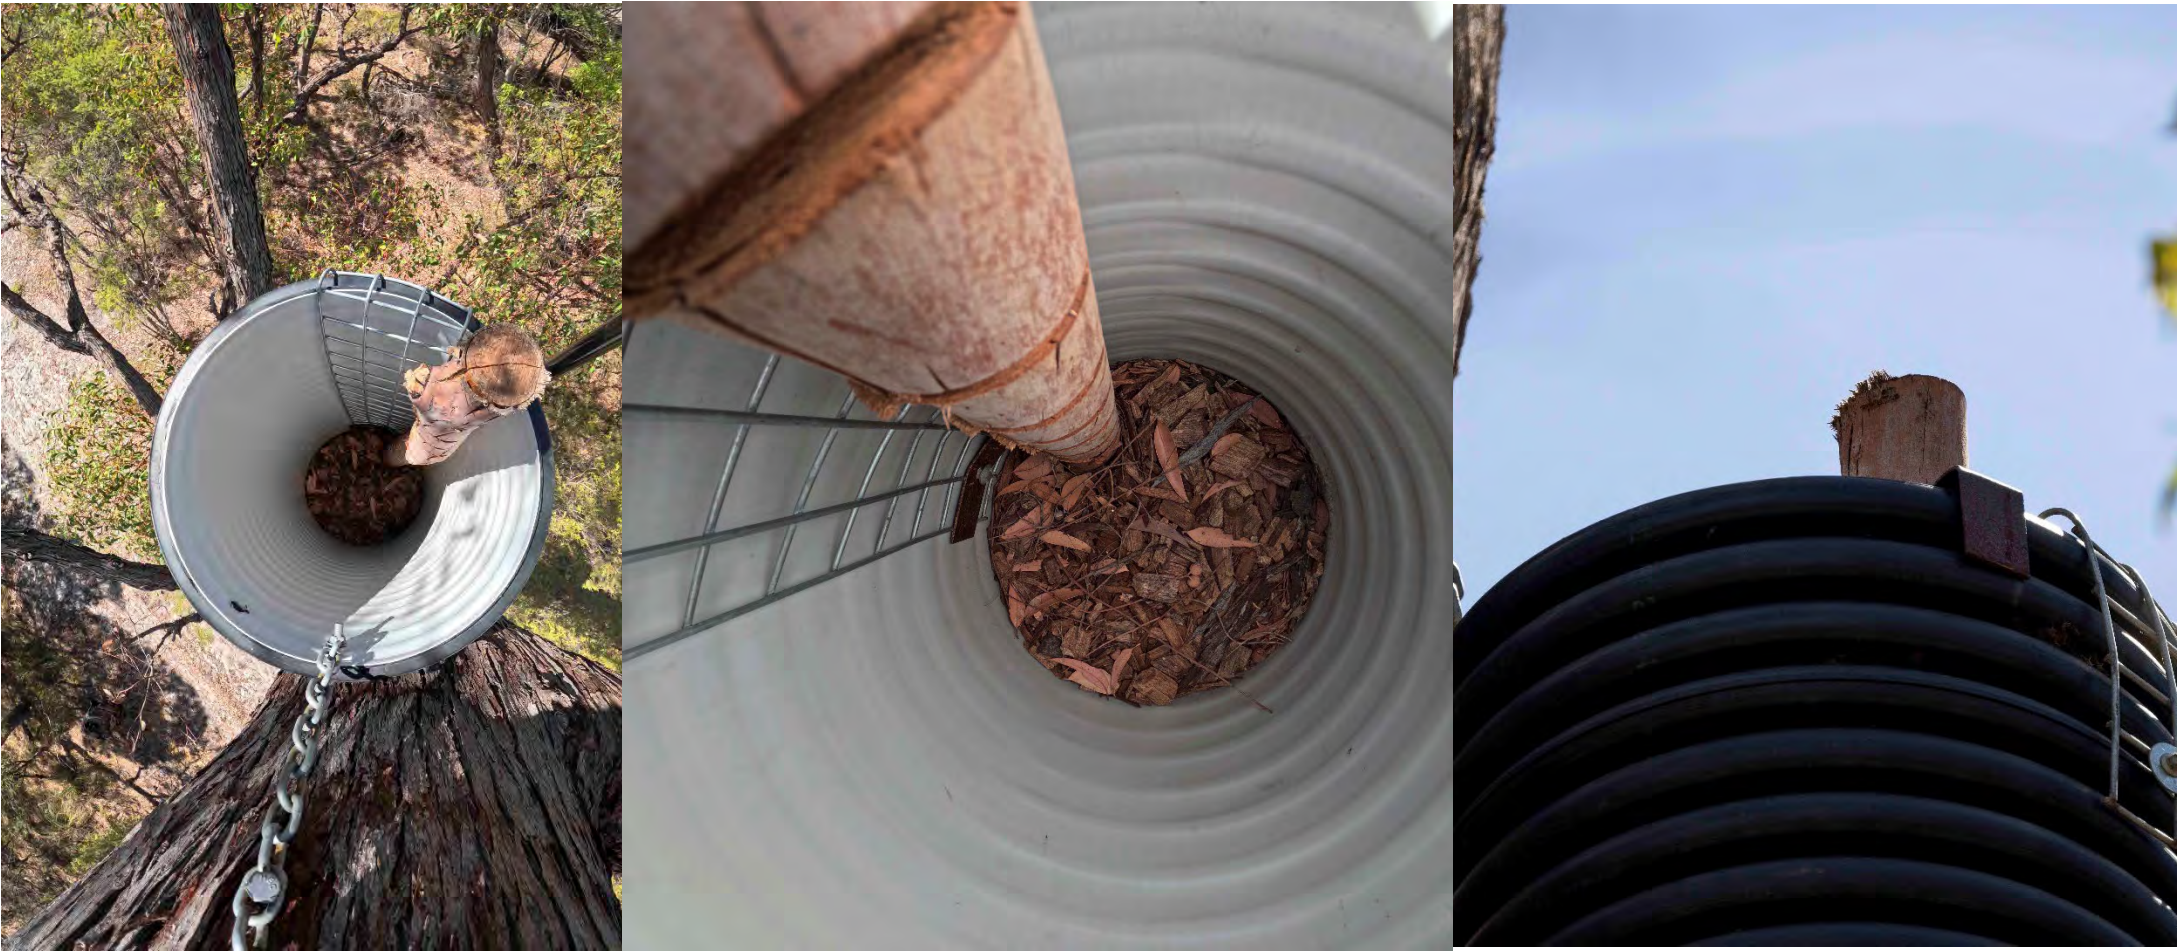
Hollow No	Comments	Chipping on Post score 0-10	Signs of nesting on floor	Recommended repairs
D02	No signs of nesting or prospecting by Black Cockatoos	0	NIL	NIL

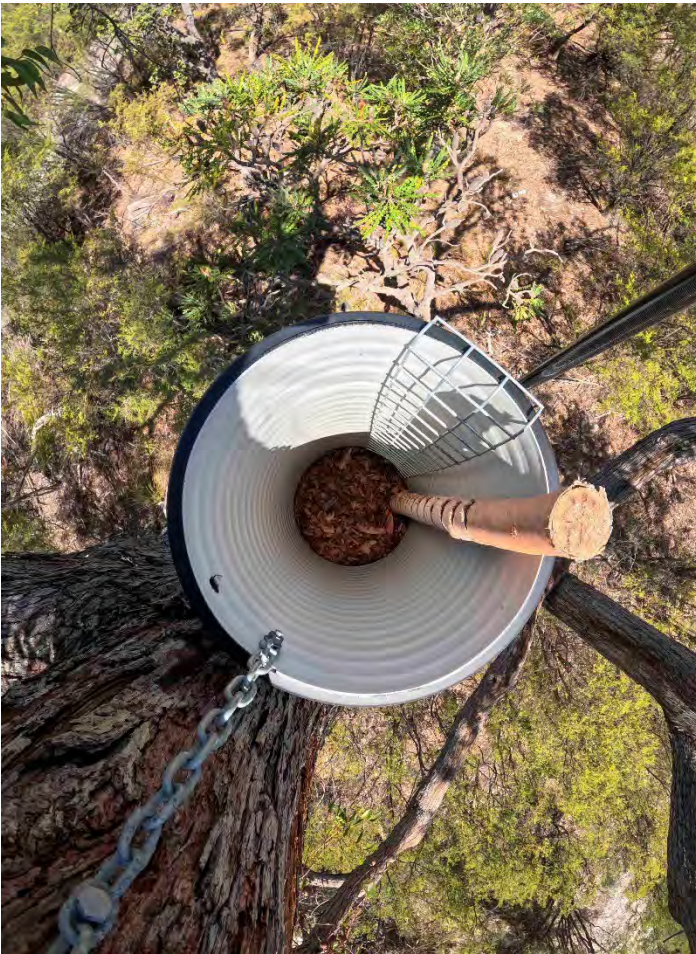
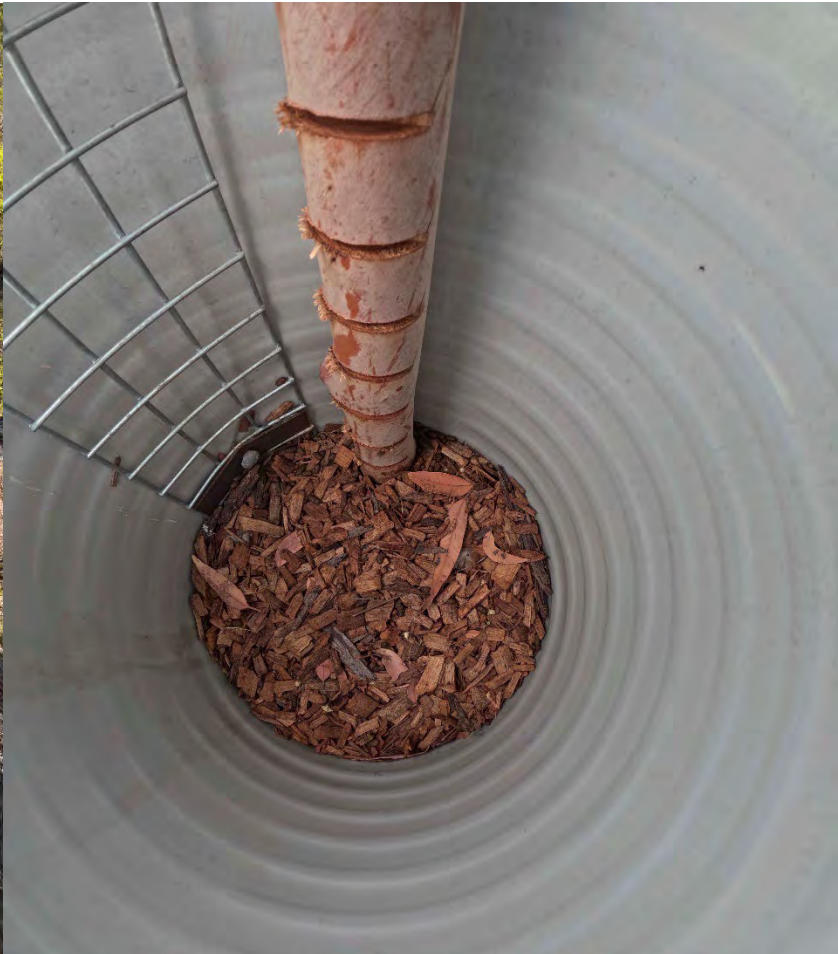
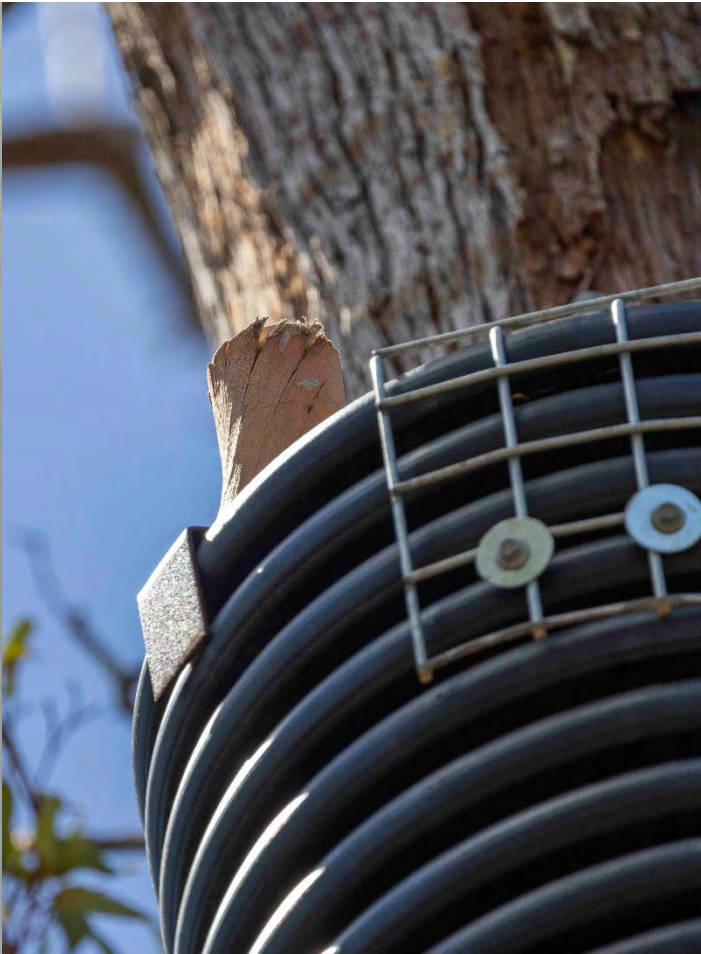
Hollow No	Comments	Chipping on Post score 0-10	Signs of nesting on floor	Recommended repairs
D03	No signs of nesting or prospecting by Black Cockatoos	0	NIL	NIL
