# Bunbury Outer Ring Road

## Southern Section

Ministerial Statement 1191

Compliance Assessment Report

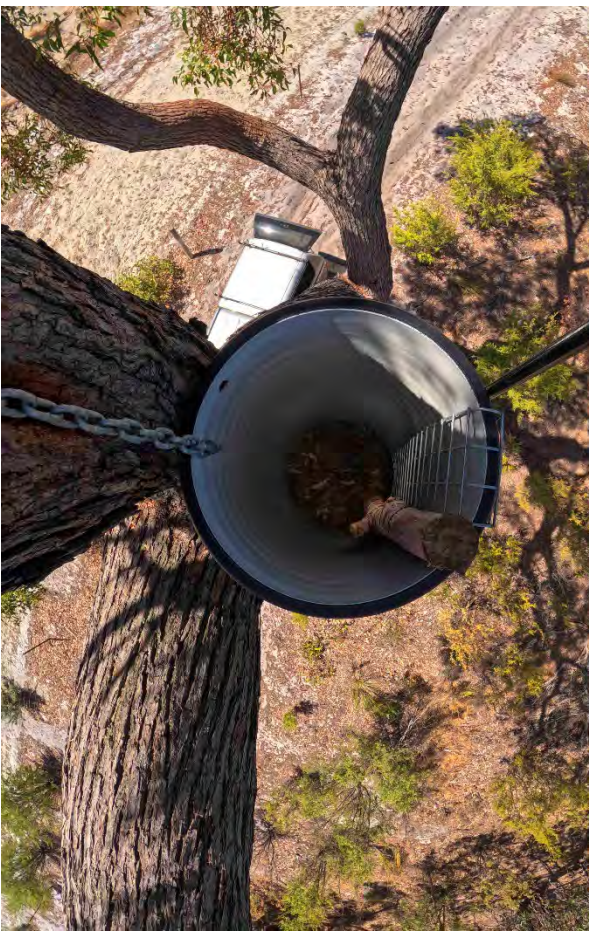
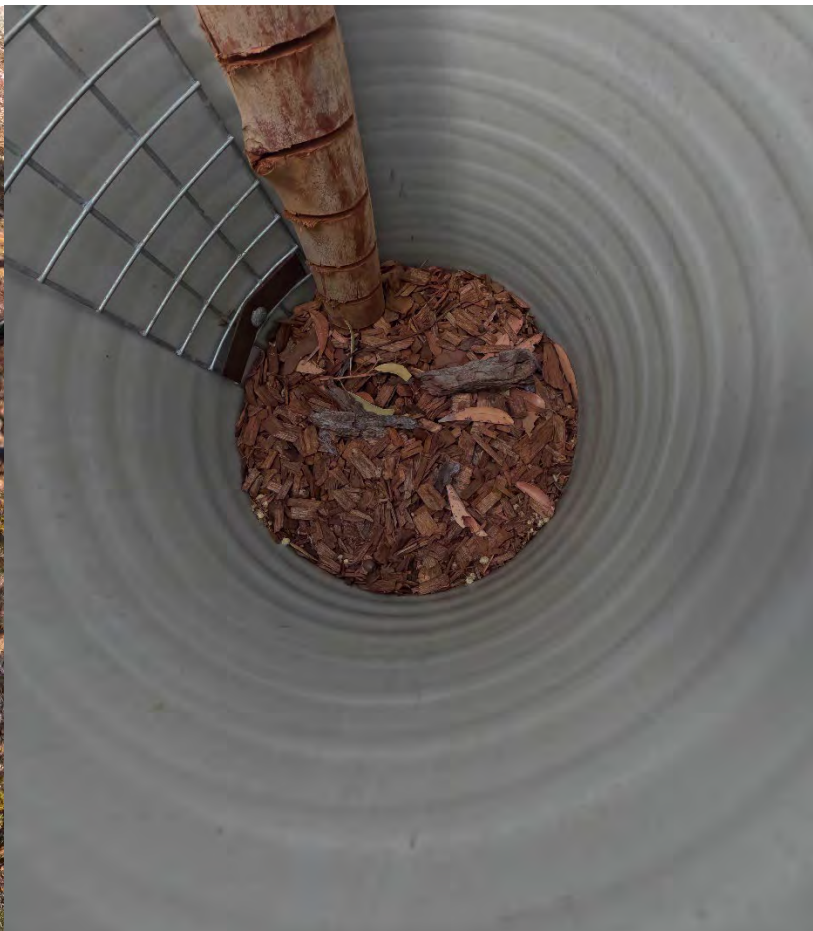
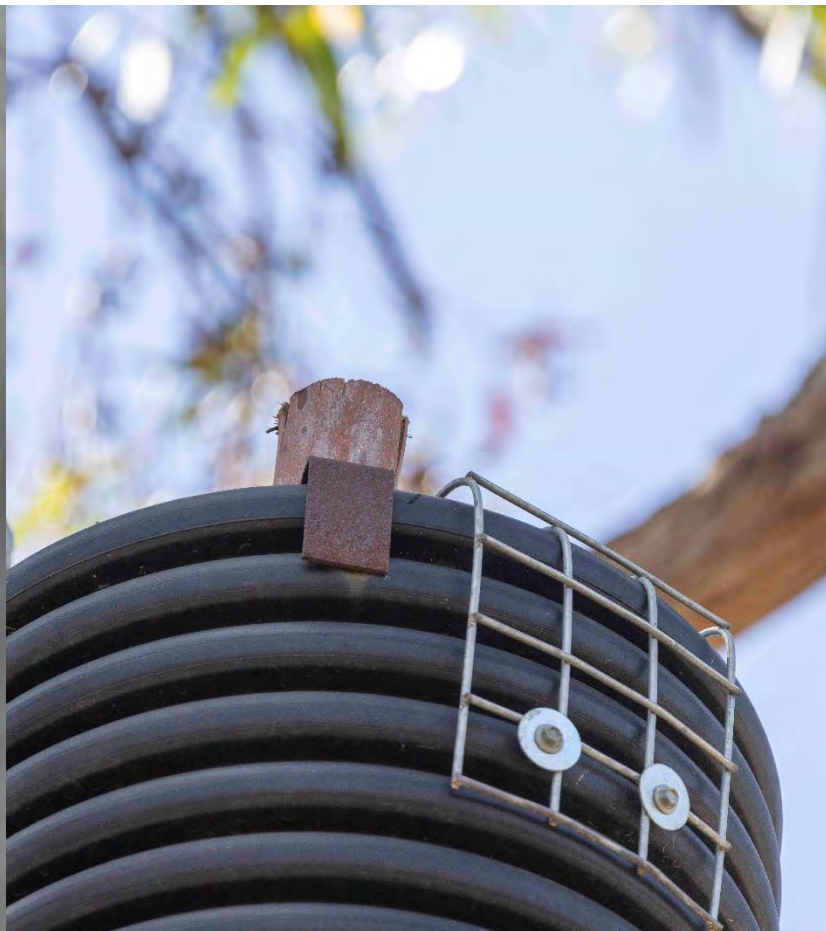
Hollow No	Comments	Chipping on Post score 0-10	Signs of nesting on floor	Recommended repairs
D04	No signs of nesting or prospecting by Black Cockatoos	0	NIL	NIL
