EPBC Act Compliance Report

Broome-Cape Leveque Road Upgrade, Western
Australia (EPBC 2013/6984)

Reporting period: 2 August 2021 to 1 August 2022

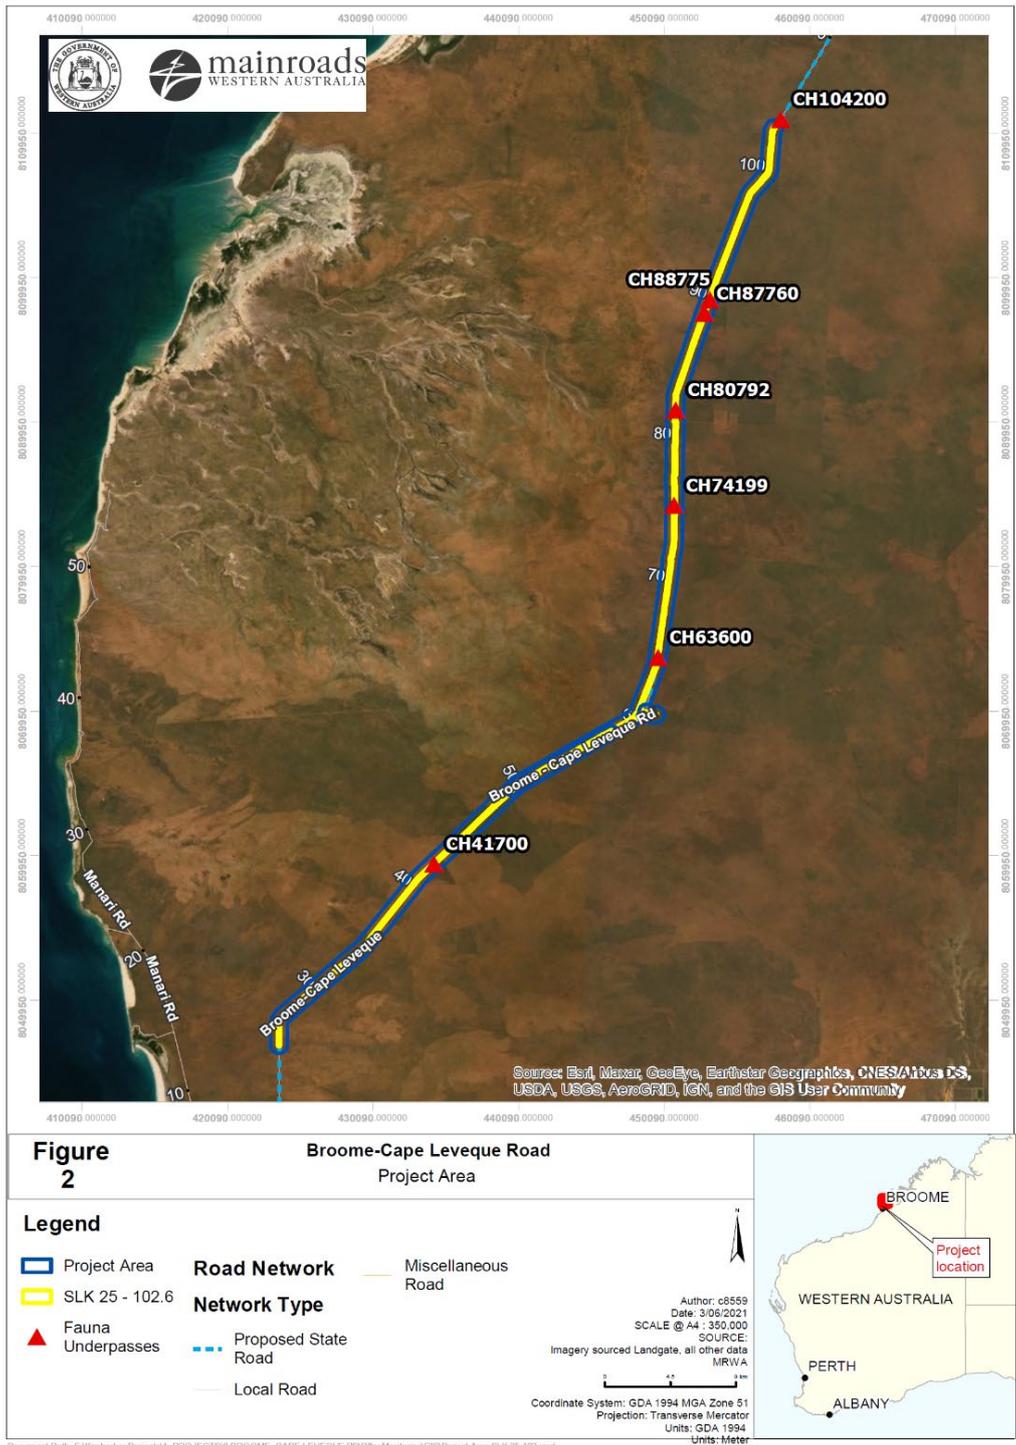
Table 1 Fauna underpass locations, culvert dimensions and condition

Underpass ID	Coordinates		Date Installed	Wide (m)	Height (m)
CH104200 (Cul67)	-17.085465°	122.605999°	18/11/2018	0.9	0.45 sand fill
CH88775 (Cul66)	-17.198170°	122.559802°	19/11/2018	0.9	0.3 open clean
CH87760 (Cul65)	-17.206832°	122.556499°	28/11/2018	0.9	0.3 sand fill
CH41700 (Cul61)	-17.550923°	122.380651°	19/09/2019	0.9	0.3 open clean
CH63600 (Cul62)	-17.421790°	122.525759°	05/09/2019	0.9	0.9 open clean
CH74199 (Cul63)	-17.327000°	122.536508°	22/08/2019	2 x 0.9	0.9 open clean
CH80792 (Cul64)	-17.267192°	122.537766°	28/07/2019	0.9	0.3 sand fill

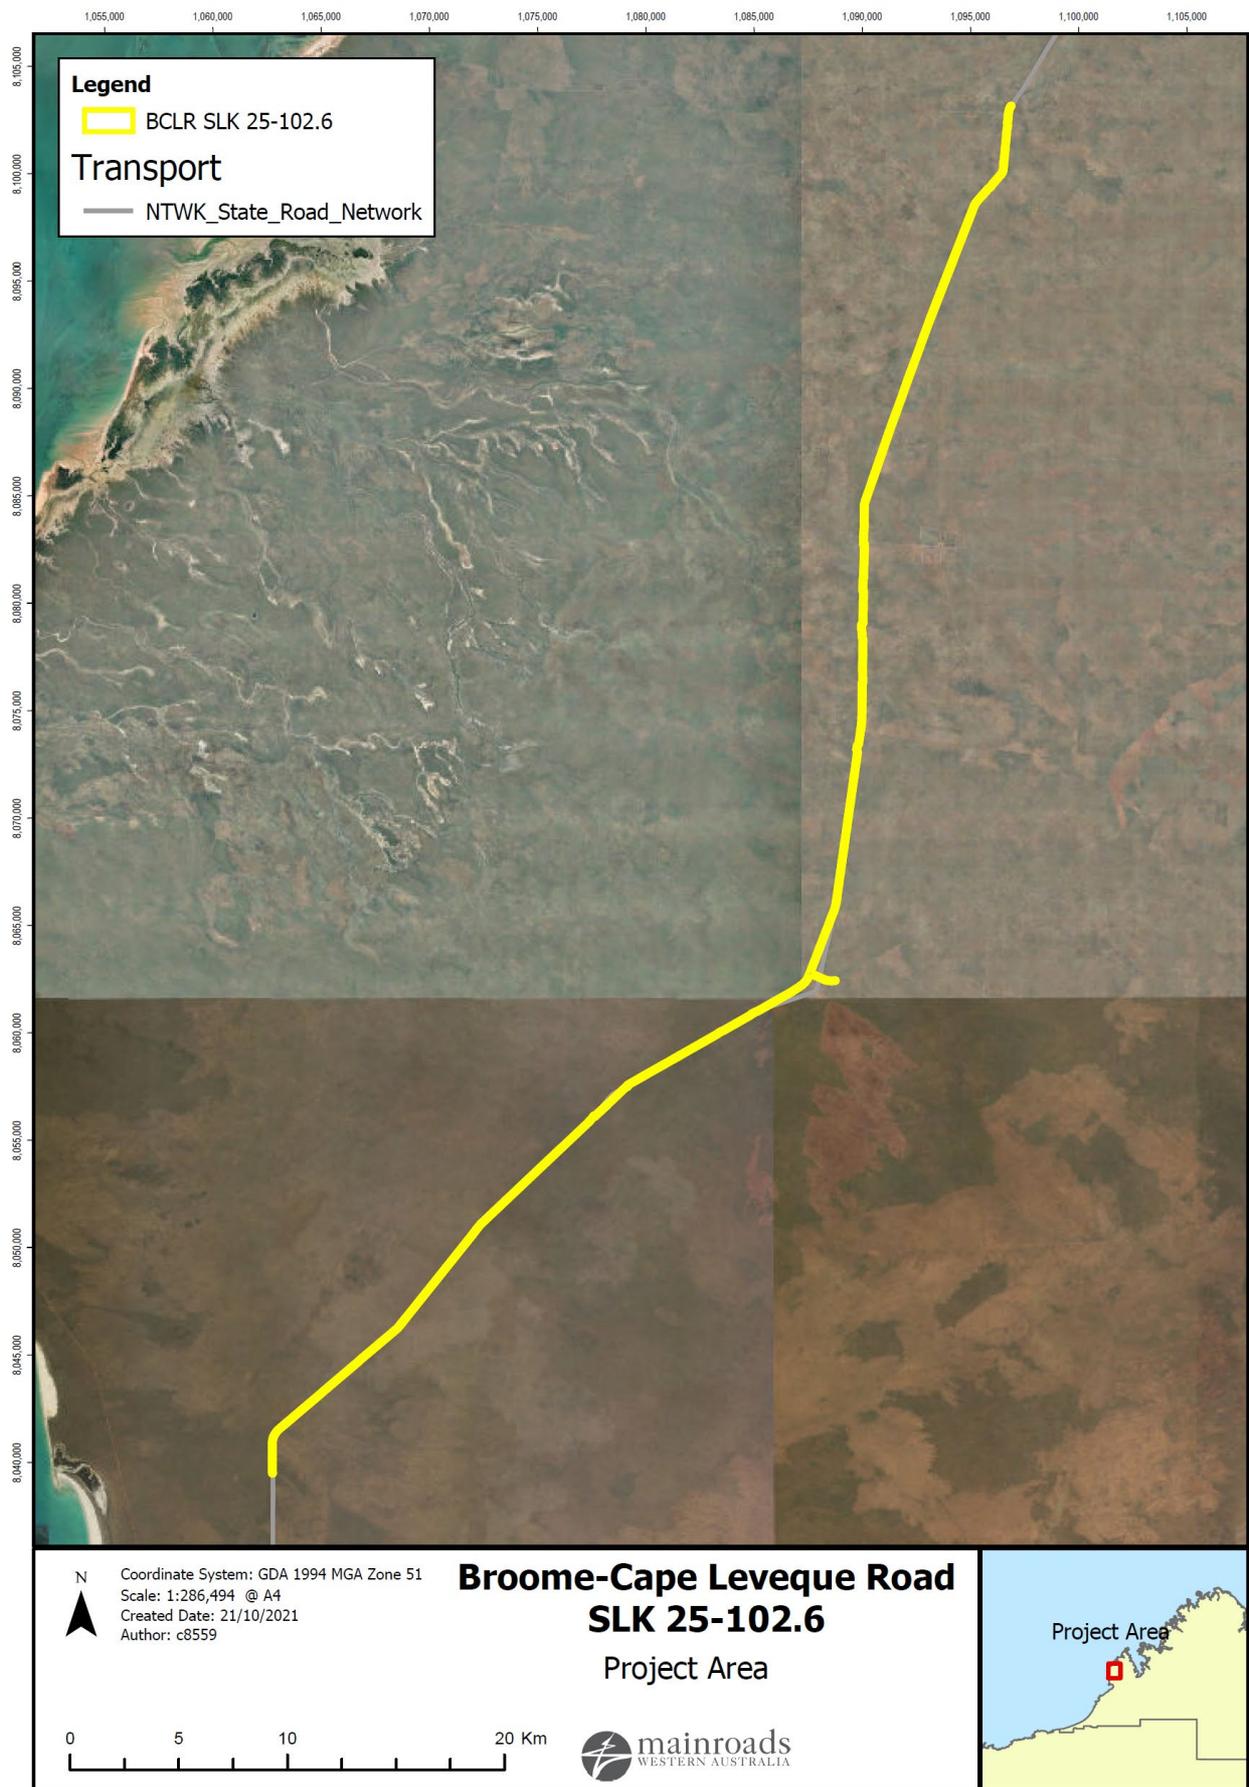
Figure 1: Project Area

Various sections of the BCLR have been upgraded to a sealed standard over the last ten years. Main Roads Western Australia (Main Roads) upgraded 77.6 km (Straight Line Kilometre (SLK) 25 to 102.6) of the unsealed section of the BCLR (Figure 1). The upgrade involved construction of a new road generally parallel to the existing unsealed road. Road user safety and reduced maintenance are two of the key reasons for the upgrade.

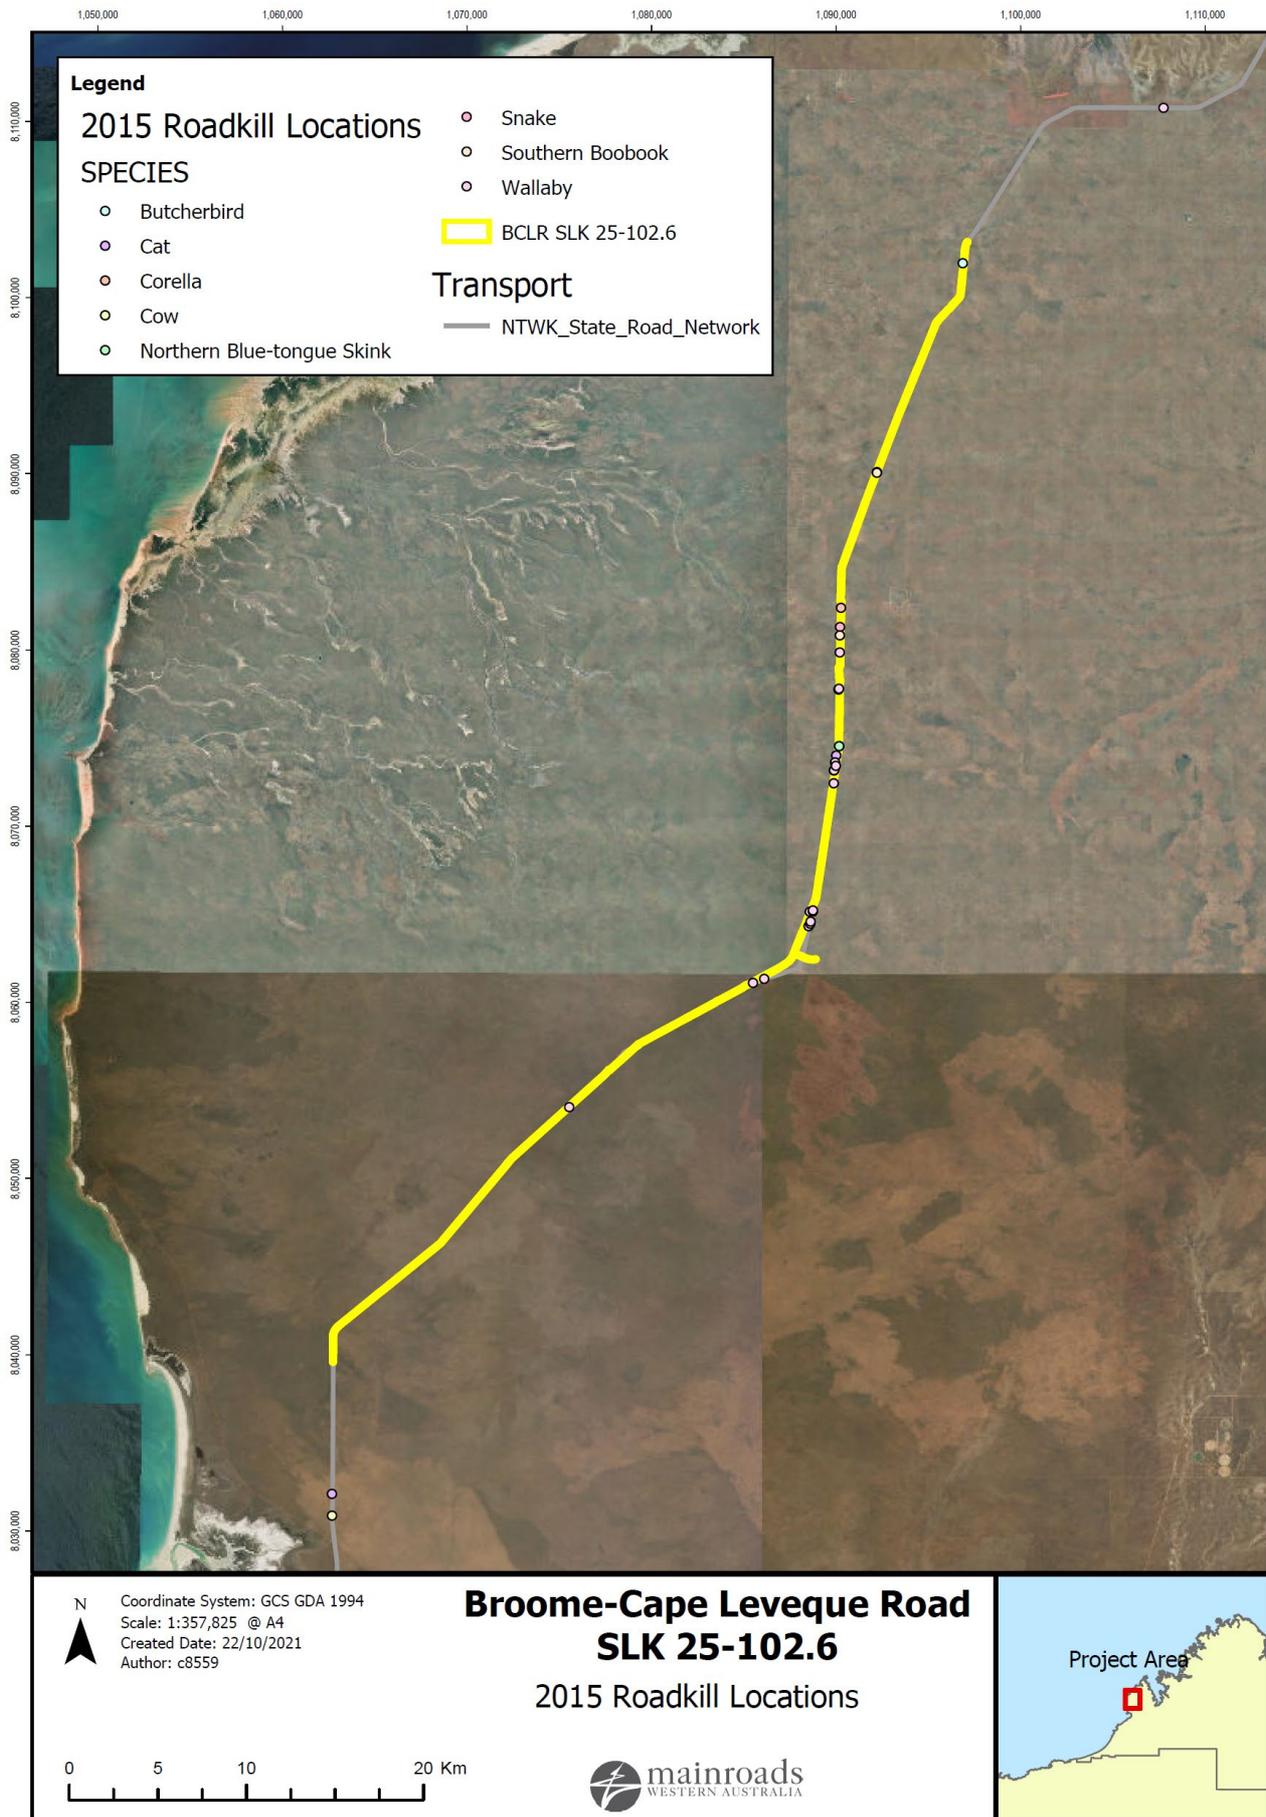
Figure 2: 2015 Roadkill Locations

YEAR	MONTH	DATE	SLK	SPECIES	CARCASS CONDITION	LONGITUDE	LATITUDE	COMMENTS	WEATHER	LUNAR CYCLE
2015	October	23	62.289	Wallaby	Dry Decay	122.52196	-17.43986		Overcast to scattered clouds	Waxing Gibbous
2015	October	23	62.411	Wallaby	Dry Decay	122.52215	-17.43877		Overcast to scattered clouds	Waxing Gibbous
2015	October	27		NO ROADKILL FOUND					Partly sunny	Full Moon
2015	October	29	88.38	Southern Boobook	Black Putrefaction	122.55575	-17.20926		Passing clouds	Waning Gibbous
2015	October	29	80.39	Corella	Black Putrefaction	122.53755	-17.27832		Passing clouds	Waning Gibbous
2015	November	3		NO ROADKILL FOUND					Passing clouds	Last Quarter
2015	November	6	75.78	Wallaby	Putrefaction	122.53654	-17.31969		Scattered clouds	Waning Crescent
2015	November	11		NO ROADKILL FOUND					Scattered clouds	New Moon
2015	November	13	70.7	Wallaby	Black Putrefaction	-17.364127	122.534578		Passing clouds	Waxing Crescent
2015	November	13	96.4	Wallaby	Black Putrefaction	-17.141744	122.582406		Passing clouds	Waxing Crescent

2015	November	18		NO ROADKILL FOUND					Haze Passing clouds	First Quarter
2015	November	19		NO ROADKILL FOUND					Haze Passing clouds	First Quarter
2015	November	25		NO ROADKILL FOUND					Partly sunny	Full Moon
2015	November	26		NO ROADKILL FOUND					Passing clouds	Full Moon

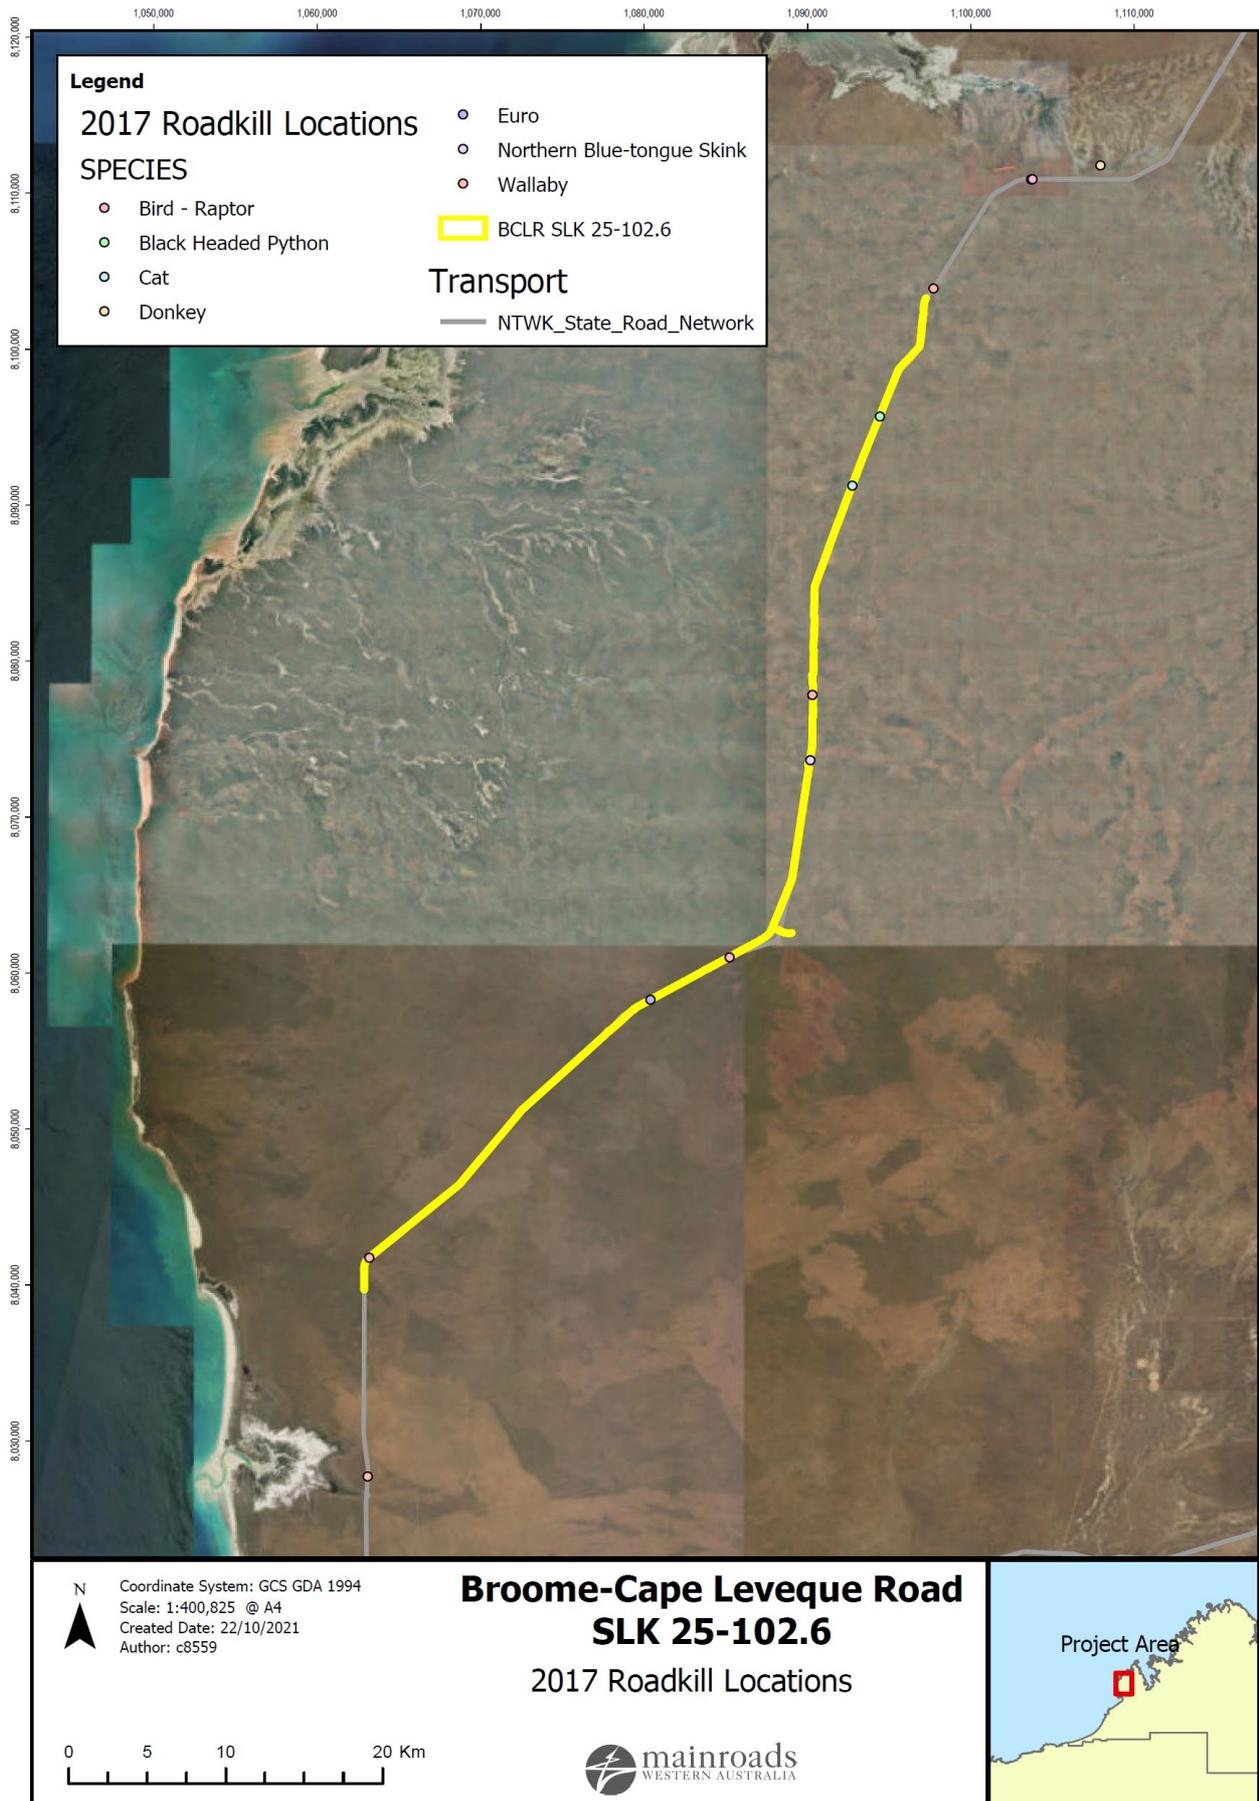
Figure 3: 2017 Roadkill Locations

YEAR	MONTH	DATE	SLK	SPECIES	CARCASS CONDITION	LONGITUDE	LATITUDE	COMMENTS	WEATHER	LUNAR CYCLE
2017	June	23	75.69	Wallaby	Fresh	122.53656	-17.320475			New Moon
2017	June	23	89.53	Cat	Dry Decay	122.559402	-17.199589			New Moon
2017	June	26	27.08	Wallaby	Fresh	122.28286	-17.645613	Blind corner - photo taken after moving	Waxing Crescent	
2017	July	10	94.28	Black Headed Python	Fresh	122.575183	-17.159644			Full Moon
2017	July	10	12.94	Wallaby		122.281919	-17.771962			Full Moon
2017	July	14	56.62	Wallaby		122.489108	-17.472096			Waning Gibbous
2017	July	14	103.38	Wallaby		122.605879	-17.085679			Waning Gibbous
2017	September	1	71.49	Northern Blue-tongue Skink	Fresh	122.535346	-17.3582		Cloudy 0.2mm	Waxing Gibbous
2017	September	1	51.08	Euro		122.443835	-17.49654		Cloudy 0.2mm	Waxing Gibbous
2017	October	4		NO ROADKILL FOUND						Waxing Gibbous
2017	October	26	113.01	Cat	Dry Decay	122.661757	-17.022675			First Quarter

2017	October	26	113.09	Bird - Raptor	Dry Decay	122.662535	-17.022598			First Quarter
2017	October	26	117.5	Donkey	Black Putrefaction	122.7014607	-17.014607			First Quarter
2017	October	26	104.6	Zebra Finch	Dry Decay					First Quarter

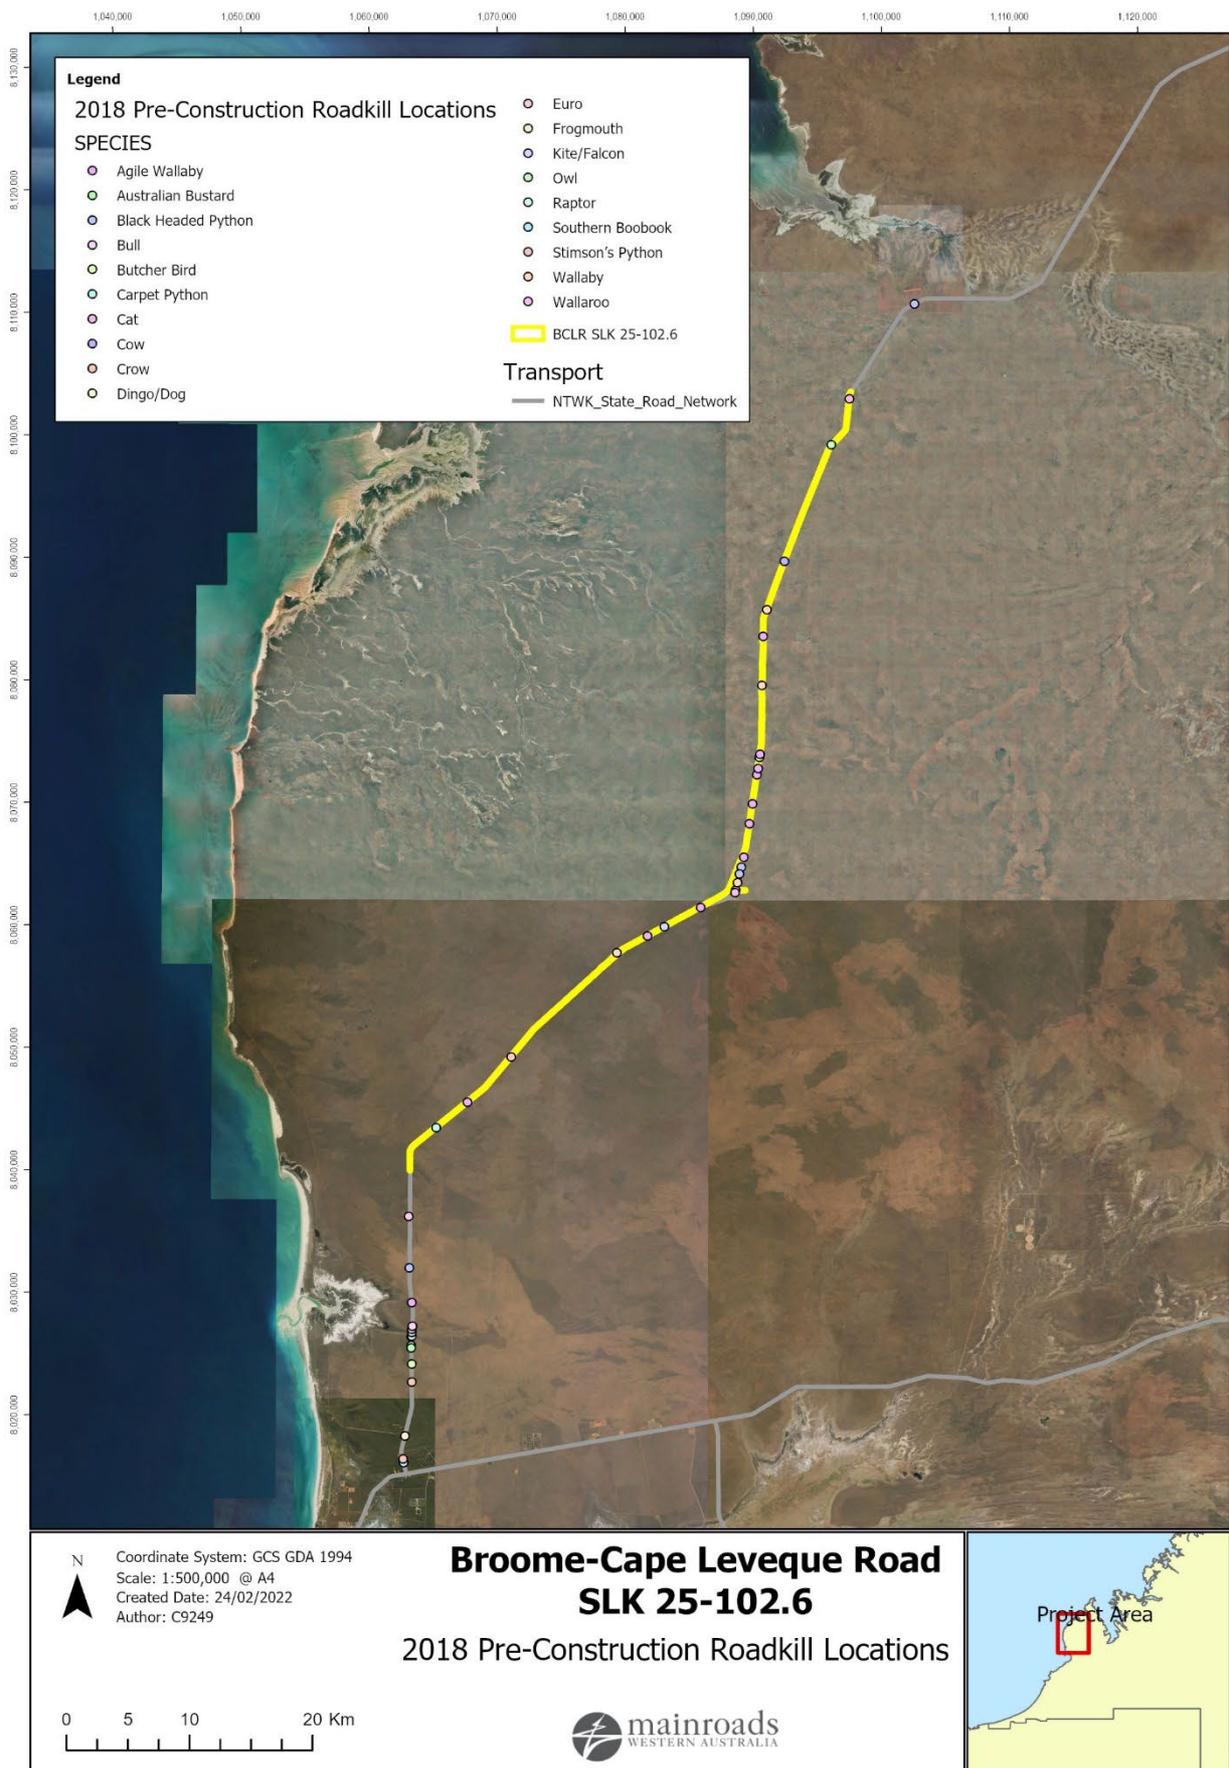
Figure 4: 2018 Pre-Construction Roadkill Locations

2018	November	21		NO ROADKILL FOUND						Waxing Gibbous
2018	November	22	12.18	Bull	Fresh	122.28156	-17.77877	Sealed	Scattered clouds	Full Moon
2018	November	26		NO ROADKILL FOUND					Passing clouds	Waning Gibbous

YEAR	MONTH	DATE	SLK	SPECIES	CARCASS CONDITION	LONGITUDE	LATITUDE	COMMENTS	WEATHER	LUNAR CYCLE
2018	November	27		NO ROADKILL FOUND					Overcast	Waning Gibbous
2018	November	29		NO ROADKILL FOUND					Passing clouds	Last Quarter
2018	December	3		NO ROADKILL FOUND					Passing clouds	Waning Crescent
2018	December	11		NO ROADKILL FOUND						Waxing Crescent
2018	December	12	81.16	Agile Wallaby	Fresh	122.53772	-17.27142	Unsealed, pinkie alongside	Overcast	Waxing Crescent
2018	December	13		NO ROADKILL FOUND					Passing clouds	Waxing Crescent

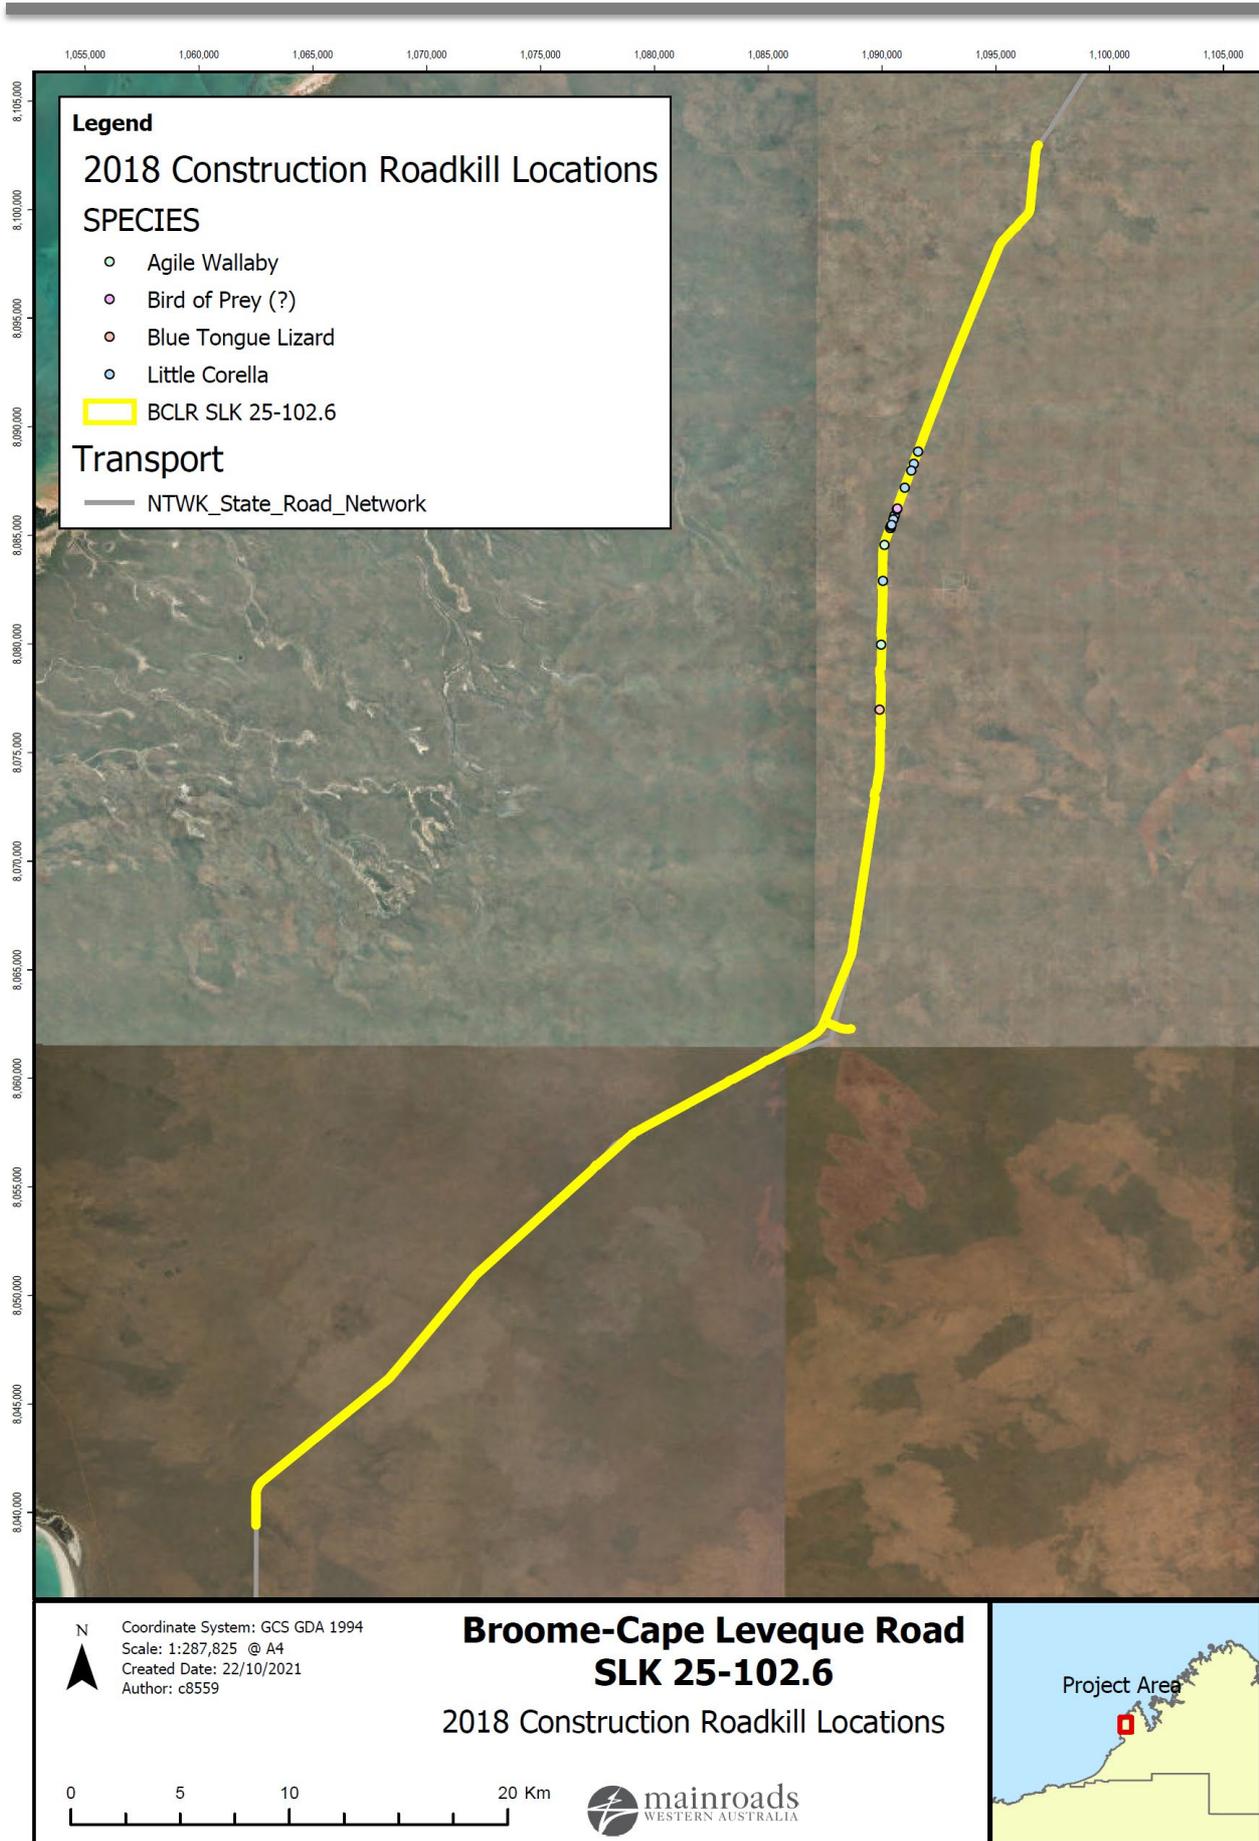
Figure 5: 2018 Construction Roadkill Locations

YEAR	MONTH	DATE	SLK	SPECIES	CARCASS CONDITION	LONGITUDE	LATITUDE	COMMENTS	WEATHER	LUNAR CYCLE
2018	December	12		NO ROADKILL FOUND						Waxing Crescent

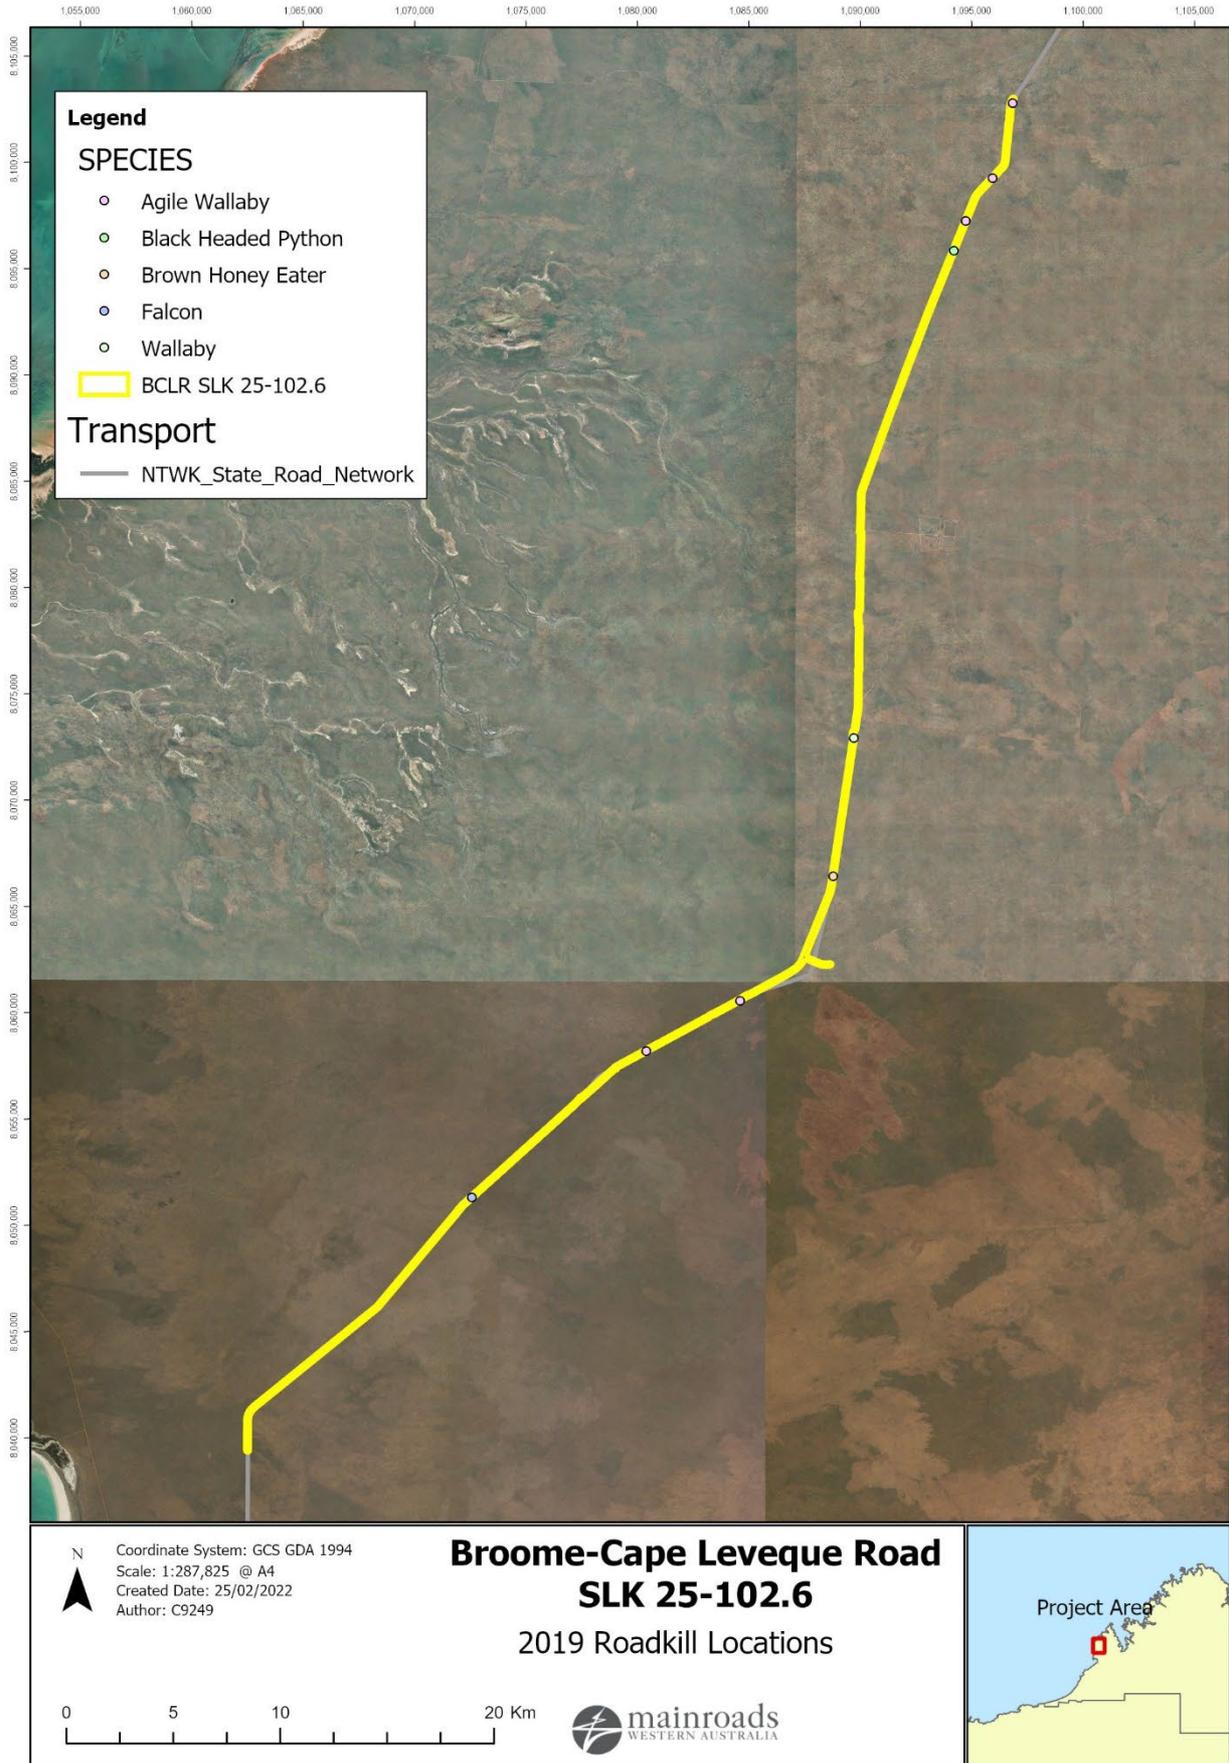
Figure 6: 2019 Roadkill Locations

YEAR	MONTH	DATE	SLK	SPECIES	CARCASS CONDITION	LONGITUDE	LATITUDE	COMMENTS	WEATHER	LUNAR CYCLE
2019	December	7	62.500	Wallaby	Fresh					Waxing Gibbous

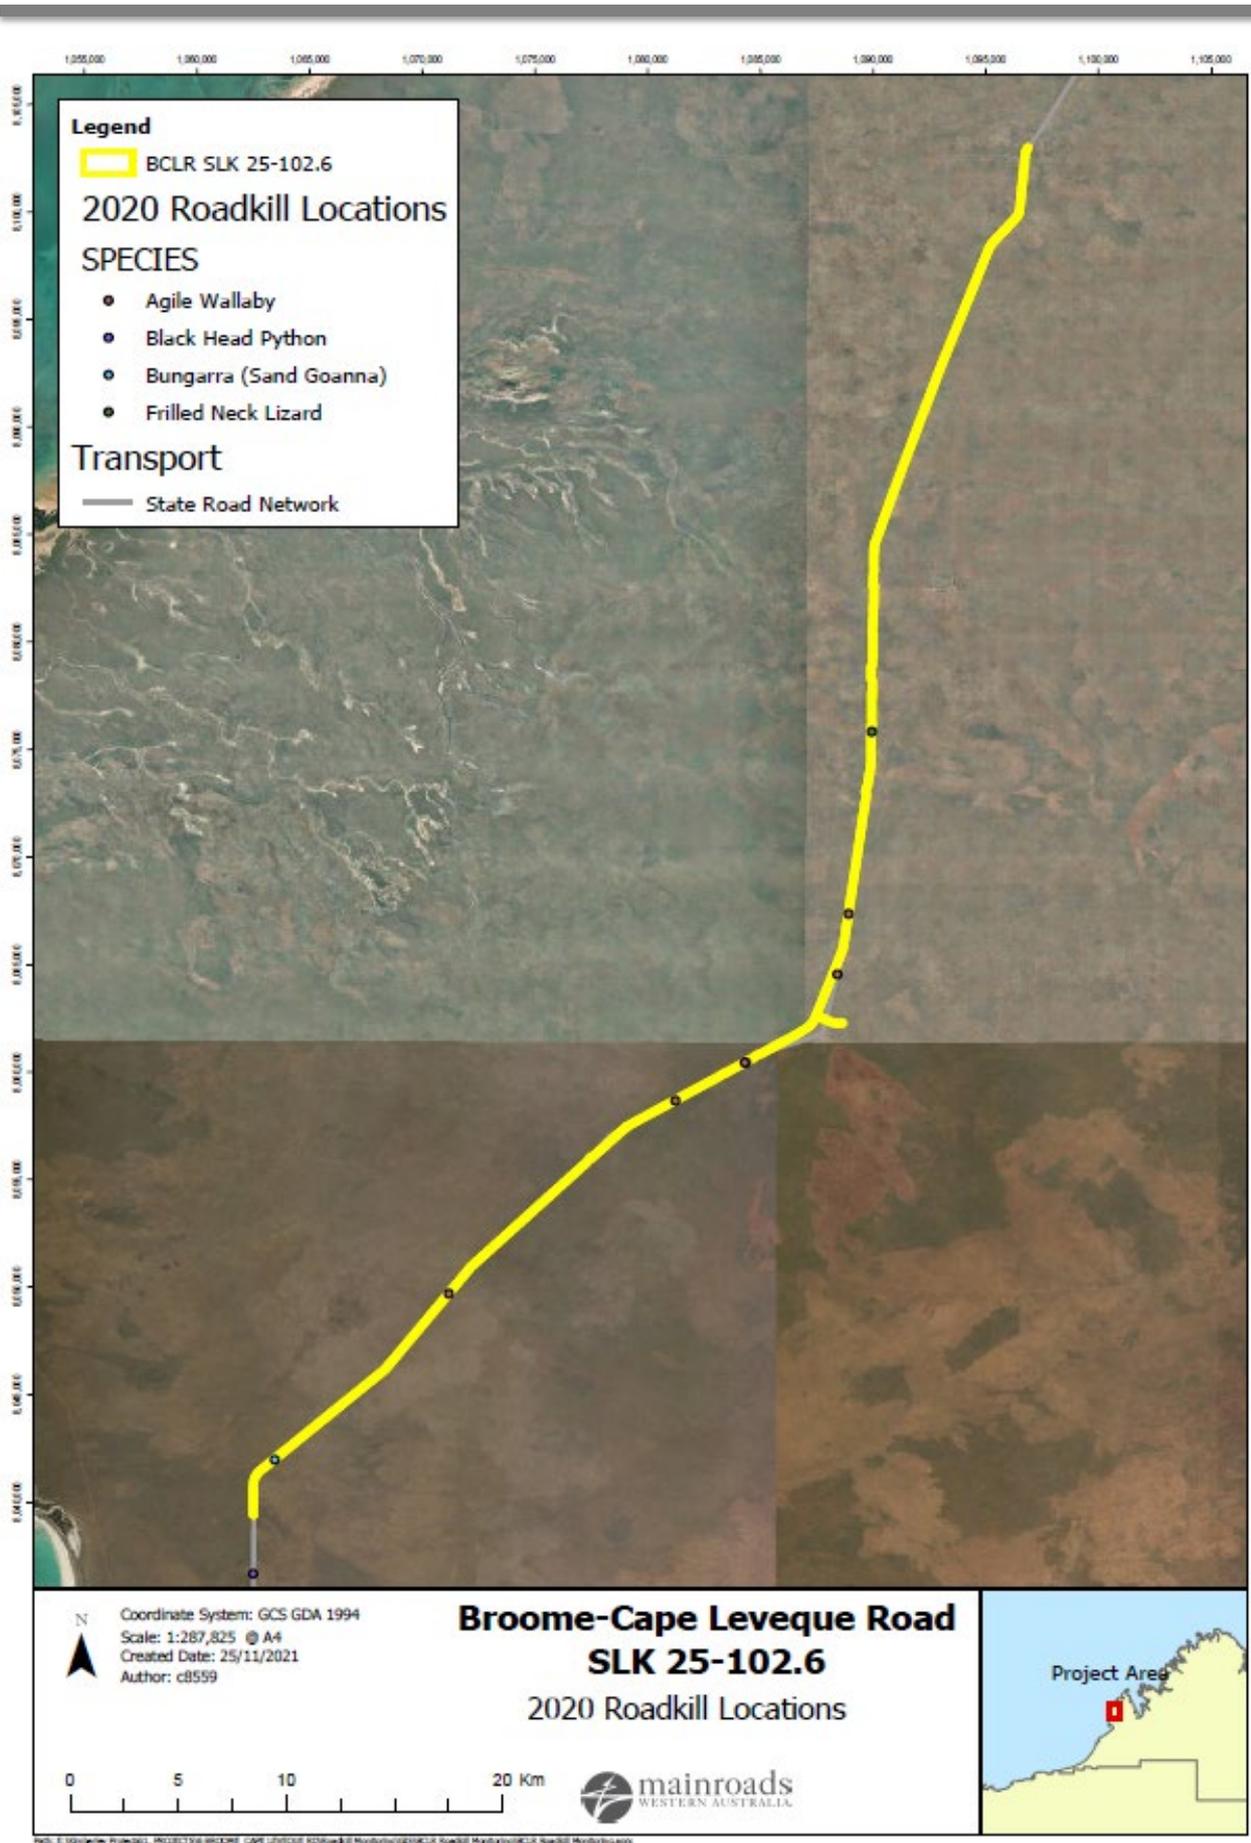
Figure 7: 2020 Roadkill Locations

YEAR	MONTH	DATE	SLK	SPECIES	CARCASS CONDITION	LATITUDE	LONGITUDE	COMMENTS	WEATHER	LUNAR CYCLE
2020	July	22		NO ROADKILL FOUND						Waxing Crescent
2020	August	4		NO ROADKILL FOUND						Full Moon
2020	August	12	62.55	Agile Wallaby	Initial Decay	-17.43762	122.52254	Post-construction	Overcast	Last Quarter
2020	August	21		NO ROADKILL FOUND						Waxing Crescent
2020	August	27		NO ROADKILL FOUND						Waxing Gibbous
2020	September	3	2.01	Bird of Prey	Initial Decay	-1786949	122.27365	Pre-construction		Full Moon
2020	September	8		NO ROADKILL FOUND				Pre-construction		Waning Gibbous
2020	September	15		NO ROADKILL FOUND					Passing clouds	Waning Crescent
2020	October	2		NO ROADKILL FOUND					Passing clouds	Full Moon
2020	October	9	52.47	Agile Wallaby	Fresh	-17.49051	122.45523	Post-construction		Last Quarter
2020	October	14	3.04	Agile Wallaby	Fresh	-17.86035	122.27604	Post-construction		Waning Crescent
2020	October	21	22.21	Black Head Python	Fresh	-17.688755	122.2798			Waxing Crescent

2020	October	25	38.87	Agile Wallaby	Fresh	-17.5714	122.3611	Post-construction	Partly sunny	Waxing Gibbous
2020	November	10	56.03	Agile Wallaby	Black Putrefaction	-17.47459	122.48414			Waning Crescent
2020	November	23		NO ROADKILL FOUND						First Quarter
2020	November	26	4.2	Bungarra	Fresh	-17.85018	122.27839	Pre-construction		Waxing Gibbous
2020	December	9		NO ROADKILL FOUND					Overcast	Waning Crescent
2020	December	17		NO ROADKILL FOUND					Overcast	Waxing Crescent

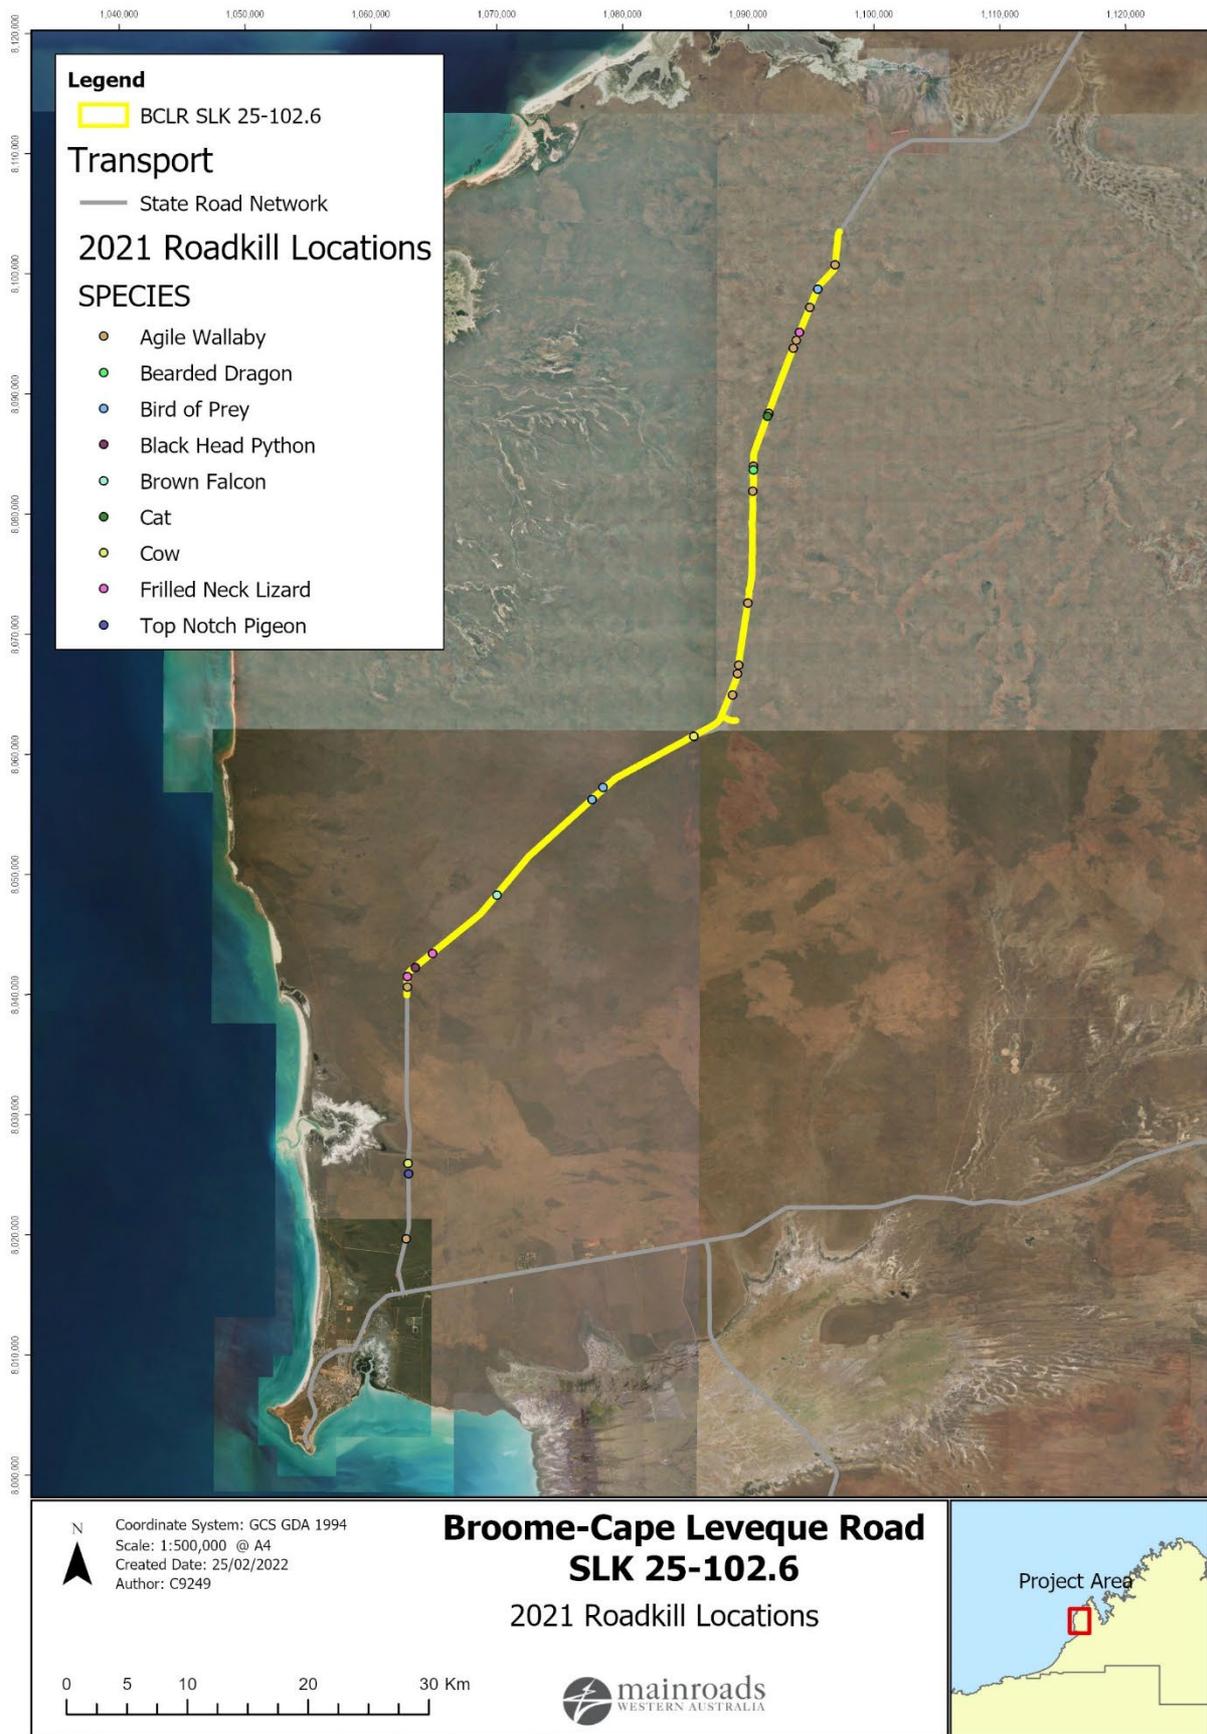
Figure 8: 2021 Roadkill Locations

YEAR	MONTH	DATE	SLK	SPECIES	CARCASS CONDITION	LONGITUDE	LATITUDE	COMMENTS	WEATHER	LUNAR CYCLE
2021	June	2		NO ROADKILL FOUND						Last Quarter
2021	June	11	70.15	Agile Wallaby	Putrefaction	122.533524	-17.370079			New Moon
2021	June	22	47.12	Bungarra	Initial Decay	122.416027	-17.51903			Waxing Gibbous
2021	July	8	10.06	Top Notch Pigeon	Initial Decay	122.280994	-17.797799			New Moon
2021	July	19	97.31	Bird of Prey	Black Putrefaction	122.585348	-17.134264			Waxing Gibbous
2021	August	4	10.89	Cow	Fresh	122.2808	-17.79003		Passing clouds	Waning Crescent
2021	August	10	64.95	Agile Wallaby	Fresh	122.526563	-17.41658			Waxing Crescent
2021	August	23	4.59	Agile Wallaby	Fresh	122.27931	-17.84662			Full Moon
2021	September	6		NO ROADKILL FOUND						New Moon
2021	September	22	48.75	Bird of Prey	Initial Decay	122.42588	-17.50799			Full Moon
2021	October	1	27.51	Black Head Python	Initial Decay	122.2861	-17.6433			Waning Crescent

2021	October	29	95.64	Agile Wallaby	Black Putrefaction	122.57965	-17.14821			Last Quarter
2021	November	8	80.72	Agile Wallaby	Initial Decay	122.537812	-17.26721			Waxing Crescent
2021	November	8	86.19	Agile Wallaby	Black Putrefaction	122.54882	-17.22778			Waxing Crescent
2021	November	8	86.2	Agile Wallaby	Black Putrefaction	122.54884	-17.22773			Waxing Crescent
2021	November	8	85.94	Cat	Black Putrefaction	122.54801	-17.22997			Waxing Crescent
2021	November	8	81.3	Bearded Dragon	Fresh	122.537618	-17.270057			Waxing Crescent
2021	November	8	36.38	Brown Falcon	Fresh	122.346684	-17.588929			Waxing Crescent
2021	November	8	26.49	Frilled Neck Lizard	Fresh	122.280337	-17.650166			Waxing Crescent

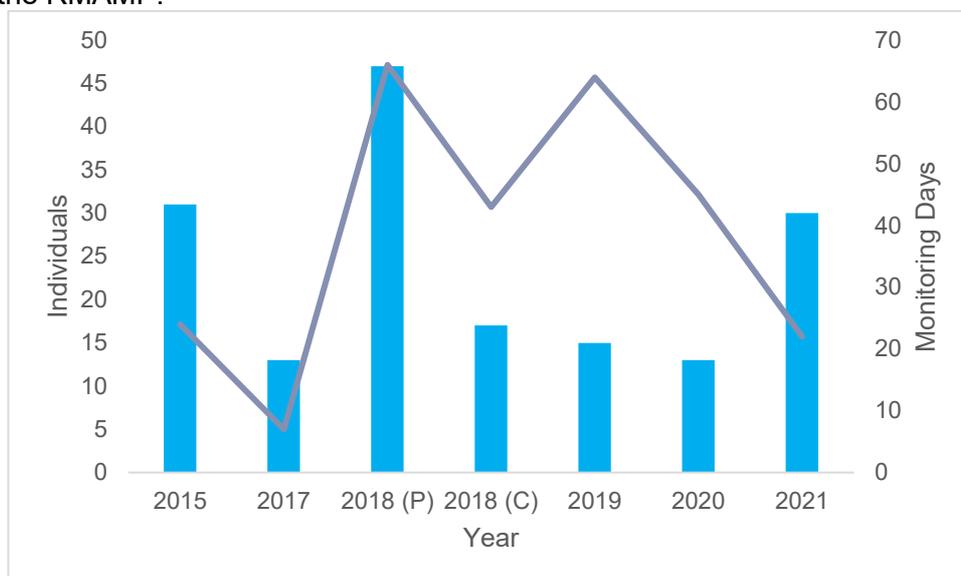
Figure 9: Roadkill Rates and Monitoring Effort

No Greater Bilby roadkill individuals have been recorded on the BCLR during any of the monitoring periods. One Greater Bilby roadkill individual was recorded in 2020, however, as the record was outside the monitoring area, it does not trigger any Greater Bilby management conditions as specified in the RMAMP.
