# EPBC Annual Compliance Report

**EPBC Approval 2013/6984**

**Broome-Cape Leveque Road Upgrade**

**Reporting Period: 2 August 2024 to 1 August 2025**

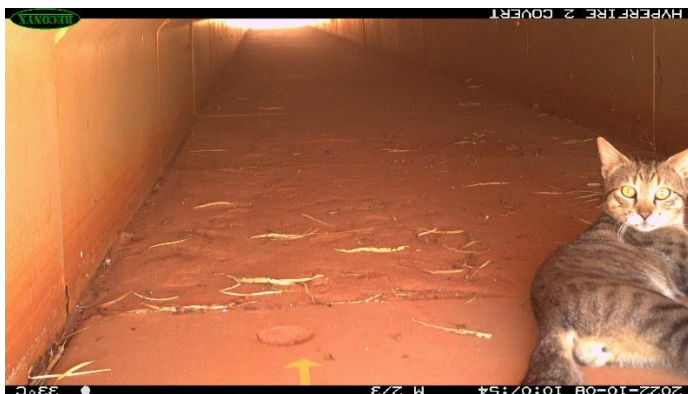
Fig. 3 A feral cat relaxing in Culvert 65

None of the other target species except for feral cats were detected to enter or traverse through a culvert. Cameras placed internally or facing a culvert opening detected more than three times more cat activity than those placed along animal pads in the vicinity of a culvert. These results were consistent among years and indicate that cats were strongly attracted to culvert structures. Cats were observed to rest during the day within some of the culverts. The cameras placed internally detected more cat activity than those placed at an opening presumably because internal cameras captured some activity initiated from either end of the culvert. The distribution of cat activity was not uniform and overall, more cat activity was detected in the northern part of the study area.

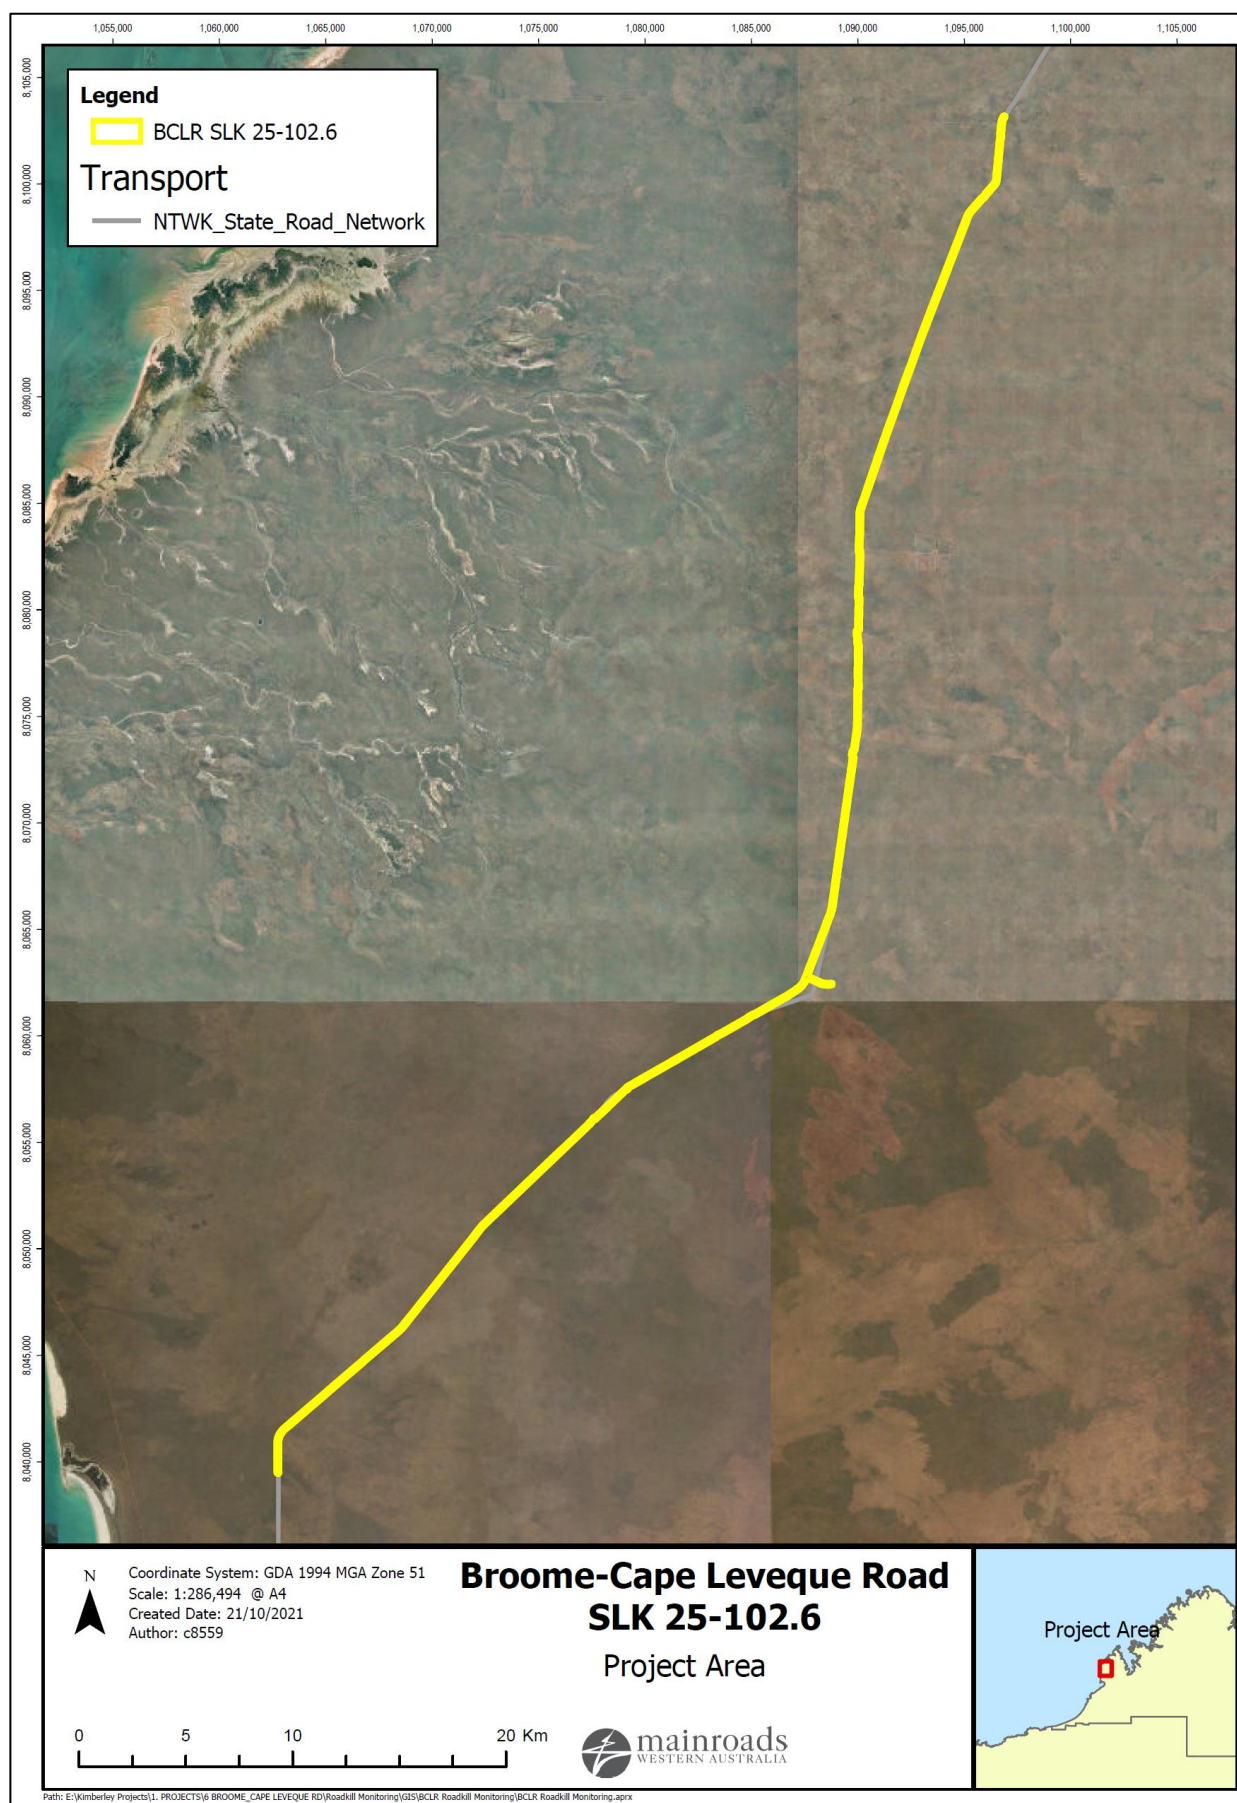
Figure 1: Project Area

Various sections of the BCLR have been upgraded to a sealed standard over the last ten years. Main Roads Western Australia (Main Roads) upgraded 77.6 km (Straight Line Kilometre (SLK) 25 to 102.6) of the unsealed section of the BCLR (Figure 1). The upgrade involved construction of a new road generally parallel to the existing unsealed road. Road user safety and reduced maintenance are two of the key reasons for the upgrade.

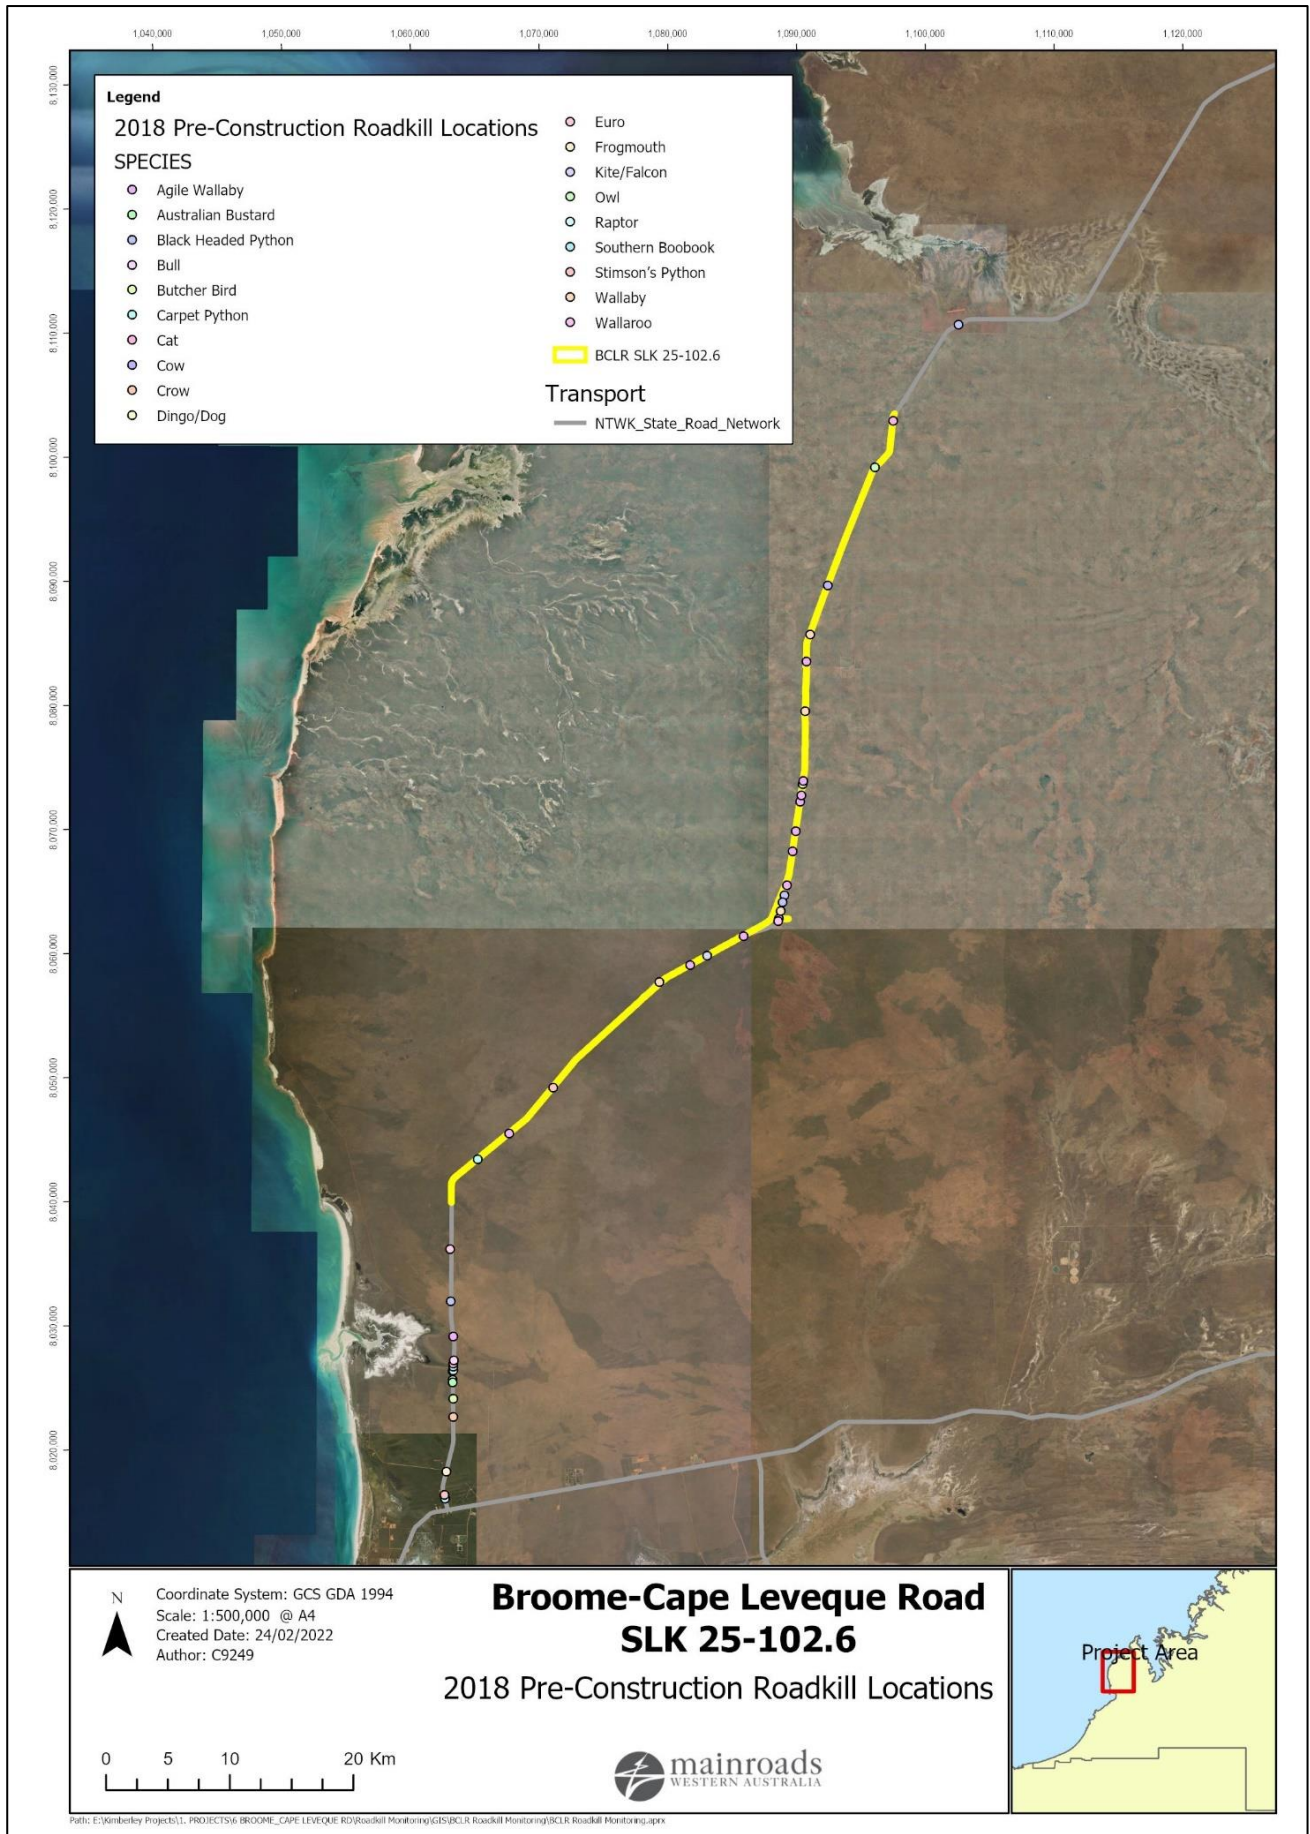
Figure 4: 2018 Pre-Construction Roadkill Locations

In 2018, pre-construction of the BCLR (January – December), 47 roadkill individuals were recorded from 66 monitoring days (Table 3). These comprised 11 Agile Wallabies, seven wallabies, four Black Headed Pythons, four Southern Boobooks, three Stimson's Pythons, two Dingos/dogs, two kites/falcons, one Euro, one Frogmouth, one raptor, one cow, one Bungarra, one Australian Bustard, one crow, one Carpet Python, one Butcherbird, one cat, one owl, one Wallaroo, one bird of prey (unknown) and one bull. No Greater Bilby individuals were recorded. The road kills appear to be spread along the length of the road (Figure 4). Lunar cycle does not appear to influence level of roadkill.

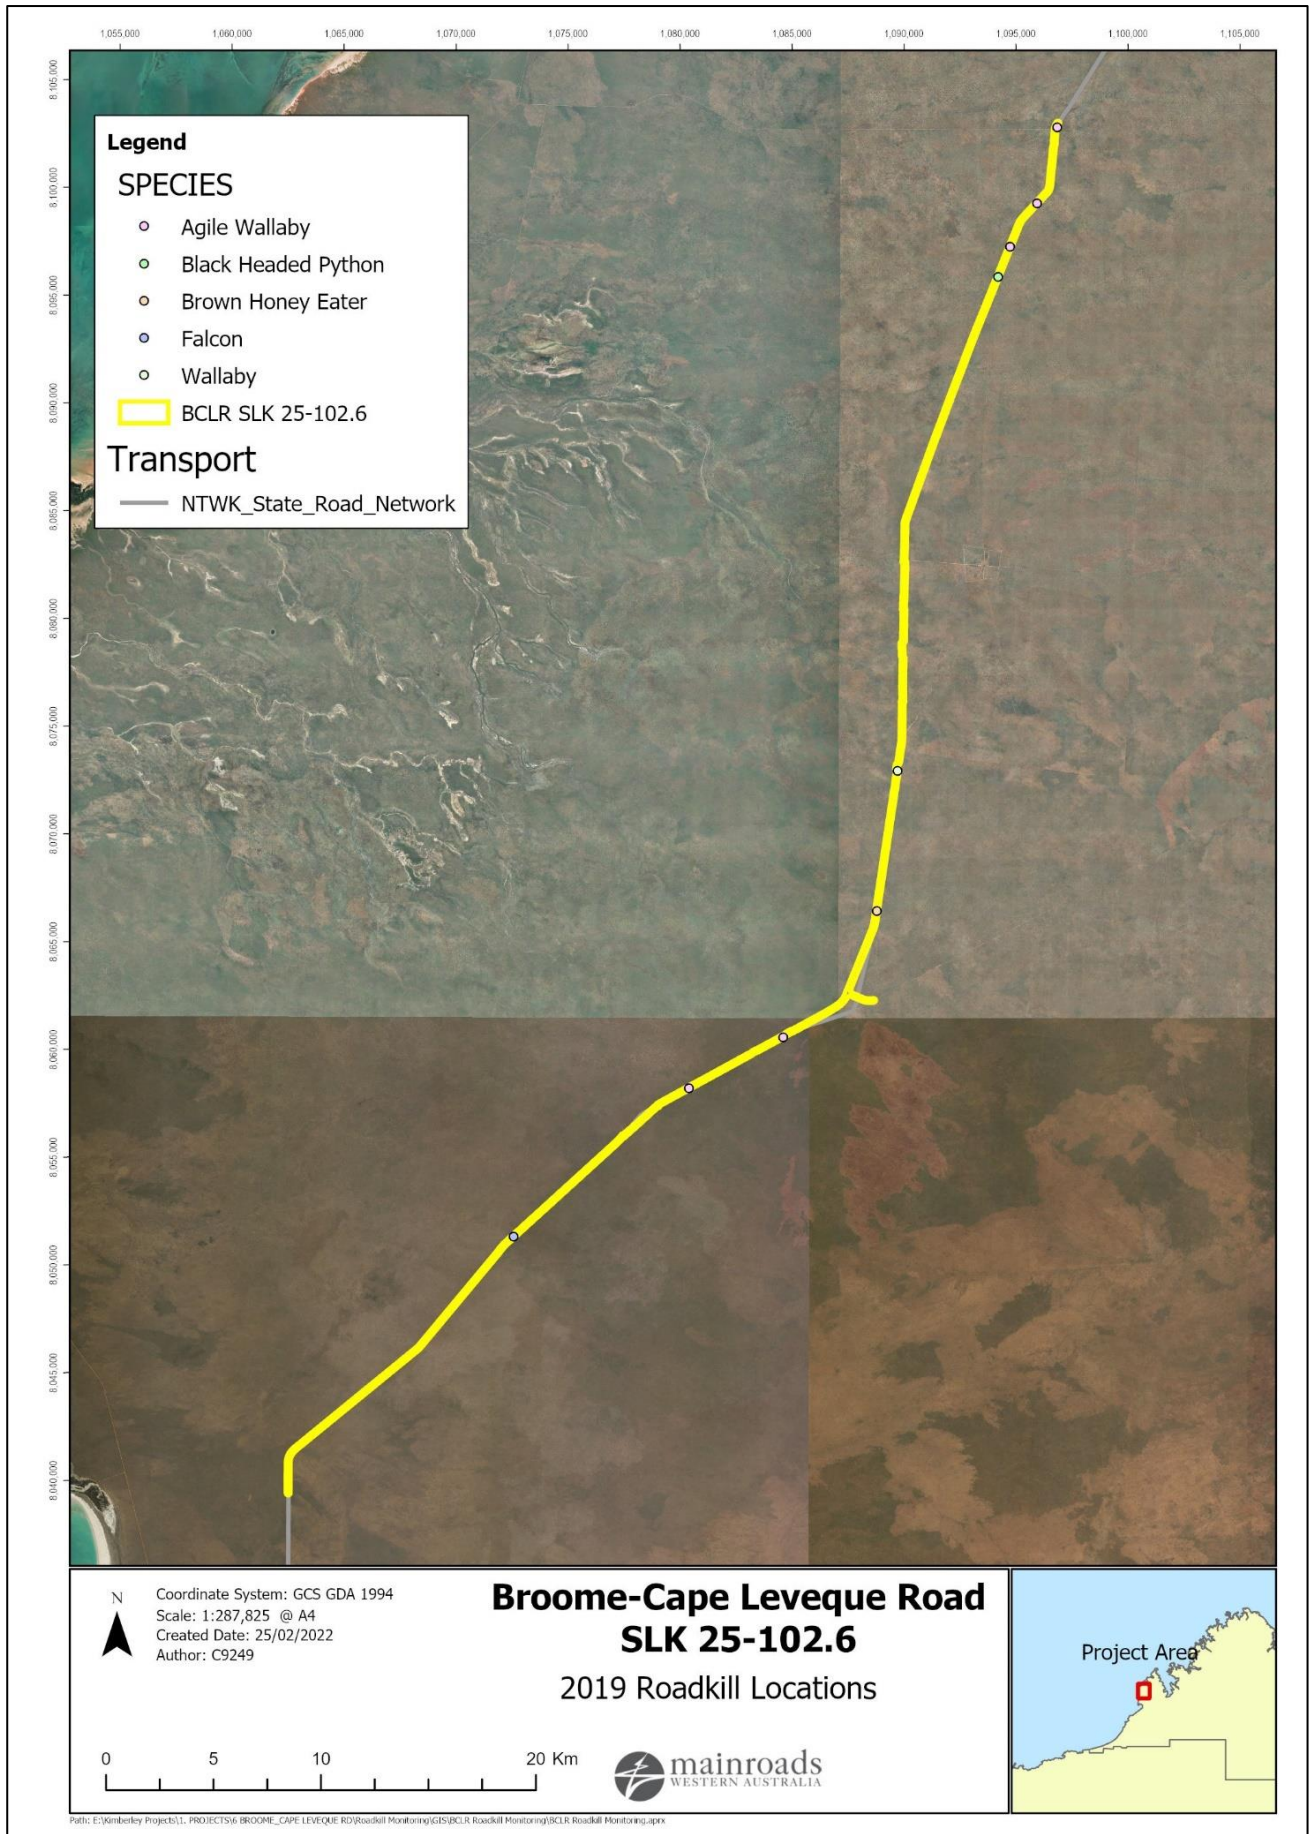
Figure 6: 2019 Roadkill Locations

In 2019 between the months of April and December, 15 roadkill individuals were recorded from 64 monitoring days (Table 5). These comprised seven Agile Wallabies, three falcons, two wallabies, one Dingo, one Black Headed Python and one Brown Honey Eater. No Greater Bilby individuals were recorded. The road kills appear to be spread along the length of the road (Figure 6). Lunar cycle does not appear to influence level of roadkill.

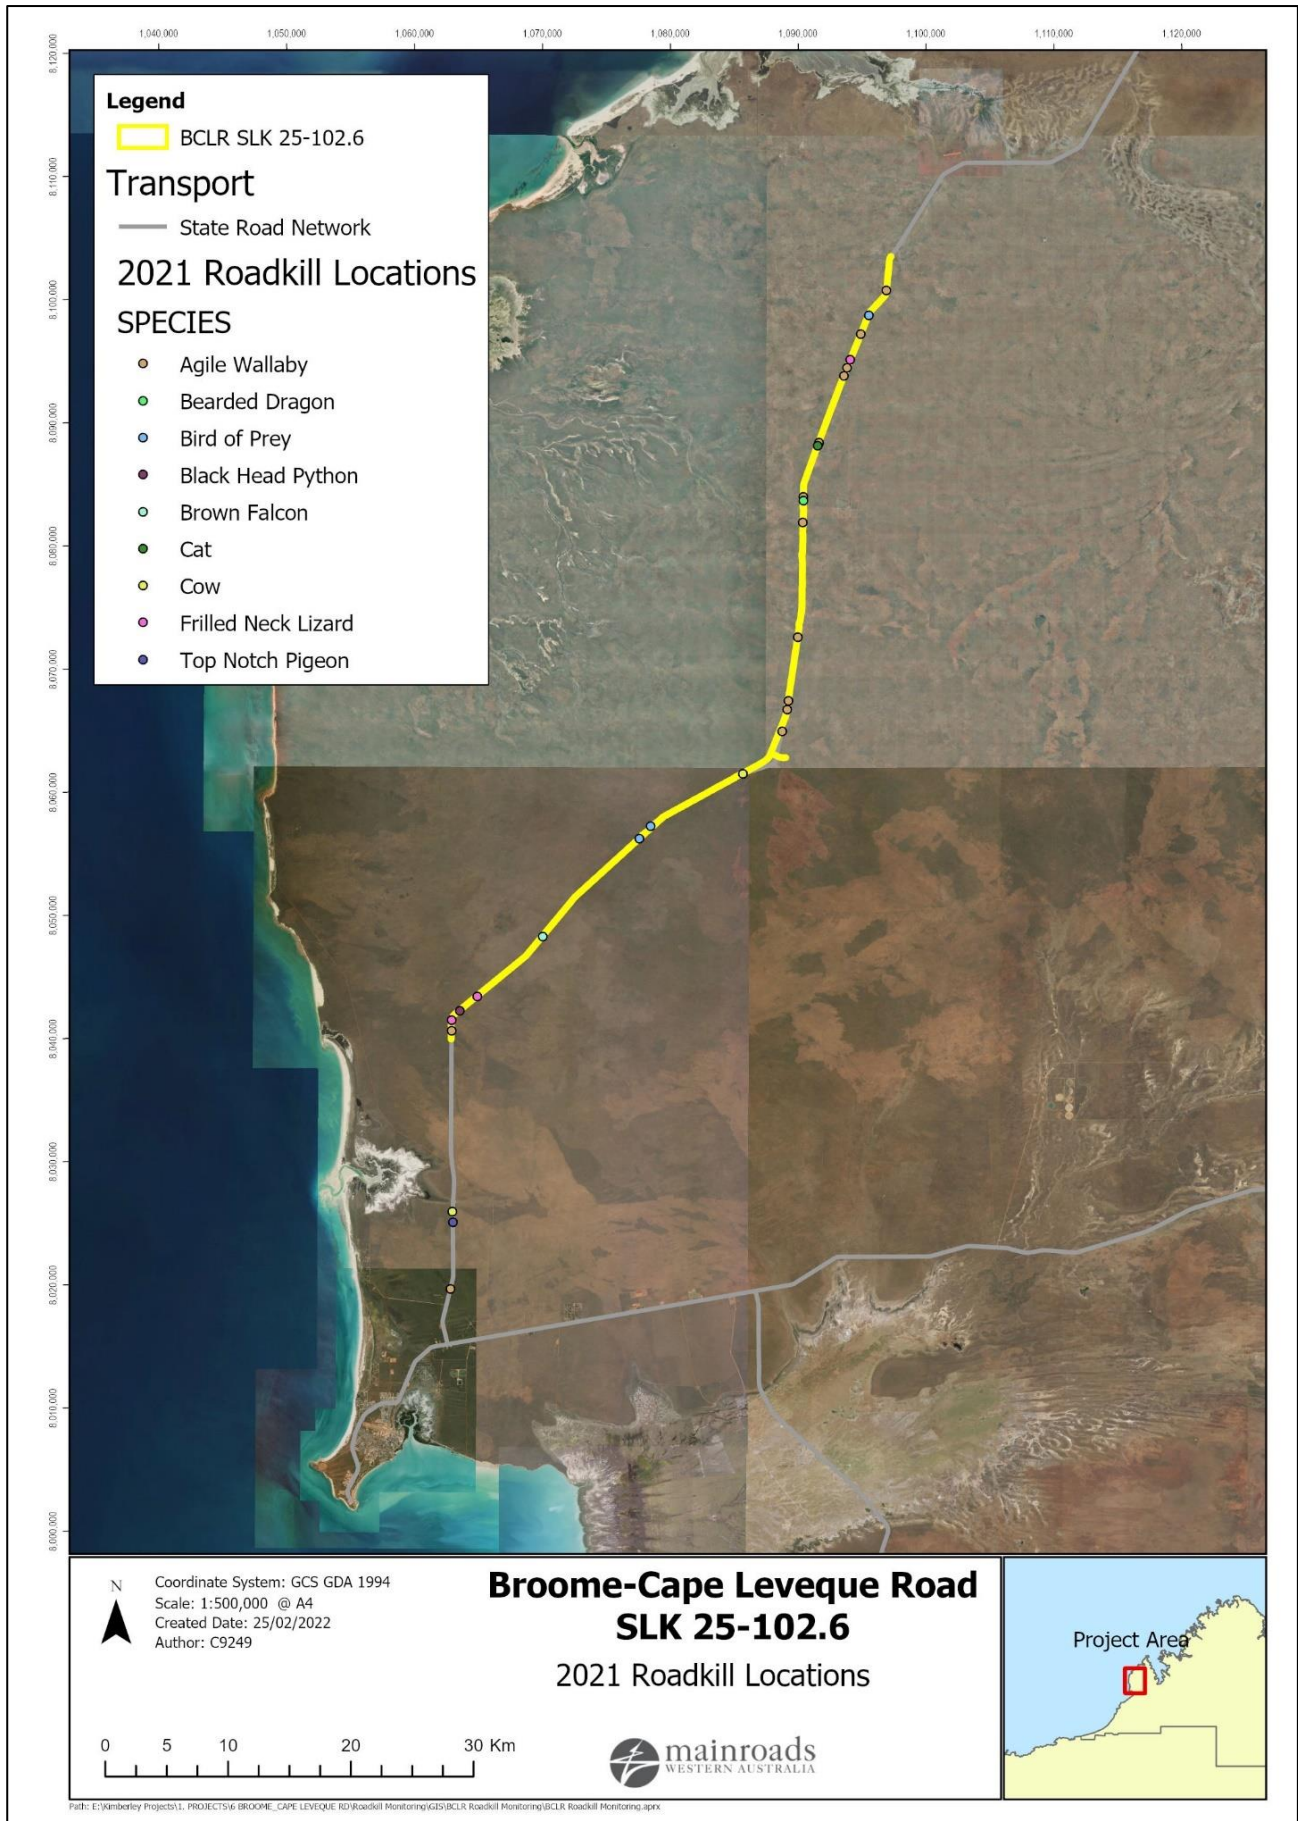
Figure 8: 2021 Roadkill Locations

In 2021 between the months of January and November, 30 roadkill individuals were recorded from 22 monitoring days (Table 7). These comprised 15 Agile Wallabies, four Birds of Prey, three Frilled Neck Lizards, two Cows, one Bungarra (Sand Goanna), one Top Notch Pigeon, one Black Head Python, one Bearded Dragon, one Brown Falcon and one Cat. No Greater Bilby individuals were recorded. The road kills appear to be spread along the length of the road (Figure 8). Lunar cycle does not appear to influence level of roadkill.

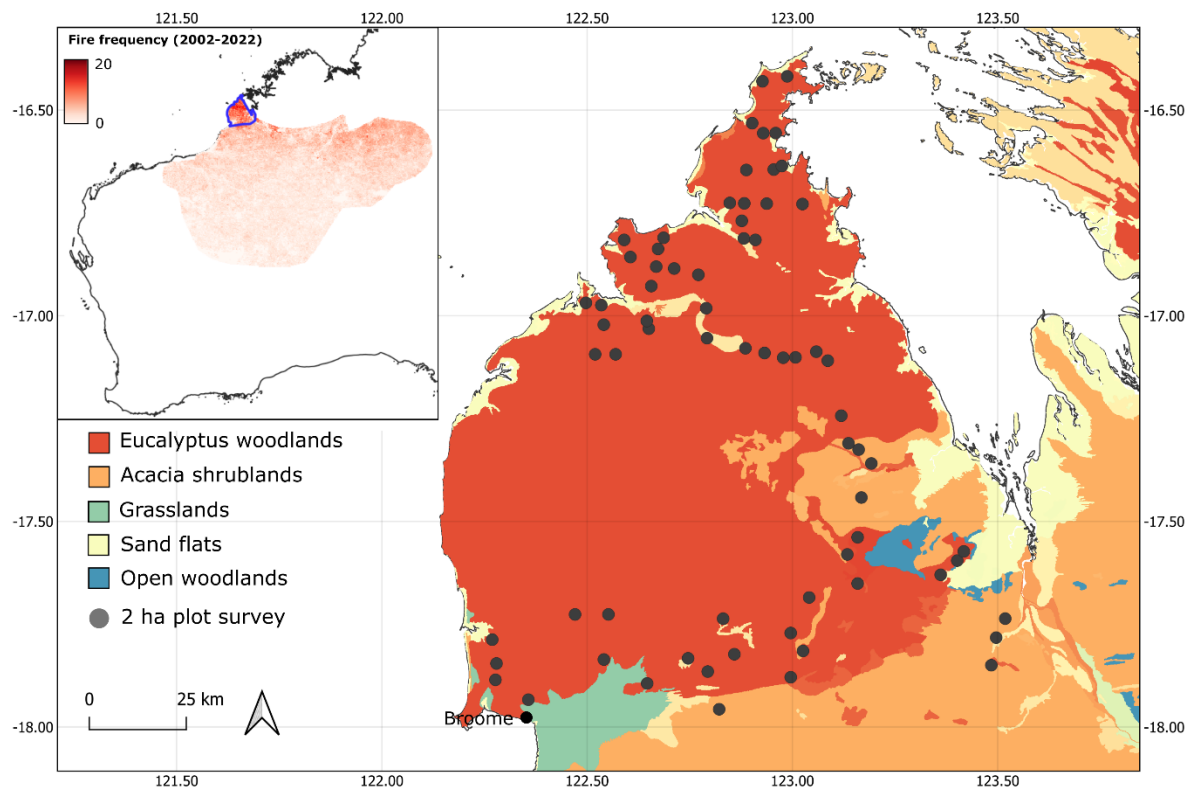
**Figure 2** – Location of 2-ha sign plots located on the Dampier Peninsula in north-west Australia. Inset shows fire frequency across the greater bilby's (*Macrotis lagotis*) contemporary range (excluding the isolated Queensland population), with the study area outlined in blue.

Bilby occupancy on the Dampier Peninsula was sampled across 69 x 2-ha sign plots (Figure 2). Collaborative planning sessions for sign plot locations was completed with Nyul Nyul, Bardi Jawi Oorany, Nyikina Mangala Rangers and Yawuru Country Managers. Sites were stratified according to fire frequency and the majority of plots sampled four times each (with a small number of plots three times). At the time of field surveys, some areas of the Dampier Peninsula remained as undetermined Native Title Claim and were not sampled. As a result, full spatial coverage of the Dampier Peninsula was not possible.

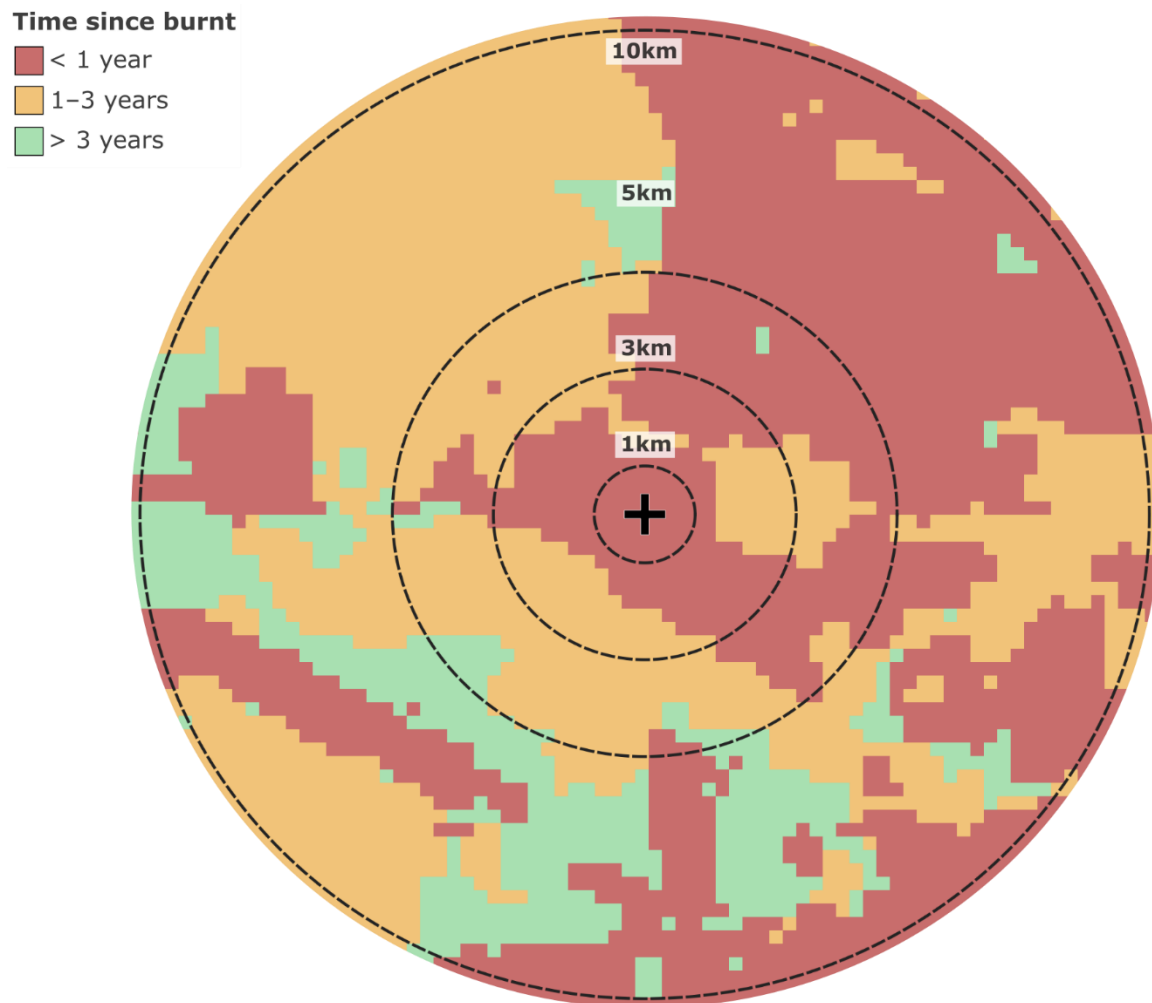
**Figure 4** – Burn data used to measure fire attributes on the Dampier Peninsula in Northern Australia. The black cross represents the centre of a 2-ha plot site.

Research has shown that fire attributes can have varying impacts on species depending on the scale at which they are measured (Nimmo *et al.* 2019; Wan *et al.* 2020). To account for this, we measured fire attributes at multiple scales for every animal presence record. We did this by creating buffers of different sizes for each presence record and then clipping fire data to those buffers, following Radford *et al.* (2021). The buffer sizes were 1 km ( $A = 3.14 \text{ km}^2$ ), 3 km ( $28.26 \text{ km}^2$ ), 5 km ( $78.5 \text{ km}^2$ ), and 10 km ( $314 \text{ km}^2$ ) from the presence records (Figure 4).

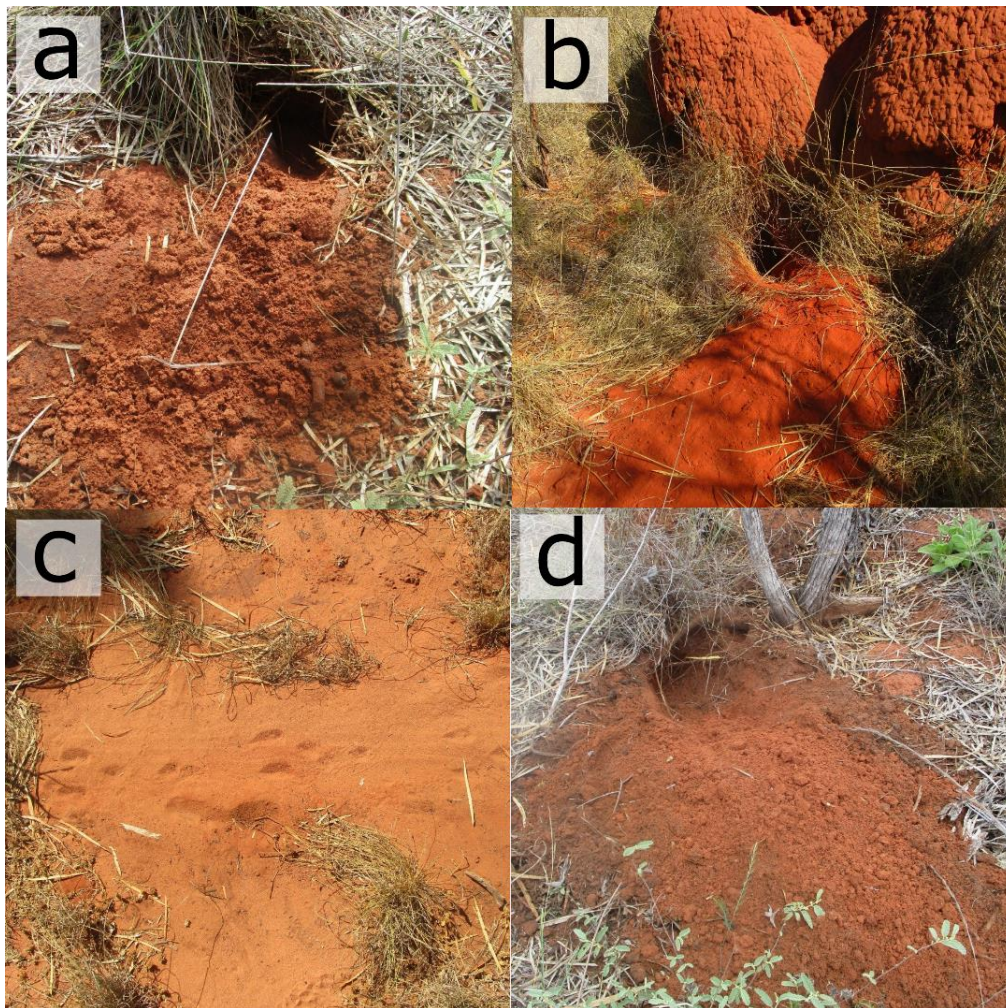
**Figure 5** – Active bilby signs encountered to confirm presence during occupancy surveys, active burrow, diggings (note digging at base of *Acacia eriopoda* extracting root dwelling larvae), digging and scat and tracks.

The most detected species across all plots were cattle (92.8%), followed by feral cats (62.3%), dingoes (55.1%) and donkeys (30.4%) (Figure 6). Bilbies were detected at 18.8% of plots. Bilby detections were made primarily from diggings, burrows, tracks and presence of scats (Figure 5).

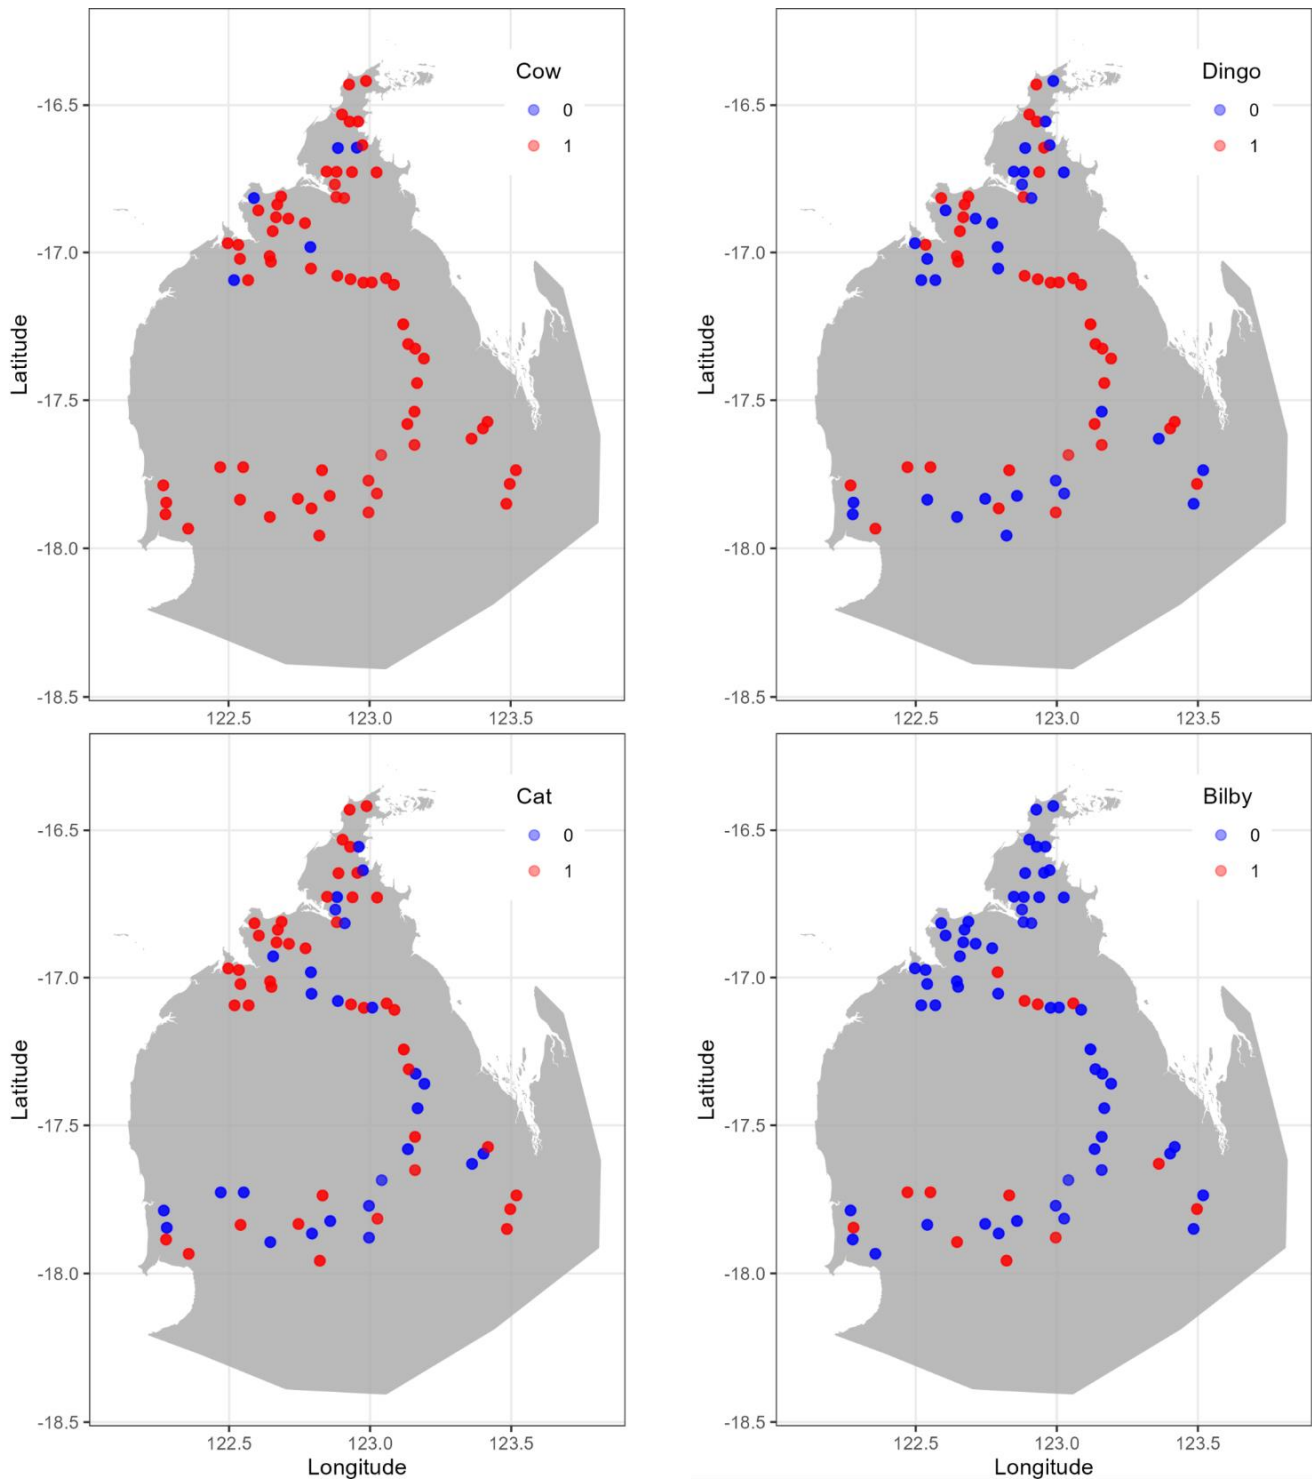
**Figure 6** – Species occurrence data collected using 2-ha plot surveys on the Dampier Peninsula.

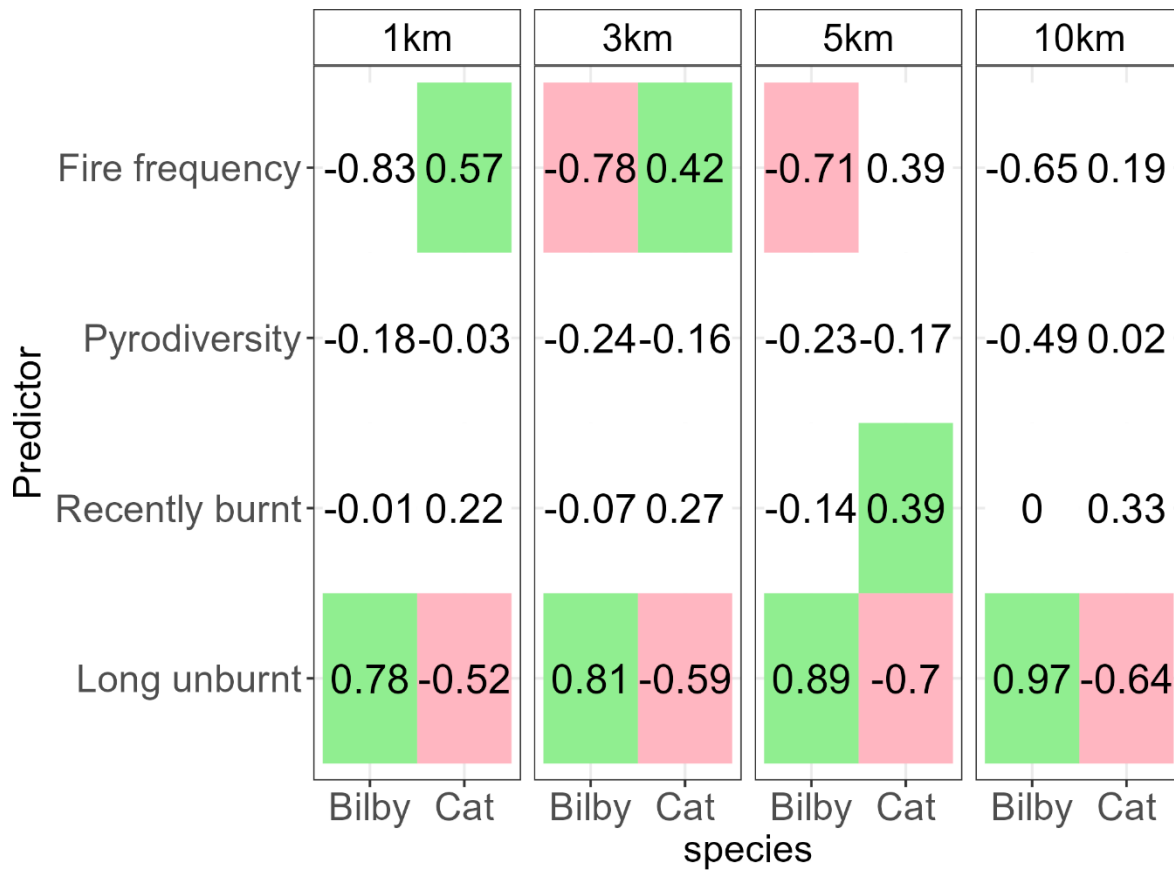
**Figure 7** – Model estimates from generalized linear mixed-effects models testing the influence of fire attributes on the presence of greater bilbies and feral cats on the Dampier Peninsula in north-west Australia. Coloured cells show estimates where the effect was significant ( $p < 0.05$ ). Red cells indicate a negative effect, and green cells indicated a positive effect.

Bilby presence was influenced by the proportion of unburnt habitat, with the largest effect observed at the largest scale (10 km) (Figure 7). Here, the likelihood of bilby presence increased from absent (0%) when there was no unburnt habitat to 24.2% when the entire site was unburnt (Figure 8). Fire interval also influenced bilby presence at the 3 km and 5 km scales, with presence decreasing from 34.8% at sites that had been burnt 7 times in the previous 20 years to 0% at sites that had been burnt 20 times in the same period (Figure 8). Bilby occurrence predictions were associated with wide confidence intervals, likely due to the limited sample size.

Feral cat presence was also related to the proportion of unburnt habitat, but the effect was in the opposite direction when compared to bilbies (Figure 7). For example, the likelihood of feral cat presence decreased by ~30% between sites that were 100% long unburnt and 0% long unburnt, and this was consistent across scales (Figure 7). The likelihood of feral cat presence also increased with increasing fire frequency at the 3 km and 5 km scales and decreased with increasing proportion of habitat long unburnt at the 5 km scale.

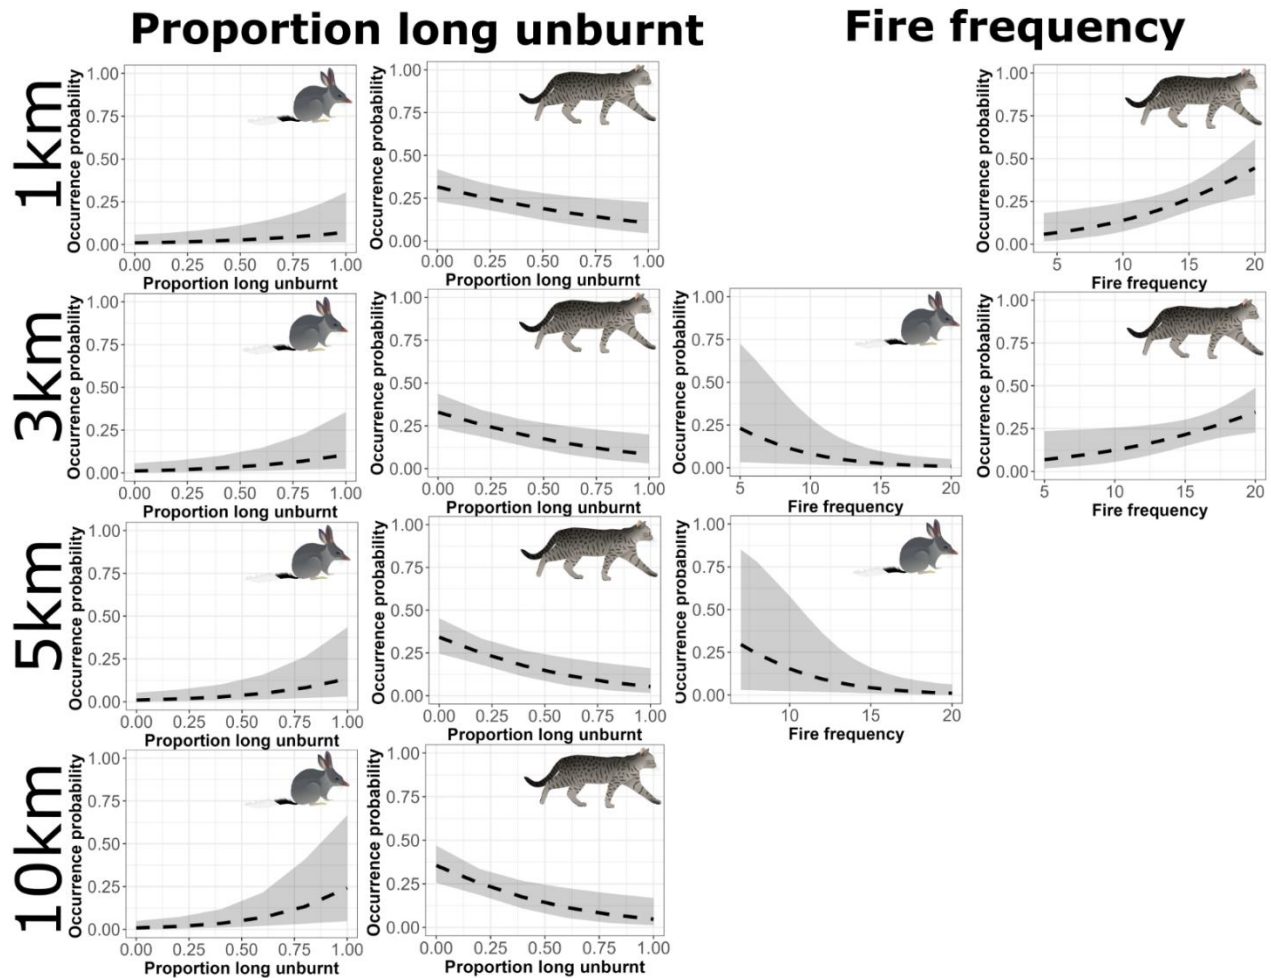
**Figure 8** – Model predictions from generalized linear mixed-effects models testing the influence of fire attributes on the presence of greater bilbies and feral cats on the Dampier Peninsula in north-west Australia. Grey shading indicates 95% confidence intervals. Each row shows predictions from models using data collected at varying distance from 2-ha plot (site, patch, landscape).

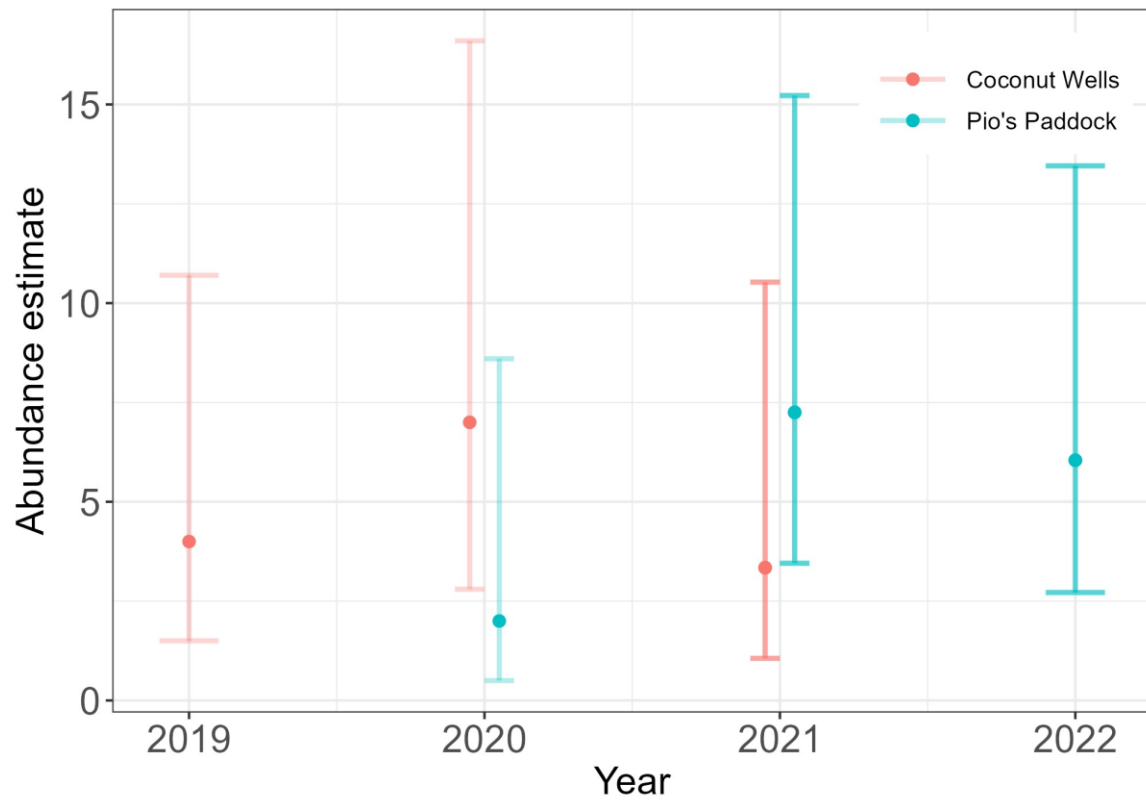
**Figure 9** – Abundance estimates from Coconut Wells and Pio's Paddock populations between 2019 and 2022.

Across all populations and years, a total of 243 scats (successfully genotyped) were collected across 74.2 km of transects (Table 3). Abundance estimates ranged between 2 and 16 (mean = 7). While surveys in 2019 and 2020 indicated that abundance was highest at the Coconut Wells populations, a decline was recorded in 2021, and the population could not be located in 2022 (Figure 9). By contrast, the Pio's Paddock population increased between 2020 and 2021, and remained stable in 2022.

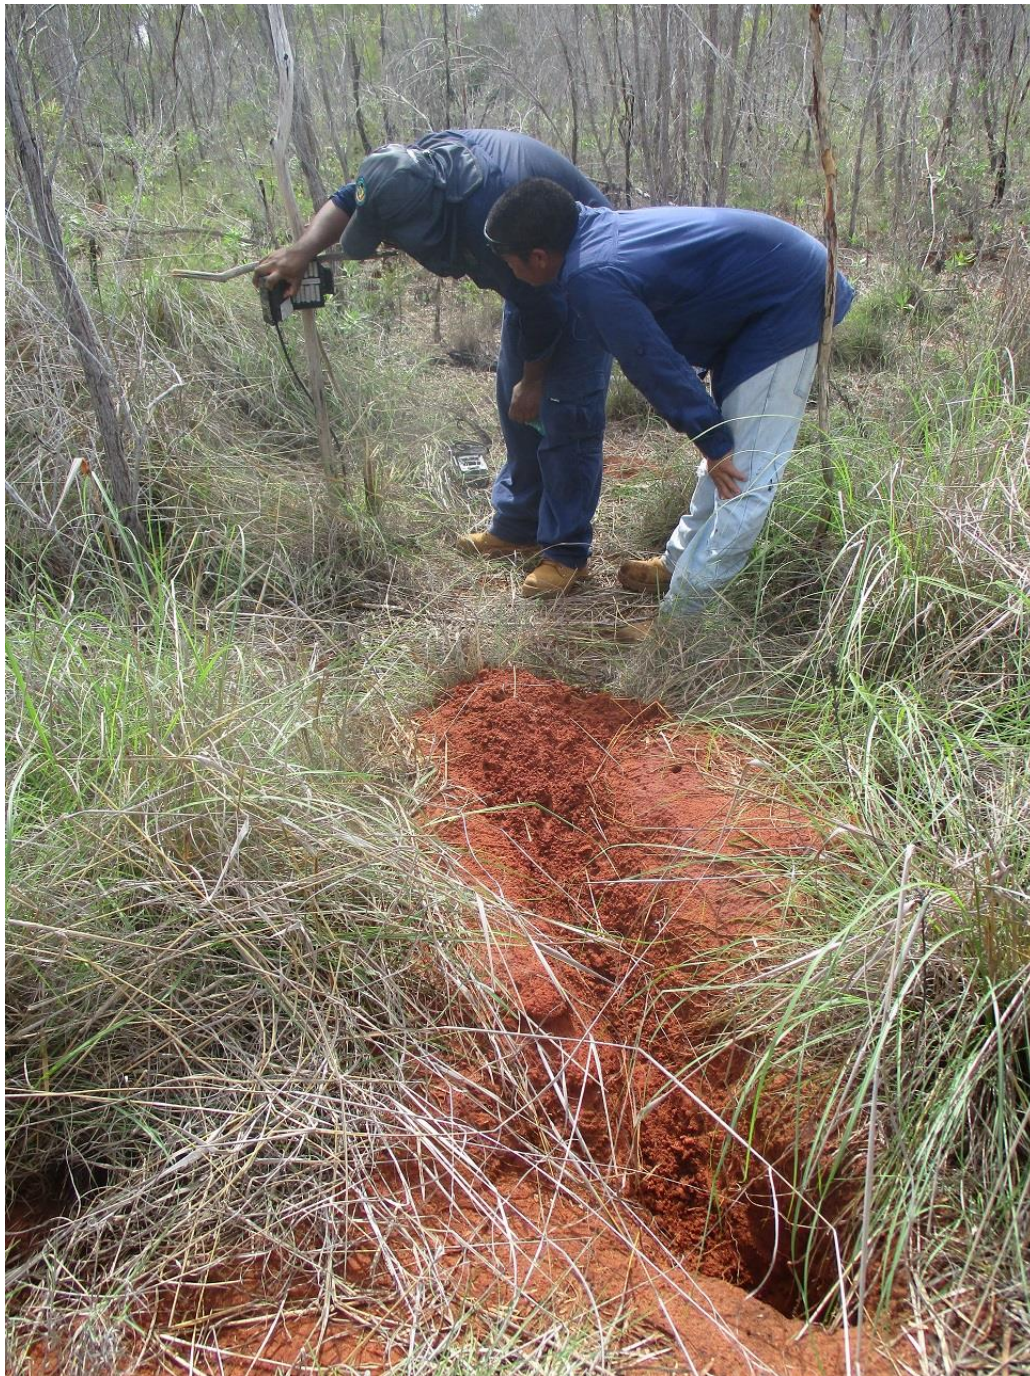
**Figure 13**– Predator camera traps are deployed by Yawuru rangers on a bilby burrow.

Predator occupancy was monitored via a network of remote sensing cameras deployed at Coconut Wells and Pio's Paddock bilby populations between 2020 and 2022 (Figure 13. Figure 14). A minimum of five cameras were deployed at each site in each year. Cameras were deployed for a minimum of 6 weeks. Cameras were positioned to observe vehicle tracks or face the entry of bilby burrows. Vehicle tracks provide movement corridors for introduced predators and their activity on tracks is often higher than off tracks (Raiter *et al.* 2018). Bilby burrows can also act as natural lures in the landscape, with many other prey species as well as bilbies inhabiting them, attracting predators that regularly visit these features in an often barren landscape (Hofstede and Dziminski 2017; Dawson *et al.* 2019).

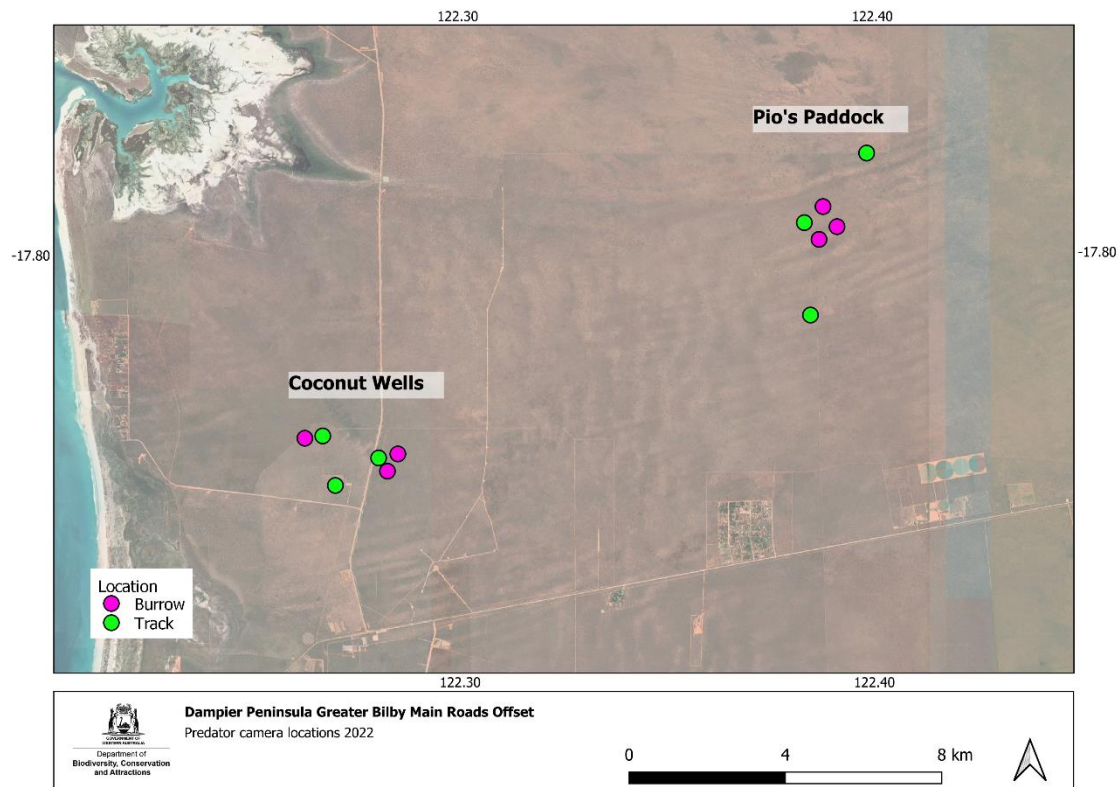
**Figure 14–** Predator camera locations at Coconut Wells and Pio's Paddock in 2022
