# EPBC Annual Compliance Report

**EPBC Approval 2013/6984**

**Broome-Cape Leveque Road Upgrade**

**Reporting Period: 2 August 2024 to 1 August 2025**

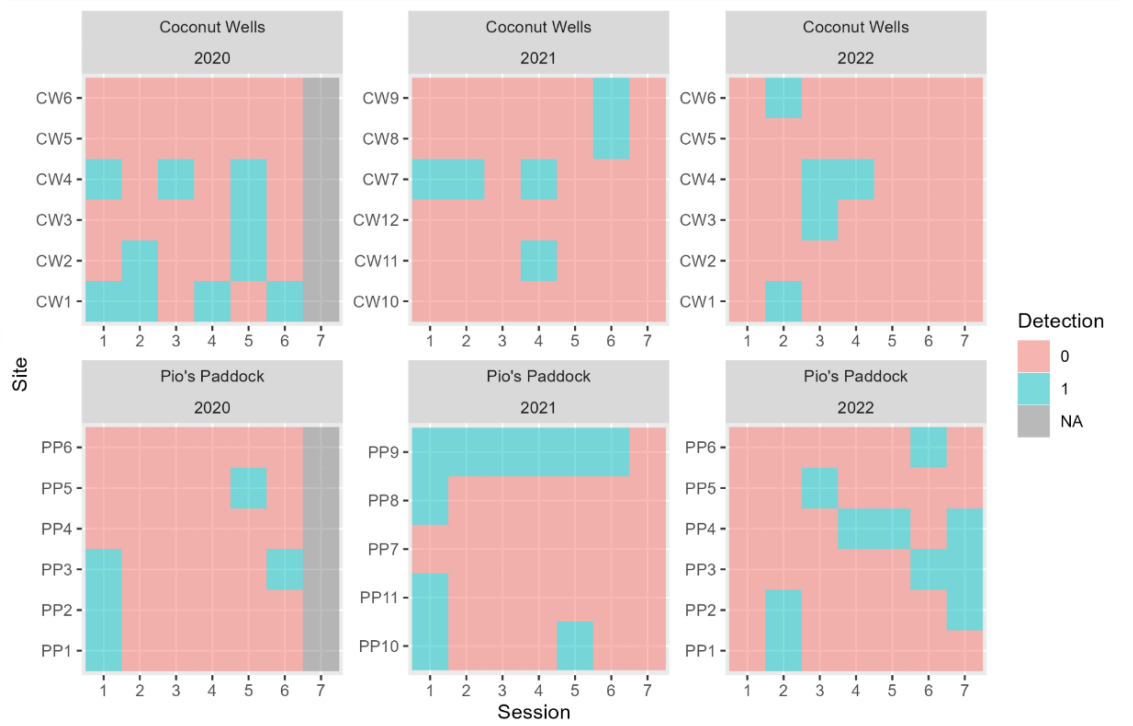
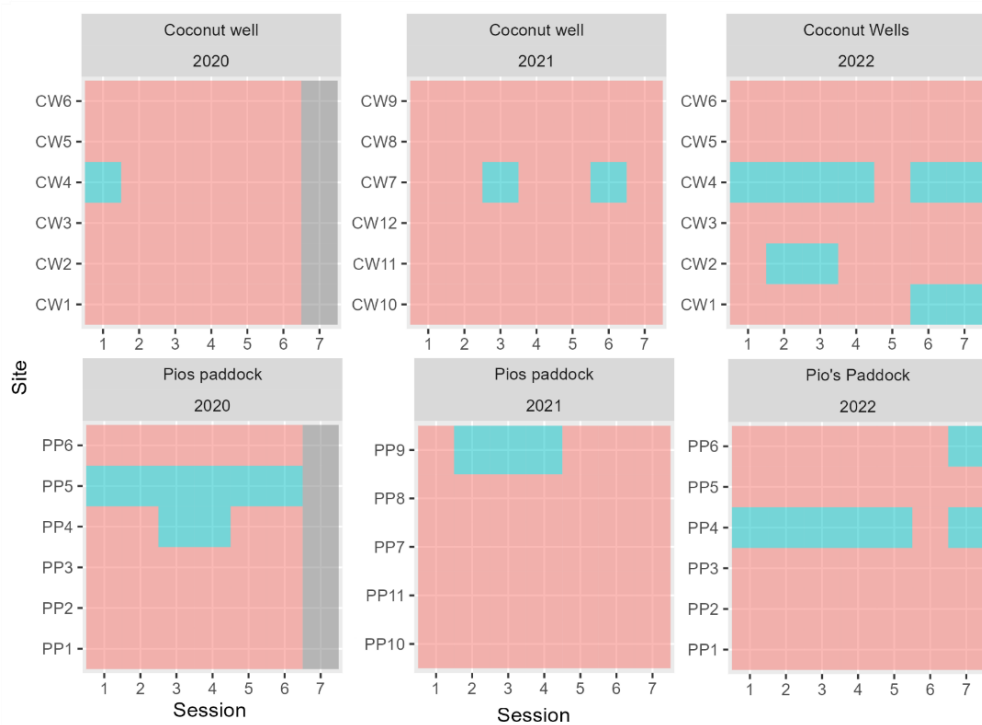
**Figure 15–** Feral cat and dingo detection histories at Coconut Wells and Pio's Paddock between 2020 and 2022.

Sampling effort between 2020 and 2022 totalled 233 one-week sampling occasions (Figure 15, Figure 16). Feral cats and dingoes were detected in 20% (46/233) and 13% (31/233) of all sampling occasions, respectively (Figure 15). No foxes were detected.

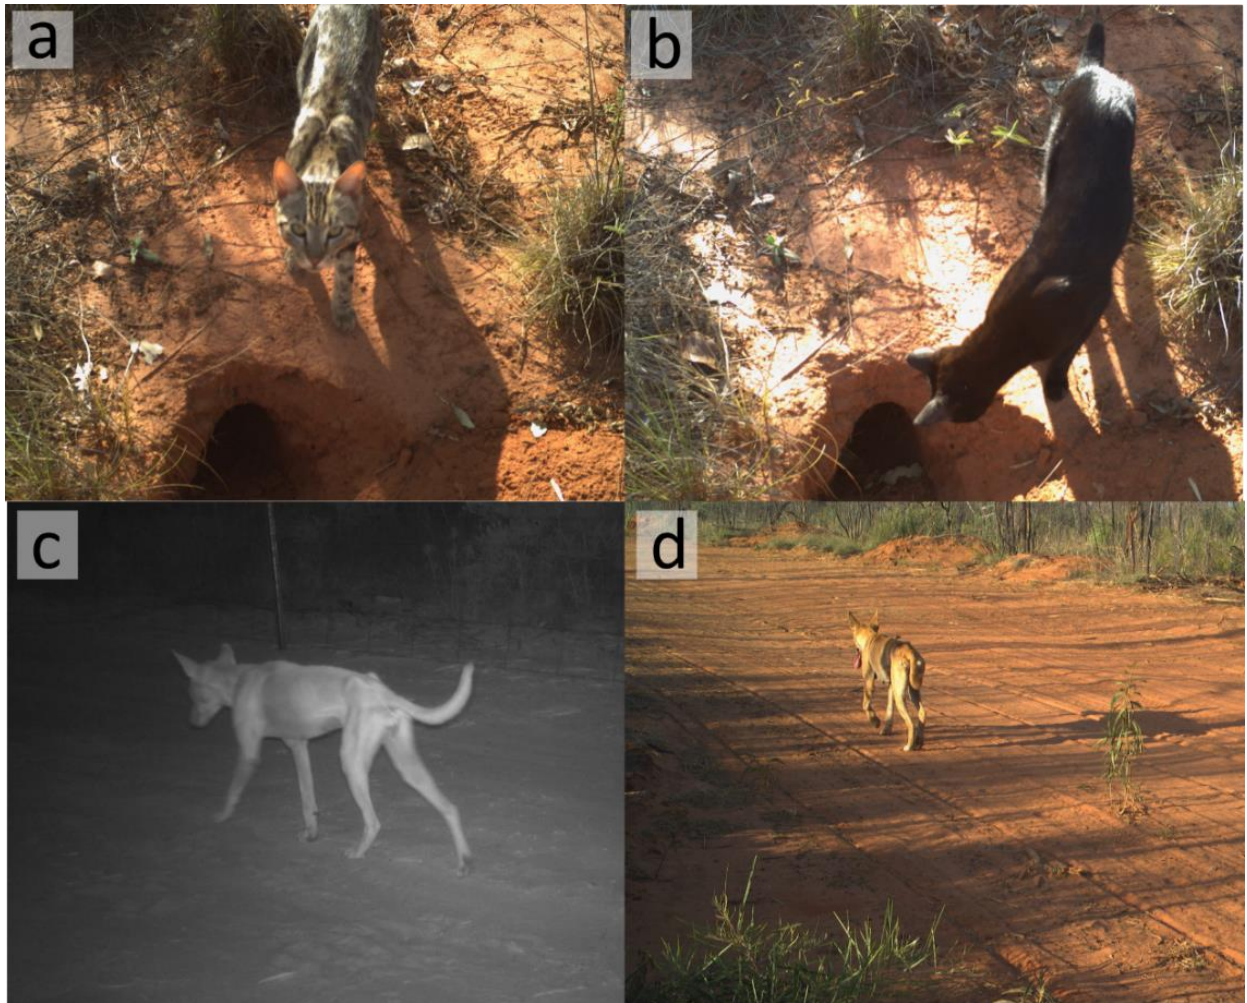
**Figure 16** – Feral cat and dingoes detected on camera trap and Pio's Paddock and Coconut Wells in 2022.

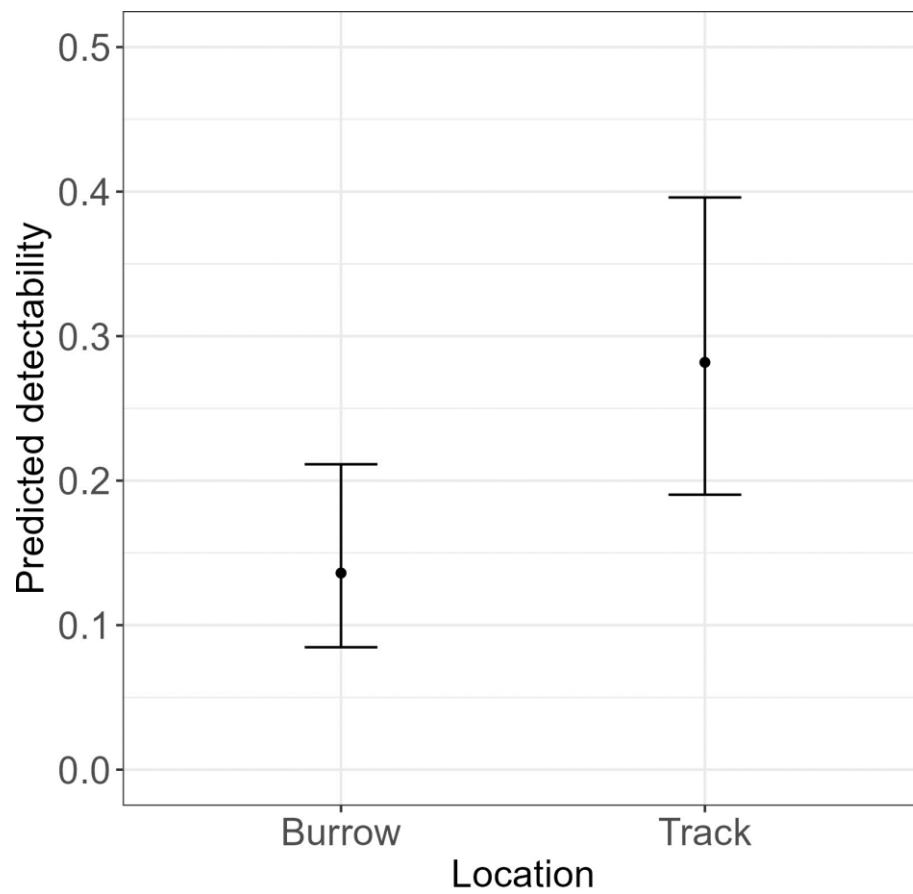
**Figure 17** - A comparison of predicted feral cat detectability (per 2 week sampling period) between cameras located on burrows and tracks.

The most parsimonious model for feral cats included location (track, burrow) as a predictor for detectability, but included no predictors for occupancy (Table 3), indicating no difference in feral cat occupancy either between sampling years, or between populations (Pio's Paddock, Coconut Wells). Predicted feral cat occupancy across all sites and years for feral cats was over 99.4%. Results from the top model indicated cameras located on tracks were more than twice as likely to detect feral cats than cameras located on burrows, similar to modelling from 2021 (Figure 17) (Moore *et al.* 2022).

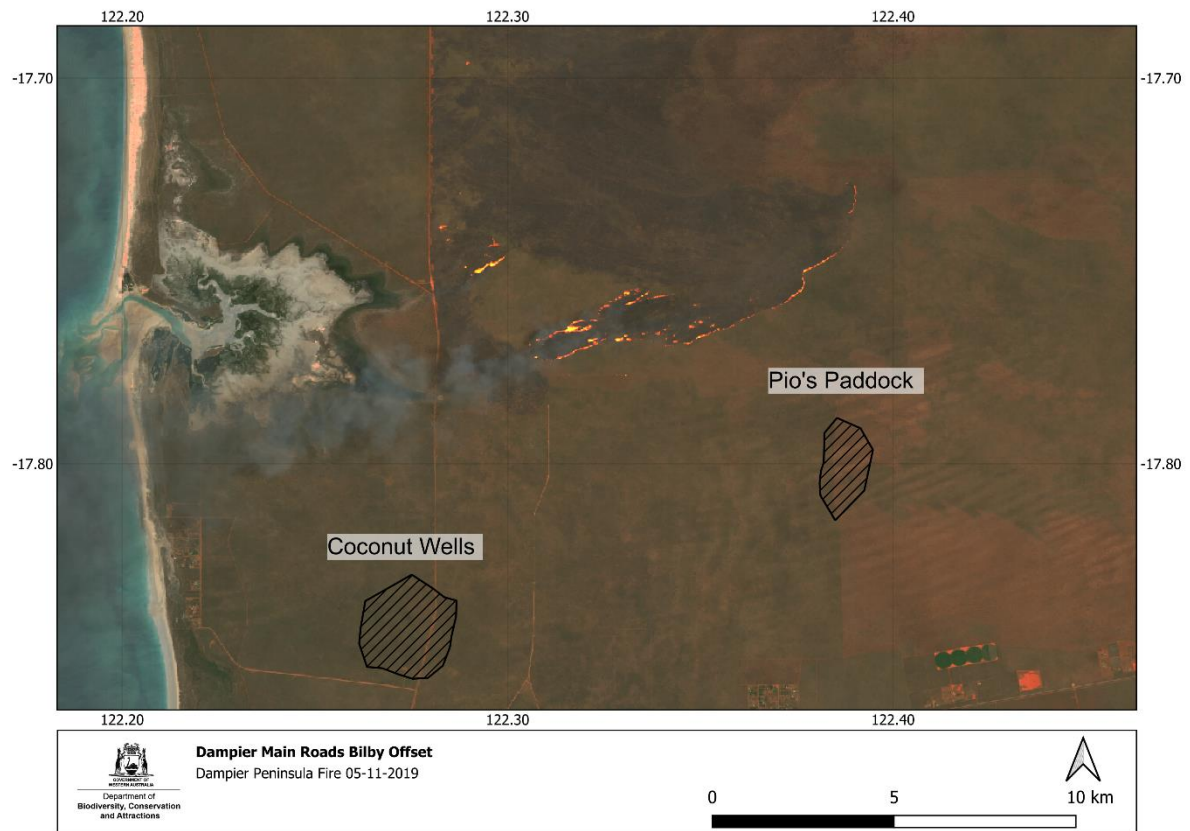
**Figure 18** – Sentinel 2 satellite imagery showing the 2019 late dry season fire which impacted the Coconut Wells bilby population.

In May 2019, DBCA executed strategic cool burns (not associated with this project) approximately 1 km north of the Pio's Paddock population, along with a larger burn spanning roughly 11 km in length, 10 km to the northeast (Figure 23). These measures effectively buffered the area from large-scale, late dry season wildfires fuelled by strong easterly winds that affected the Dampier Peninsula in November 2019, including the habitat occupied by the Coconut Wells bilby population (Figure 18, Figure 19).

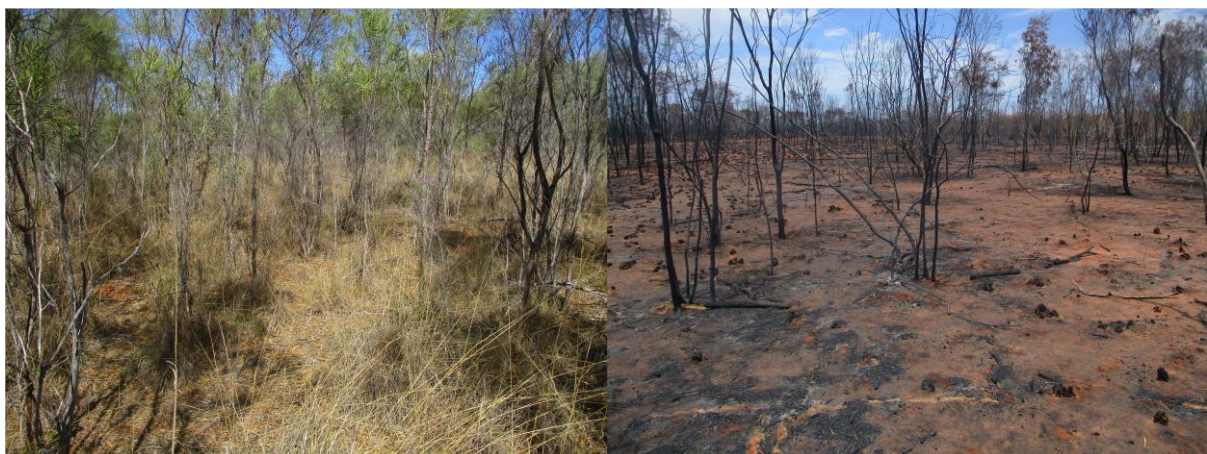
**Figure 19** – Vegetation at Coconut Wells before and after the 2019 late dry season fire.

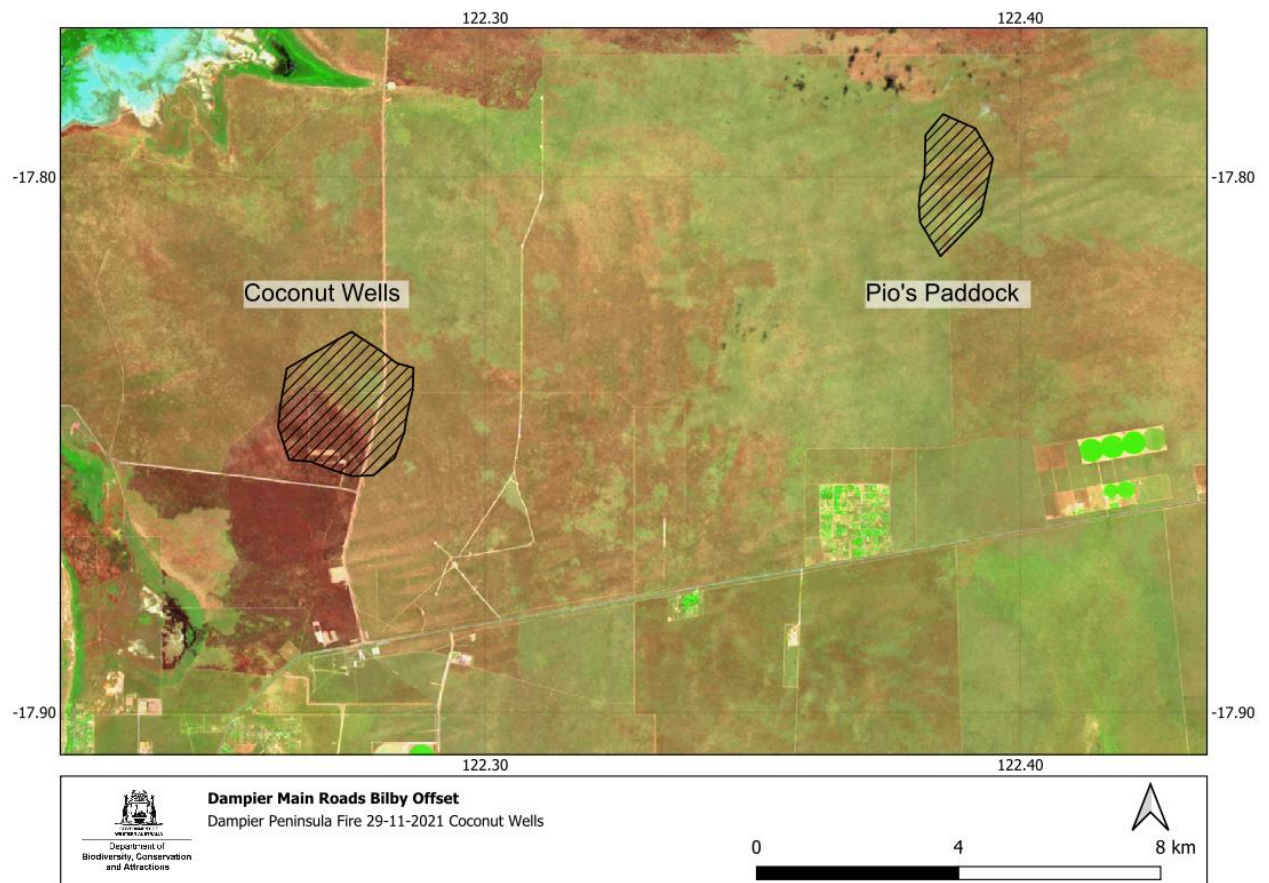
**Figure 20** – Sentinel 2 imagery showing the 2021 late dry season fire which impacted the Coconut Wells bilby colony.

In 2021, fire management efforts were concentrated on the northern boundary of Pio's Paddock, where DBCA conducted aerial burning during the early dry season (June 2021) (Figure 23). This strategy was designed to complement the fire management work carried out in 2020. The Broome region, including the monitoring site at Pio's Paddock, faced the threat of late dry season wildfires in November 2021. DBCA staff effectively communicated the area's environmental importance to Department of Fire and Emergency Services (DFES) staff during the emergency response, leading to successful protection of the Pio's Paddock monitoring site with the support of DBCA's on-ground wildfire suppression efforts. During the October 2021 wildfires, a section of the Coconut Wells monitoring site was impacted (Figure 20).

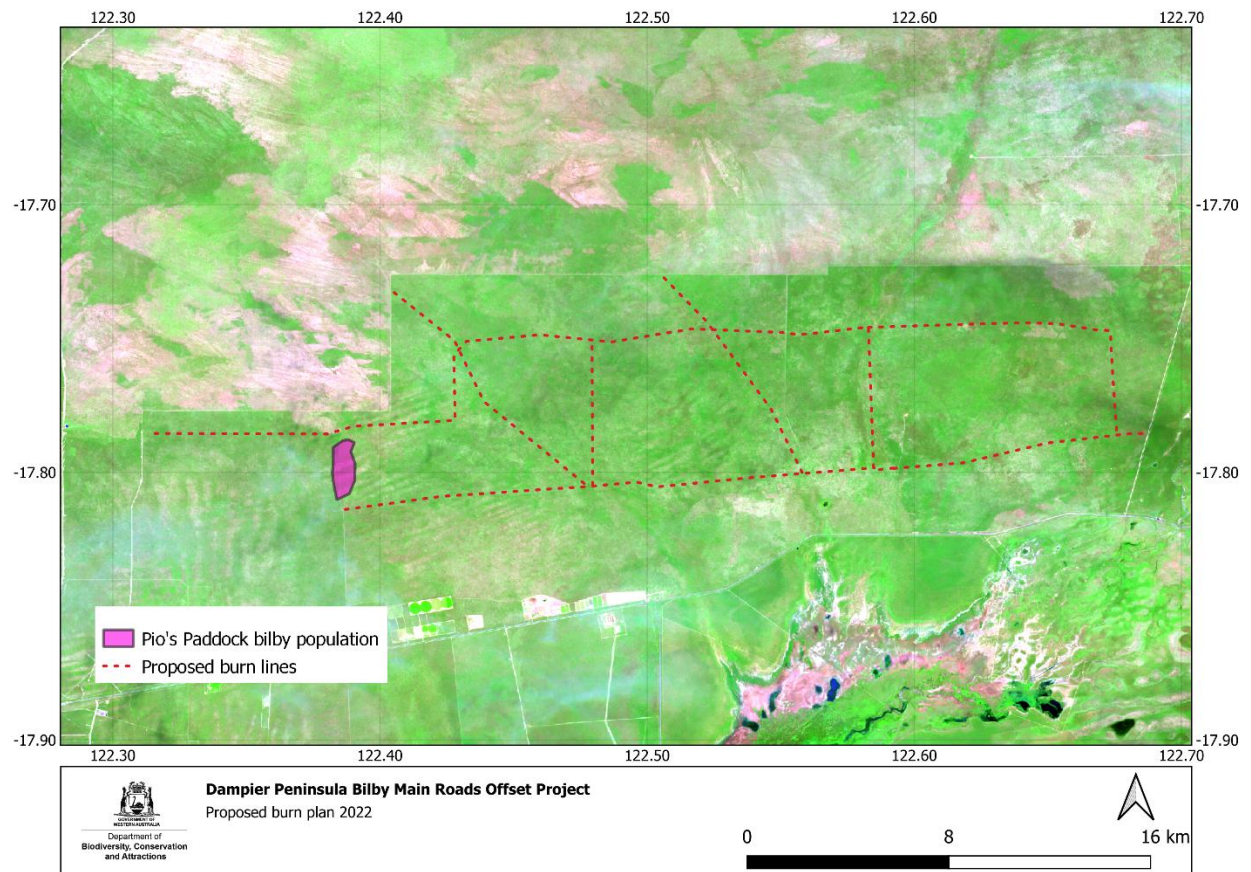
**Figure 21** – 2022 proposed burn lines at Pio’s Paddock on the Dampier peninsula.

The 2022 burn plan for Pio's Paddock involved strategic aerial ignition lines to prevent late dry season wildfires typically fuelled by strong south-easterly winds (Figure 21). Lines were proposed to run in a north-west/south-east direction for better effectiveness with dry season winds. Fine-scale ground burning around the bilby population was also proposed to achieve patchiness and promote desirable vegetation bilby food plants. This comprehensive approach to fire management at Pio's Paddock aimed to balance the protection of bilby populations with the reduction of fire risk. By incorporating both aerial and ground-based techniques, the burn plan was designed to maintain a mosaic of habitats that support bilby food plants and provide refuge from predators.

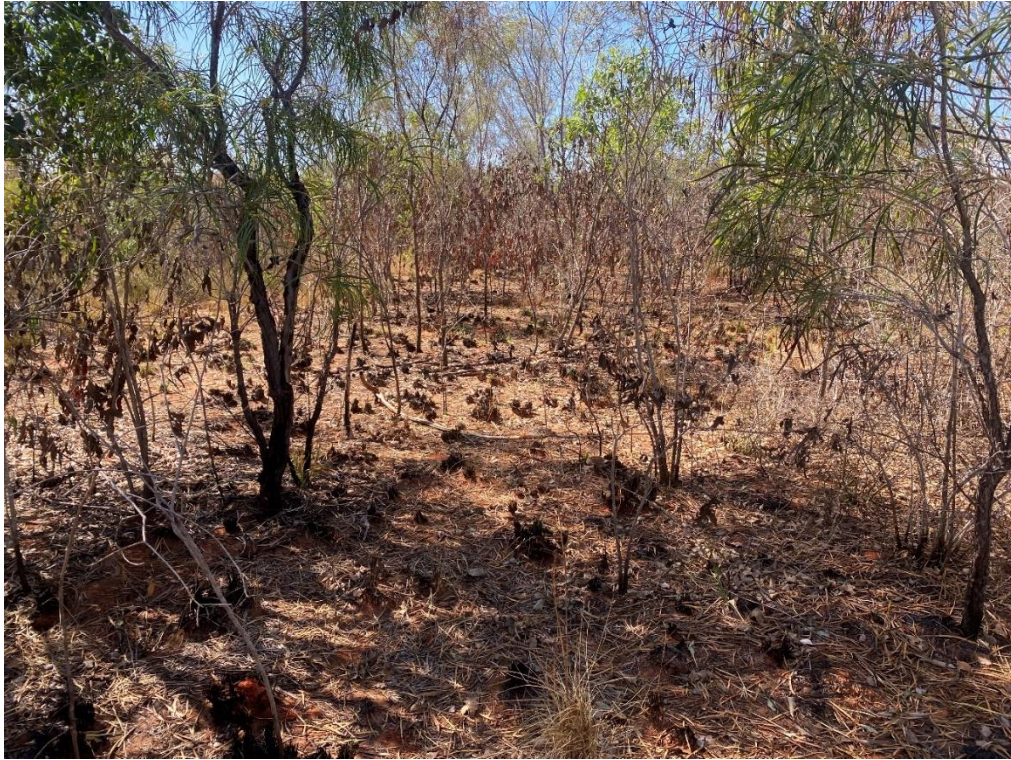
**Figure 22** – Low intensity strategic burn conducted at Pio's Paddock on the Dampier Peninsula in 2022.

Burns were implemented in two stages between the 23rd of May and the 2nd of July as part of a collaborative effort between the Department of Biodiversity, Conservation and Attractions (DBCA) and Yawuru country managers. Sentinel satellite imagery indicated that burns achieved reasonable take in the targeted locations, which provided good protection from late dry season fire, which typically spread in a south-easterly direction (Figure 23). On-ground assessments confirmed strategic fires burnt at low intensity, as indicated by the large proportion of mature *Acacia tumida* (an important food plant for bilbies) that remained intact (Figure 22).

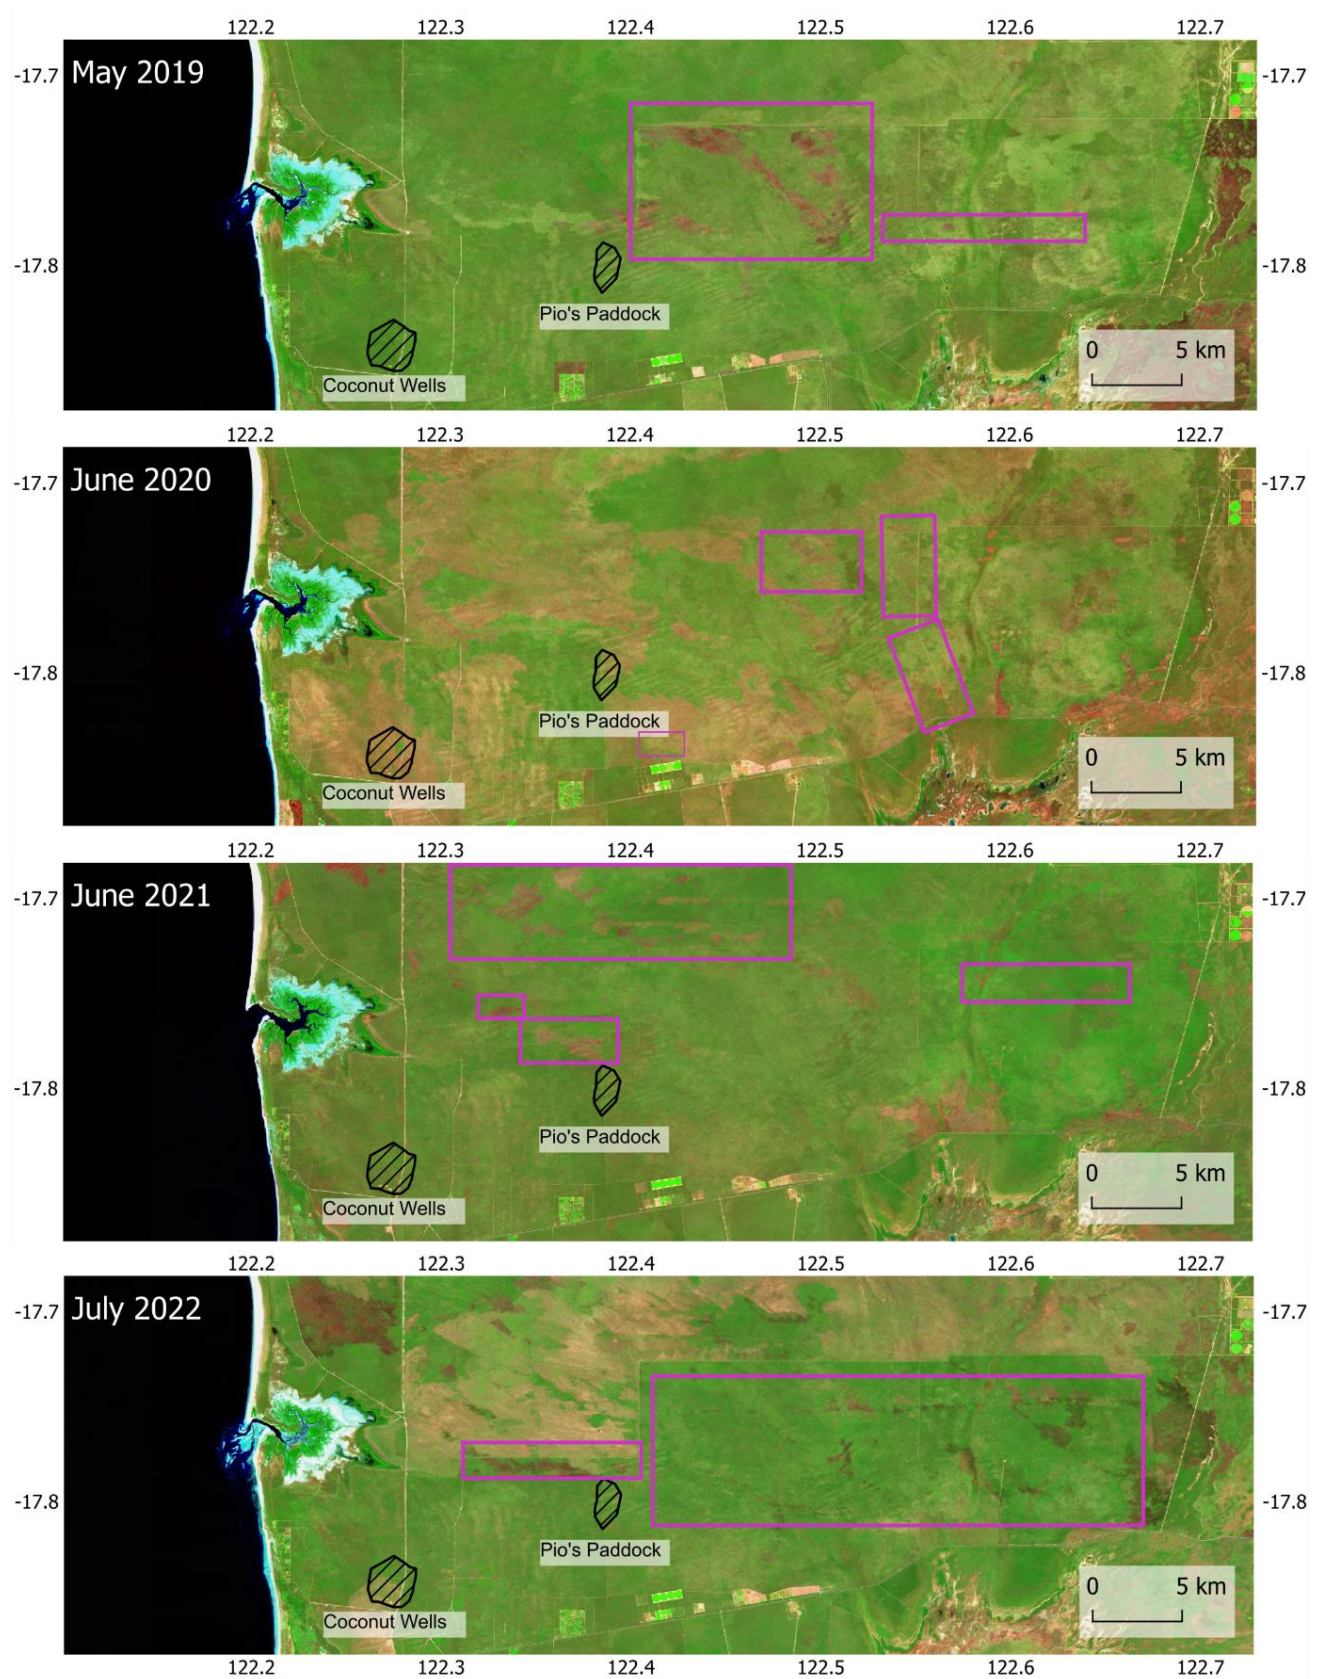
**Figure 23** – Sentinel 2 imagery showing early dry season strategic burning implemented by DBCA between 2019 and 2022 near Pio's Paddock and Coconut Wells.

Fire-take and scarring effectiveness varied due to factors like vegetation, grass cover, and environmental conditions. In areas where fire take was achieved, the fire behaviour was optimal for prescribed fire conditions. About 62 hectares were burnt during ground burning operations, and 514 hectares during aerial burn operations. Although scarring was not as effective as desired, the burnt areas provided fire age and vegetation heterogeneity within the landscape, which is preferred by bilbies and could be used for future prescribed fire operations (Figure 23).

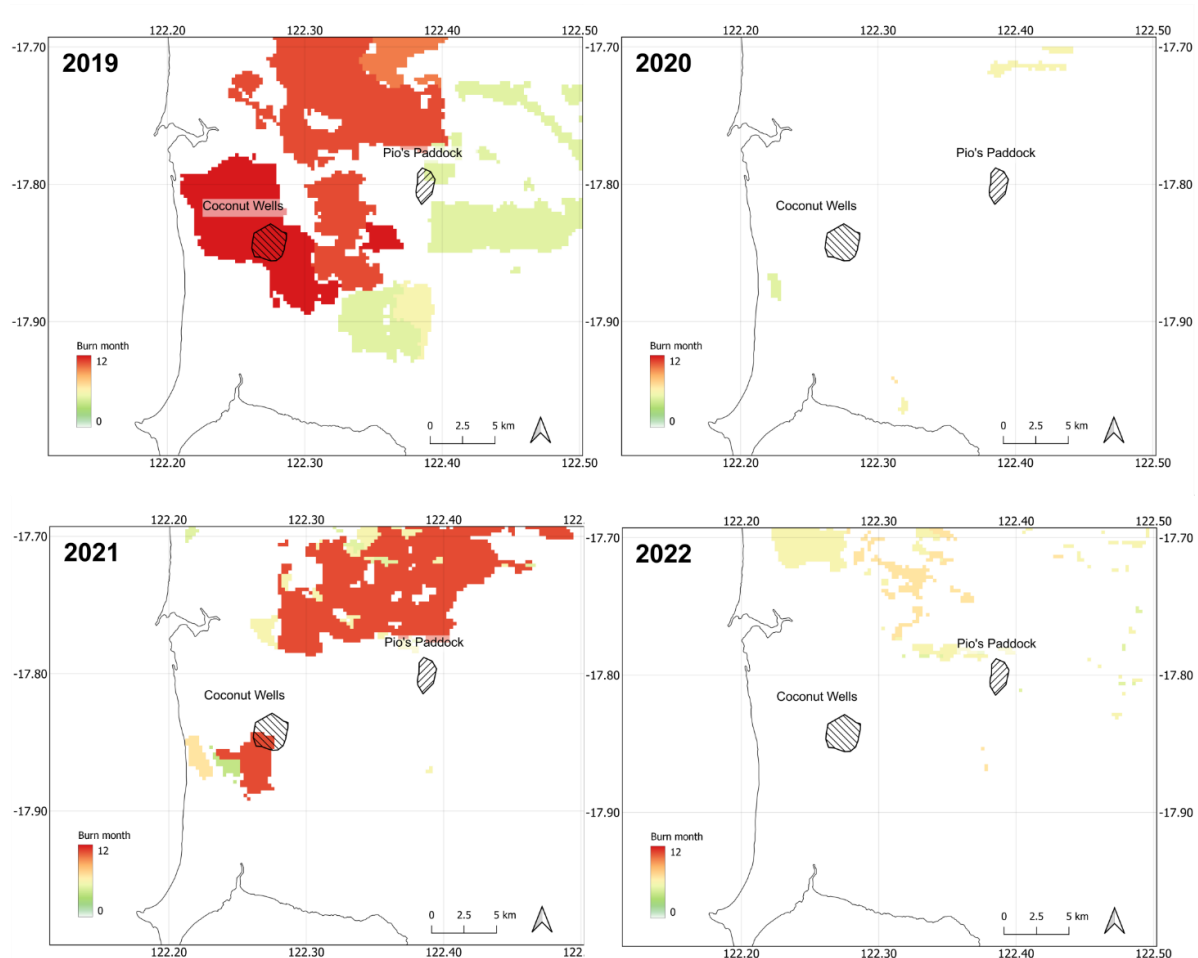
**Figure 24** – Northern Australian Fire Information data showing fire histories at Pio's Paddock and Coconut Wells between 2019 and 2022.

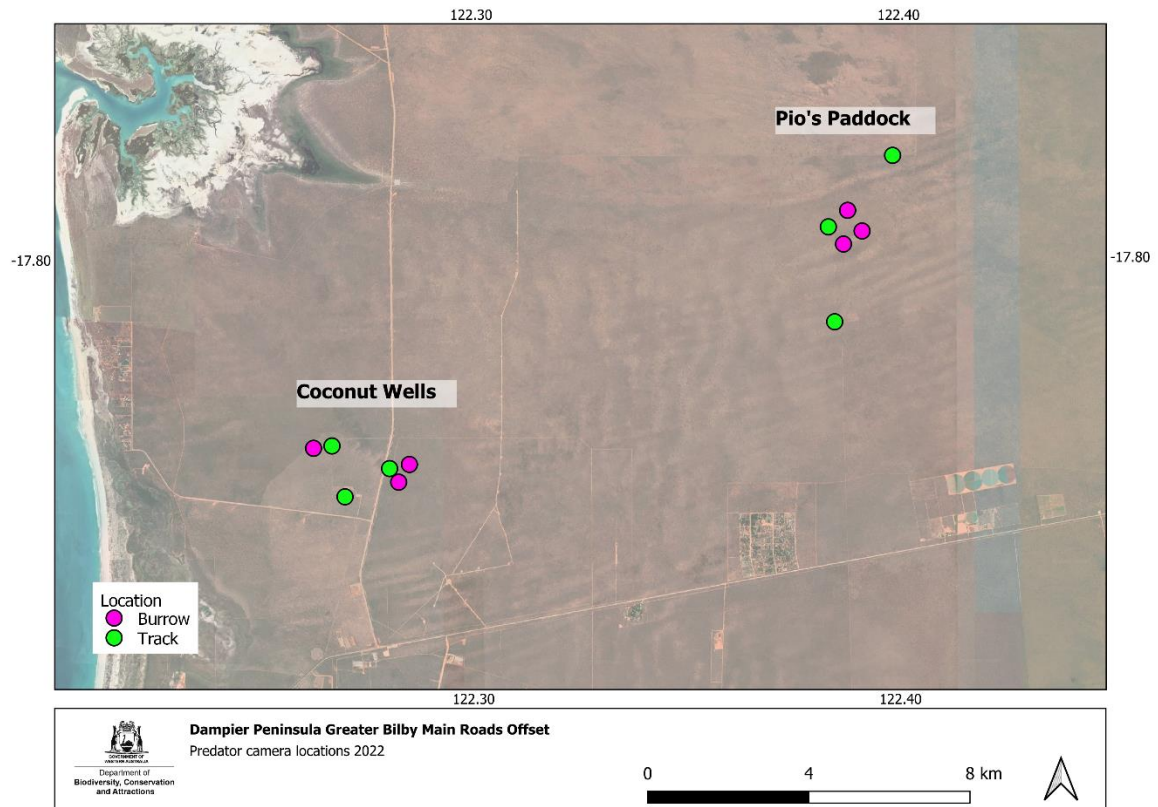
**Figure S1** – Location of camera traps at Coconut Wells and Pio's Paddock bilby populations to monitor occurrence.

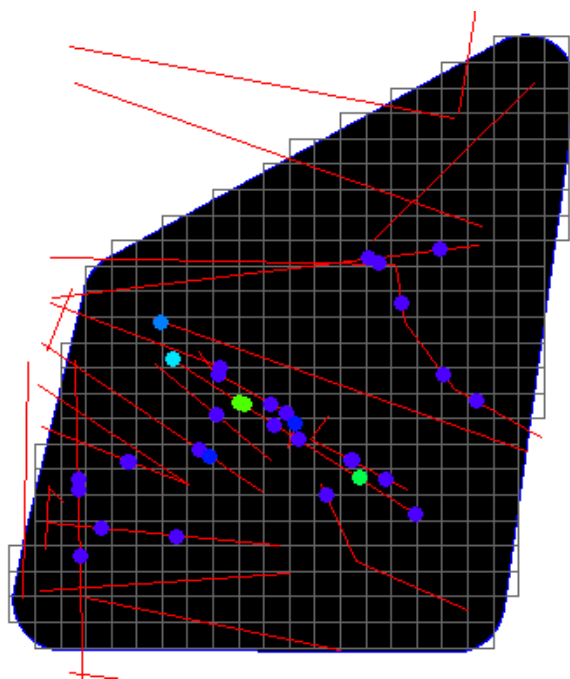
**Figure S7** – Spatially Explicit Capture-Recapture (SECR) grid used to estimate bilby density at Pio's Paddock.

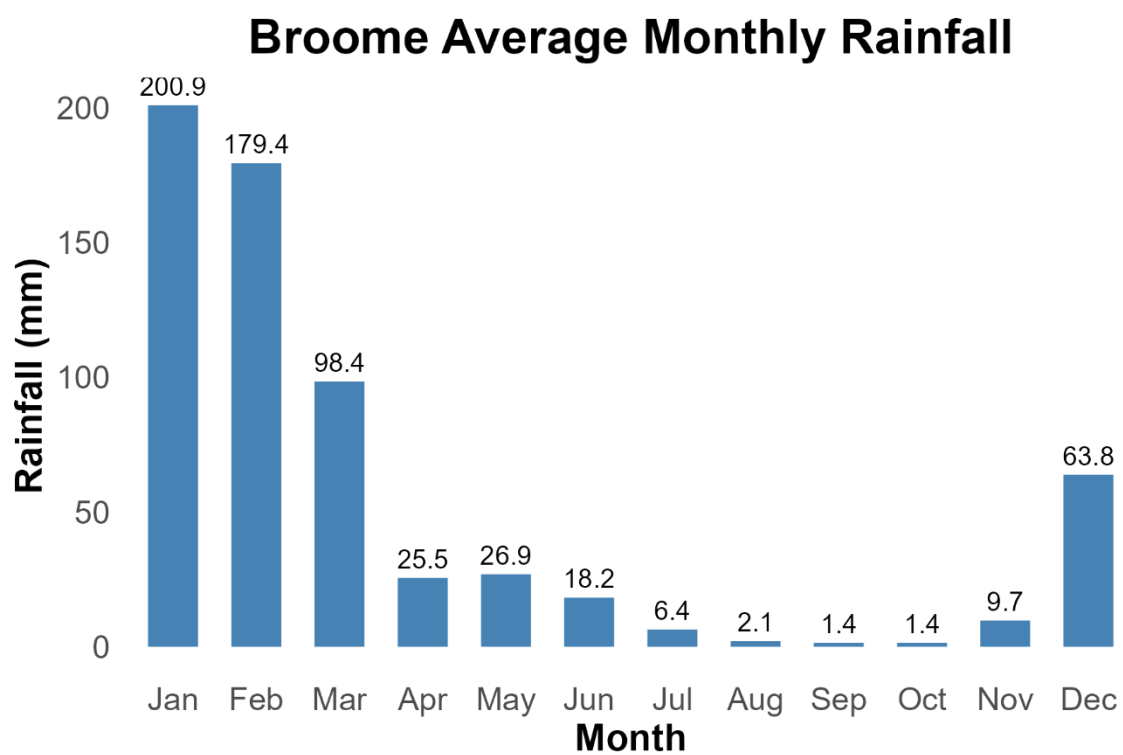
**Figure S8** – Average monthly rainfall for the Coconut Wells and Pio's Paddock bilby populations.

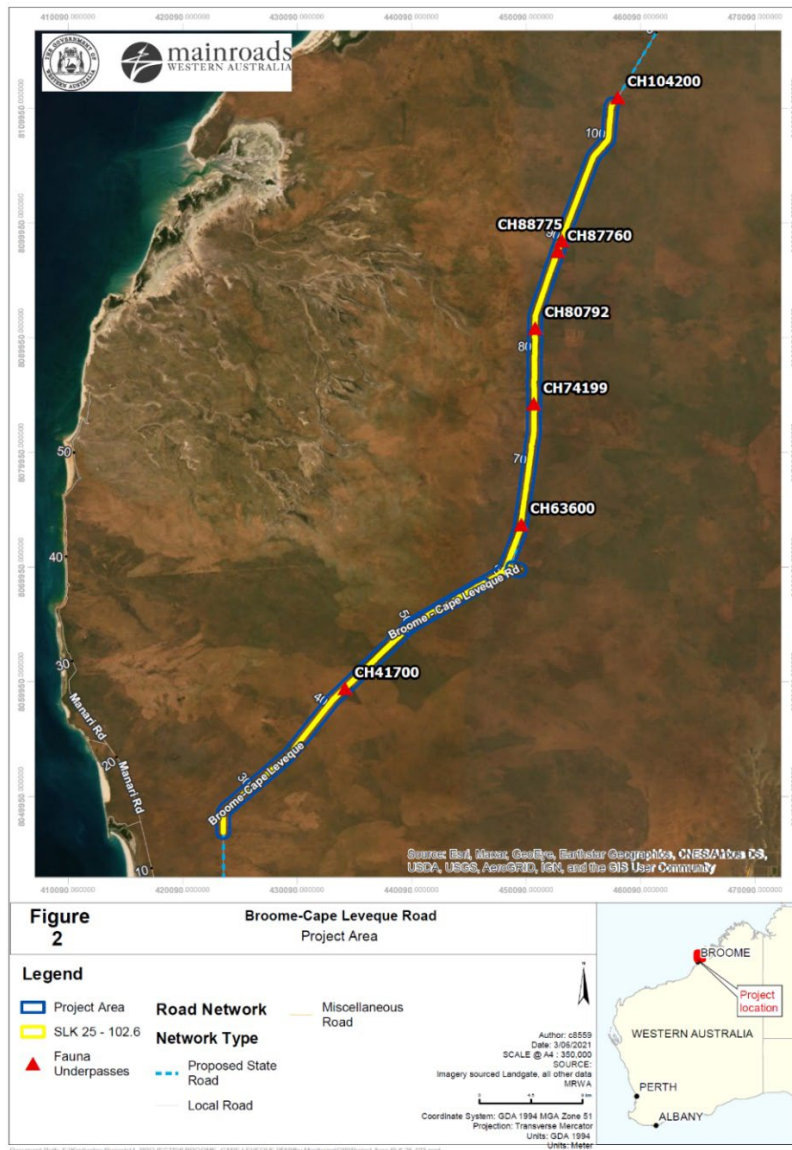
Fig. 1 The location of fauna underpass culverts surveyed along the BCLRU

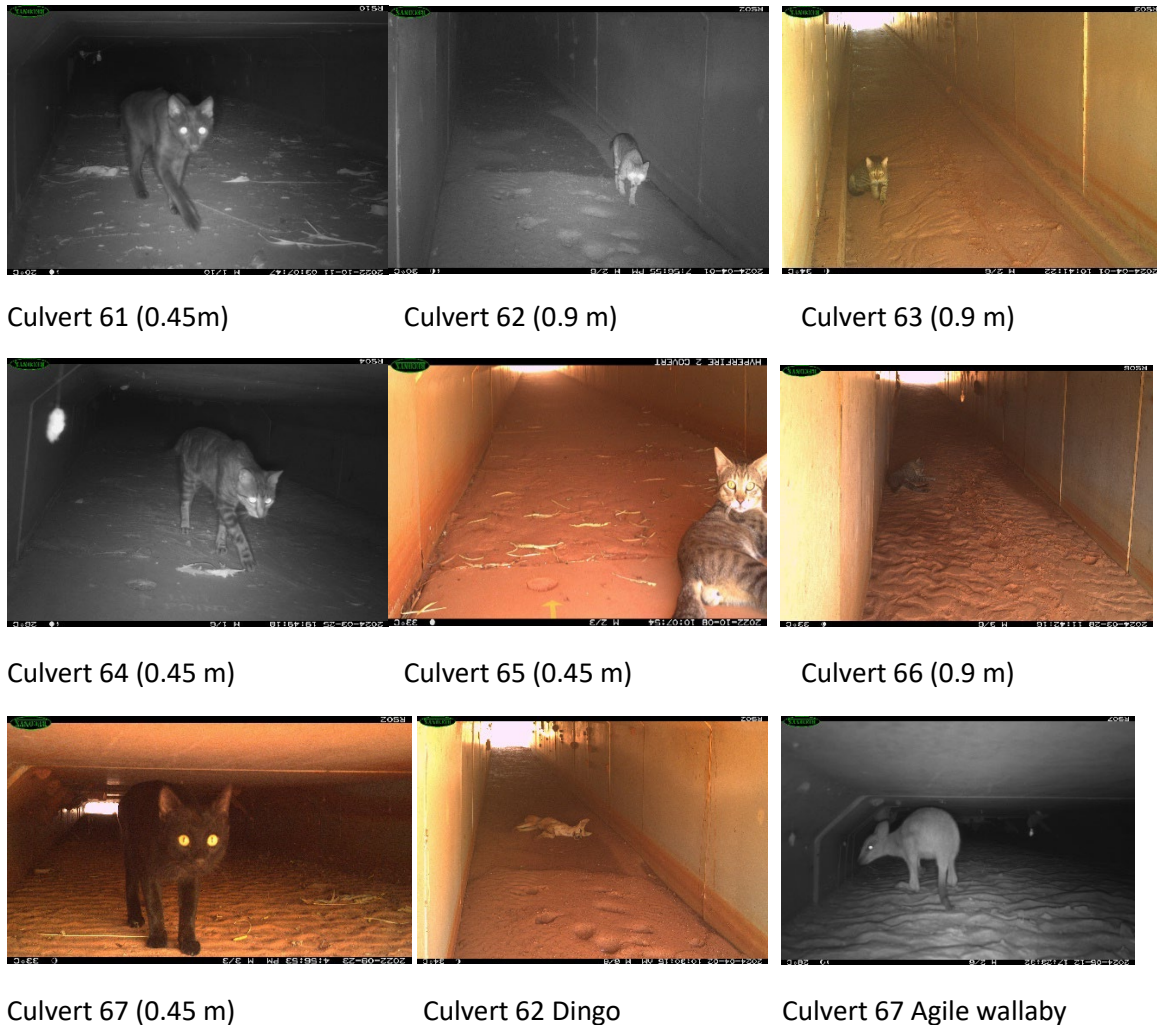
Fig. 2 Feral cat, dingo and agile wallaby images recorded within the seven culverts monitored along the BCLRU

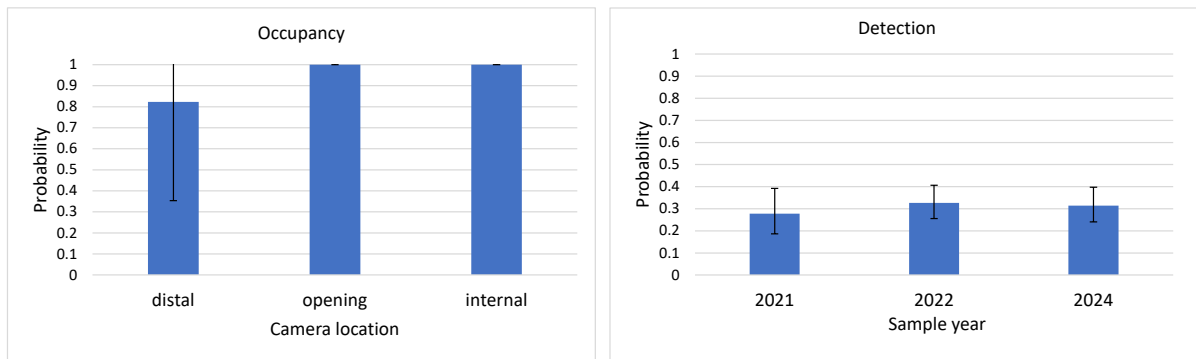
Fig. 3 Feral cat occupancy at the distal, facing and internally-set cameras and detection probability derived for sample year.

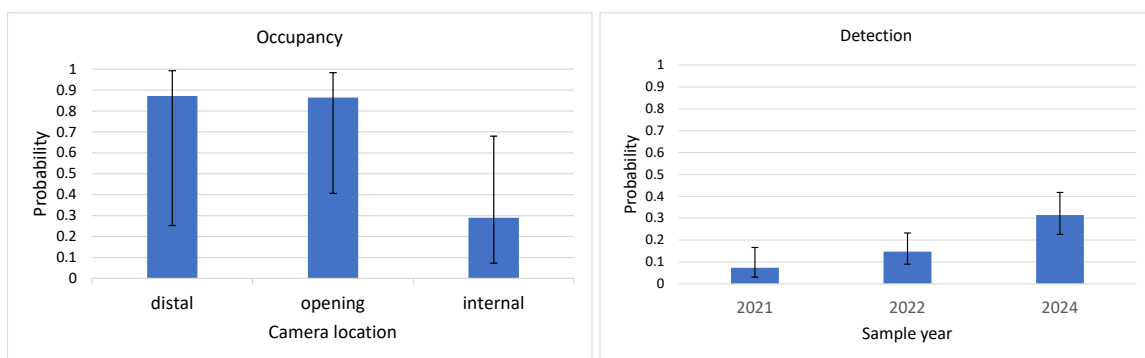
Fig. 4 Dingo occupancy at distal, facing and internally-set cameras and detection probability derived for sample year.

the study period and was significantly greater in 2024 compared to 2021. Although dingo activity was detected commonly at the culvert entrance and at distal cameras (Fig. 4), dingo activity was rarely detected within a culvert. Entry was detected during the post-wet season period (Fig. 2) and only two culverts (0.3 m high and 0.9 m high) were entered on three occasions in total.

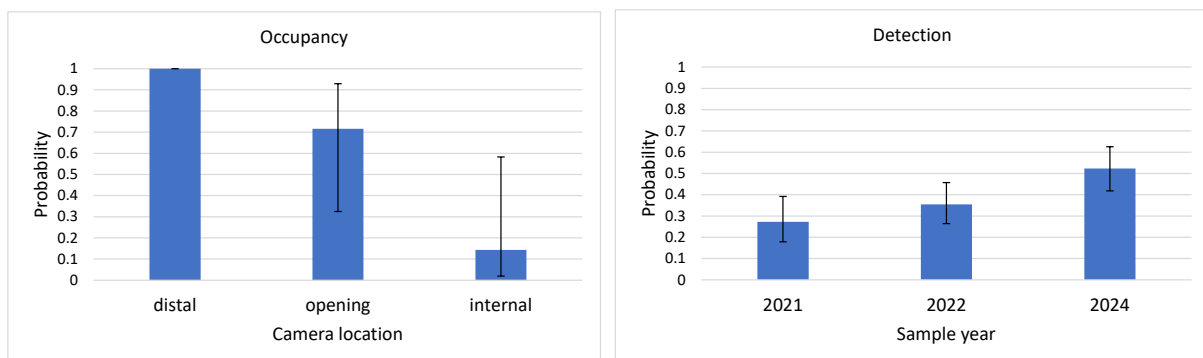
Fig. 5 Agile wallaby occupancy at distal, facing and internally-set cameras and detection probability derived for sample year.

Agile wallabies were detected in the vicinity of each culvert during the study. Occupancy was greatest at distal cameras and significantly lower at cameras facing or set within a culvert (Fig. 5). Only one culvert (0.45 m high) was entered by a wallaby on a single occasion during the post-wet season period (Fig. 2). The probability of wallaby detection also increased over the study period and was significantly greater in 2024 compared to 2021.
