mainroads
WESTERN AUSTRALIA

Revegetation Publication Report

SWR0092

As part of the State and Federal offset requirement, Main Roads WA (MRWA) is required to implement a rehabilitation program to enable construction of the Vasse Bypass and future Bunbury Outer Ring Road.

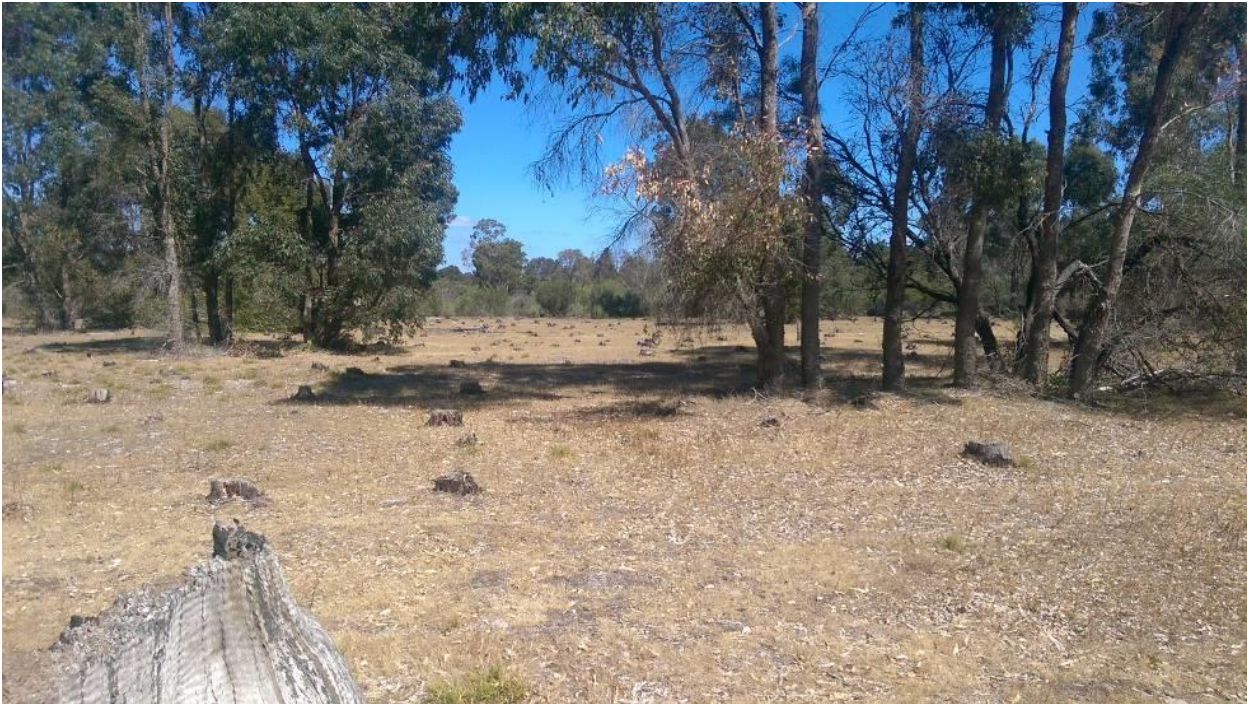
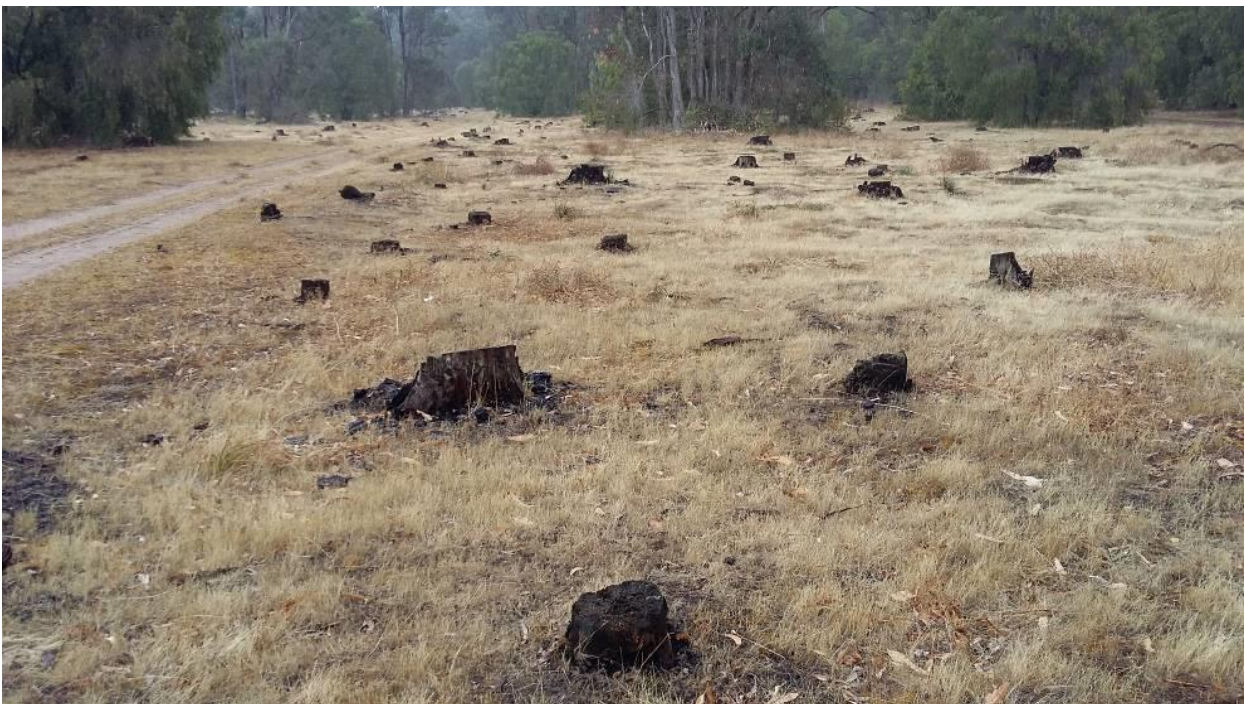
Figure 1. Site condition in 2016 prior to commencement of works.

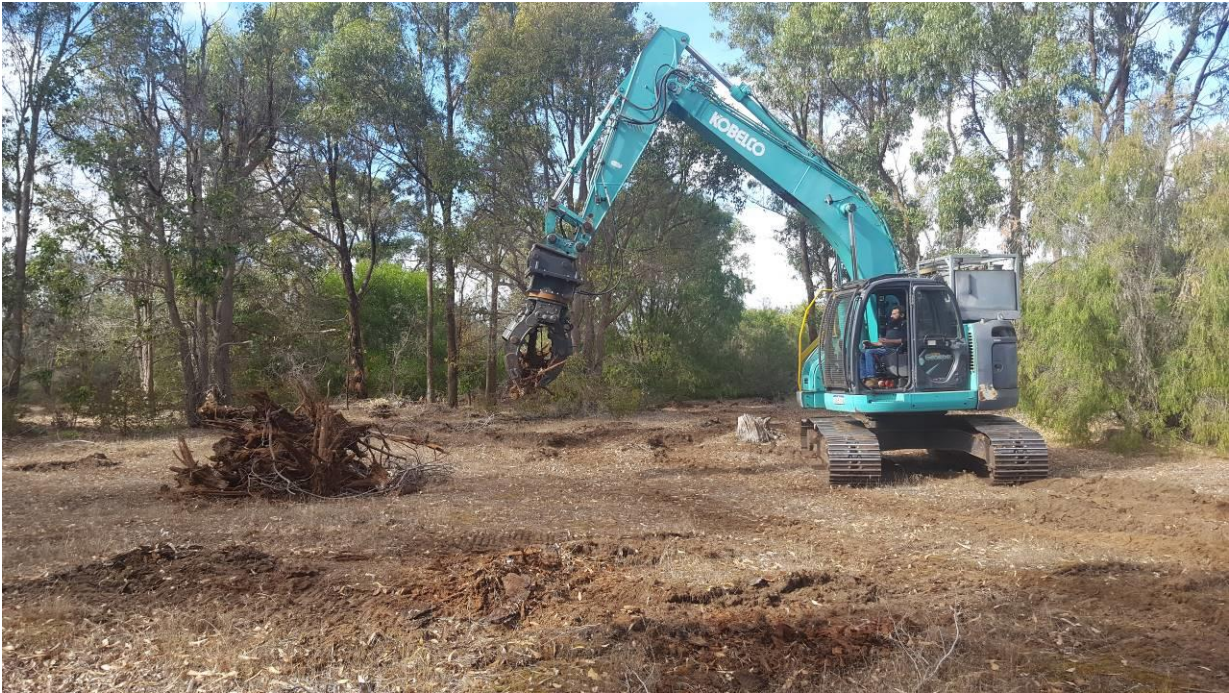
Figure 2. The rehabilitation area was previously used as a pine plantation until the early 1990's. Pine stumps were removed and stacked in preparation for burning.

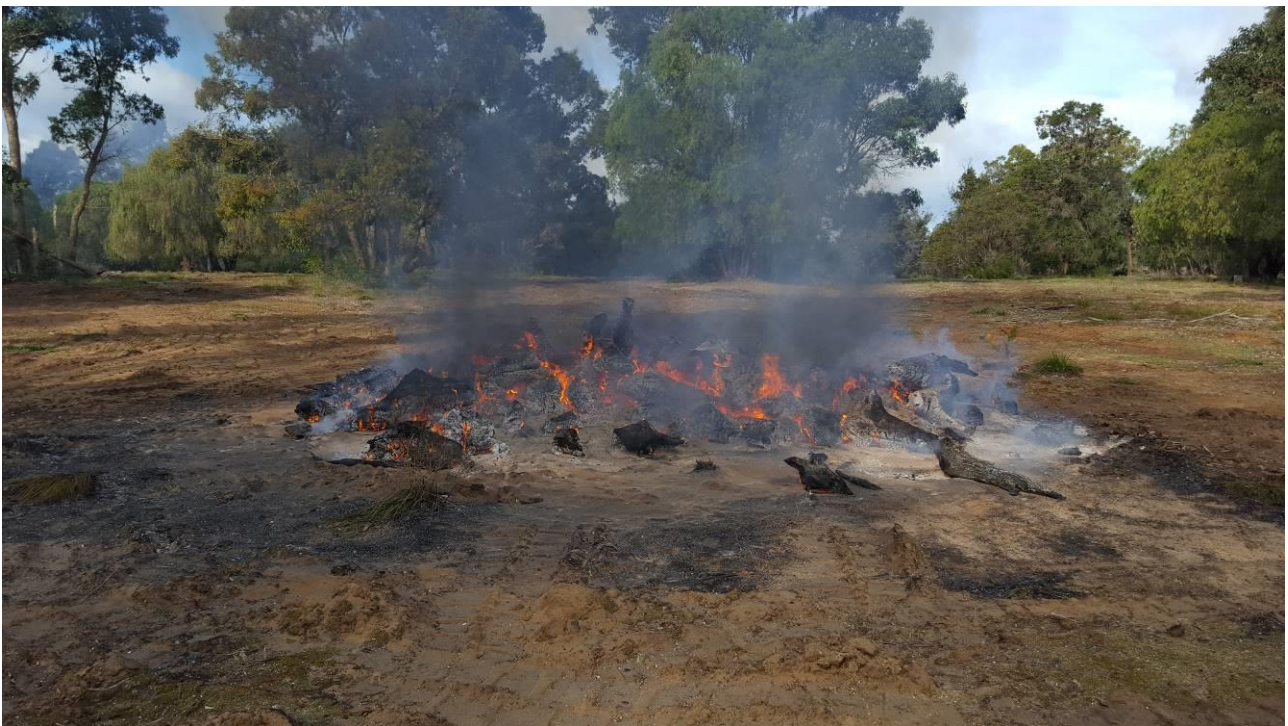
Figure 3. Pine stumps are burnt to create ash beds, which are known to support the germination of Tuart's Trees.

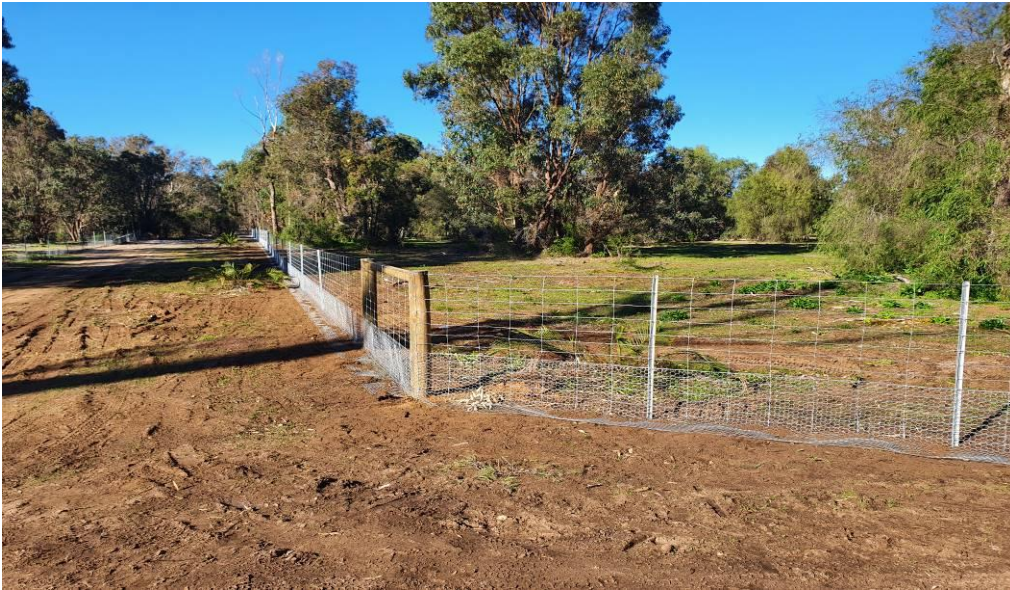
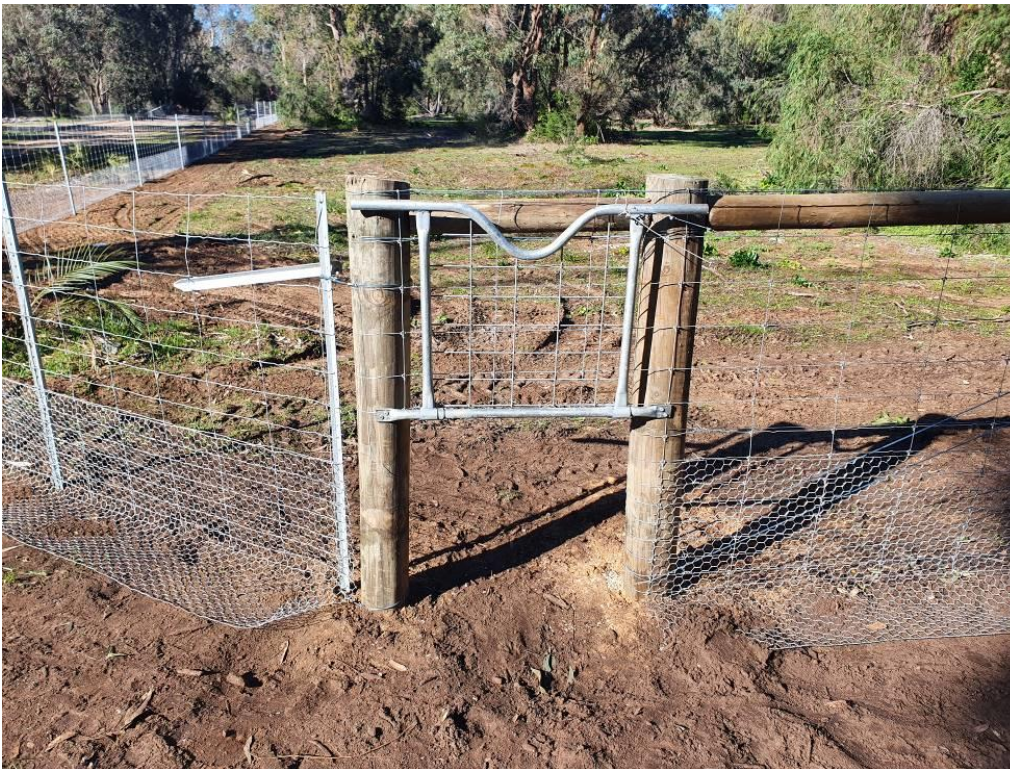
Figure 4: Each Stage of the revegetation is fenced with a fauna fence to deter kangaroos and rabbits from entering the revegetation area. Fauna gates are used to allow kangaroos to exit the fenced area (photo shown in open position). Rabbit wire apron is also used to prevent burrowing pests from entering the site.

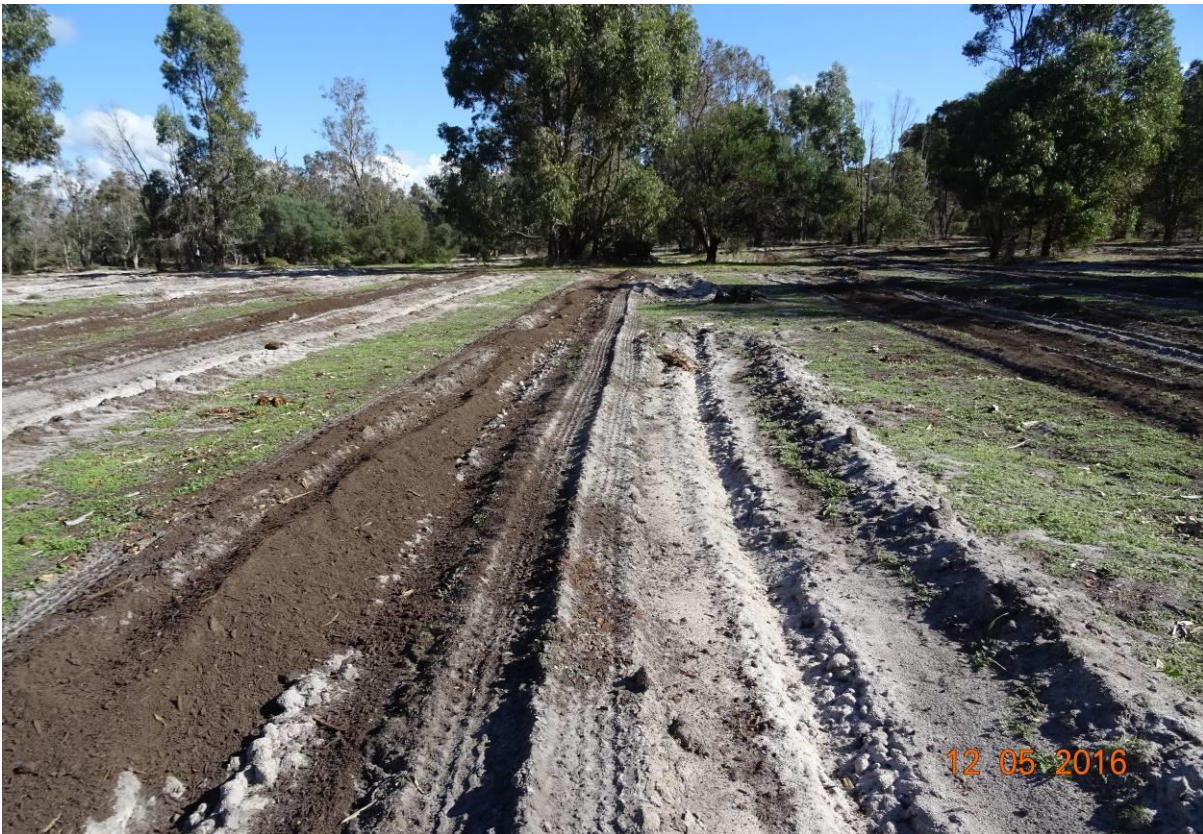
Figure 5. Rip mound planting used for most of the revegetation area. Compost was added to the rip lines in some areas to improved carbon and nutrient levels in the poor quality soils.

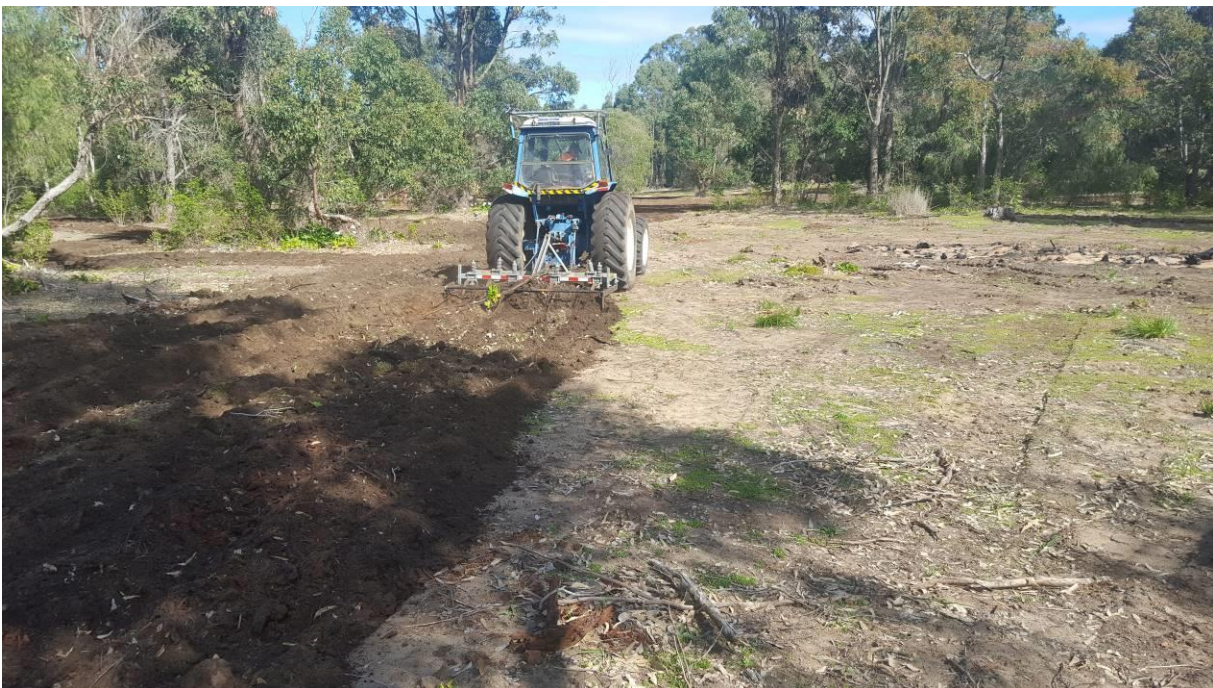
Figure 6. Areas to be direct seeded were rotary hoed. This process also reduced the occurrence of onion weed and reduced compaction ahead of direct seeding operations.

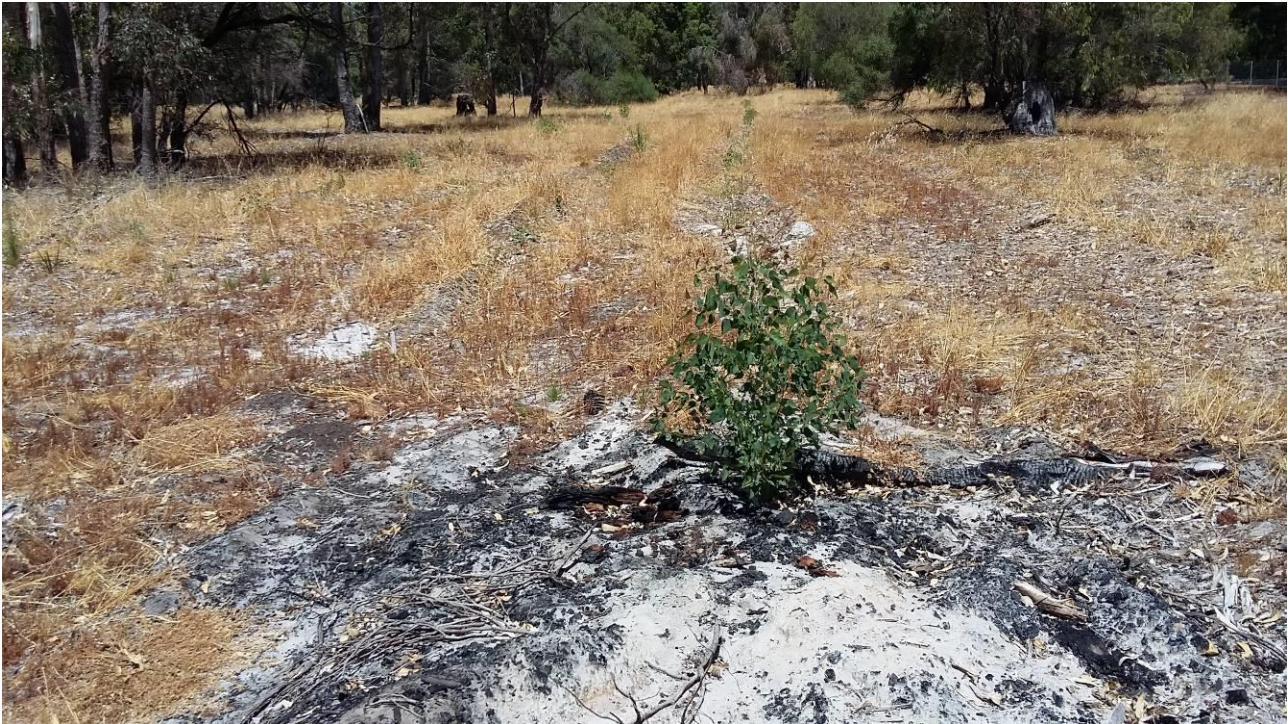
Figure 6. Six months post planting the tuart trees and other planted vegetation showed excellent growth. Tuart trees planted in or near the ash beds showed a significant amount of growth as compared to others.

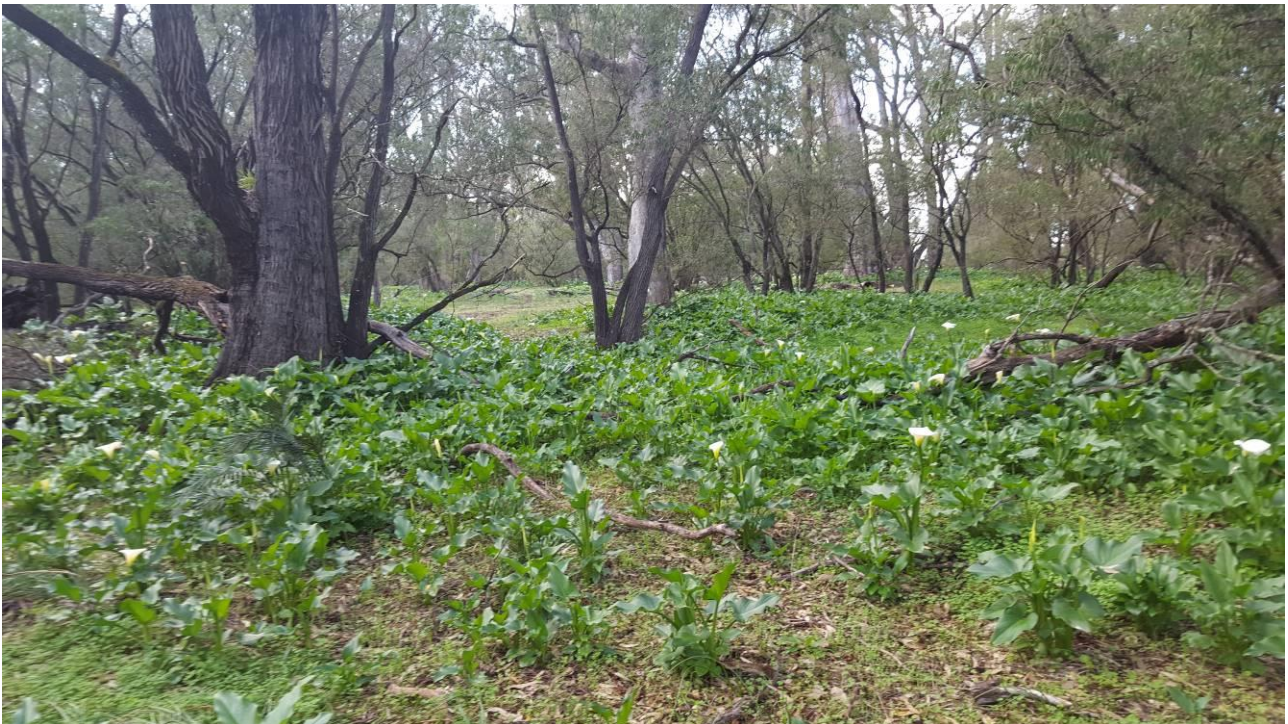
Figure 7. Annual winter weeds are managed though mechanical removed or with chemical control. The Tuart Forest is badly affected with Arum Lilly infestations. Through careful control, the revegetation site has seen a 95% reduction in Arum populations.

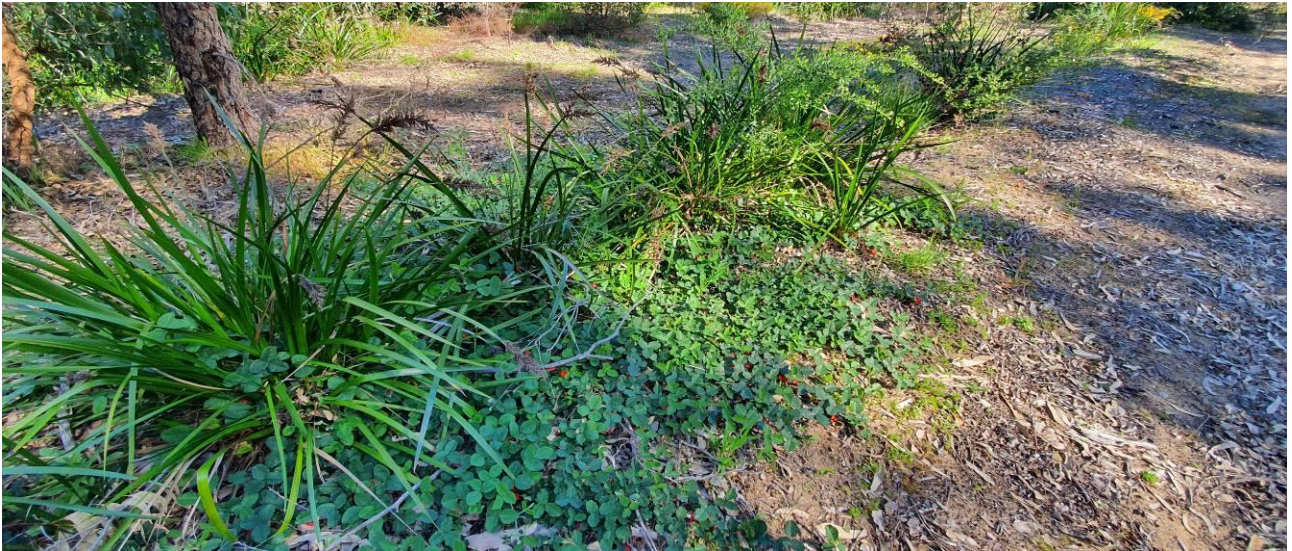
Figure 8. Rip / mound planted sites well established (2019). Seedlings remain in excellent health. Soil amendments are added in liquid form to encourage plant and soil health.

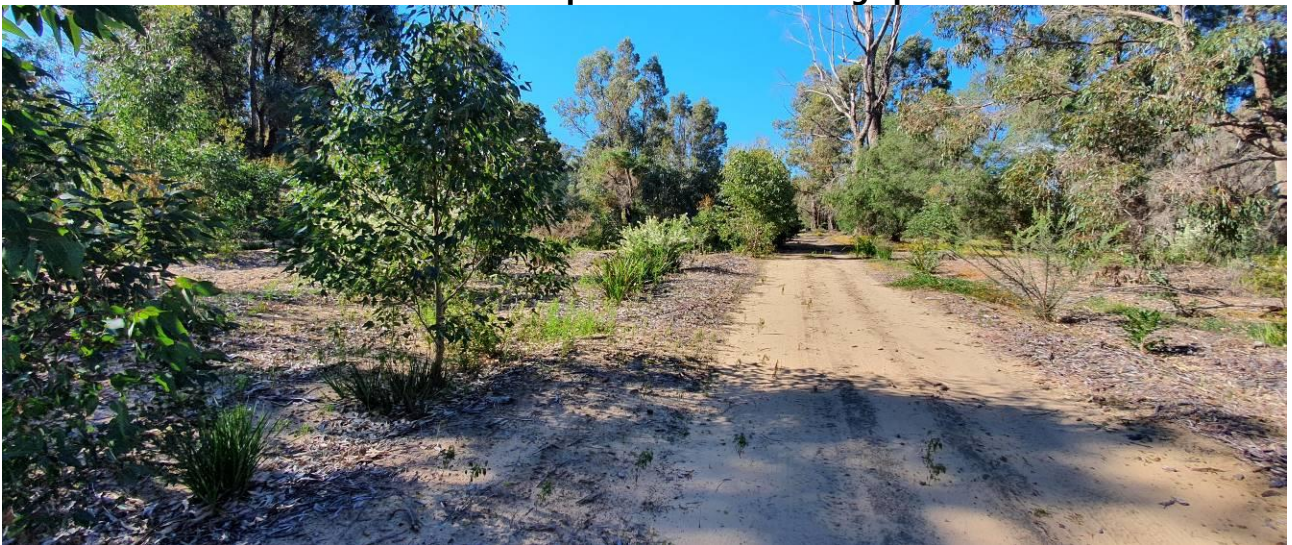
Figure 9. Infill planting will be undertaken to achieve the desired density and diversity.

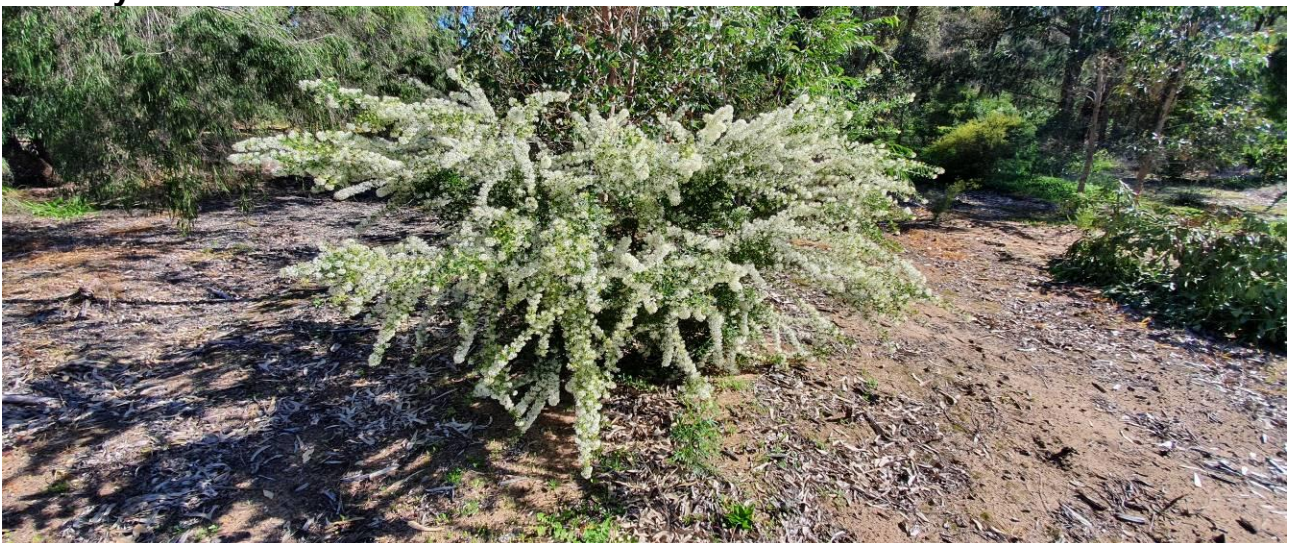
Figure 10. Ongoing weed management is required to enable planted vegetation to become established.
