# EPBC Annual Compliance Report

EPBC 2016/7656

**Great Northern Highway Upgrade:  
Muchea to Wubin – Muchea North  
D24#1330778**

**Reporting period: 21 September 2023 to 20 September 2024**

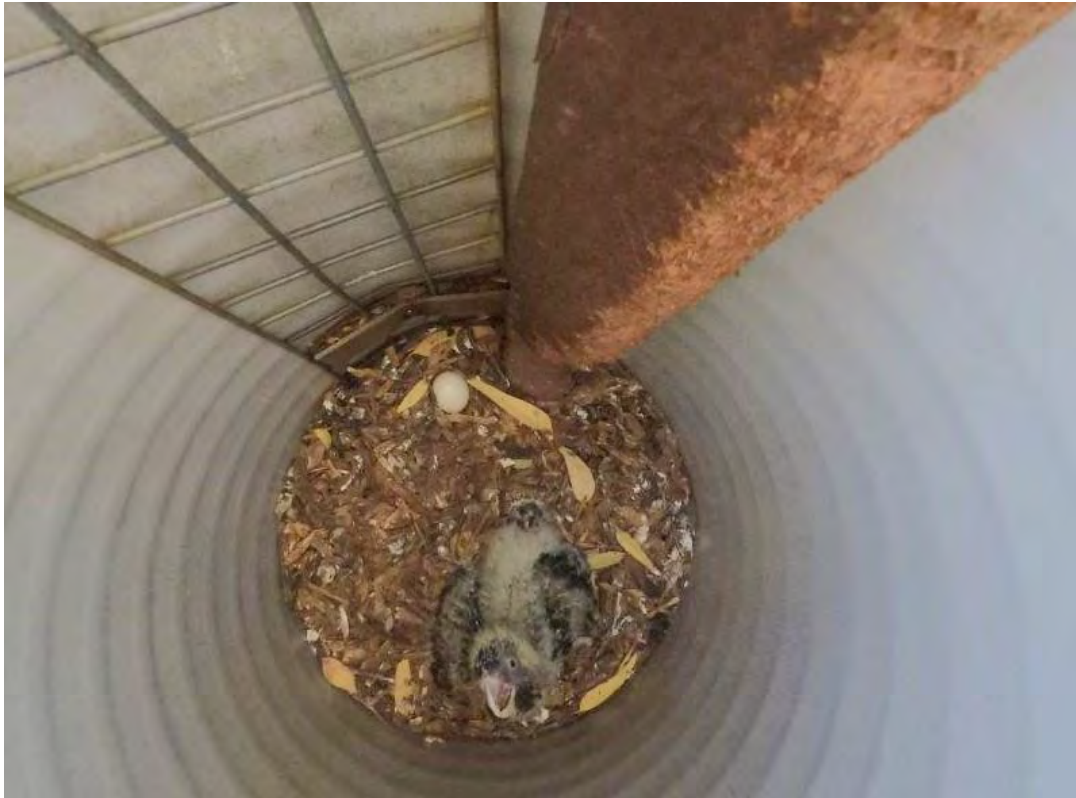
**Figure 3** Pin feathered chick in nest box (NB63) (October 2023) (Photograph by T. Kirkby)

All of the artificial nesting hollows surveyed were observed to be in good condition, however 10 artificial nesting hollows require a new sacrificial post installed (NB04, NB06, NB10, NB32, NB63, NB64, NB65, NB68, NB71, NB77).

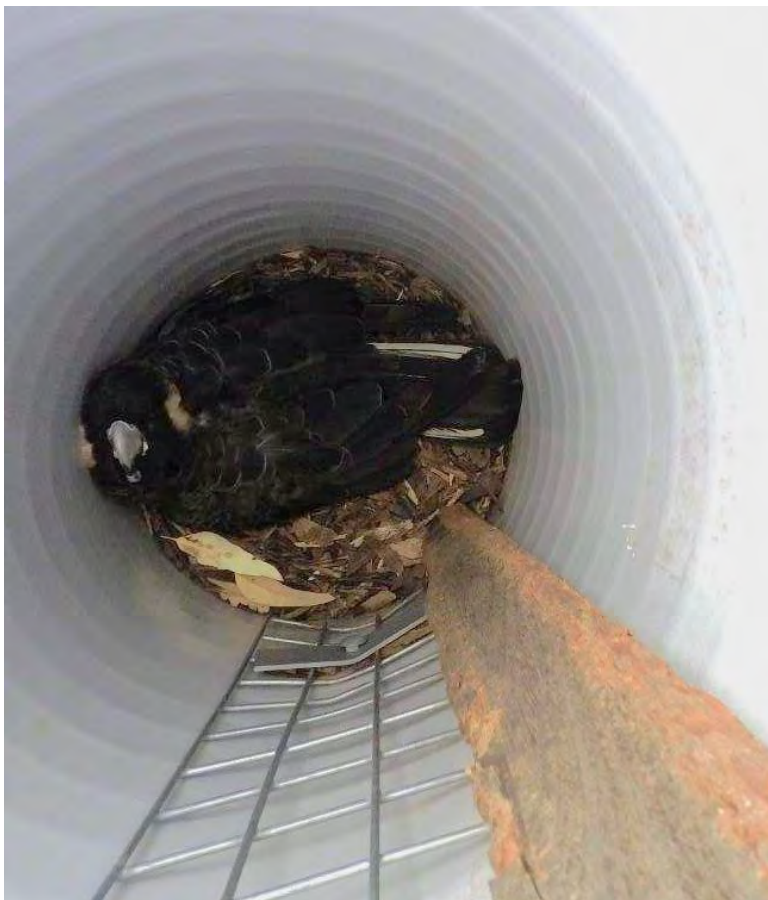
**Figure 4** Large, feathered chick a nest box NB12 (October 2023) (Photograph by T. Kirkby)

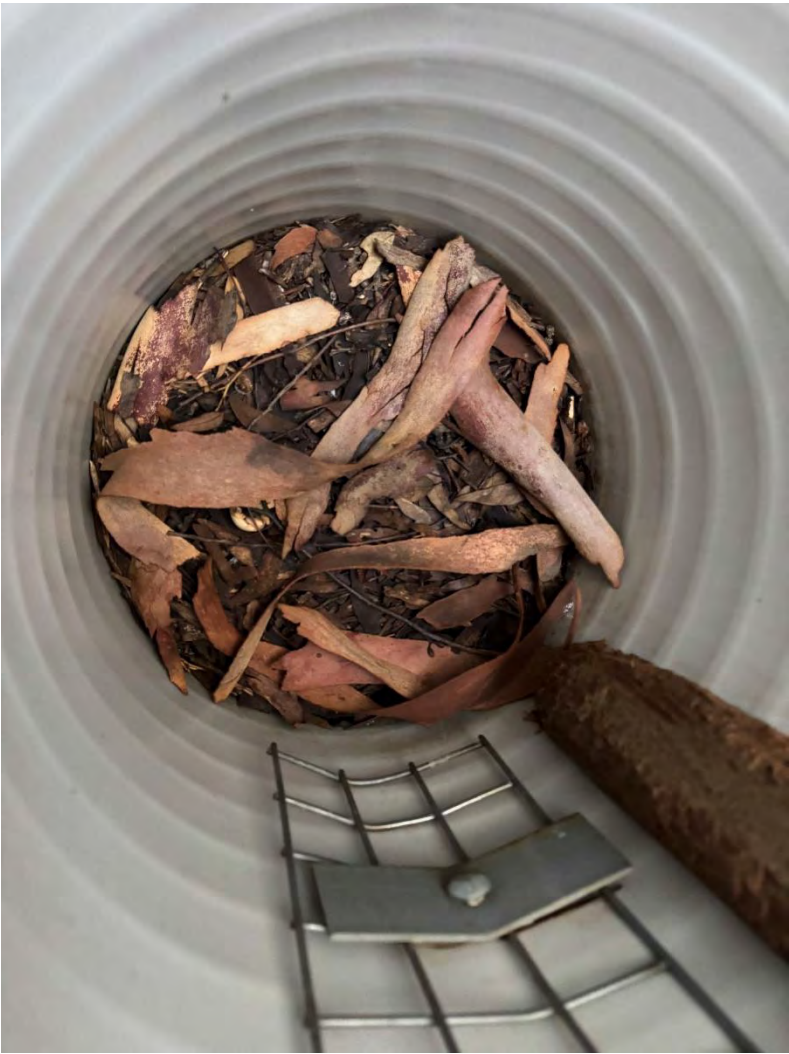
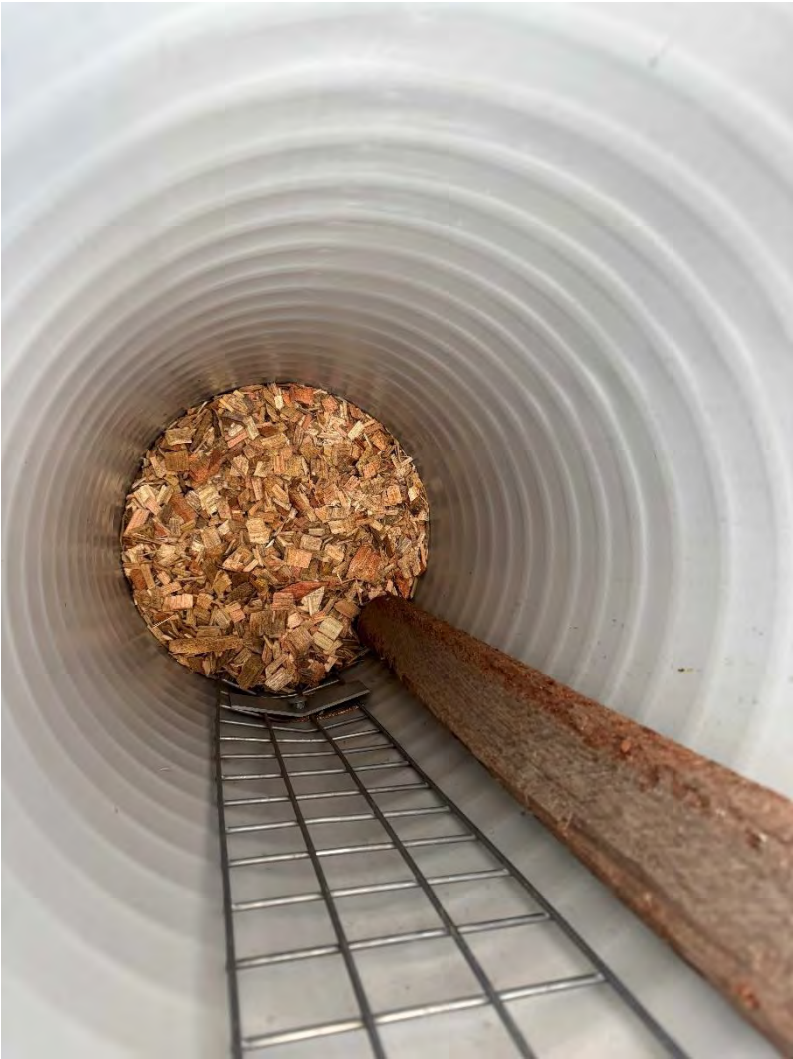
Replenishment of ANH NB68

ANH#	Latitude	Longitude	Height Mts	Wood chips Lts	Post	Comments
NB68			8.975	10lts	Bracket relocated

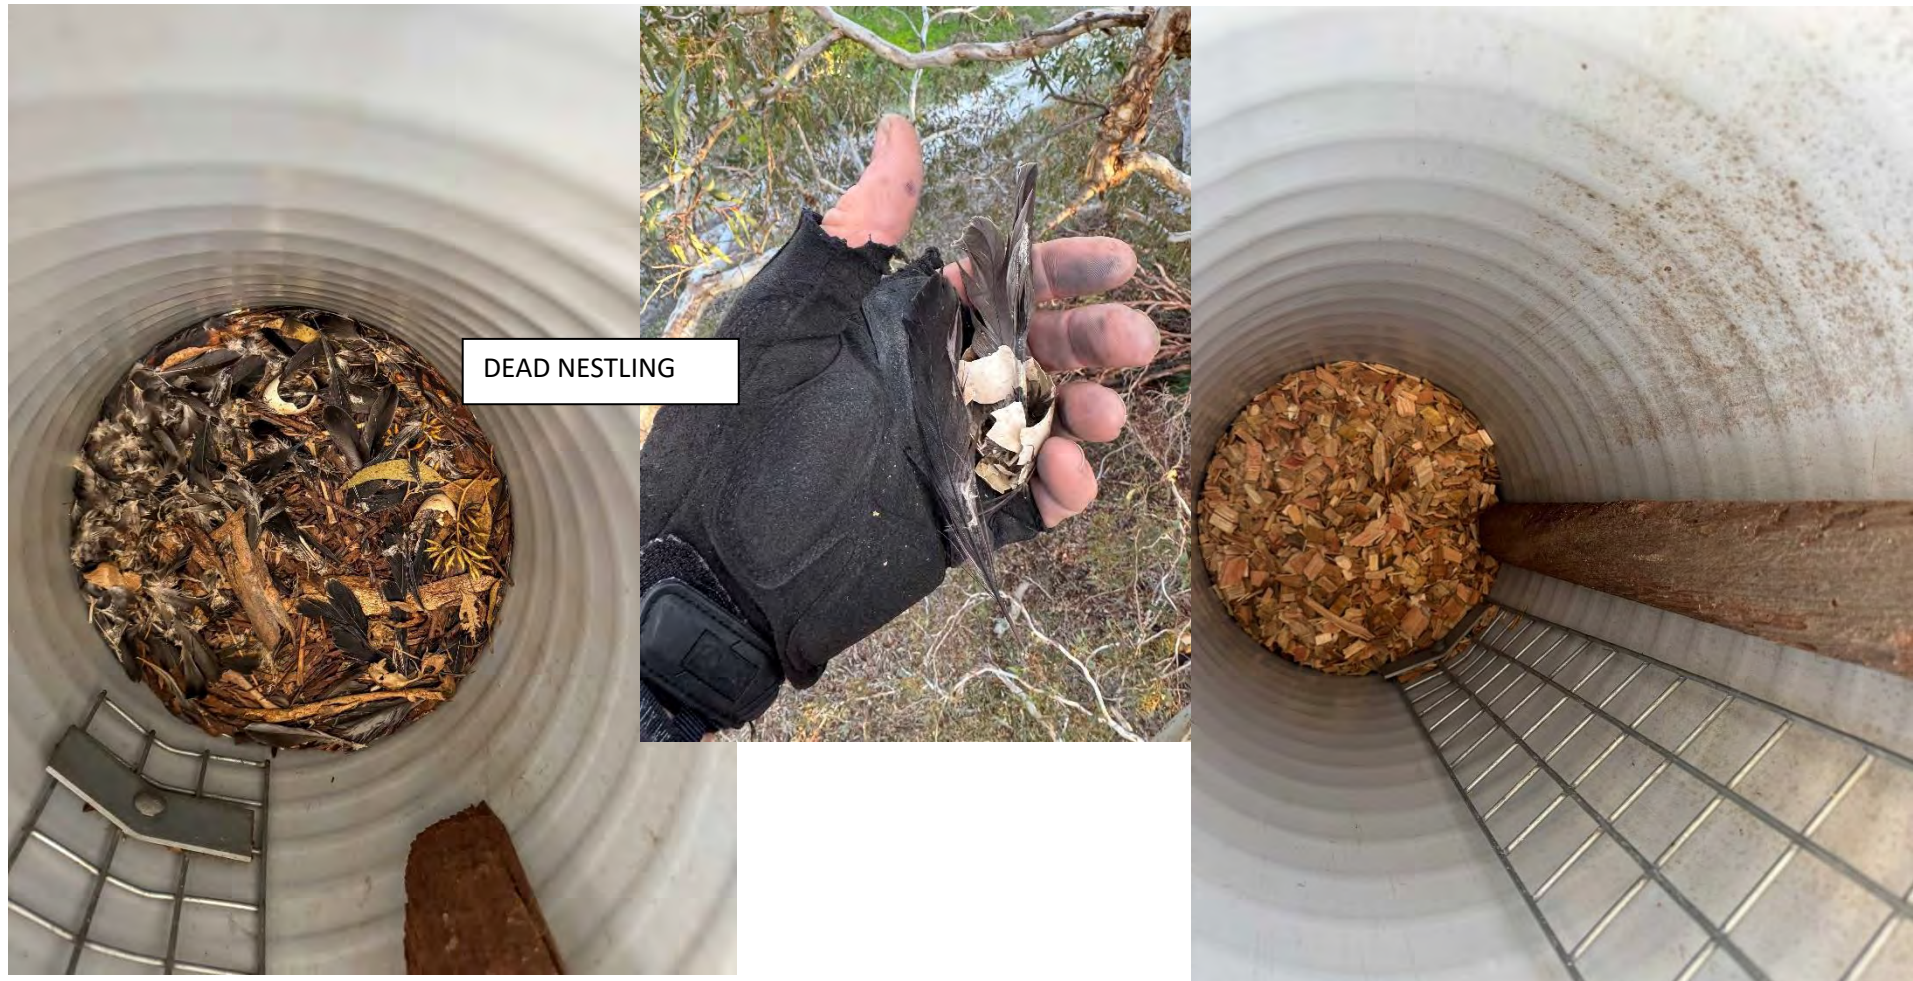
## Replenishment of ANH NB69

ANH#	Latitude	Longitude	Height Mts	Wood chips Lts	Post	Comments
NB69			8.200	20lts	Bracket relocated	1 x broken CC egg and 1 x dead CC nestling

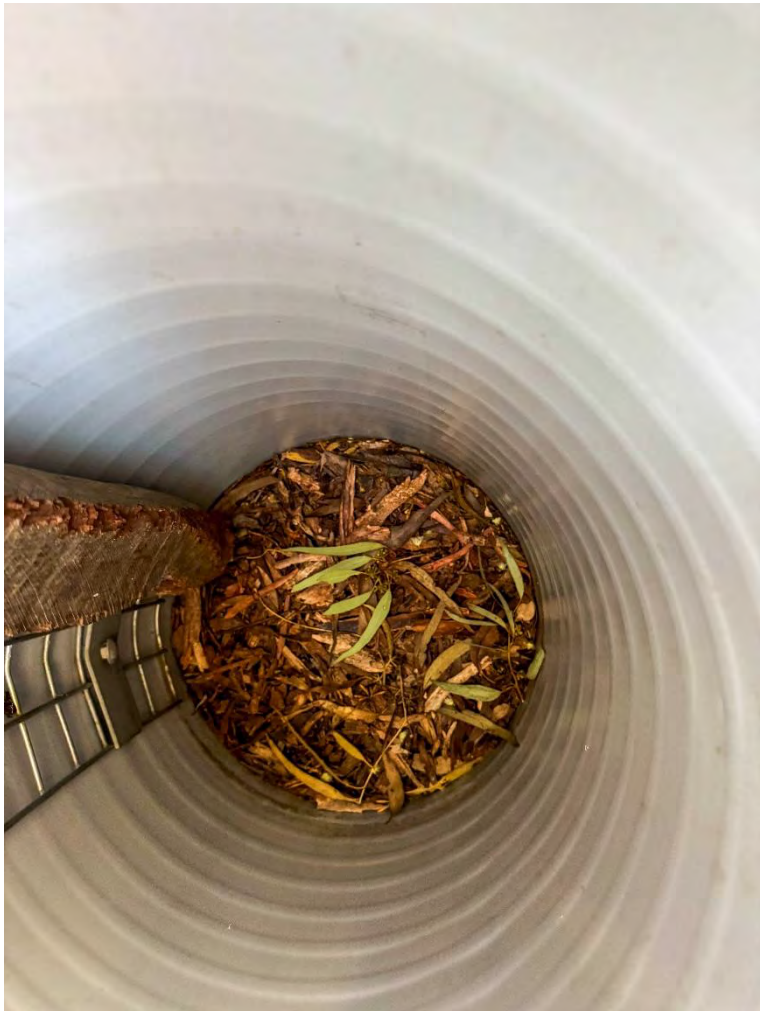
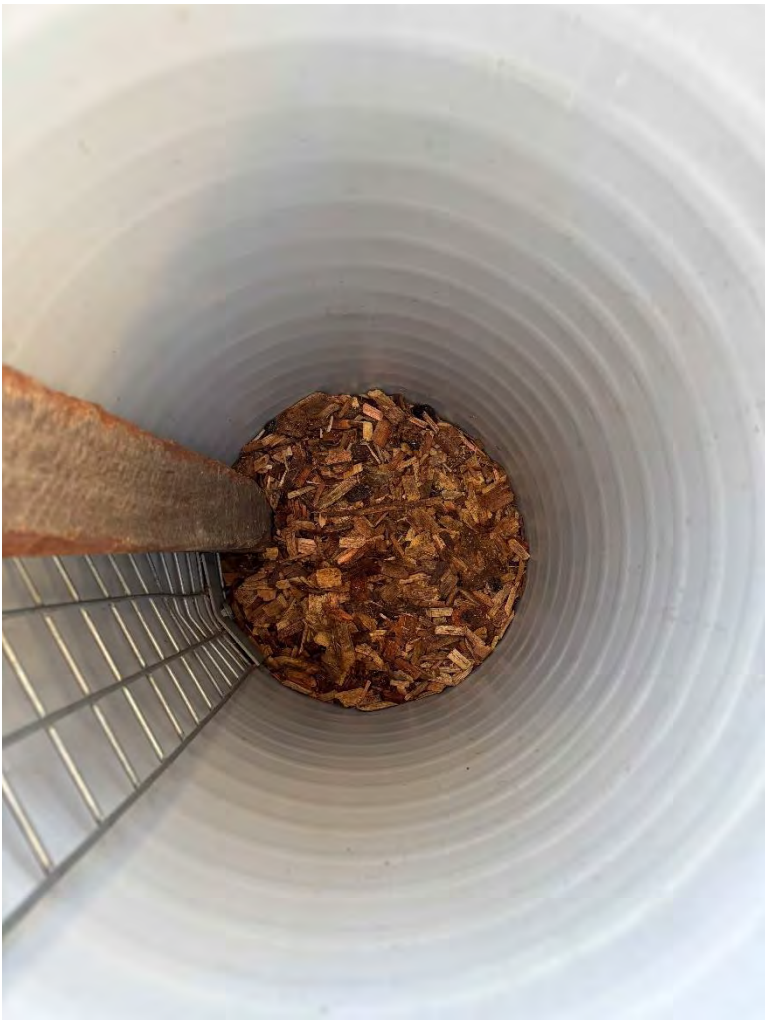
# Replenishment of ANH NB64

ANH#	Latitude	Longitude	Height Mts	Wood chips Lts	Post	Comments
NB64			8.600	15lts	Not replaced

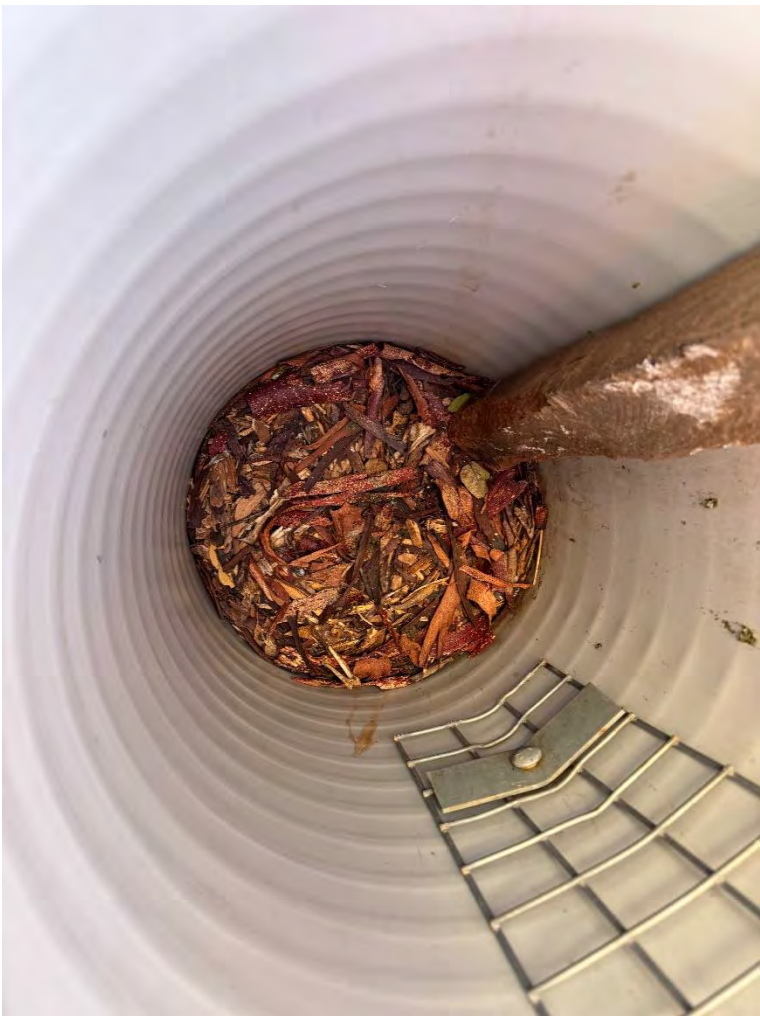
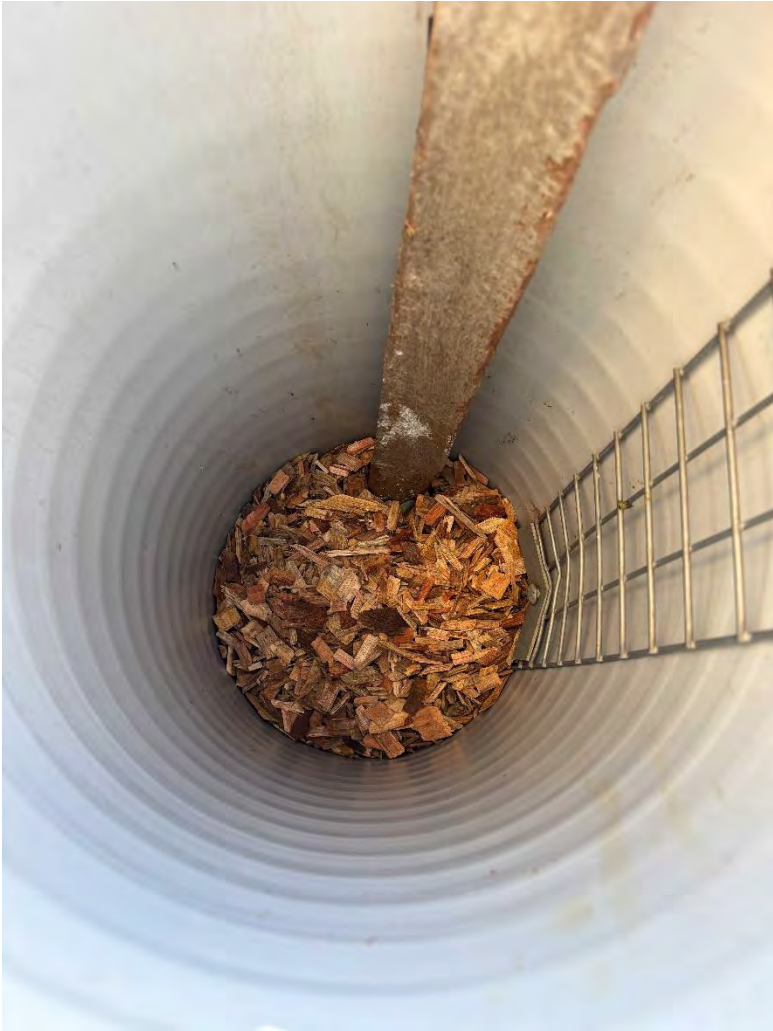
# Replenishment of ANH NB65

ANH#	Latitude	Longitude	Height Mts	Wood chips Lts	Post	Comments
NB65			9.350	30lts	Bracket relocated

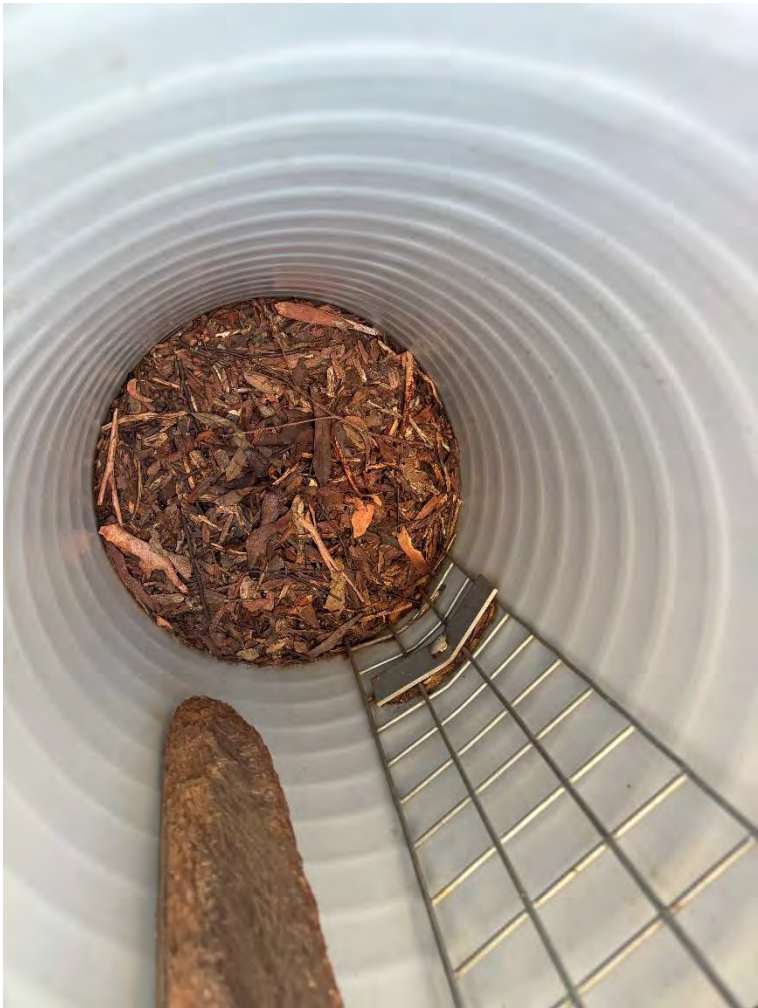
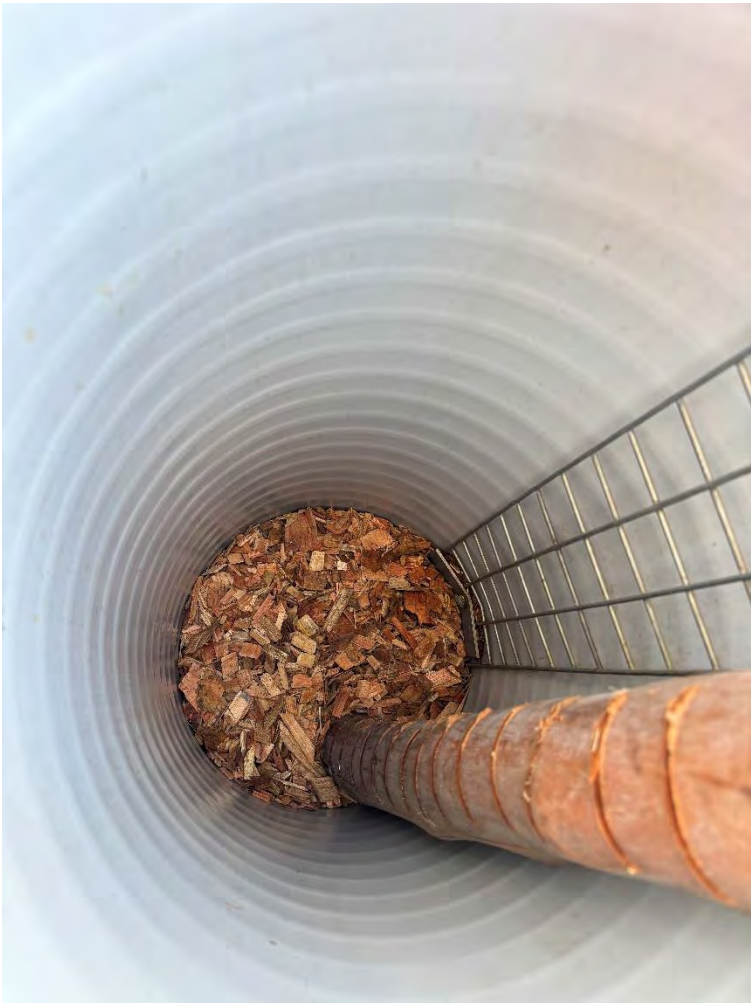
# Replenishment of ANH NB10

ANH#	Latitude	Longitude	Height Mts	Wood chips Lts	Post	Comments
NB10			7.690	15lts	New Post

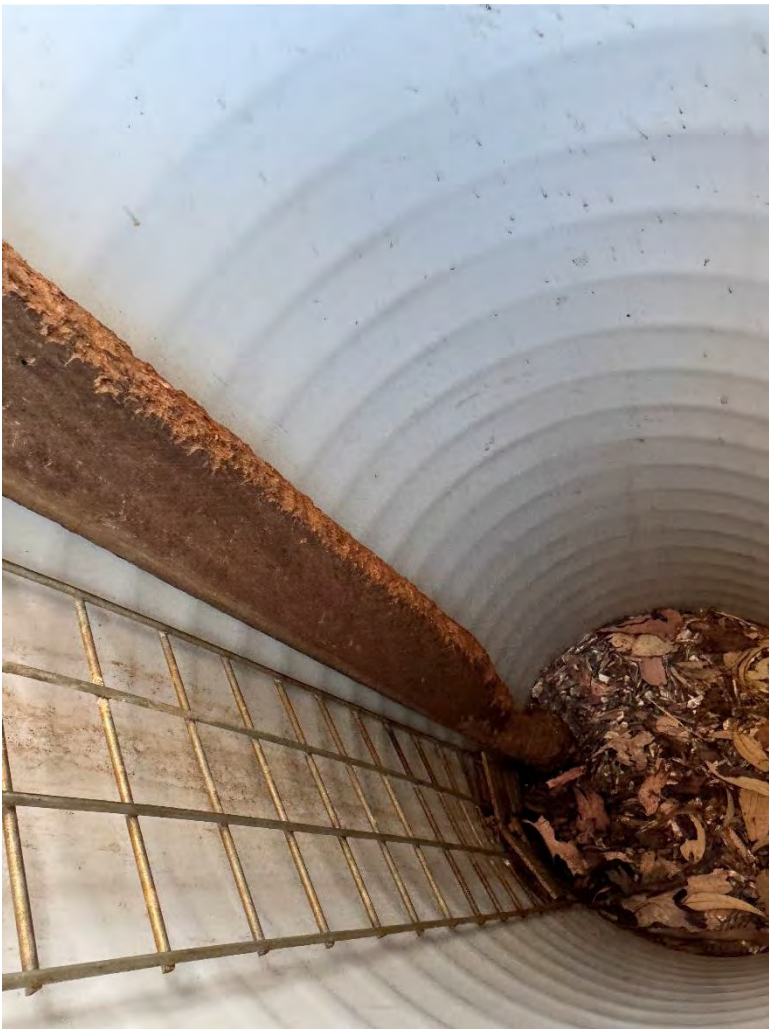
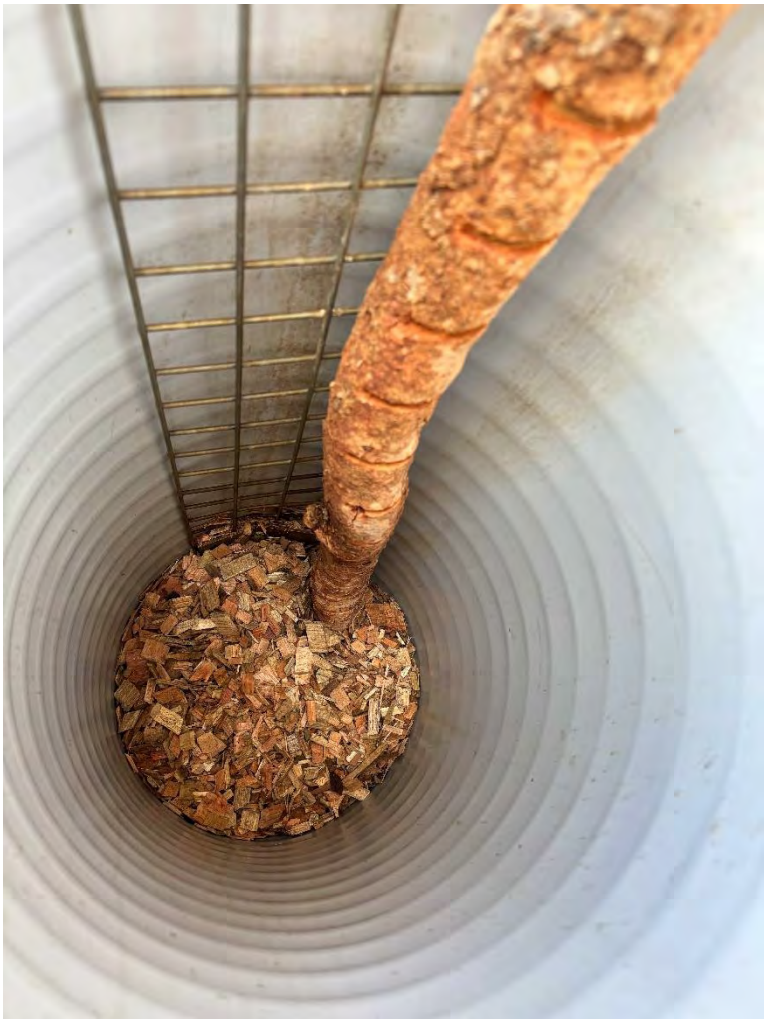
# Replenishment of ANH NB62

ANH#	Latitude	Longitude	Height Mts	Wood chips Lts	Post	Comments
NB62			9.030	15lbs	New Post	Nesting Fledged

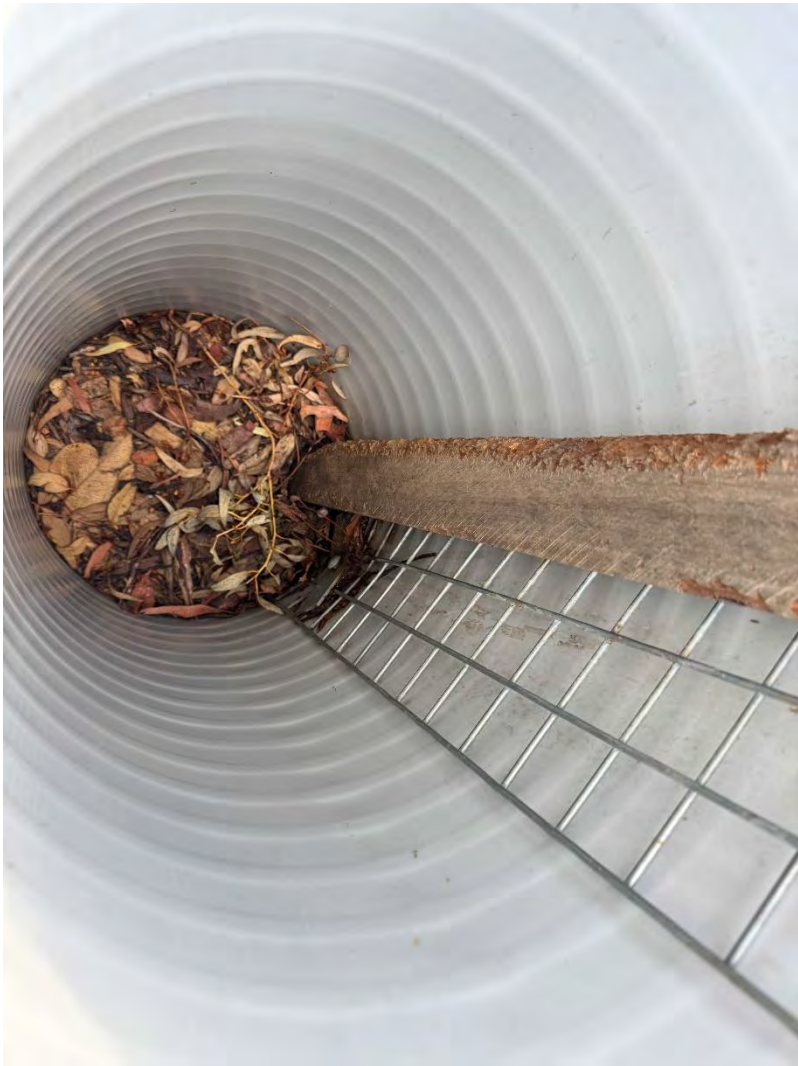
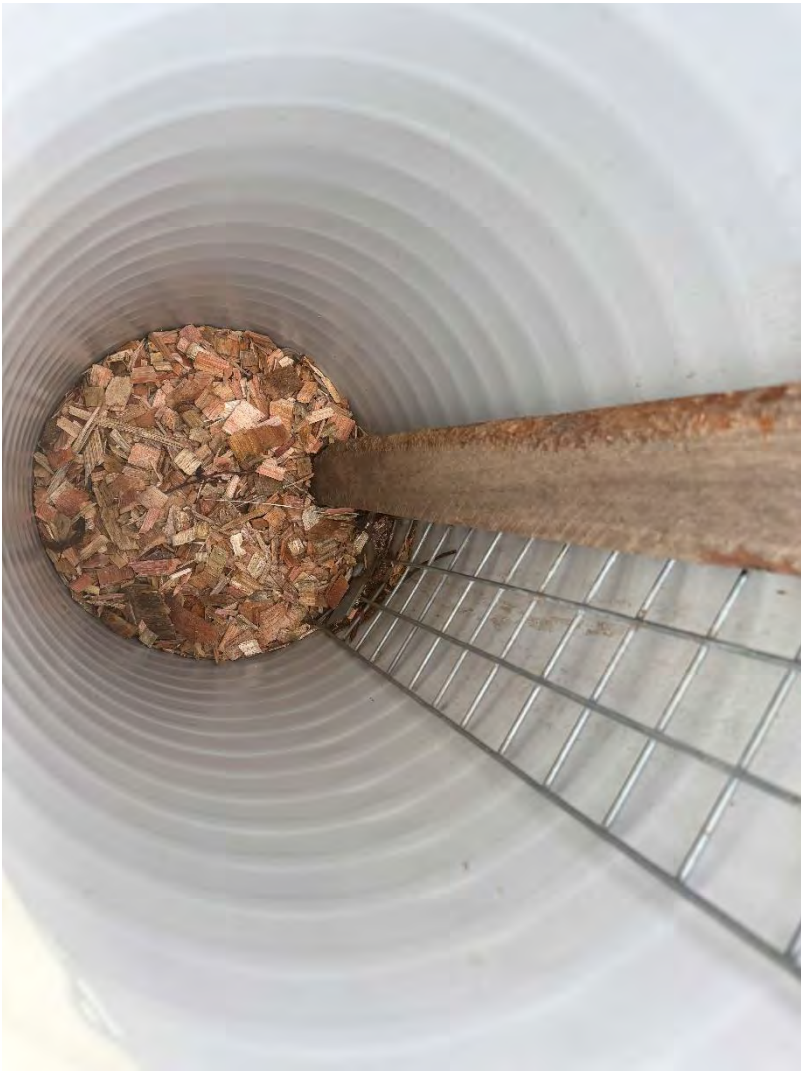
# Replenishment of ANH NB63

ANH#	Latitude	Longitude	Height Mts	Wood chips Lts	Post	Comments
NB63			8.420	15lts	Not replaced

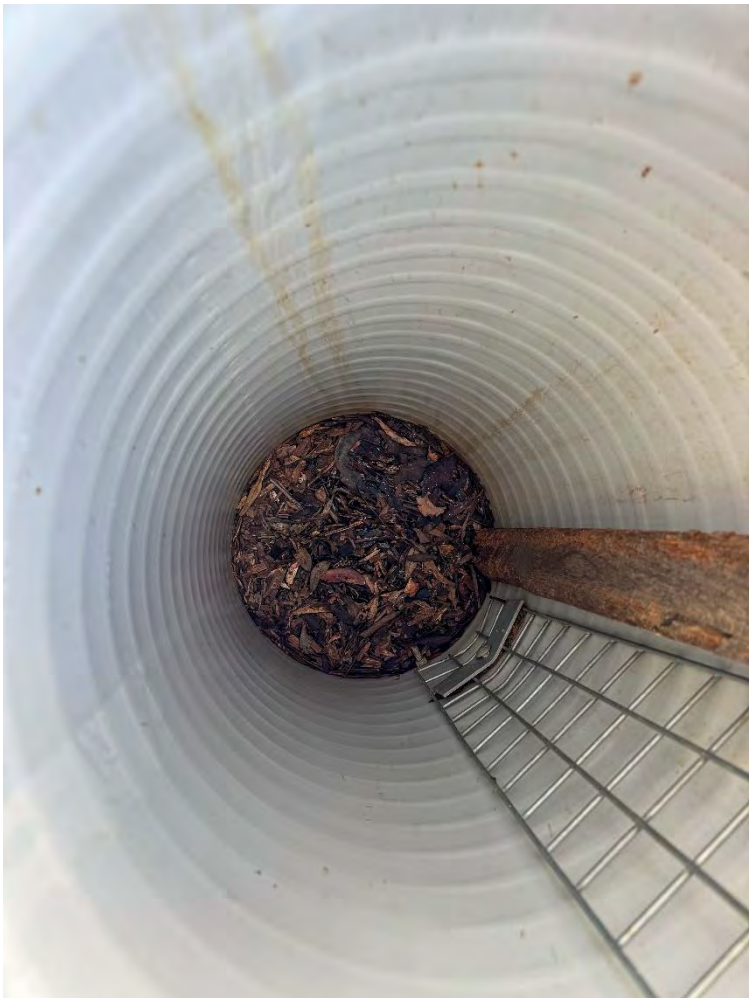
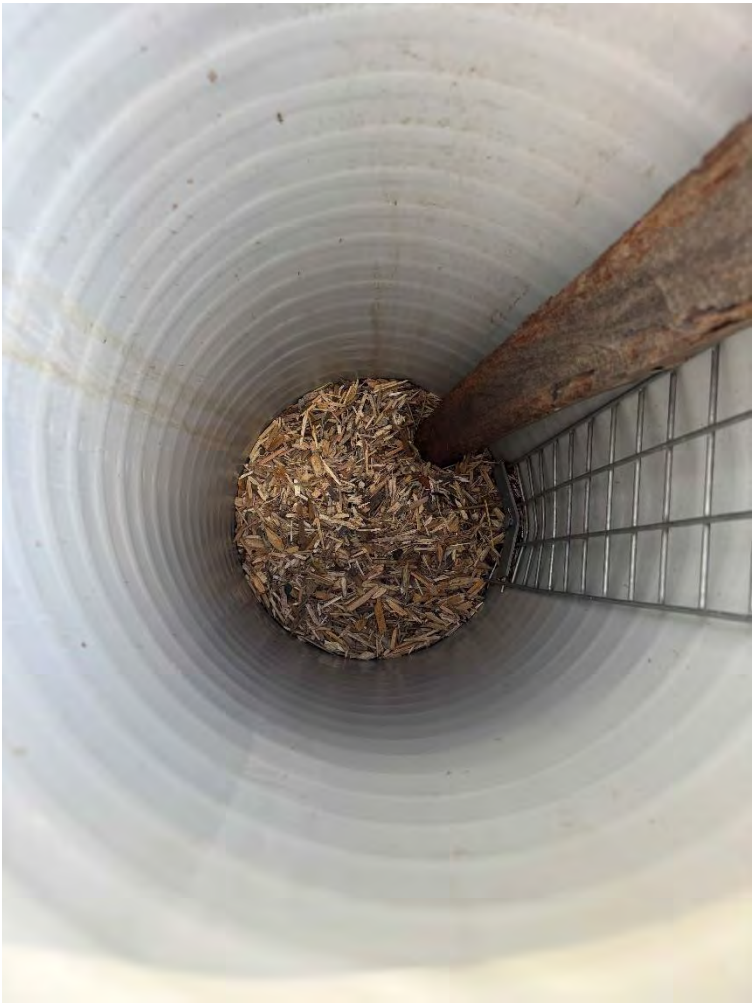
# Replenishment of ANH NB12

ANH#	Latitude	Longitude	Height Mts	Wood chips Lts	Post	Comments
NB12			93.30	15lbs	Not replaced

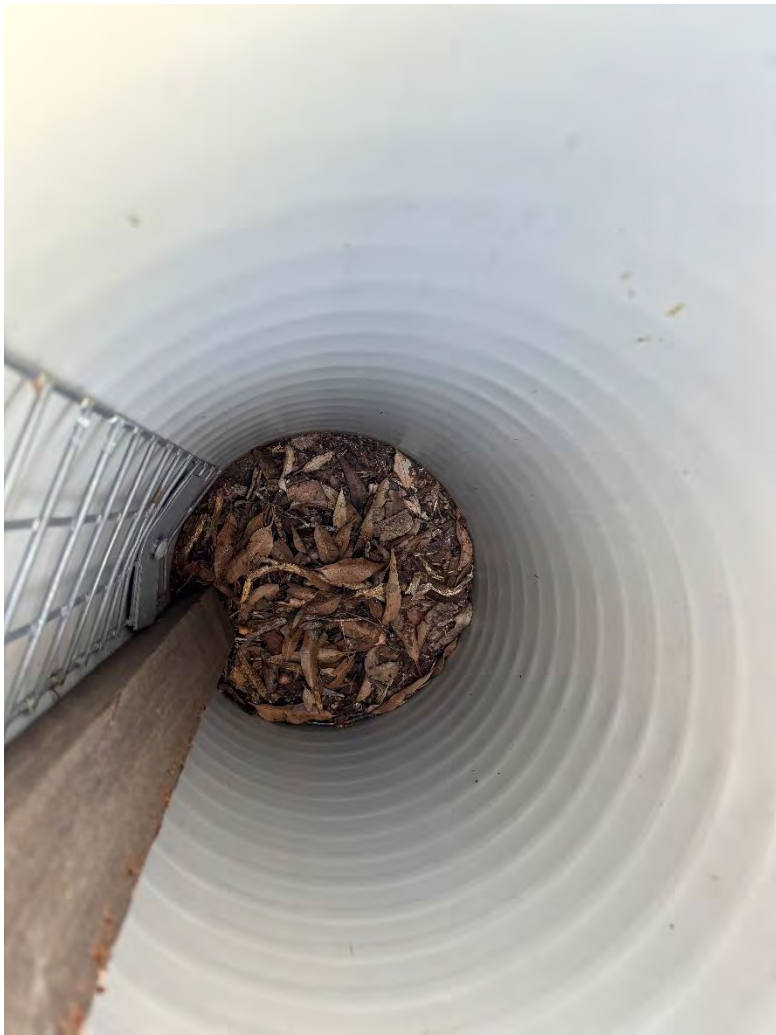
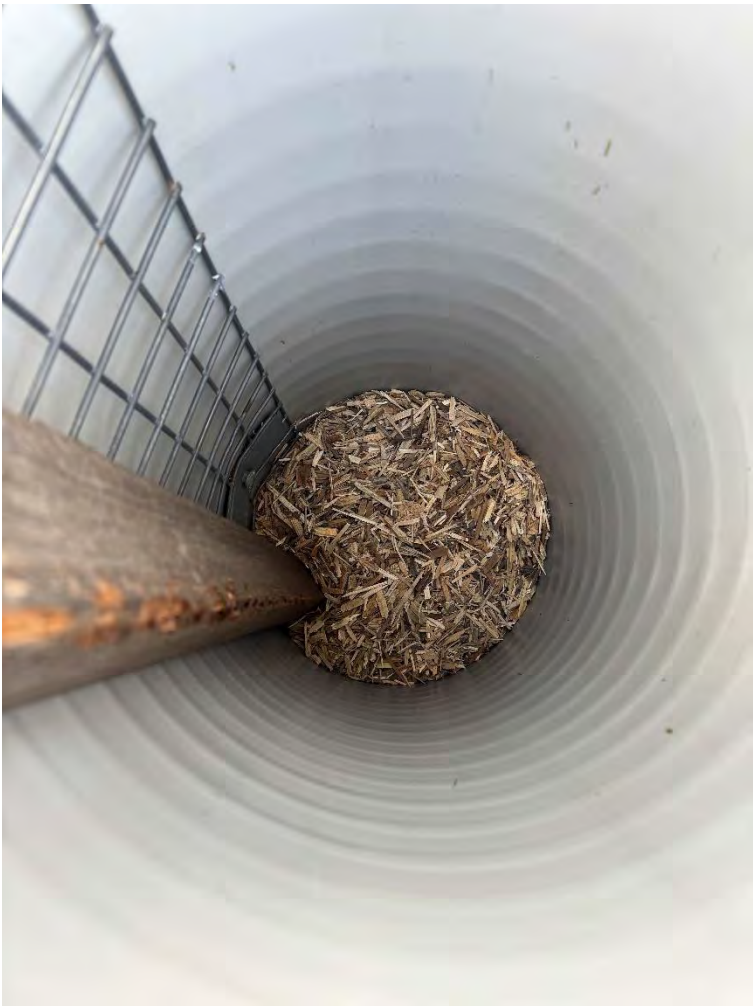
# Replenishment of ANH NB11

ANH#	Latitude	Longitude	Height Mts	Wood chips Lts	Post	Comments
NB11			6.920	15lts	Not replaced

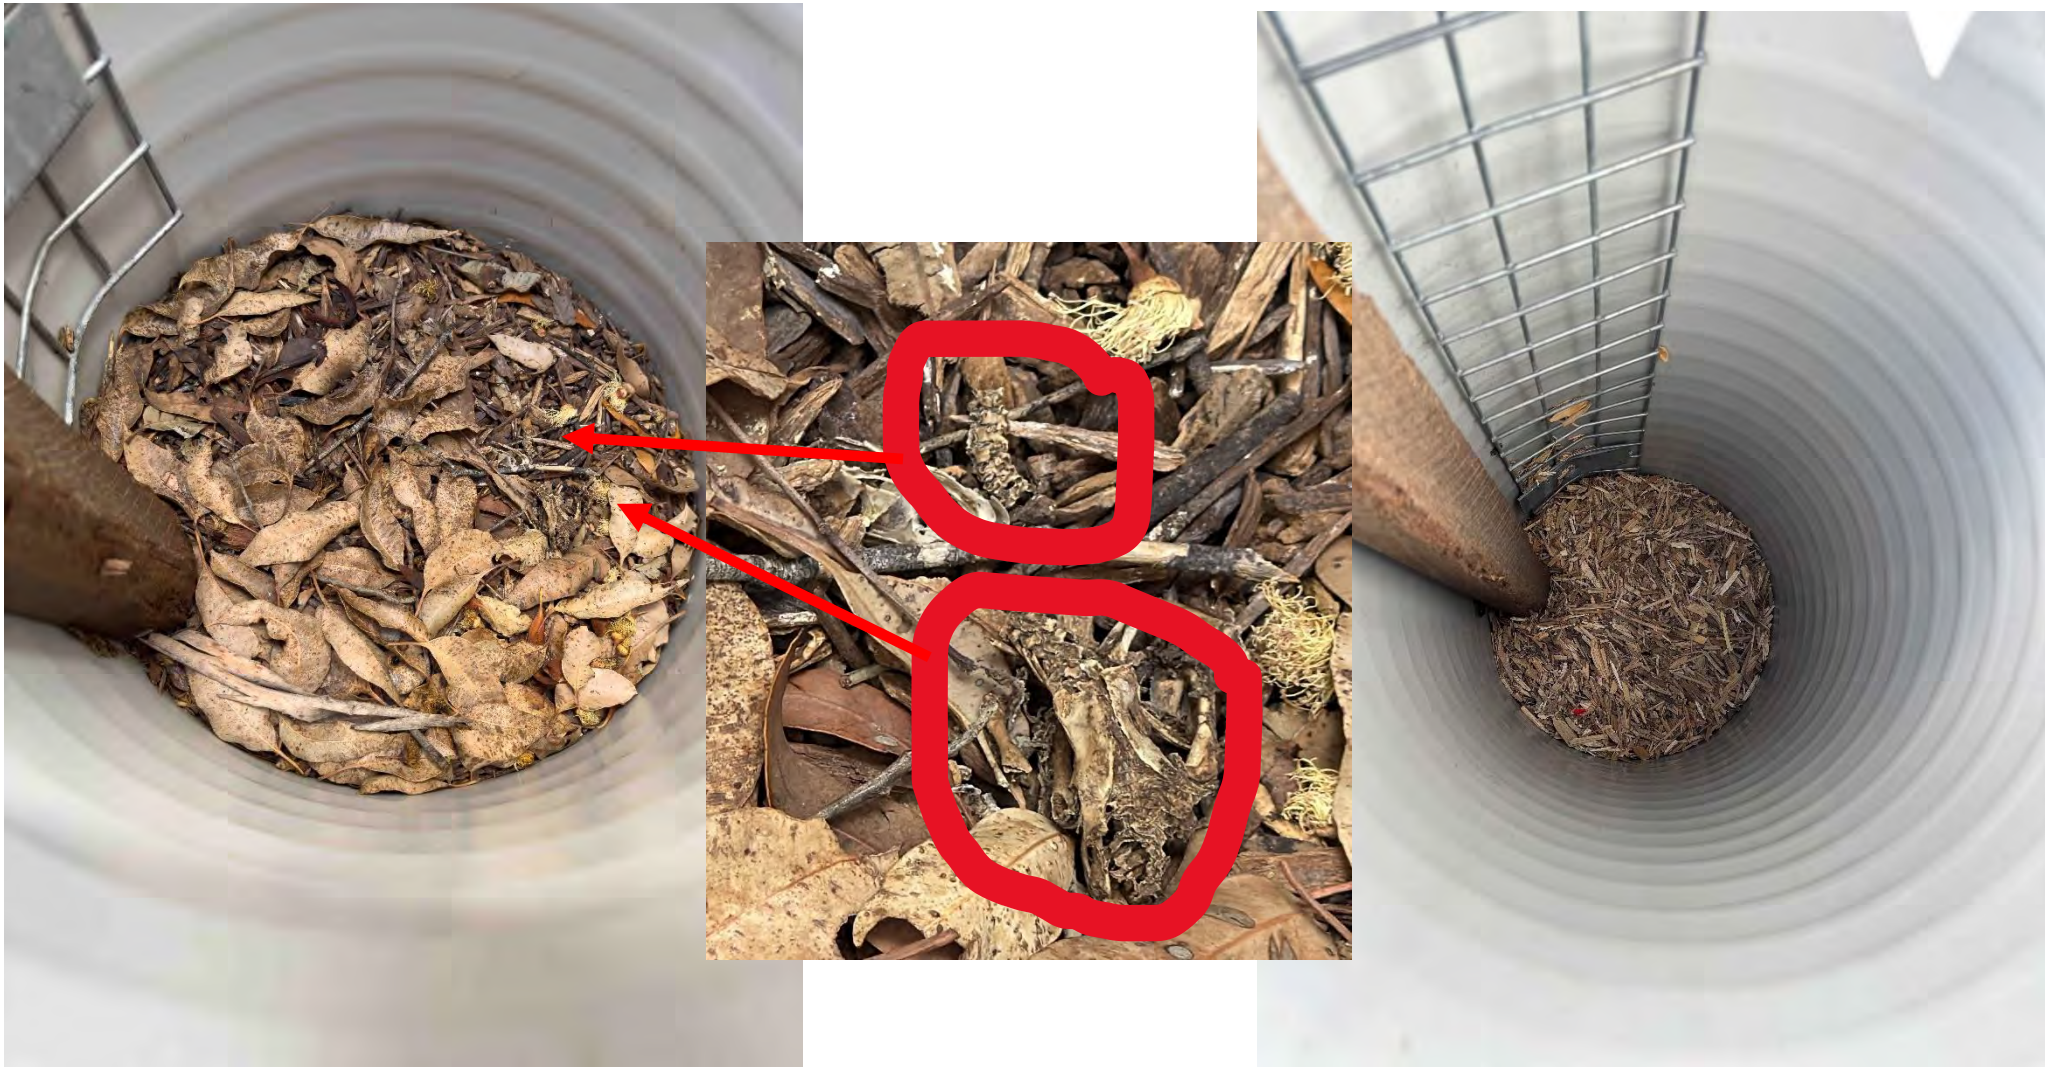
# Replenishment of ANH NB77

ANH#	Latitude	Longitude	Height Mts	Wood chips Lts	Post	Comments
NB77			7.770	15lbs	Not replaced	1 x CC old skeleton

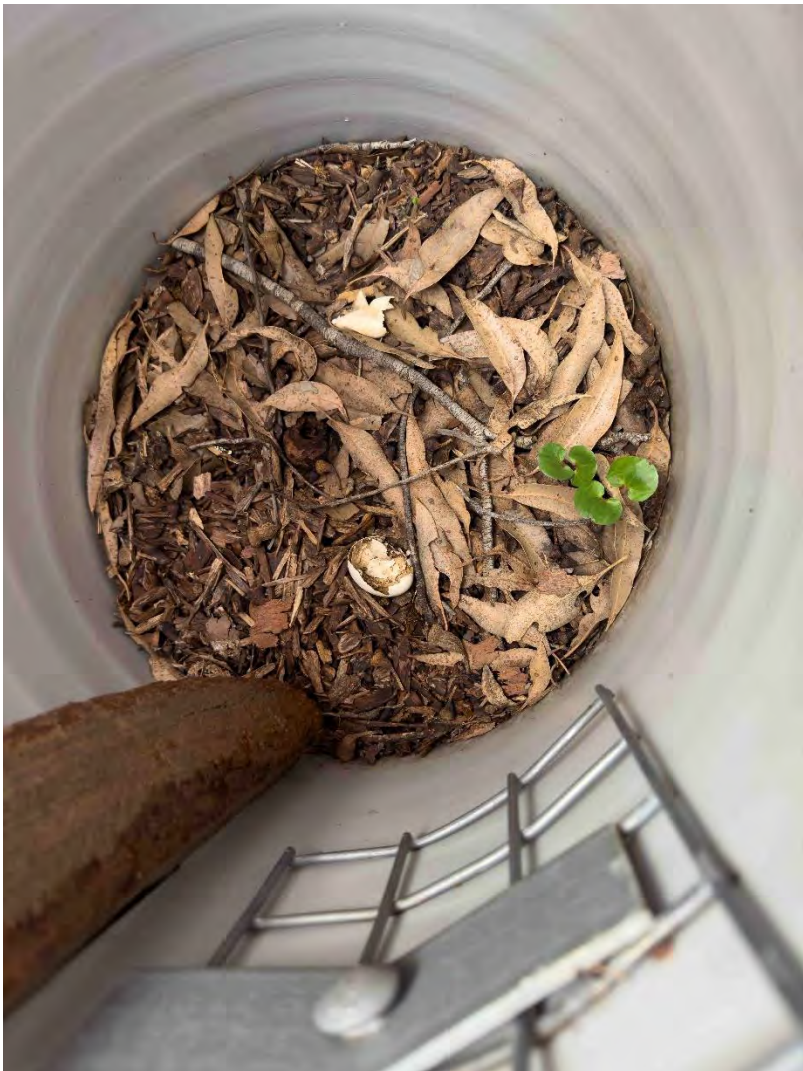
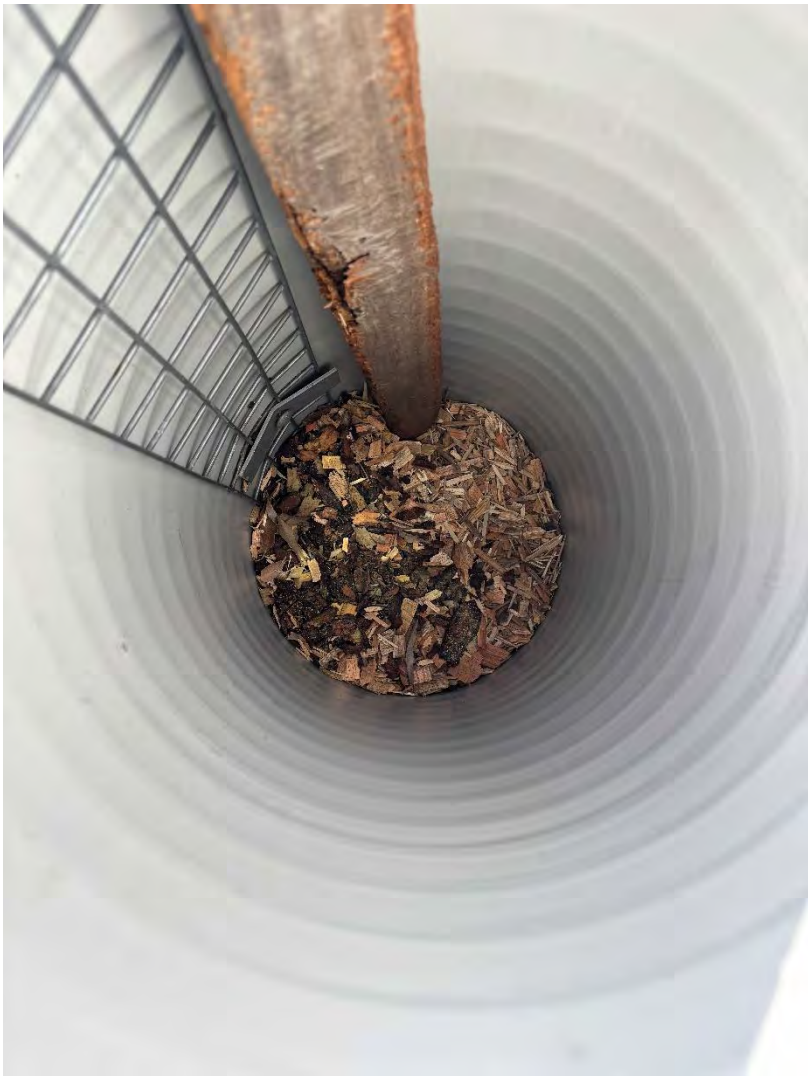
# Replenishment of ANH NB76

ANH#	Latitude	Longitude	Height Mts	Wood chips Lts	Post	Comments
NB76			7.750	15lts	Not replaced	1 x broken CC egg

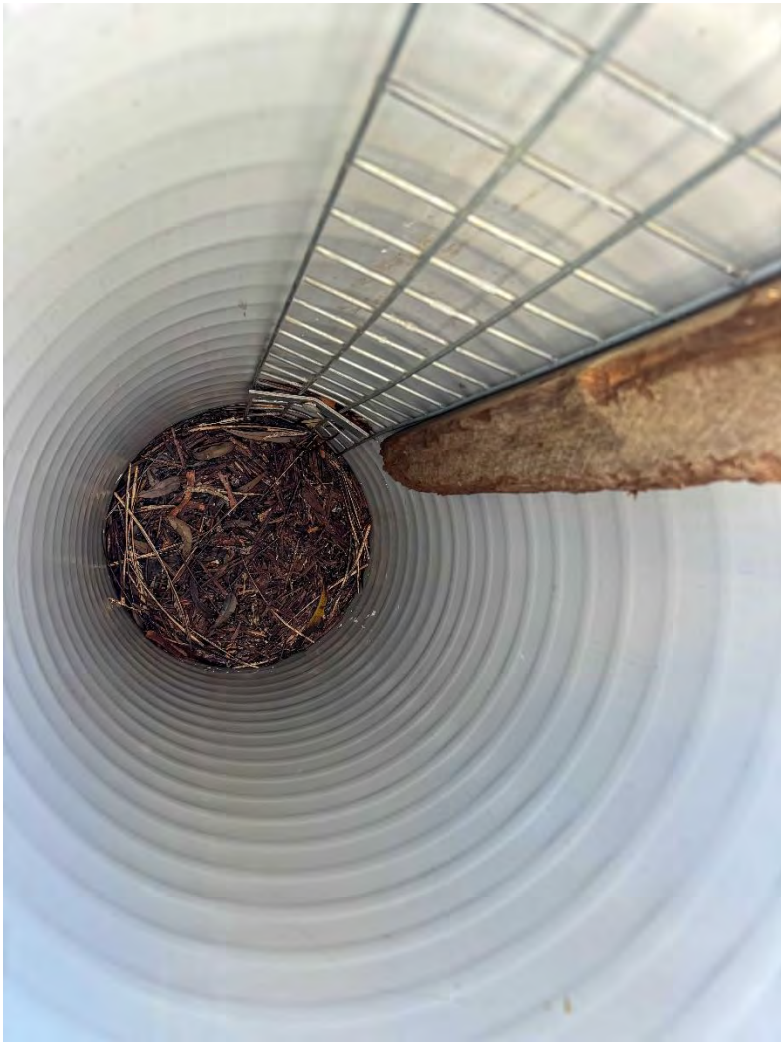
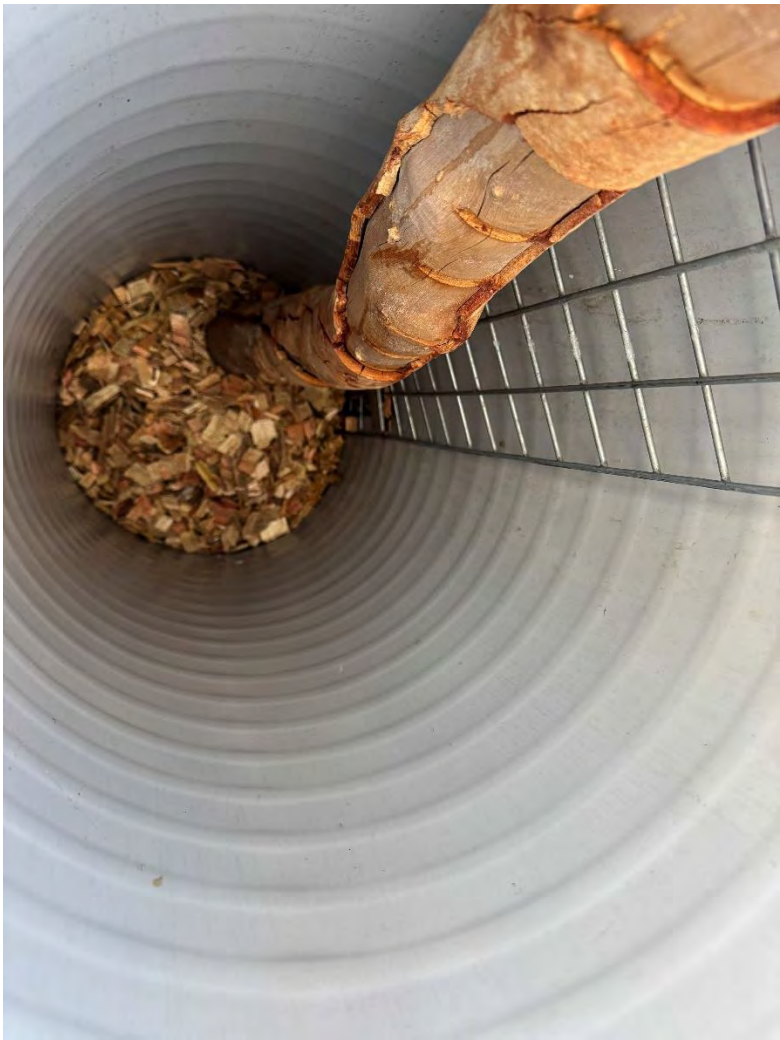
# Replenishment of ANH NB04

ANH#	Latitude	Longitude	Height Mts	Wood chips Lts	Post	Comments
NB04			8.975	10lts	New Post	Nesting Fledged (Old CC feather quills)
