# EPBC Annual Compliance Report

EPBC 2016/7656

**Great Northern Highway Upgrade:  
Muchea to Wubin – Muchea North  
D24#1330778**

**Reporting period: 21 September 2023 to 20 September 2024**

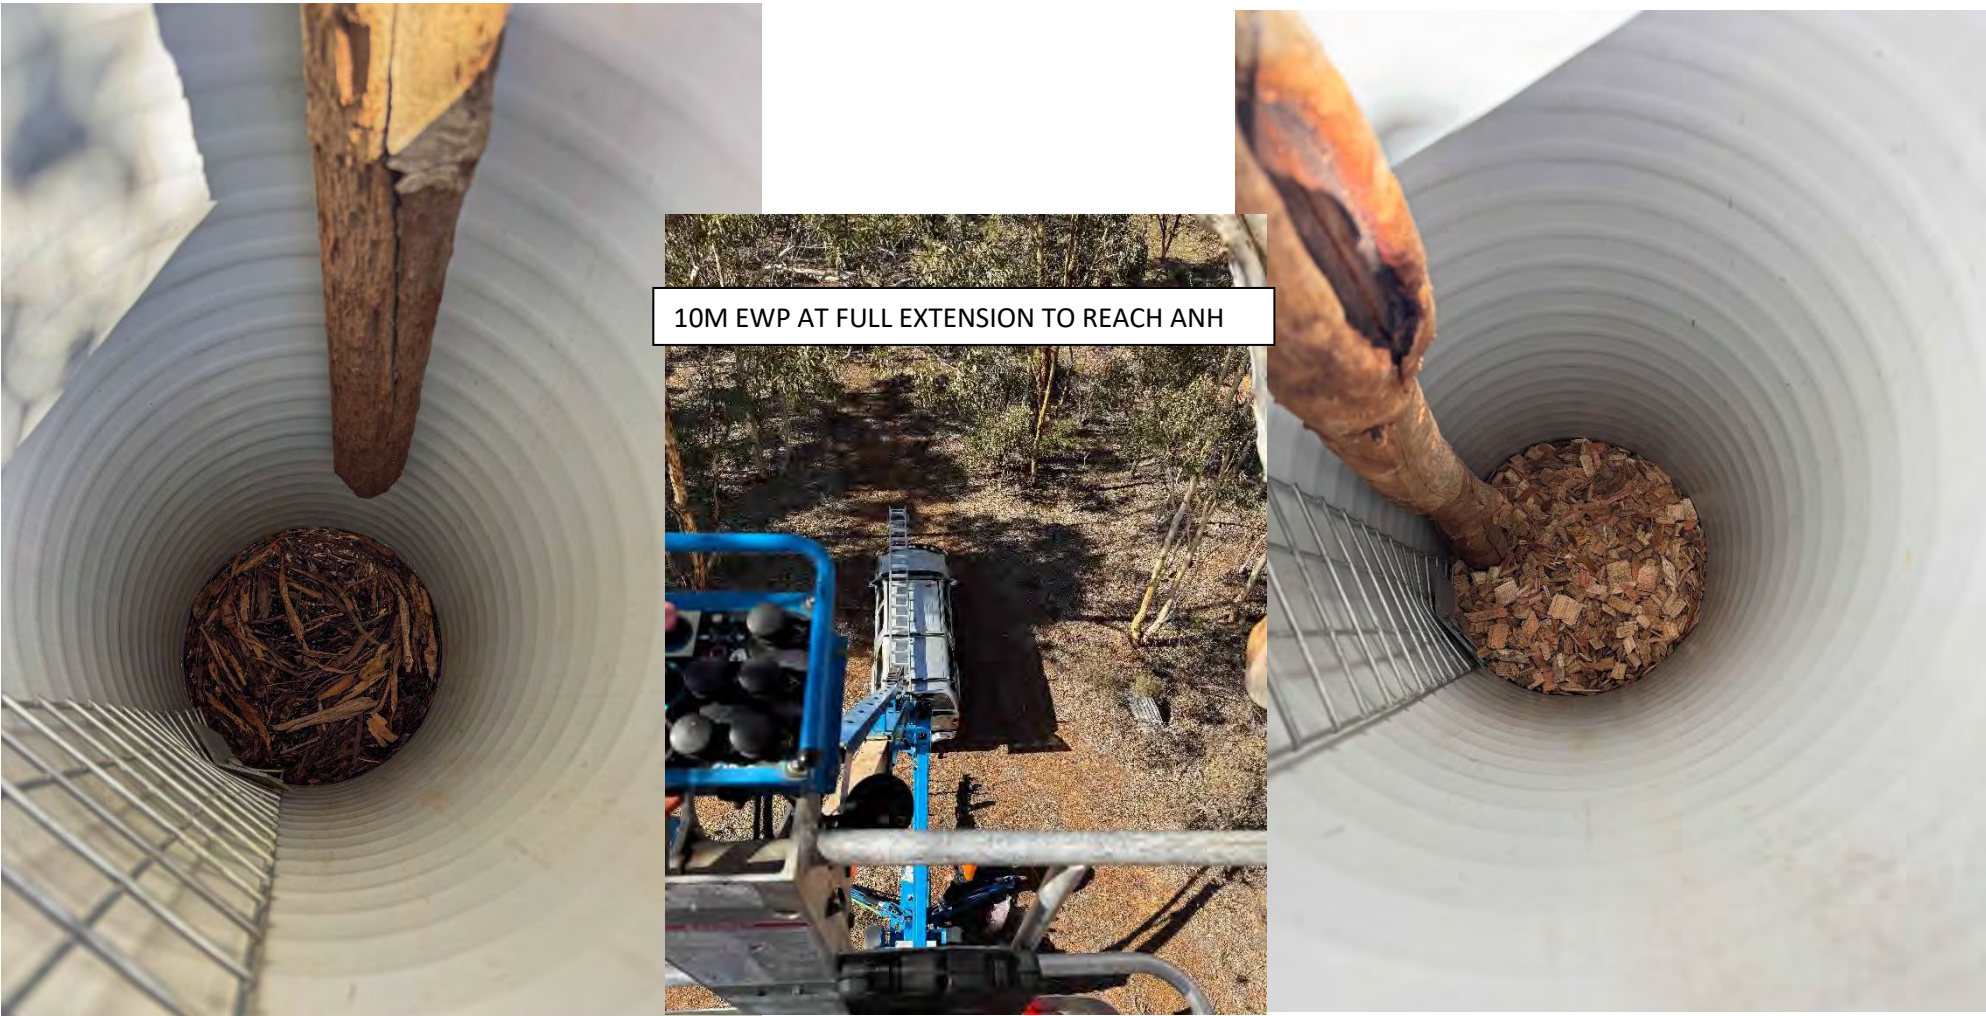
# Replenishment of ANH NB06

ANH#	Latitude	Longitude	Height Mts	Wood chips Lts	Post	Comments
NB06			9.990	10lts	New Post	Nesting Fledged

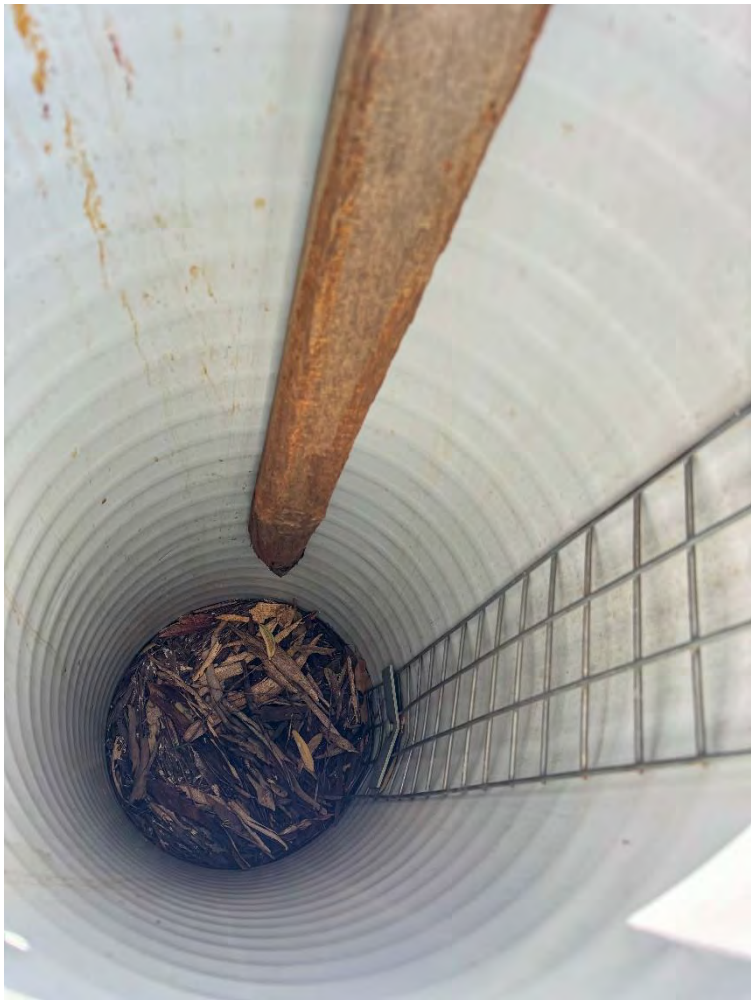
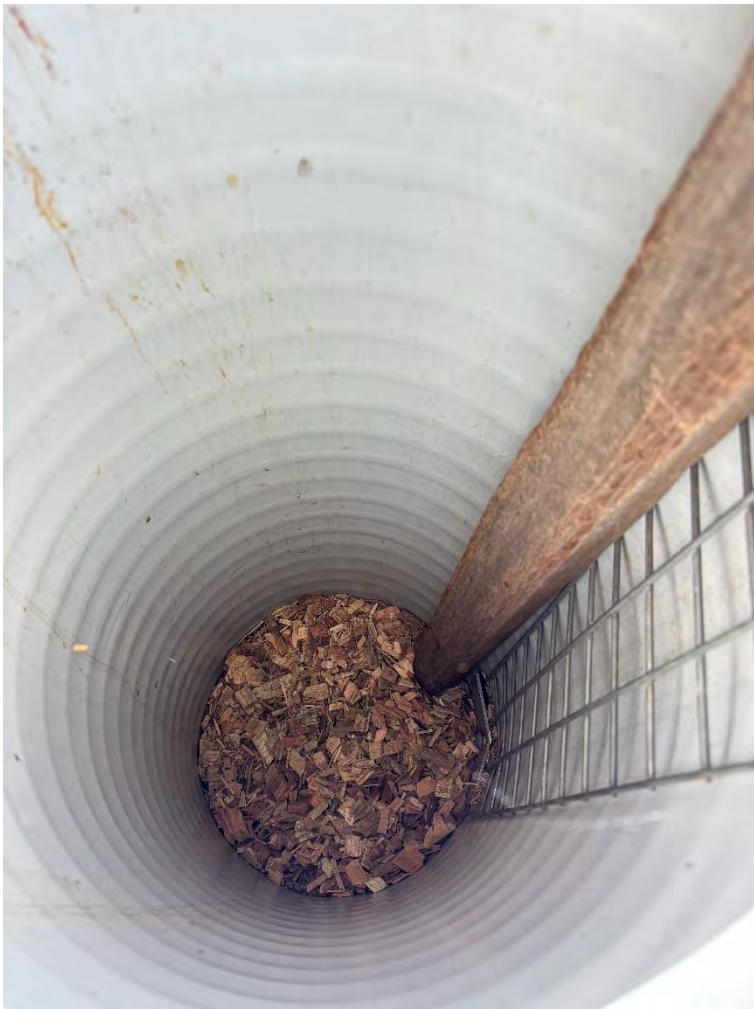
# Replenishment of ANH NB32

ANH#	Latitude	Longitude	Height Mts	Wood chips Lts	Post	Comments
NB32			7.750	10lbs	Bracket relocated	Nesting Fledged

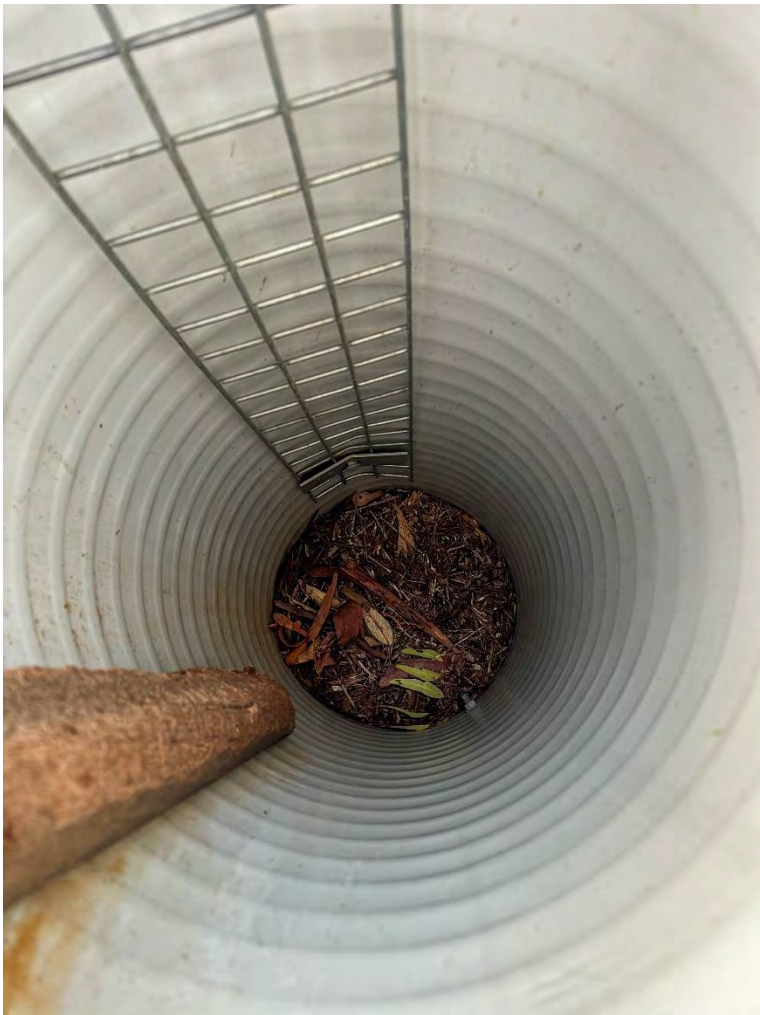
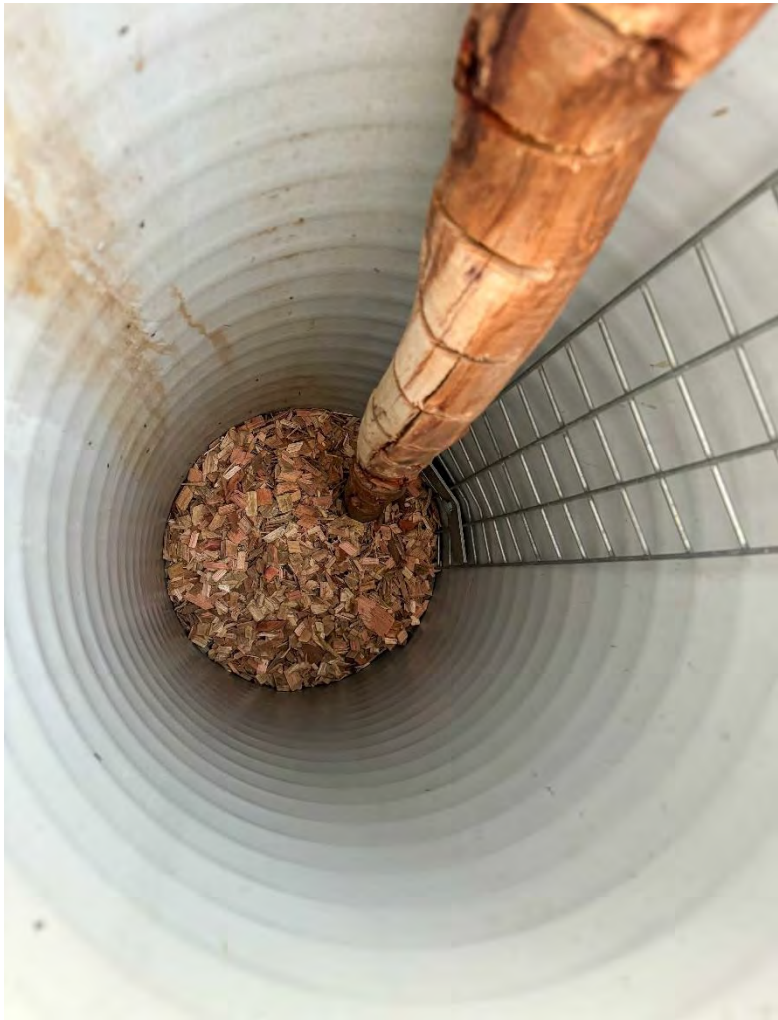
# Replenishment of ANH NB71

ANH#	Latitude	Longitude	Height Mts	Wood chips Lts	Post	Comments
NB71			7.500	15	New Post

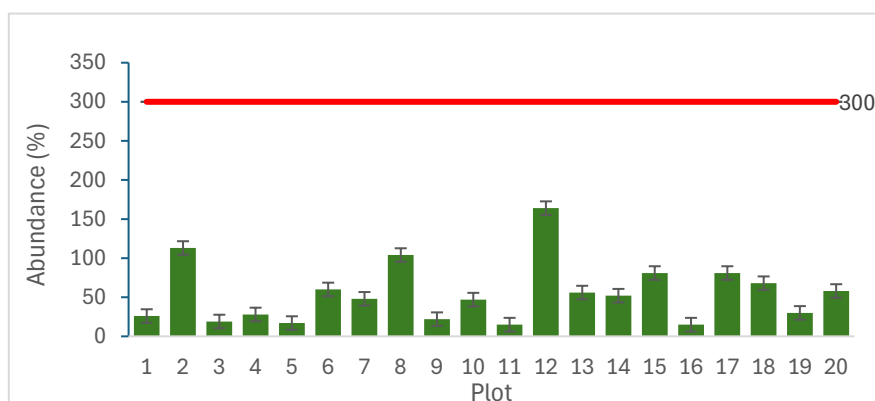
**Figure 2.** The abundance of native species within each monitoring plot, compared against the completion target (red line).

The average native plant abundance per plot is  $55.2 \pm 8.67$ . Plot 12 recorded the highest number of native plants, with 163 stems observed. In contrast, Plots 1, 3, 11, and 16 had the lowest abundance, each with fewer than 16 stems. The site does not meet the completion criterion of 300 native stems per plot (100 m<sup>2</sup>) or 3 stems per m<sup>2</sup>. Significant variation between monitoring plots is noted, primarily due to a range of biotic and abiotic factors, including soil conditions, water availability, weed cover, and predation, which have affected mortality and success rates.

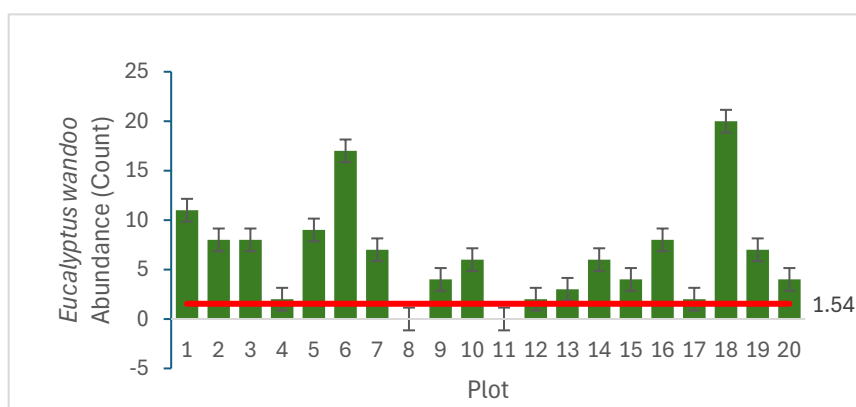
**Figure 3.** *Eucalyptus wandoo* (%) within each monitoring plot, compared against the completion target (red line).

The average abundance of *Eucalyptus wandoo* per plot is  $6.4 \pm 1.15$ , exceeding the completion criterion target of 1.54 native stems per plot (100 m<sup>2</sup>). Therefore, the site meets the completion criterion. Plots 18 and 6 recorded the highest abundance of *Eucalyptus wandoo*, with 20 and 17 native stems, respectively. In contrast, Plots 8 and 11 are the only plots where no *Eucalyptus wandoo* was observed. However, *Eucalyptus wandoo* was also observed outside the plots.

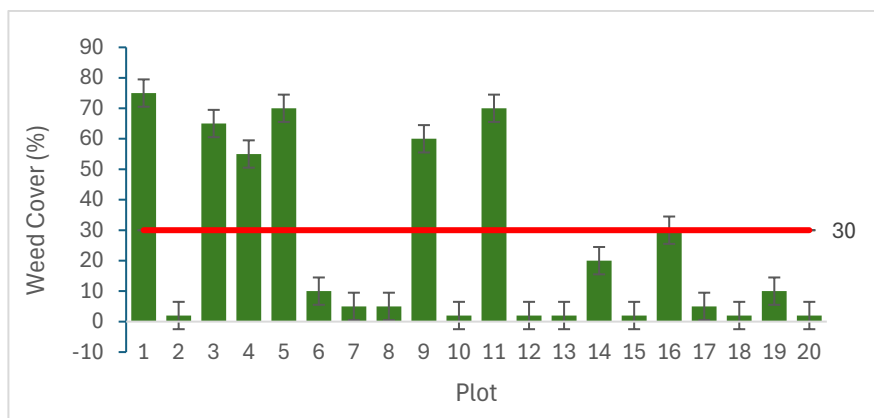
**Figure 4.** Weed coverage (%) within each monitoring plot, compared against the completion target (red line).

Weed cover across the site is relatively low, with an average weed cover of  $24.7\% \pm 6.42$ . Most plots meet the completion criterion of less than 30% weed coverage, except for seven plots (see Figure 4). Plots 1, 5, and 11 exhibit the highest weed loads, with weed cover exceeding 70% in these plots. High native foliage cover was observed in plots with the lowest weed loads (see Figure 4 and Figure 5).

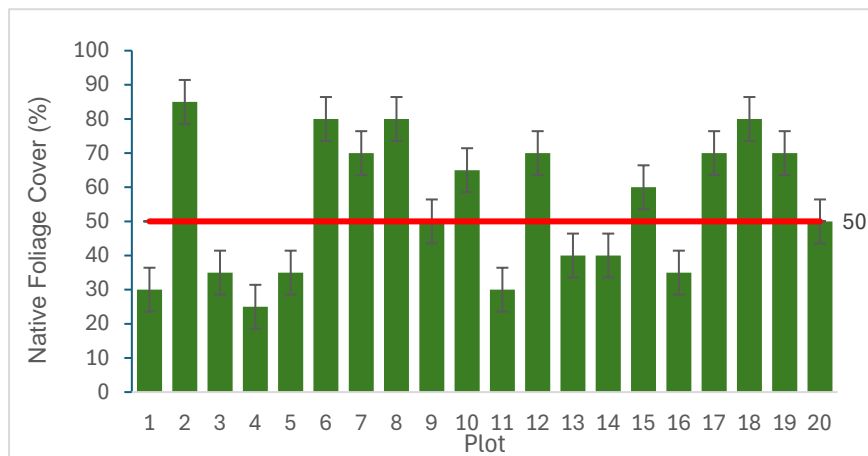
**Figure 5.** Native foliage coverage (%) within each monitoring plot.

The average native foliage cover on site is 55%. Only 6 out of 20 plots did not meet the compliance criterion target of 50%, but these plots are on track to achieve the target (see Figure 5). The lower foliage cover in some plots can be attributed to both lower native stem abundance and slower plant growth, which may be due to soil nutrient deficiencies. Plot 2 has the highest native foliage cover at 85%, while Plot 4 has the lowest at 25% (see Figure 5). *Eucalyptus* natives contribute significantly to native foliage cover, dependent on their size and health.

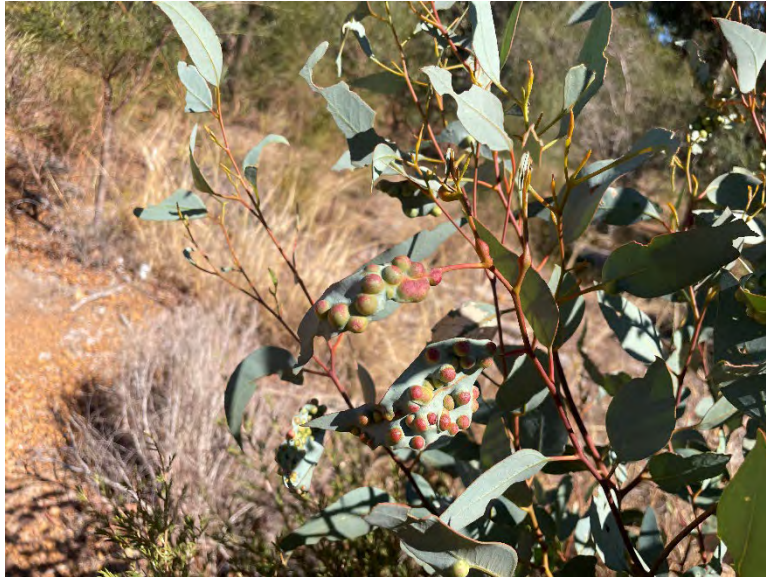
Disease and senescence on site are minimal. Wasp-induced gall disease was observed only in young *Eucalyptus* natives (see Figure 6). Leaf yellowing was also noted among several plants on site. Overall, the occurrence of disease among native plants is low, resulting in minimal impacts on plant health and survivability.

**Figure 6.** Wasp-induced gall disease present in *Eucalyptus wandoo* leaf. Photos taken by Steven Madamecila on the 3<sup>rd</sup> of April 2024.

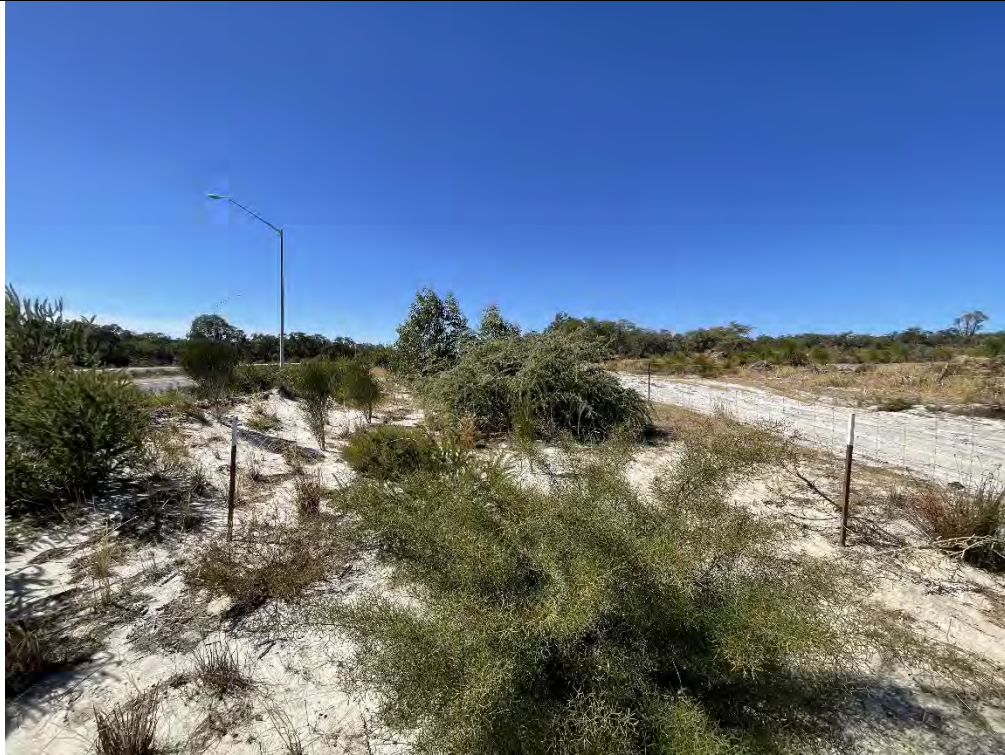
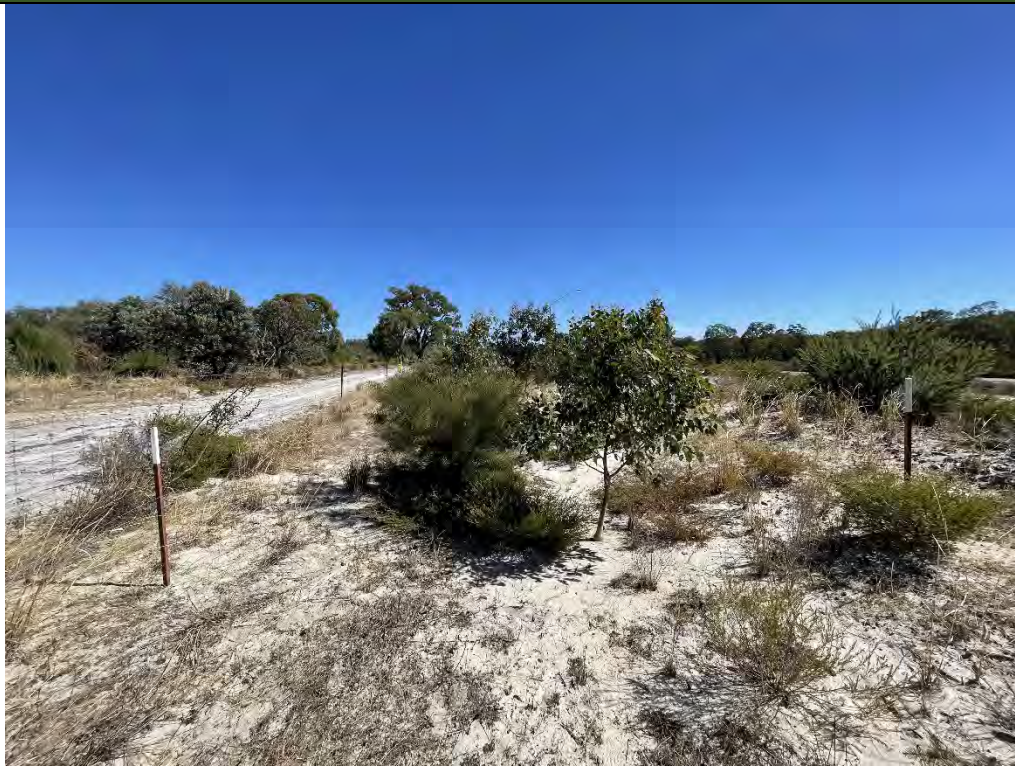
Soil Profile type	Sandy grey dry soil.
Native foliage coverage	70%
Weed species coverage (assessed against total planting area)	10%
Major weed species	<i>Avena fatua</i> (Wild oats) and <i>Eragrostis curvula</i> (African lovegrass).
Native germination observed.	None
Seedlings and mature planting survival (general description)	
Bare ground cover	10%
Any other comments that may affect or contribute to progress.	Light predations present in <i>Eucalyptus</i> .

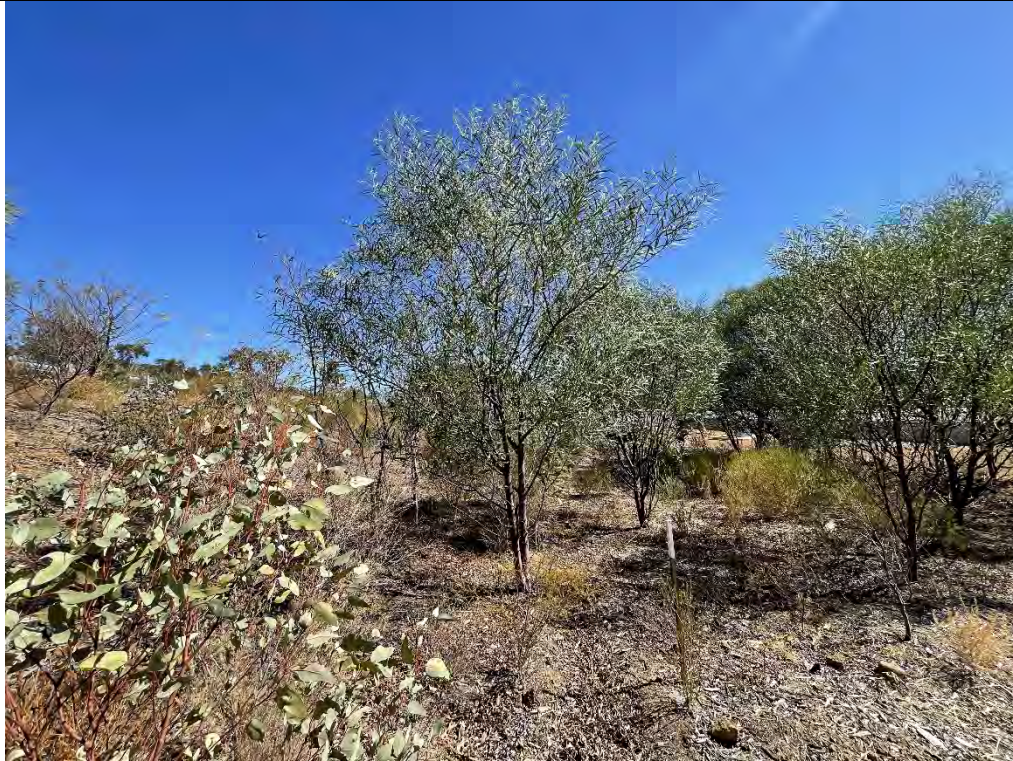
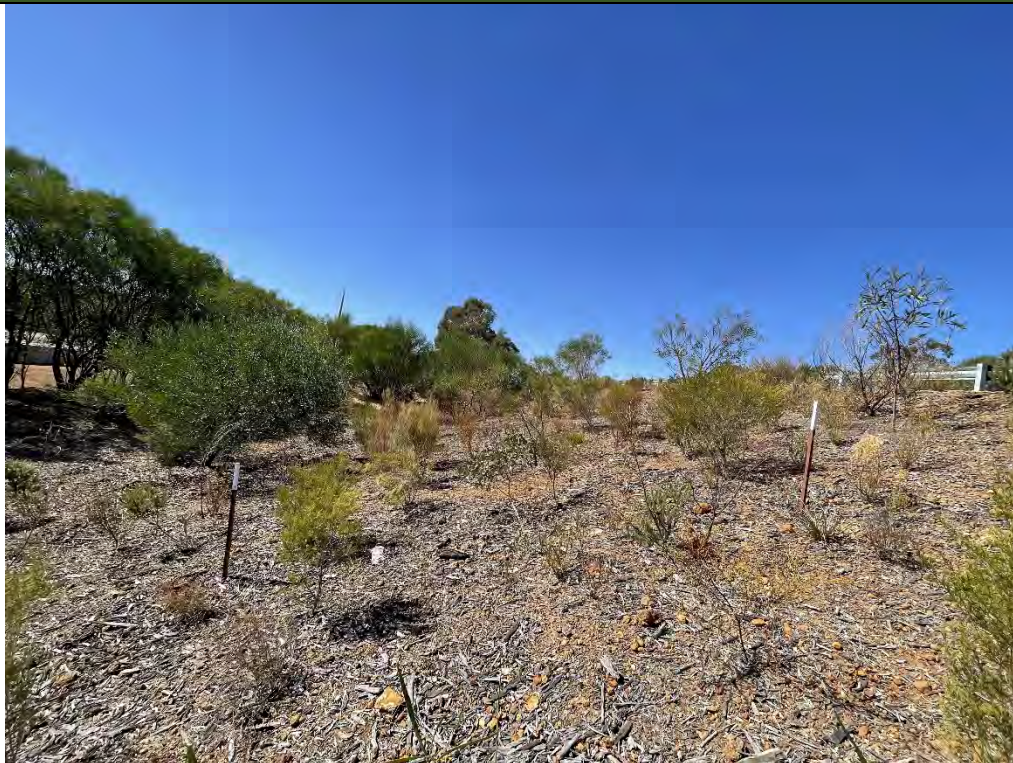
Soil Profile type	Gravel dark grey soil.
Native foliage coverage	50%
Weed species coverage (assessed against total planting area)	20%
Major weed species	<i>Avena fatua</i> (Wild oats)
Native germination observed.	None
Seedlings and mature planting survival (general description)	Native plants are generally healthy.
Bare ground cover	25%
Any other comments that may affect or contribute to progress.	<i>Melaleuca</i> are observed to be successful and dominant.
