Main Roads

Mitchell Freeway Extension

Phytophthora Dieback occurrence assessment – Version 1.0

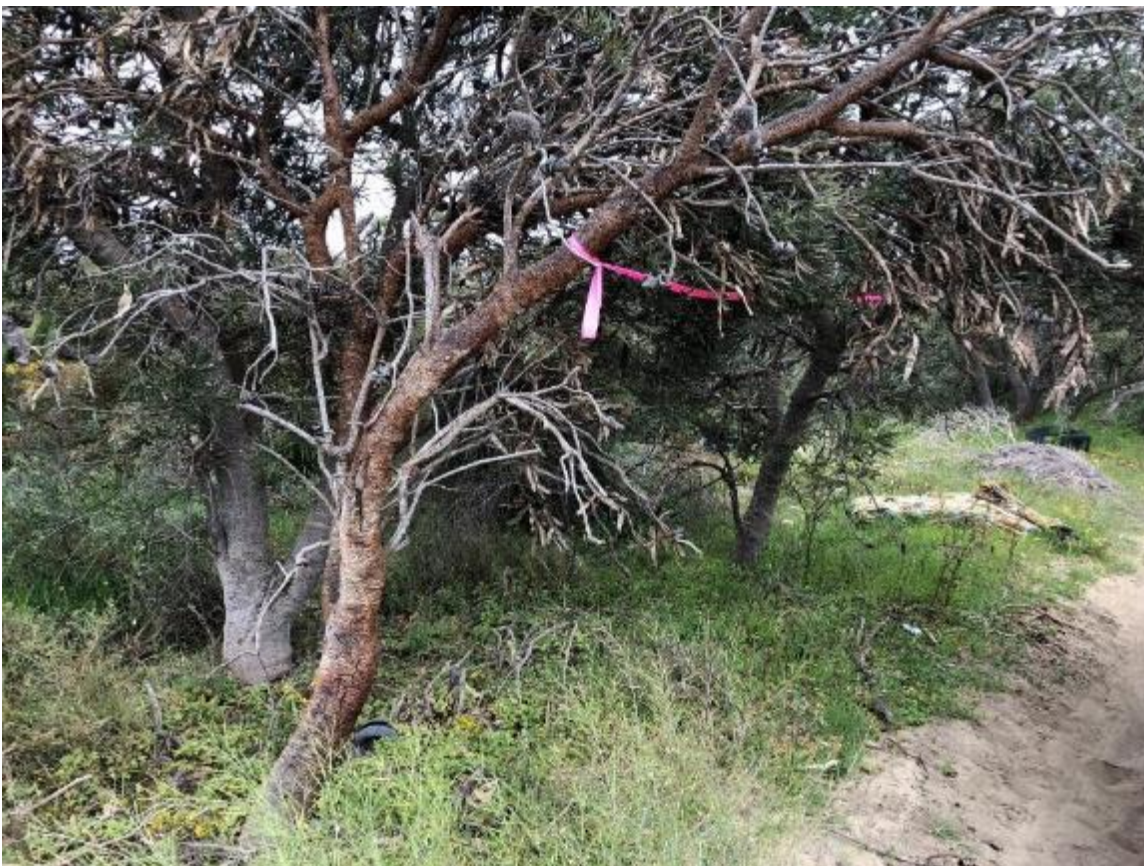
Plate 6 - Sample site 6

Sample 6 was taken at the entrance to the Uninfested vegetation on the southern side of Romeo Road (Figure 5; Appendix B, Plate 6). This sample returned a negative result for the presence of Phytophthora. This site is associated with a well-used track, which then intersects with all tracks that traverse south through the Neerabup NR.
