mainroads  
WESTERN AUSTRALIA

# Clearing Assessment Report – CPS 818

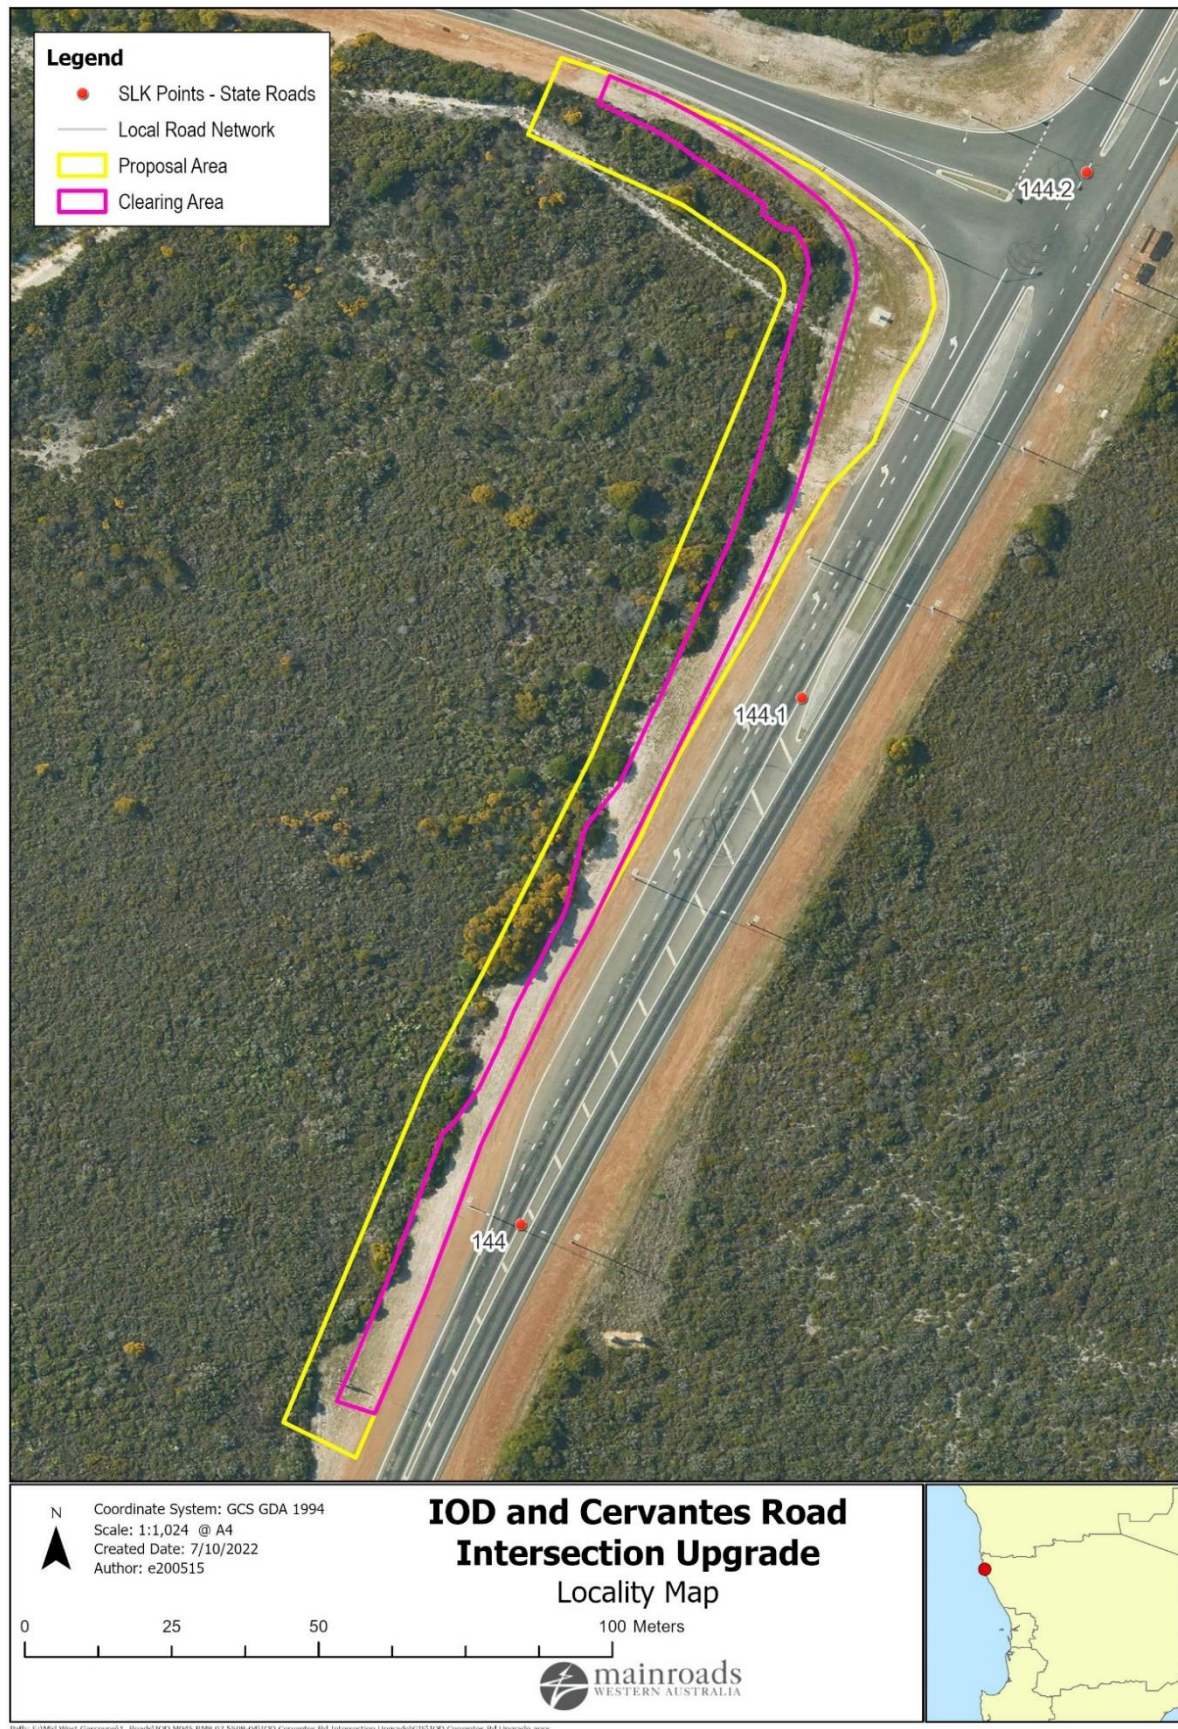
**Figure 1. Proposal Area and Native Vegetation Clearing Boundary**

The clearing area is located on IOD at Straight Line Kilometre (SLK) 144.19, approximately 2 km east of Cervantes in the Shire of Dandaragan, as shown in Figure 1.

**Areas of Native Vegetation Clearing:** The areas of native vegetation to be cleared are shown Figure 1.

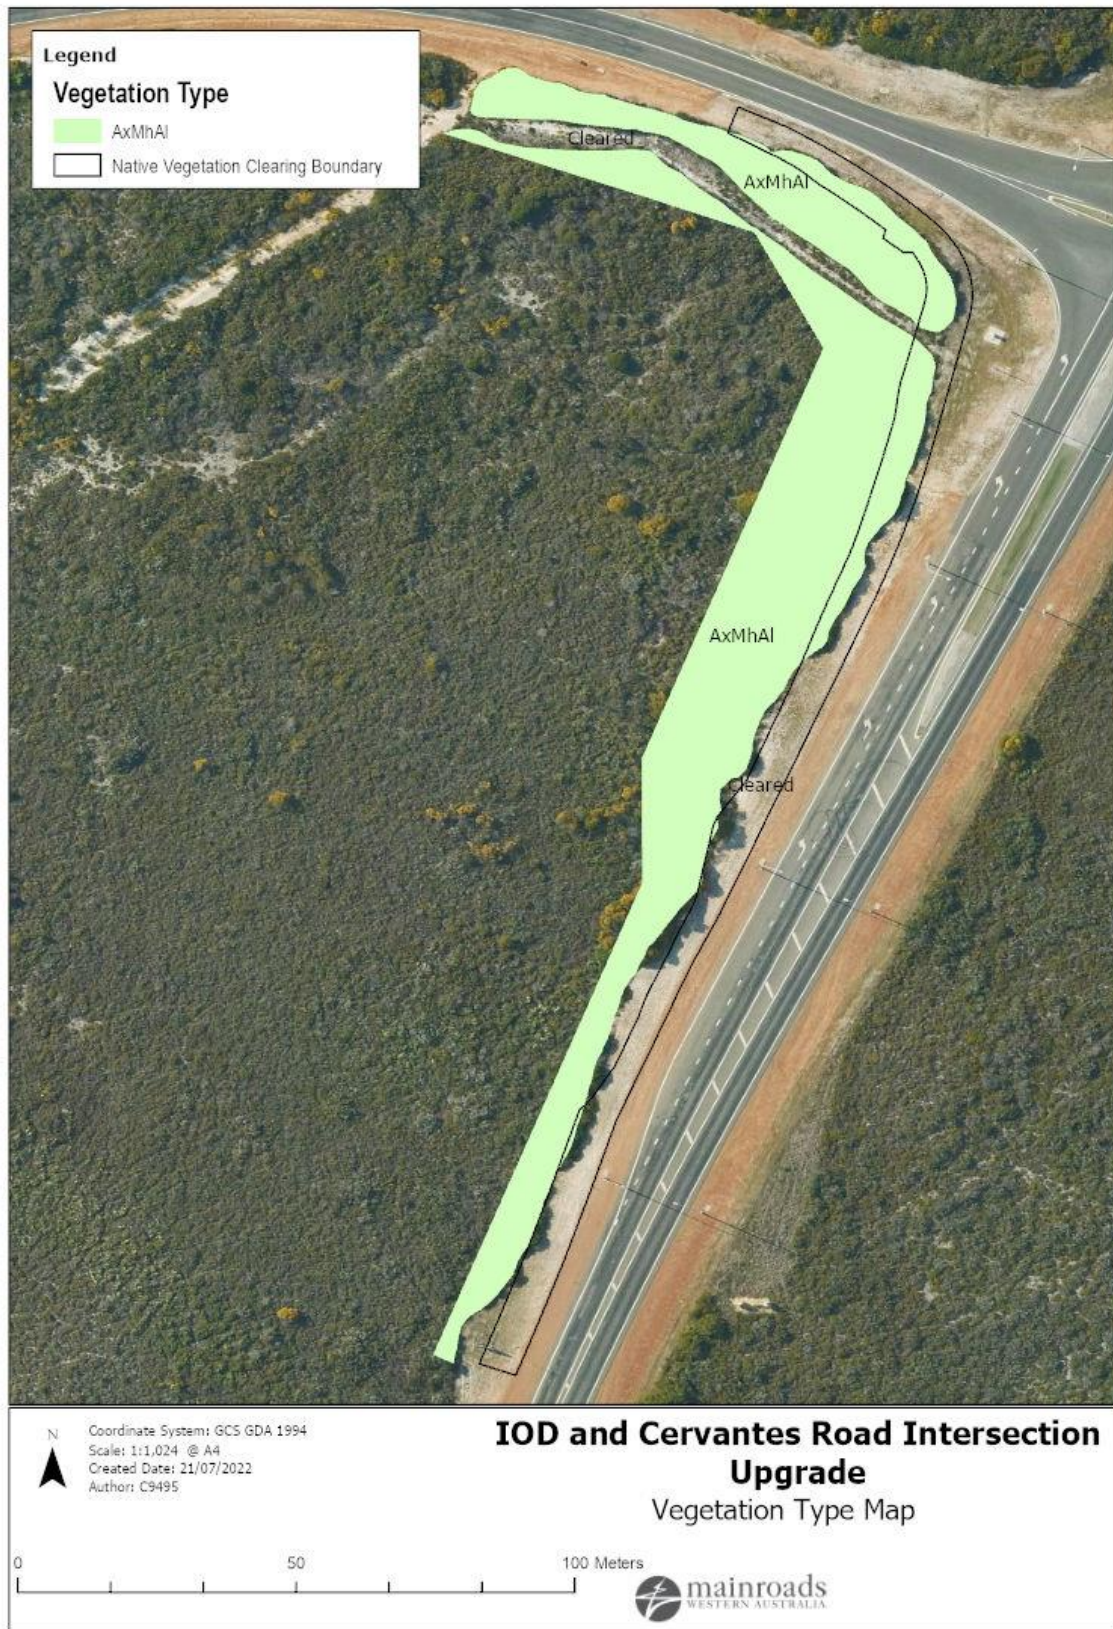
**Figure 2. Vegetation Type**

**Type of Native Vegetation:** The type of vegetation to be cleared under this proposal is *Acacia xanthina*, *Melaleuca cardiophylla* tall open shrubland over *Melaleuca huegelii* subsp. *huegelii*, *Spyridium globulosum*, *Myoporum insulare* mid open shrubland over *Acacia lasiocarpa* var. *lasiocarpa*, *Melaleuca systena* low open shrubland and *Gahnia trifida* low sparse sedgeland (**AxMhAI**). This is shown in Figure 2.
