# Clearing Desktop Report – Short Form

| <b>Project Name:</b> | Bridge 0753 and 0754 Replacement and Road Realignment – Geotechnical Investigation | | |
| <b>Road/Bridge Name and No:</b> | Northam Pithara Road (M032) <ul style="list-style-type: none"> <li>• Bridge 0753 – Mortlock River</li> <li>• Bridge 0754 – Mallabine Creek</li> </ul> | | |

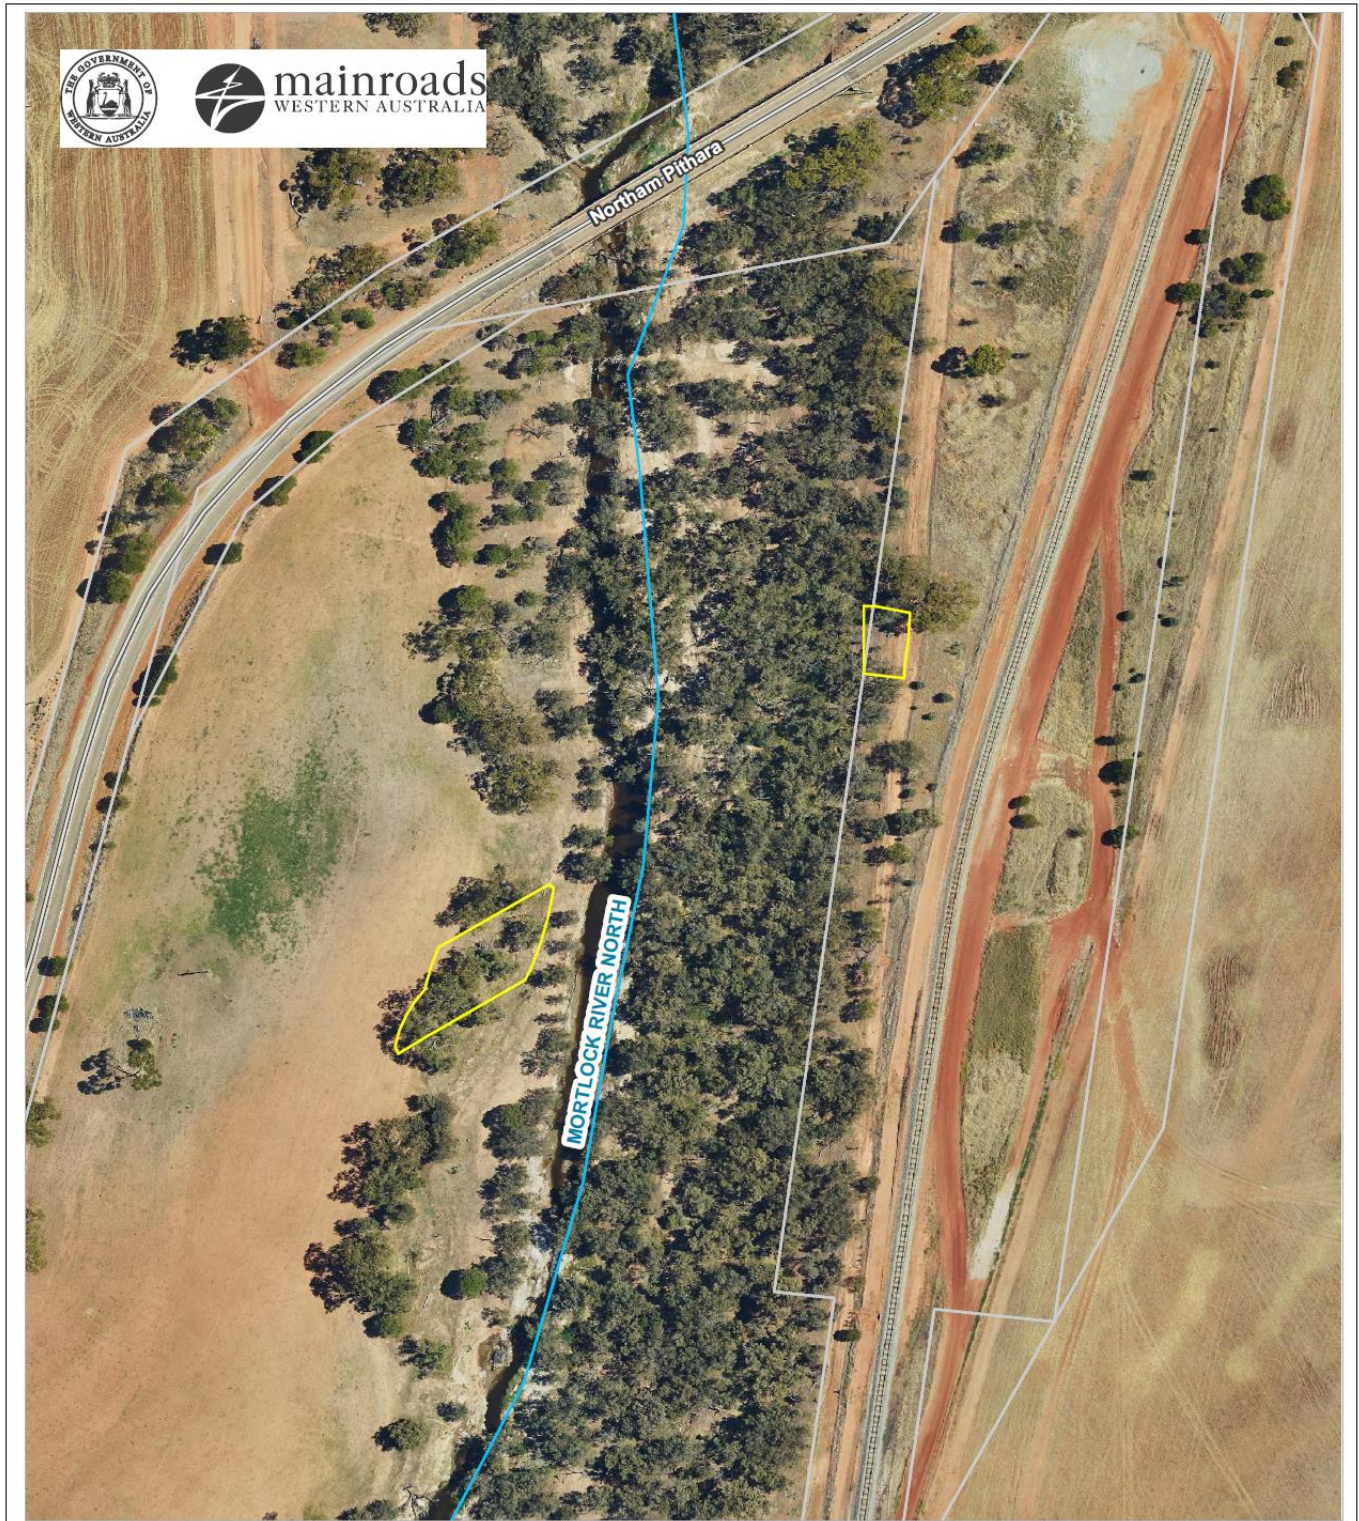
**Figure 1**

Bridges 753/754 Realignment - Northam Pithara Road (M032)  
Geotechnical Investigation - CPS818/15
