# Clearing Assessment Report – CPS 818

M002 Bindoon-Moora 26.4-30.6 SLK

September 2021

**Project Name:** Bindoon-Moora Road (M002) 20.6-30.6 SLK Widening

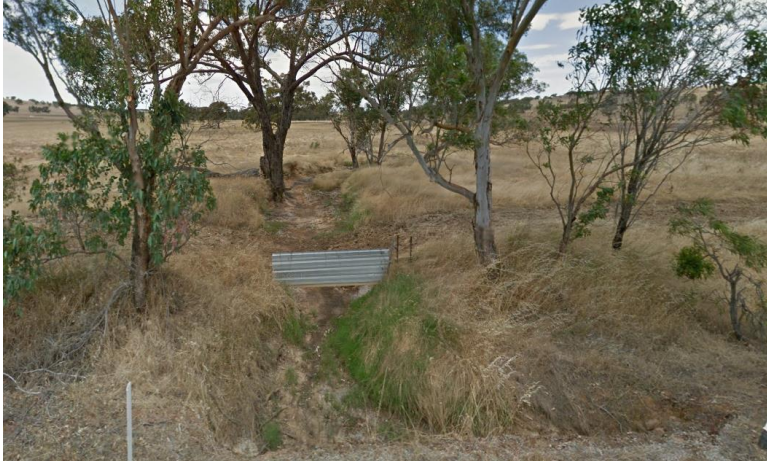
Plate 1: Looking upstream, RHS of Bindoon-Moora Road

As shown in Plates 1 and 2 below, the water course is heavily degraded and traverses through active farming land before intersecting the project and ultimately flowing into Lake Wannamal Nature Reserve

Clearing within the watercourse is minor, localised, will not result in appreciable land degradation and will not significantly impact upon the water quality or any other environmental areas.

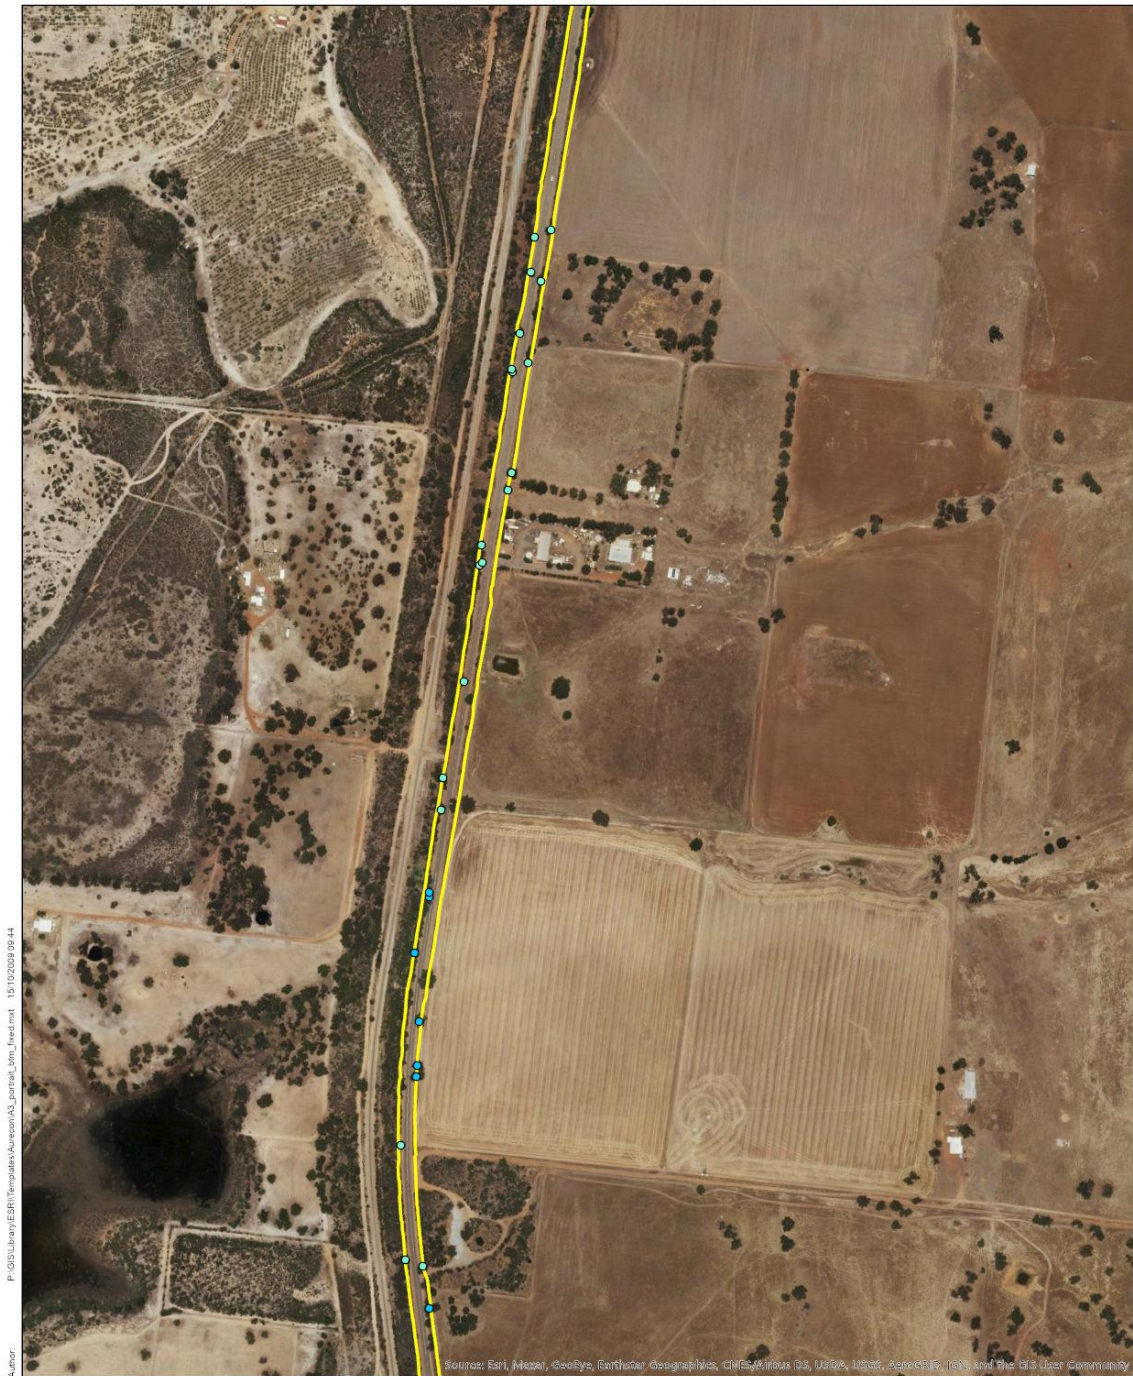
**M002 Bindoon-Moora Upgrade Project**  
**Figure 6a: Black Cockatoo Potential Breeding Trees**

- The black cockatoo habitat assessment identified a total of 78 trees with a diameter at breast height (DBH) of >50 cm (>30 cm for wandoo) within the 9.4 ha survey area. The majority of these trees were not observed to contain hollows of any size;

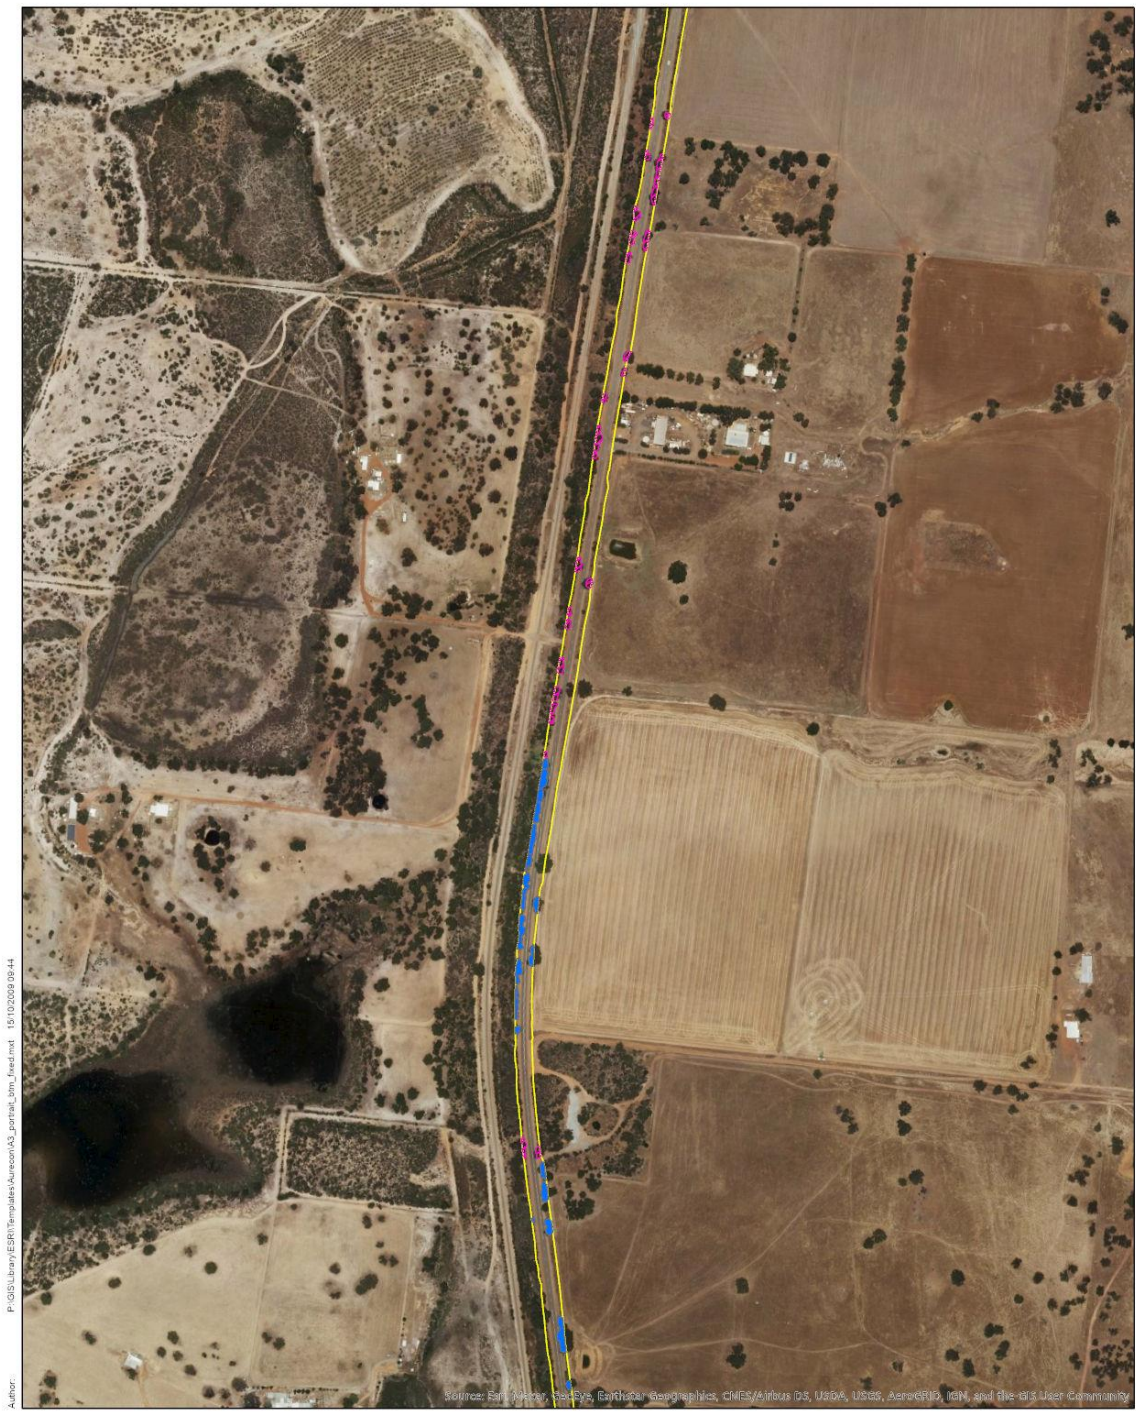
**M002 Bindoon-Moora Upgrade Project**  
**Figure 7a: Black Cockatoo Potential Foraging Habitat**

Foraging evidence was observed only within the small occurrences (0.3 ha) of marri and were attributed to Forest Red-tailed Black Cockatoo (Harewood, 2018). No foraging evidence was recorded by Western Ecological (2021).
