Albany Ring Road Stages 2 and 3b, WA (EPBC 2020/8769)

**Conservation Significant Fauna
Environmental Management Plan**

Main Roads

16 November 2021

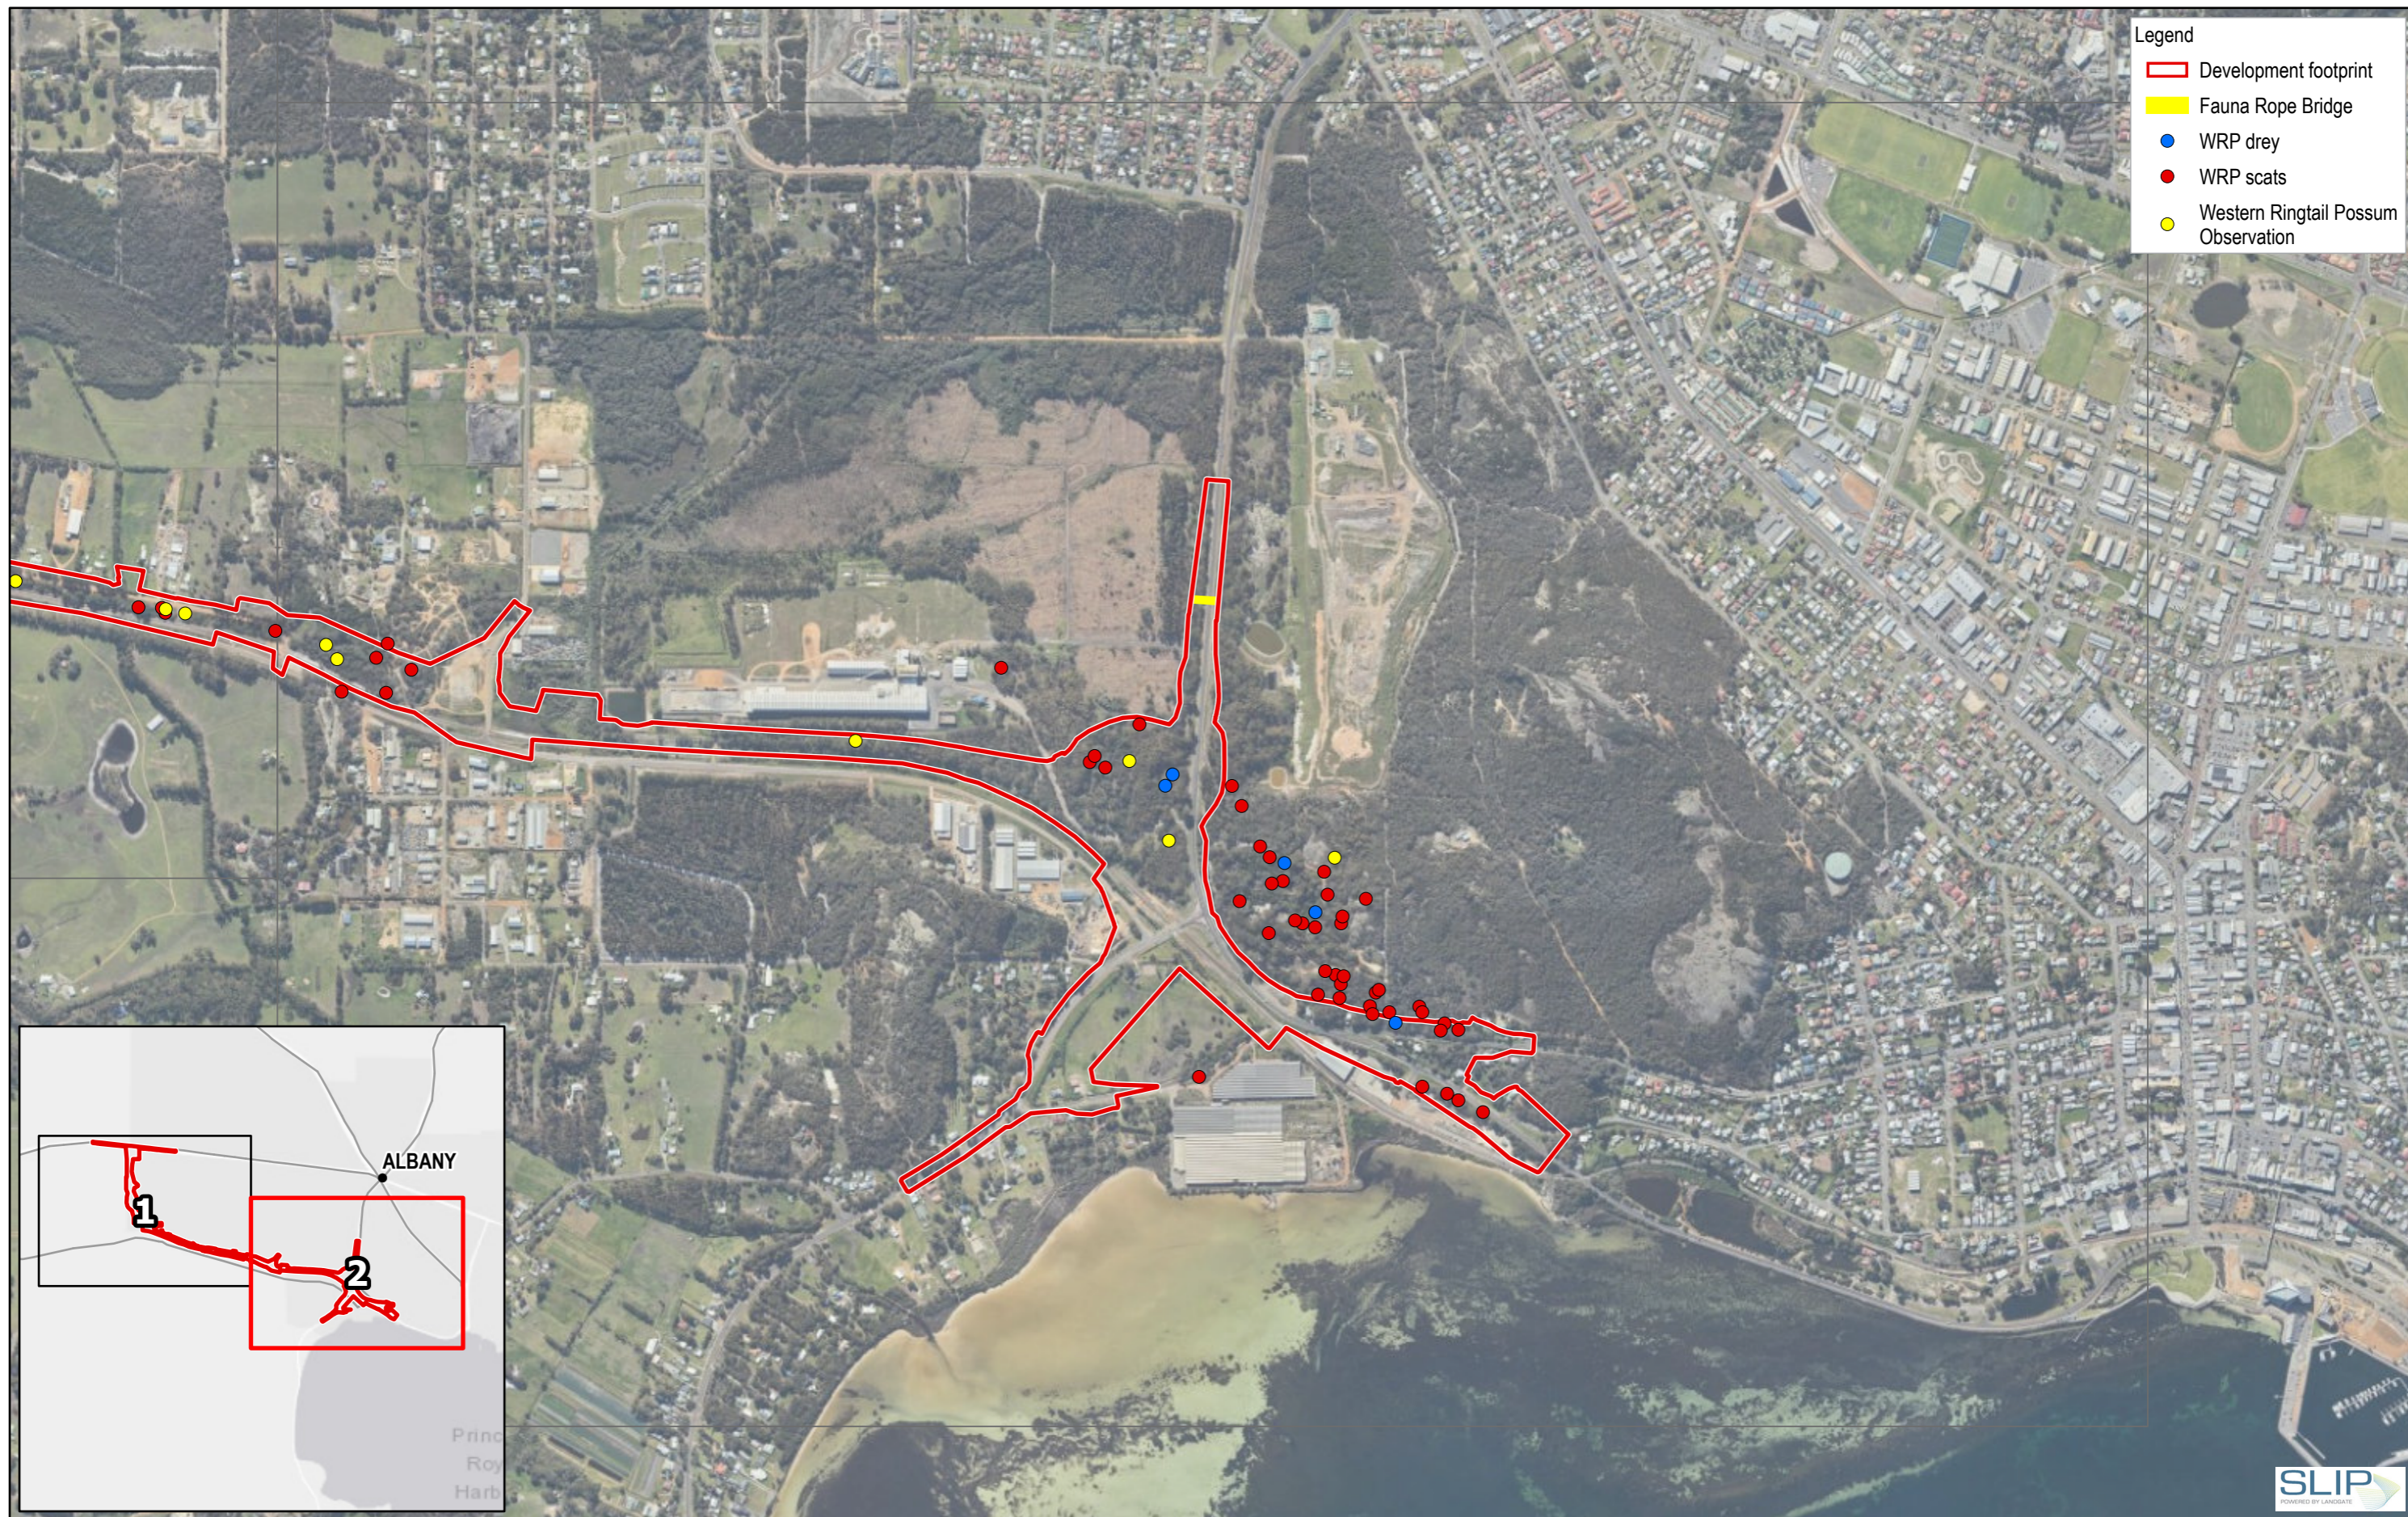
- Legend**
- ▭ Development footprint
 - ▭ Fauna Rope Bridge
 - WRP drey
 - WRP scats
 - Western Ringtail Possum Observation

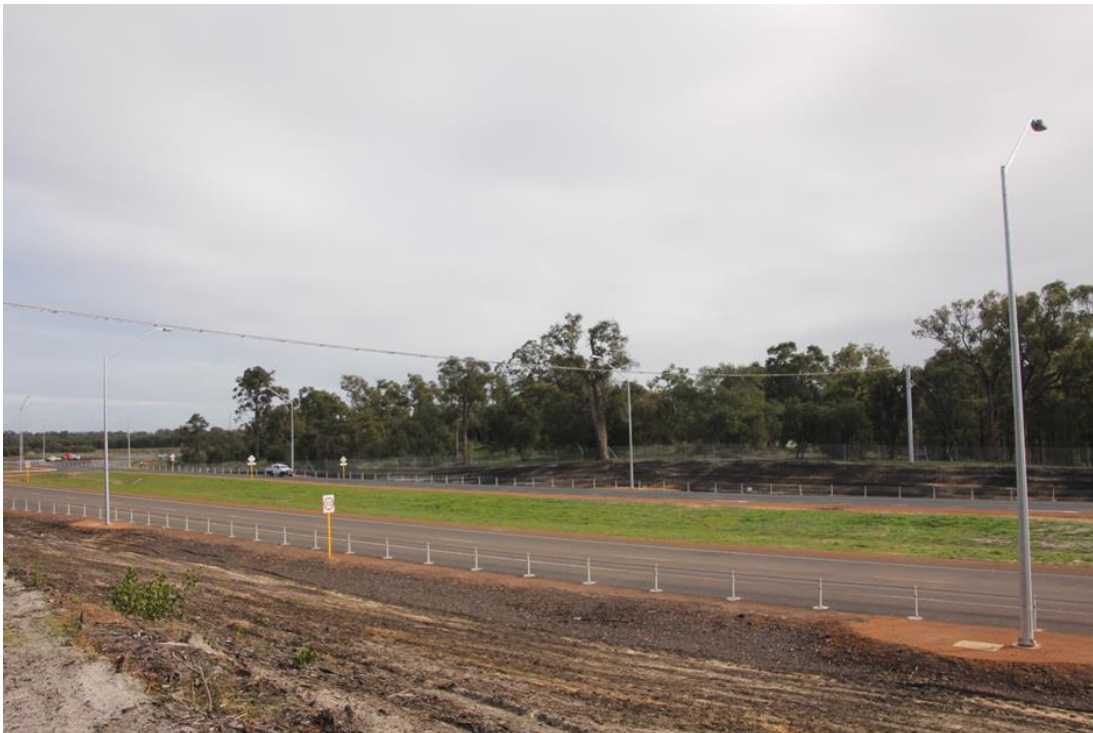
Plate 1 *Rope bridge layout and components*

There is no standard design for a rope bridge, however, the design will be consistent with other successful rope bridges constructed in the southwest. The rope bridge will consist of a canopy bridge, which is a rope netting suspended above the traffic from vertical poles, to provide connectivity (see Plate 1 and Plate 2). The rope bridge for the Proposed Action will be much shorter than that shown Plate 1, as the bridge will be located over a single carriageway. Evidence has been obtained of use of these structures following construction, as shown in Plate 2.

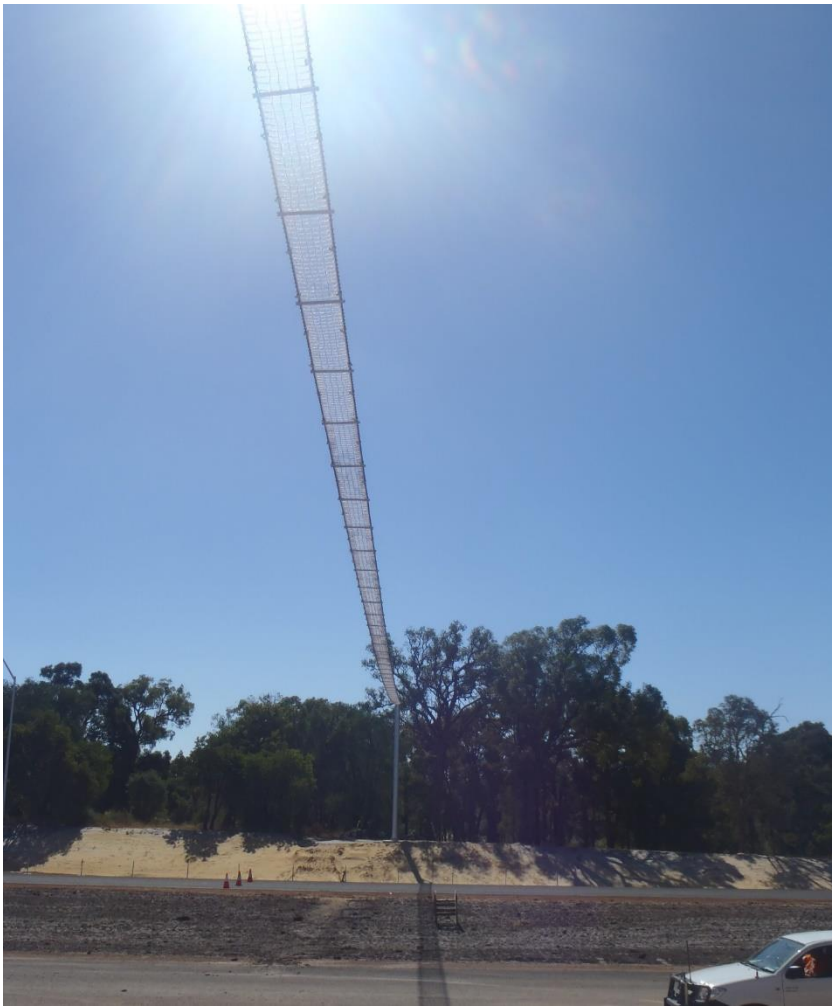
Plate 3 **Rope bridge layout**

- Rope bridge constructed to resemble a ladder (Plate 3)
 - The Rope length between poles will be approximately 26 m in length
 - Screw eyelets into the pole and attach rope and attach 12-14 gauge marine grade silver (high UV rating) rope and stainless steel cables and frames (for rope ladder)

- Appropriately tension canopy bridge
- Final heights, lengths and tie off locations will be decided by a WRP specialist onsite following the final design of the road
