# Bunbury Outer Ring Road

## Southern Section

Ministerial Statement 1191

Compliance Assessment Report

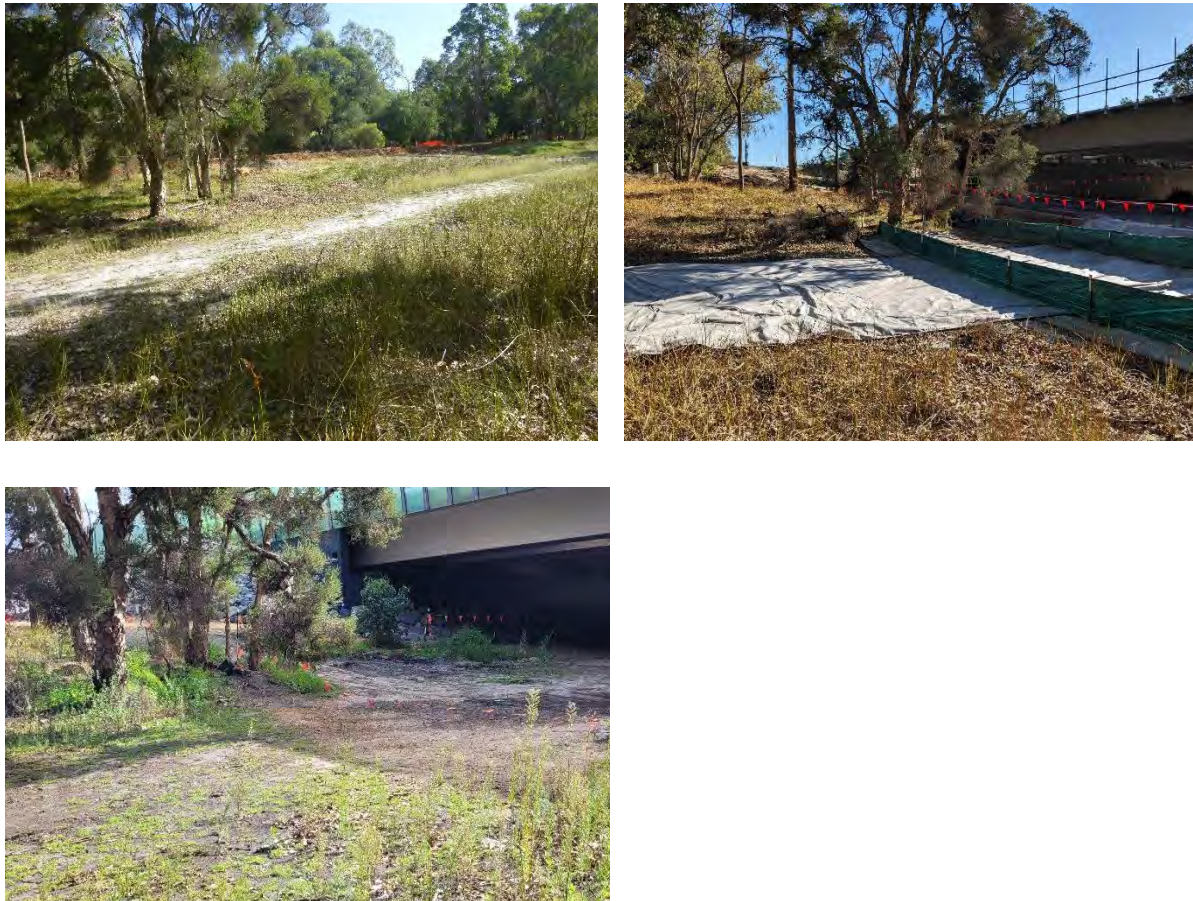
Changes to habitat due to ongoing construction activities were observed at upper Five Mile Brook (BSM-S-PI-1 and BSM-S-PI-2) during the survey period. Works at BSM-S-PI-1 included the installation of a temporary access in the immediate receiving area downstream of the sampling location (Plate 2) and the construction of a bridge structure, with additional erosion control measures including sediment fences and geo-fabric to protect BSM habitat. By the end of Q2 monitoring in 2025, all construction works impacting the habitat of BSM-S-PI-1 are expected to be completed.

**Plate 2. Differences in sampling habitat and the development of construction at BSM-S-PI-1. Top Left: BSM-S-PI-1 in Q2 2023. Top Right: BSM-S-PI-1 in Q2 2024. Bottom Left: BSM-S-PI-1 in Q2 2025.**

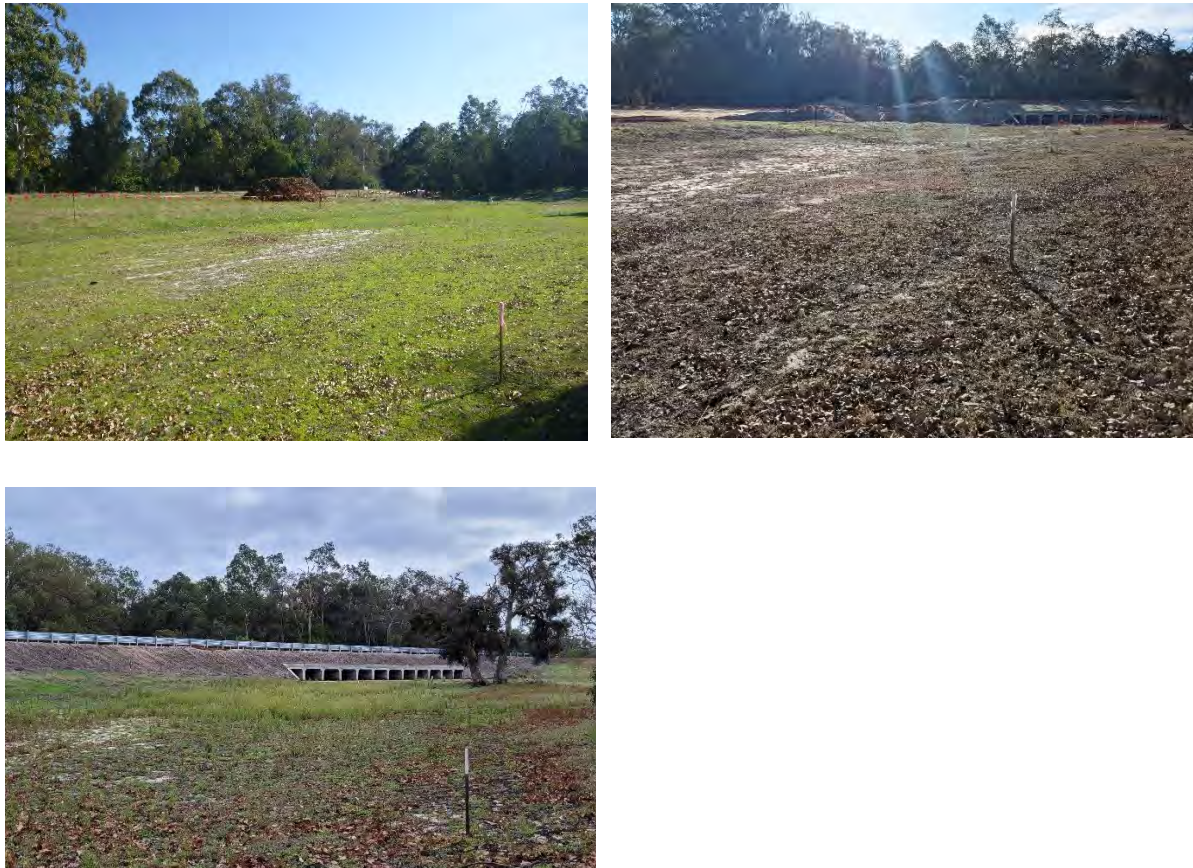
The installation of large box-culverts downstream of the BSM-S-PI-2 was also observed during this sampling period. Clearing works commenced directly after Q2 monitoring in 2023, with the completed installation of the culverts in Q2 2024 (Plate 3). With this in mind, there are not expected to be any further impacts on habitat at BSM-S-PI-2 as part of construction activities for the BORR.

**Plate 3. Ongoing construction works at BSM-S-PI-2 from photopoint monitoring locations. Top Left: BSM-S-PI-2 during Q2 monitoring 2023. Top Right: BSM-S-PI-2 in Q2 2024. Bottom Left: BSM-S-PI-2 in Q2 2025.**

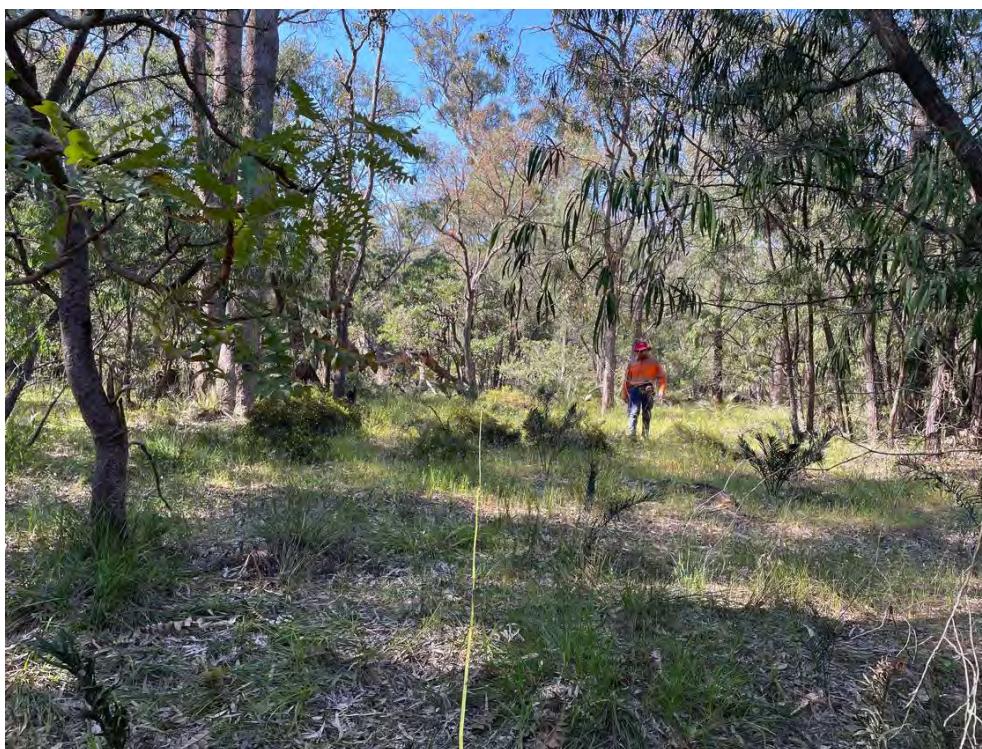
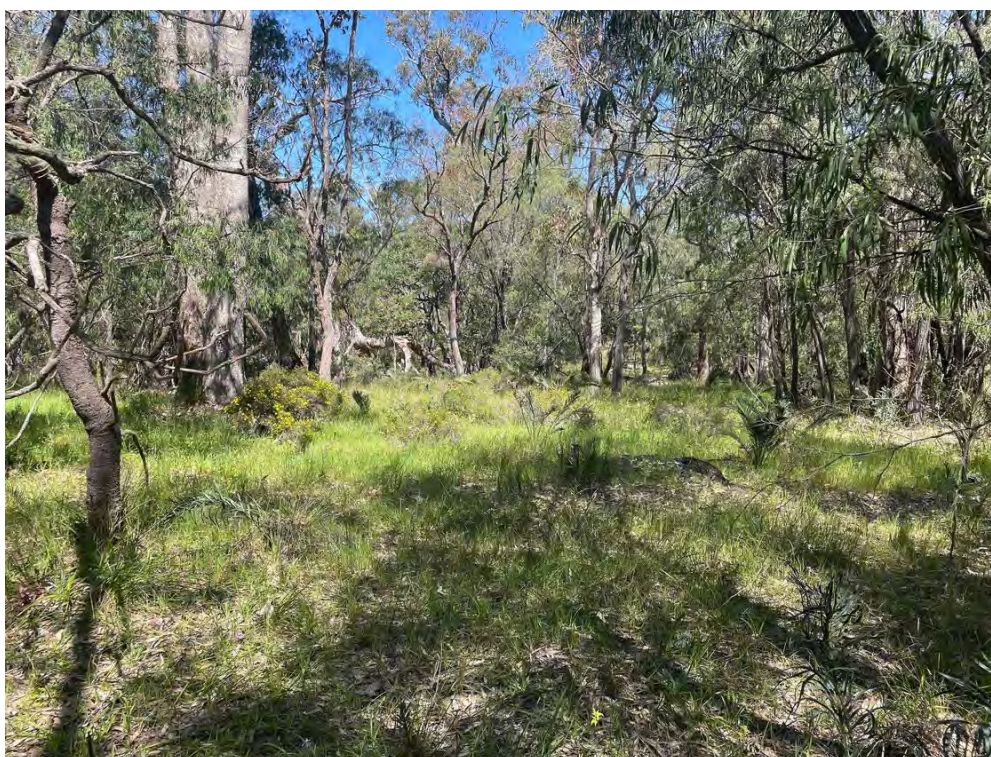
Plate 1. Increase in weed cover from spring 2022 to spring 2024, for BTW-S-R-2.

There was an increase in the average weed cover at three banksia woodland monitoring potential impact sites since construction commenced in 2022 (**Figure 13**). These increases occurred at BW-S-PI-1, BW-S-PI-4, BW-S-PI-5 and were generally of a similar magnitude to one reference site, BTW-S-R-2 (**Figure 13**). Photographs of the increase in weed from spring 2022 to spring 2024 are shown in **Plate 1**. The increases in average cover at the monitoring sites reflect the increases in weed cover at individual monitoring points within these sites, as shown in **Table 17**. All of these increases relate to the presence of invasive grasses already present at the site. In respect of the other sites, BW-S-PI-3 remained steady with regards to weeds, and BW-S-PI-8 experienced a decrease in weeds. No increases were recorded for two of the three reference sites (BW-S-R-1 and BTW-S-R-1) as these sites were largely weed-free.

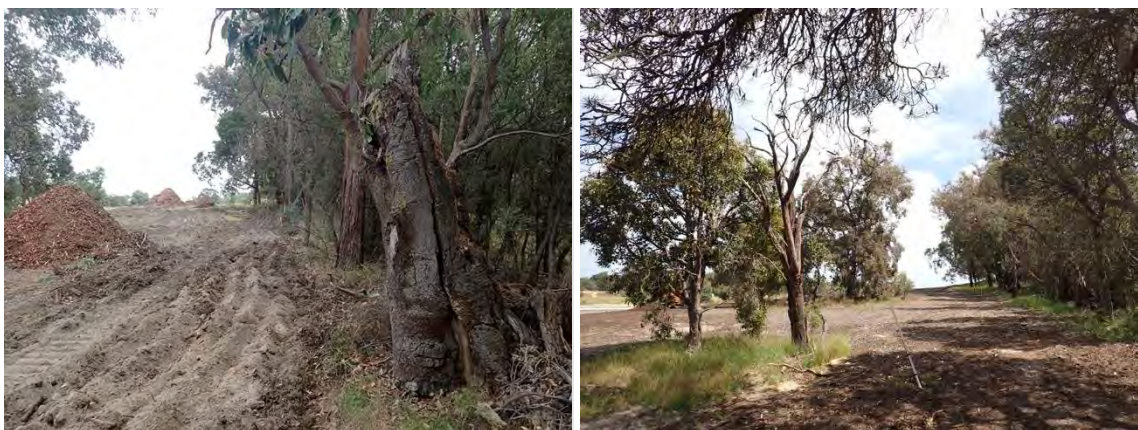
Plate 2. Cleared areas adjacent to TW-S-PI-2 are relatively free of weeds in autumn 2024 and spring 2024

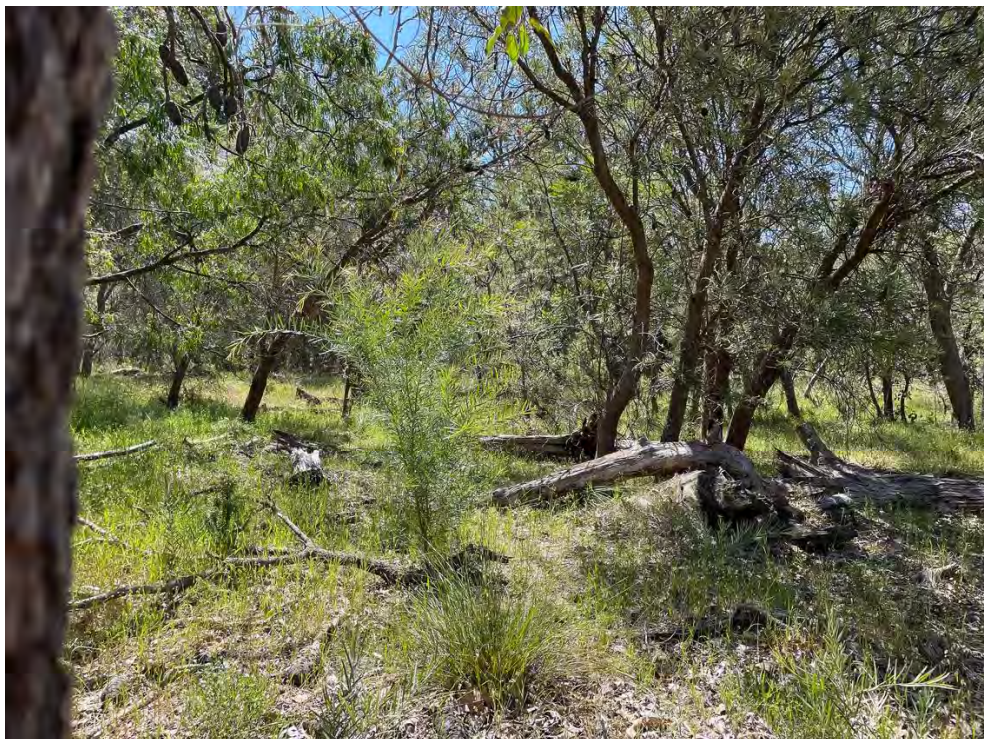
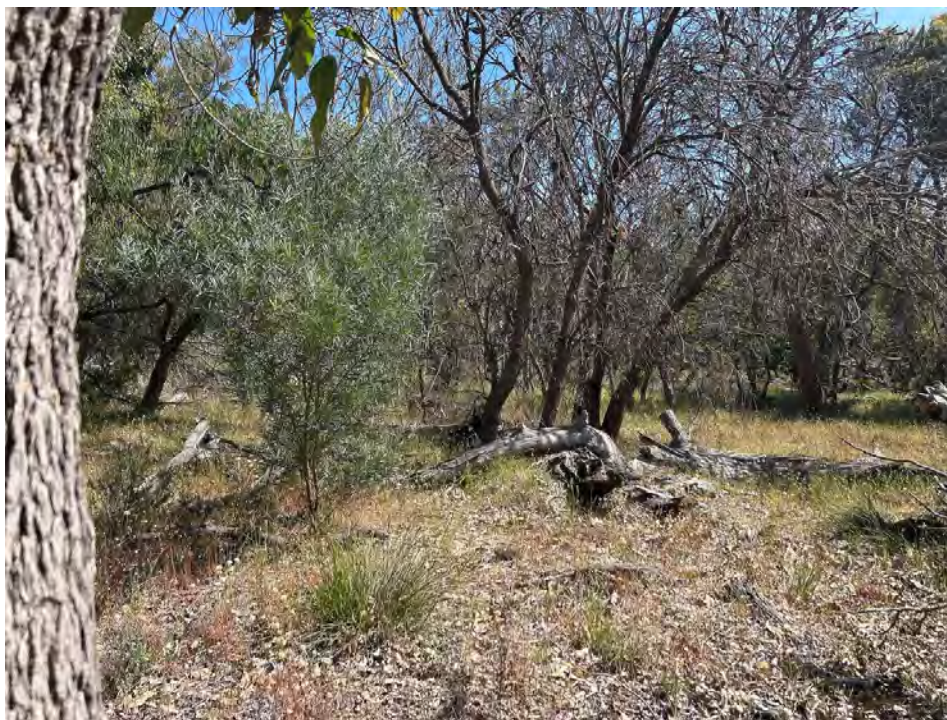
Plate 3. BW-S-PI-1\_P03 plant stress in spring 2024 compared to spring 2022.

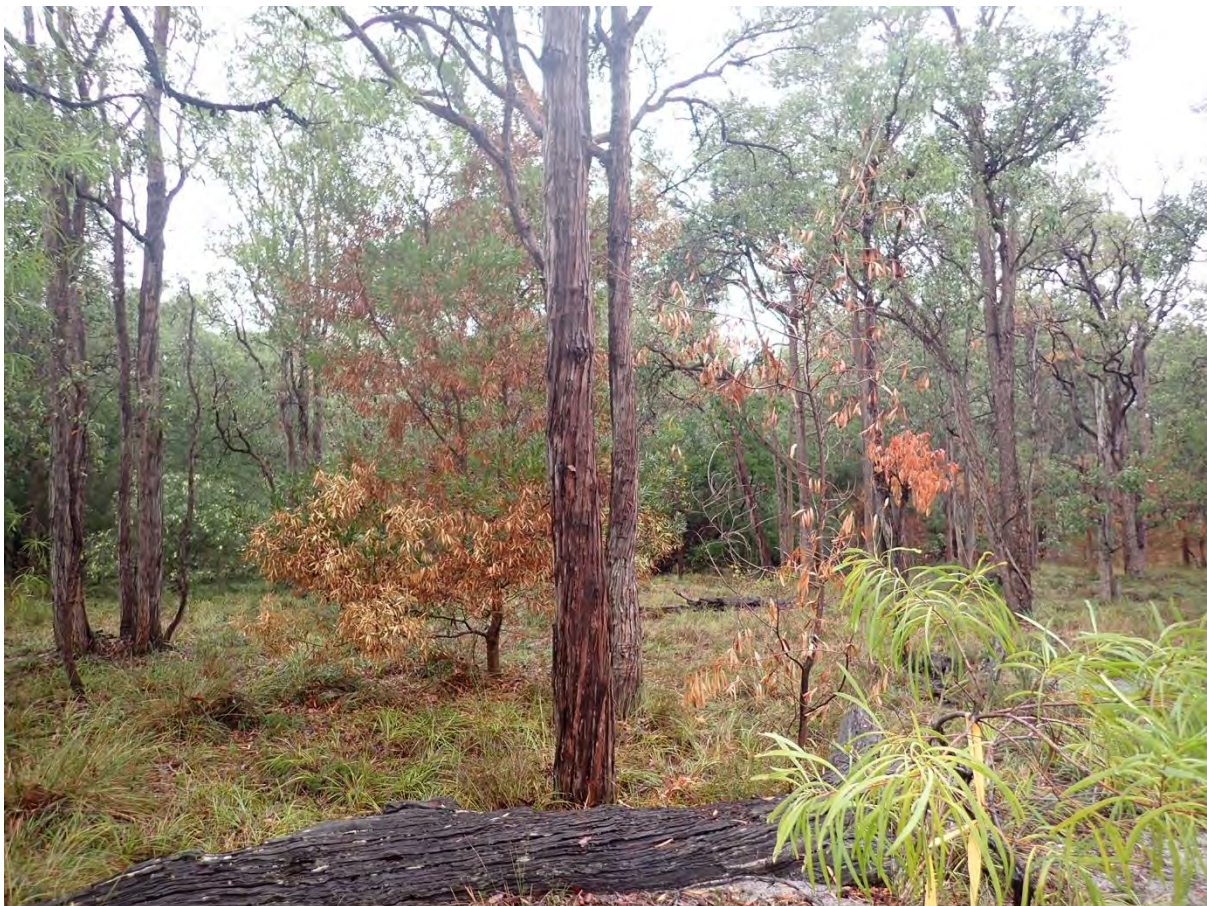
Plate 4. Dead *Acacia longifolia* trees within BW-S-PI-4.

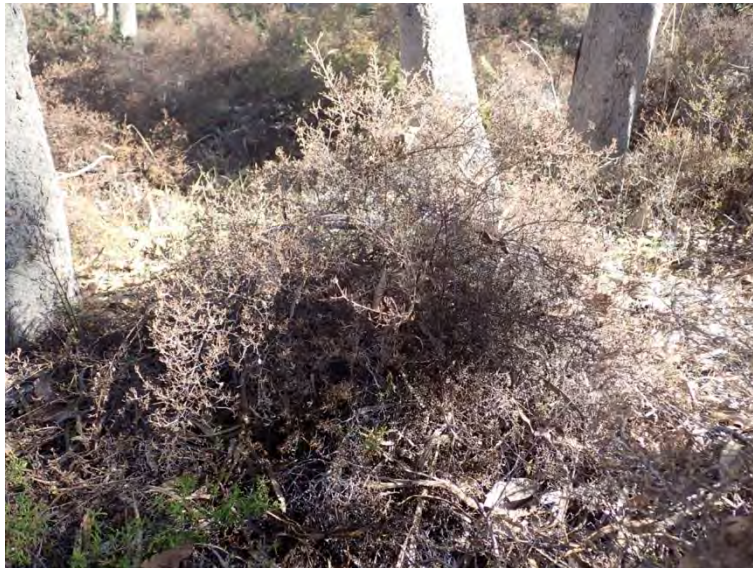
Plate 5. Drought affected *Hibbertia hypericoides* located near BW-S-PI-5\_P23, autumn 2024.

scattered, or patchy impacts across most of the site (**Plate 5** and **Plate 6**). It is just that the scattered nature of impacts and monitoring of large shrubs and trees meant that only two sites, BW-S-PI-5\_P34 and BW-S-PI-5\_TN1 recorded stress impact due to the 2024 autumn drought. The impact observed at the monitoring points and across the broader site was limited mainly to certain species, such as *Banksia grandis*, *Banksia attenuata*, *Eucalyptus marginata* (mostly saplings), the small shrub *Hibbertia hypericoides* and the forb *Caesia micrantha*.

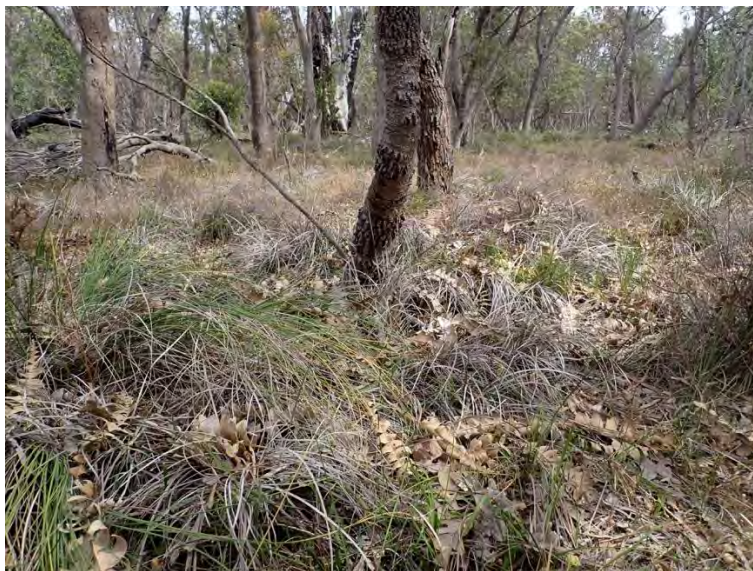
Plate 6. Drought affected *Phlebocarya ciliata* located near BW-S-PI-5\_P33, autumn 2025

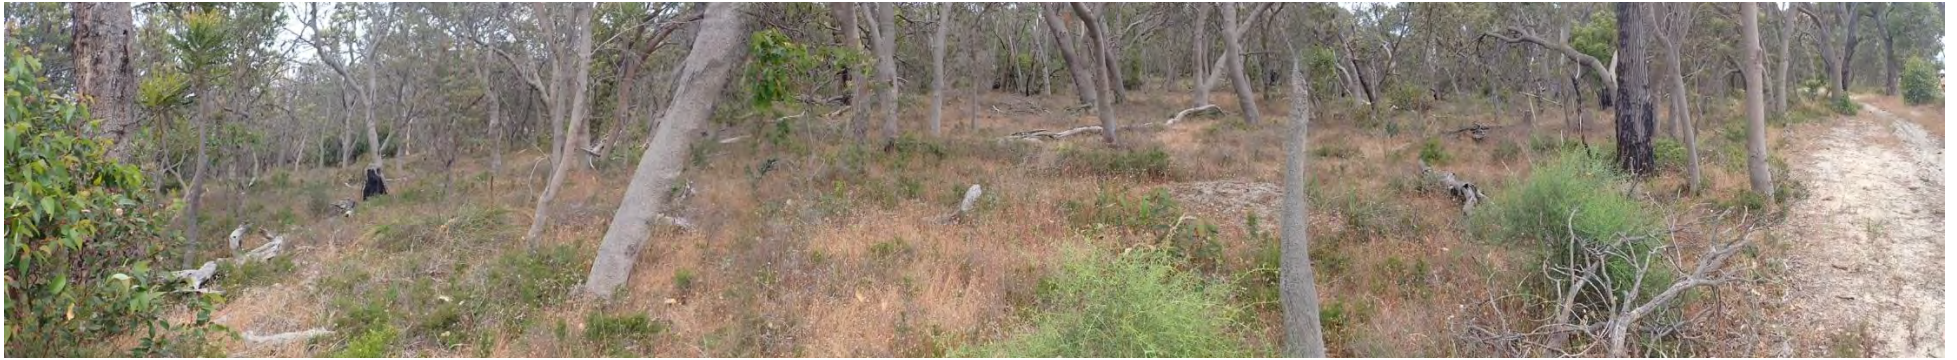
Plate 7. The grey shrubs in the understorey are stressed *Hibbertia hypericoides* near BW-S-PI-5\_P16, autumn 2025

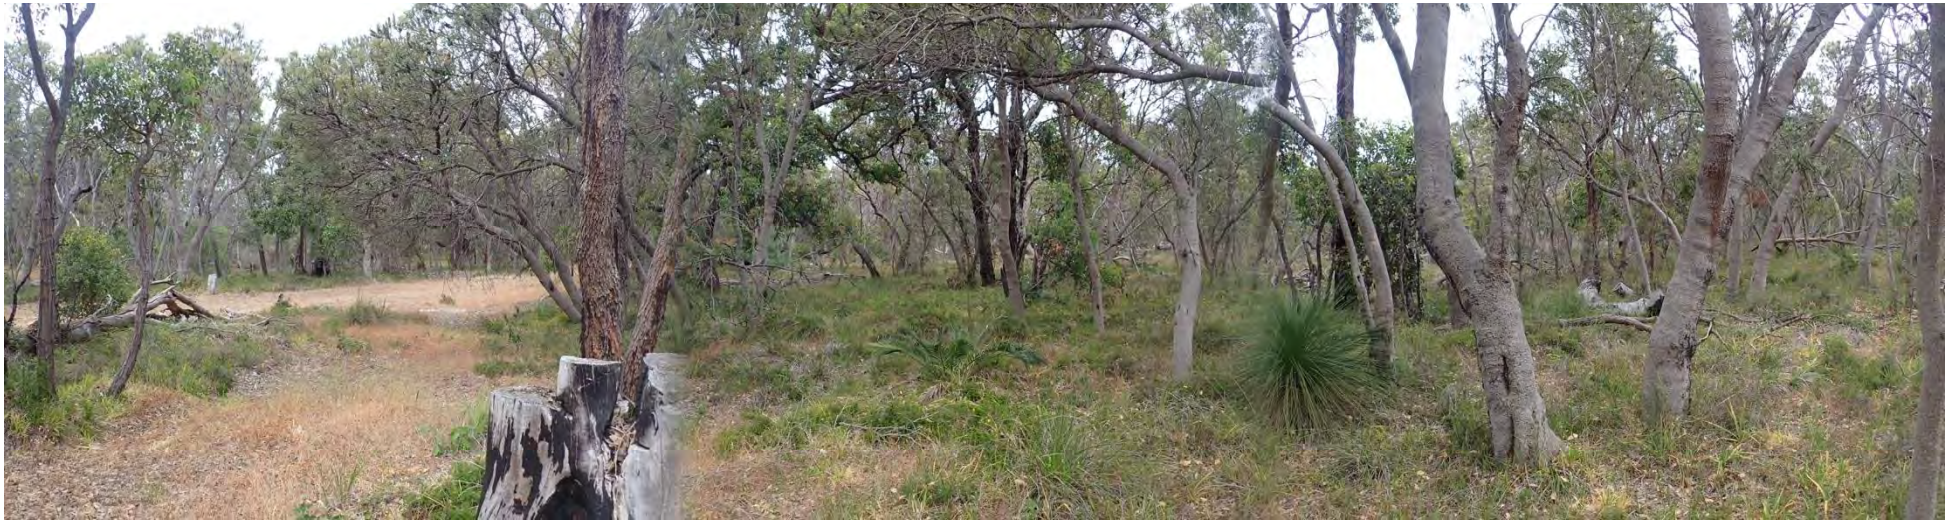
Plate 8. Shows an essentially healthy understorey including *Hibbertia hypericoides* near BW-S-PI-5\_P25 autumn 2025.

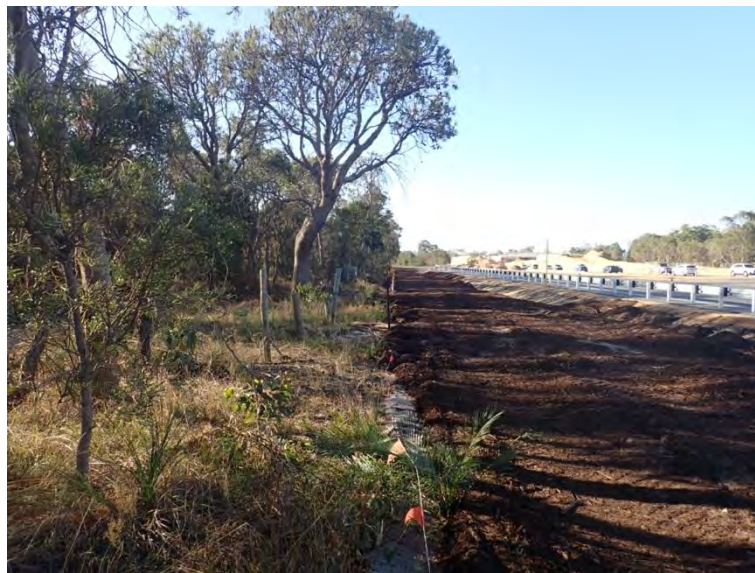
Plate 9. Healthy, unstressed vegetation adjacent to the cleared edge along Bussell Highway east of BW-S-PI-5\_P014, autumn 24.

It was also clear that the BORR was not an obvious cause of the manifested stress observed across the site, as much of the vegetation directly adjacent to the BORR was observed to be in a generally healthy condition.

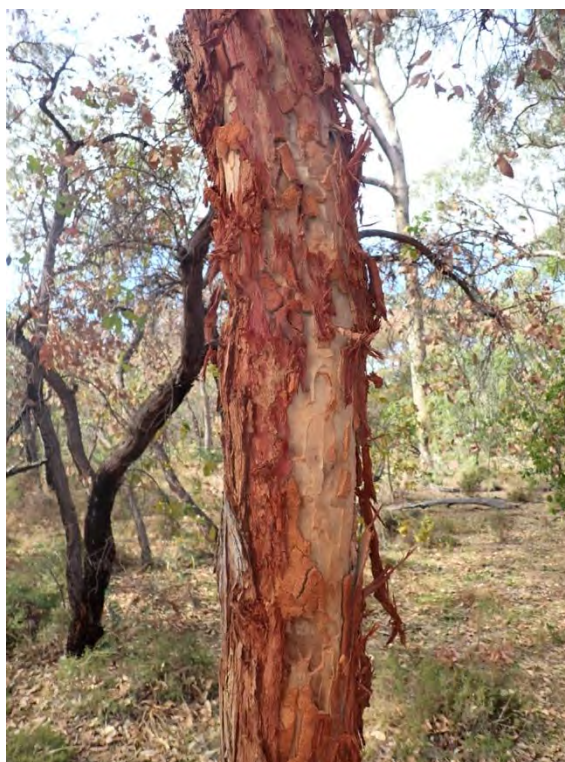
Plate 10. Highly stressed Jarrah sapling tunnelled out by Jarrah wood borer, which has been predated by forest red-tail-cockatoos, autumn 2024.

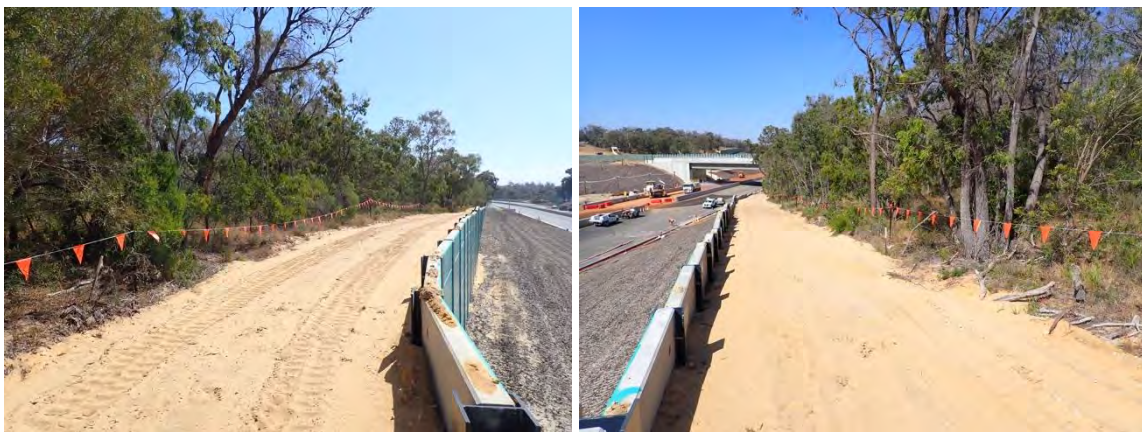
Plate 11. Healthy vegetation taken from north of BW-S-PI-8\_P07 showing generally healthy vegetation adjacent to the batter spring 2024

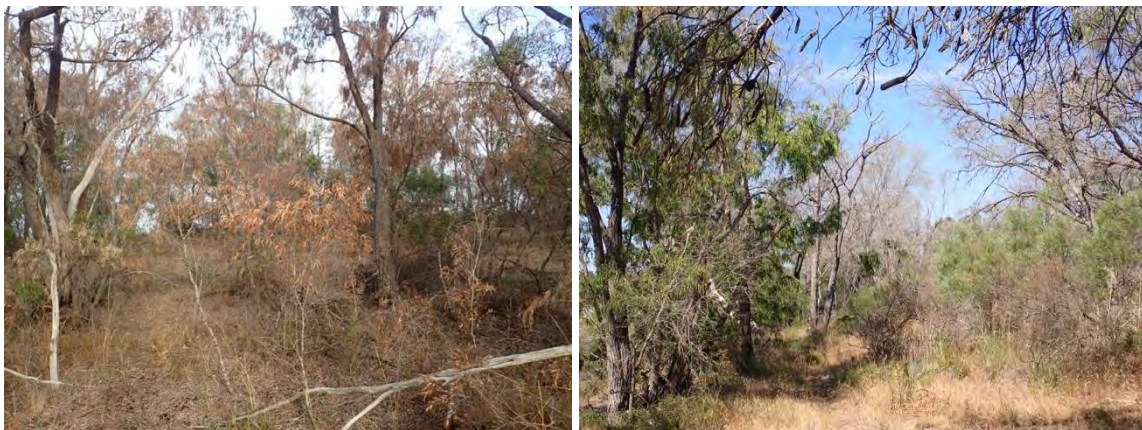
Plate 12. Stressed and dead *Agonis flexuosa* and *Banksia attenuata* near BW-S-PI-8\_P06 and P07 autumn 2024. Showing signs of recovery spring 2024.

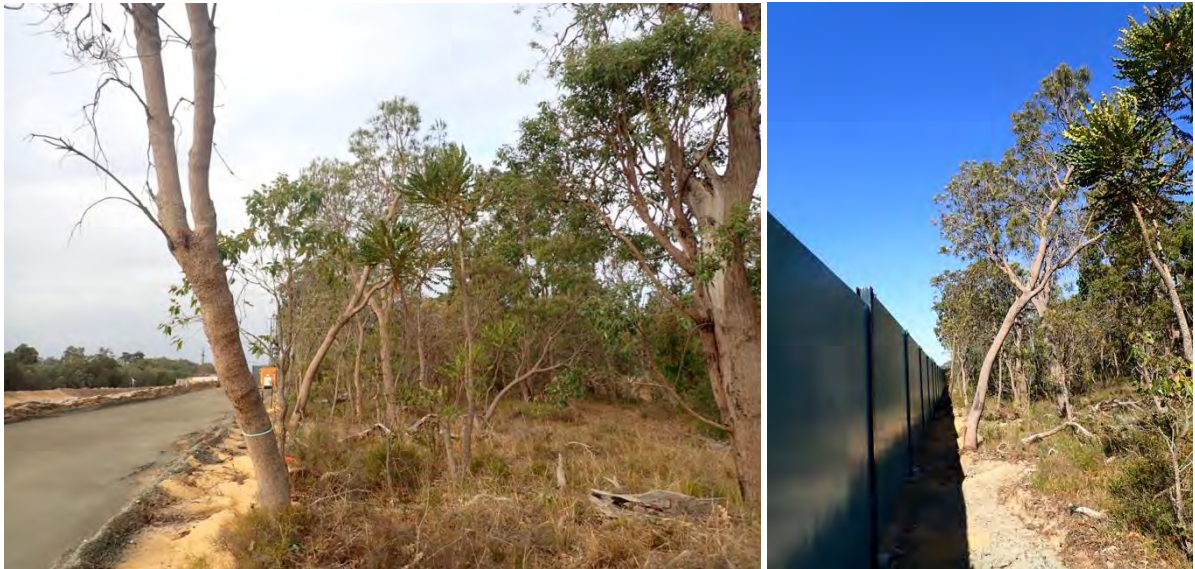
Plate 13. BW-S-PI-8\_P01 autumn 24 and spring 24. Note that the Banksia in the foreground had to be removed for the installation of the sound wall.

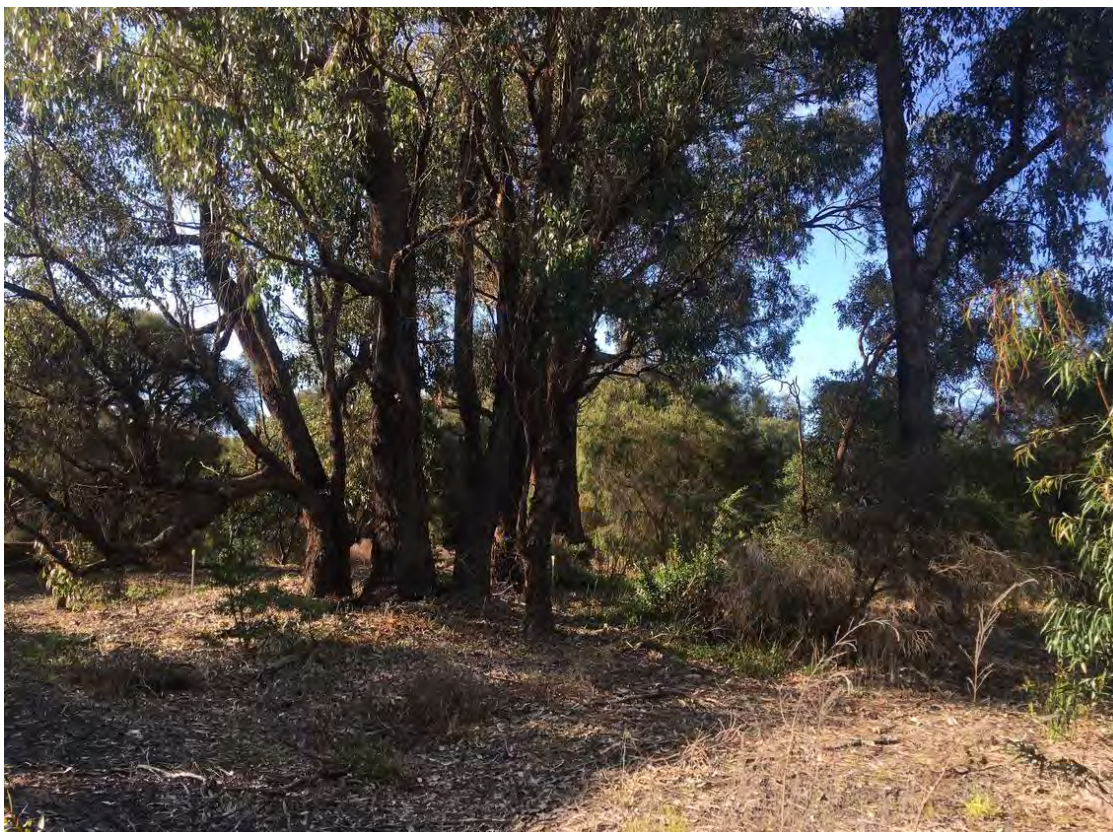
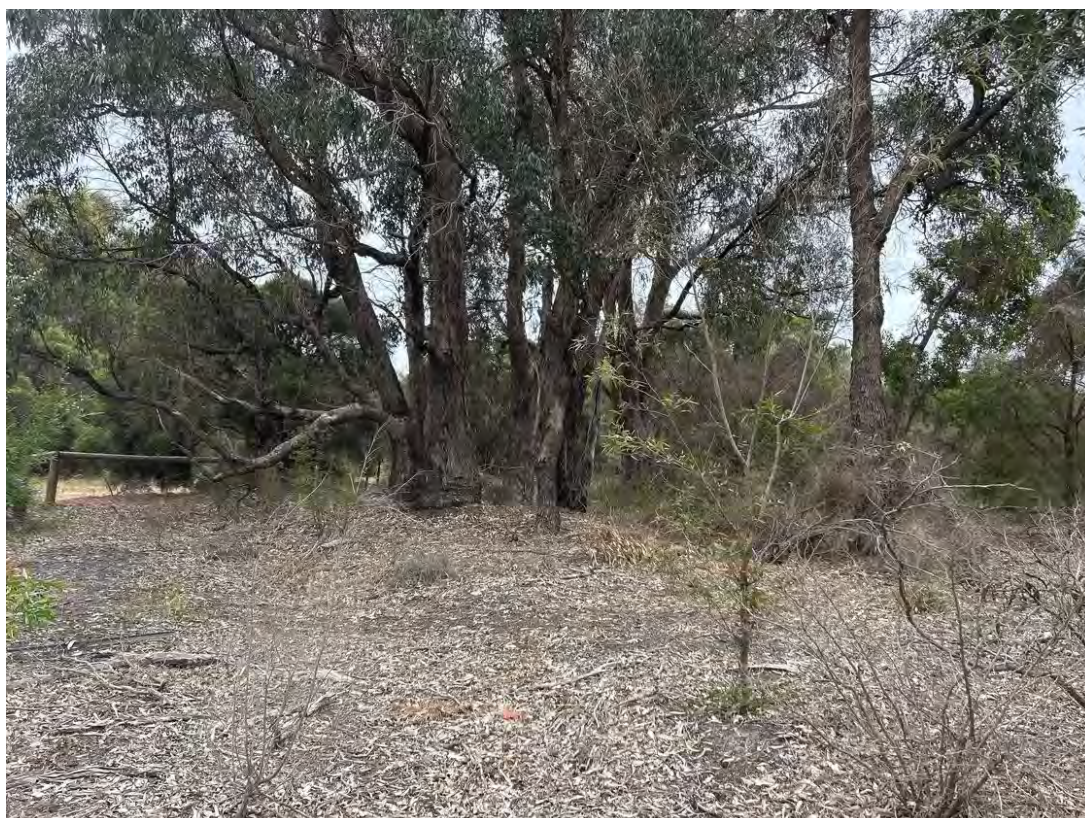
Plate 14. Comparison of stress at site TW-S-PI-3\_ P01, between spring 2022 and 2024.

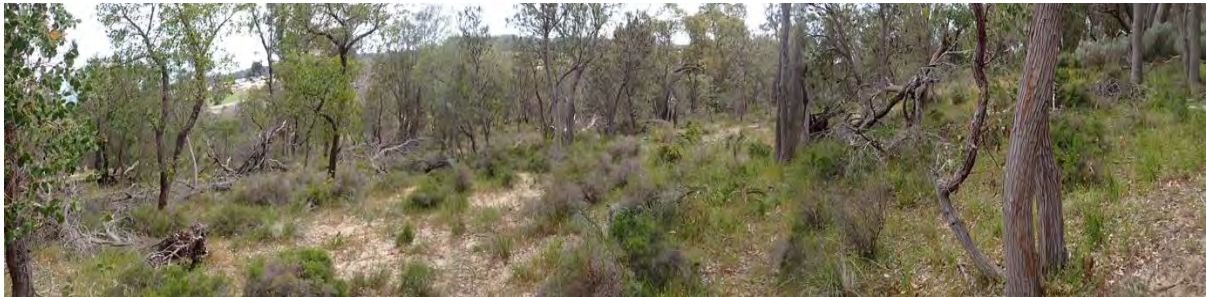
Plate 15. Patches of stressed vegetation looking north from TW-S-PI-2, the dead / stressed low shrub is *Hibbertia hypericoides*.

The widespread effects of the autumn 2024 drought are reported in the 2023 / 2024 report<sup>15</sup> were still evident across the site with patches of stressed and almost dead *Agonis flexuosa*, *Banksia attenuata*, *Banksia grandis*, *Xylomelum occidentale* and *Eucalyptus marginata* trees scattered across the site. Stress was also evident in the common small shrub *Hibbertia hypericoides*, and to a lesser extent *Styphelia racemulosa*, as shown in **Plate 15**.

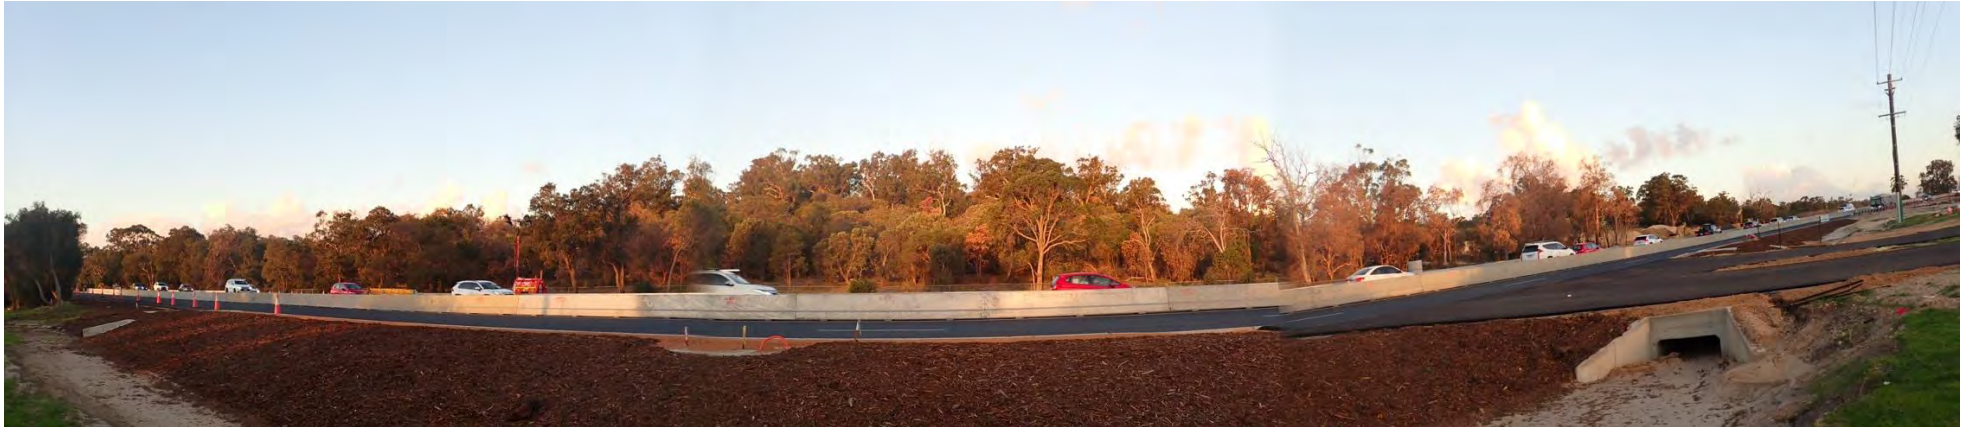
Plate 16. Panoramic view looking east towards TW-S-PI-2 showing patchy, stressed vegetation extending north well beyond the TW-S-PI-2 monitoring area, autumn 2024.

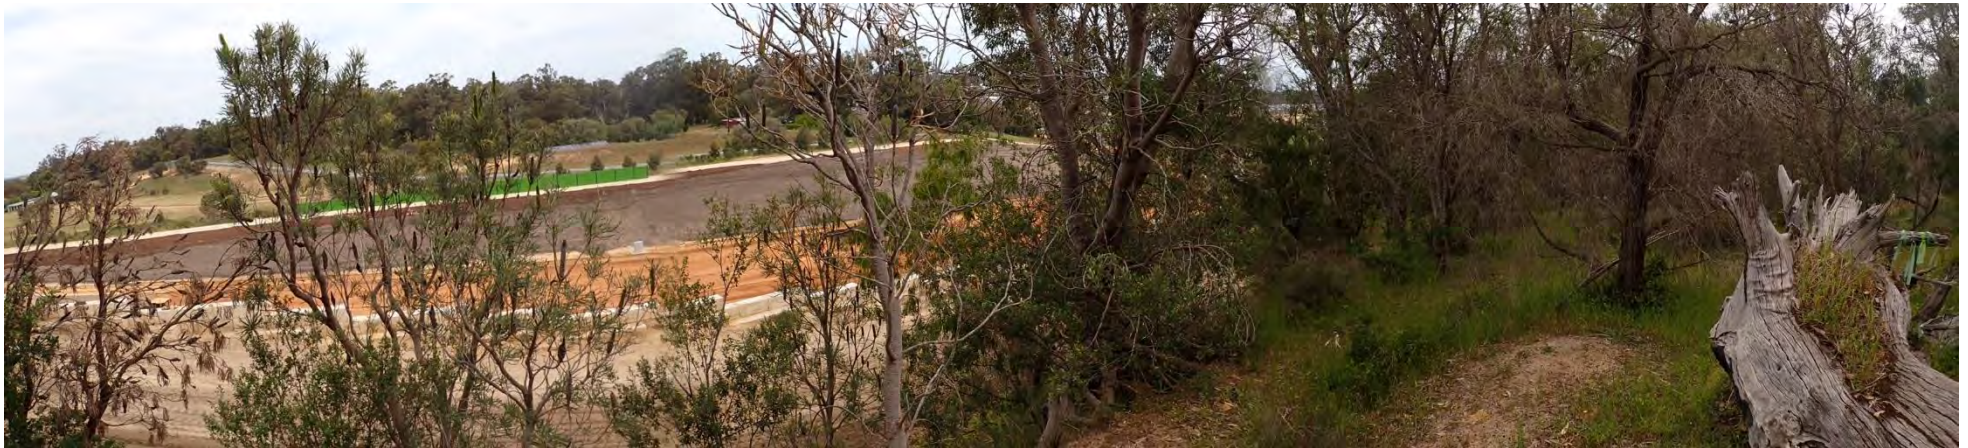
Plate 17. Panoramic view from near monitoring point TW-S-PI-2\_P04 showing healthy vegetation to the south on the old batter adjacent to BORR with stressed vegetation to the north, further from the BORR, spring 2024.

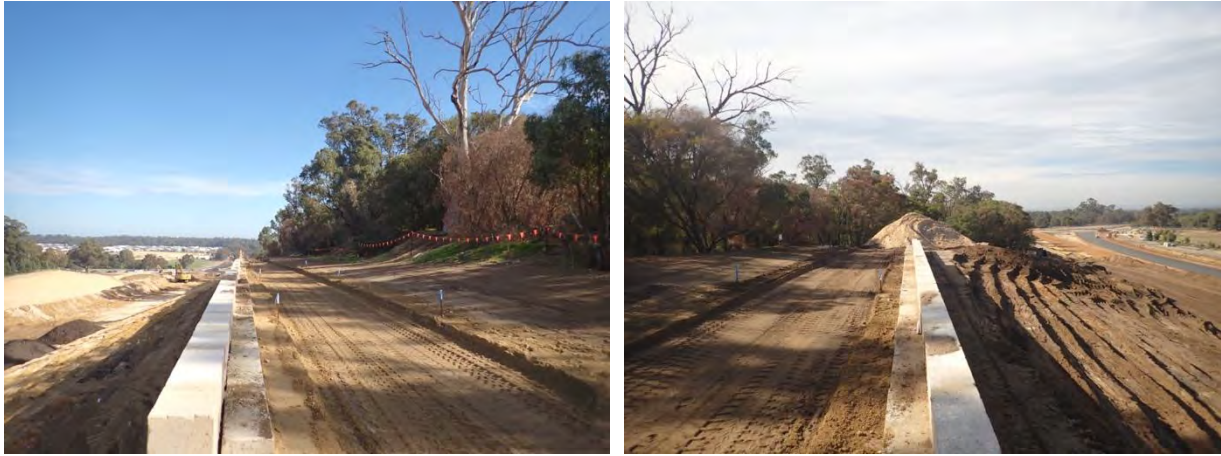
Plate 18. Location of steep cutting adjacent to TW-S-PI-2\_P07.

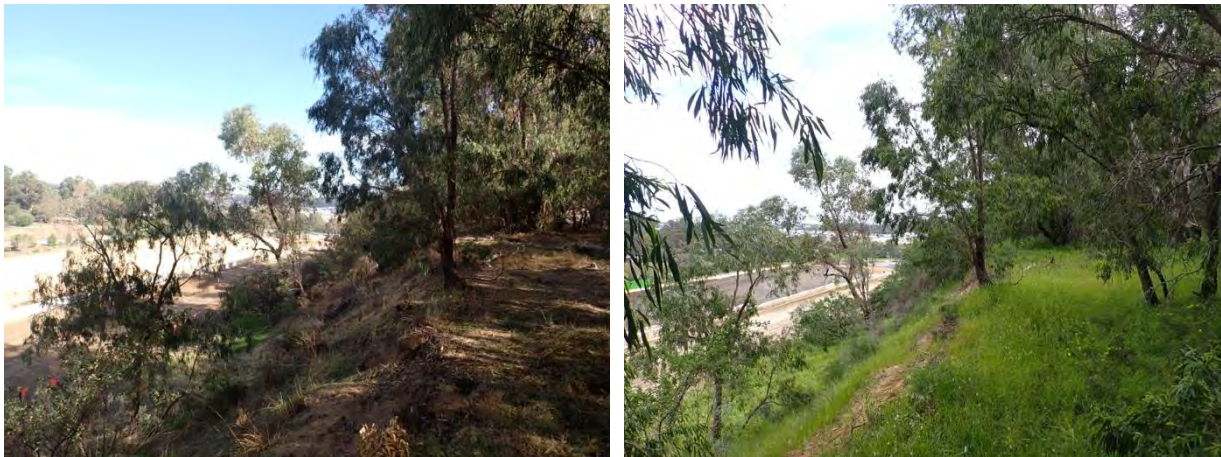
Plate 19. Relatively unstressed vegetation adjacent to TW-S-PI-2\_P07 autumn 2024 and spring 2024.

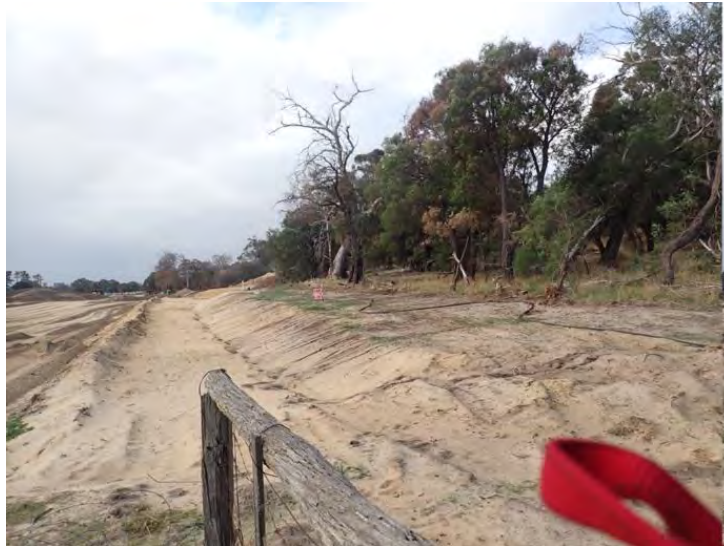
Plate 20. Vegetation adjacent to works near TW-S-PI-3\_P01 autumn 2024

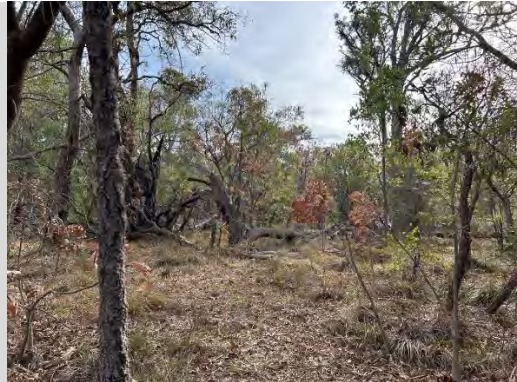
| # | Site | Site name | Affected species | General comments | latitude | longitude | Estimated level of impact. | Photo |
|---|---|---|---|---|---|---|---|---|
| 1 | BW-S-PI-1 | BW-S-PI-1_D1 (a24) | <i>Banksia grandis</i> ,<br><i>Banksia attenuata</i> | Regularly scattered <i>Banksia</i> death, approximately 50% dead of banksia species only | -33.38588156 | 115.6516445 | 2-10% | |

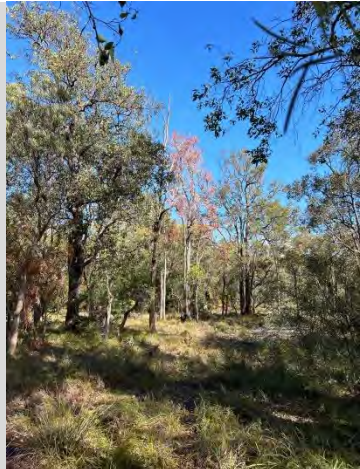
| # | Site | Site name | Affected species | General comments | latitude | longitude | Estimated level of impact. | Photo |
|---|---|---|---|---|---|---|---|---|
| 3 | BW-S-PI-4 | BW-S-PI-4_D1(w20) | <i>Eucalyptus marginata</i> | Wood borer and Bark stripping by cockatoos affecting some <i>E. marginata</i> | -33.42666702 | 115.639844 | 2-10% | |

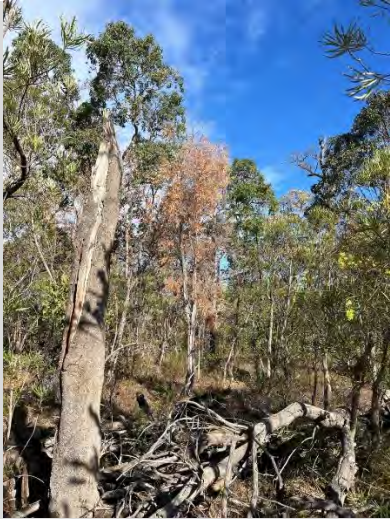
| # | Site | Site name | Affected species | General comments | latitude | longitude | Estimated level of impact. | Photo | |
|---|---|---|---|---|---|---|---|---|--|
| 5 | BW-S-PI-8 | BW-S-PI-8_D1 (su22) | <i>Agonis flexuosa</i> | Stressed <i>flexuosa</i> A. | -33.43058108 | 115.6277186 | 30-70% | | |

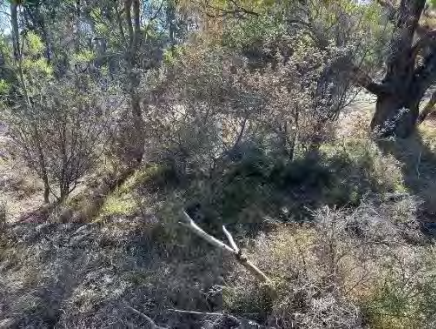
| # | Site | Site name | Affected species | General comments | latitude | longitude | Estimated level of impact. | Photo |
|---|---|---|---|---|---|---|---|---|
| 7 | TW-S-PI-2 | TW-S-PI-2_D1 (su 22) | Shrubs | Localise drying low shrubs – <i>Hibbertia hypericoides</i> , <i>Orthrosanthus laxus</i> and <i>Styphelia racemulosa</i> | -33.38544358 | 115.6461724 | 10-30% | |

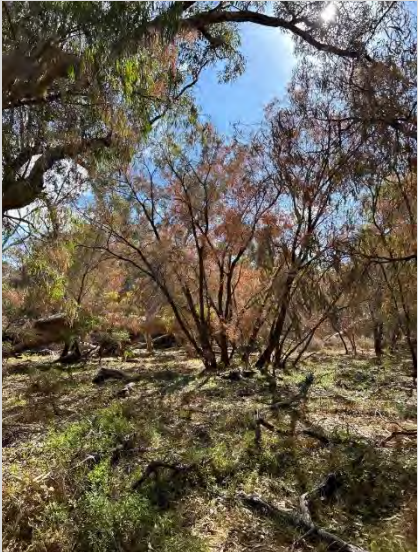
| # | Site | Site name | Affected species | General comments | latitude | longitude | Estimated level of impact. | Photo |
|---|---|---|---|---|---|---|---|---|
| | TW-S-PI-2 | TW-S-PI-2_D1 (a24) | <i>Agonis flexuosa</i> | Patches of dead <i>A. flexuosa</i> . Tuart alive | -33.38515578 | 115.6469832 | 10-30% | |

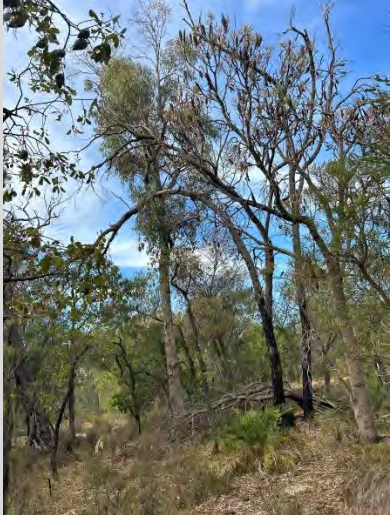
| # | Site | Site name | Affected species | General comments | latitude | longitude | Estimated level of impact. | Photo |
|---|---|---|---|---|---|---|---|---|
| 11 | BTW-S-R-1 | BTW-S-R-1_D1 (a24) | <i>Banksia attenuata</i> | Understory shrubs showing signs of drought stress | -33.38218656 | 115.6519813 | 2-10% | |

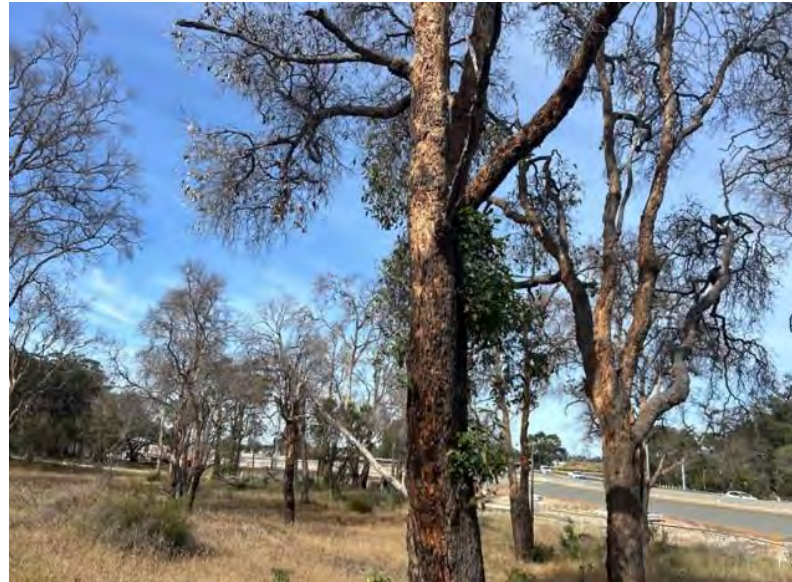
Epicormic growth in spring 2024.

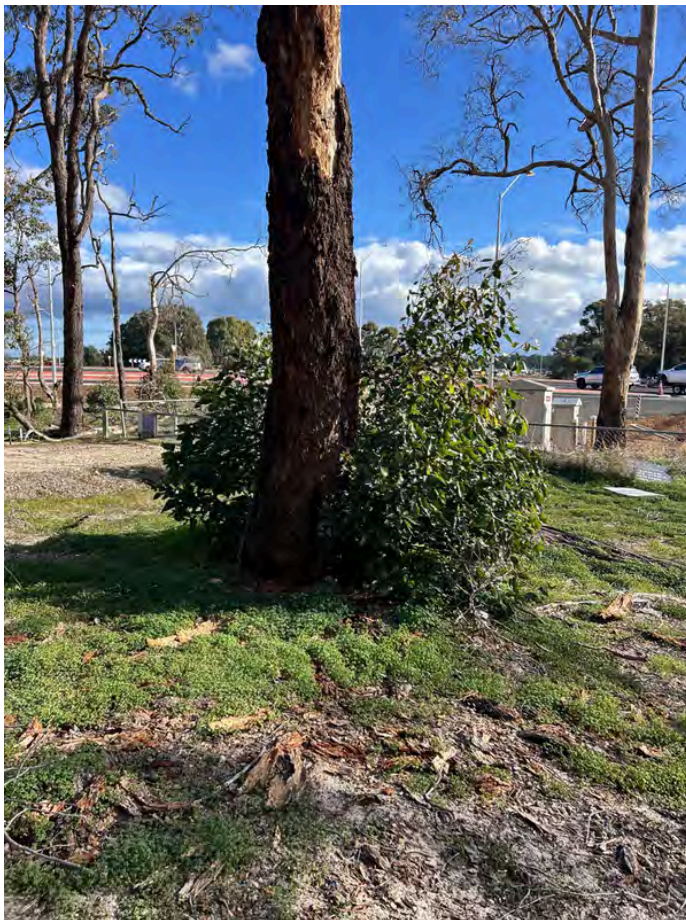
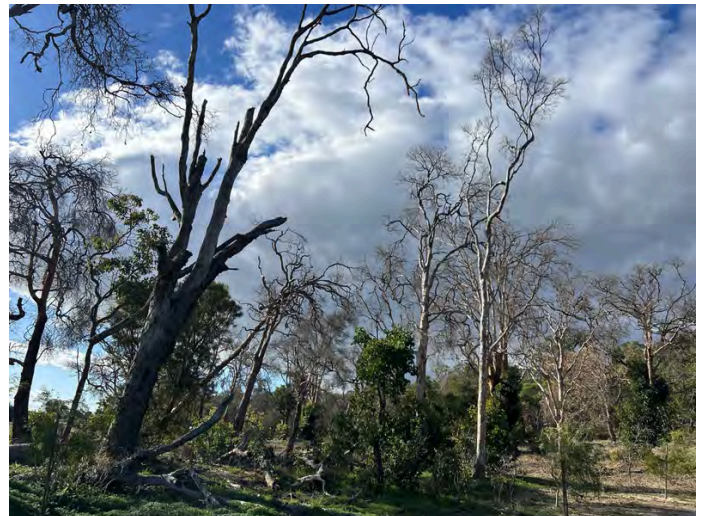
## TW-S-PI-2\_D1 (a24)

| General comments | Stable ( no worse) 24/25 su . same au 25. Epicormic growth |
