# Bunbury Outer Ring Road

## Southern Section

Ministerial Statement 1191

Compliance Assessment Report

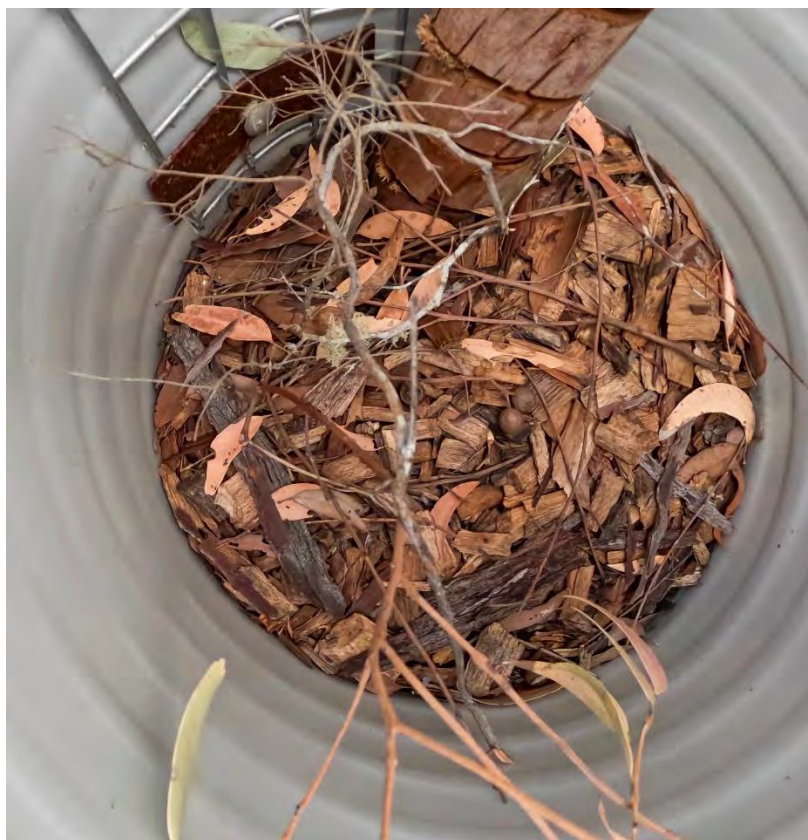
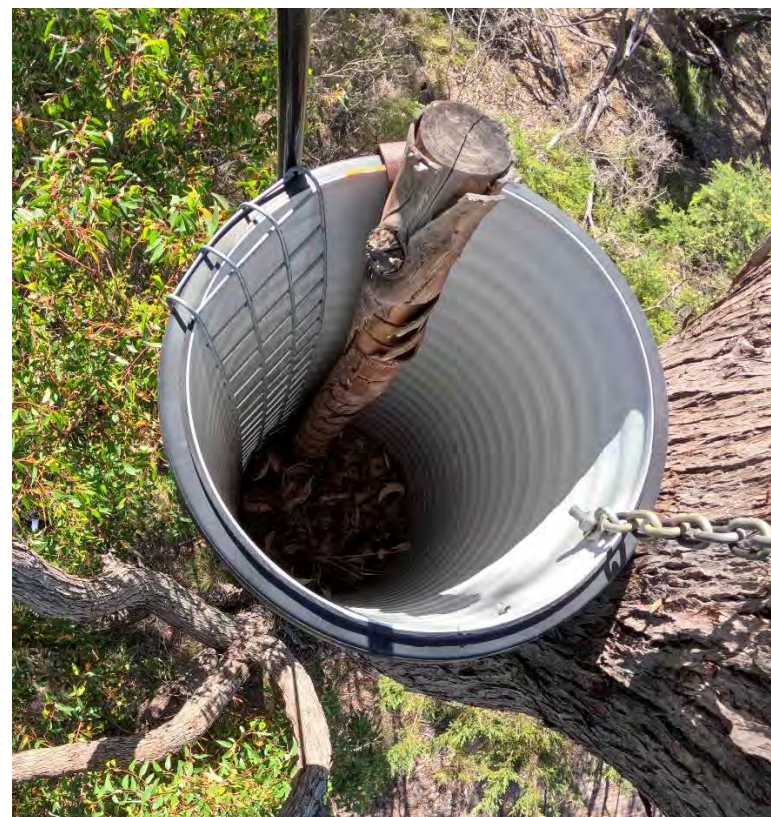
## Artificial Hollow D02

| Hollow No | Comments | Chipping score 0-10 | Wood Chips | Tree condition | Fixings and Hollow condition | Recommended repairs |
|---|---|---|---|---|---|---|
| D02 | No signs of nesting or inspection by Black Cockatoos | 0 | Nil | Good | Good | Nil |

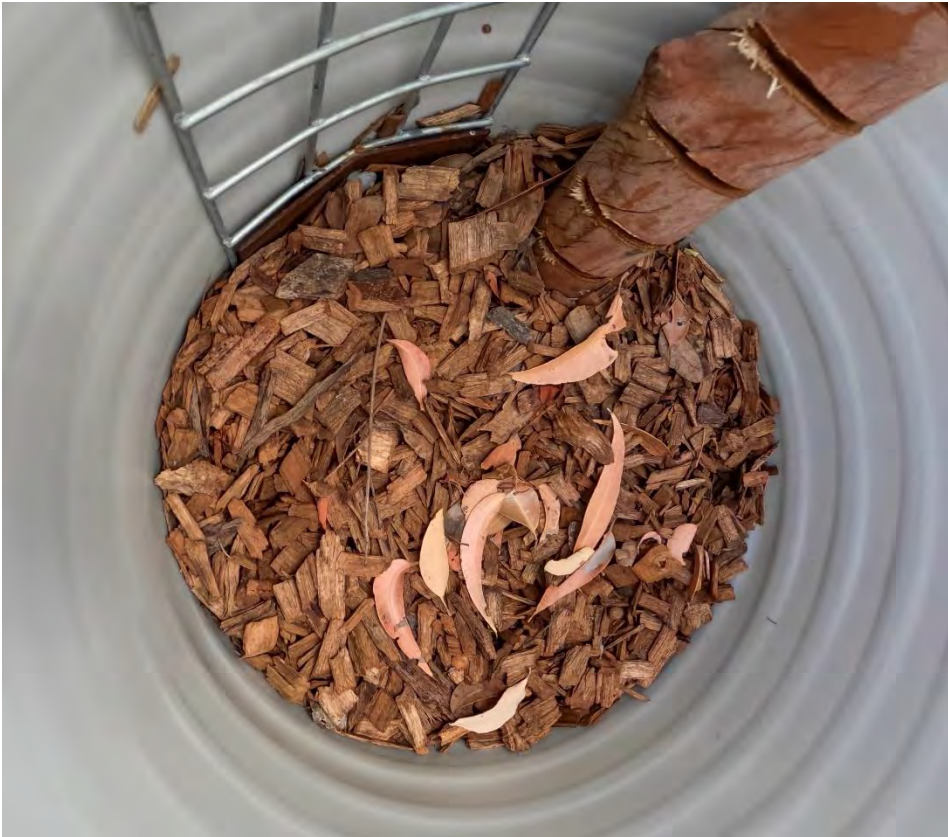
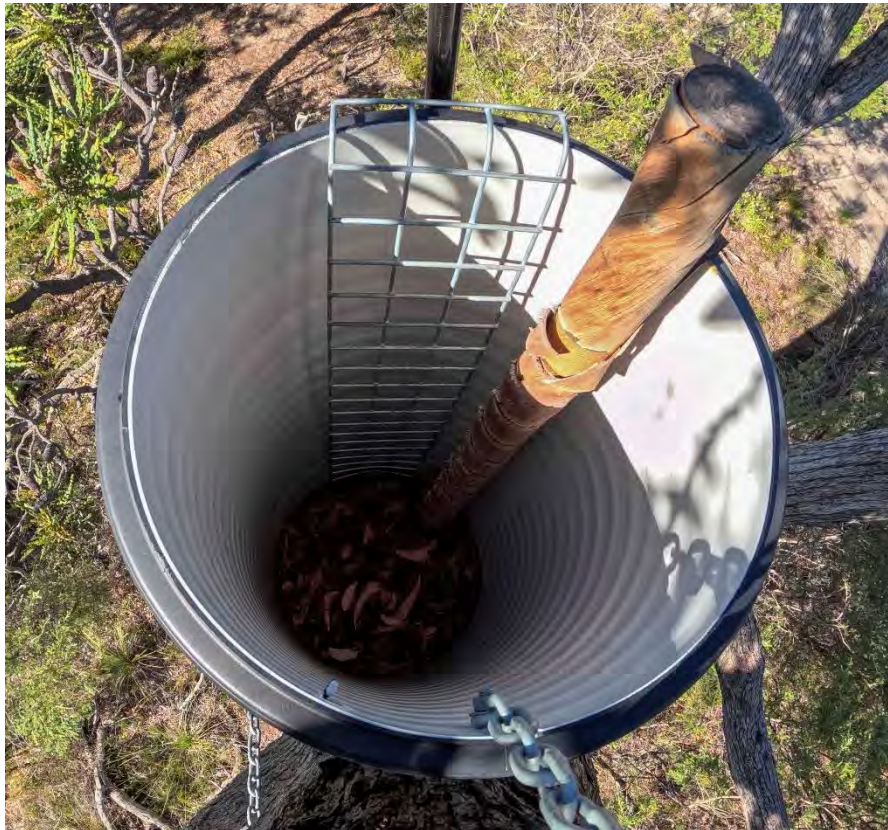
# Artificial Hollow D03

| Hollow No | Comments | Chipping<br>score 0-10 | Wood<br>Chips | Tree<br>condition | Fixings and<br>Hollow<br>condition | Recommended repairs |
|---|---|---|---|---|---|---|
| D03 | No signs of nesting or inspection by Black Cockatoos. Cobwebs at entry | 0 | Nil | Good | Good | Nil |

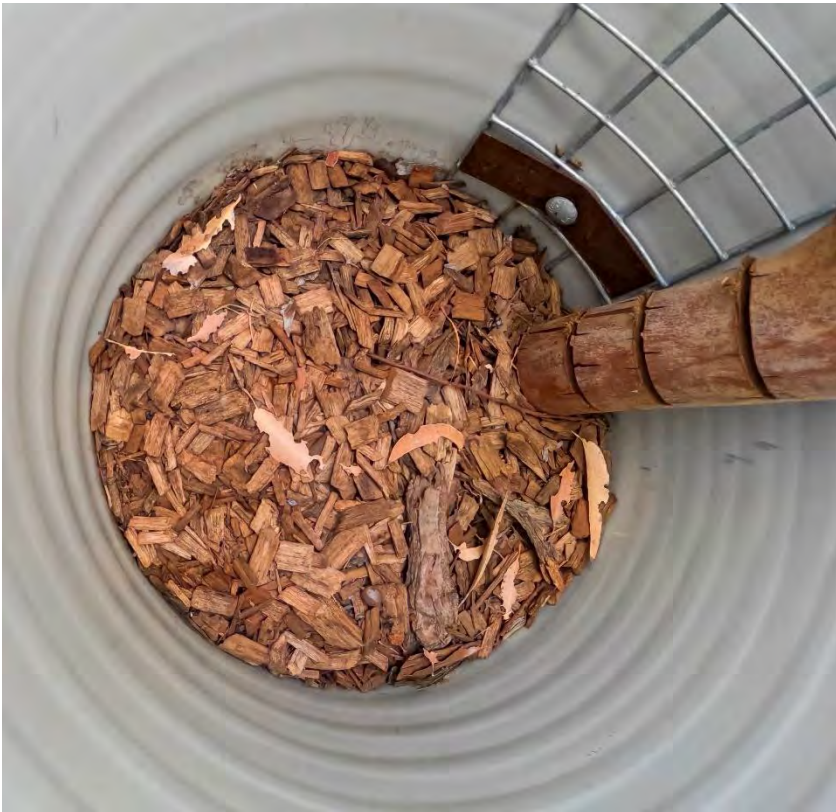
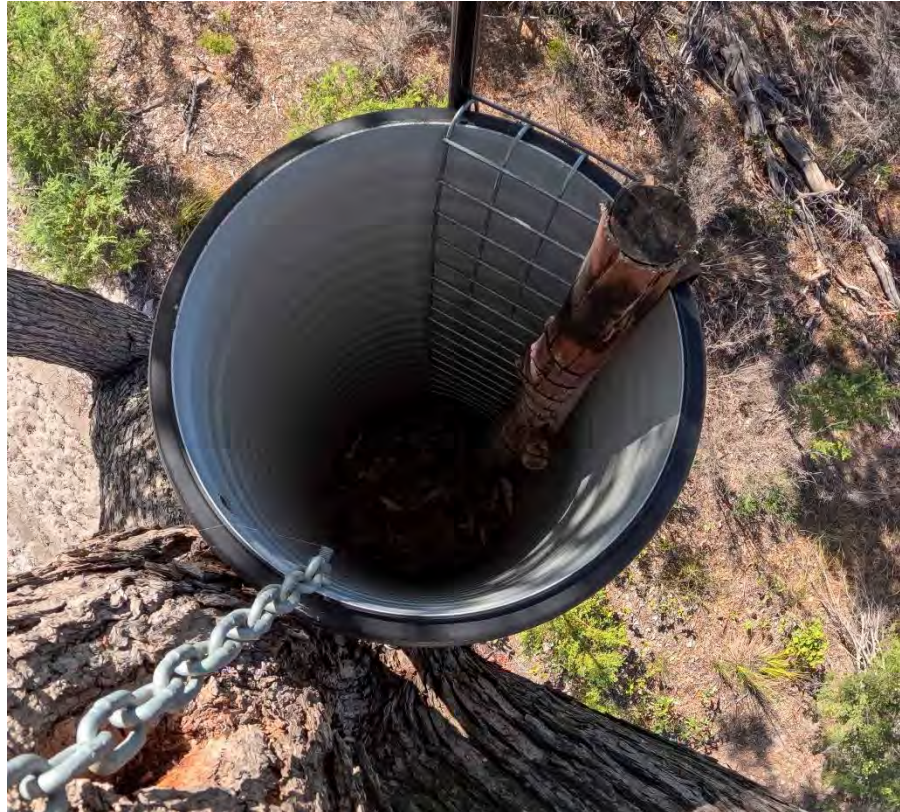
# Artificial Hollow D04

| Hollow No | Comments | Chipping score 0-10 | Wood Chips | Tree condition | Fixings and Hollow condition | Recommended repairs |
|---|---|---|---|---|---|---|
| D04 | No signs of nesting or inspection by Black Cockatoos | 0 | Nil | Good | Good | Nil |

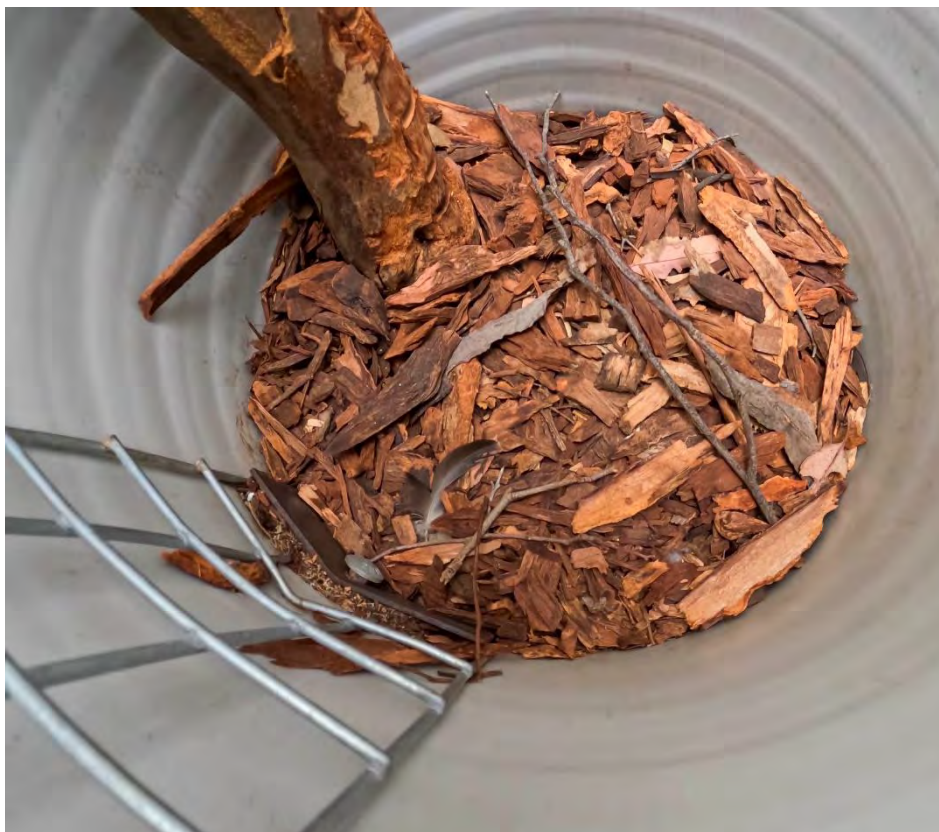
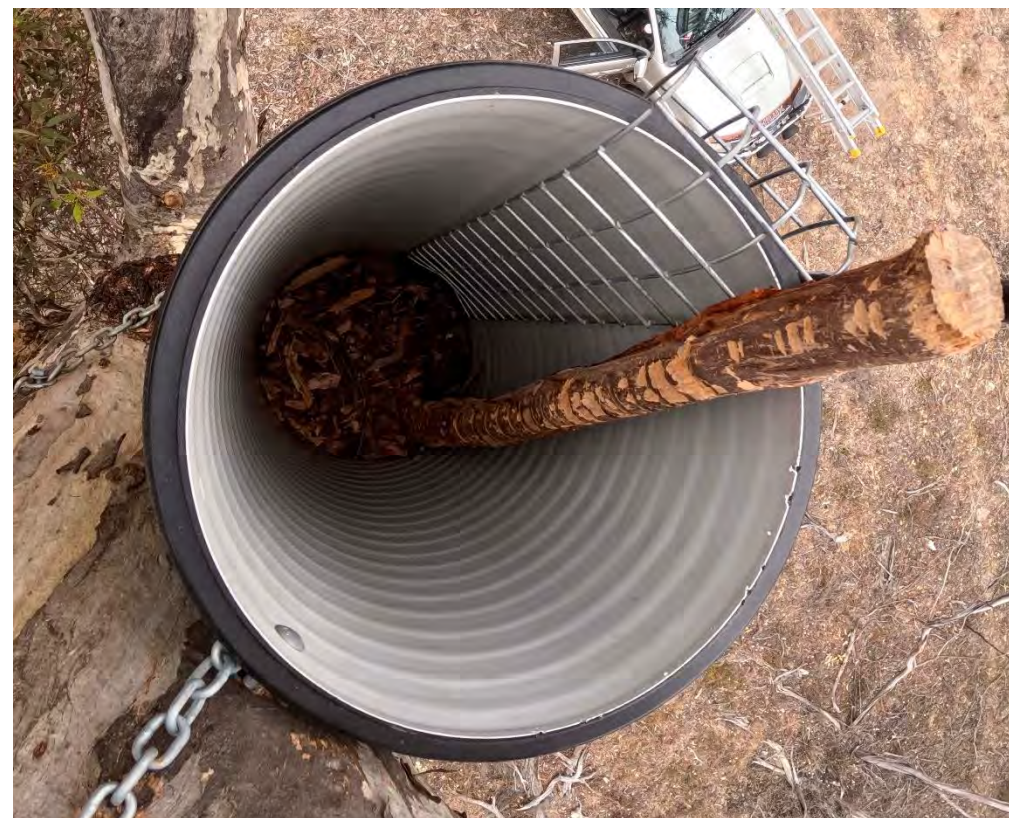
## Artificial Hollow BY01

| Hollow No | Comments | Chipping score 0-10 | Wood Chips | Tree condition | Fixings and Hollow condition | Recommended repairs |
|---|---|---|---|---|---|---|
| BY01 | Chewing on post no signs of Breeding | 3 | Nil | Good | Good | Nil |

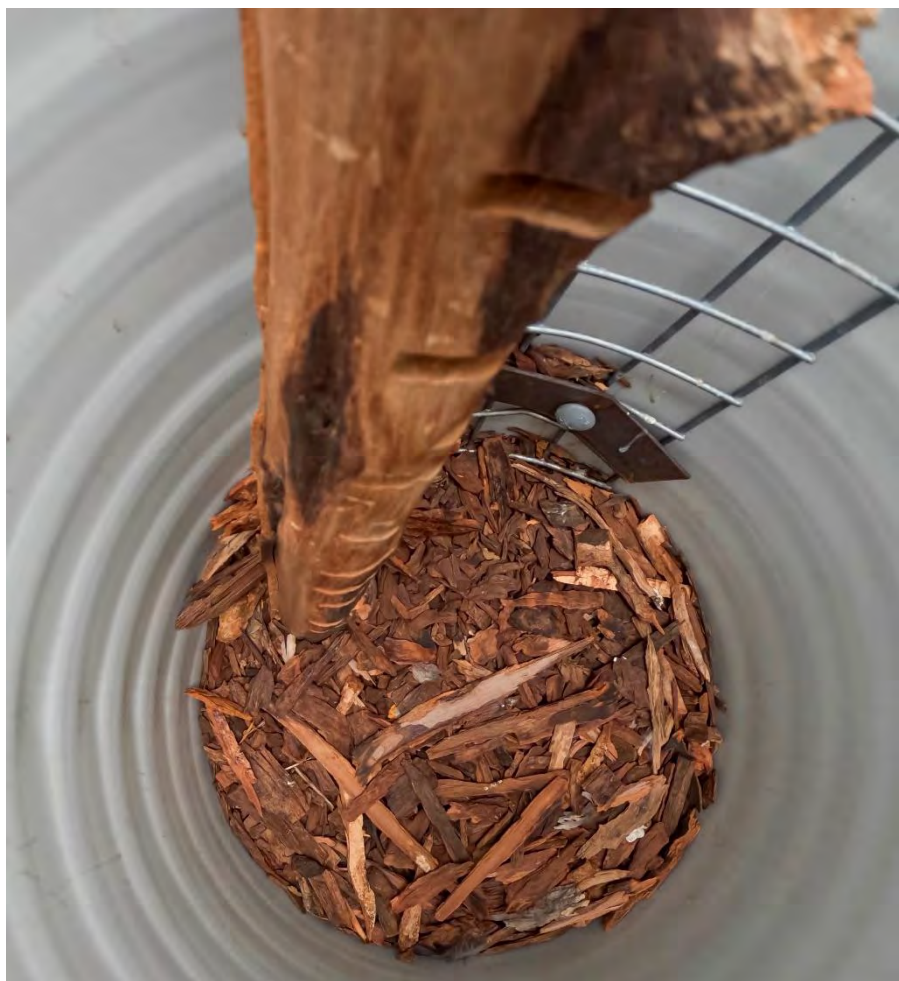
## Artificial Hollow BY02

| Hollow No | Comments | Chipping score 0-10 | Wood Chips | Tree condition | Fixings and Hollow condition | Recommended repairs |
|---|---|---|---|---|---|---|
| BY02 | Chewing on post no signs of Breeding | 2 | Nil | Good | Good | Nil |

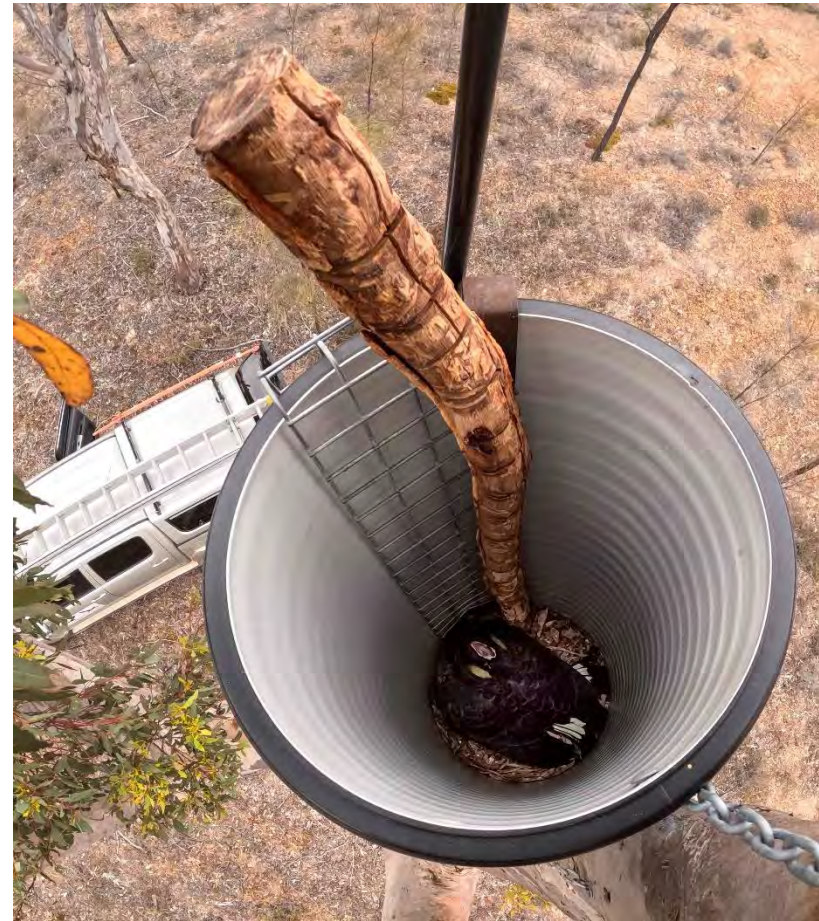
## Artificial Hollow BY03

| Hollow No | Comments | Chipping score 0-10 | Wood Chips | Tree condition | Fixings and Hollow condition | Recommended repairs |
|---|---|---|---|---|---|---|
| BY03 | One 79-day old female Carnaby's nestling, Still in nest will fledge any day Chewing on post. | 3 | Nil | Good | Good | Nil |

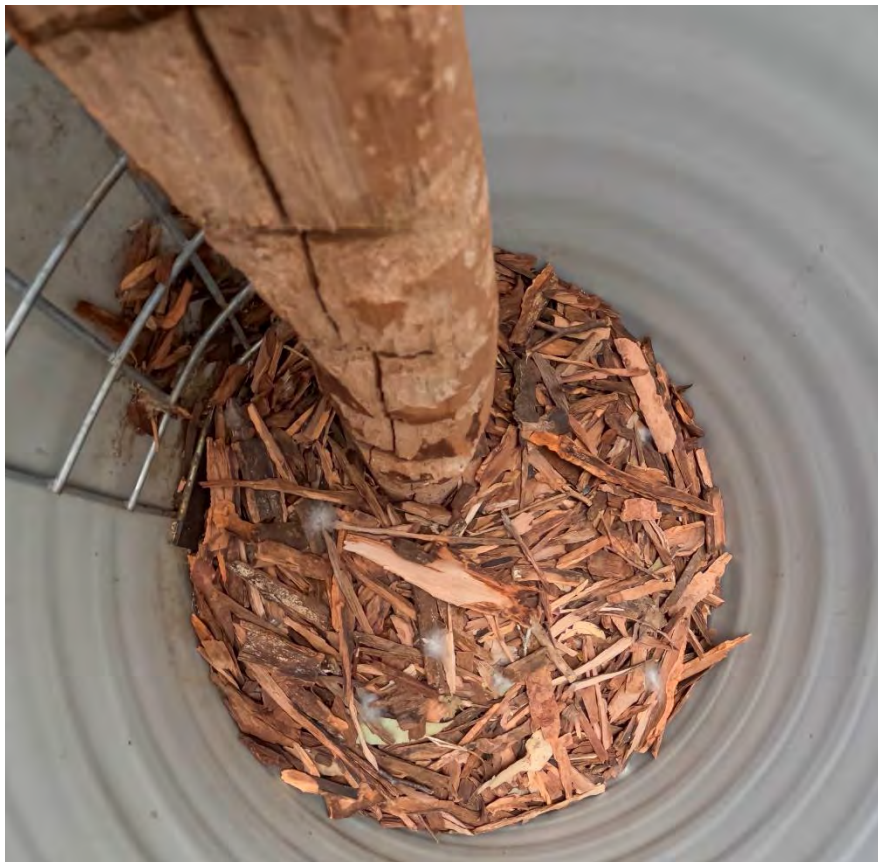
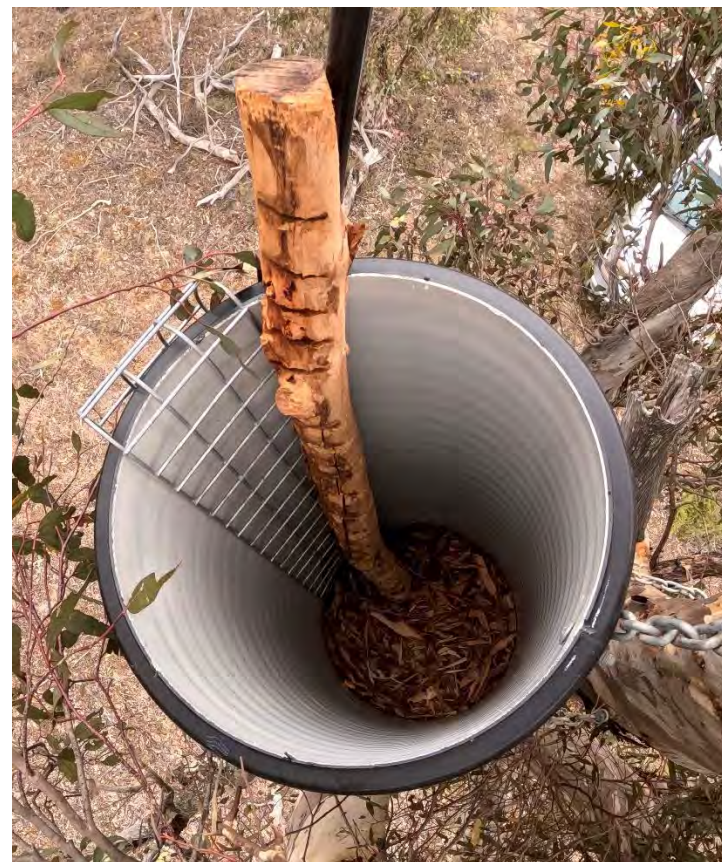
## Artificial Hollow BY04

| Hollow No | Comments | Chipping score 0-10 | Wood Chips | Tree condition | Fixings and Hollow condition | Recommended repairs |
|---|---|---|---|---|---|---|
| BY04 | No sign of CC egg from October 24 survey. CC breast feathers on base.- <u>Failed</u> | 3 | Nil | Good | Good | Nil |

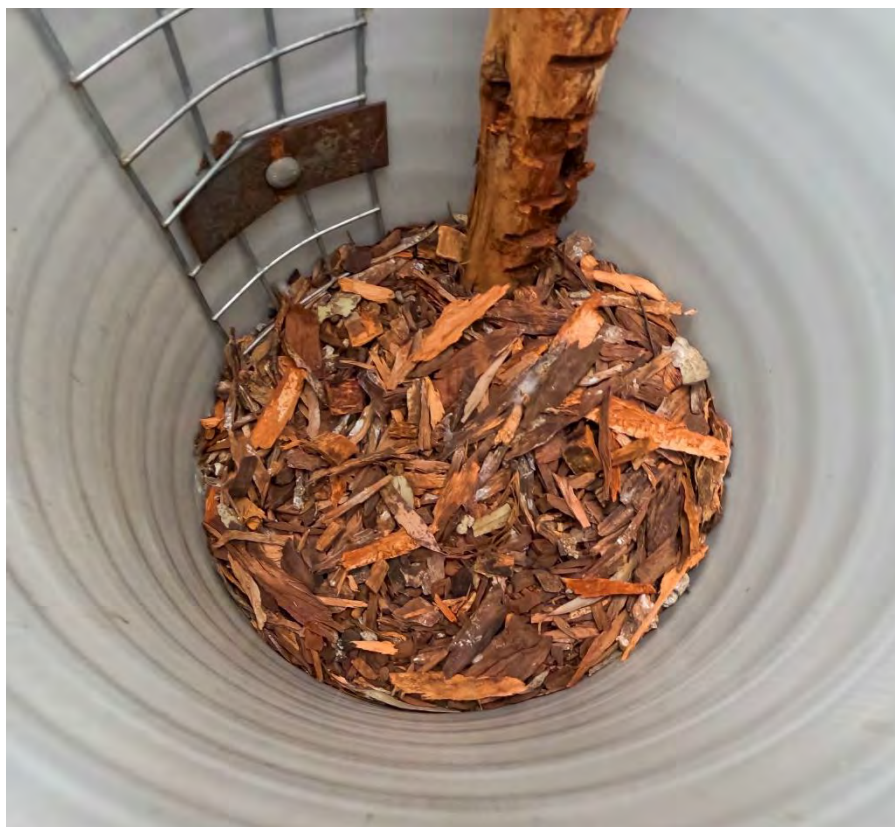
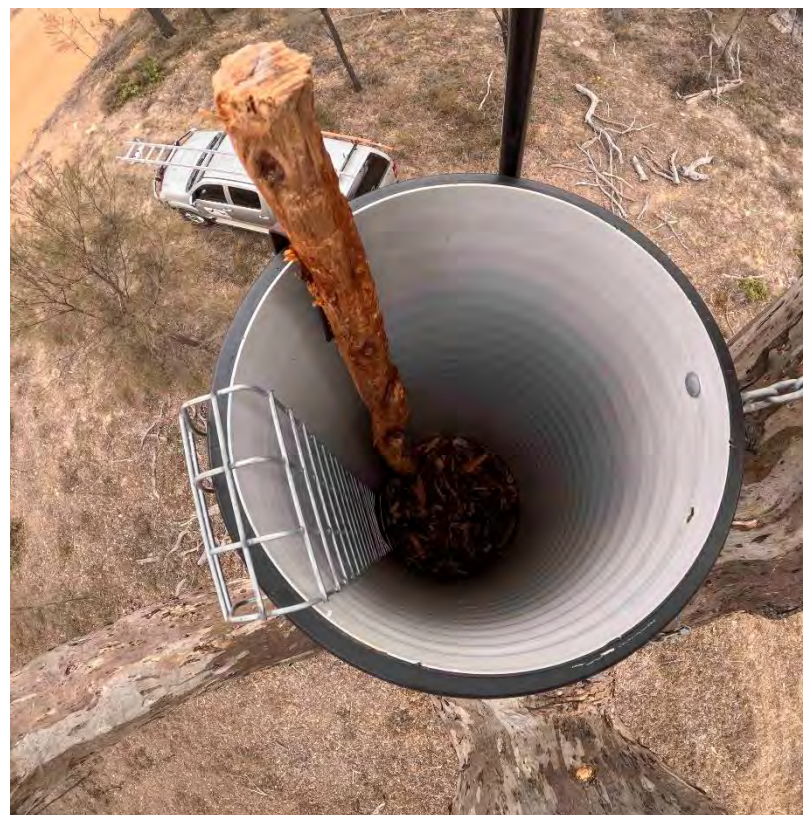
## Artificial Hollow BY05

| Hollow No | Comments | Chipping score 0-10 | Wood Chips | Tree condition | Fixings and Hollow condition | Recommended repairs |
|---|---|---|---|---|---|---|
| BY05 | Chewing on post no signs of Breeding. Faeces in bottom of hollow | 3 | Nil | Good | Good | Nil |

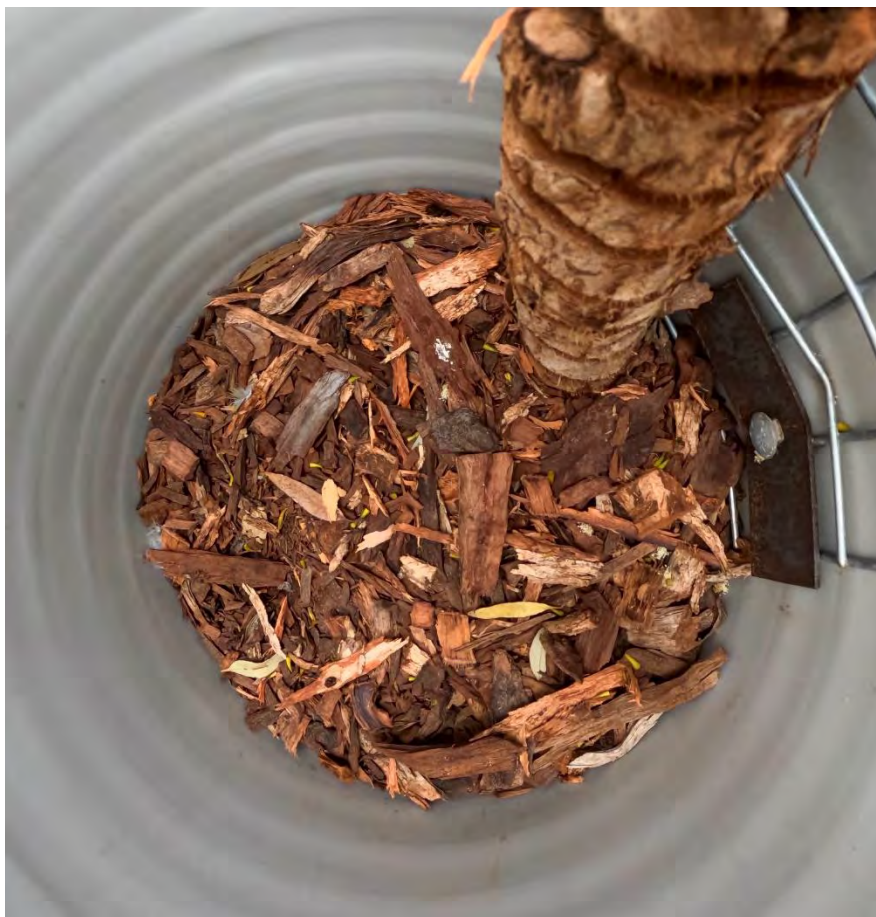
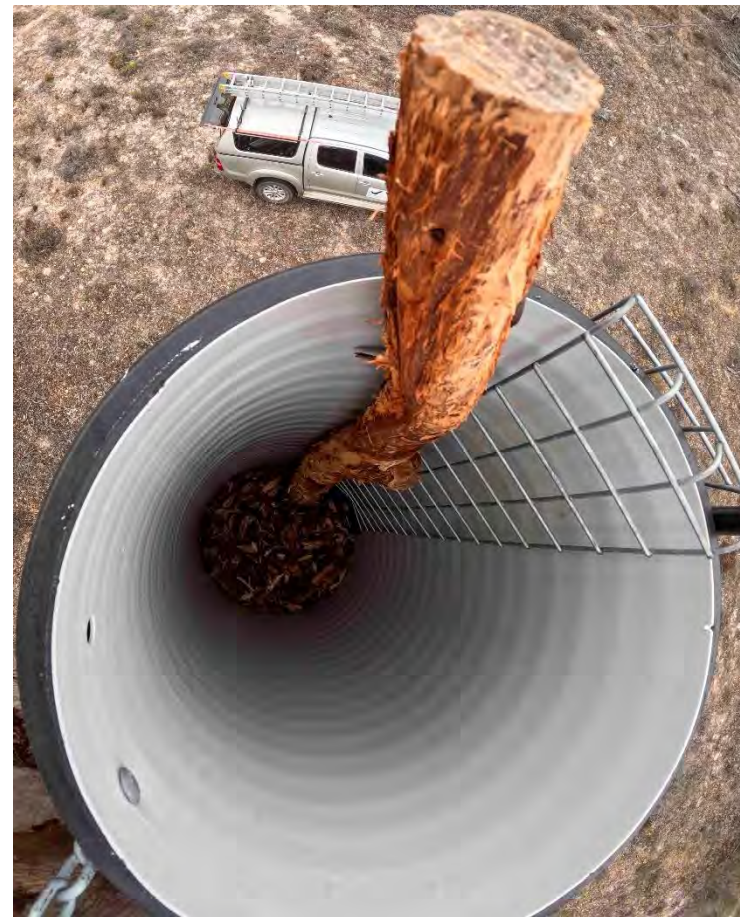
## Artificial Hollow BY06

| Hollow No | Comments | Chipping score 0-10 | Wood Chips | Tree condition | Fixings and Hollow condition | Recommended repairs |
|---|---|---|---|---|---|---|
| BY06 | Minor chewing on post, no signs of Breeding | 2 | Nil | Good | Good | Nil |

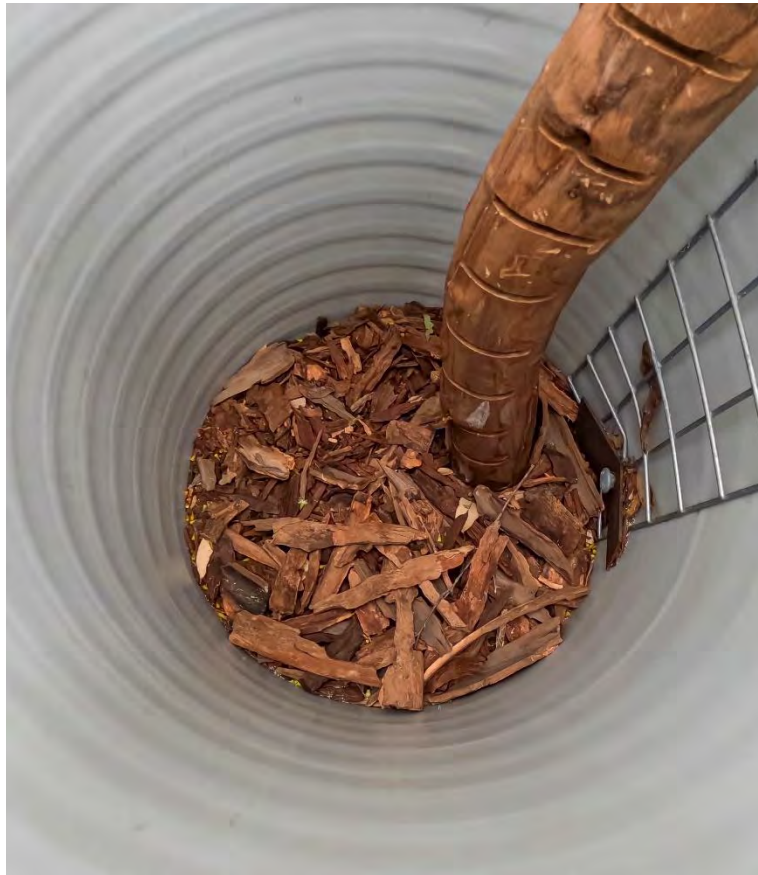
## Artificial Hollow BY07

| Hollow No | Comments | Chipping score 0-10 | Wood Chips | Tree condition | Fixings and Hollow condition | Recommended repairs |
|---|---|---|---|---|---|---|
| BY07 | Chewing on post no signs of Breeding | 2 | Nil | Good | Good | Nil |

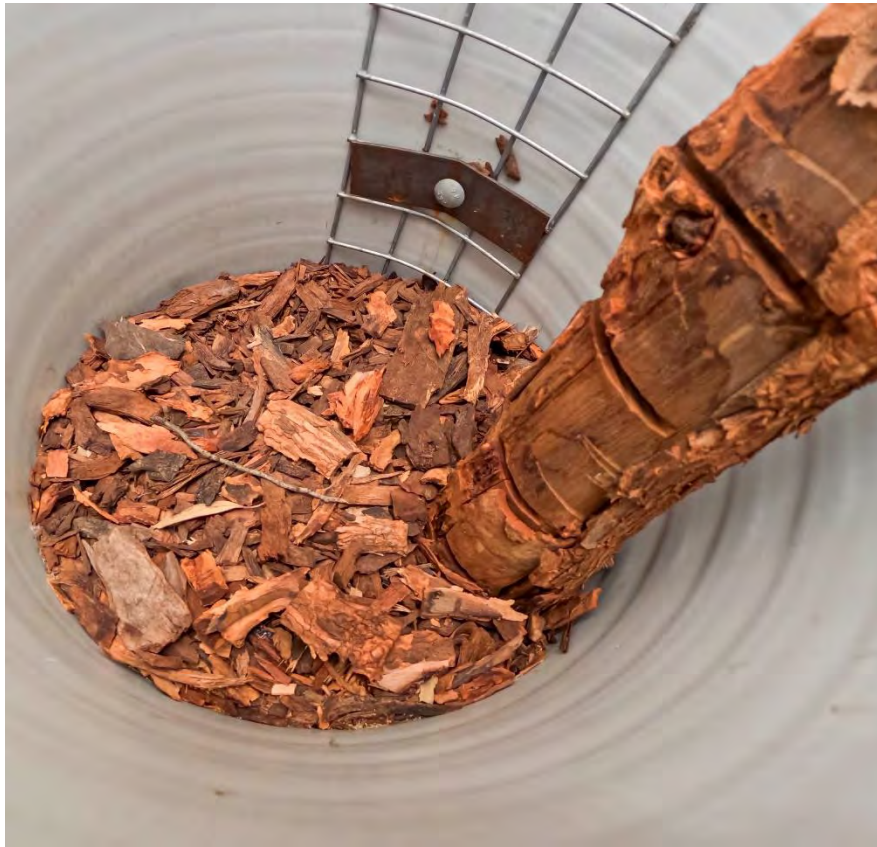
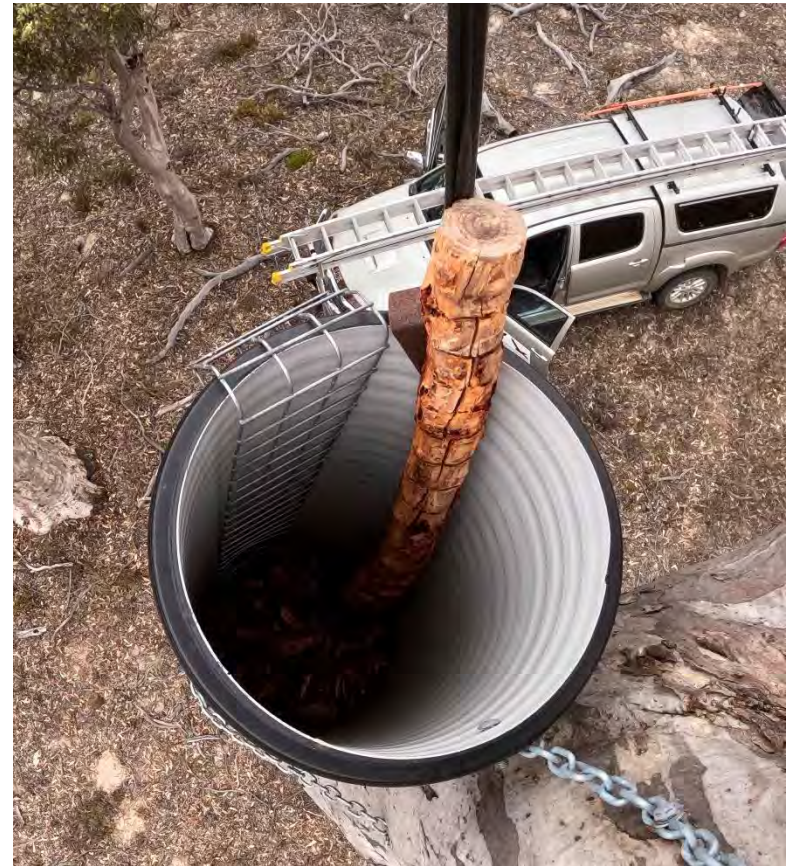
## Artificial Hollow BY08

| Hollow No | Comments | Chipping score 0-10 | Wood Chips | Tree condition | Fixings and Hollow condition | Recommended repairs |
|---|---|---|---|---|---|---|
| BY08 | Chewing on post no signs of Breeding | 2 | Nil | Good | Good | Nil |

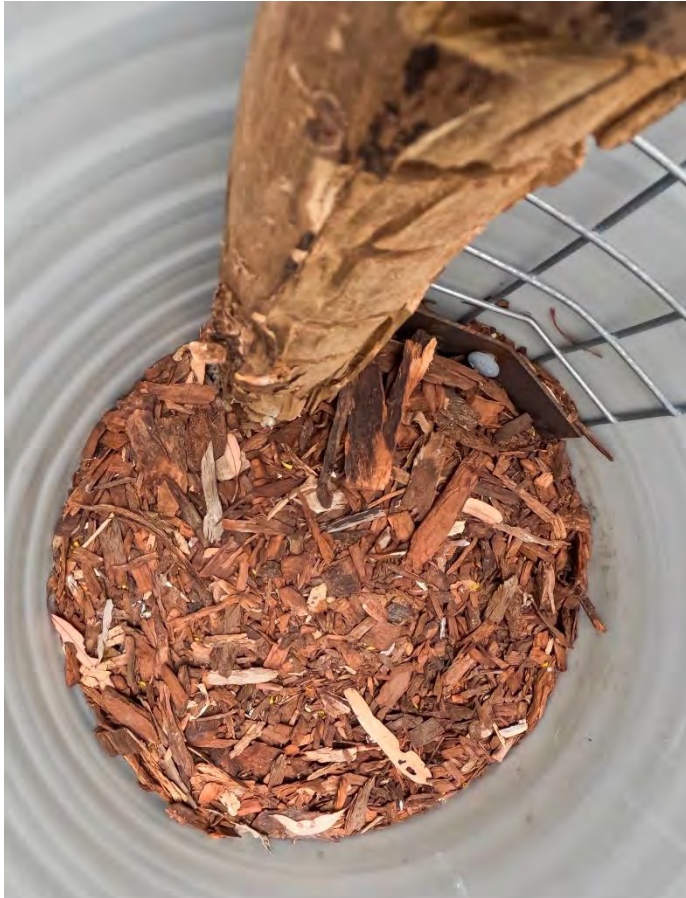
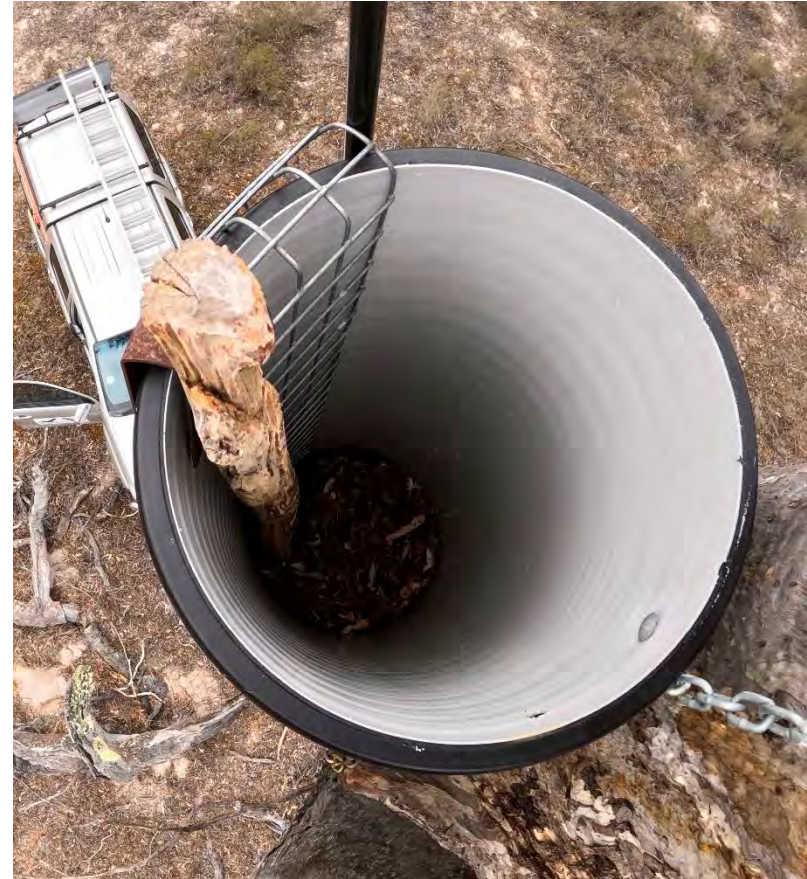
## Artificial Hollow BY09

| Hollow No | Comments | Chipping<br>score 0-10 | Wood<br>Chips | Tree<br>condition | Fixings and<br>Hollow<br>condition | Recommended repairs |
|---|---|---|---|---|---|---|
| BY09 | Chewing on post no signs of Breeding | 2 | Nil | Good | Good | Nil |

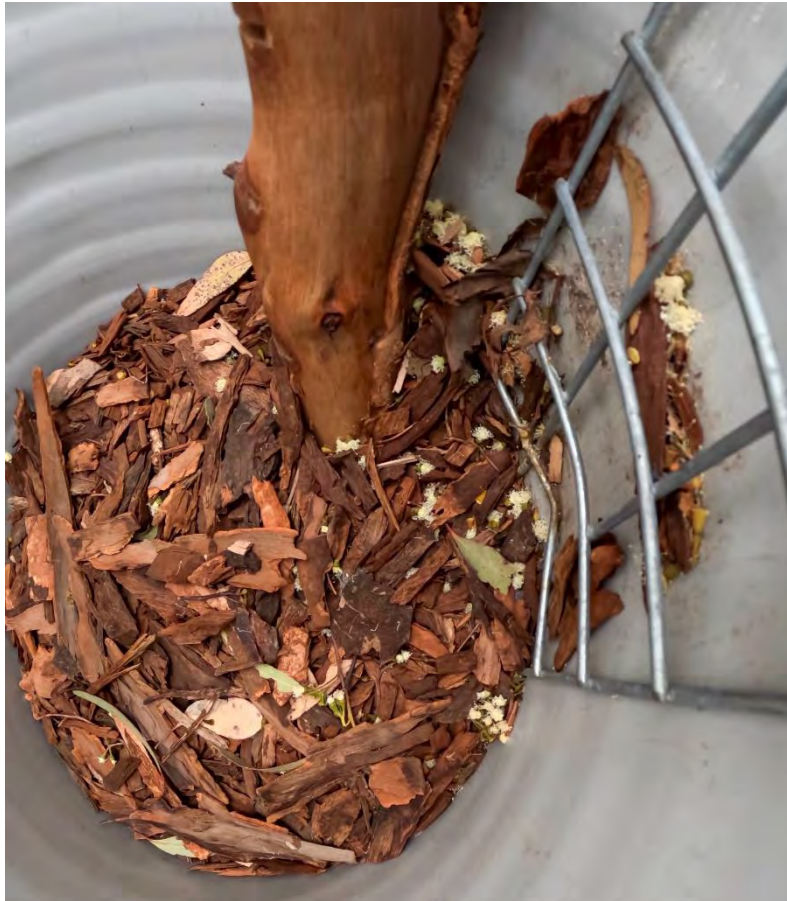
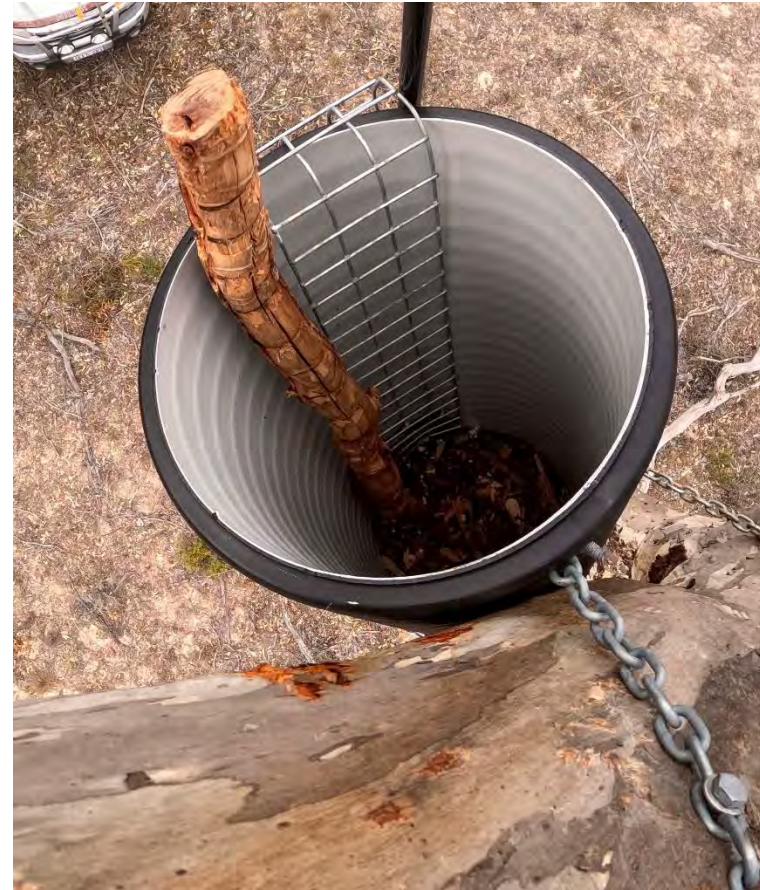
## Artificial Hollow BY10

| Hollow No | Comments | Chipping score 0-10 | Wood Chips | Tree condition | Fixings and Hollow condition | Recommended repairs |
|---|---|---|---|---|---|---|
| BY10 | Chewing on post no signs of Breeding | 1 | Nil | Good | Good | Nil |

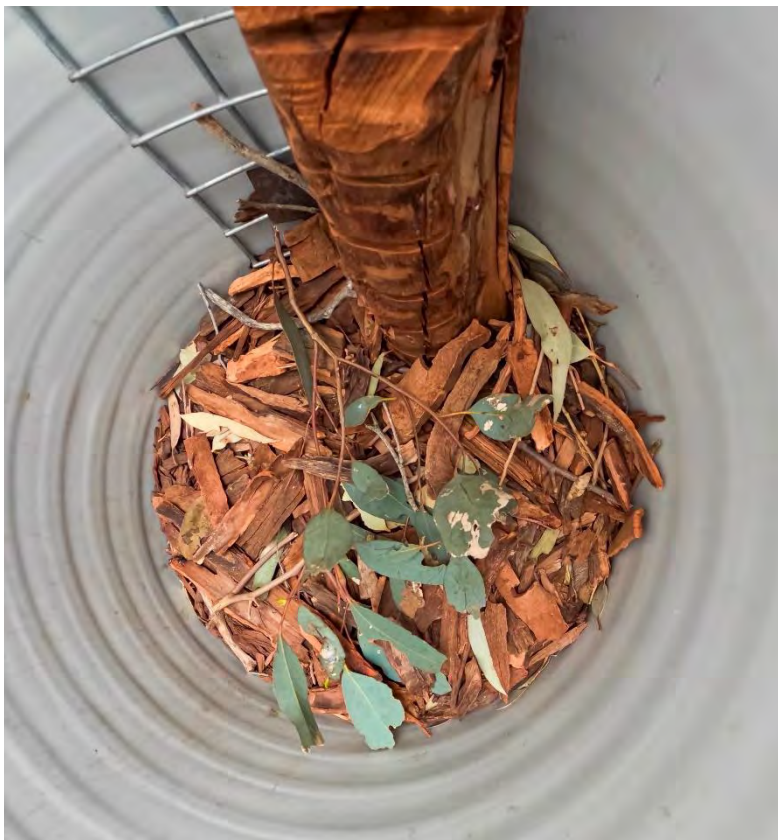
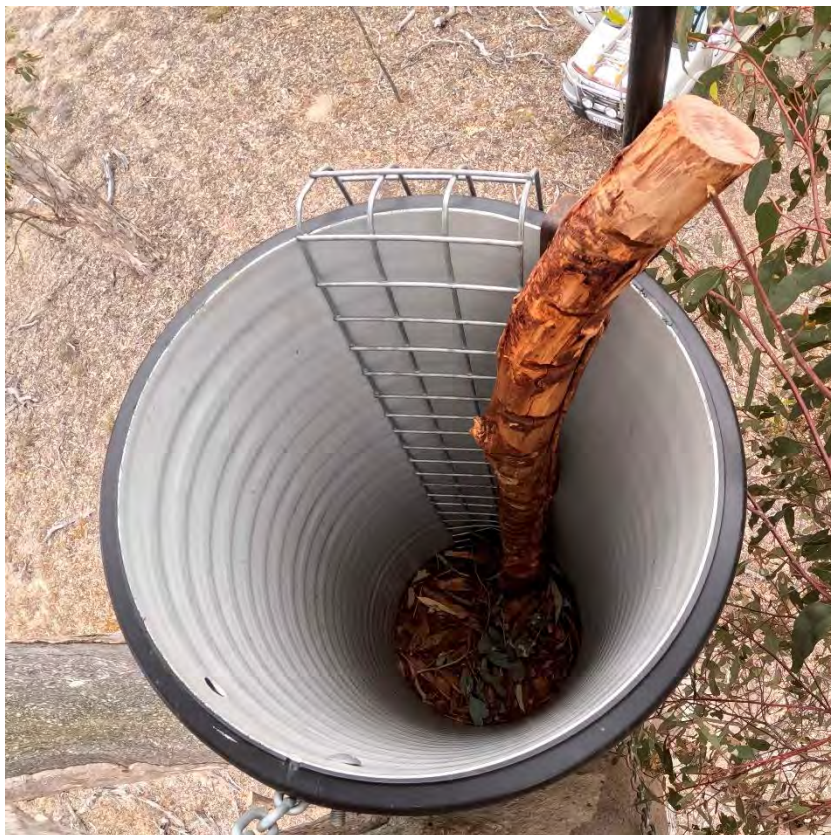
## Artificial Hollow BY11

| Hollow No | Comments | Chipping score 0-10 | Wood Chips | Tree condition | Fixings and Hollow condition | Recommended repairs |
|---|---|---|---|---|---|---|
| BY11 | Chewing on post no signs of Breeding | 2 | Nil | Good | Good | Nil |

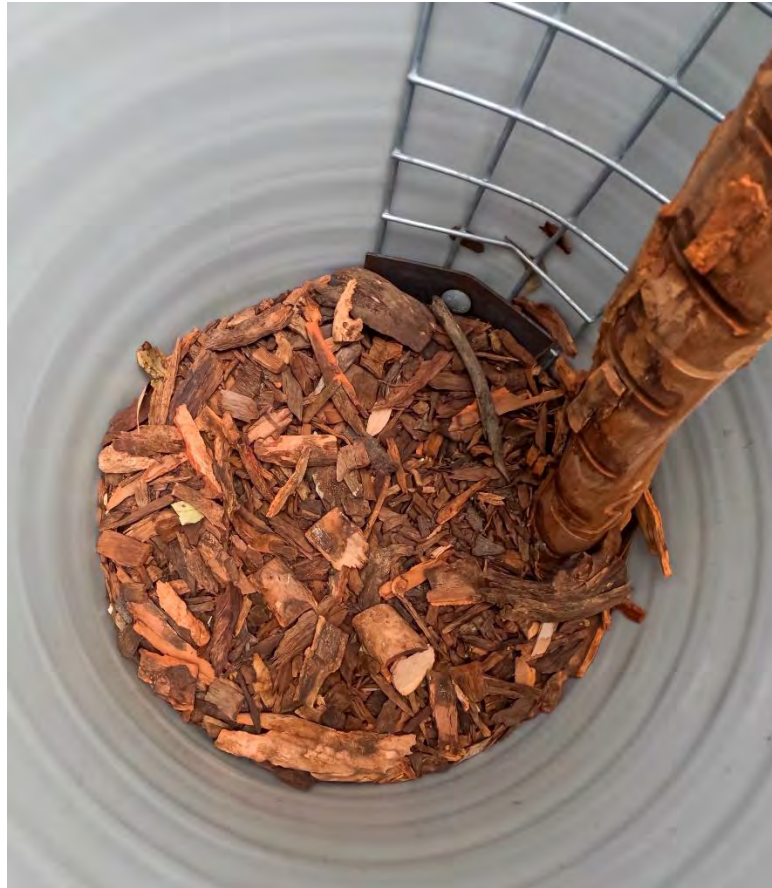
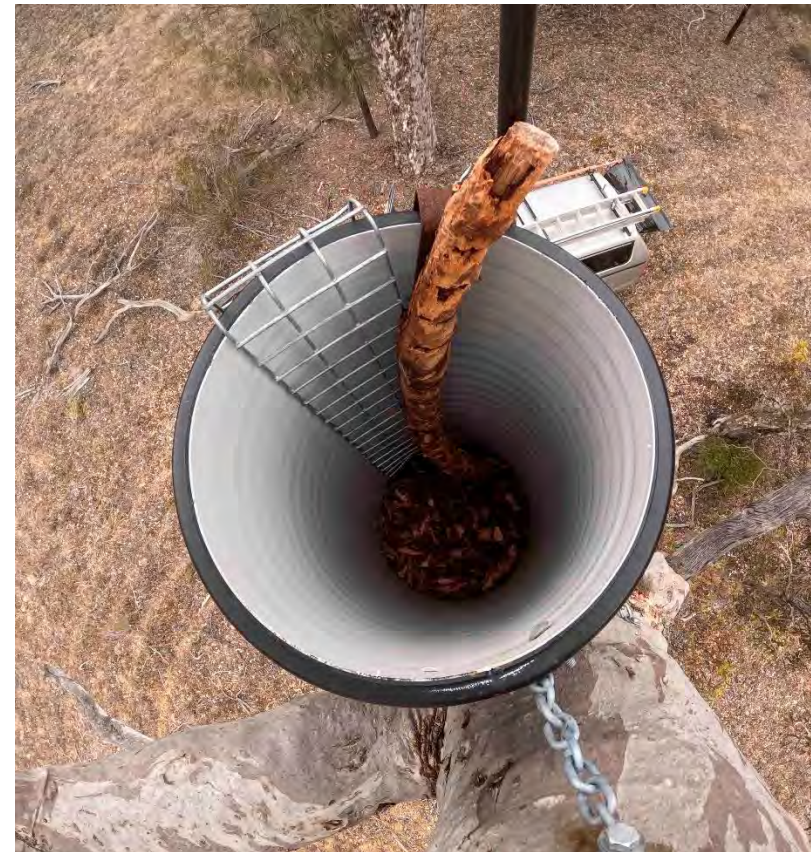
## Artificial Hollow BY12

| Hollow No | Comments | Chipping score 0-10 | Wood Chips | Tree condition | Fixings and Hollow condition | Recommended repairs |
|---|---|---|---|---|---|---|
| BY12 | Chewing on post no signs of Breeding | 2 | Nil | Good | Good | Nil |

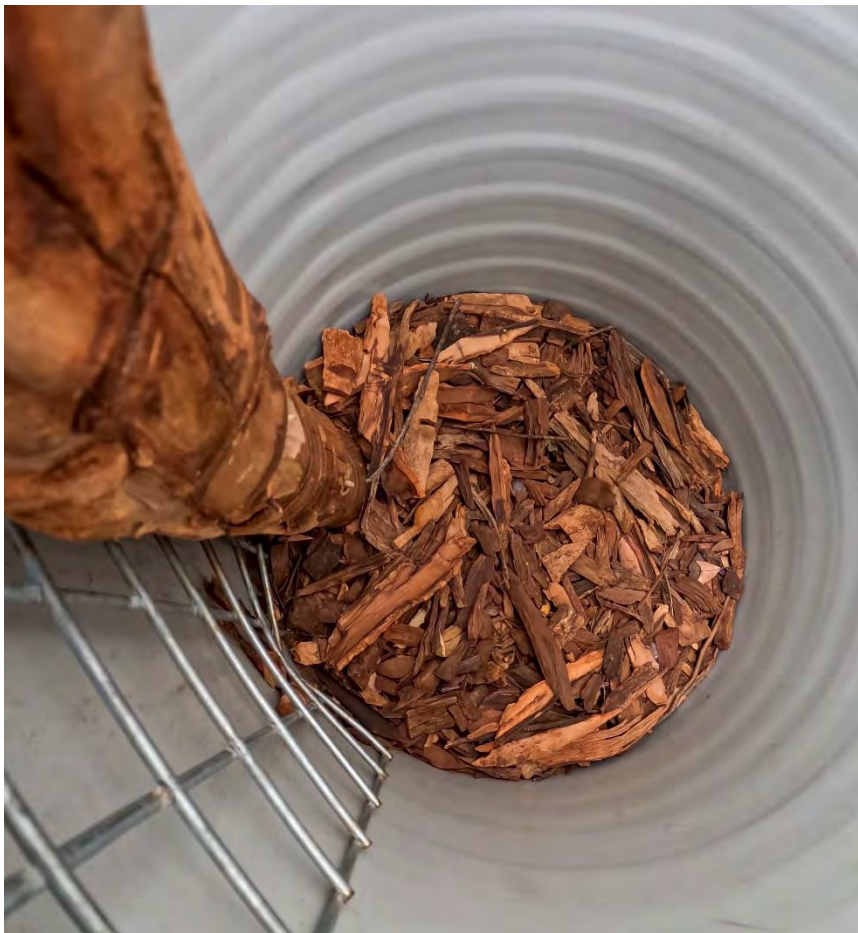
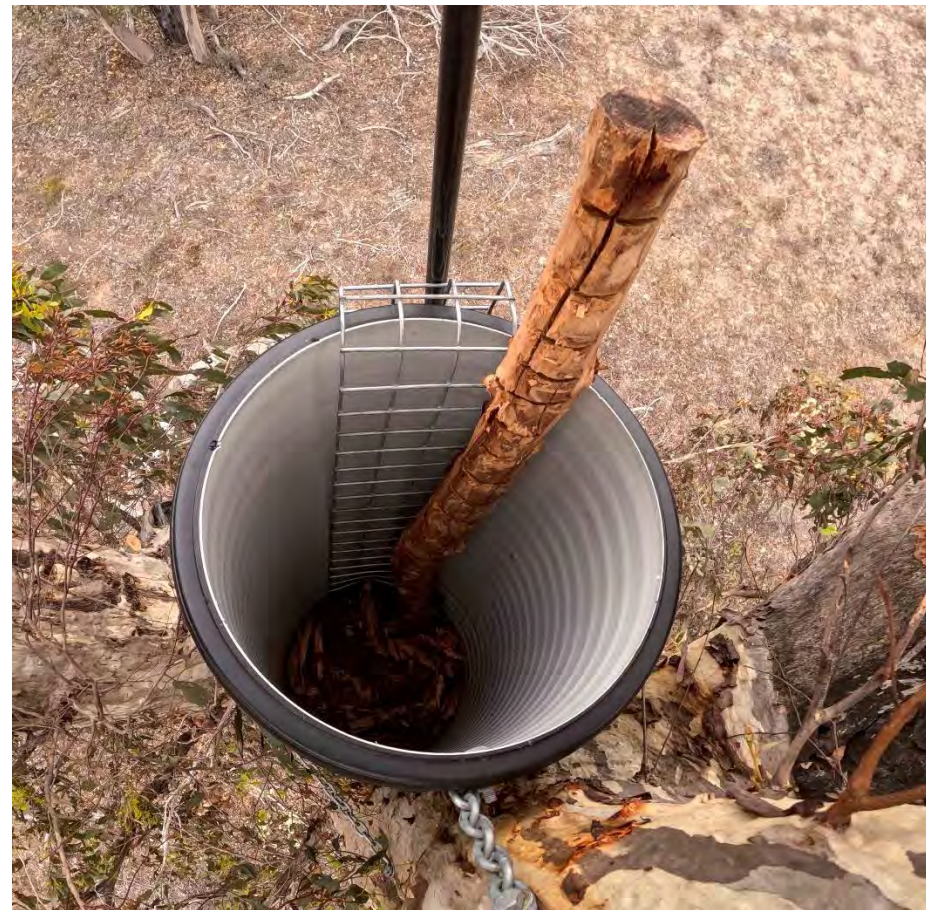
## Artificial Hollow BY13

| Hollow No | Comments | Chipping score 0-10 | Wood Chips | Tree condition | Fixings and Hollow condition | Recommended repairs |
|---|---|---|---|---|---|---|
| BY13 | Chewing on post no signs of Breeding | 2 | Nil | Good | Good | Nil |
