# Bunbury Outer Ring Road

## Southern Section

Ministerial Statement 1191

Compliance Assessment Report

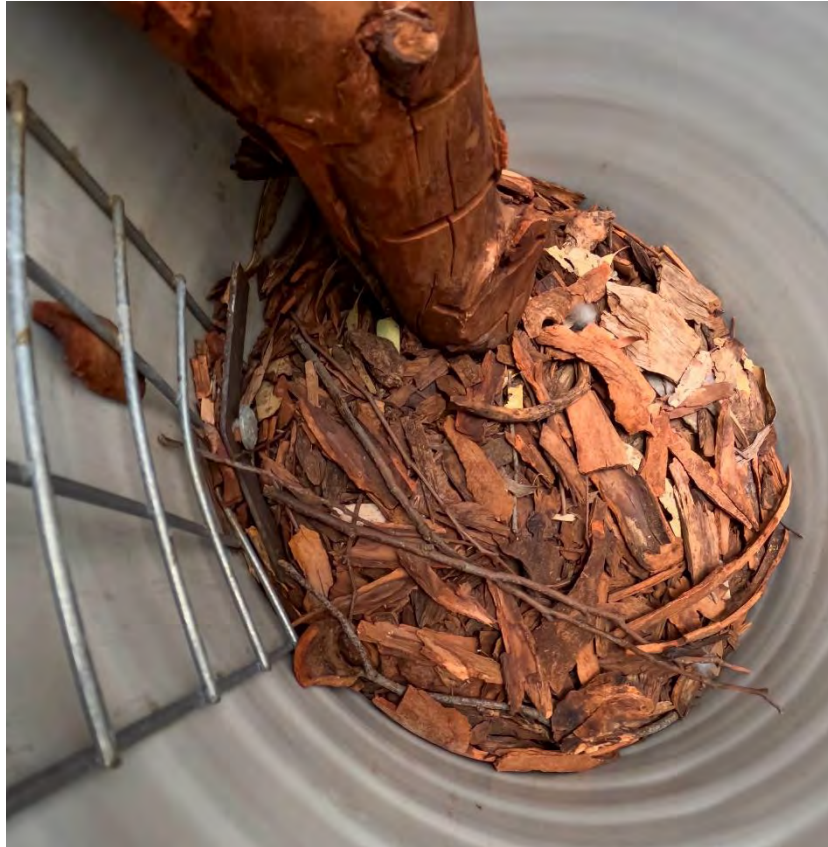
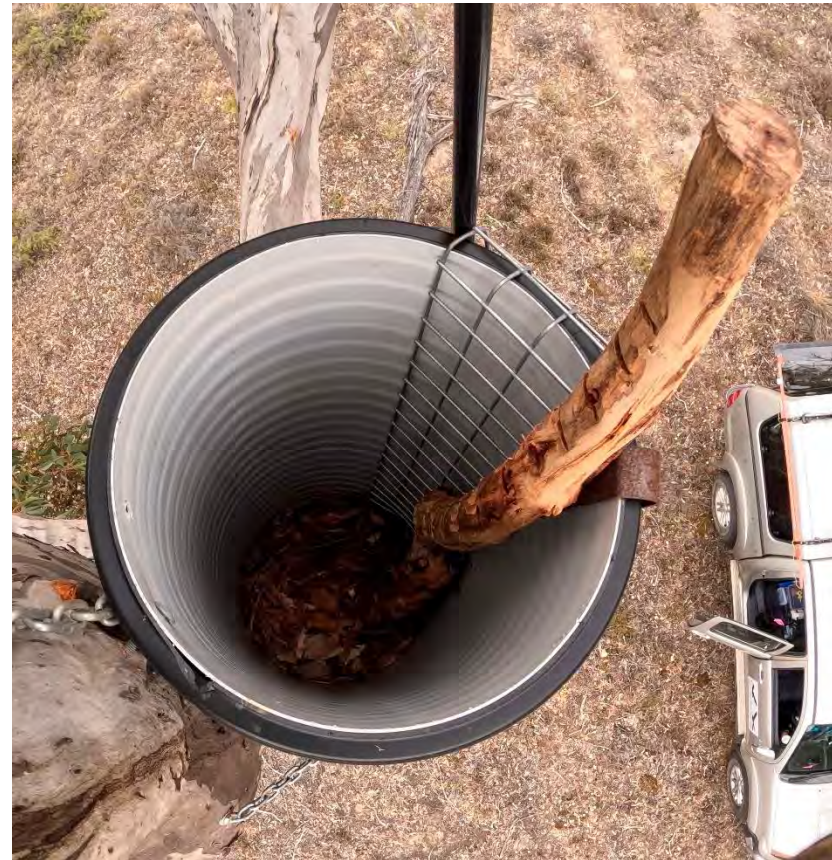
## Artificial Hollow BY14

| Hollow No | Comments | Chipping score 0-10 | Wood Chips | Tree condition | Fixings and Hollow condition | Recommended repairs |
|---|---|---|---|---|---|---|
| BY14 | Chewing on post no signs of Breeding | 2 | Nil | Good | Good | Nil |

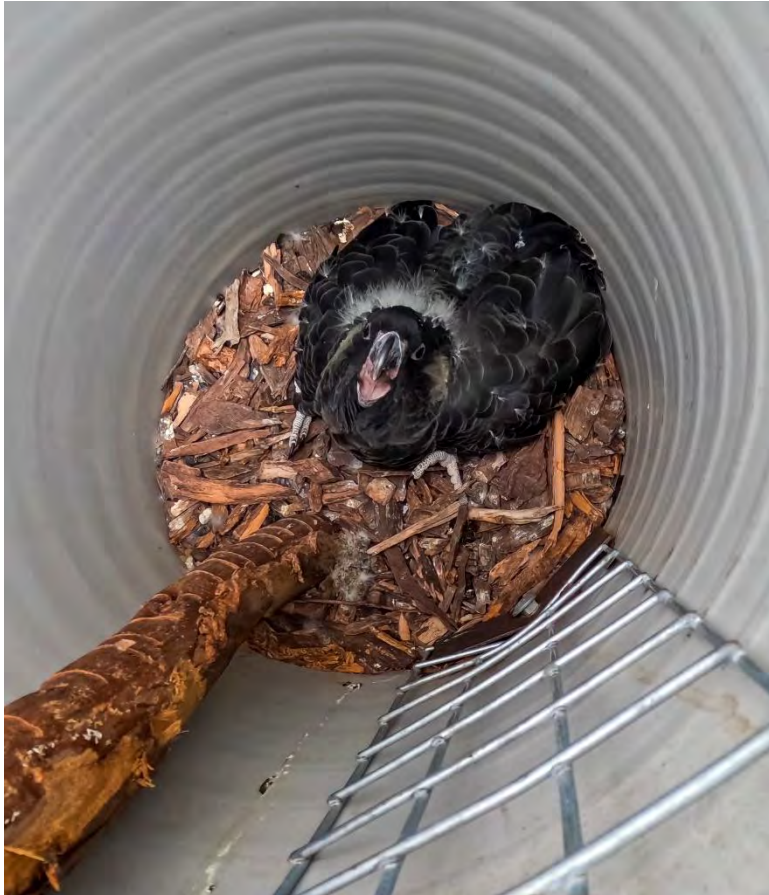
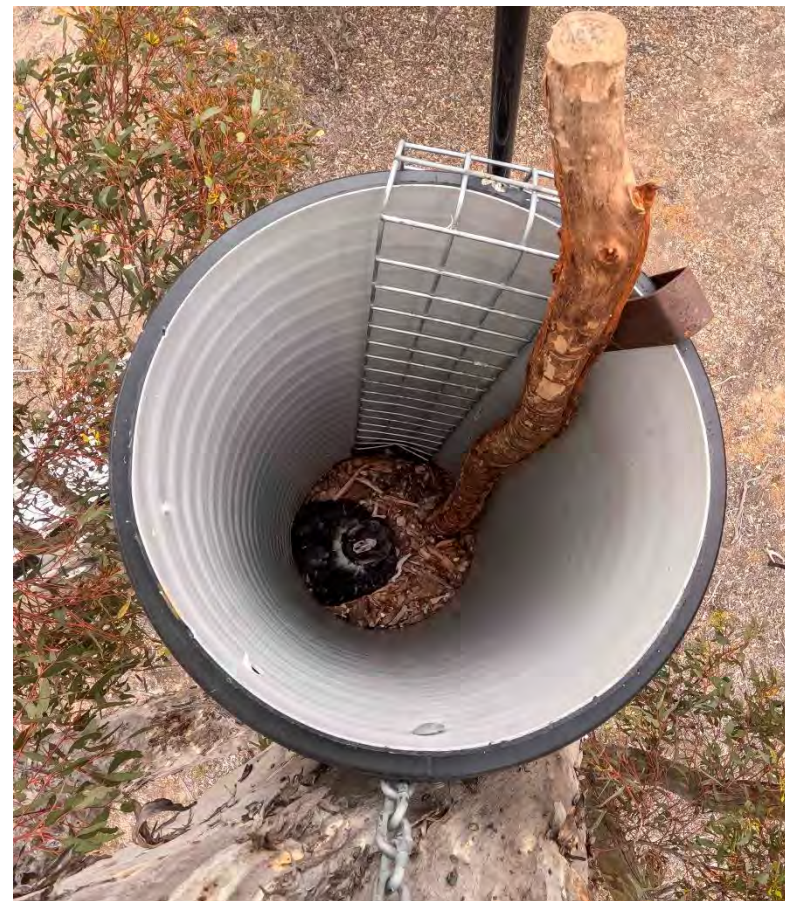
## Artificial Hollow BY15

| Hollow No | Comments | Chipping score 0-10 | Wood Chips | Tree condition | Fixings and Hollow condition | Recommended repairs |
|---|---|---|---|---|---|---|
| BY15 | One 9-day old Carnaby's nestling.<br>Chewing on post | 3 | Nil | Good | Good | Nil |

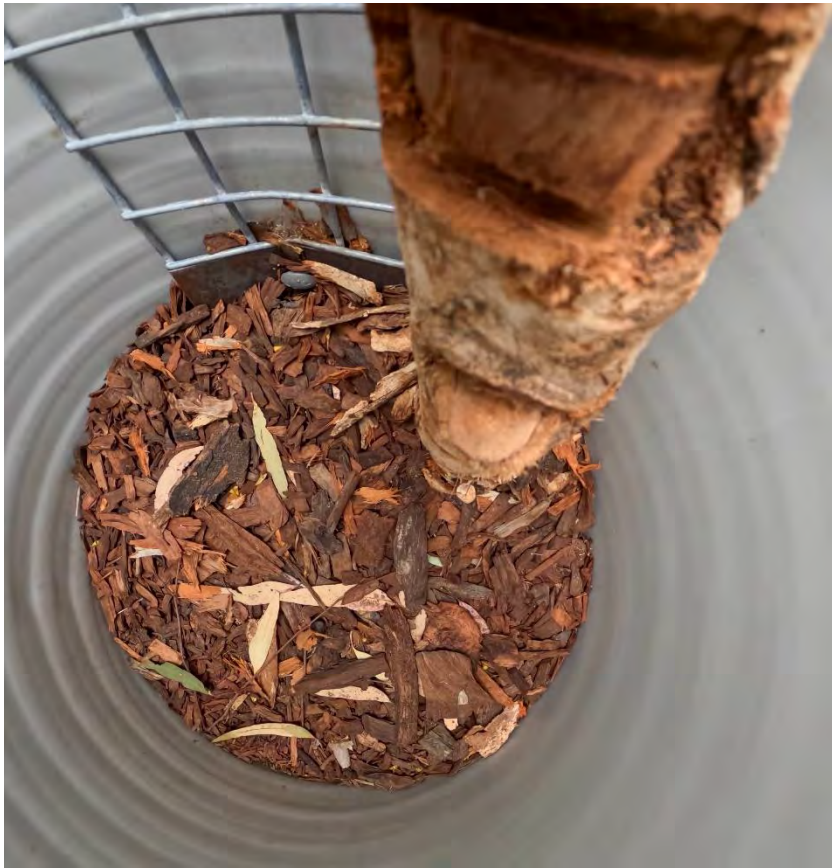
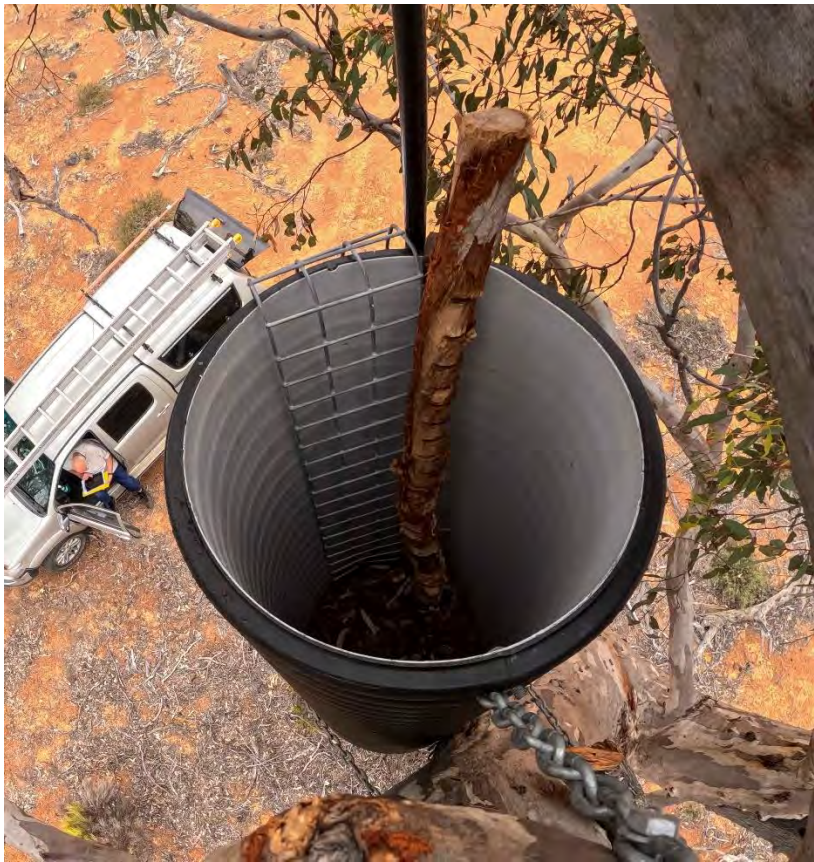
Artificial Hollow BY16

| Hollow No | Comments | Chipping score 0-10 | Wood Chips | Tree condition | Fixings and Hollow condition | Recommended repairs |
|---|---|---|---|---|---|---|
| BY16 | Chewing on post no signs of Breeding | 3 | Nil | Good | Good | Nil |

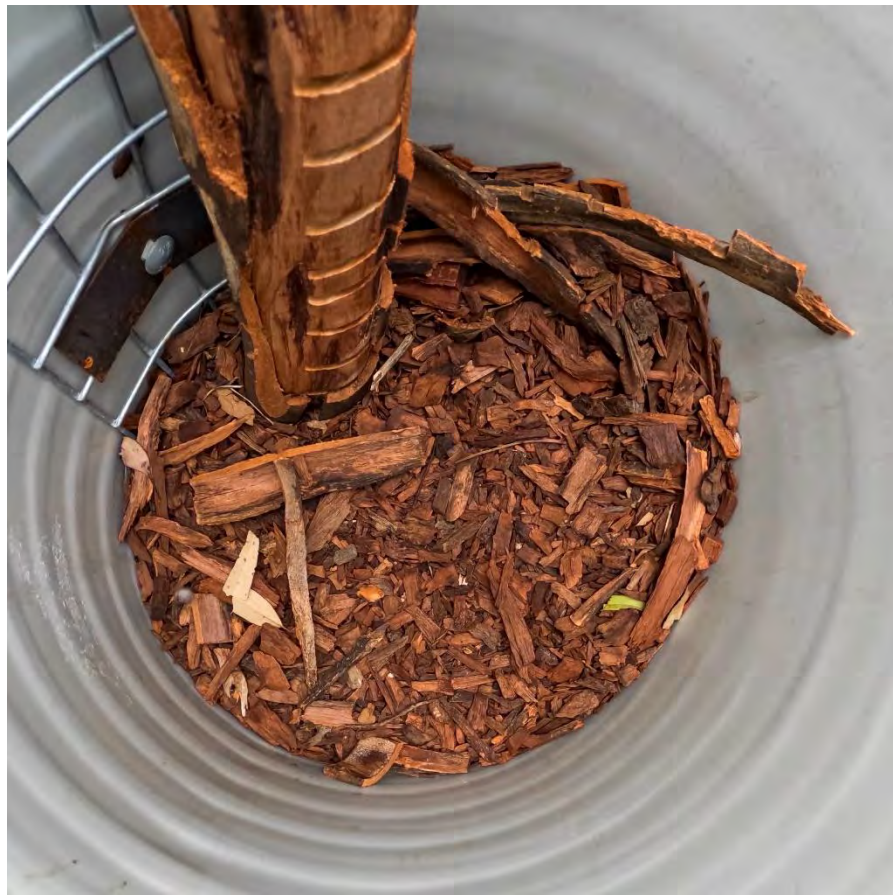
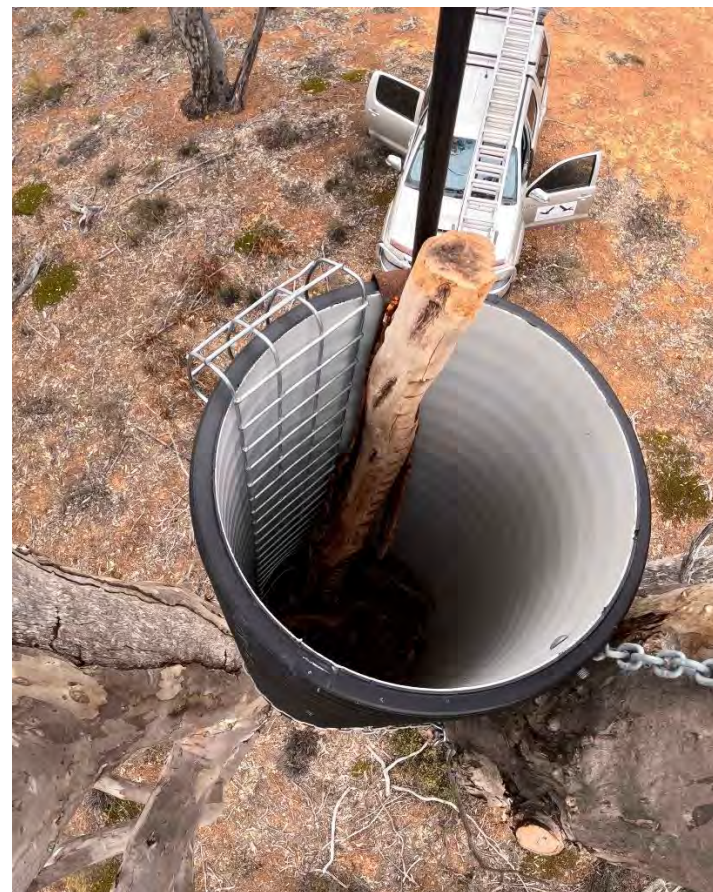
## Artificial Hollow BY17

| Hollow No | Comments | Chipping score 0-10 | Wood Chips | Tree condition | Fixings and Hollow condition | Recommended repairs |
|---|---|---|---|---|---|---|
| BY17 | Chewing on post no signs of Breeding | 2 | Nil | Good | Good | Nil |

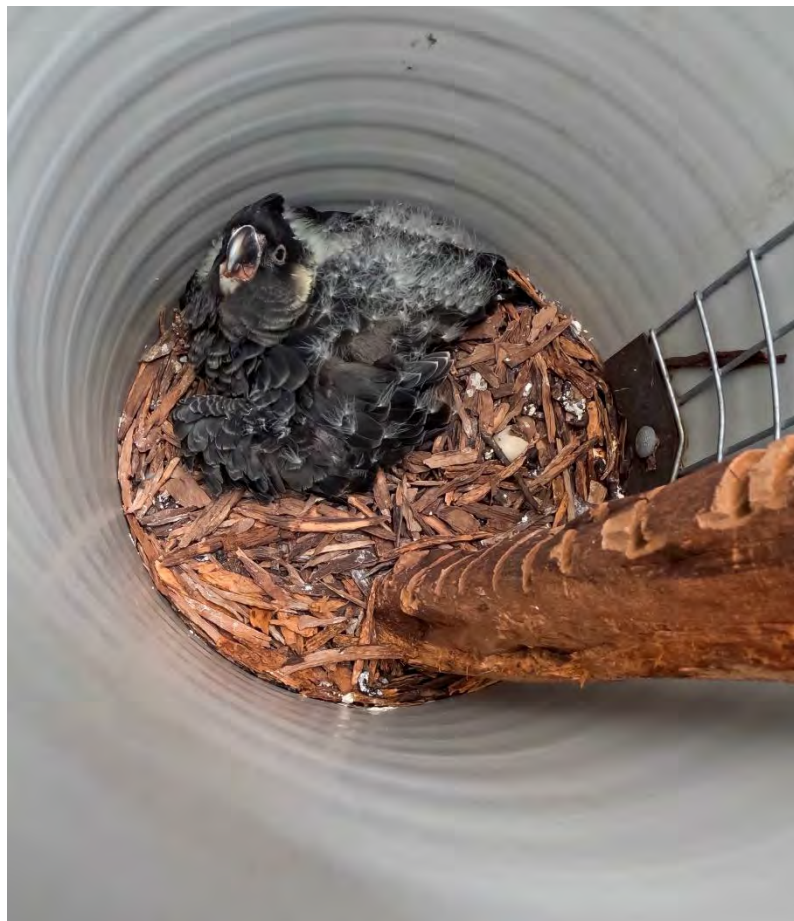
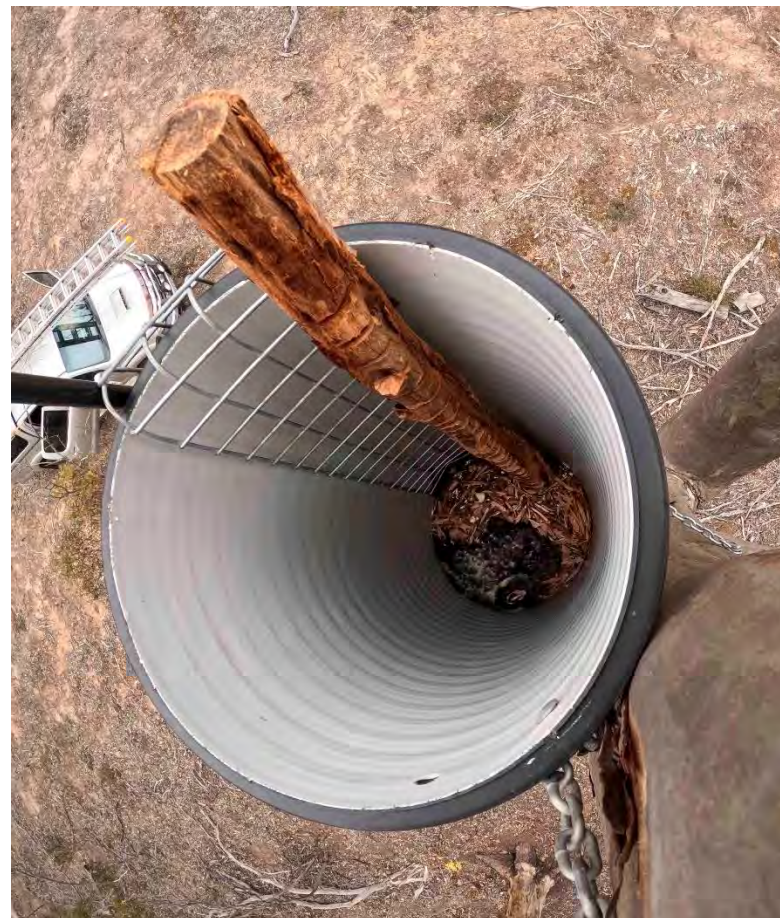
## Artificial Hollow BY18

| Hollow No | Comments | Chipping score 0-10 | Wood Chips | Tree condition | Fixings and Hollow condition | Recommended repairs |
|---|---|---|---|---|---|---|
| BY18 | One Male CC nestling 49-days old. Chewing on post | 3 | Nil | Good | Good | Nil |

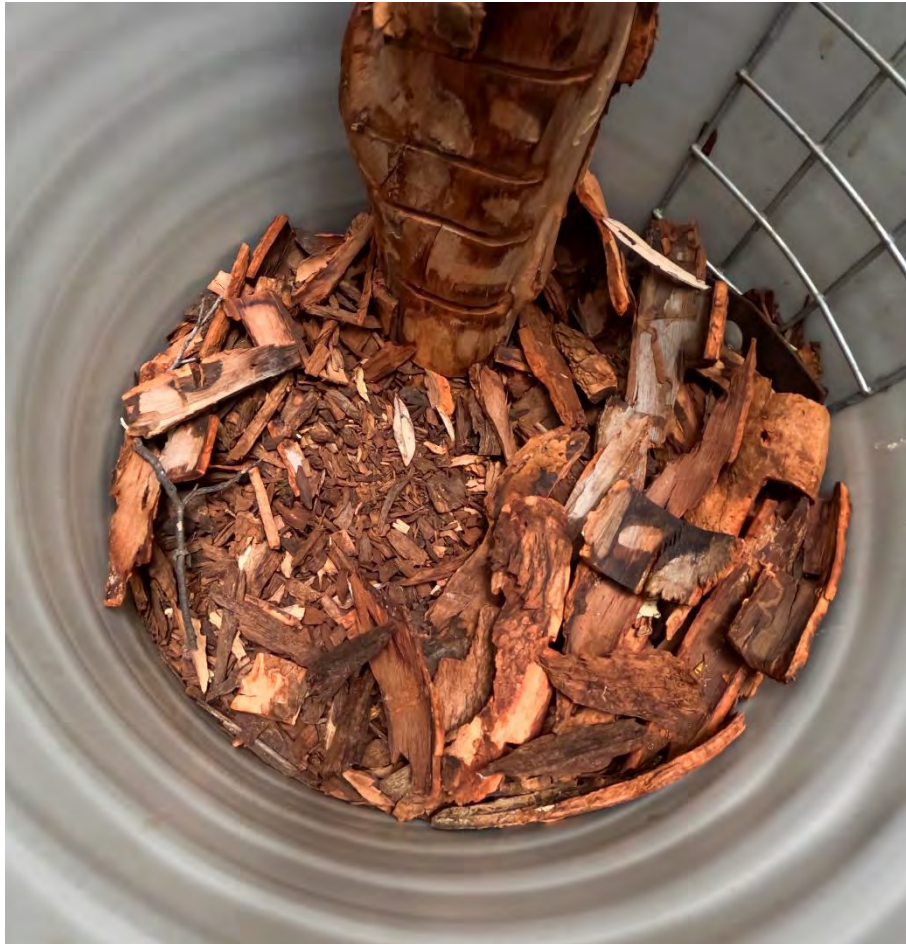
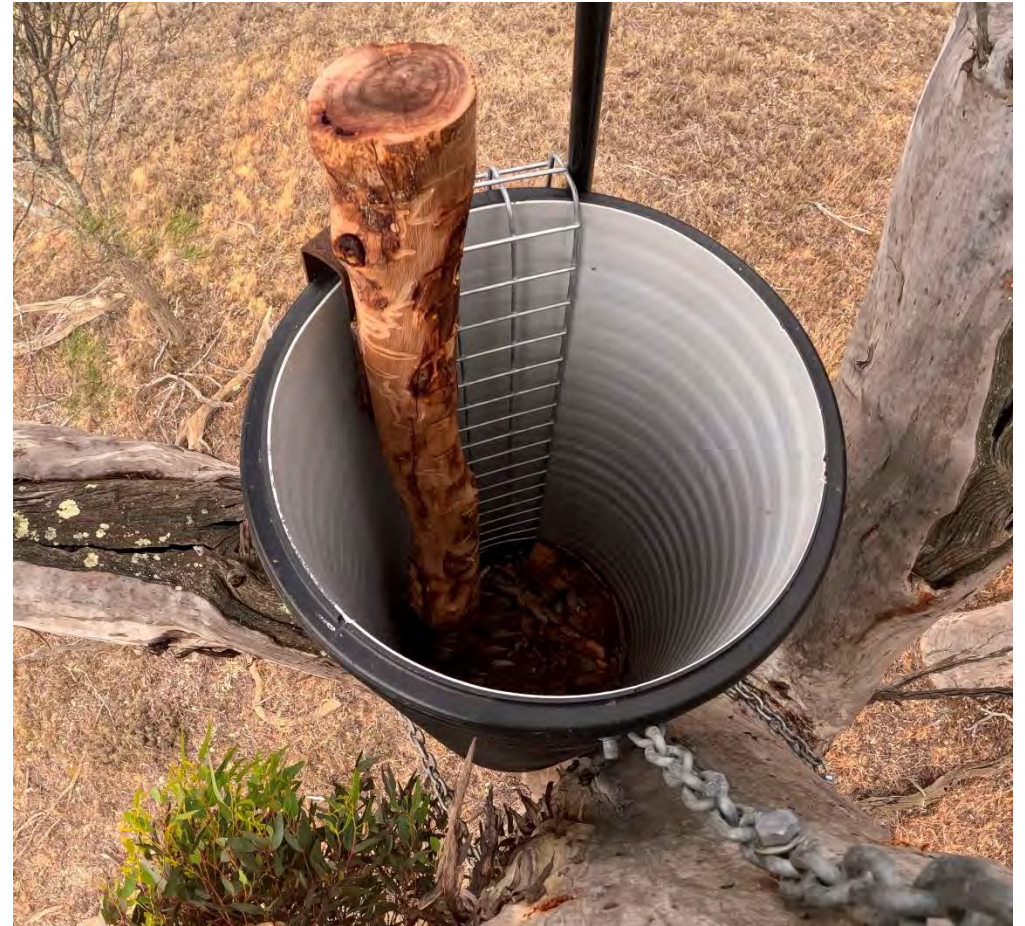
## Artificial Hollow BY19

| Hollow No | Comments | Chipping score 0-10 | Wood Chips | Tree condition | Fixings and Hollow condition | Recommended repairs |
|---|---|---|---|---|---|---|
| BY19 | Chewing on post no signs of Breeding | 2 | Nil | Good | Good | Nil |

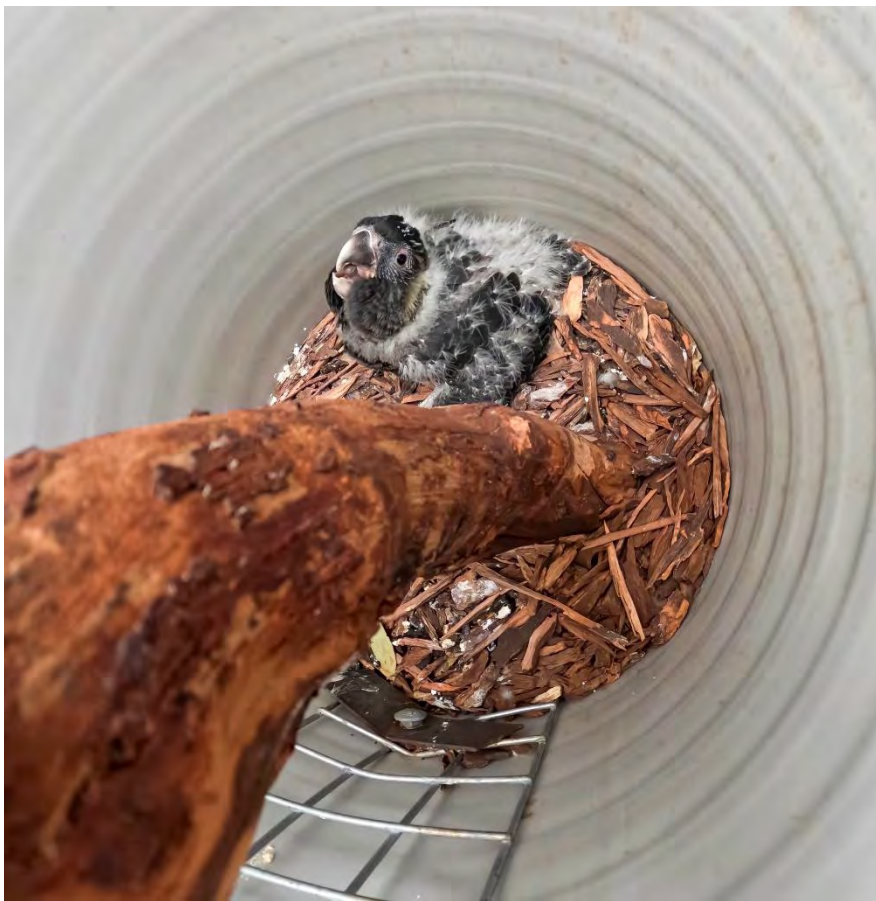
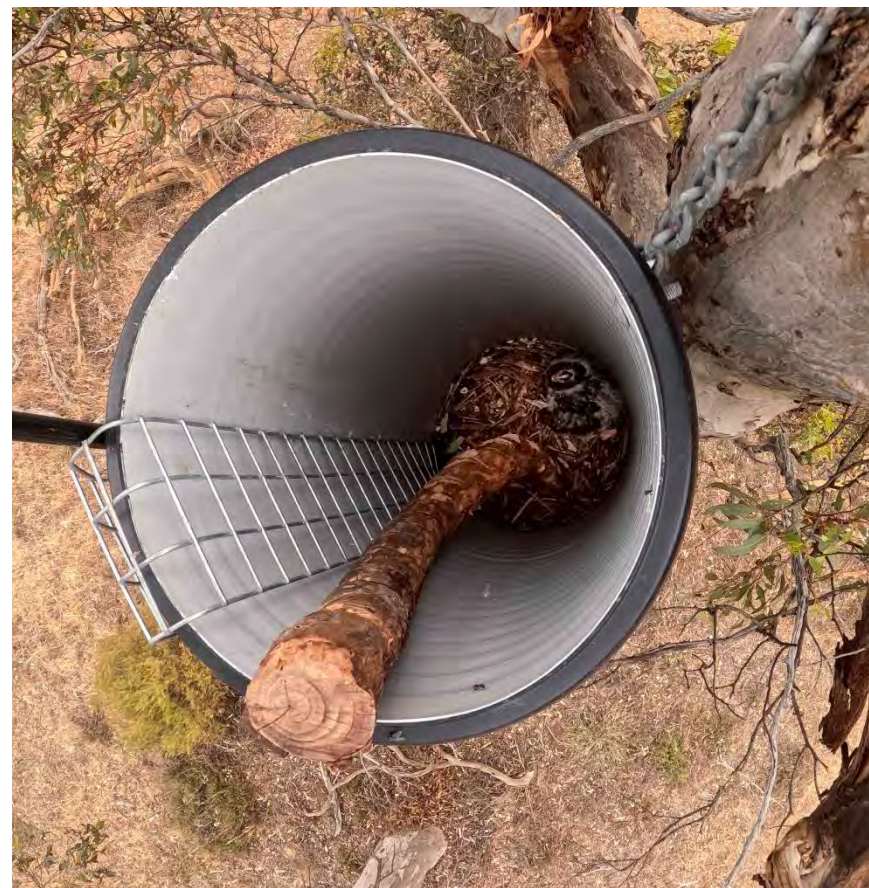
## Artificial Hollow BY20

| Hollow No | Comments | Chipping score 0-10 | Wood Chips | Tree condition | Fixings and Hollow condition | Recommended repairs |
|---|---|---|---|---|---|---|
| BY20 | One Female CC nestling 35 days old. Chewing on post | 3 | Nil | Good | Good | Nil |

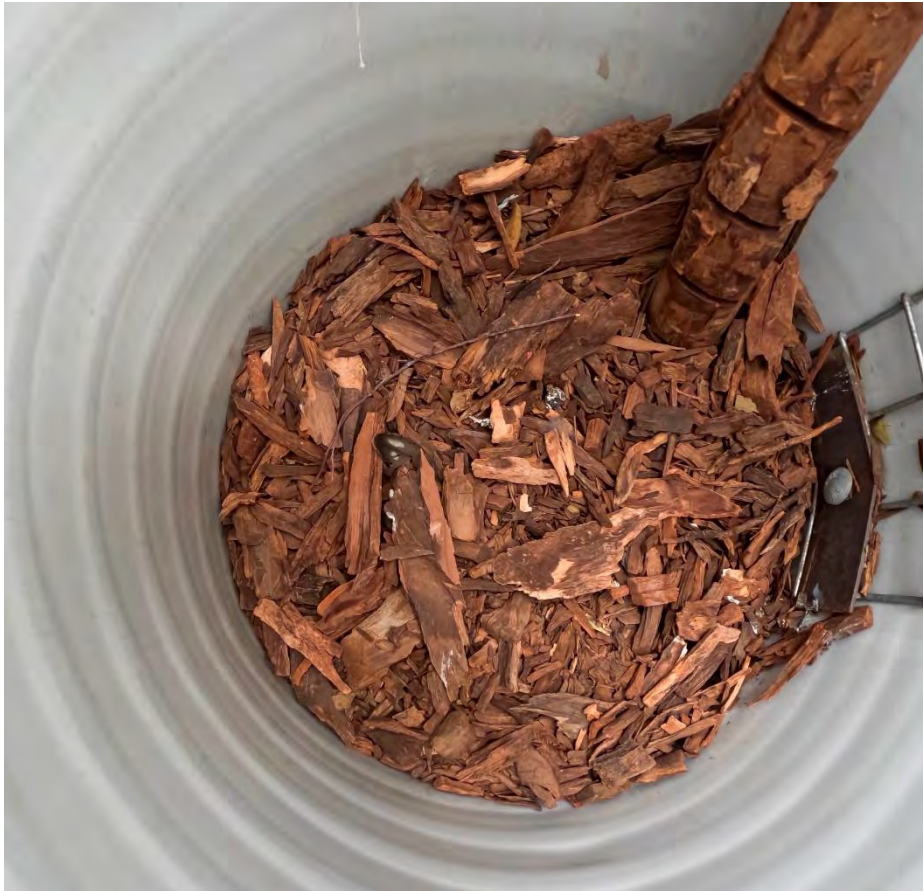
## Artificial Hollow BY21

| Hollow No | Comments | Chipping score 0-10 | Wood Chips | Tree condition | Fixings and Hollow condition | Recommended repairs |
|---|---|---|---|---|---|---|
| BY21 | Chewing on post no signs of Breeding | 1 | Nil | Good | Good | Nil |

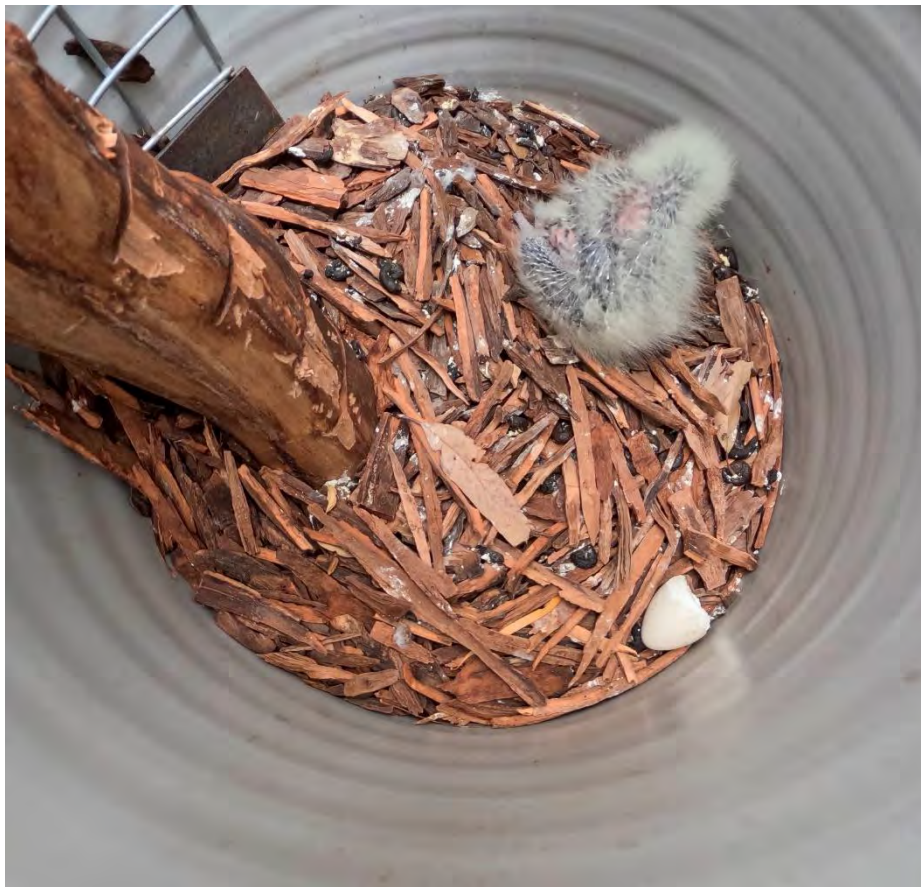
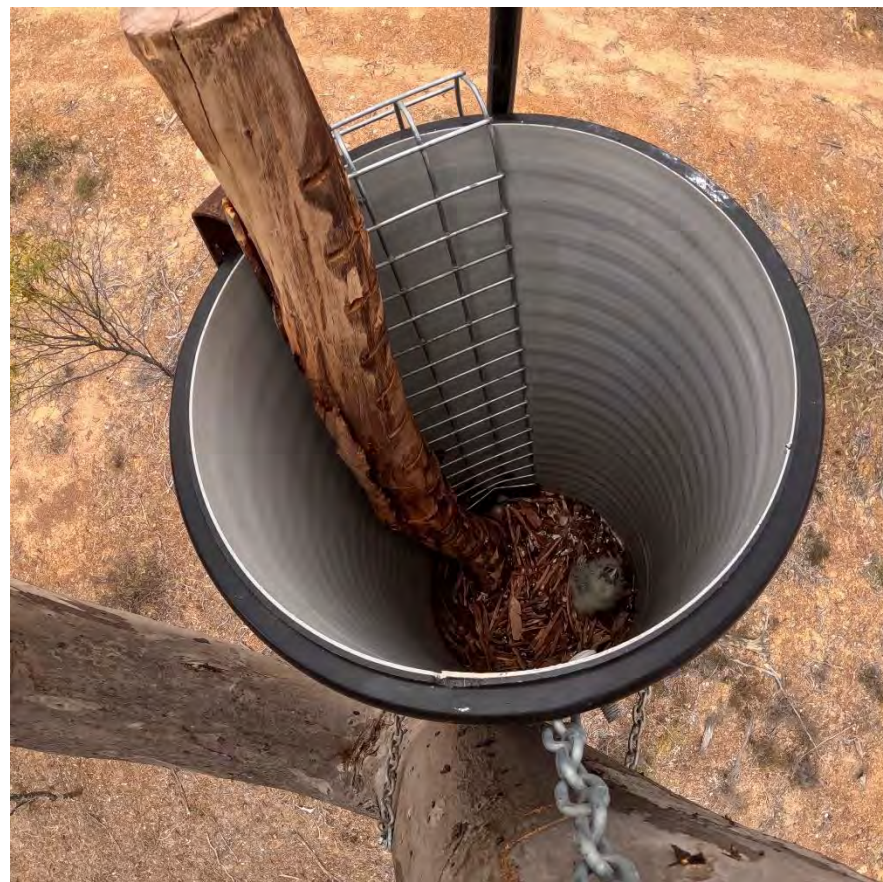
## Artificial Hollow BY22

| Hollow No | Comments | Chipping score 0-10 | Wood Chips | Tree condition | Fixings and Hollow condition | Recommended repairs |
|---|---|---|---|---|---|---|
| BY22 | One CC nestling 20-days old.<br>Chewing on post | 3 | Nil | Good | Good | Nil |

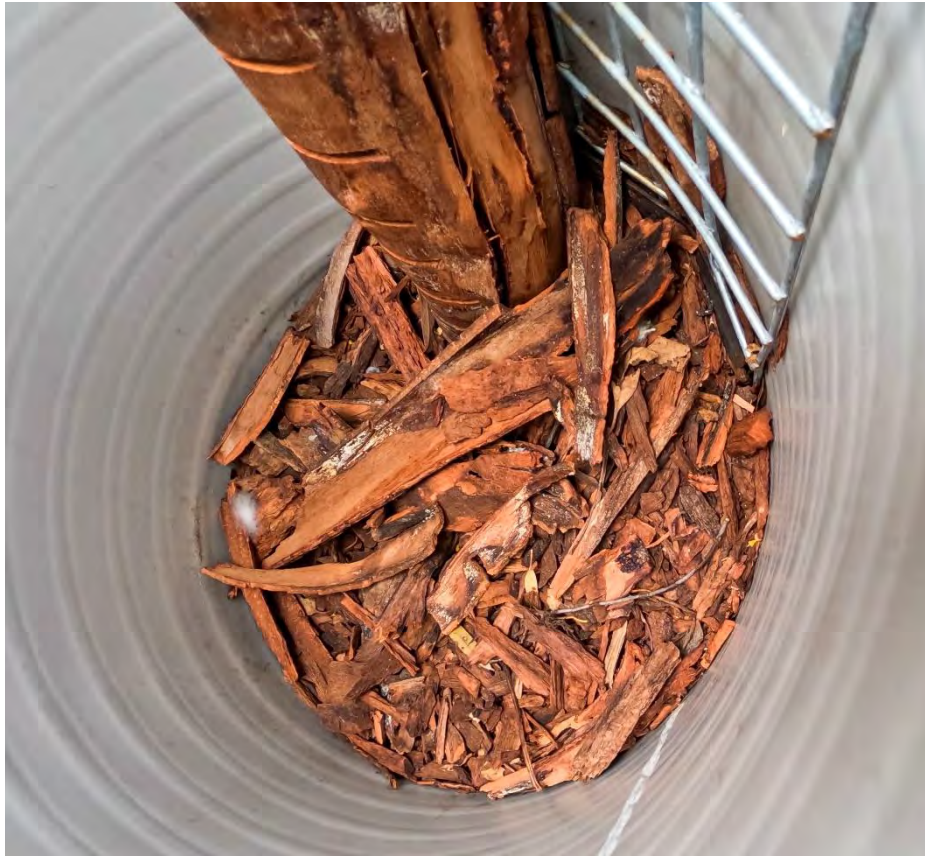
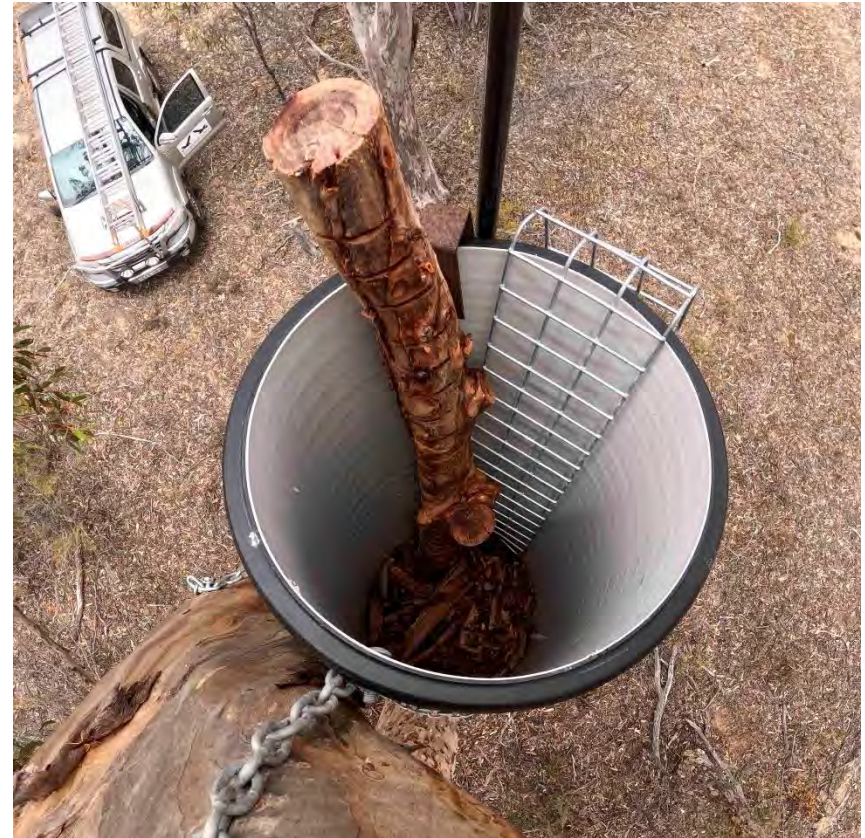
## Artificial Hollow BY23

| Hollow No | Comments | Chipping score 0-10 | Wood Chips | Tree condition | Fixings and Hollow condition | Recommended repairs |
|---|---|---|---|---|---|---|
| BY23 | Minor chewing on post, no signs of Breeding | 1 | Nil | Good | Good | Nil |

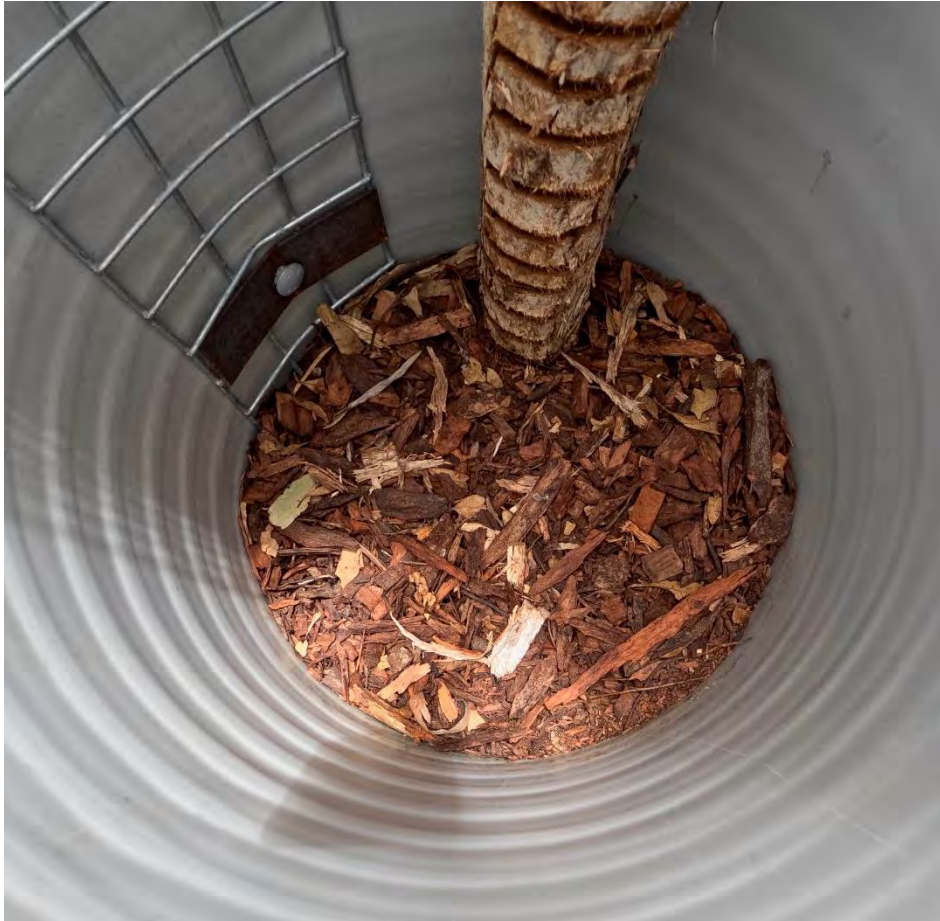
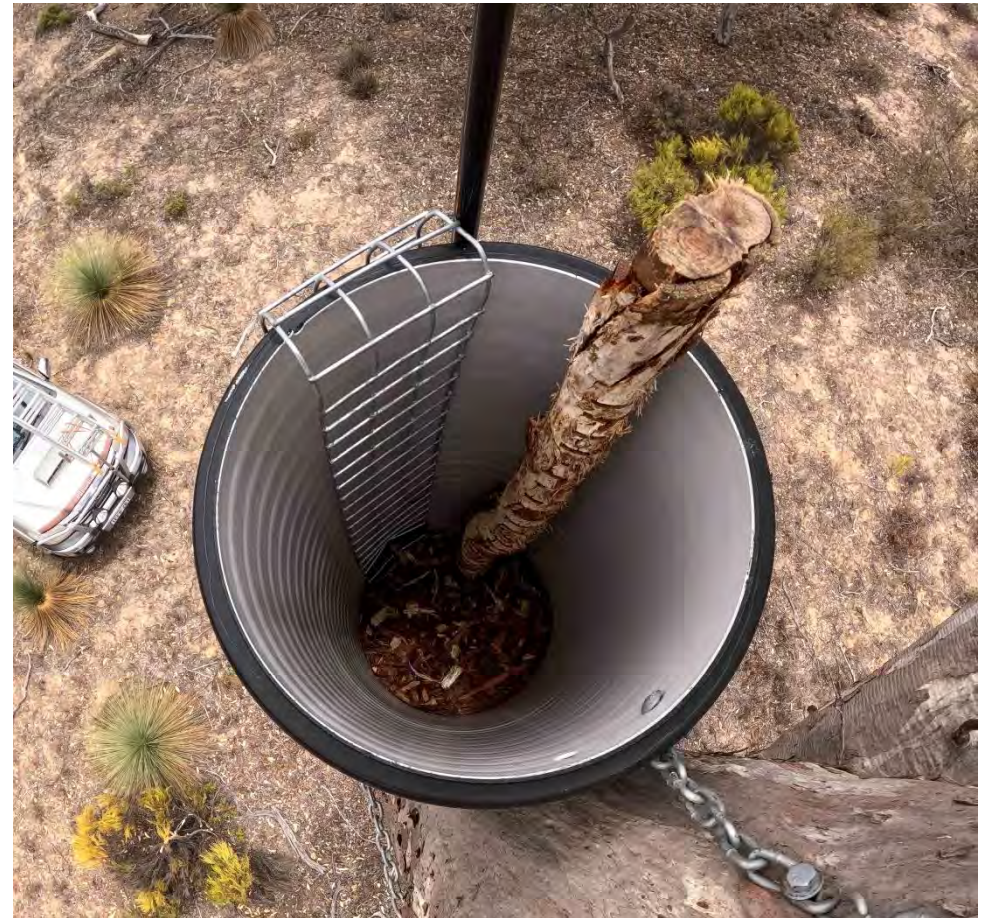
## Artificial Hollow BY24

| Hollow No | Comments | Chipping score 0-10 | Wood Chips | Tree condition | Fixings and Hollow condition | Recommended repairs |
|---|---|---|---|---|---|---|
| BY24 | No signs of nesting or inspection by Black Cockatoos | 0 | Nil | Good | Good | Nil |

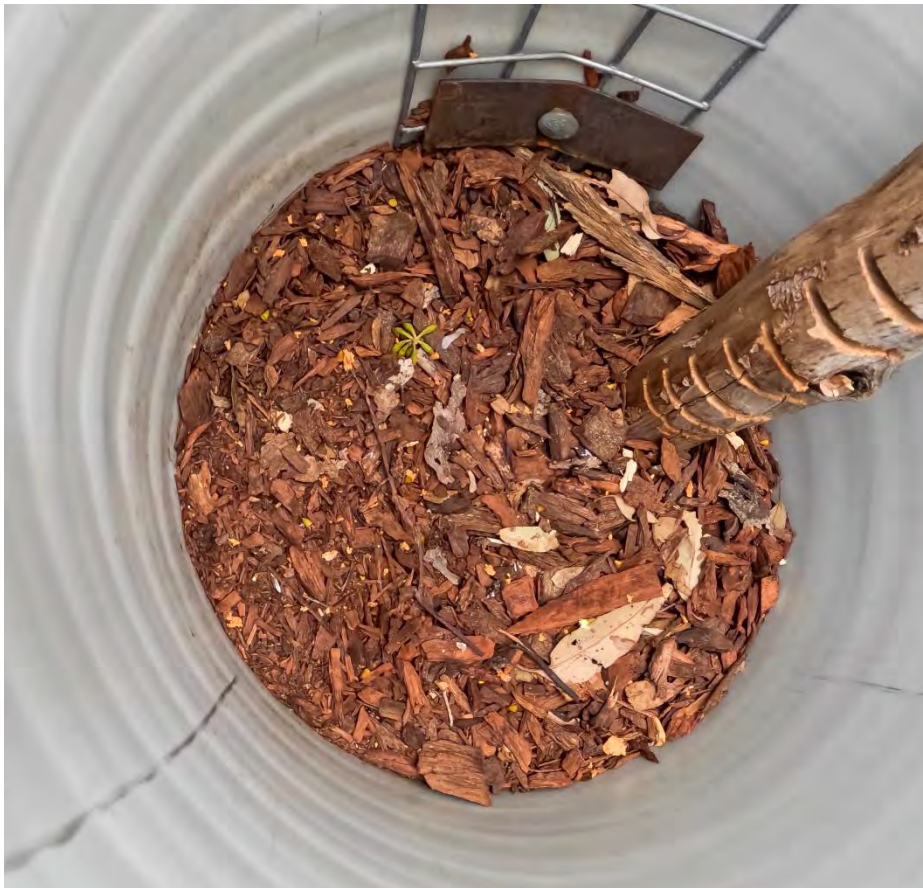
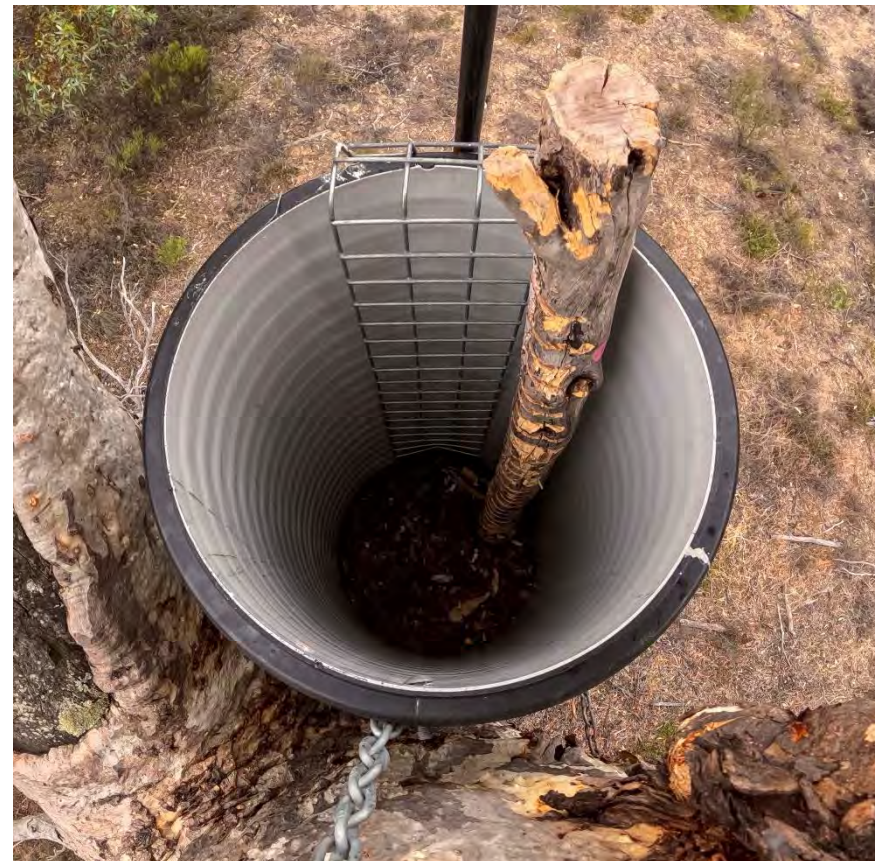
## Artificial Hollow BY25

| Hollow No | Comments | Chipping score 0-10 | Wood Chips | Tree condition | Fixings and Hollow condition | Recommended repairs |
|---|---|---|---|---|---|---|
| BY25 | Chewing on post, no signs of Breeding | 3 | Nil | Good | Good | Nil |

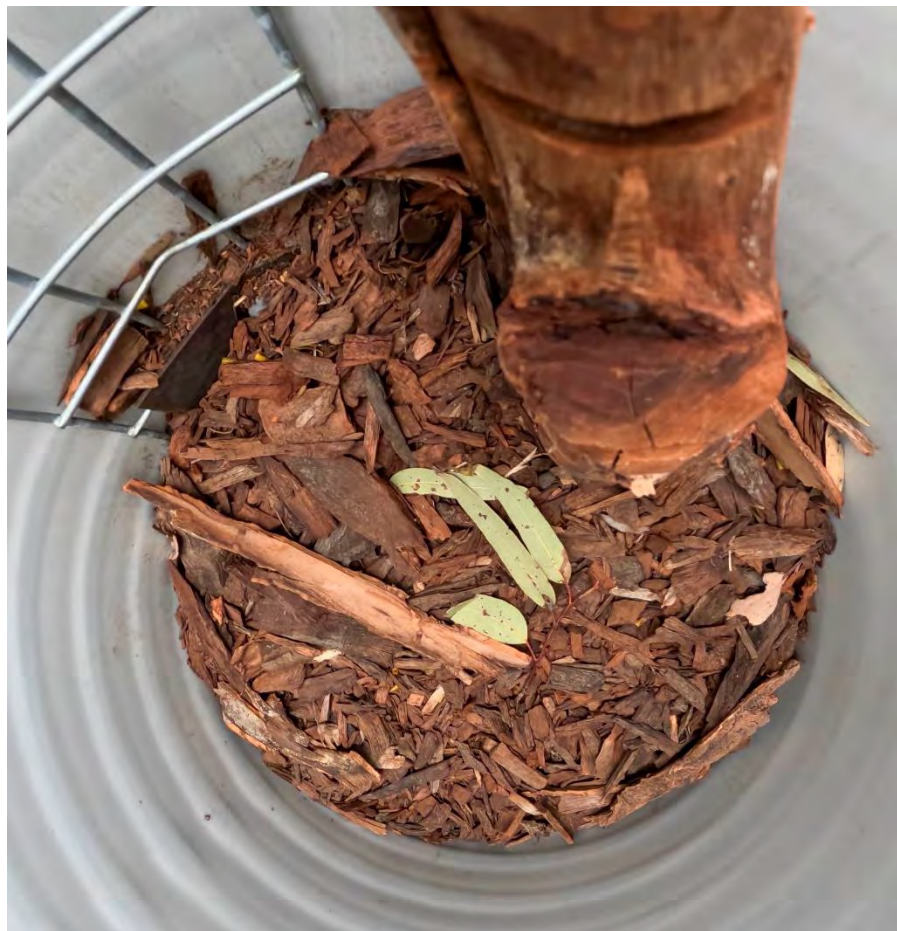
## Artificial Hollow BY26

| Hollow No | Comments | Chipping score 0-10 | Wood Chips | Tree condition | Fixings and Hollow condition | Recommended repairs |
|---|---|---|---|---|---|---|
| BY26 | Minor chewing on post, no signs of Breeding | 1 | Nil | Good | Good | Nil |

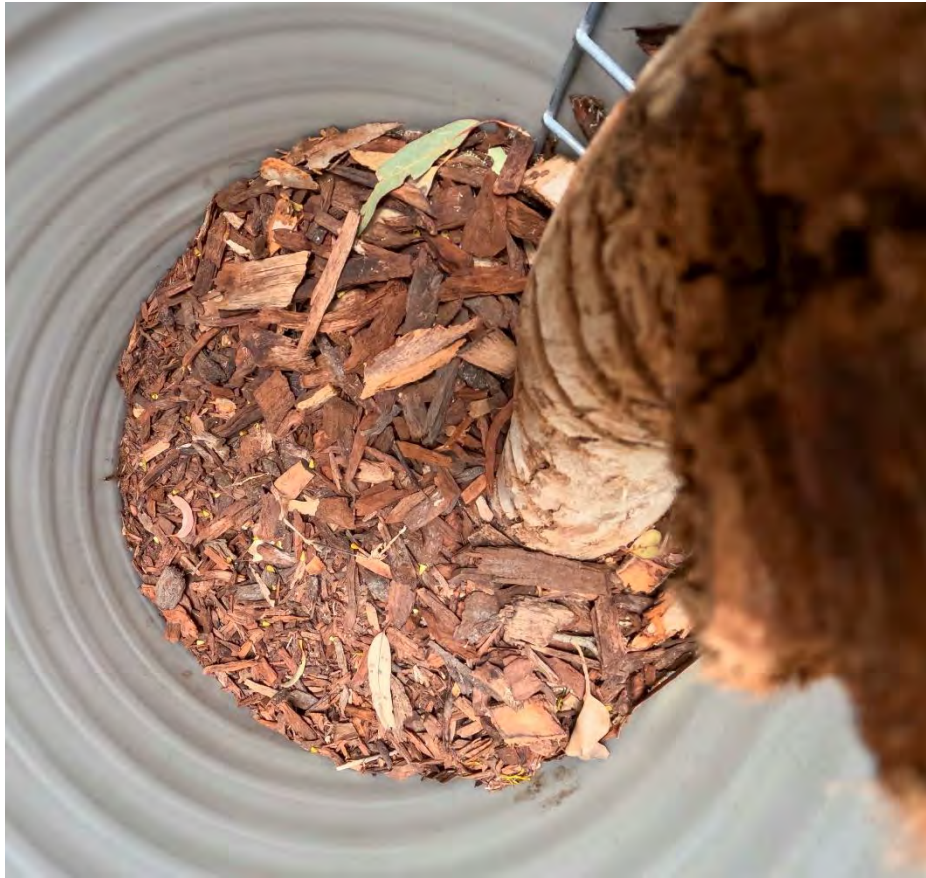
## Artificial Hollow BY27

| Hollow No | Comments | Chipping score 0-10 | Wood Chips | Tree condition | Fixings and Hollow condition | Recommended repairs |
|---|---|---|---|---|---|---|
| BY27 | Minor chewing on post, no signs of Breeding | 1 | Nil | Good | Good | Nil |

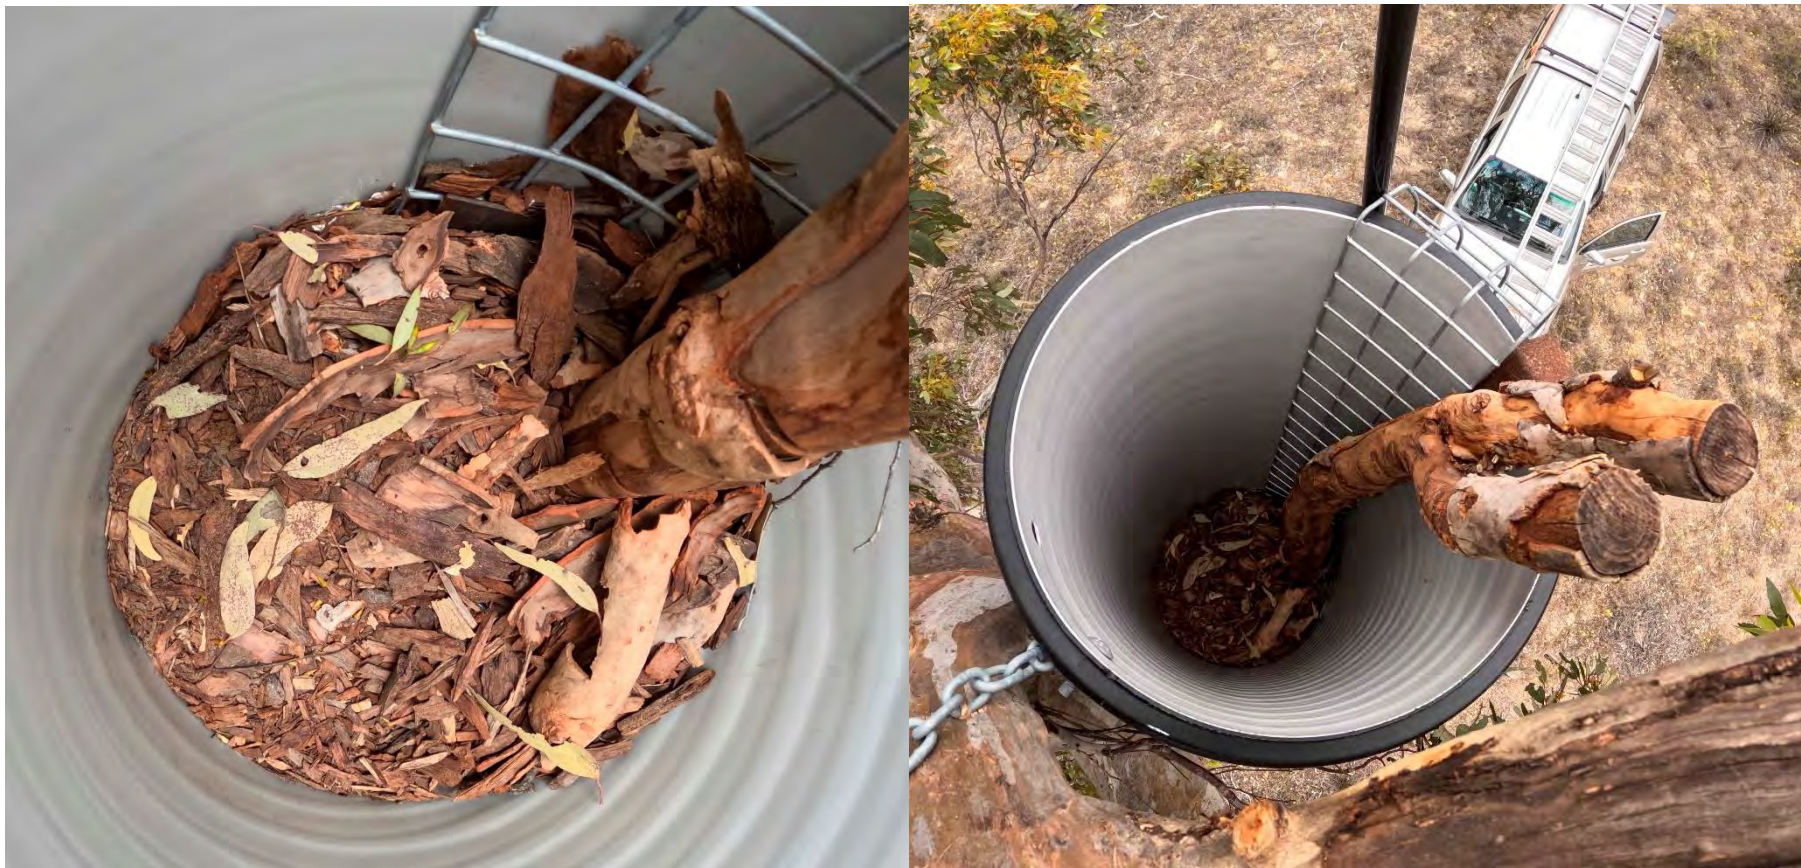
## Artificial Hollow BY28

| Hollow No | Comments | Chipping score 0-10 | Wood Chips | Tree condition | Fixings and Hollow condition | Recommended repairs |
|---|---|---|---|---|---|---|
| BY28 | No signs of nesting or inspection by Black Cockatoos | 0 | Nil | Good | Good | Nil |
