# Bunbury Outer Ring Road

## Southern Section

Ministerial Statement 1191

Compliance Assessment Report

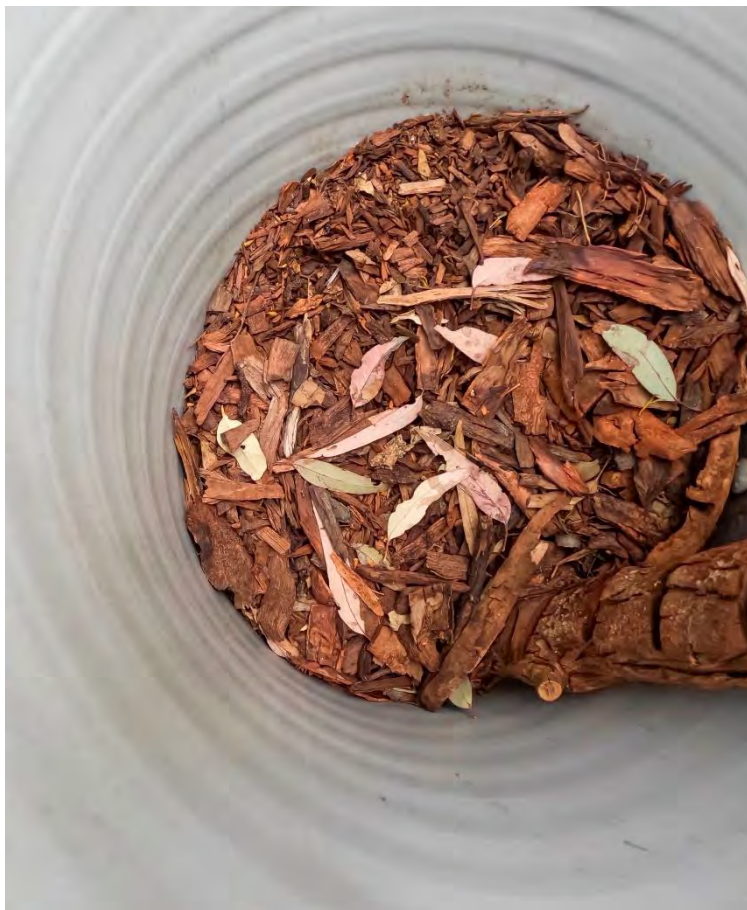
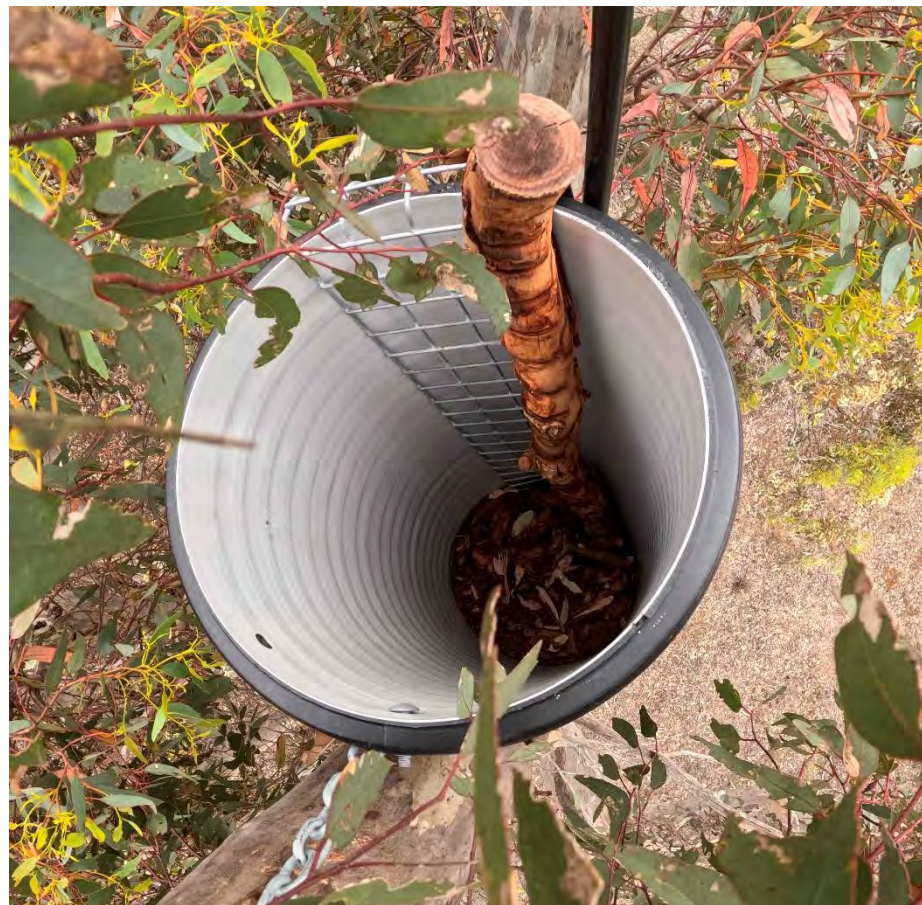
## Artificial Hollow BY30

| Hollow No | Comments | Chipping score 0-10 | Wood Chips | Tree condition | Fixings and Hollow condition | Recommended repairs |
|---|---|---|---|---|---|---|
| BY30 | No signs of nesting or inspection by Black Cockatoos | 0 | Nil | Good | Good | Nil |

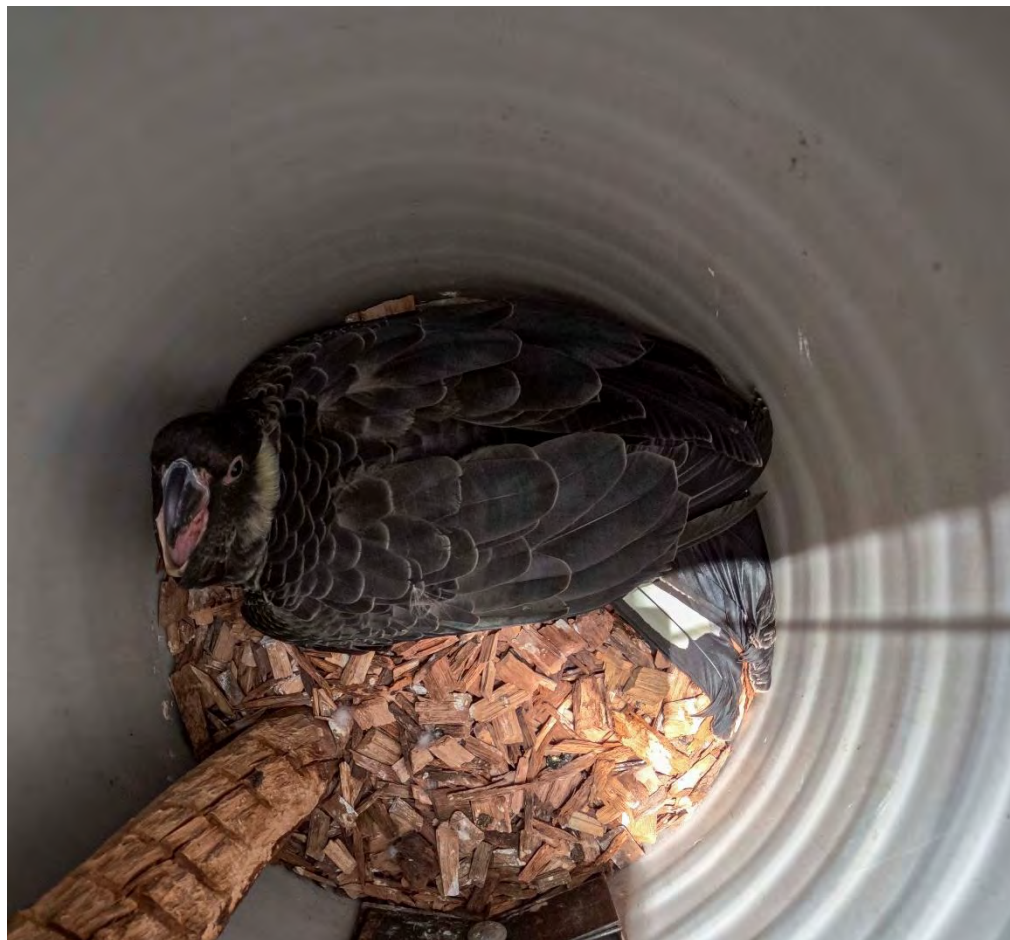
## Artificial Hollow BY31

| Hollow No | Comments | Chipping score 0-10 | Wood Chips | Tree condition | Fixings and Hollow condition | Recommended repairs |
|---|---|---|---|---|---|---|
| BY31 | 80-day old Nestling still present, will fledge any day. | 3 | Nil | Good | Good | Nil |

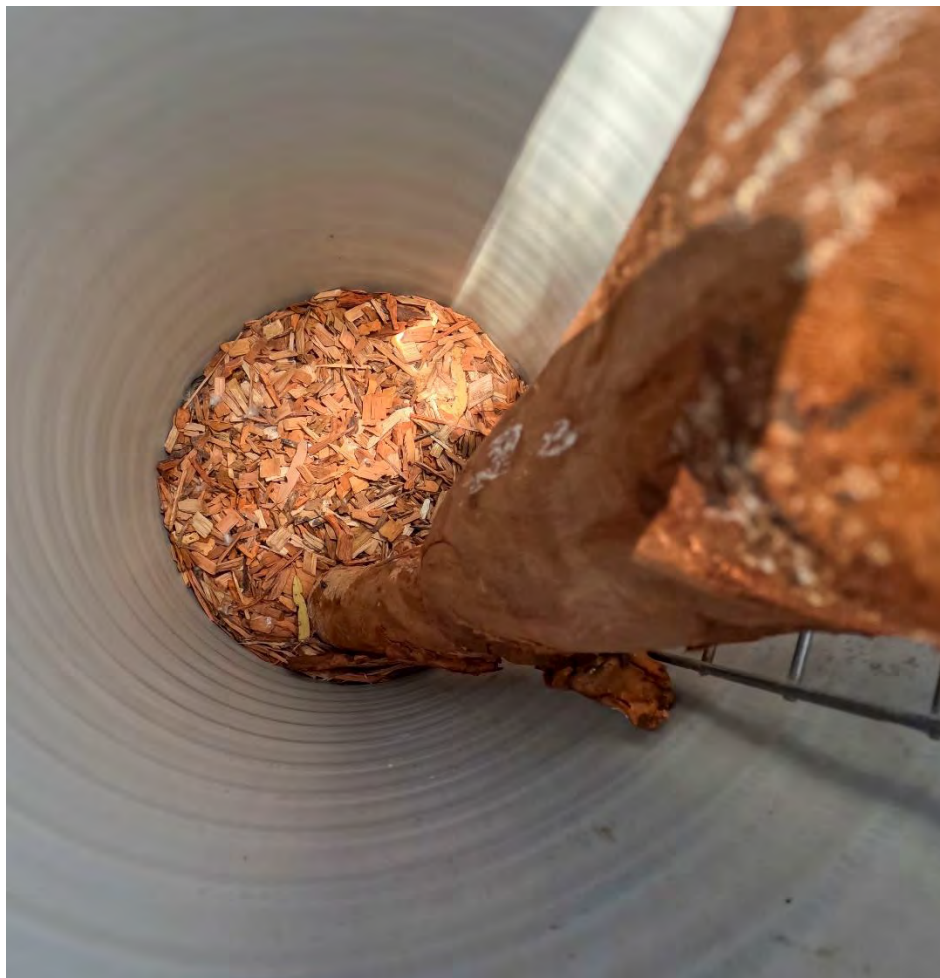
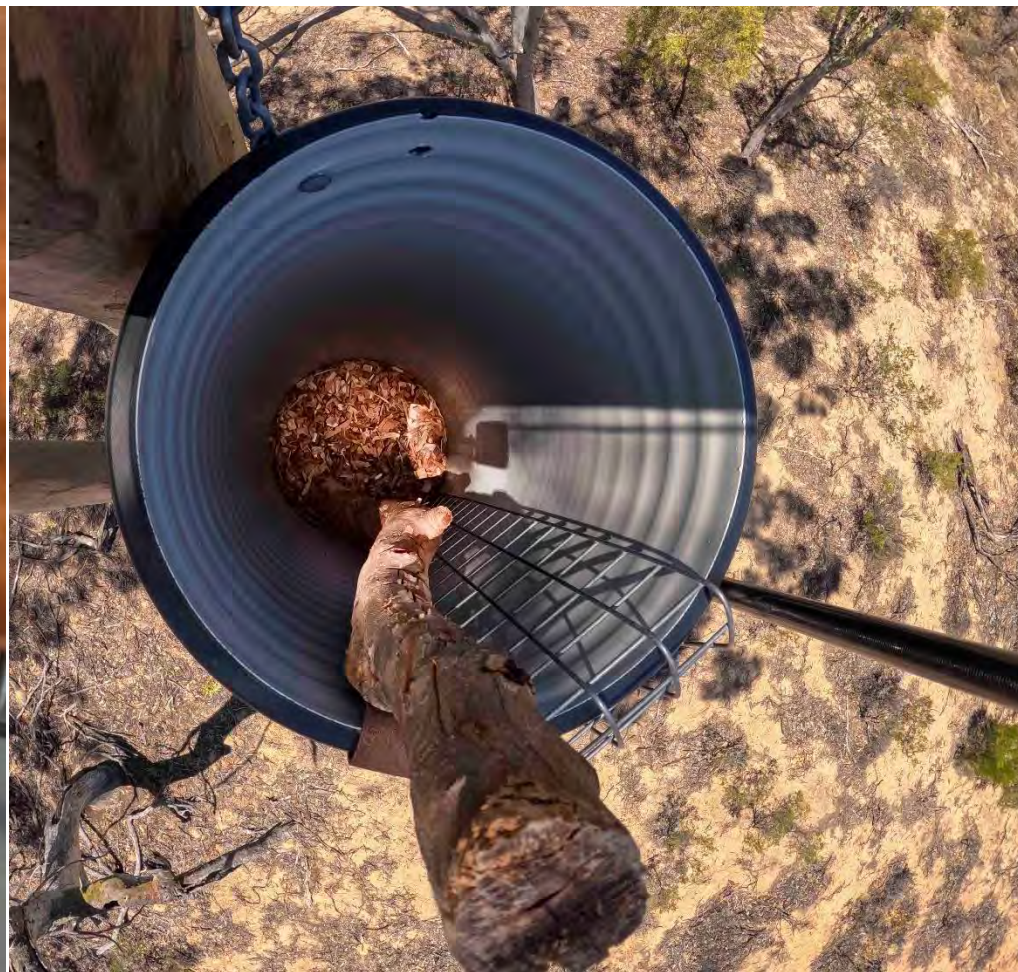
## Artificial Hollow BY32

| Hollow No | Comments | Chipping score 0-10 | Wood Chips | Tree condition | Fixings and Hollow condition | Recommended repairs |
|---|---|---|---|---|---|---|
| BY32 | Chewing on post no signs of Breeding | 3 | Nil | Good | Good | Nil |

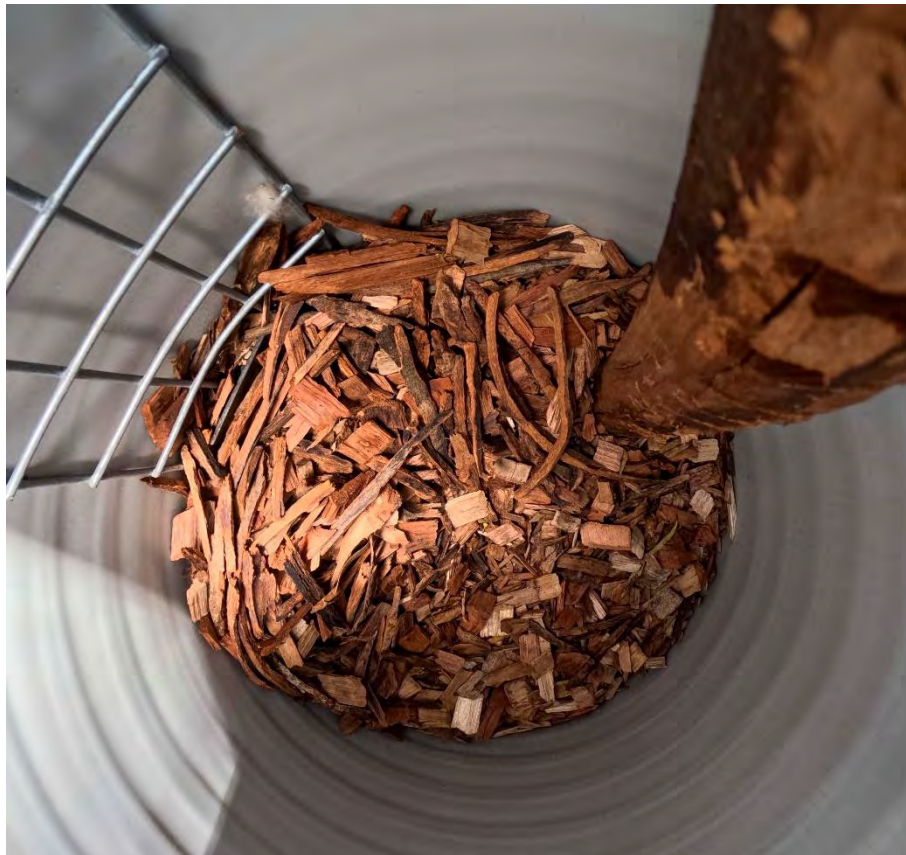
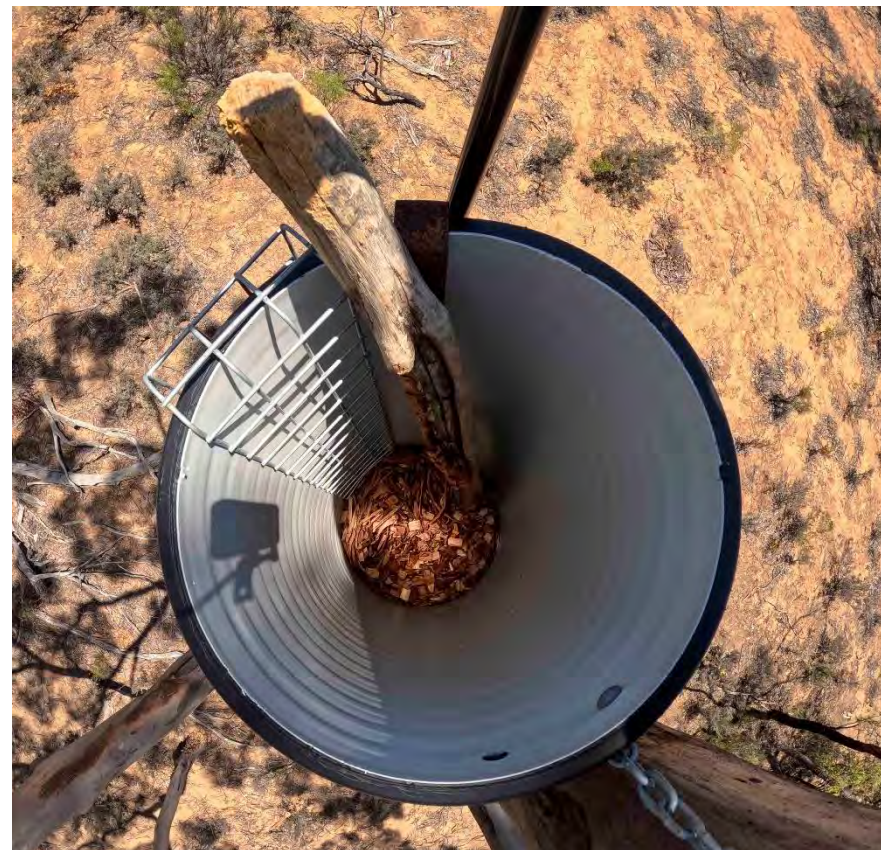
## Artificial Hollow BY33

| Hollow No | Comments | Chipping score 0-10 | Wood Chips | Tree condition | Fixings and Hollow condition | Recommended repairs |
|---|---|---|---|---|---|---|
| BY33 | Chewing on post no signs of Breeding | 3 | Nil | Good | Good | Nil |

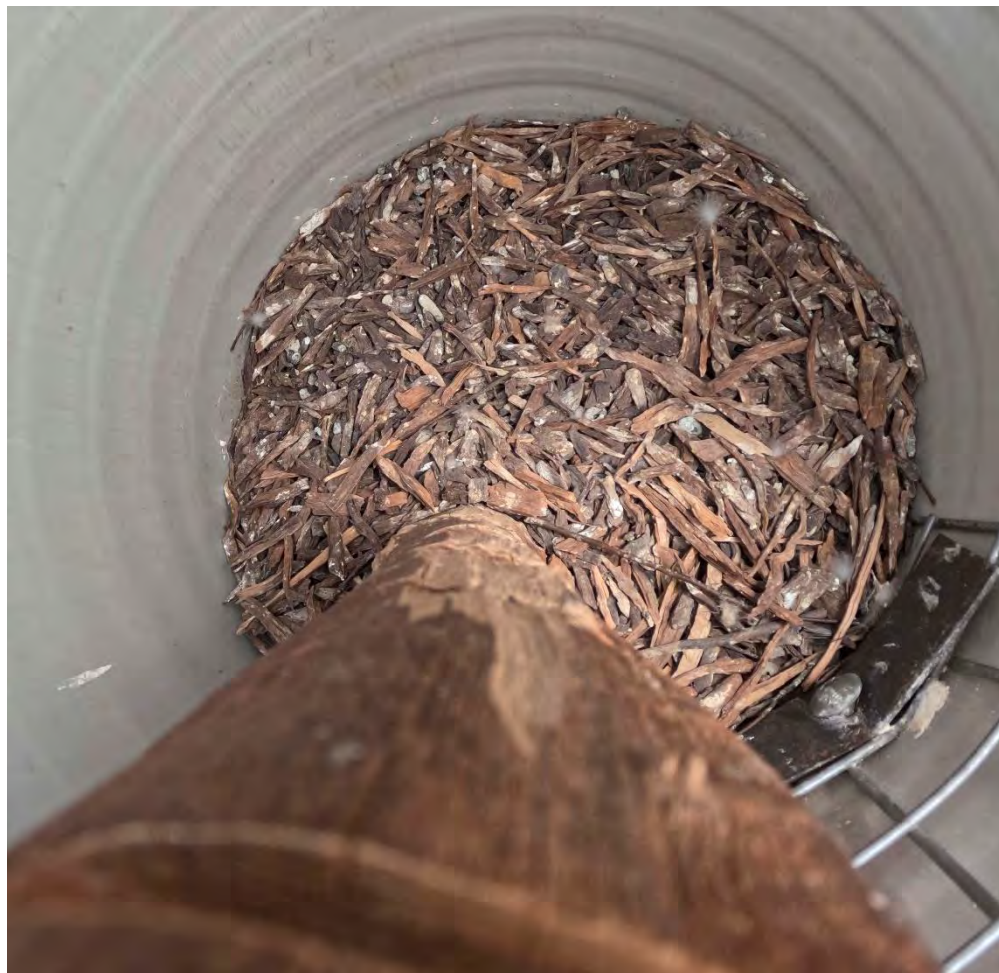
## Artificial Hollow BY34

| Hollow No | Comments | Chipping score 0-10 | Wood Chips | Tree condition | Fixings and Hollow condition | Recommended repairs |
|---|---|---|---|---|---|---|
| BY34 | Nestling Fledged | 3 | Nil | Good | Good | Nil |

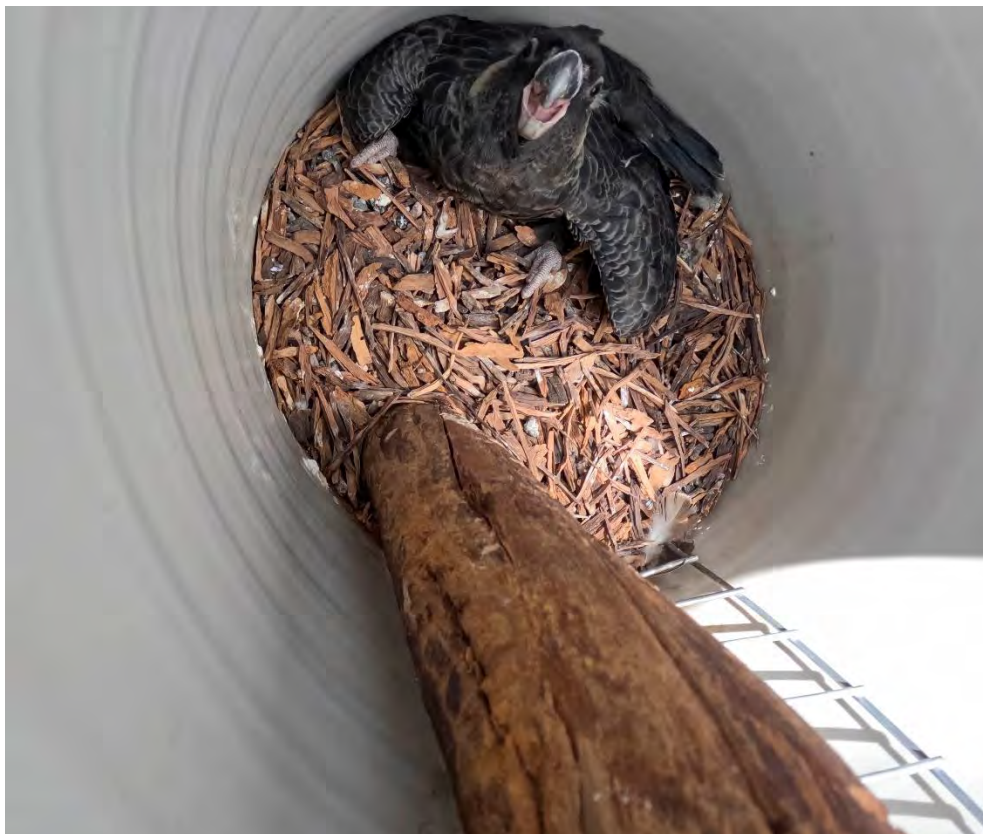
## Artificial Hollow BY35

| Hollow No | Comments | Chipping score 0-10 | Wood Chips | Tree condition | Fixings and Hollow condition | Recommended repairs |
|---|---|---|---|---|---|---|
| BY35 | Male Carnabys,50 days old CC,<br>Chewing on post | 3 | Nil | Good | Good | Nil |

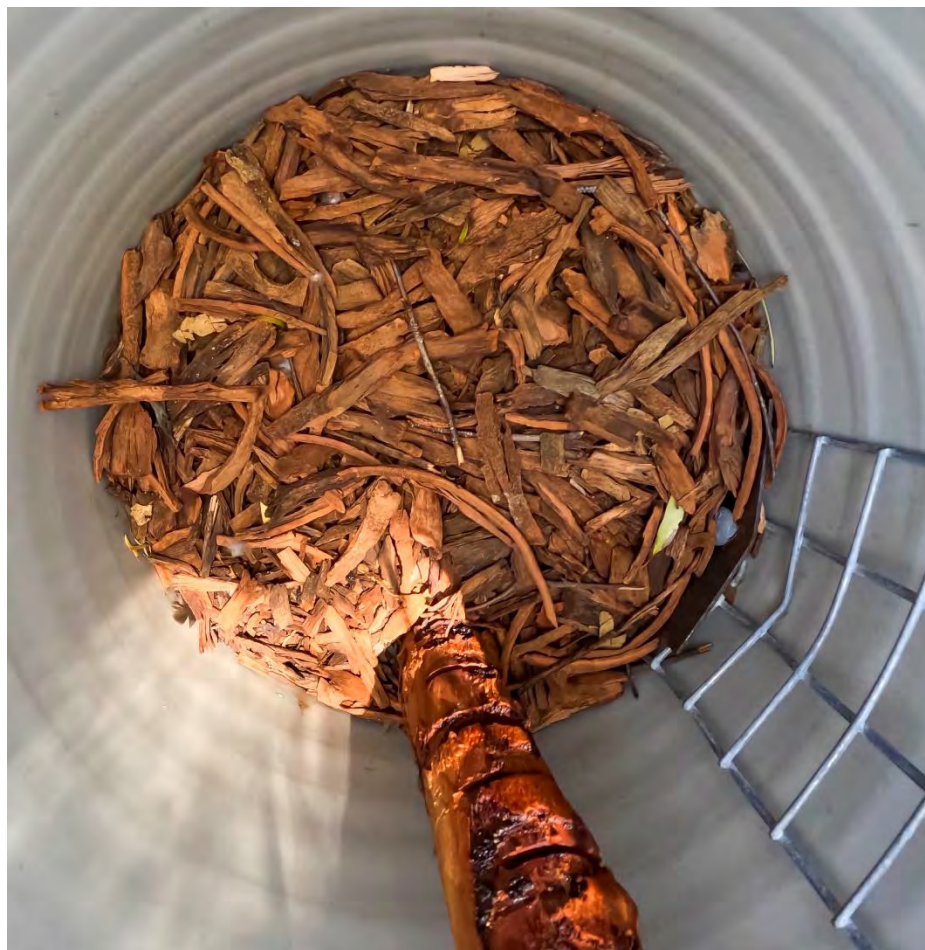
## Artificial Hollow BY36

| Hollow No | Comments | Chipping score 0-10 | Wood Chips | Tree condition | Fixings and Hollow condition | Recommended repairs |
|---|---|---|---|---|---|---|
| BY36 | Chewing on post no signs of Breeding | 2 | Nil | Good | Good | Nil |

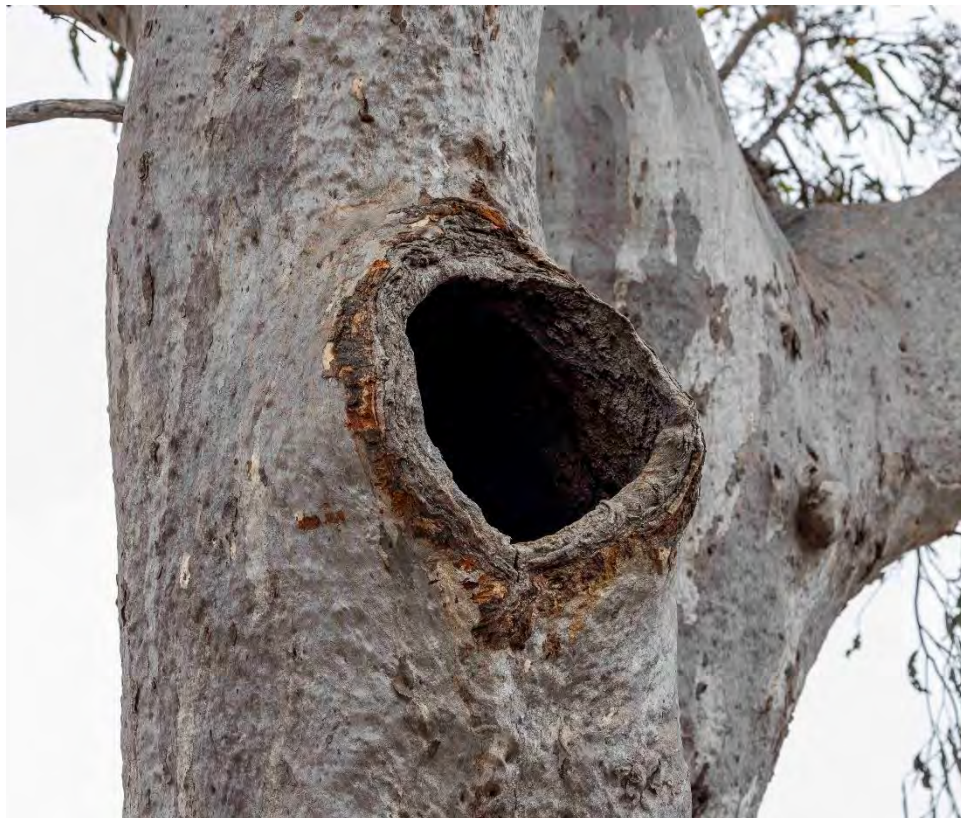
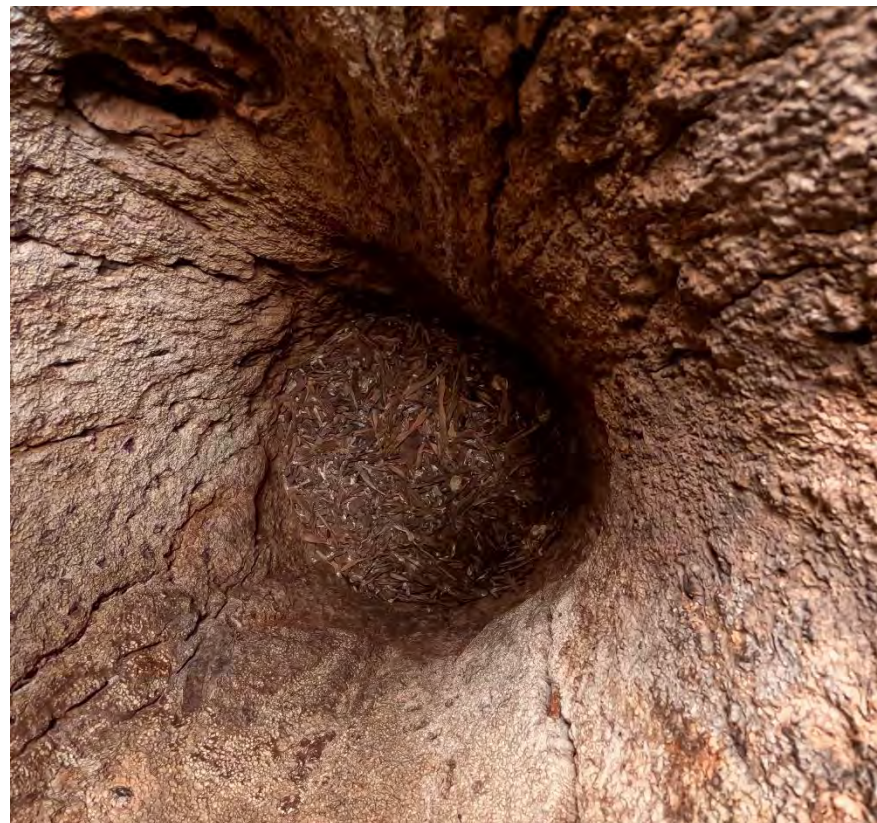
## Natural Hollow Repair One (Badgebup

| Hollow No | Comments | Chipping score 0-10 | Wood Chips | Tree condition | Fixings and Hollow condition | Recommended repairs |
|---|---|---|---|---|---|---|
| Badgebup 01 | Carnaby's Nestling Fledged | 2 | Nil | Good | N/A | Nil |

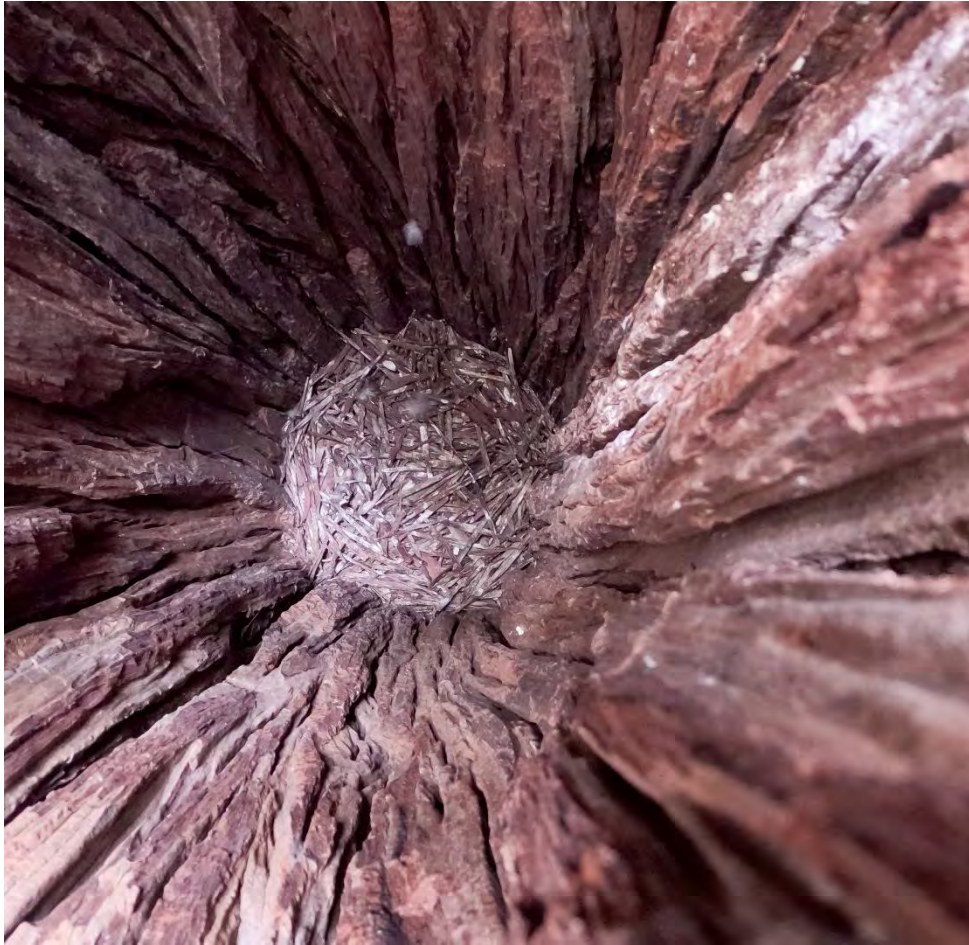
## Natural Hollow Repair Two (Kwobrup)

| Hollow No | Comments | Chipping score 0-10 | Wood Chips | Tree condition | Fixings and Hollow condition | Recommended repairs |
|---|---|---|---|---|---|---|
| Kwobrup 02 | Carnaby's Nestling Fledged | 5 | Nil | Good | N/A | Nil |

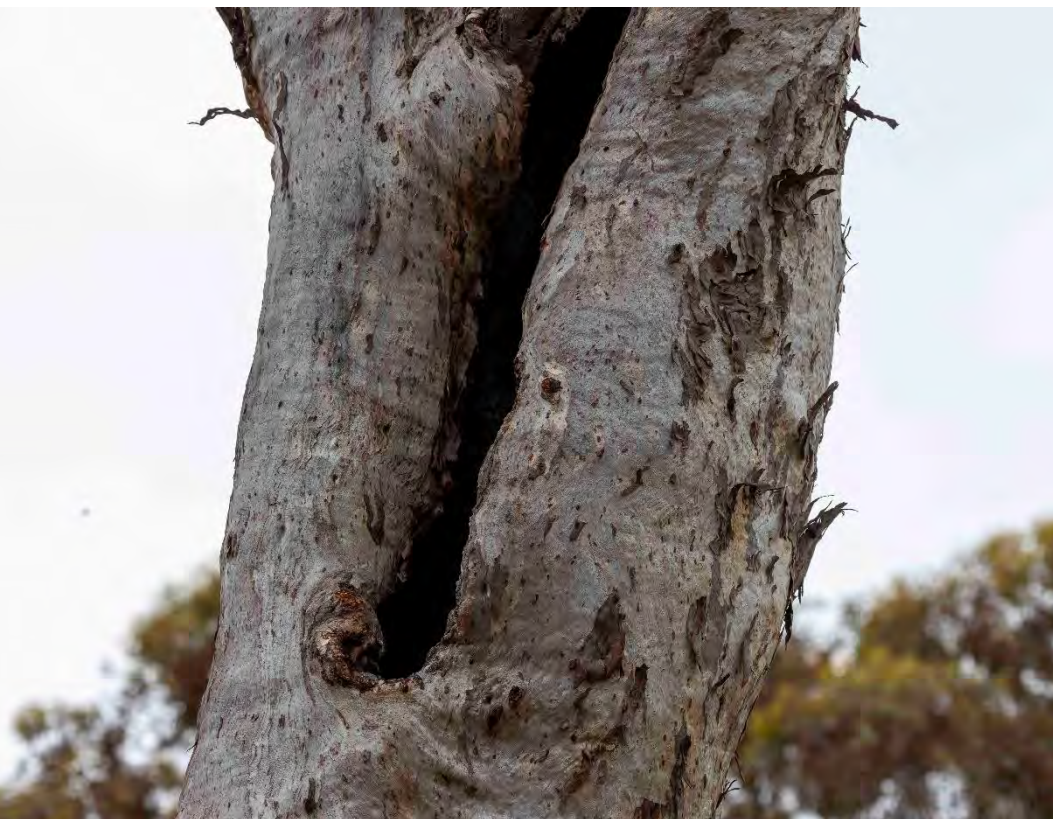
## Natural Hollow Repair Three (Kwobrup)

| Hollow No | Comments | Chipping score 0-10 | Wood Chips | Tree condition | Fixings and Hollow condition | Recommended repairs |
|---|---|---|---|---|---|---|
| Kwobrup 03 | No signs of nesting or inspection by Black Cockatoos. Cobwebs in hollow | 0 | NIL | Good | N/A | NIL |

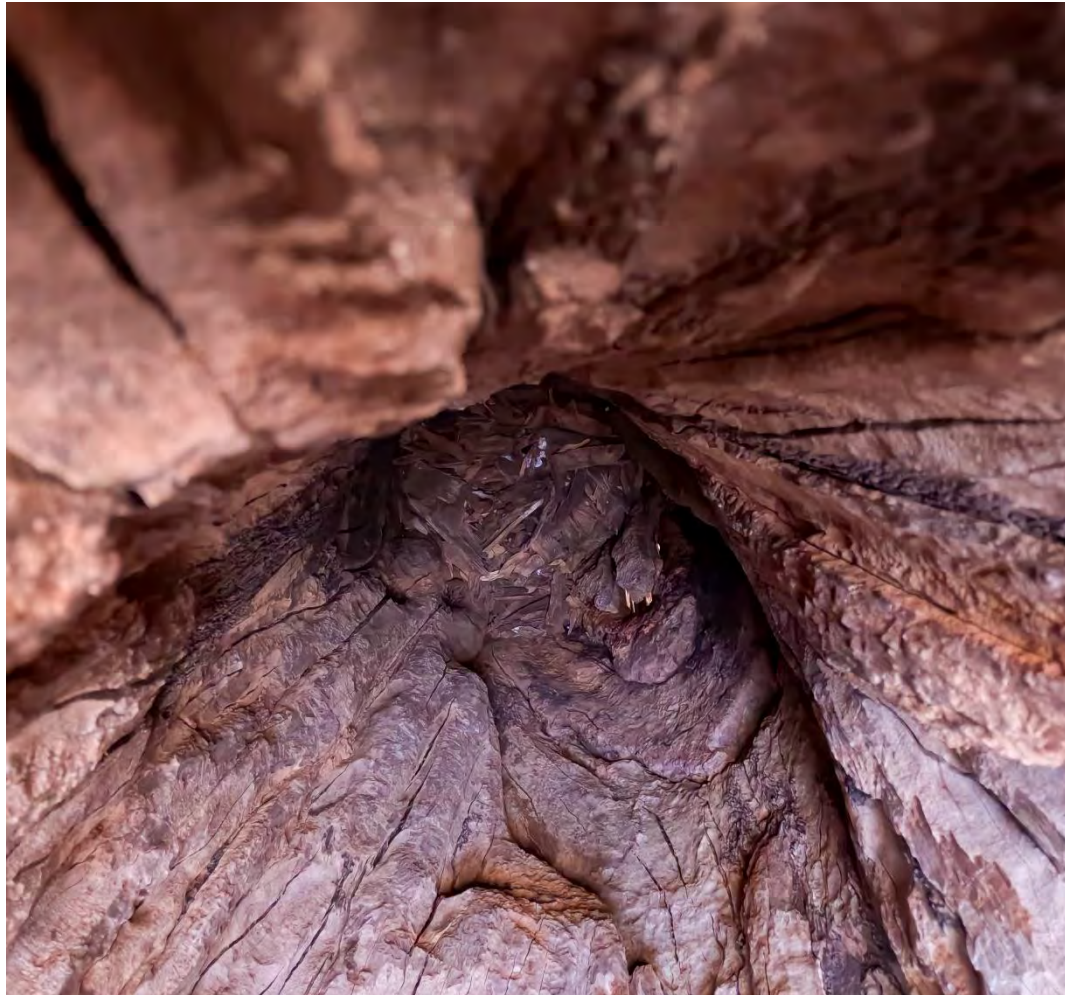
## Natural Hollow Repair One (Elphin)

| Hollow No | Comments | Chipping score 0-10 | Wood Chips | Tree condition | Fixings and Hollow condition | Recommended repairs |
|---|---|---|---|---|---|---|
| Elphin 01 | Chewing in hollow no signs of Breeding | 2 | Nil | Good | N/A | Nil |

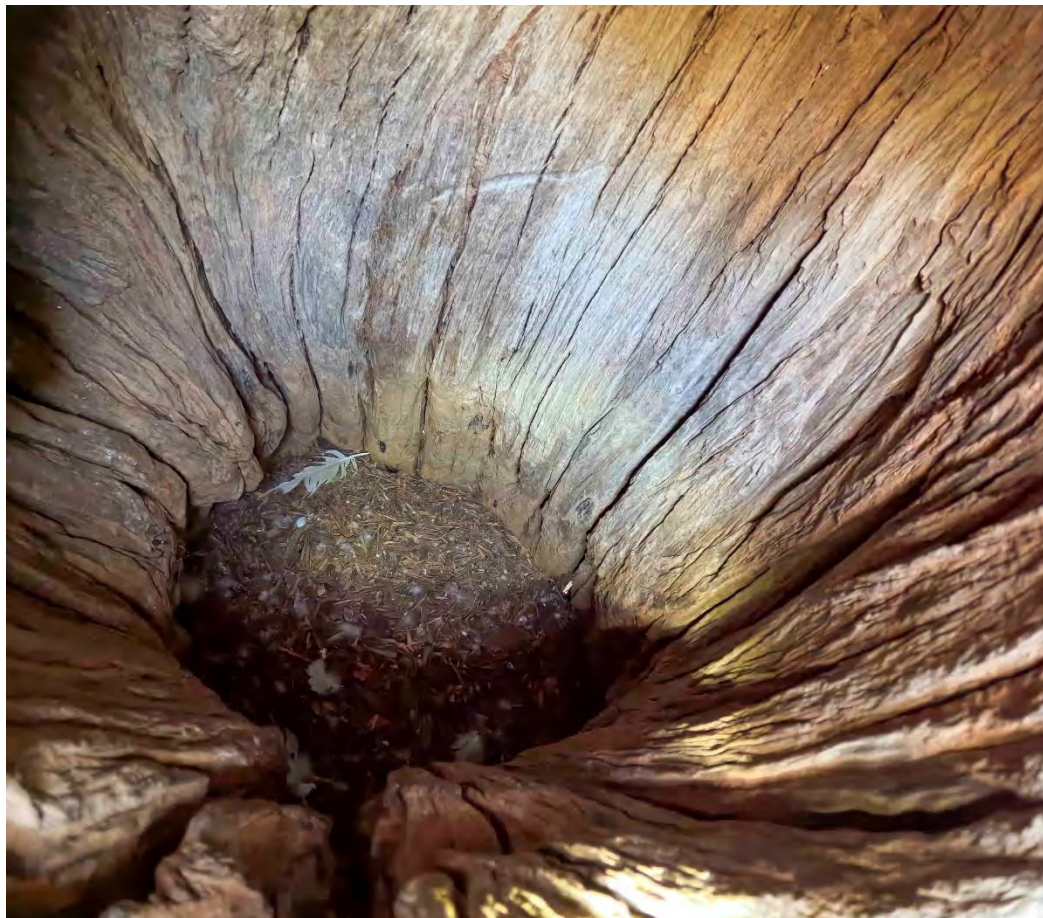
## Natural Hollow Repair Two (Elphin)

| Hollow No | Comments | Chipping score 0-10 | Wood Chips | Tree condition | Fixings and Hollow condition | Recommended repairs |
|---|---|---|---|---|---|---|
| Elphin 02 | Corellas have fledged | 2 | Nil | Good | N/A | Nil |

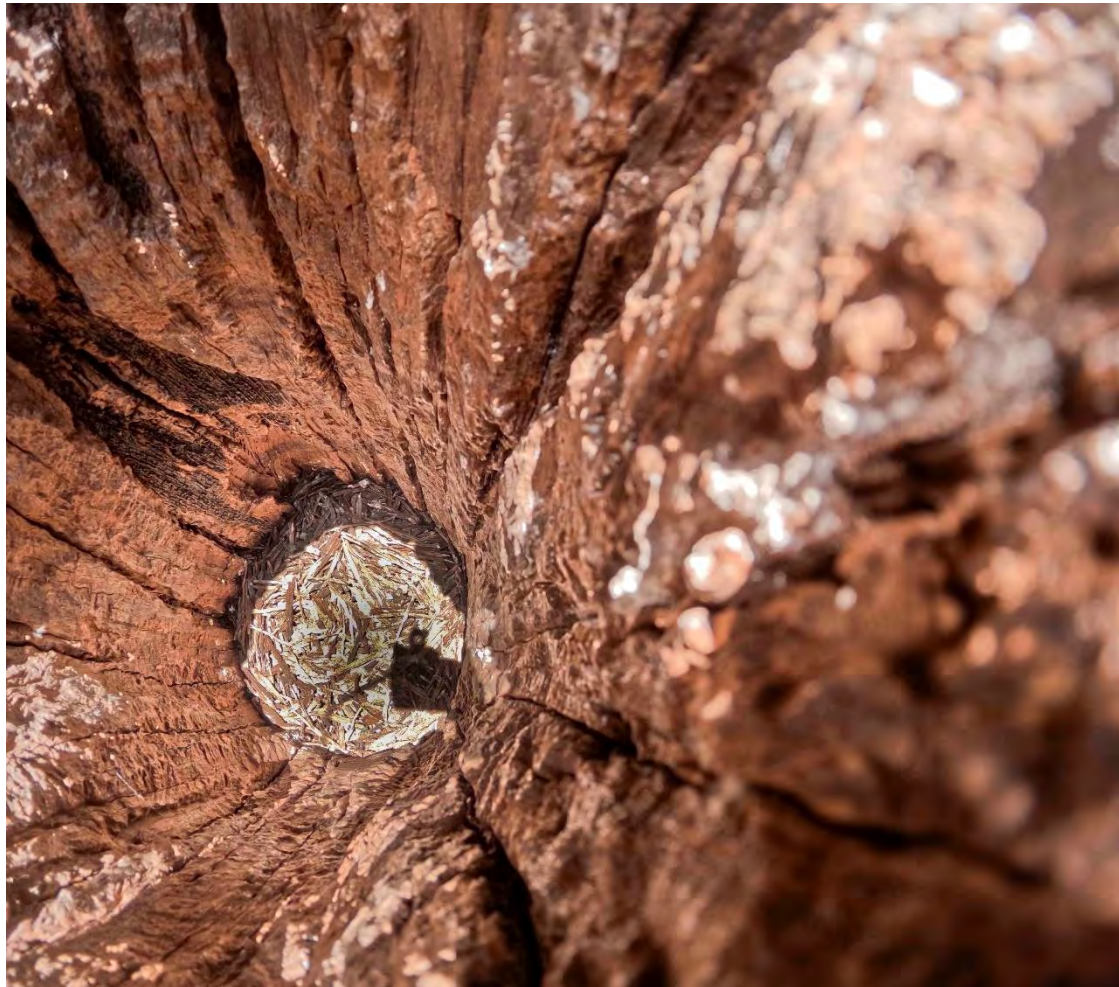
## Natural Hollow Repair Three (Elphin)

| Hollow No | Comments | Chipping score<br>0-10 | Wood<br>Chips | Tree condition | Fixings and<br>Hollow condition | Recommended repairs |
|---|---|---|---|---|---|---|
| Elphin 03 | CC Nestling has fledged. | 3 | 0 | Good | N/A | Nil |

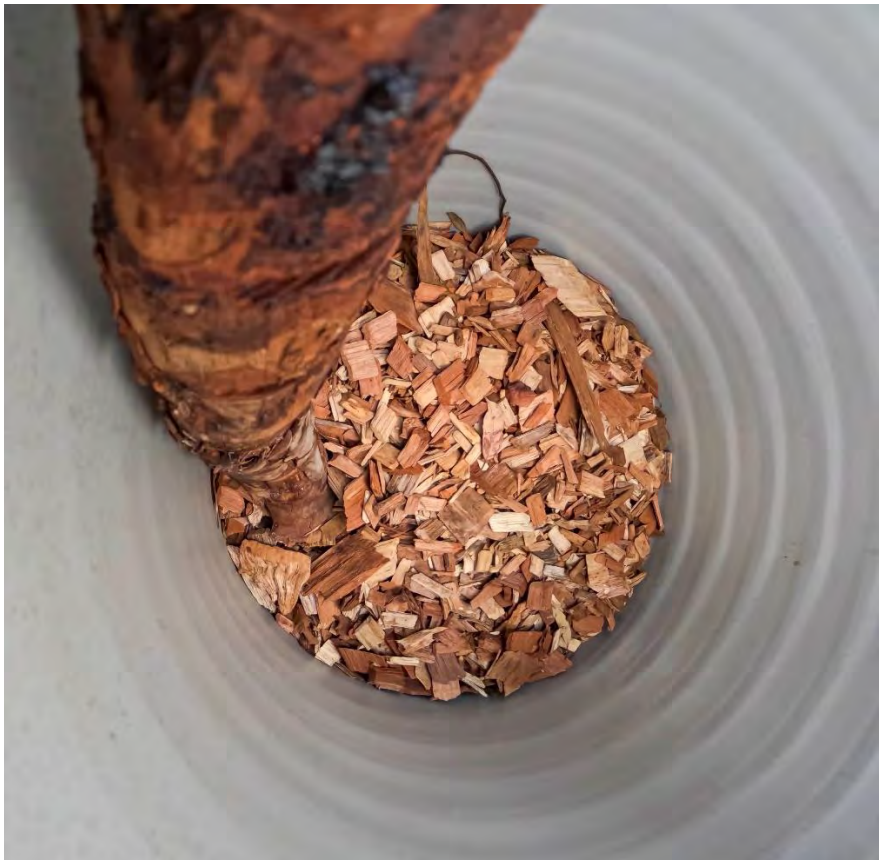
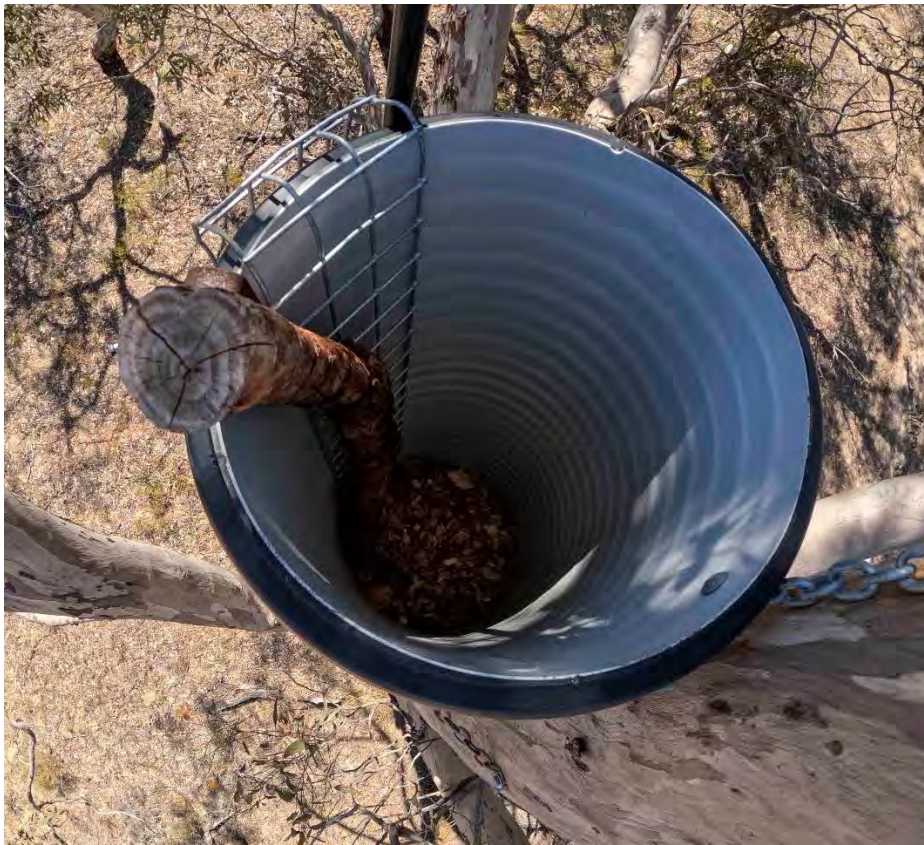
Artificial Hollow BY37

| Hollow No | Comments | Chipping score 0-10 | Wood Chips | Tree condition | Fixings and Hollow condition | Recommended repairs |
|---|---|---|---|---|---|---|
| BY37 | No signs of nesting or inspection by Black Cockatoos | 0 | Nil | Good | Good | Nil |

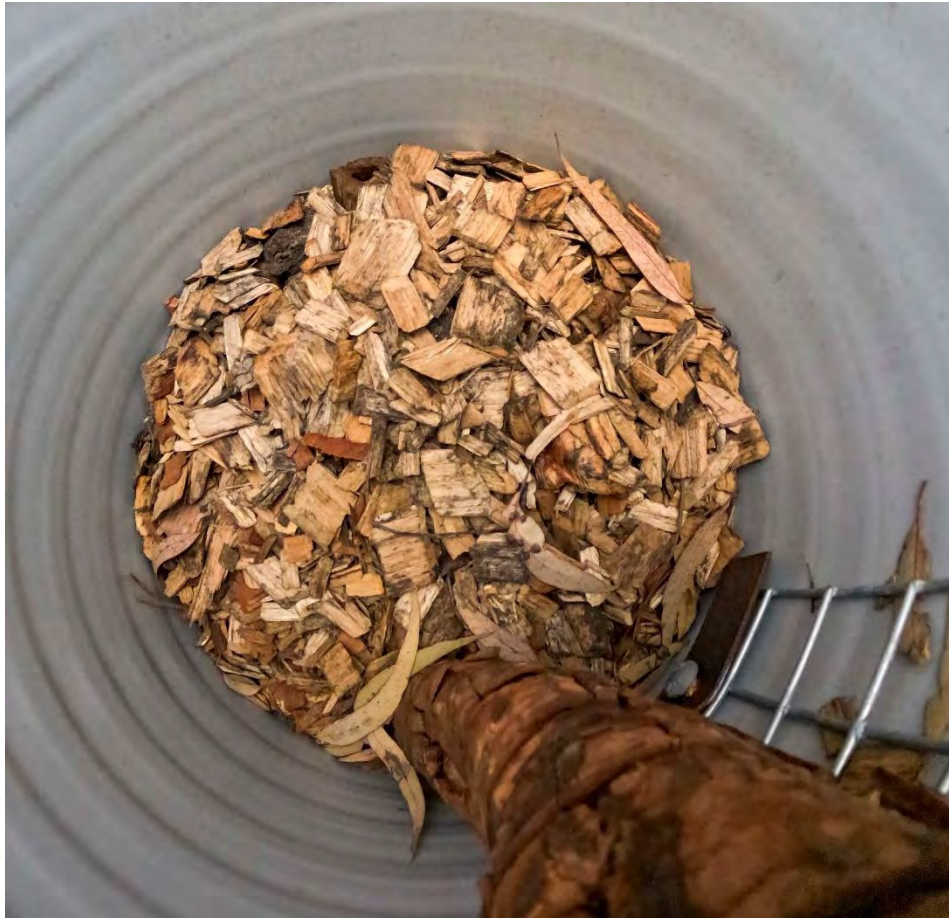
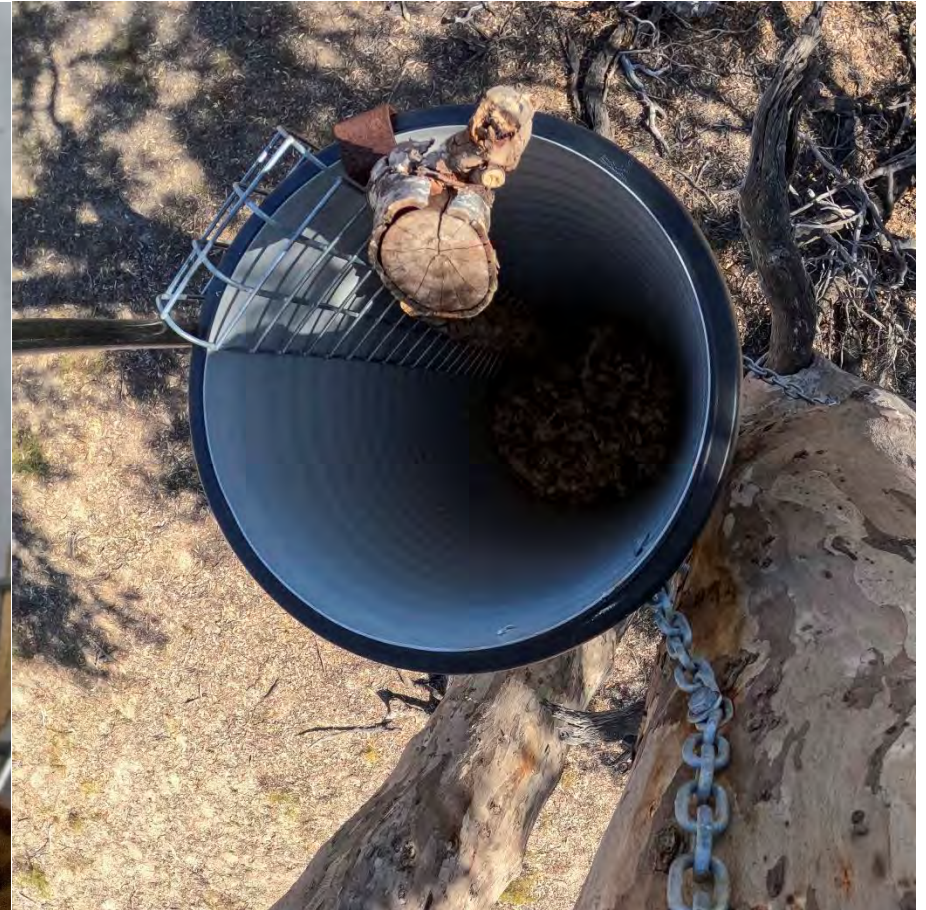
## Artificial Hollow BY38

| Hollow No | Comments | Chipping score 0-10 | Wood Chips | Tree condition | Fixings and Hollow condition | Recommended repairs |
|---|---|---|---|---|---|---|
| BY38 | No signs of nesting or inspection by Black Cockatoos | 0 | Nil | Good | Good | Nil |

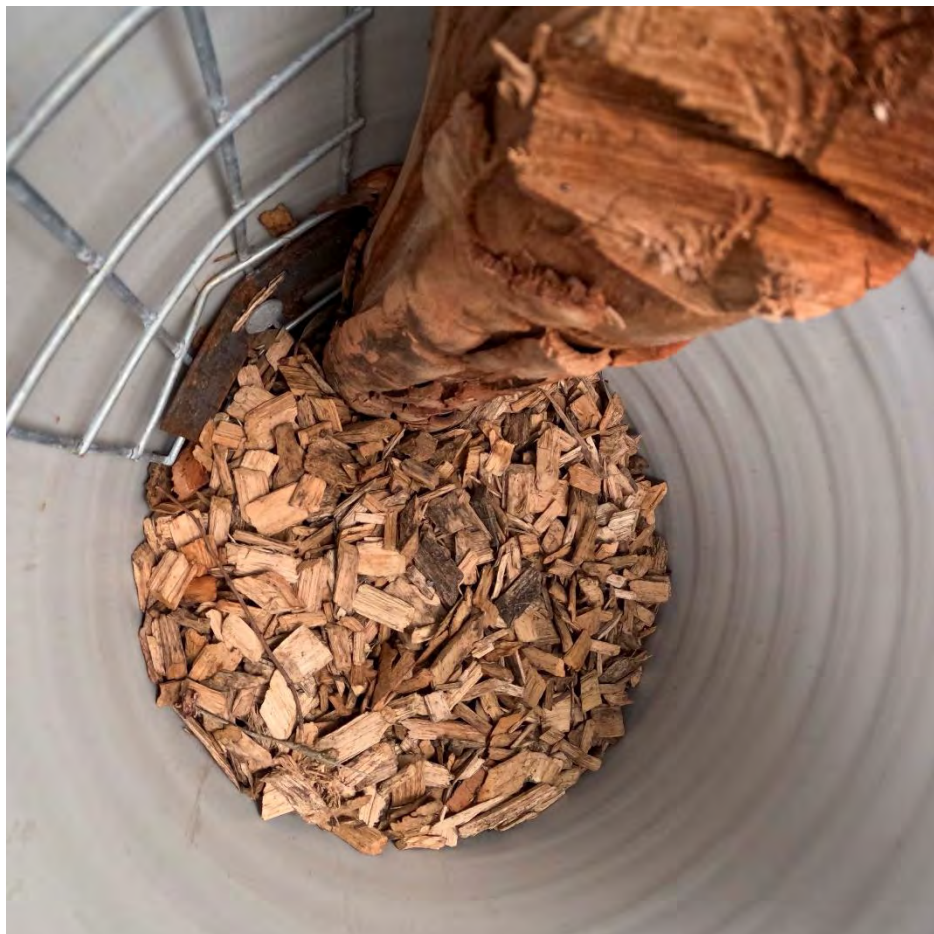
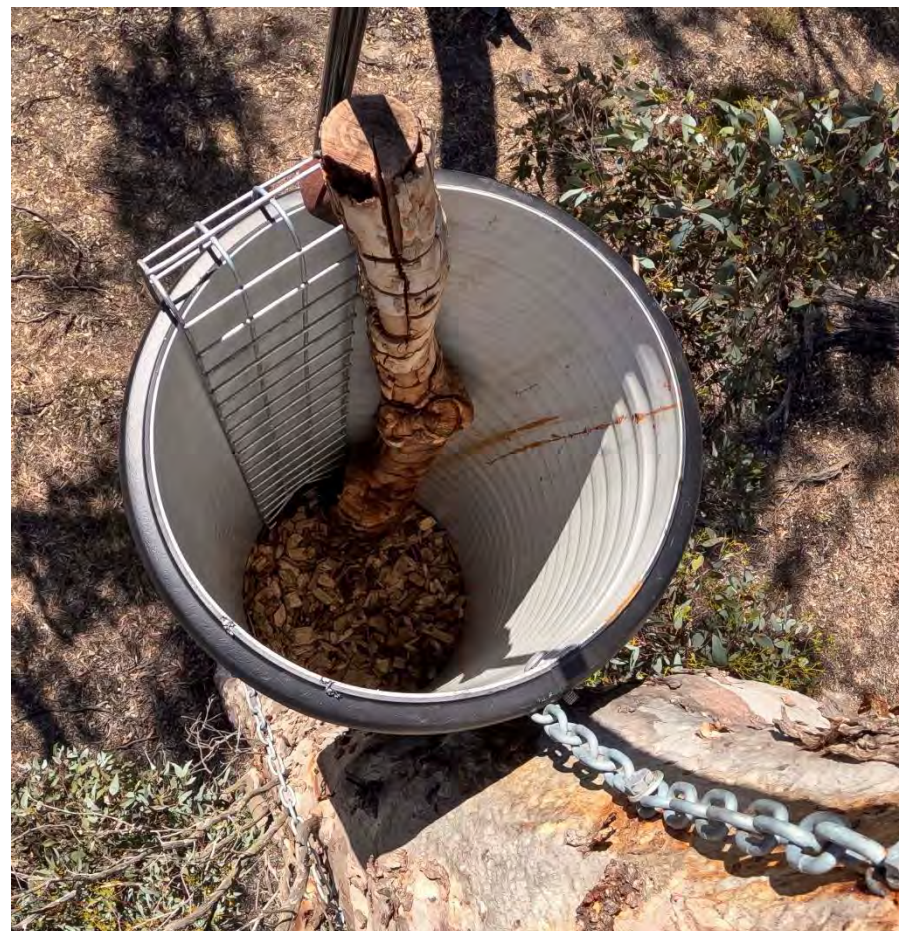
## Artificial Hollow BY39

| Hollow No | Comments | Chipping score<br>0-10 | Wood<br>Chips | Tree<br>condition | Fixings and<br>Hollow condition | Recommended<br>repairs |
|---|---|---|---|---|---|---|
| BY39 | No signs of nesting or inspection by Black<br>Cockatoos | 0 | Nil | Good | Good | Nil |

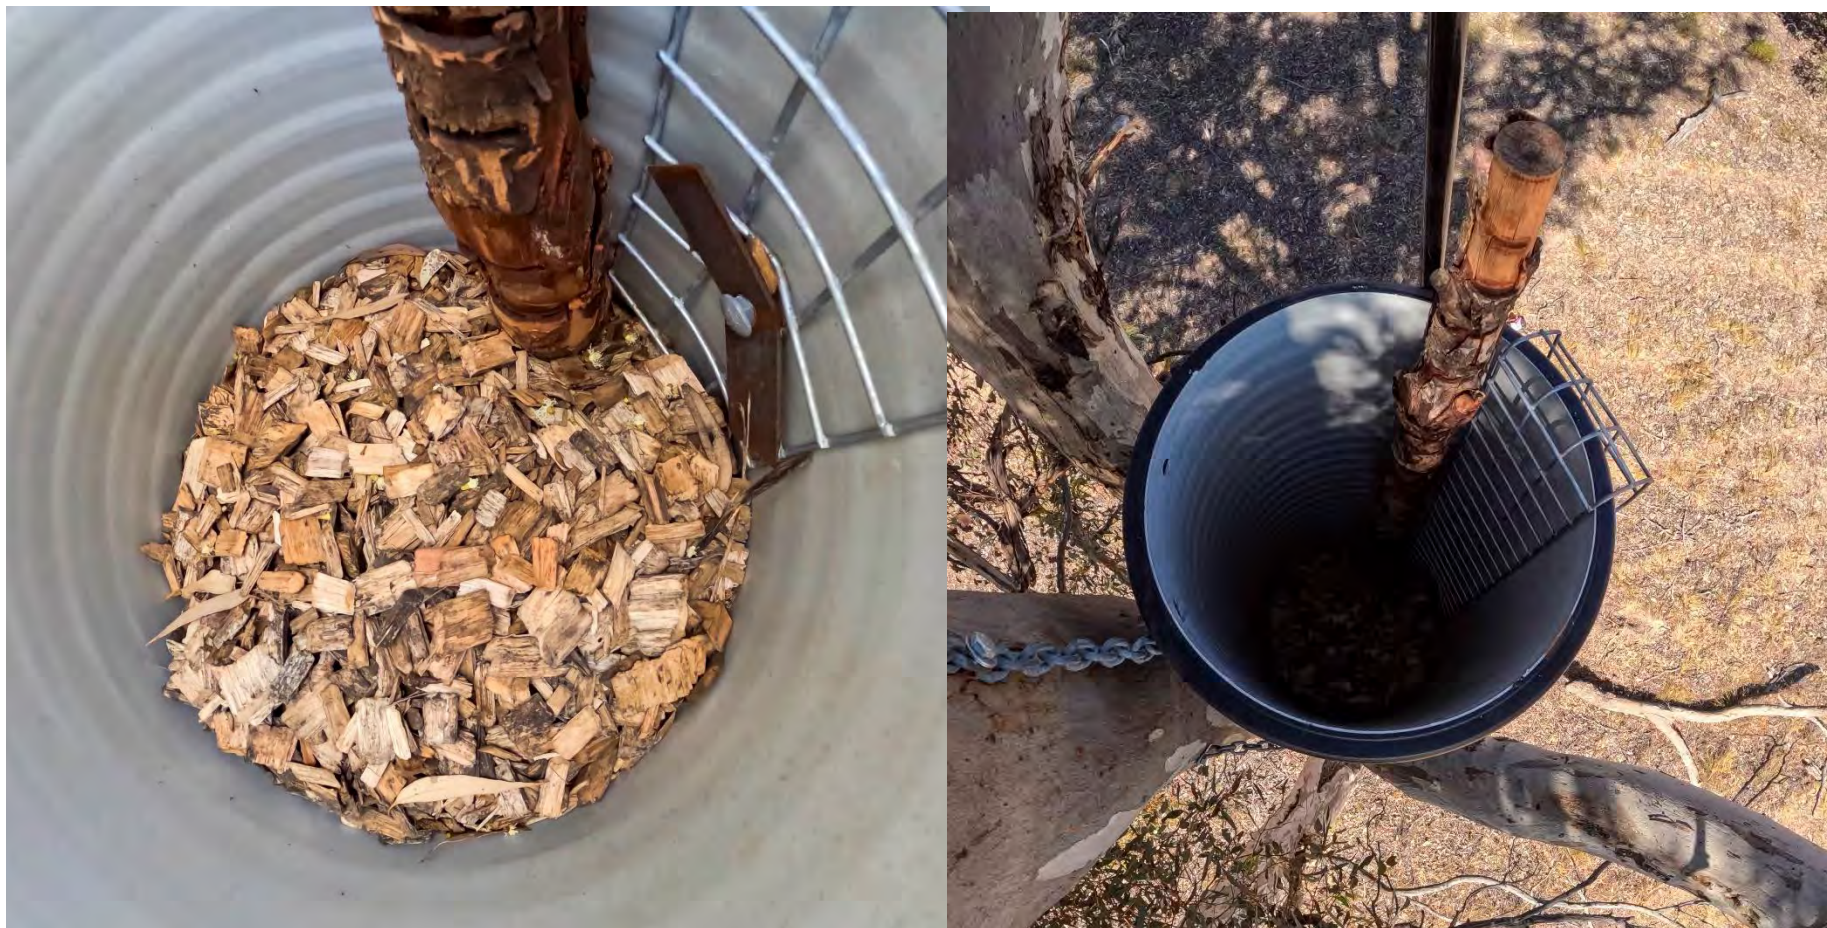
## Artificial Hollow BY40

| Hollow No | Comments | Chipping score 0-10 | Wood Chips | Tree condition | Fixings and Hollow condition | Recommended repairs |
|---|---|---|---|---|---|---|
| BY40 | No signs of nesting or inspection by Black Cockatoos | 0 | Nil | Good | Good | Nil |
