# Bunbury Outer Ring Road

## Southern Section

Ministerial Statement 1191

Compliance Assessment Report

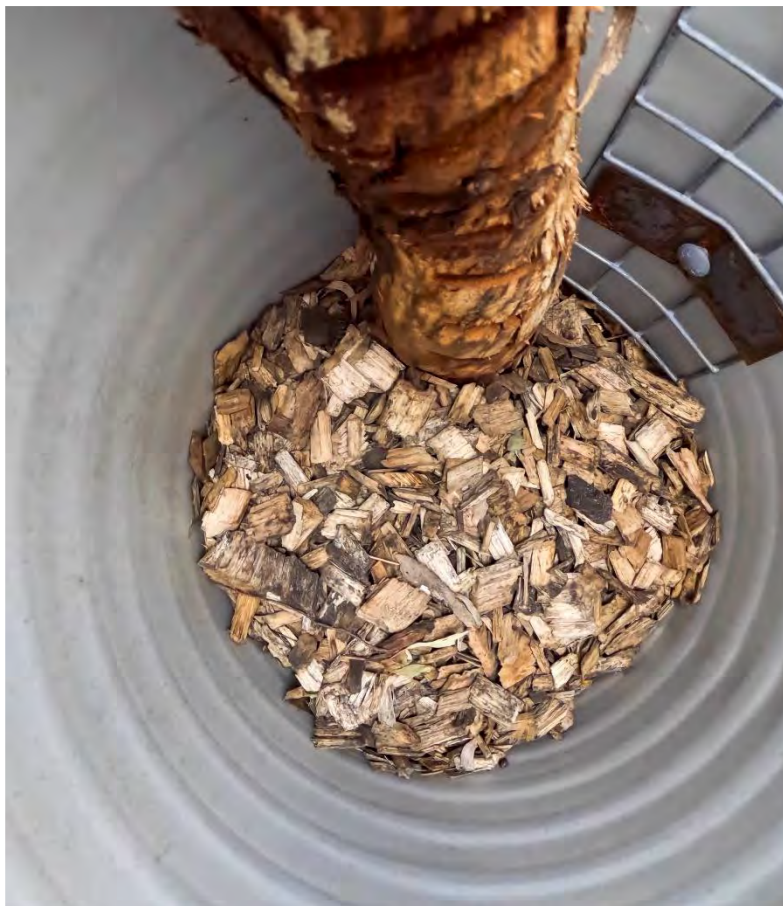
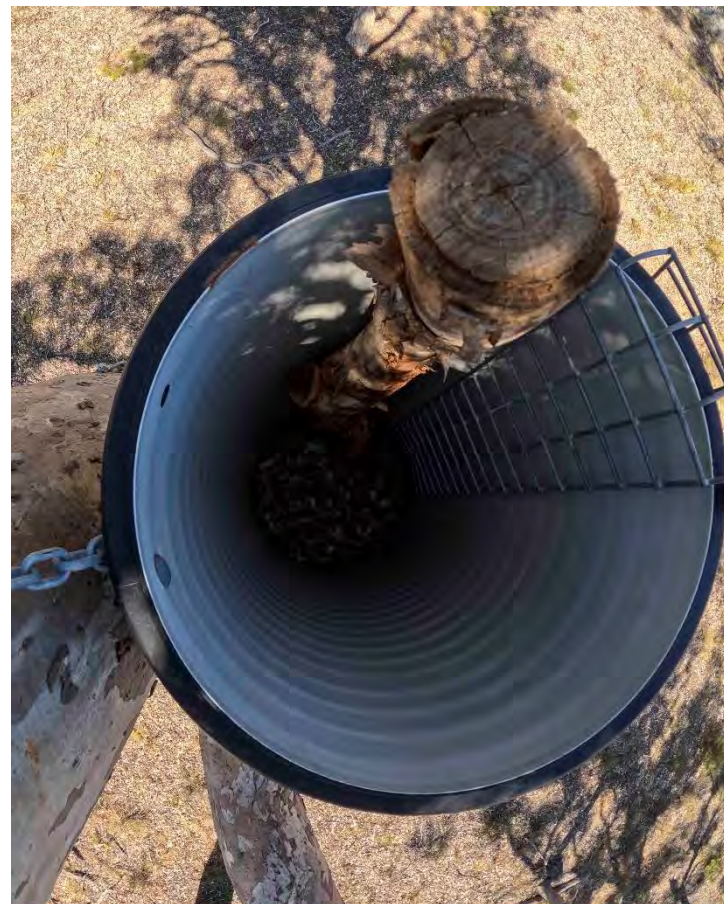
## Artificial Hollow BY41

| Hollow No | Comments | Chipping score 0-10 | Wood Chips | Tree condition | Fixings and Hollow condition | Recommended repairs |
|---|---|---|---|---|---|---|
| BY41 | No signs of nesting or inspection by Black Cockatoos | 0 | Nil | Good | Good | Nil |

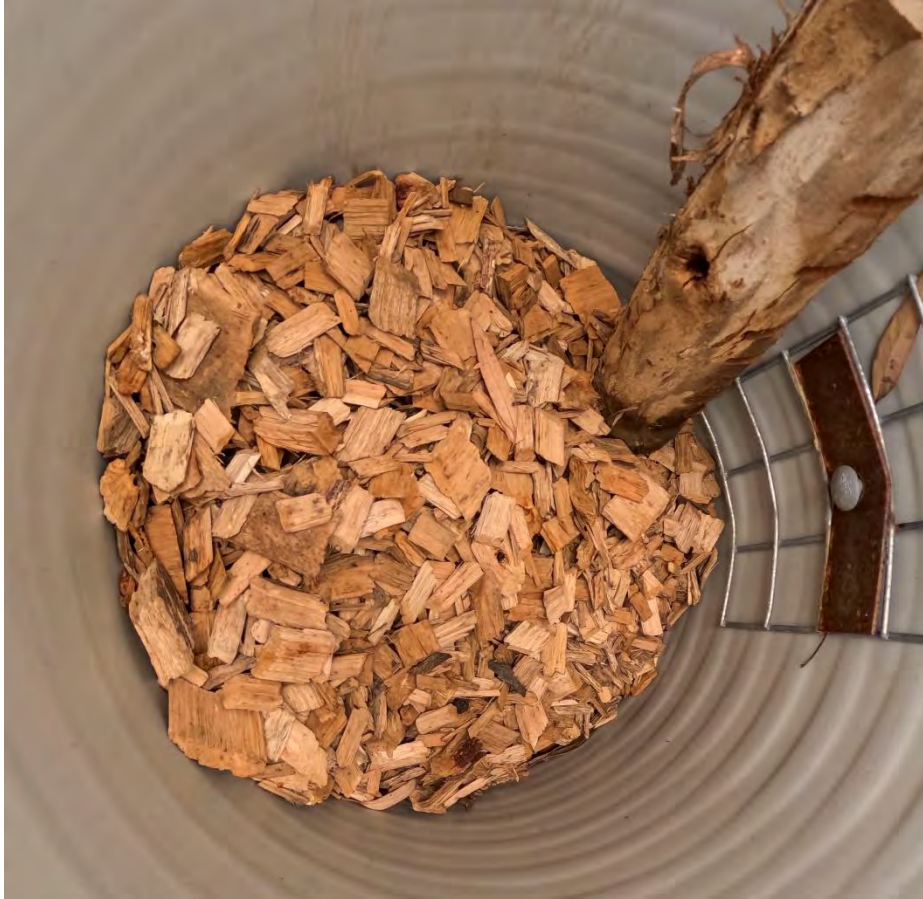
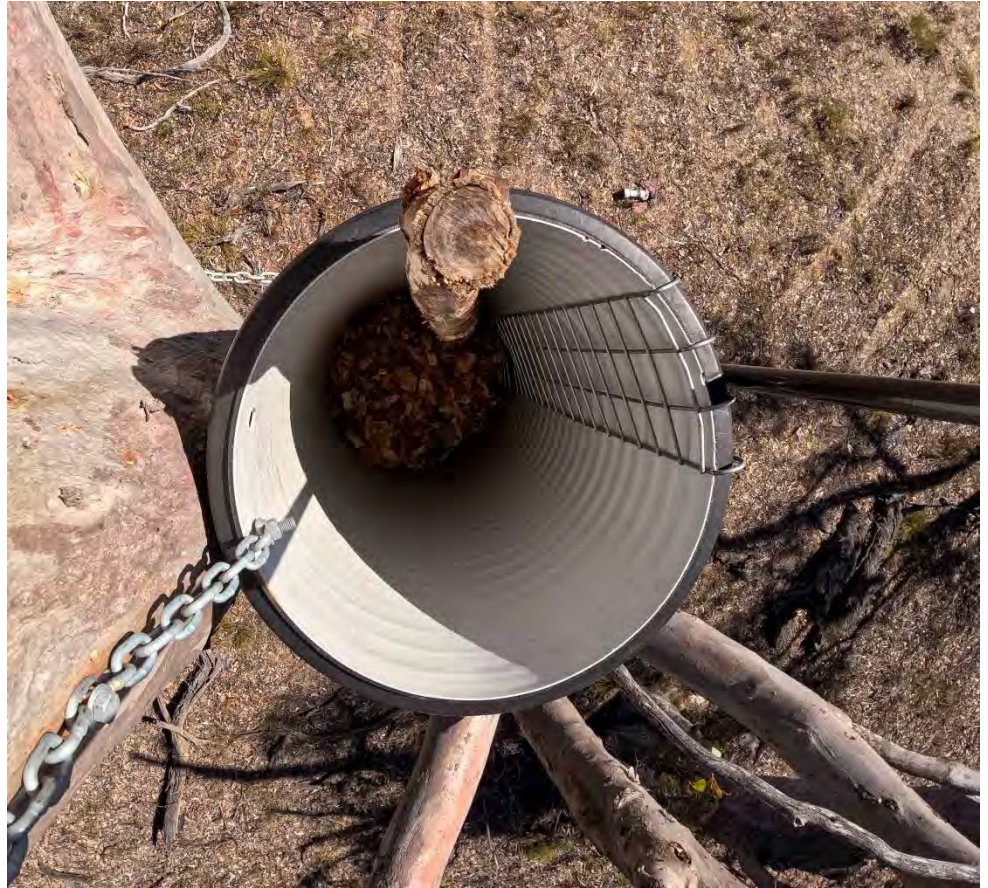
## Artificial Hollow BY42

| Hollow No | Comments | Chipping score 0-10 | Wood Chips | Tree condition | Fixings and Hollow condition | Recommended repairs |
|---|---|---|---|---|---|---|
| BY42 | No signs of nesting or inspection by Black Cockatoos | 0 | Nil | Good | Good | Nil |

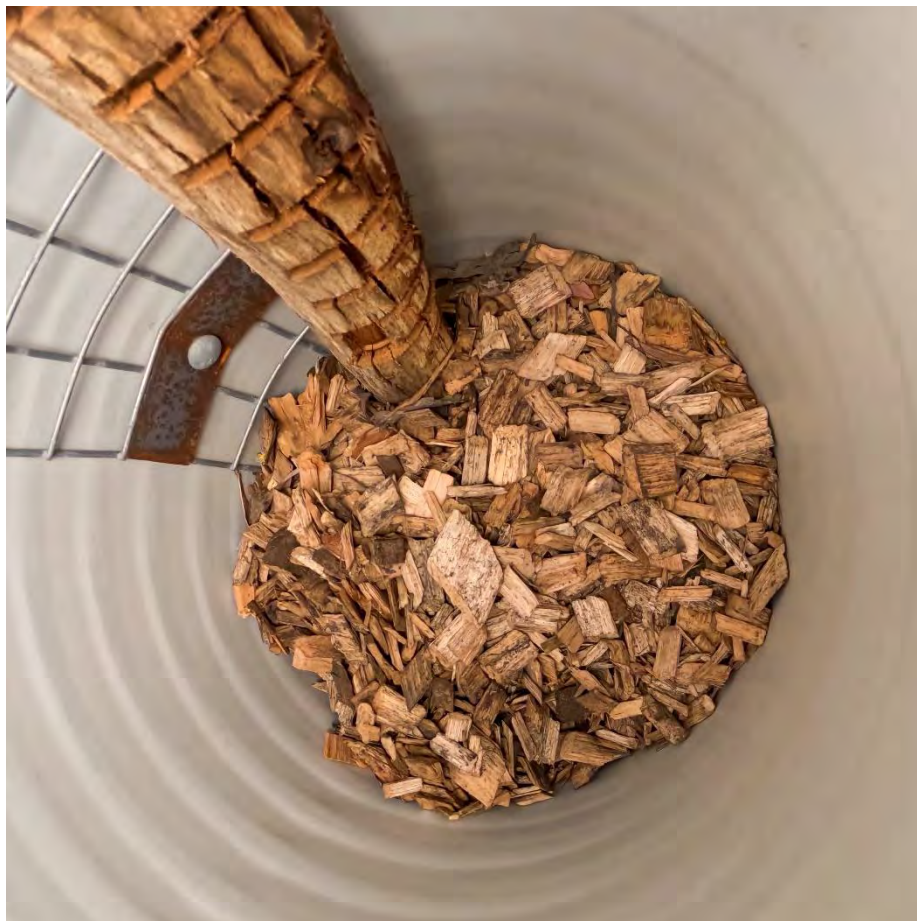
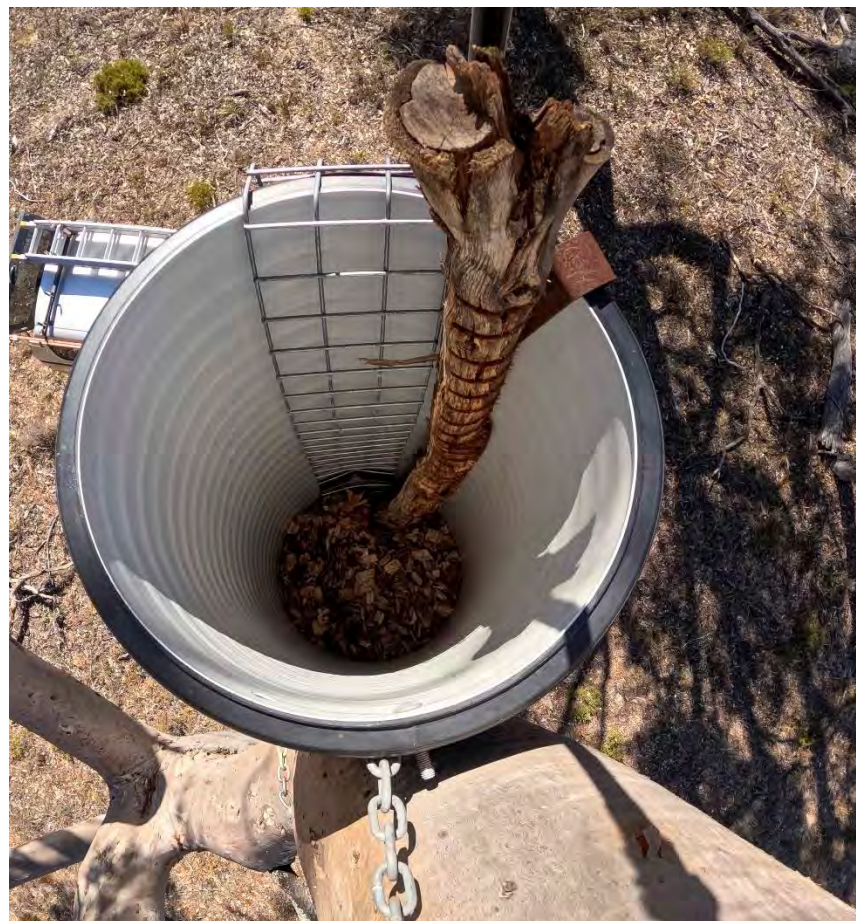
## Artificial Hollow BY43

| Hollow No | Comments | Chipping score 0-10 | Wood Chips | Tree condition | Fixings and Hollow condition | Recommended repairs |
|---|---|---|---|---|---|---|
| BY43 | No signs of nesting or inspection by Black Cockatoos | 0 | Nil | Good | Good | Nil |

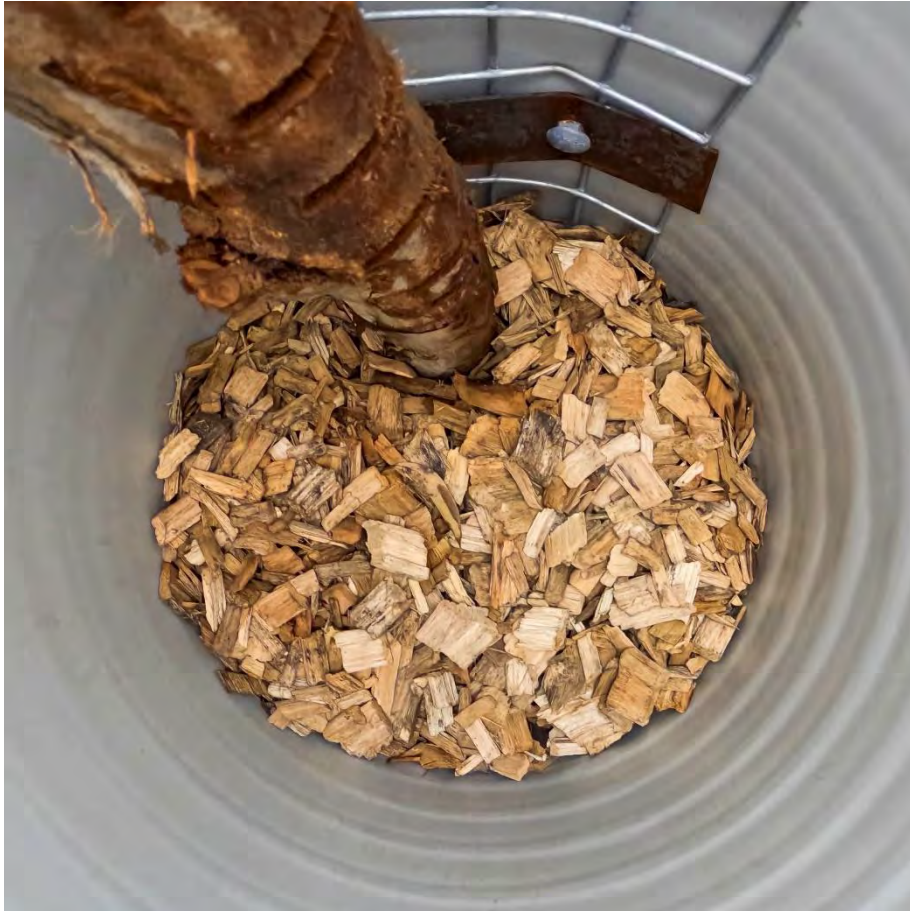
## Artificial Hollow BY44

| Hollow No | Comments | Chipping score 0-10 | Wood Chips | Tree condition | Fixings and Hollow condition | Recommended repairs |
|---|---|---|---|---|---|---|
| BY44 | No signs of nesting or inspection by Black Cockatoos | 0 | Nil | Good | Good | Nil |

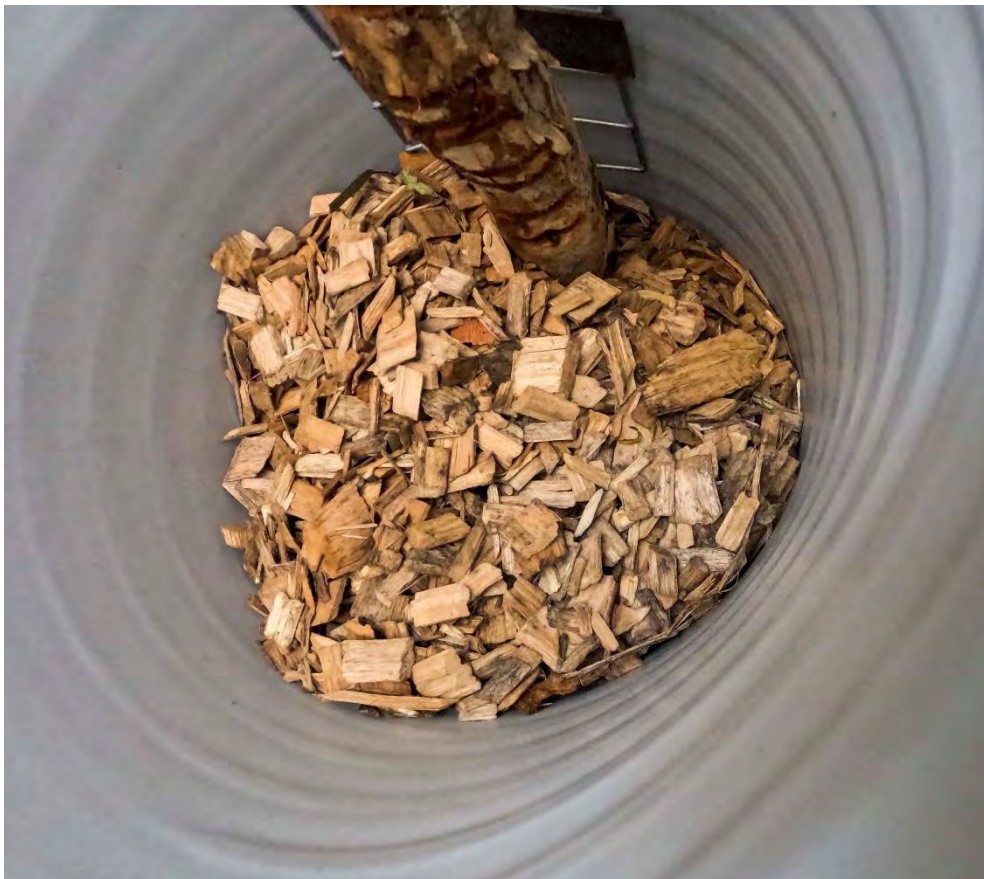
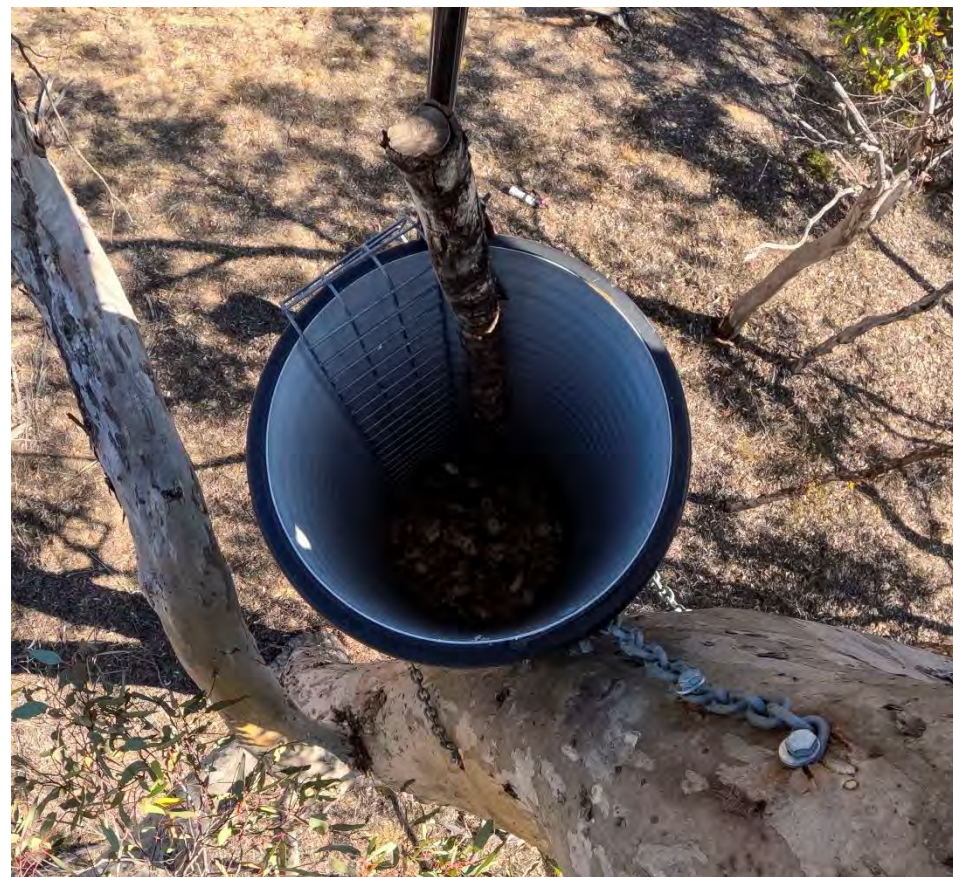
## Artificial Hollow BY45

| Hollow No | Comments | Chipping score 0-10 | Wood Chips | Tree condition | Fixings and Hollow condition | Recommended repairs |
|---|---|---|---|---|---|---|
| BY45 | No signs of nesting or inspection by Black Cockatoos | 0 | Nil | Good | Good | Nil |

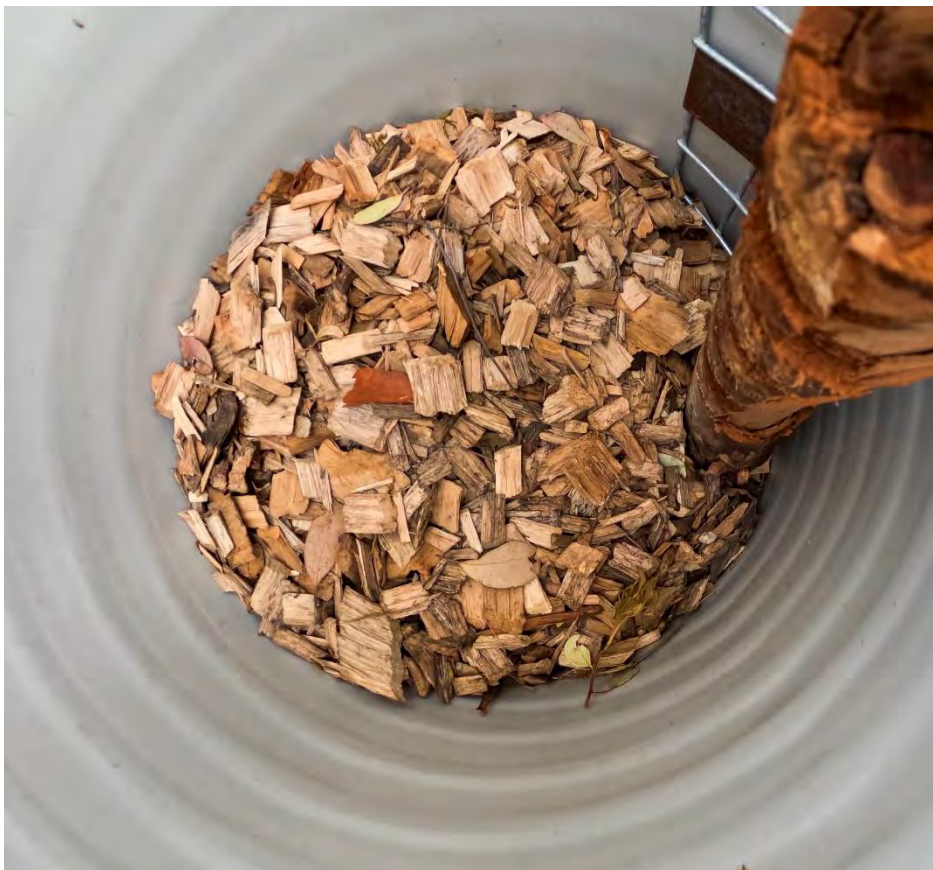
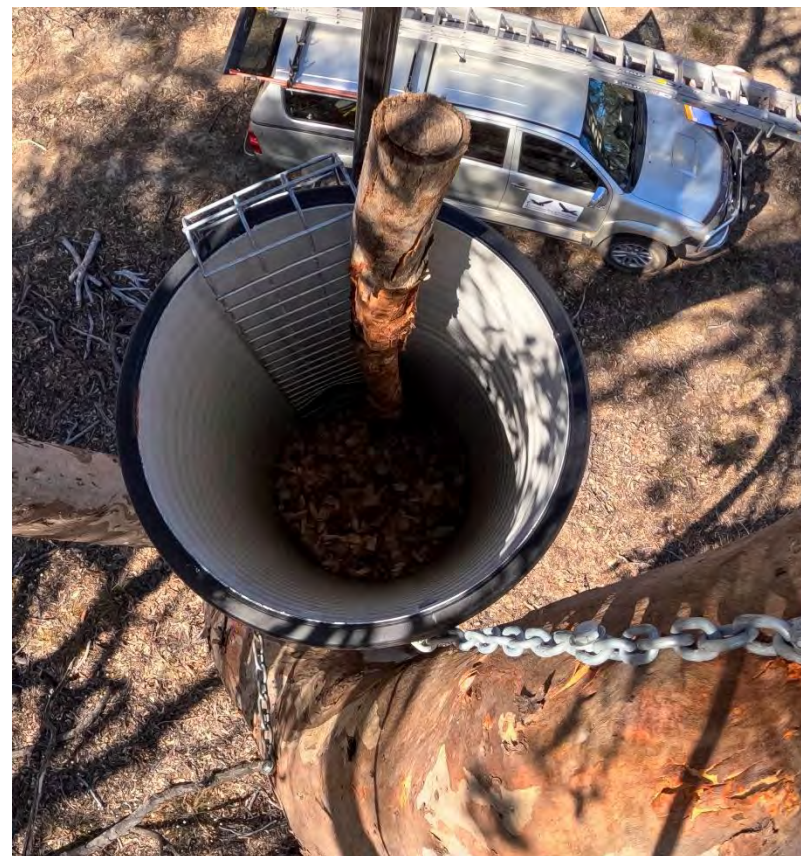
## Artificial Hollow BY46

| Hollow No | Comments | Chipping score 0-10 | Wood Chips | Tree condition | Fixings and Hollow condition | Recommended repairs |
|---|---|---|---|---|---|---|
| BY46 | No signs of nesting or inspection by Black Cockatoos | 0 | Nil | Good | Good | Nil |

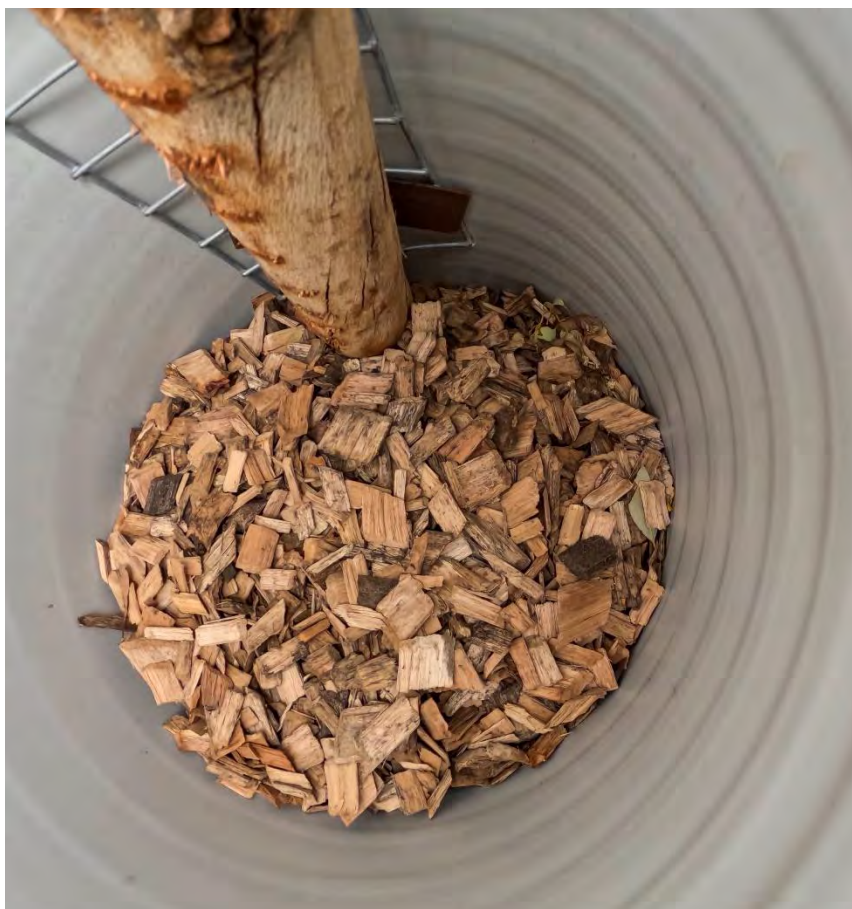
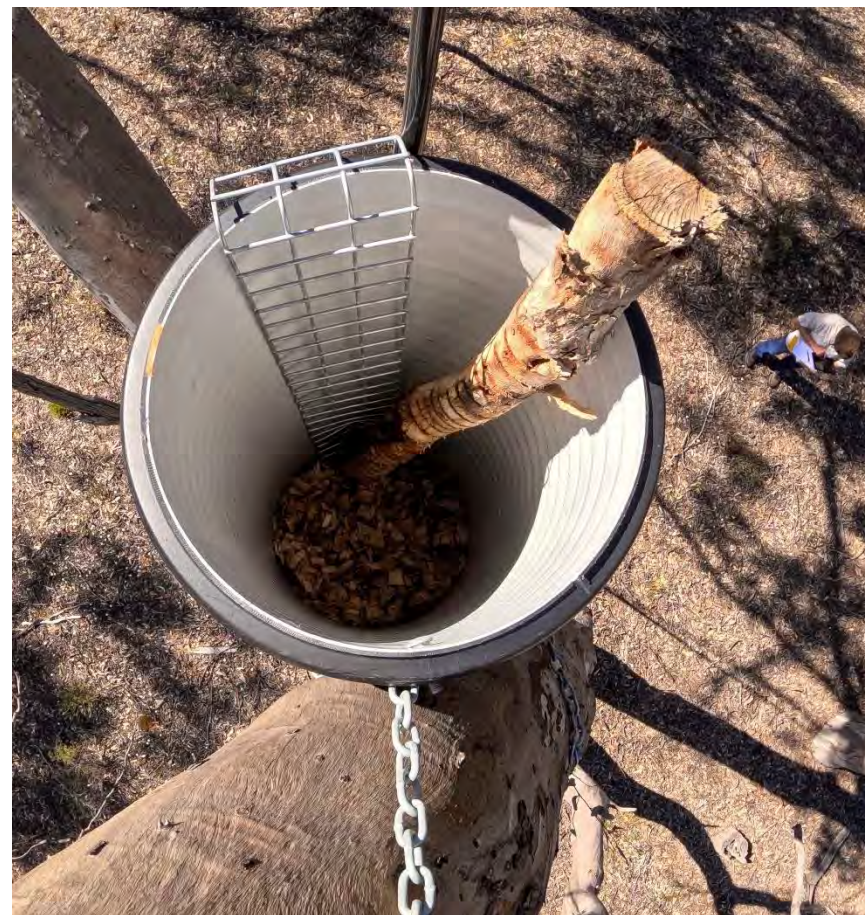
## Artificial Hollow BY47

| Hollow No | Comments | Chipping score 0-10 | Wood Chips | Tree condition | Fixings and Hollow condition | Recommended repairs |
|---|---|---|---|---|---|---|
| BY47 | No signs of nesting or inspection by Black Cockatoos | 0 | Nil | Good | Good | Nil |

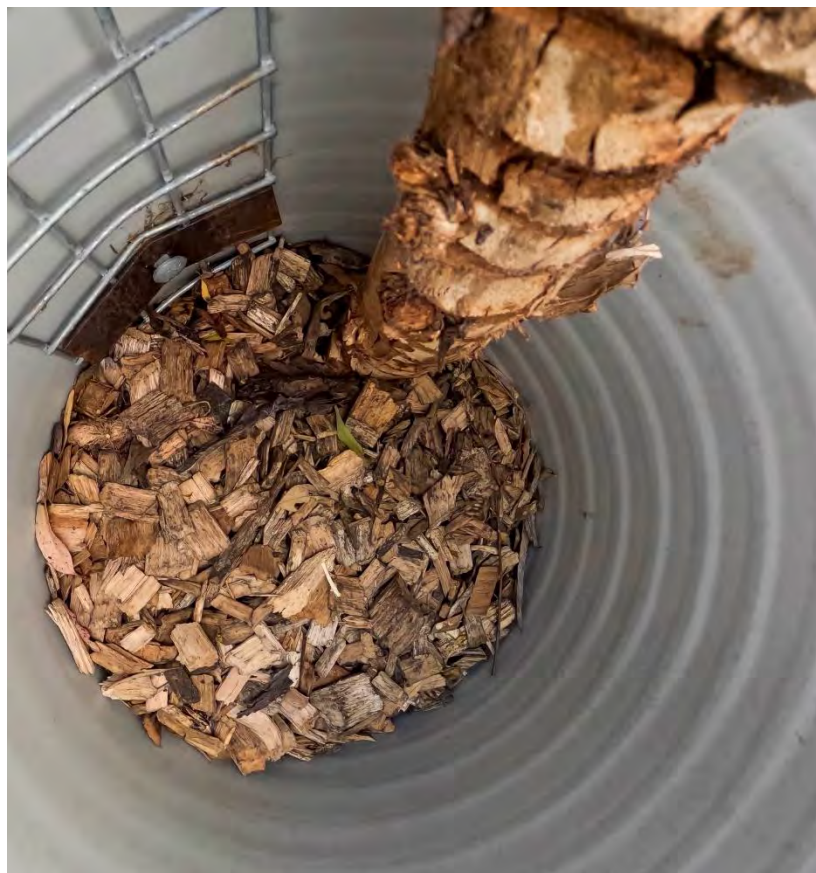
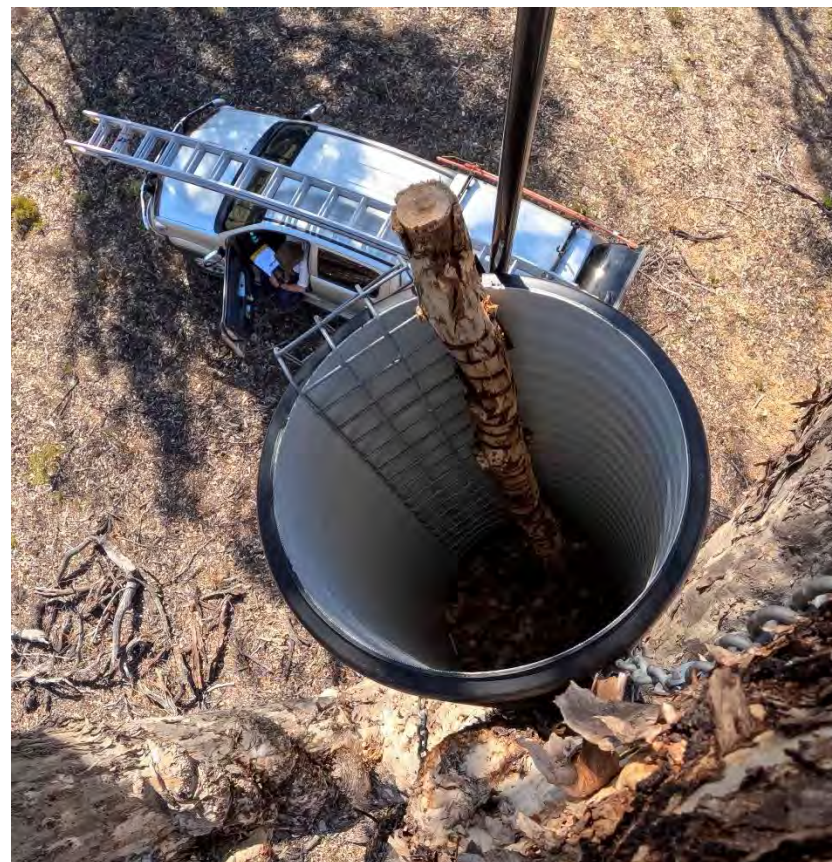
## Artificial Hollow BY48

| Hollow No | Comments | Chipping score 0-10 | Wood Chips | Tree condition | Fixings and Hollow condition | Recommended repairs |
|---|---|---|---|---|---|---|
| BY48 | No signs of nesting or inspection by Black Cockatoos | 0 | Nil | Good | Good | Nil |

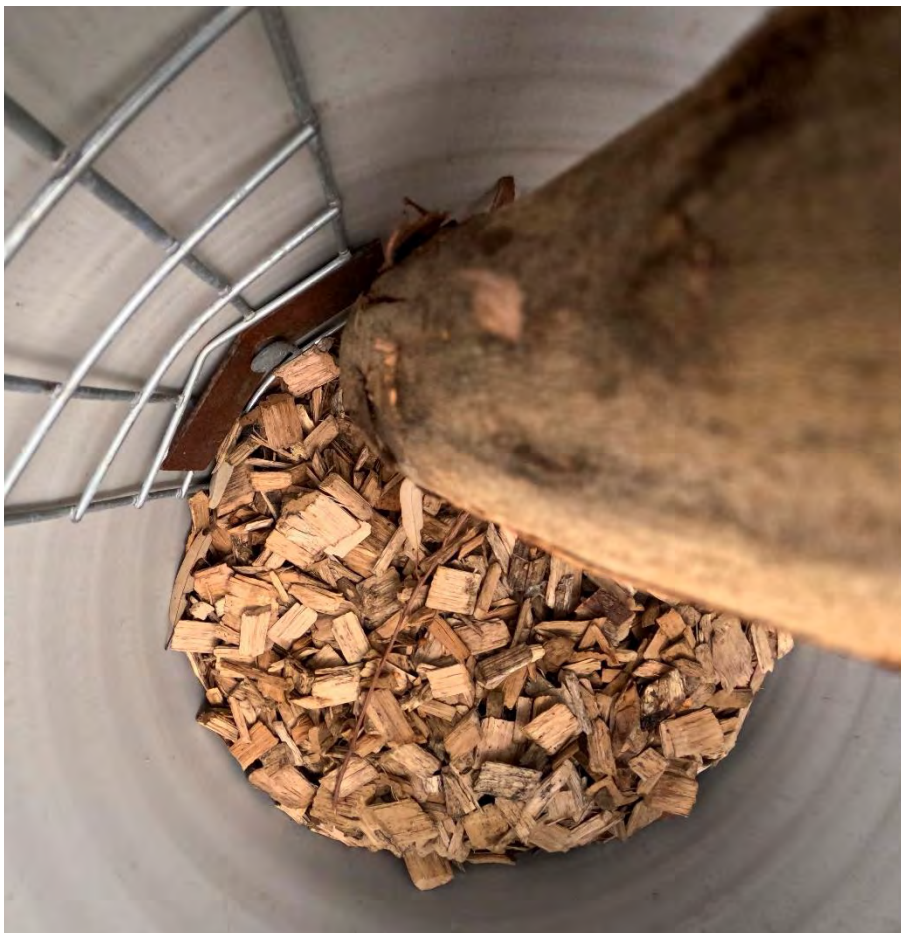
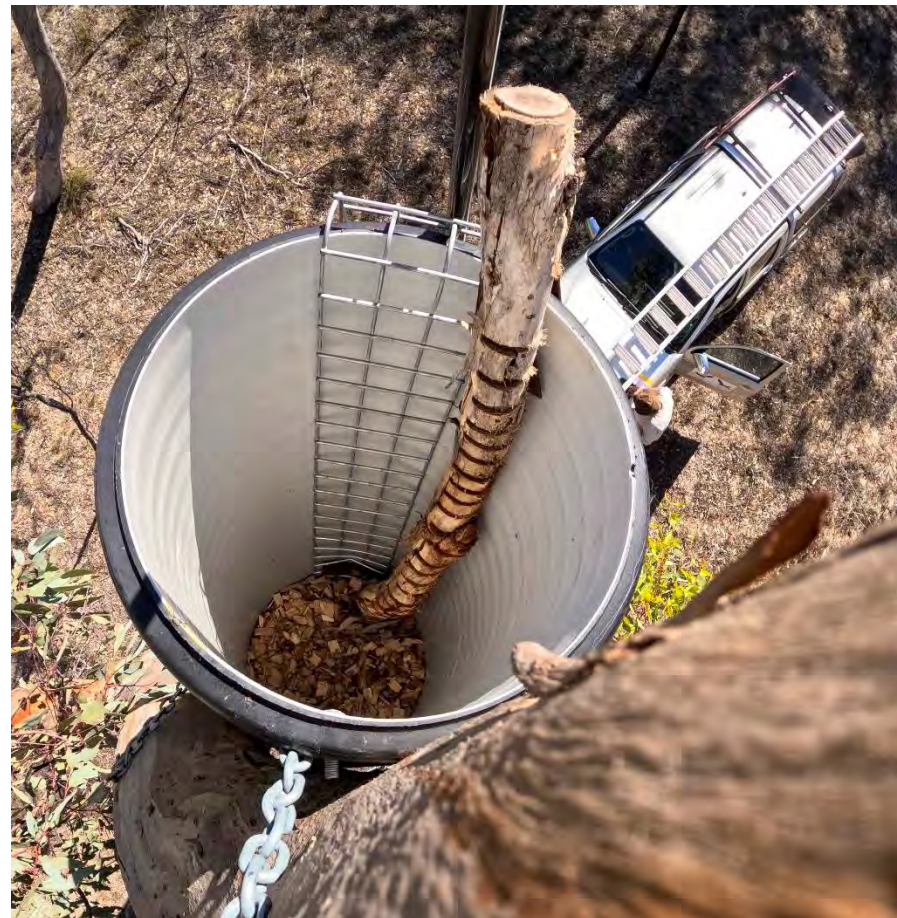
## Artificial Hollow BY49

| Hollow No | Comments | Chipping score 0-10 | Wood Chips | Tree condition | Fixings and Hollow condition | Recommended repairs |
|---|---|---|---|---|---|---|
| BY49 | No signs of nesting or inspection by Black Cockatoos | 0 | Nil | Good | Good | Nil |

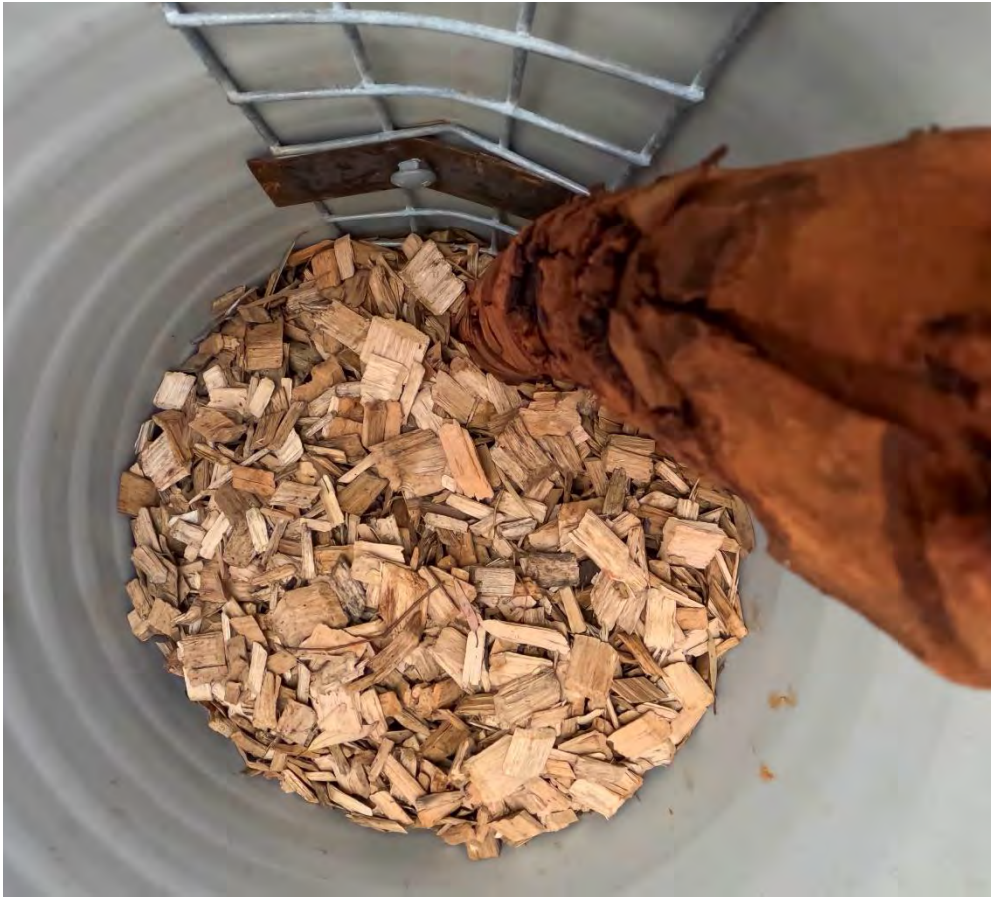
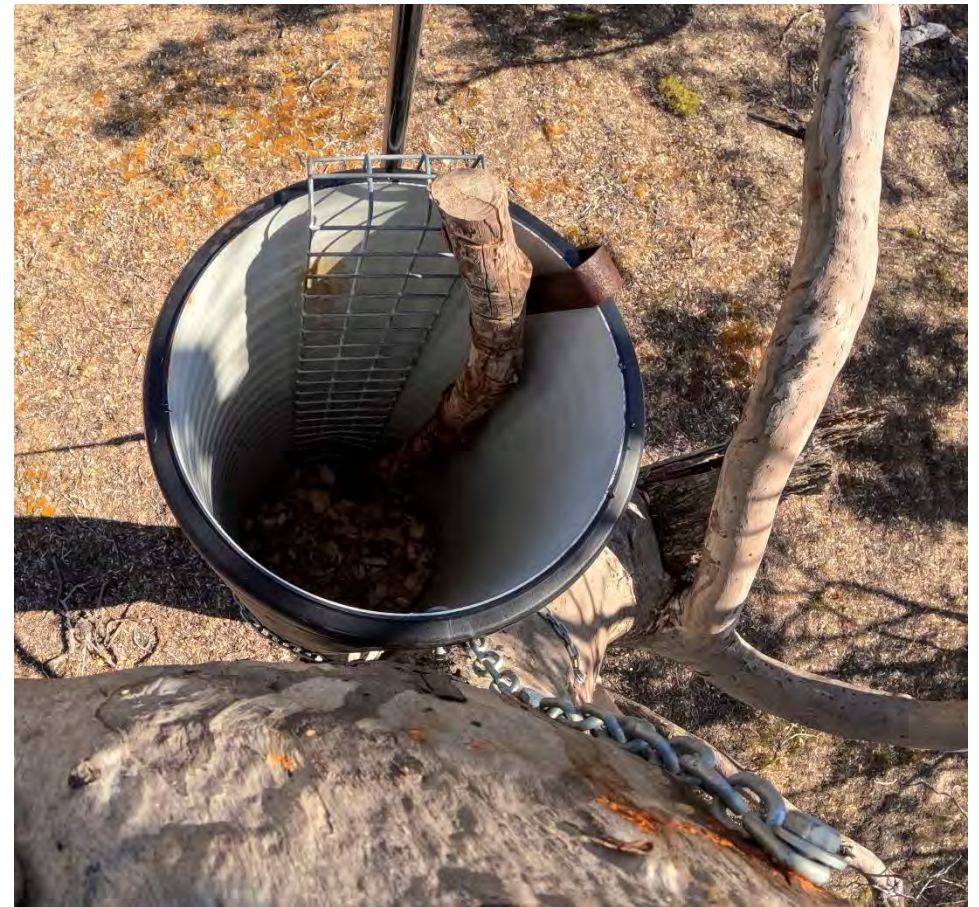
## Artificial Hollow BY50

| Hollow No | Comments | Chipping score 0-10 | Wood Chips | Tree condition | Fixings and Hollow condition | Recommended repairs |
|---|---|---|---|---|---|---|
| BY50 | No signs of nesting or inspection by Black Cockatoos | 0 | Nil | Good | Good | Nil |

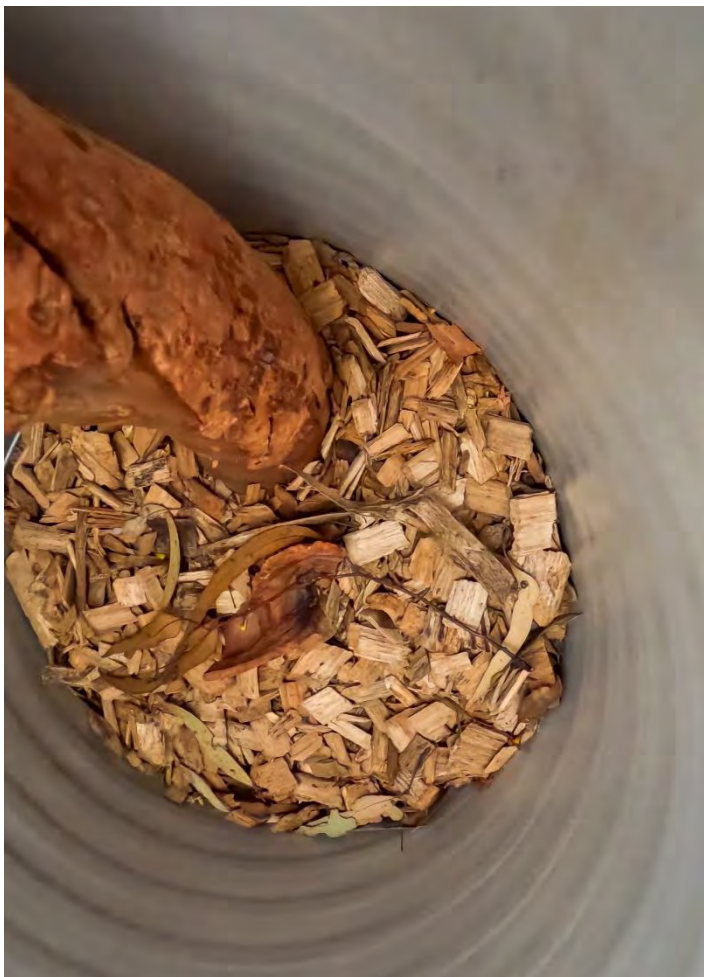
## Artificial Hollow BY51

| Hollow No | Comments | Chipping<br>score 0-10 | Wood<br>Chips | Tree<br>condition | Fixings and<br>Hollow condition | Recommended repairs |
|---|---|---|---|---|---|---|
| BY49 | No signs of nesting or inspection by Black<br>Cockatoos | 0 | Nil | Good | Good | Nil |

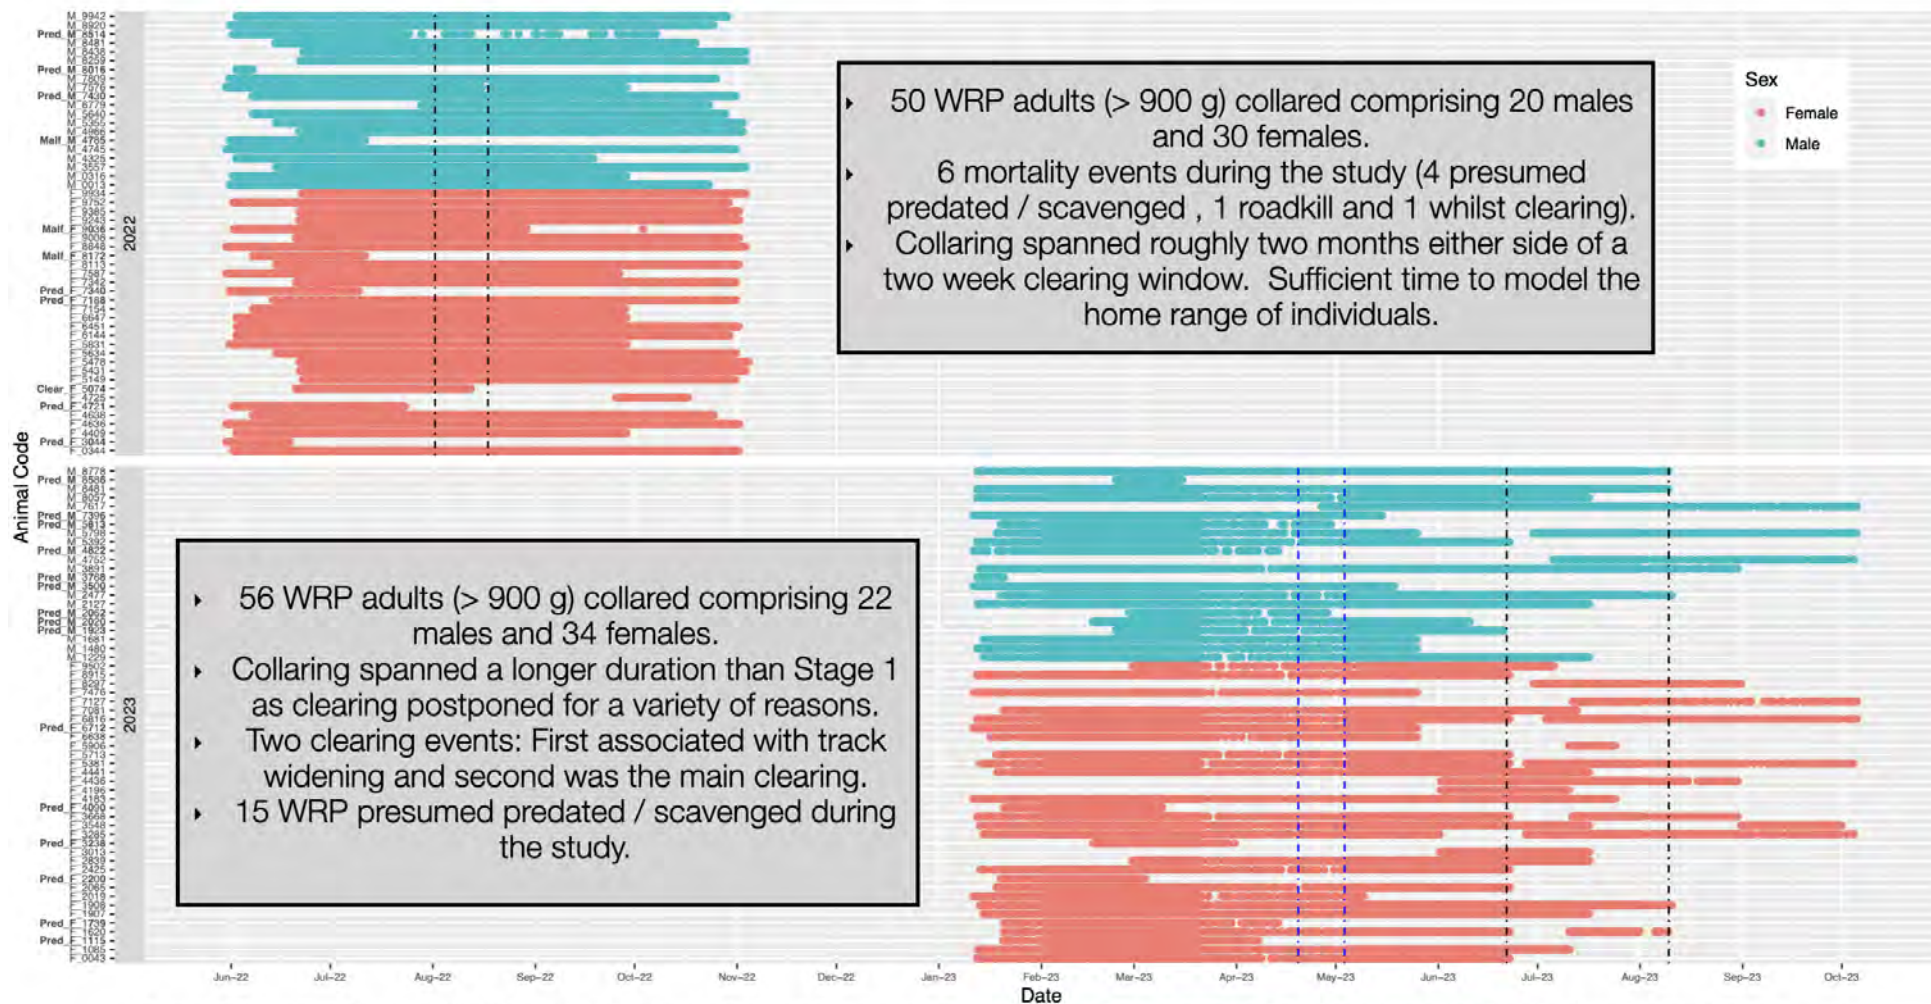
**Figure 3. Summary of duration over which WRP were GPS collars during phases 1 (Bussell Highway to Yalinda Drive) and 2 (Yalinda Drive to Jilly Road) of clearing within the Gelorup corridor.** Note that the current reporting period extends from May 31<sup>st</sup> 2024 to May 31<sup>st</sup> 2025 and the collaring study was completed in early October 2023.

Operationally, daily radio-tracking of collared WRP identified diurnal roosts and enabled tailored clearing (staging works, targeted trapping, arborists working around animals, and canopy retention).
