# Ministerial Statement Compliance Assessment Report

**Bunbury Outer Ring Road - South  
Ministerial Statement 1191**

**2025 - 2026 Reporting Period**

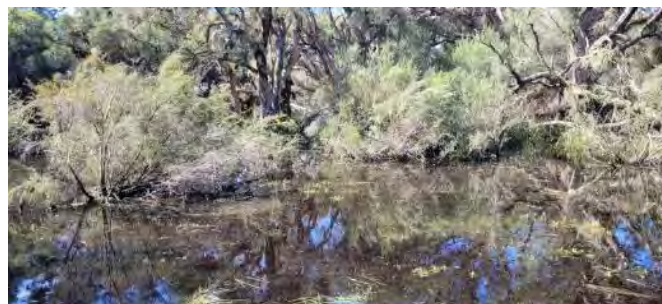
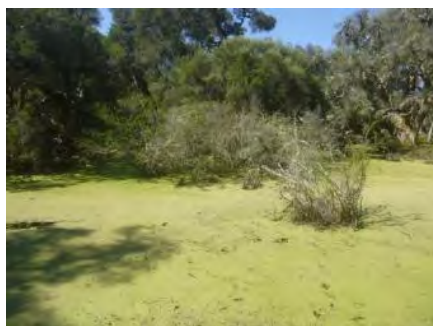
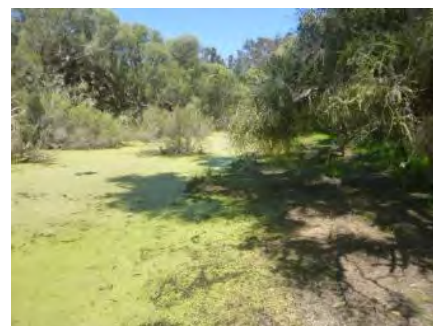
**Plate 2. Difference in floating vegetation (duck weed) between 2025 (top) and 2024 (bottom left & right).**

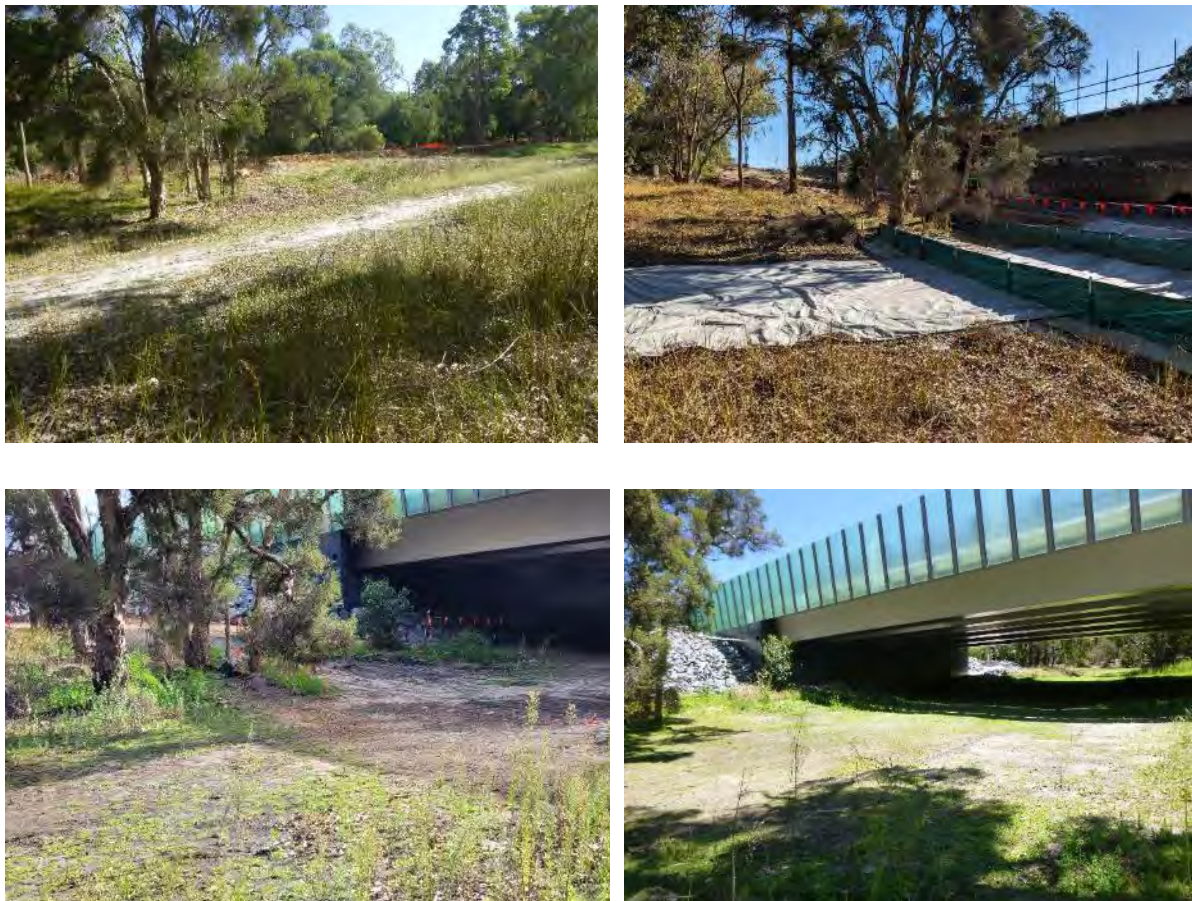
**Plate 3. Differences in sampling habitat and the development of construction at BSM-S-PI-1. Top left: Q2 2023, top right: Q2 2024, bottom left: Q2 2025, bottom right: Q4 2025.**

Infrastructure associated with the BORR has now been completed at sites within the southern alignment, with the installation of a traffic overpass as BSM-S-PI-1 (Plate 3), and the installation of culverts and a single carriageway at BSM-S-PI-2 (Plate 4). Additional photopoints are provided in Appendix B.

The installation of infrastructure was in accordance with State and Commonwealth environmental approvals for the Project. The design has incorporated a number of elements to mitigate the impact to BSM at this location, including a large overpass to keep habitat type intact (see Section 4.2), and box culverts to maintain a low flow, and baffles on the walls of the culvert to assist BSM. Additionally, minimal in-stream habitats were altered as part of the construction activities, with the use of an over-pass keeping habitat within site BSM-S-PI-1 unaltered, and construction activities occurring downstream of sampling site BSM-S-PI-2. Flow and movement of BSM through these areas, in particular BSM-S-PI-2, should however be monitored closely in future sampling events.

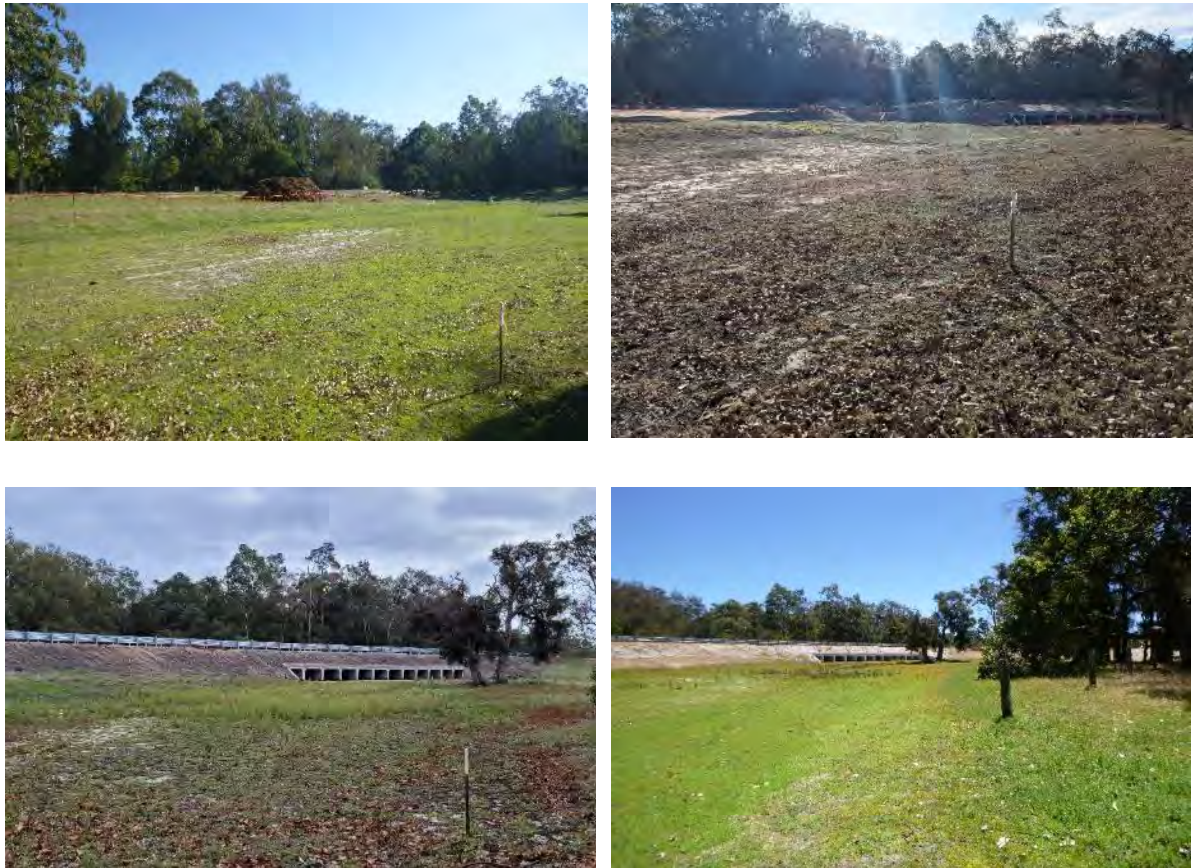
**Plate 4. Ongoing construction works at BSM-S-PI-2 from photopoint monitoring locations. Top left: Q2 monitoring 2023, top right: Q2 2024, bottom left: Q2 2025, bottom right: Q4 2025.**

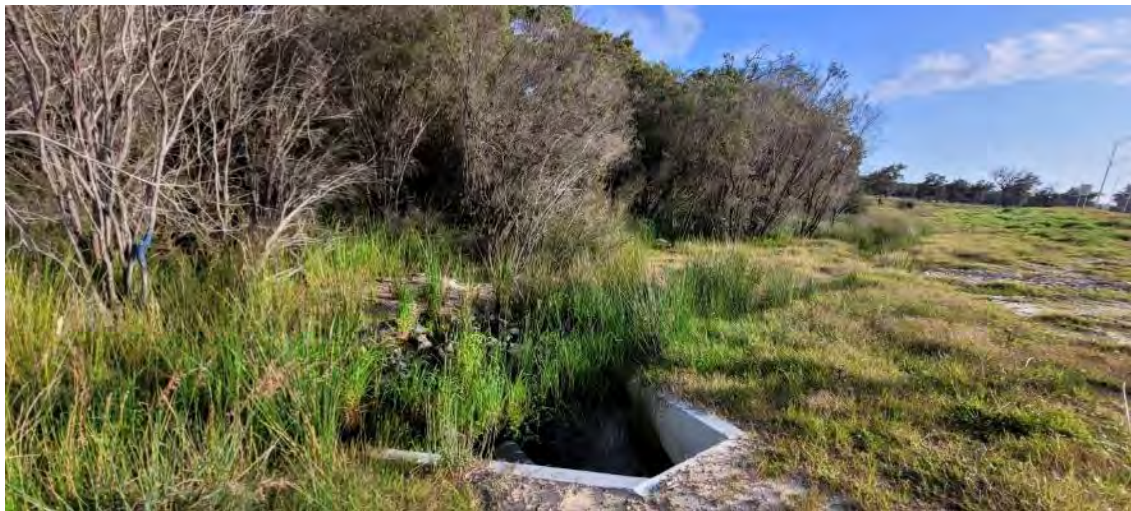
Infrastructure associated with the BORR Stage 1 has now been completed at and adjacent to UFI-wetlands within the southern alignment. Of note, was the installation of culverts and run-off drains associated with the construction of the BORR at site UFI-1117. This infrastructure (Plate 5) feeds away from wetland UFI-1117, underneath the BORR alignment.

**Plate 5. Infrastructure (culvert / run-off drain) into receiving wetland UFI-1117**

The installation of infrastructure was in accordance with State and Commonwealth environmental approvals for the Project. The design has incorporated a number of elements to mitigate the impact to UFI-listed wetlands at this location. No additional infrastructure was determined to have any influence on UFI-listed wetlands as part of this monitoring program.

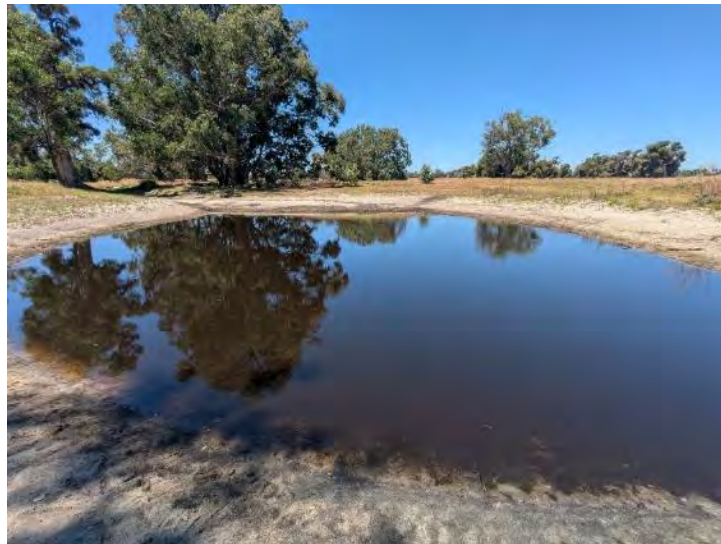
**Plate 6. Receded pool at site BSM-S-PI-2 during Q1 2025.**

Noting that BSM prefer sites with a more acidic pH (range of 3 – 6.5; Morgan *et al.* 1998), an increase in pH in recent survey periods at site BSM-S-PI-2 may be influencing the occurrence of BSM therein. Whilst there have been no significant differences observed between pre and post disturbance at site BSM-S-PI-2, it is noted that pH levels have reached values as high as 9.2 during recent, warmer months (data from Q2, 2025). This may have influenced populations dynamics at site BSM-S-PI-2, particularly if these areas were used as refuges for aestivating BSM. pH ranges within site BSM-S-PI-2 should be considered in relation to the presence or absence of BSM in future monitoring periods. It is currently unclear what the cause of these rising pH values are within this area, however the degradation of water quality at the site in warmer months (to a receded pool upstream of the sampling site) may be an influencing factor (Plate 6). It is also noted that high levels of TRH have been identified at this site in previous monitoring periods (after SGC; F3 = 1100µg/L in Q1 2024, F3 = 3600µg/L in Q2 2025). Further investigation into the source-sink relationship between this pool, and the sampling site during BSM monitoring, should be considered, if BSM are absent in future monitoring periods.

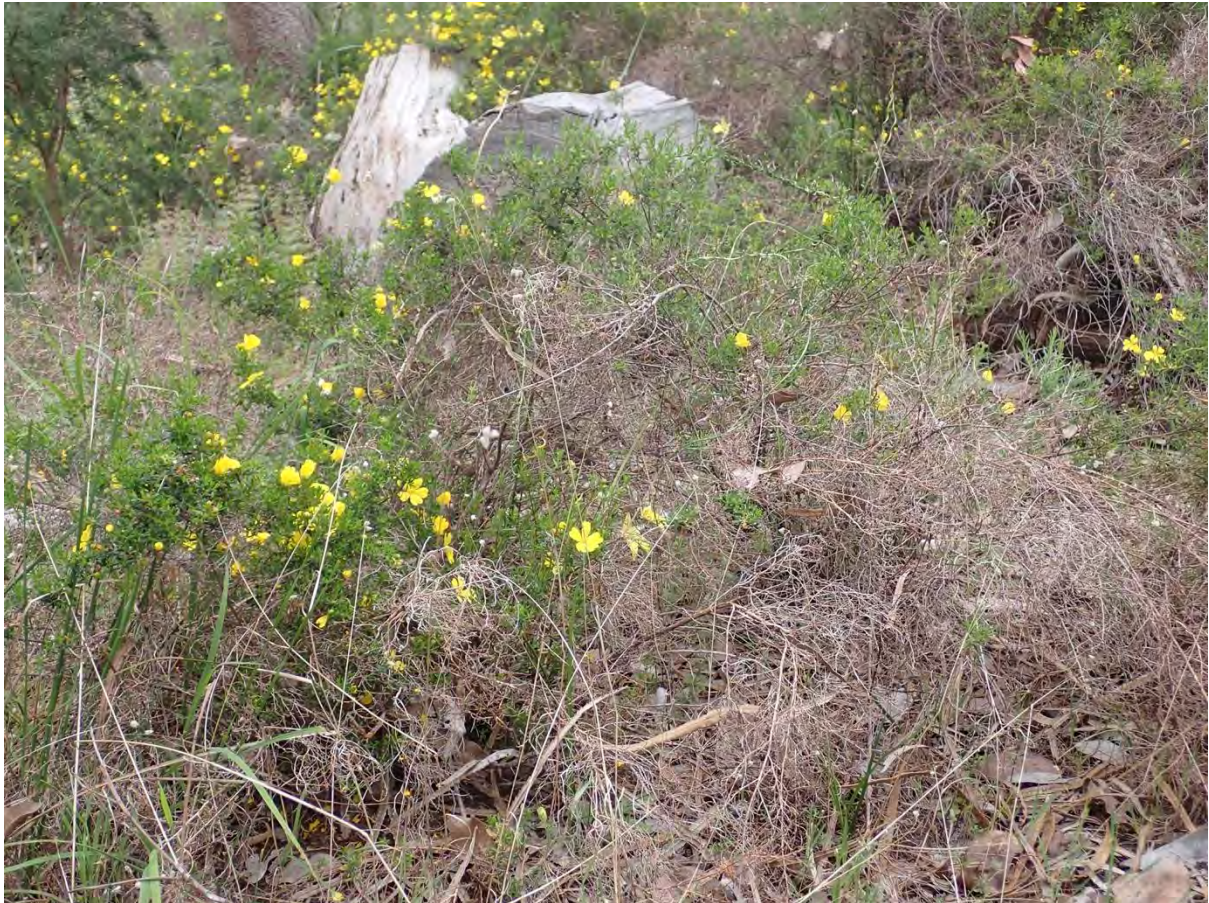
Plant deaths for all perennial shrubs and trees have been recorded within potential impact and reference site transects since monitoring commenced in 2019, with deaths recorded for the first time in 2024. These were observed in the low shrub *Hibbertia hypericoides* in four quadrats within the two sites, BW-S-PI-5 and BW-S-PI-8. Widespread stress in *Hibbertia hypericoides* was observed outside of the monitoring quadrats at these sites, and the primary cause of reported stress in the transects at these sites. These deaths are attributed to the record summer and autumn drought experienced in 23/24. Monitoring in 25/26 showed no further deaths or increases in stress observed in *H. hypericoides*, but the effects of the 23/24 drought were still evident in the plants, with many half dead per **Plate 1**.

Plate 1. *Hibbertia hypericoides* in spring 2025 (BW-S-PI-5), showing relictual evidence of the 23/24 drought.

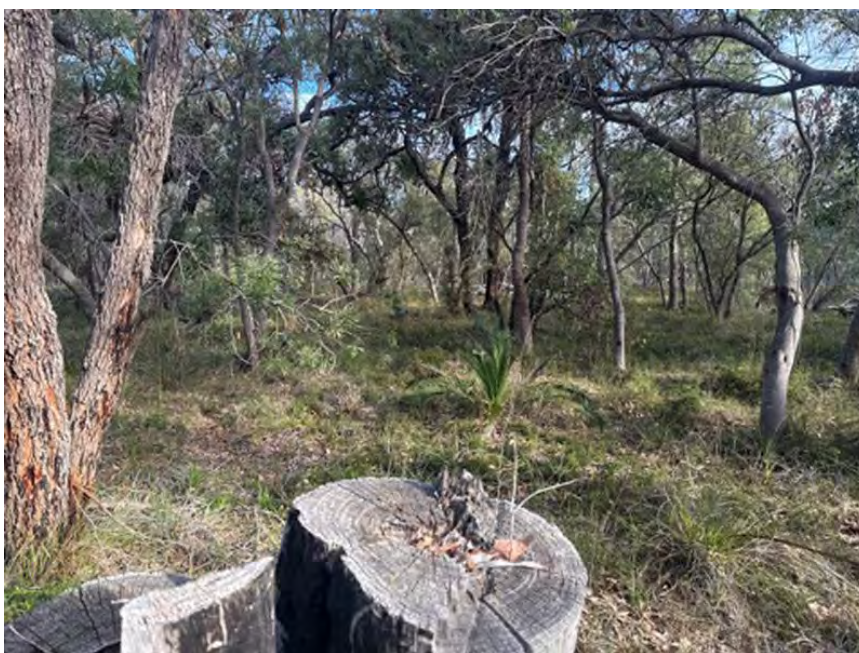
There have been six changes in vegetation condition out of the 125 monitoring points between the 2019 and 2026 autumn monitoring rounds for all monitored Banksia woodland, Claypan and Tuart woodland PEC/TEC occurrences. These were all recorded in the Banksia woodland community at four sites, BW-S-PI-1 (T1W), BW-S-PI-3 (P05), BW-S-PI-4 (P02) and BW-S-PI-5 (P04, P09 and P28) (**Table 15**). The greatest potential for a downgrading of vegetation condition is within marginally Excellent condition monitoring points due to the invasion of aggressive weeds and the modification of vegetation structure, which can be caused by a range of factors such as repeated fire, phytophthora dieback and grazing. This was the case for only downgrading of condition for the 25/26 monitoring period, which occurred at BW-S-PI-5\_P28 with the relatively recent colonisation of two aggressive weeds, *oxalis pes-caprae* and *Freesia alba x leichtlinii*. Both these weeds present nearby and were not introduced from BORR related activities (**Plate 2**).

Plate 2. BW-S-PI-5\_P28 with *Freesia* and *Oxalis pes-caprae* colonising the site.

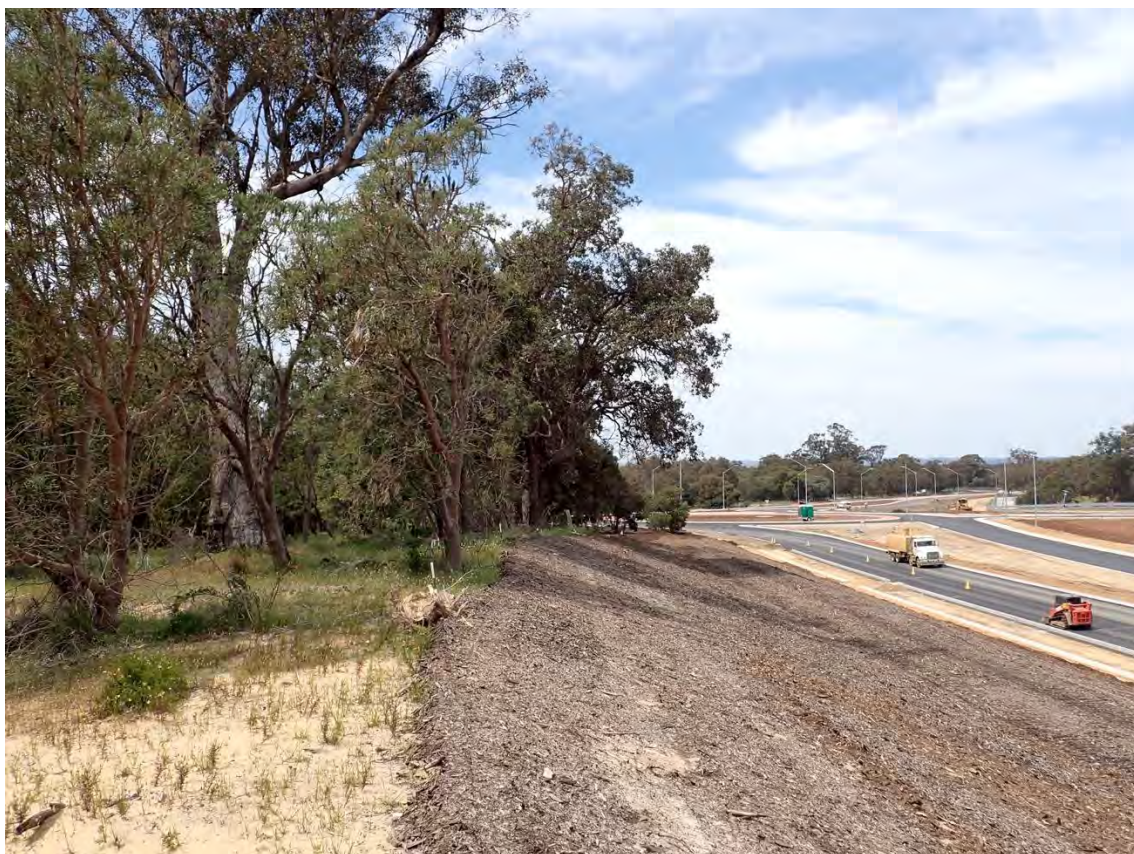
As of spring 2025, two of the seven monitoring points at monitoring site BW-S-PI-1 experienced increases in weed cover (**Plate 3**). Both increases first occurred in spring 2024 at BW-S-PI-1\_P01 and BW-S-PI-1\_T1W, with covers at both sites increasing from 20 - 30% to 30-70%. Both increases are not attributed to the project, but instead to the existing grass weed loads on site, in particular *Briza maxima*. The good weed hygiene adjacent to the BORR project near BW-S-PI-1\_P01 is shown in **Figure 14**. Noting that weed loads at BW-S-PI-1\_P01 decreased at BW-S-PI-1\_P01 due to the dry autumn, resulting in a delayed germination of annual grasses.

Plate 3. Weed loads adjacent to BORR, near to BW-S-PI-1\_P01, are suppressed with mulch autumn 2026.

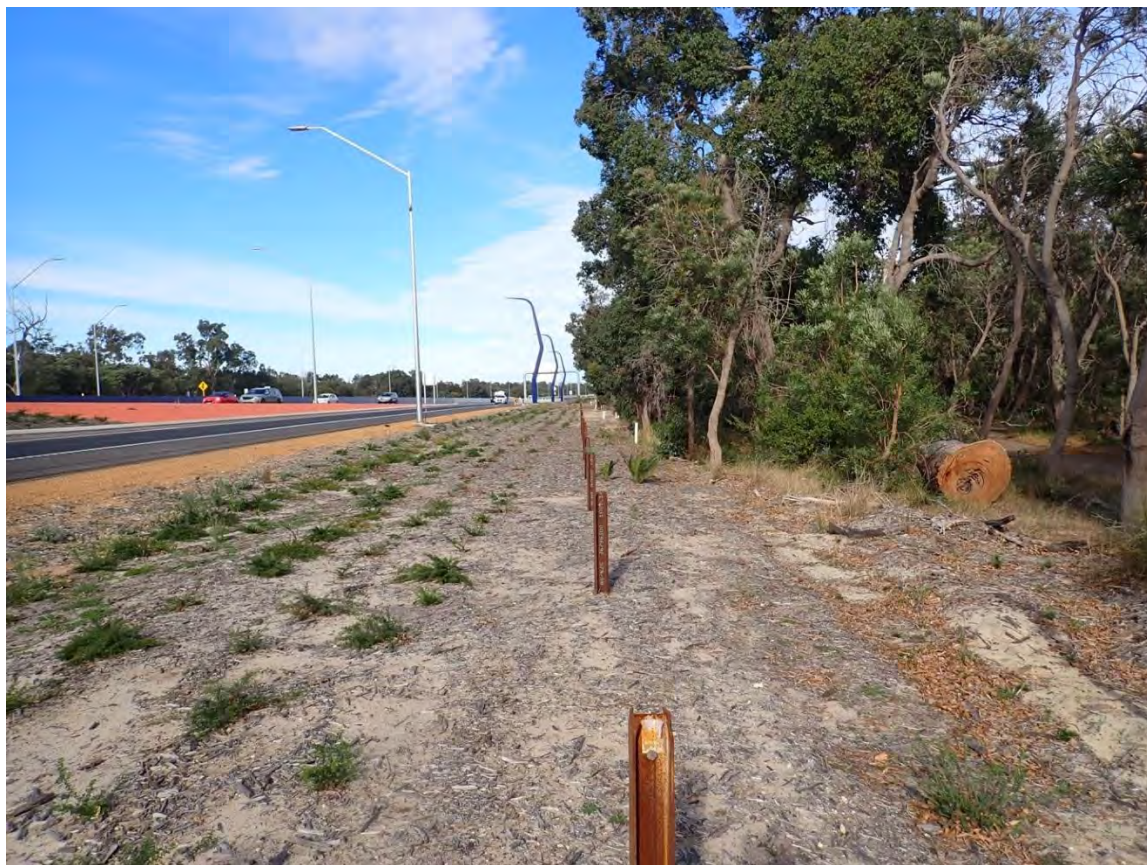
Plate 4. Well maintained revegetation area with a low weed load adjacent to BW-S-PI-5\_P21 in autumn 2026.

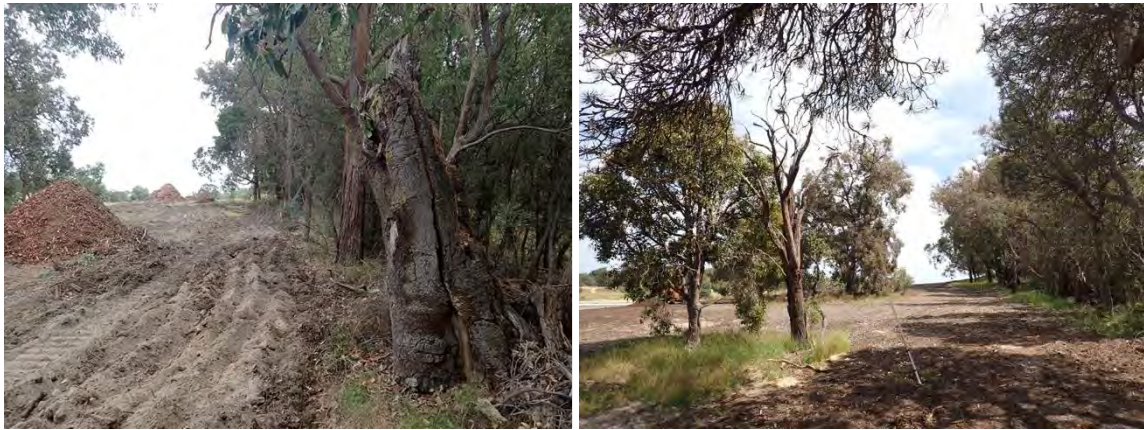
The average increase at TW-S-PI-2 was relatively minor (~5%) and was attributed to increases at four out of the 19 site monitoring points, TW-S-PI-2\_P03, TW-S-PI-2\_P05 and TW-S-PI-2\_P14 and TW-S-PI-2\_P18, where weed loads increased from 30 – 70 % to >70%. These increases in weeds are attributed to local weed banks and not to the BORR, as the area adjacent to this monitoring site has been well maintained and kept relatively free of weeds, see **Plate 5 (Figure 20)**.

Plate 5. Cleared areas adjacent to TW-S-PI-2 are relatively free of weeds in autumn 2024 and spring 2024

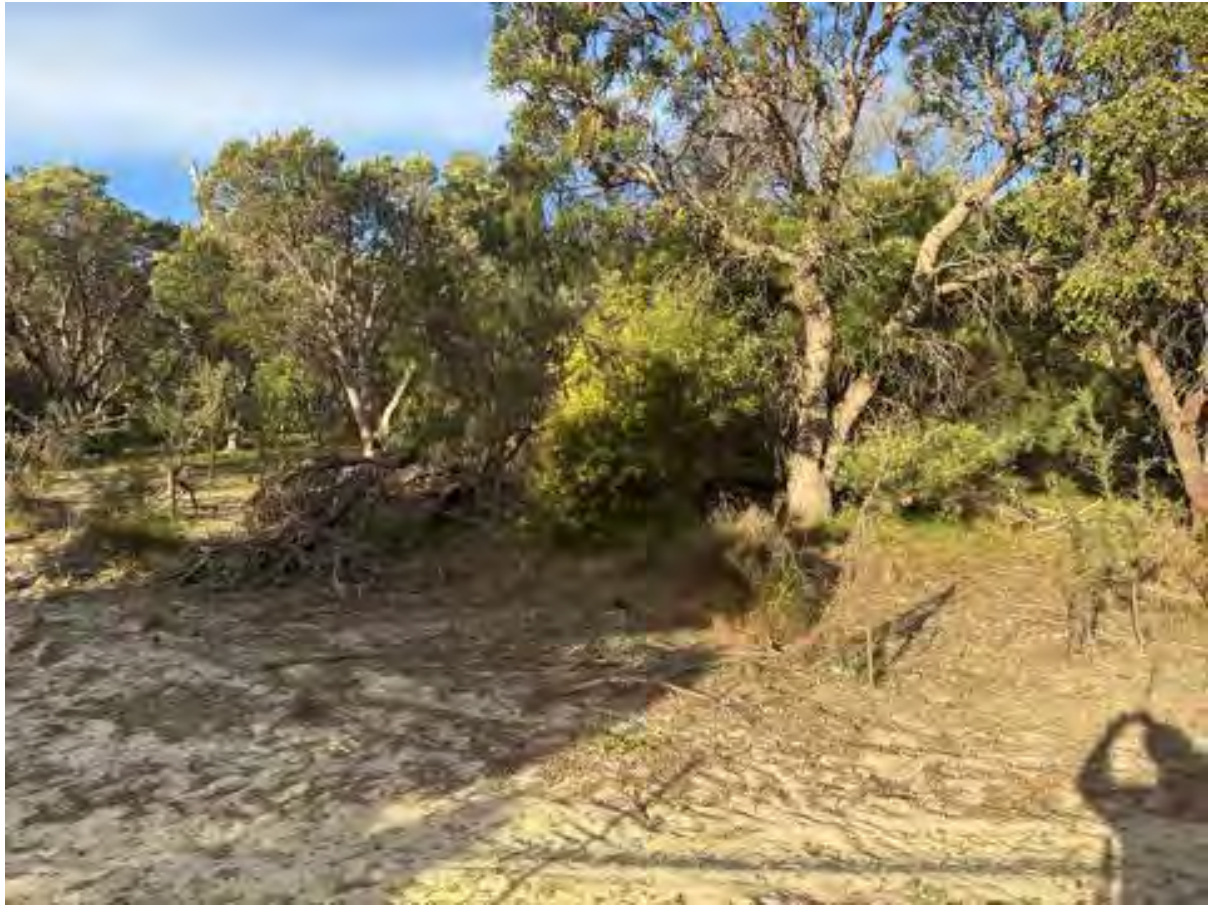
Plate 6. TW-S-PI-3\_P02 in a Degraded condition.

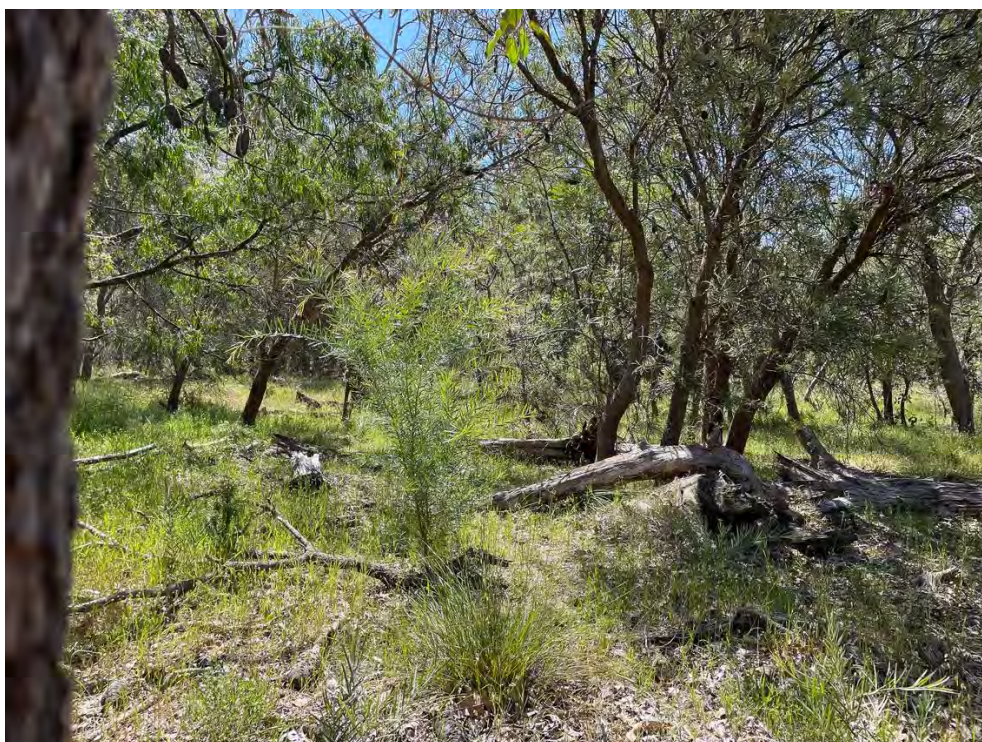
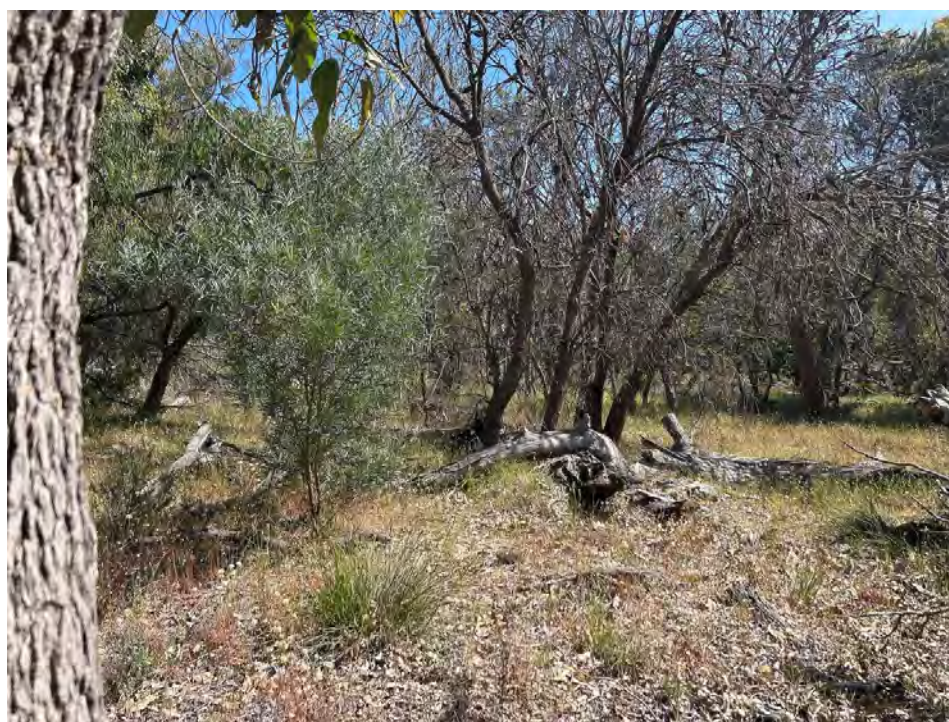
Plate 7. BW-S-PI-1\_P03 plant stress in spring 2024 compared to spring 2022.

The increases in BW-S-PI-1\_P03 and BW-S-PI-1\_T1W occurred as a result of the impacts of the summer autumn 23/24 drought, with almost all *Banksia attenuata* and *B. grandis* saplings dead. *Corymbia calophylla* and *Xylomelum occidentale* trees were also very stressed. The stress at both these sites was observed to increase in 2025 and then stabilised in 2026, with trees manifesting about a 50% canopy cover. These impacts were also observed to be scattered throughout the surrounding vegetation. The effects of stress at BW-S-PI-1\_P03 are shown in **Plate 7**. The recent increase in stress observed in autumn 2026 at BW-S-PI-1\_P05 was due to a localised decline in health in *Banksia attenuata*. This increase in stress is unlikely to be attributed to the BORR, as the impact was observed to be localised, with no clear or consistent pattern of stress that could directly link it to the BORR. For example, both BW-S-PI-1\_P01 and BW-S-PI-1\_P02, which are an equal distance, approximately 40 m, from the BORR, as BW-S-PI-1\_P05 had a stable stress pattern. **Plate 8** shows the area adjacent to BW-S-PI-1\_P05 being largely undisturbed and free of weeds.

Spring 2022

Spring 2024

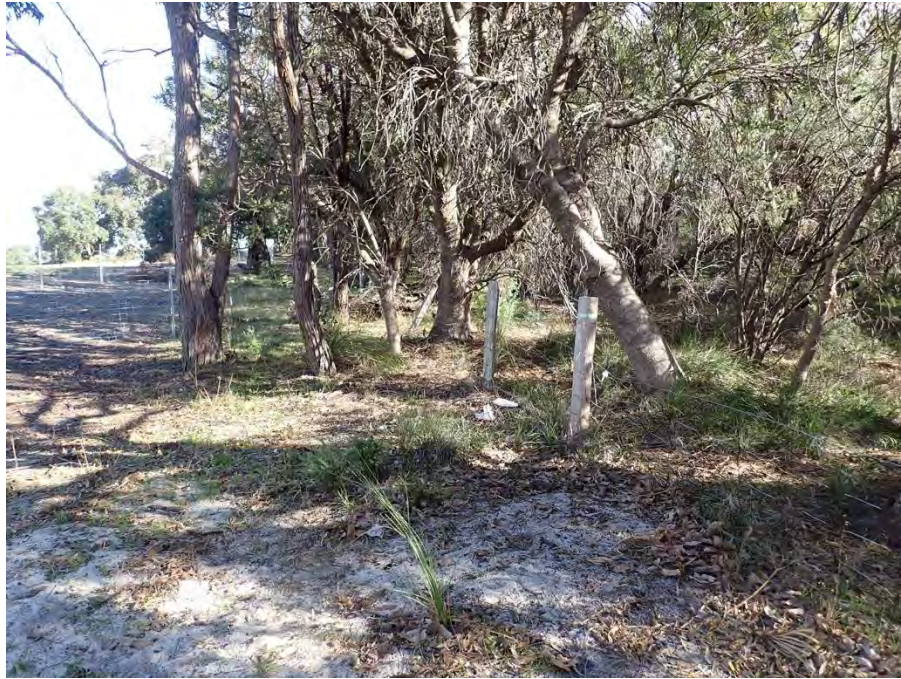
Plate 8. Photo showing the area adjacent to BORR and BW-S-PI-1\_P1\_P05, undisturbed and free of weeds.

There are no project attributable indirect impacts and therefore no reportable declines associated with the potential impact site BW-S-PI-1. The increases in stress at two monitoring points are attributable to the impacts of autumn summer 23/24 drought conditions, and the recent increases at BW-S-PI-1\_P05 are due to local factors, unlikely to be related to the BORR.

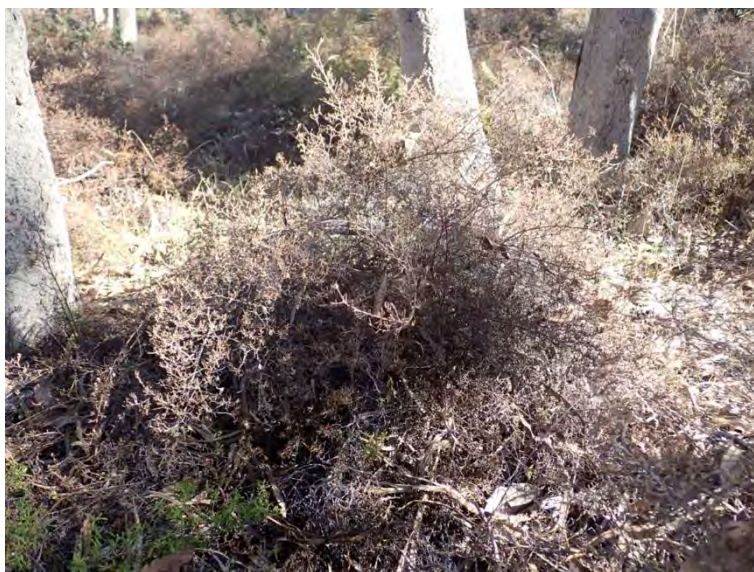
The stress at BW-S-PI-5\_P34 recorded in autumn 2024 was due to the severe drought in 23/24. The apparent absence of stress in the balance of the site did not mean that it was without stress, with the observed residual impacts of the severe 23/24 drought still evident in 2026 with scattered, or patchy impacts across most of the site (**Plate 9** and **Plate 10**). The impact observed at the monitoring points and across the broader site was and is still limited mainly to certain species, such as *Banksia grandis*, *Banksia attenuata*, *Eucalyptus marginata*

(mostly saplings), the small shrub *Hibbertia hypericoides* and the forb *Caesia micrantha* (**Plate 9** and **Plate 10**).

Plate 9. Drought affected *Hibbertia hypericoides* near BW-S-PI-5\_P23 in autumn 2024.

It is believed the BORR is not a cause of the increase in stress at BW-S-PI-5\_P34 and BW-S-PI-5\_TN1 or the other scattered impacts not monitored. This is because there is no clear pattern of stress that would link the cause to the BORR, as much of the vegetation directly adjacent to the BORR is observed to be in a generally healthy condition **Plate 11** and **Plate 12**. Results are provided in **Figure 31**. **Plate 13** and **Plate 14** shows a healthy understorey and canopy vegetation and low weed revegetation near BW-S-PI-5\_P18, autumn 2026.

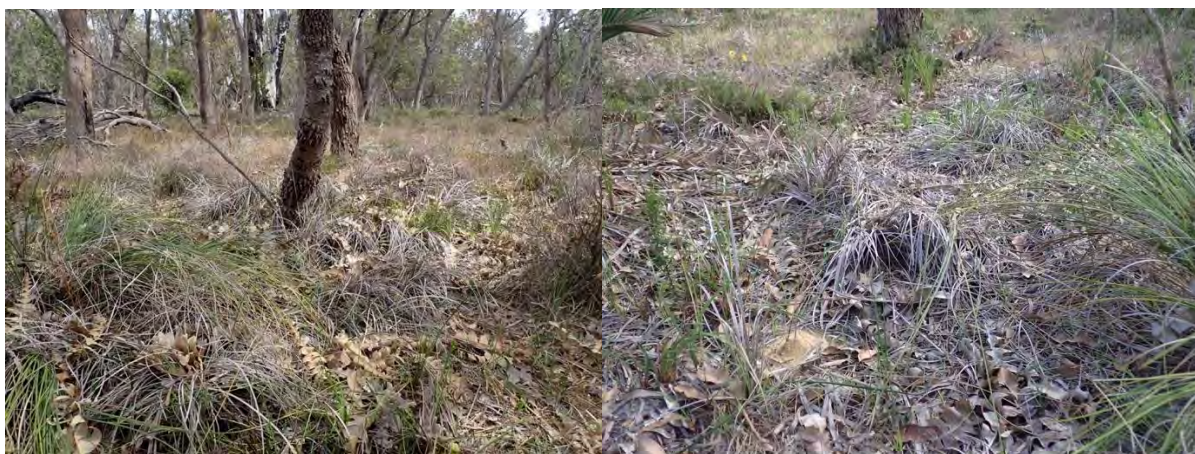
Plate 10. Drought affected *Phlebocarya ciliata* located near BW-S-PI-5\_P33, autumn 25 and autumn 26

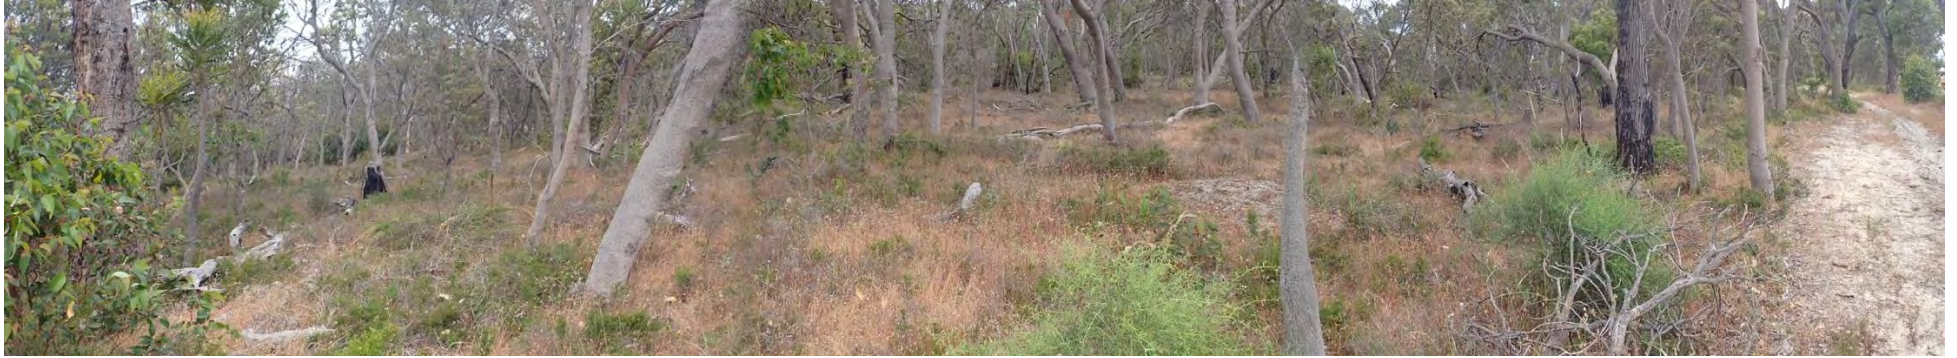
Plate 11. The grey shrubs in the understory are stressed *Hibbertia hypericoides* near BW-S-PI-5\_P16, autumn 2025.

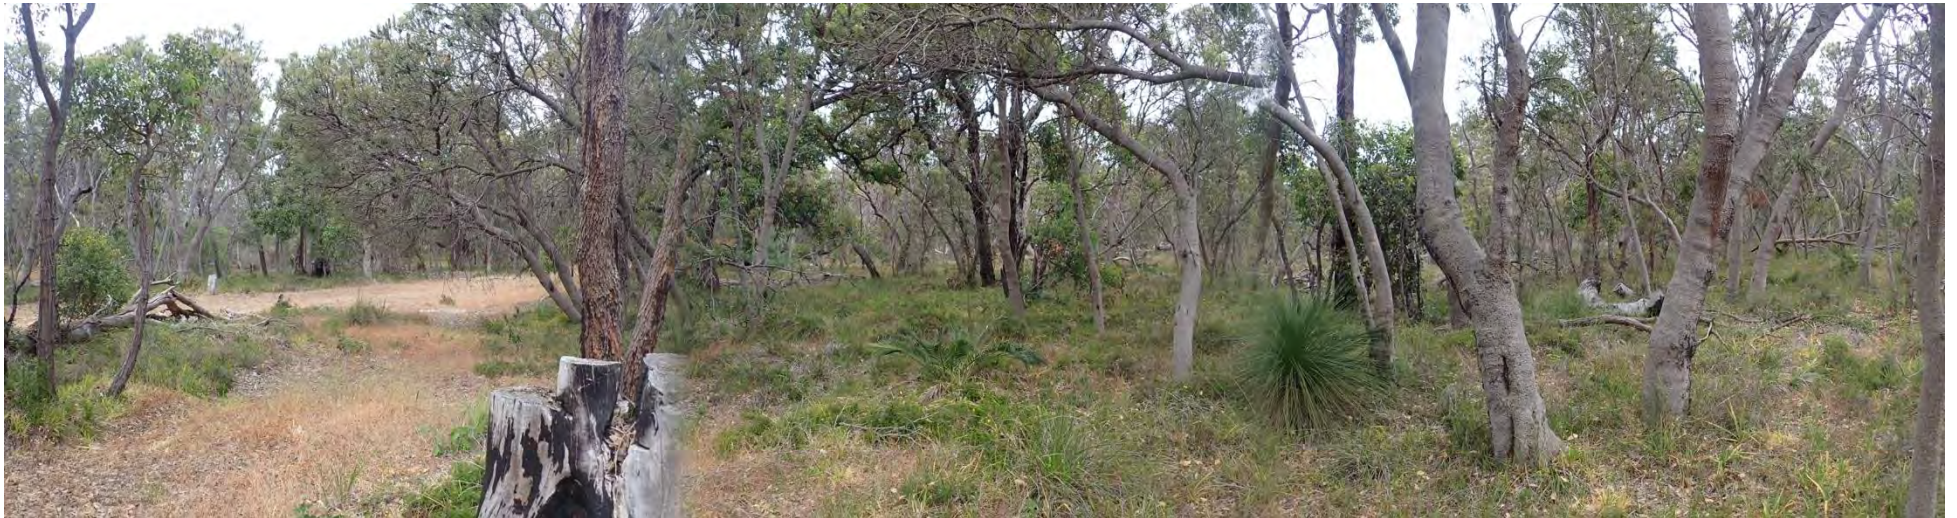
Plate 12. Shows an essentially healthy understory, including *Hibbertia hypericoides*, near BW-S-PI-5\_P25, autumn 2025.

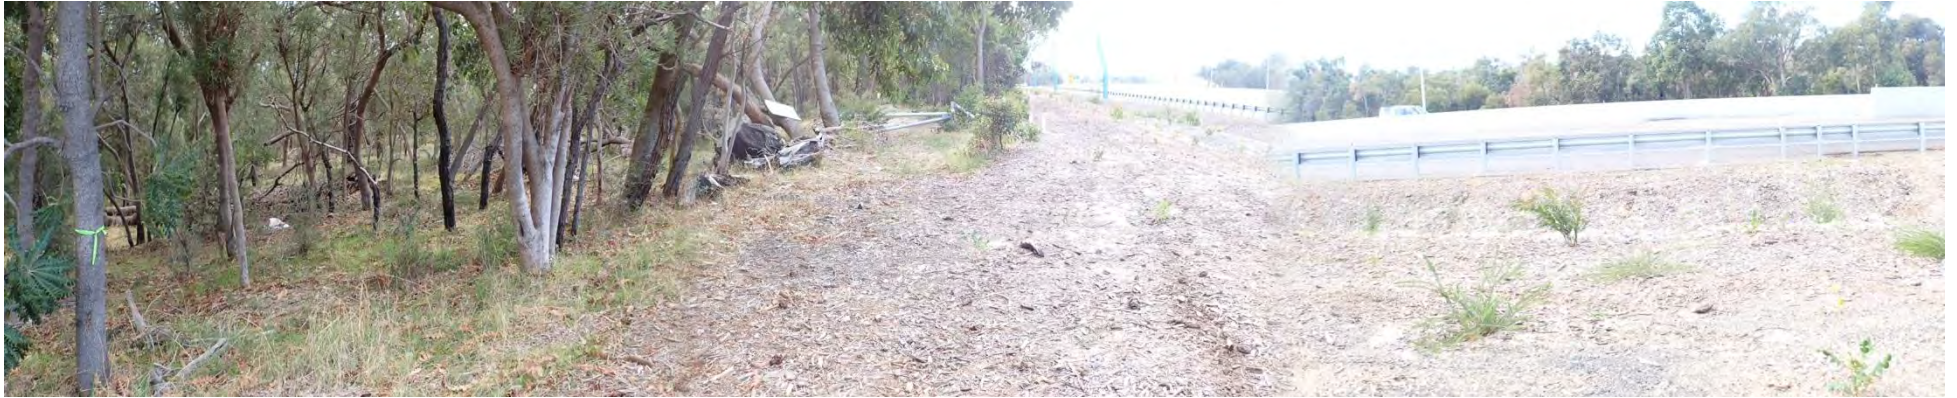
Plate 13. Shows a healthy understorey and canopy vegetation and low weed revegetation near BW-S-PI-5\_P18, autumn 2026.

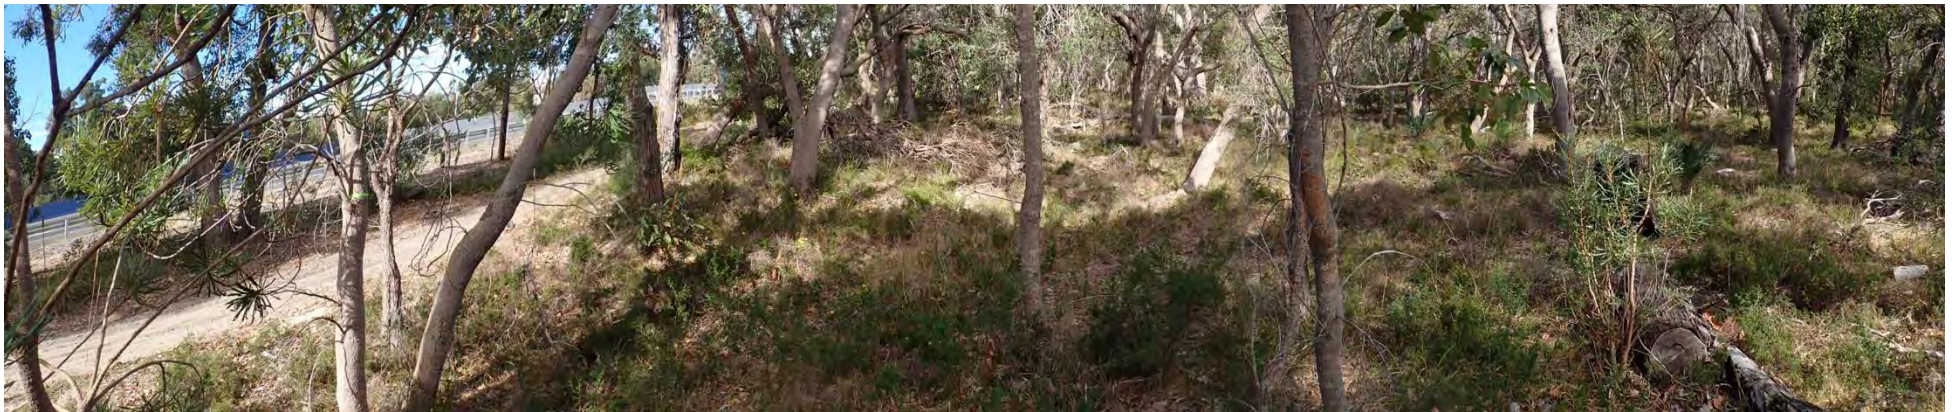
Plate 14. Shows a healthy understorey and canopy vegetation near BW-S-PI-5\_P18, autumn 2026.

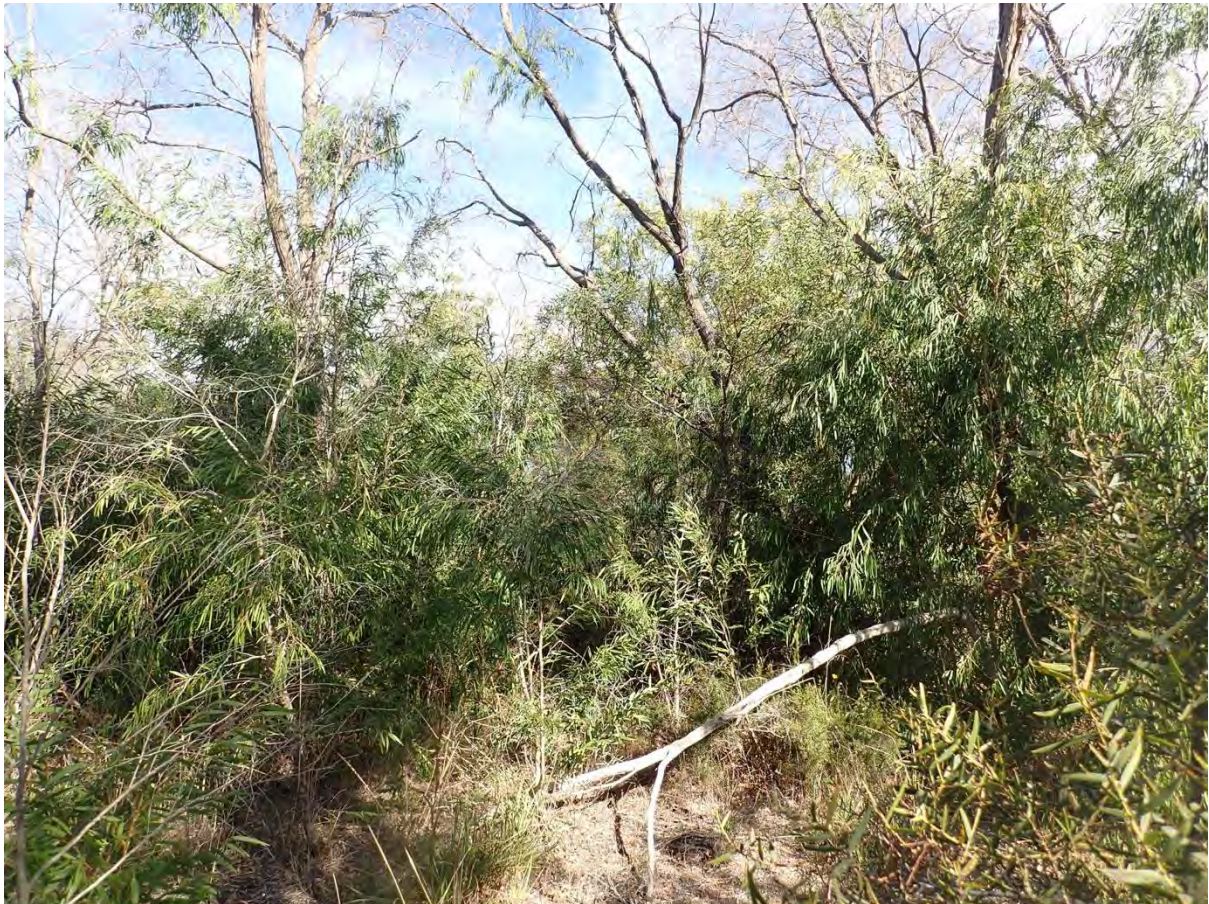
Plate 15. Recovering *Agonis flexuosa* trees and some young saplings near BW-S-PI-8\_P07

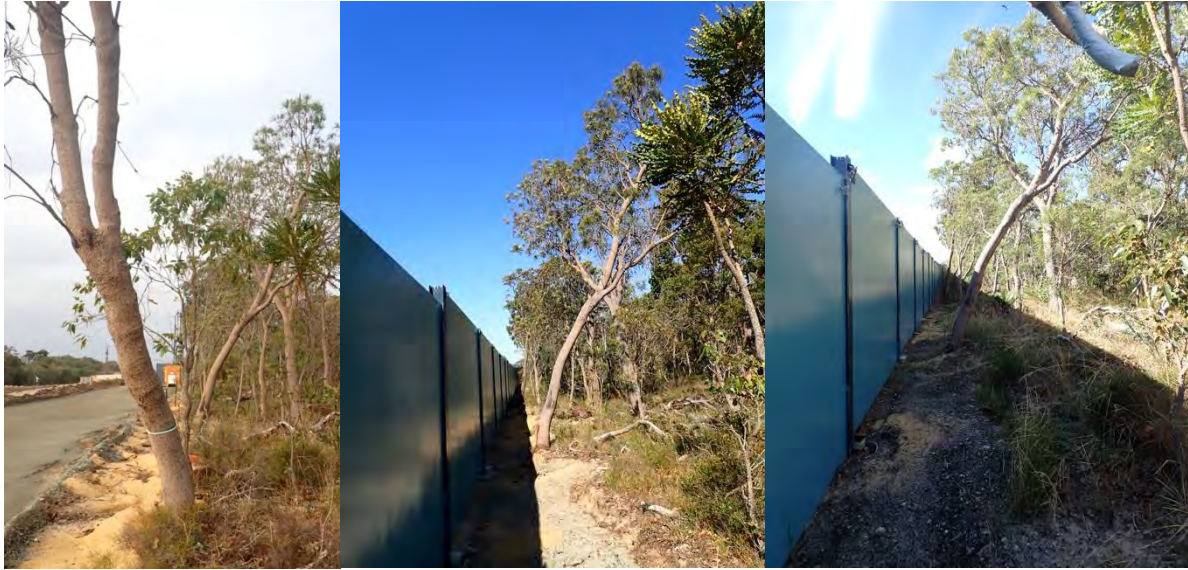
jarrah trees on the site. The 2023 report considered it unlikely that the stress was project-related because increases in stress independent of the clearing activities were commonly observed in Jarrah and Marri trees in intact vegetation, such as that evidenced at transect BW-S-R\_T1E and the drainage monitoring points BW-S-PI-3\_D1 (w20), BW-S-PI-5\_D1 (w20) and BW-S-R-1\_D1(w20) refer to **Table 17**. No further increases in stress have been recorded for this point **Plate 16**.

Plate 16. BW-S-PI-8\_P01 autumn 24 and spring 24. Note that the Banksia in the foreground had to be removed for the installation of the sound wall.

Project attributable indirect impacts and or reportable decline: There are no project attributable indirect impacts and therefore no reportable declines associated with the potential impact site BW-S-PI-8. There were no new impacts of stress observed during the 25/26 monitoring round and all previously reported increases in stress are attributed to the record-breaking 23/24 drought and not to BORR-related activities, as there is no clear pattern of stress at the site that would indicate it was the cause.

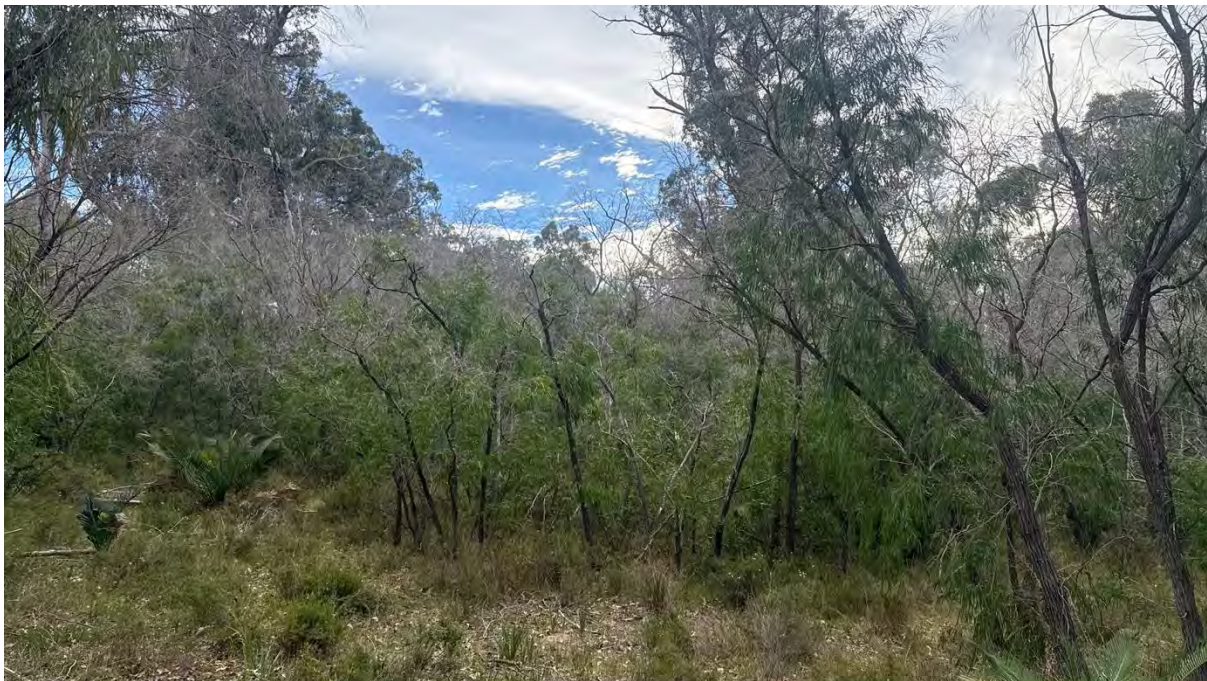
Like BW-S-PI-8, TW-S-PI-2 (**Figure 34**) experienced severe drought impacts to parts of its vegetation following the record breaking 23/24 drought and like BW-S-PI-8, there was concern that the impacts of the drought reported in the two previous monitoring rounds, Ecoedge (2024) and Ecoedge (2025), would continue and result in worsening impacts at the site. However, the above-average rainfall that followed the 2024 drought and the average rainfall in 2025 appear to have had only a limited impact, with only one site, TW-S-PI-2\_P11, showing increased stress in the autumn 2026 monitoring round. By contrast, three sites, TW-S-PI-2\_P12, P13 and P16, recorded a decrease in stress. **Plate 17** shows evidence of recovering Peppermint trees (*Agonis flexuosa*) near TW-S-PI-2\_P16.

Plate 17. TW-S-PI-2\_P16 showing recovering *Agonis flexuosa*.

There are no project attributable indirect impacts and therefore no reportable declines associated with the potential impact site TW-S-PI-2. There were no significant increases in stress for this monitoring round, and all previous increases in stress at the site are attributable to the record drought (BOM 2024a and BOM 2024b), as discussed above.
